COMMON DEFECTS AND FAILURE MODES IN CEMENT PLASTER

Karim P. Allana, P.E., RRC

Symposium on Building Envelope Technology
Coral Springs Marriot at Herron Bay, Florida
November 14th & 15th 2002

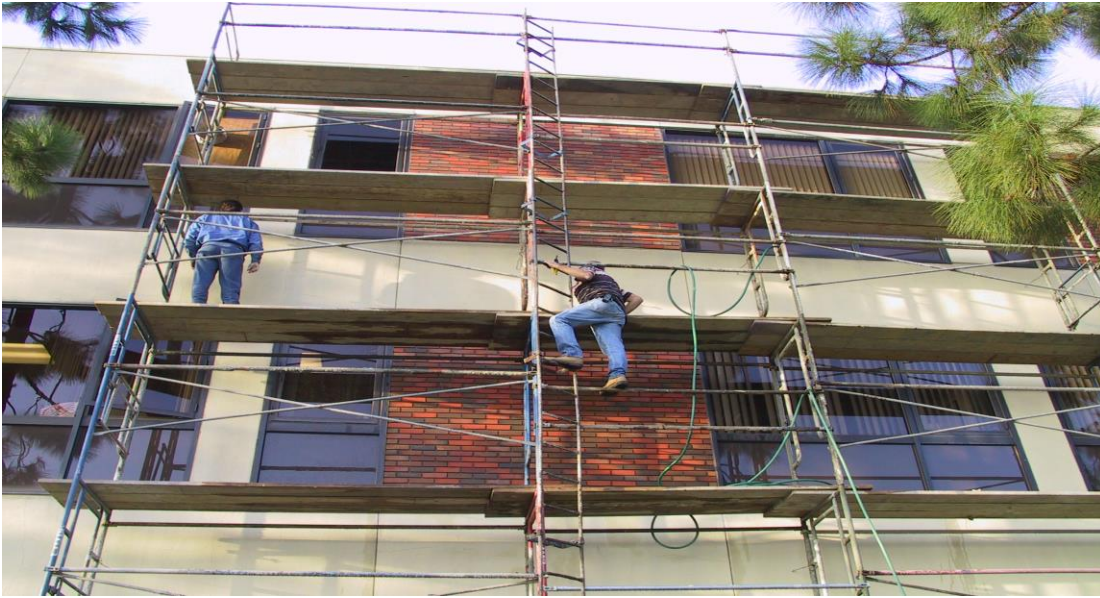
TOP: Water testing and destructive testing of the exterior wall was conducted on the south side of the building. The area selected for testing included, brick veneer, cement plaster and typical windows. **BOTTOM:** Water sprayed on third floor leaked through storefront head condition on 1st floor. Water intrusion through the exterior wall is traveling through 3 floors in the wall cavity.

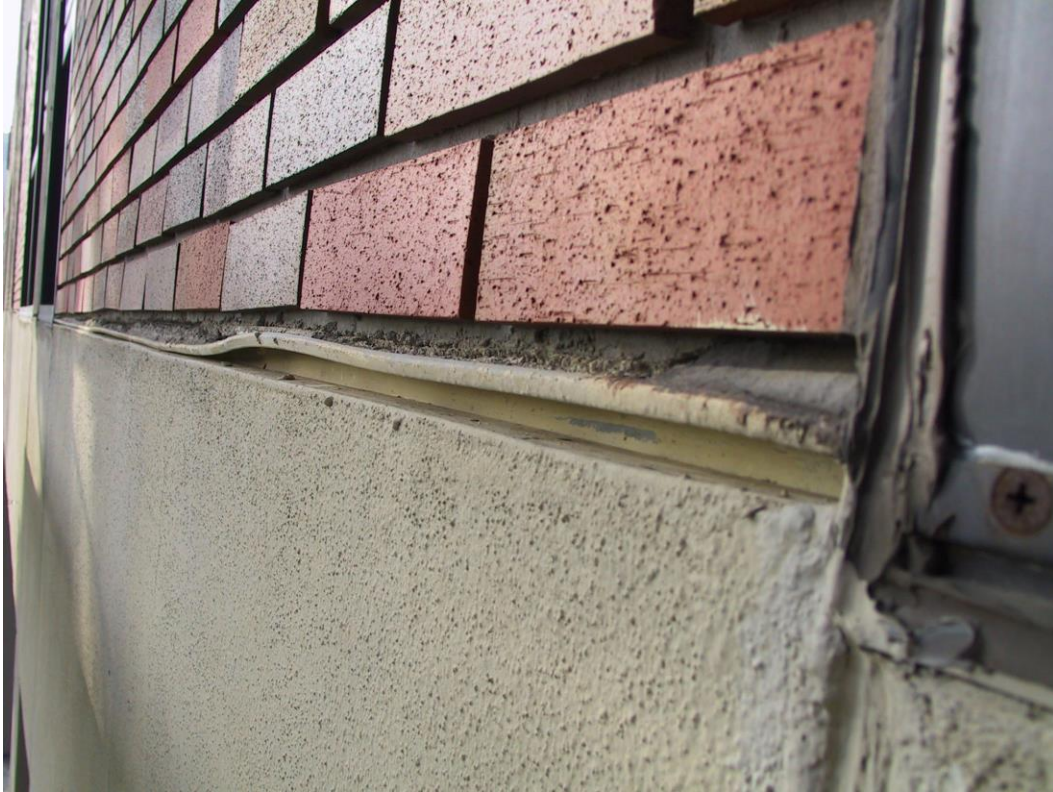
TOP: Stucco/Mortar expansion screeds are twisted and distorted due to movement

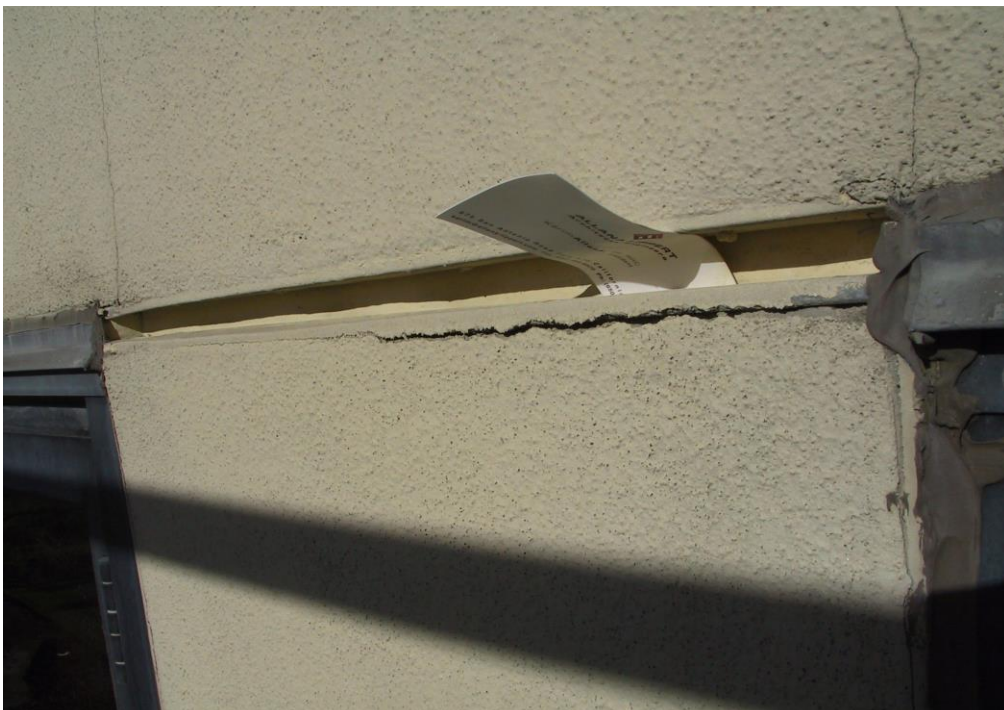
BOTTOM: Large cracks at expansion joint. Also, this type of expansion joint collects water and directs it at the sides causing water to leak down the sides.

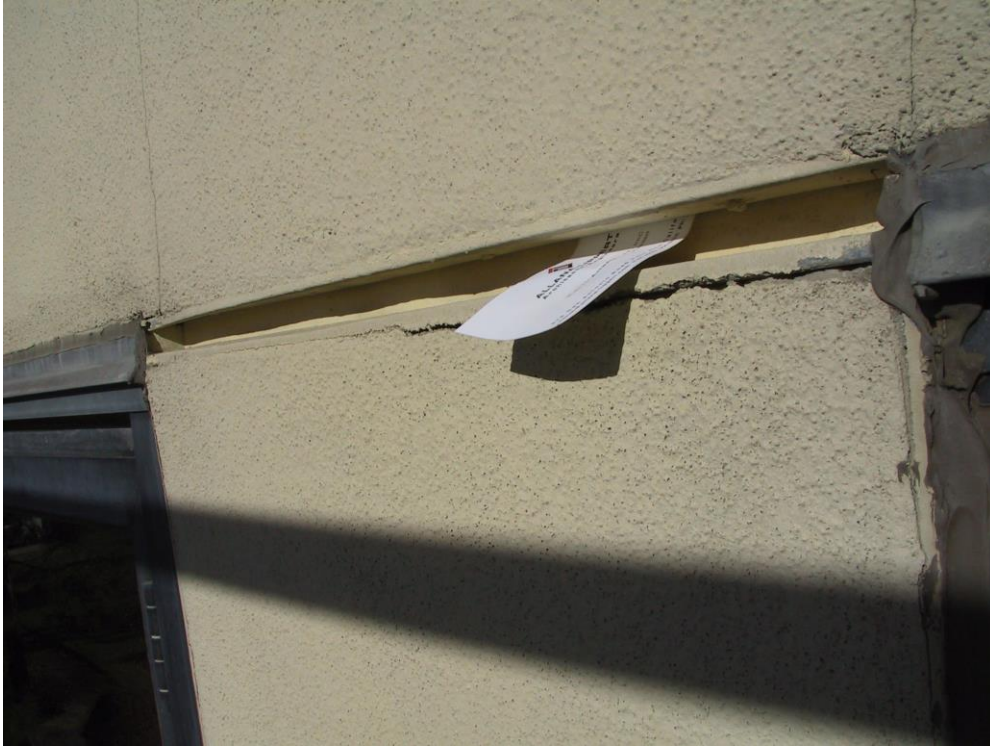
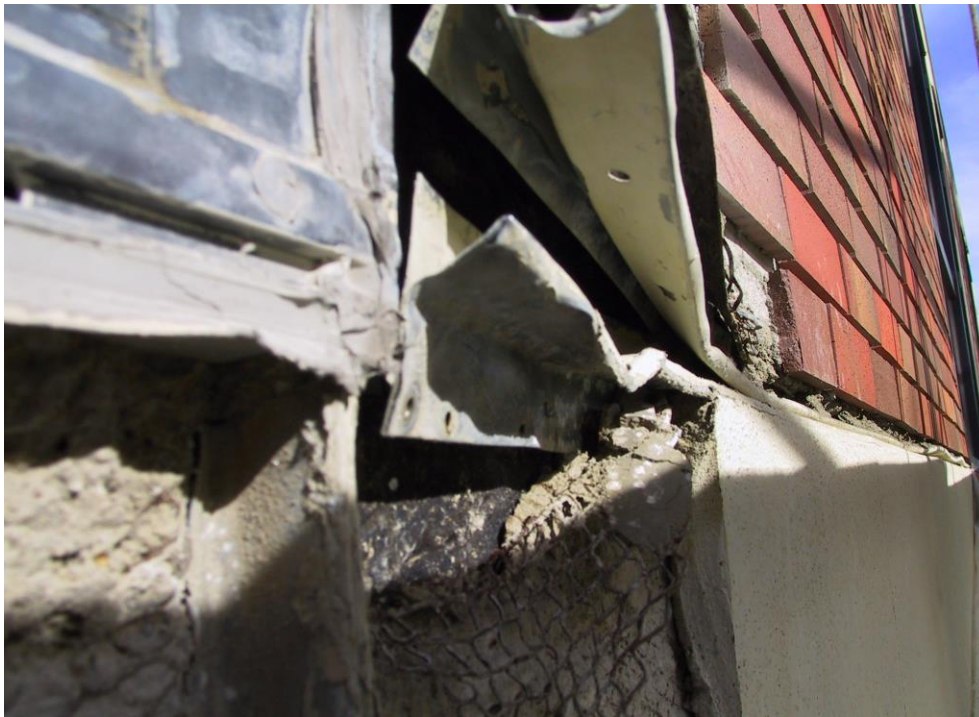
We also observed that the expansion reveal used for this project is a two-piece and the two pieces are overlapped incorrectly and the overlap is only 1/8". We also observed that the architect had detailed two horizontal metal studs 1" apart at the reveal joints so that the lath and expansion joint could be fastened properly. These horizontal studs were omitted in the actual construction. These main factors have combined to distort and damage the reveal and expansion joints and create large cracks in the stucco.

TOP: This 2 piece expansion joint has a very small overlap between the top and bottom piece. Wind driven rain can direct water behind the joint.
BOTTOM: Exploded view of the two-piece expansion screed.

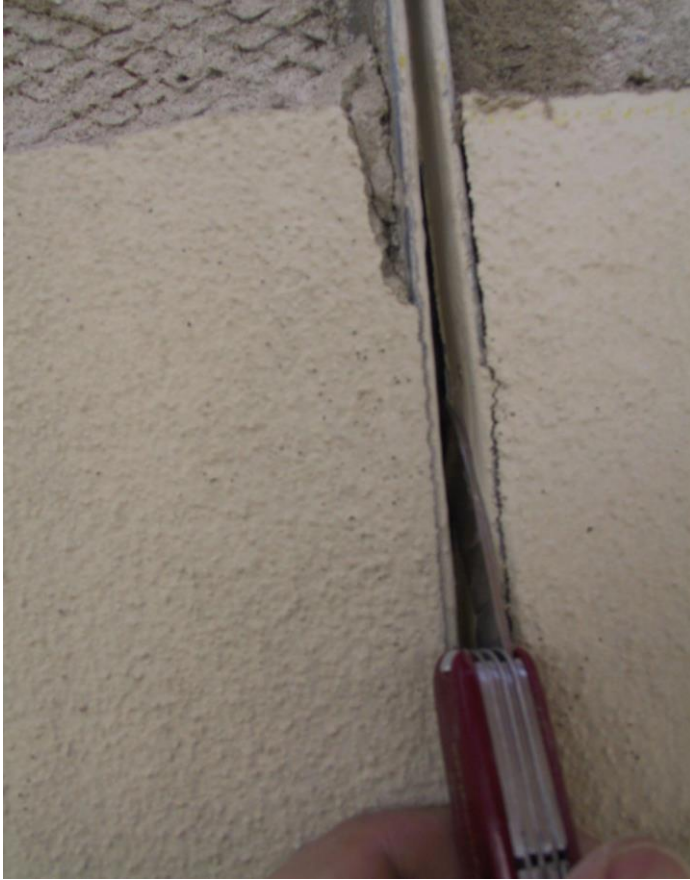
TOP: The vertical stucco expansion joint has split in fatigue, due to cyclical movement back and forth movement.

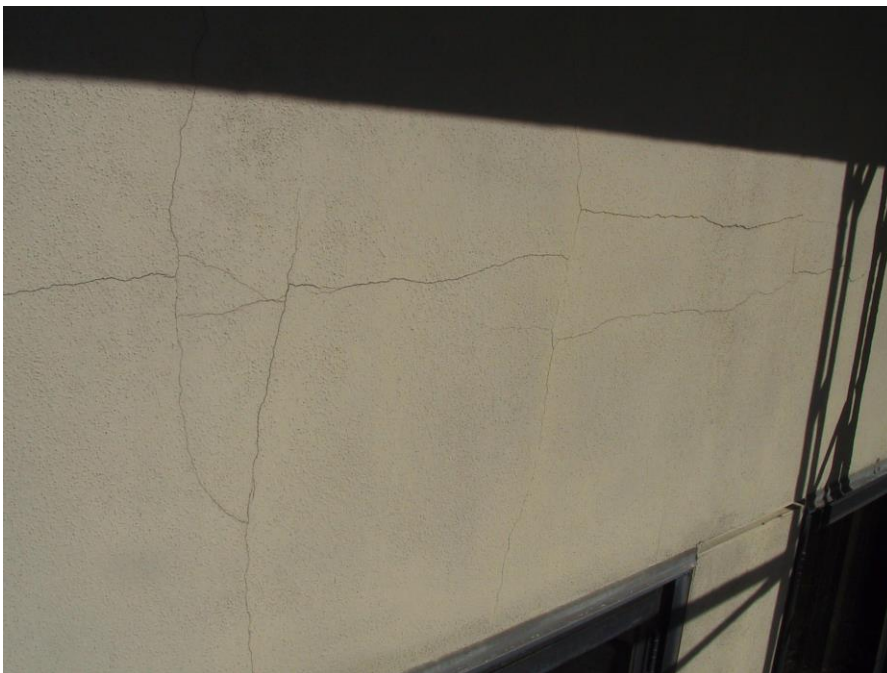
BOTTOM: Surface of the stucco is cracked throughout. Cracks range from 10 mils to 50 mils (over 1/4" thick). This level and type of cracking is not typical.

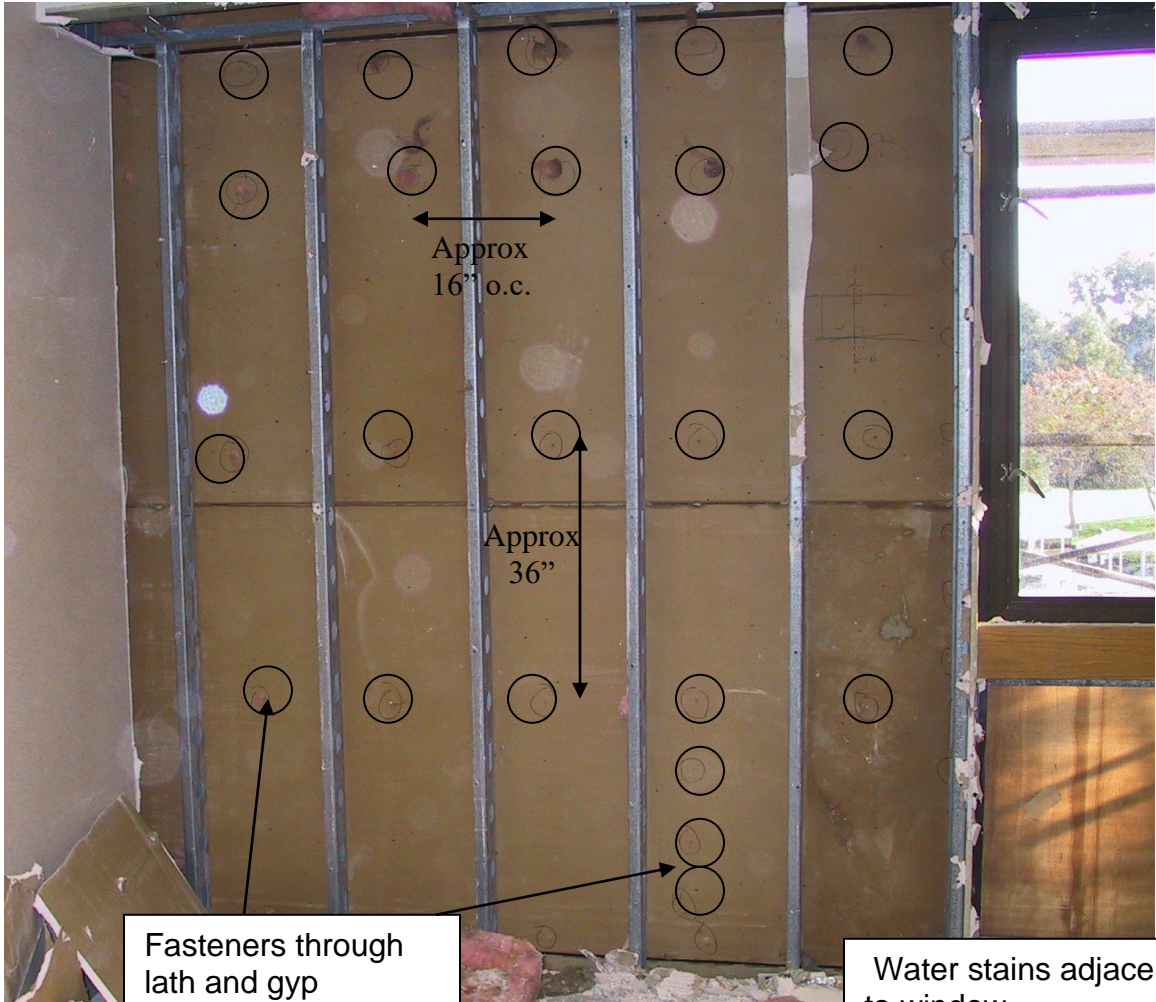
During intrusive testing it was observed and determined that the expanded metal lath for both stucco and mortar (for brick veneer) were very poorly attached to framing members. In most areas (more than 90%) the fasteners for the lath were only screwed through gypsum board sheathing and not the metal studs. The fasteners appeared to be installed horizontally 16" at head leaps in the lath; no fasteners were installed vertically on studs. Industry standard practice requires fasteners vertically on studs 6" on center, for studs that are 16" on center. This lack of proper fastening had allowed excessive movement of the stucco and mortar and subsequently had distorted and bent the horizontal and vertical expansion joints and has resulted in very wide cracks in the stucco. Mainly the movement in the exterior skin appeared to be occurring due to thermal changes. We observed that while the entire building is fastened poorly, the south and west exposures are in much worse condition than the north and east exposure due to the sun.

Fasteners through lath and gyp sheathing, typical

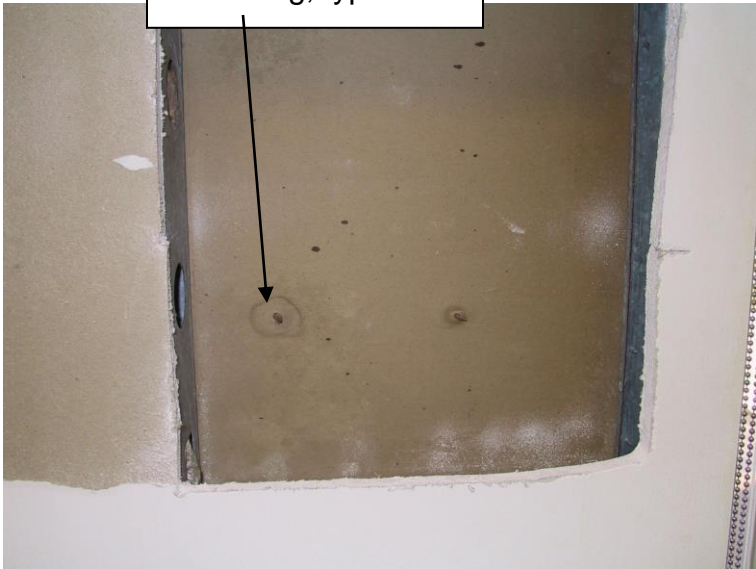
Water stains adjacent to window

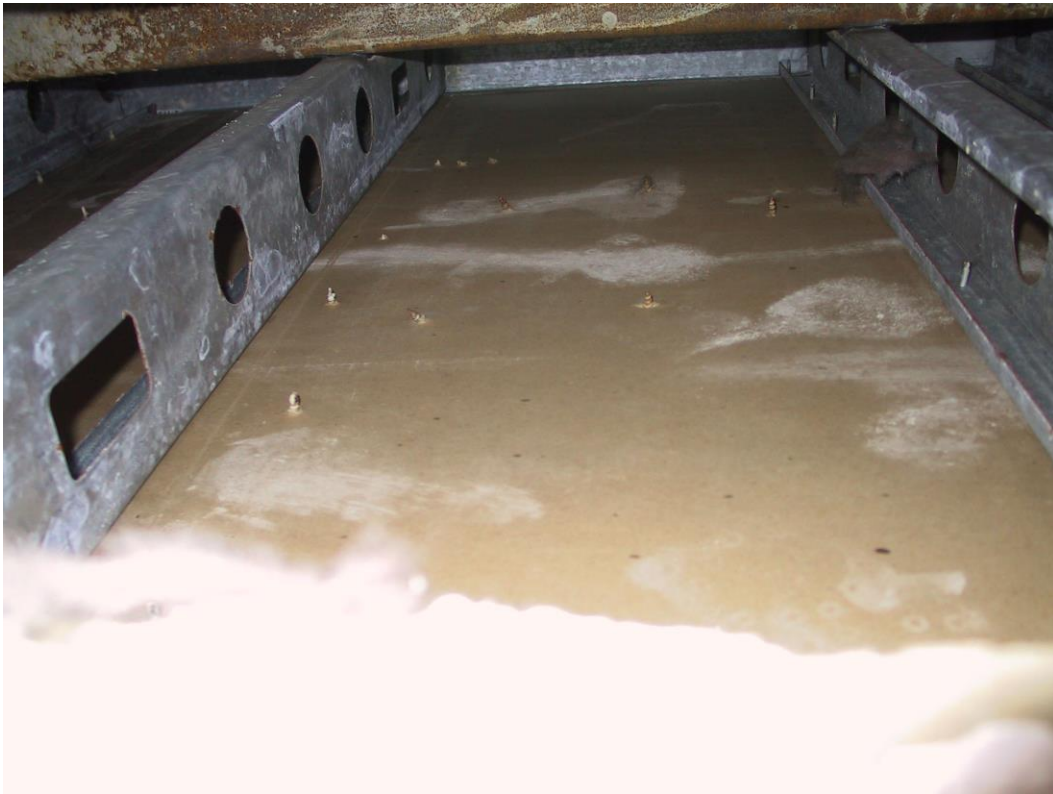
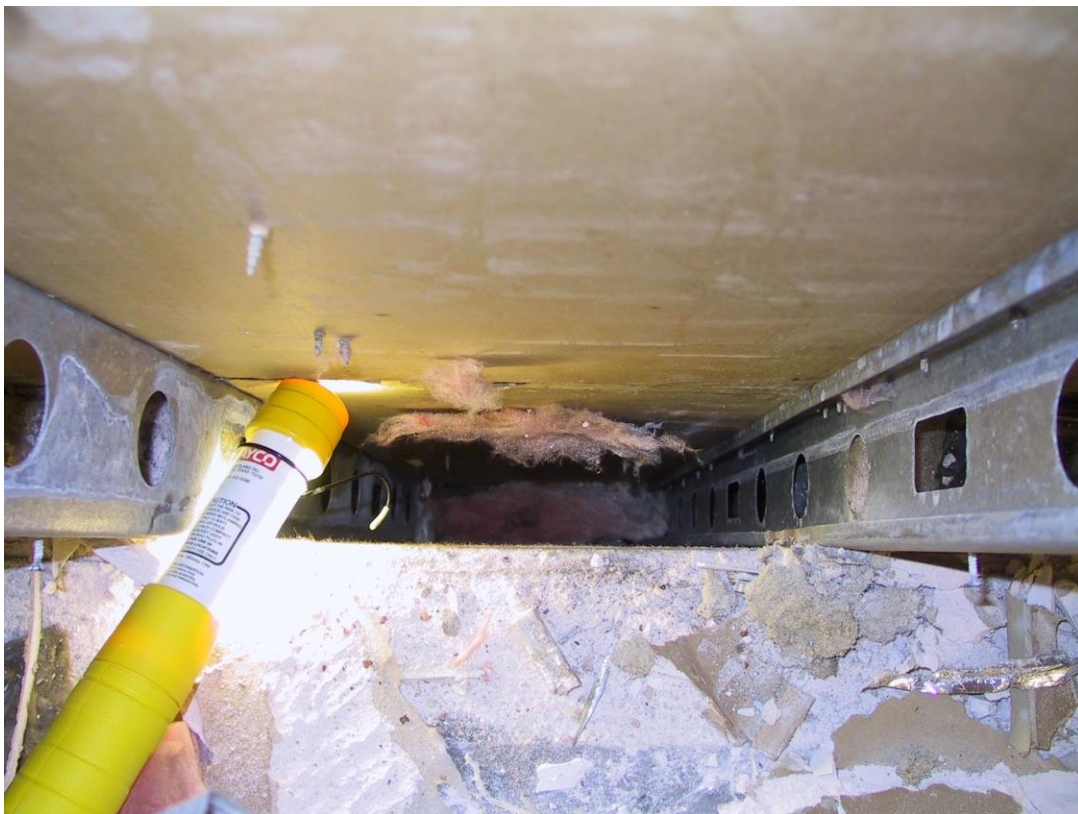
TOP & BOTTOM: Typical exterior wall framing, 18 gauge metal studs 16" on center, spot-welded to steel framing at each floor. Since the exterior wall framing is continuous from floor to floor, water can travel down the exterior wall cavity from 3rd to 1st floor.

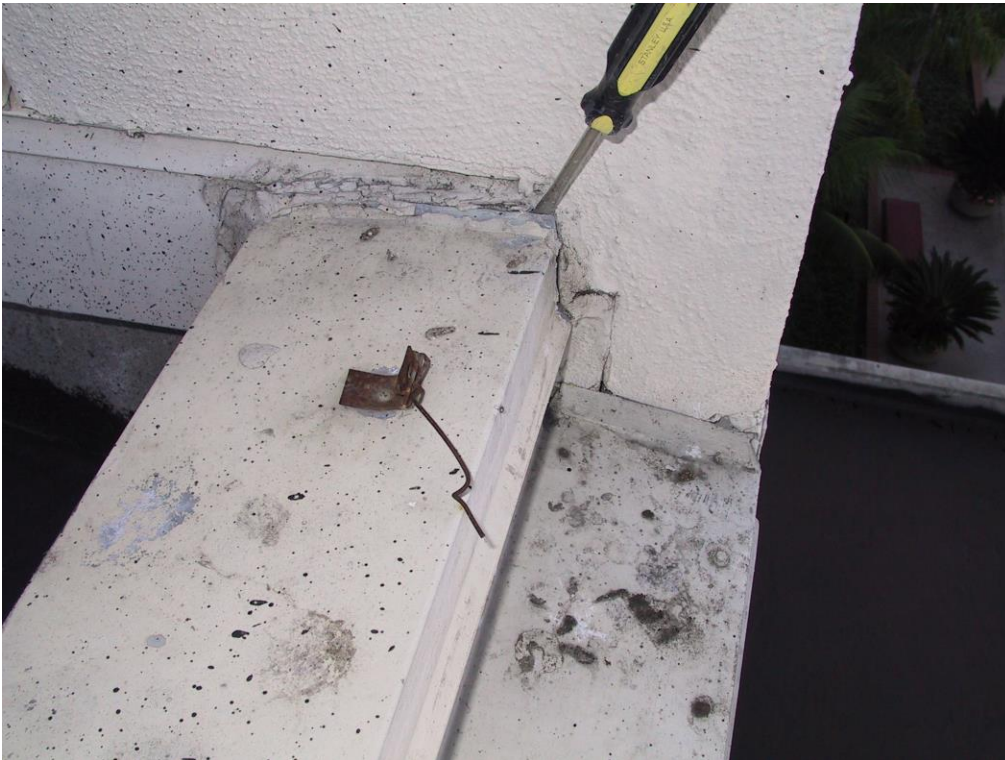
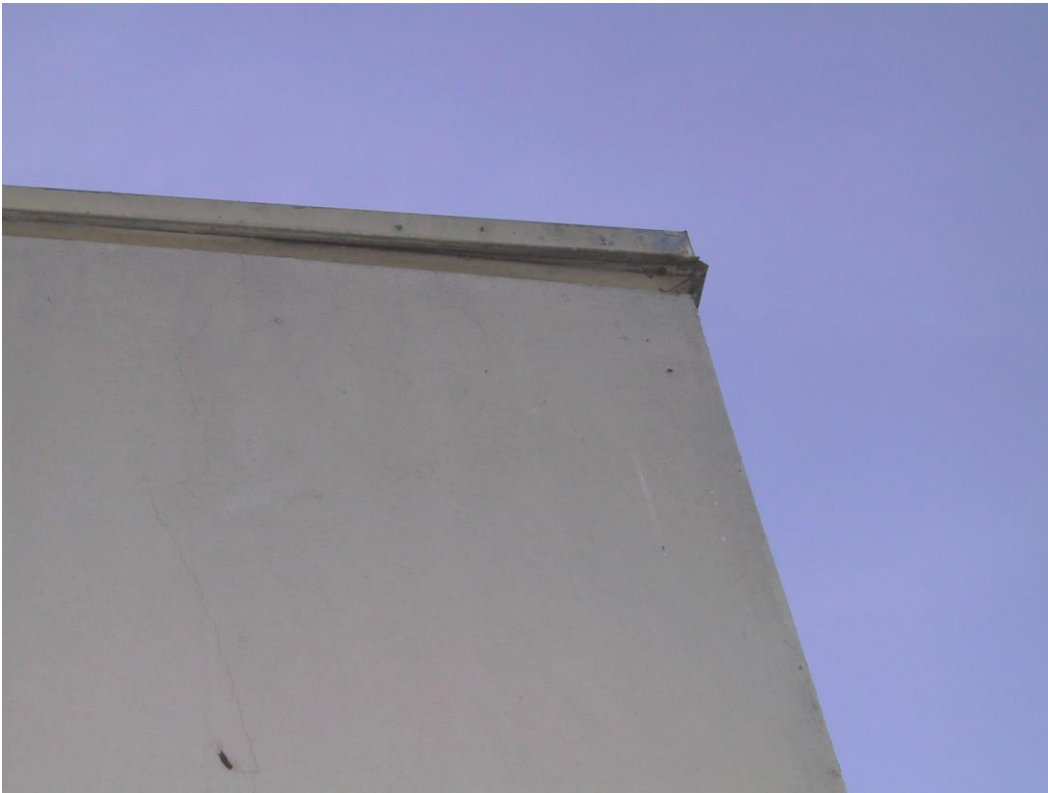
TOP: Roof parapet Coping to wall intersection has no saddle. This condition is leaking in room 314 below. **BELOW:** Edge condition at penthouse, sheet metal coping does not counterflash the stucco adequately.

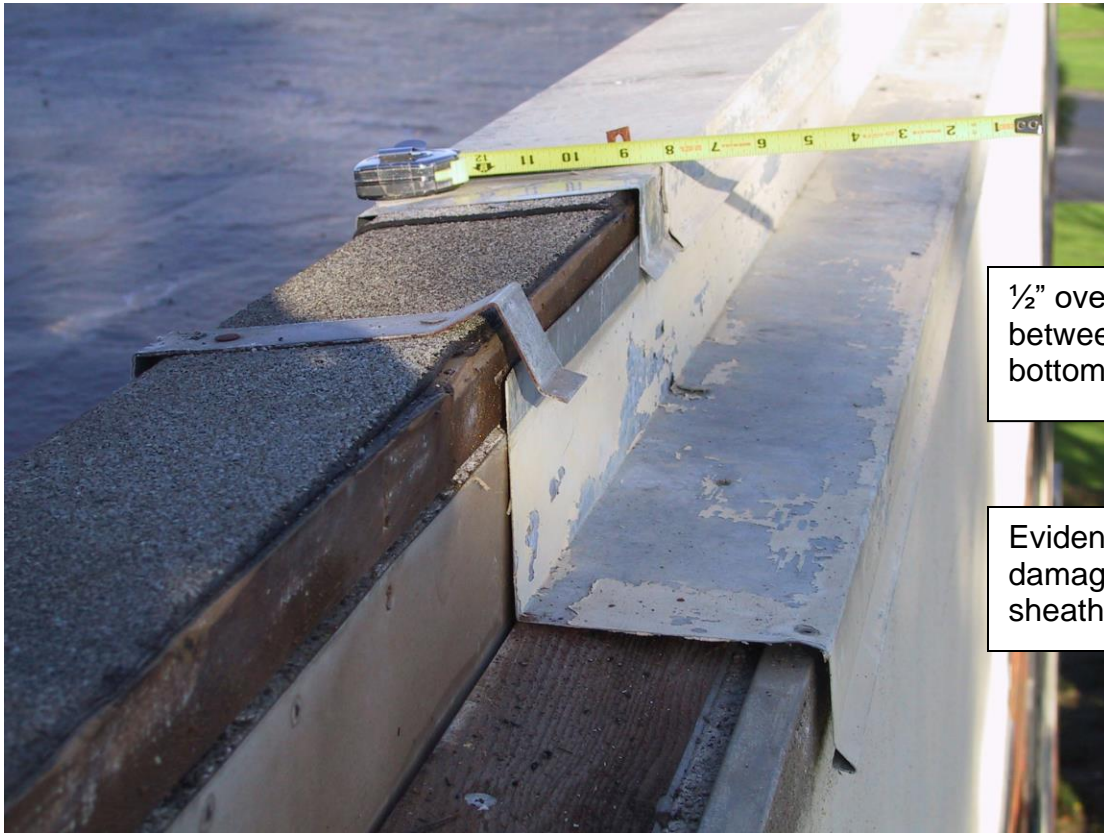
1/2" overlap between top and bottom pieces.

Evidence of water damaged gypsum sheathing

TOP: Configuration of typical metal coping at roof parapet wall. The overlap between the top and bottom piece is only 1/2", which is not adequate to prevent wind driven rain penetration. There is also no secondary protection under the sheet metal.

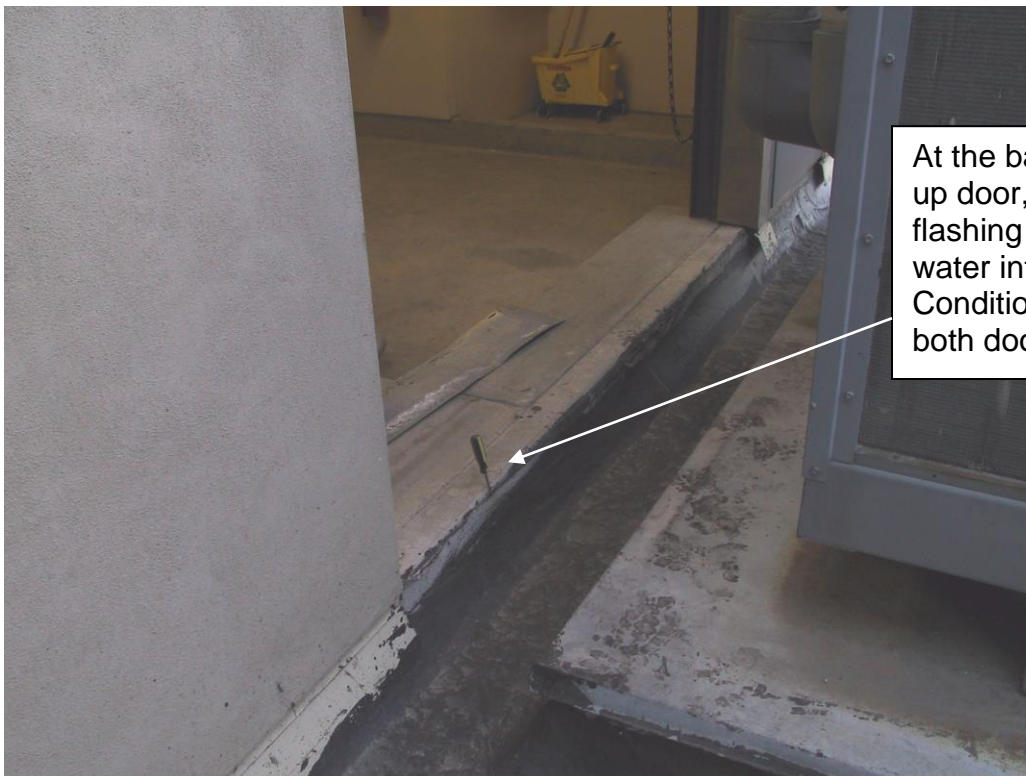
At the base of the roll up door, top of base flashing is open to water intrusion. Condition is typical of both doors.

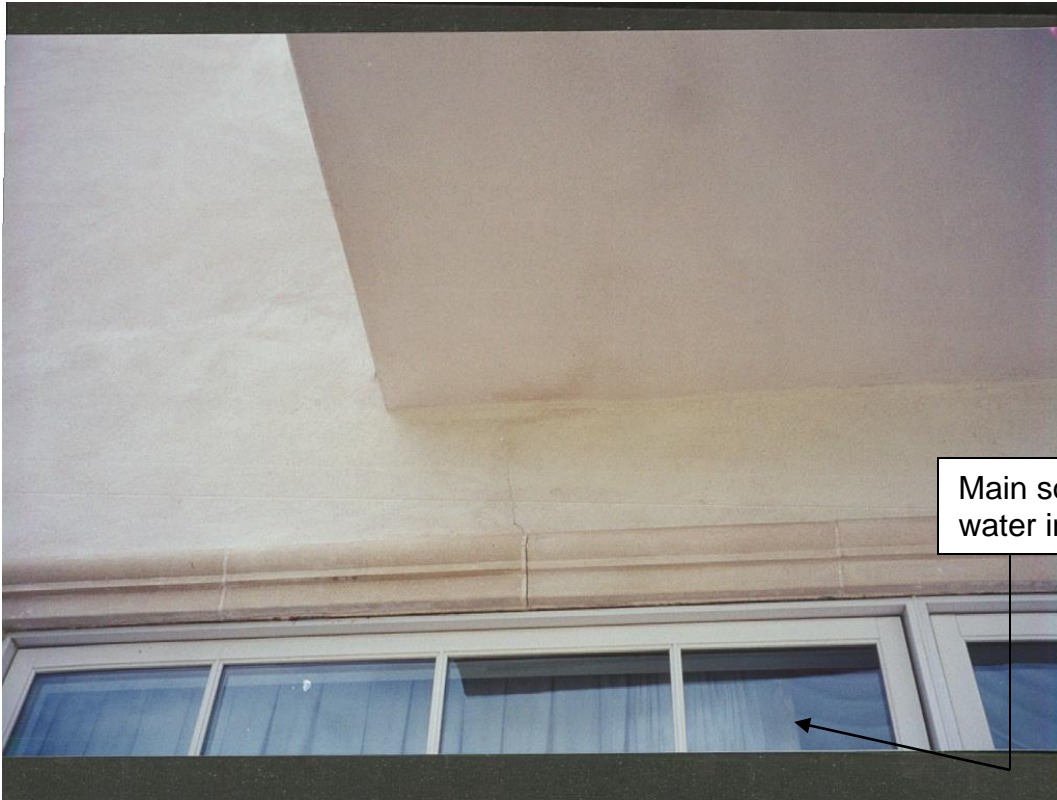
Main source for
water intrusion

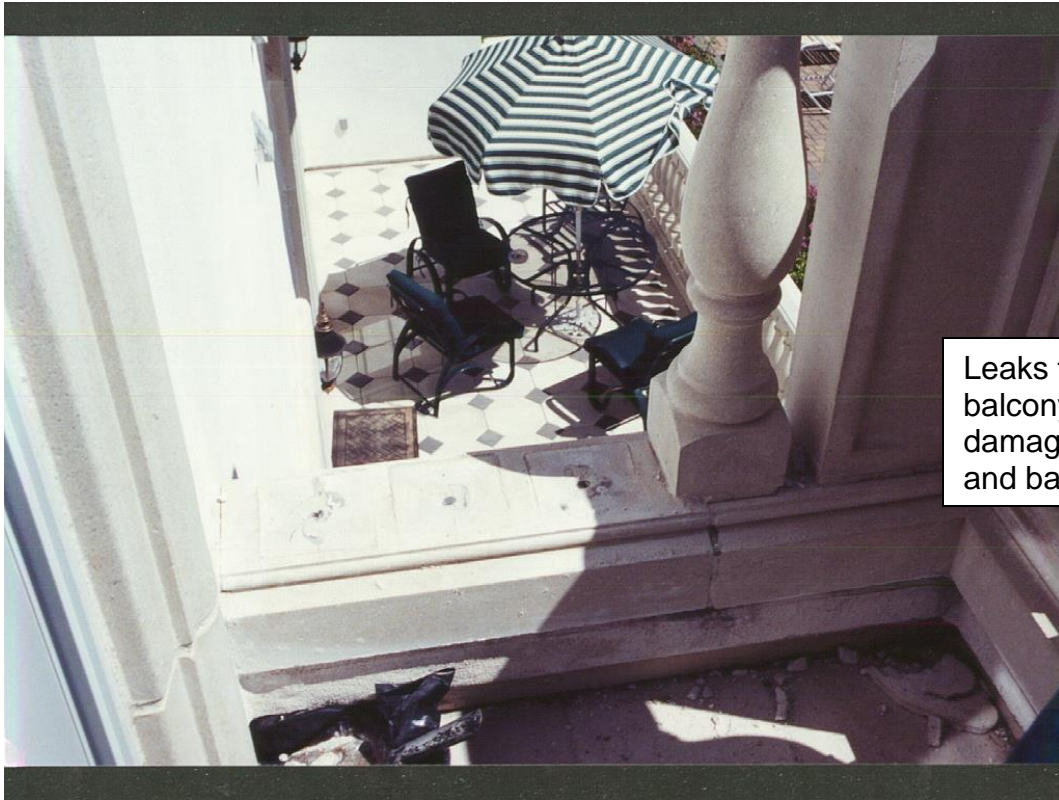
Leaks through balcony created damage to wall and balcony.

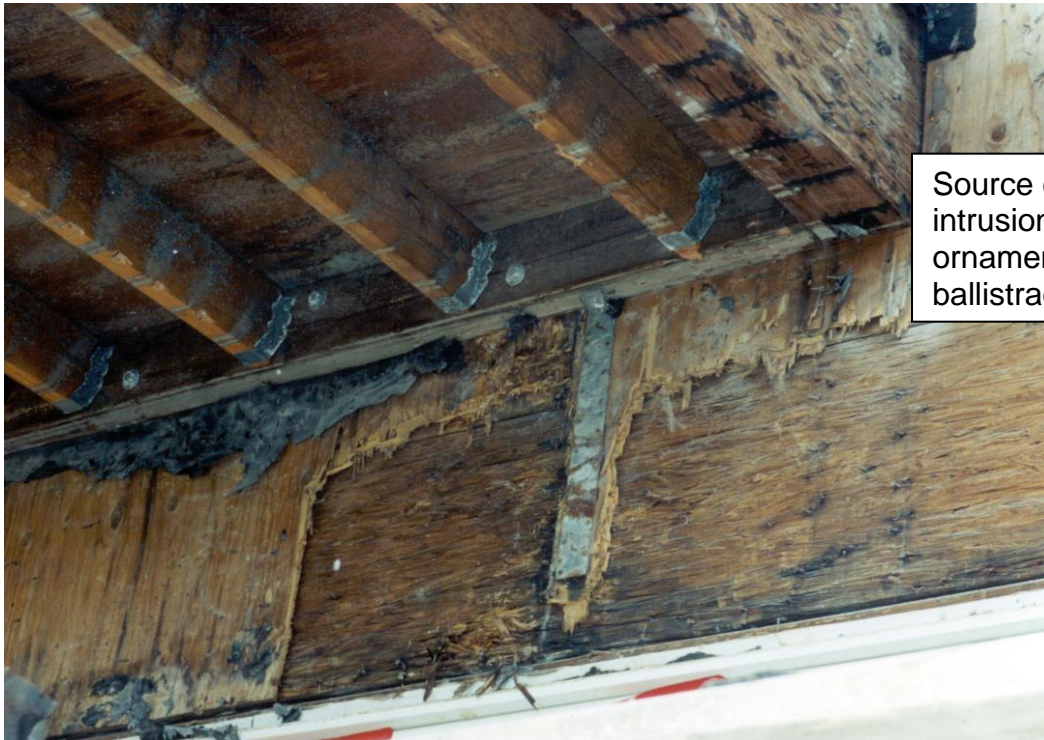
Ornamental ballustrades were improperly installed in many locations, especially the top of the balcony. Water seeped through the bottom of the ballustrades and created water damage to the balcony rail wall.

Source of water intrusion below ornamental ballustrades.

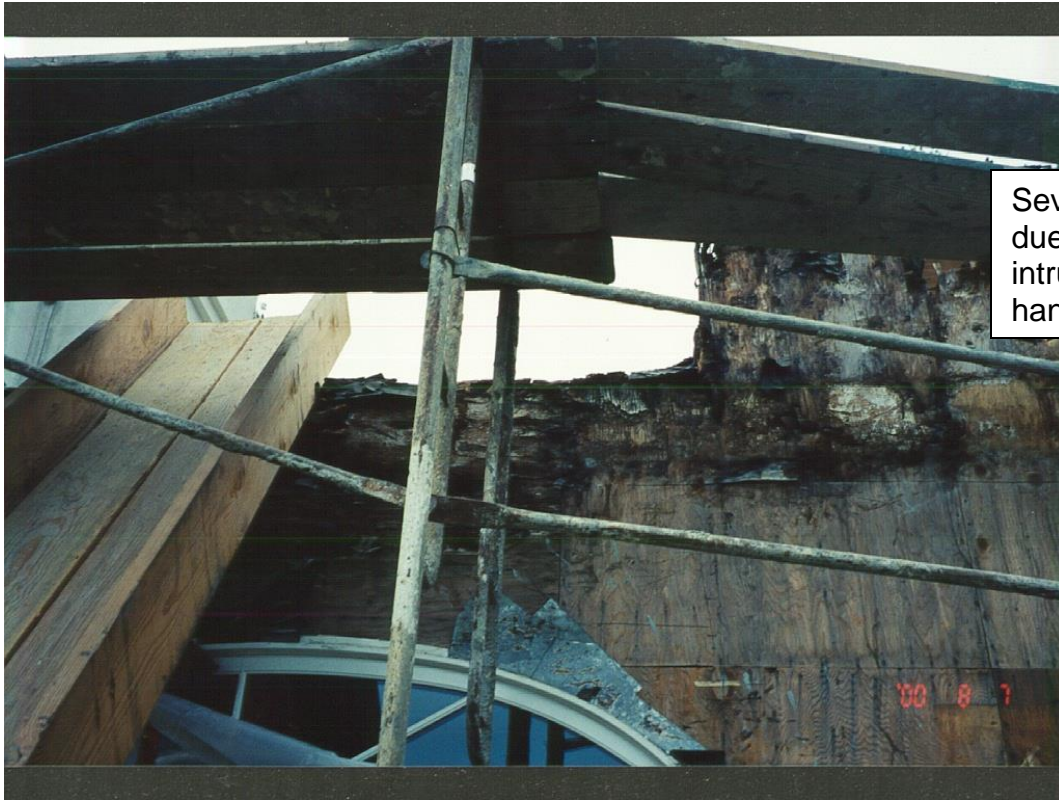
Severe damage due to water intrusion at top of hand rail wall.

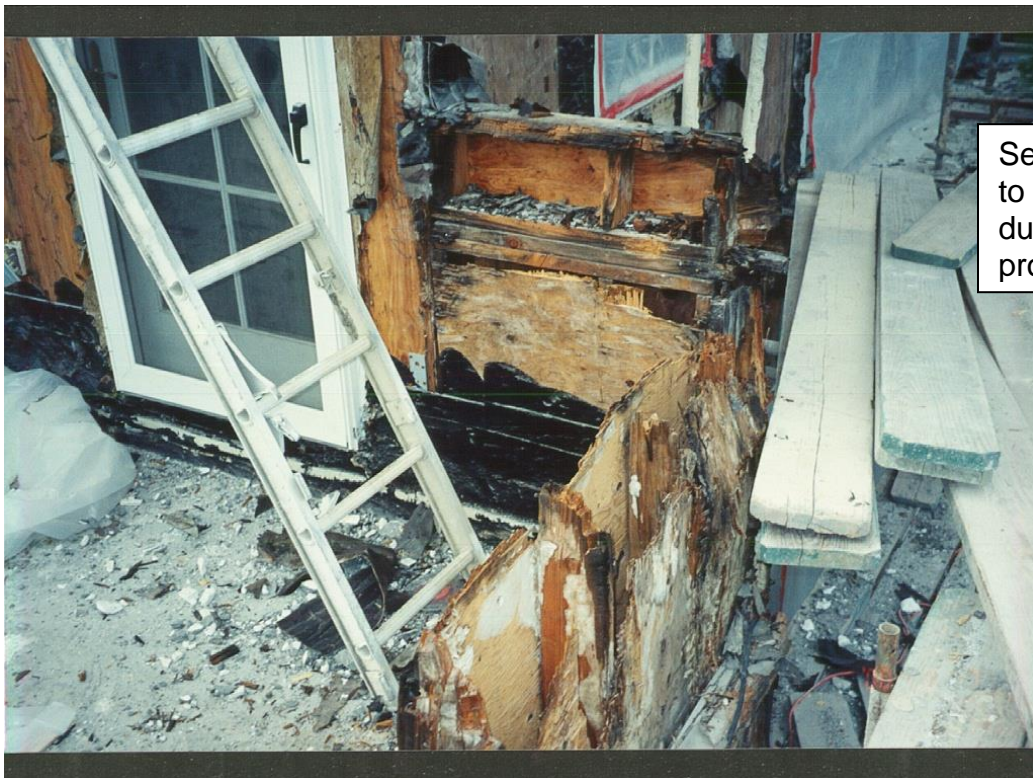
There was a lack of appropriate construction details at the top of the parapet wall surrounding the residence. Cap flashings and copings there and elsewhere were improperly installed. These conditions were also present at the chimney. This allowed water to get behind the CP at many locations and create significant damage to the plywood sheer wall and other wooden components of the building structure.

Severe damage to parapet walls due to lacking proper flashing.

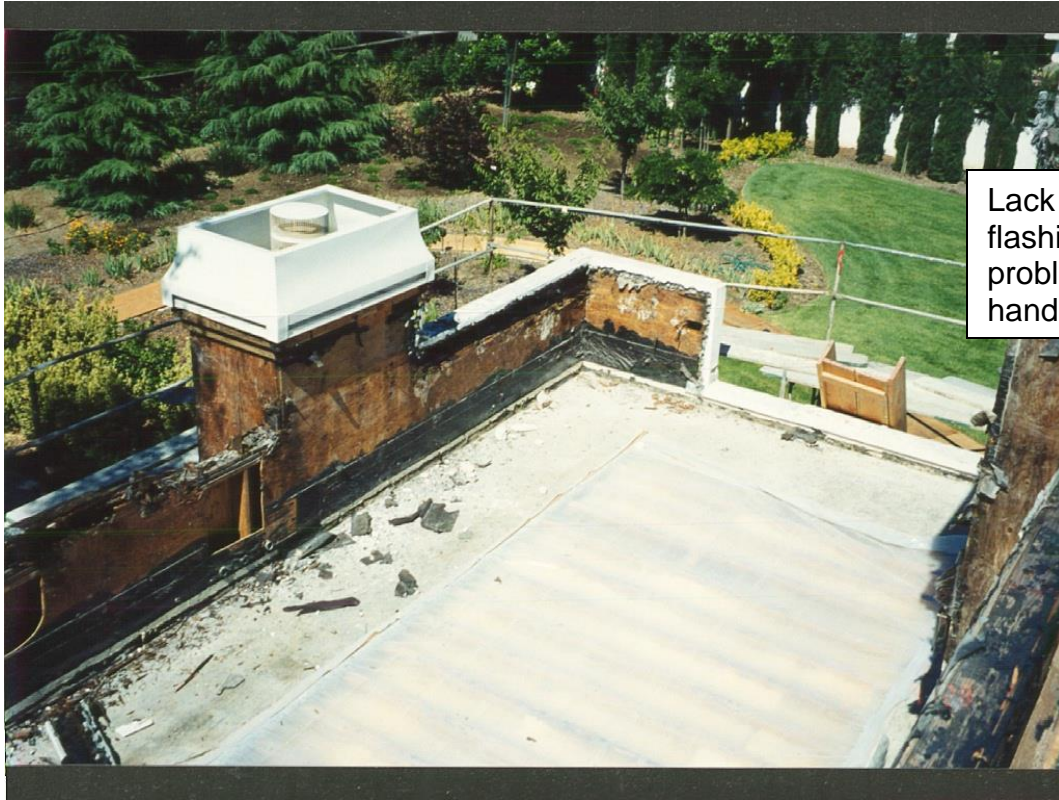
Lack of cap flashing created problems at the hand rail wall.

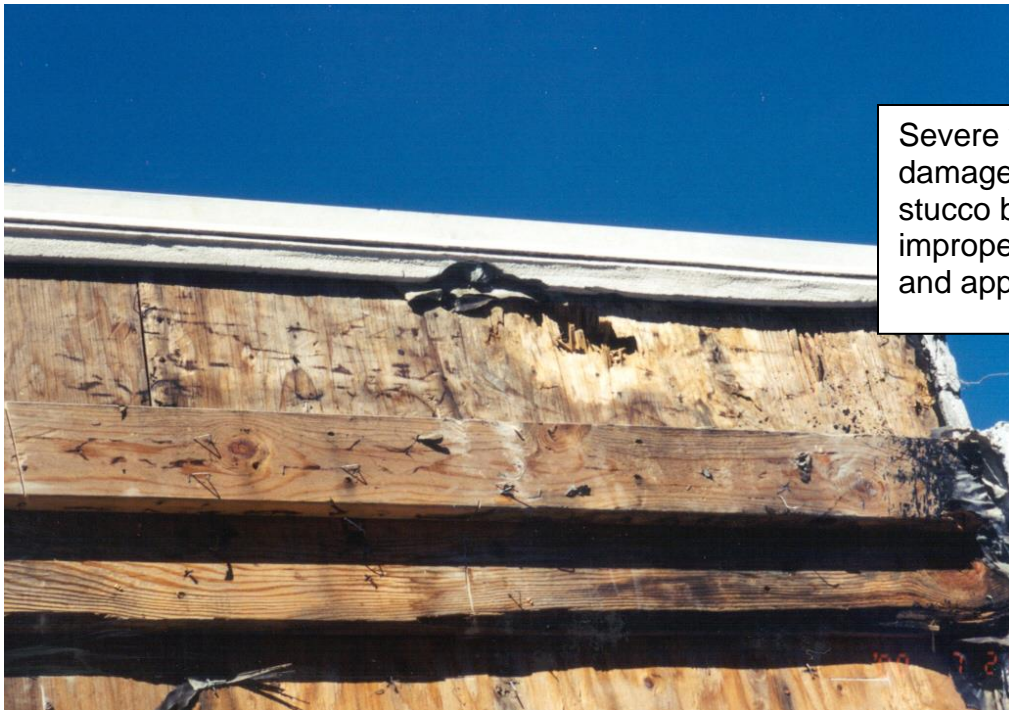
Our destructive testing revealed there was no adequate flashing at stucco cornices/bands. Although building paper has been wrapped over the wood which created the ornamental stucco bands, it is inadequate at horizontal surface of plaster and resulted in water intrusion, as shown in the photos. The self-furring lath appears to have been poorly fastened (too tight); as a result it is not furred properly. In many areas, the lath does not have minimum 1/4" coverage. There is only one layer of building paper at shear wall; the Building Code requires two plies.

Severe water damage behind stucco band due to improper design and application.

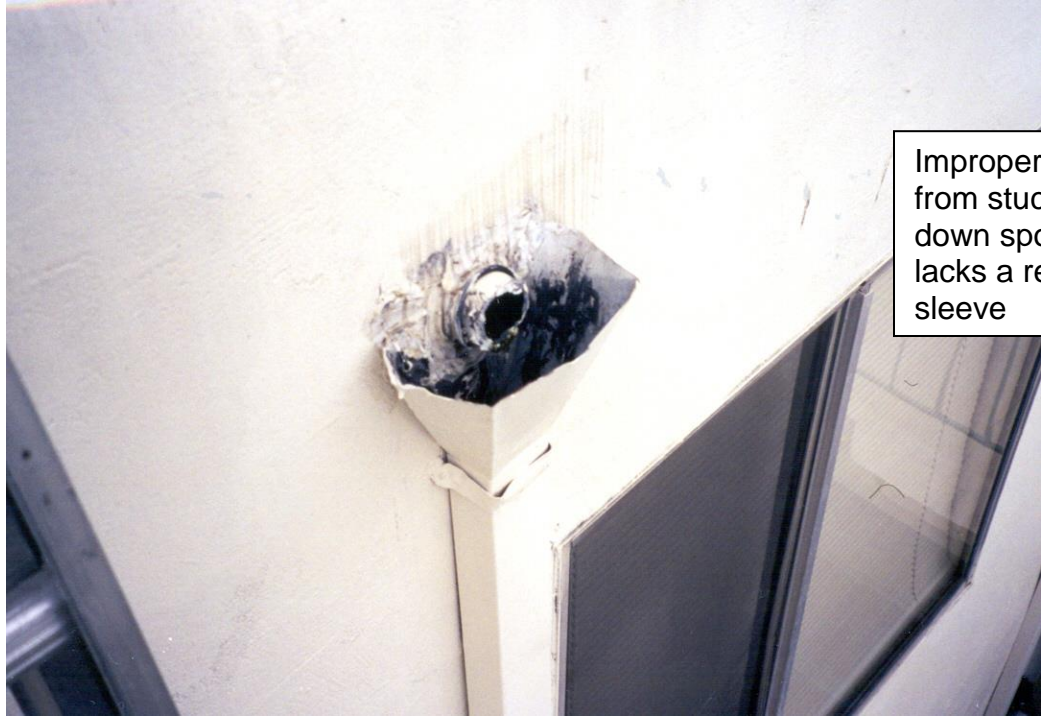
Improper transition from stucco to down spout. Detail lacks a receiver sleeve

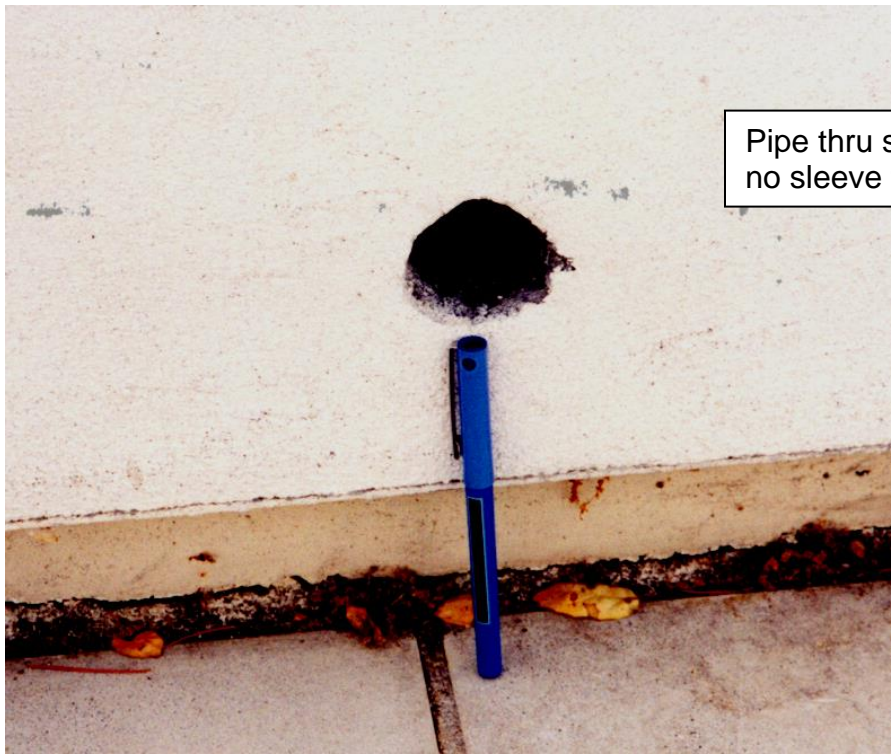
Pipe thru stucco has no sleeve flashing.

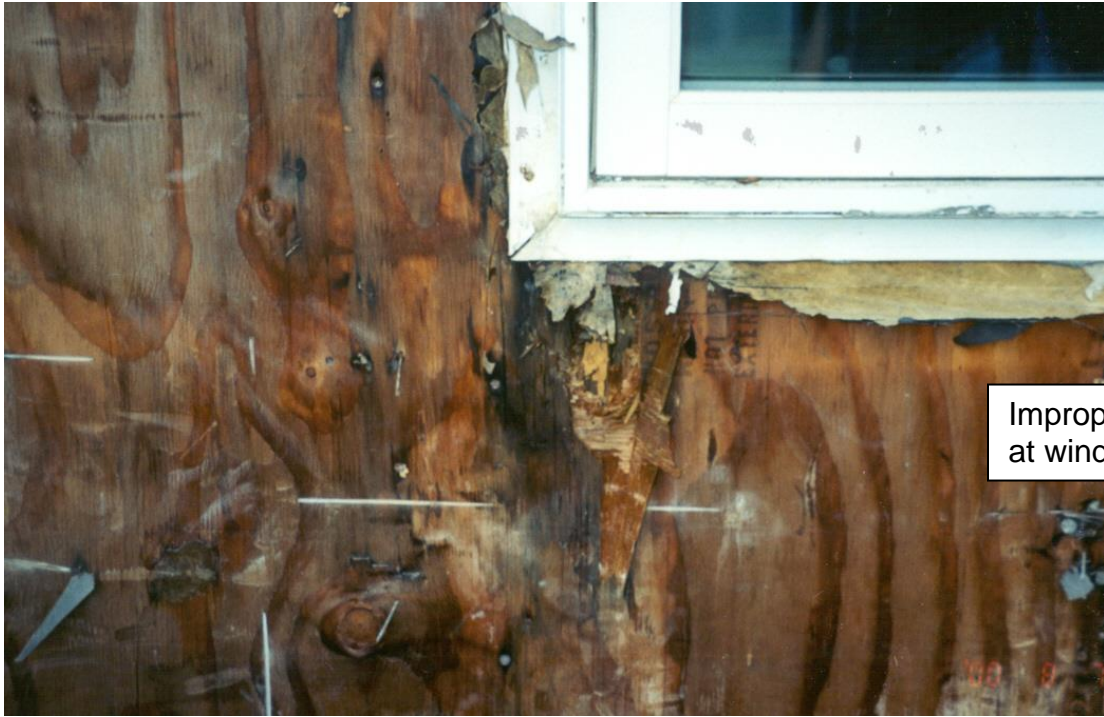
Improper flashing at window.

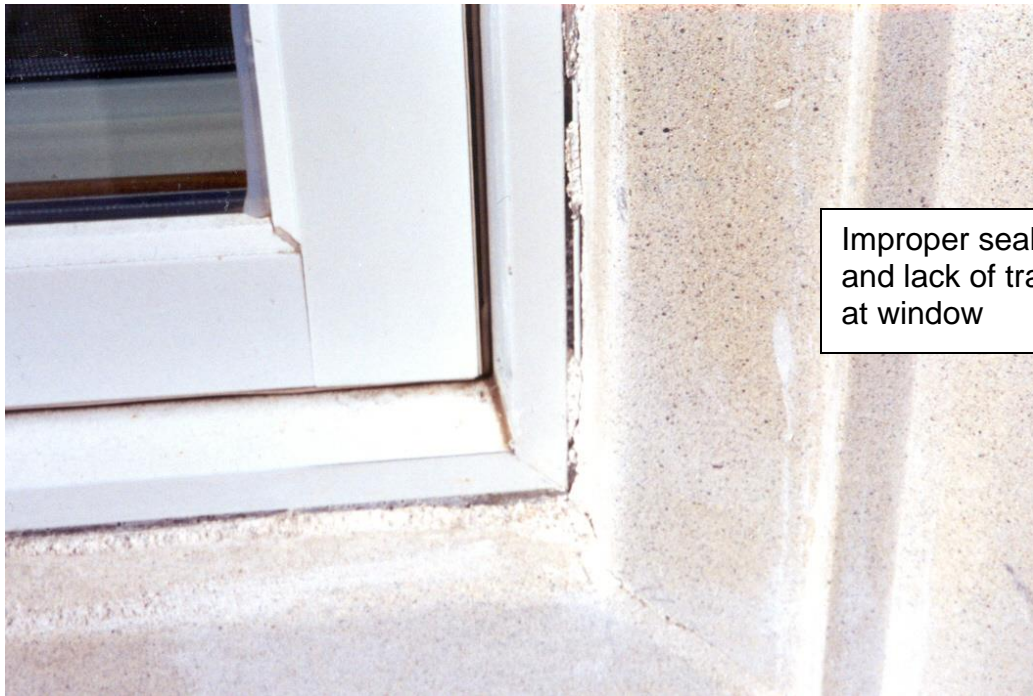
Improper sealant and lack of transition at window

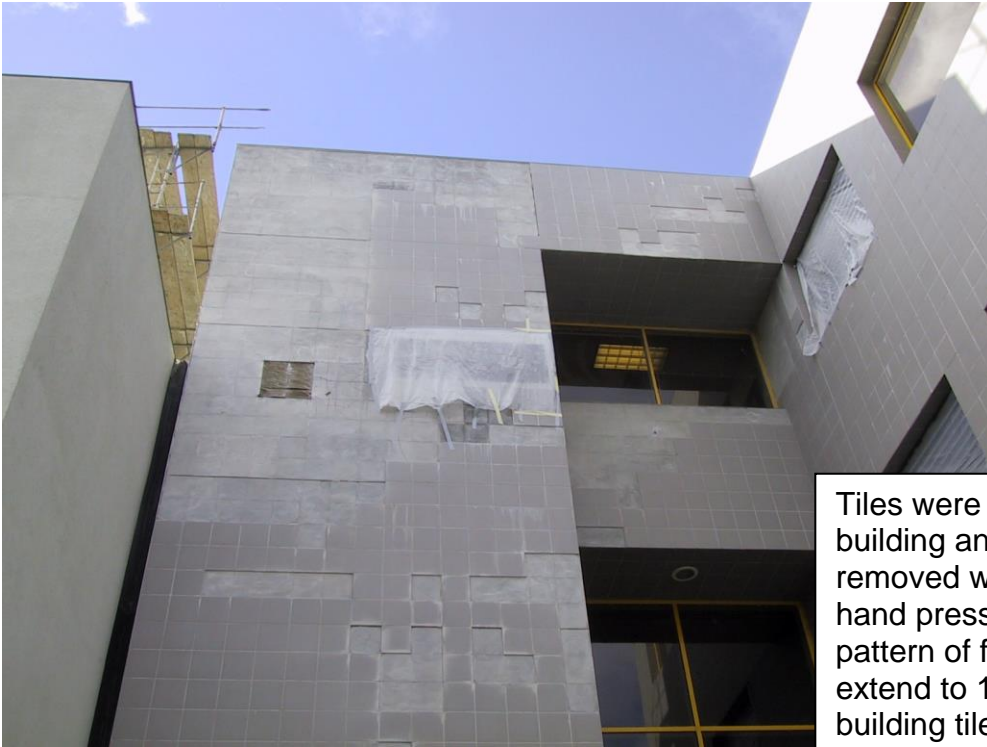
Tiles were falling from the building and could be removed with slight hand pressure – but the pattern of failure did not extend to 100% of the building tiles – and was random.

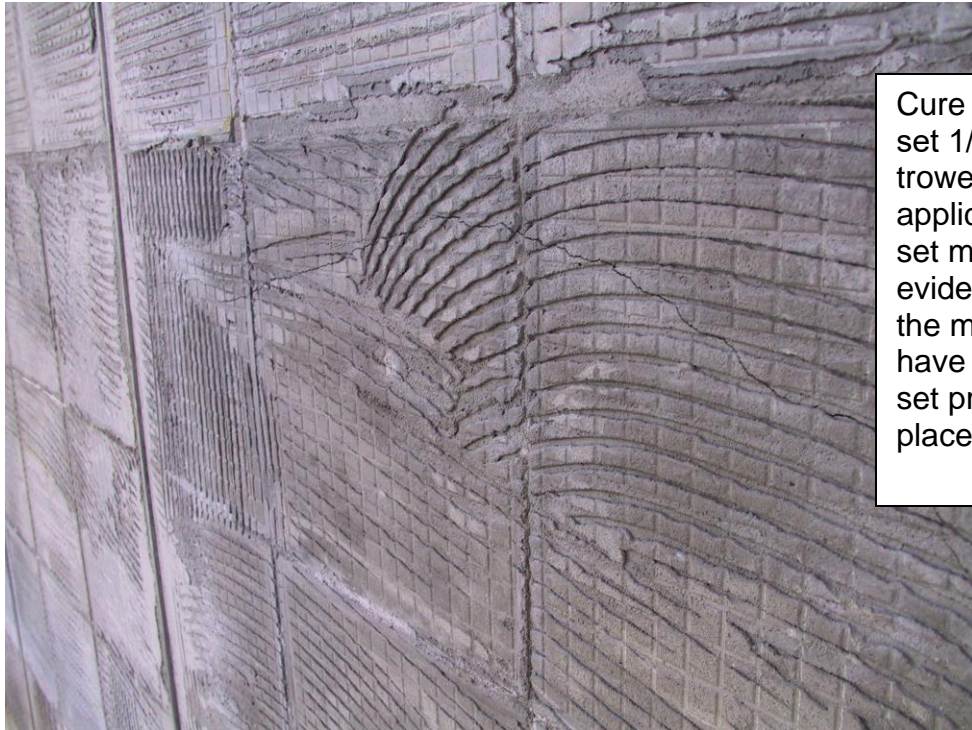
Cure time of thin set 1/4" notched trowel used for application of thin set mortar is evident indicating the material may have skinned or set prior to placement of tile.
