COMMON DEFECTS AND FAILURE MODES IN CEMENT PLASTER

Karim P. Allana, P.E., RRC

Symposium on Building Envelope Technology
Coral Springs Marriot at Herron Bay, Florida
November 14th & 15th 2002

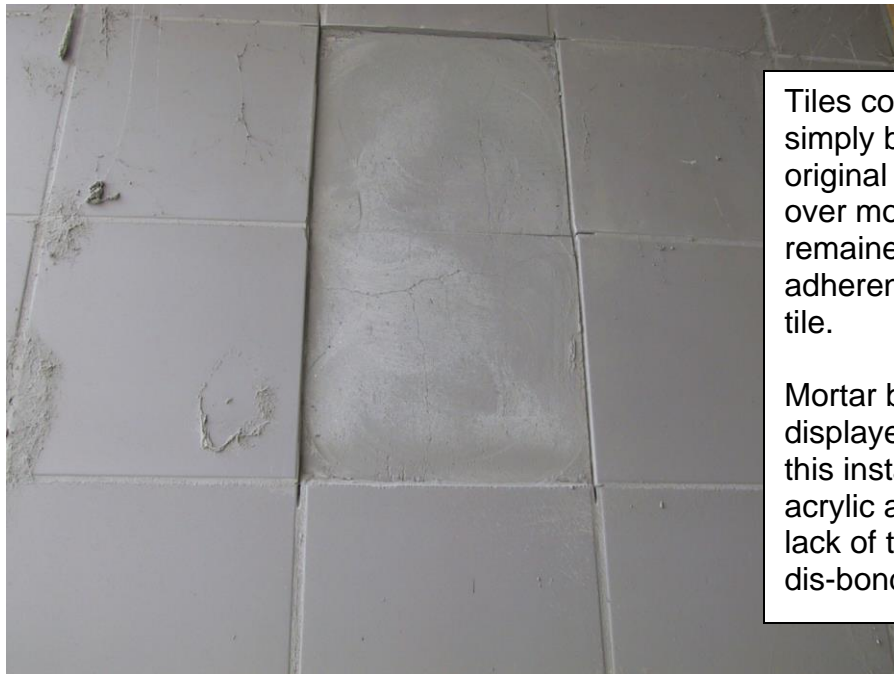
Tiles could be removed simply by hand – original thinset pattern over mortar base remained, with no adherence to removed tile.

Mortar base also displayed cracking. In this instance, use of non-acrylic admixture and lack of tile cleaning led to dis-bondment.
