Forensic Analysis of Roofing Systems Examples of Roof Performance Learn from Failures to Make Roofs More Sustainable!

Bay Area Facility Management Show – Forensic Analysis of
Roofing Systems

Case 1: Forensic Investigation of Metal Roof Failure

Case 2: PVC Single Ply Sustainability

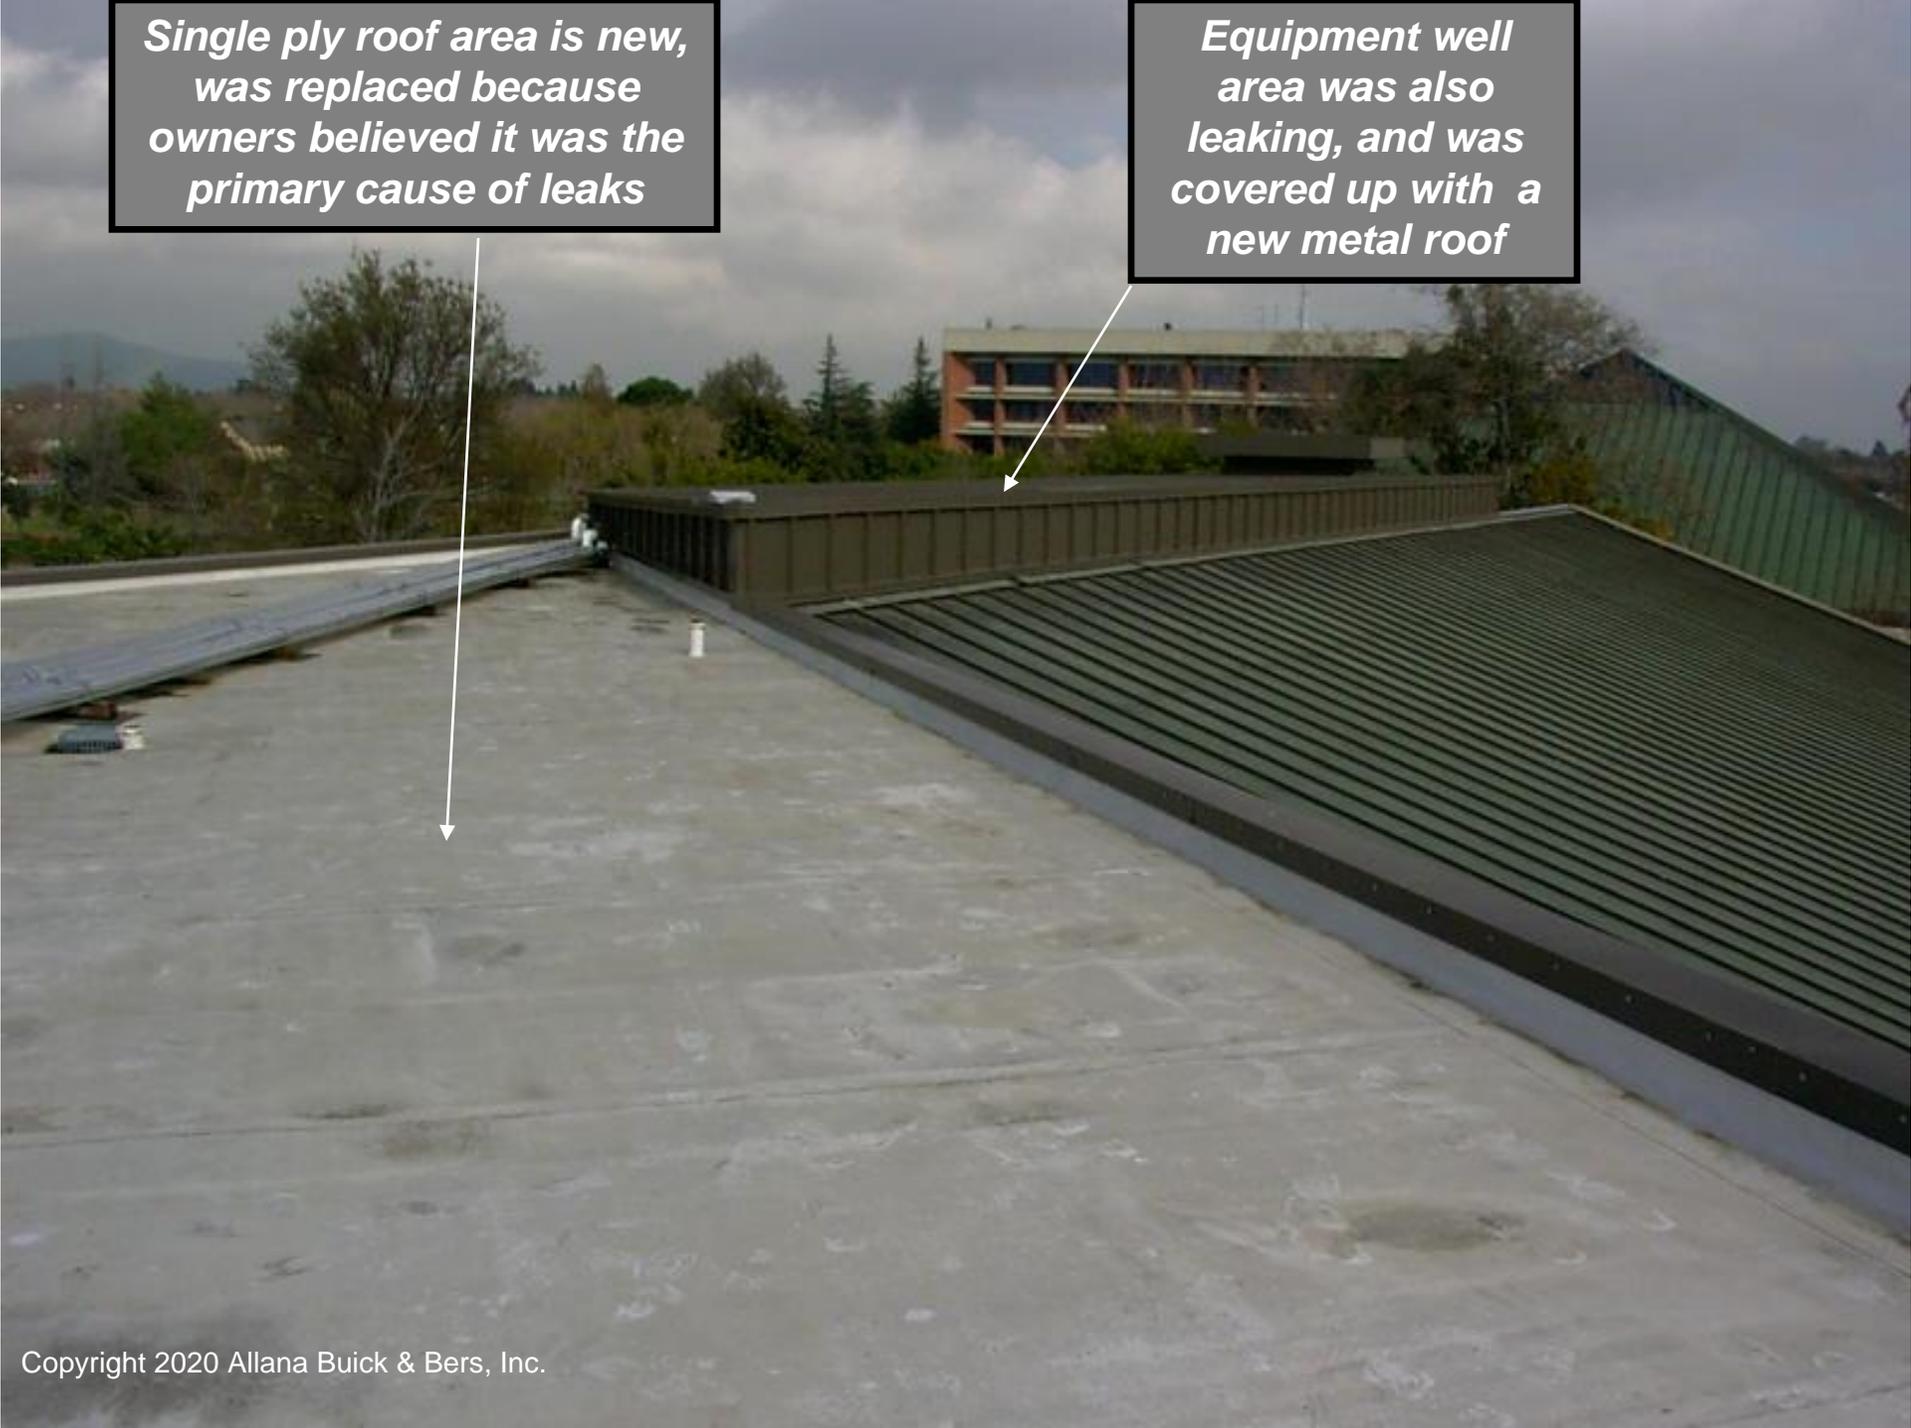
Single ply roof area is new, was replaced because owners believed it was the primary cause of leaks

Equipment well area was also leaking, and was covered up with a new metal roof

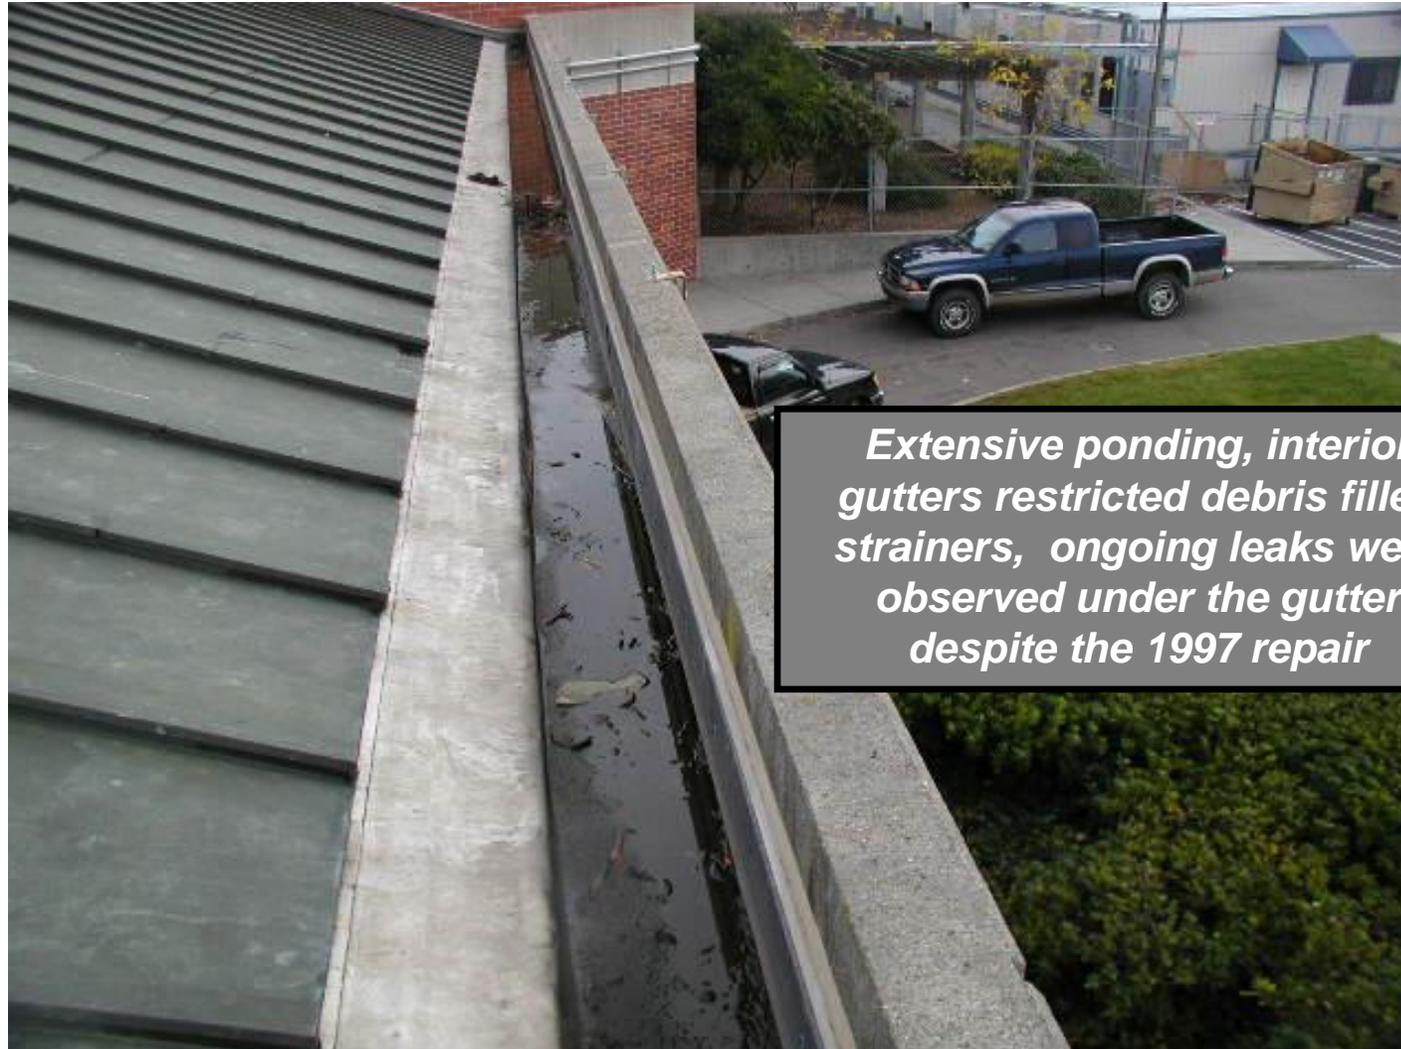
Extensive ponding, interior gutters restricted debris filled strainers, ongoing leaks were observed under the gutter despite the 1997 repair

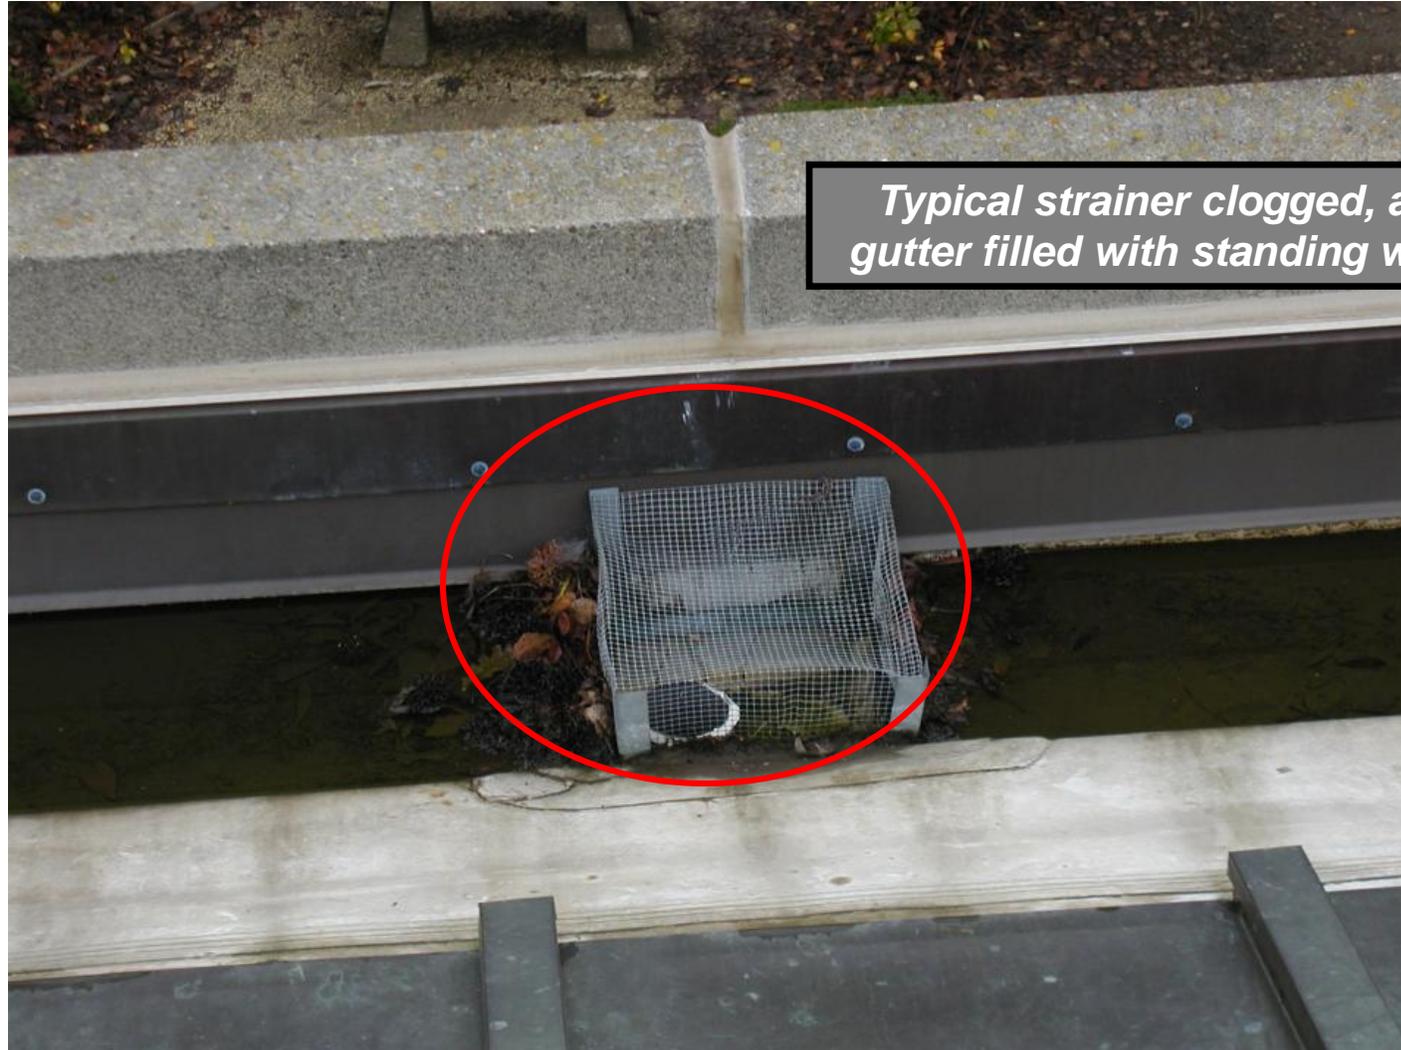
Typical strainer clogged, and gutter filled with standing water

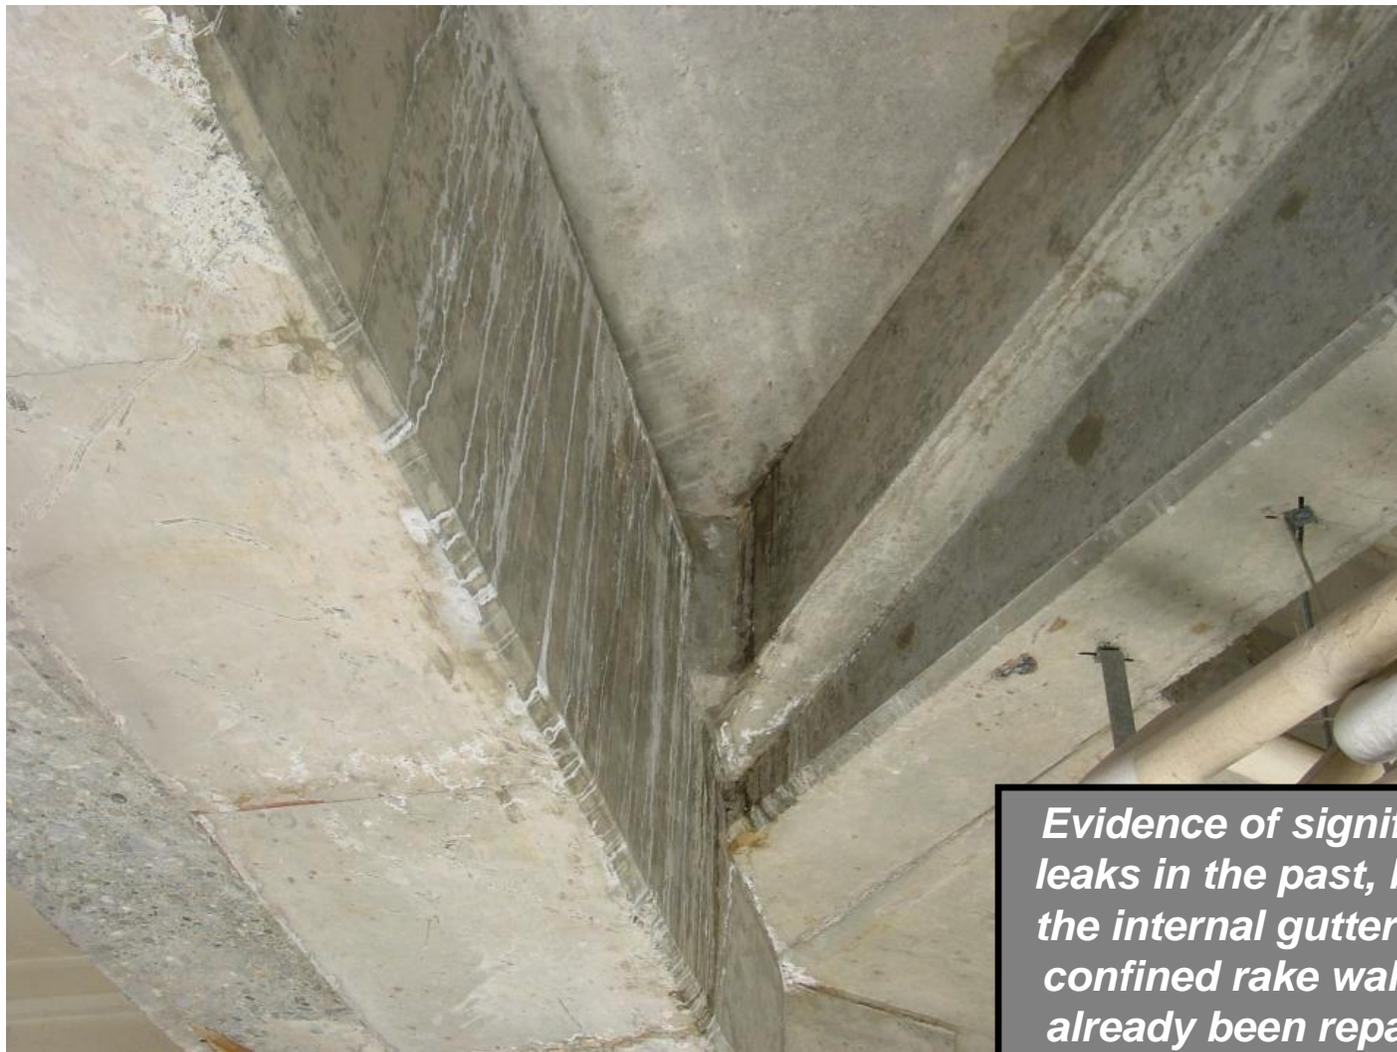
Evidence of significant leaks in the past, below the internal gutters and confined rake wall that already been repaired, once

Evidence of efflorescence through CMU wall with brick veneer

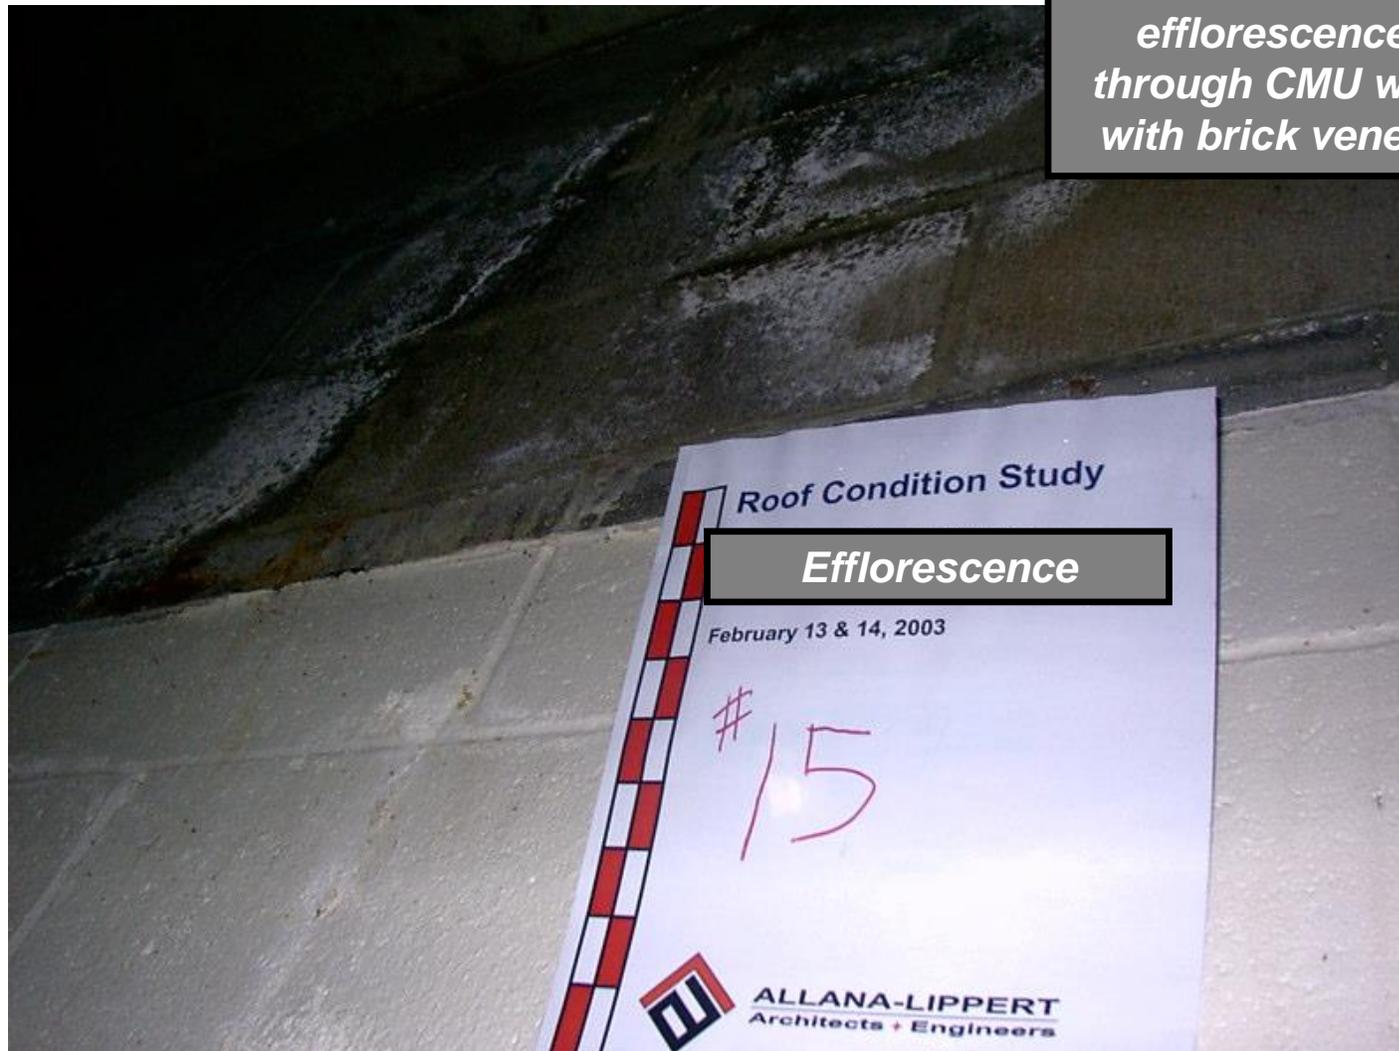
Efflorescence

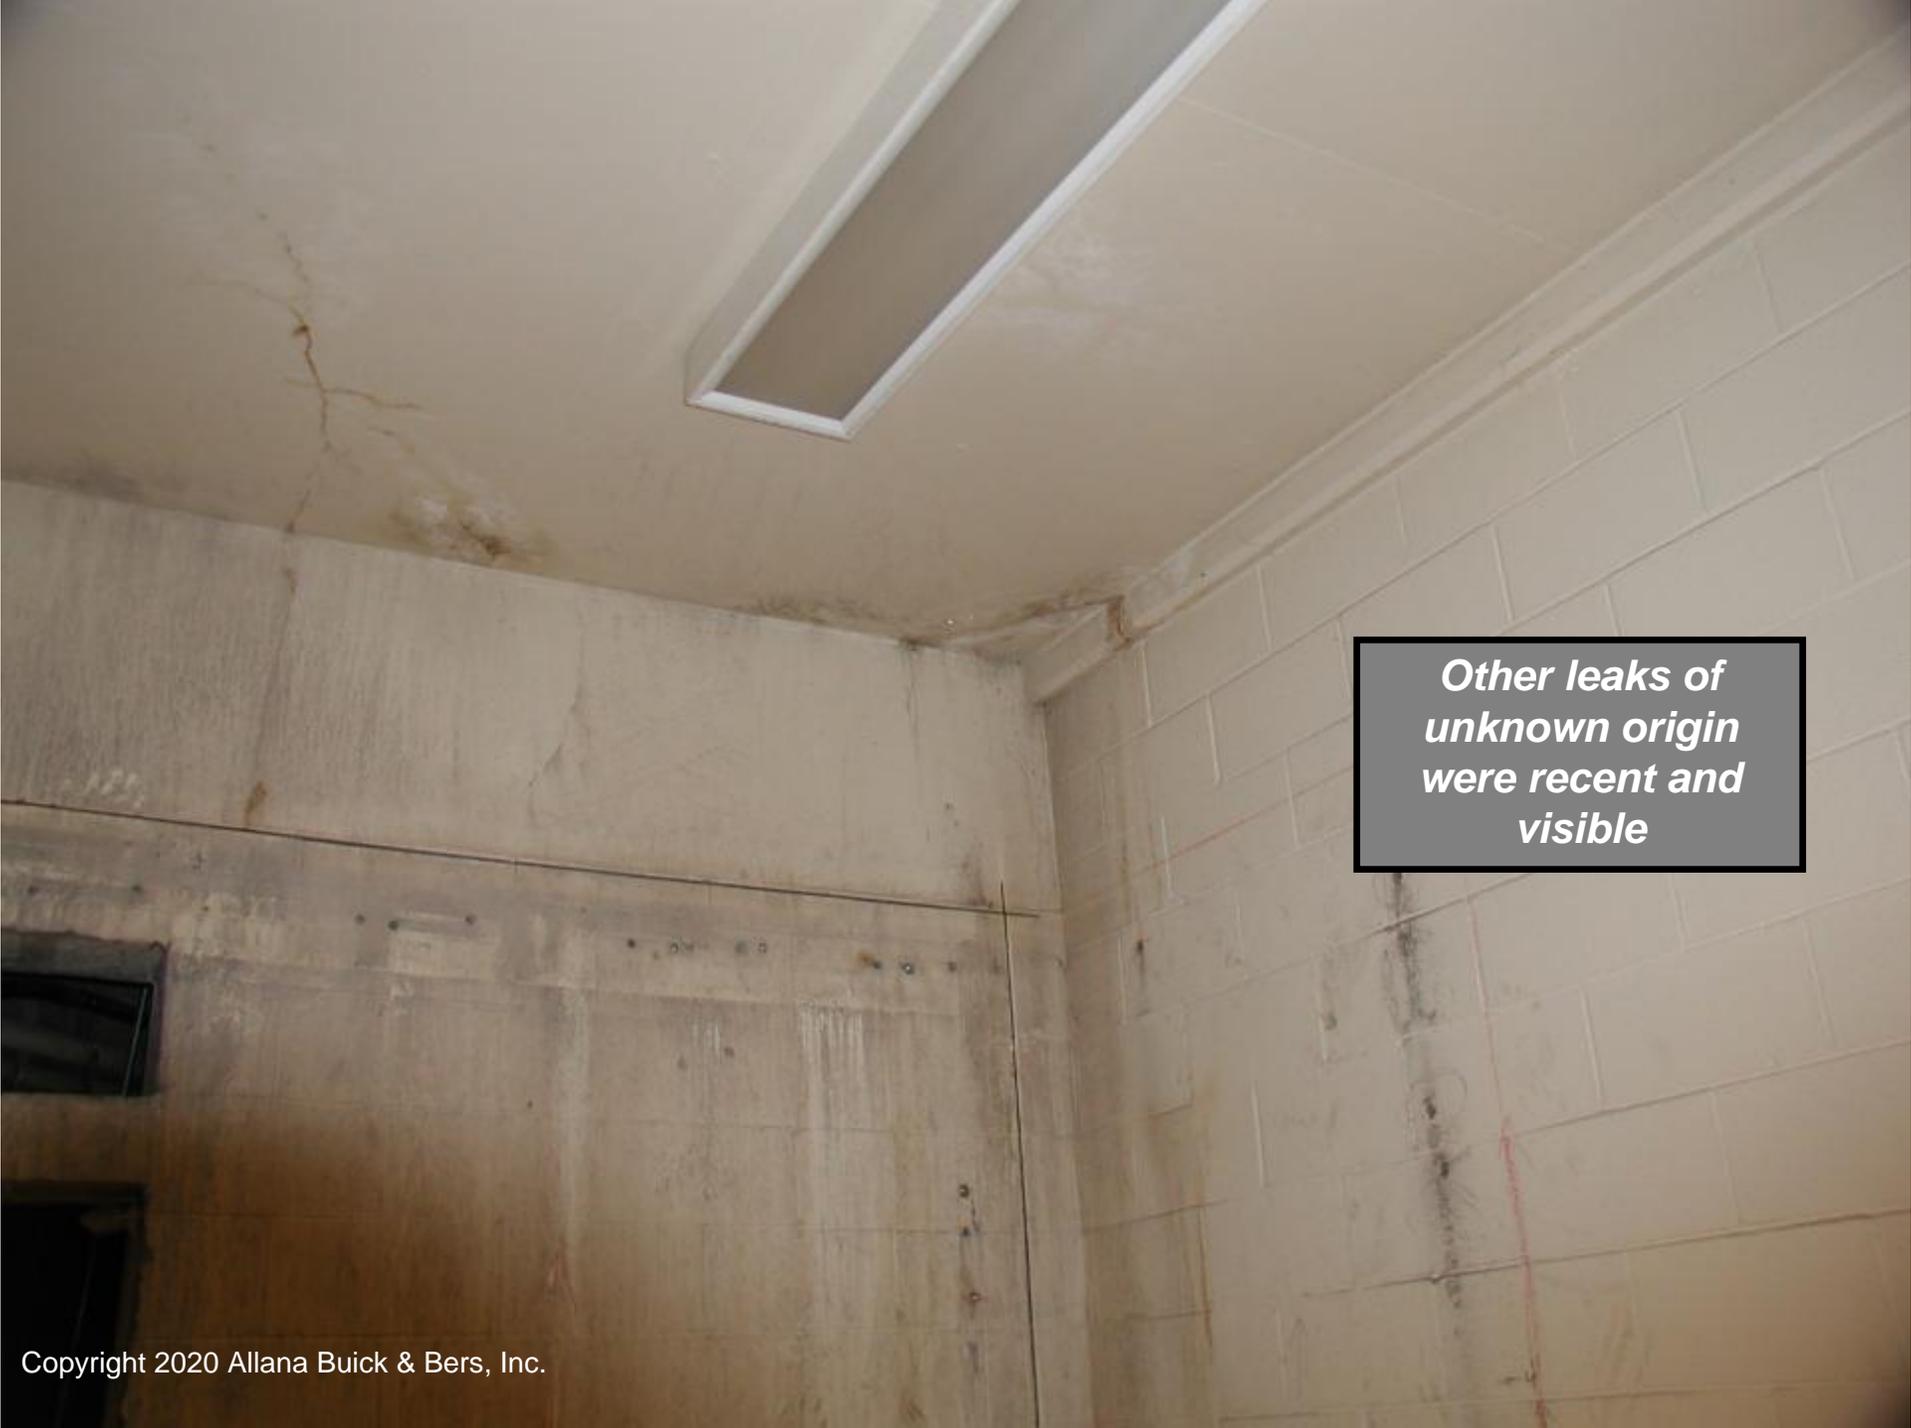
*Other leaks of
unknown origin
were recent and
visible*

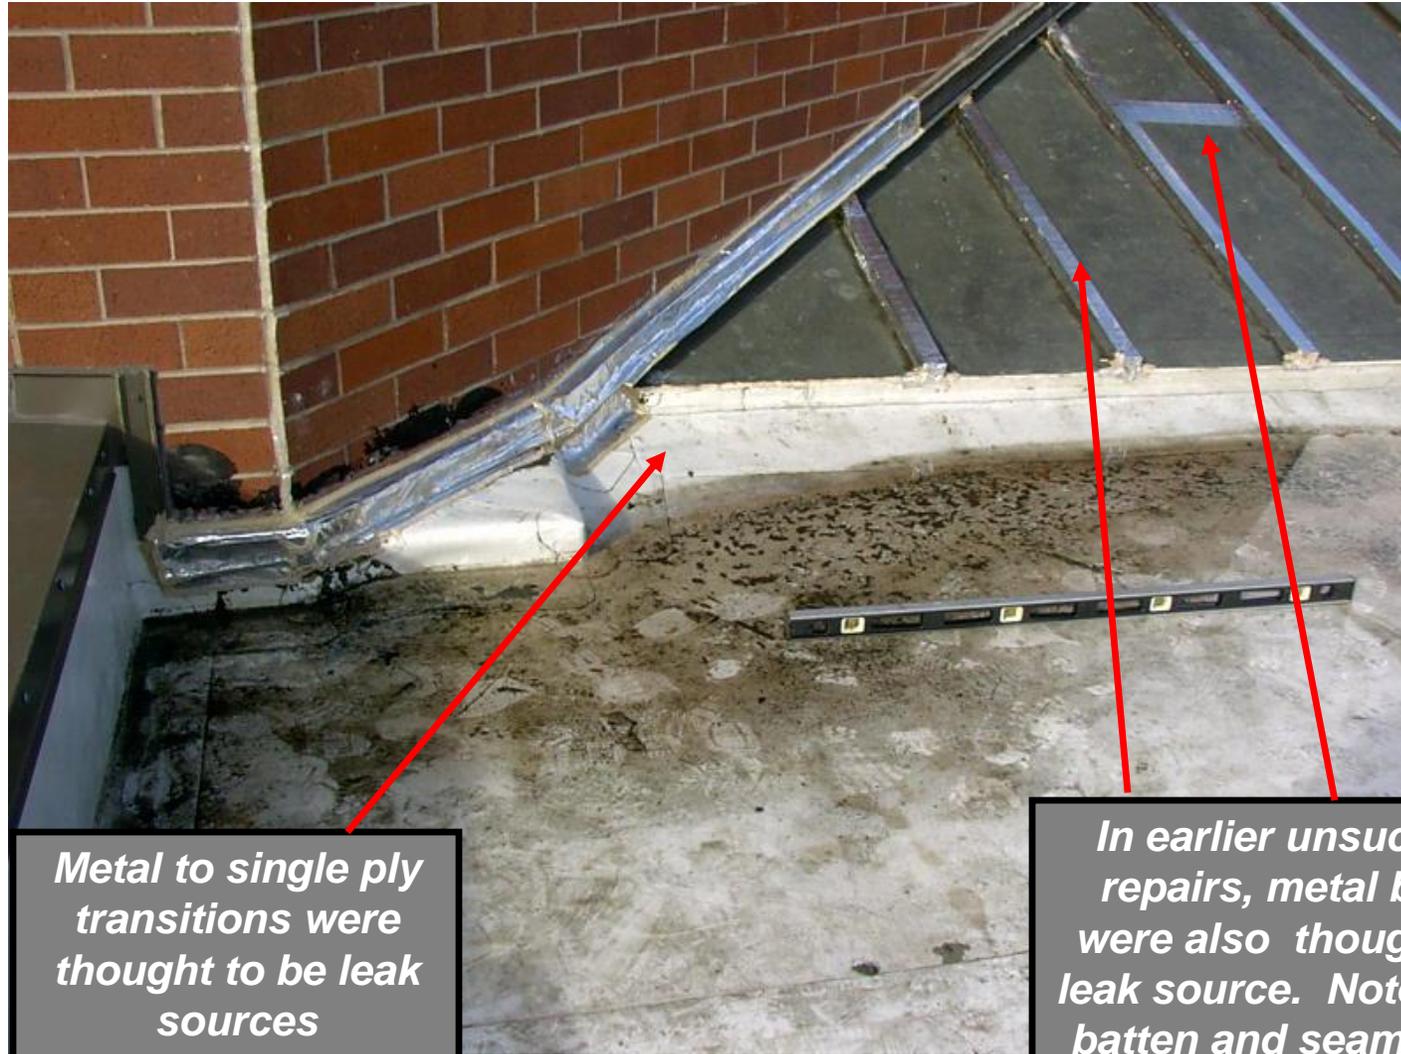
Metal to single ply transitions were thought to be leak sources

In earlier unsuccessful repairs, metal battens were also thought to be leak source. Note tape on batten and seam on field formed panel

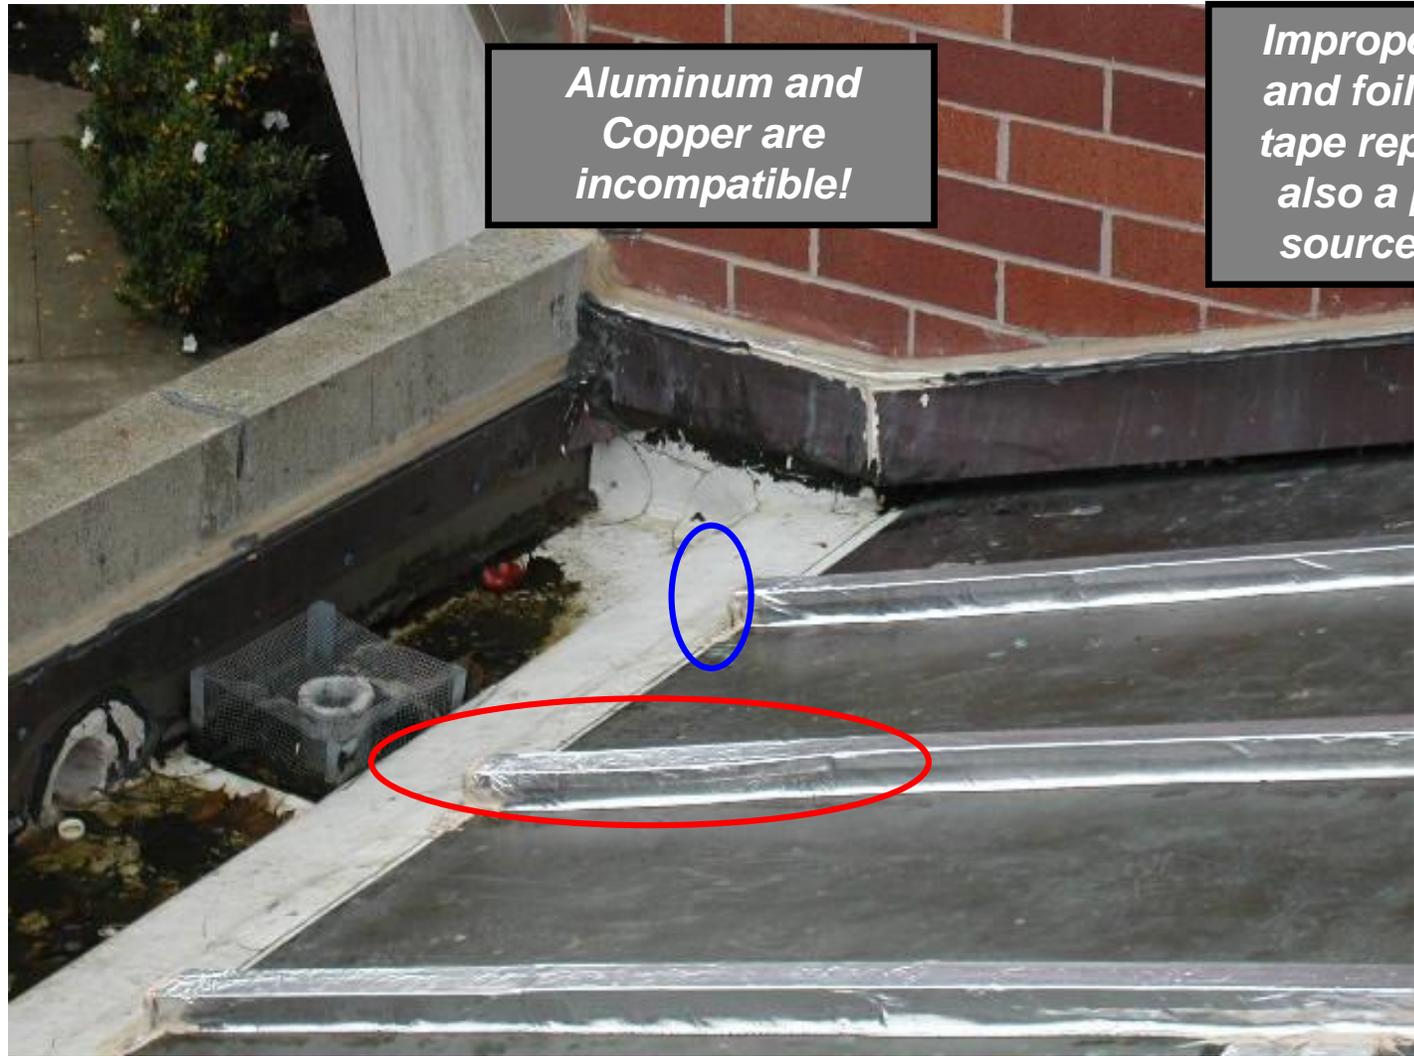
*Aluminum and
Copper are
incompatible!*

*Improper sealant
and foil surfaced
tape repairs were
also a probable
source of leaks*

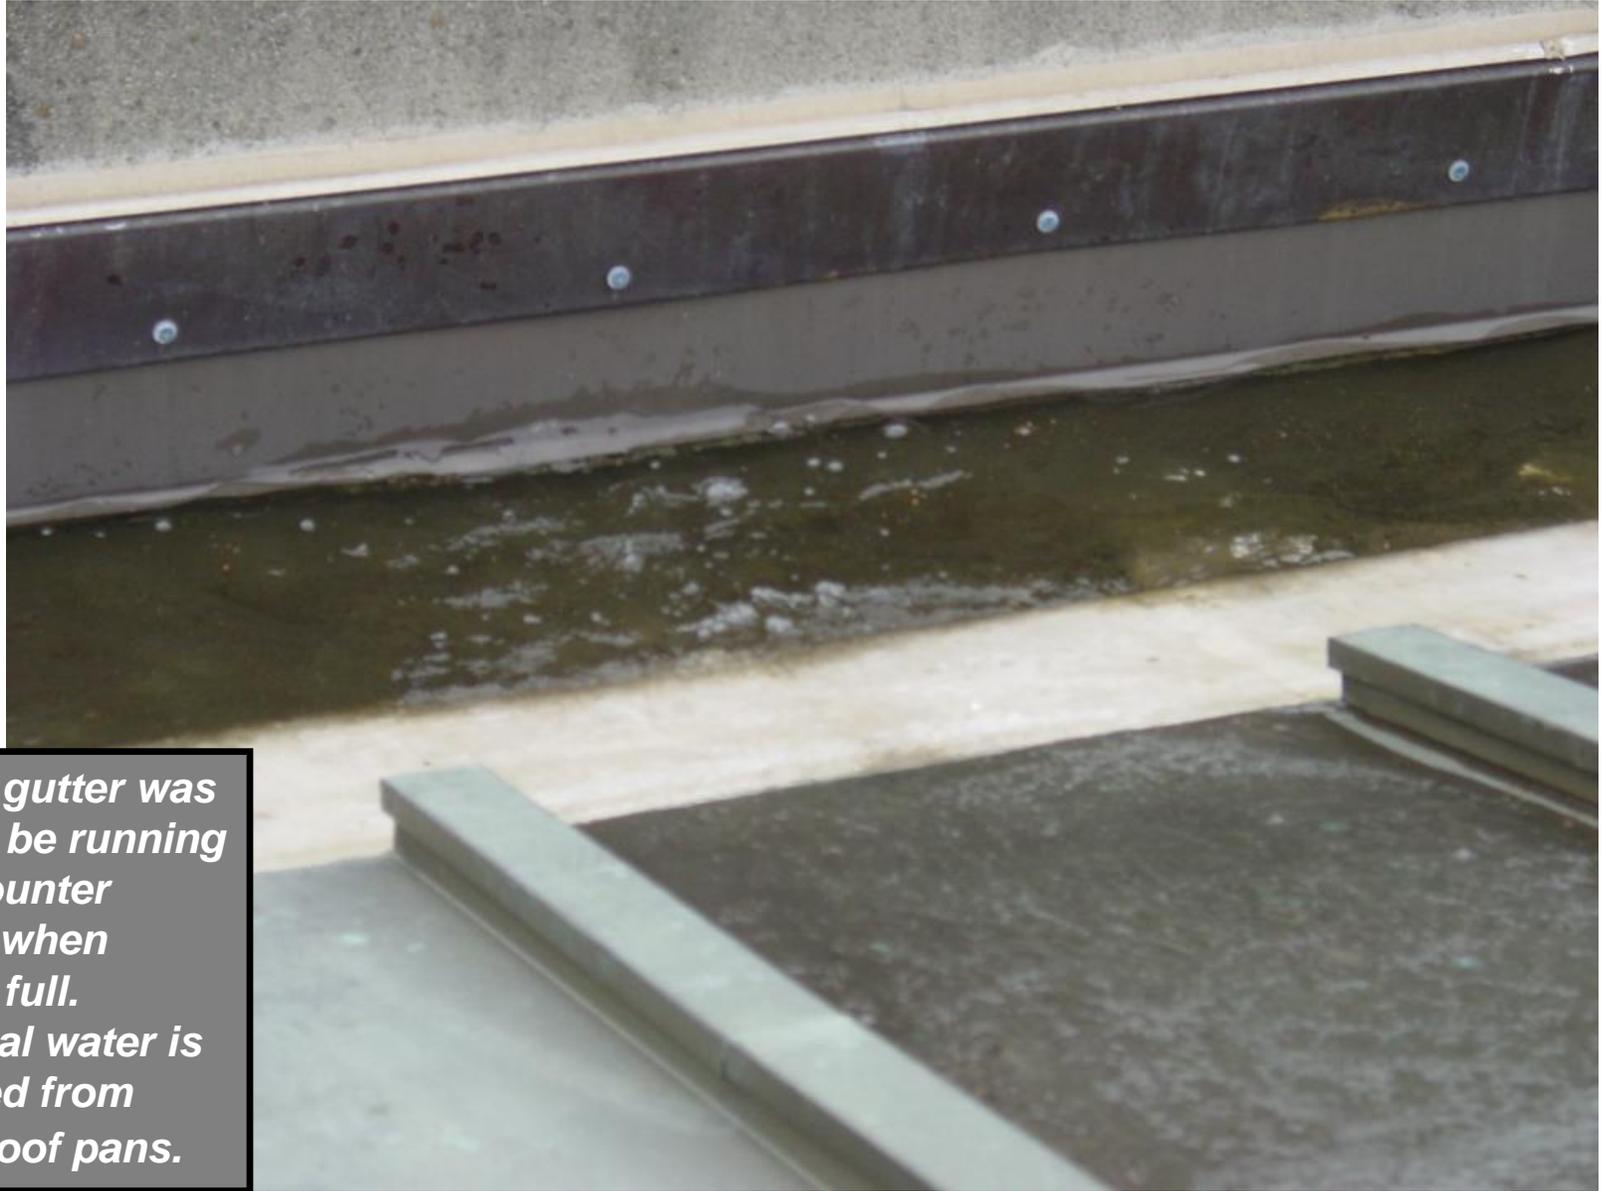
Water in gutter was found to be running under counter flashing when gutter is full. Additional water is presented from copper roof pans.

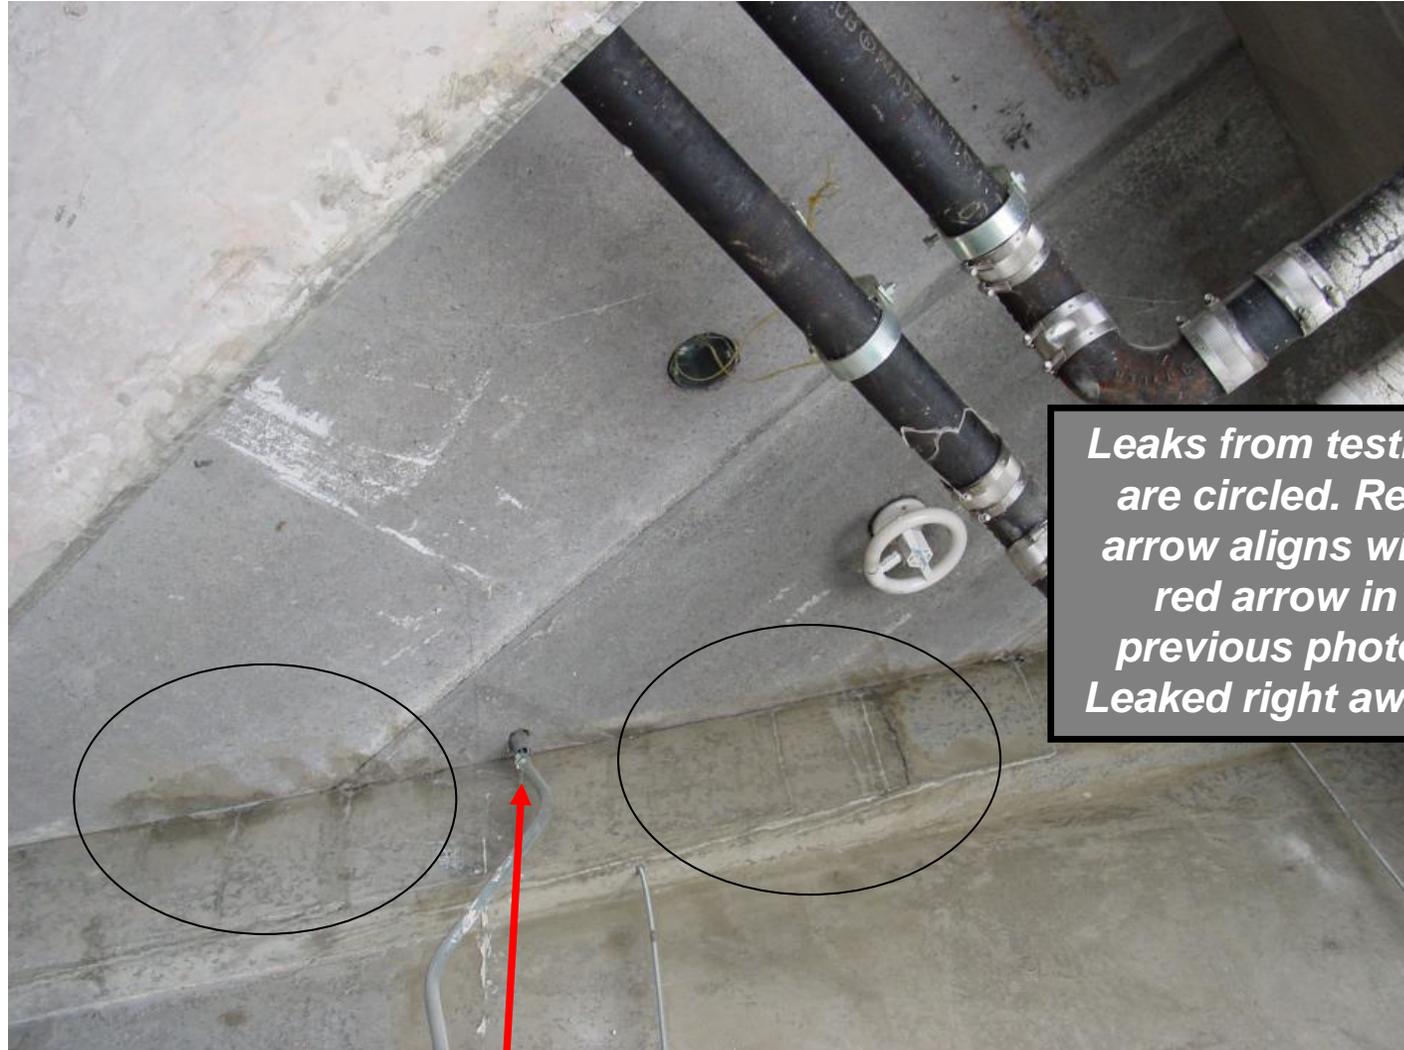
Leaks from testing are circled. Red arrow aligns with red arrow in previous photo. Leaked right away!

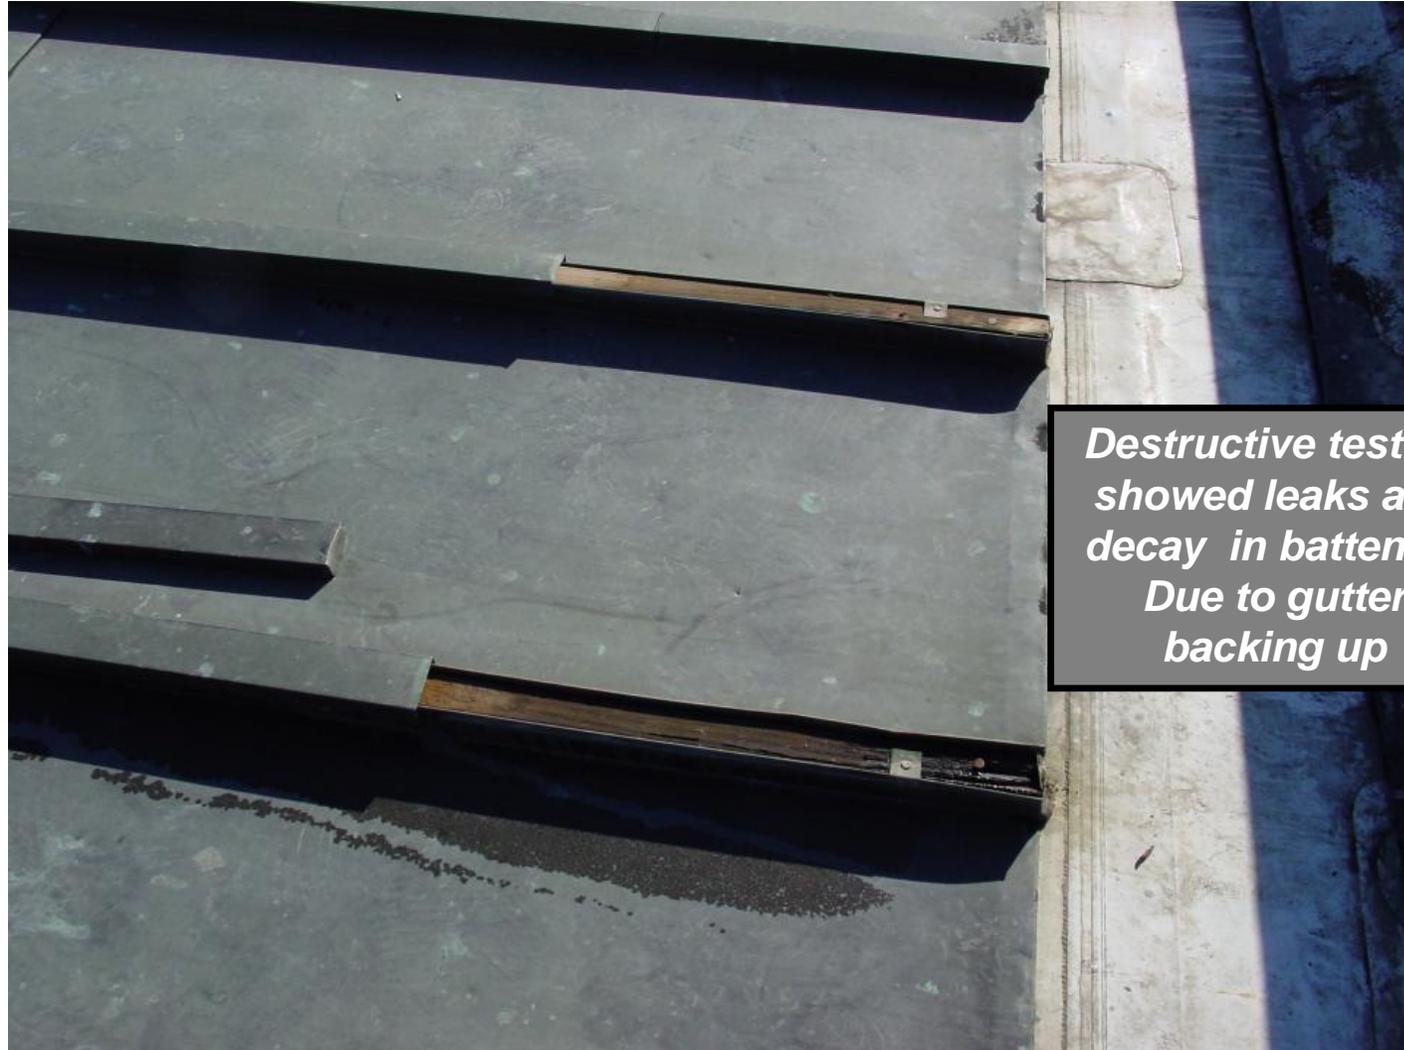
*Destructive testing
showed leaks and
decay in battens –
Due to gutter
backing up*

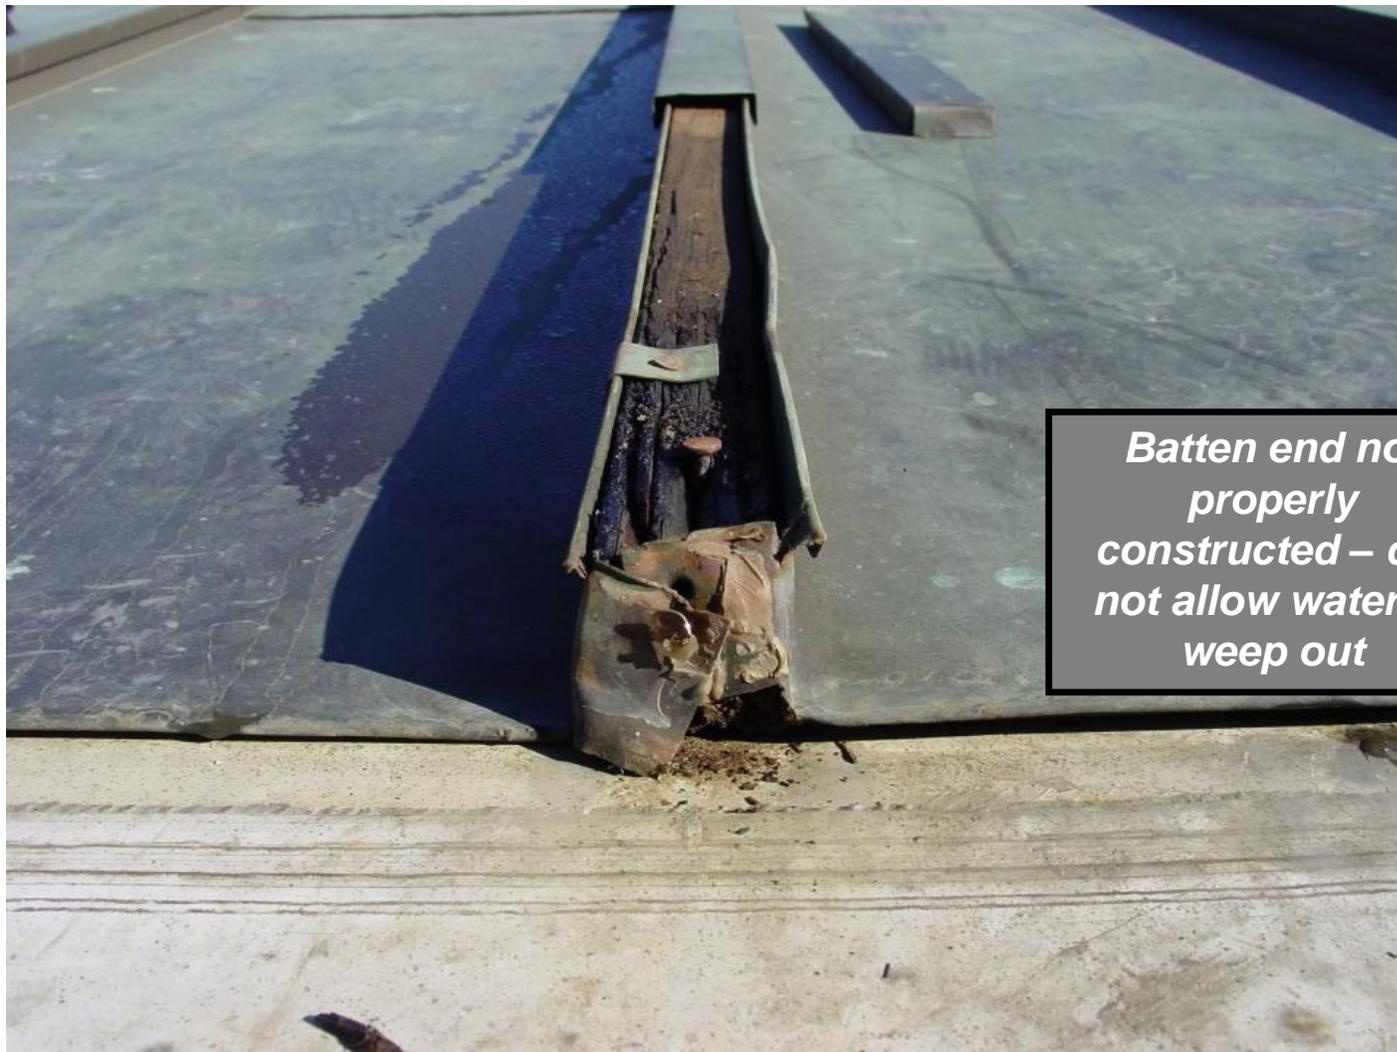
Batten end not properly constructed – did not allow water to weep out

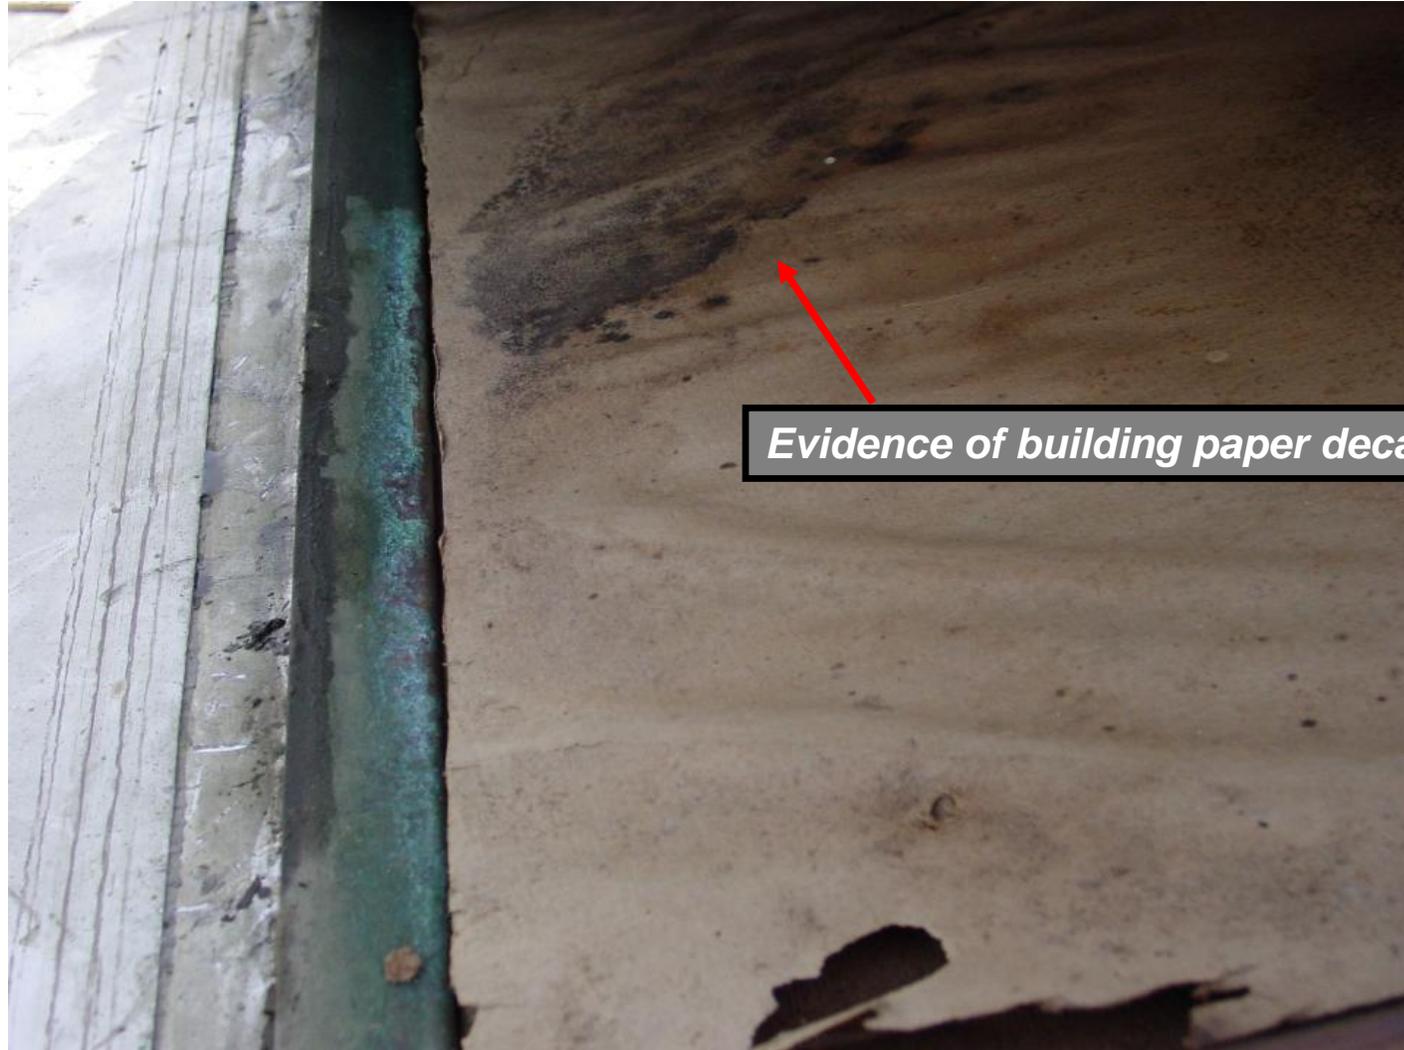
Evidence of building paper decay
