Forensic Analysis of Roofing Systems Examples of Roof Performance Learn from Failures to Make Roofs More Sustainable!

Bay Area Facility Management Show – Forensic Analysis of
Roofing Systems

Case 1: Forensic Investigation of Metal Roof Failure

Case 2: PVC Single Ply Sustainability

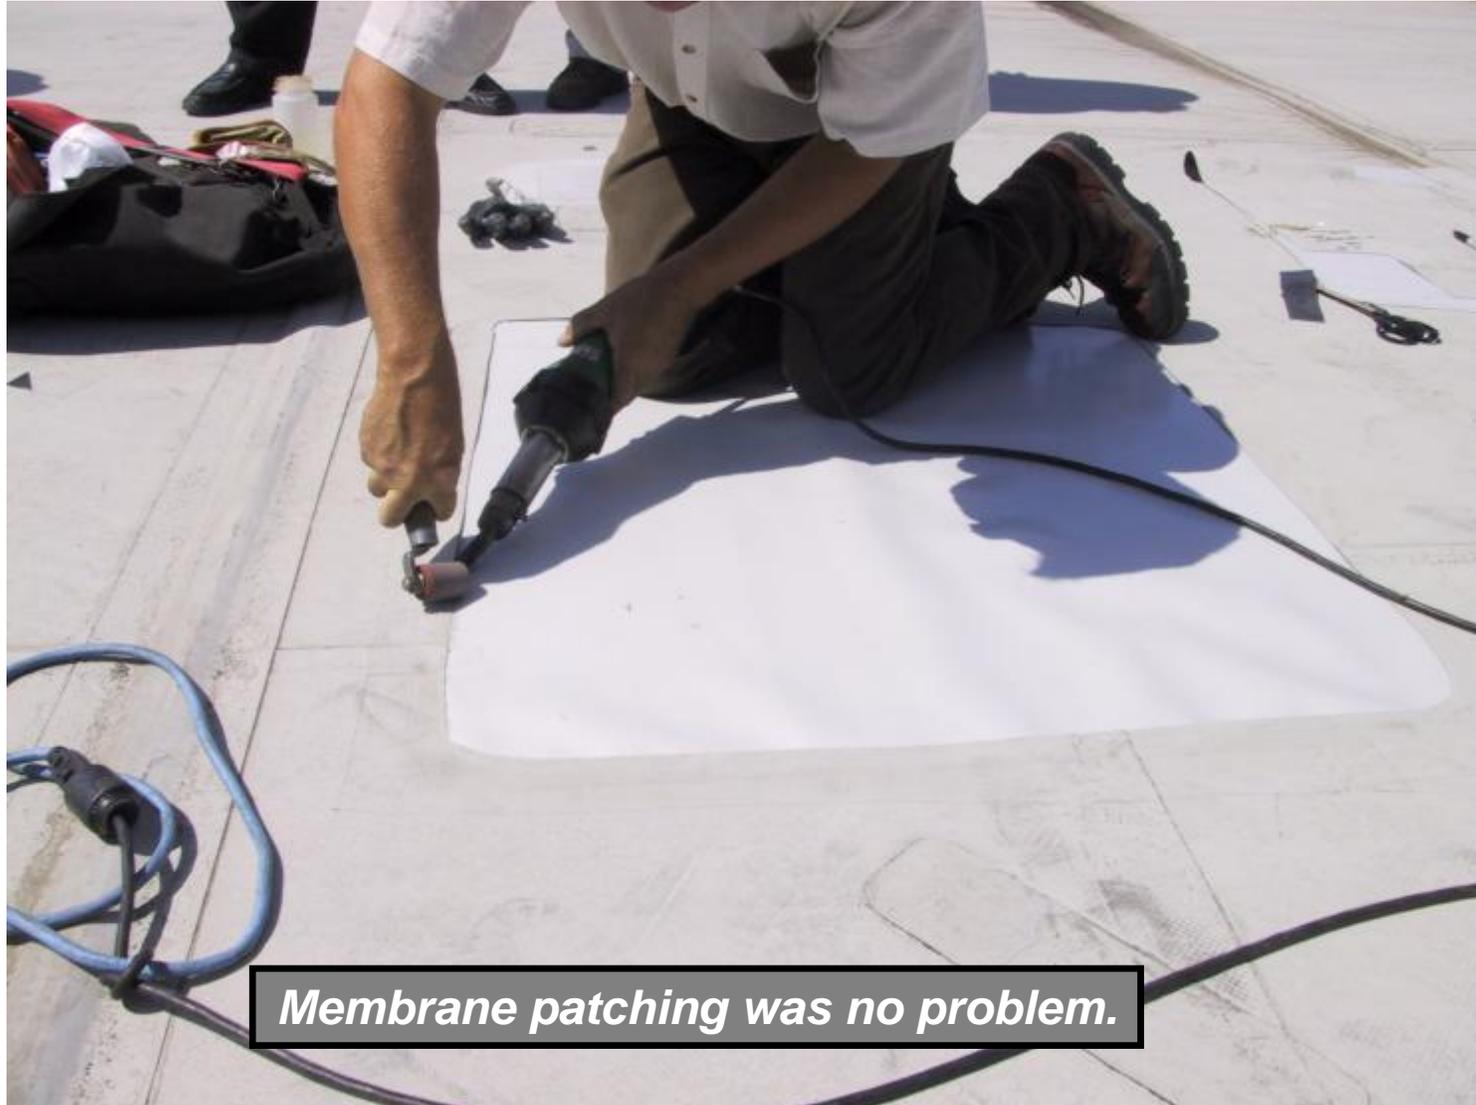
Membrane patching was no problem.

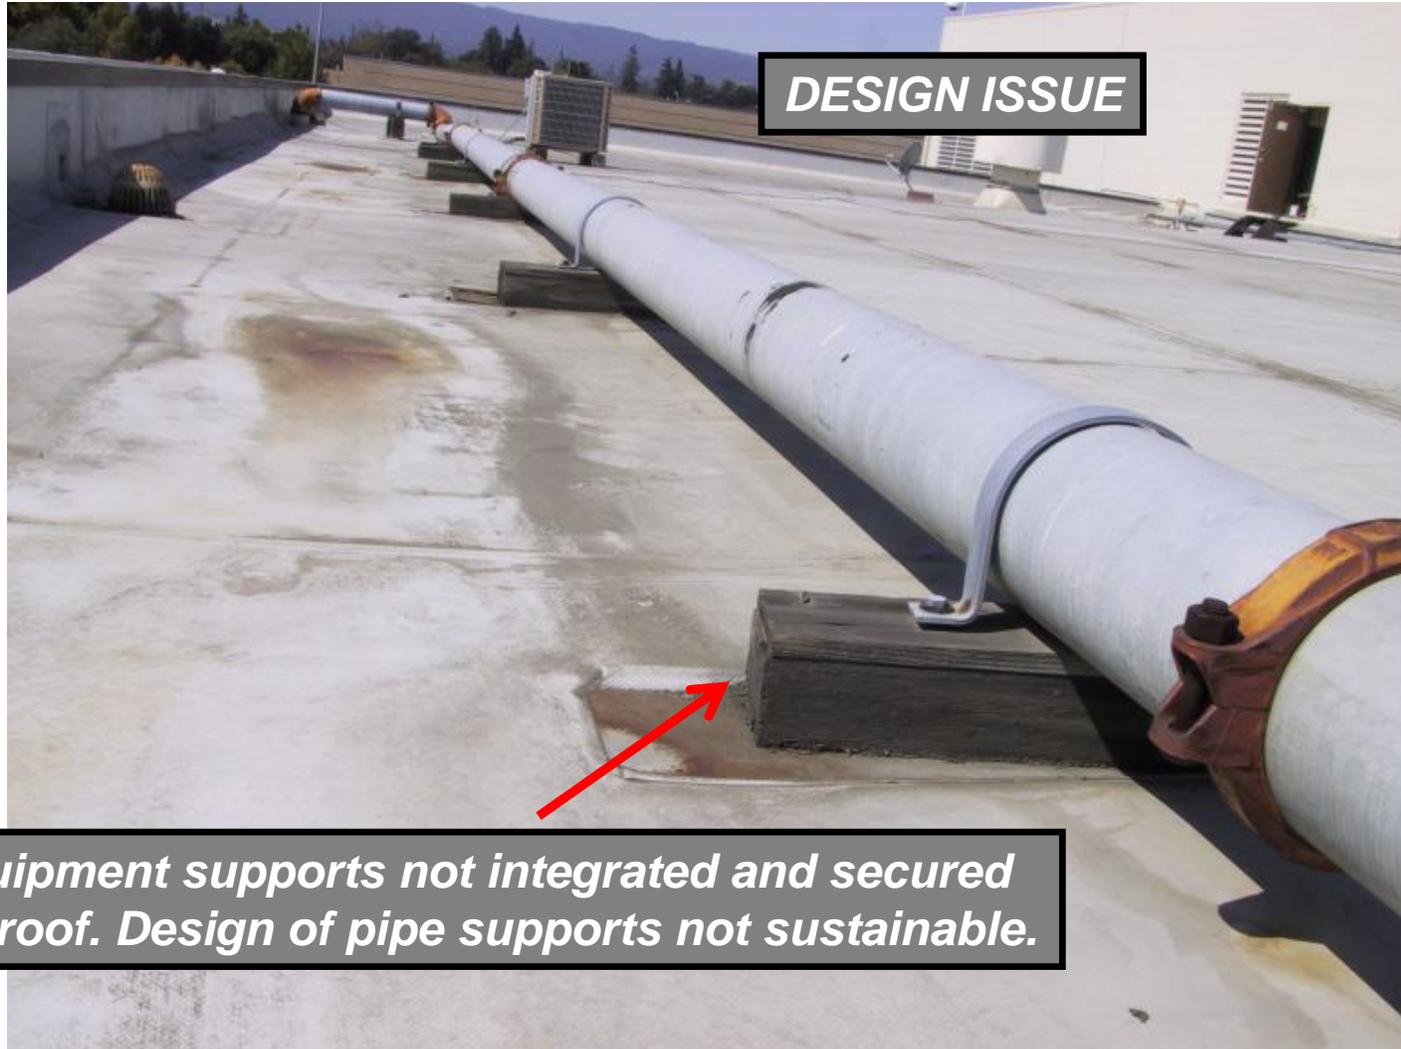
Equipment supports not integrated and secured into roof. Design of pipe supports not sustainable.

- Original poor design of pipe supports caused damage
- Poor design of roof drainage caused ponding water and damage
- Poor design of condensation control mechanism caused damage

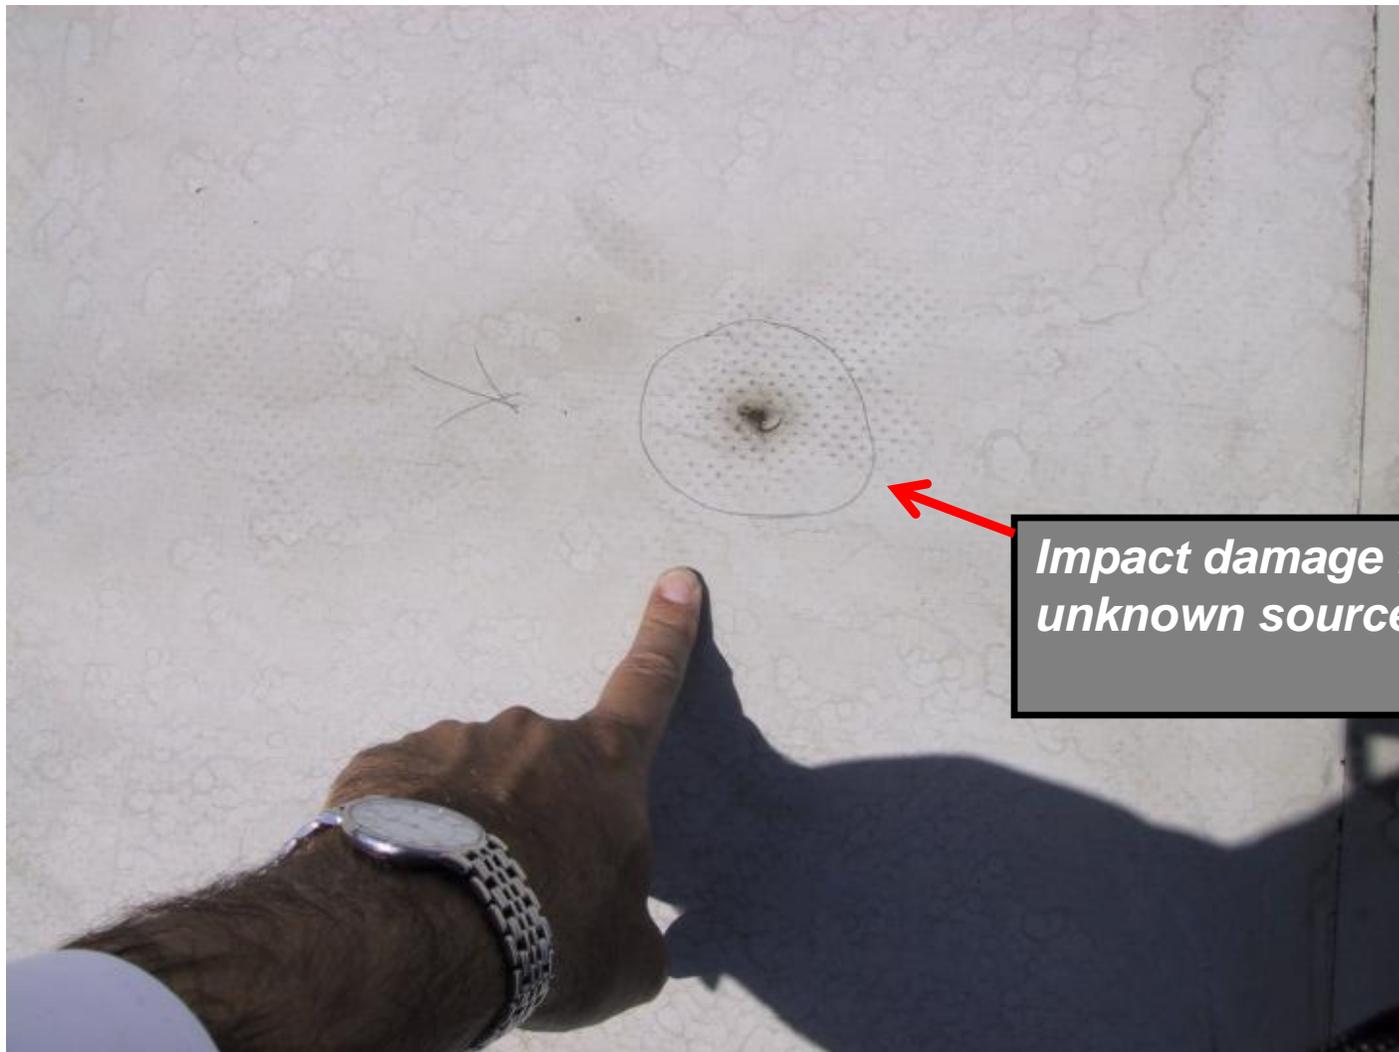
***Impact damage from
unknown source***

Evidence of Nail from
construction debris

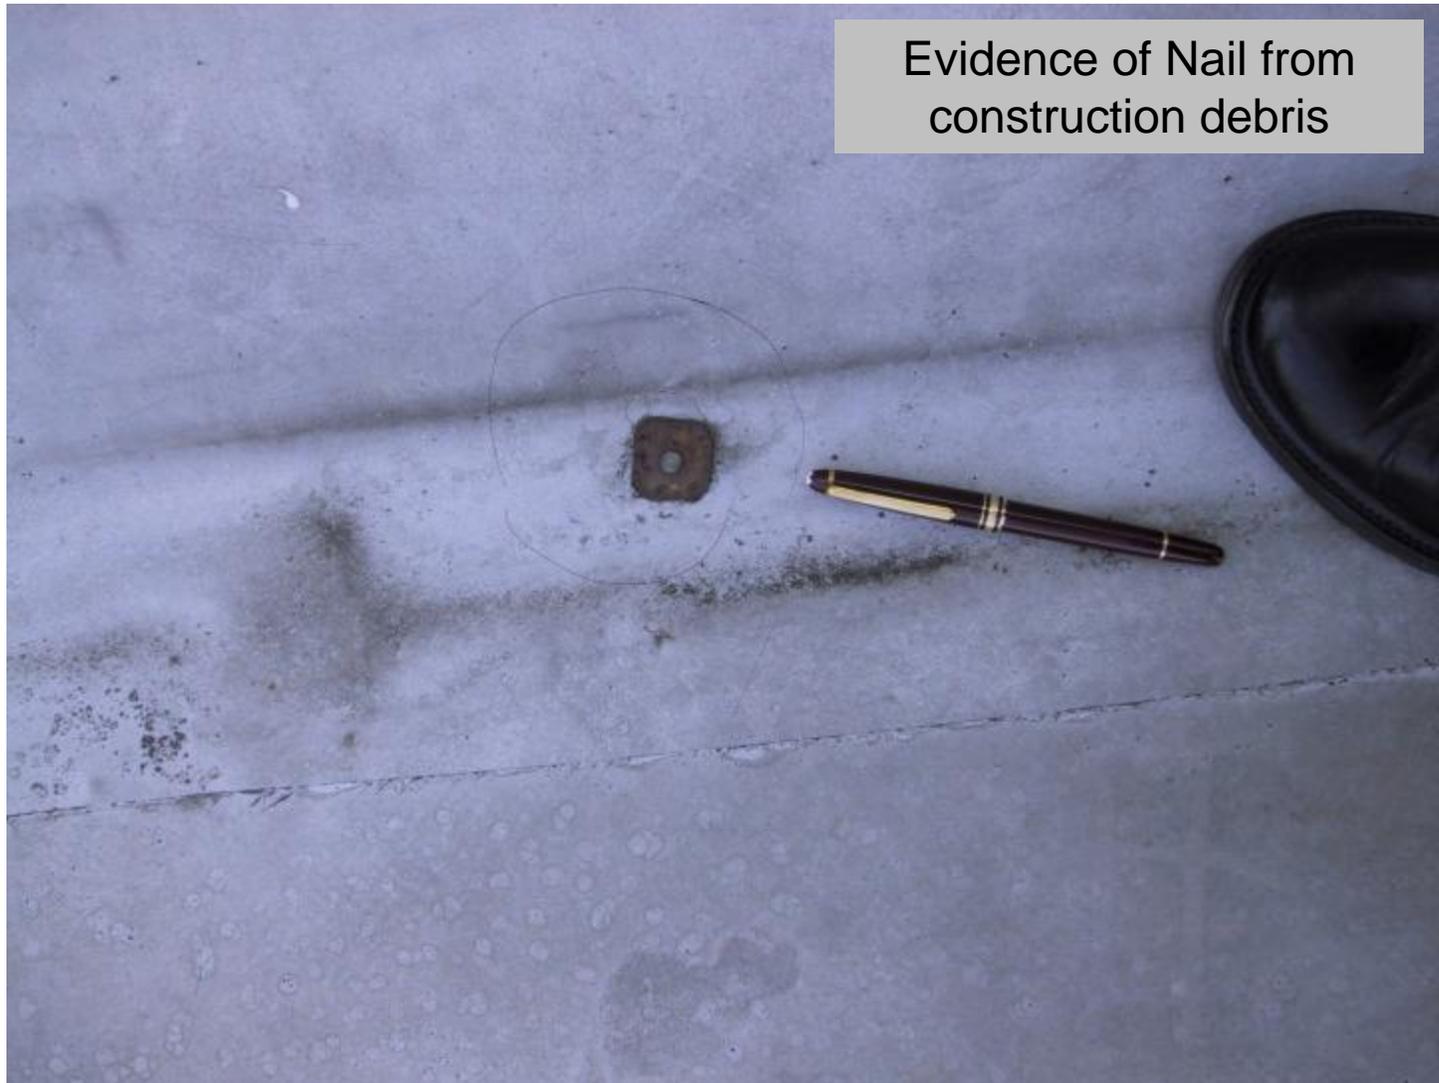
**Sustainability, impact
damage**

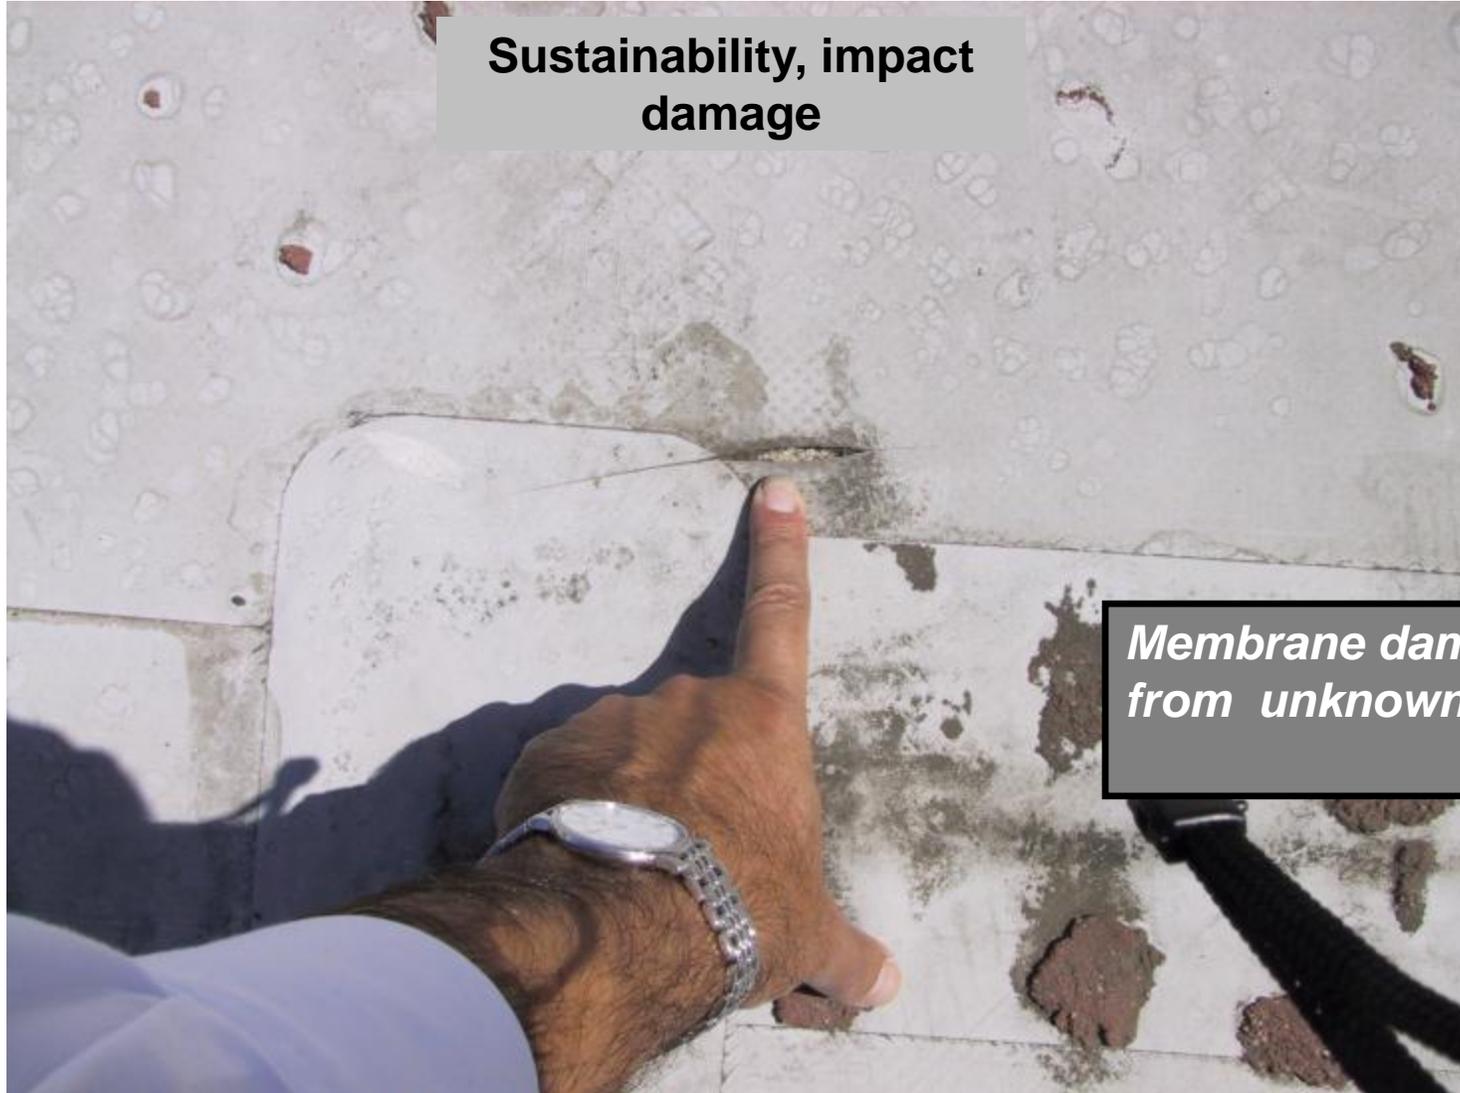
***Membrane damage
from unknown source***

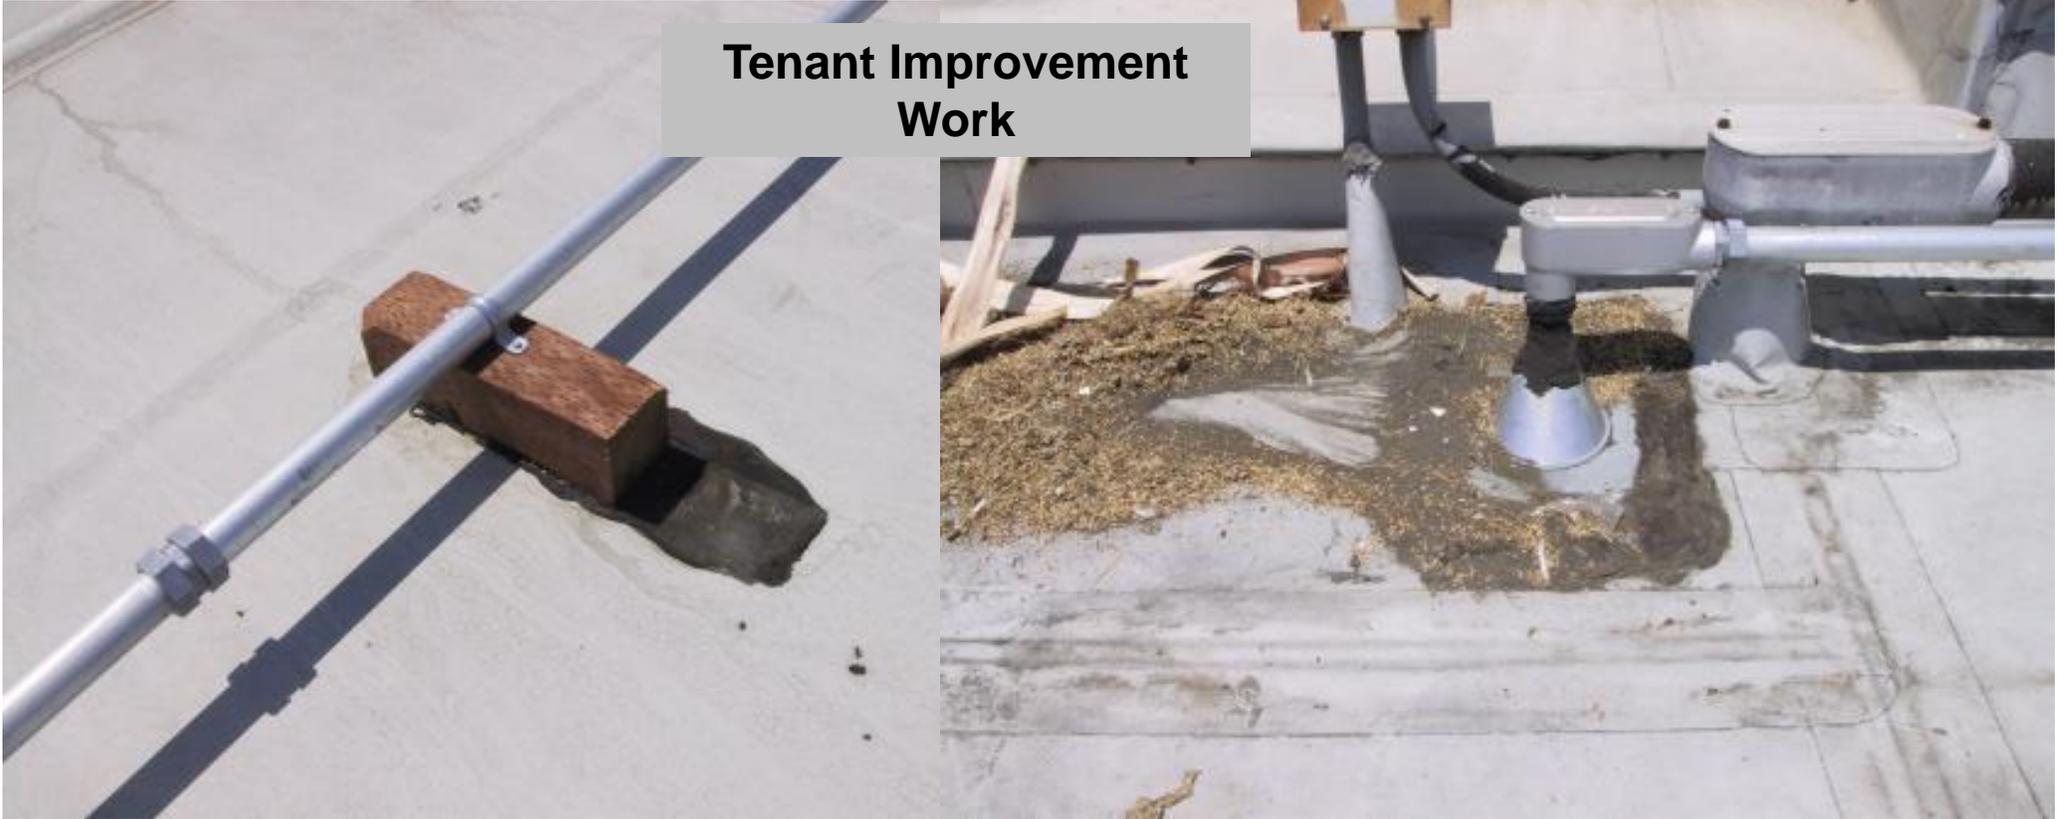
**New electrical pipe added, pipe jack set in mastic
(not properly flashed with single ply) and wood
block set in mastic (incompatible with PVC)**

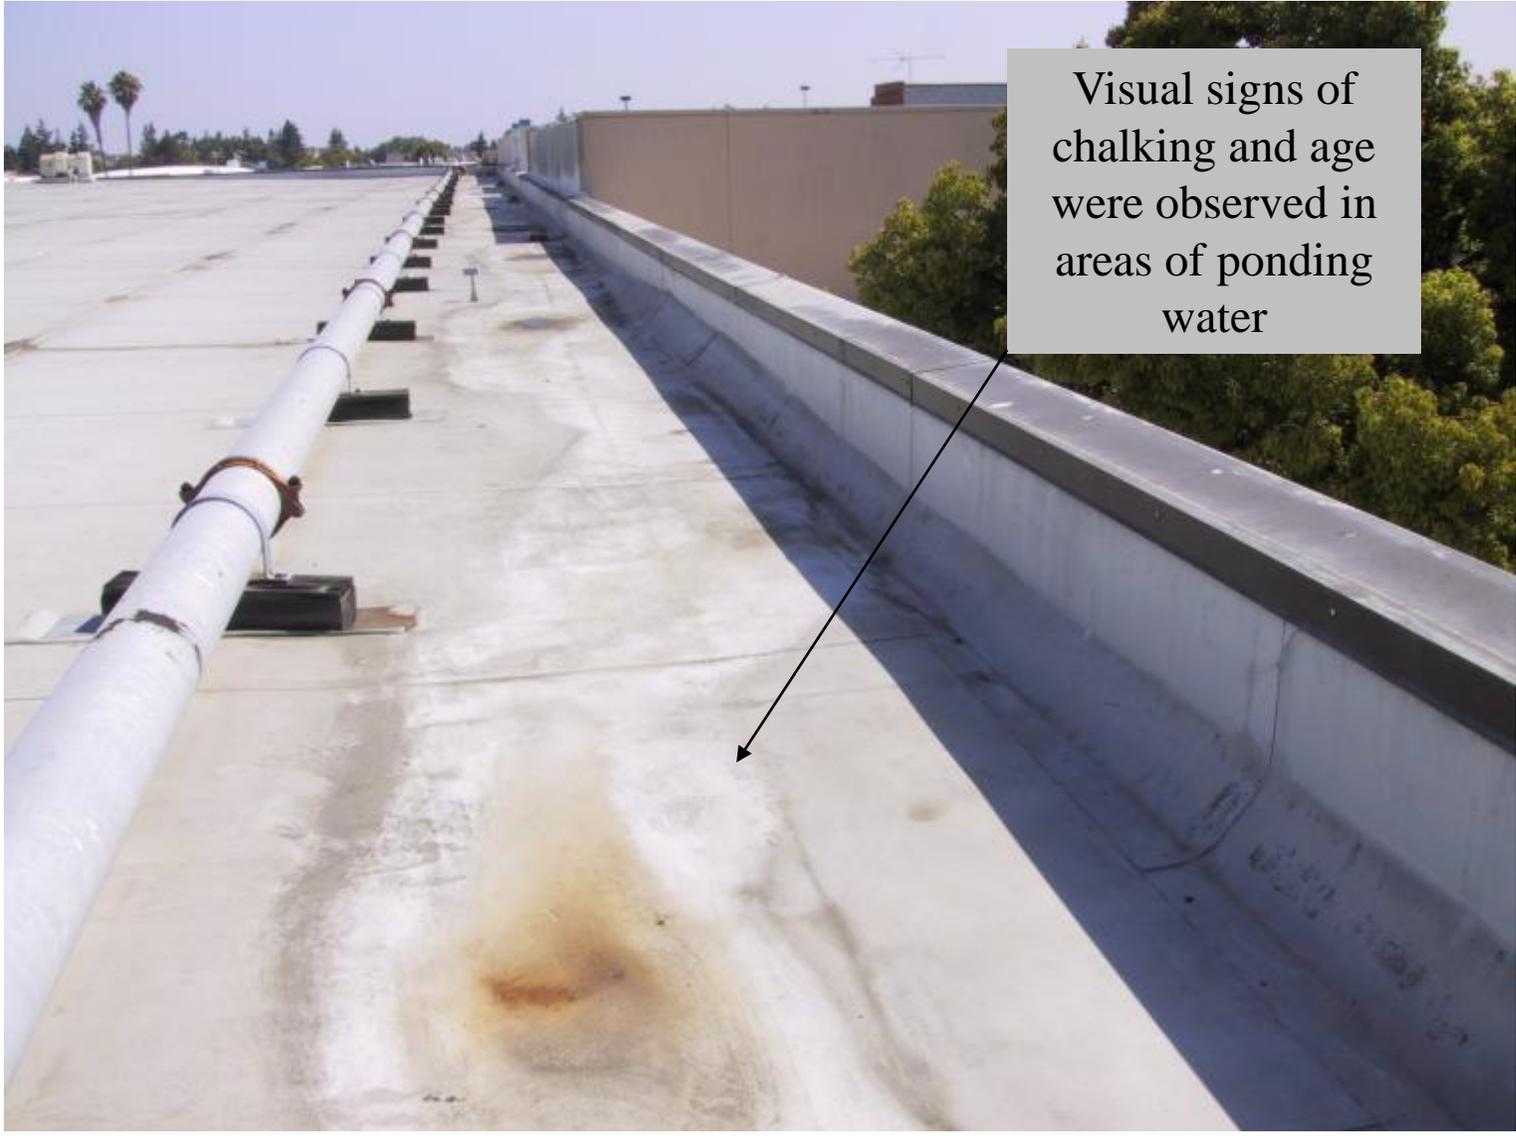
Visual signs of chalking and age were observed in areas of ponding water

Cooling tower and
condensate water leaking
over roof

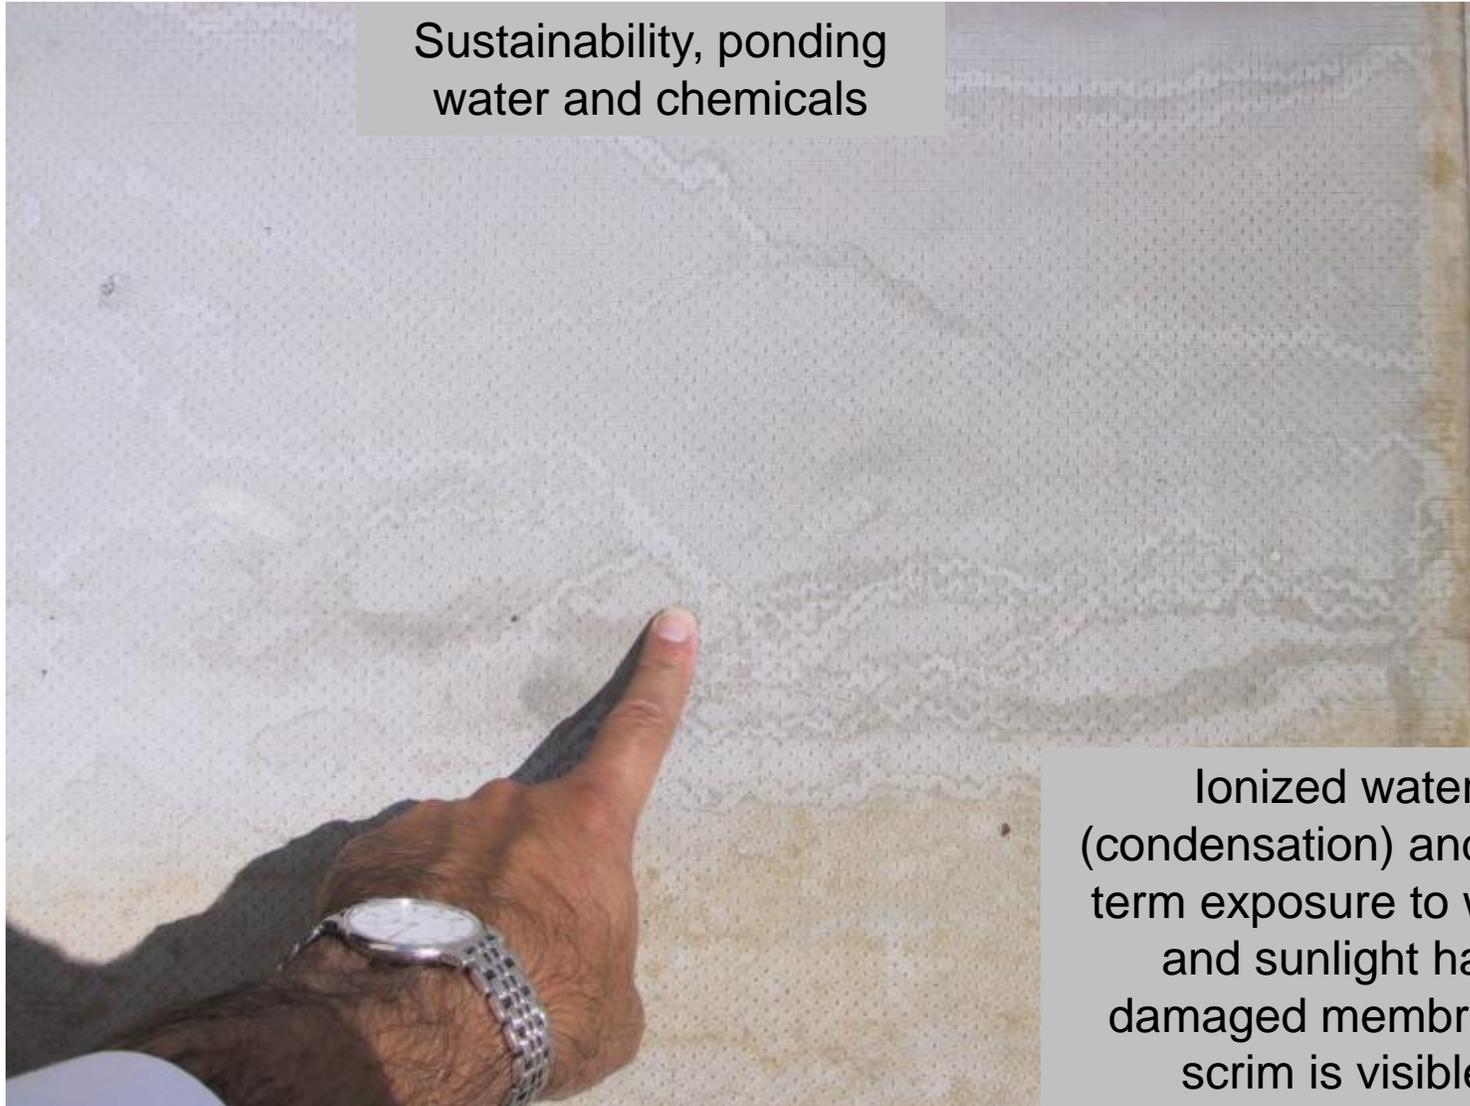
Ionized water
(condensation) and long
term exposure to water
and sunlight has
damaged membrane,
scrim is visible

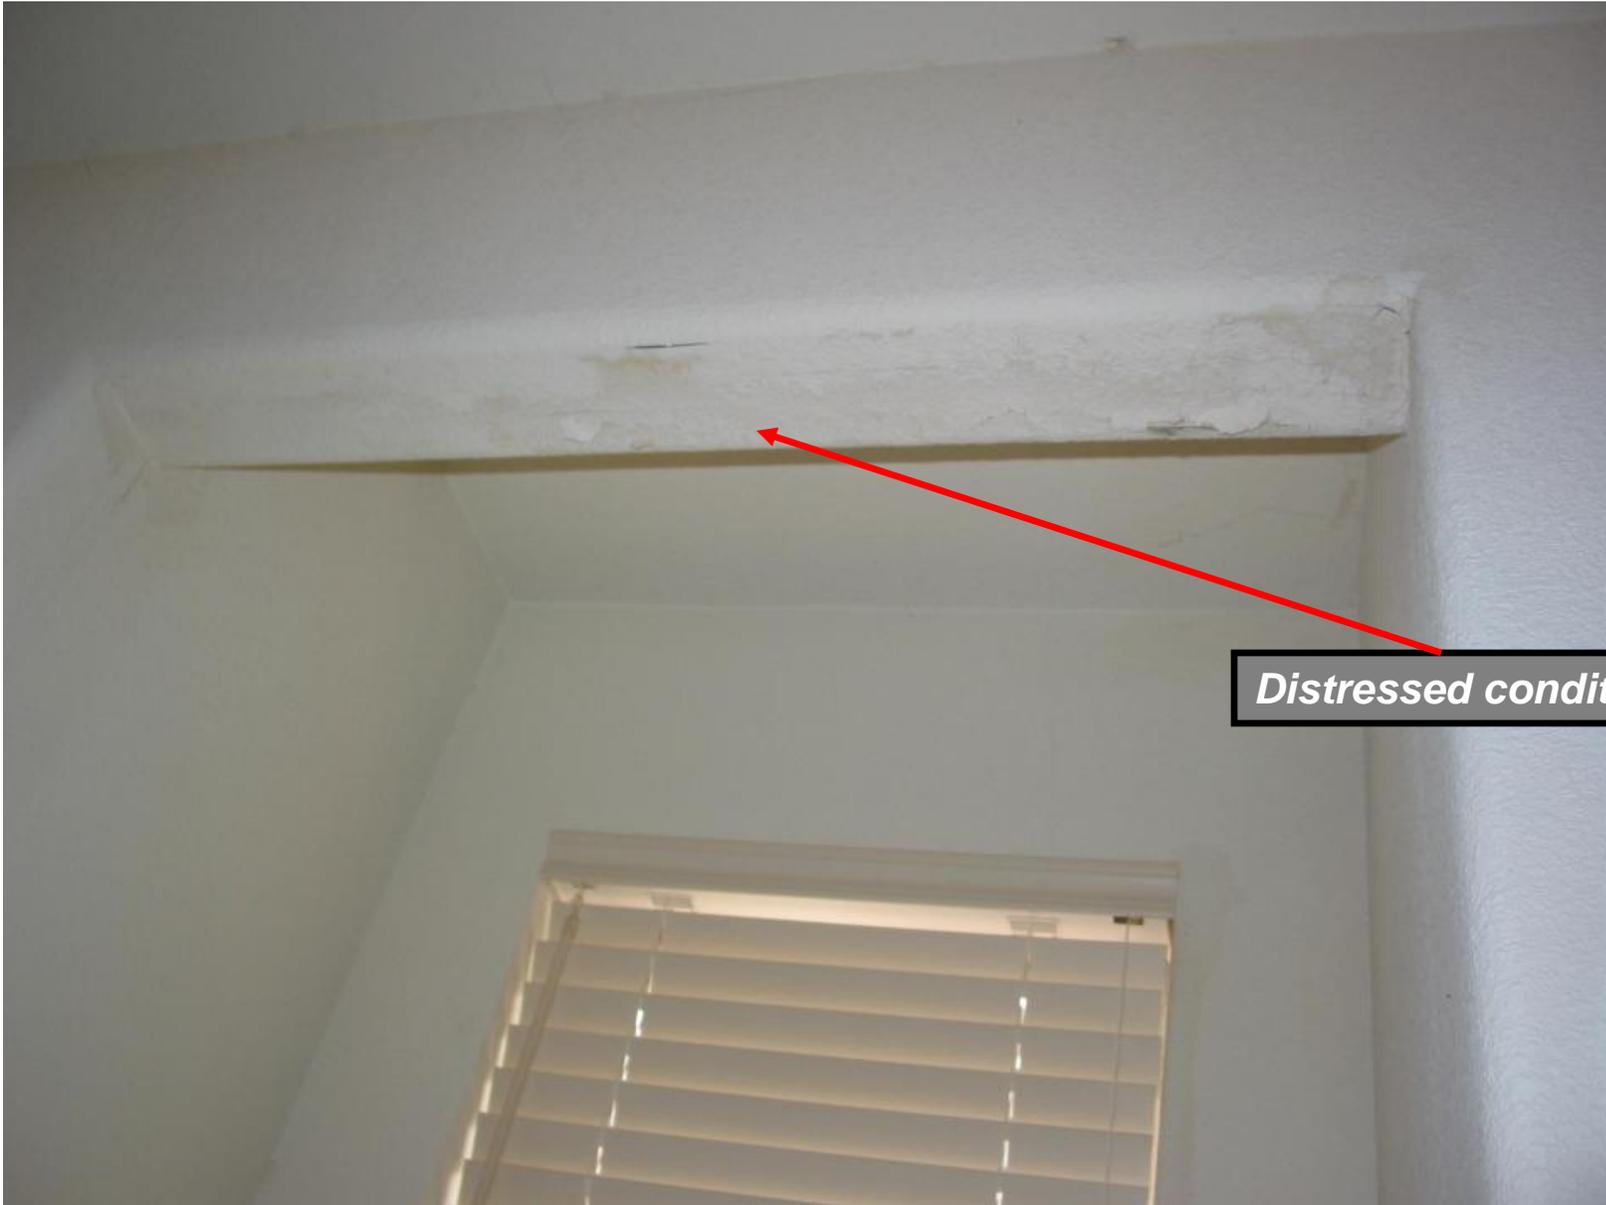
Distressed conditions

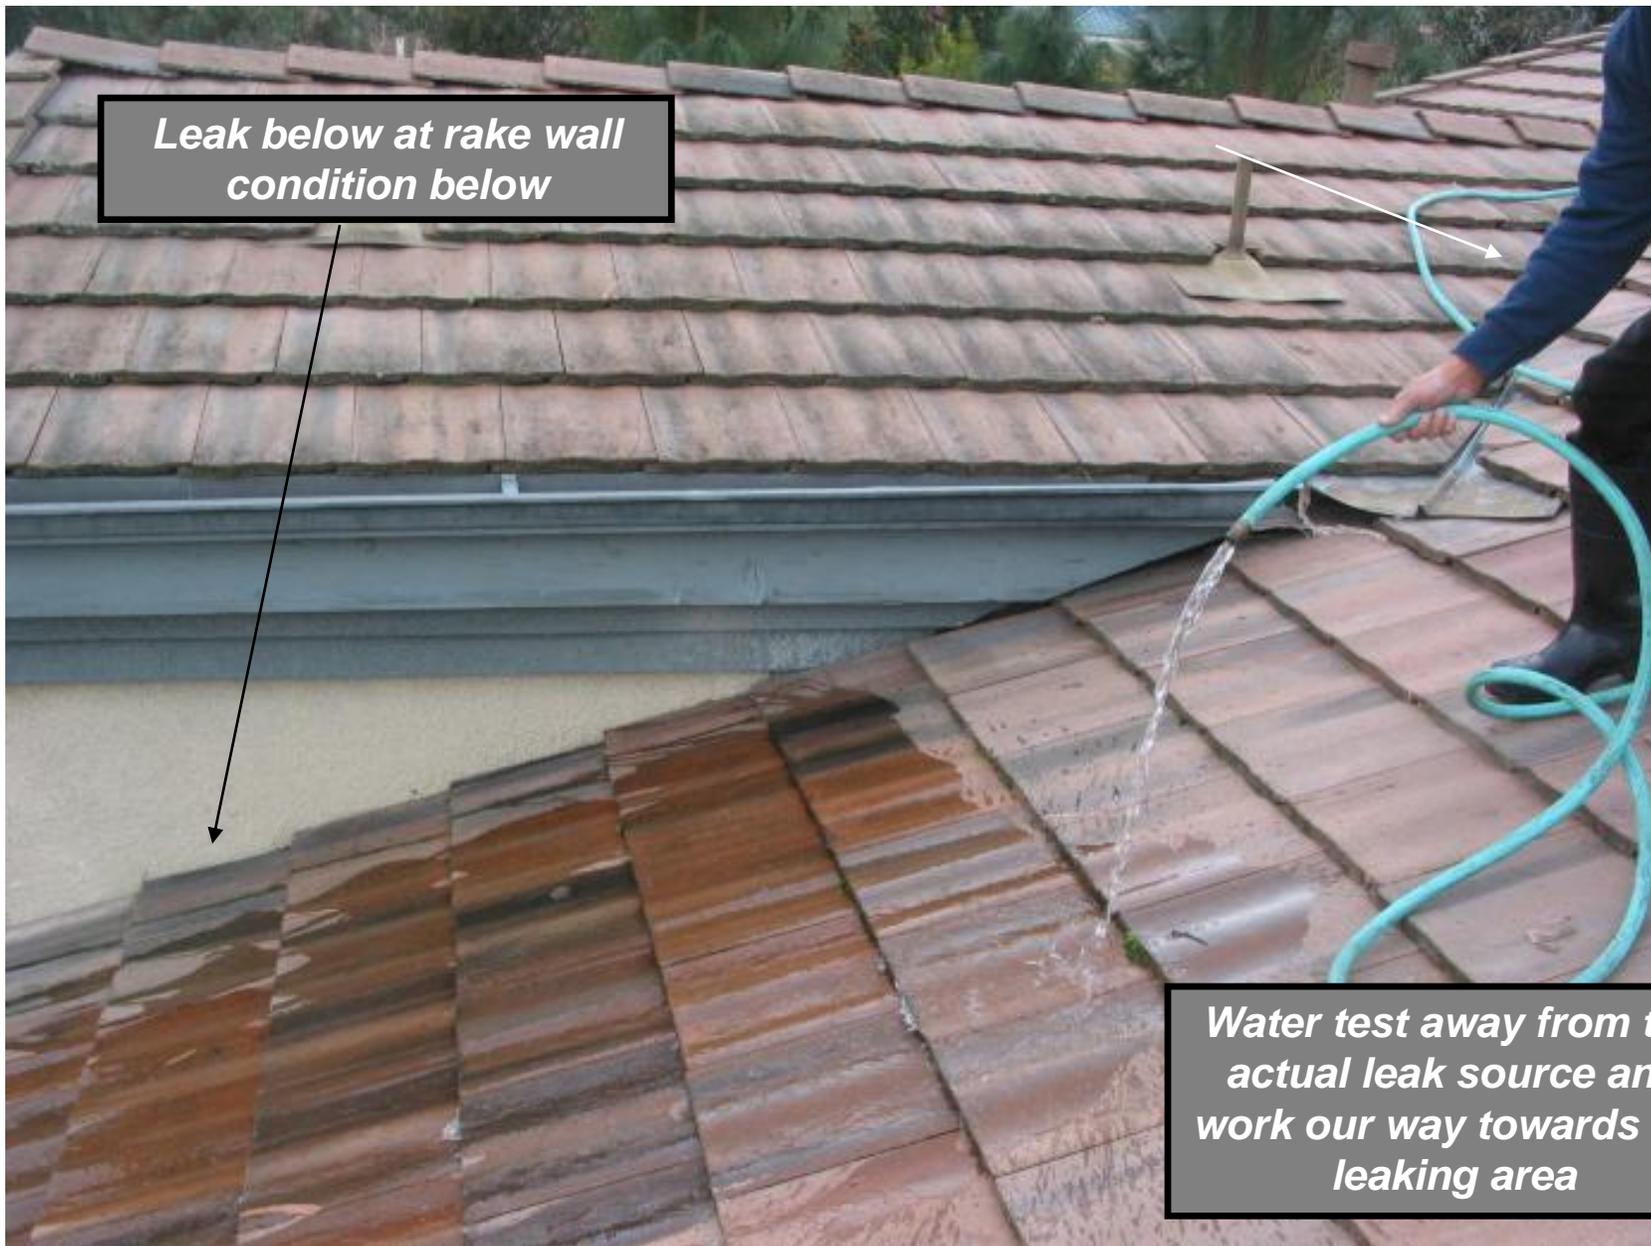
*Leak below at rake wall
condition below*

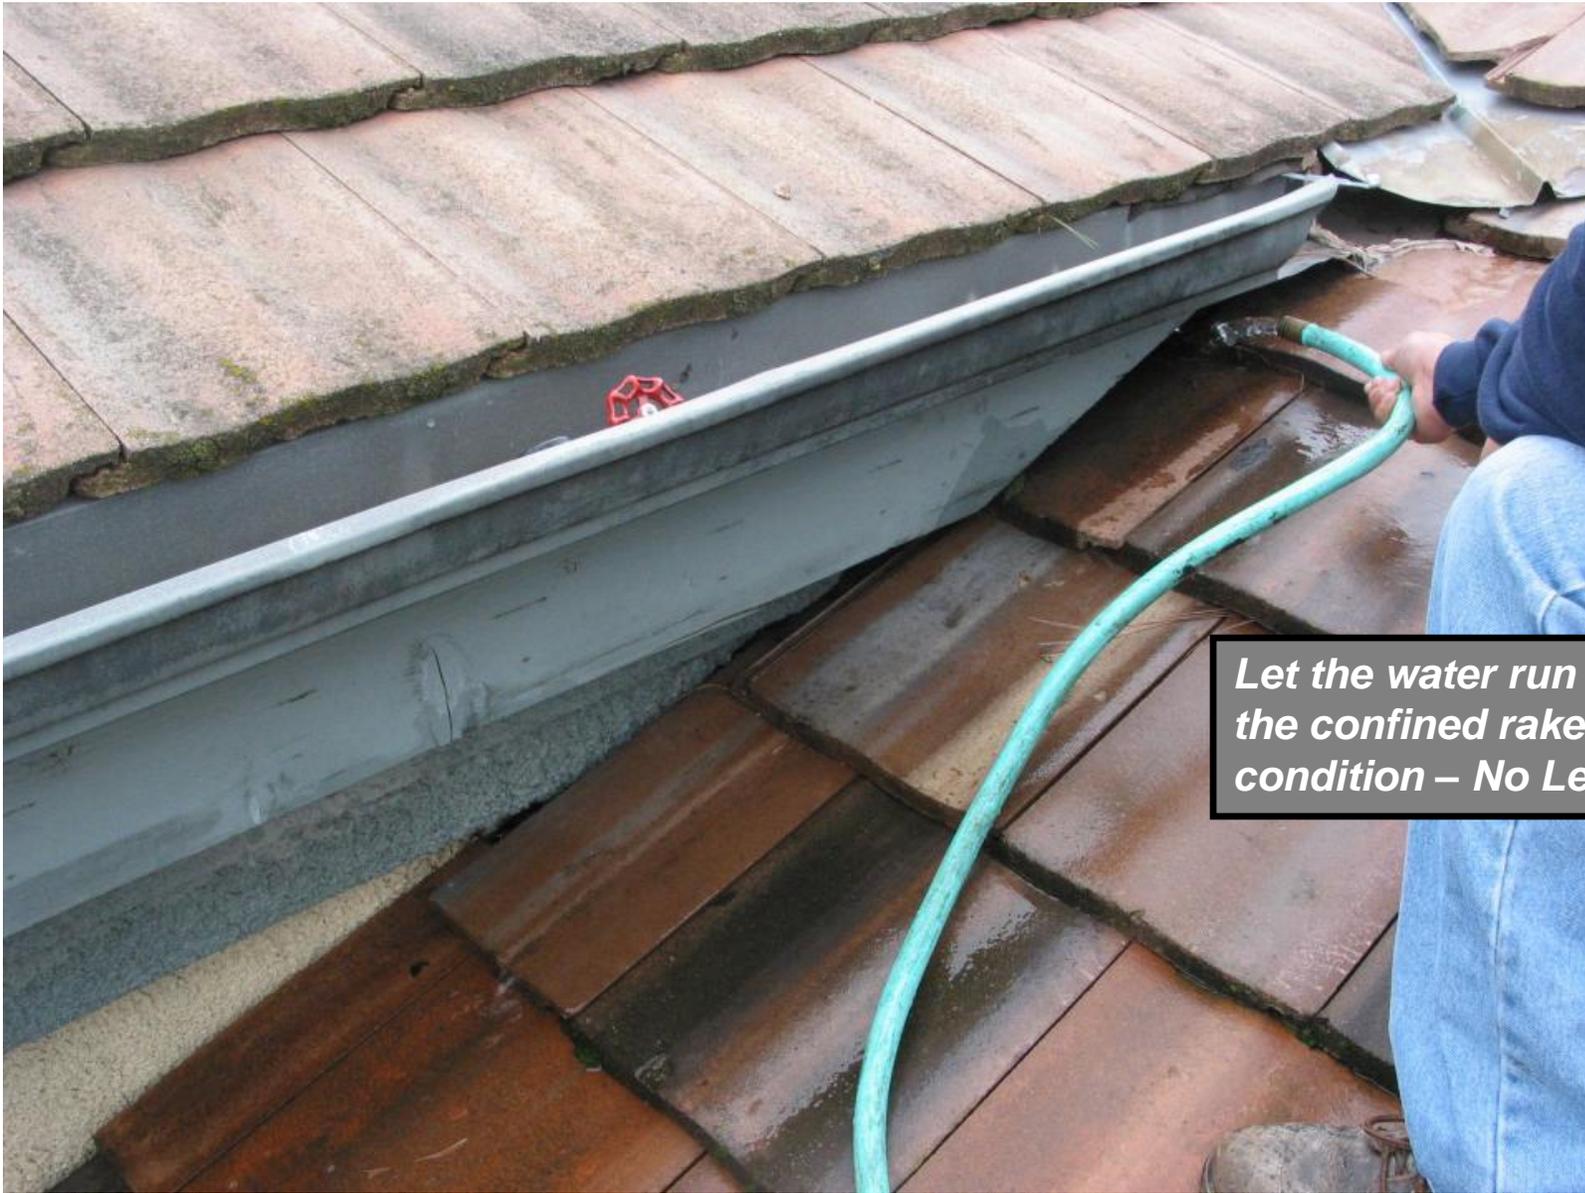
Let the water run down the confined rake condition – No Leak!

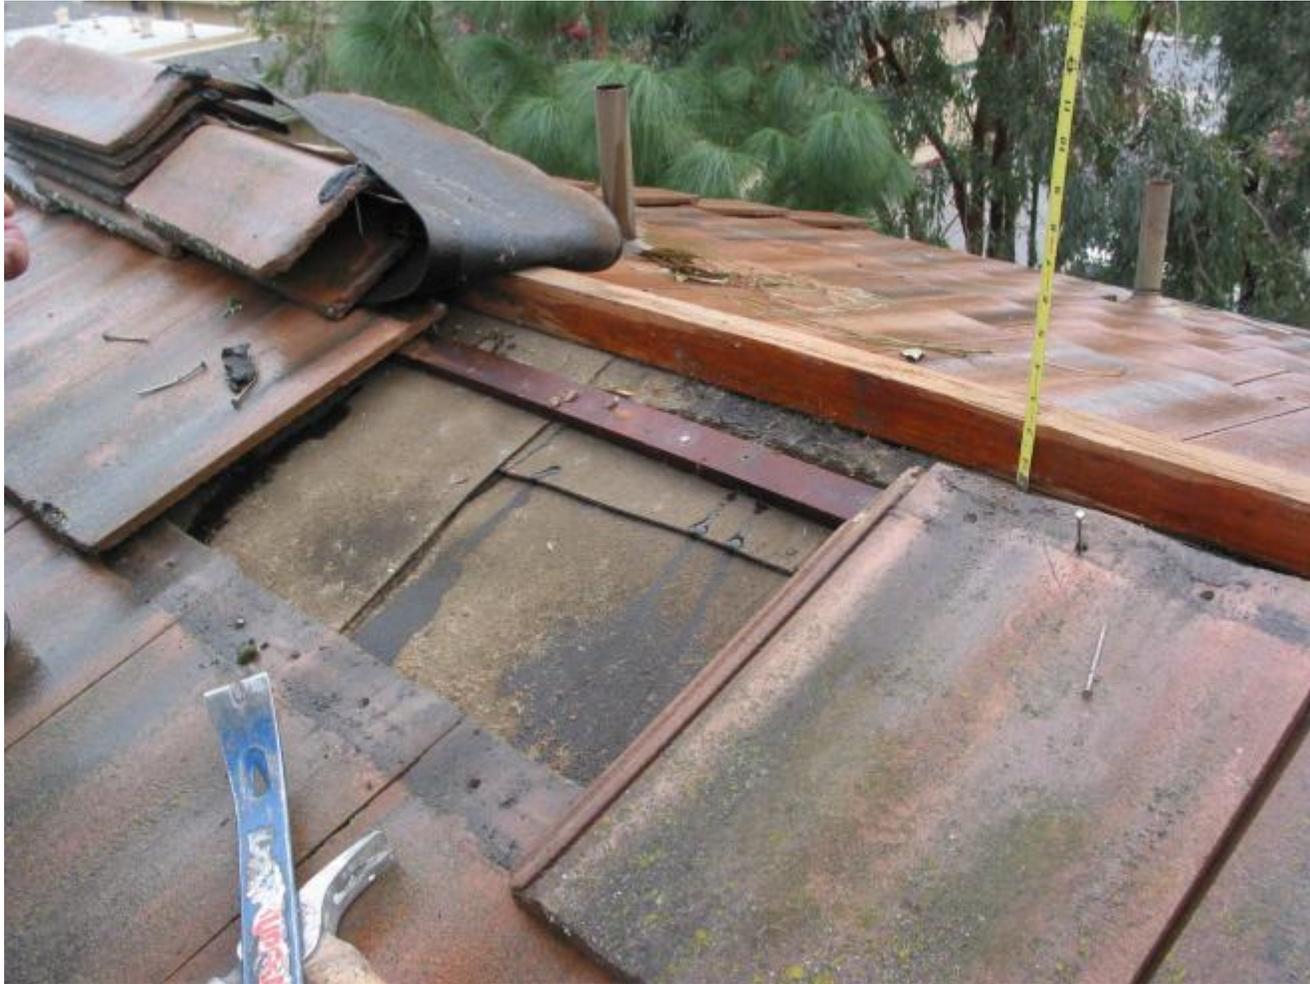
Water penetration but this was not the primary source of leak in unit below.

Improper membrane was utilized as wind block. 30lb felt was used instead of 9" pressure sensitive adhesive membrane recommended by material manufacturer.

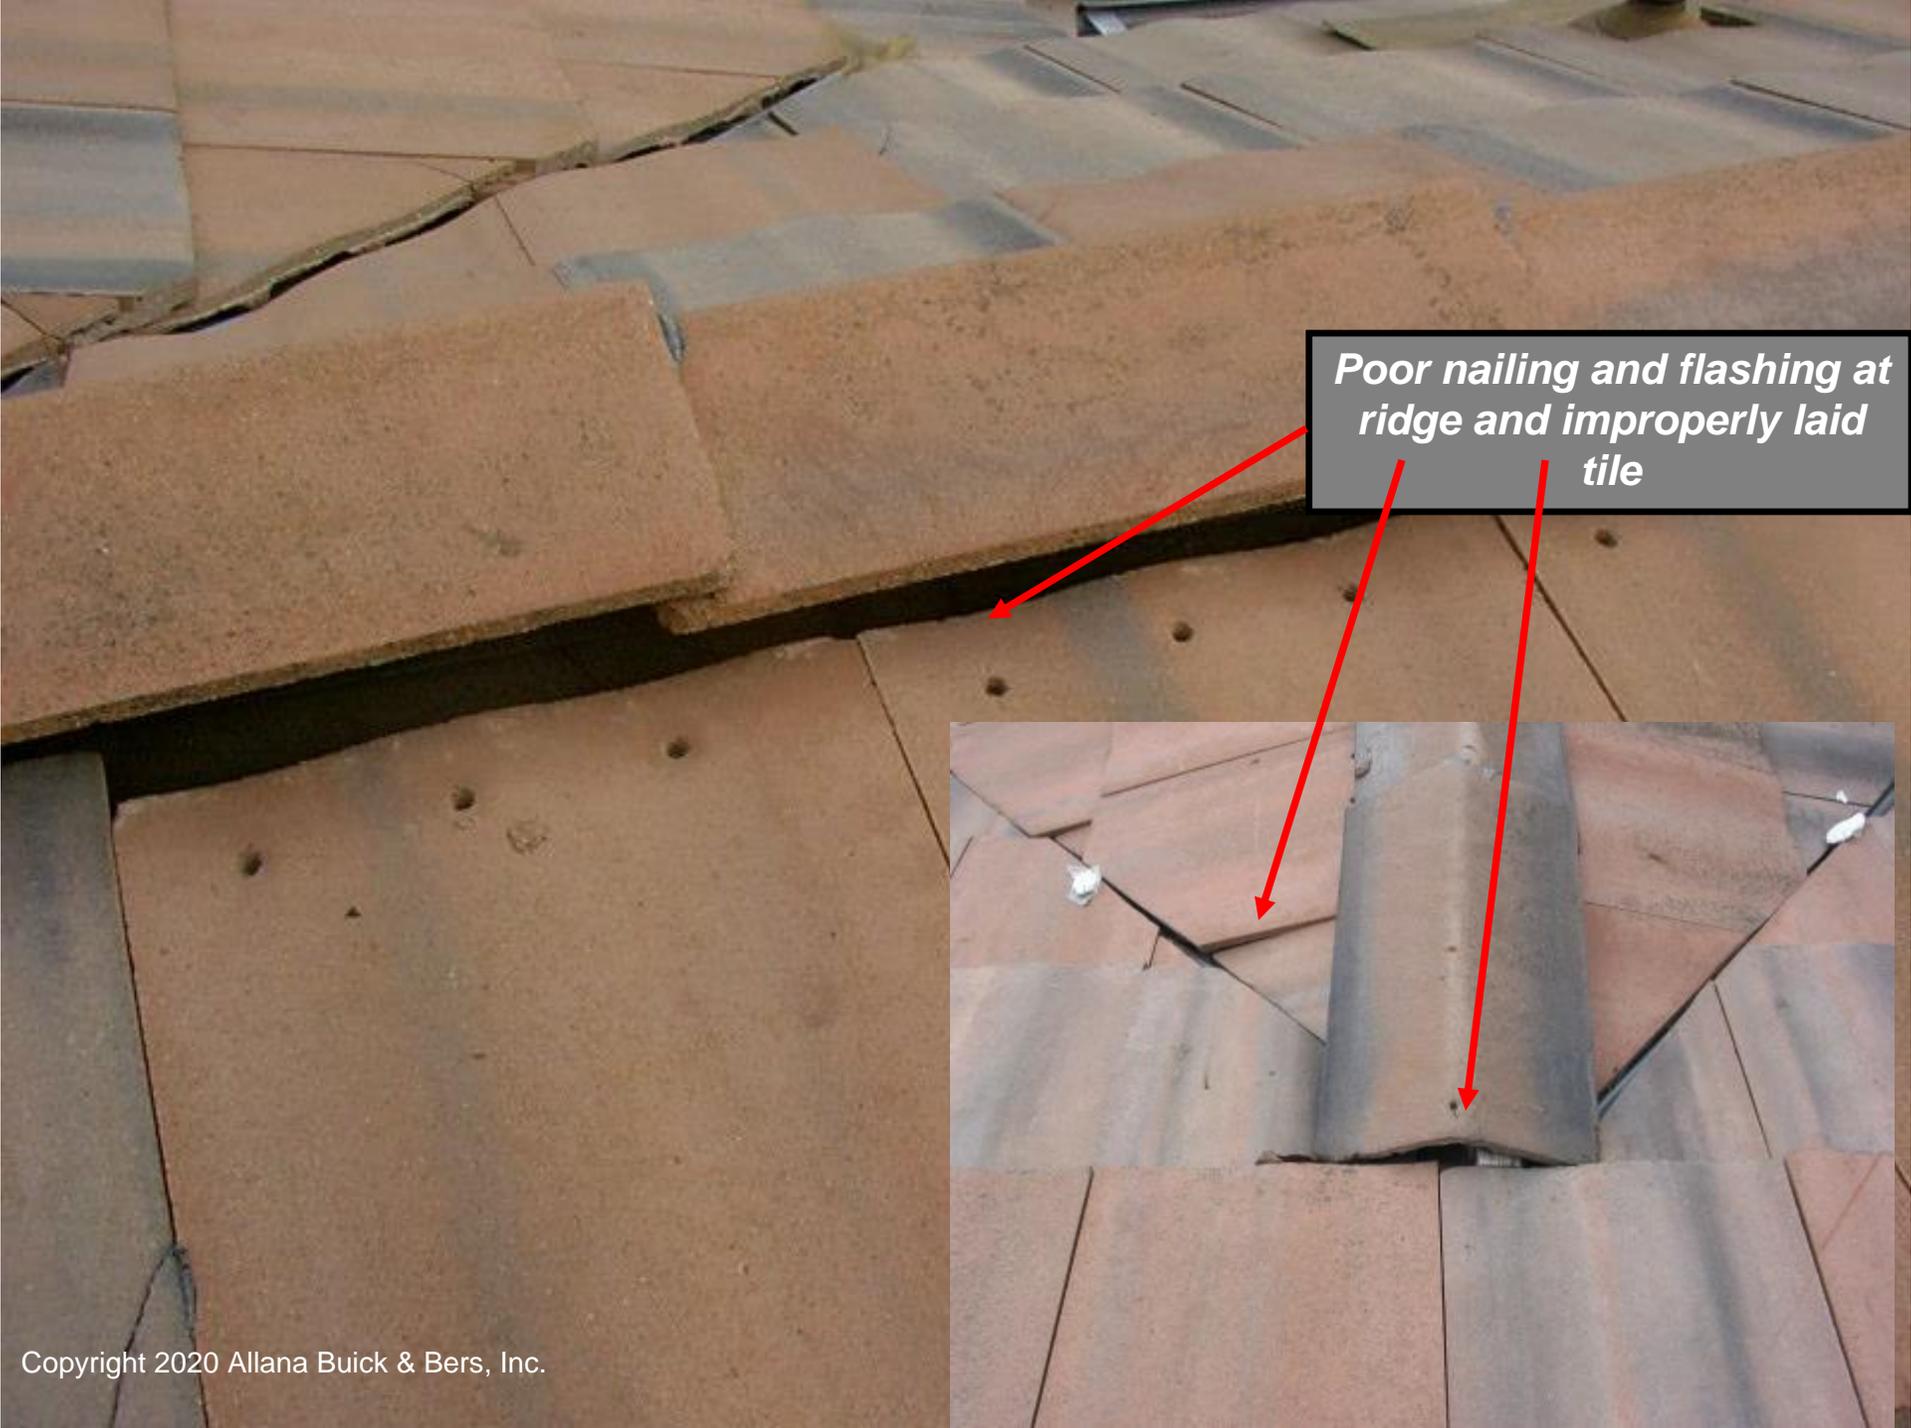
Poor nailing and flashing at ridge and improperly laid tile
