Forensic Analysis of Roofing Systems Examples of Roof Performance Learn from Failures to Make Roofs More Sustainable!

Bay Area Facility Management Show – Forensic Analysis of
Roofing Systems

Case 1: Forensic Investigation of Metal Roof Failure

Case 2: PVC Single Ply Sustainability

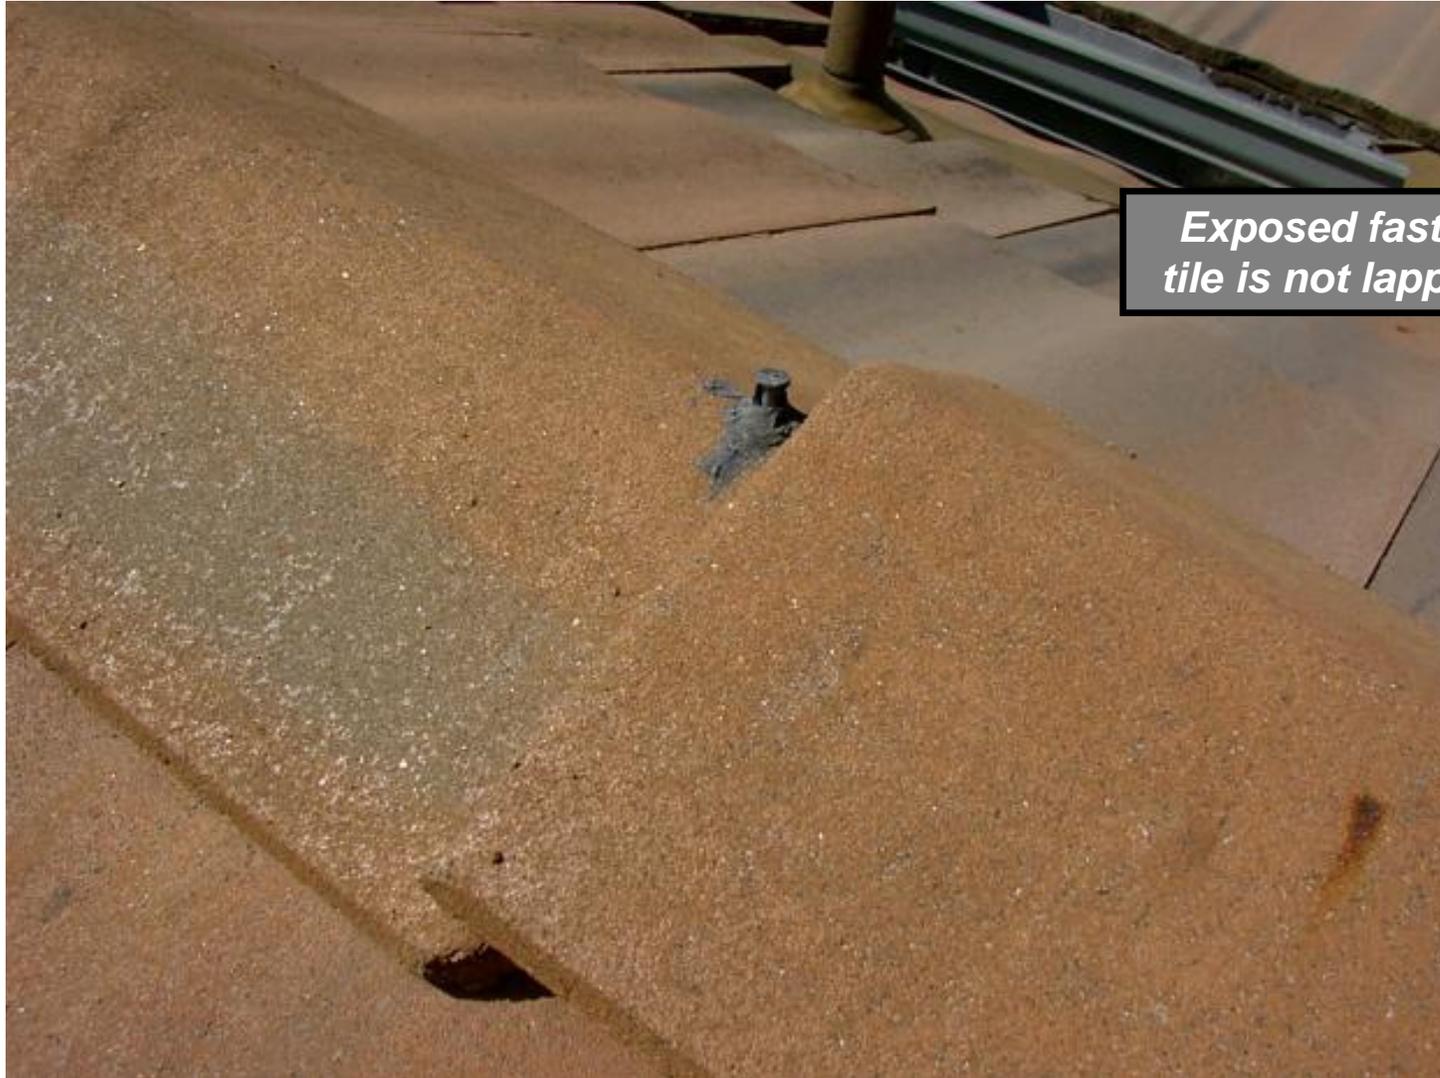
Exposed fastener. Ridge tile is not lapped properly.

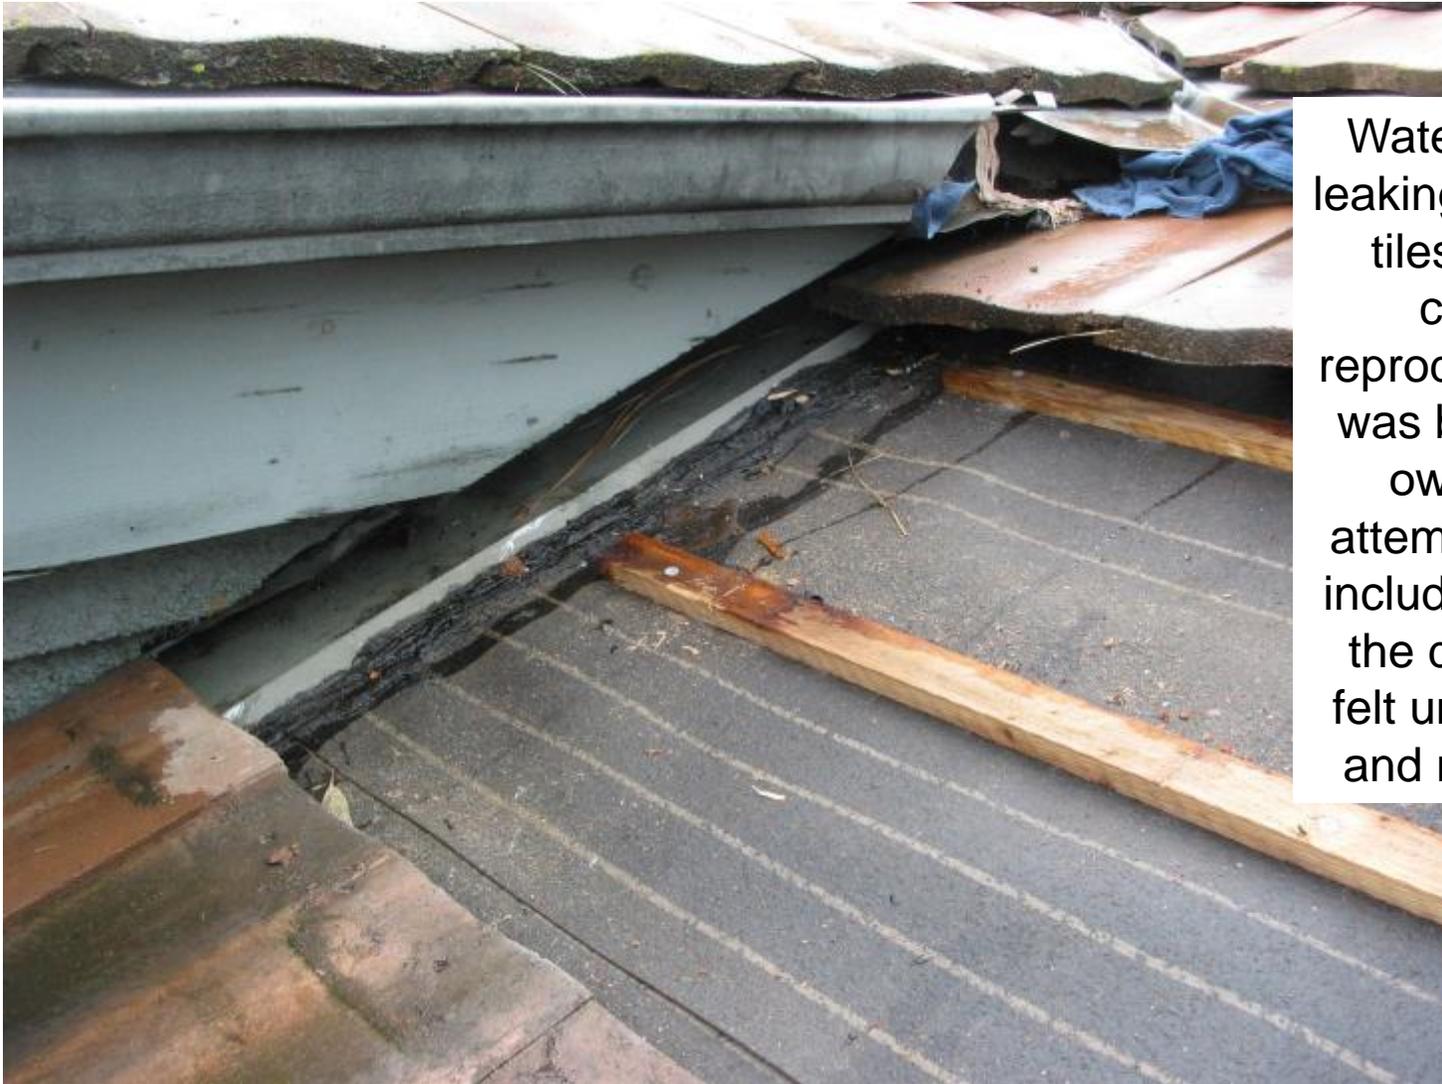
Water had been leaking through the tiles however, could not reproduce the leak was because the owner's last attempt at repairs included replacing the deteriorated felt underlayment and mastic seal.

Much of the tile was installed with staggered joints. We observed a very high incidence of broken tile corners, which was primarily the source of leaks.

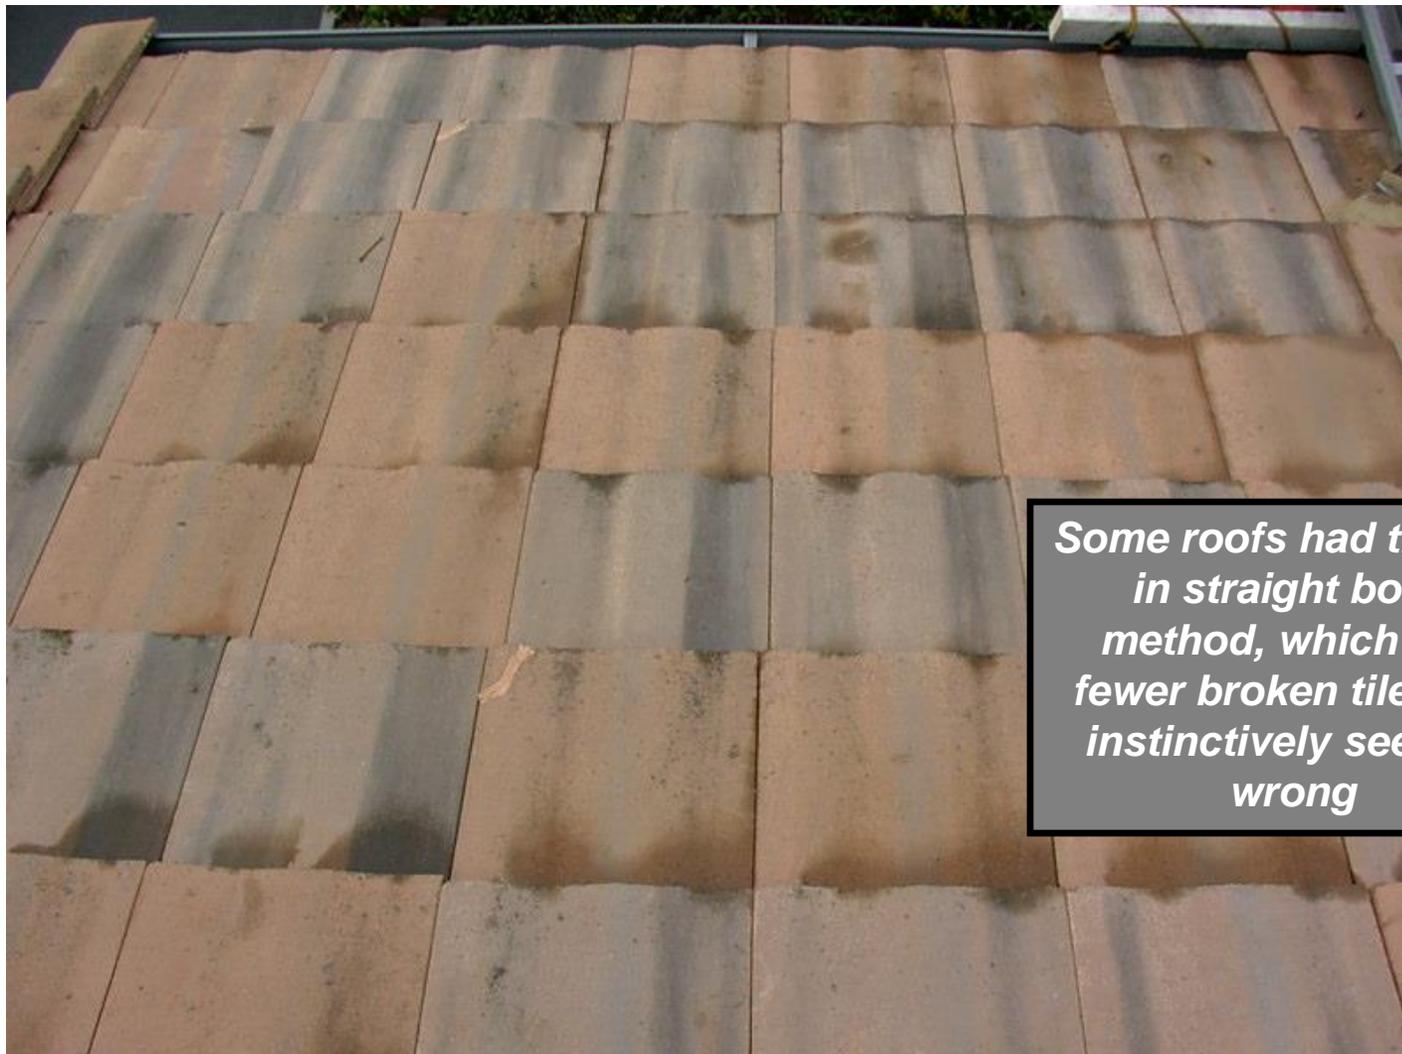
*Some roofs had tile laid
in straight bond
method, which had
fewer broken tiles but
instinctively seemed
wrong*

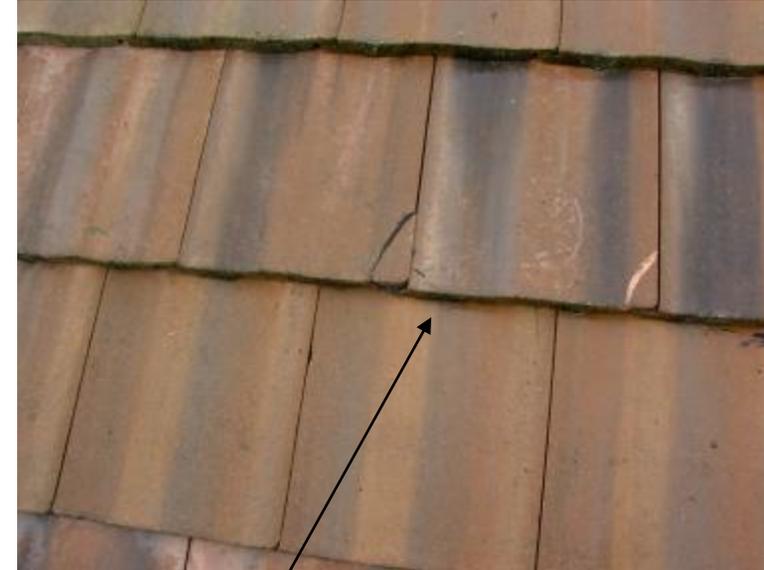
***ANOTHER DEFECT:
Joints in tile not
parallel and are too
close, contributing to
breakage***

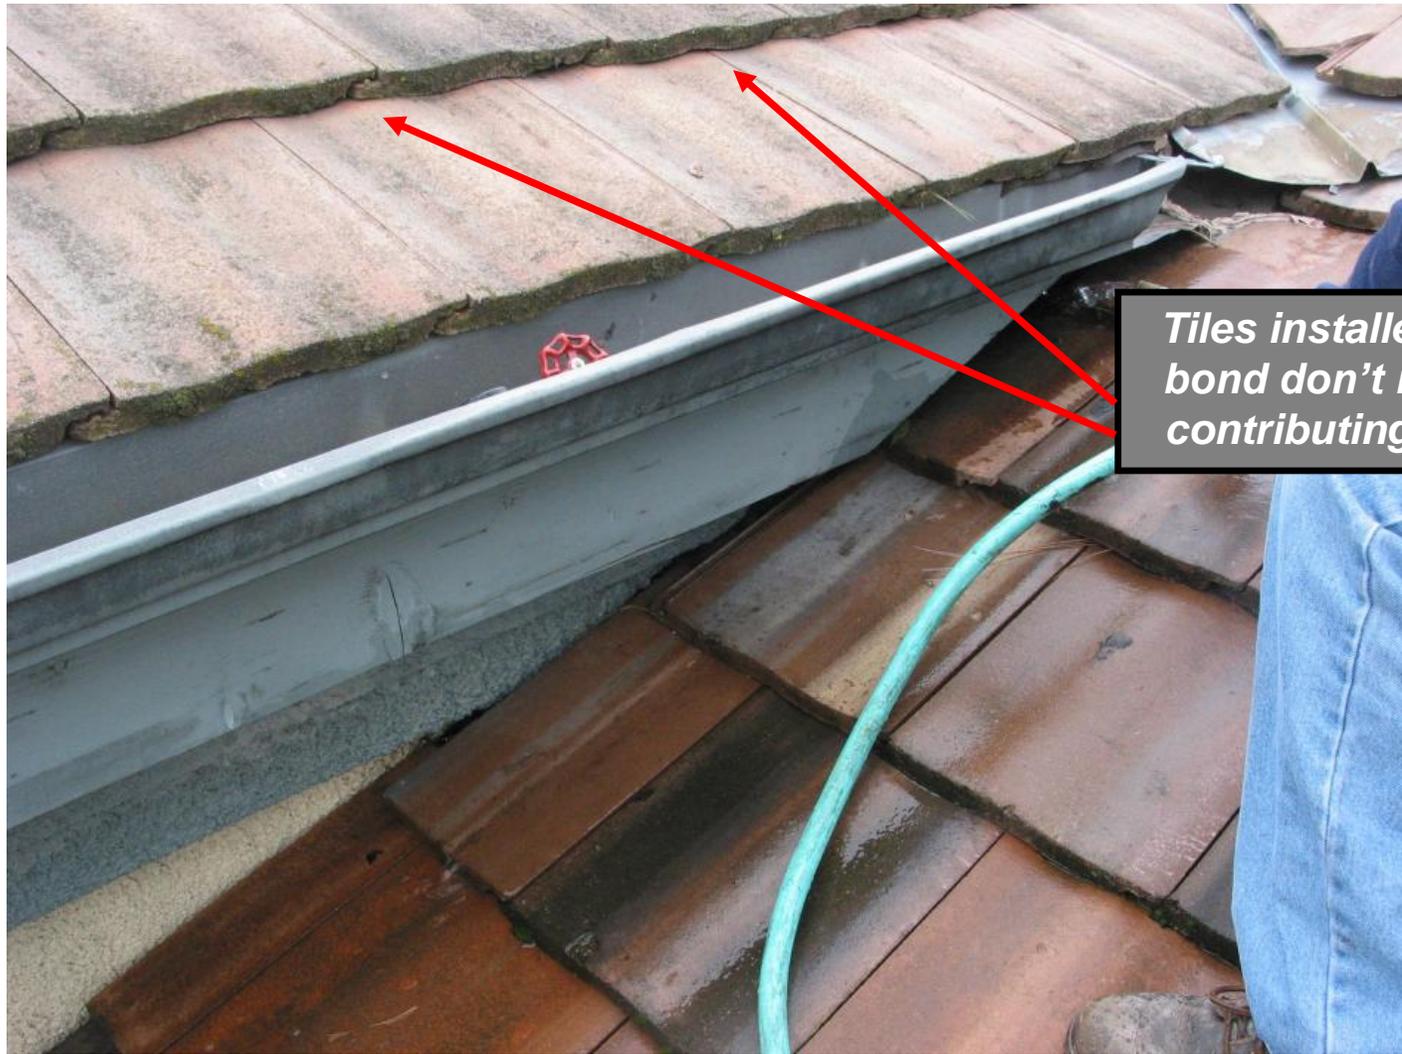
Tiles installed in a broken bond don't nest properly, contributing to breakage.

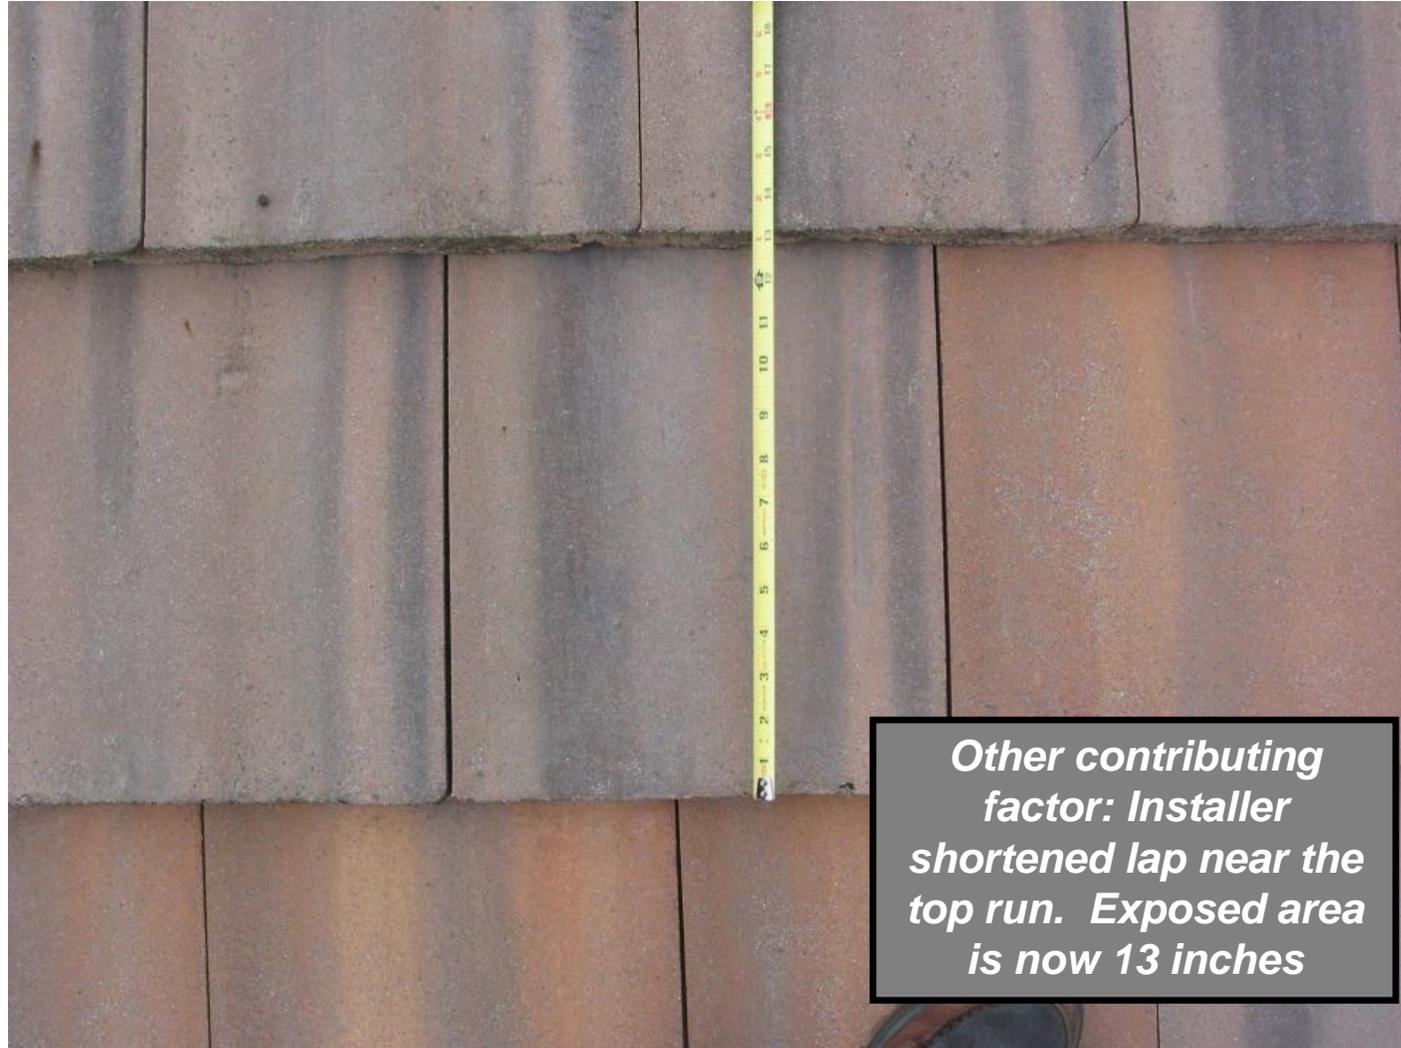
Other contributing factor: Installer shortened lap near the top run. Exposed area is now 13 inches

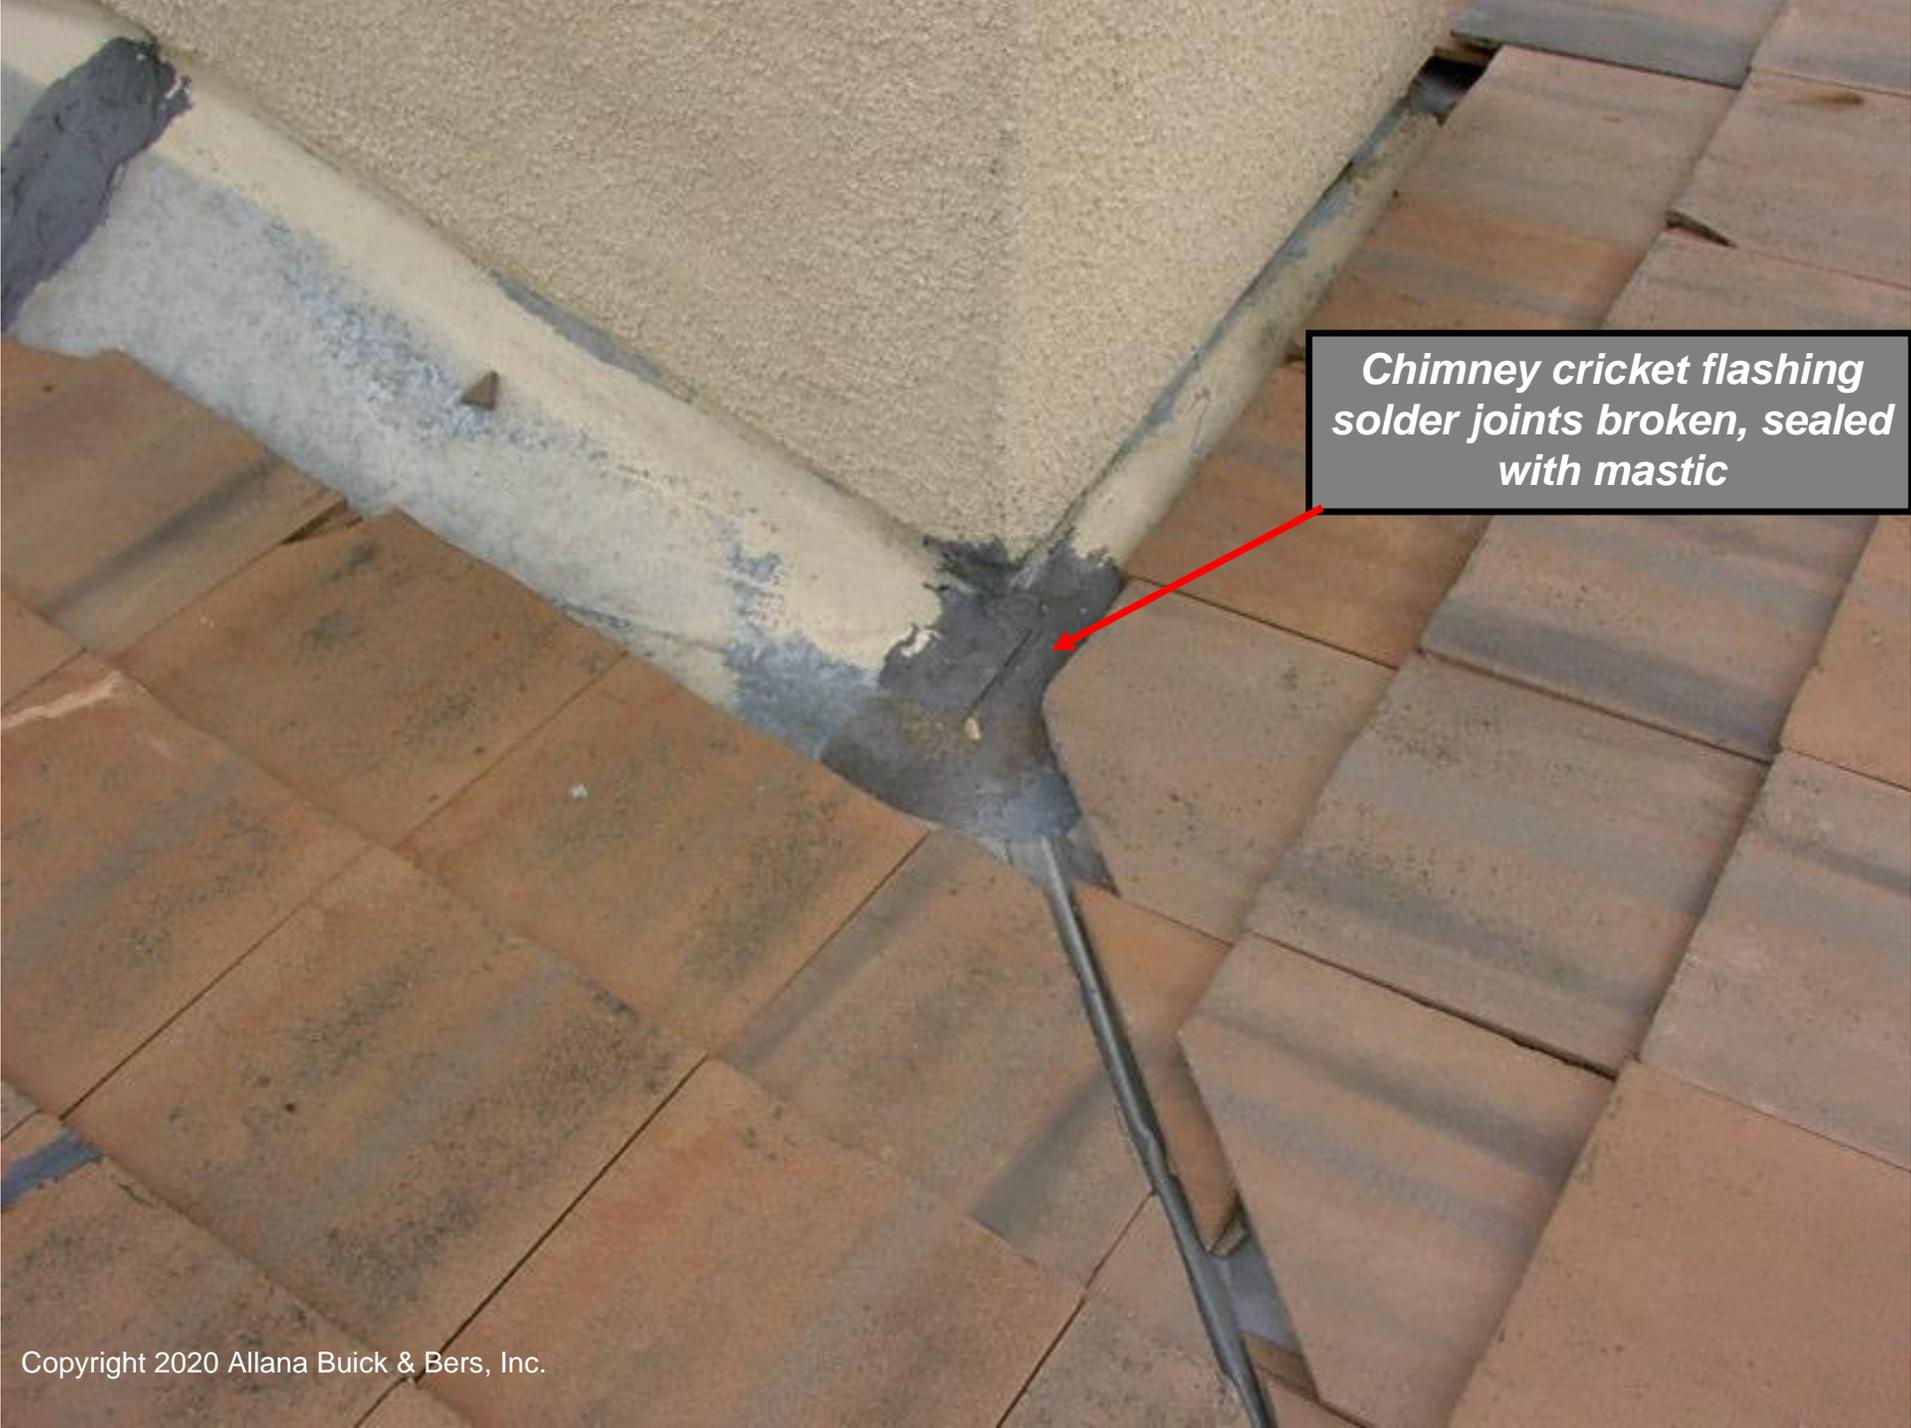
*Chimney cricket flashing
solder joints broken, sealed
with mastic*

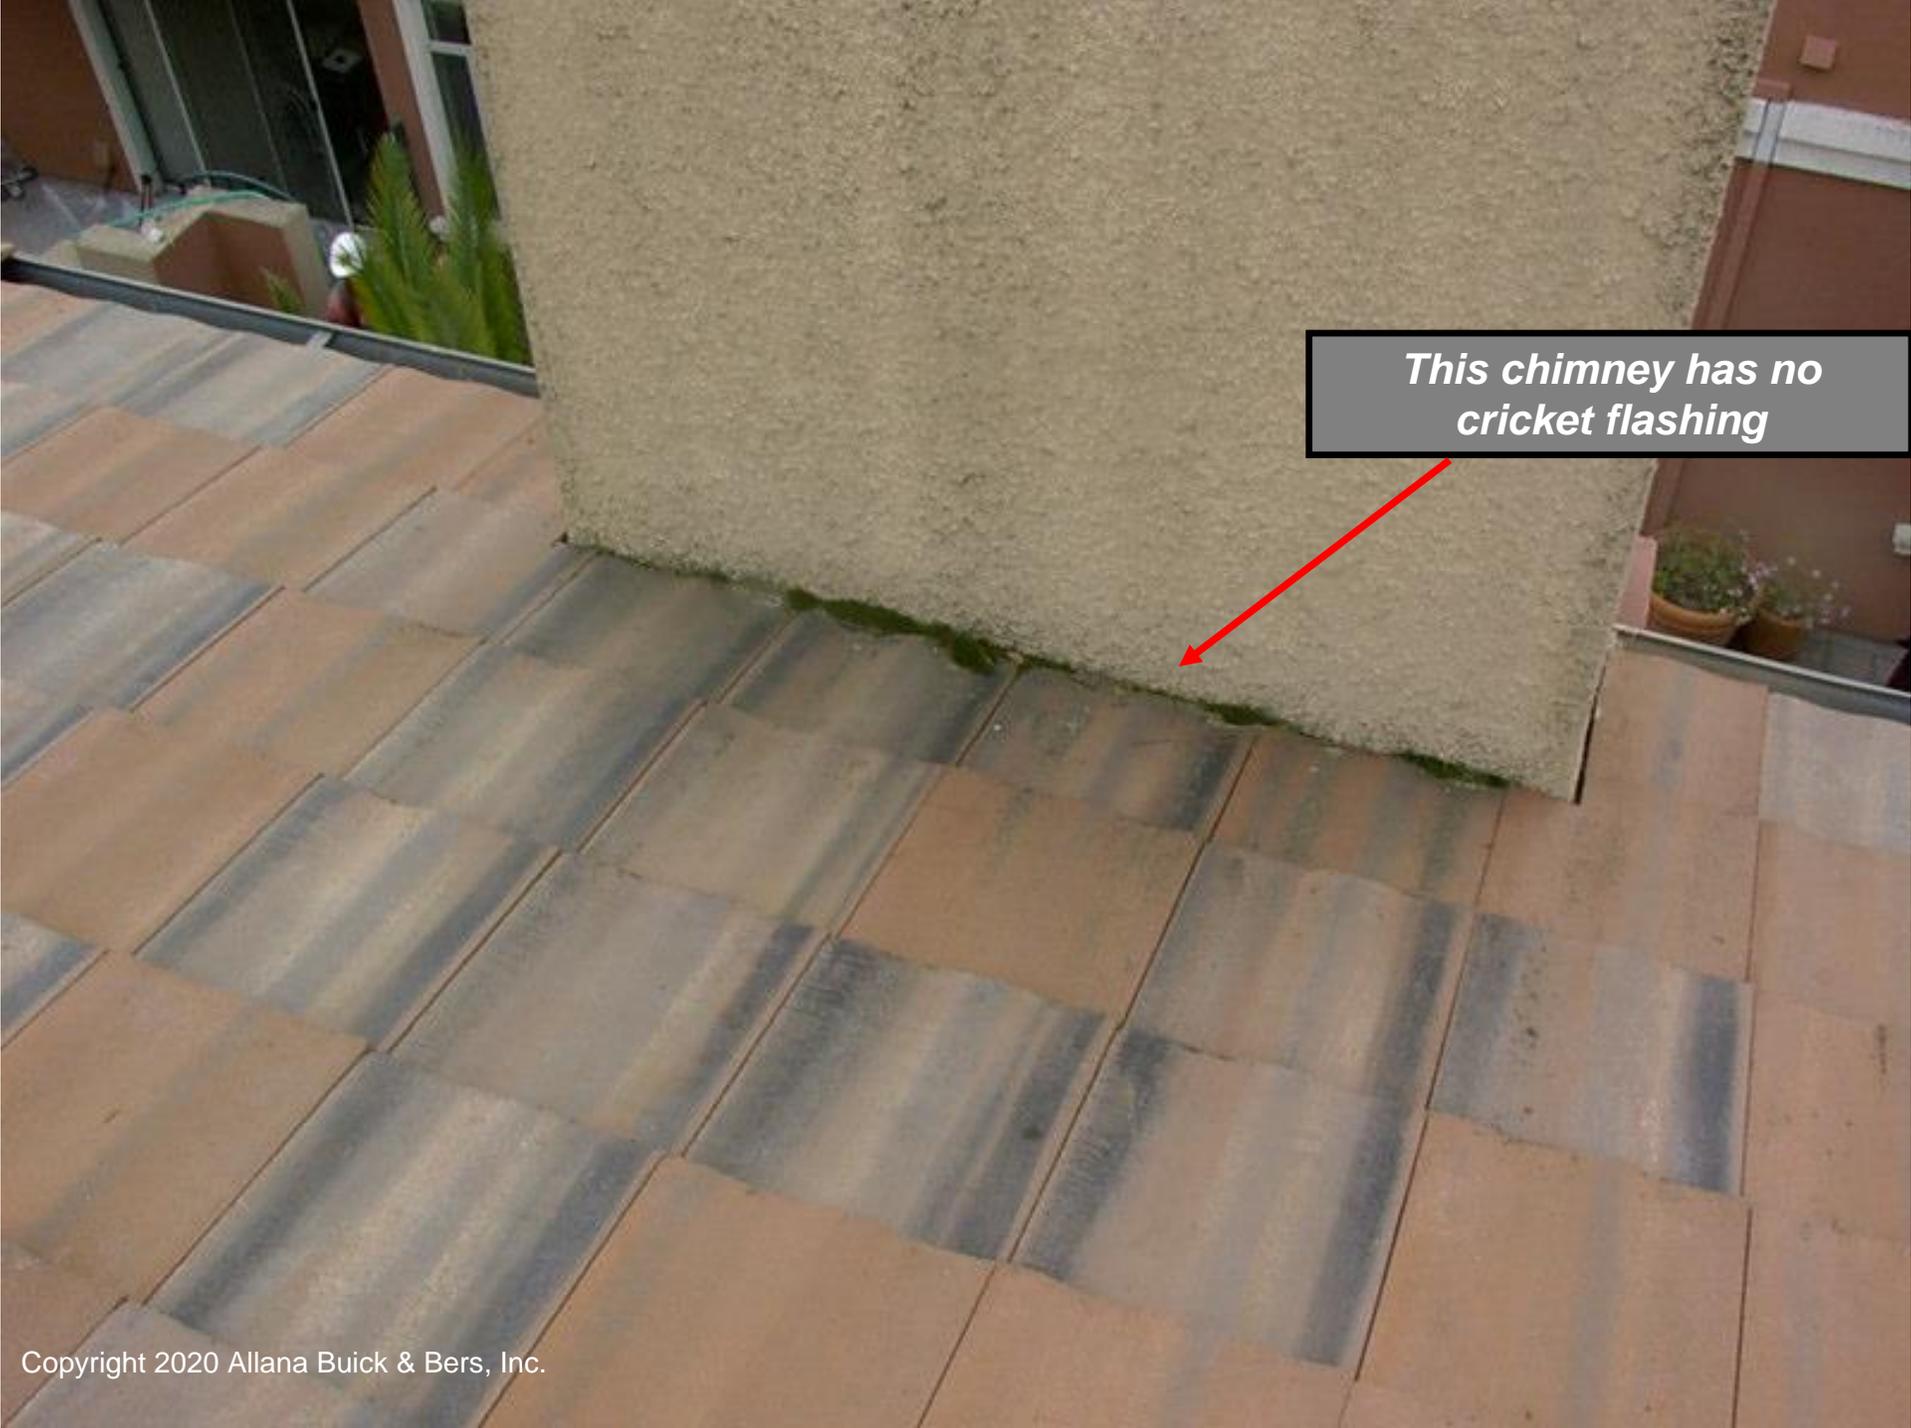
This chimney has no cricket flashing

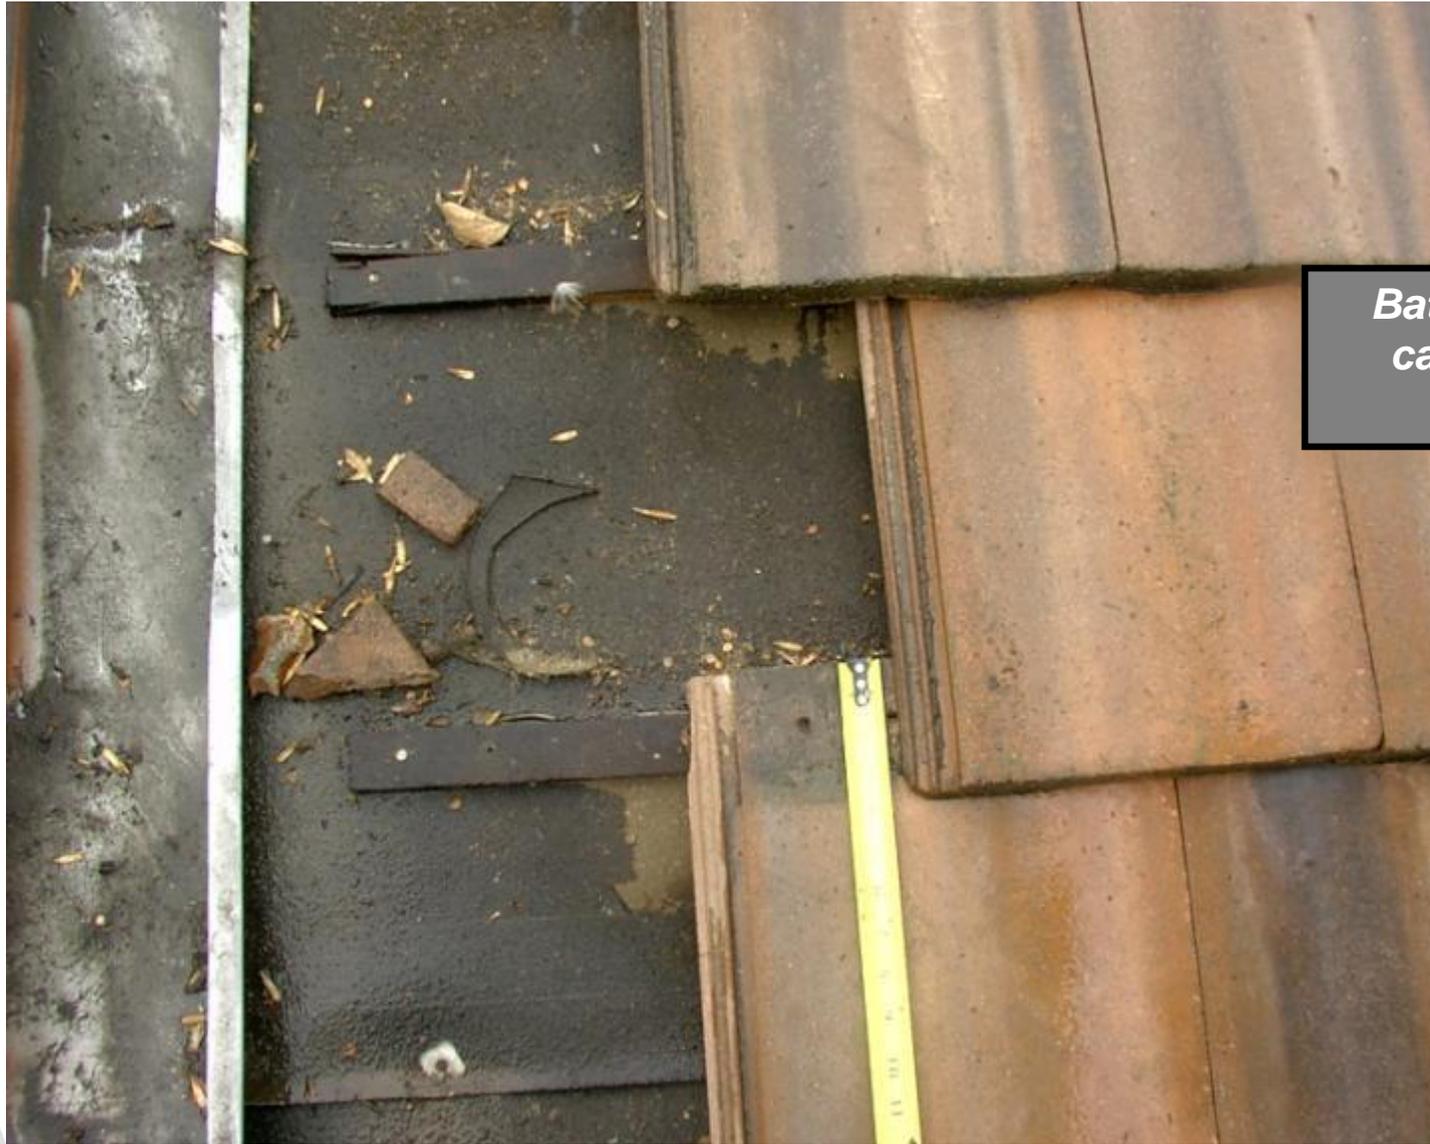
*Battens were too short,
causing tiles to fall in
wrong direction*

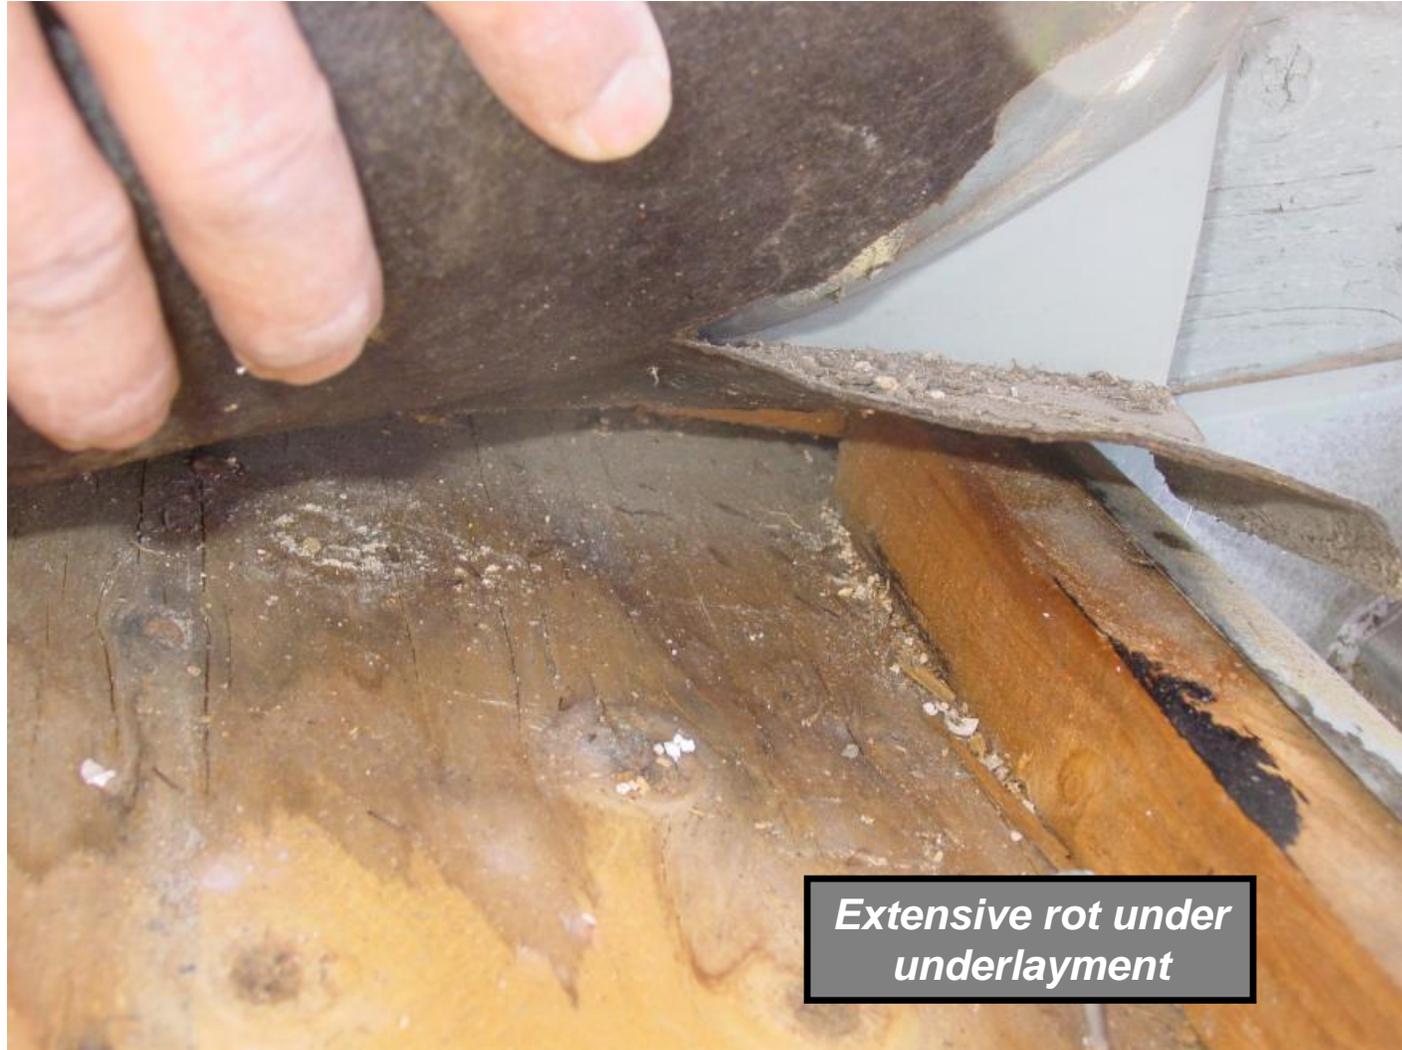
Excess water under the tiles results in rotted felt and.....
