# **Forensic Analysis of Roofing Systems Examples of Roof Performance Learn from Failures to Make Roofs More Sustainable!**

International Roofing Expos

February 16, 2005

# Case 1: Forensic Investigation of Metal Roof Failure

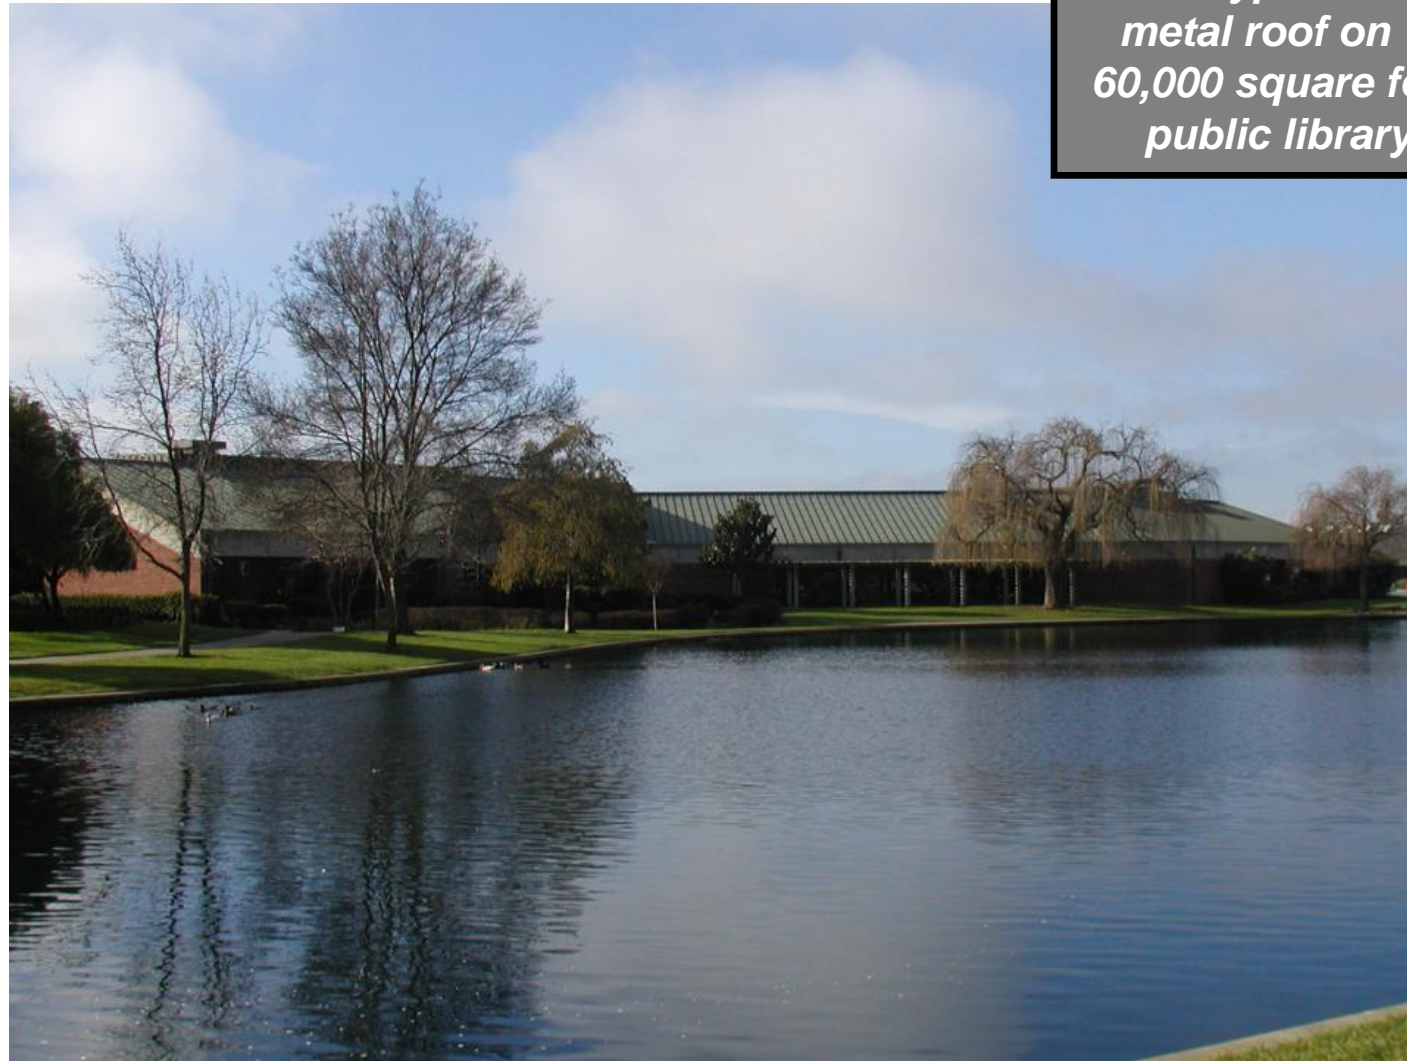
*Roof Type: Batten  
metal roof on a  
60,000 square foot  
public library*

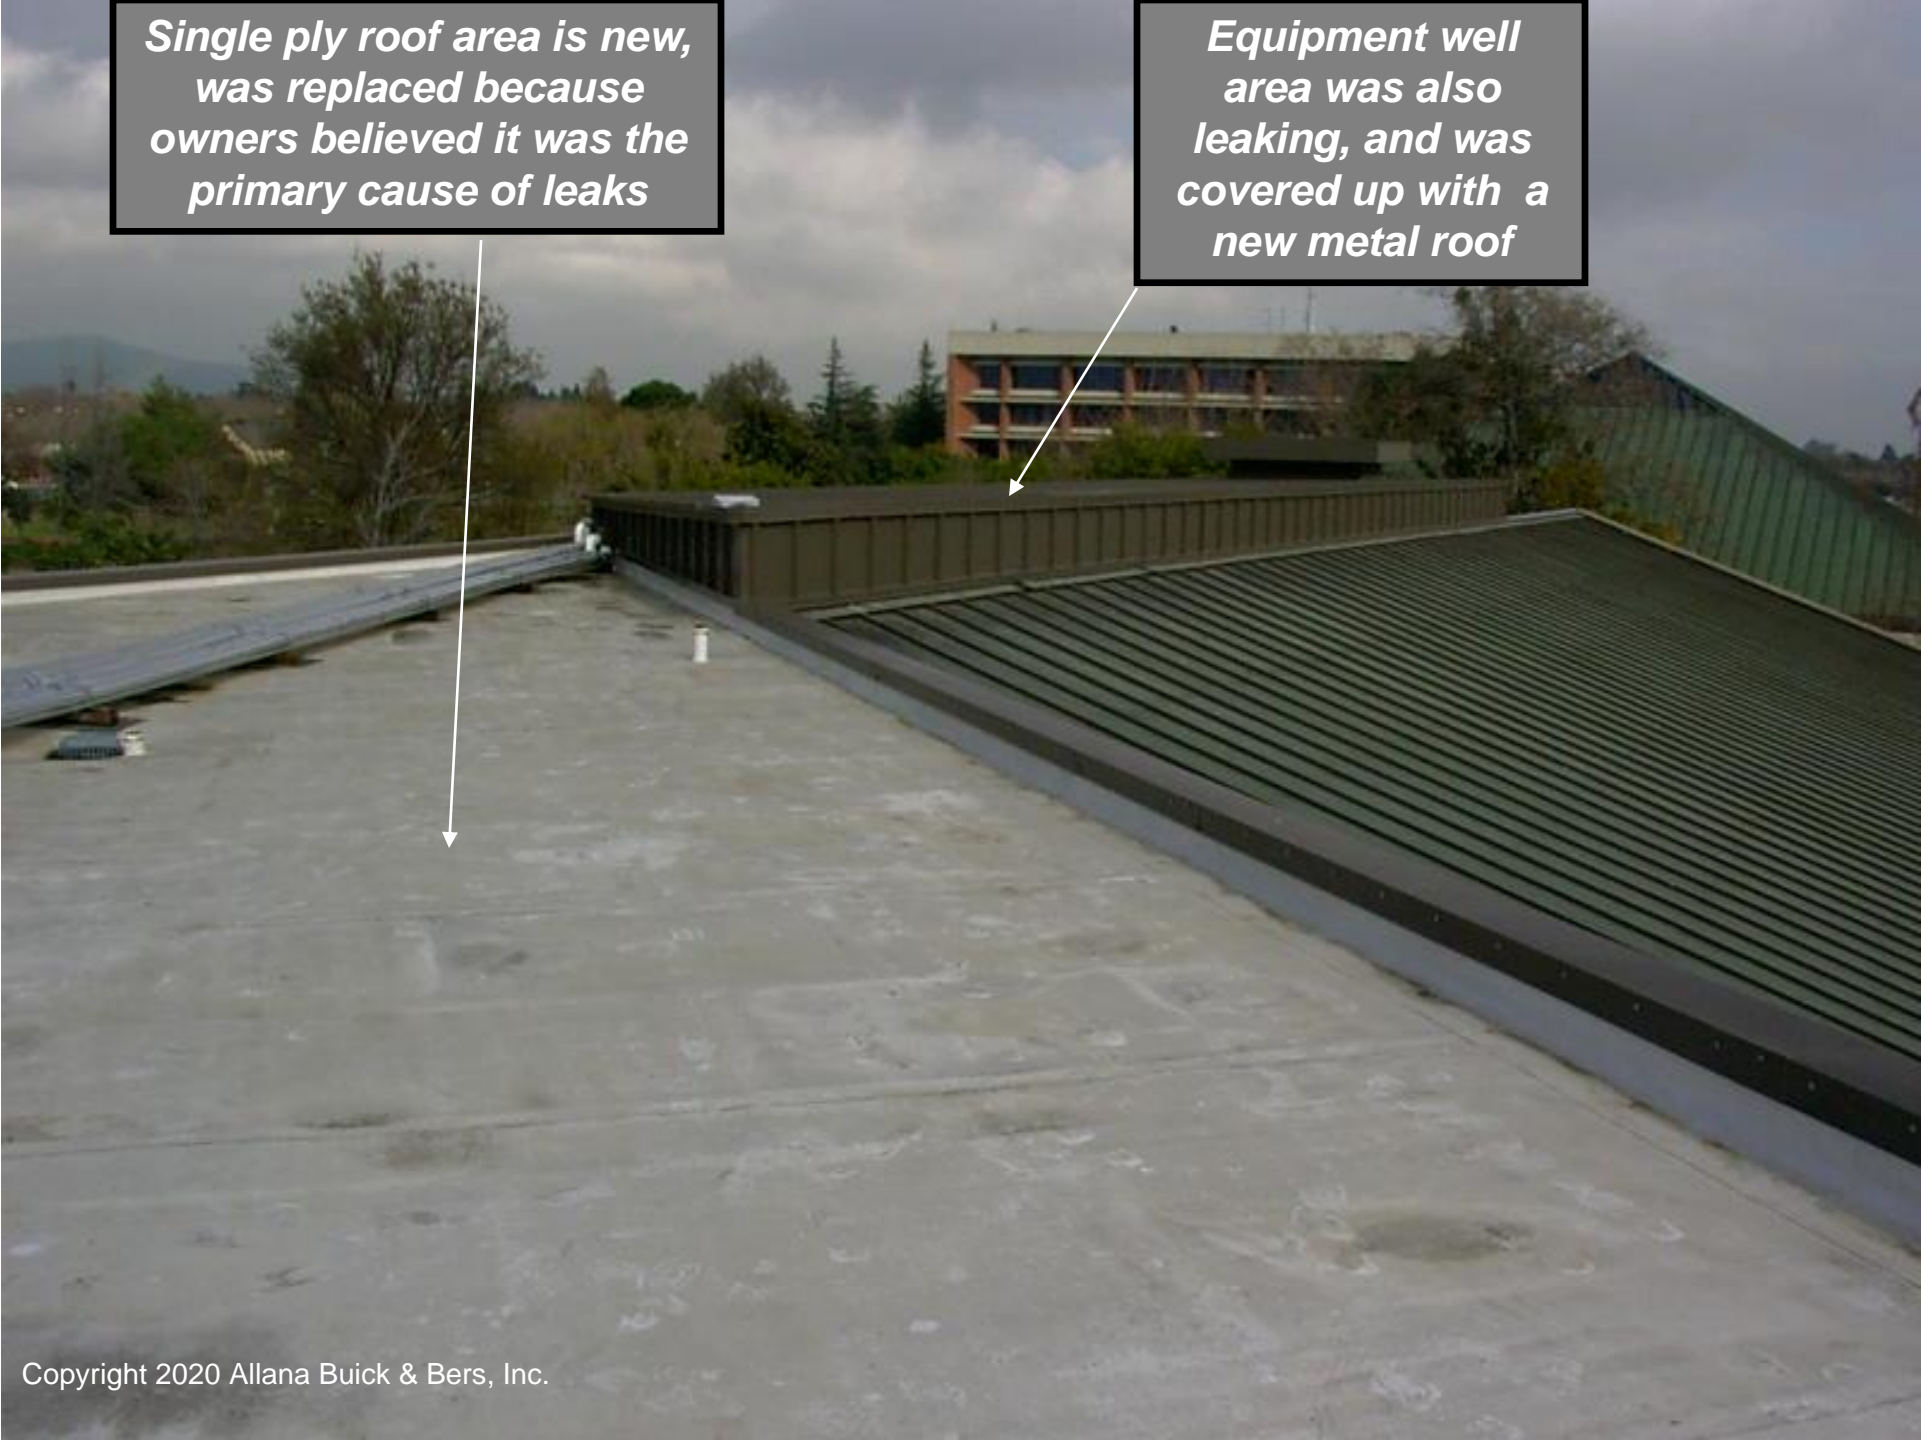
*Single ply roof area is new, was replaced because owners believed it was the primary cause of leaks*

*Equipment well area was also leaking, and was covered up with a new metal roof*

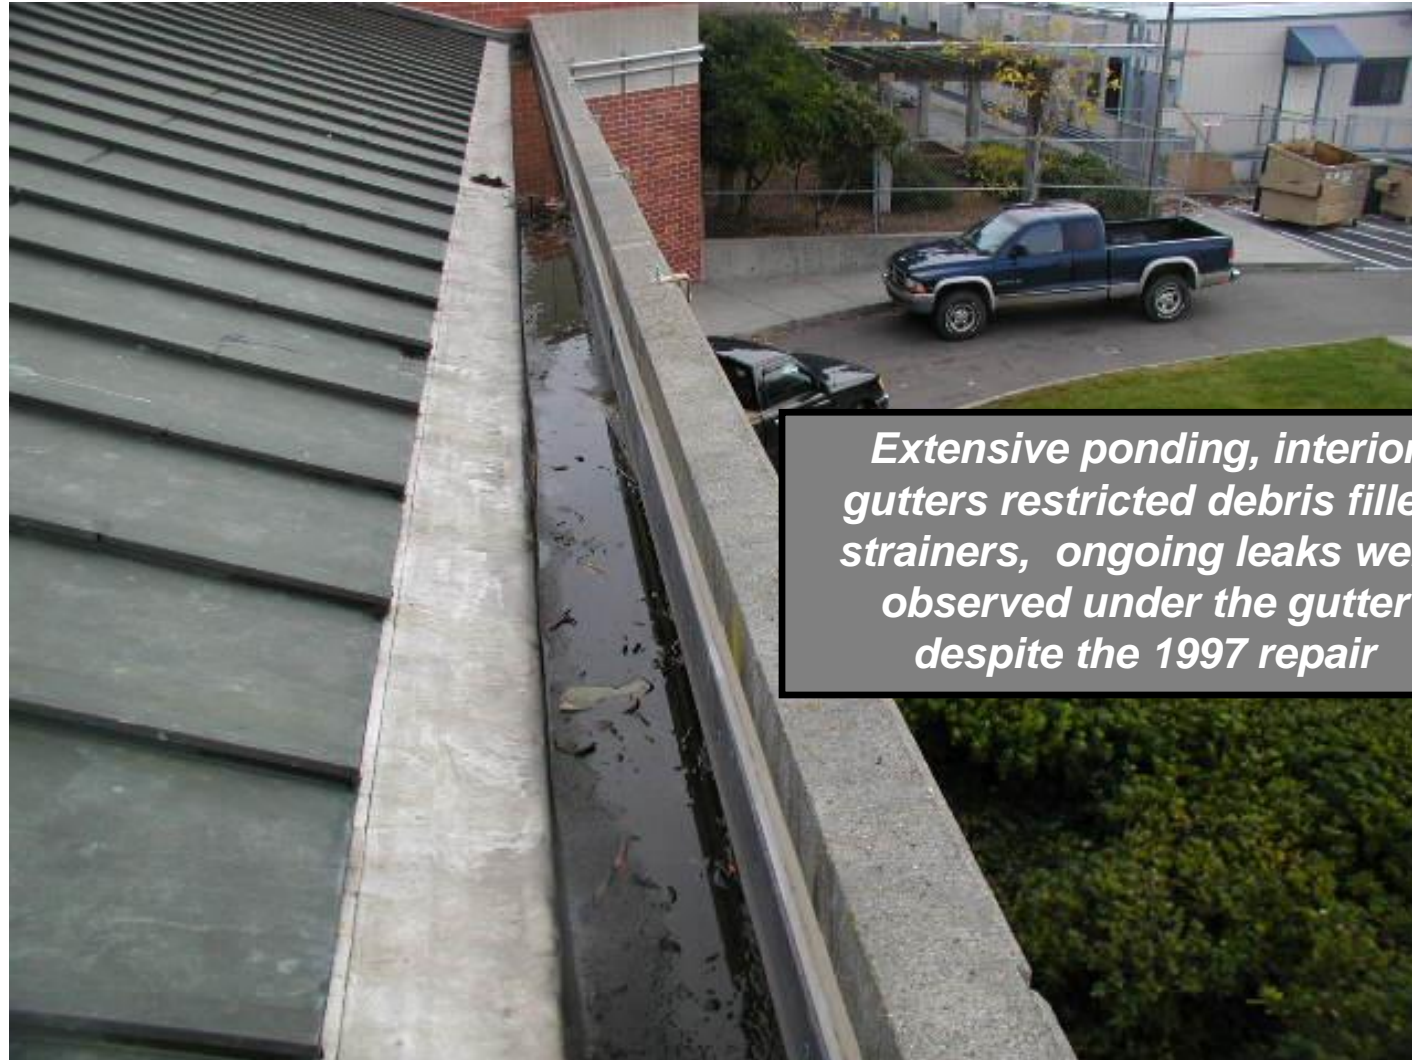
*Extensive ponding, interior gutters restricted debris filled strainers, ongoing leaks were observed under the gutter despite the 1997 repair*

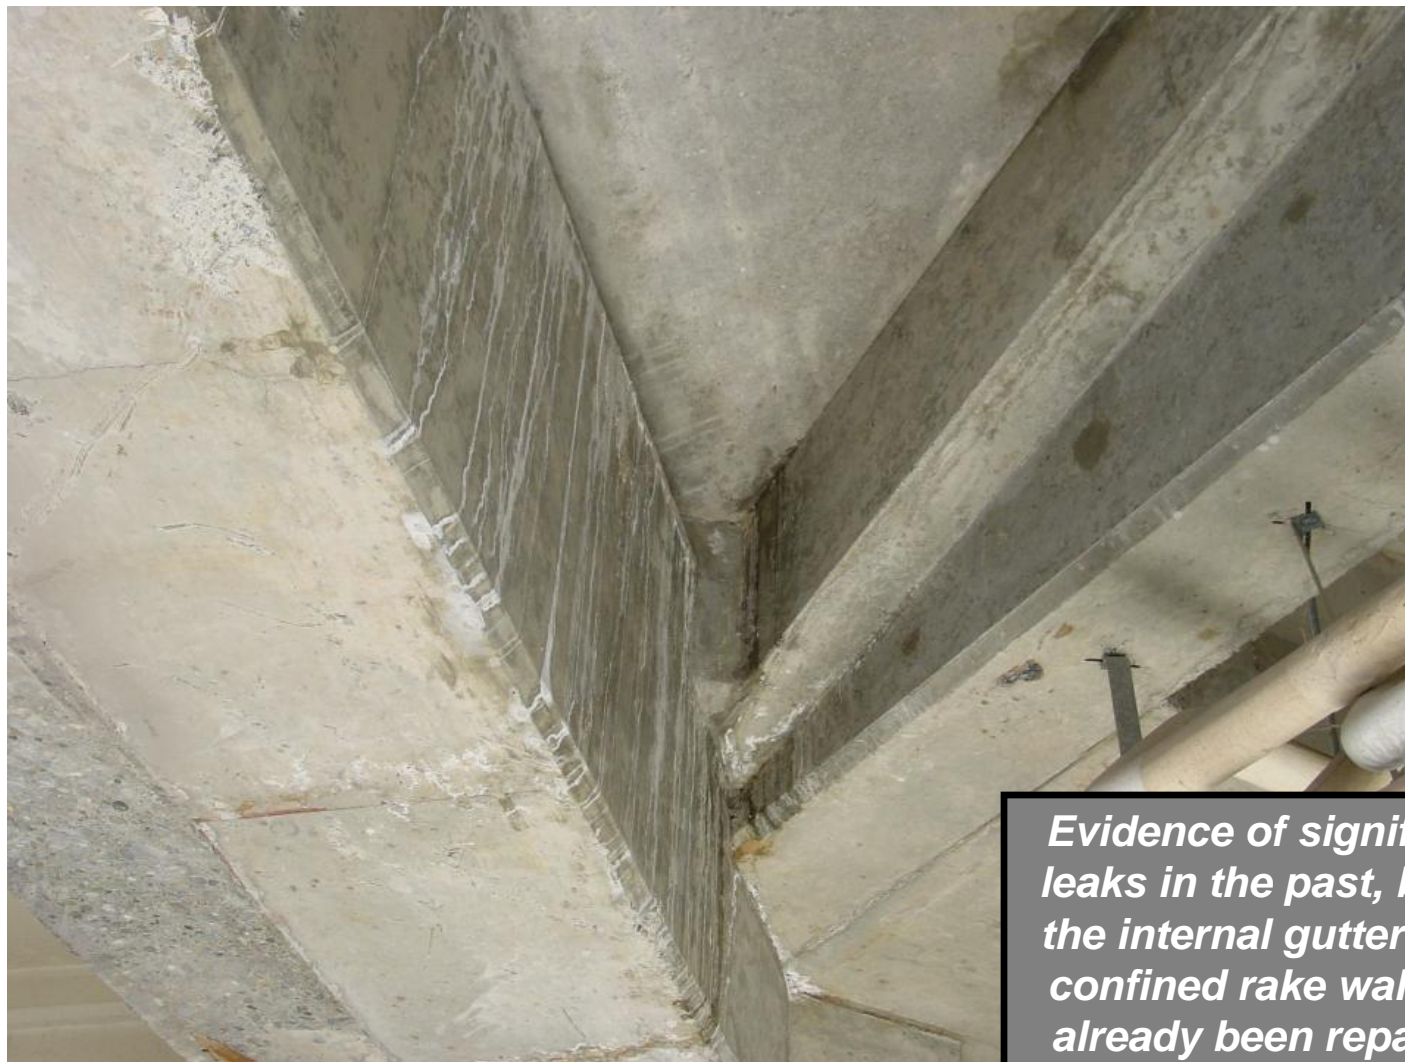
***Evidence of significant leaks in the past, below the internal gutters and confined rake wall that already been repaired, once***

*Evidence of efflorescence through CMU wall with brick veneer*

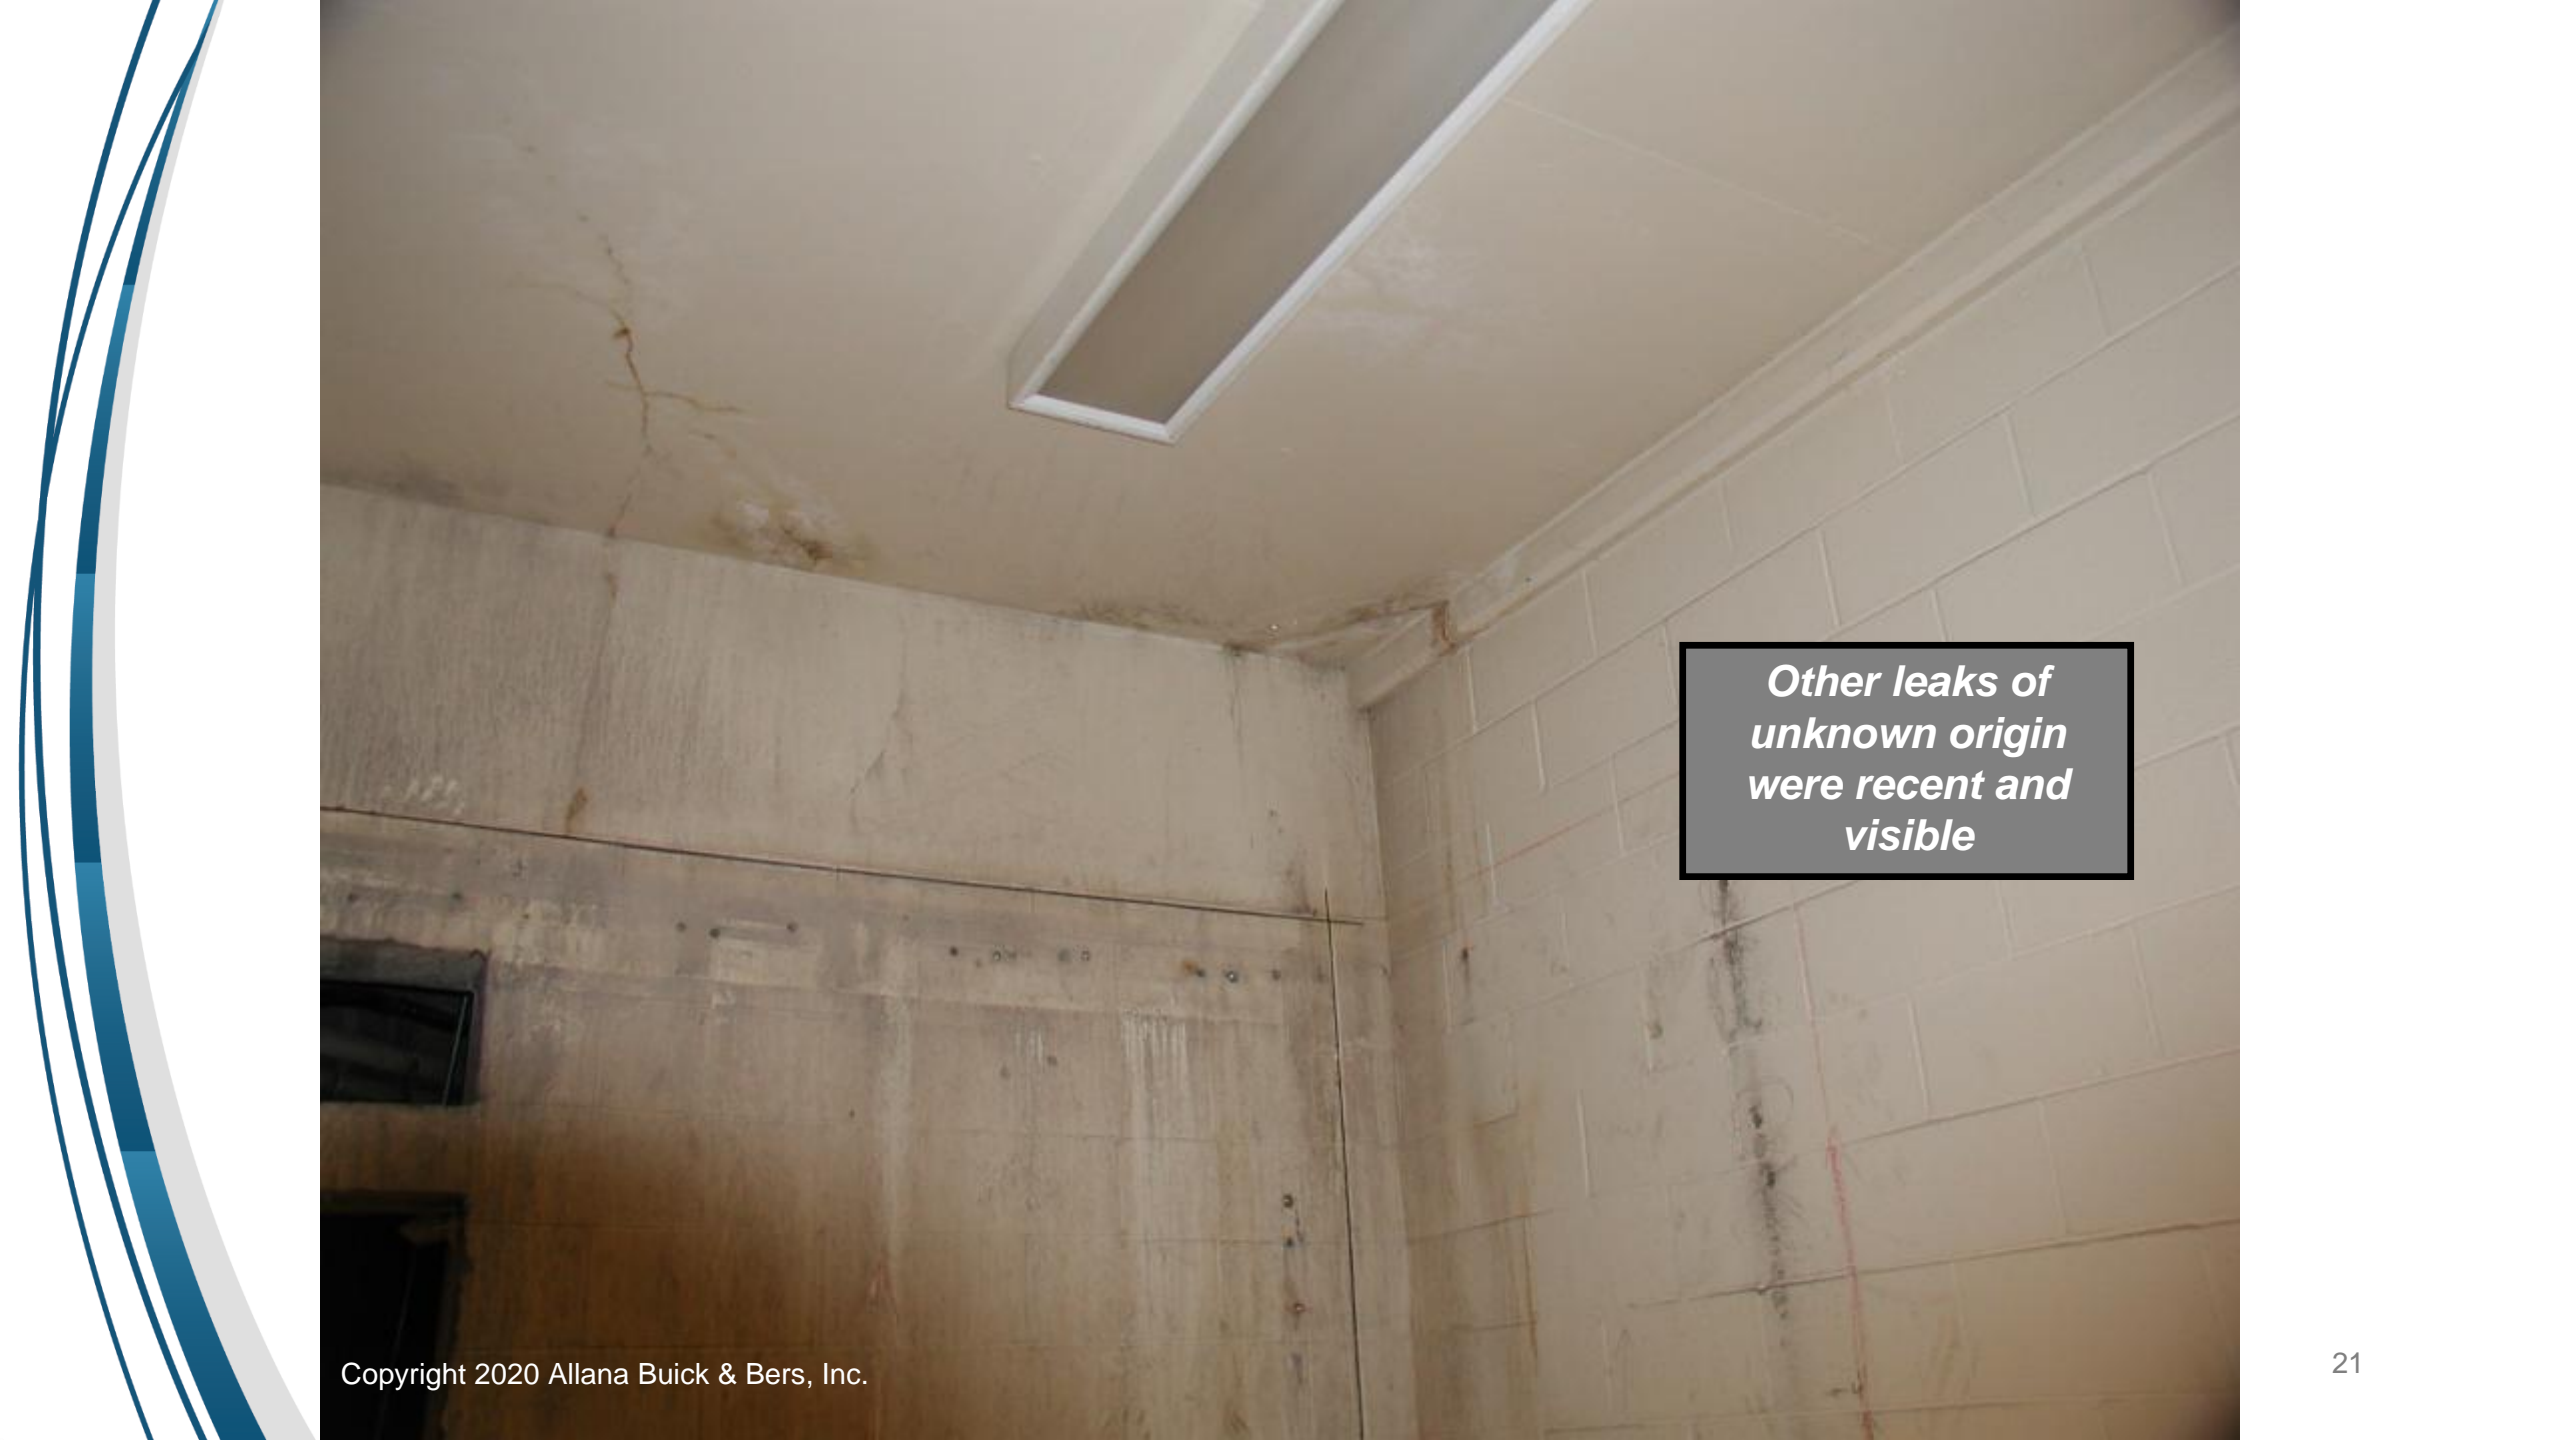
*Other leaks of  
unknown origin  
were recent and  
visible*

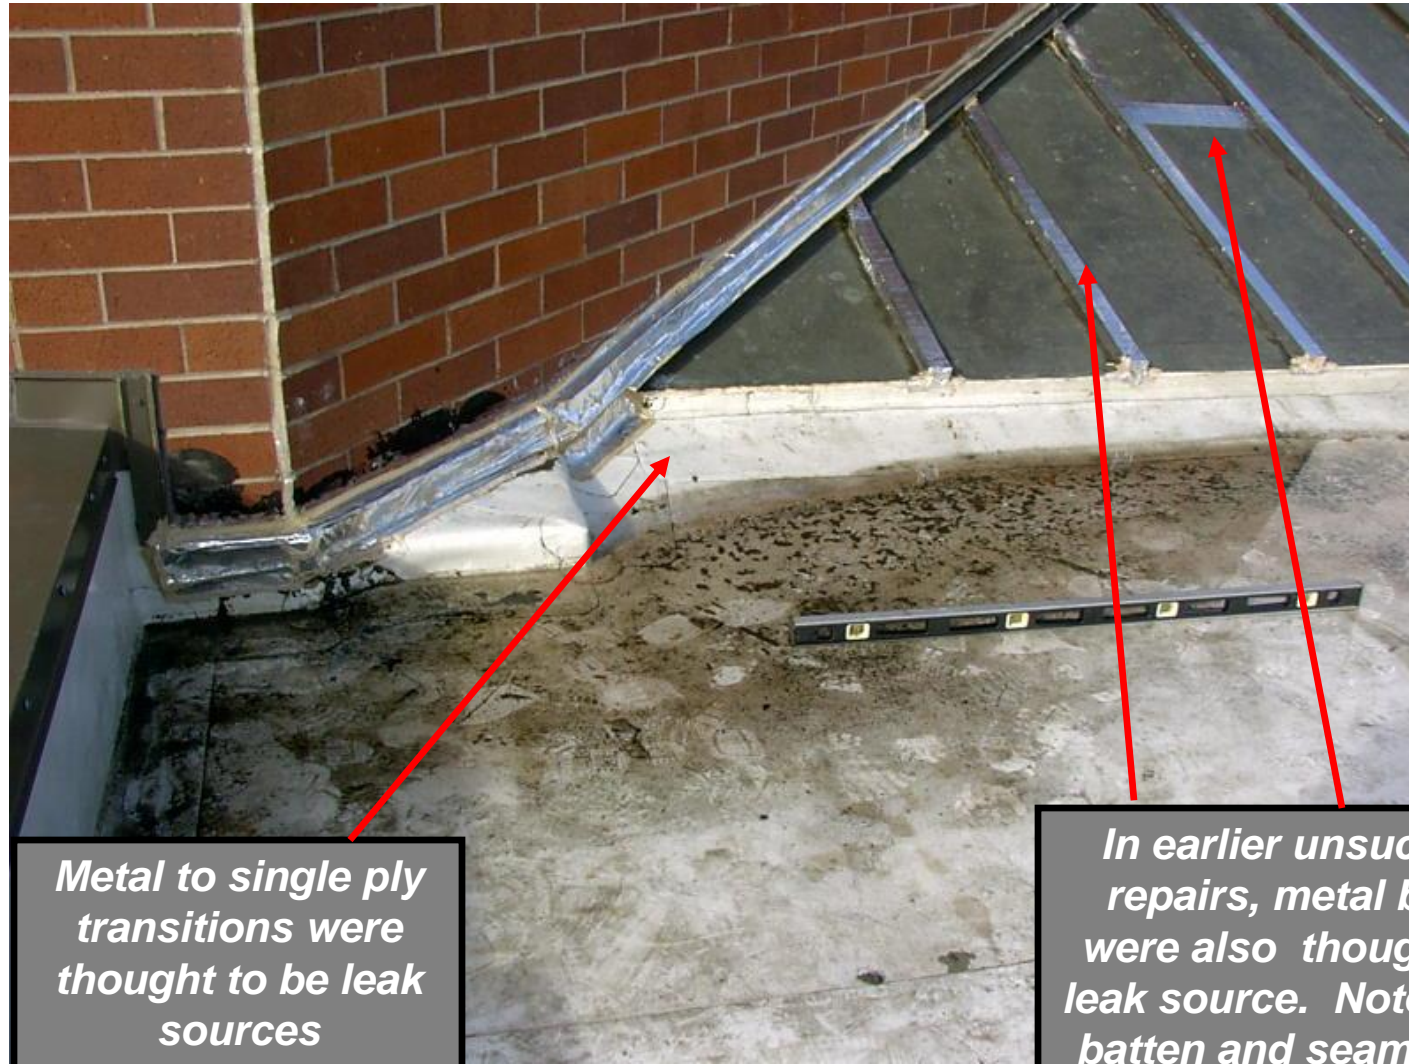
*Metal to single ply transitions were thought to be leak sources*

*In earlier unsuccessful repairs, metal battens were also thought to be leak source. Note tape on batten and seam on field formed panel*

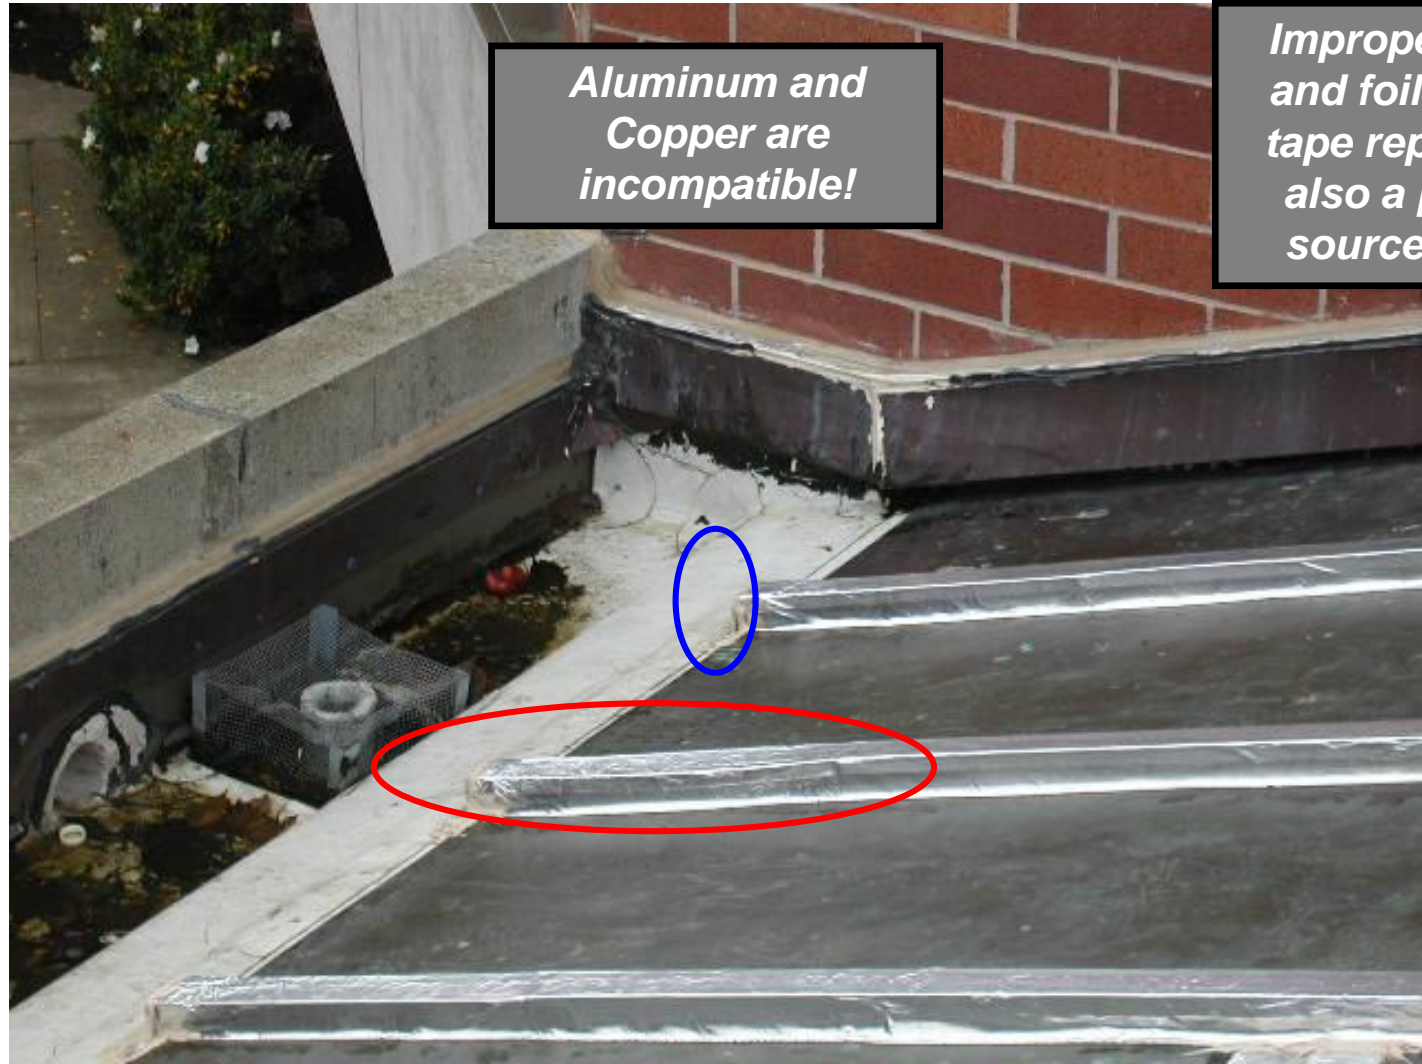
*Aluminum and  
Copper are  
incompatible!*

*Improper sealant  
and foil surfaced  
tape repairs were  
also a probable  
source of leaks*

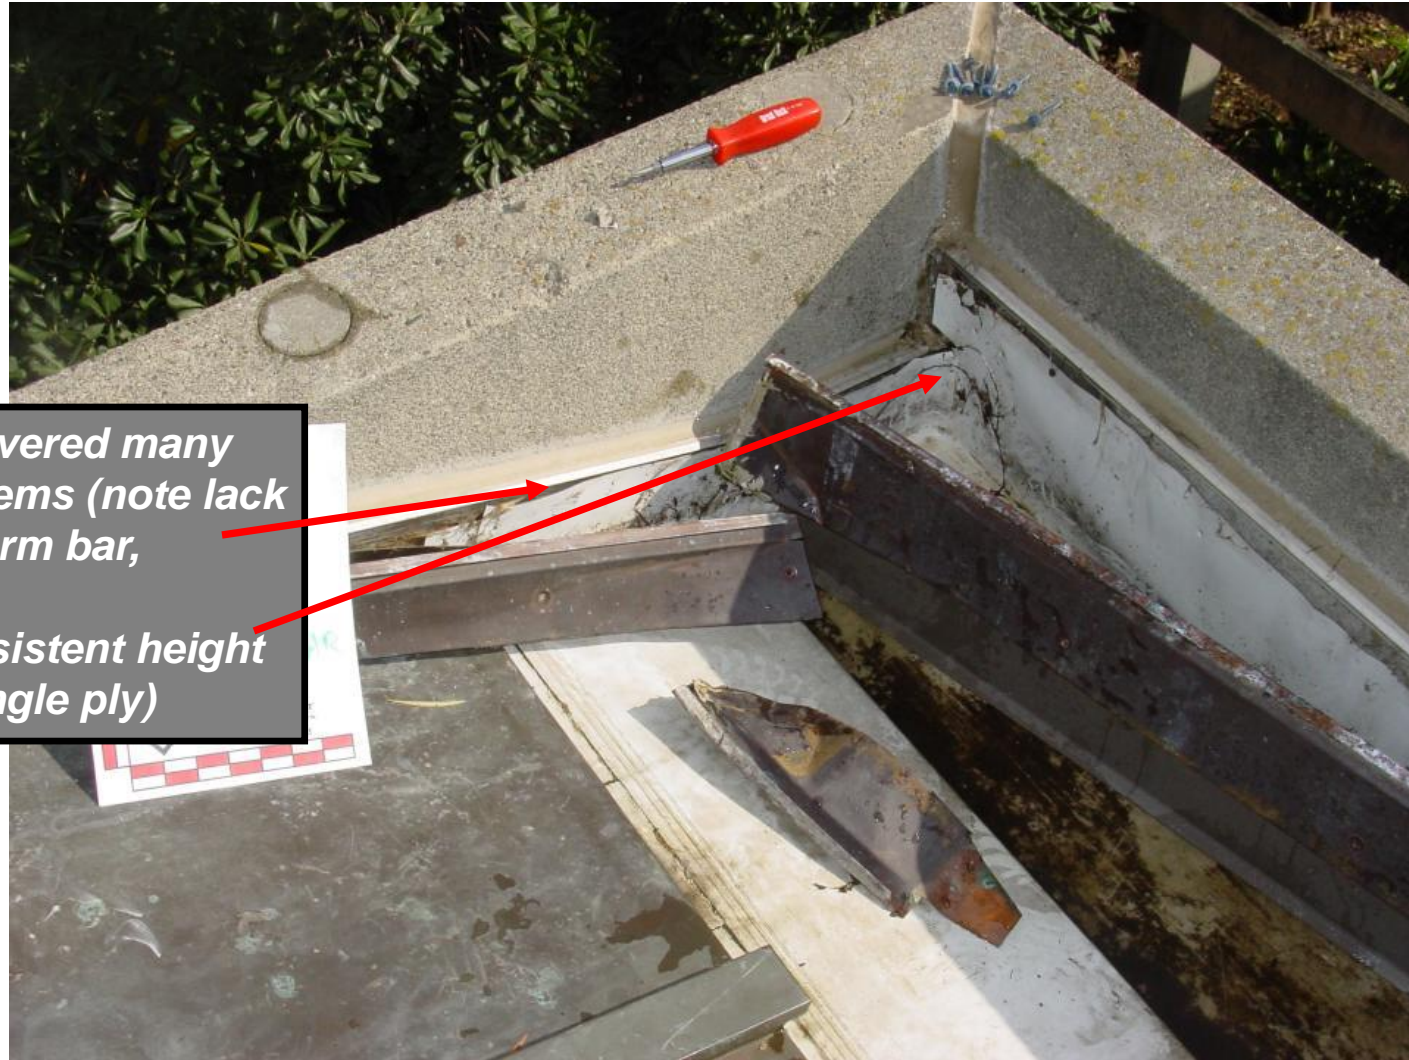
*We uncovered many other problems (note lack of term bar, and inconsistent height of single ply)*

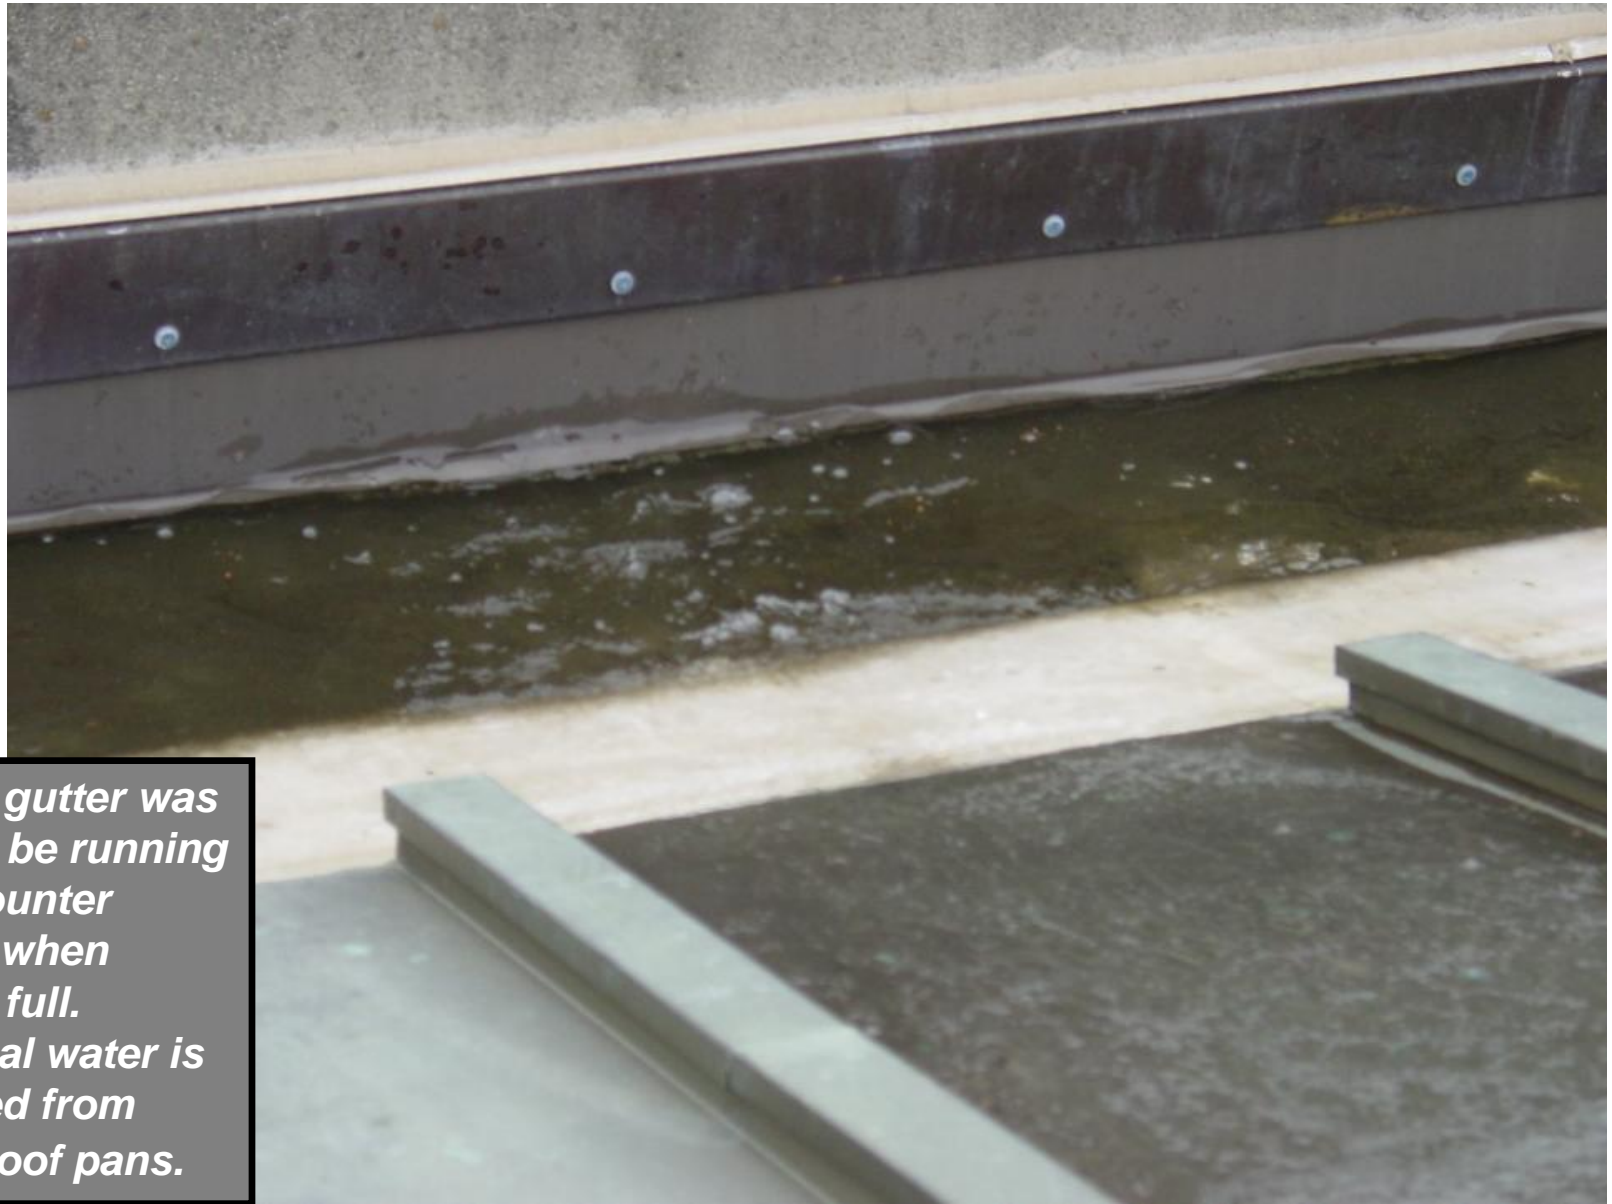
*Water in gutter was found to be running under counter flashing when gutter is full. Additional water is presented from copper roof pans.*

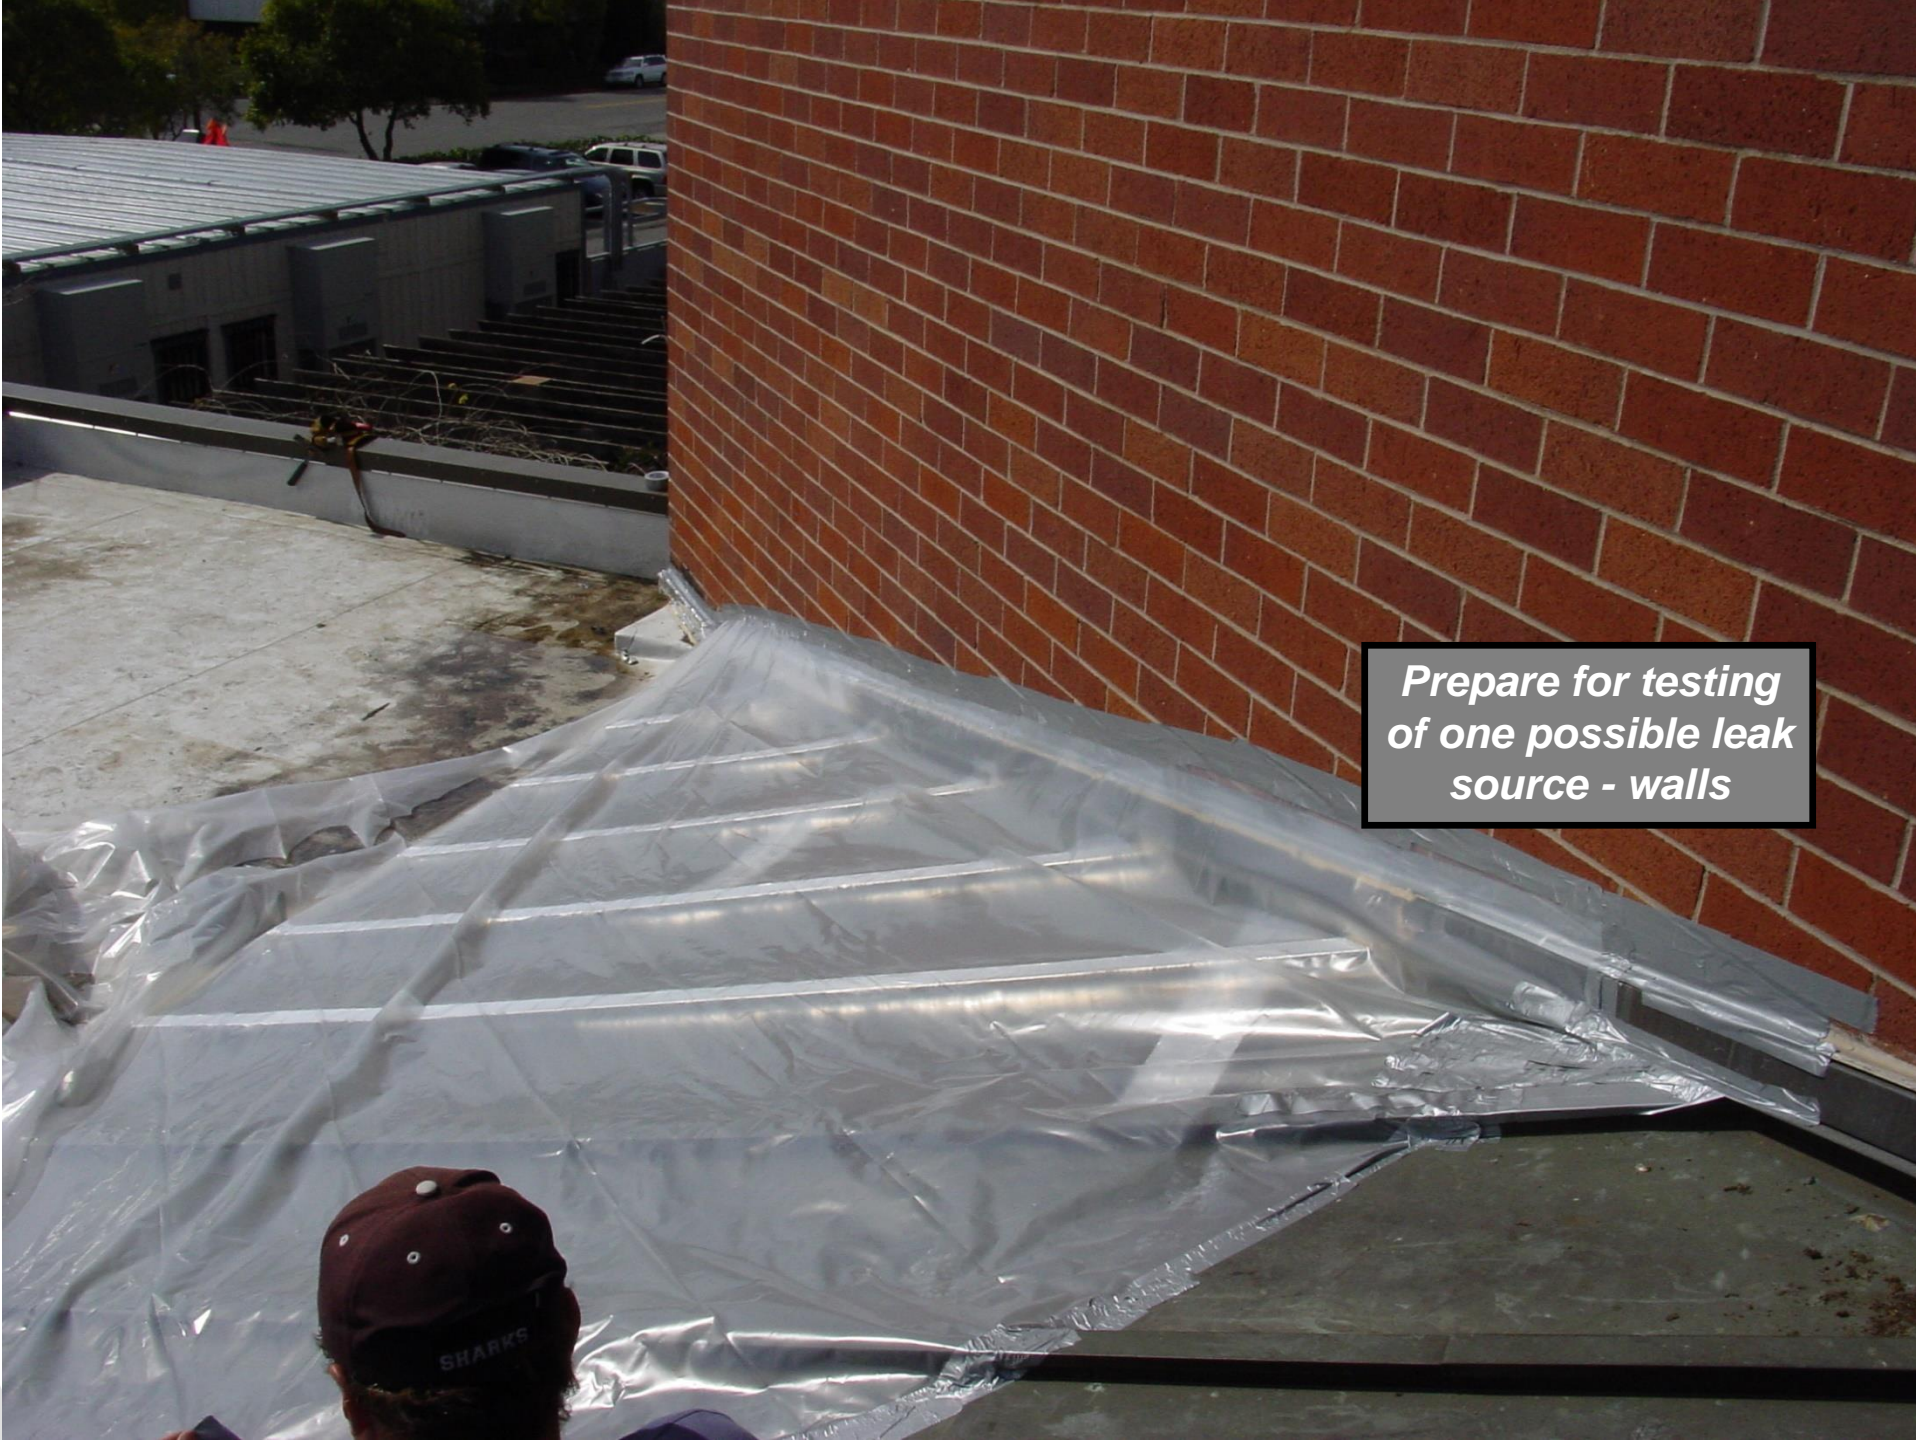
*Prepare for testing  
of one possible leak  
source - walls*

*Red arrow lines up  
with arrow in next  
slide*

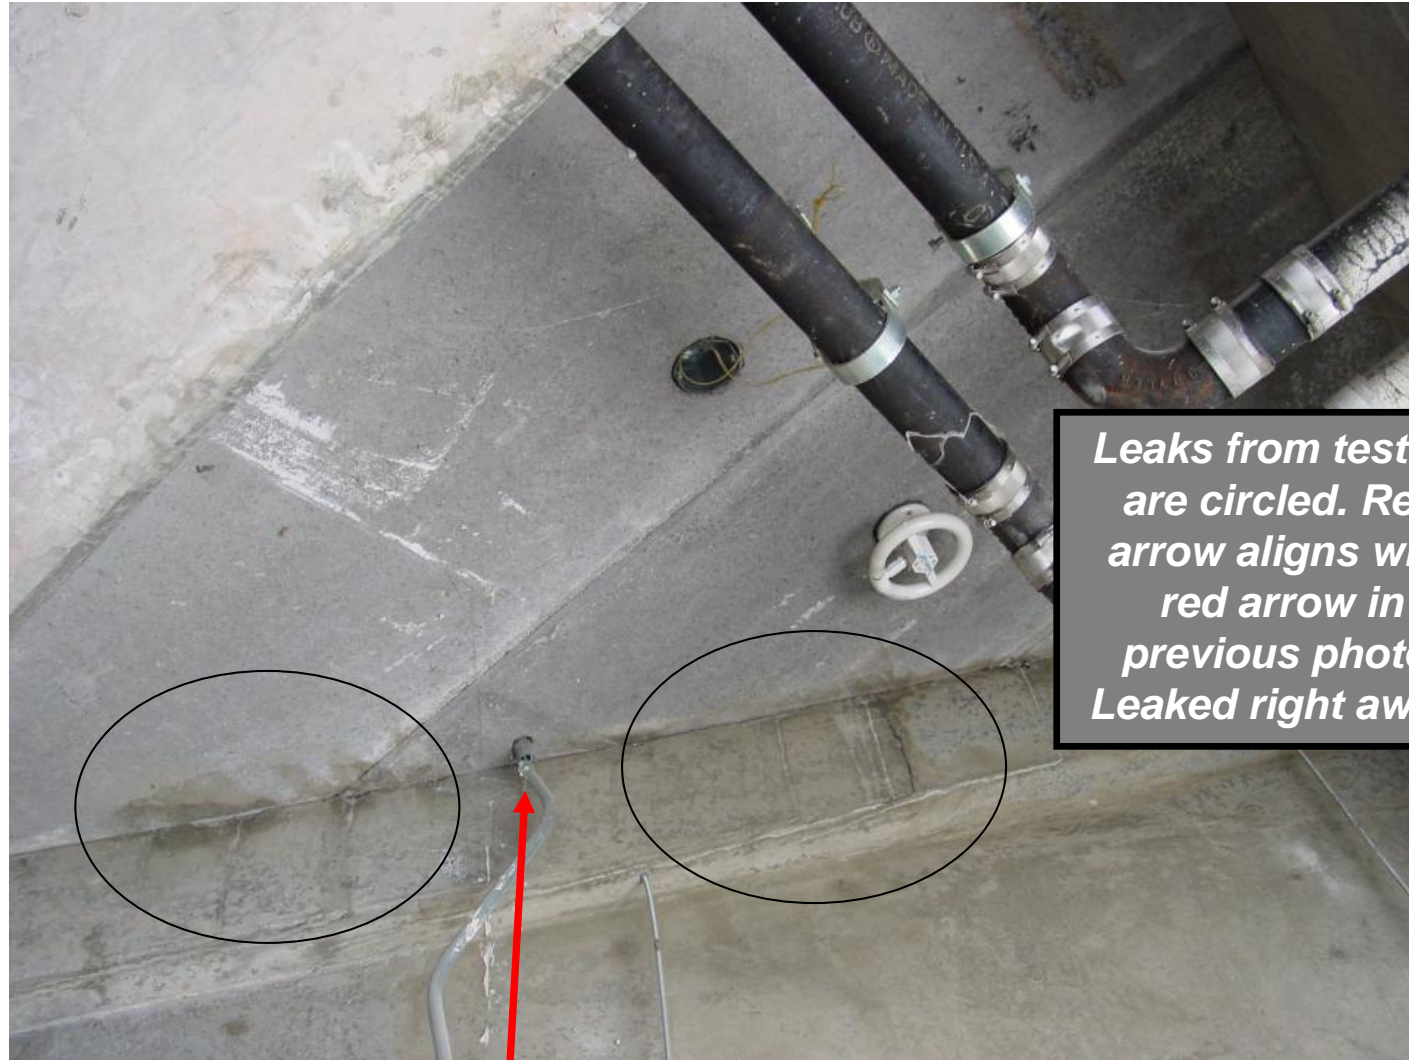
*Leaks from testing are circled. Red arrow aligns with red arrow in previous photo. Leaked right away!*
