# **Forensic Analysis of Roofing Systems Examples of Roof Performance Learn from Failures to Make Roofs More Sustainable!**

International Roofing Expos

February 16, 2005

# Case 1: Forensic Investigation of Metal Roof Failure

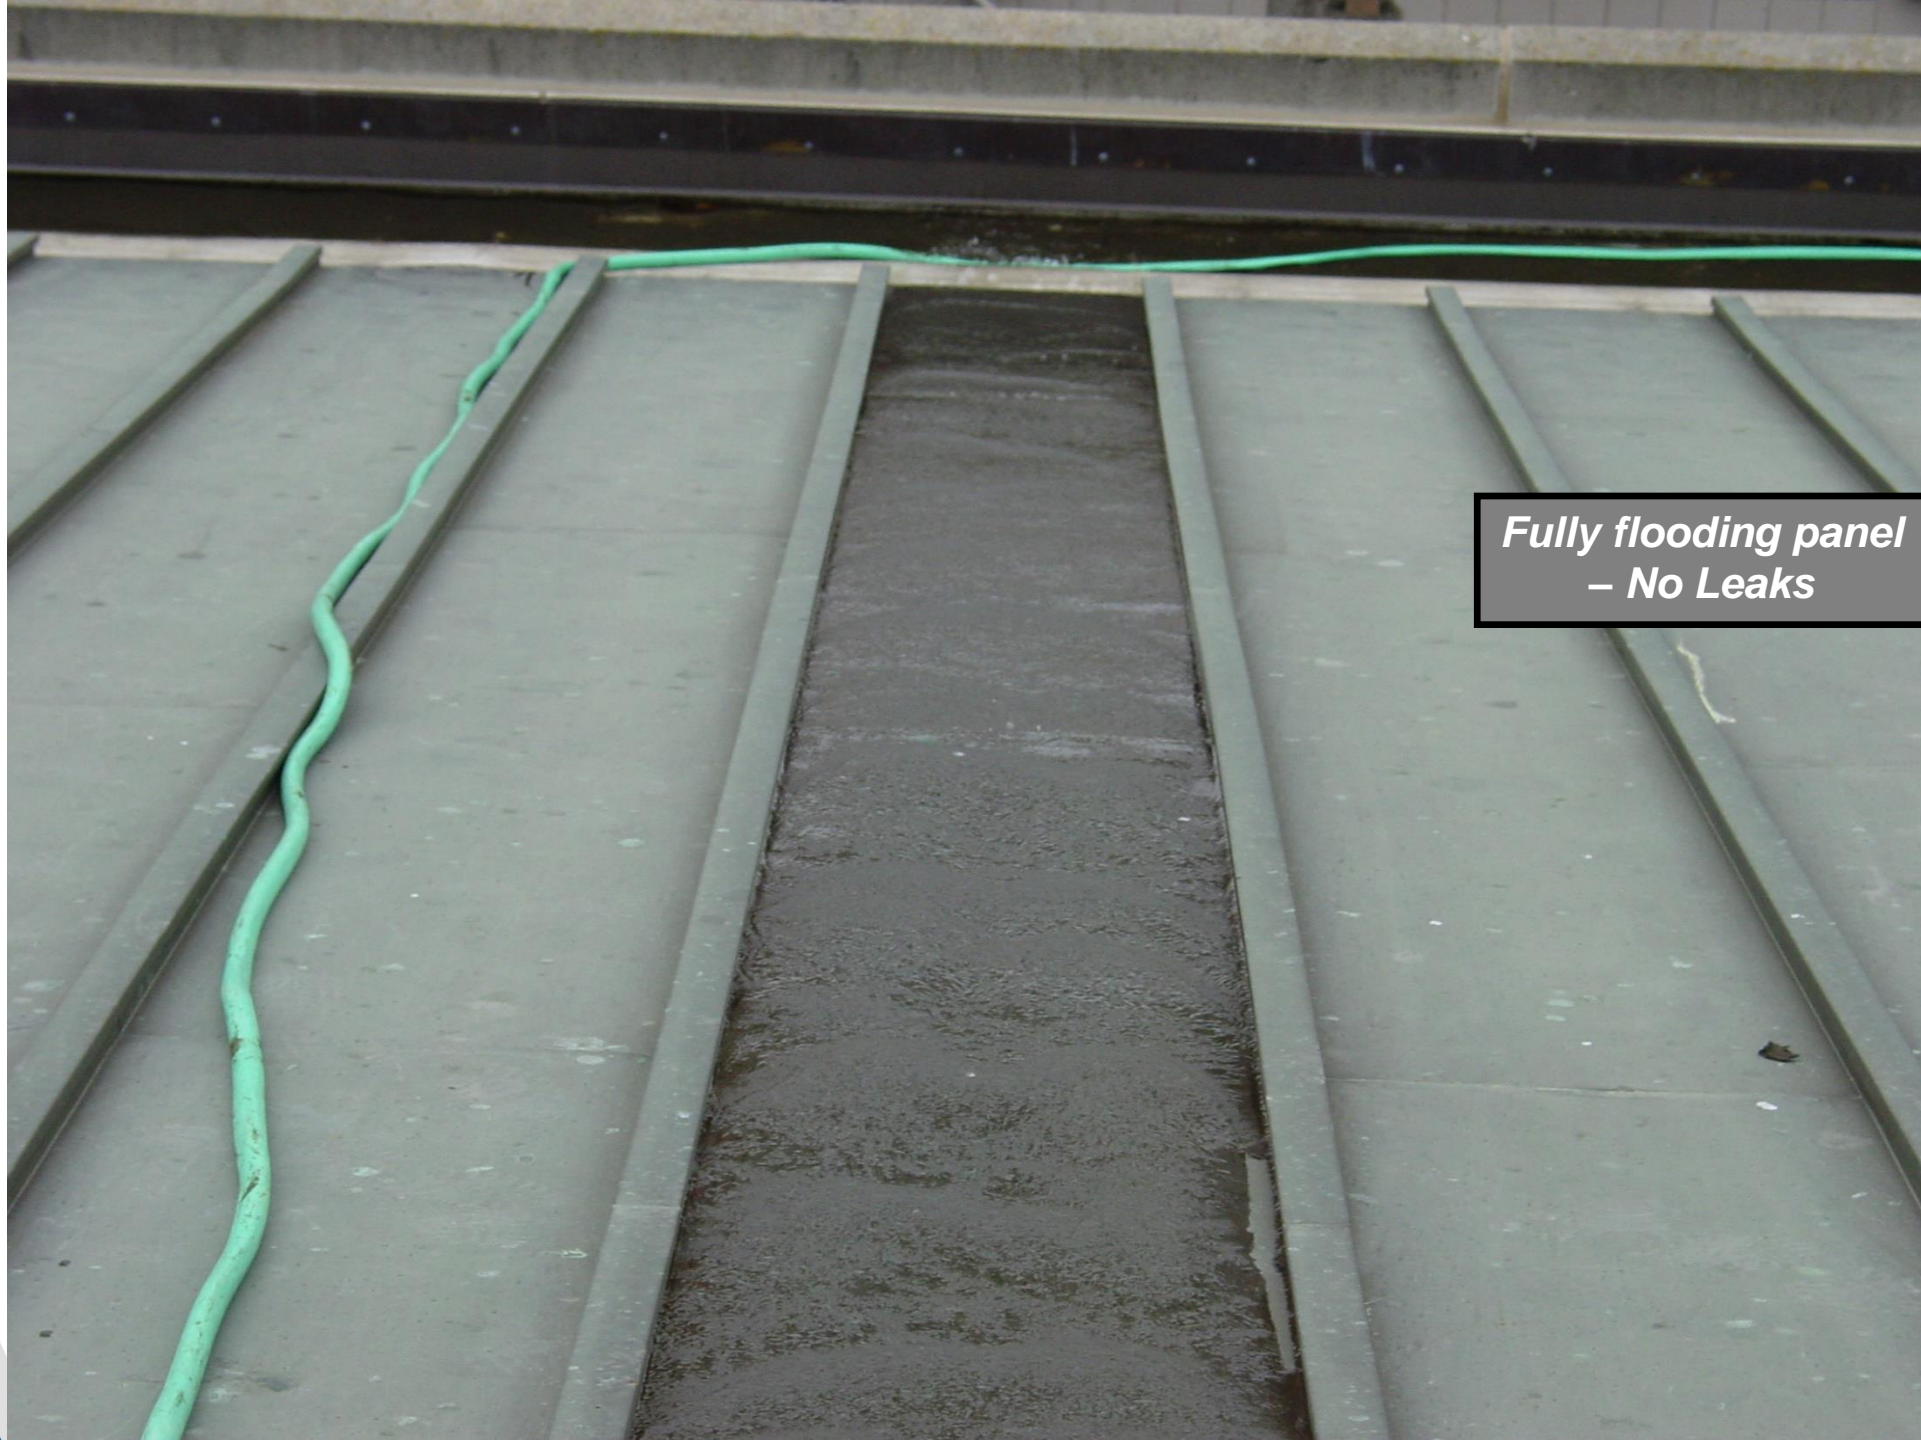
*Fully flooding panel  
– No Leaks*

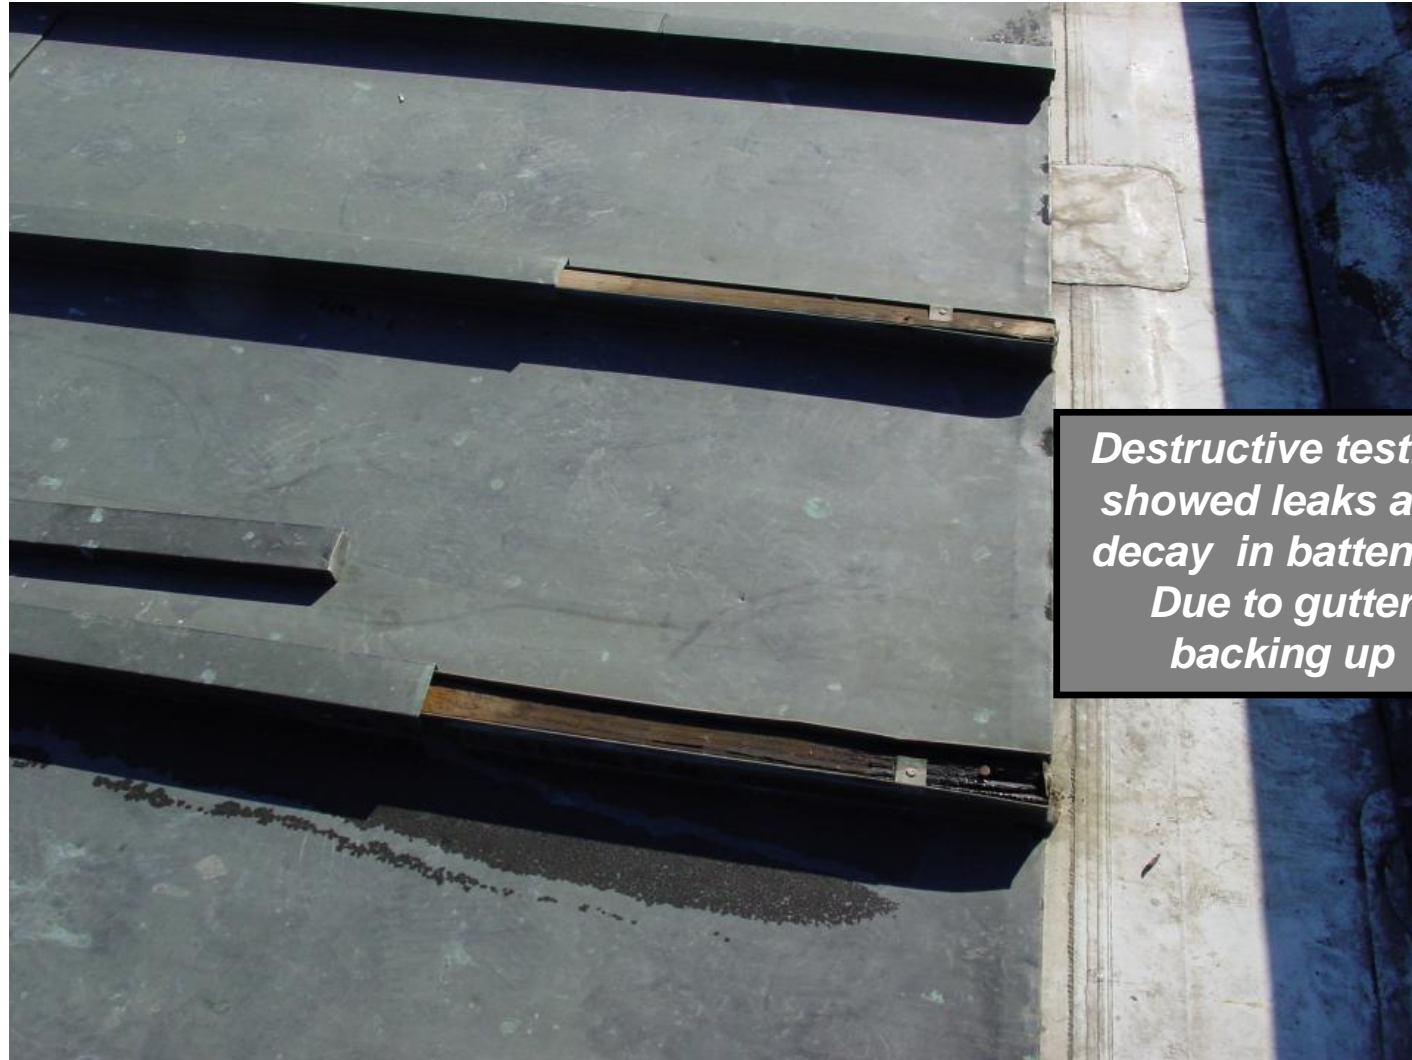
*Destructive testing showed leaks and decay in battens – Due to gutter backing up*

- Remove & Store Copper Roof
- Demolish Flashings
- Demolish Perlite Insulation
- Install Treated Wood Stringers
- Install Isocyanurate Insulation
- Apply 2 Layers of Underlayment
- Reinstall Copper (90% Reuse)
- Install New Copper Flashings
- Perform Concurrent Gutter Repairs
- 50 Year Life Expectancy

- Demo PVC and Copper Liner
- Demo Flashings
- Cut Large 8x12-inch Scuppers
- Cap Existing Outlet Drains
- Install Concrete Sloping Fill
- Install PVC Gutter Liner
- Install Flashings
- Provide Copper Collector Heads
- Install Copper Downspouts
- Provide Connection To Field Drains
- 50 Year Life Expectancy

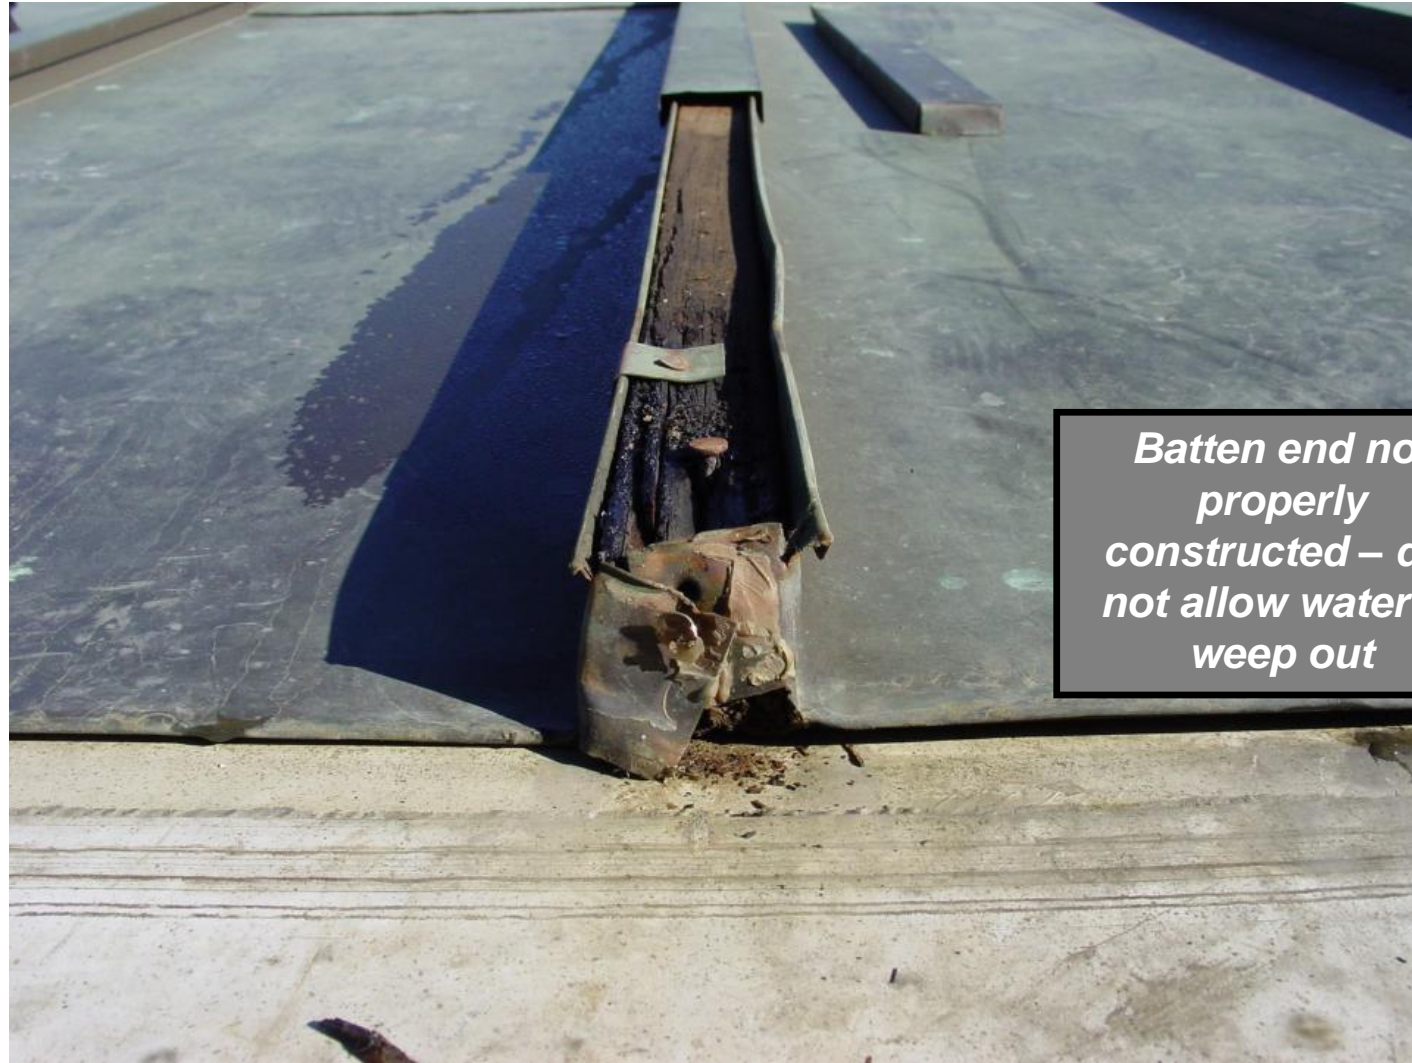
*Batten end not properly constructed – did not allow water to weep out*

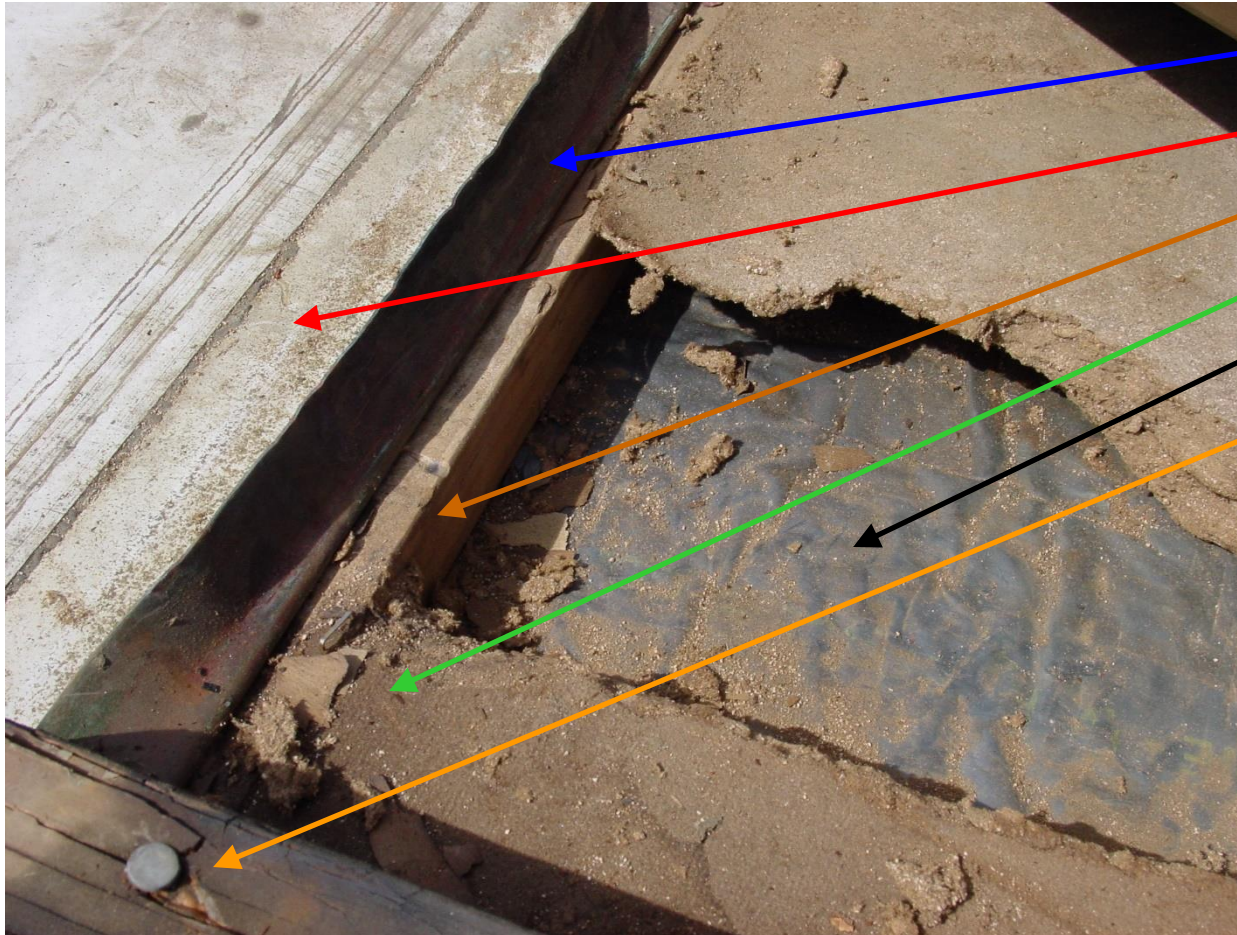
# Photograph of Conditions Found During Destructive Probing

Original Copper Gutter Liner

PVC Gutter Liner Added Later

Wood Blocking

1.5-Inches Perlite

Bituthane Membrane

Wood Batten

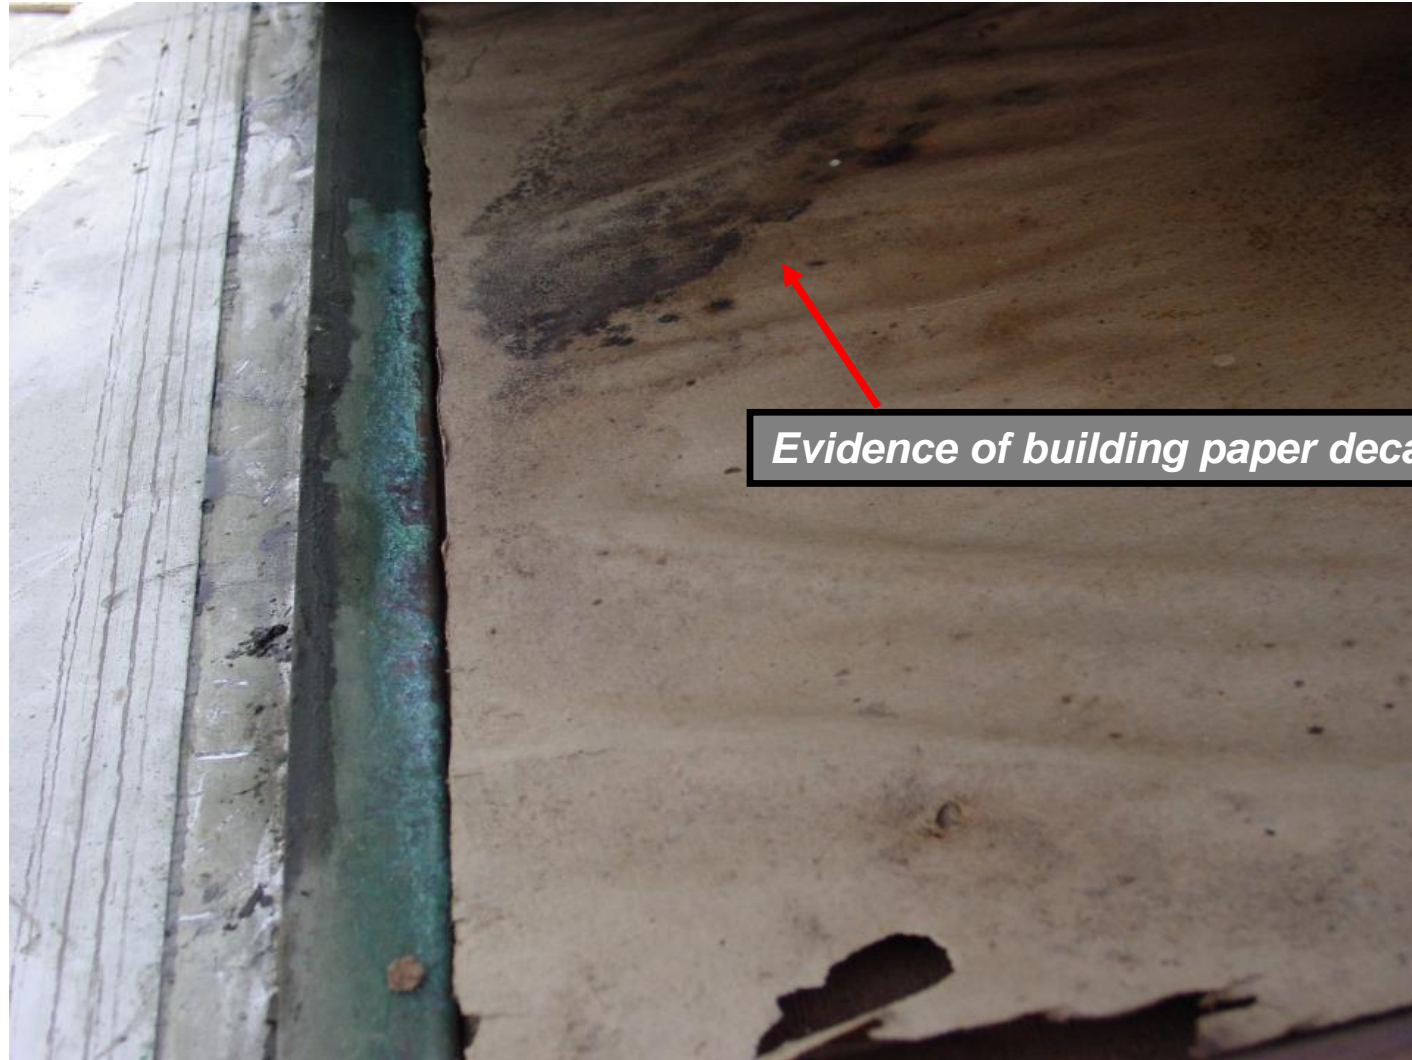
*Evidence of building paper decay*

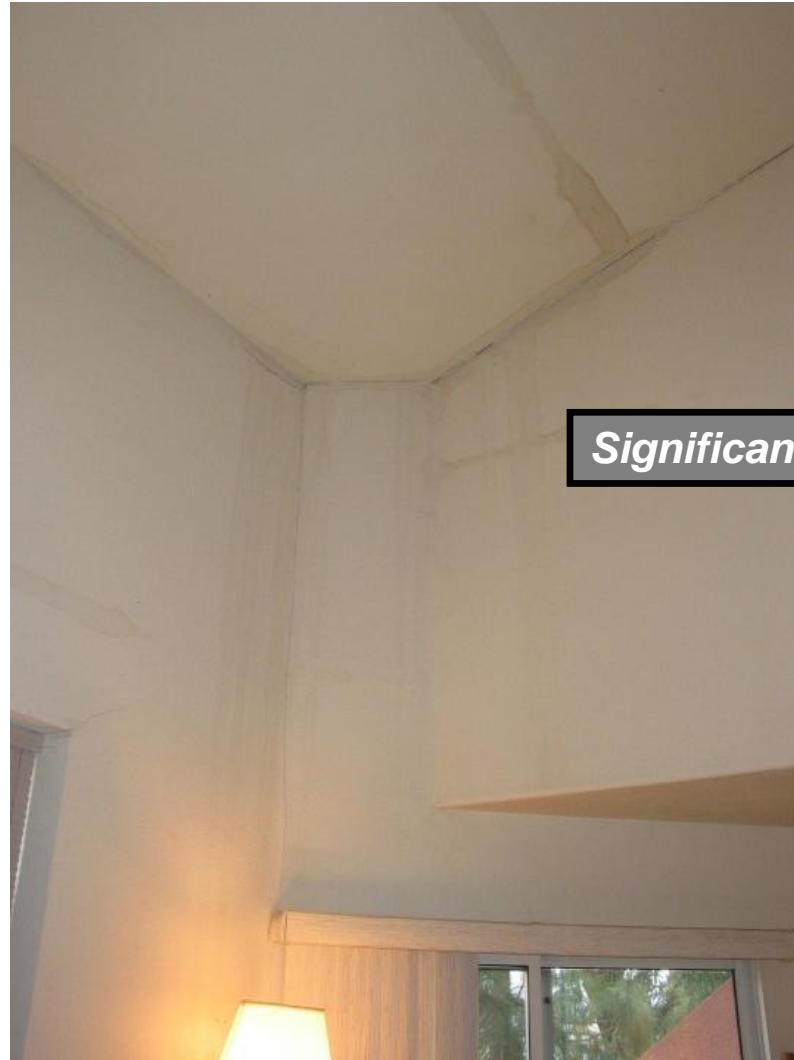
***Significant leaks in ceilings***

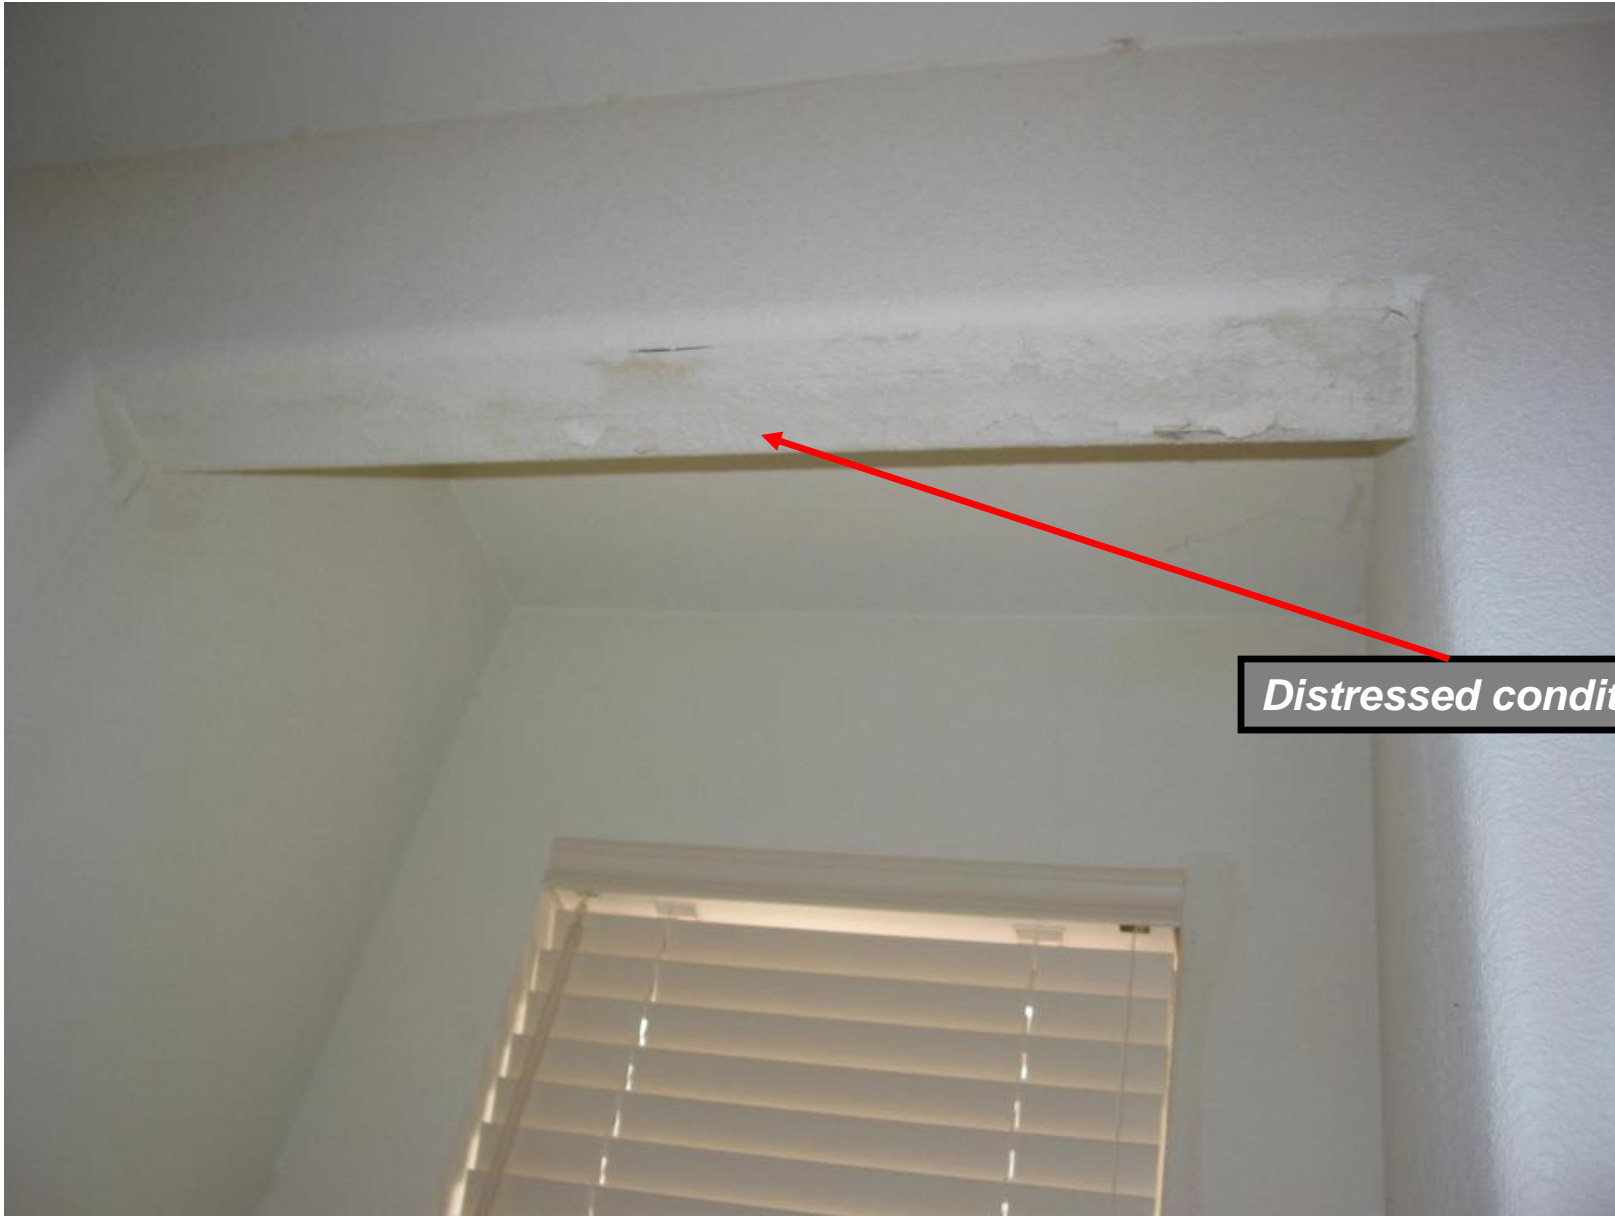
*Distressed conditions*

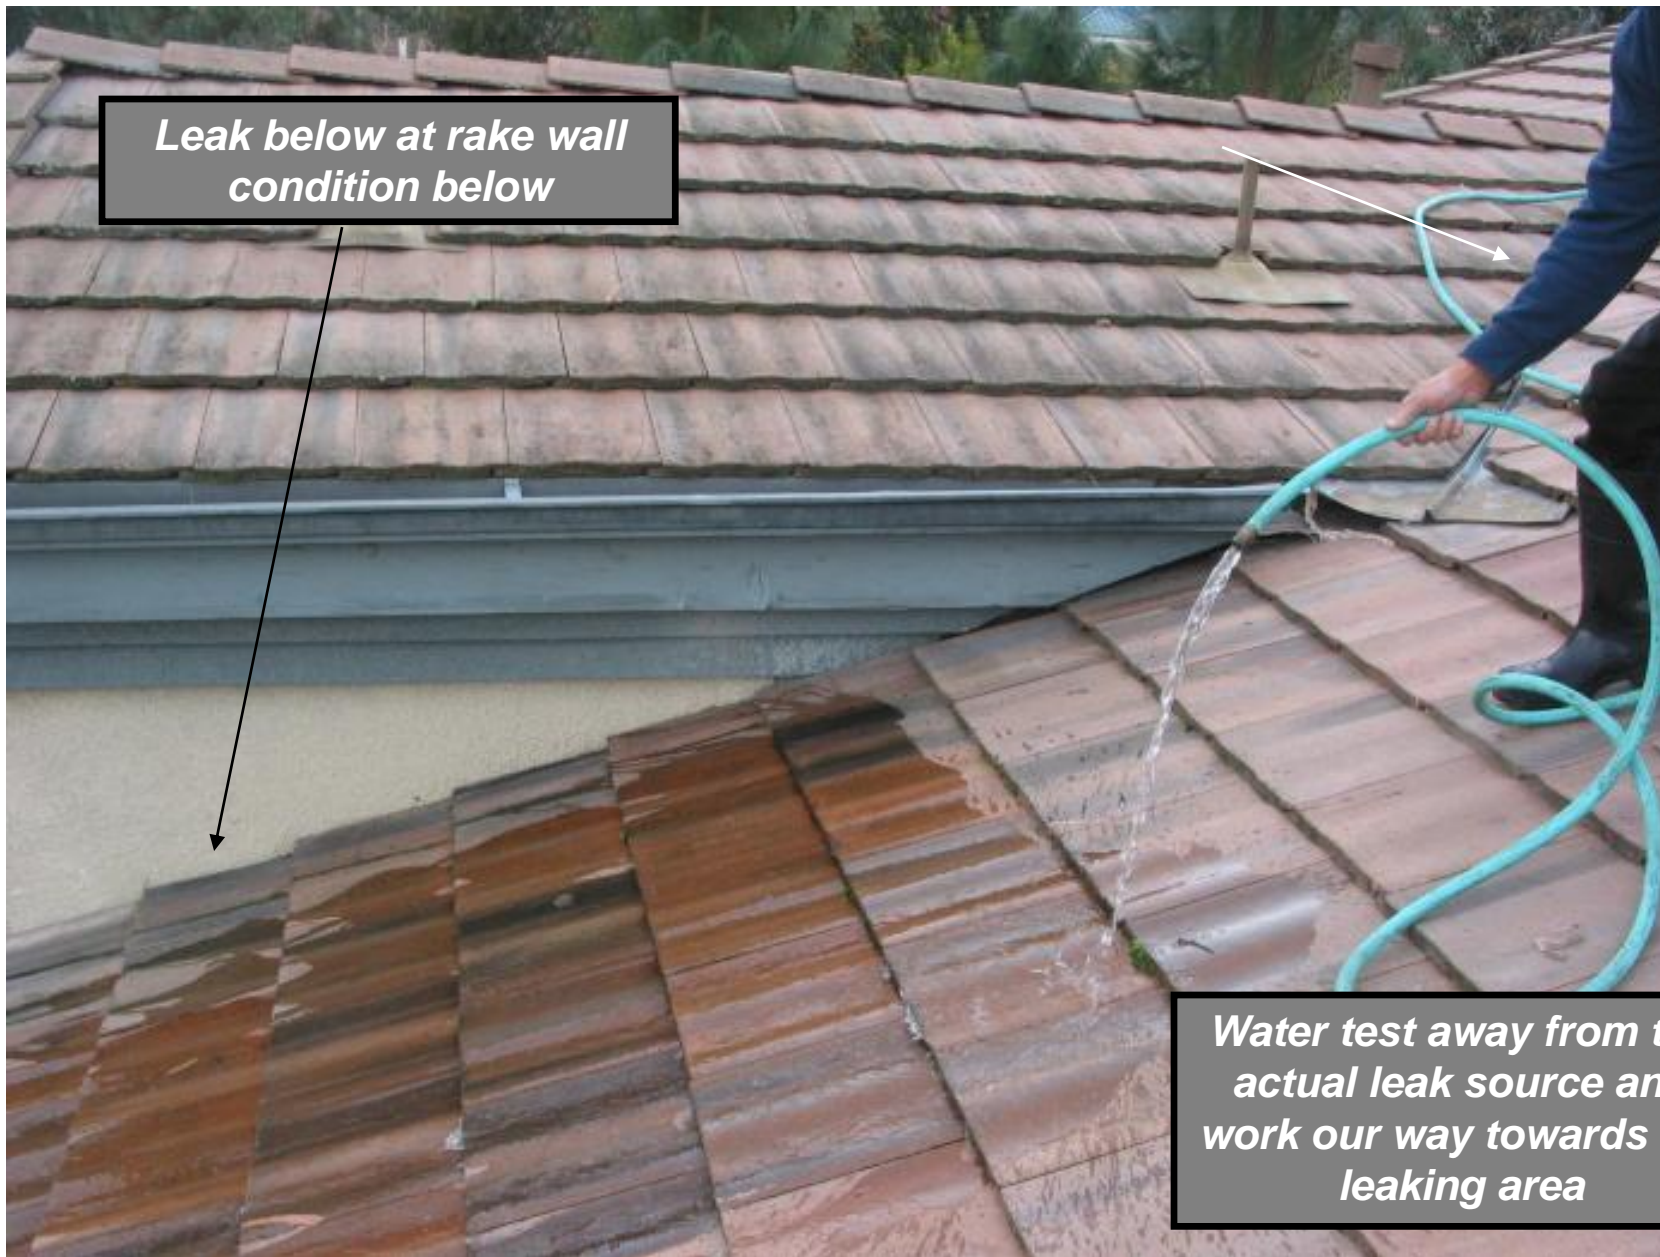
*Leak below at rake wall  
condition below*

*Water test away from the  
actual leak source and  
work our way towards the  
leaking area*

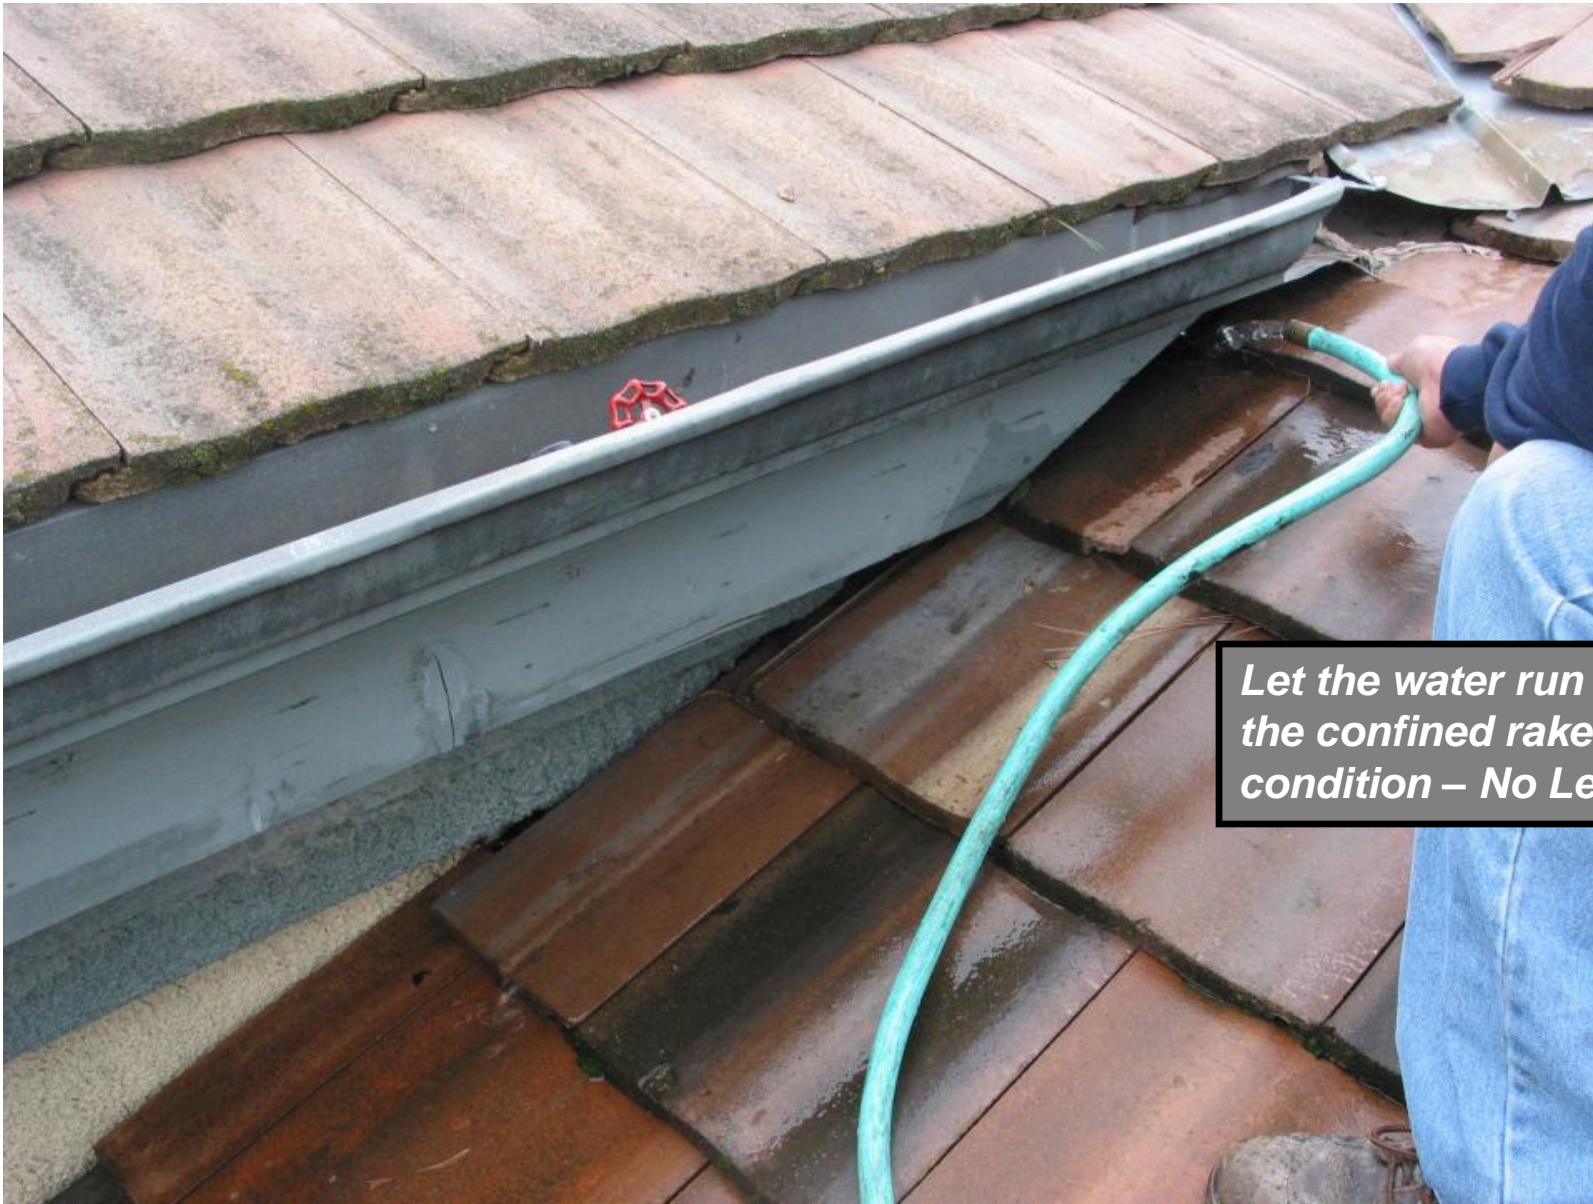
***Let the water run down  
the confined rake  
condition – No Leak!***

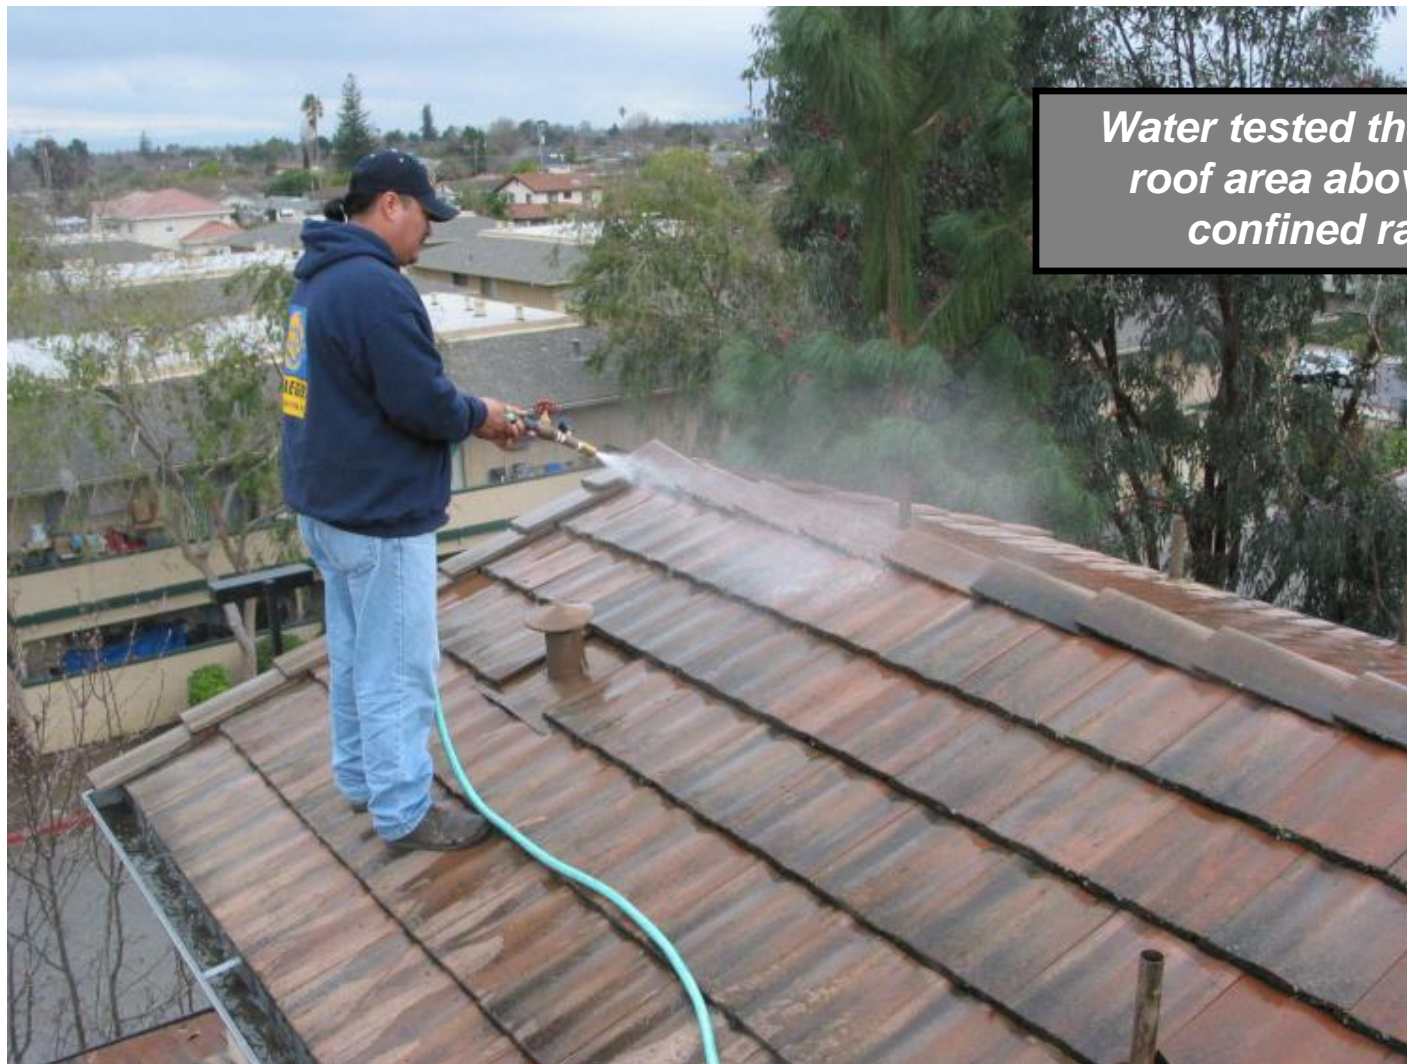
*Water tested the gable roof area above the confined rake*

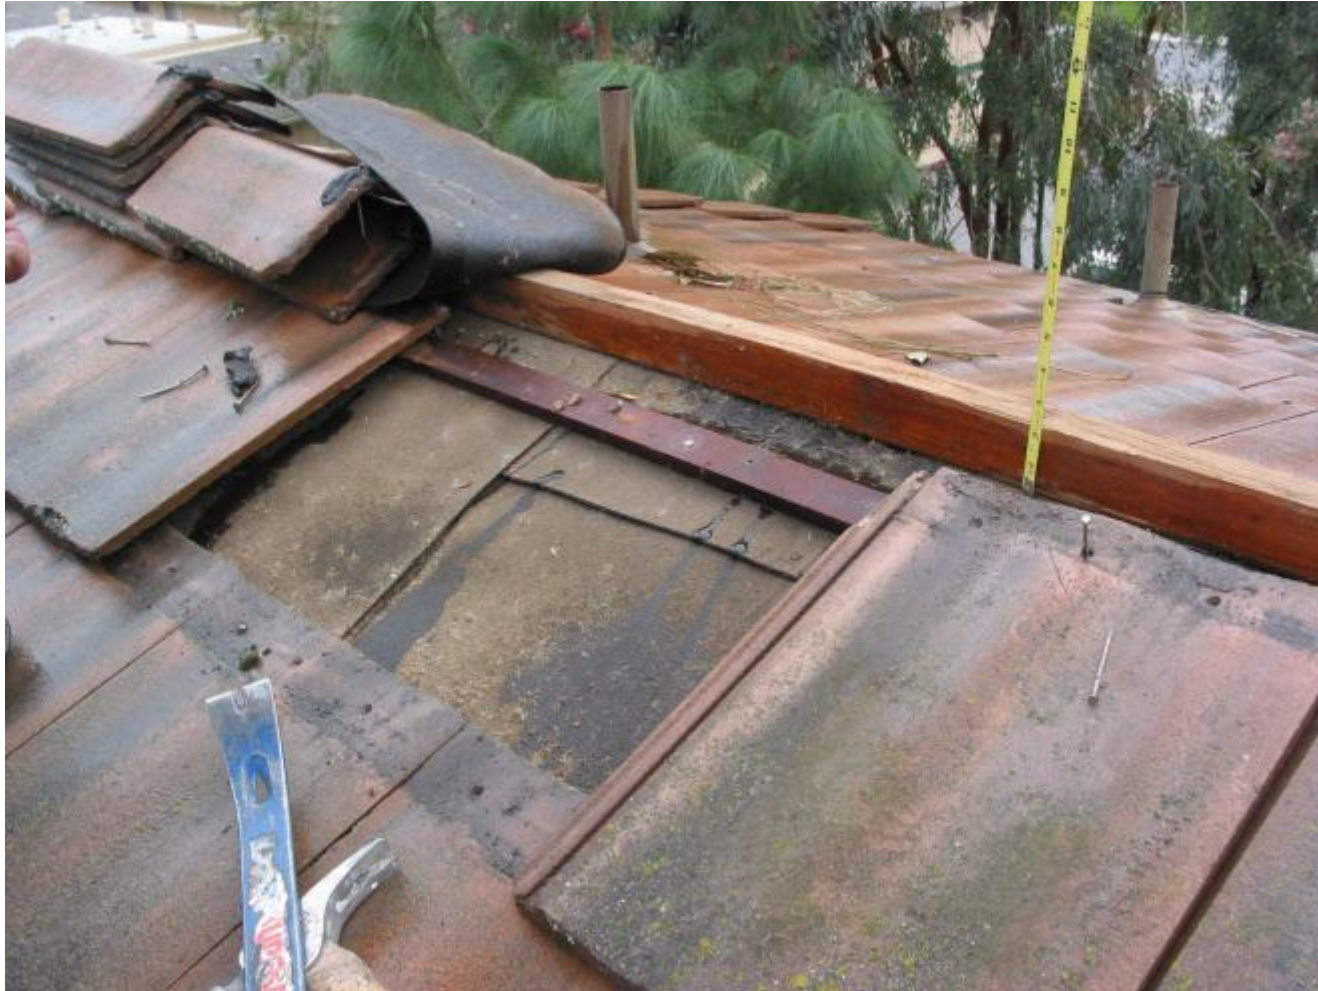
Water penetration but this was not the primary source of leak in unit below.

Improper membrane was utilized as wind block. 30lb felt was used instead of 9" pressure sensitive adhesive membrane recommended by material manufacturer.

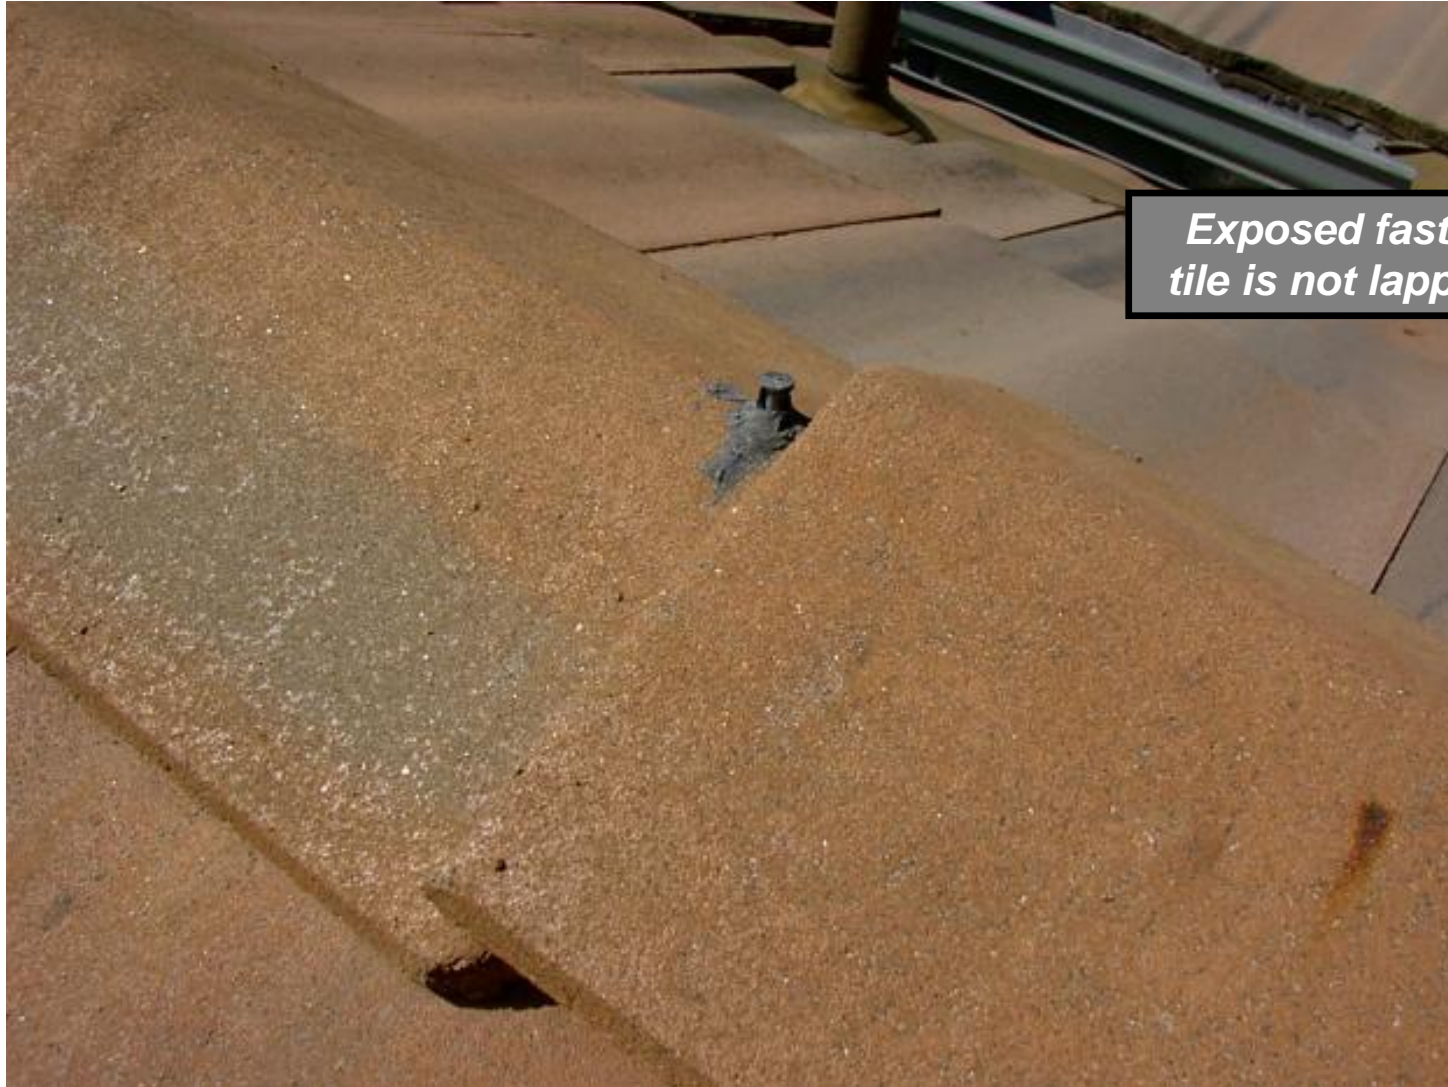
*Exposed fastener. Ridge tile is not lapped properly.*

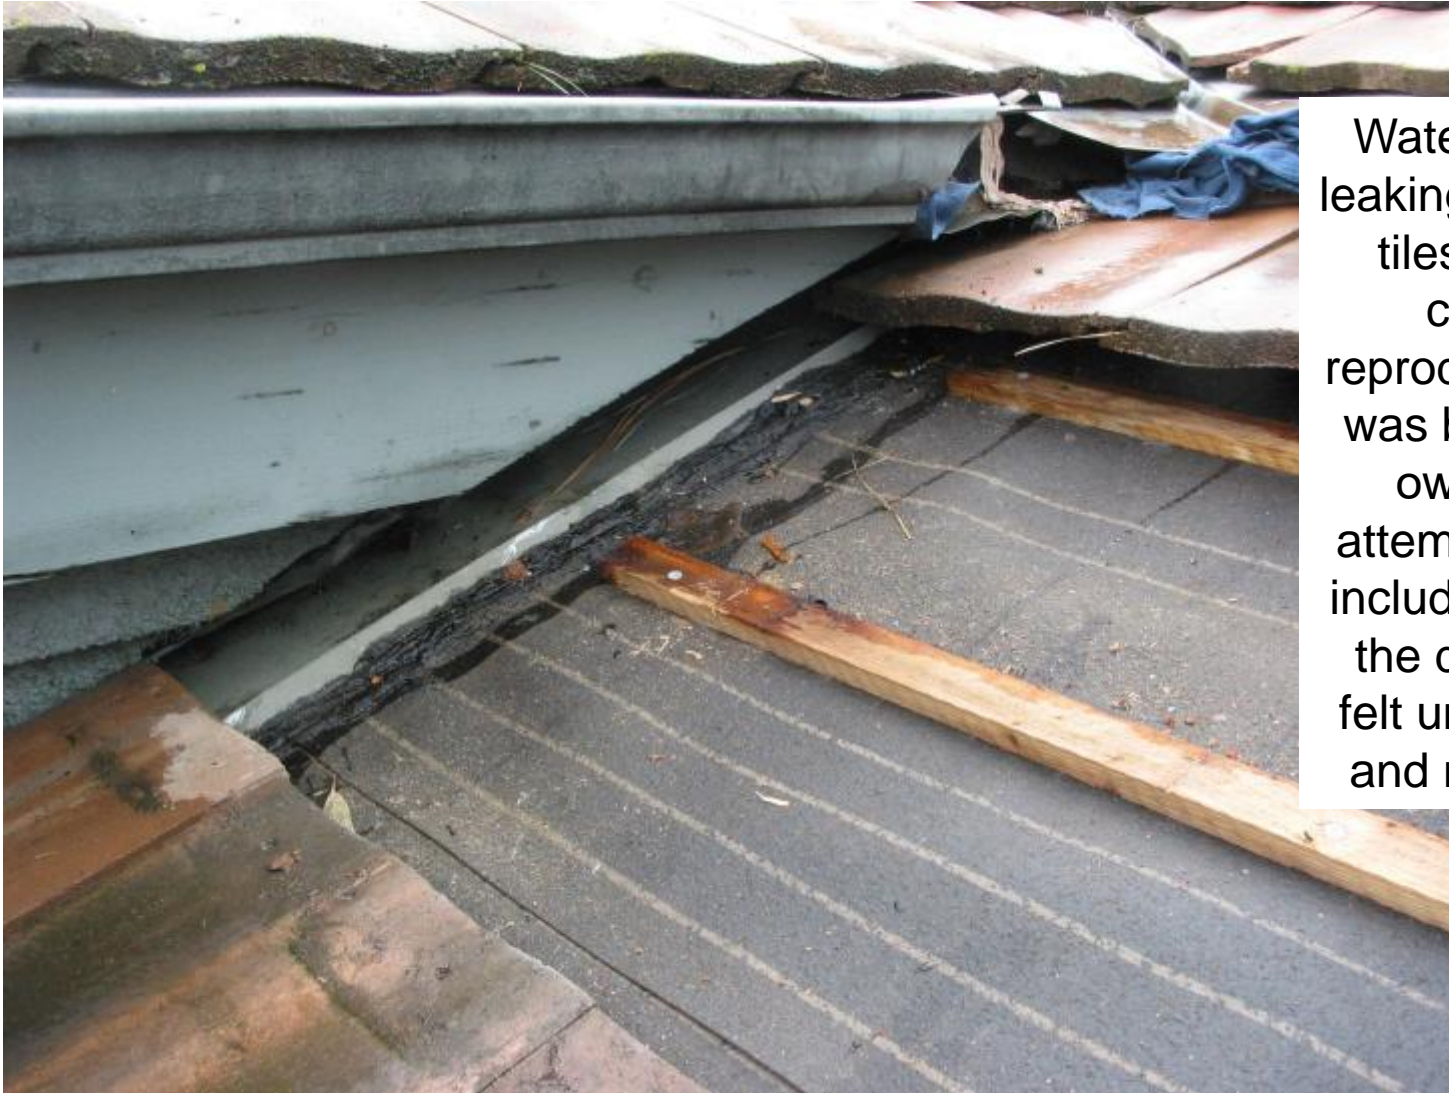
Water had been leaking through the tiles however, could not reproduce the leak was because the owner's last attempt at repairs included replacing the deteriorated felt underlayment and mastic seal.

*Much of the tile was installed with staggered joints. We observed a very high incidence of broken tile corners, which was primarily the source of leaks.*

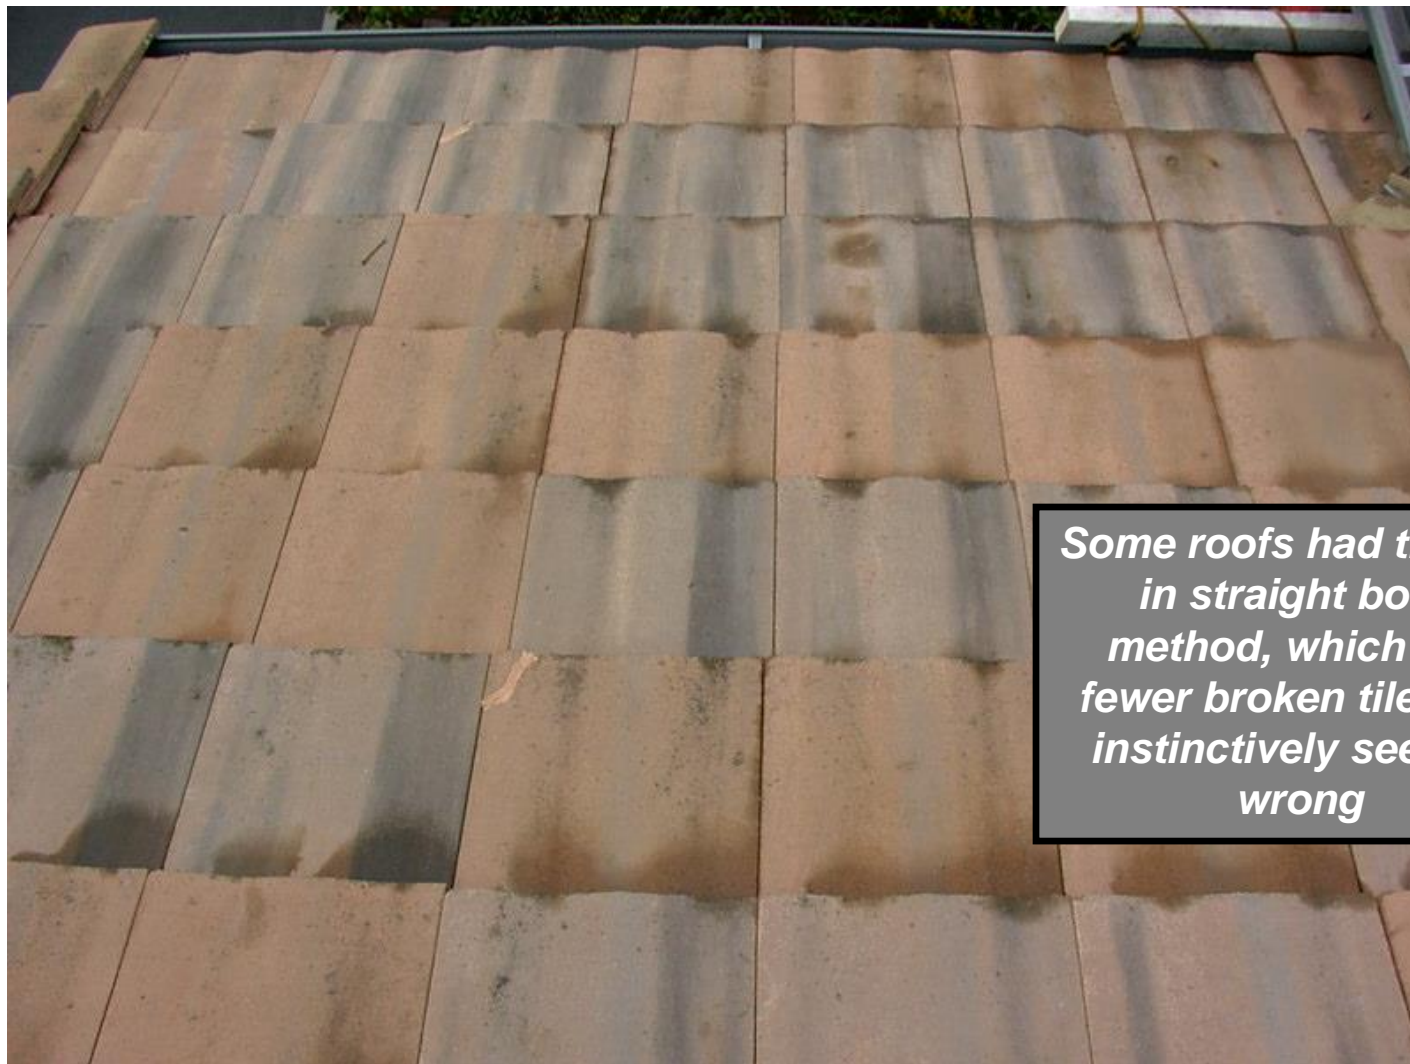
*Some roofs had tile laid in straight bond method, which had fewer broken tiles but instinctively seemed wrong*
