# **Forensic Analysis of Roofing Systems Examples of Roof Performance Learn from Failures to Make Roofs More Sustainable!**

International Roofing Expos

February 16, 2005

# Case 1: Forensic Investigation of Metal Roof Failure

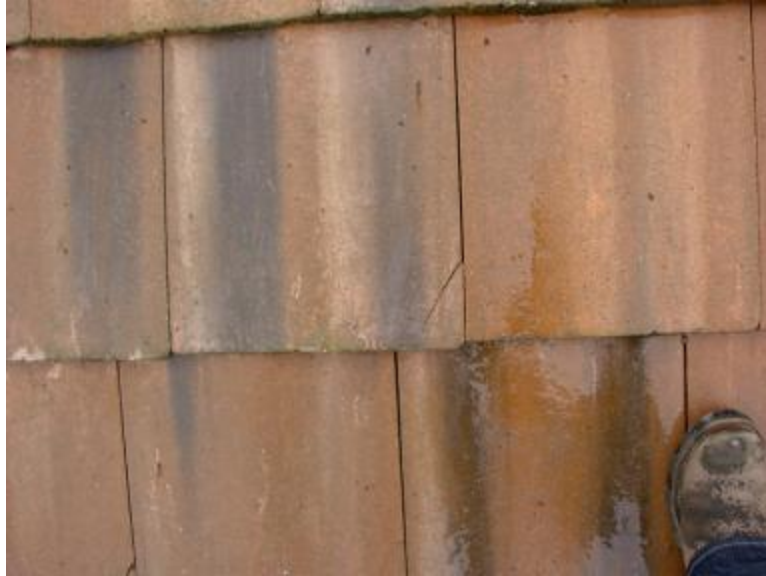
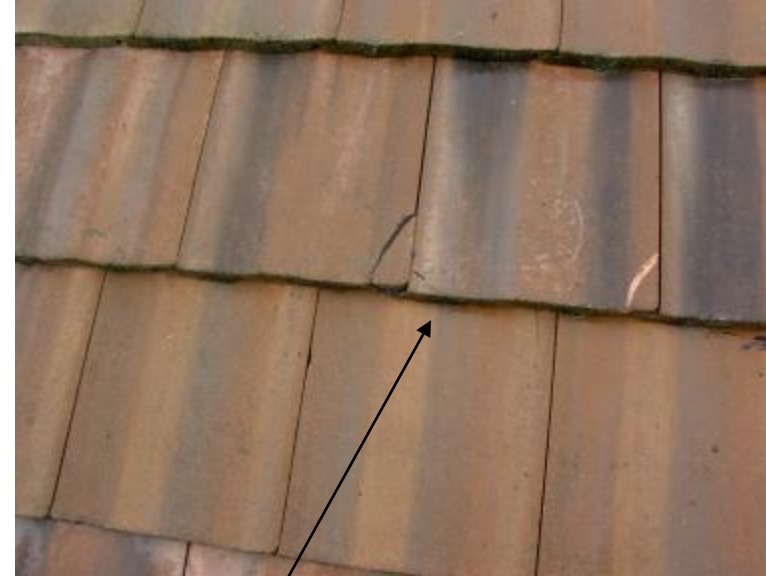
***ANOTHER DEFECT:  
Joints in tile not  
parallel and are too  
close, contributing to  
breakage***

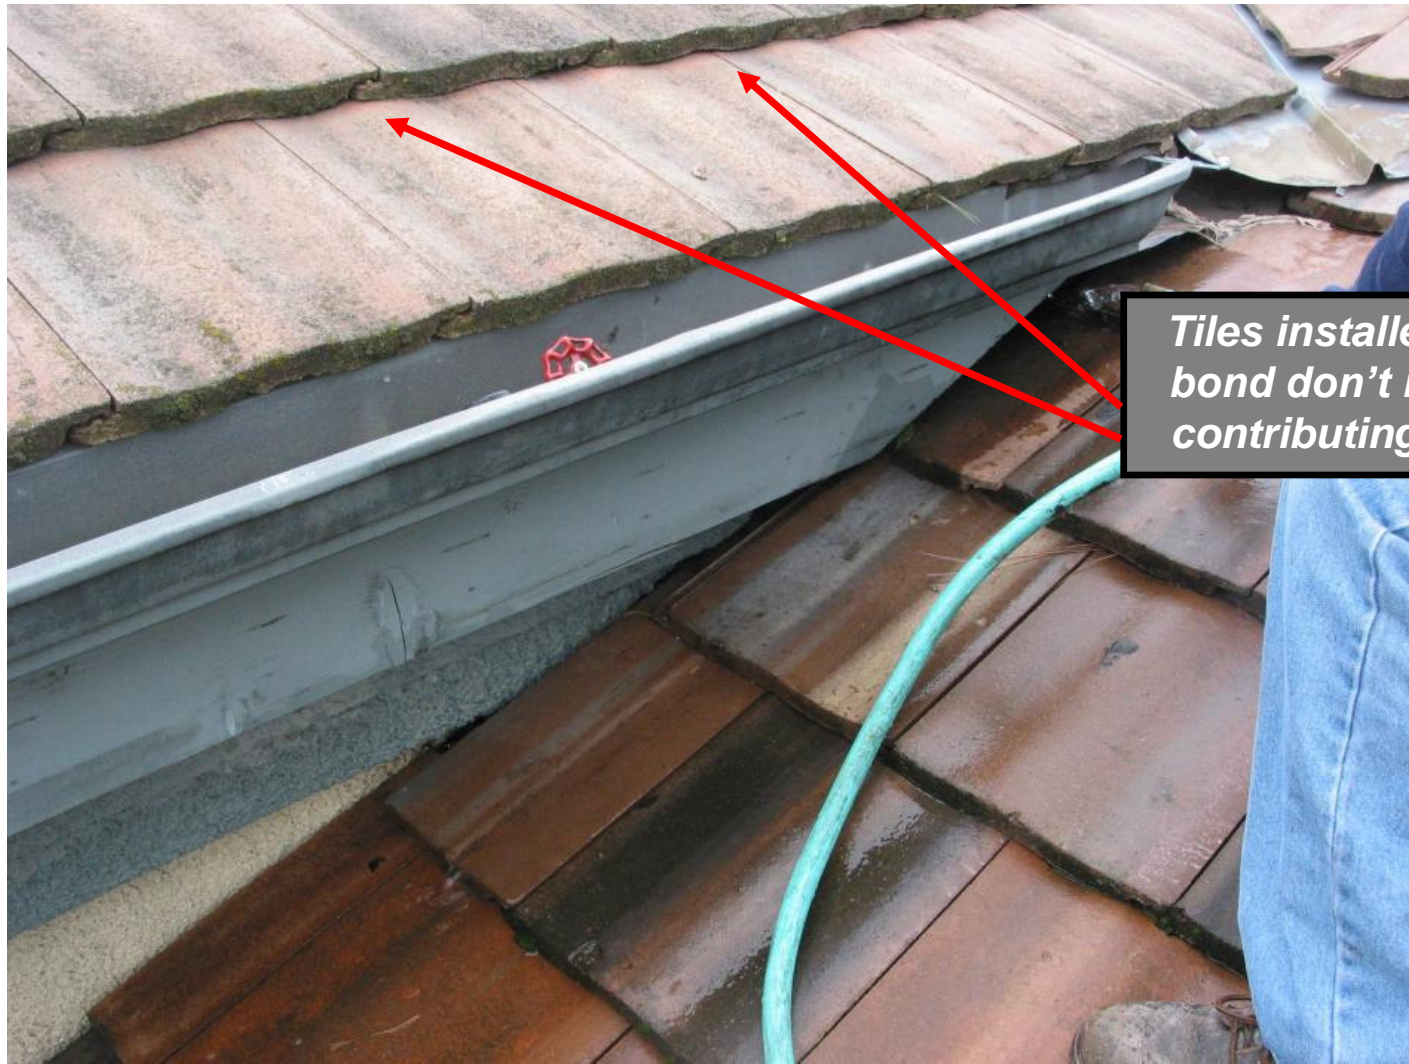
*Tiles installed in a broken bond don't nest properly, contributing to breakage.*

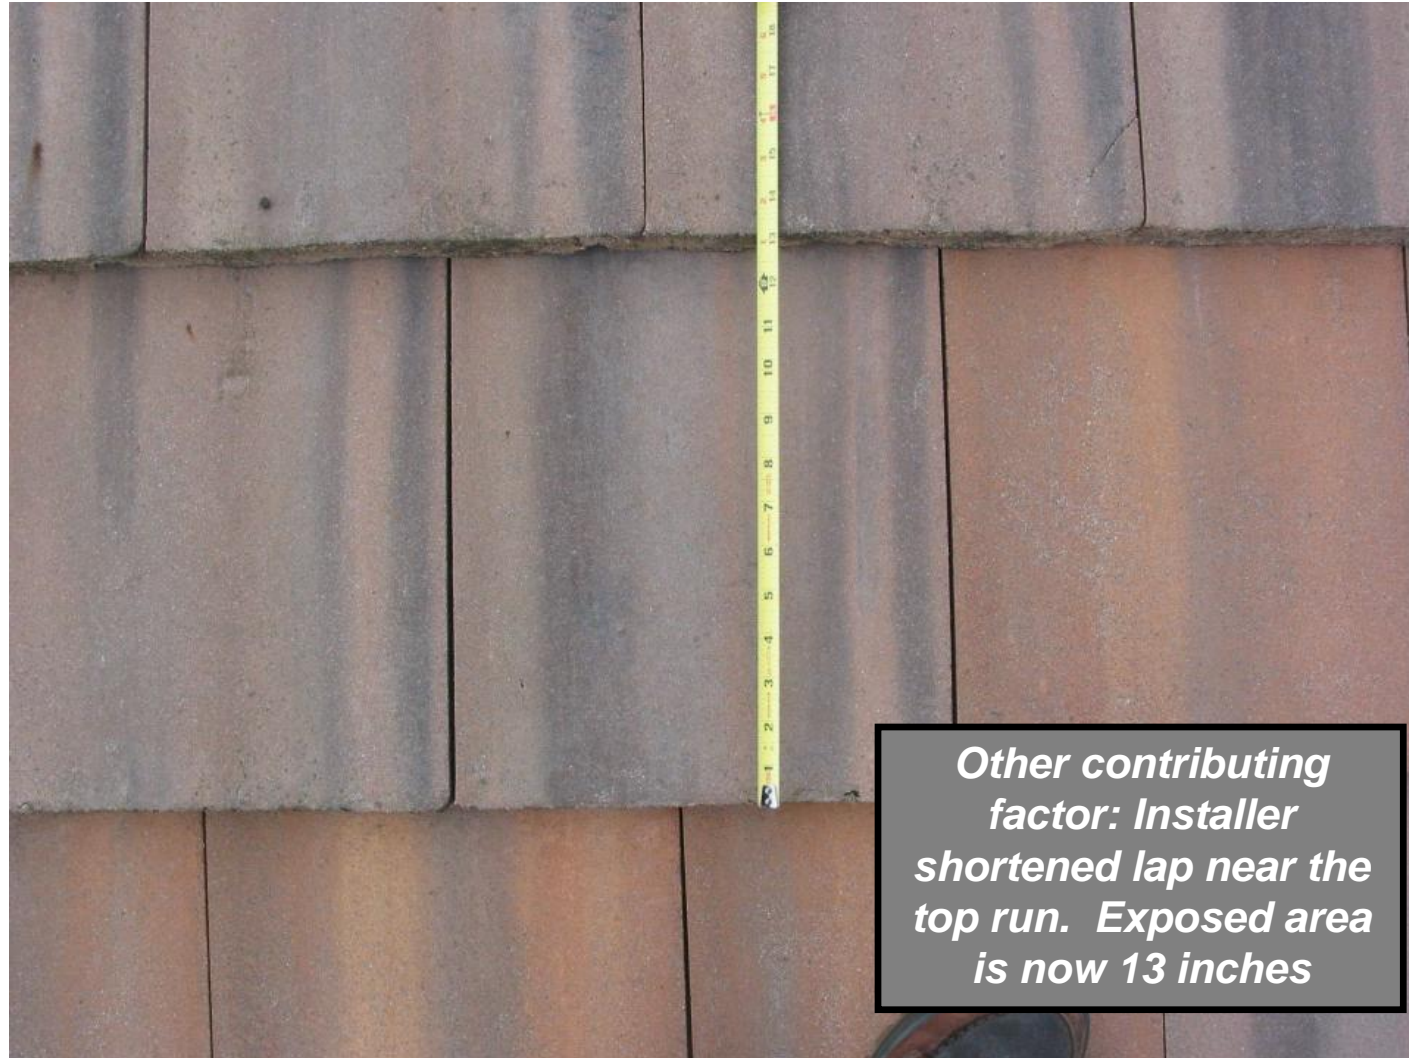
***Other contributing factor: Installer shortened lap near the top run. Exposed area is now 13 inches***

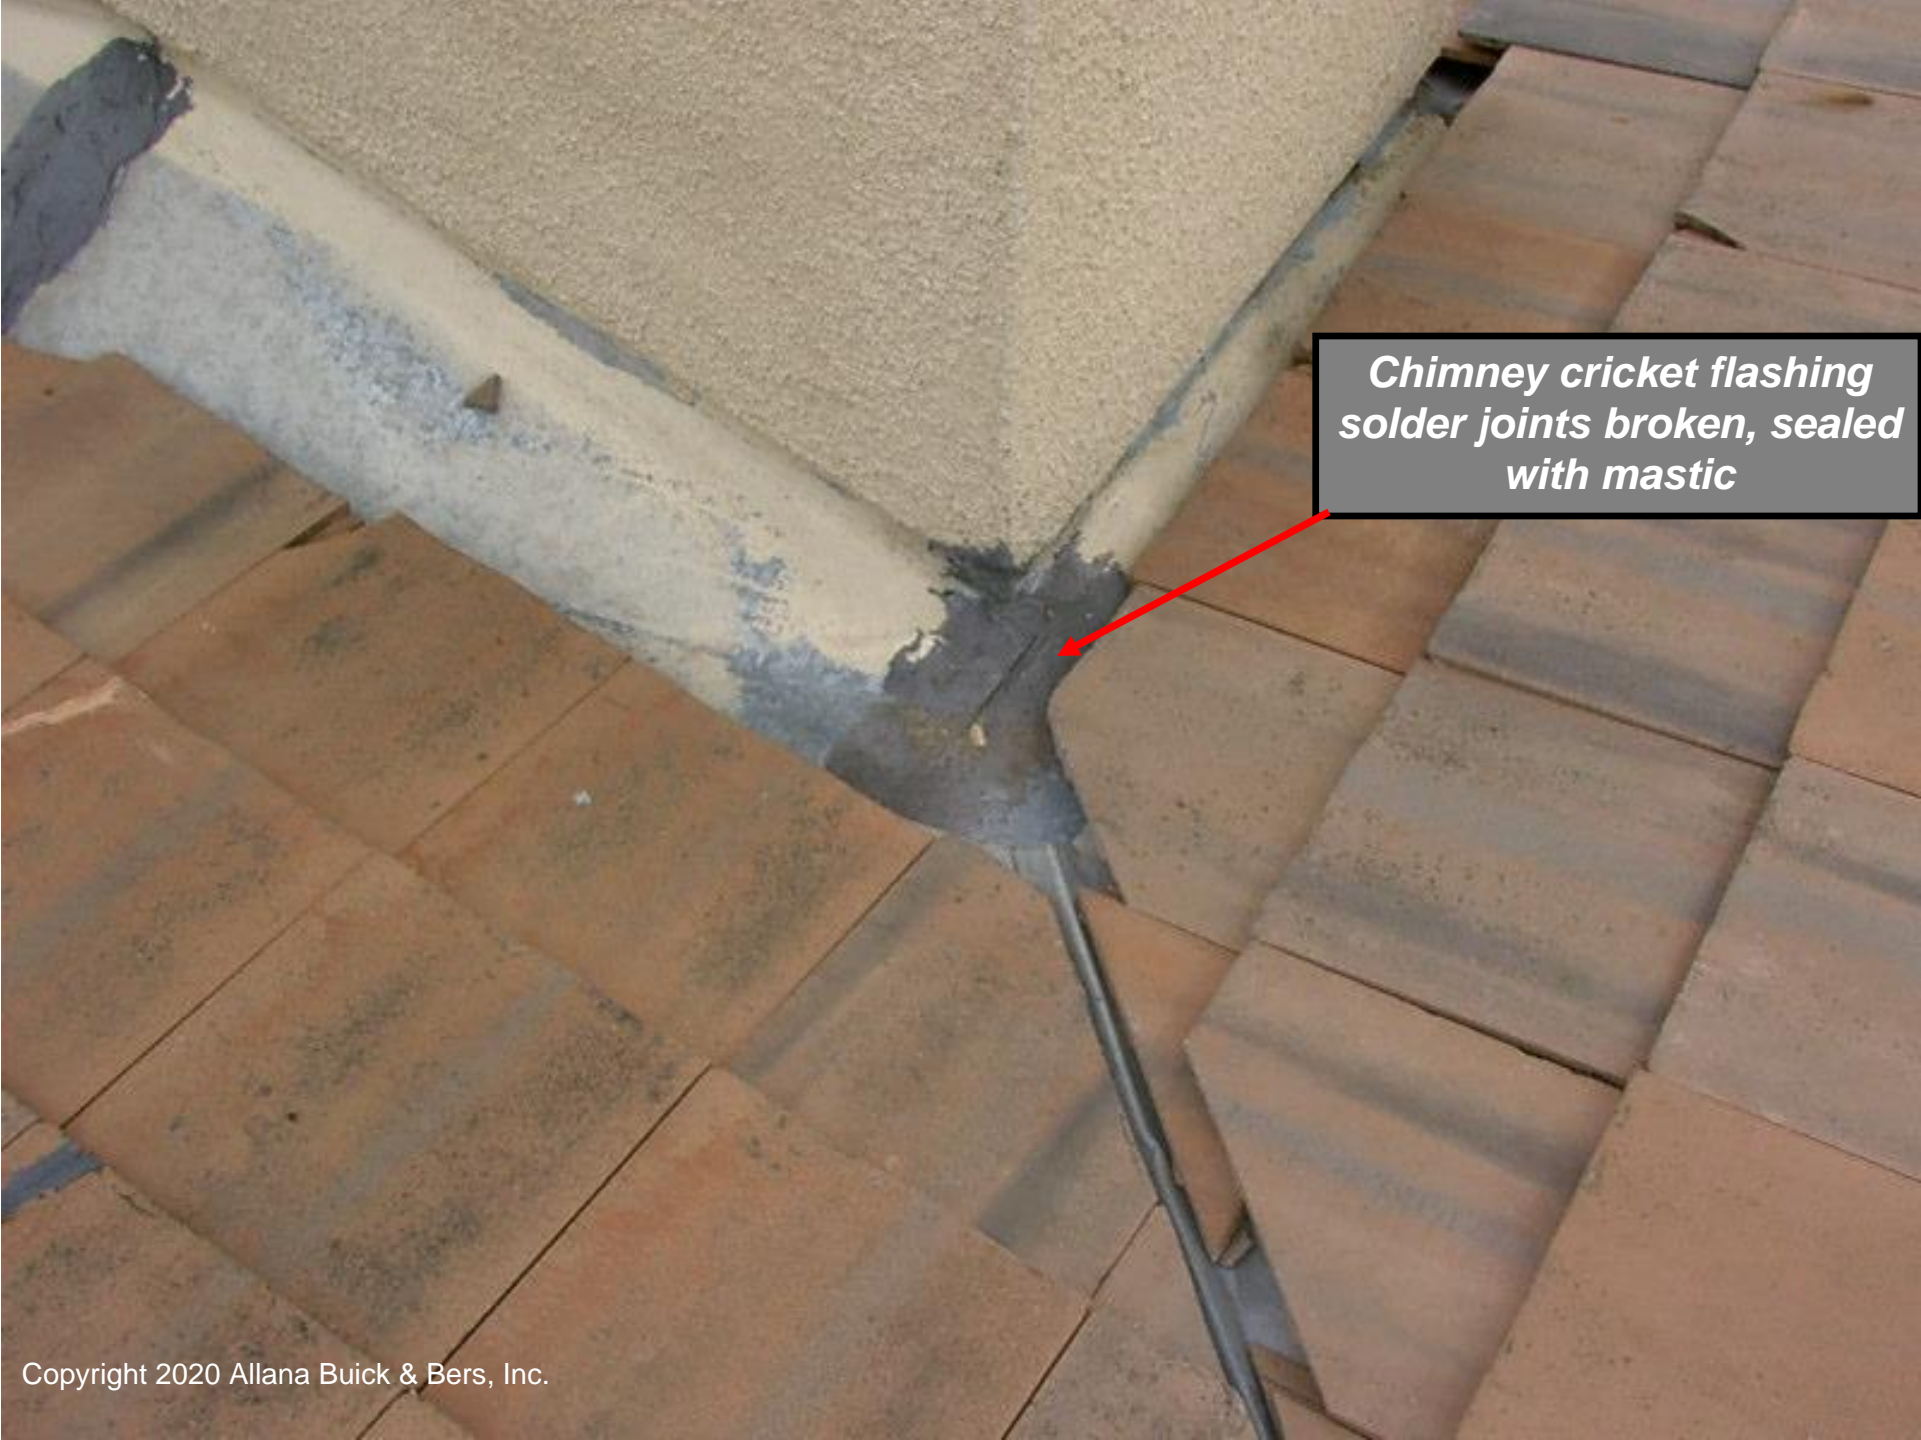
*Chimney cricket flashing  
solder joints broken, sealed  
with mastic*

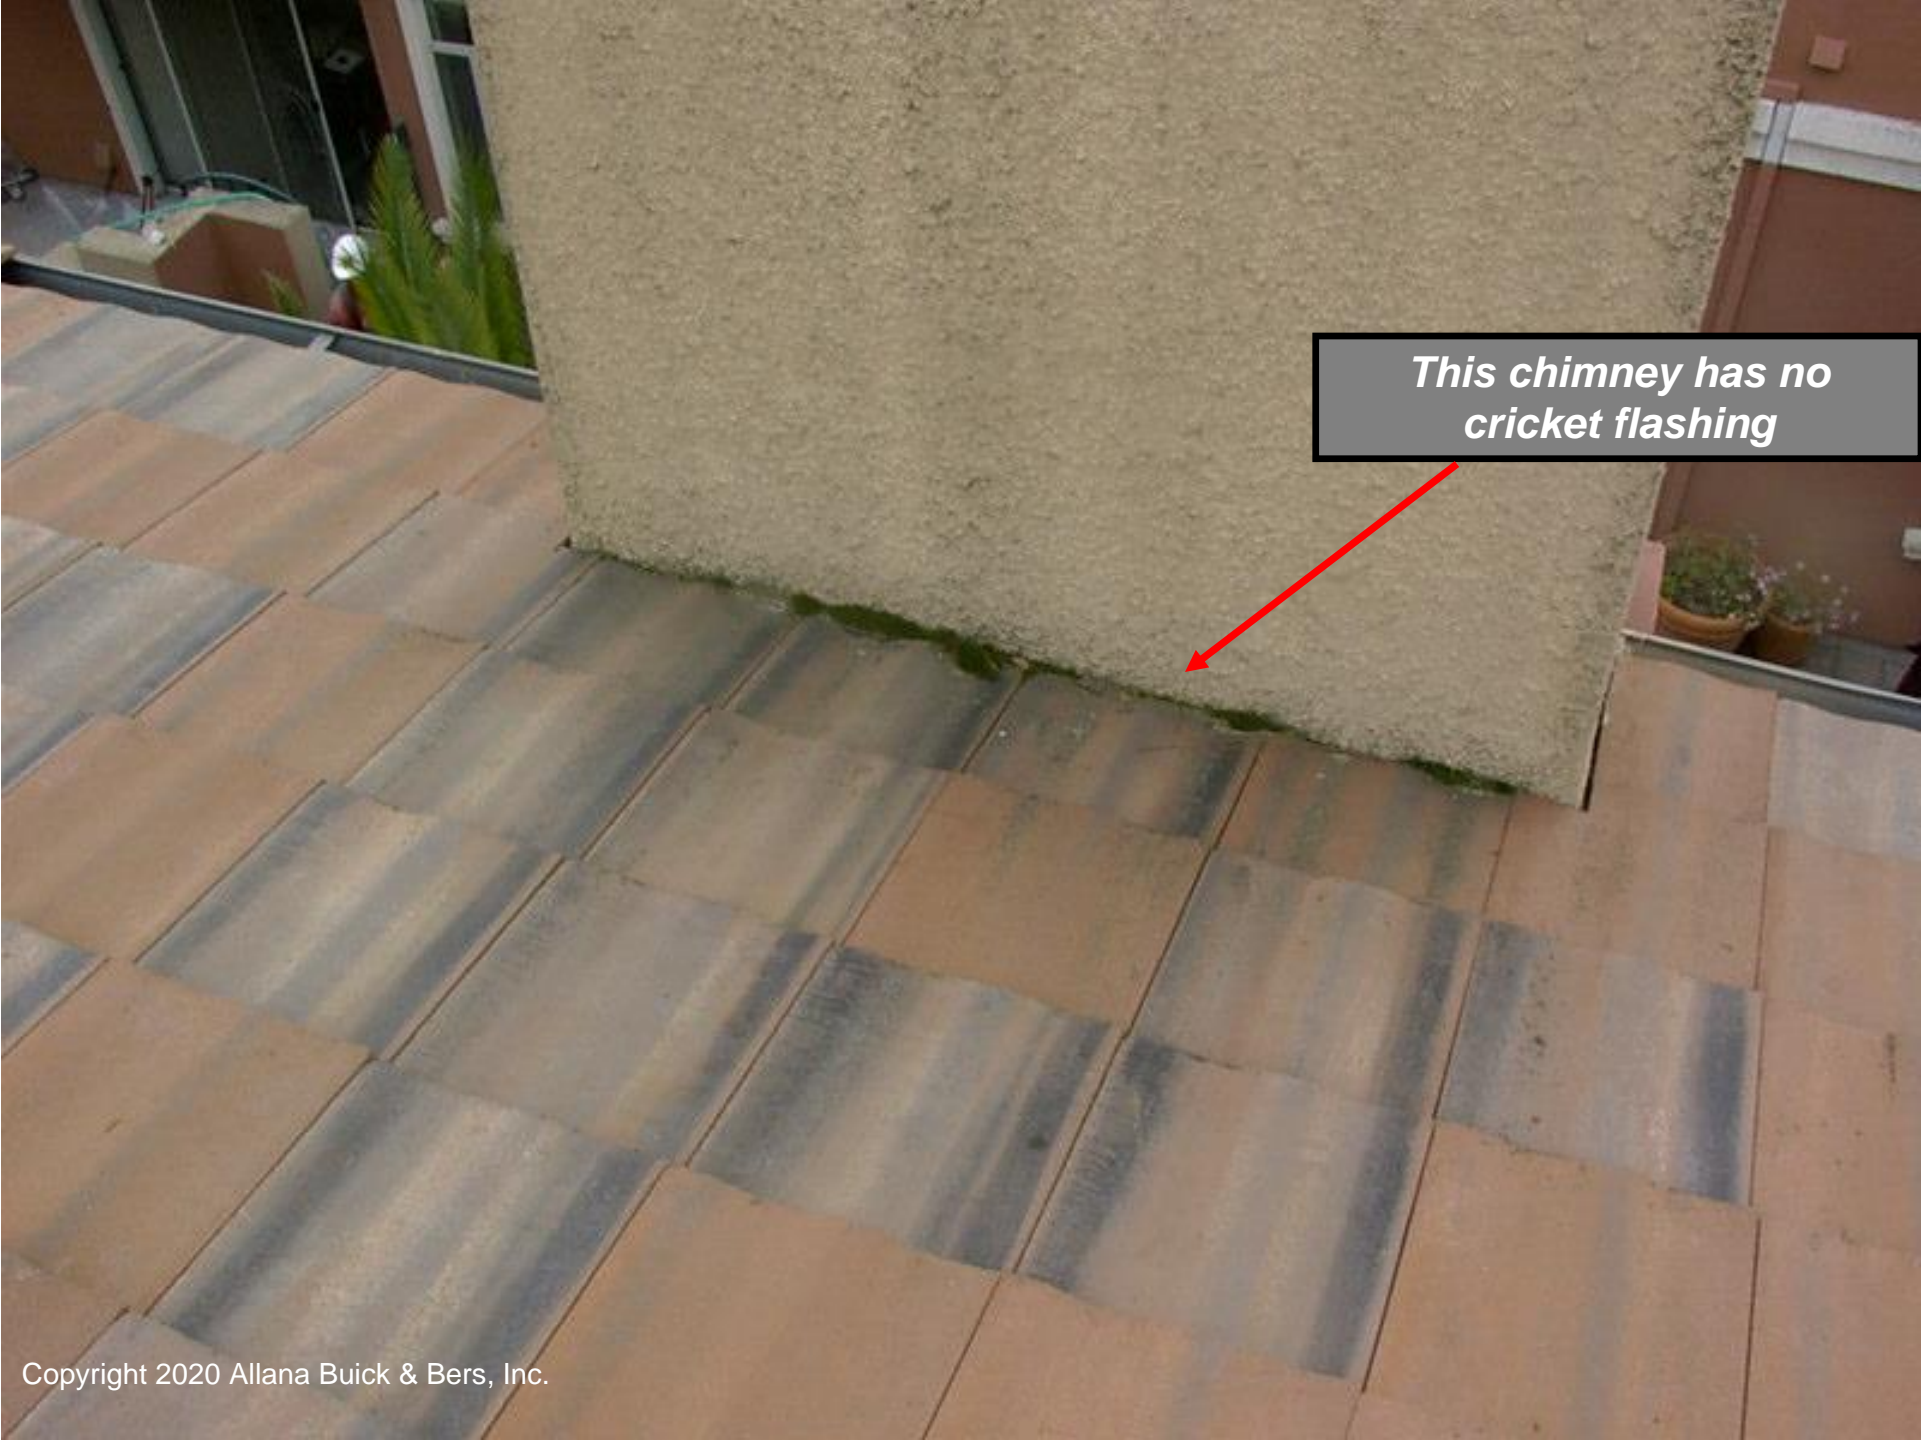
*This chimney has no cricket flashing*

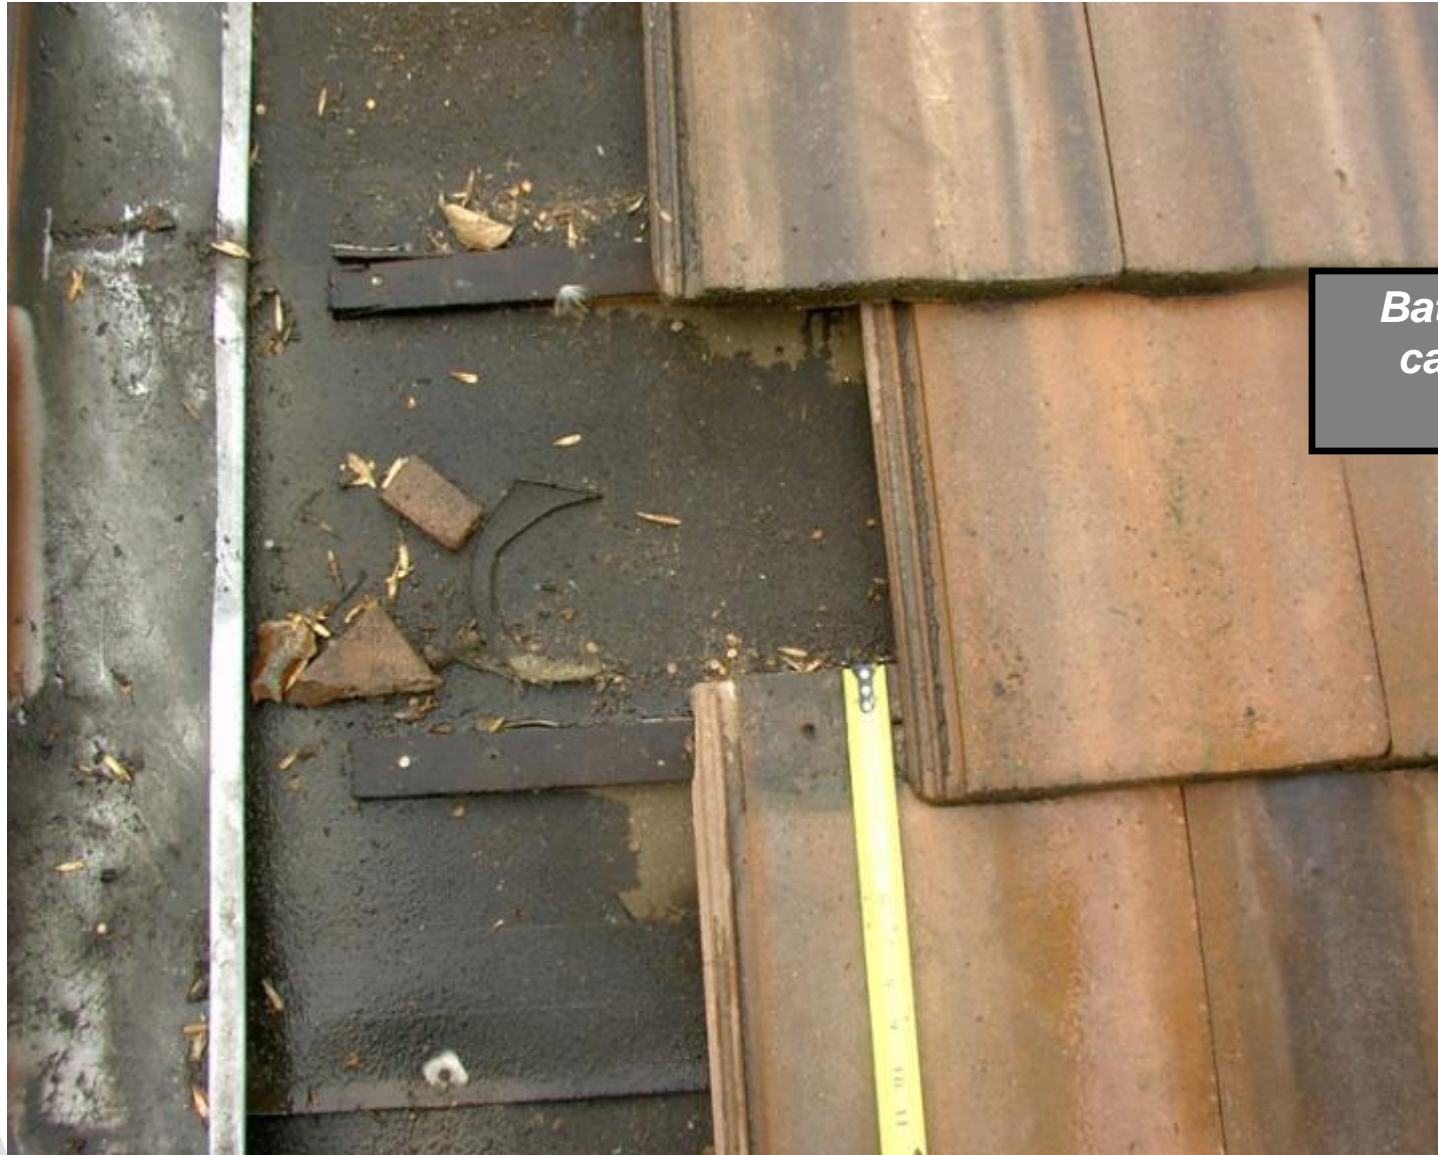
*Battens were too short,  
causing tiles to fall in  
wrong direction*

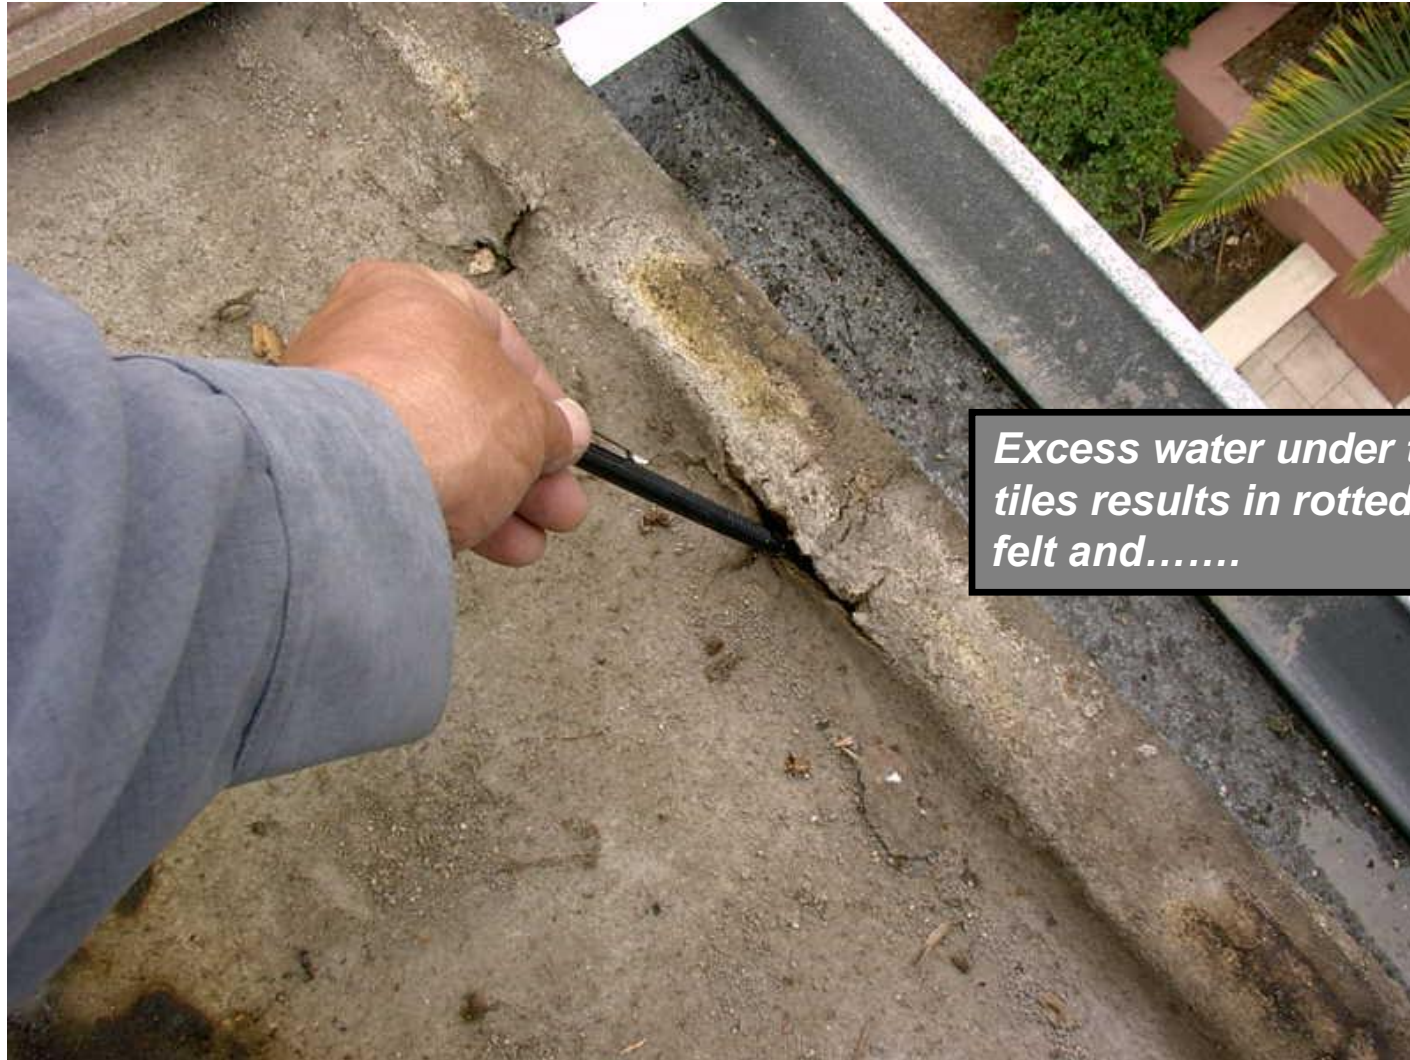
*Excess water under the tiles results in rotted felt and.....*

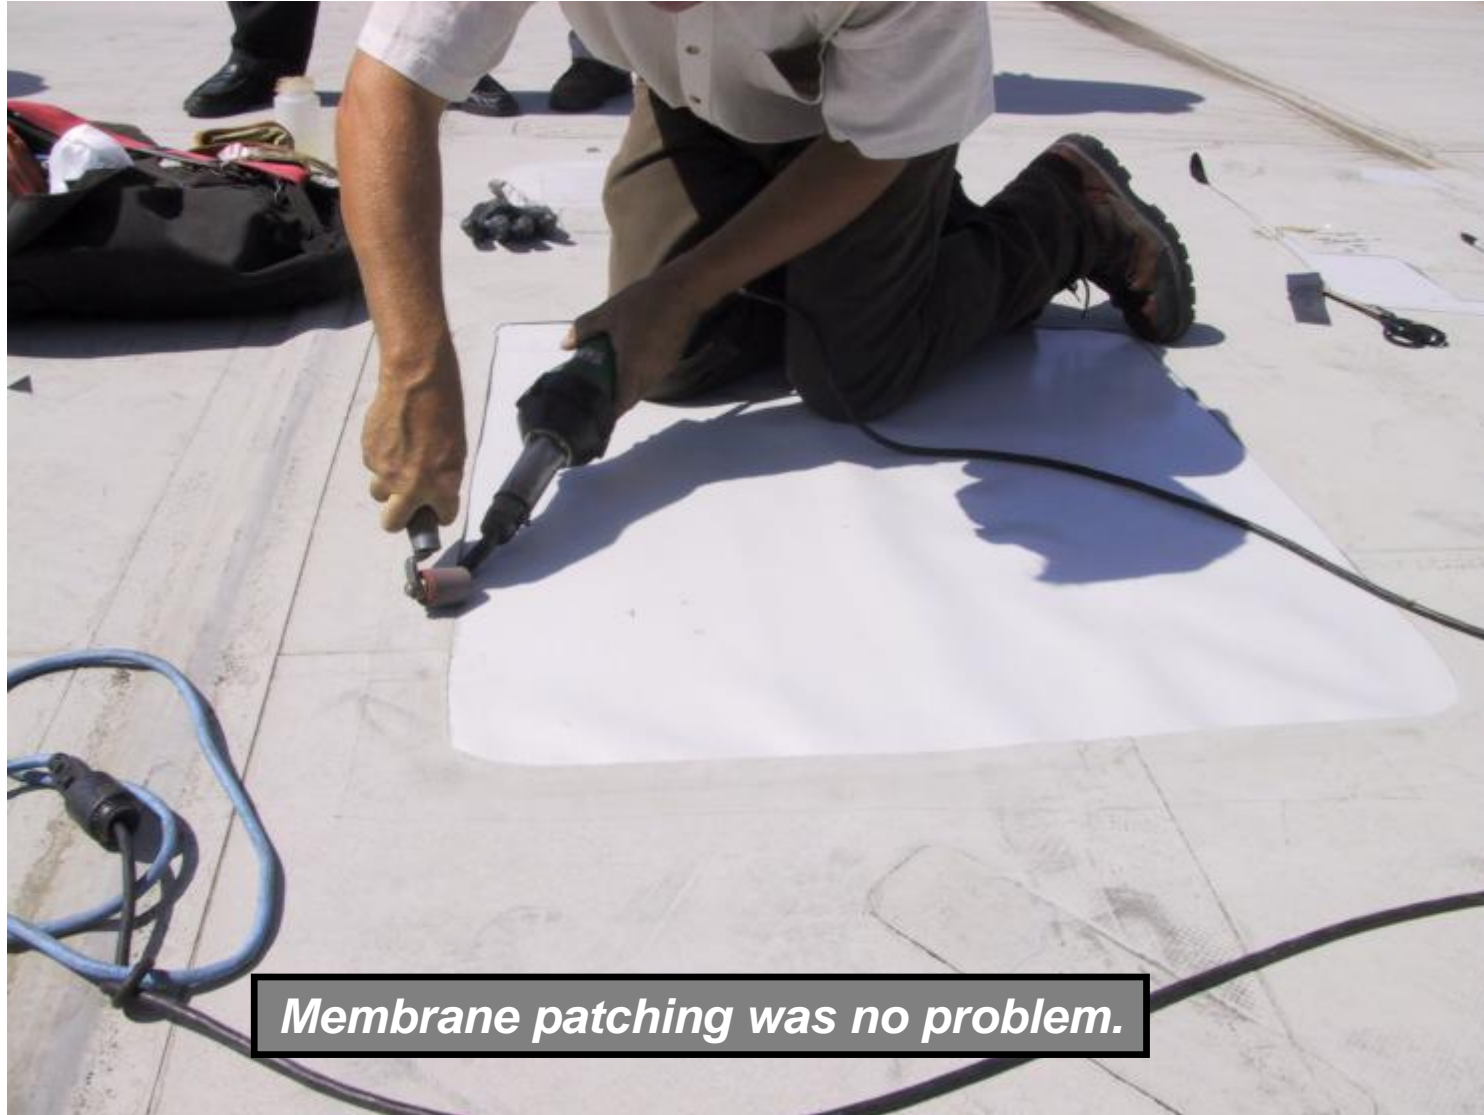
*Membrane patching was no problem.*

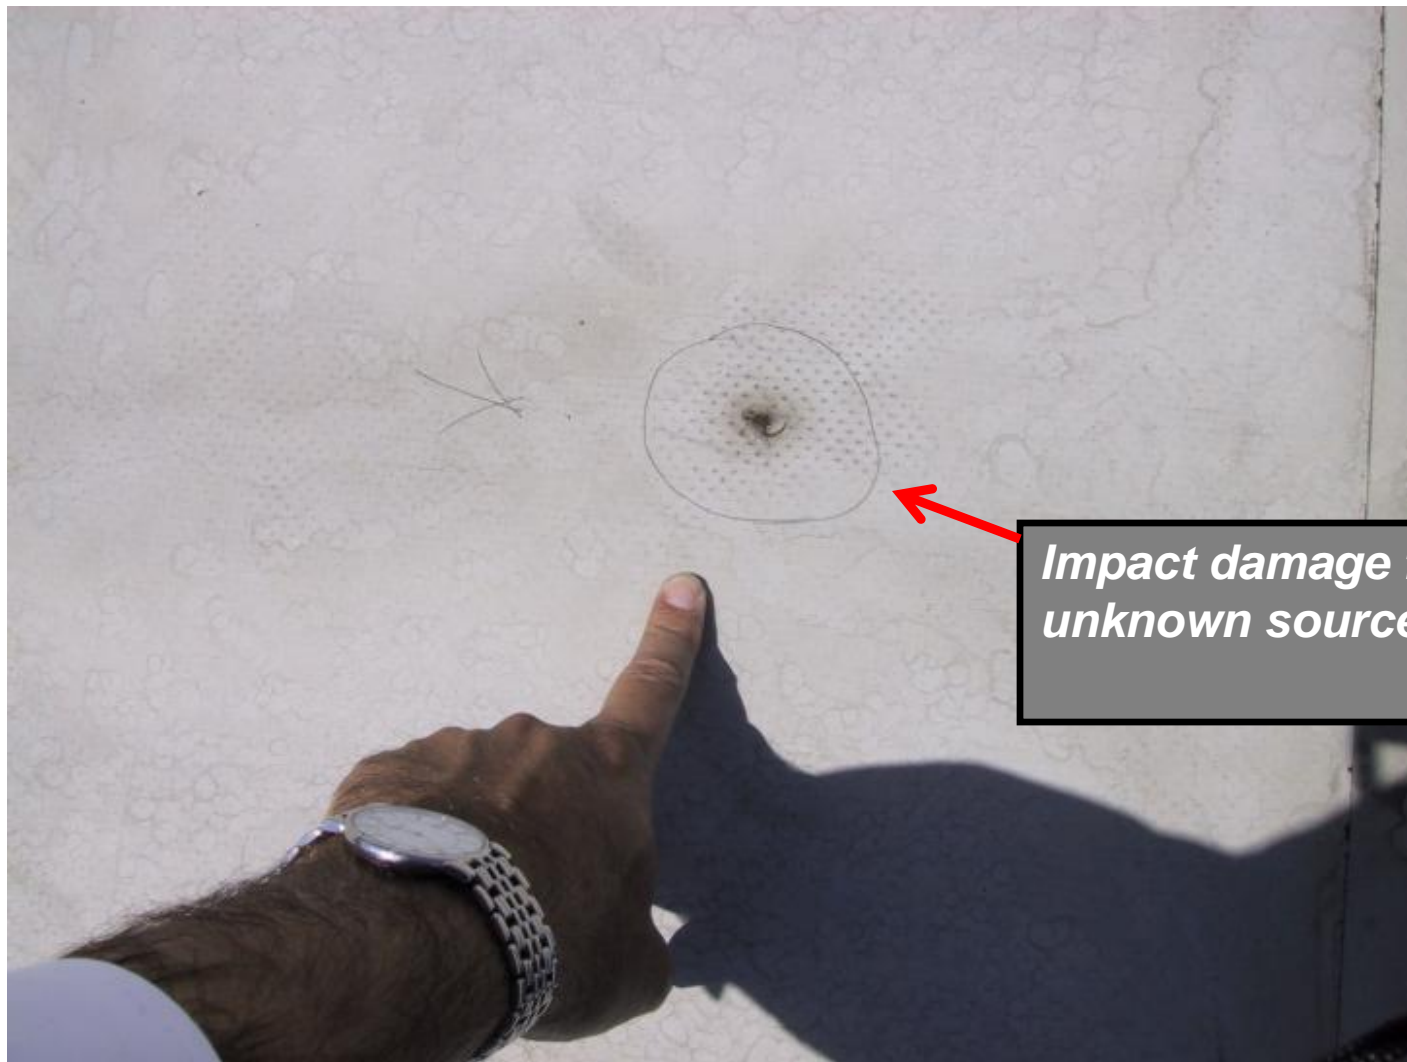
*Impact damage from  
unknown source*

Evidence of Nail from  
construction debris

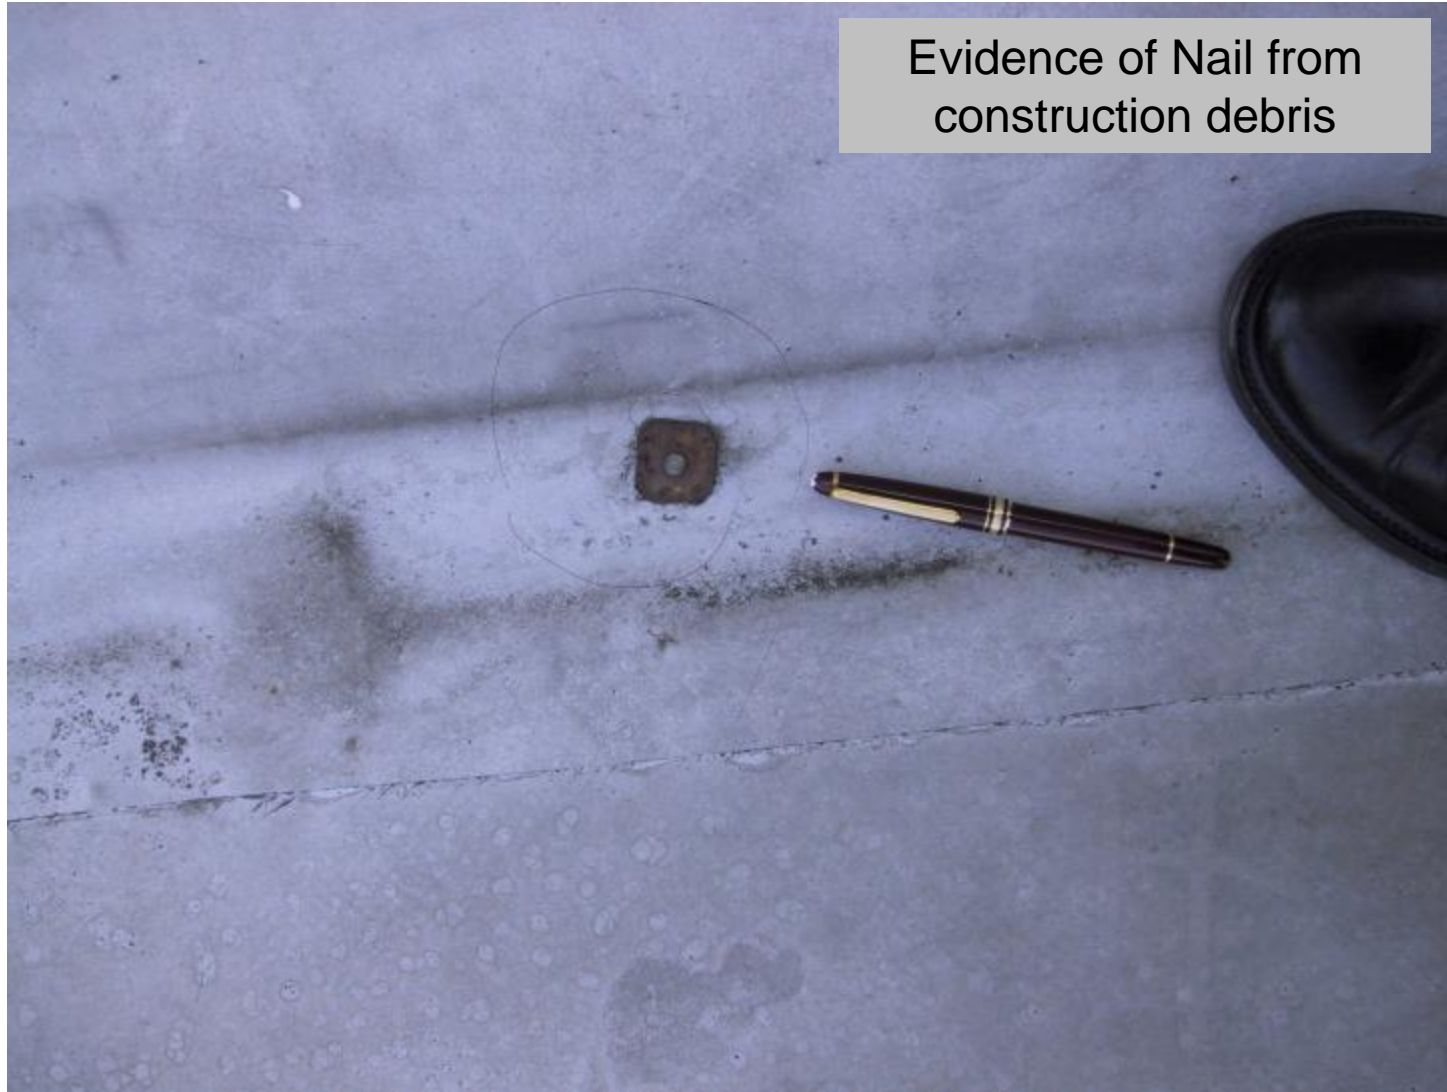
**Sustainability, impact  
damage**

*Membrane damage  
from unknown source*

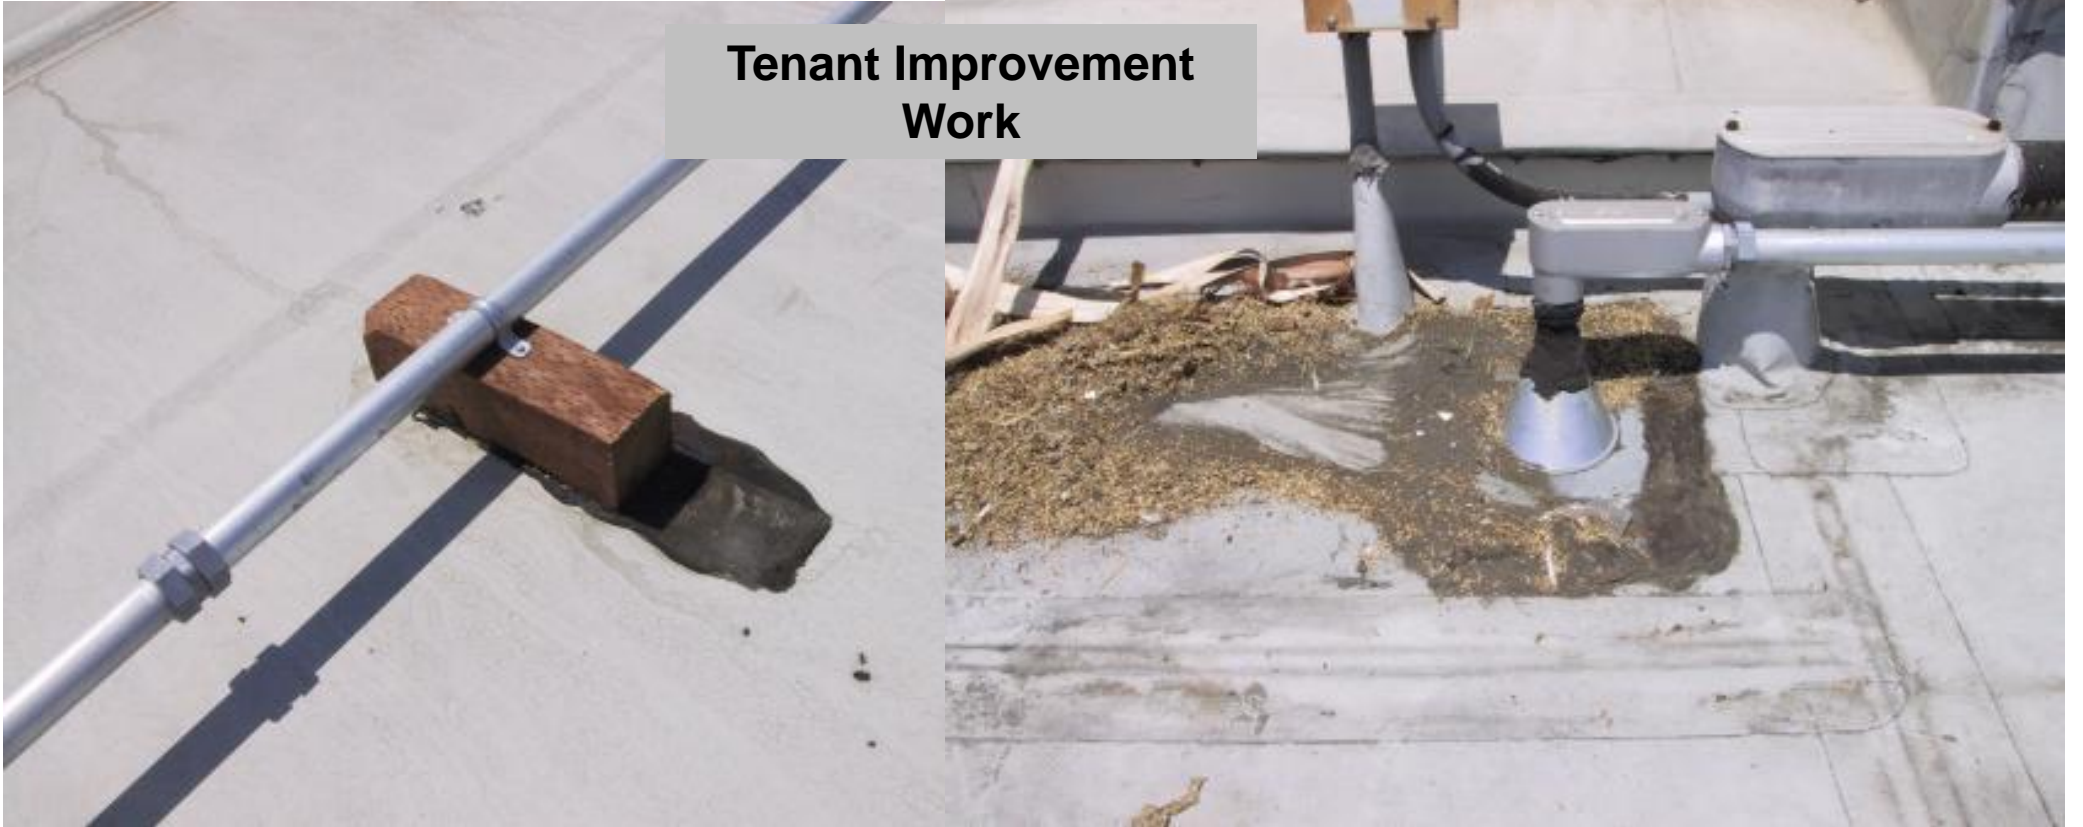
**Tenant Improvement  
Work**

**New electrical pipe added, pipe jack set in mastic  
(not properly flashed with single ply) and wood  
block set in mastic (incompatible with PVC)**

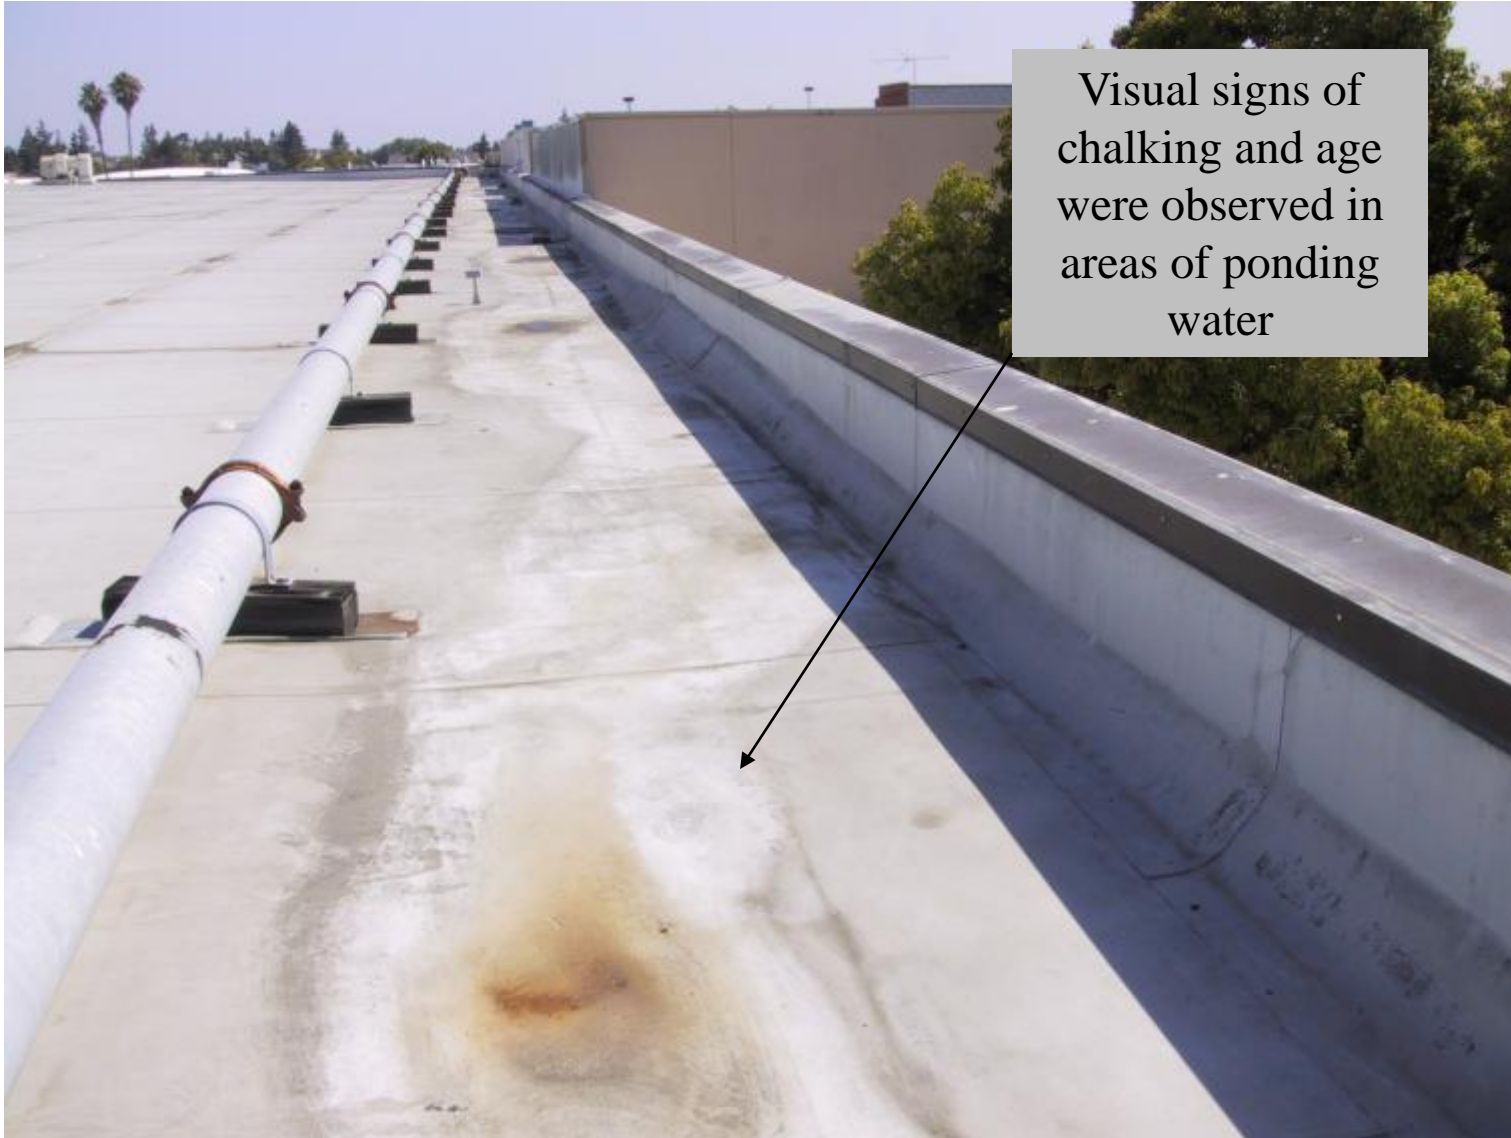
Visual signs of chalking and age were observed in areas of ponding water

Cooling tower and  
condensate water leaking  
over roof

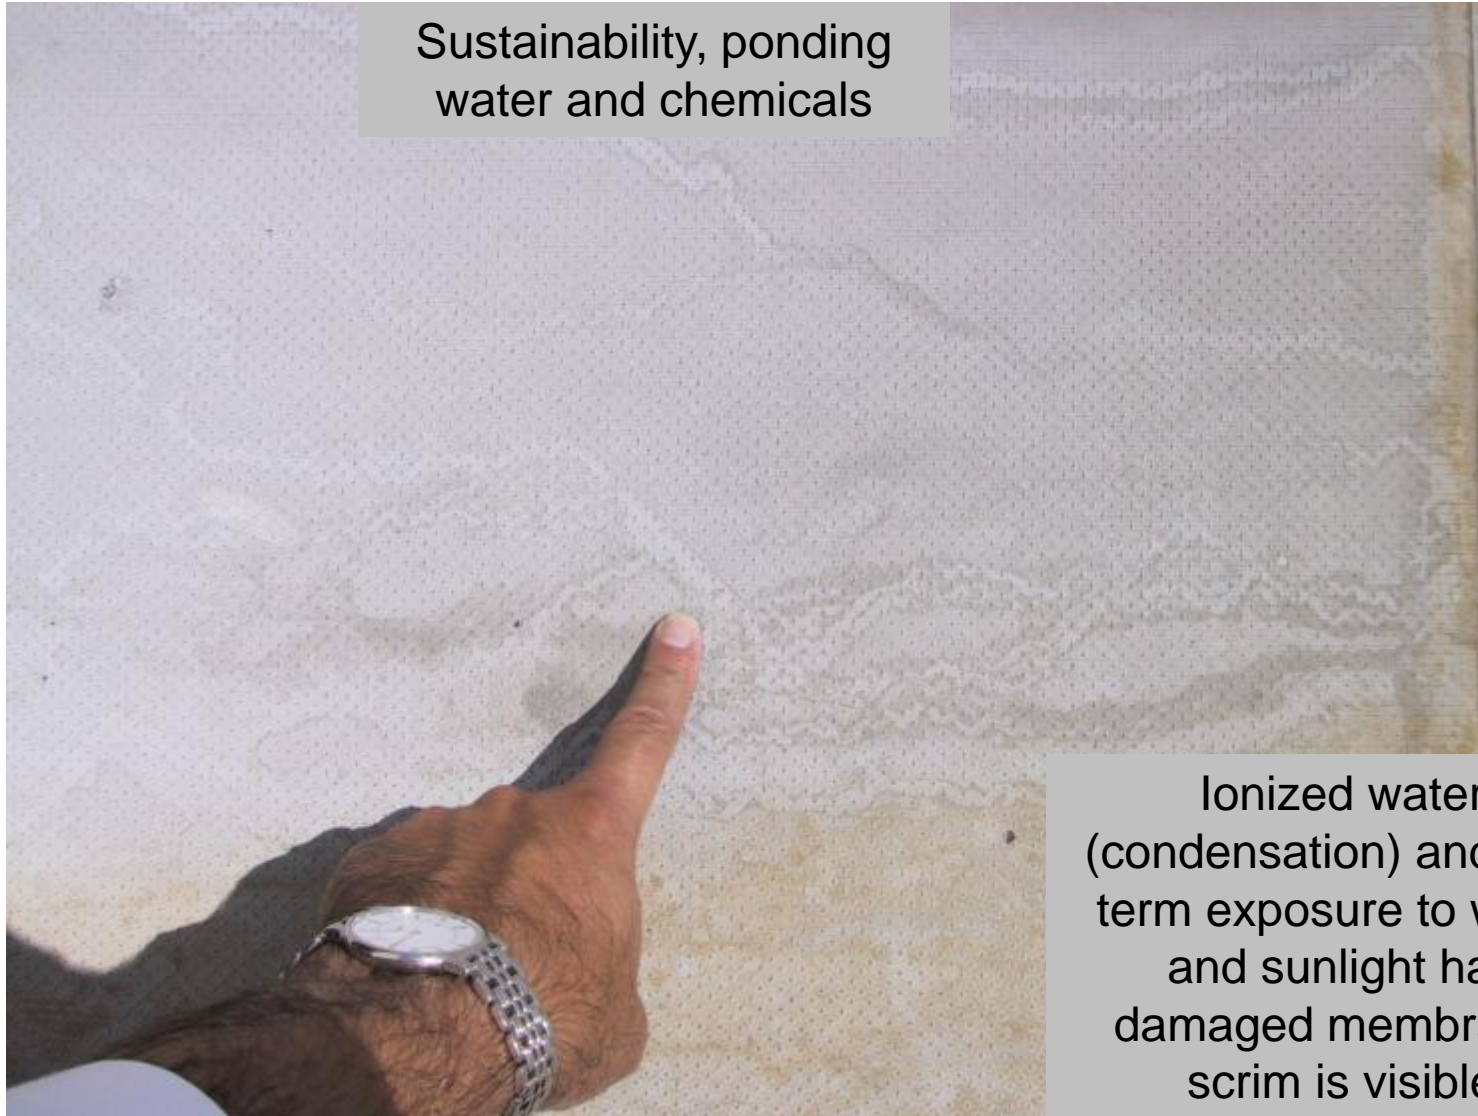
Ionized water  
(condensation) and long  
term exposure to water  
and sunlight has  
damaged membrane,  
scrim is visible
