# Avoiding Condensation Problems 2007 Pacific Building Trade Expo by AIA/CSI

Karim P. Allana, P.E., RRC, RWC

Allana Buick & Bers, Inc.

October 23, 2007

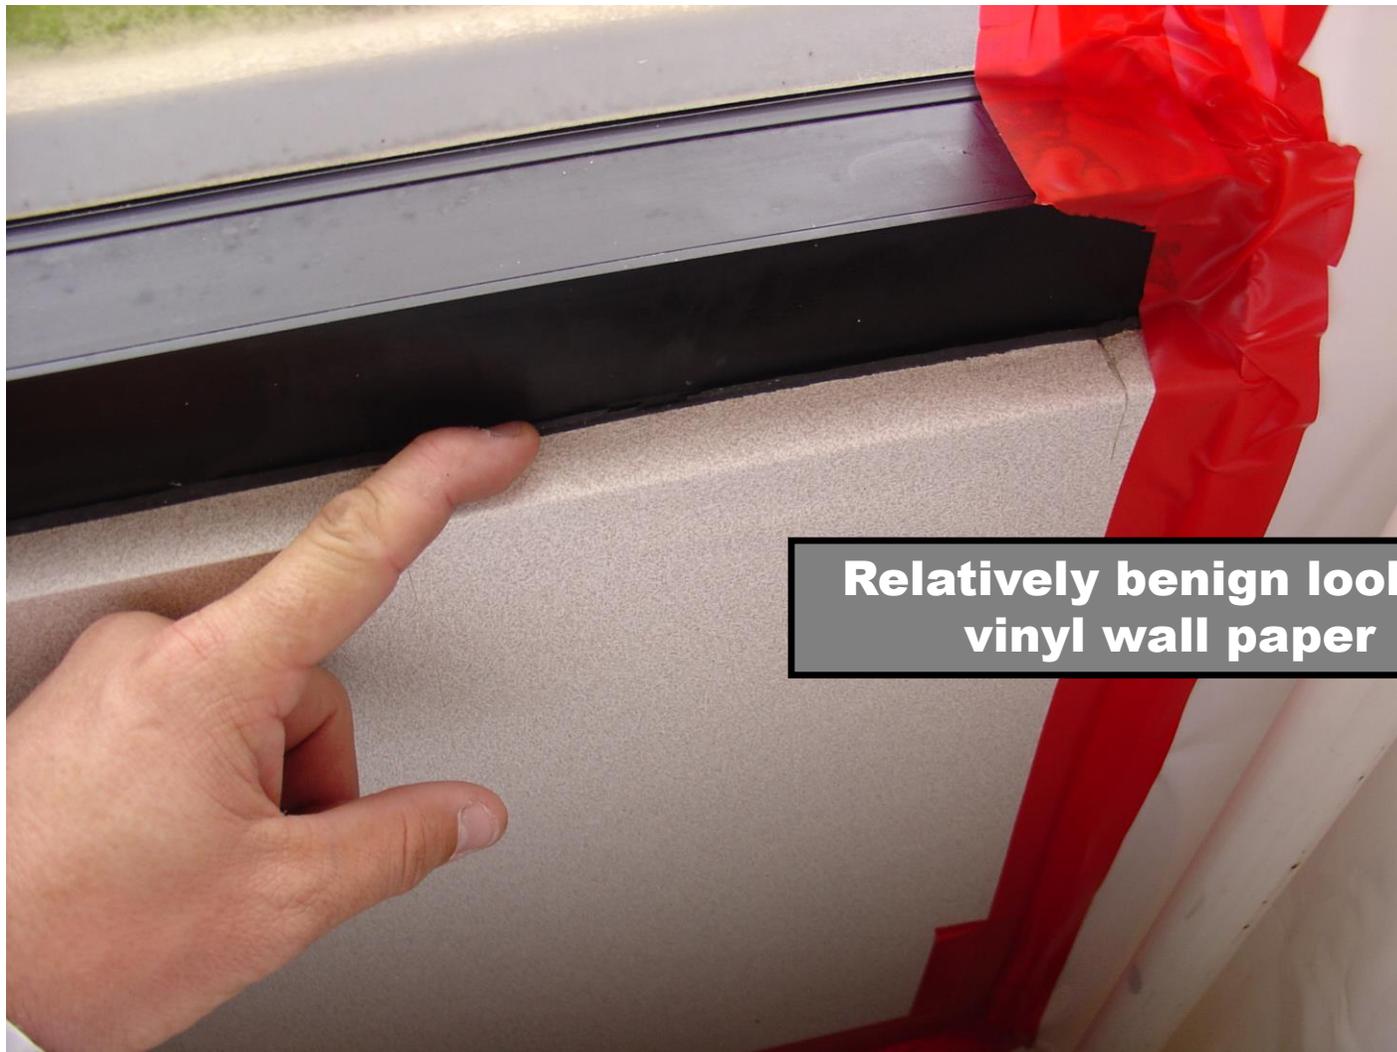
**Relatively benign looking vinyl wall paper**

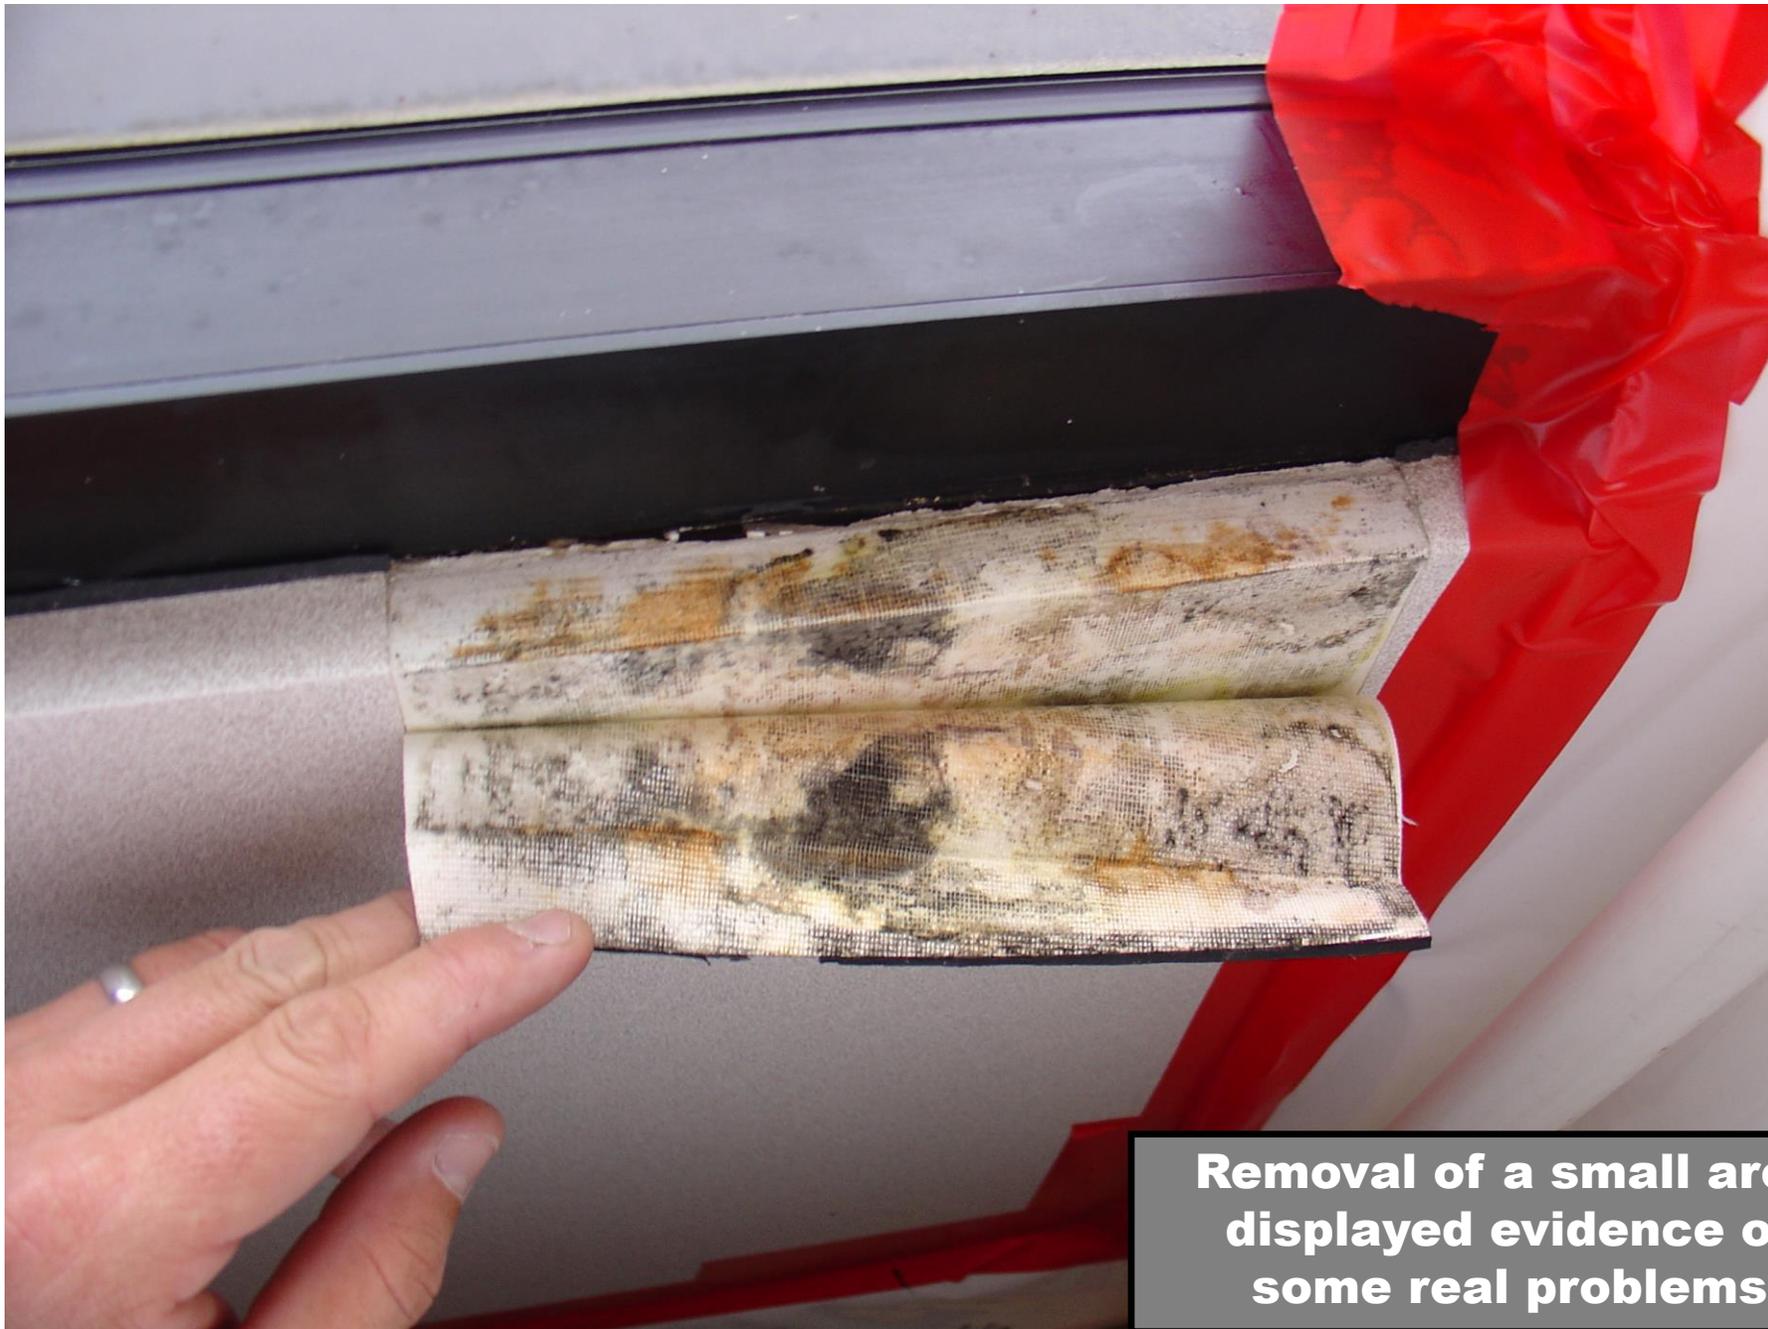
**Removal of a small area  
displayed evidence of  
some real problems**

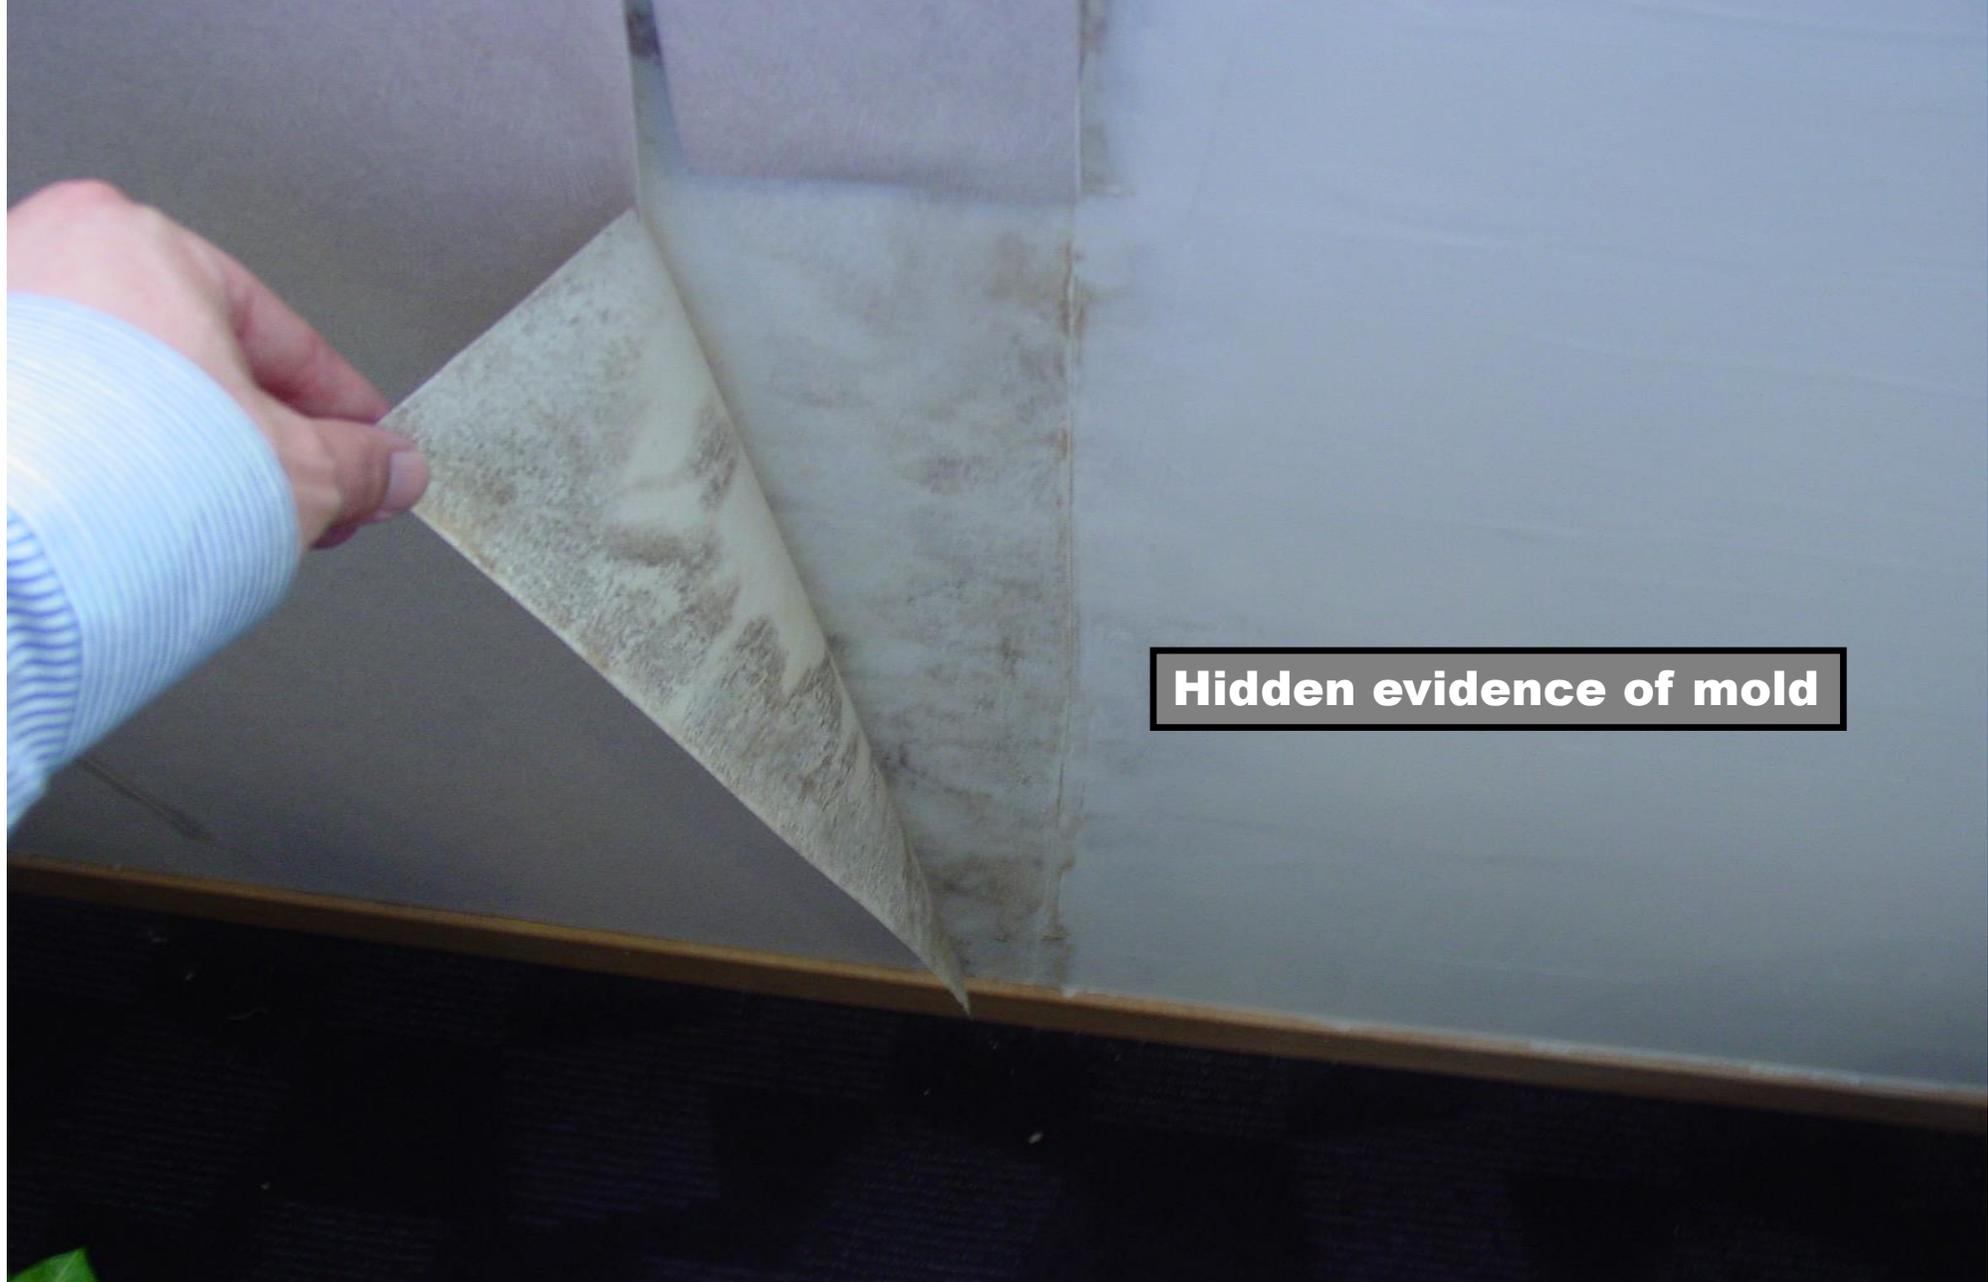
**Hidden evidence of mold**

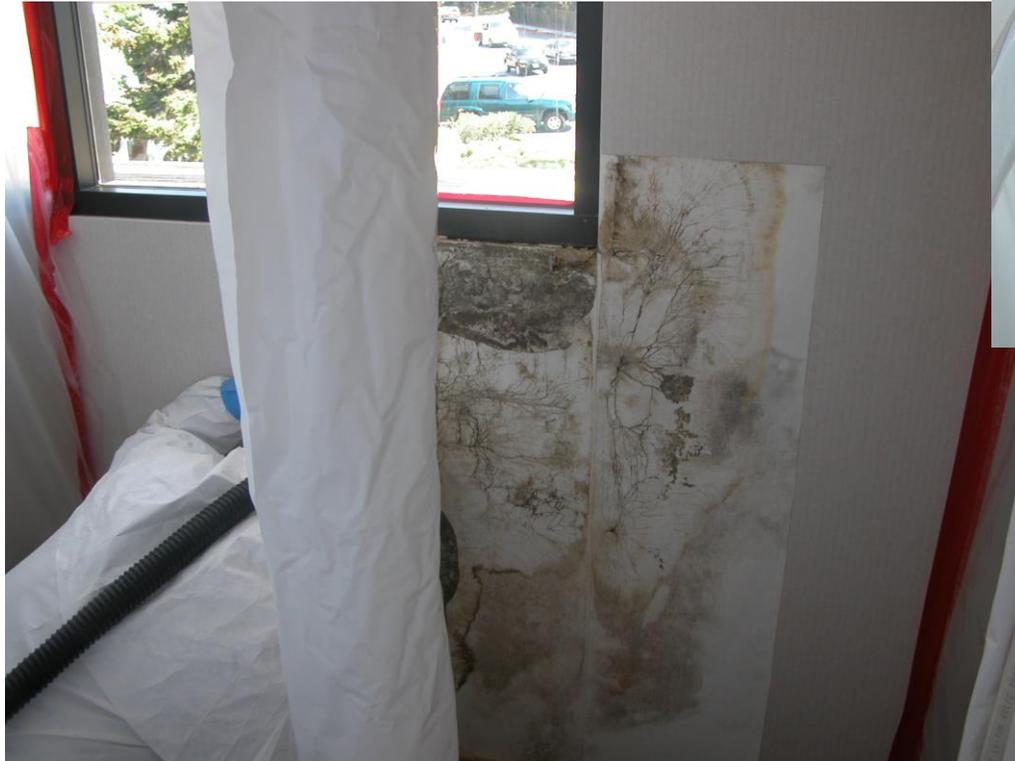
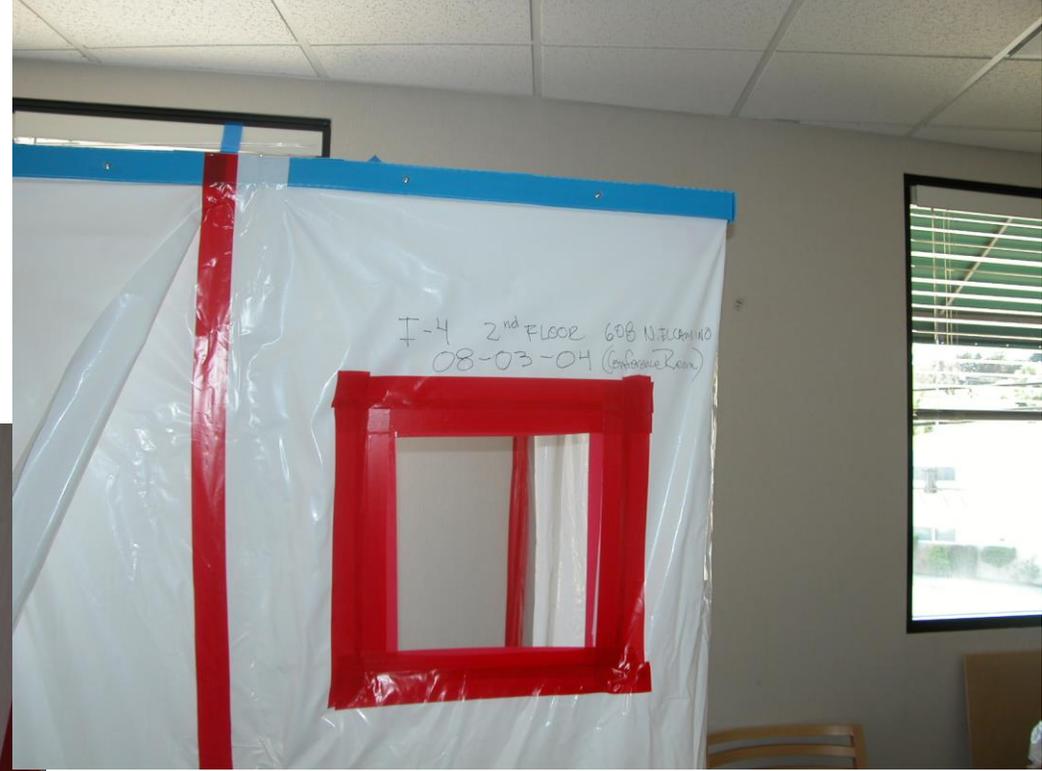
**Fully suited technicians removed wallpaper – note mold due to moisture collection at face of wall paper**

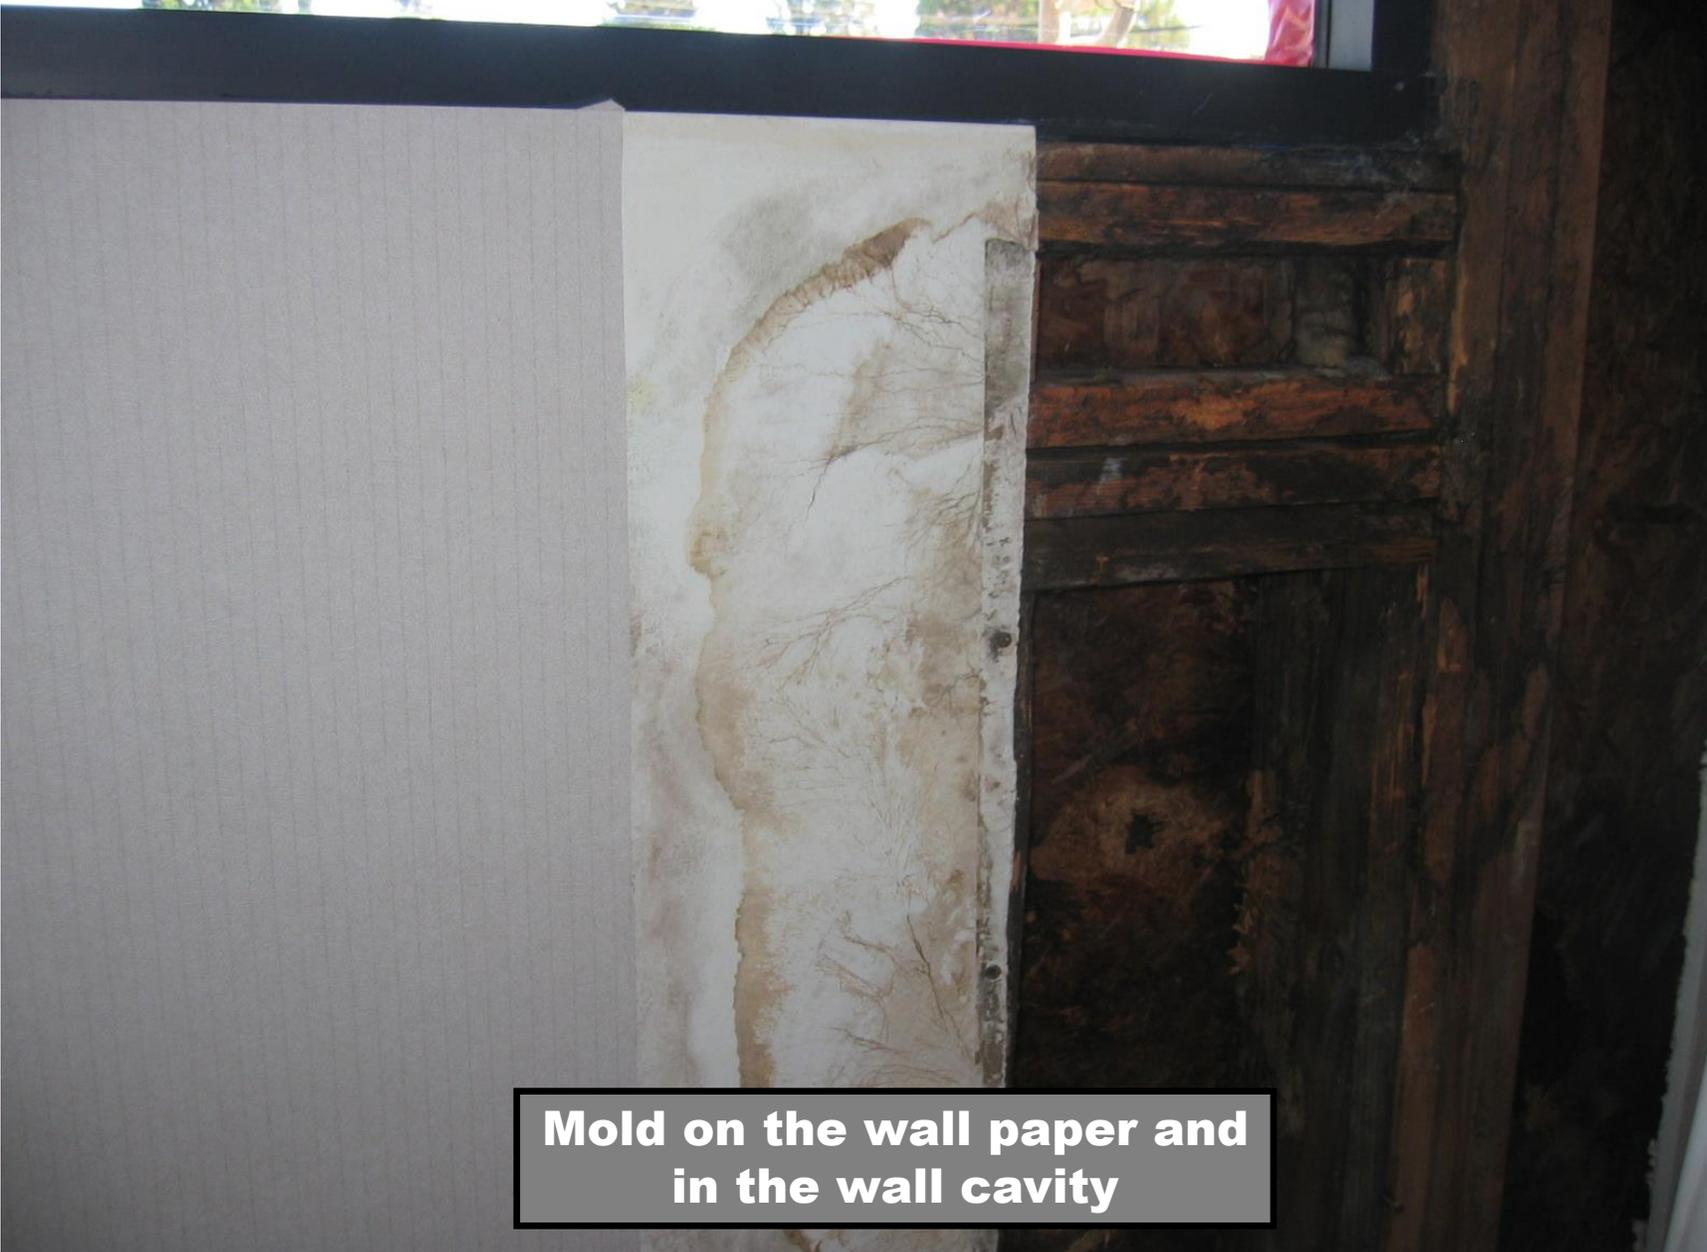
**Mold on the wall paper and  
in the wall cavity**

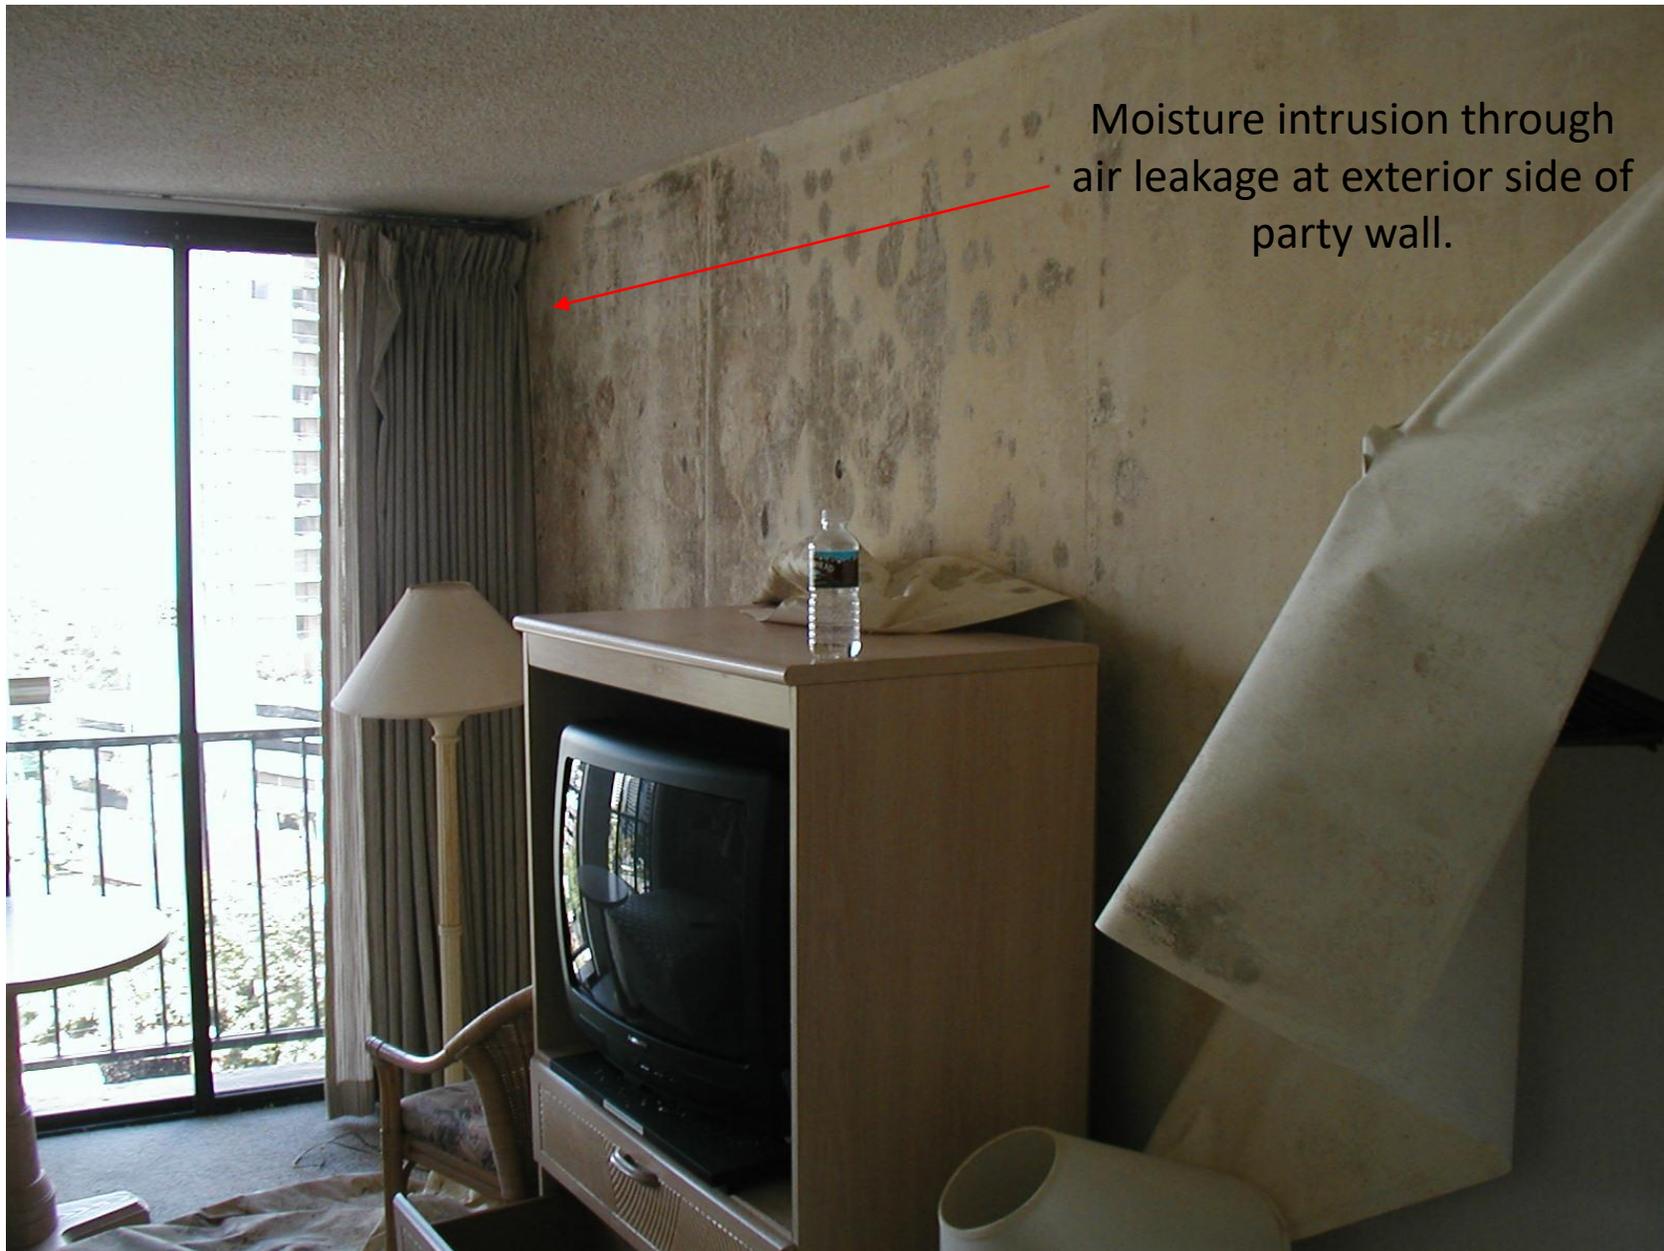
Moisture intrusion through air leakage at exterior side of party wall.

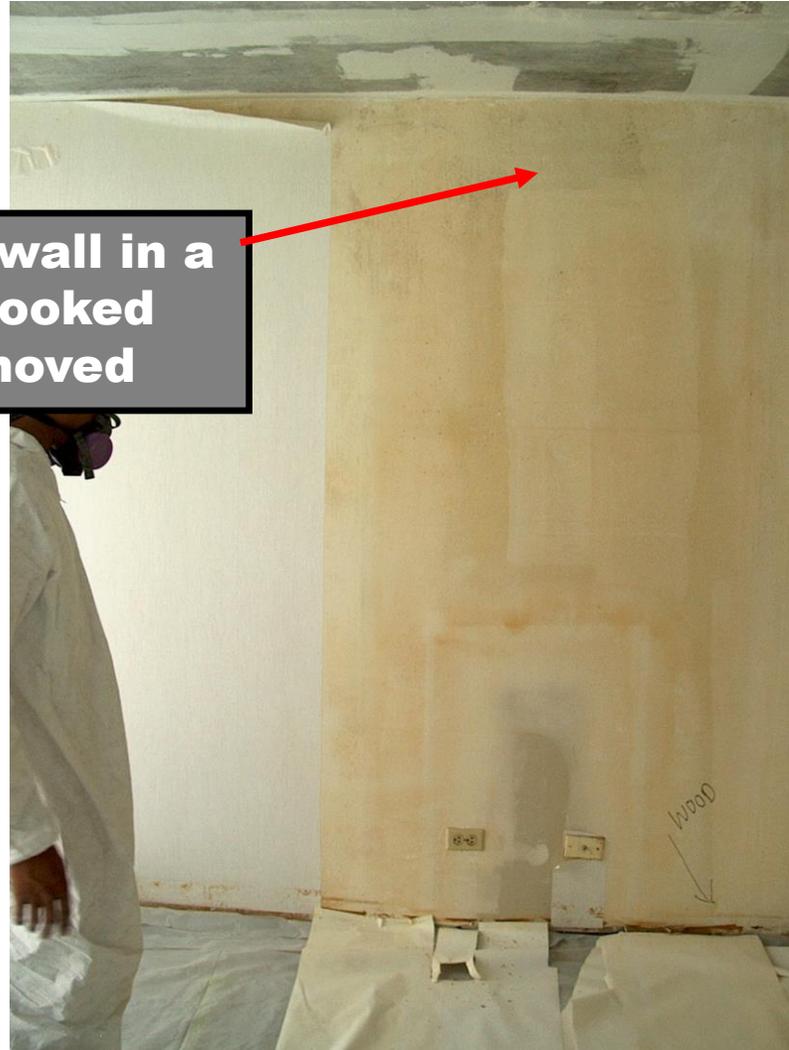
**Wallpaper on this wall in a Honolulu hotel looked clean, until removed**

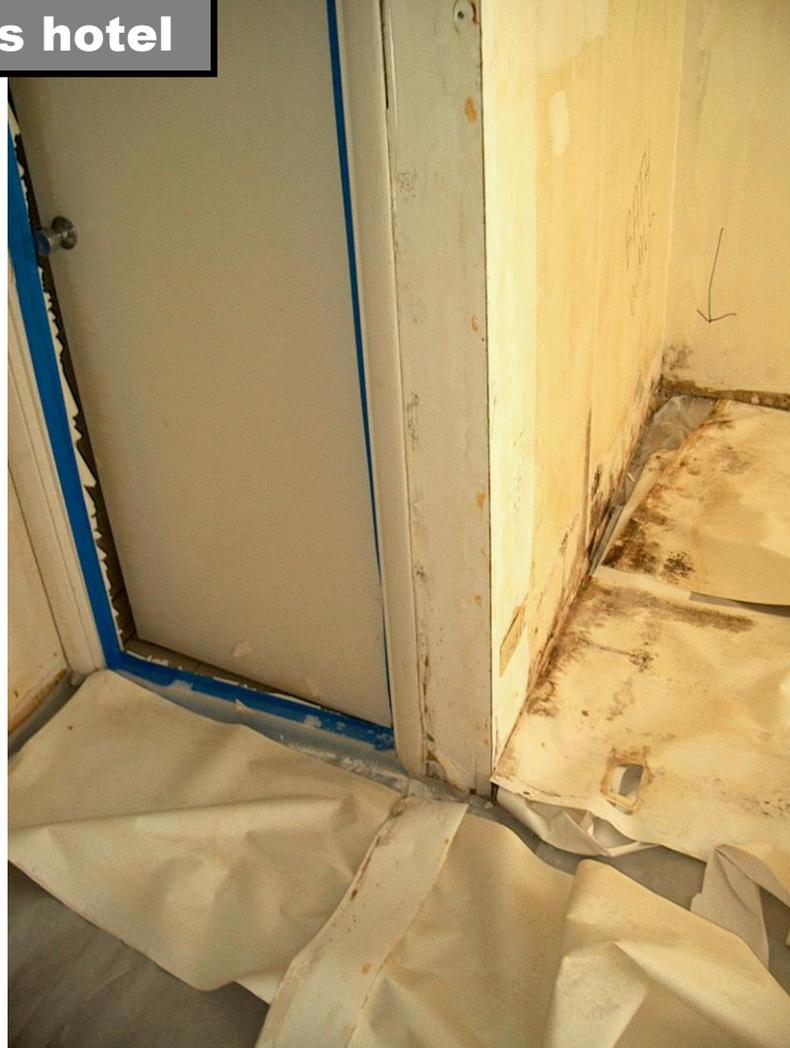
**Source of moisture was  
the bathroom in this hotel**

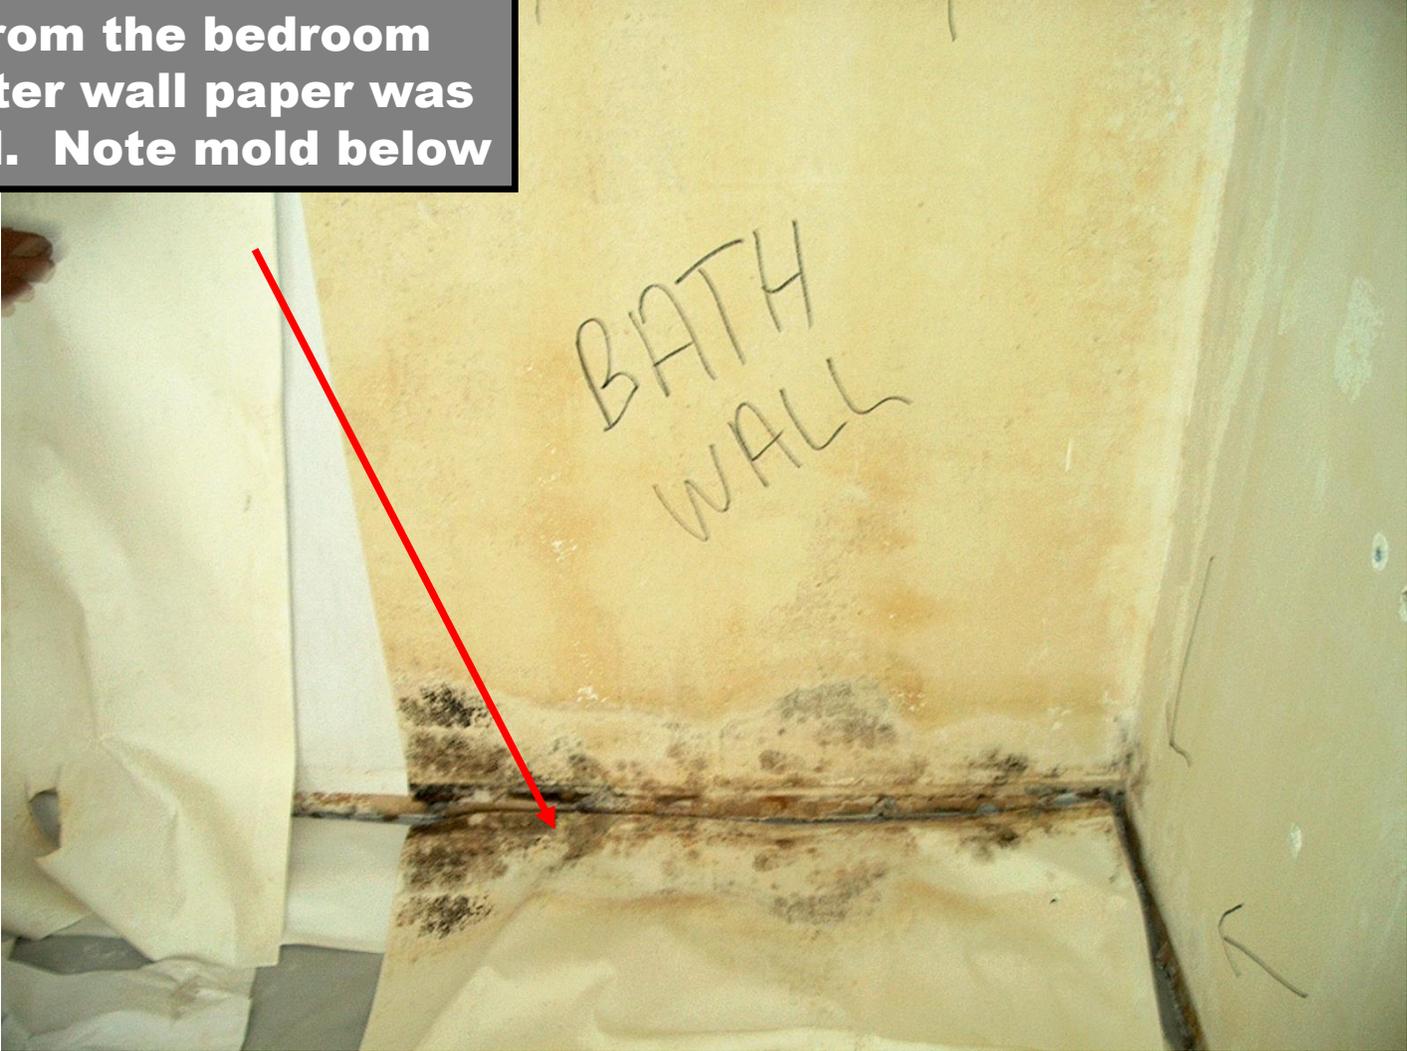
**View of interior bathroom wall from the bedroom side, after wall paper was removed. Note mold below**

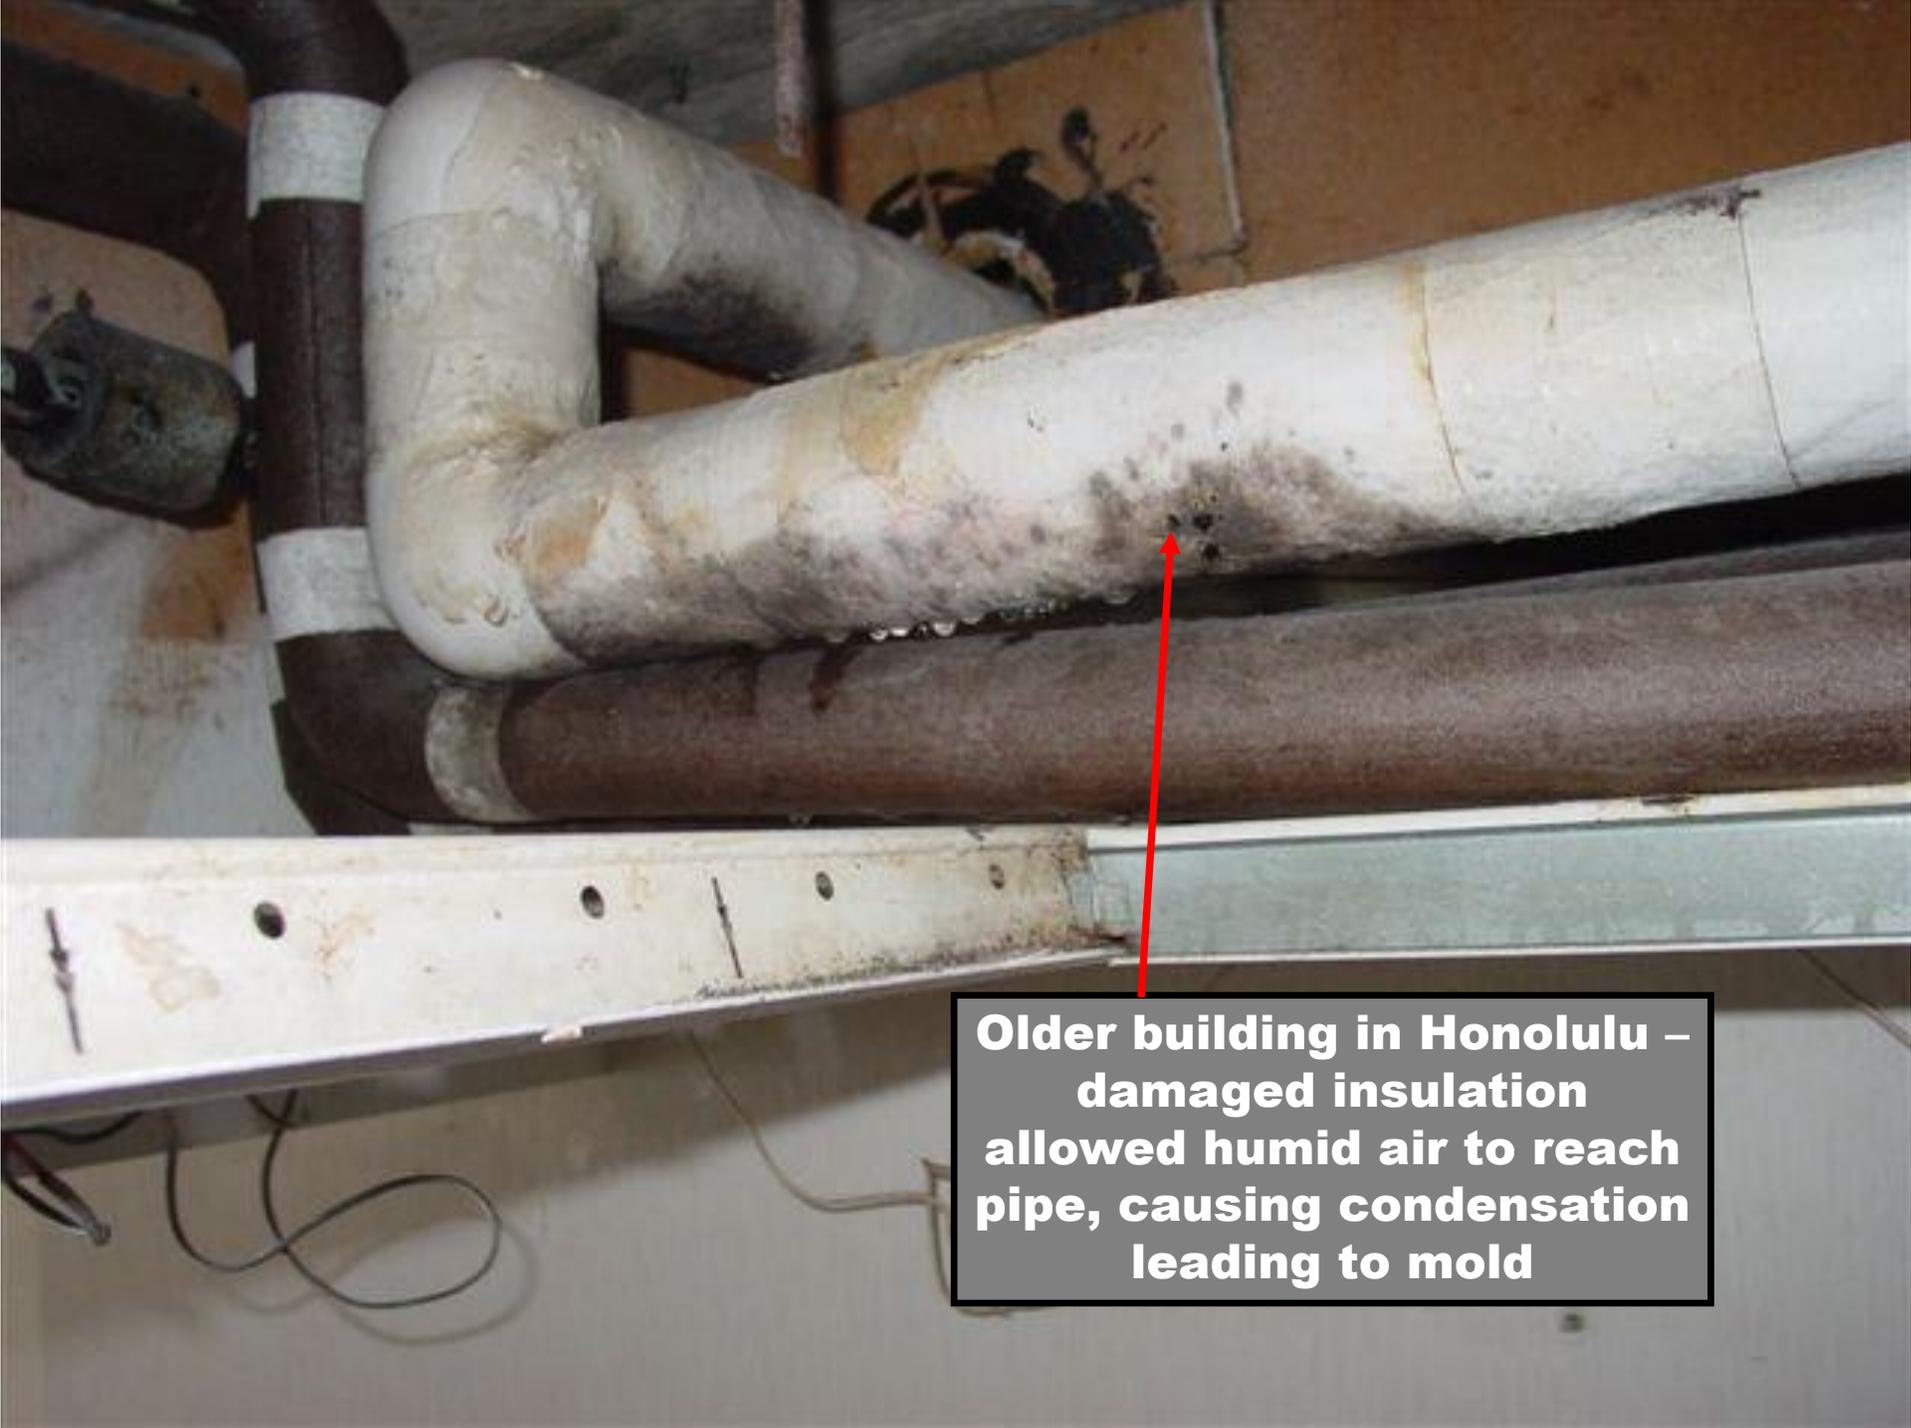
**Older building in Honolulu –  
damaged insulation  
allowed humid air to reach  
pipe, causing condensation  
leading to mold**

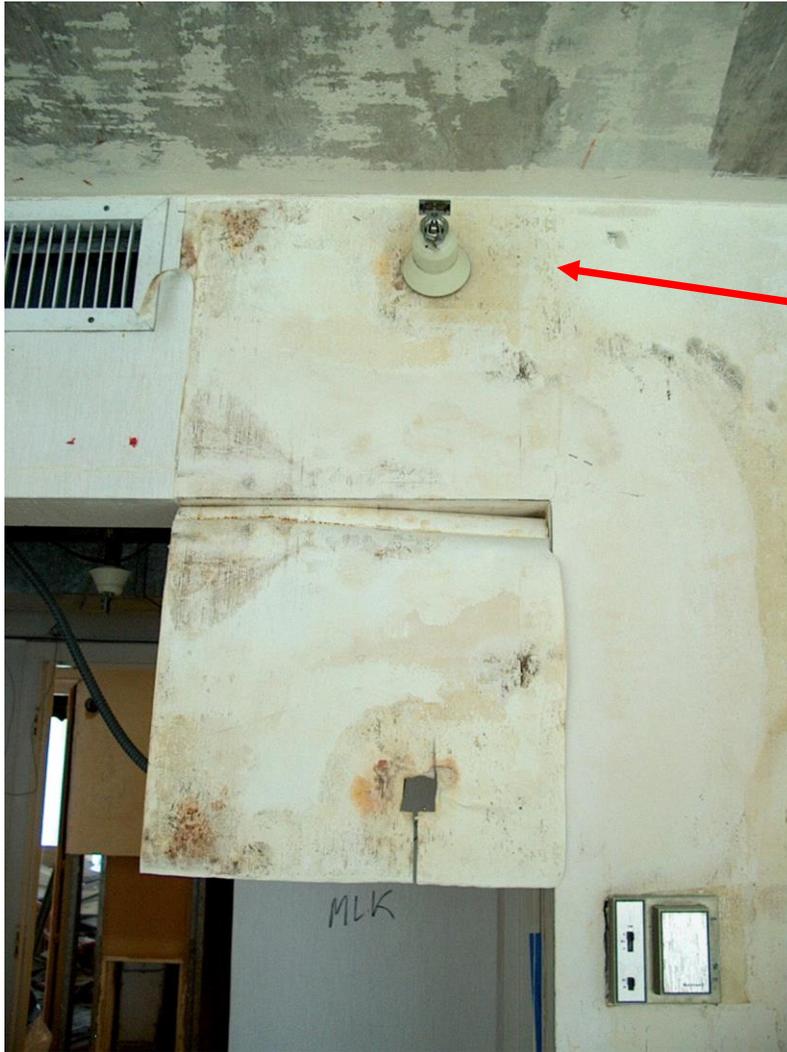
**Older building – fan coil unit created condensation, rust and mold**

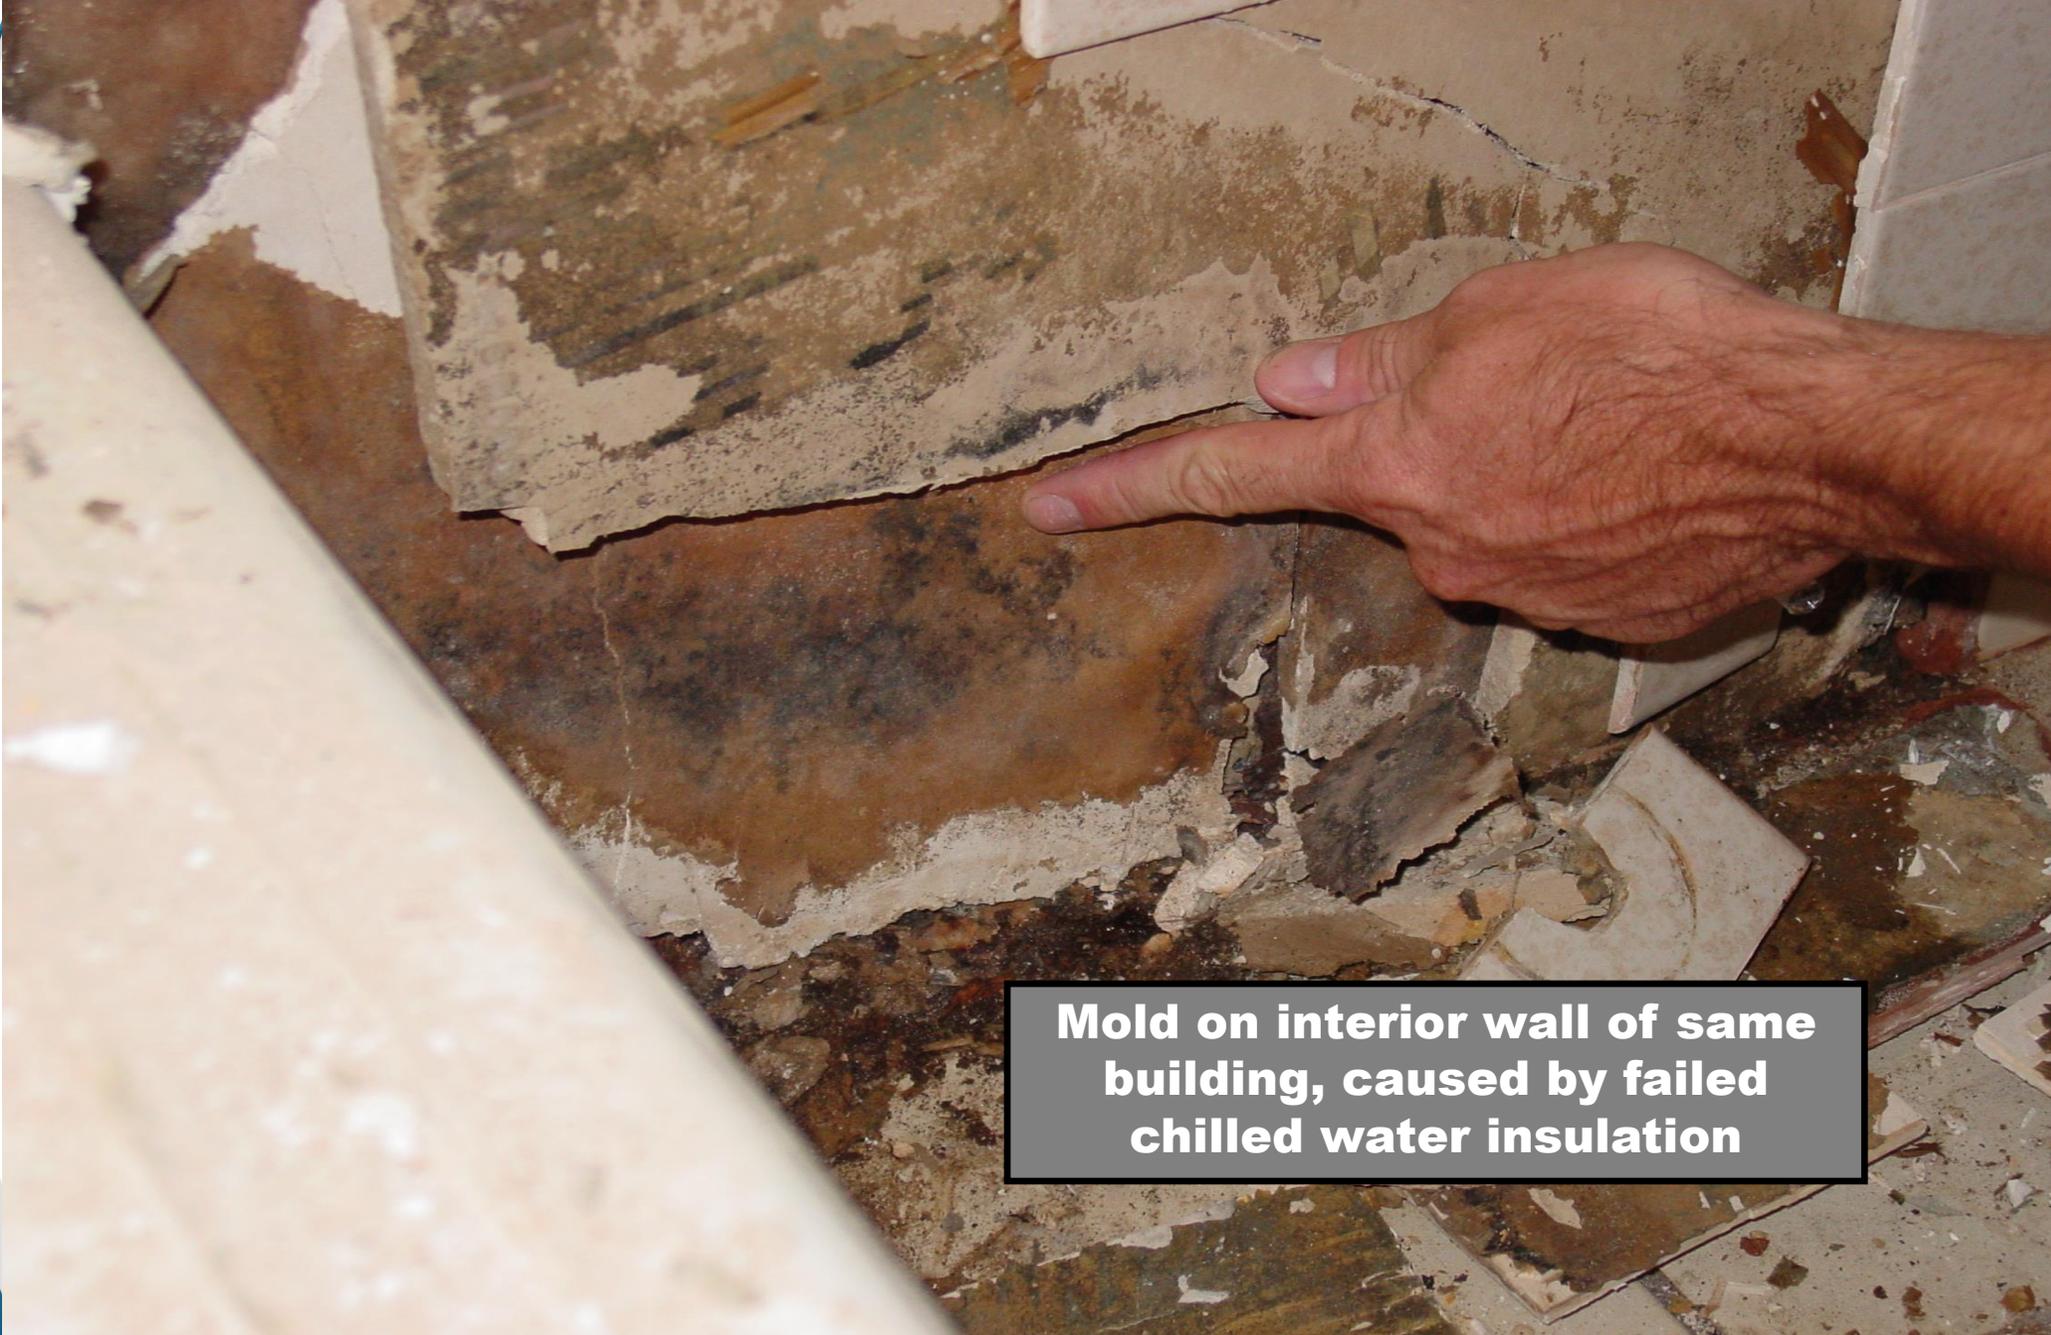
**Mold on interior wall of same building, caused by failed chilled water insulation**

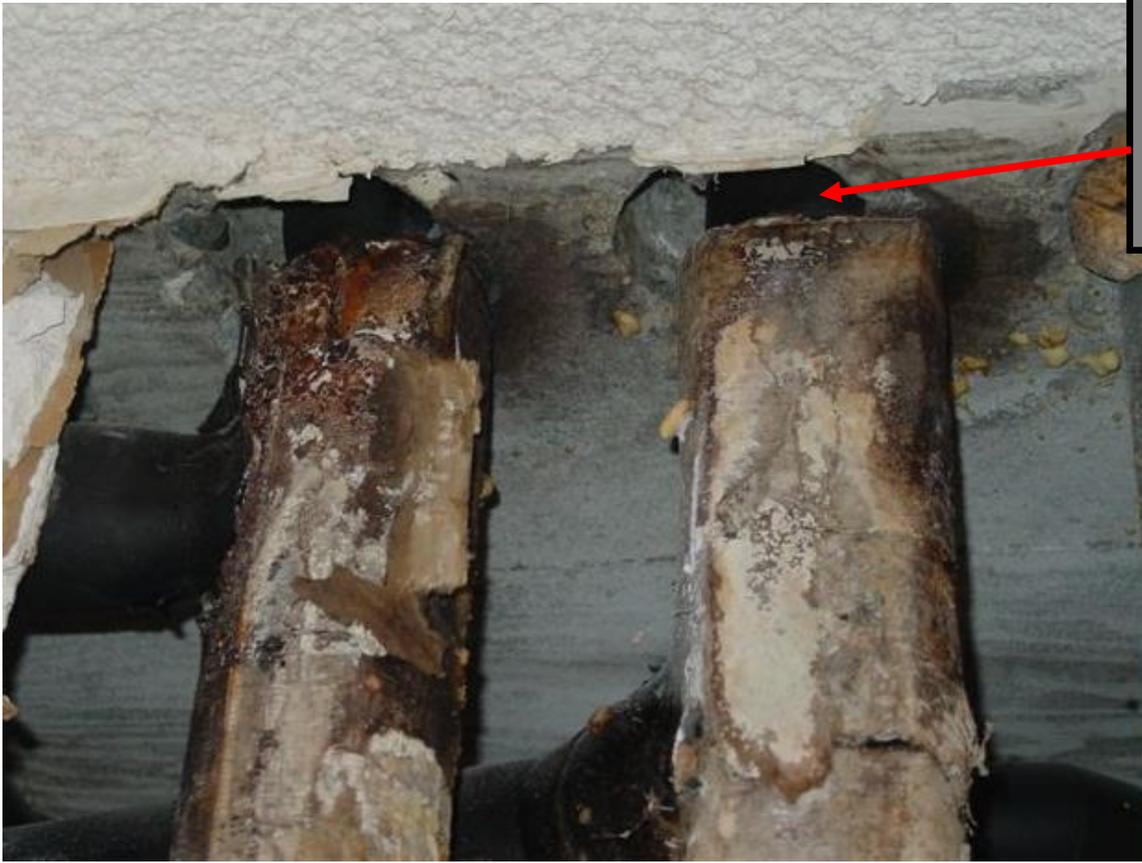
**Same building – note gap where there is no insulation, as pipe passed through floor**
