# Avoiding Condensation Problems 2007 Pacific Building Trade Expo by AIA/CSI

Karim P. Allana, P.E., RRC, RWC

Allana Buick & Bers, Inc.

October 23, 2007

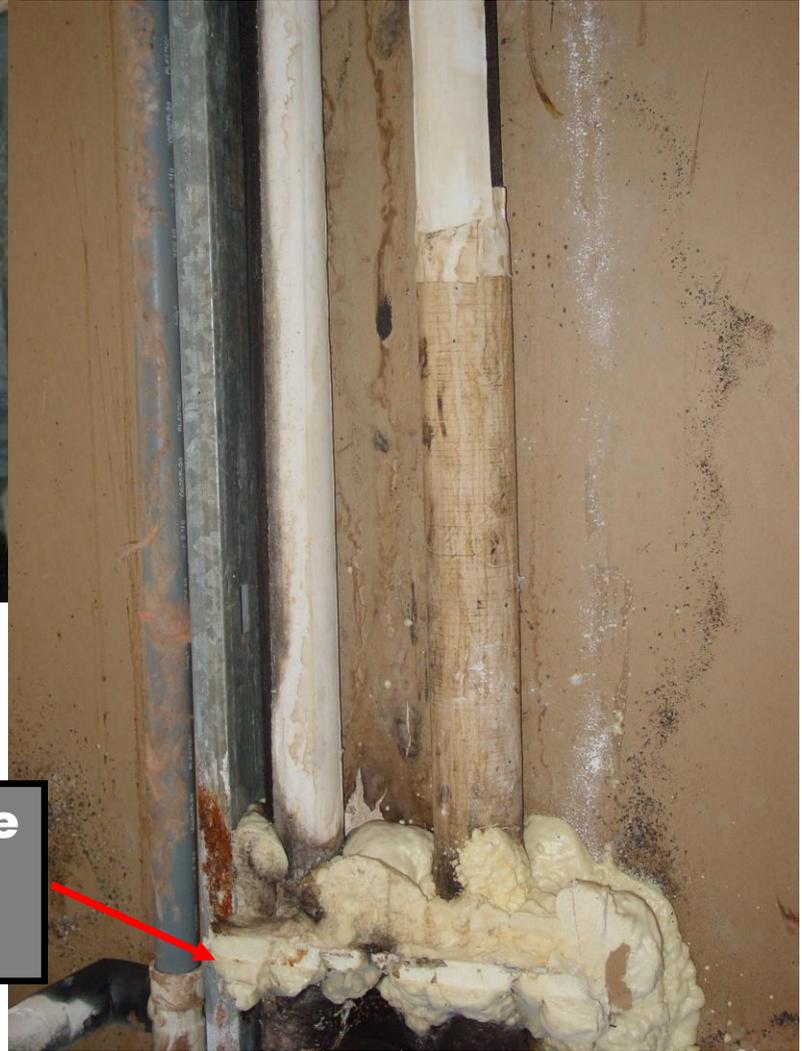
**In a failed attempt to close the gaps, foam injection was attempted in the past**

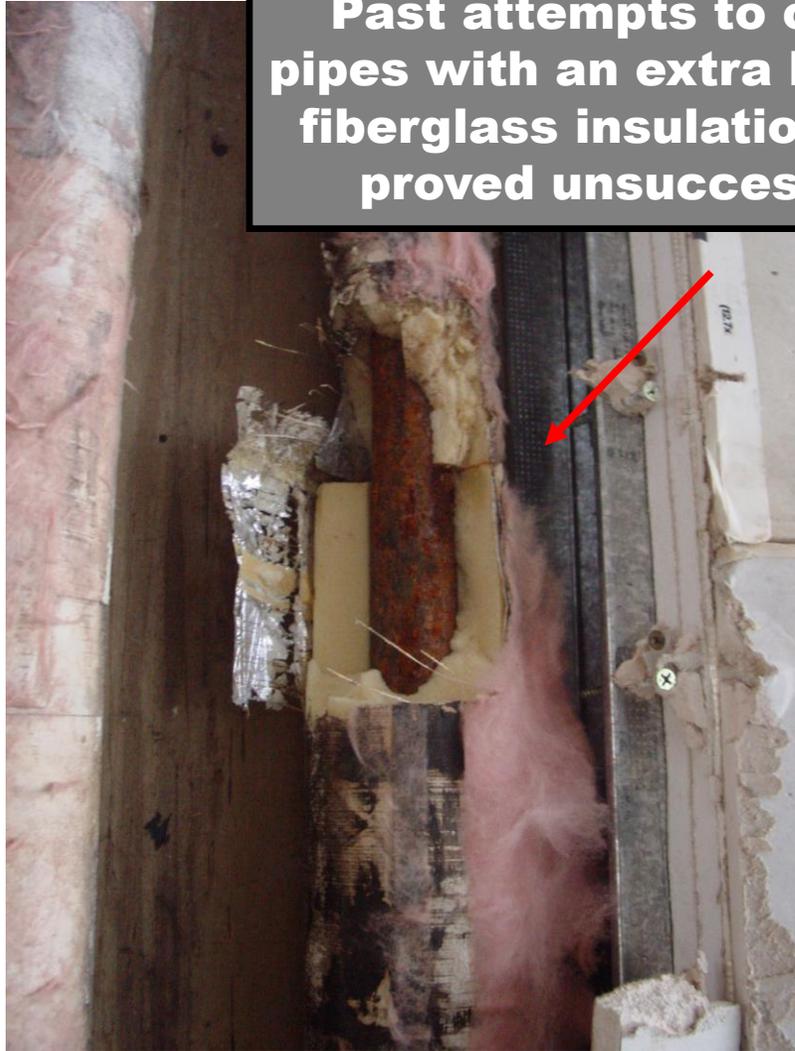
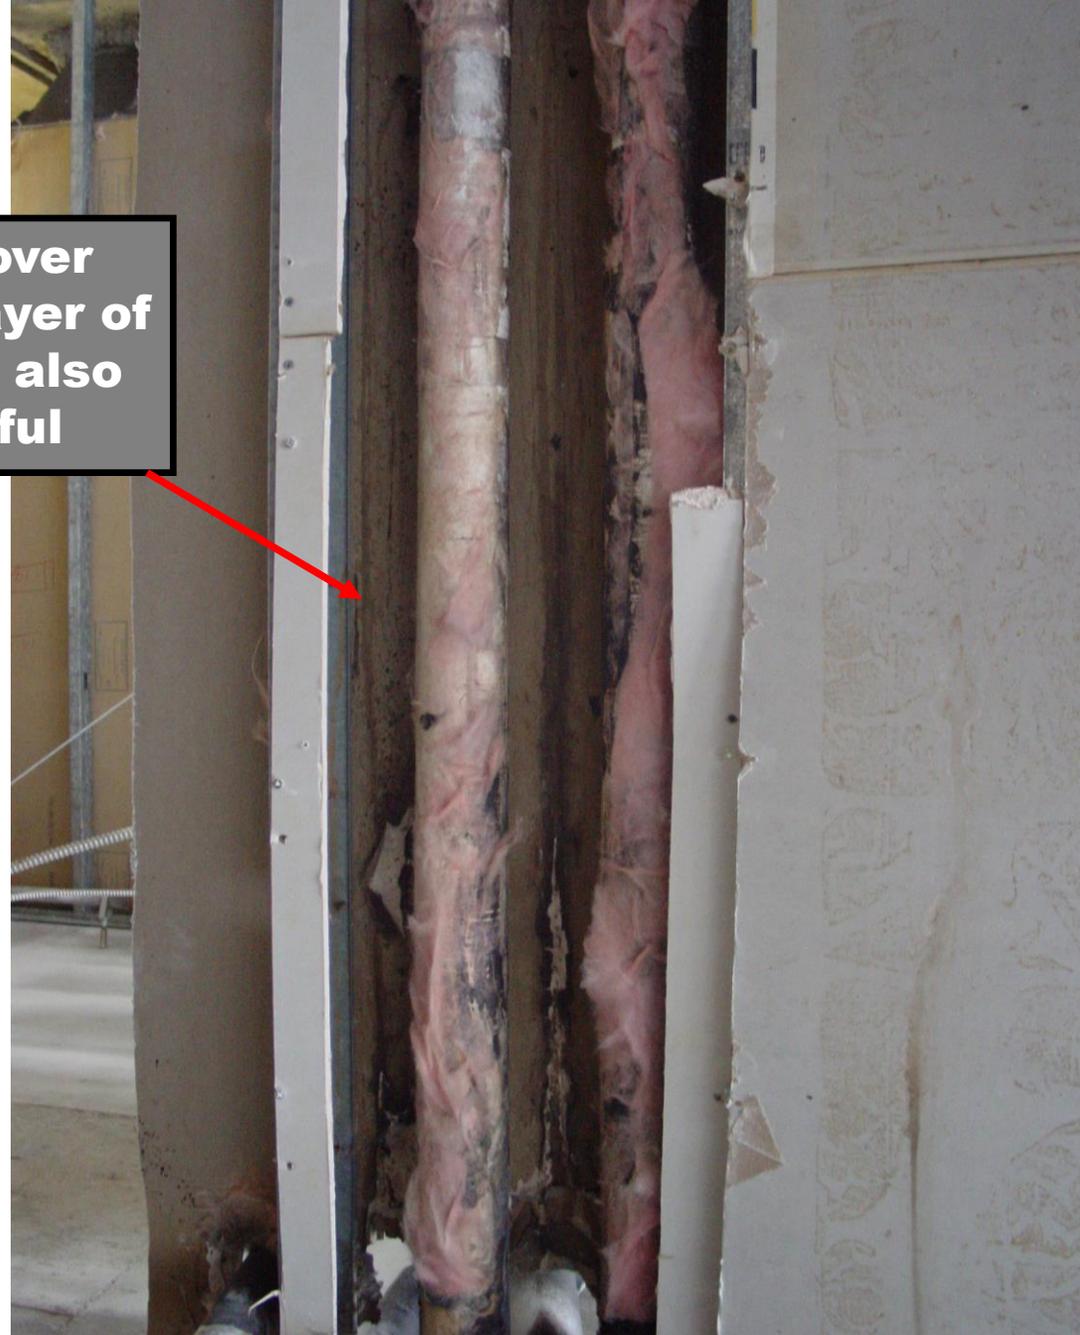
**Past attempts to cover pipes with an extra layer of fiberglass insulation also proved unsuccessful**

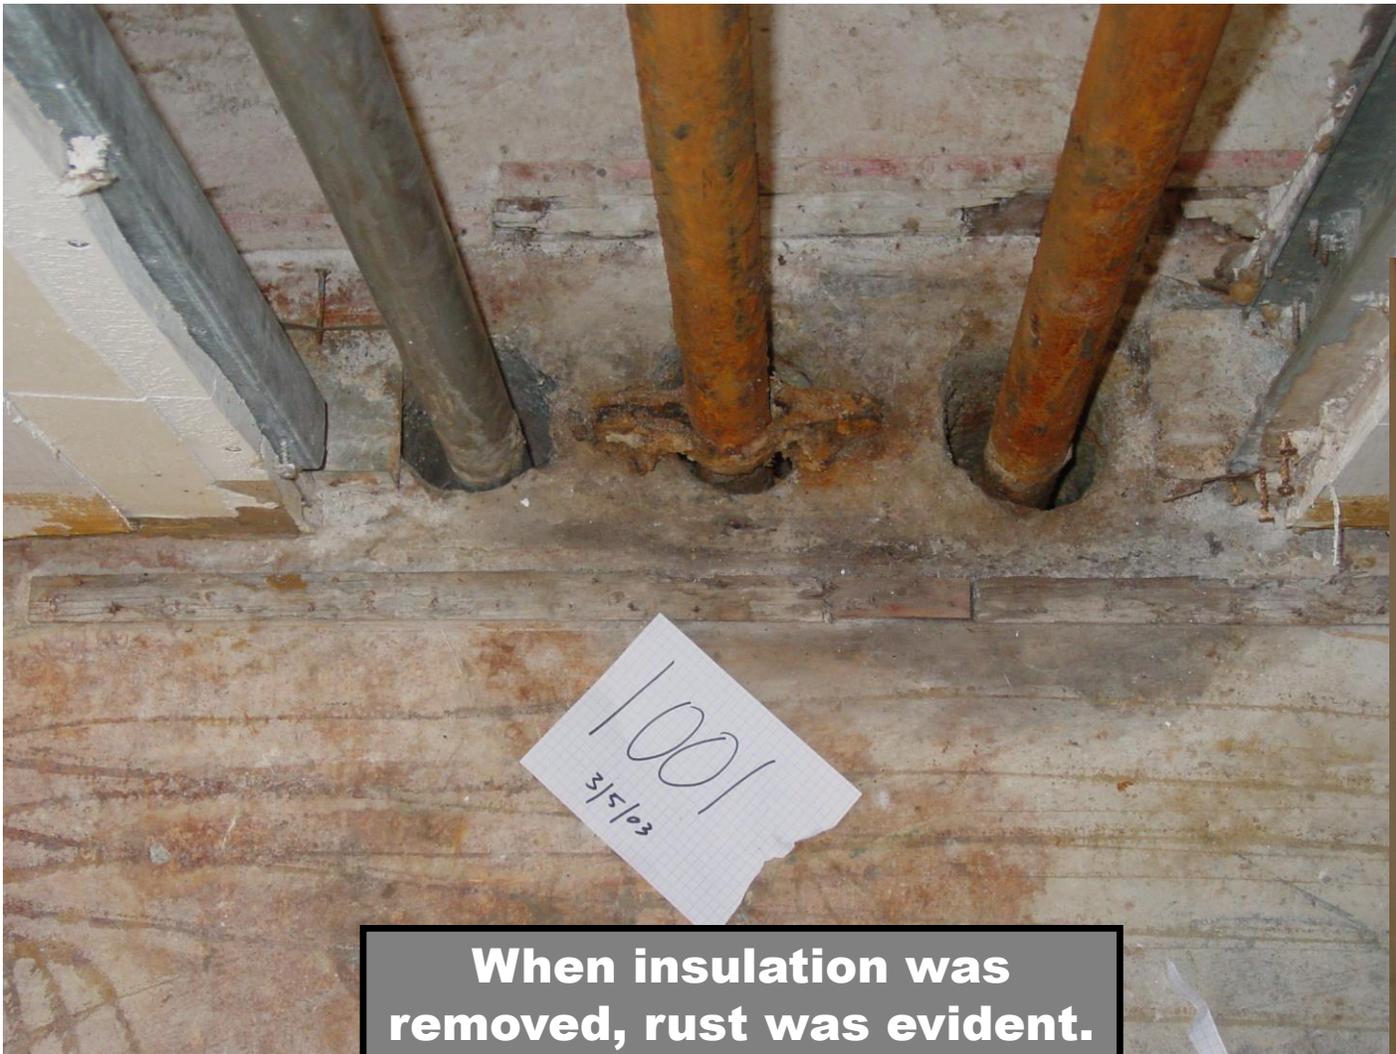
**When insulation was removed, rust was evident. Note that some openings in floor were larger than others**

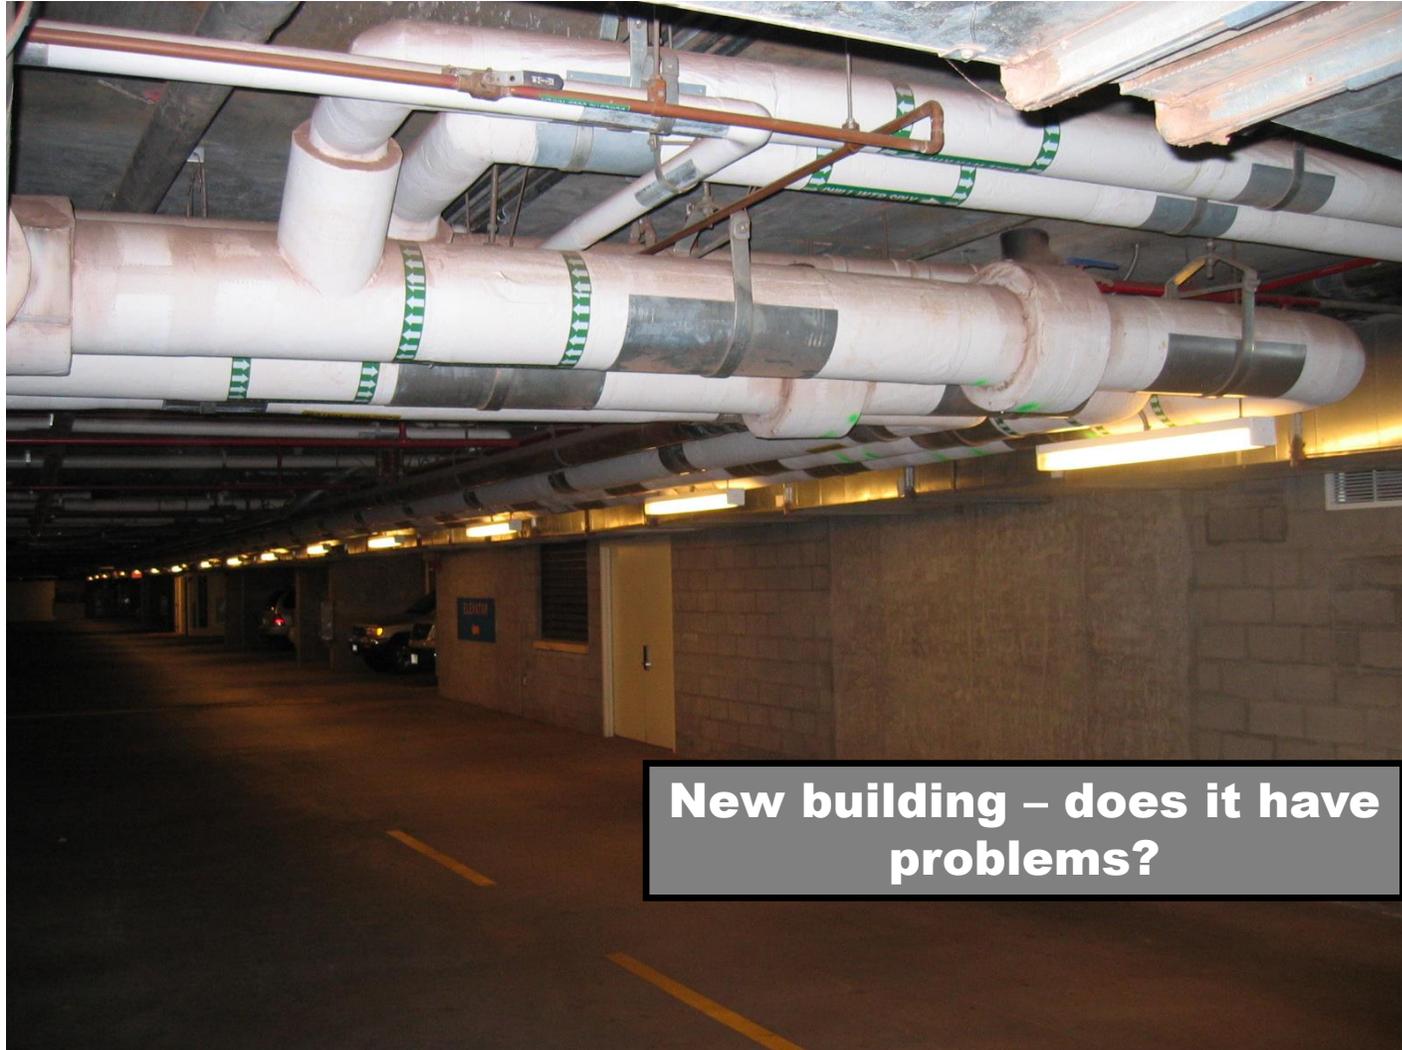
**New building – does it have problems?**

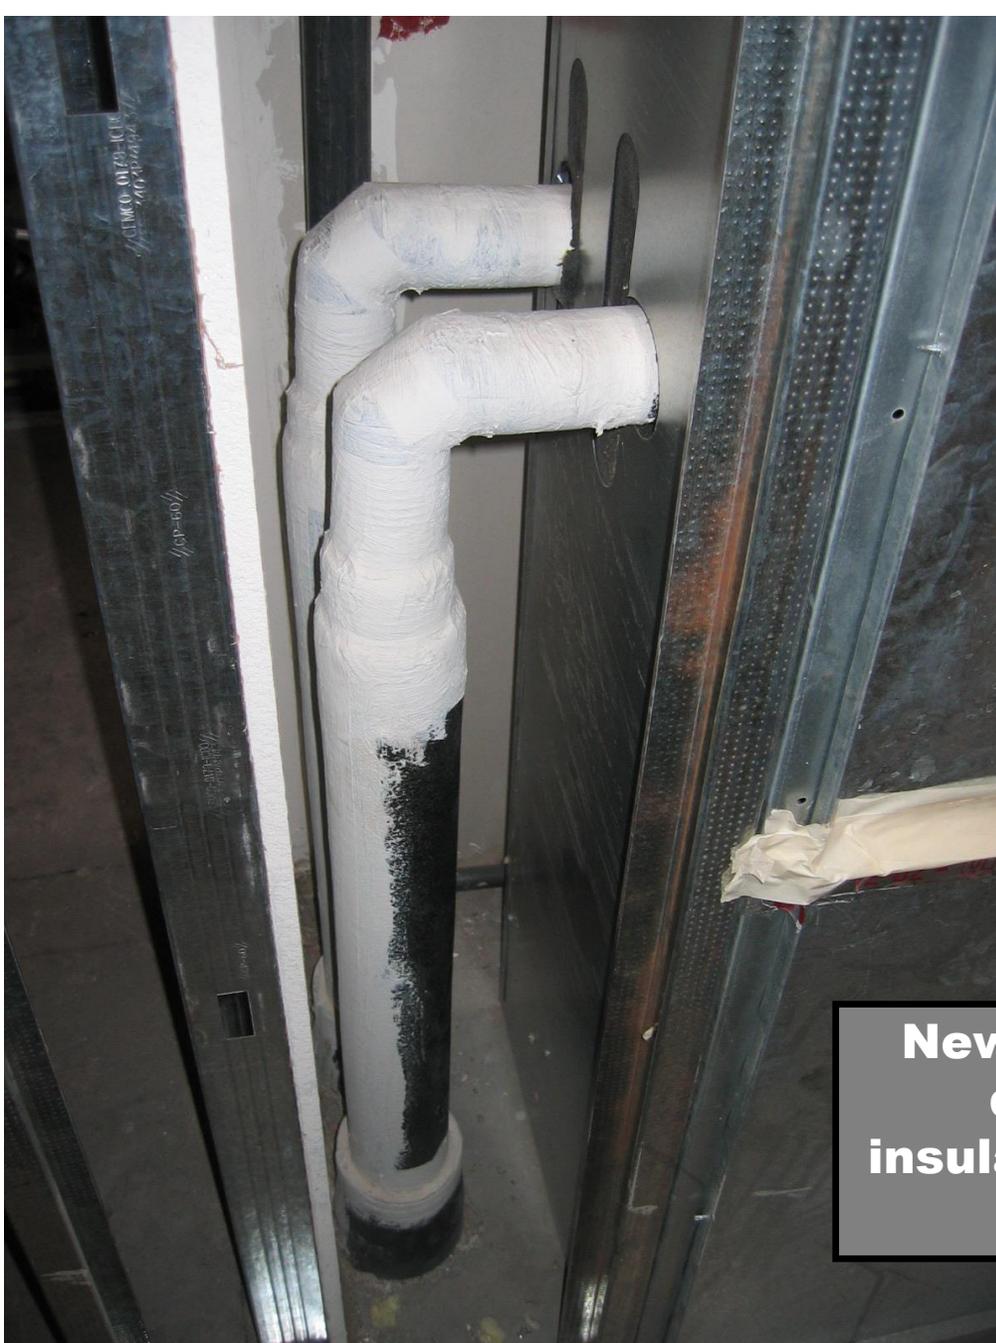
**New building – note two different kinds of insulation makes the joint susceptible**

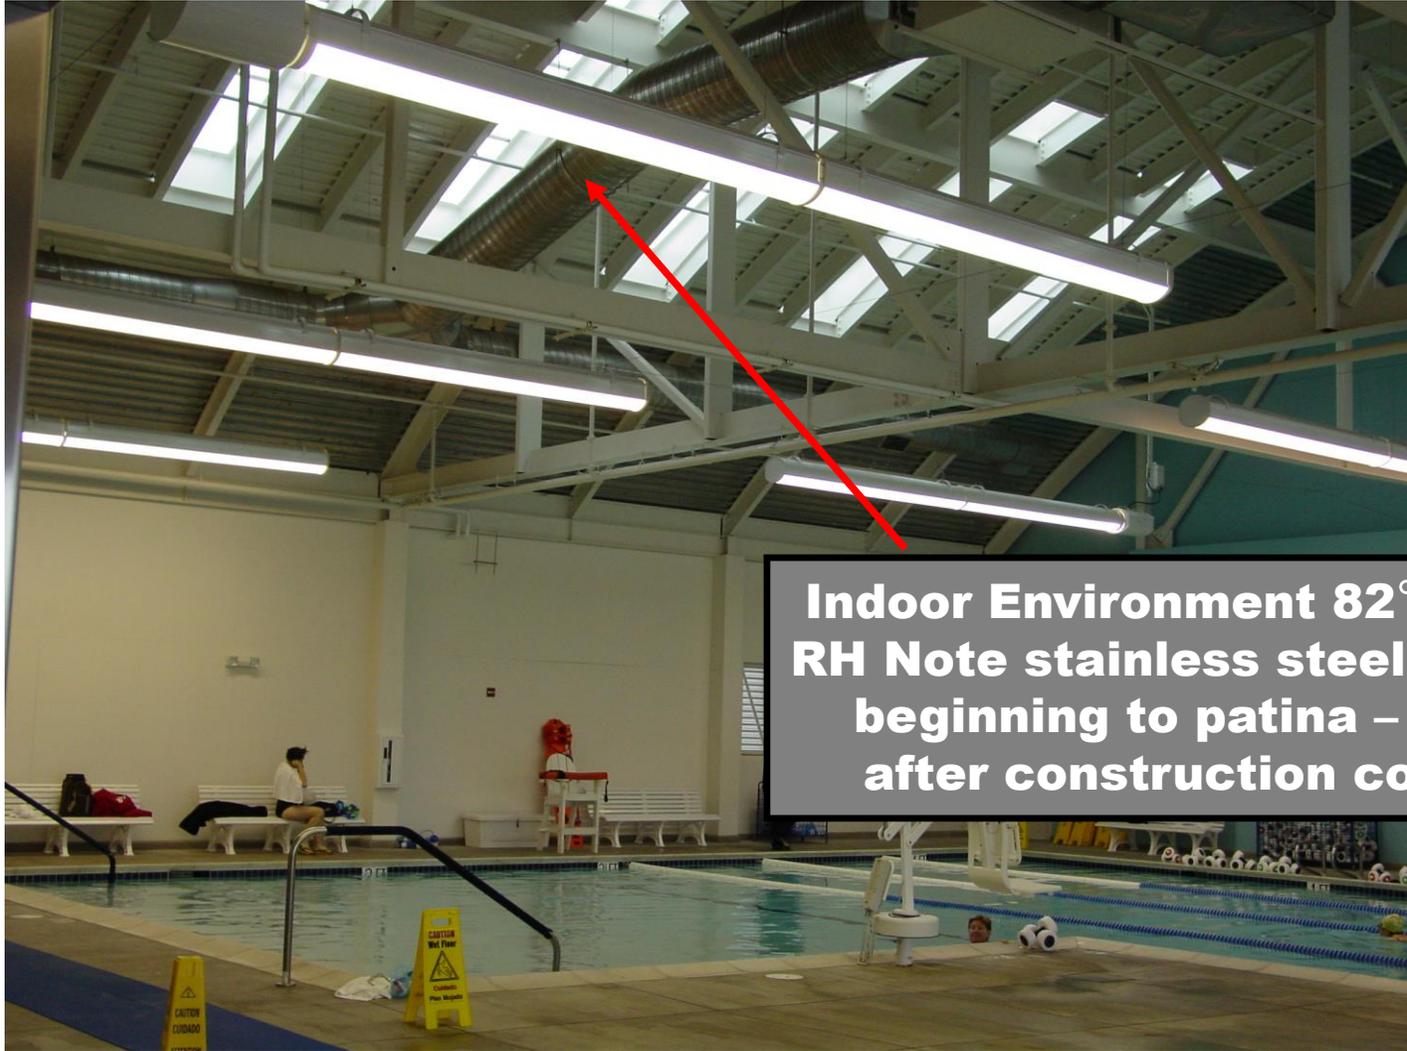
**Indoor Environment 82°F and 84% RH Note stainless steel HVAC duct beginning to patina – one year after construction completed**

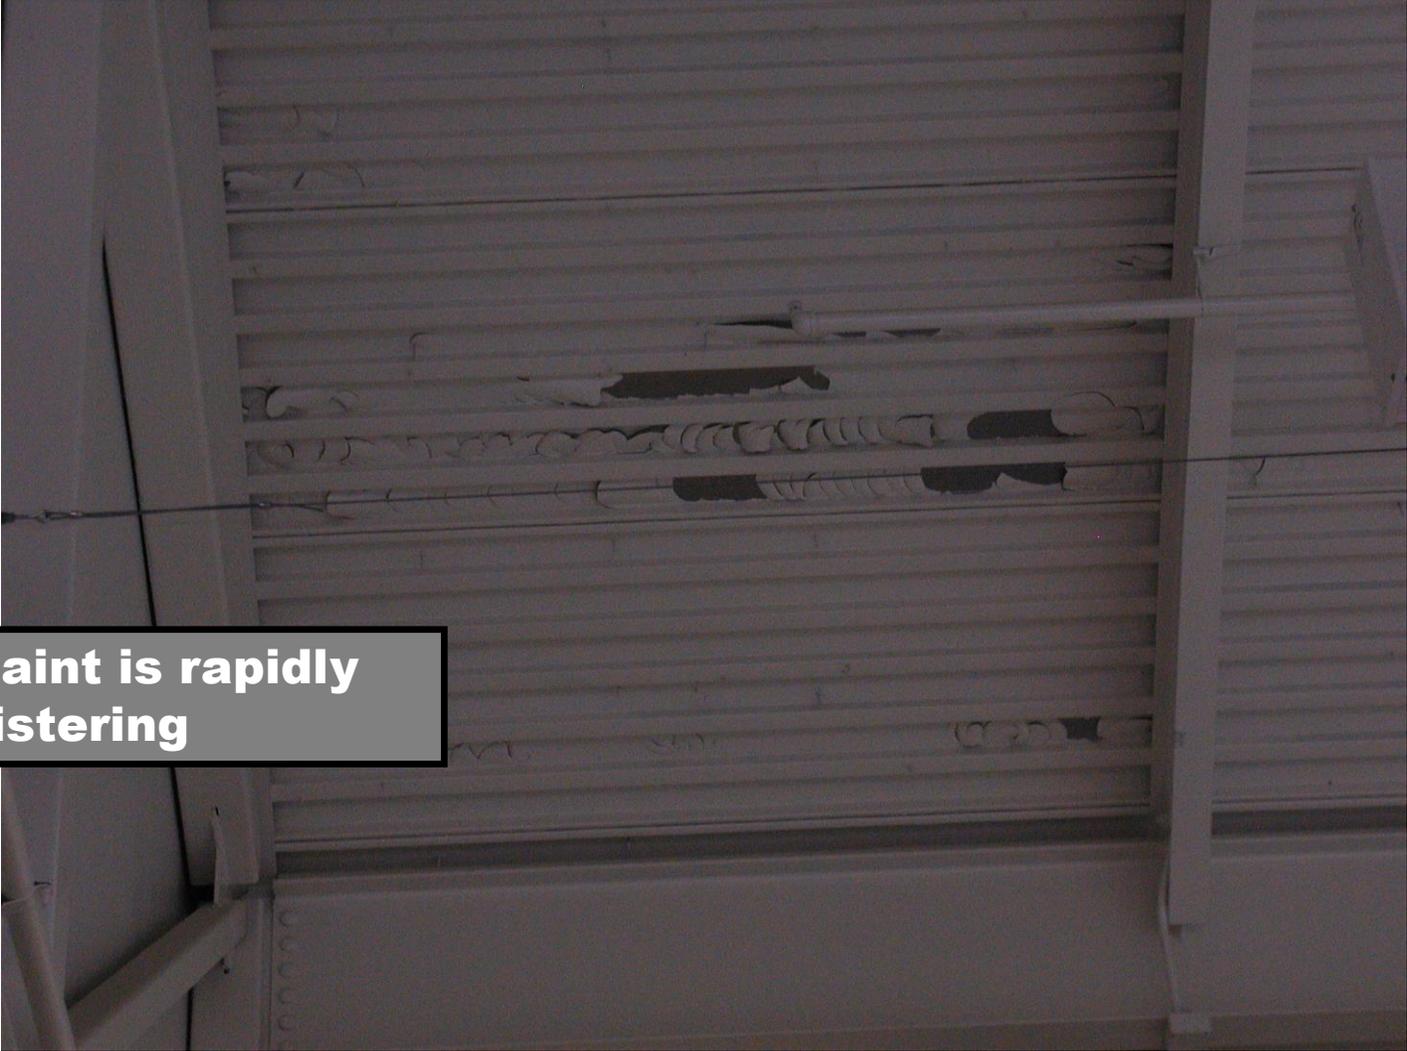
**Ceiling paint is rapidly blistering**

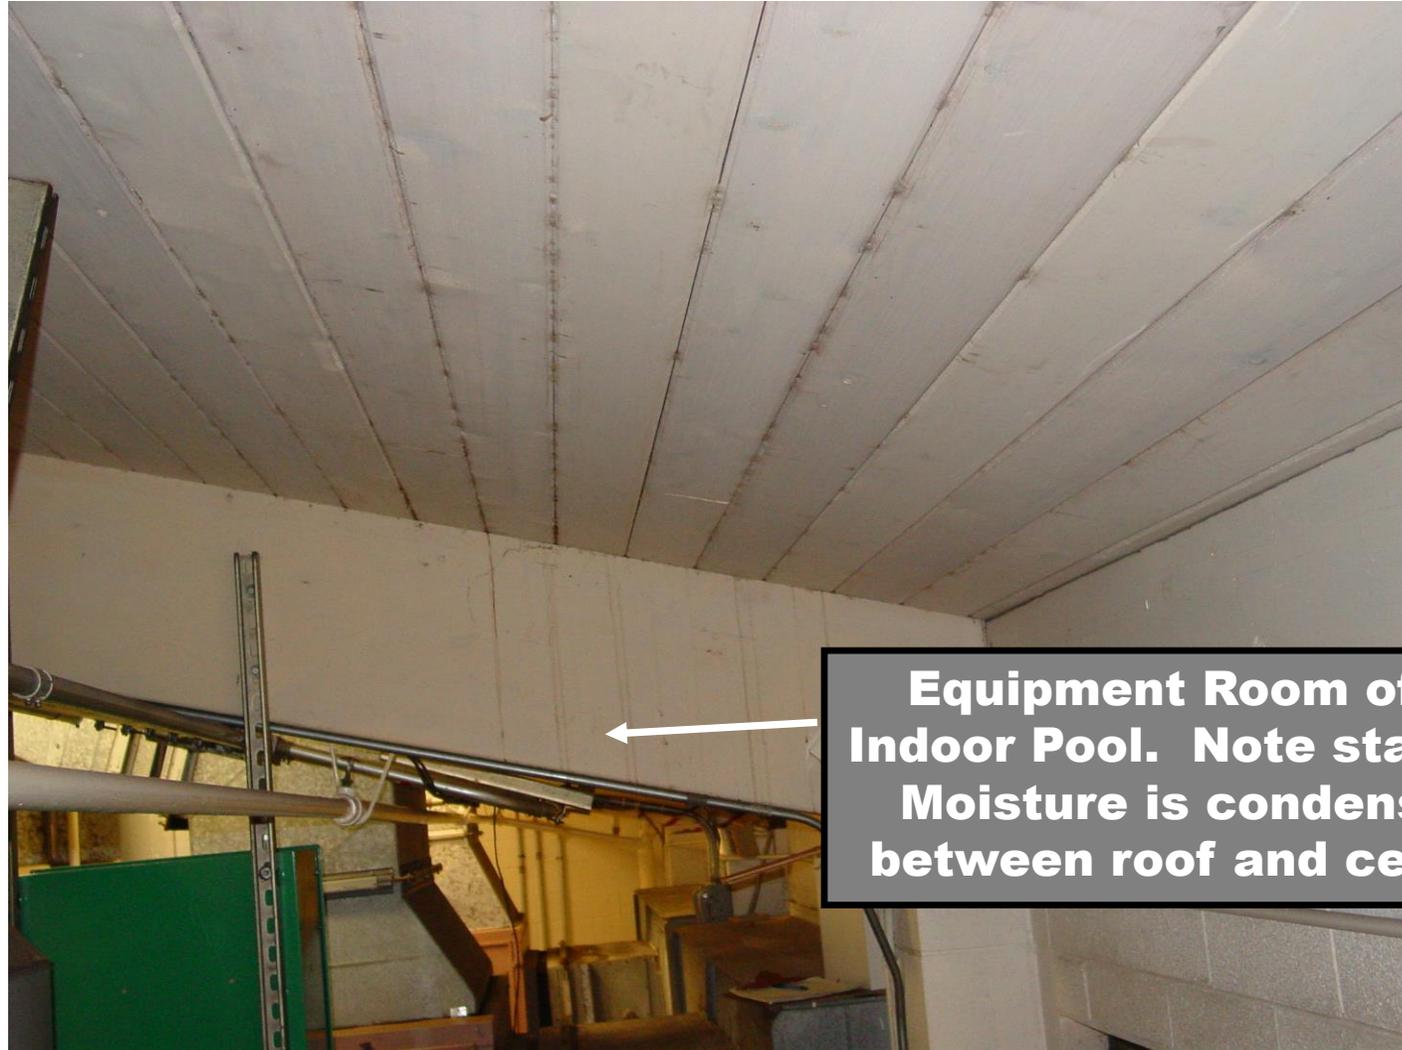
**Equipment Room of an Indoor Pool. Note staining. Moisture is condensing between roof and ceiling.**

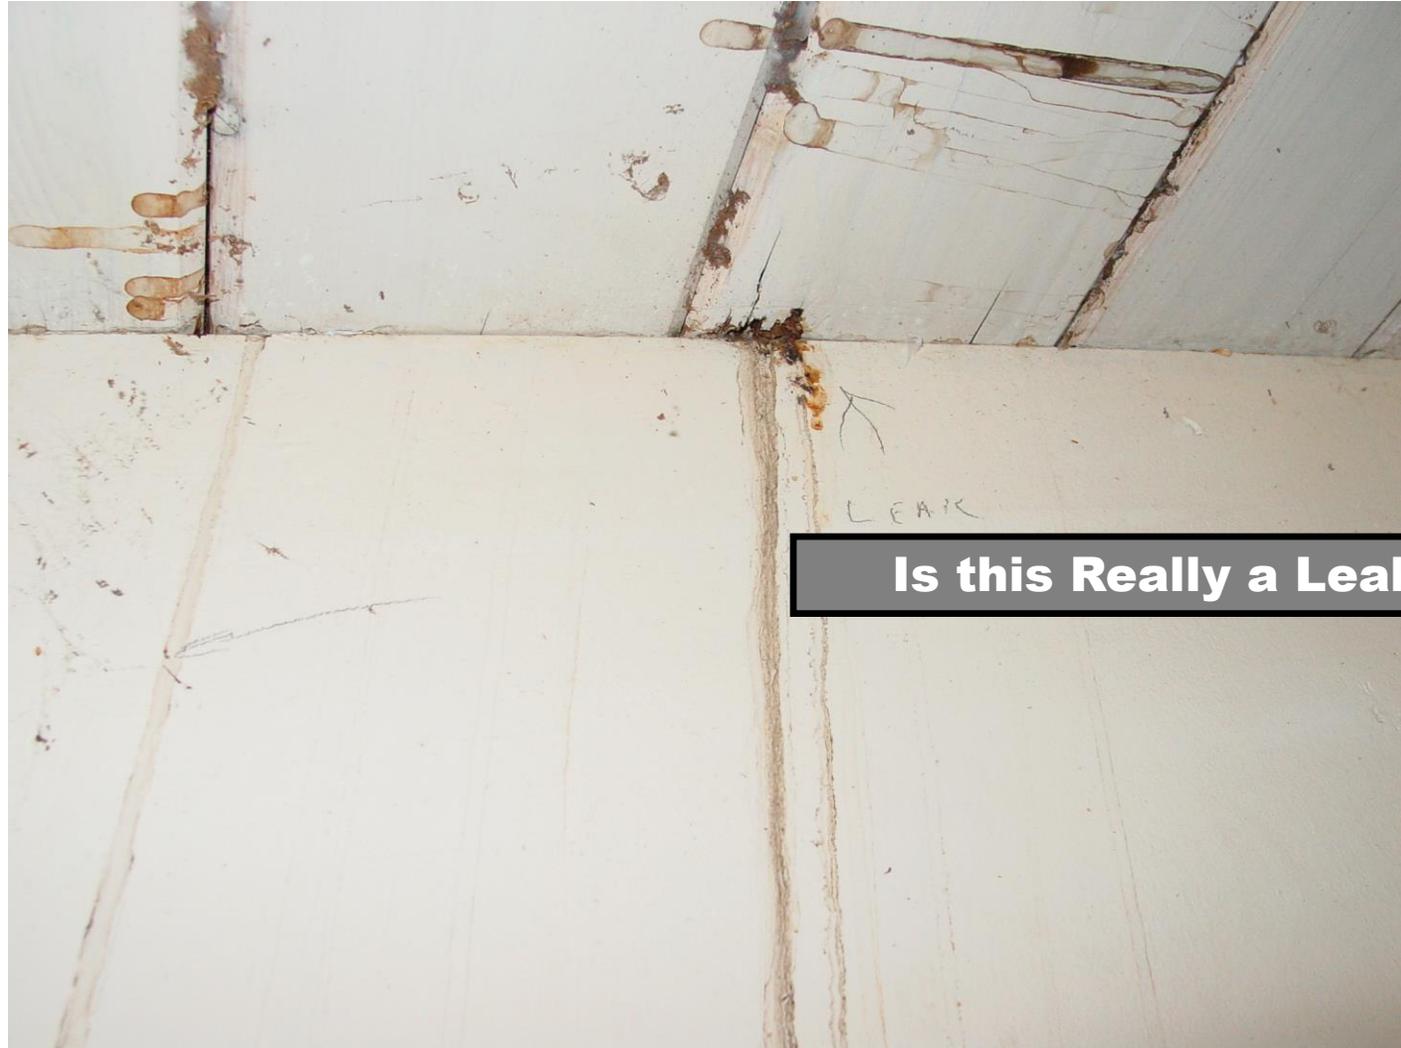
**Is this Really a Leak?**
