Forensic Waterproofing Case Study 1

Bentonite – Wood Lagging – Shotcrete Failure

FORENSIC CASE STUDY 2

High Velocity Storm Water Flow Bentonite Geotextile

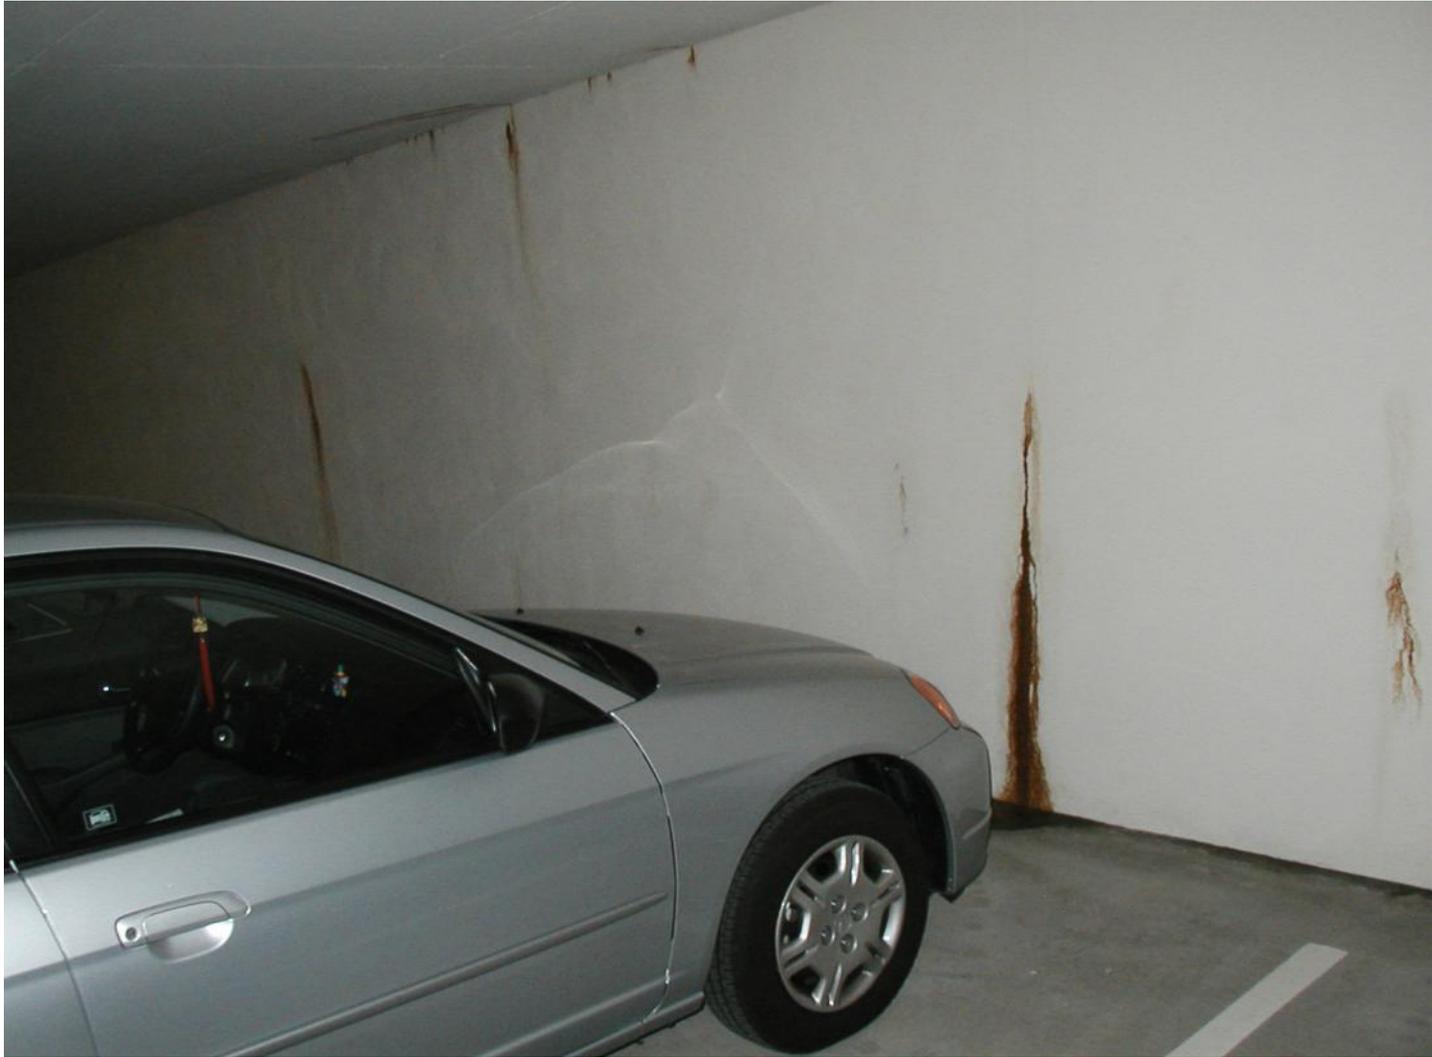
Typical Active Below Grade Leaks

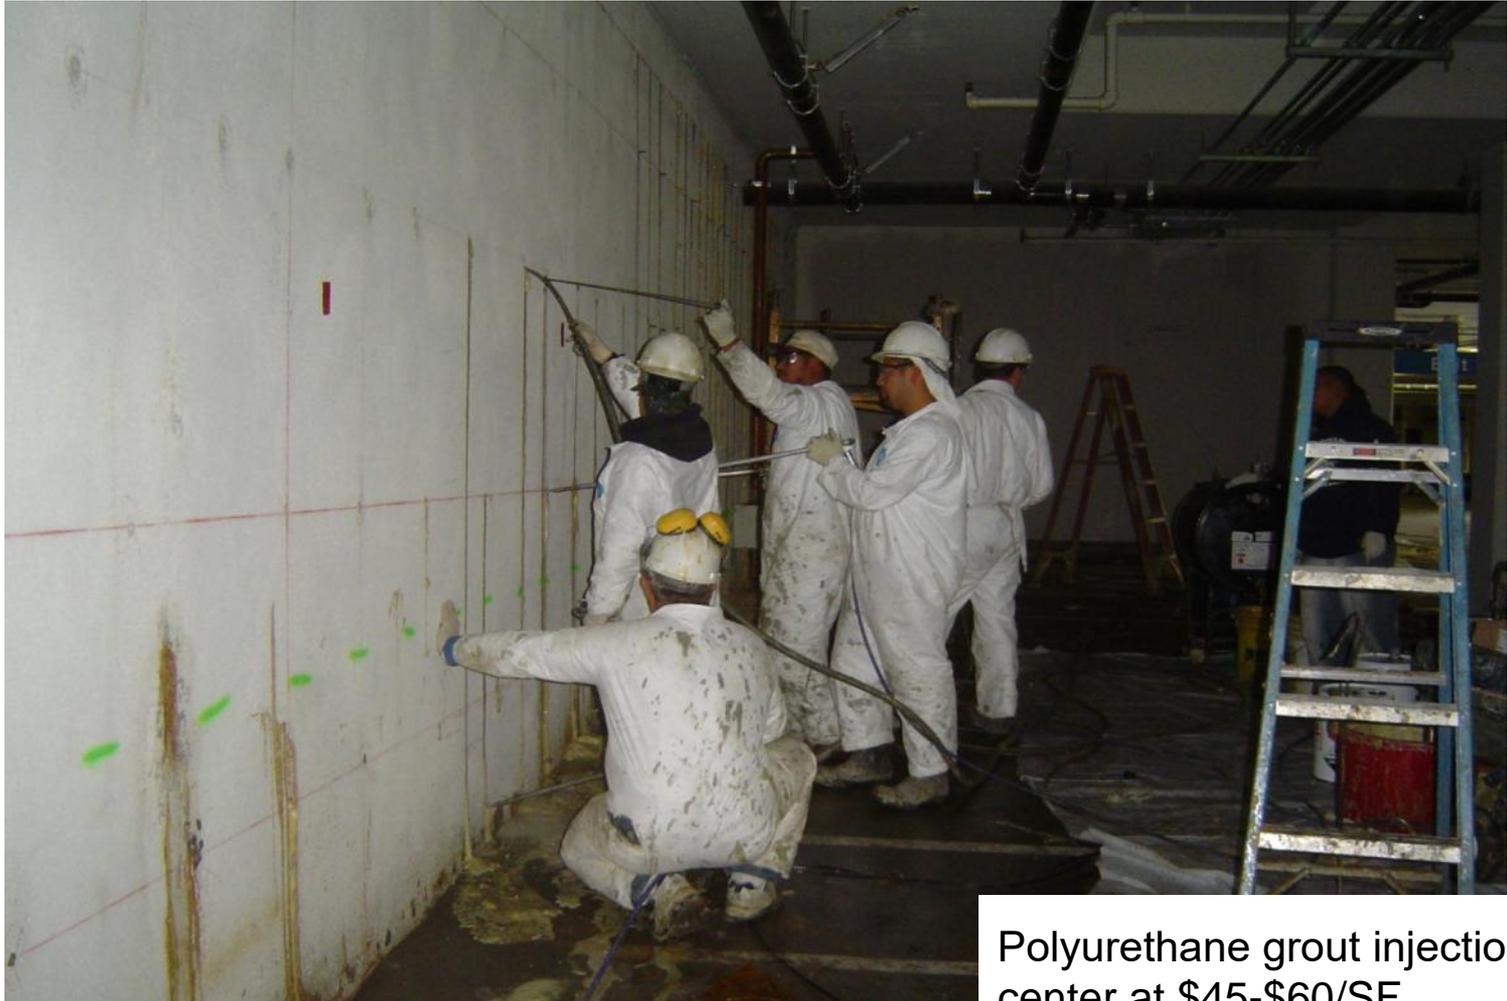
Chemical Grout Drilling and Injection

Polyurethane grout injection 2' on center at \$45-\$60/SF

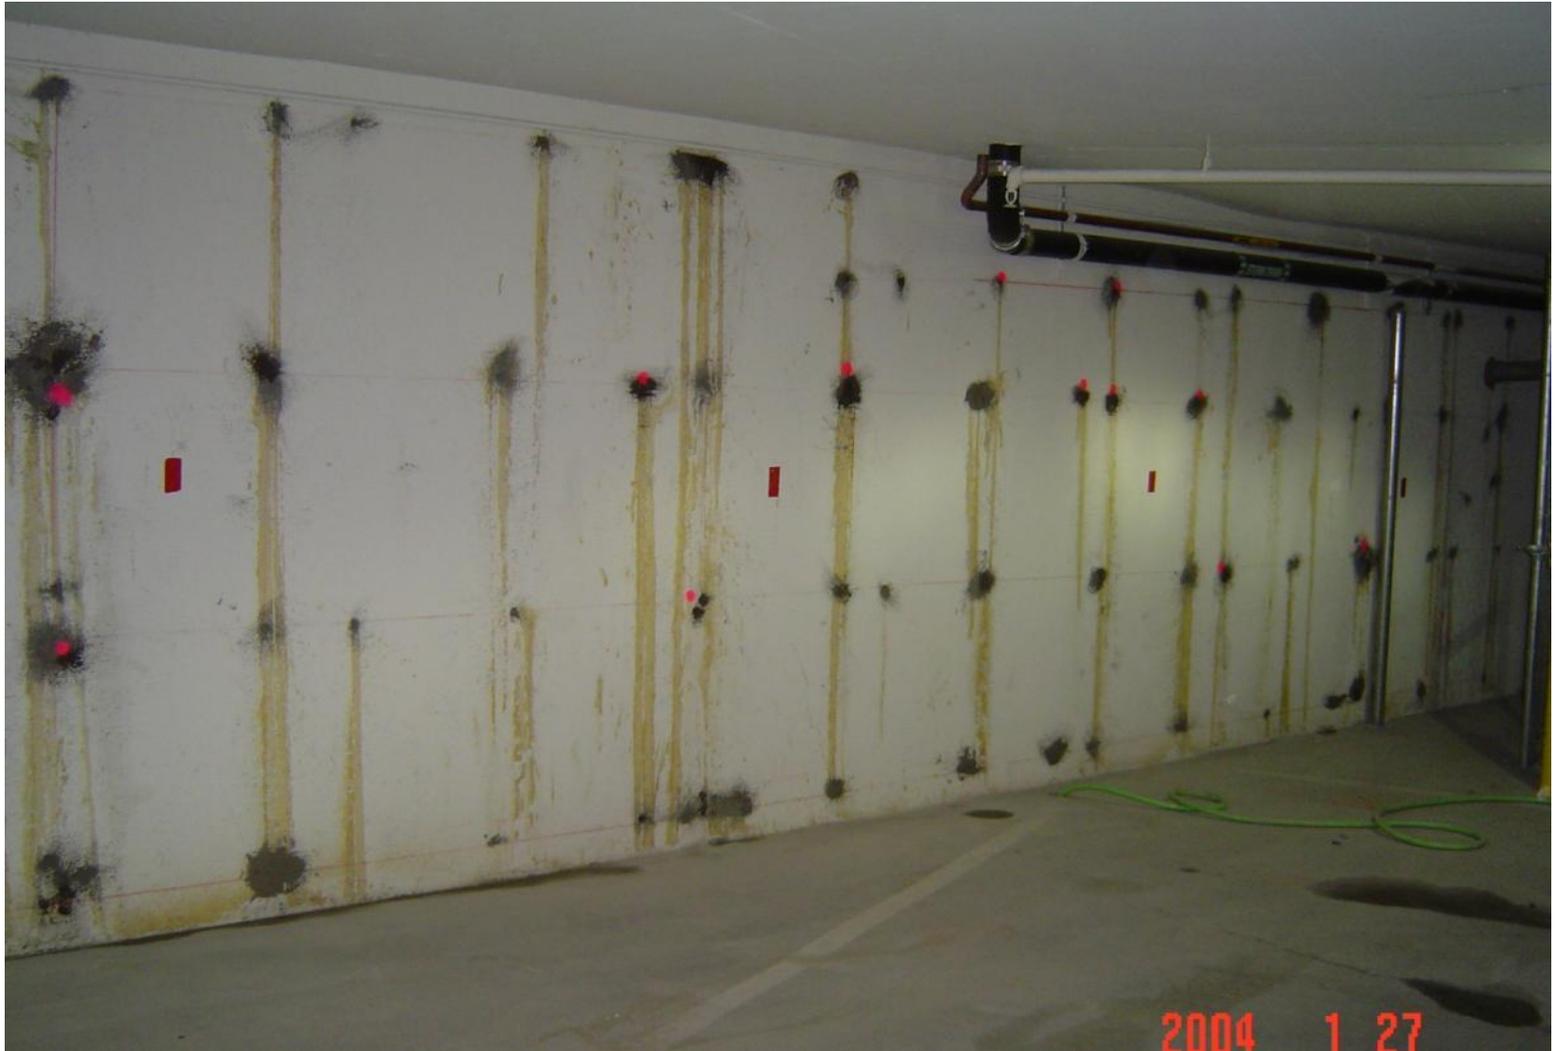
Foundation Wall After \$3,000,000 Curtain Grouting

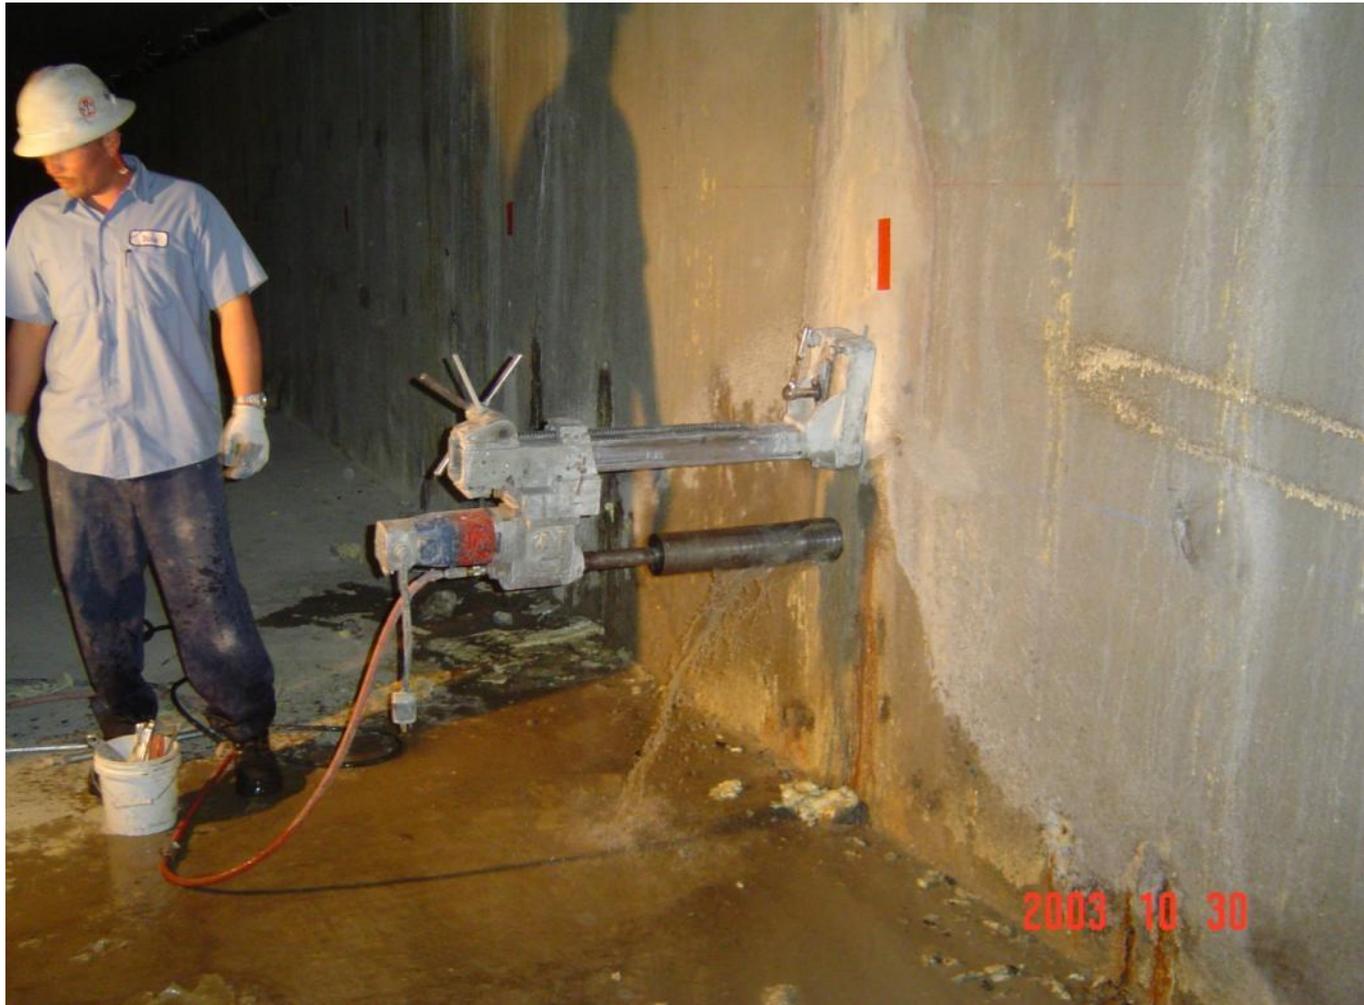
Wall Coring to Determine Grout Performance

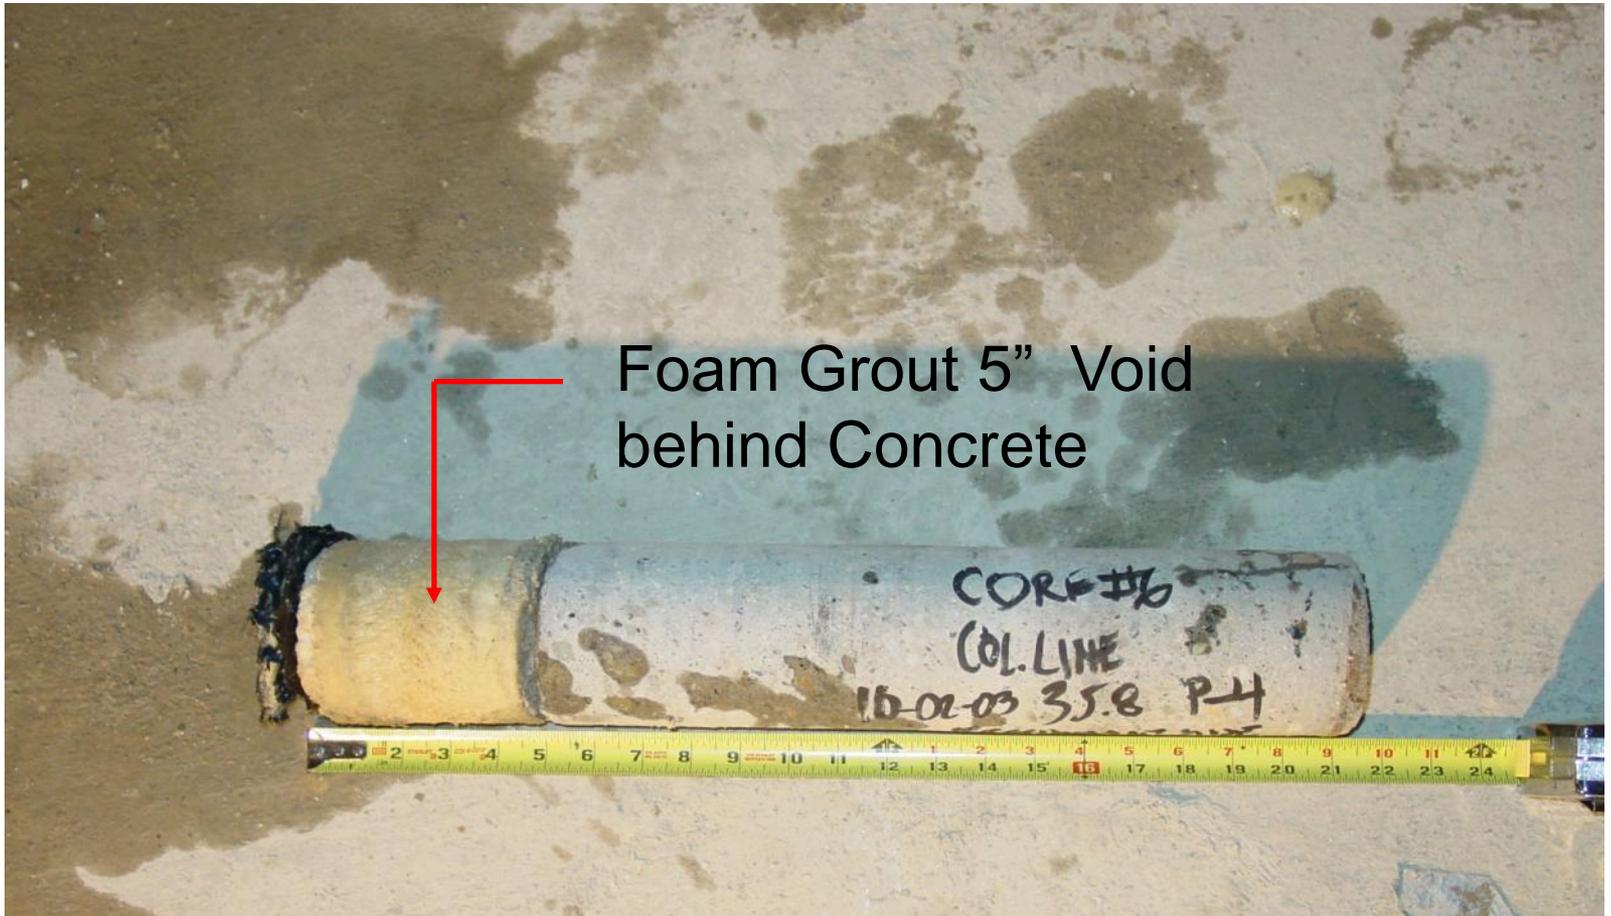
Large Voids Found Behind Shotcrete Wall

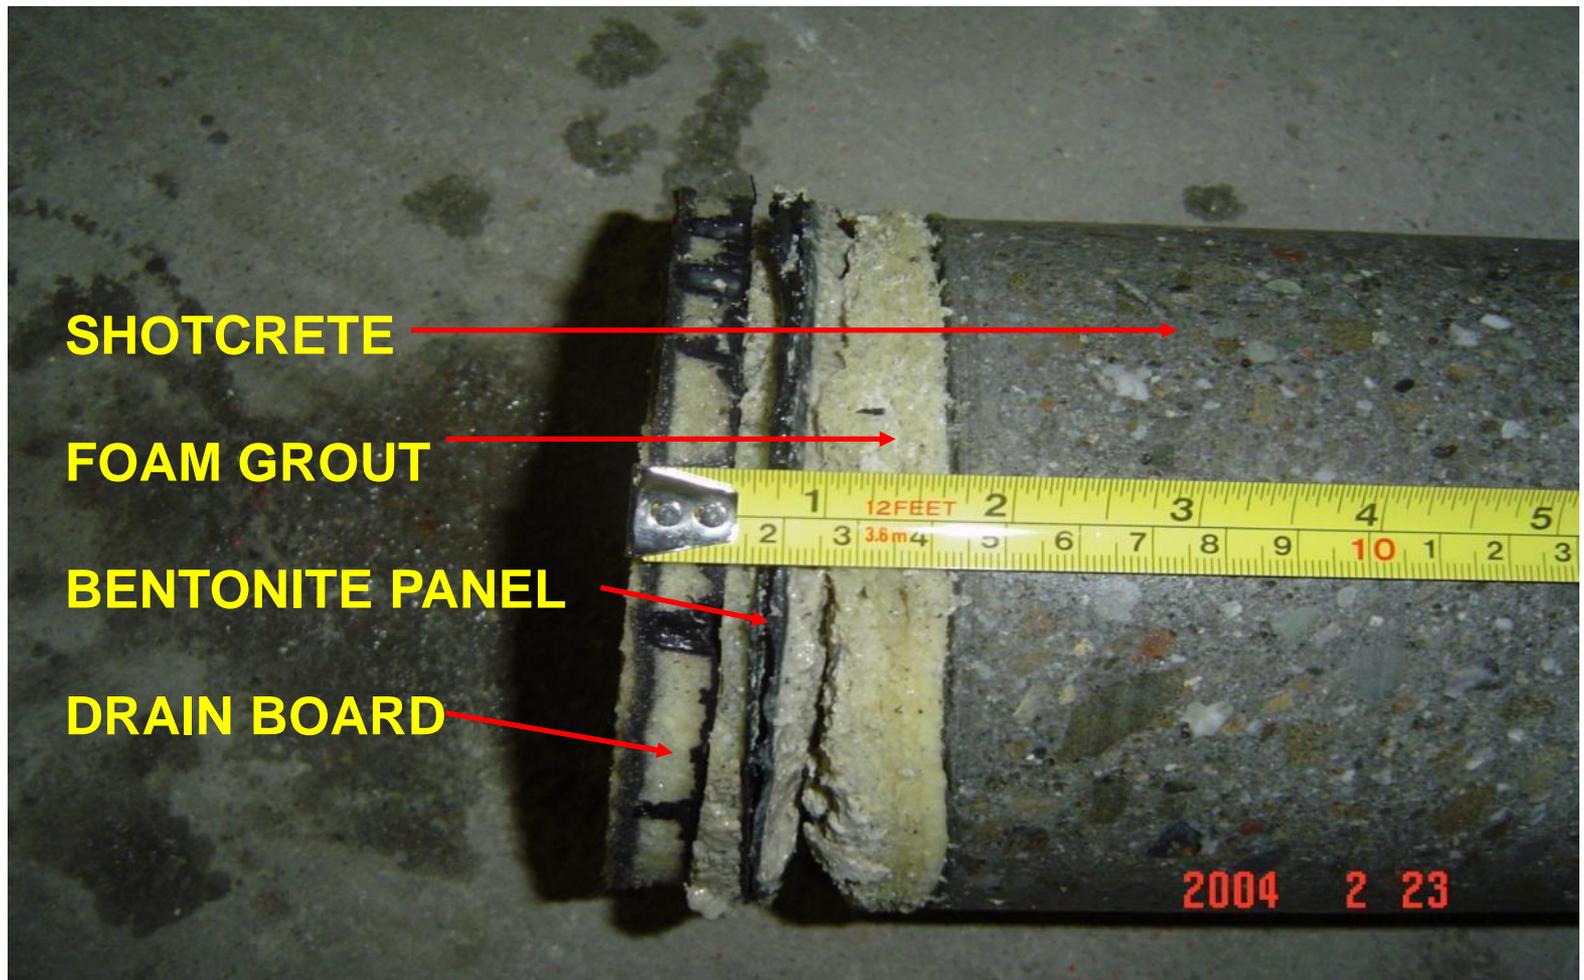
Large Voids Found Behind Shotcrete Wall

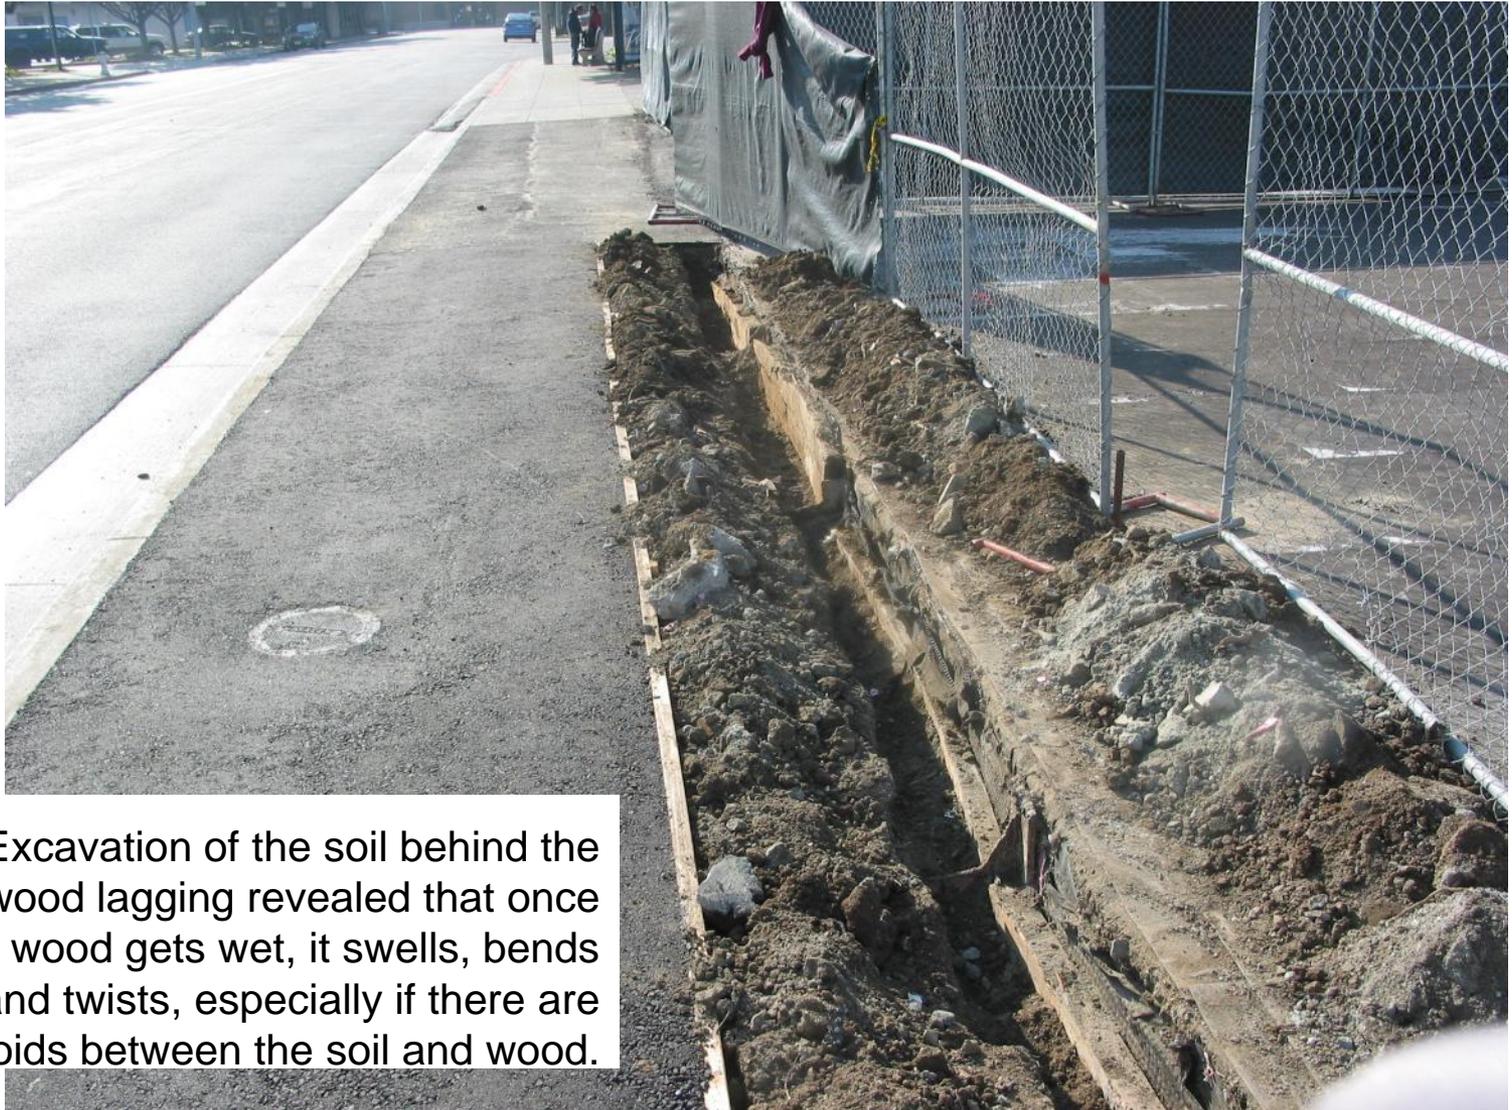
Excavation of the soil behind the wood lagging revealed that once the wood gets wet, it swells, bends and twists, especially if there are voids between the soil and wood.

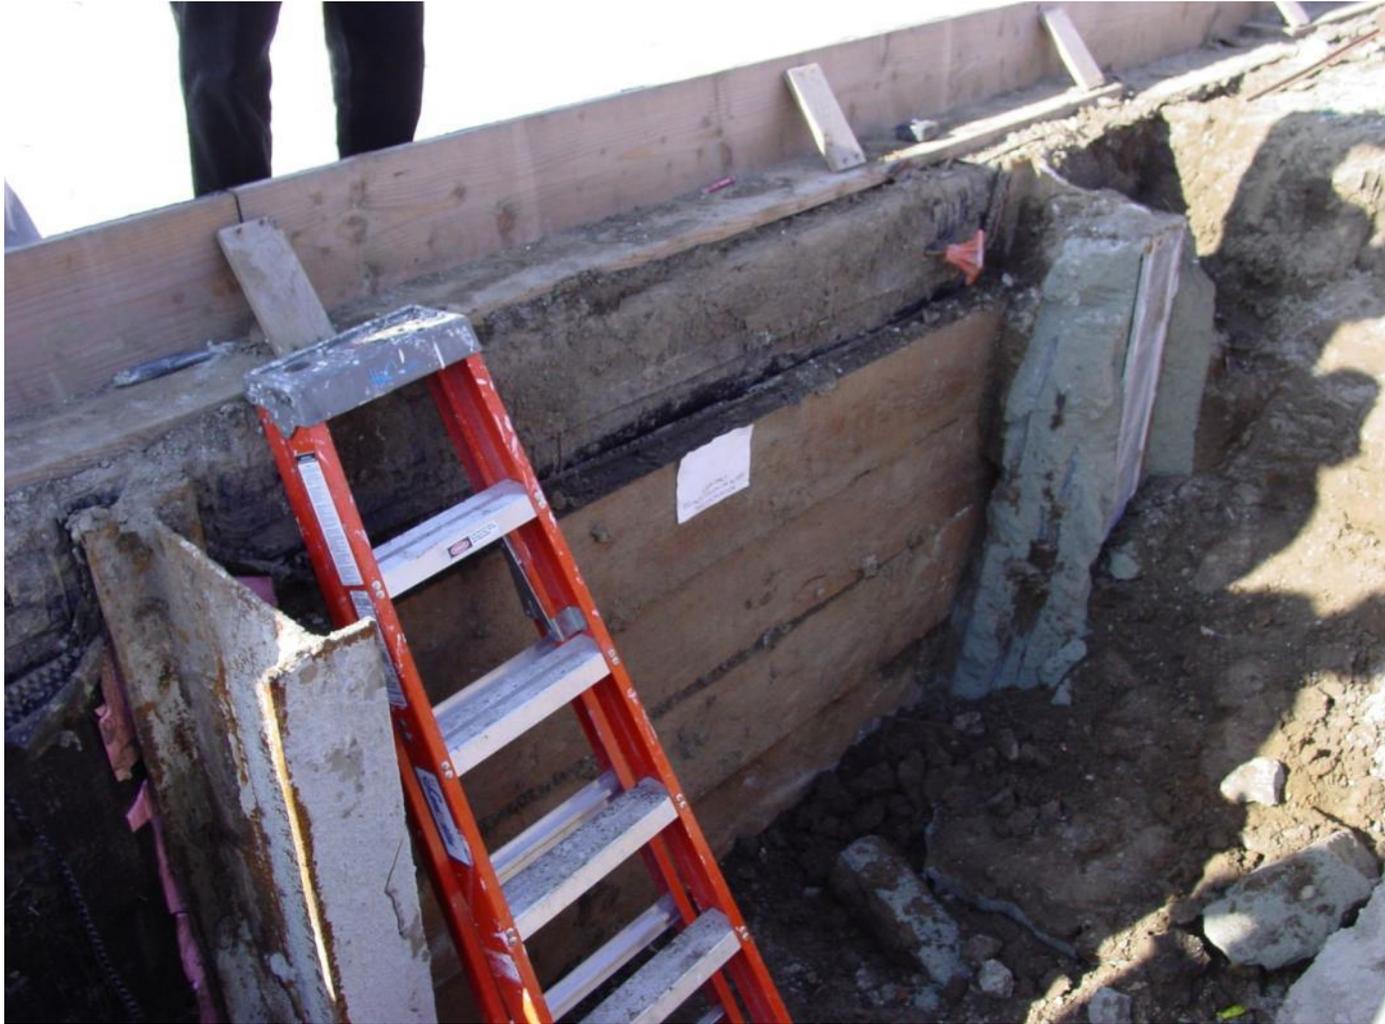
Typical Test Pit

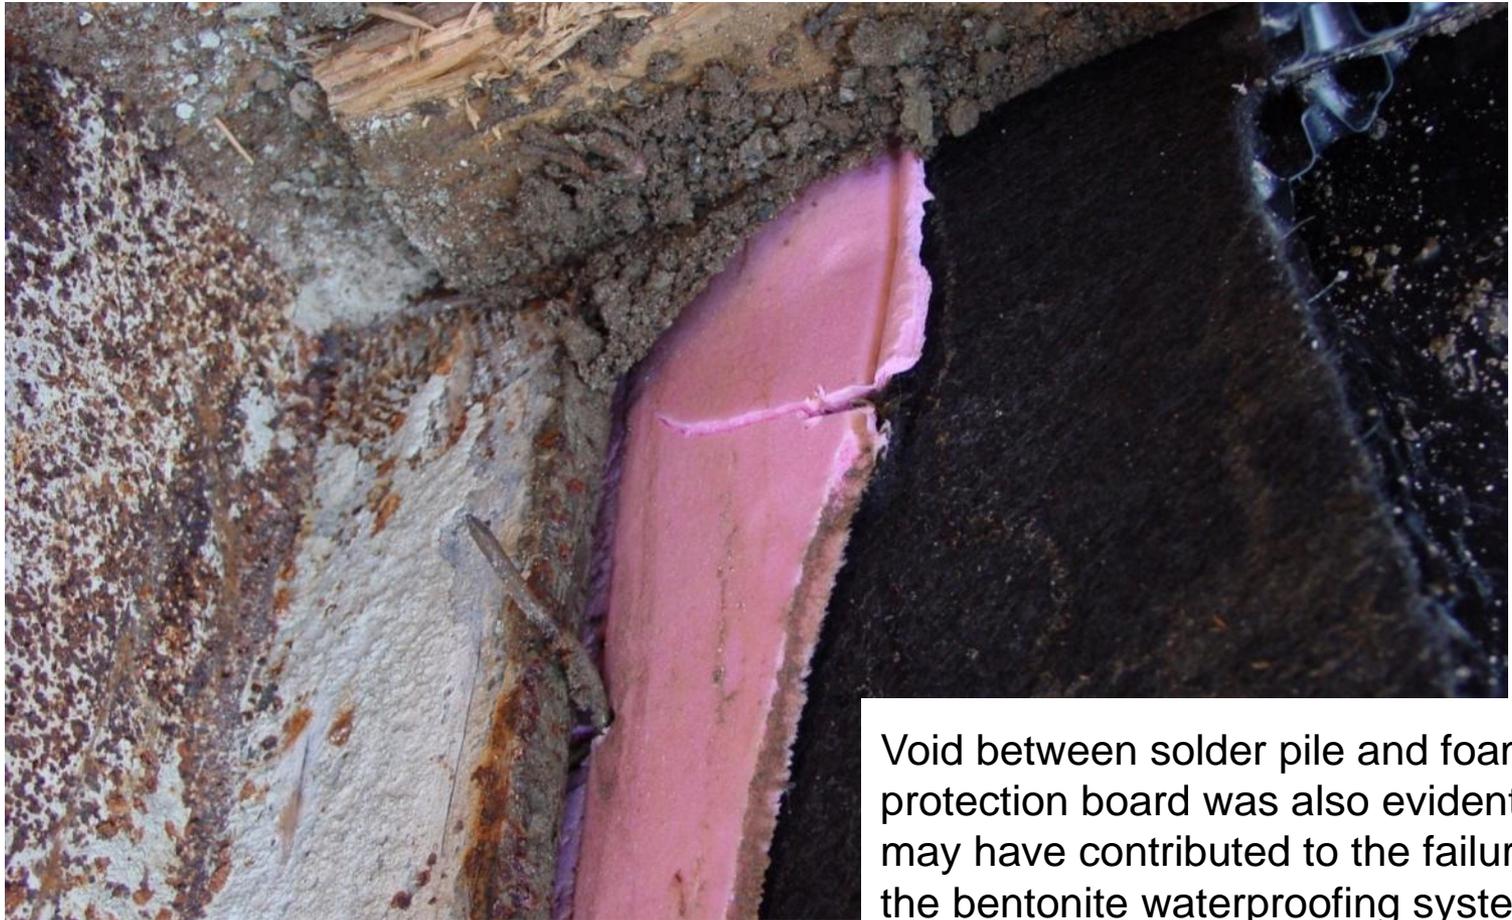
Voids Behind Foam Insulation Panels

Void between solder pile and foam protection board was also evident and may have contributed to the failure of the bentonite waterproofing system.

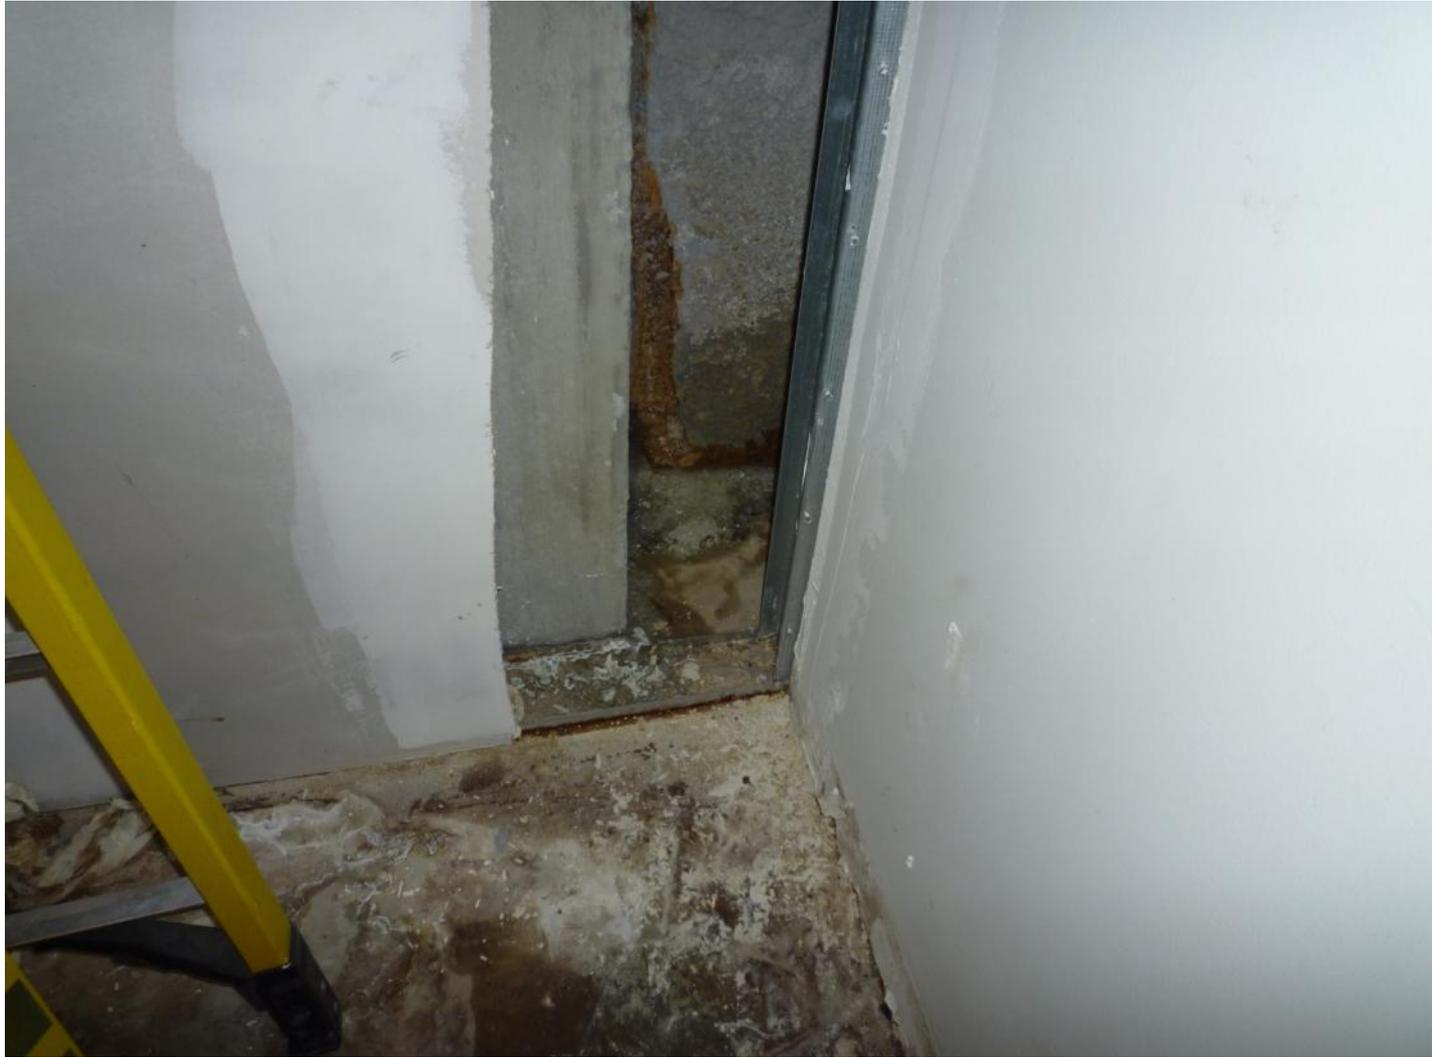
Elevation With Leakage

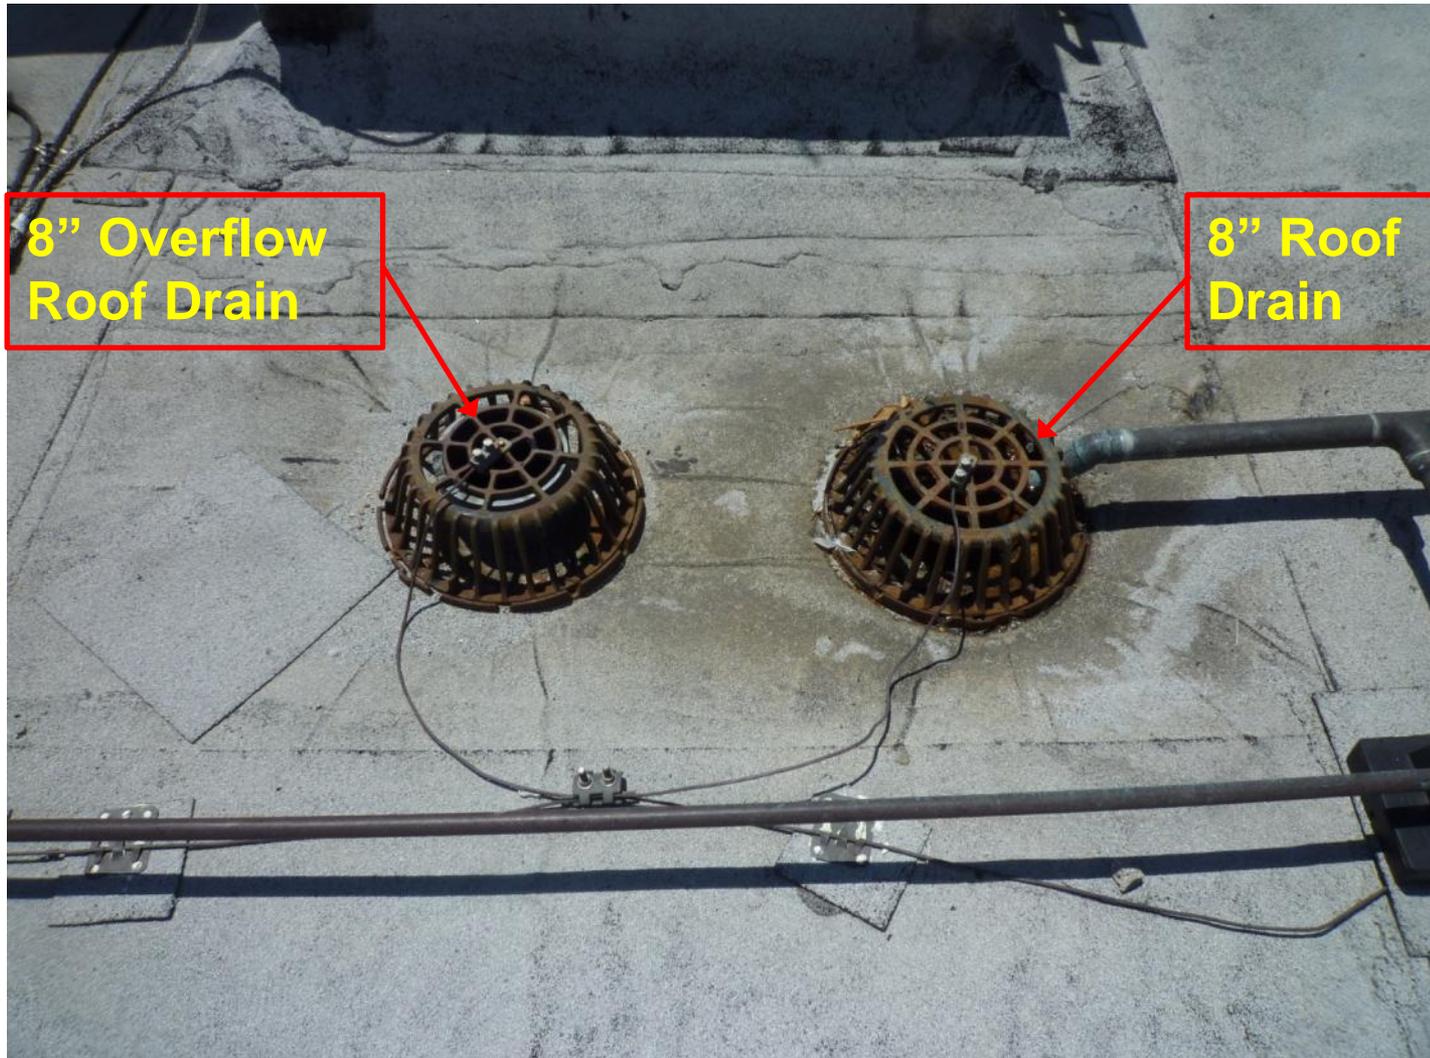
Roof Drains are Large (8-inch lines)

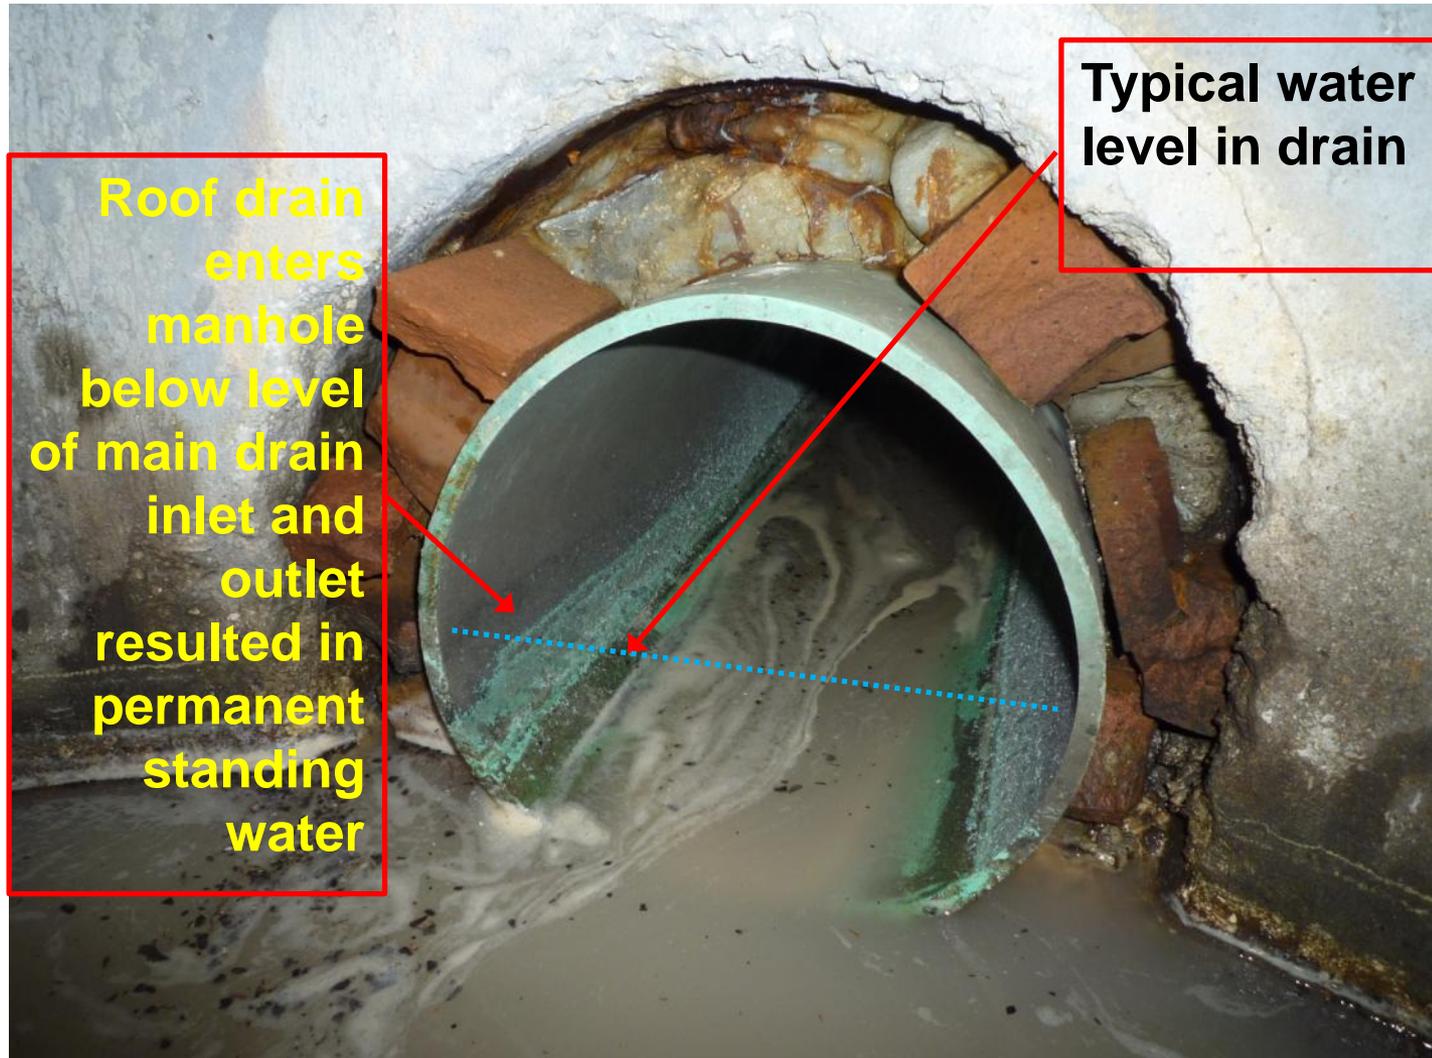
Roof Drain Inlet to Storm Drain Manhole

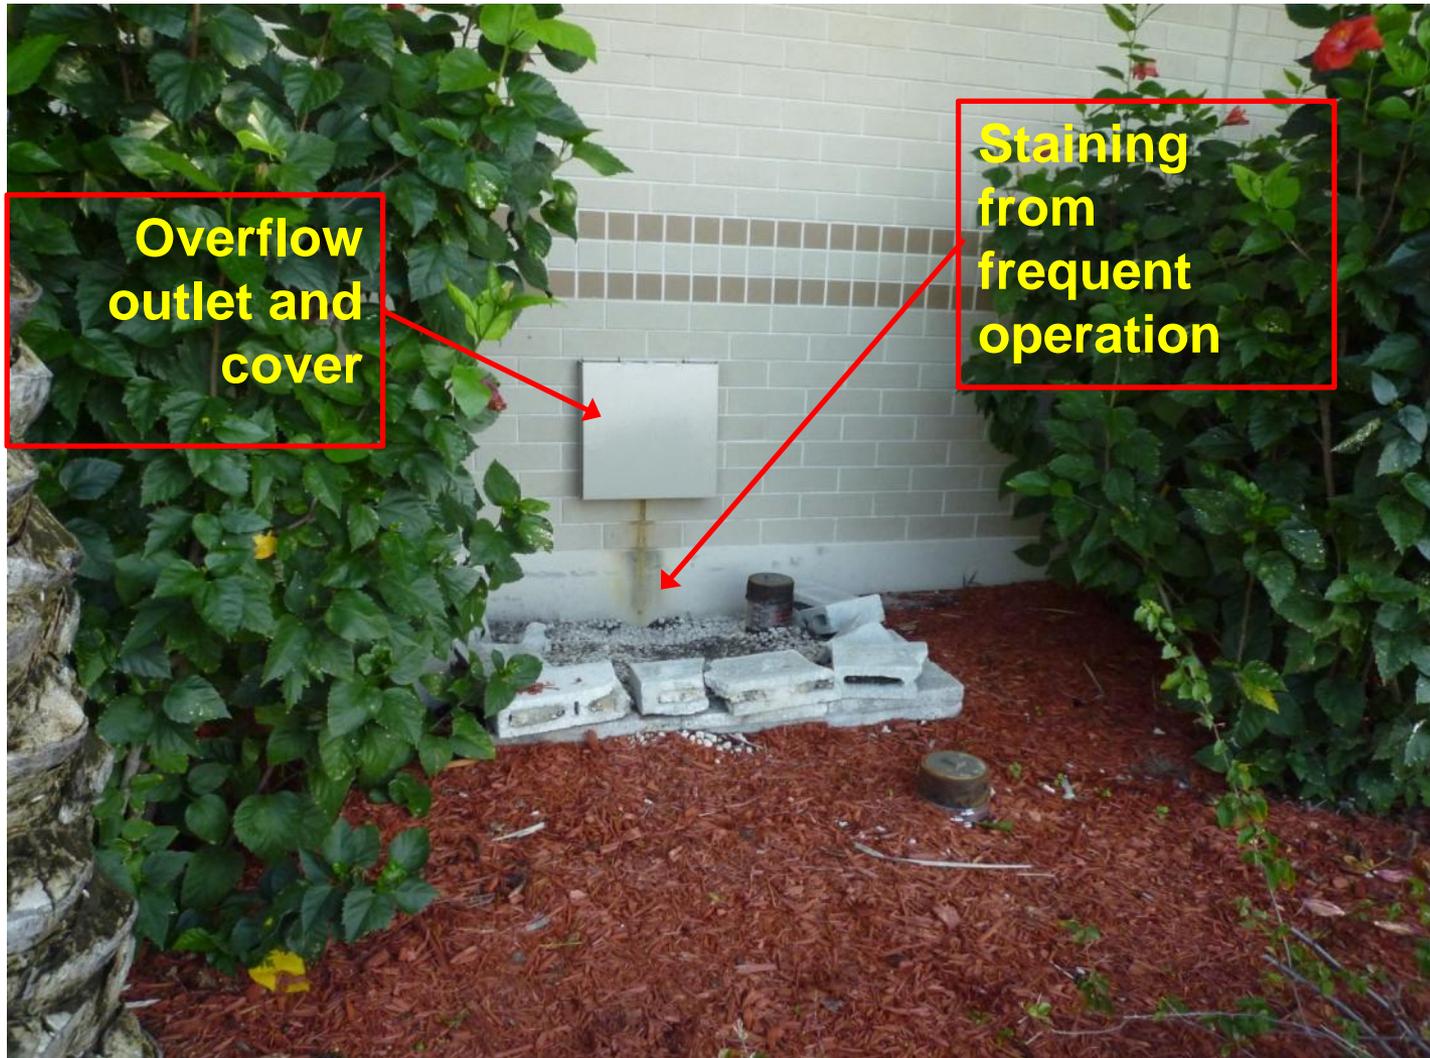
Typical Overflow Drain Outlet

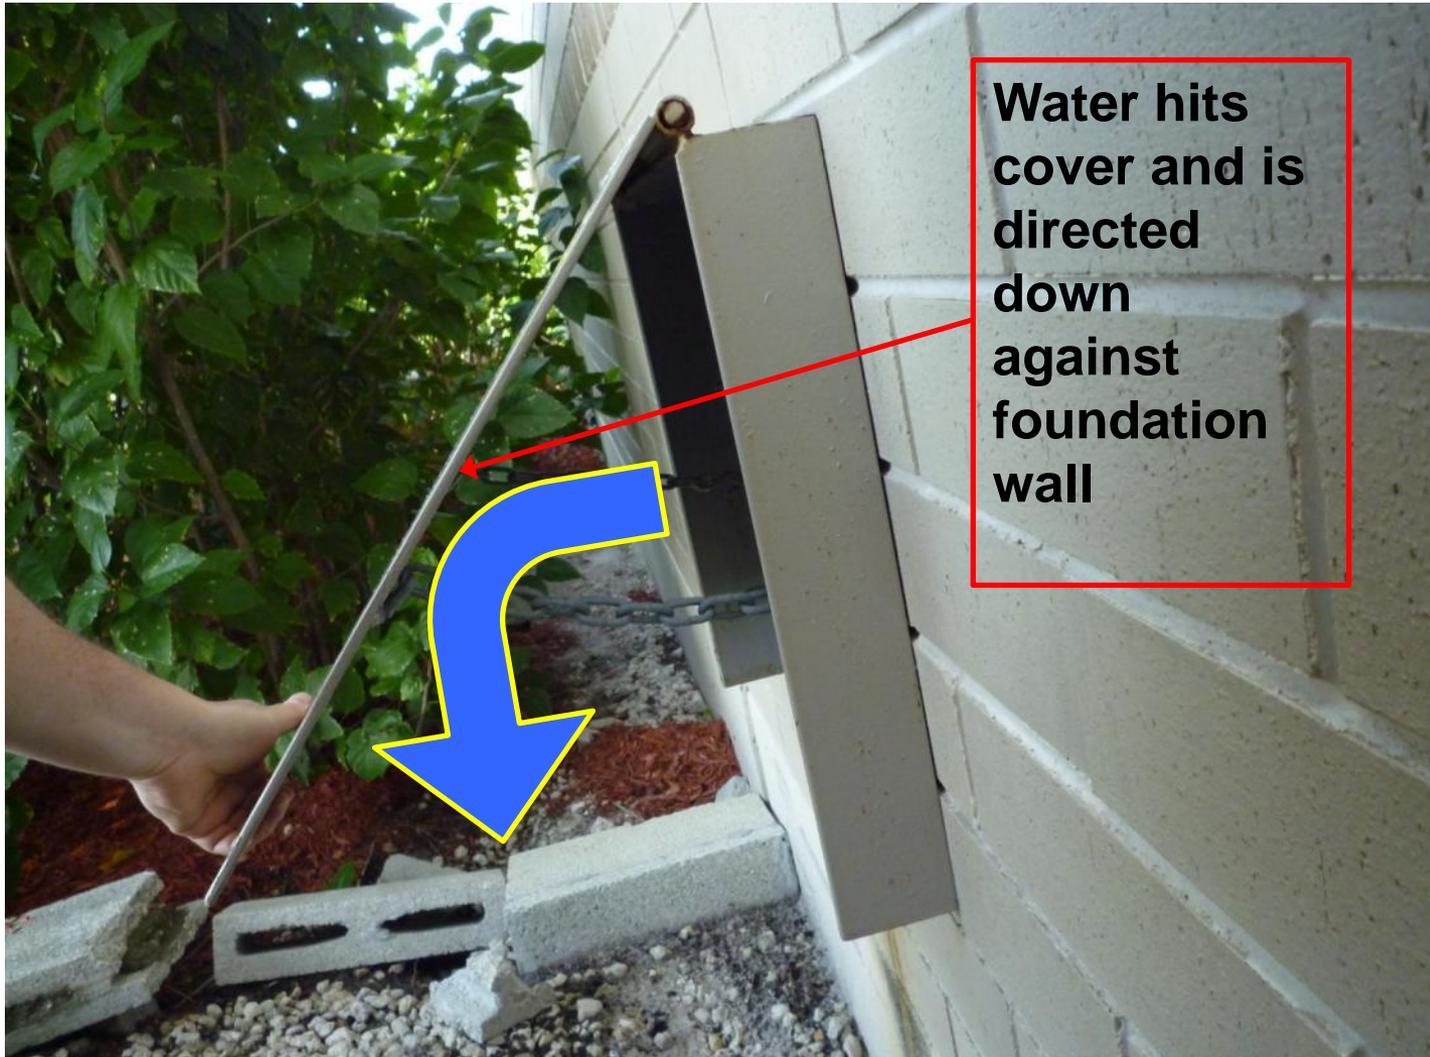
Overflow Drain Cover with Chain Restraint

Water hits cover and is directed down against foundation wall

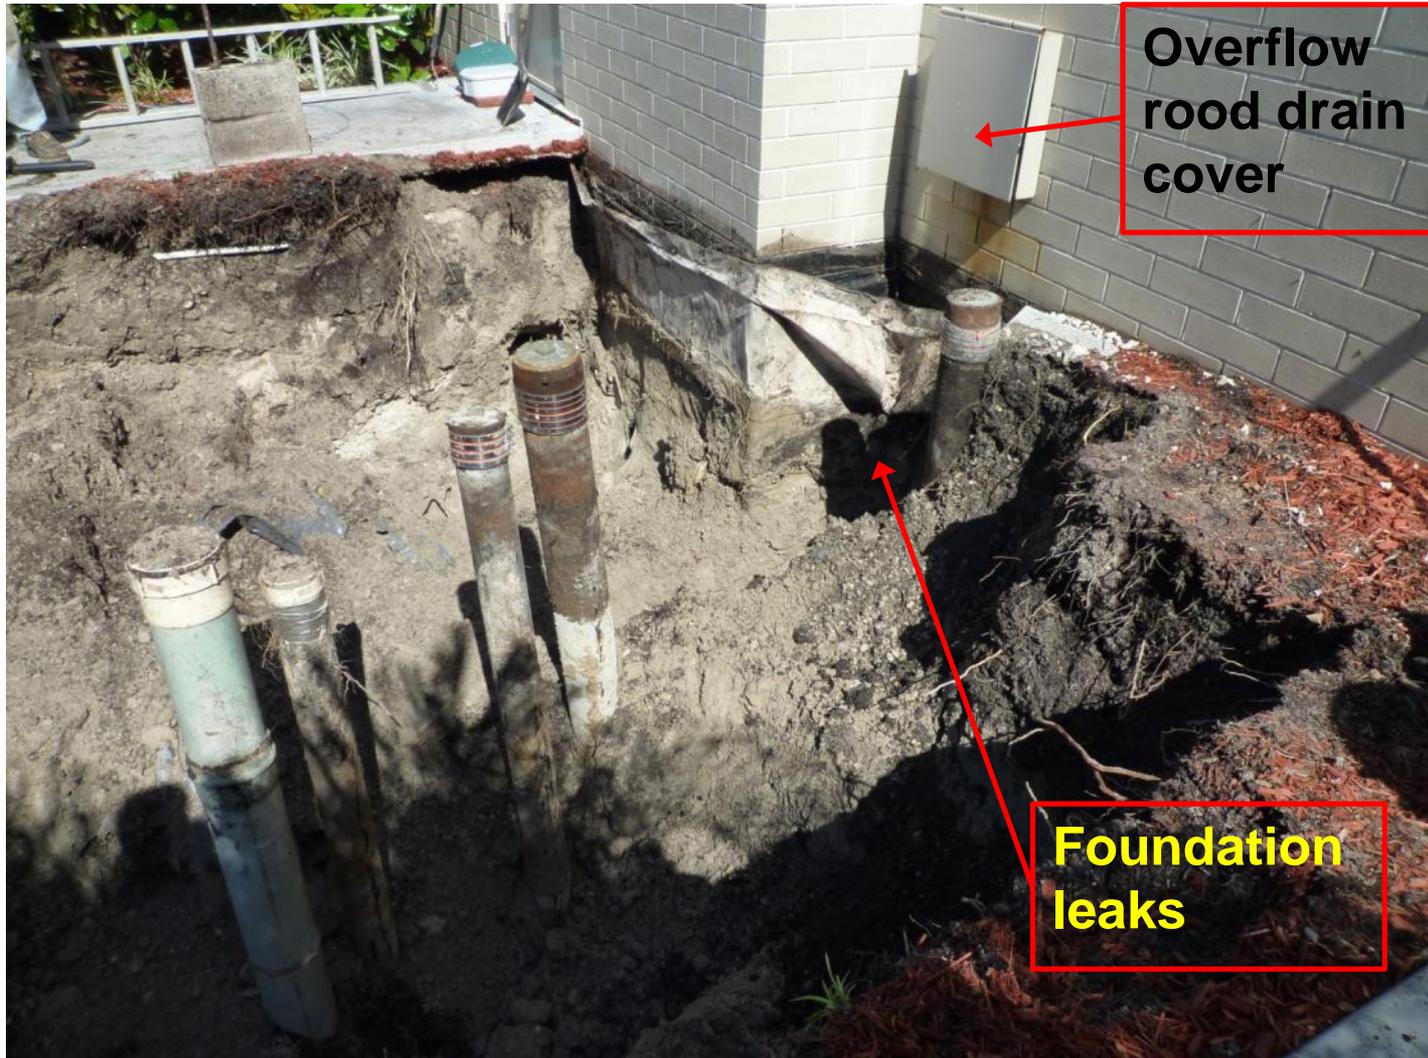
General View of Test Pit

Overflow
rood drain
cover

Foundation
leaks
