Forensic Waterproofing Case Study 1

Bentonite – Wood Lagging – Shotcrete Failure

FORENSIC CASE STUDY 2

High Velocity Storm Water Flow Bentonite Geotextile

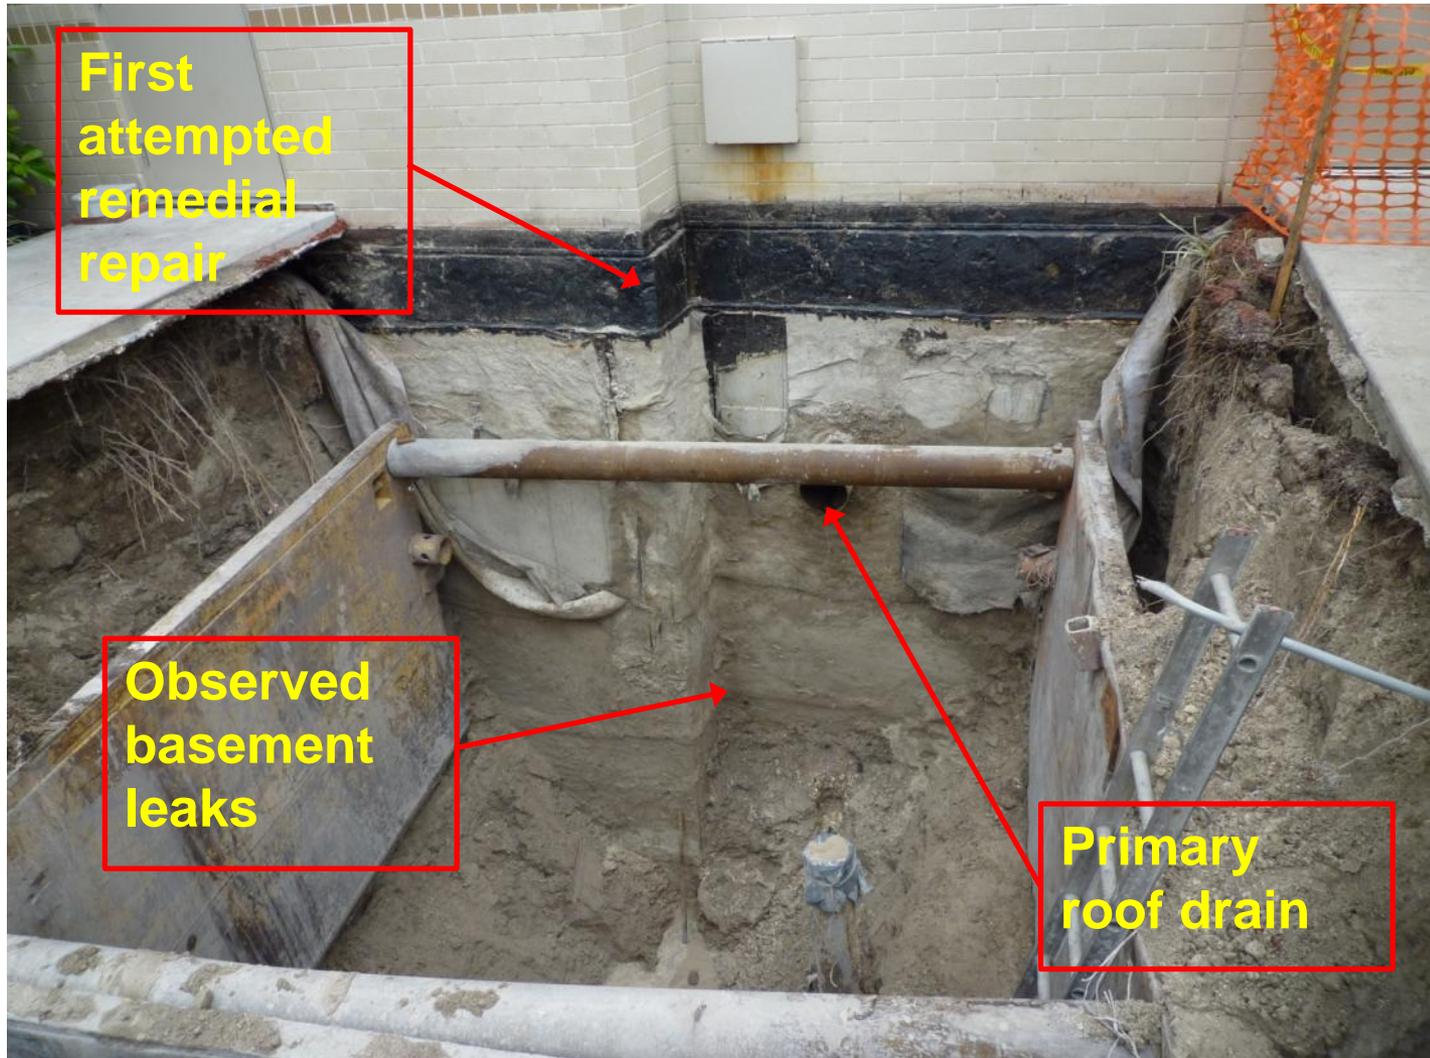
Full Depth Test Pit

First attempted remedial repair

Observed basement leaks

Primary roof drain

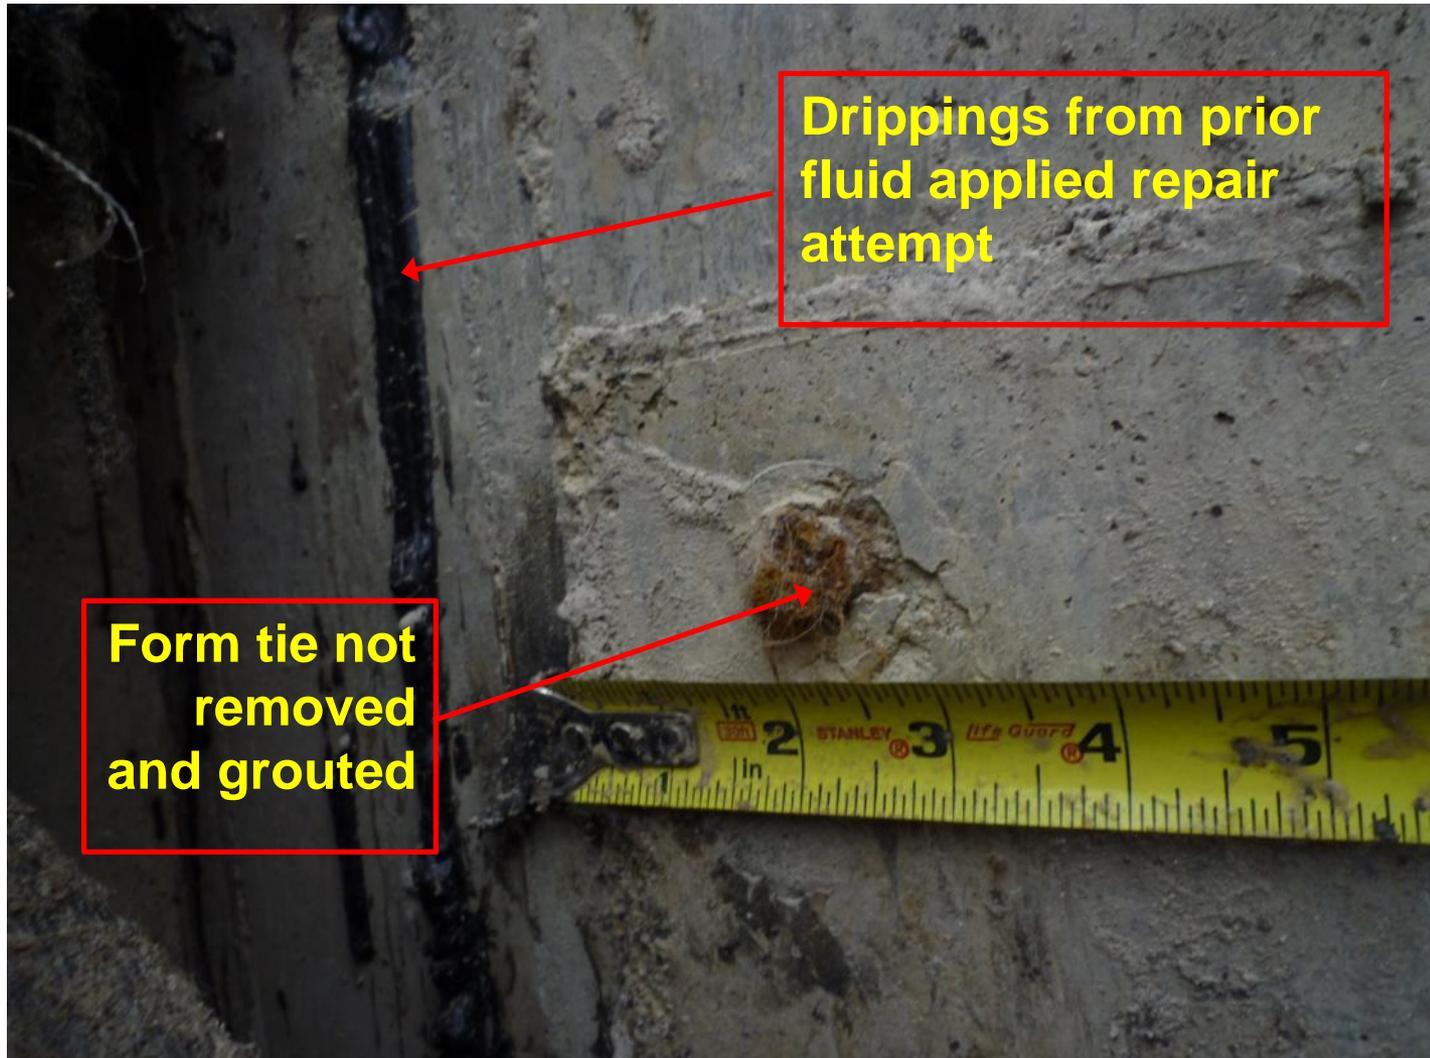
Form Ties Not Removed and Hole Grouted

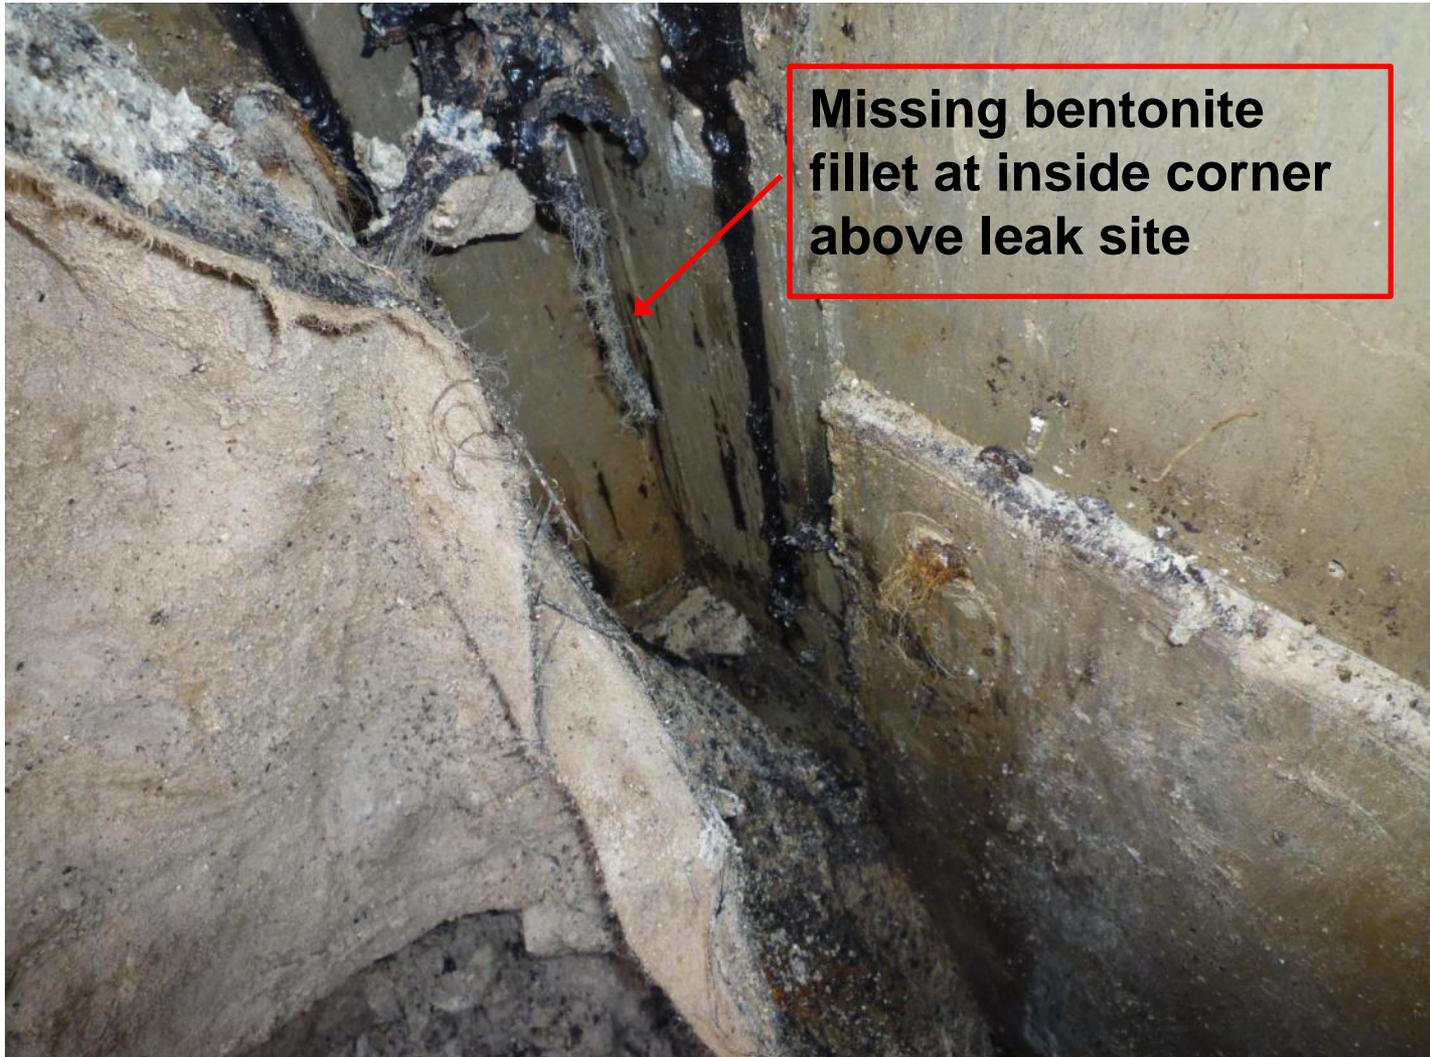
Elevation With Leakage

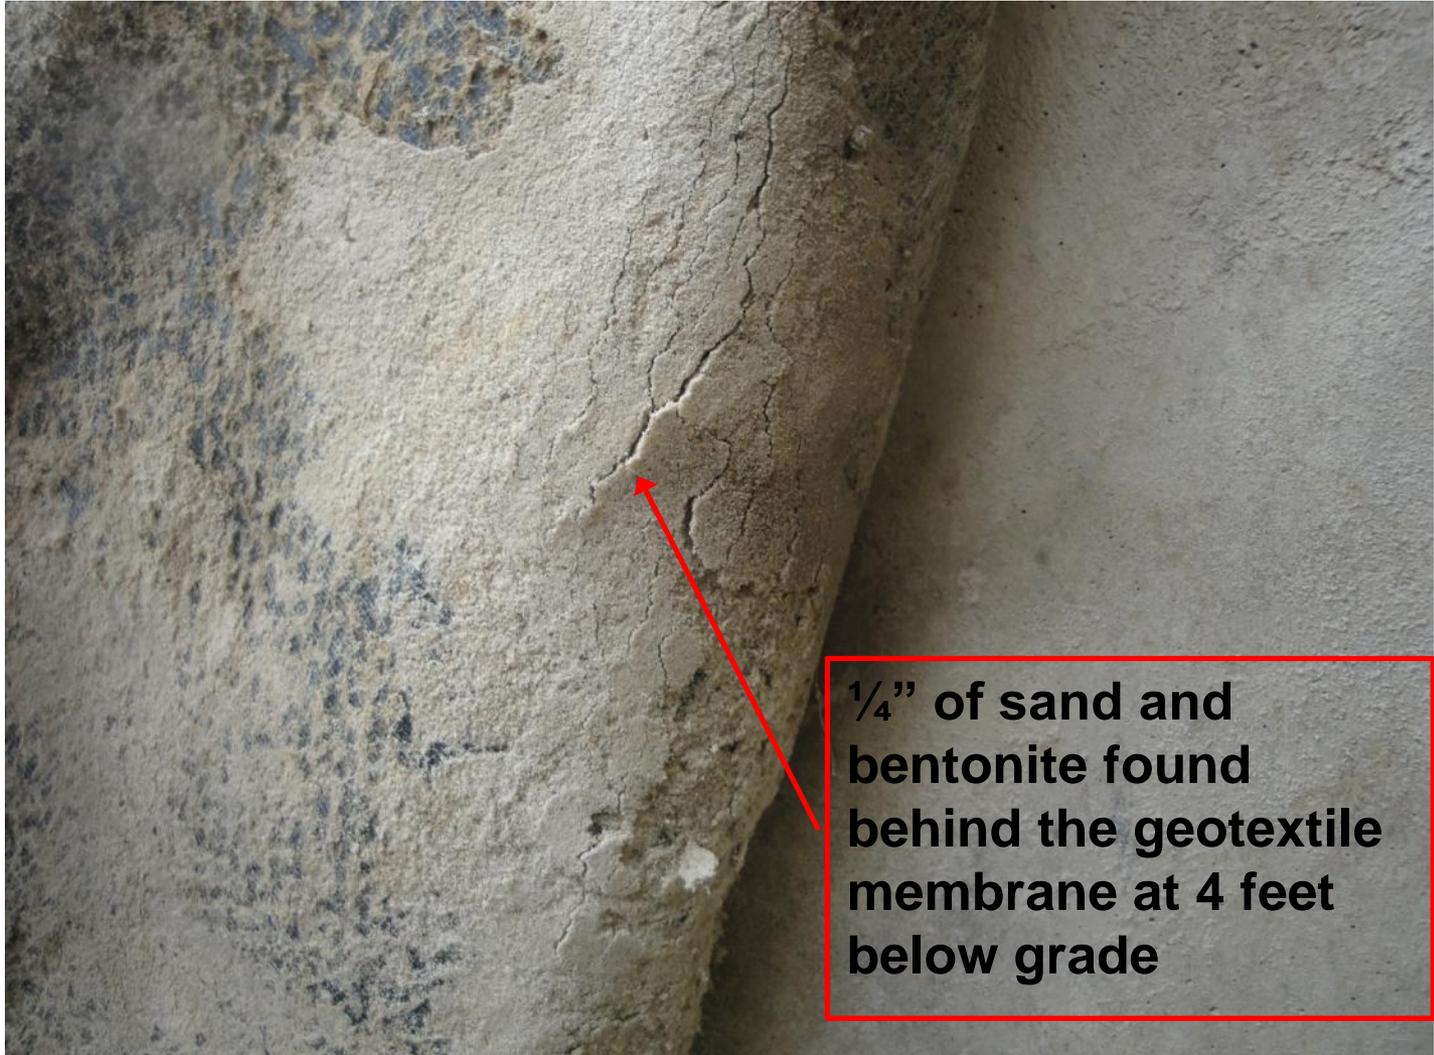
Sand and Bentonite Washed Behind Membrane

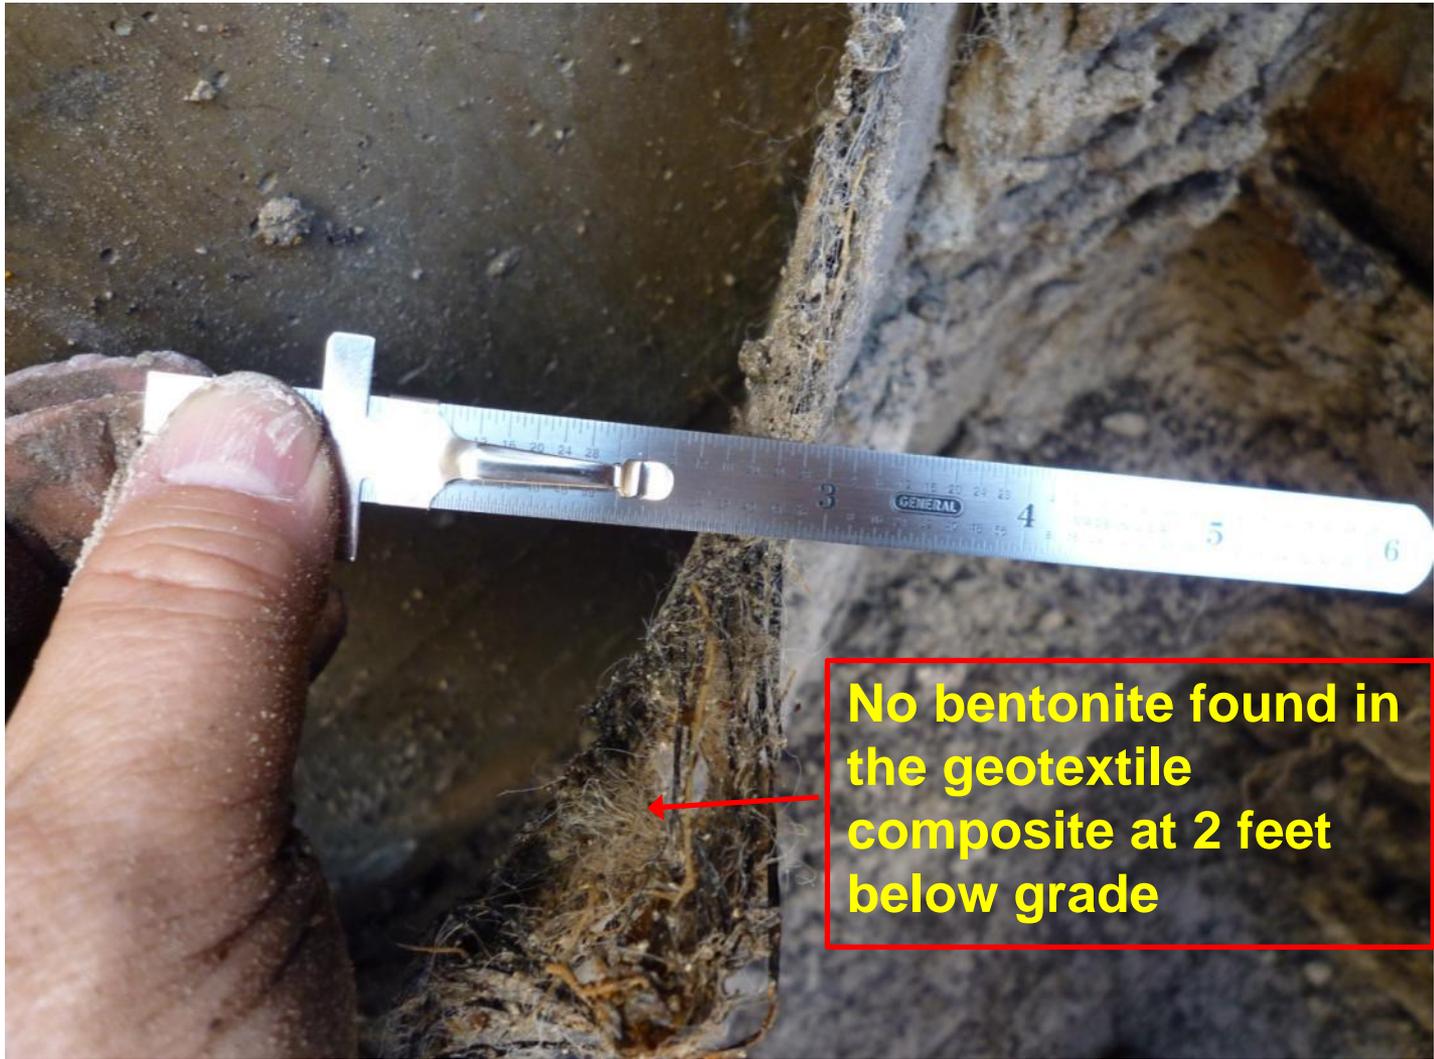
No Bentonite Found in Sheet 2 Feet Below Grade
