# Southwest Medical Associates – 12 years old

# Country Club Towers – 12 years old

# Las Vegas Valley Water District -

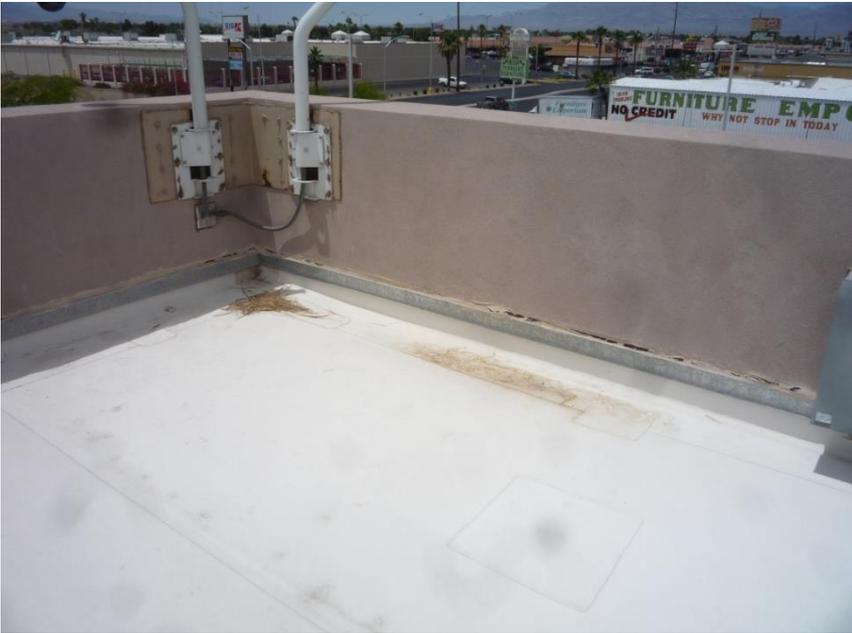
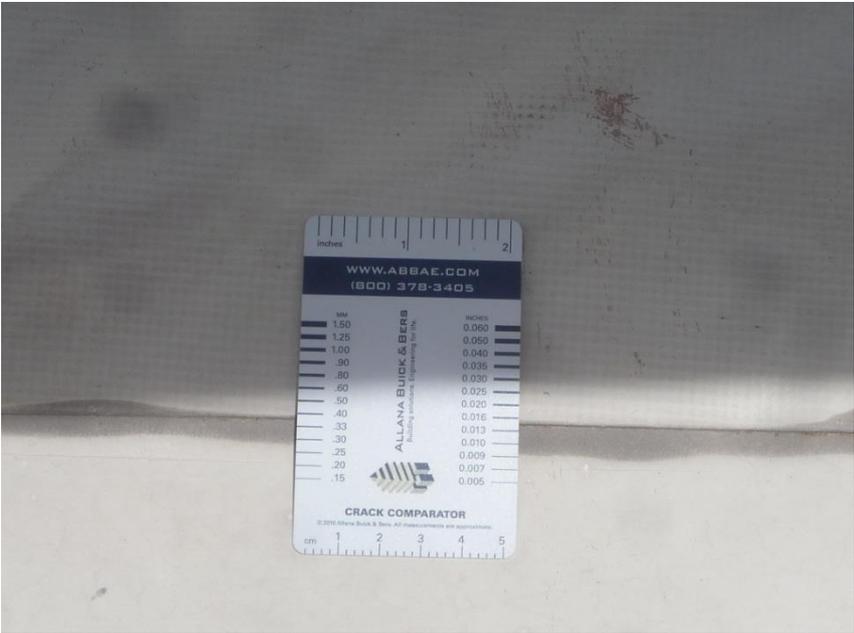
# Minor UV degrading noted at the north and east parapet

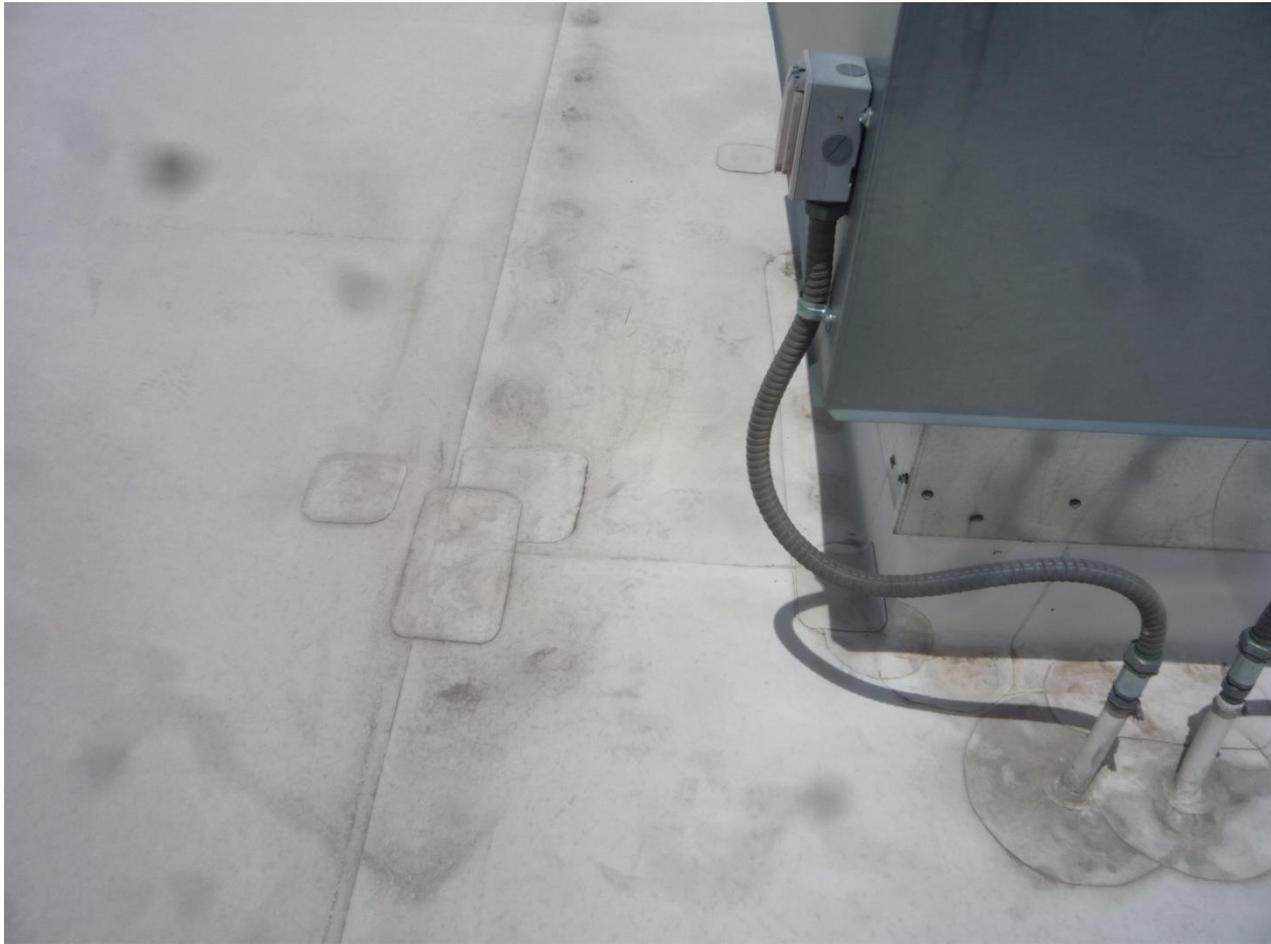
# Minor UV at the west side of the A/C unit

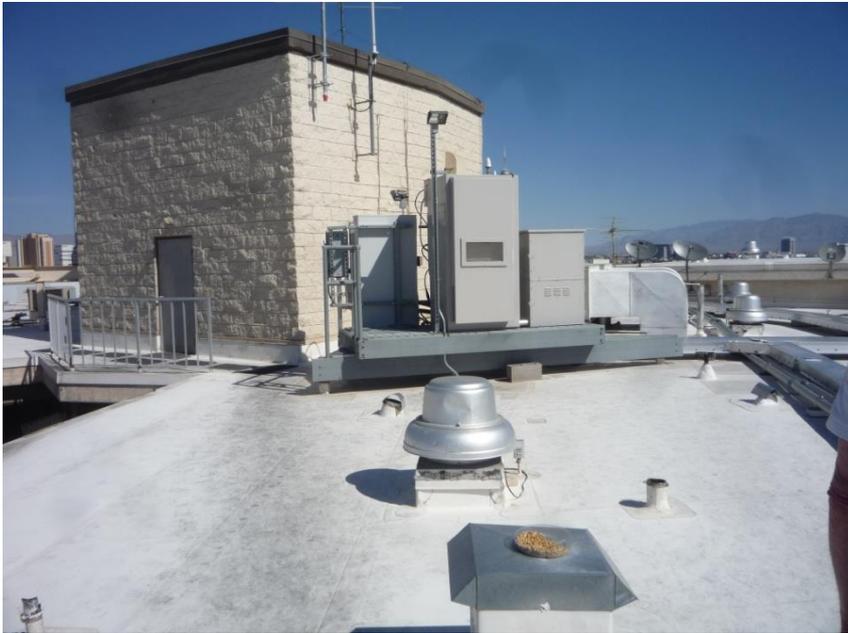
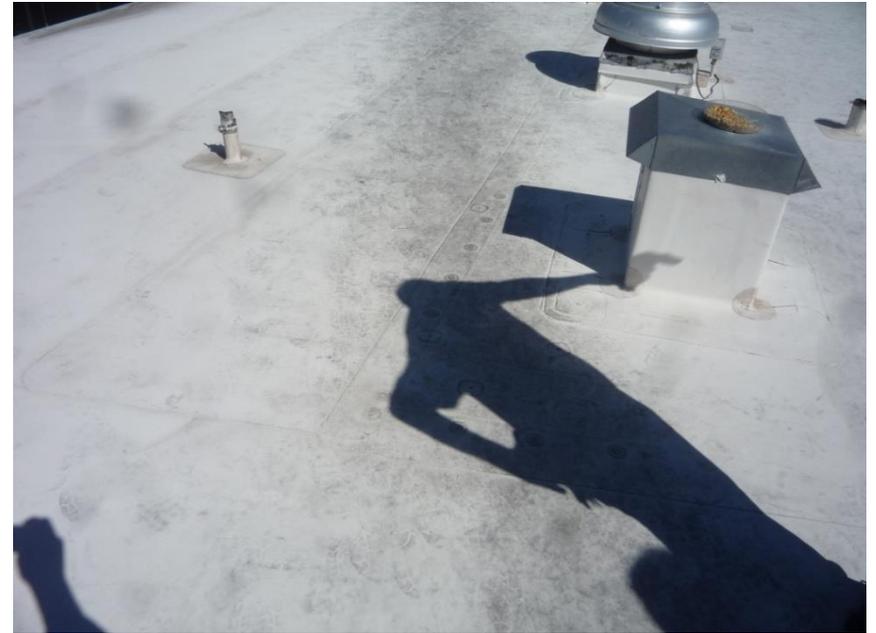
# Heavy foot traffic but no visible damage to the roof

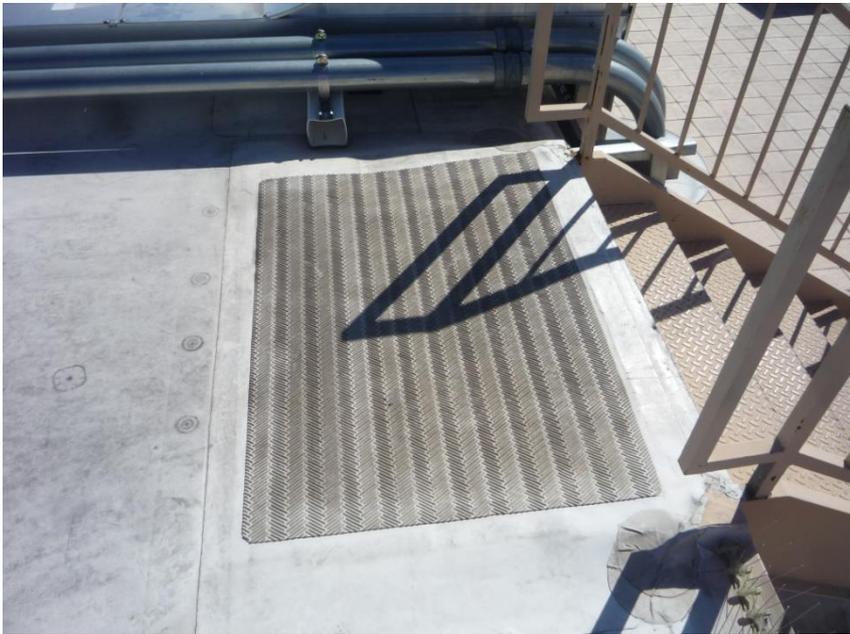
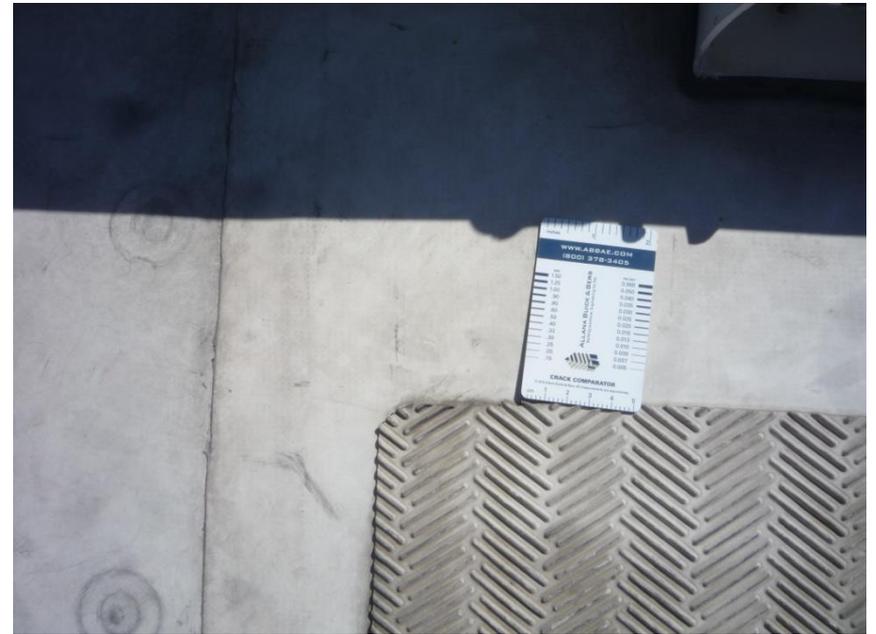
White walk pad had been installed at the top of the access stairs, but no visible damage to the roof membrane

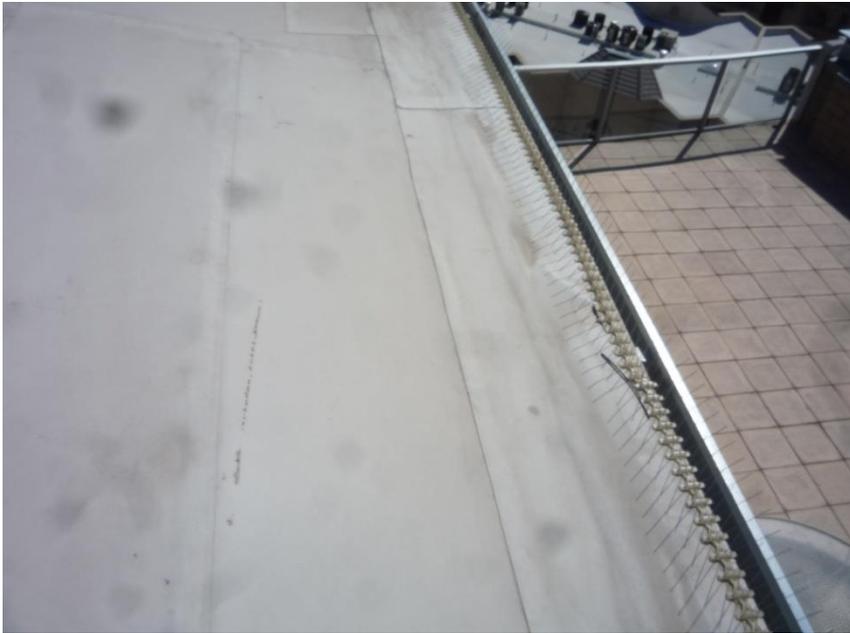
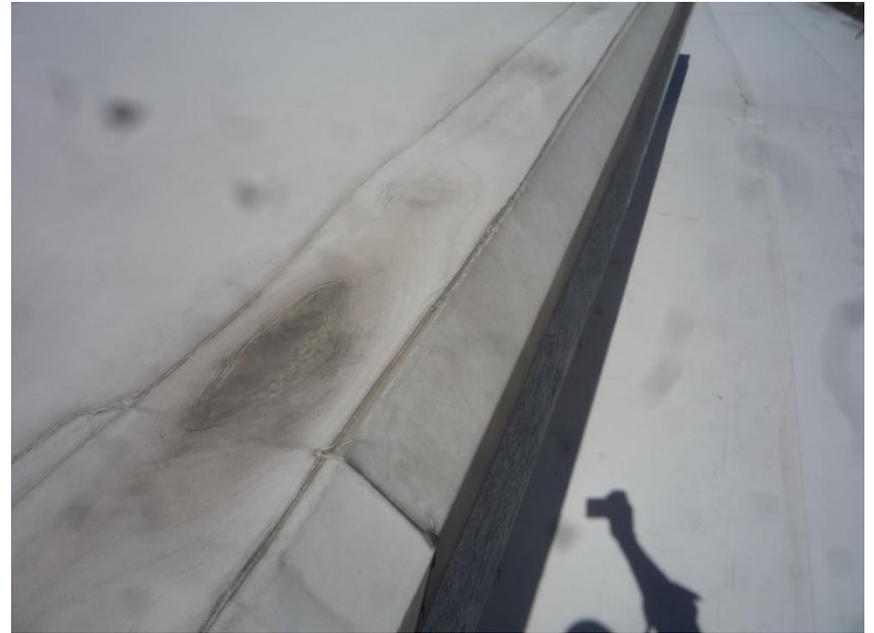
# No parapet for reflection, and no visible roof membrane damage

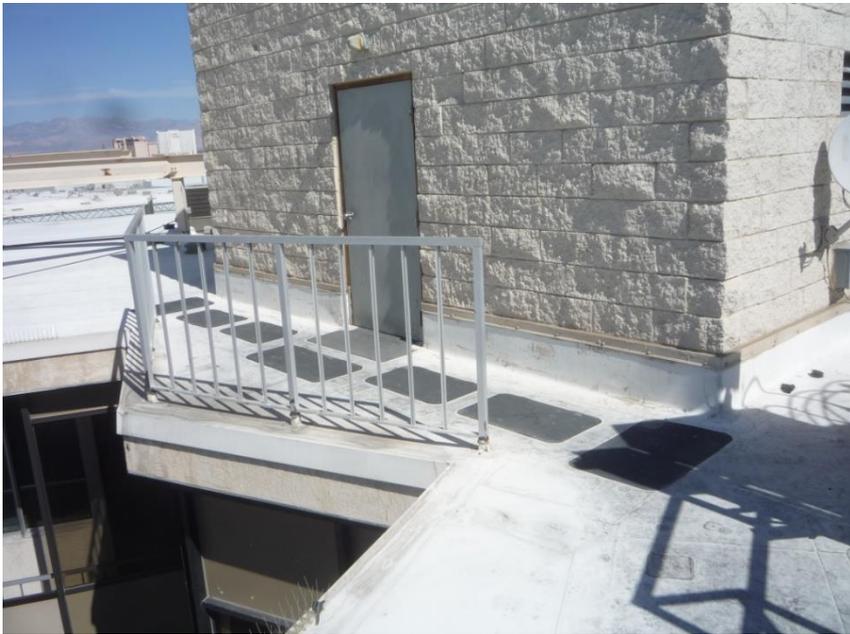
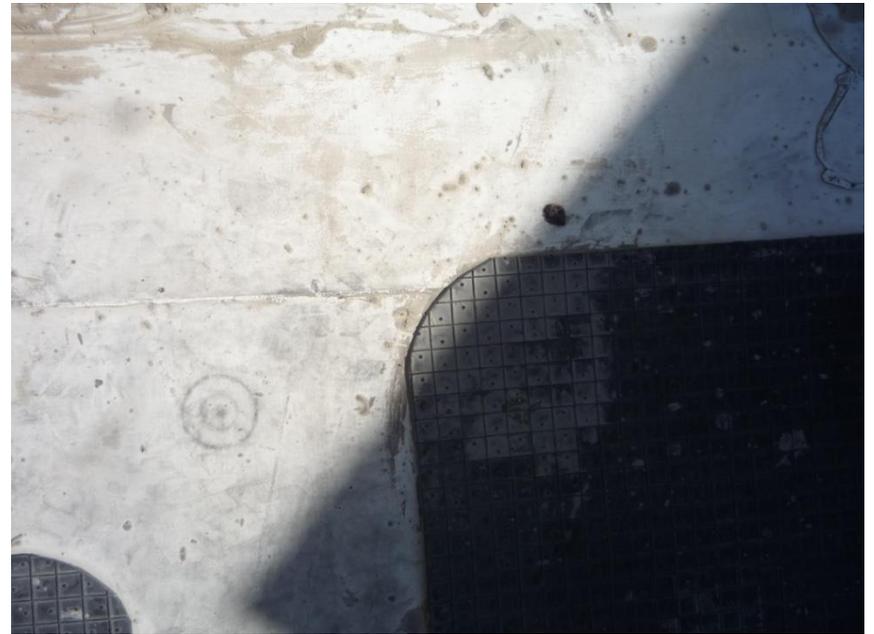
The black roof pads are partially shaded during the day and no roof membrane damage was noted

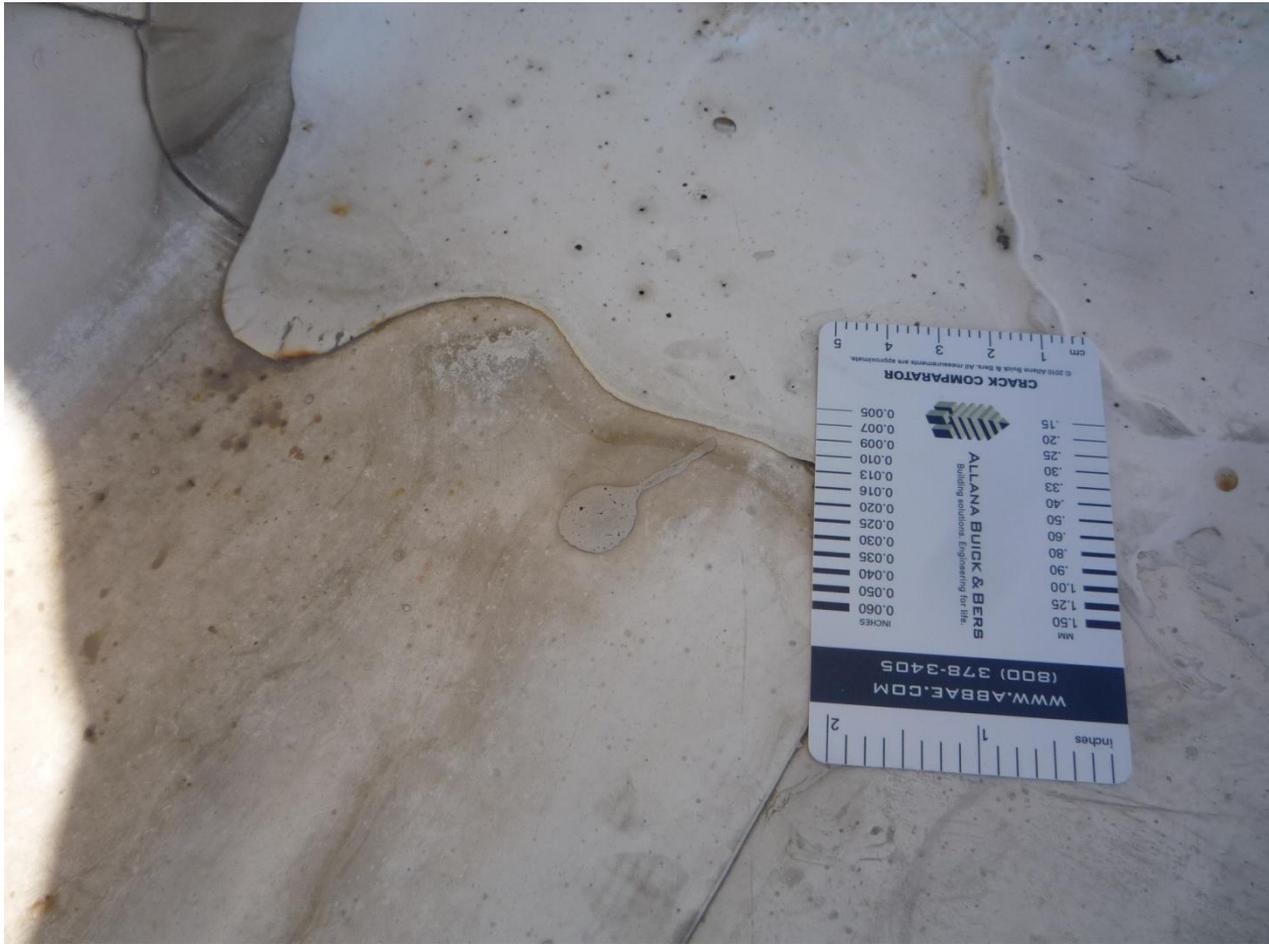
One area had previously been coated by the reason for the coating is unknown

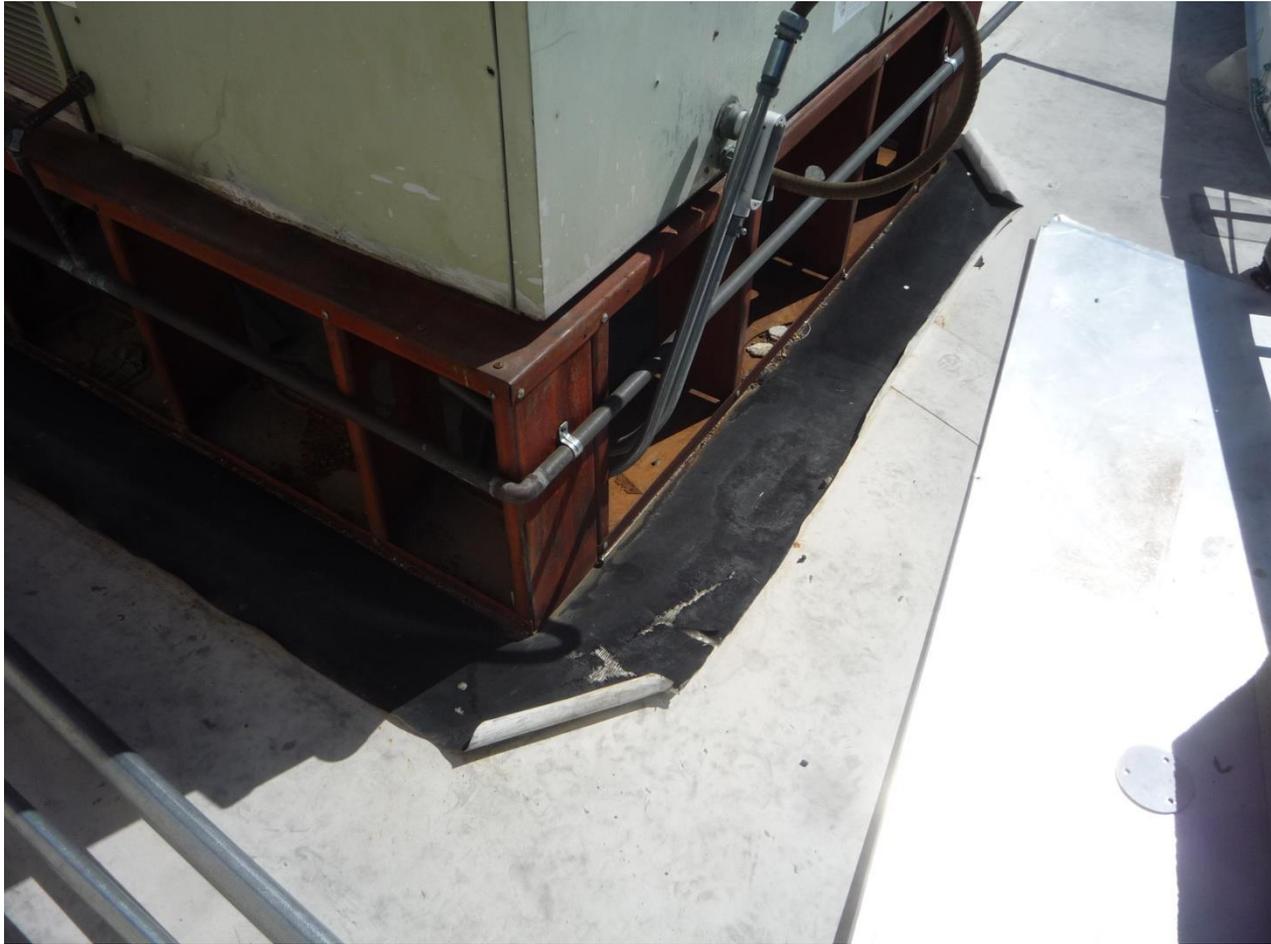
Roofing membrane was inverted and used under the A/C unit for protection

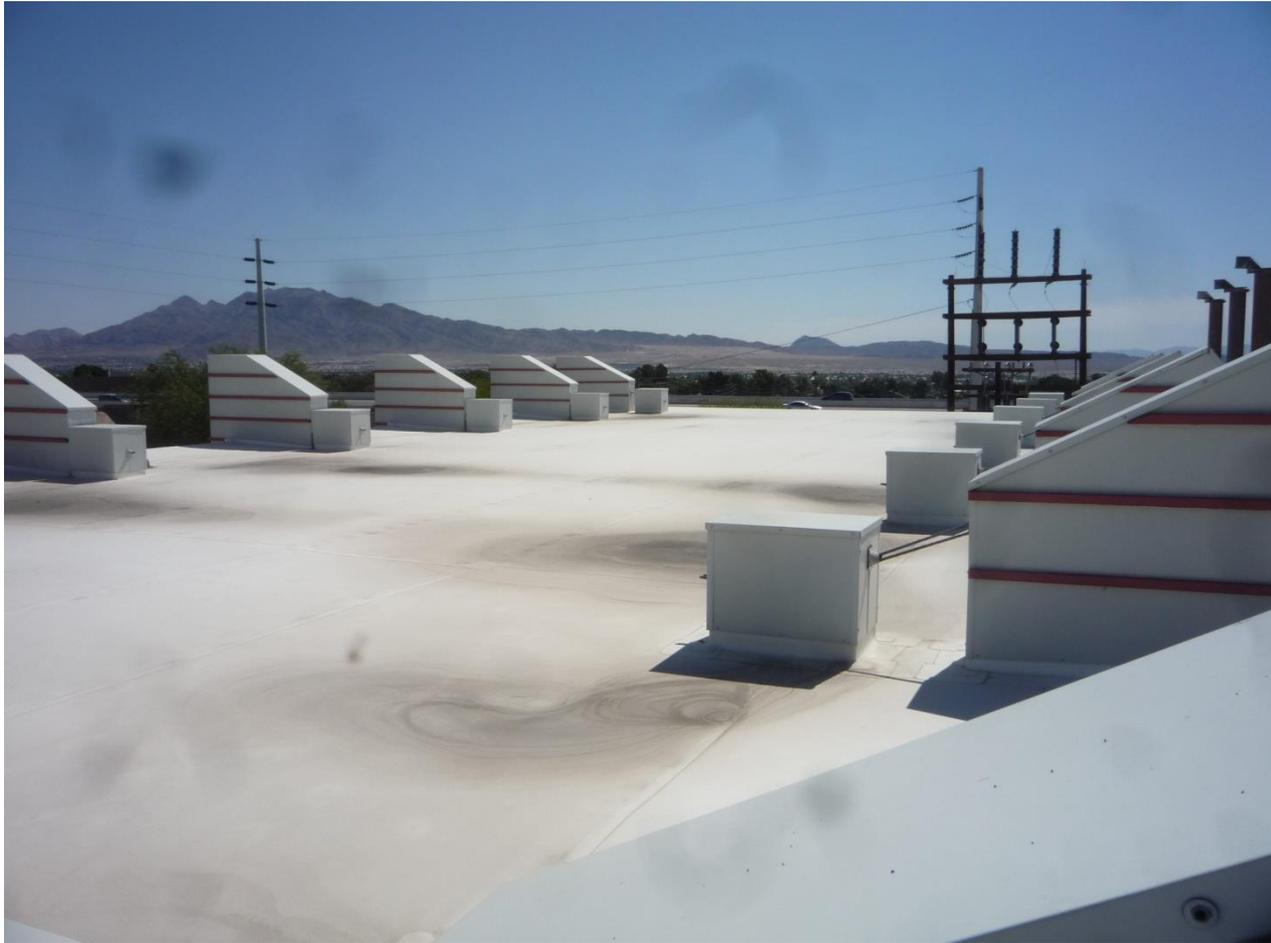
# Decorative wing walls on the roof

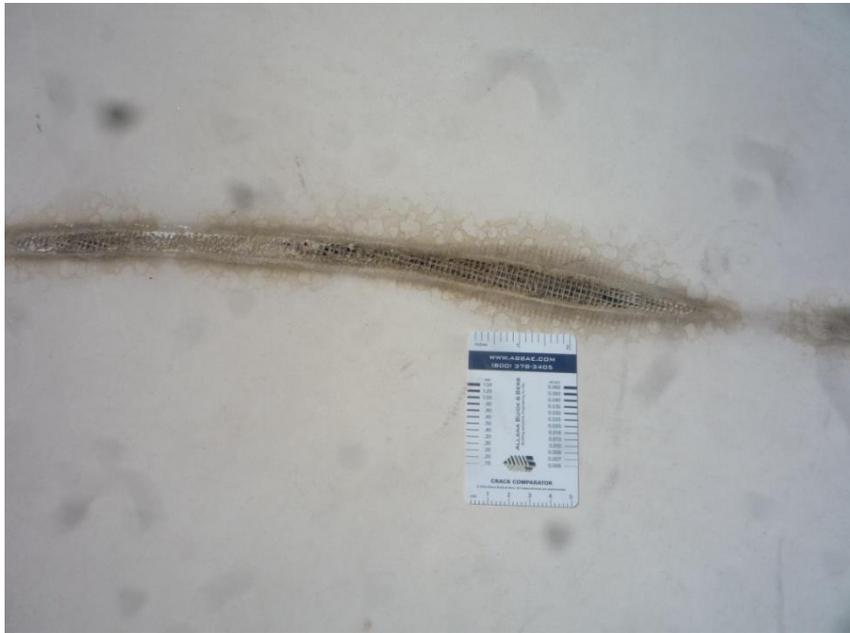
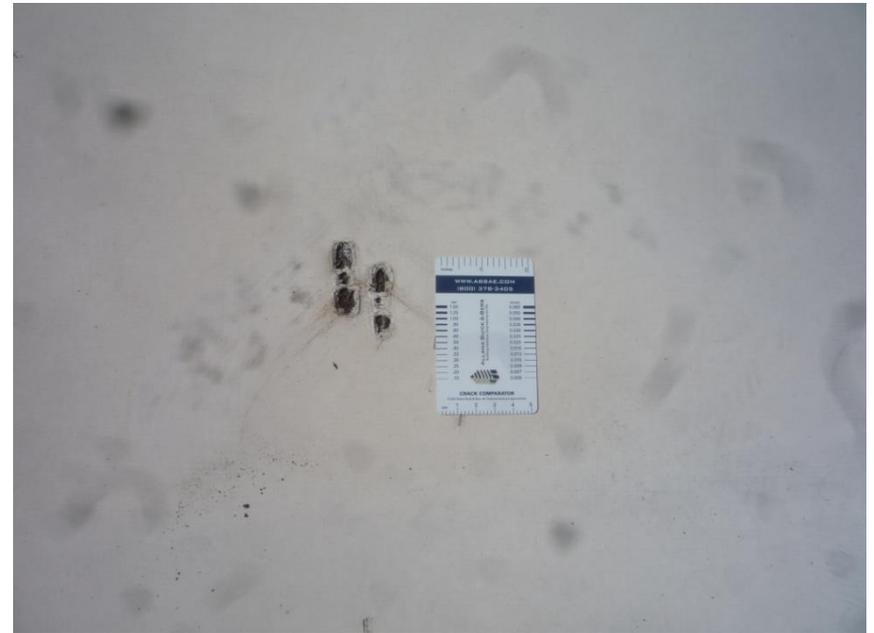
# Damage to the membrane from cable wear and discharge from a generator

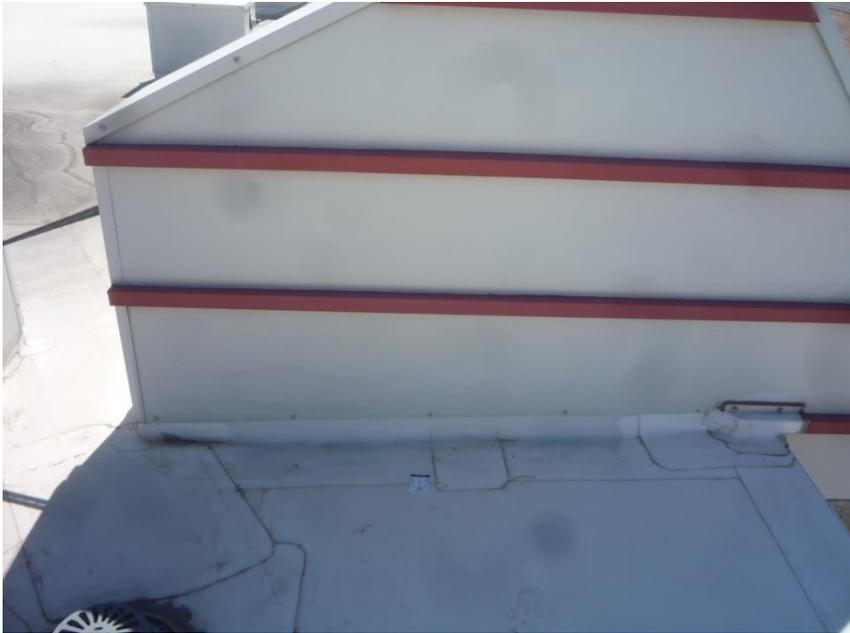
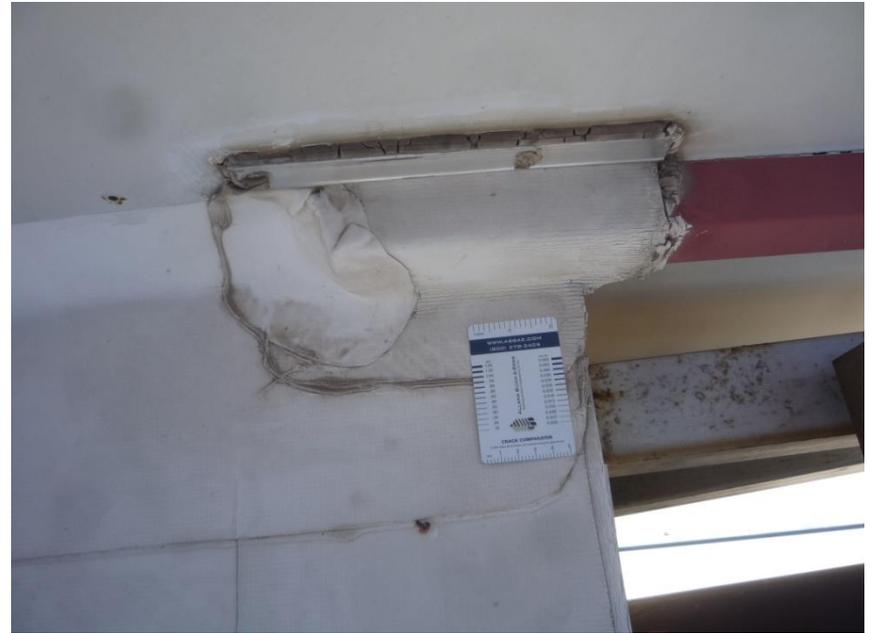
# Wing wall flashing have UV damage throughout the complex

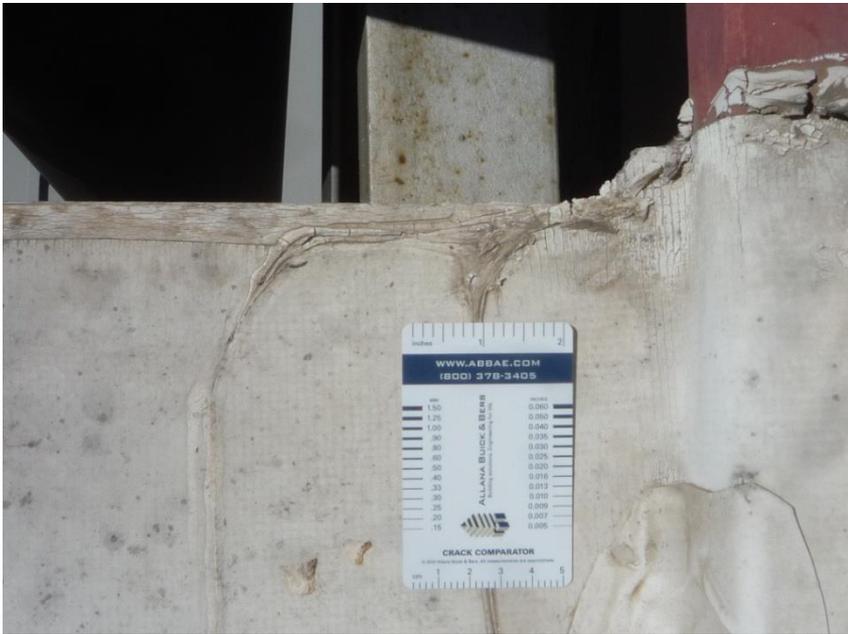
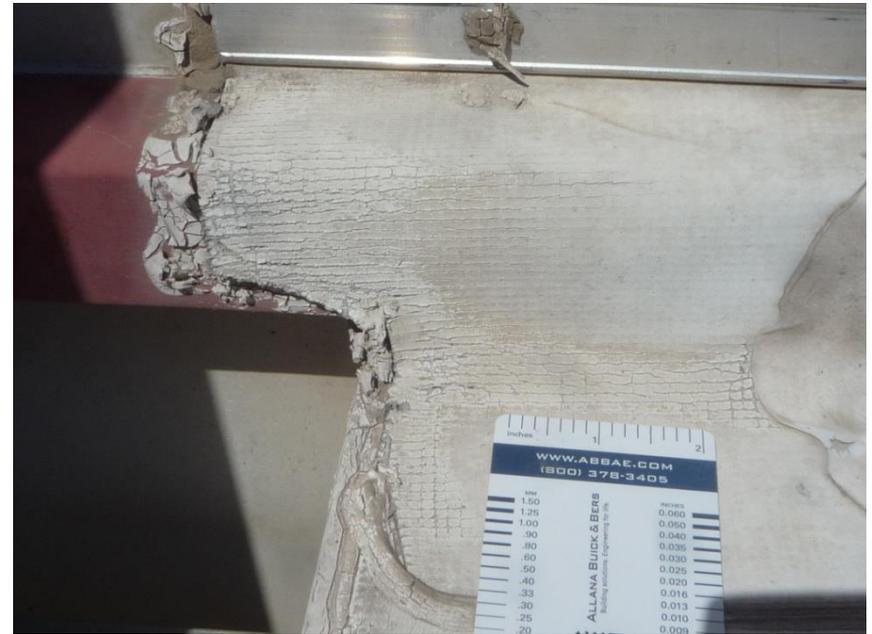
# Typical damage to the flashing at the wing walls

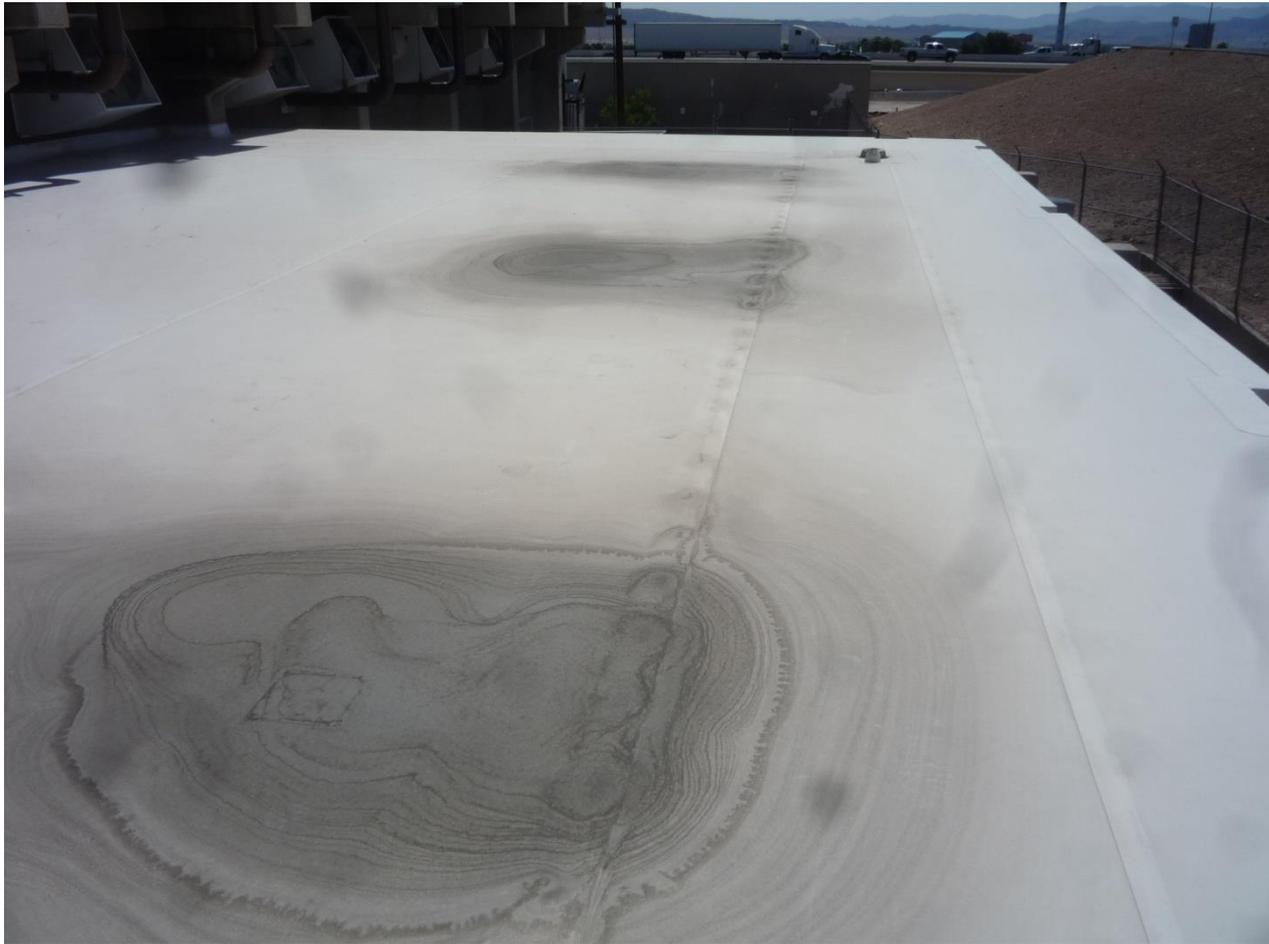
Ponding water areas in the field were checked but no substantial change of the membrane
