**Critical Review of the Life Span of TPO and
PVC**

WSRCA

June 8, 2011

**Karim P. Allana, P.E., RRC, RWC
Allana Buick & Bers, Inc.**

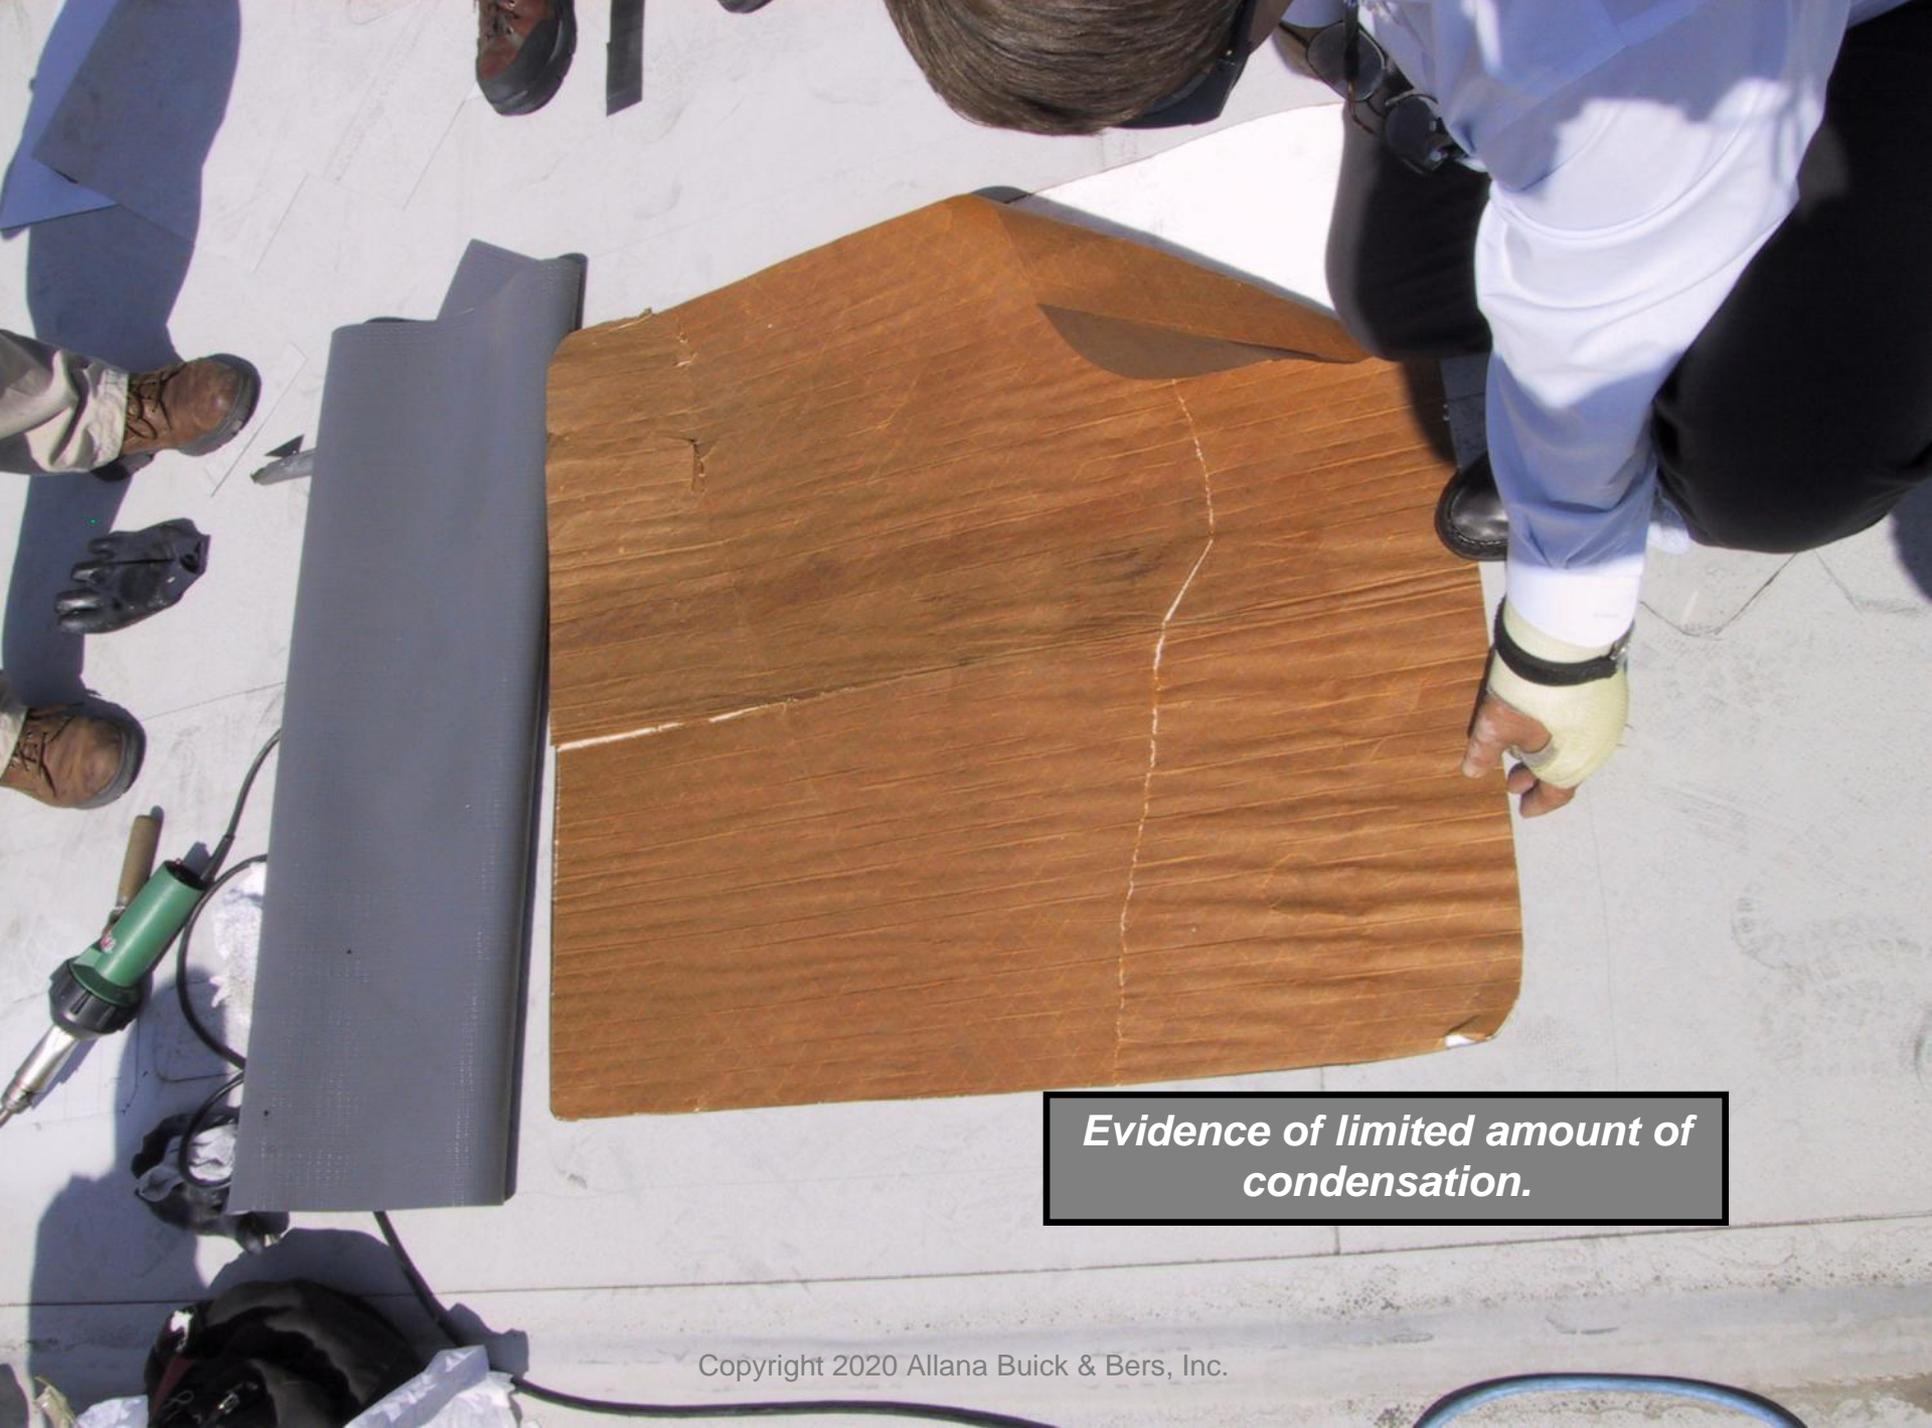
Test cut exposing rosin paper and insulation.

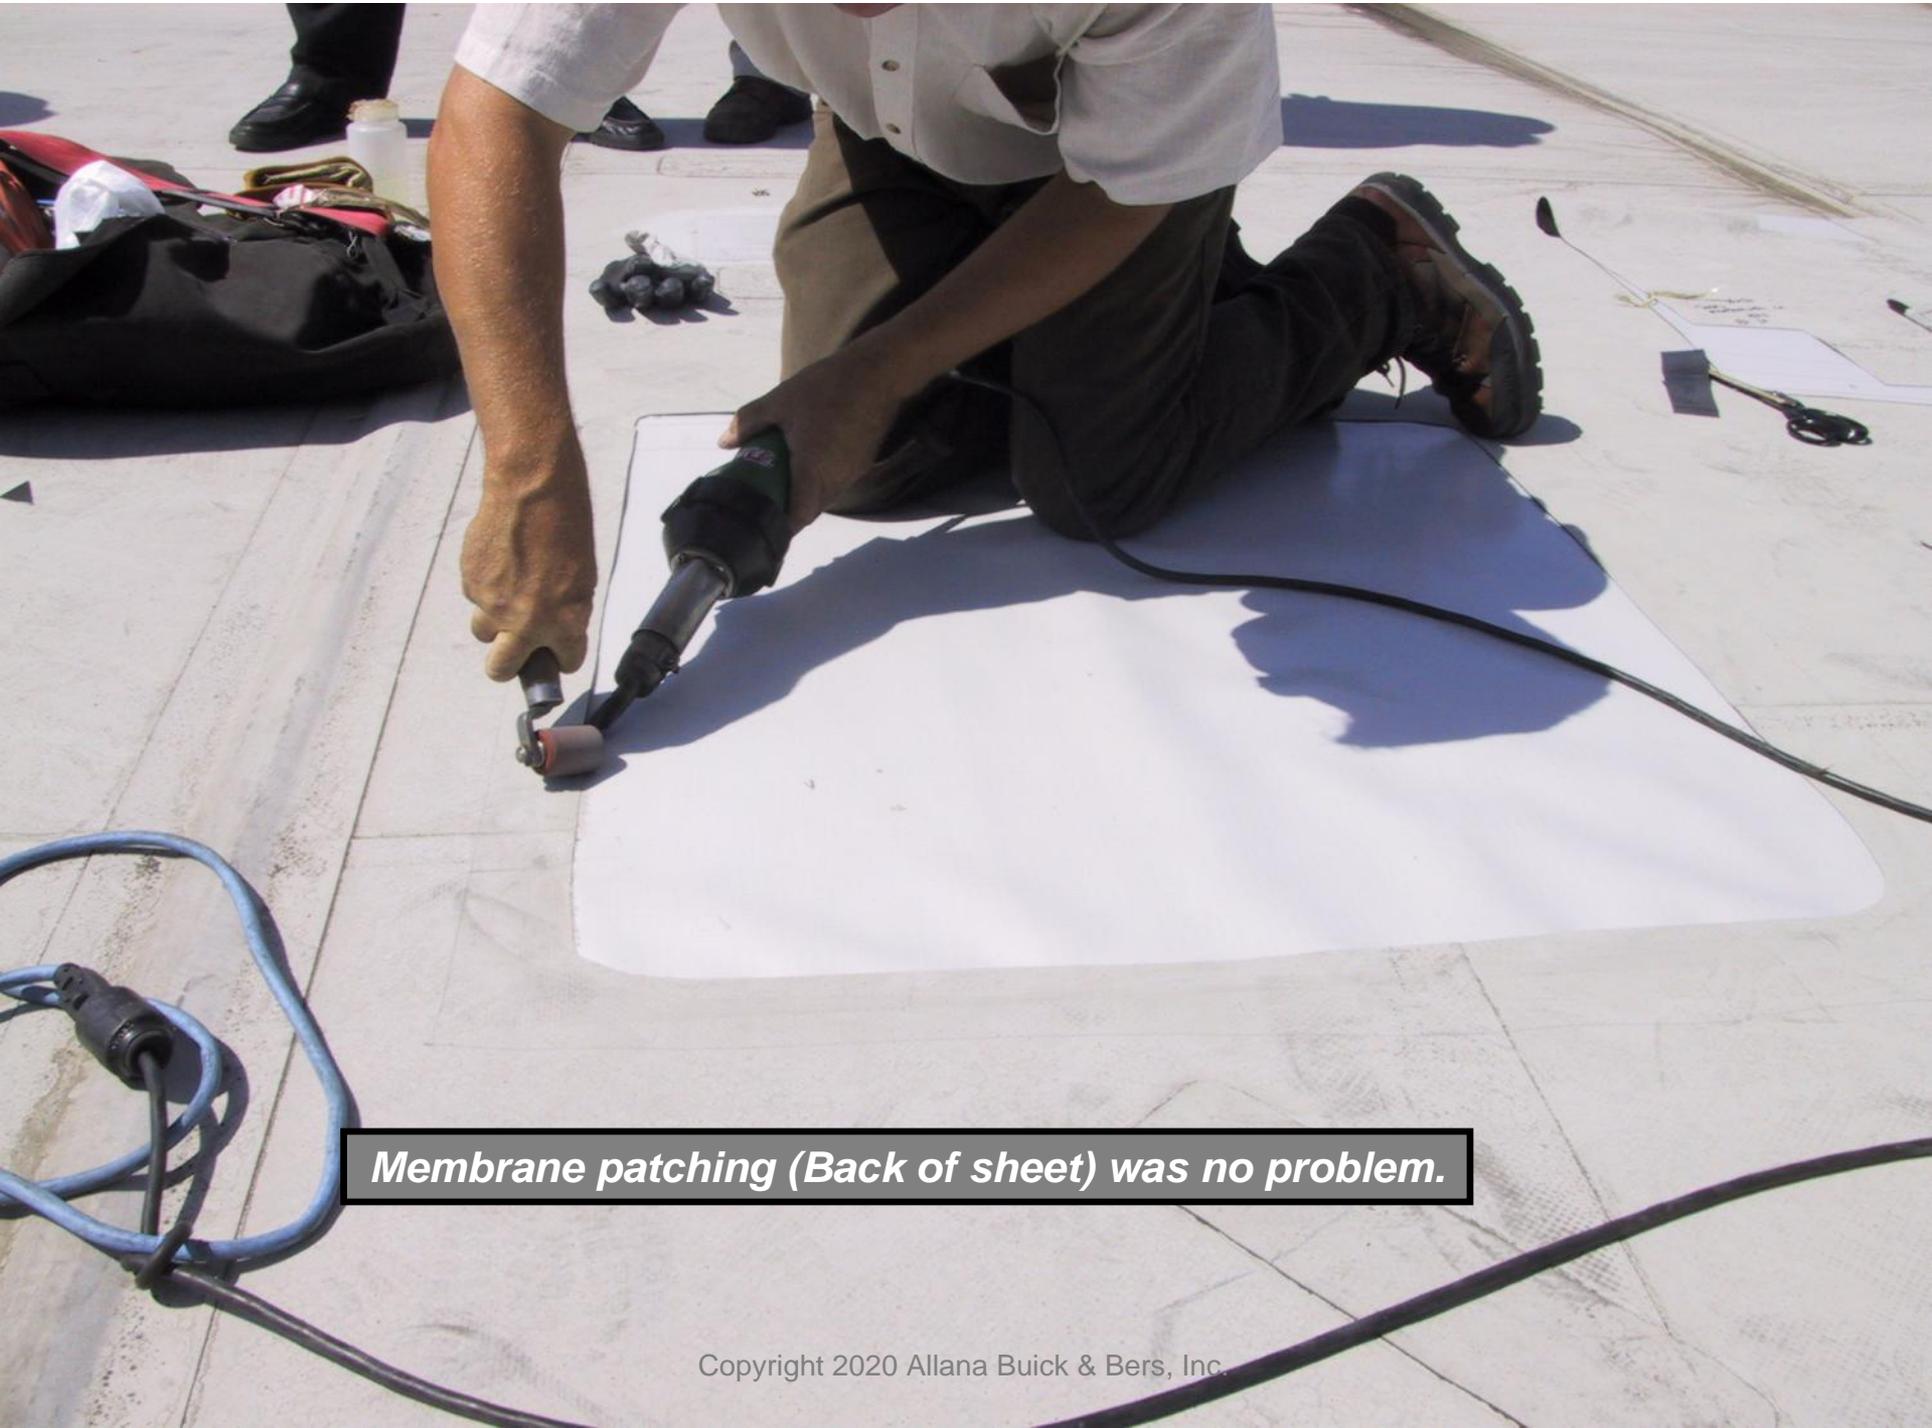
Membrane patching (Back of sheet) was no problem.

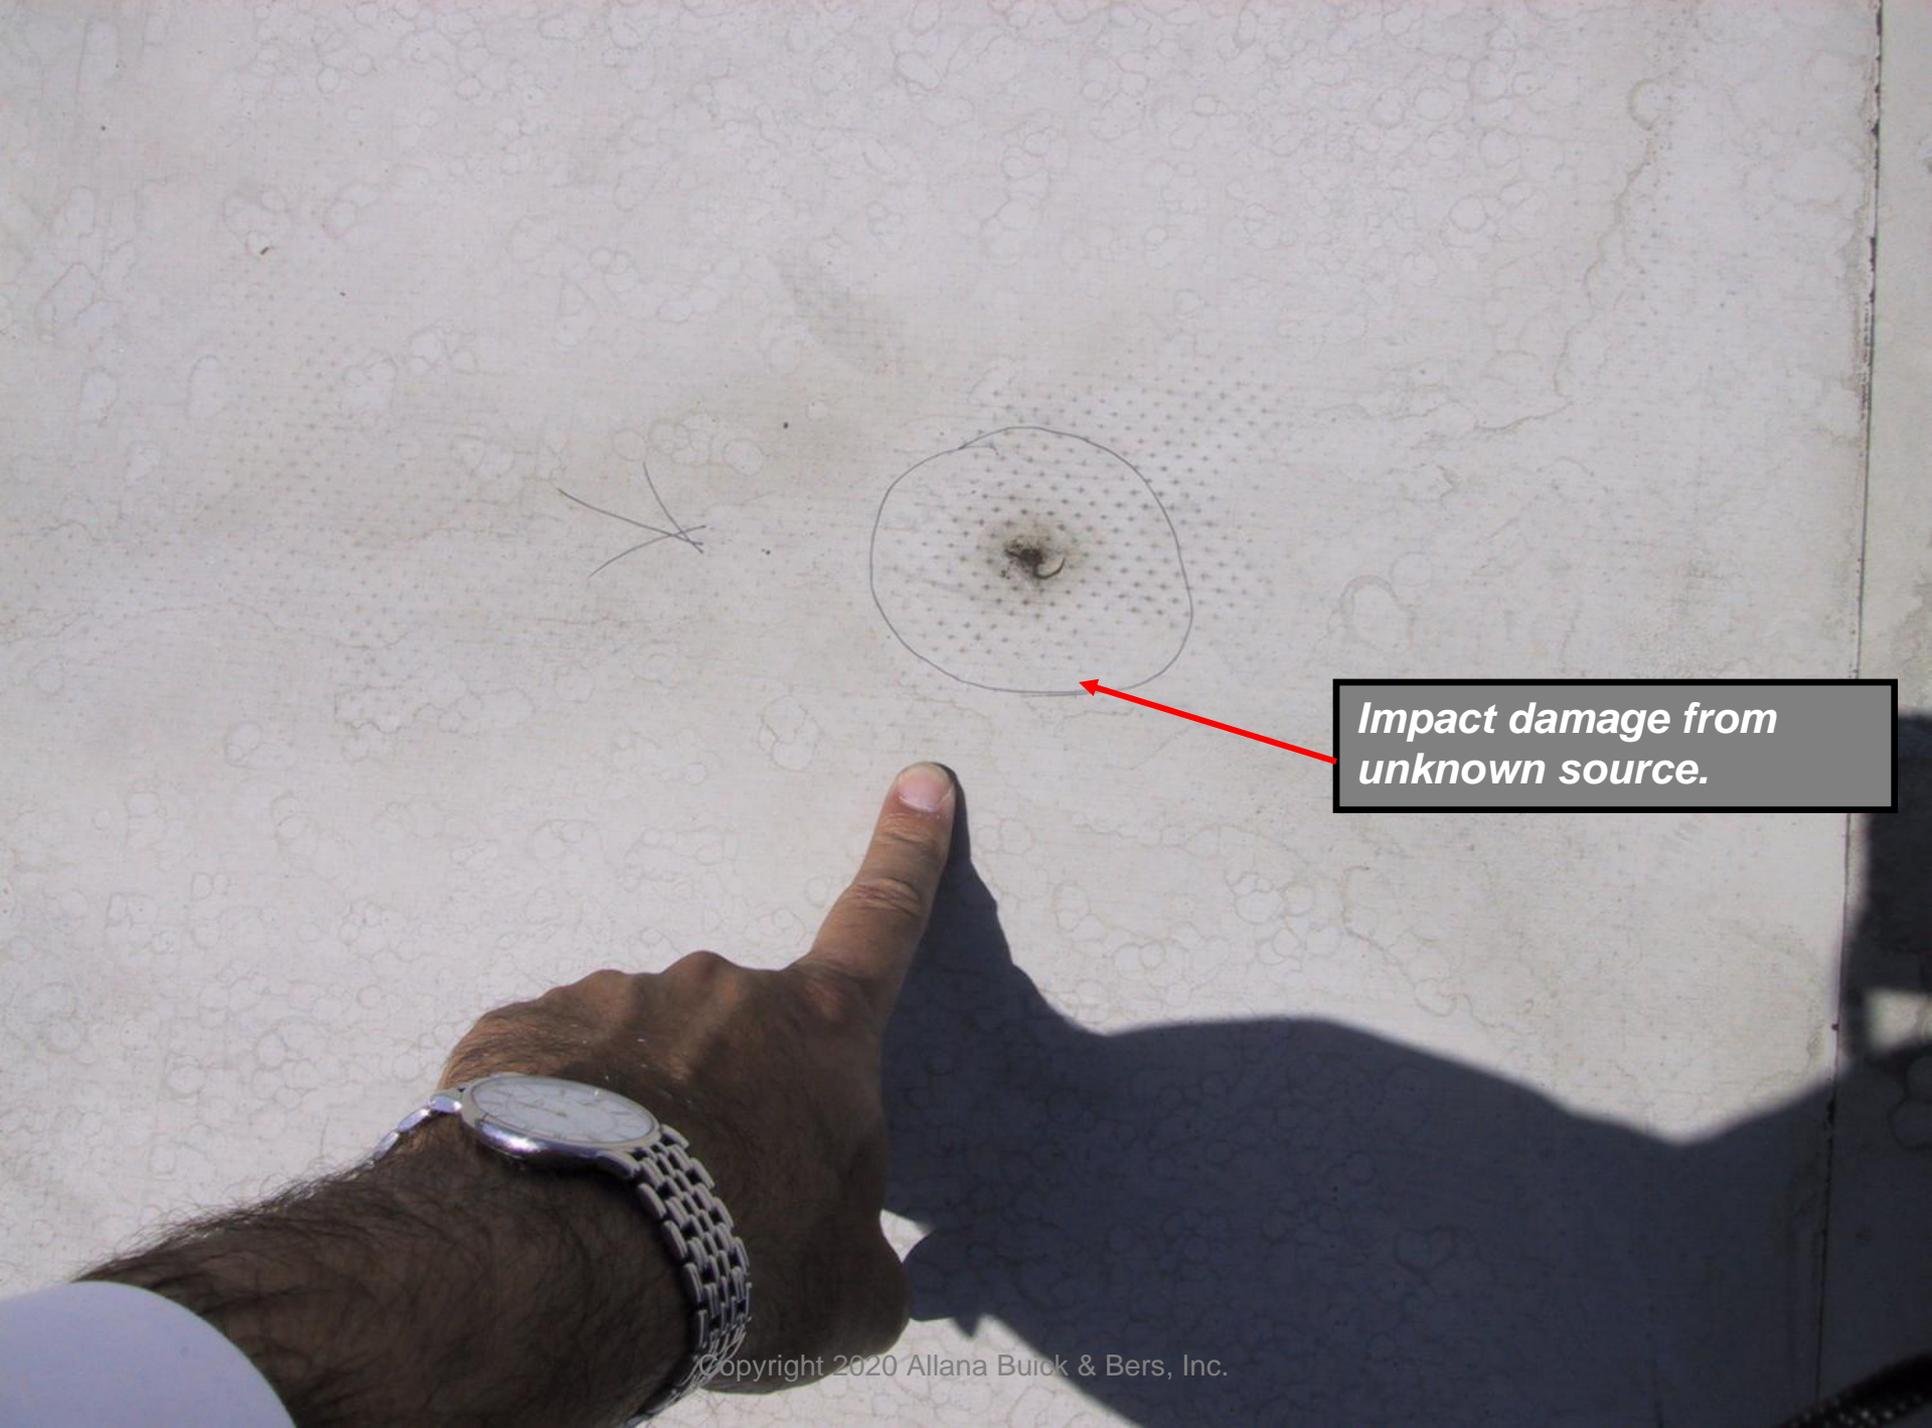
***Impact damage from
unknown source.***

Evidence of nail from
construction debris.

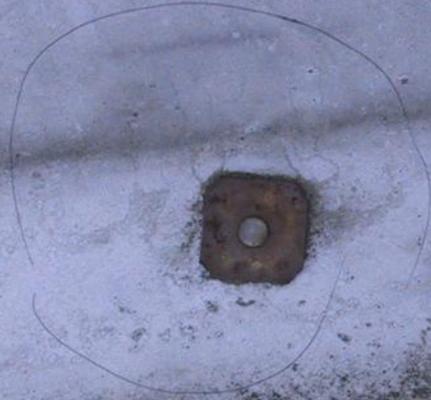
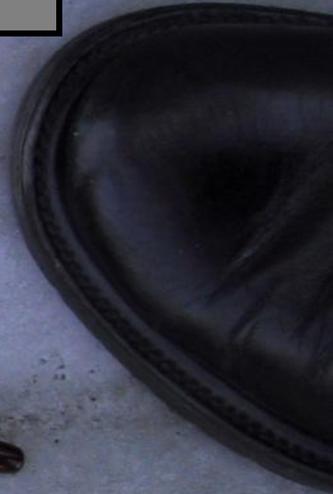
**Sustainability, impact
damage.**

***Membrane damage from
unknown source.***

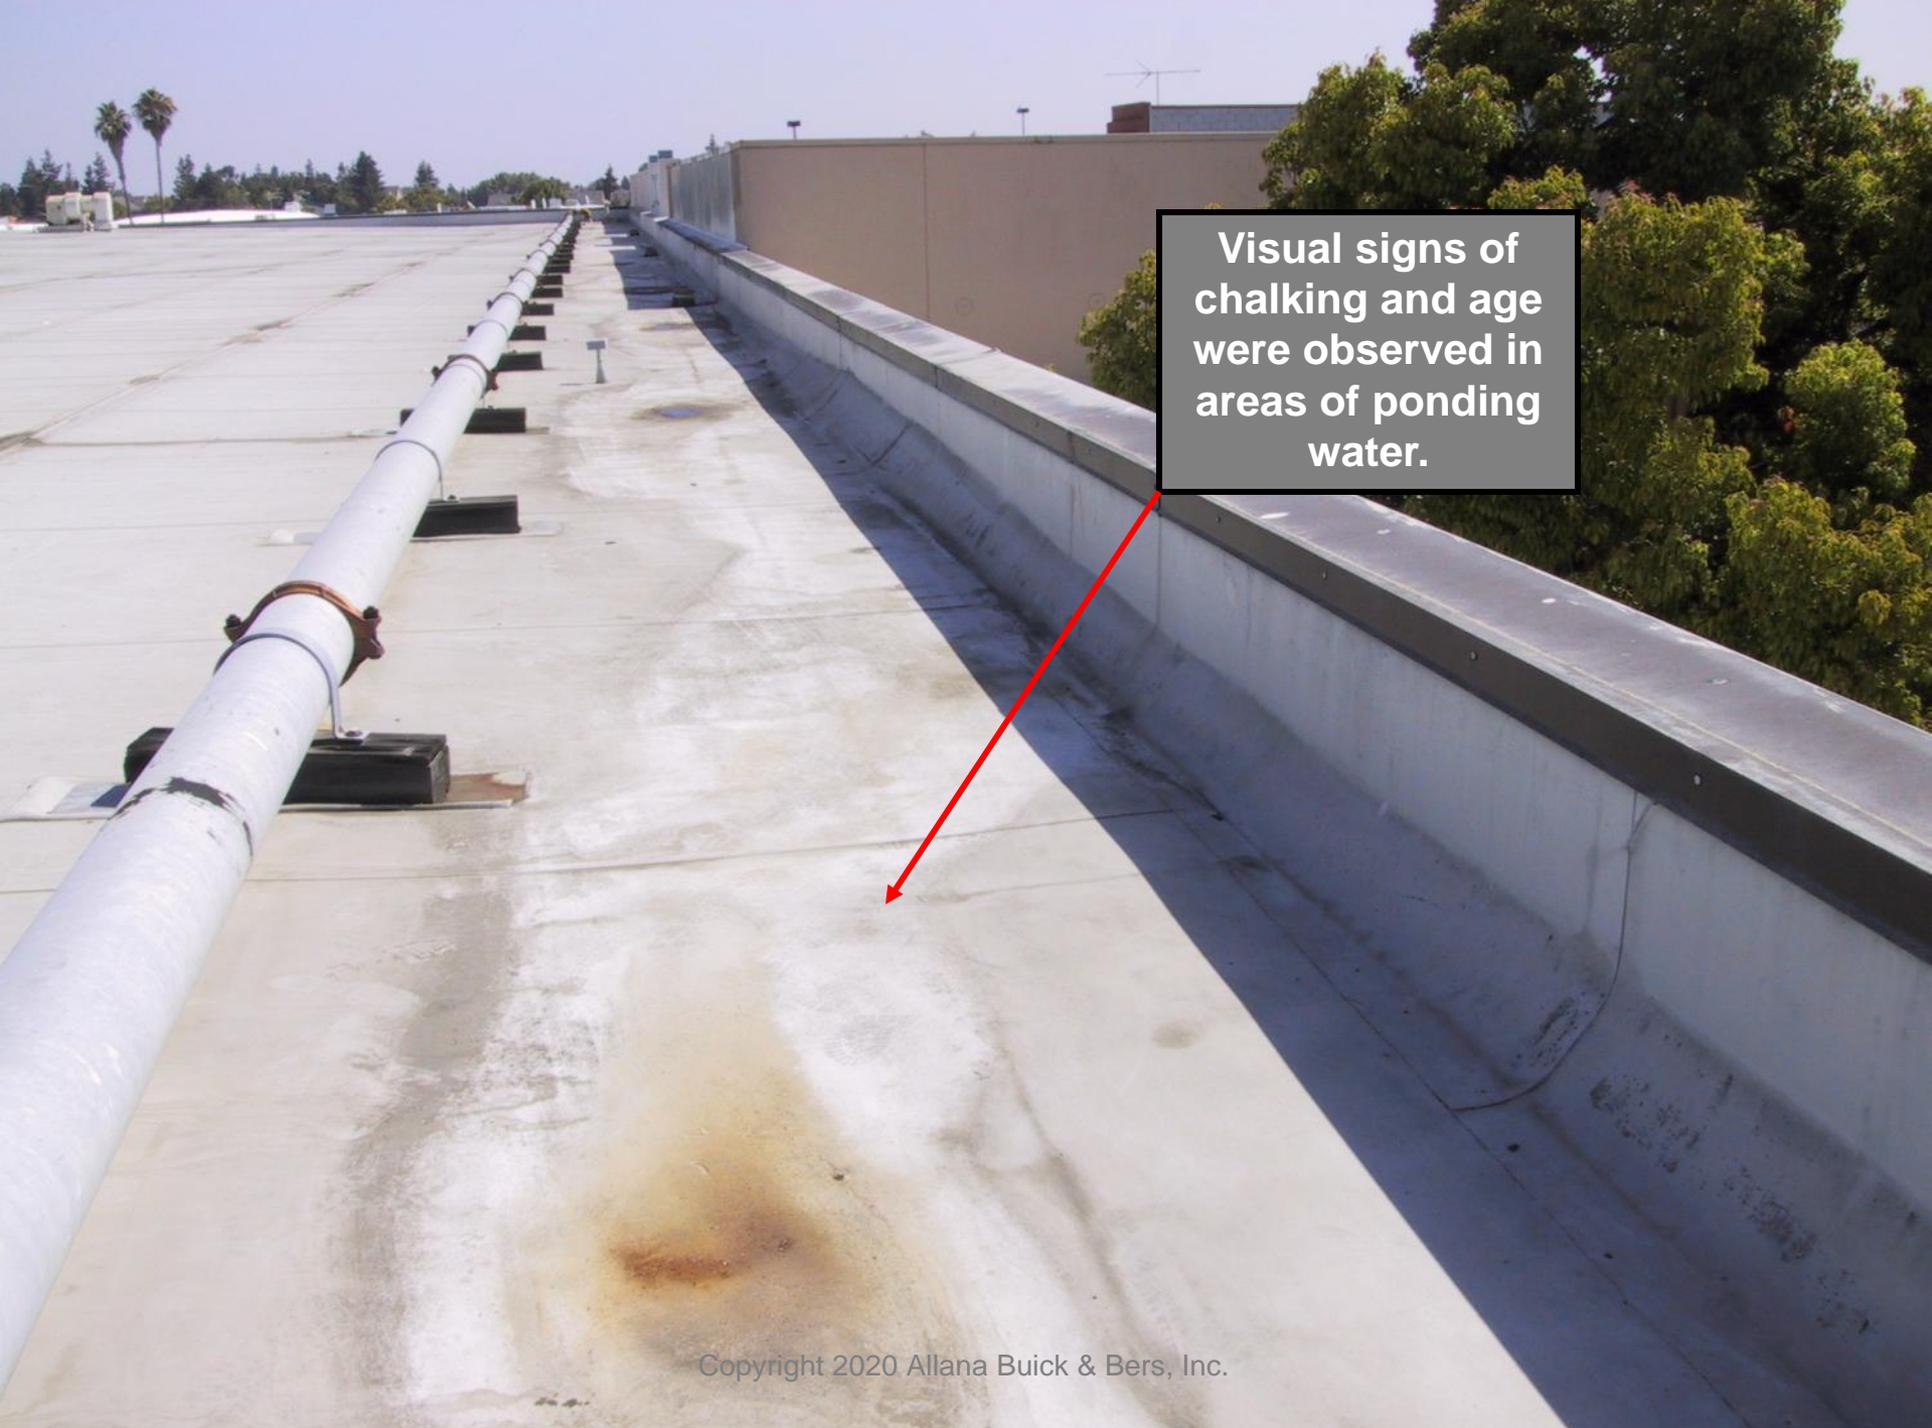
Visual signs of chalking and age were observed in areas of ponding water.

**Cooling tower and
condensate water leaking
over roof.**

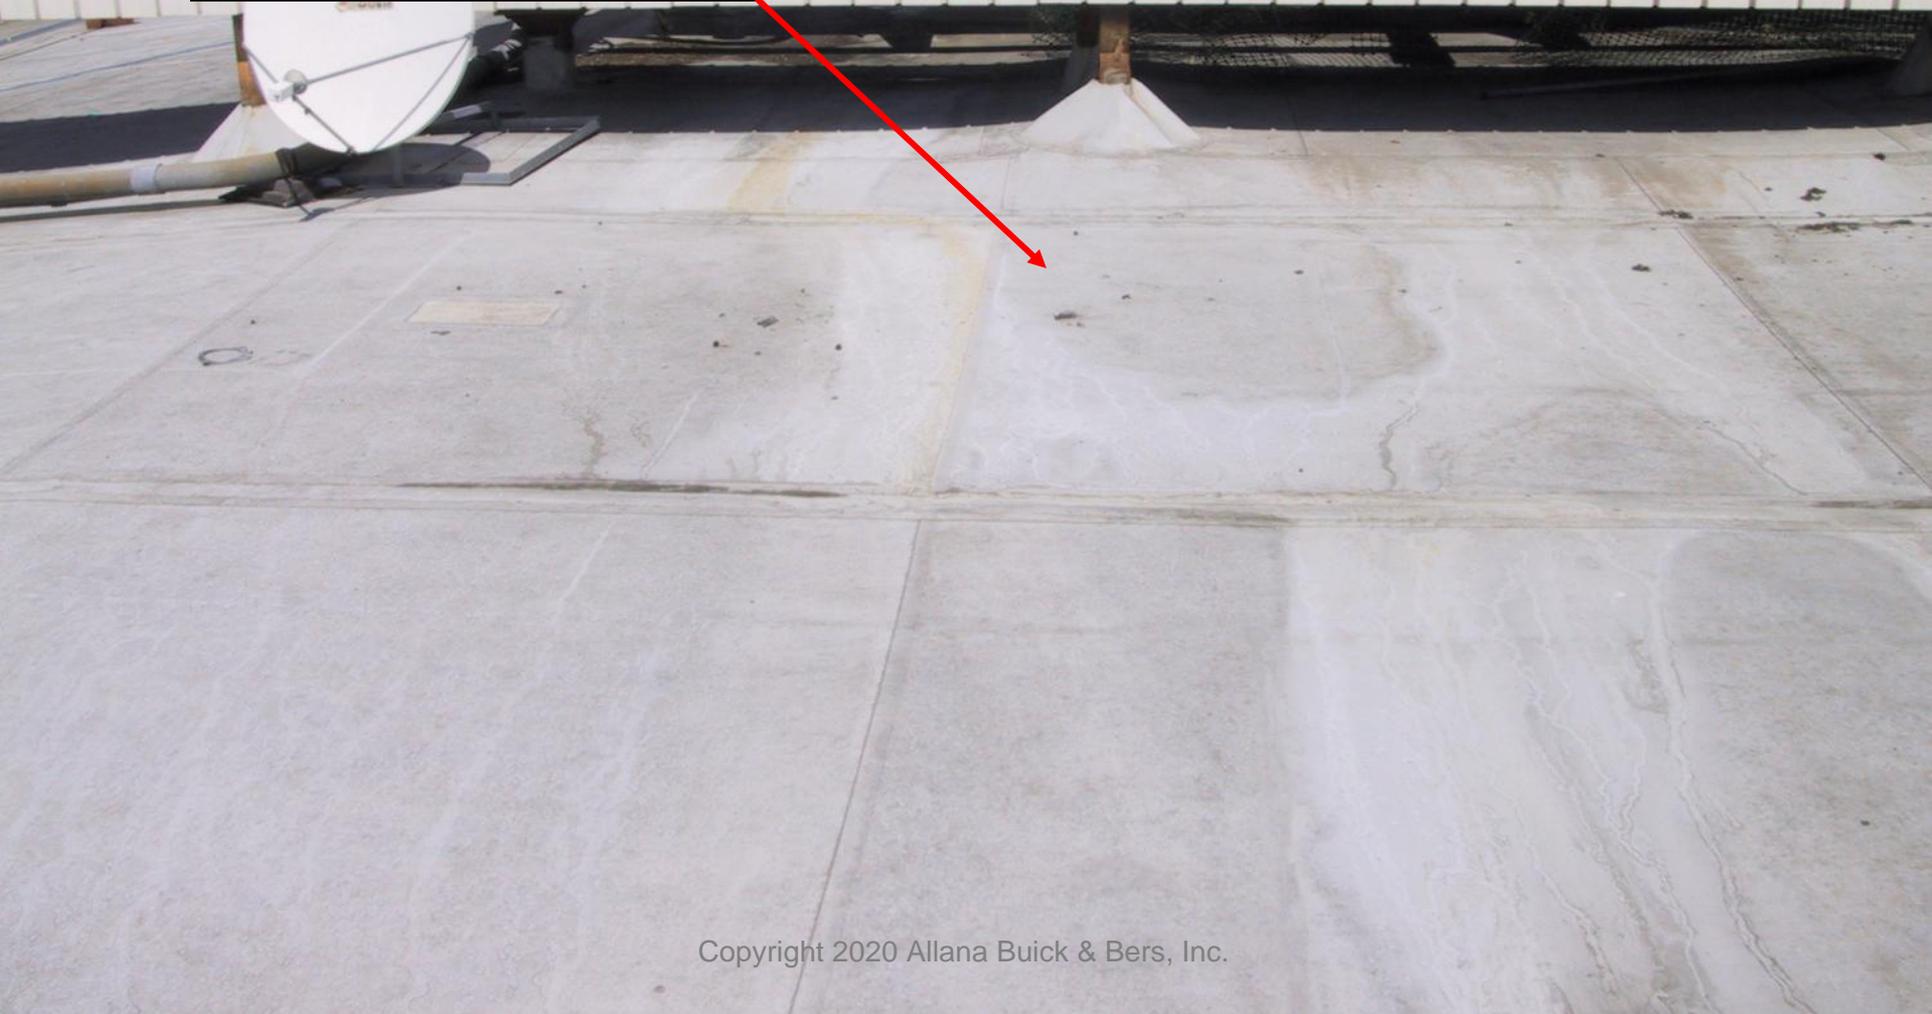
**Sustainability, ponding
water and chemicals.**

**Erosion of membrane due
to water had deteriorated
membrane, scrim is
visible.**

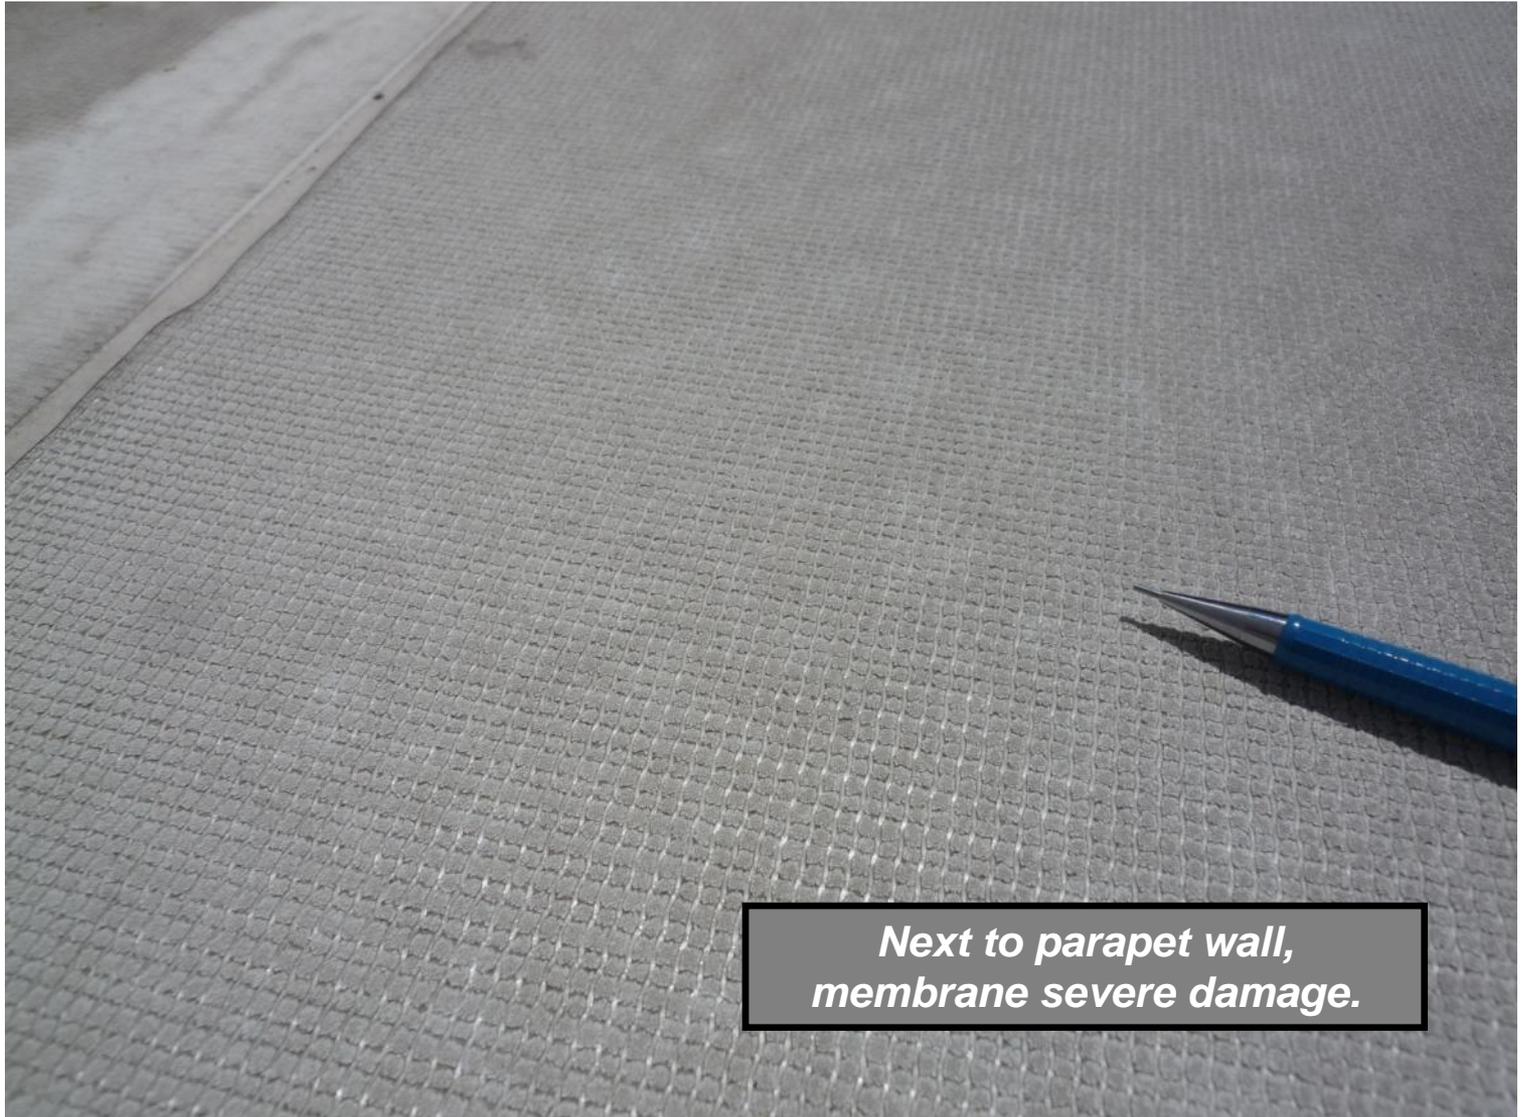
5 Years Old Carlisle, Hospital Building, Vegas

*Next to parapet wall,
membrane severe damage.*

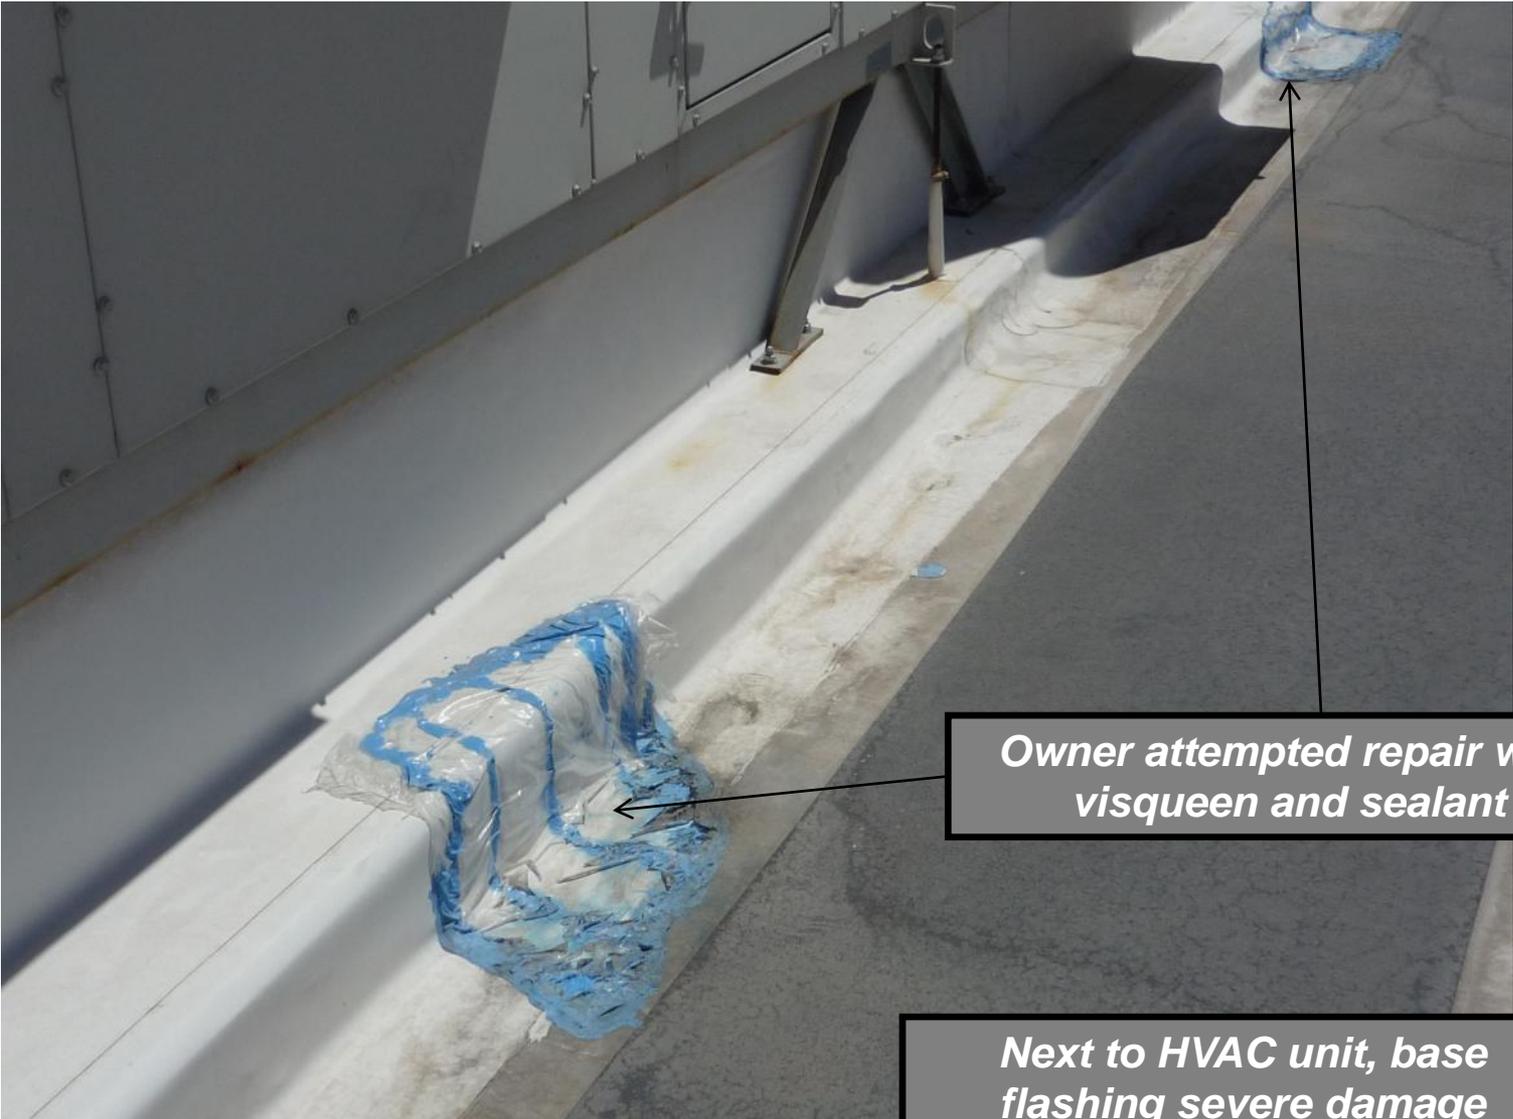
5 Years Old Carlisle, Hospital Building, Vegas

Owner attempted repair with visqueen and sealant

Next to HVAC unit, base flashing severe damage

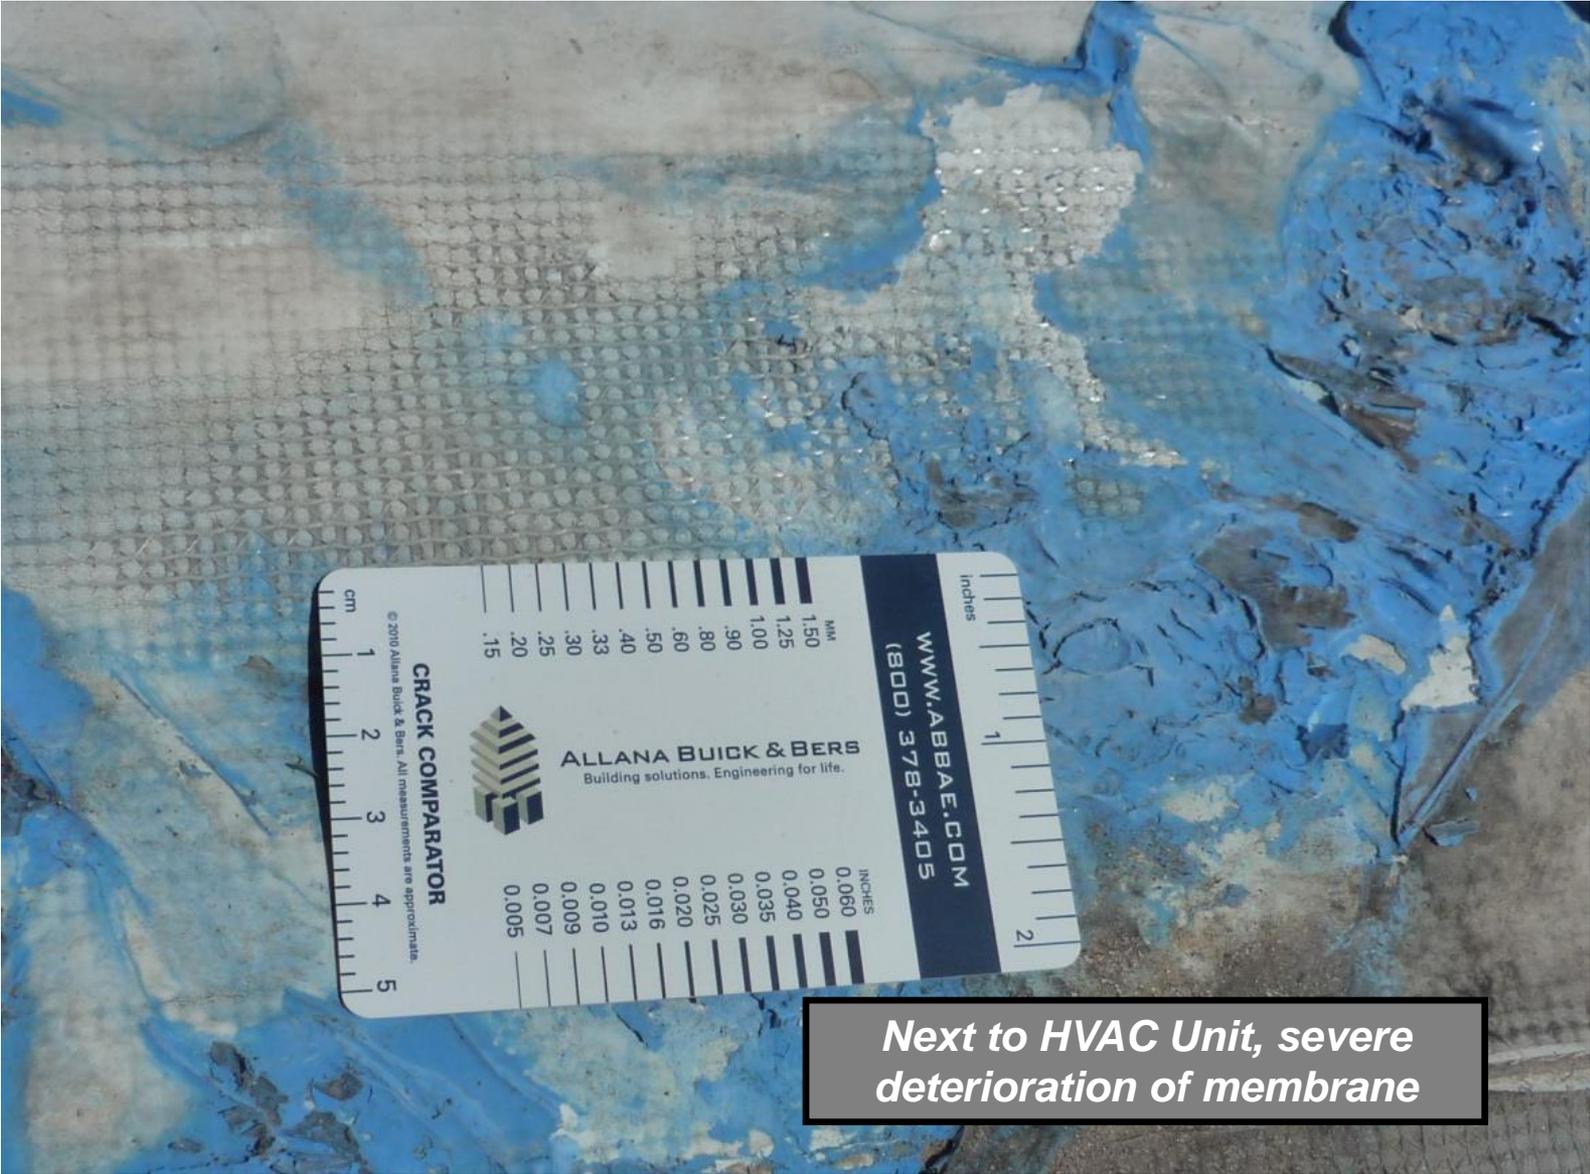
5 Years Old Carlisle, Hospital Building, Vegas

Next to HVAC Unit, severe deterioration of membrane

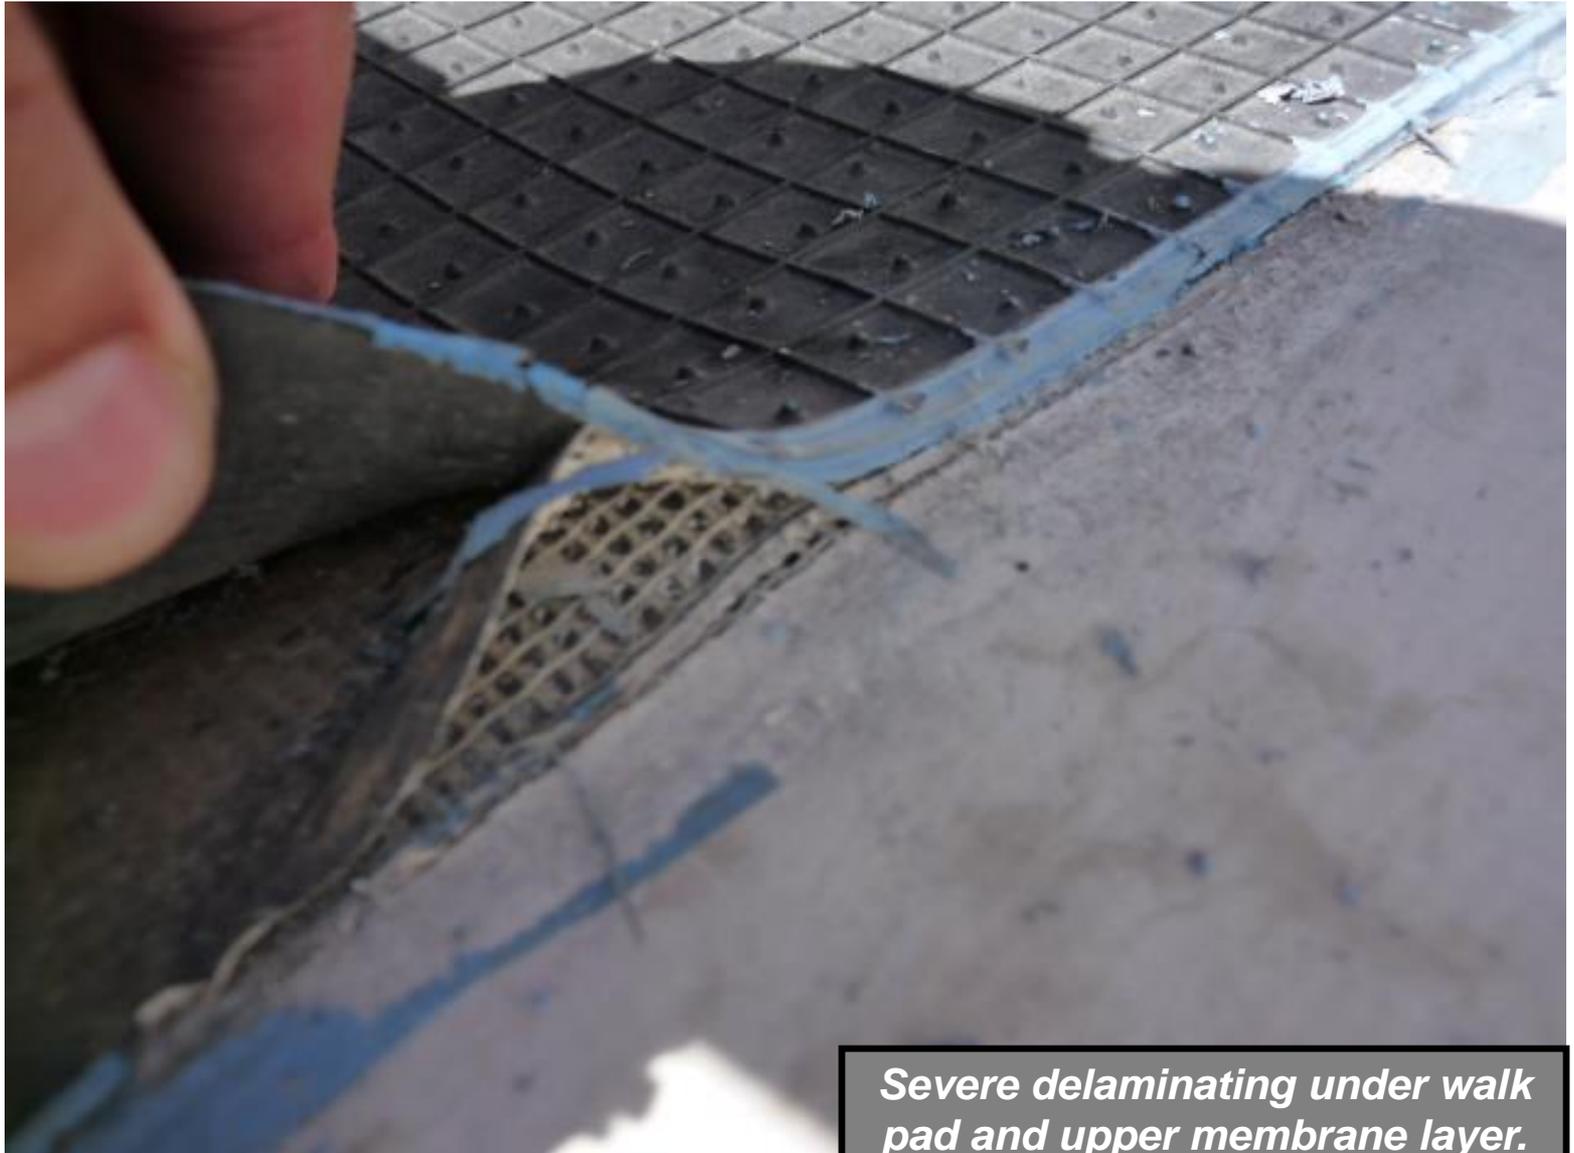
7 Years Old Carlisle, Hospital Building, Vegas

Severe delaminating under walk pad and upper membrane layer.

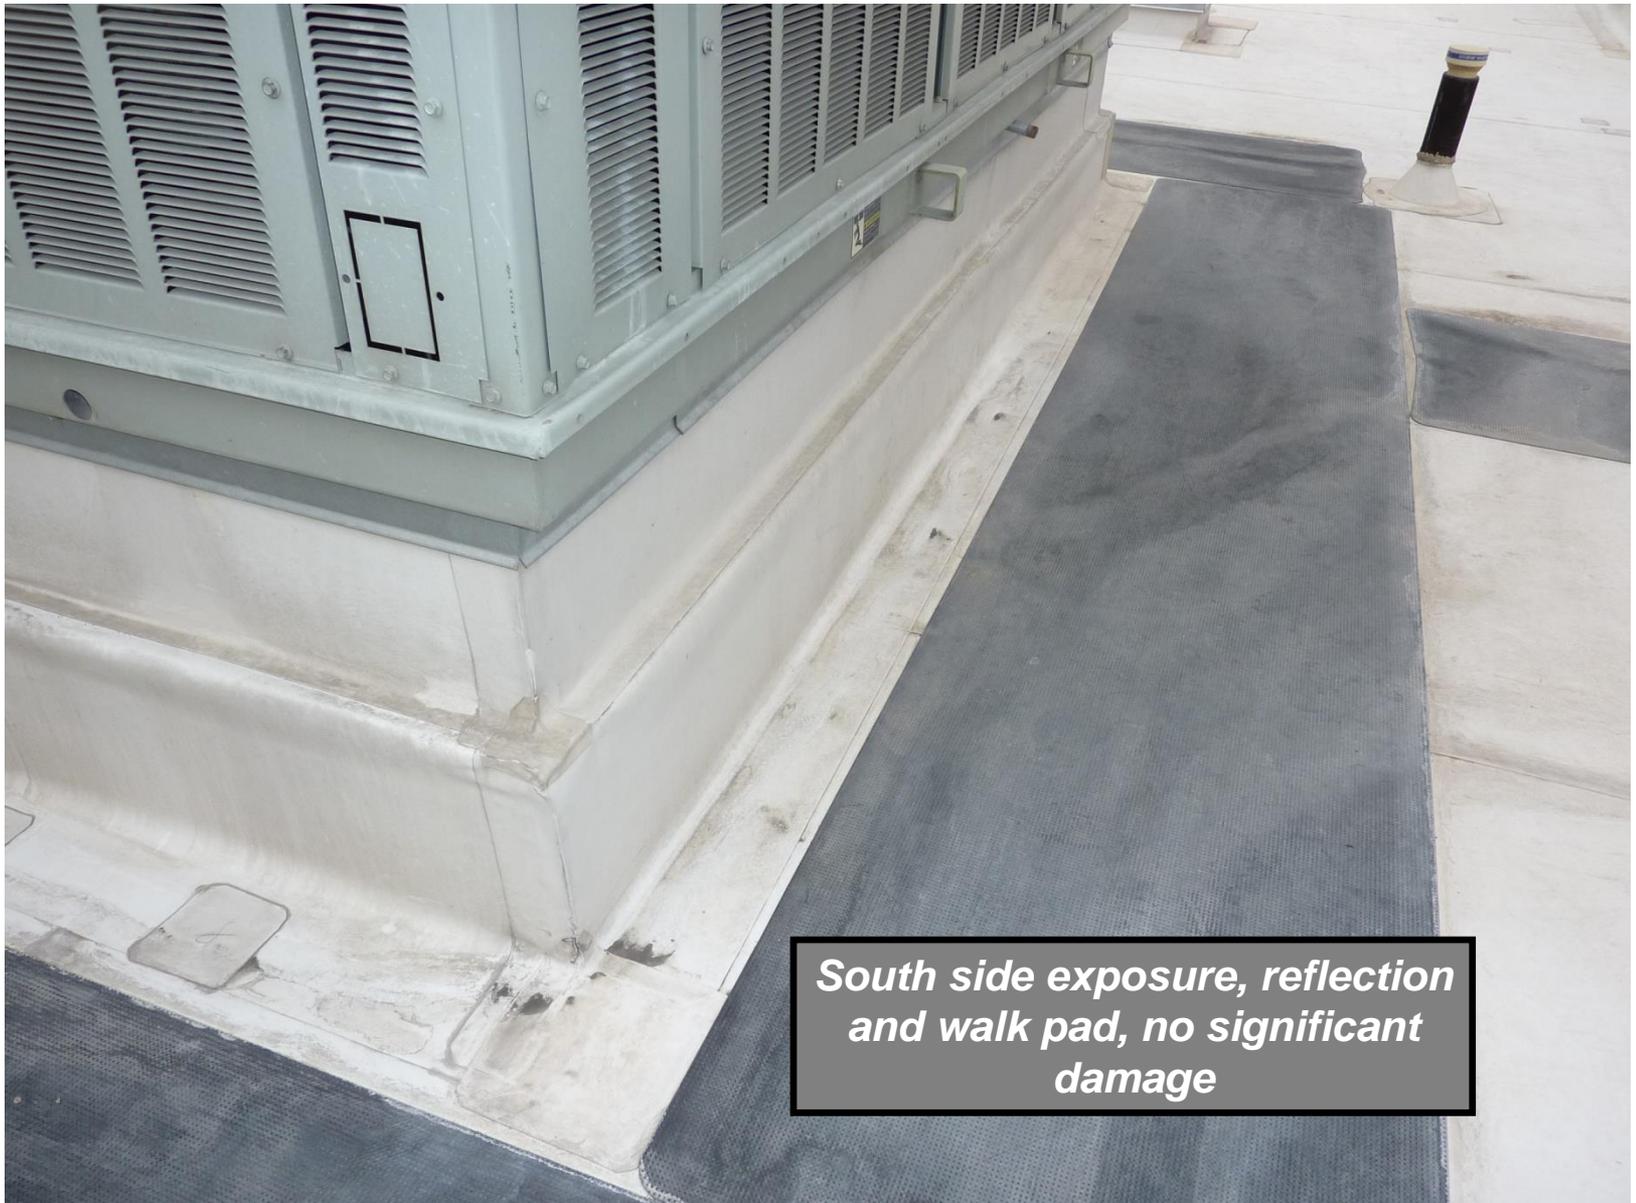
5 Years Old, Firestone 40 Mil, Molasky Bldg.

South side exposure, reflection and walk pad, no significant damage
