**Critical Review of the Life Span of TPO and
PVC**

WSRCA

June 8, 2011

**Karim P. Allana, P.E., RRC, RWC
Allana Buick & Bers, Inc.**

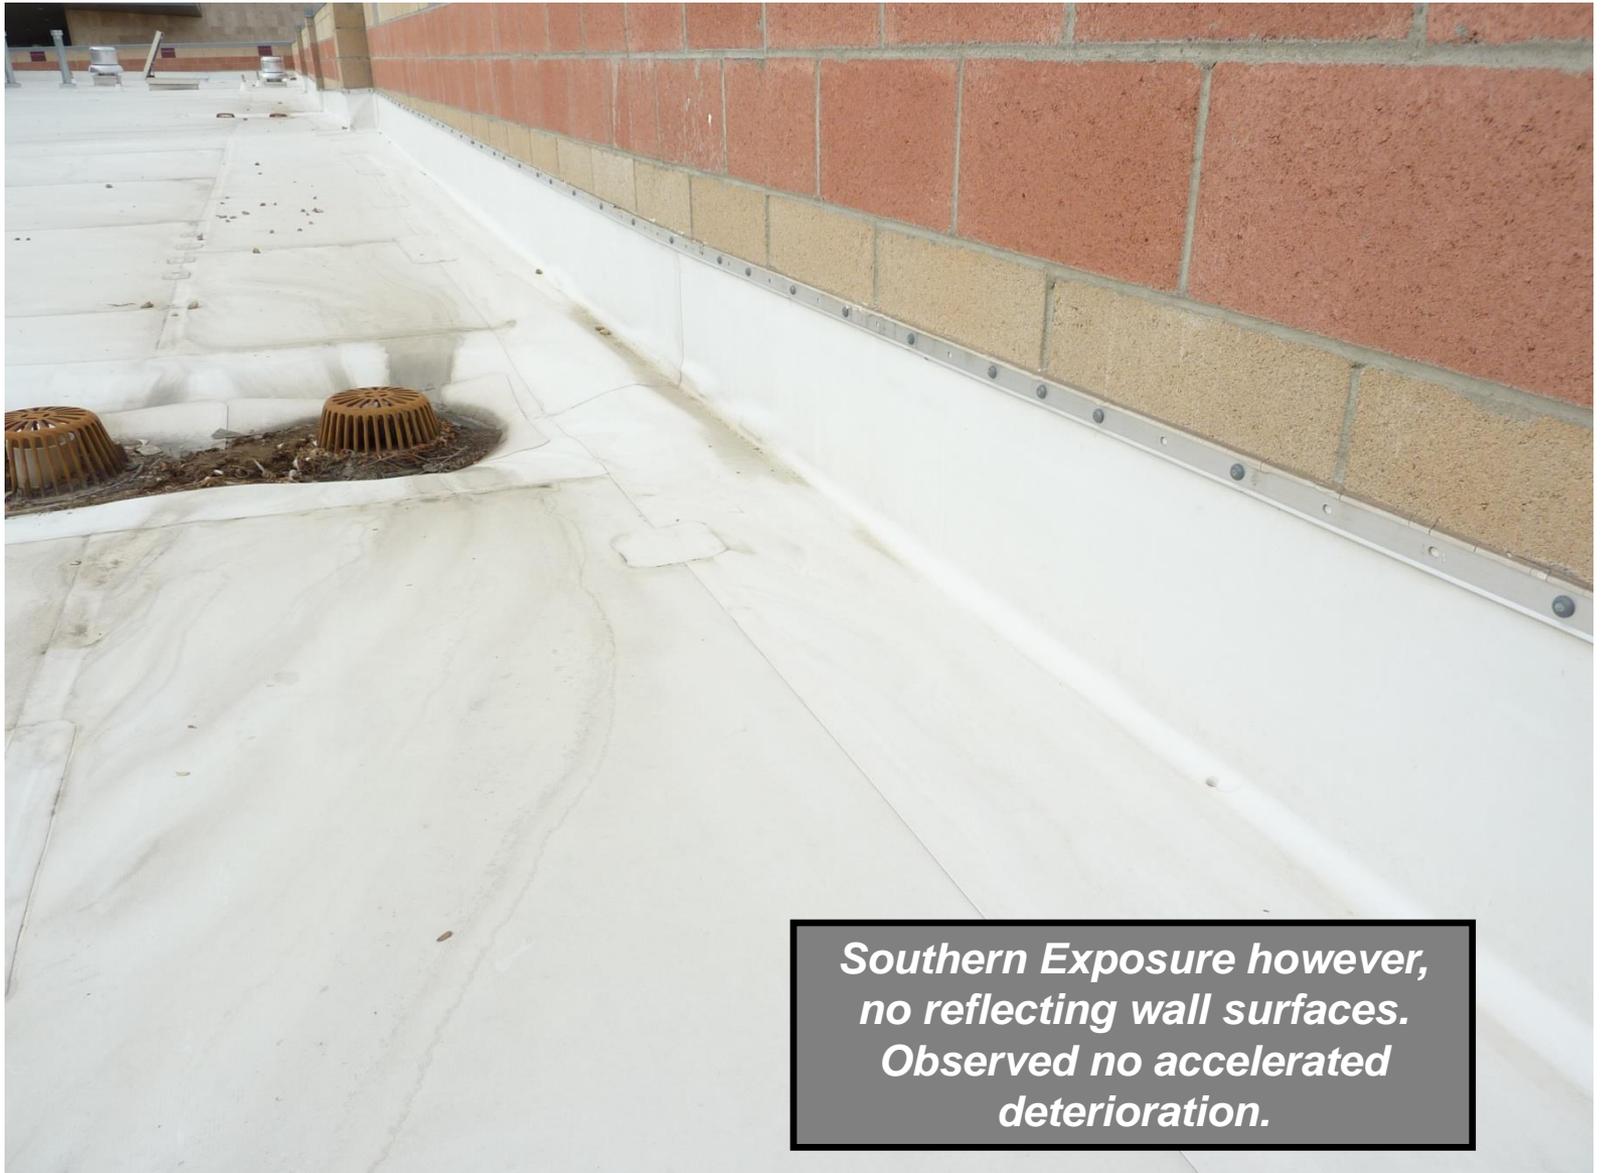
7 Years Old Firestone, Agasi College, Vegas

*Southern Exposure however,
no reflecting wall surfaces.
Observed no accelerated
deterioration.*

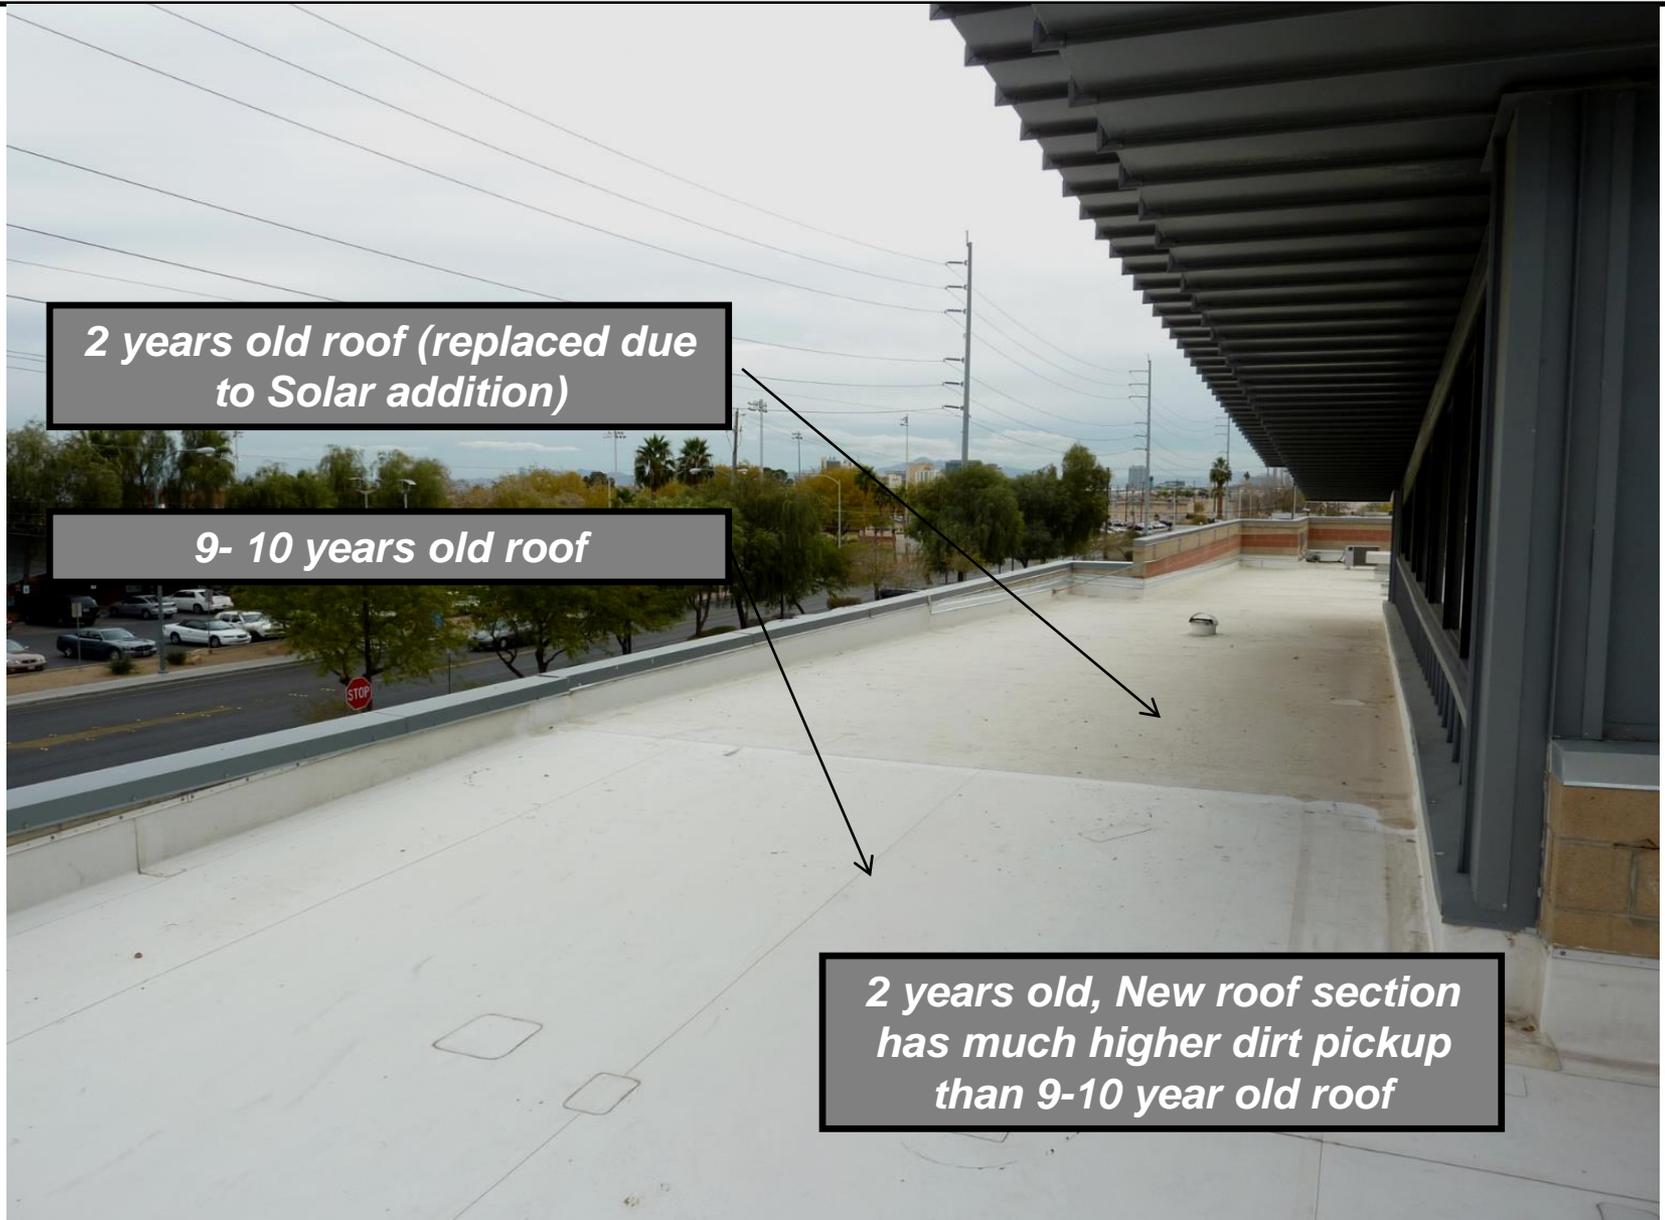
7 Years Old Firestone, Agasi College, Vegas

2 years old roof (replaced due to Solar addition)

9- 10 years old roof

2 years old, New roof section has much higher dirt pickup than 9-10 year old roof

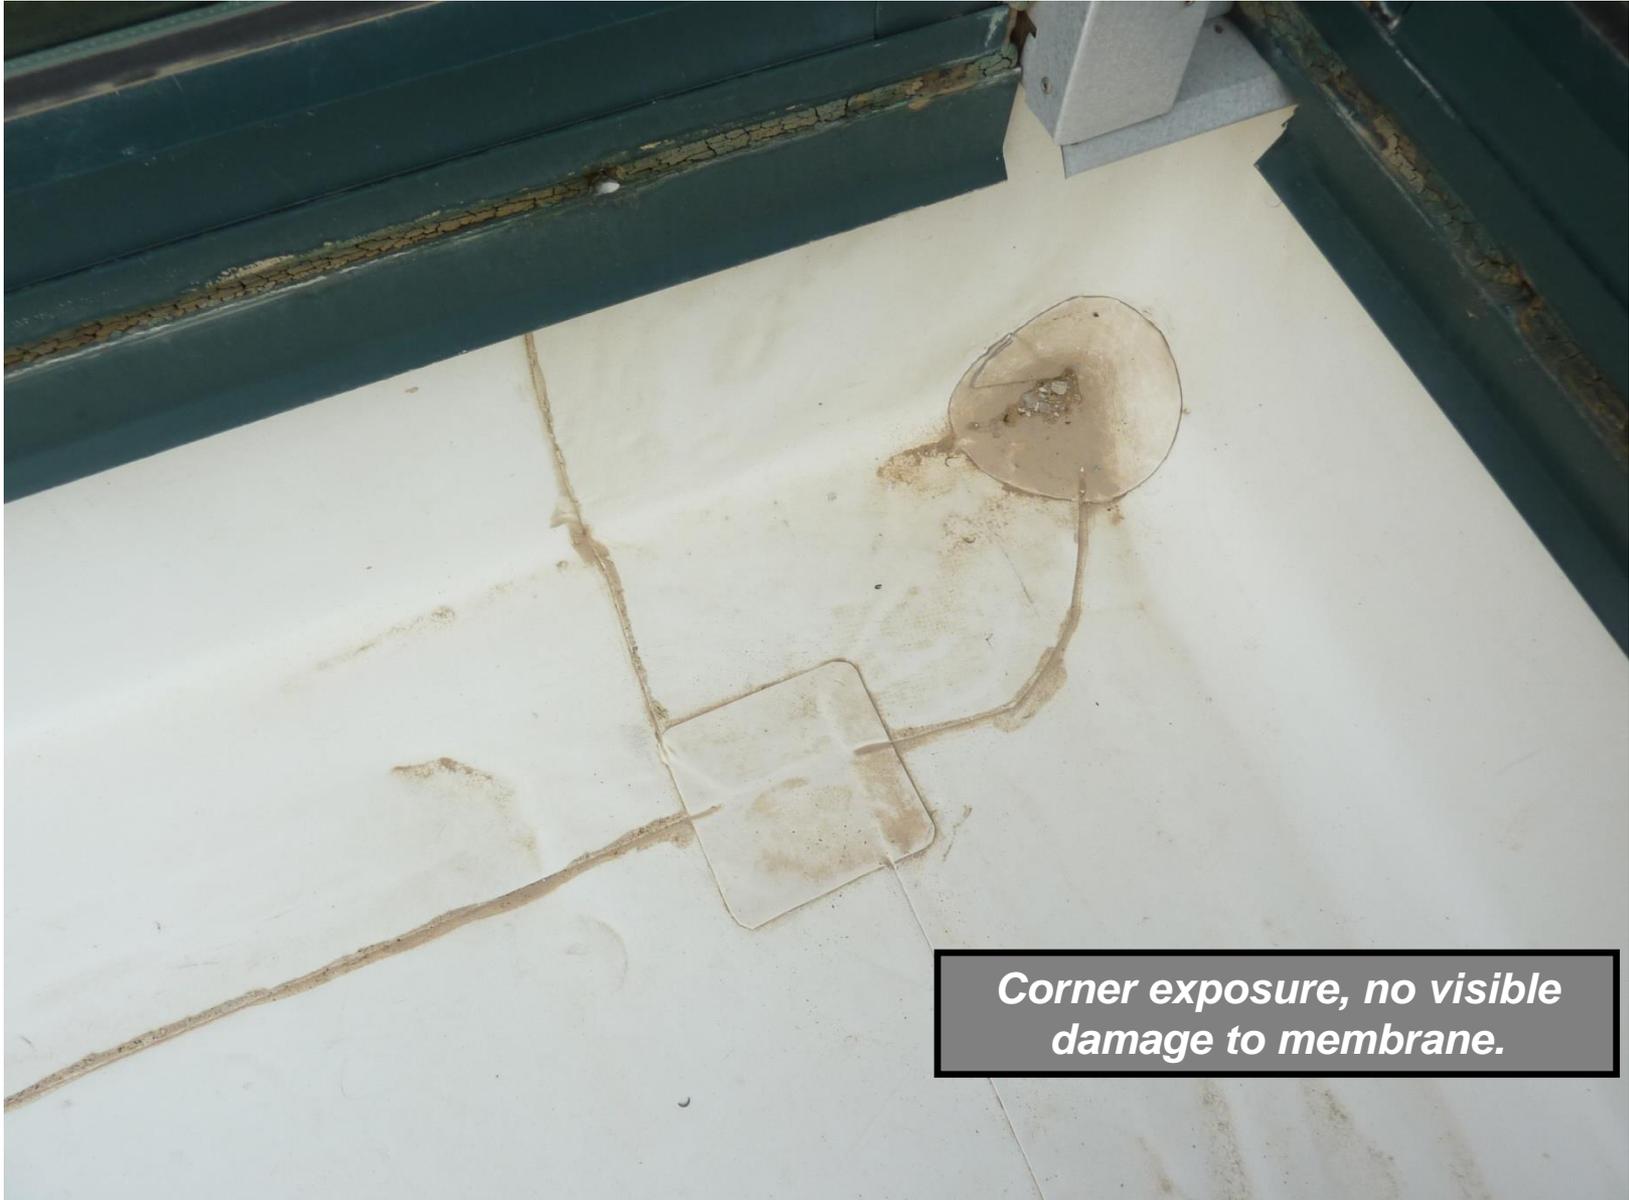
5 Years Old Firestone, Bass Sporting Goods

Corner exposure, no visible damage to membrane.

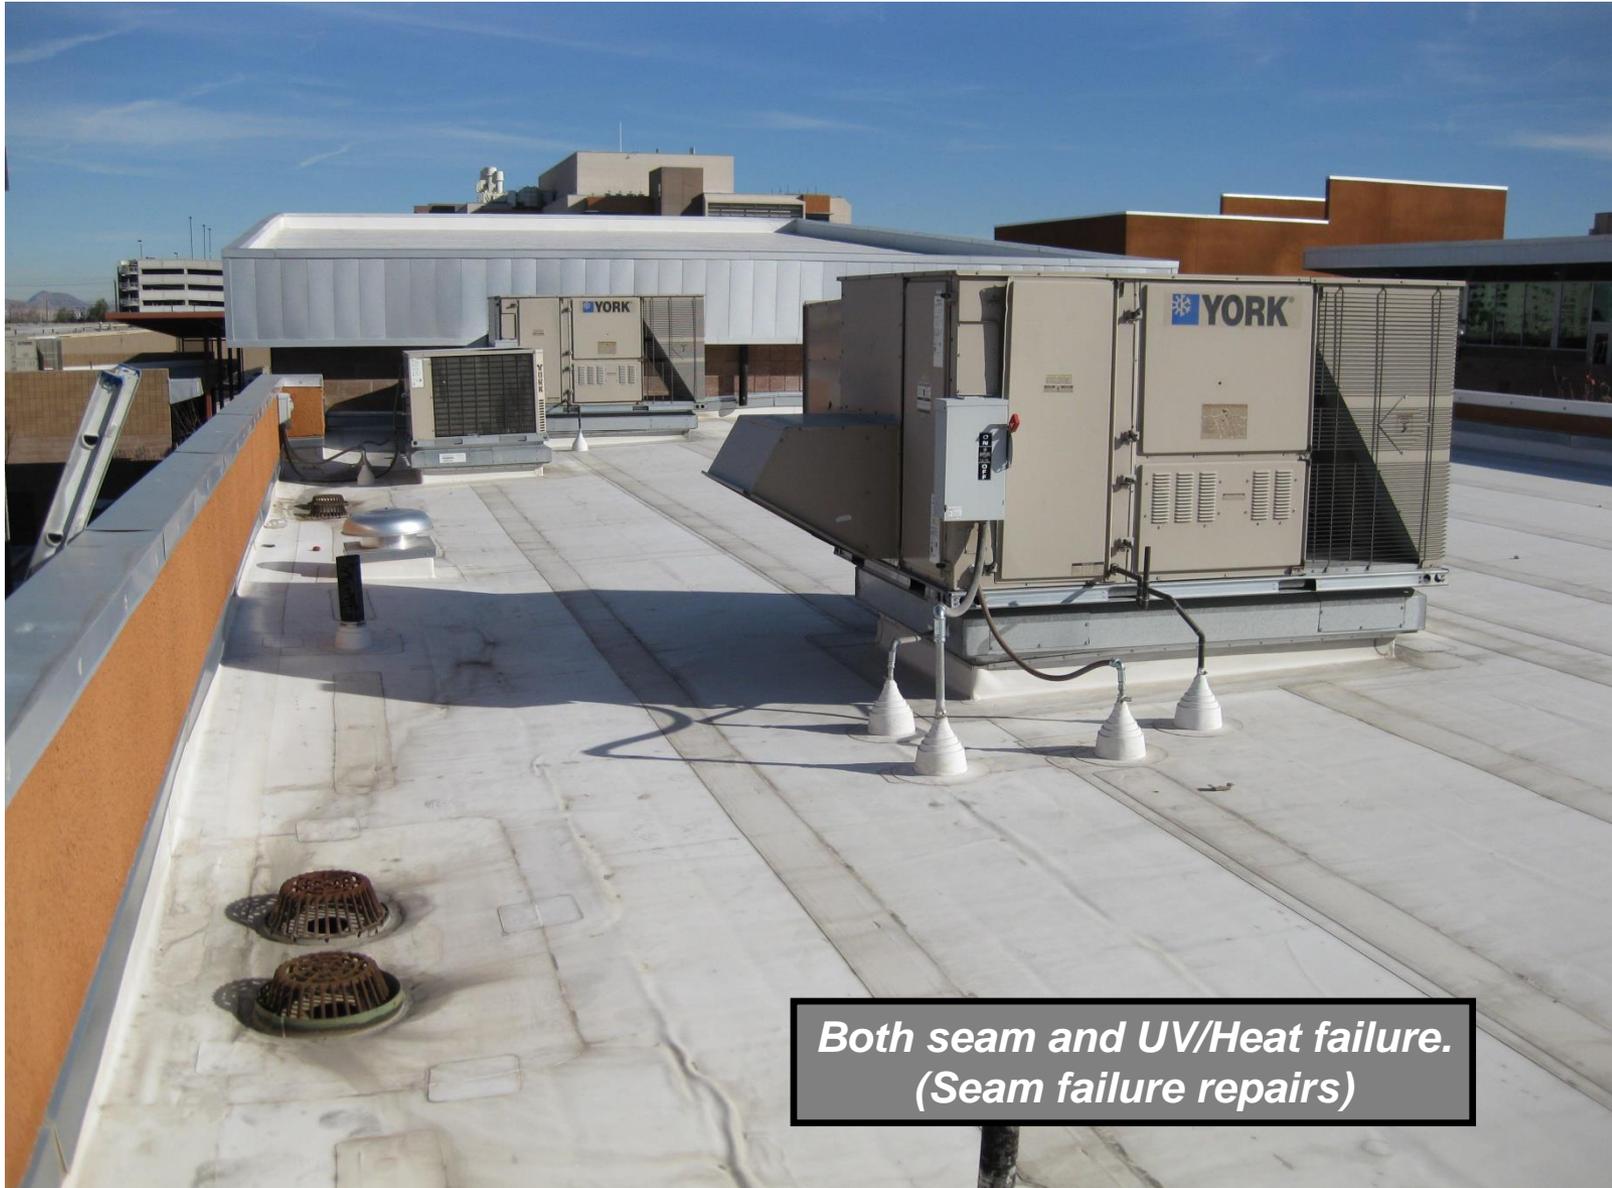
UNLV, LBC Building, GAF 7 years old

*Both seam and UV/Heat failure.
(Seam failure repairs)*

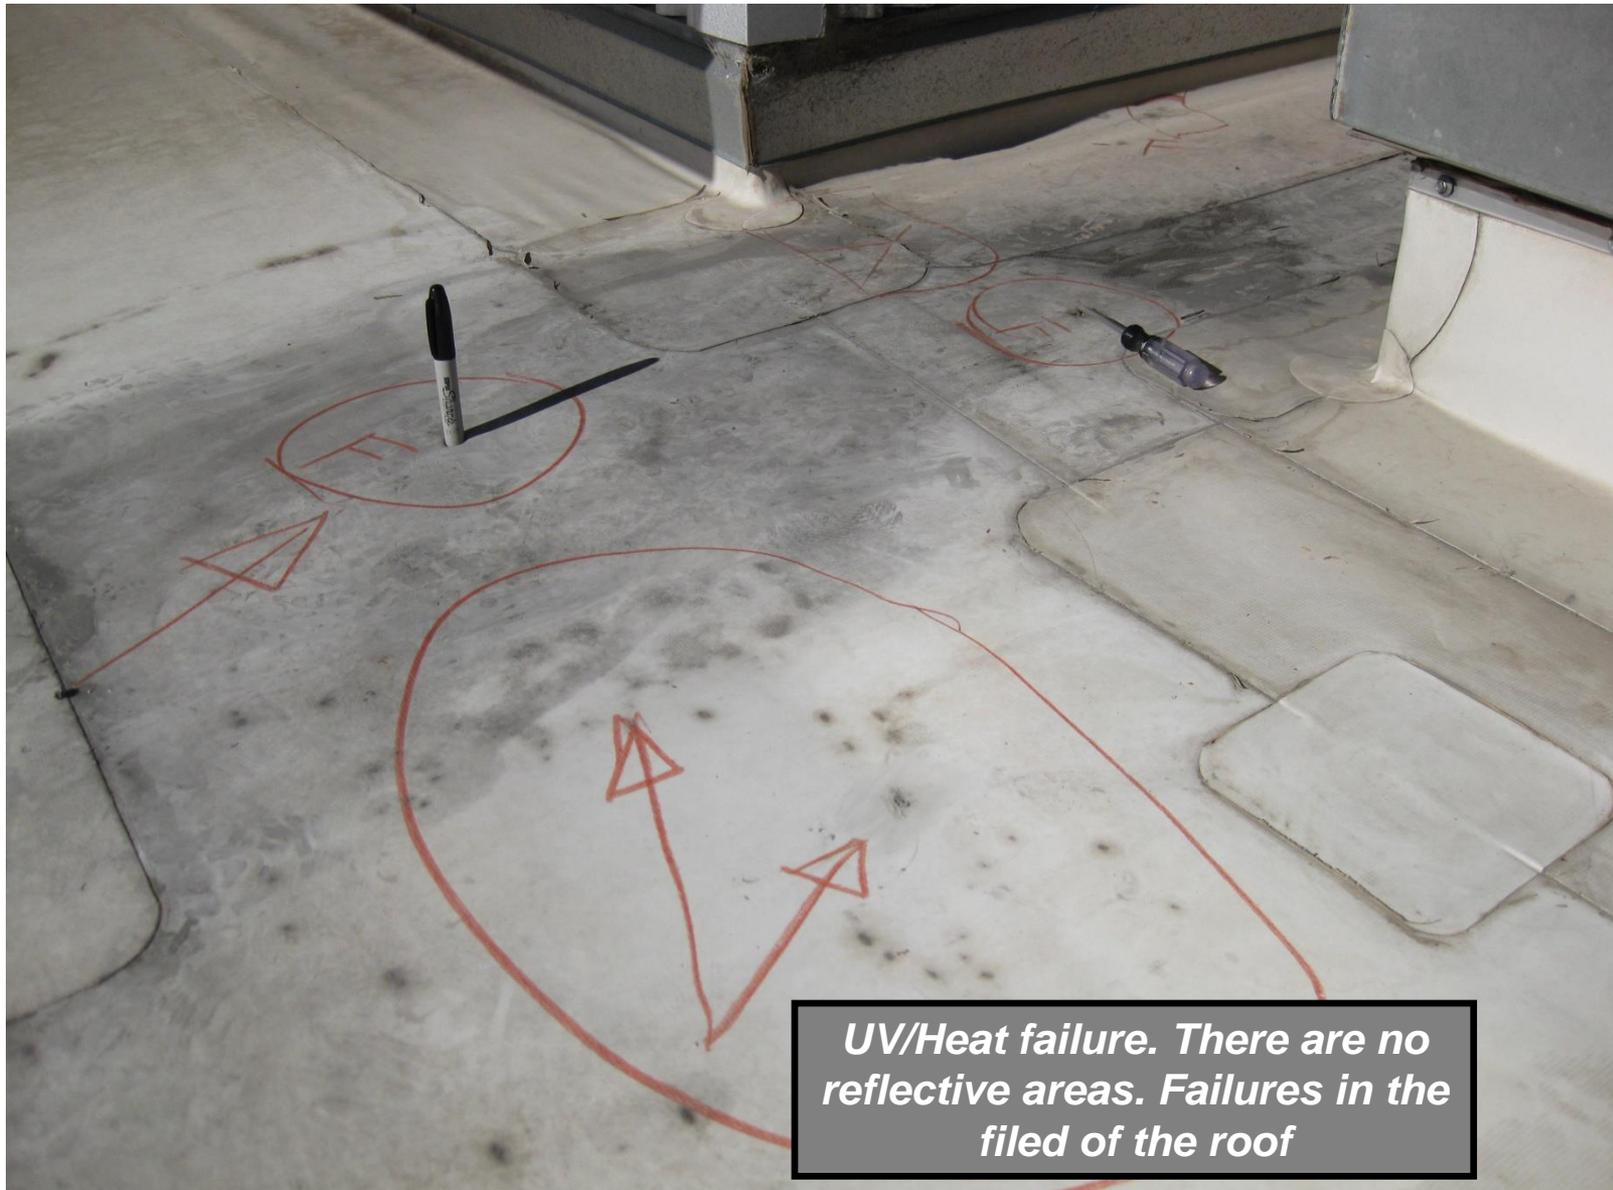
UNLV, LBC Building, GAF 7 years old

UV/Heat failure. There are no reflective areas. Failures in the field of the roof

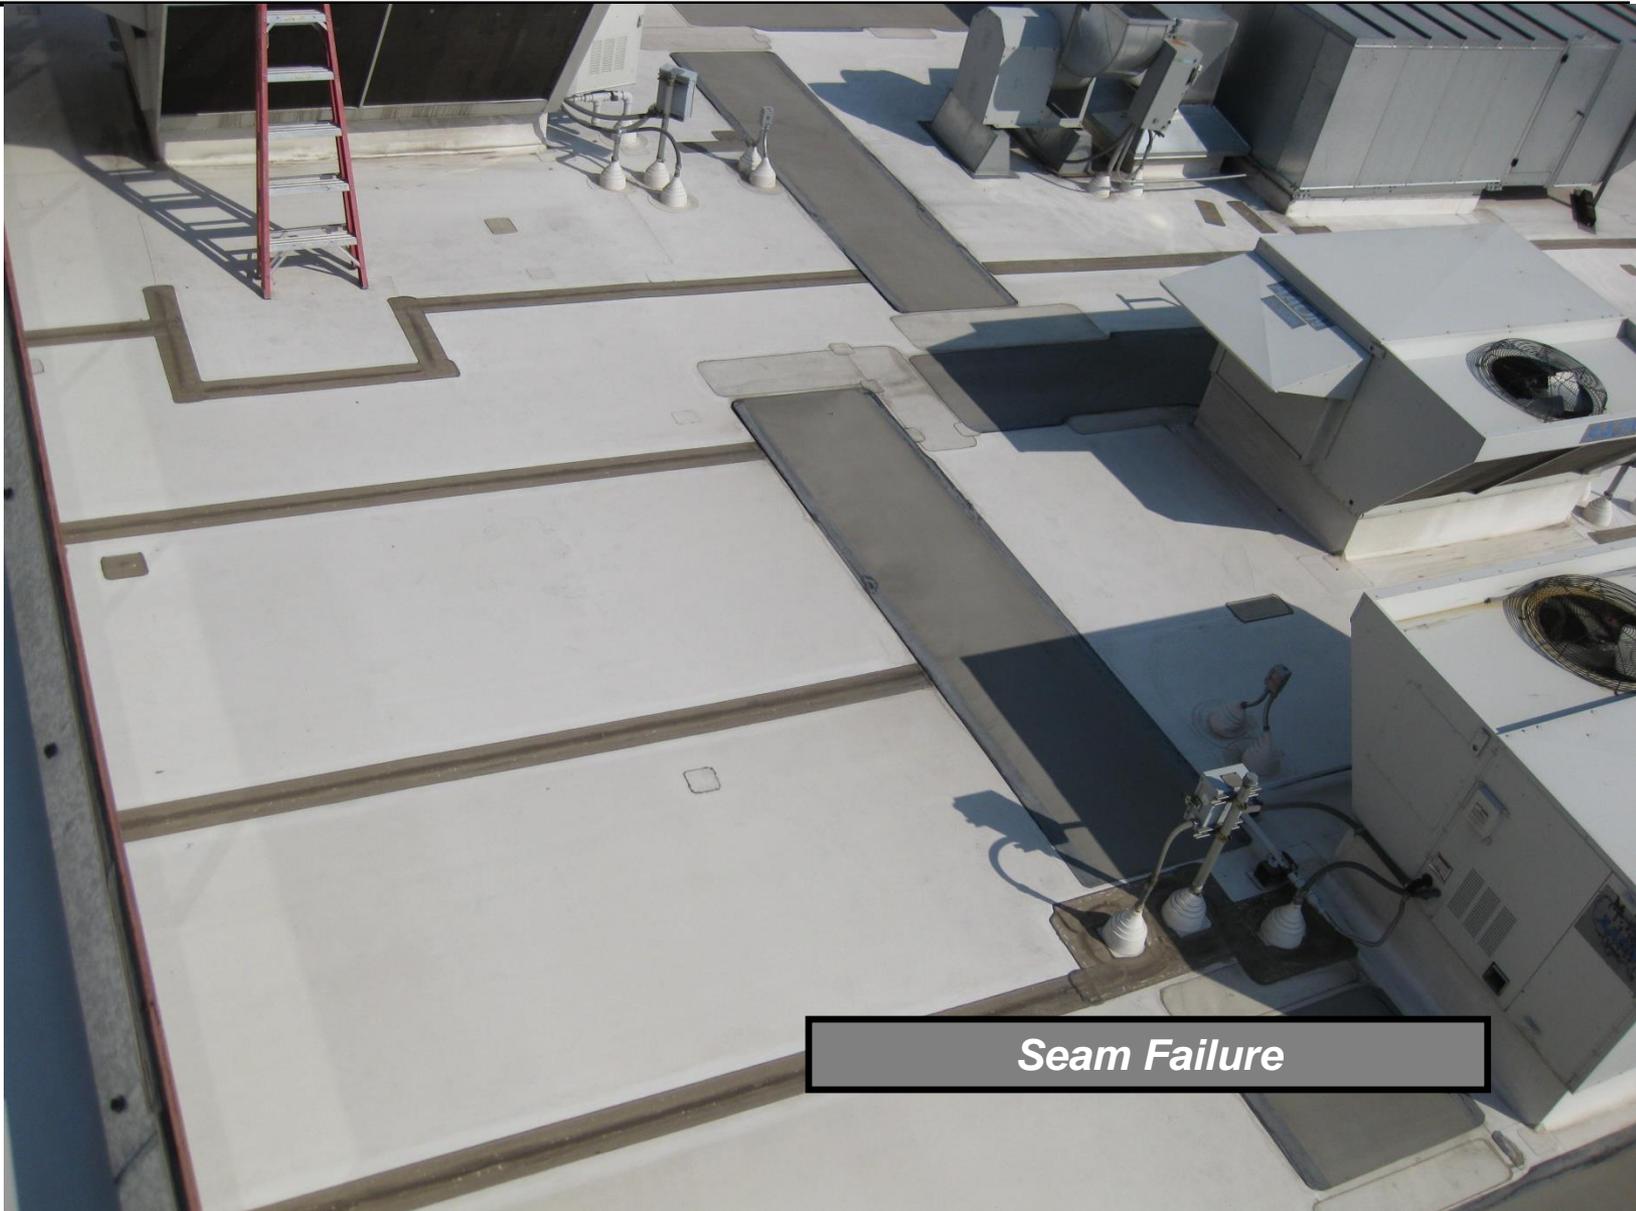
UNLV LLB Building, Dow/Stevens

Seam Failure

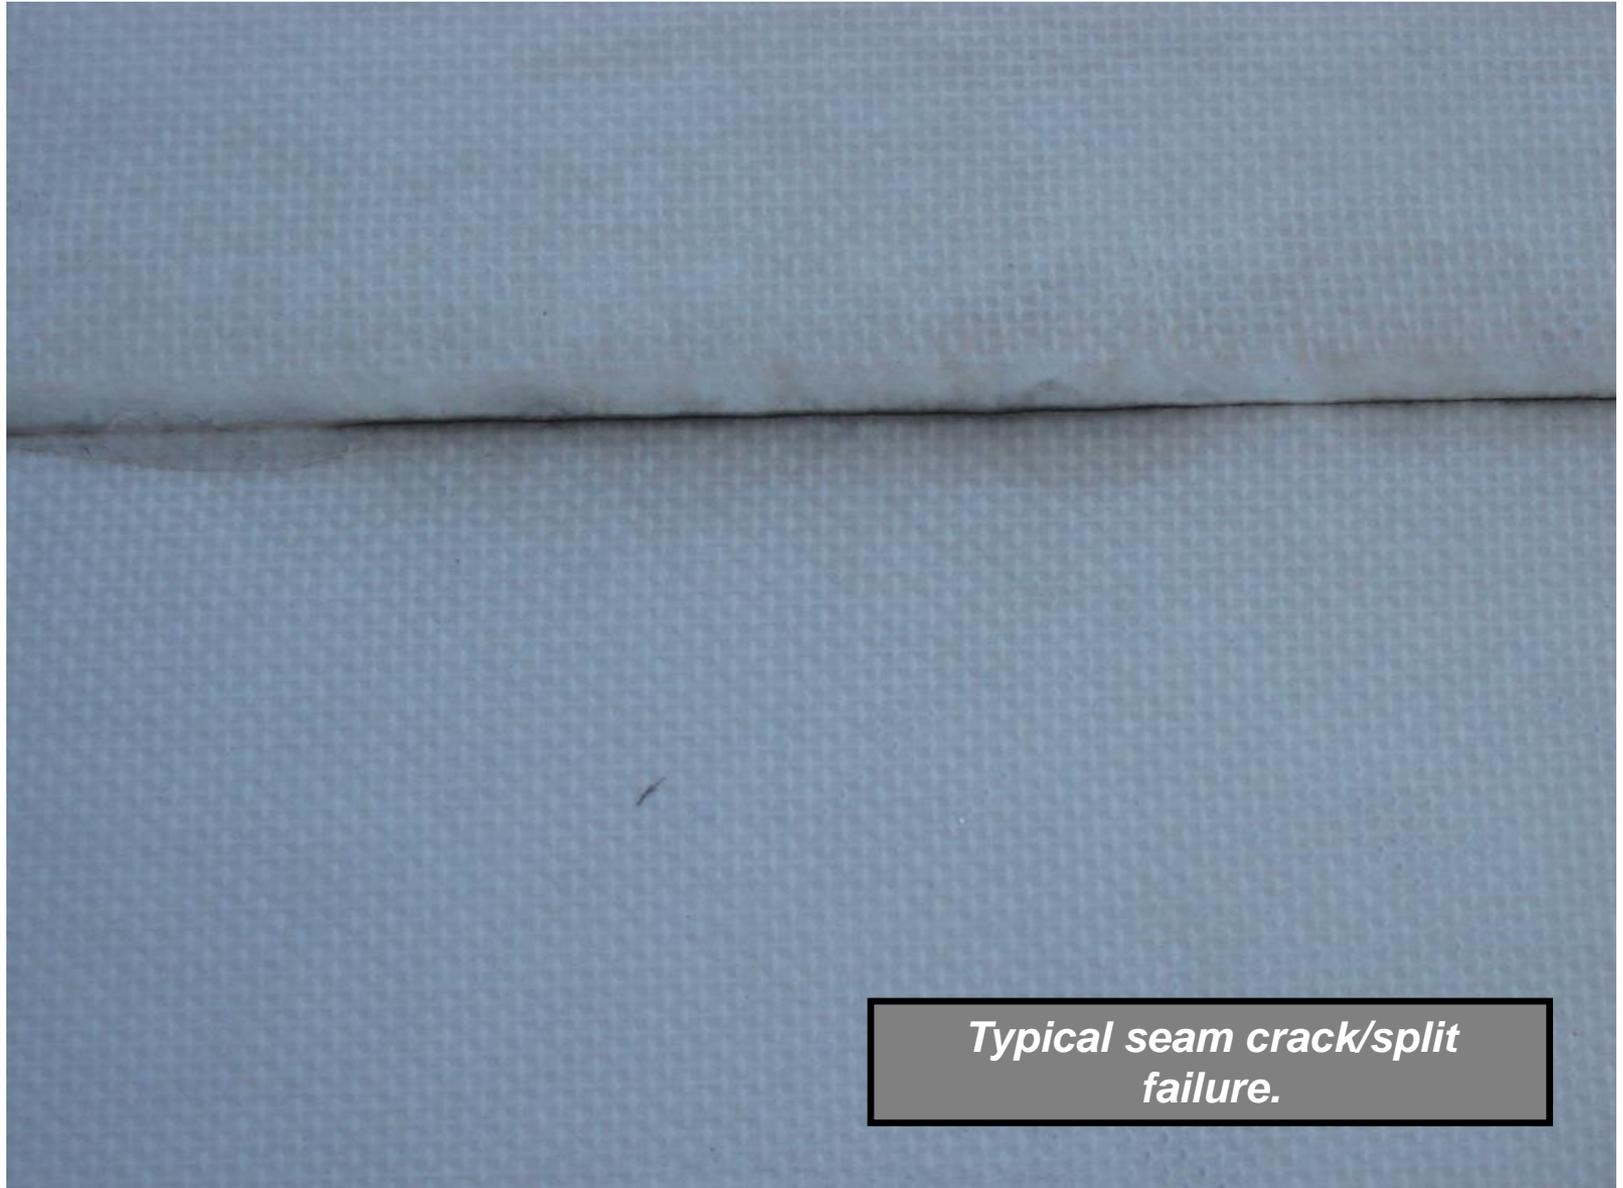
UNLV LLB Building, Dow/Stevens

Typical seam crack/split failure.

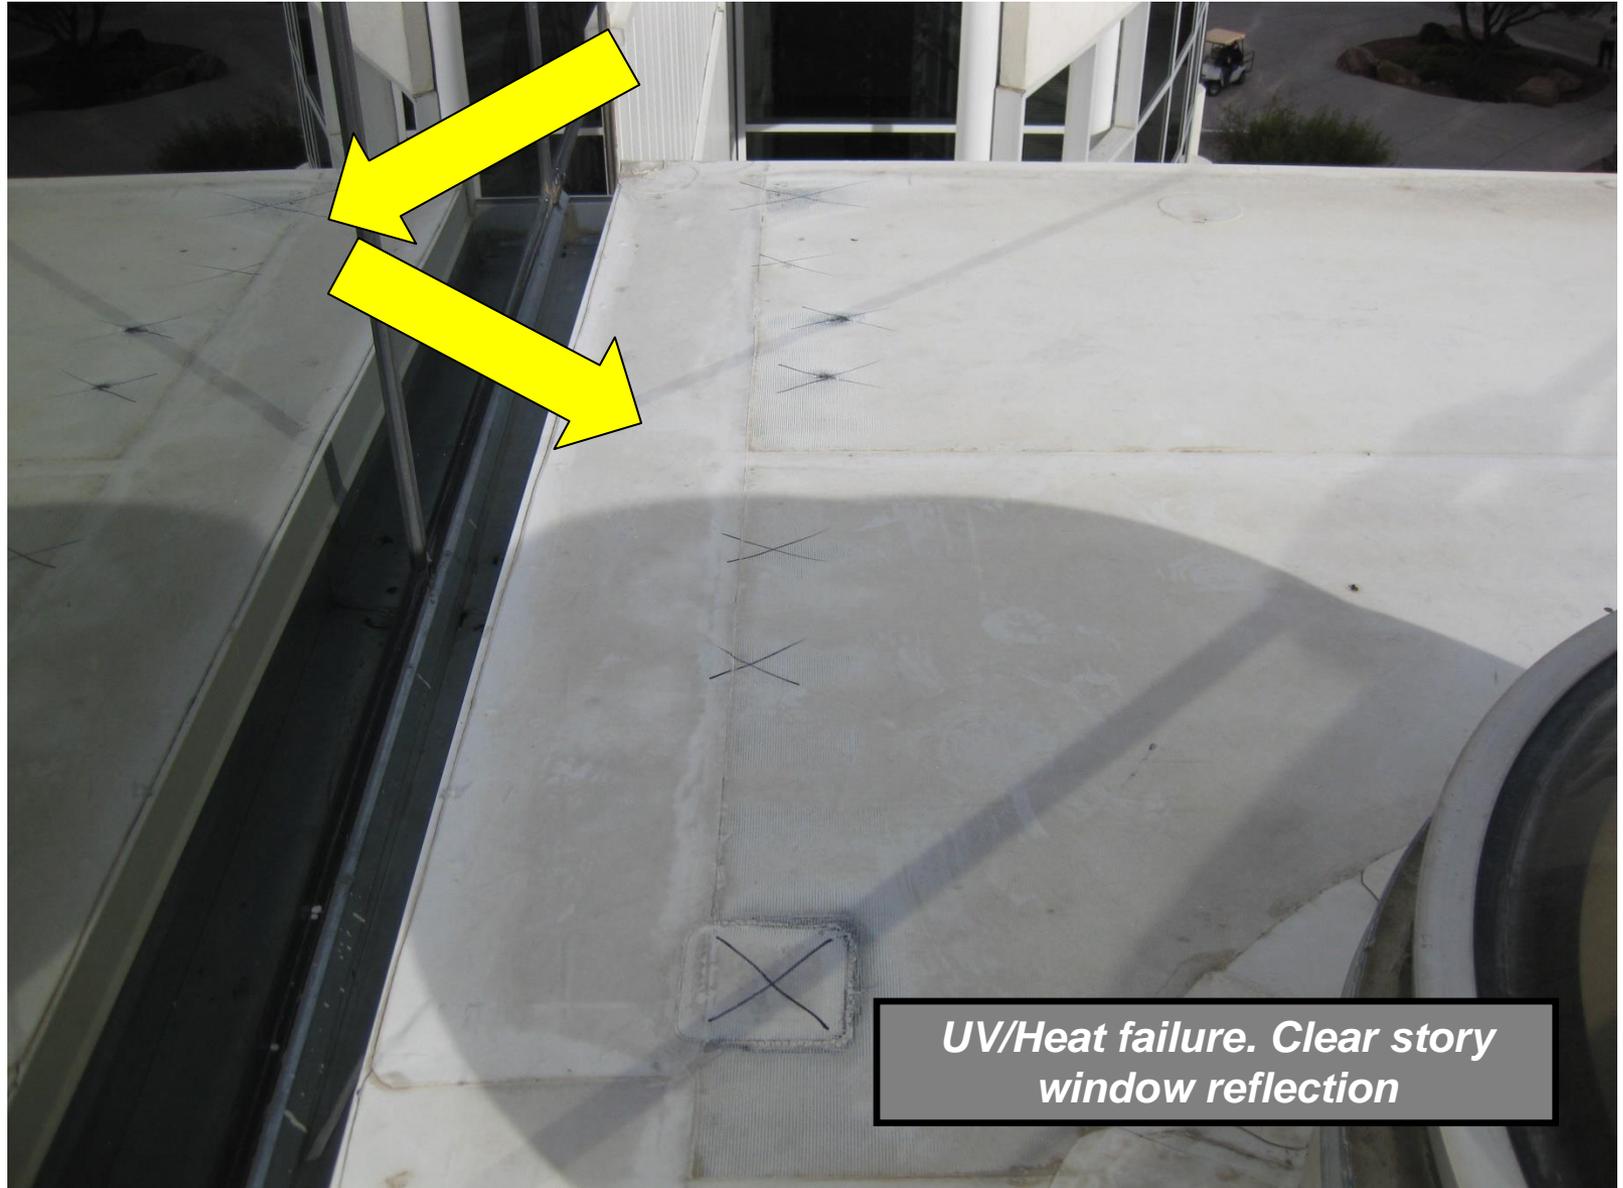
UNLV, BSL Bridge Way, Carlisle, 10 years old

UV/Heat failure. Clear story window reflection

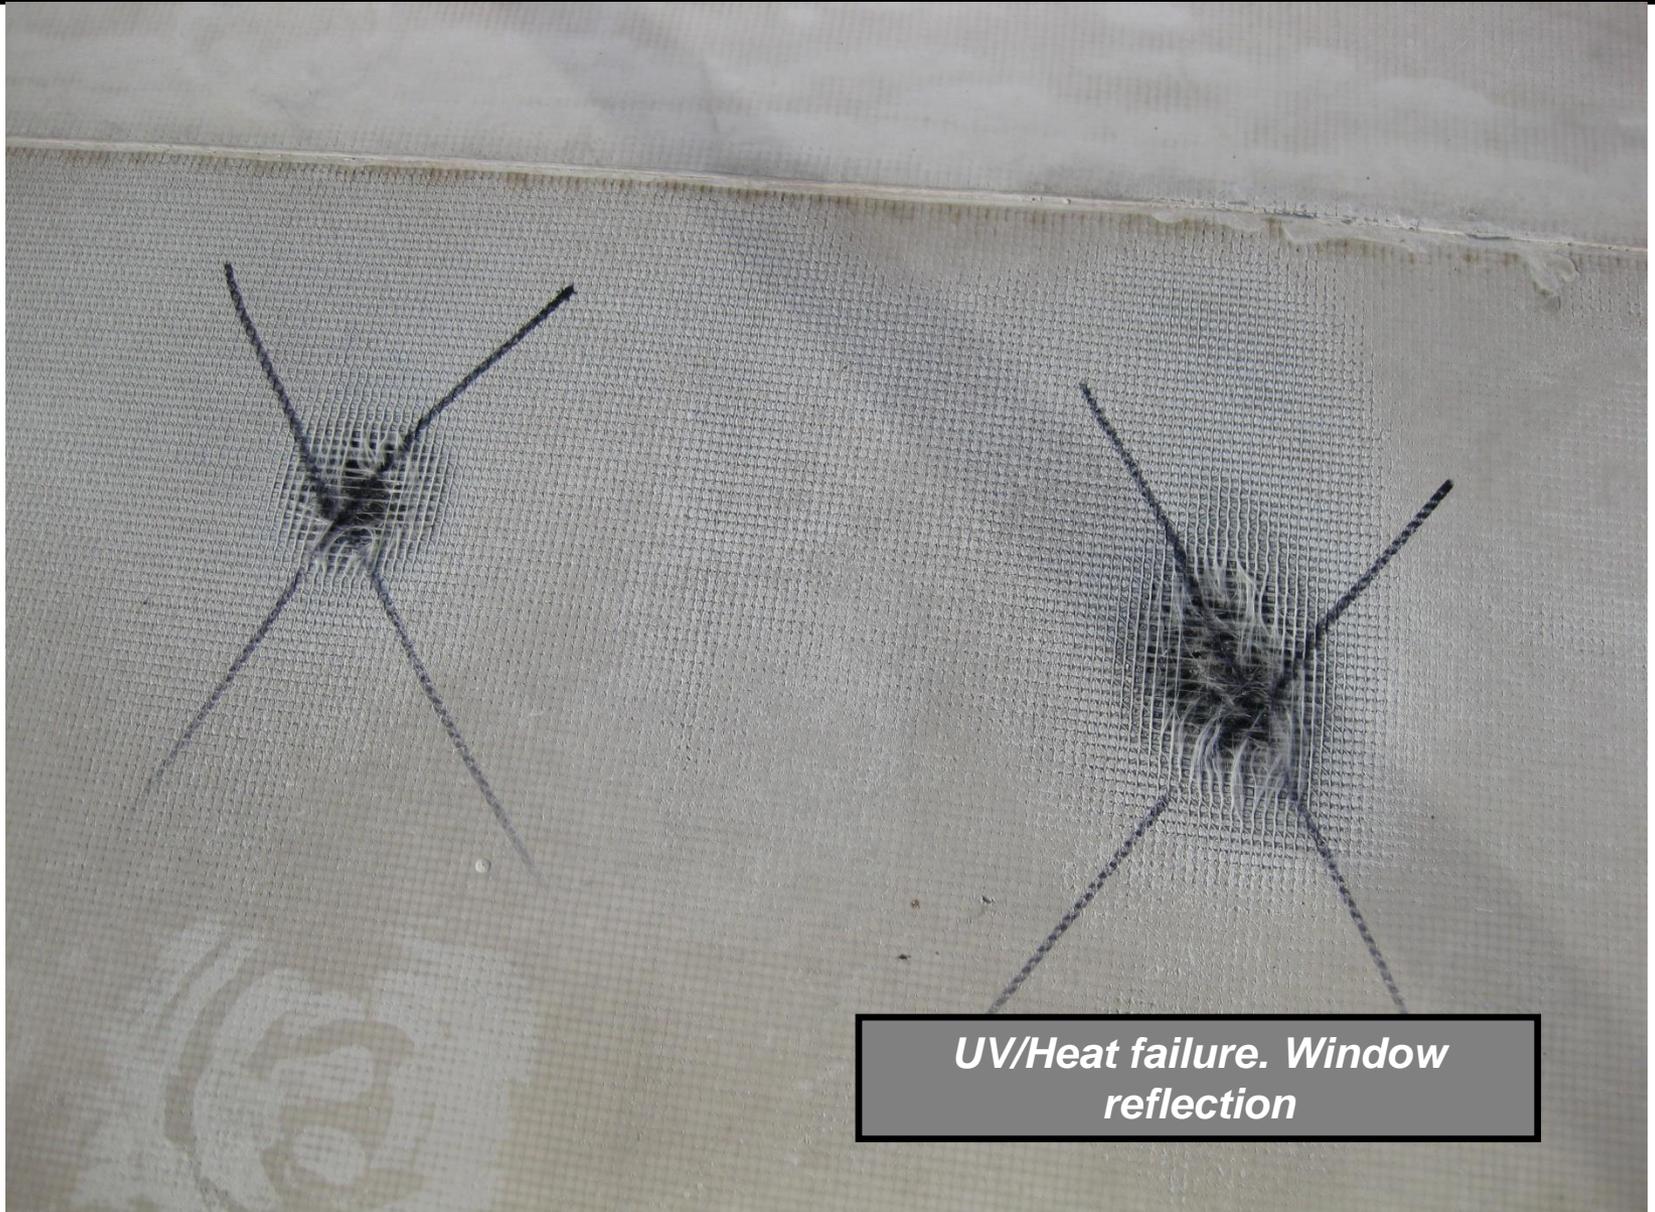
UNLV, BSL Bridge Way, Carlisle, 10 years old

UV/Heat failure. Window reflection

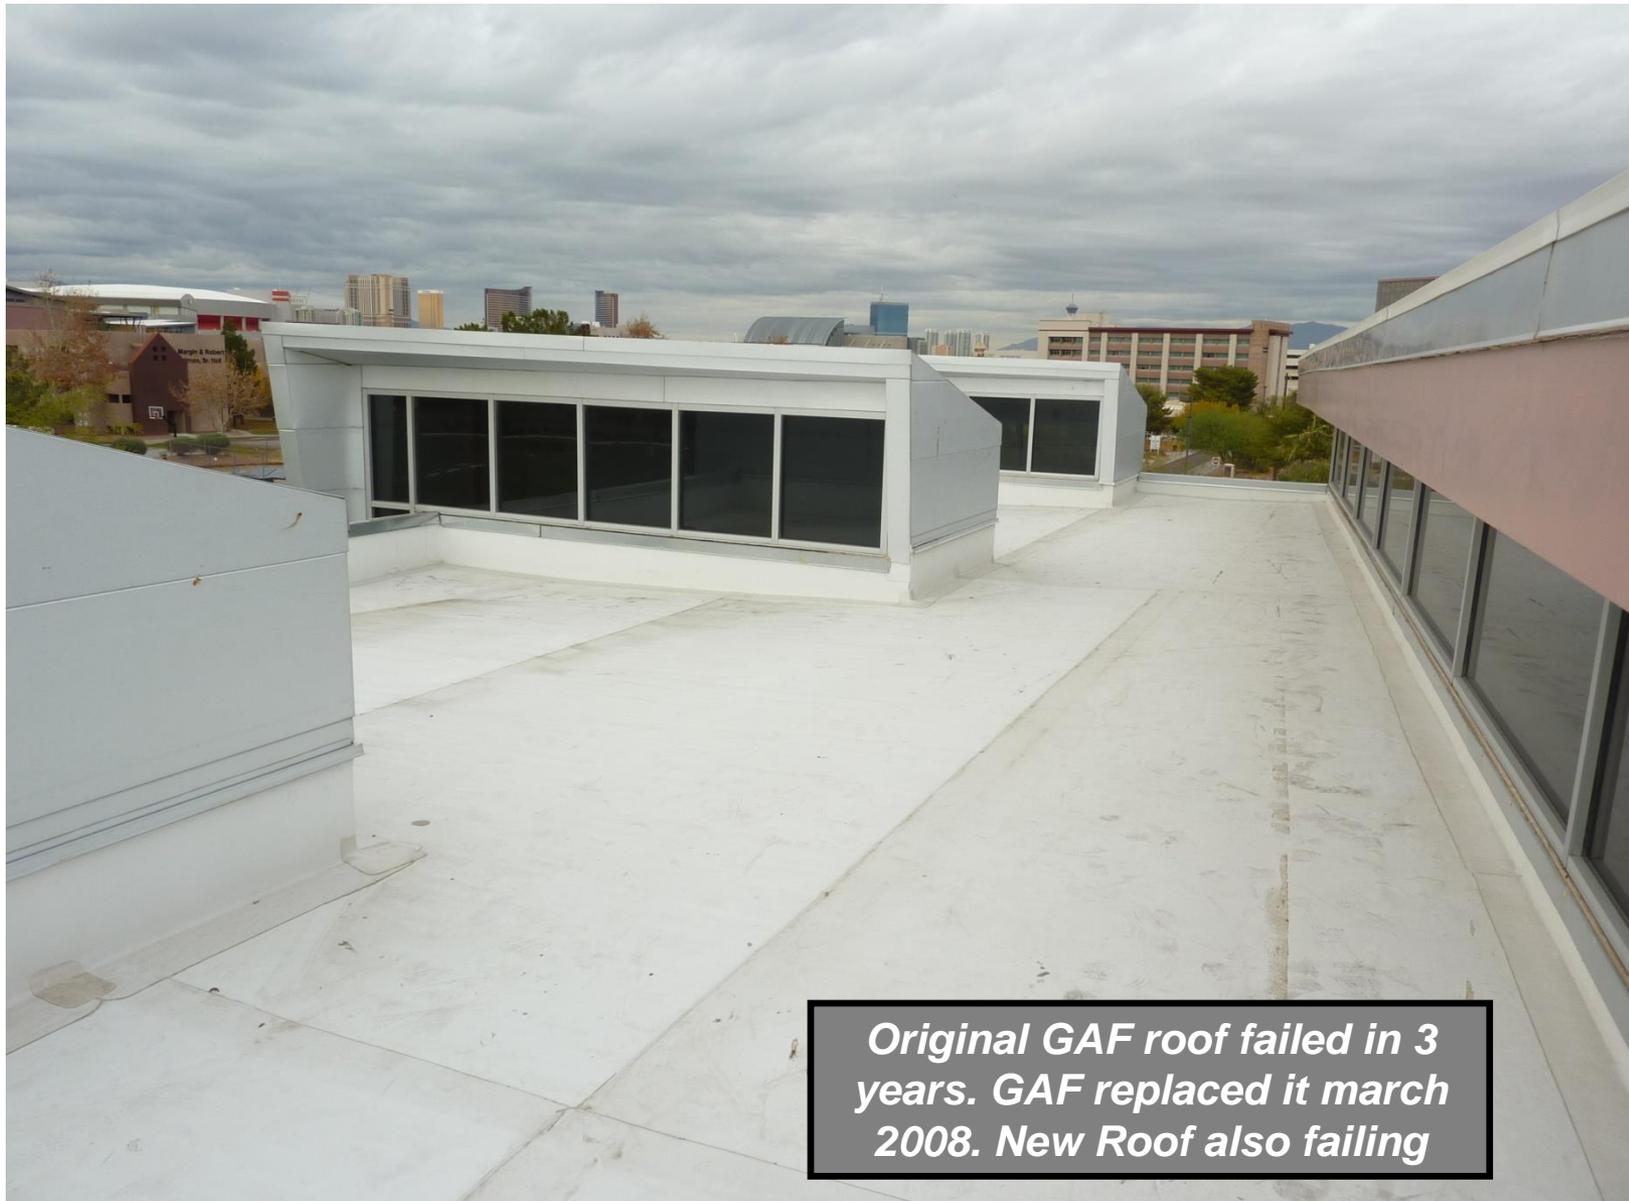
UNLV, ARC Building, GAF TPO 2.5 years old

Original GAF roof failed in 3 years. GAF replaced it march 2008. New Roof also failing

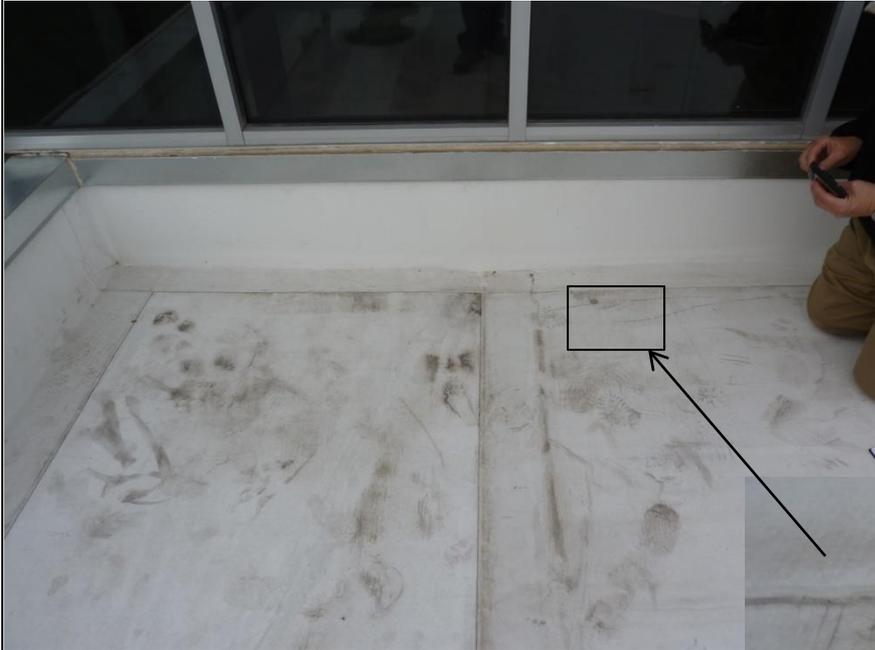
UNLV, ARC Building, GAF TPO 2.5 years old

This replacement GAF roof is less than 3 years old!

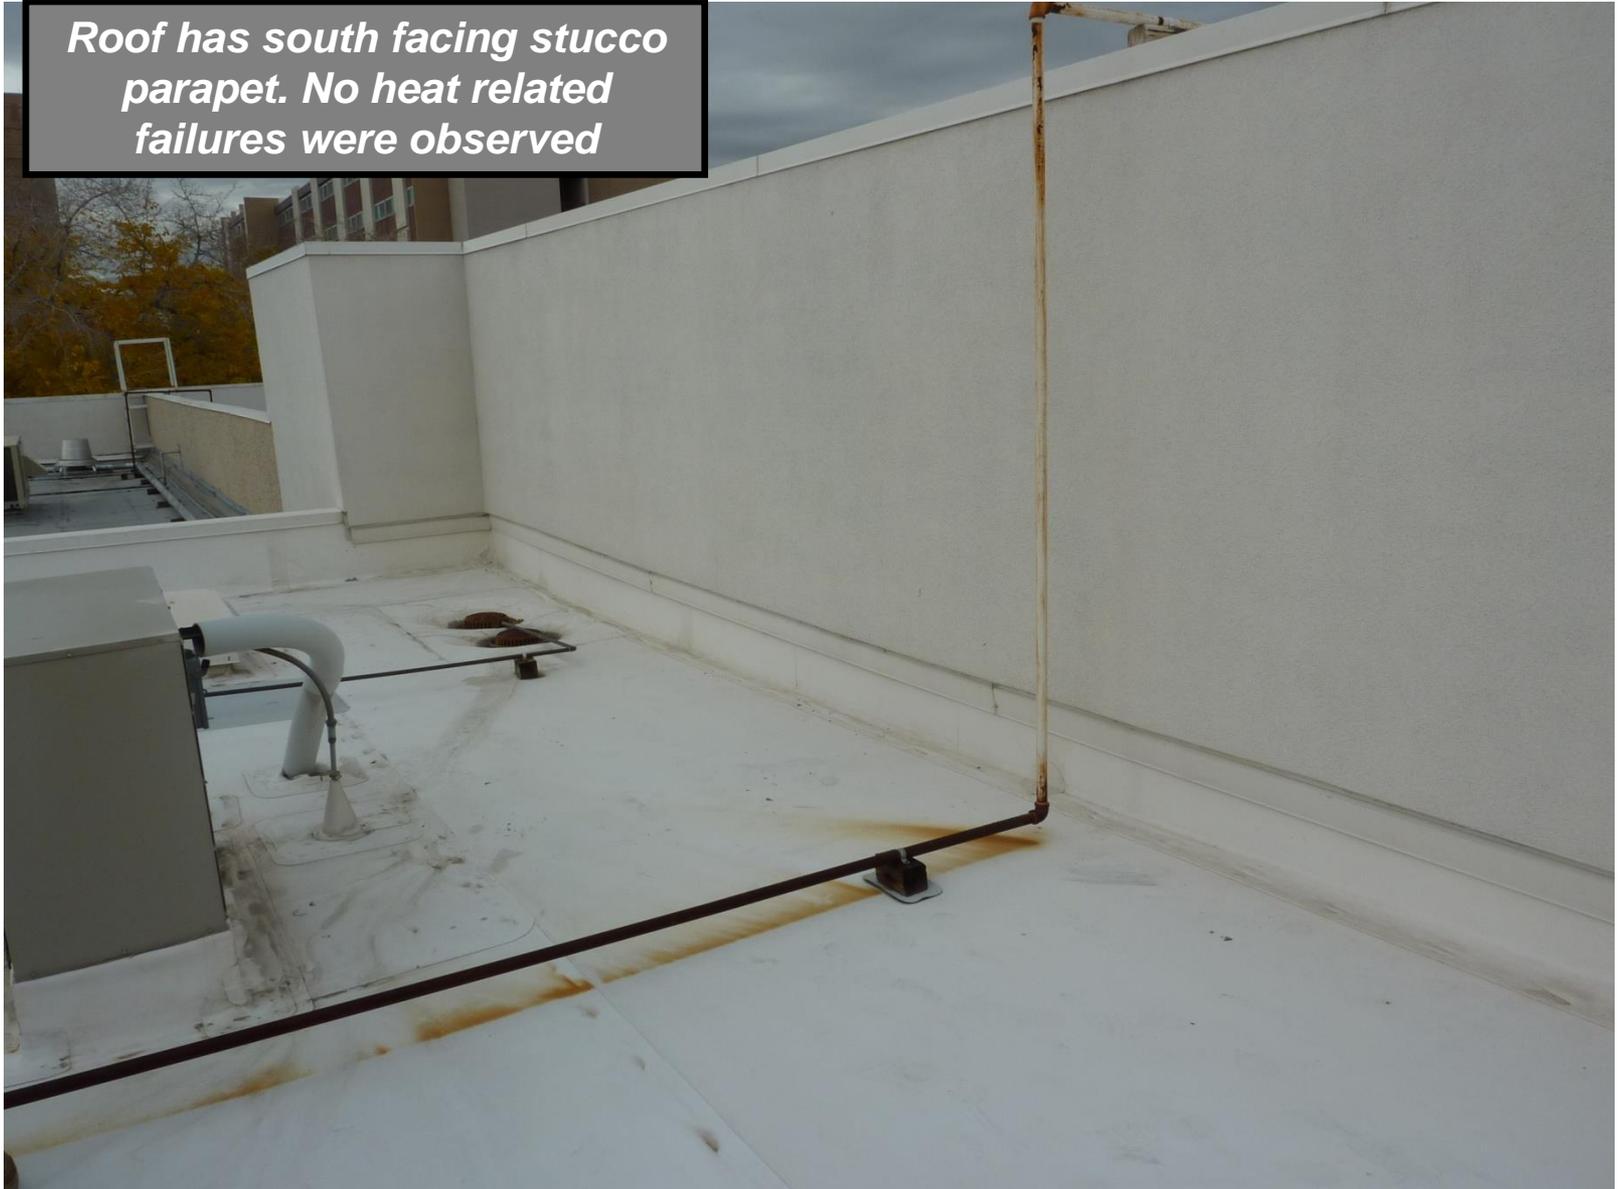
UNLV Bookstore, Firestone 11 Years Old

Roof has south facing stucco parapet. No heat related failures were observed
