**Critical Review of the Life Span of TPO and
PVC**

WSRCA

June 8, 2011

**Karim P. Allana, P.E., RRC, RWC
Allana Buick & Bers, Inc.**

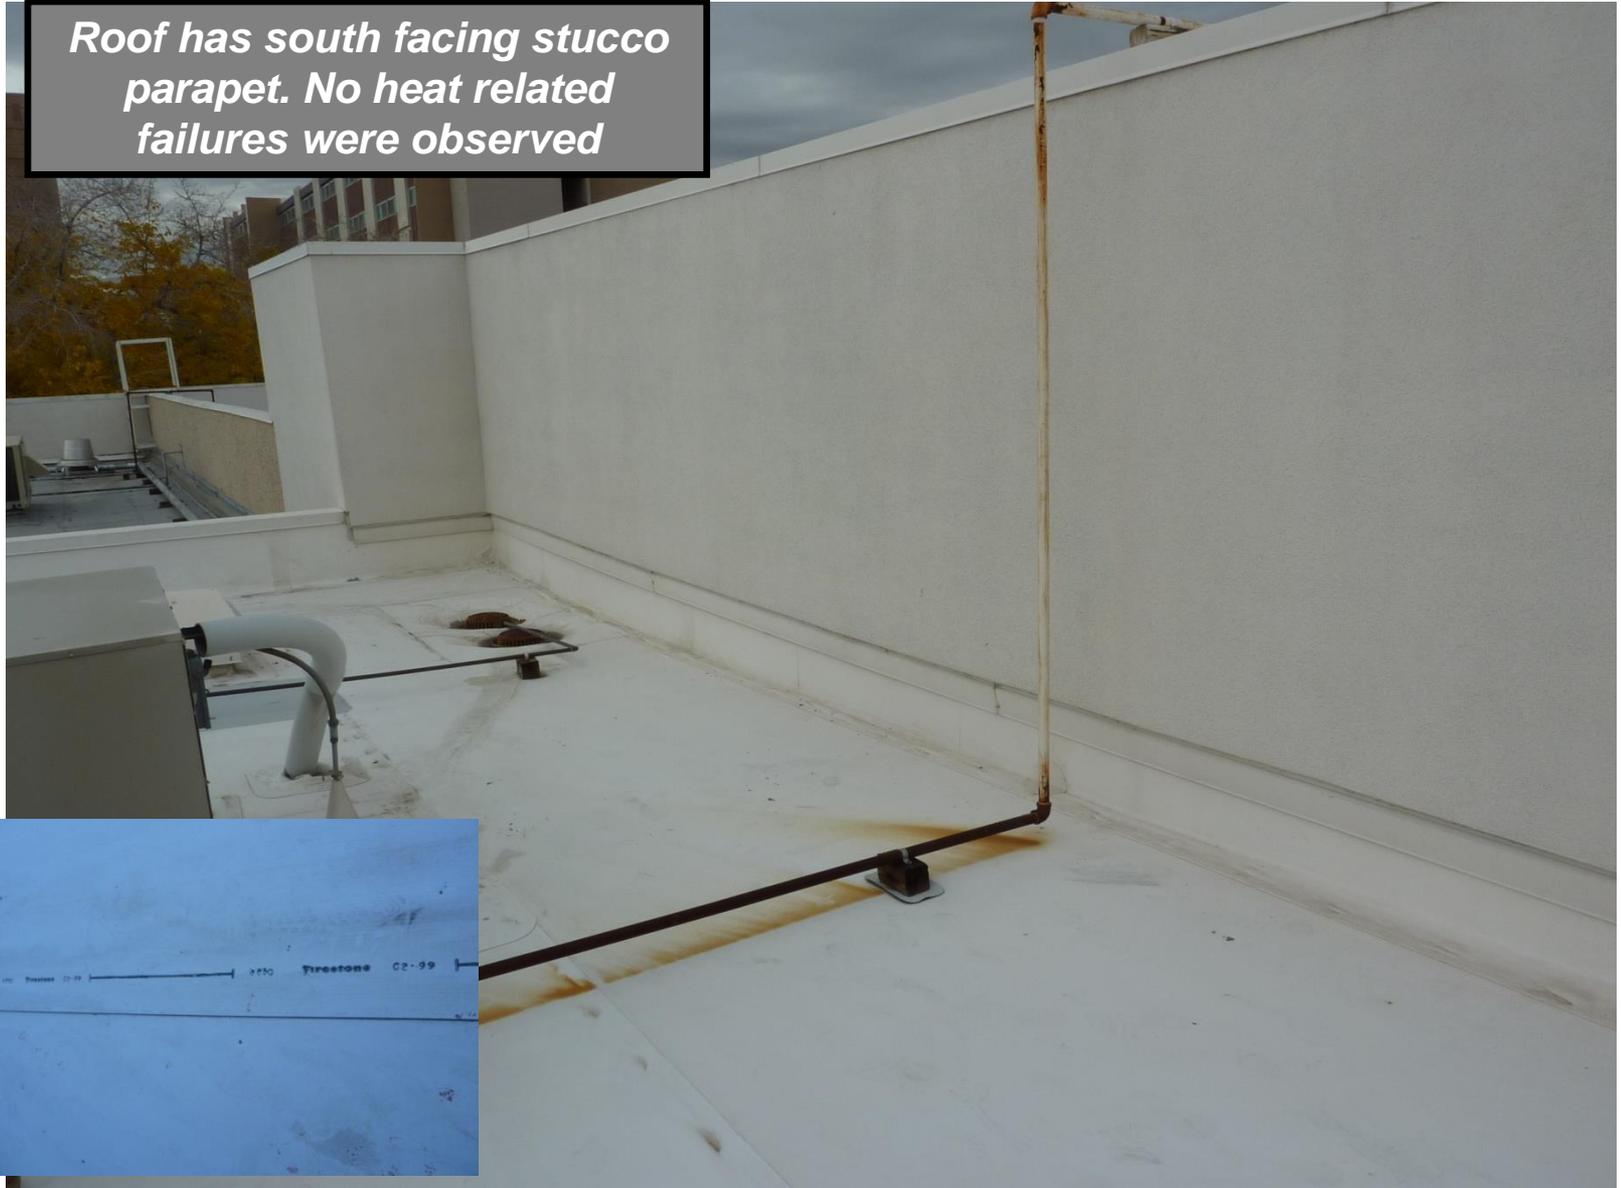
UNLV Bookstore, Firestone 11 Years Old

Roof has south facing stucco parapet. No heat related failures were observed

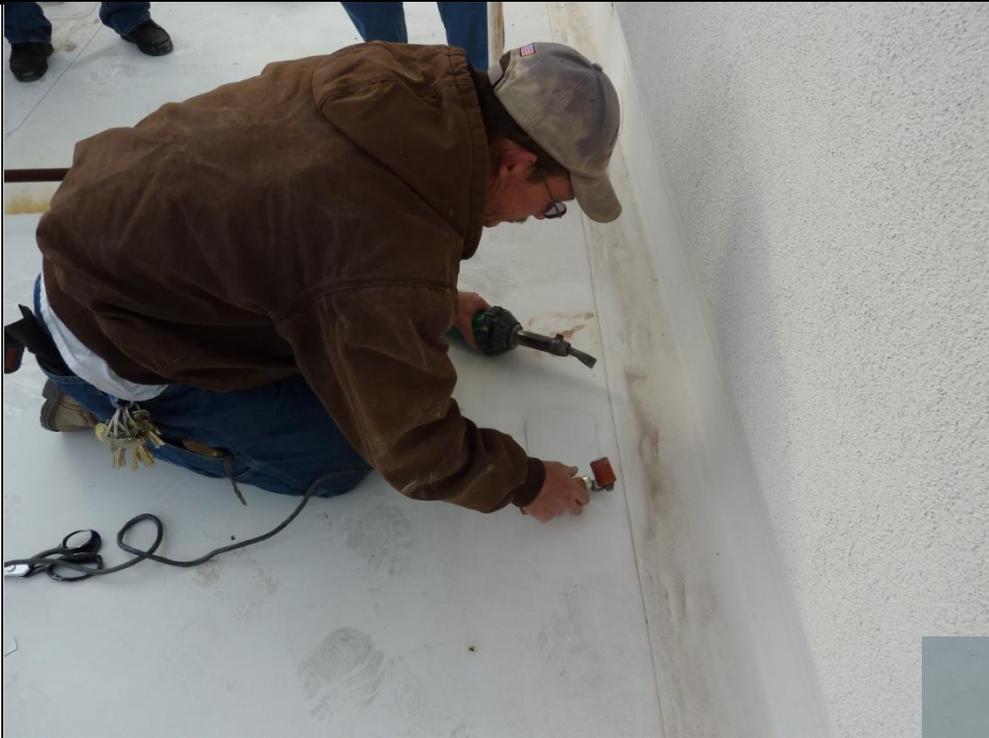
UNLV Bookstore, Firestone 11 Years Old

While there were no heat related failures, all attempts to heat weld/patch the roof were unsuccessful.

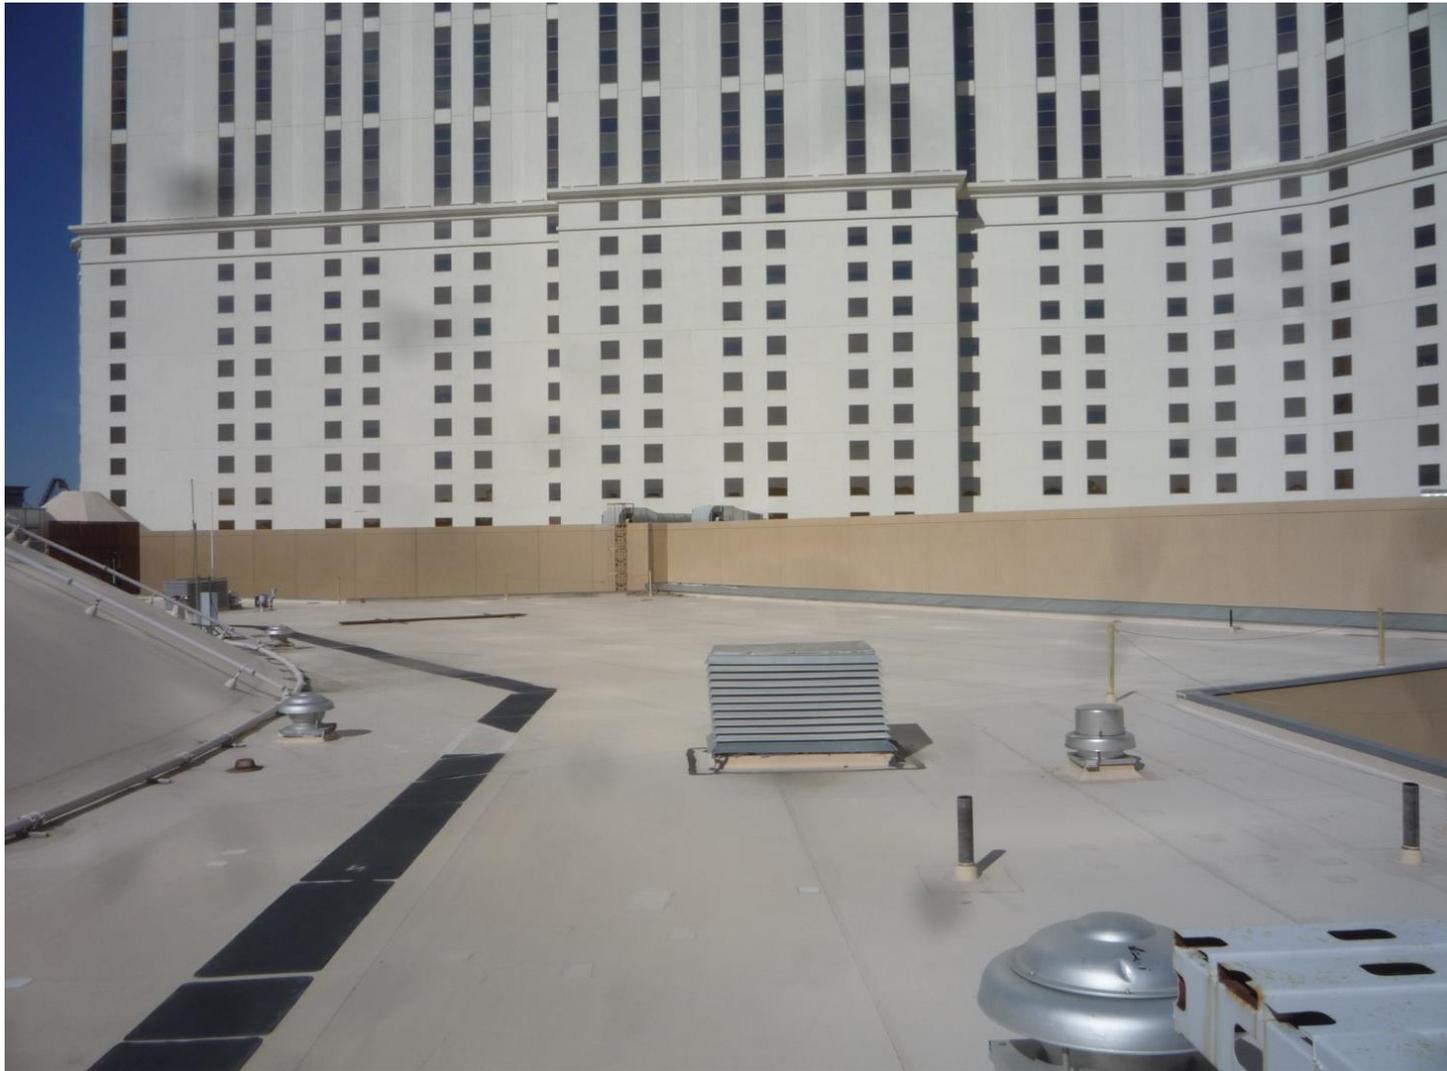
Walk pad damage

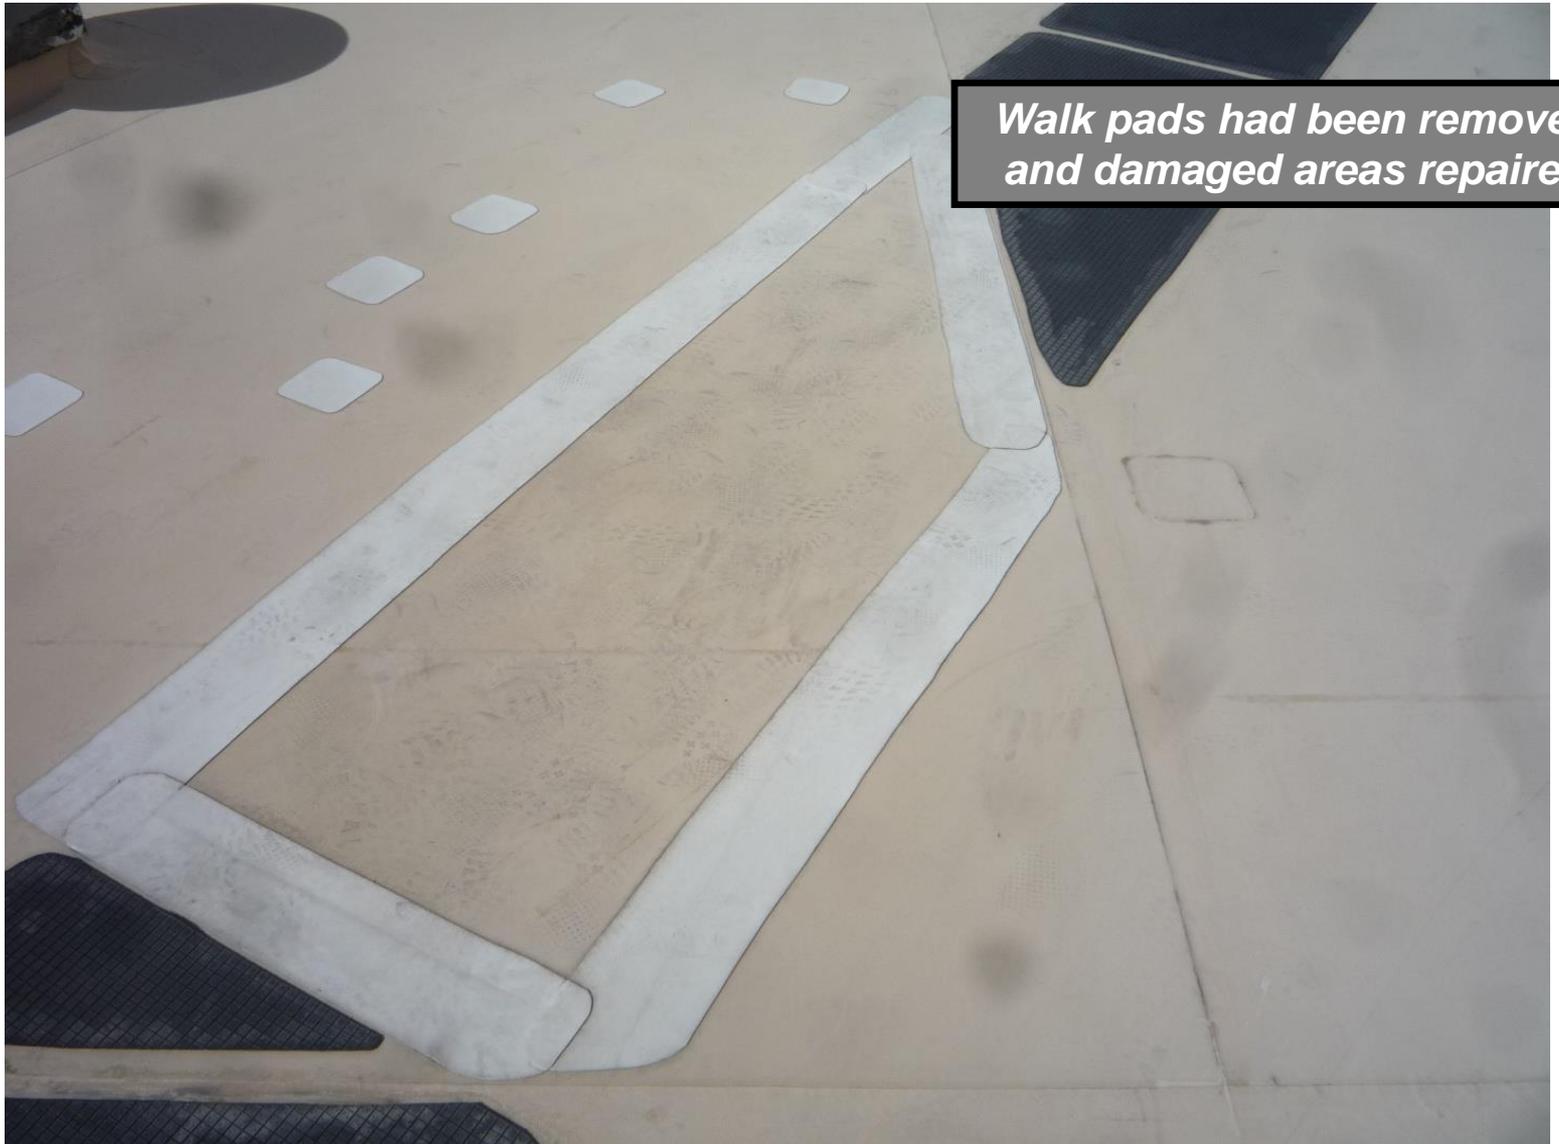
Walk pads had been removed and damaged areas repaired

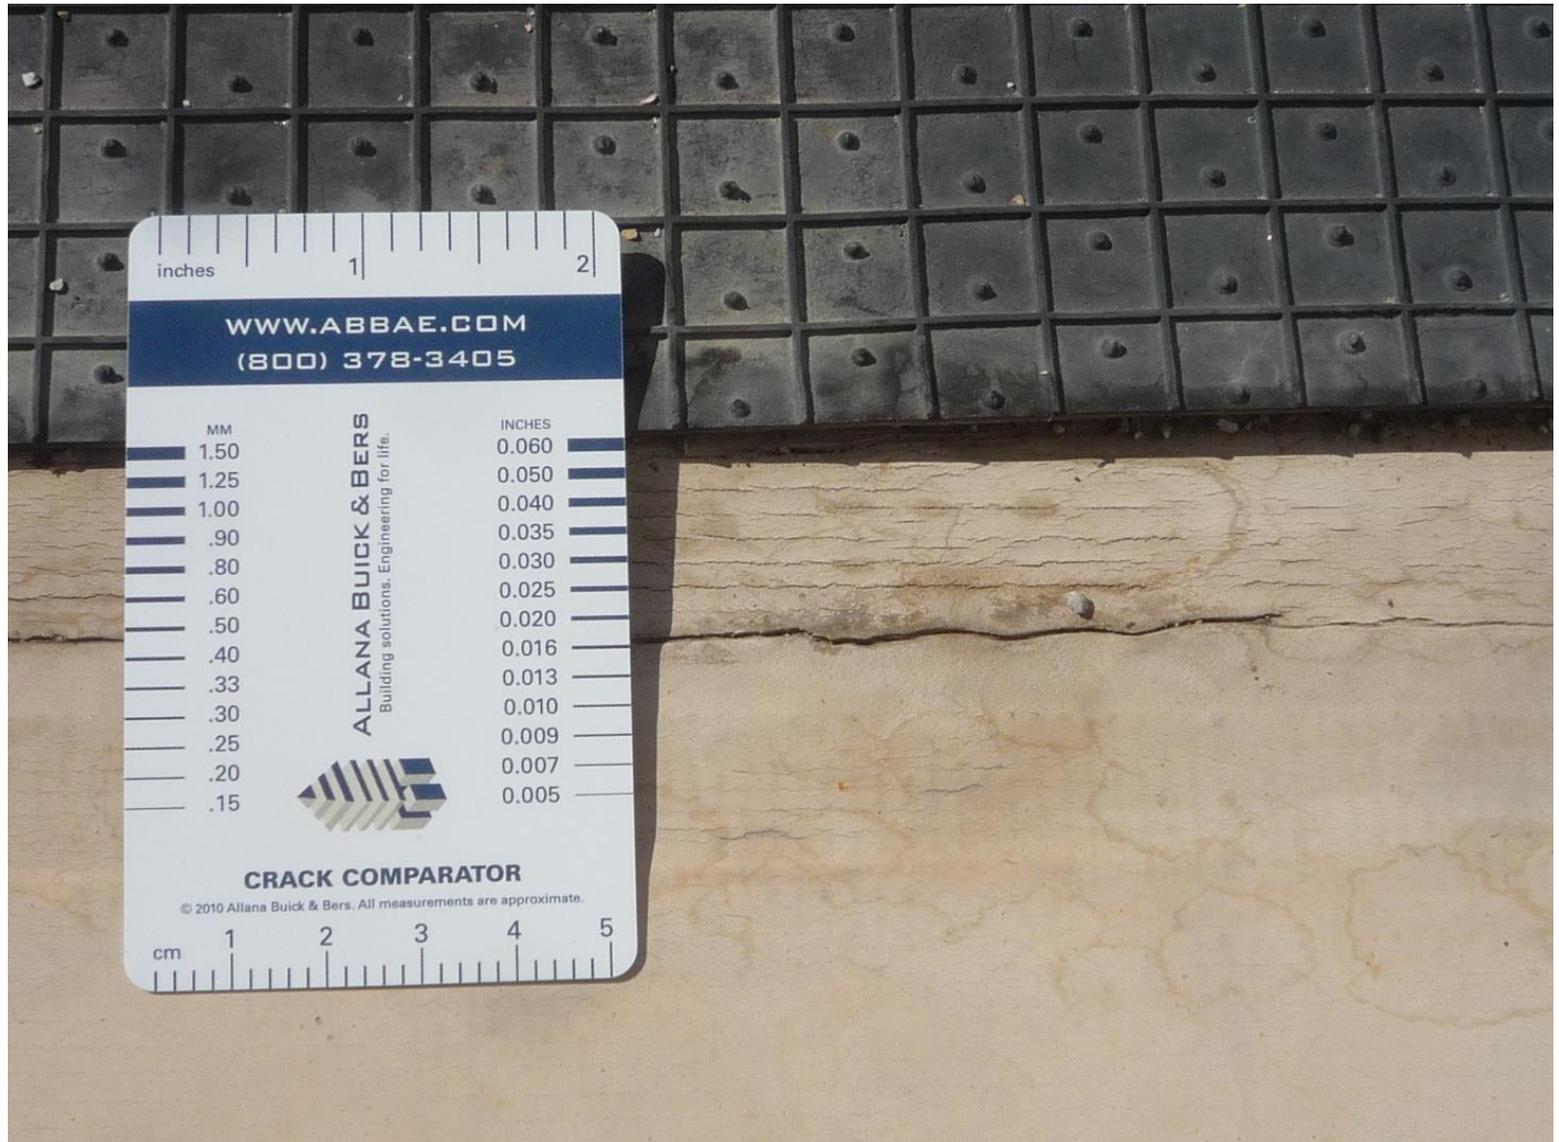
Seam and walk pad issues

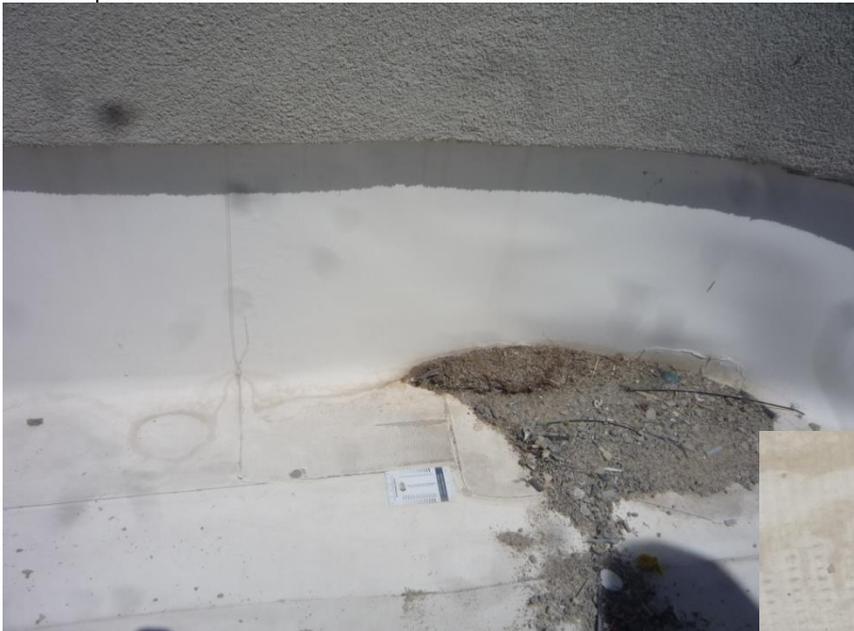
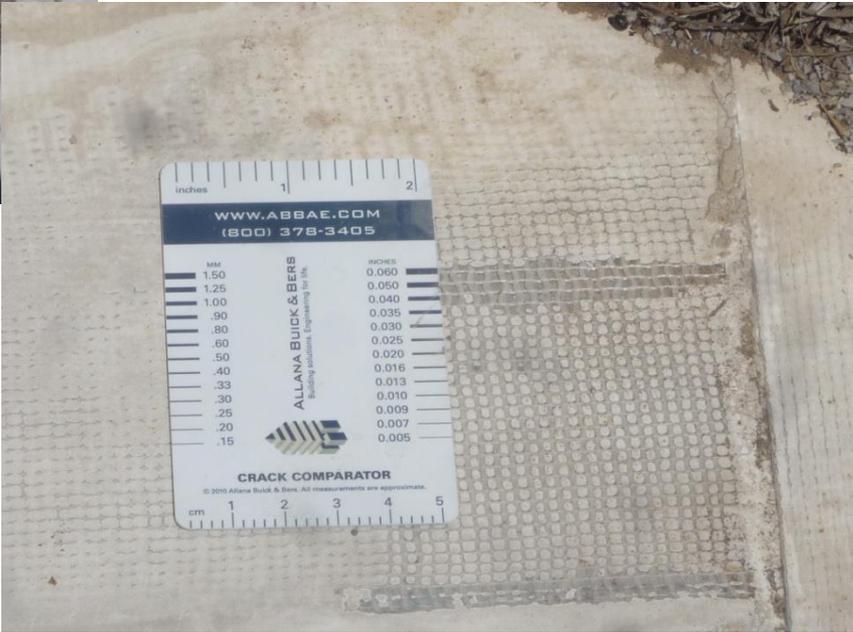
UV Damage at walk pad at the bottom of the transition ladder

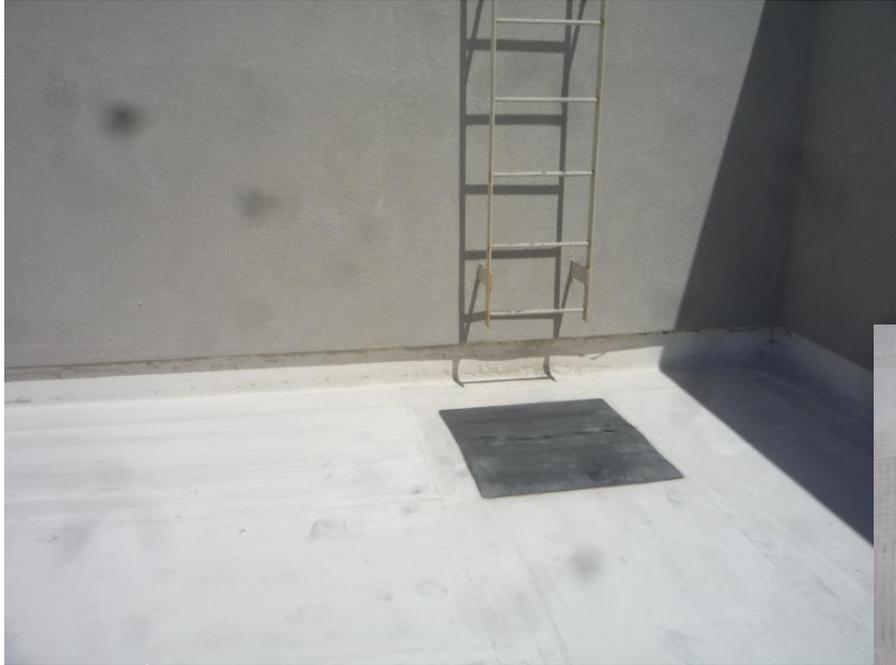
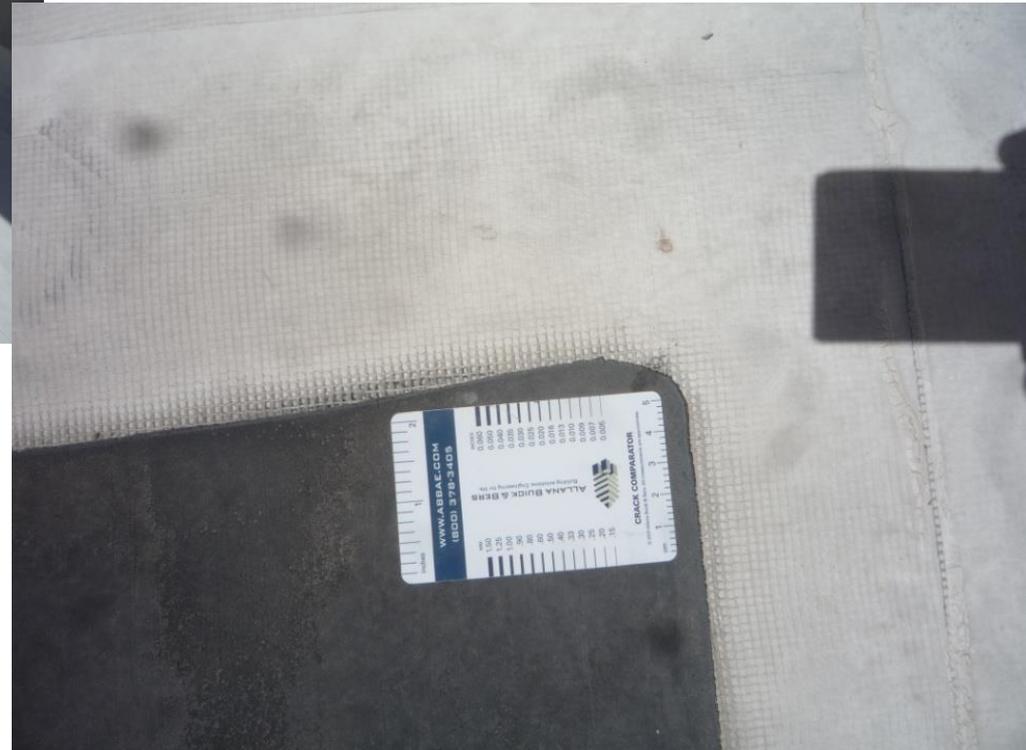
UV Damage at Edge of Walk Pad

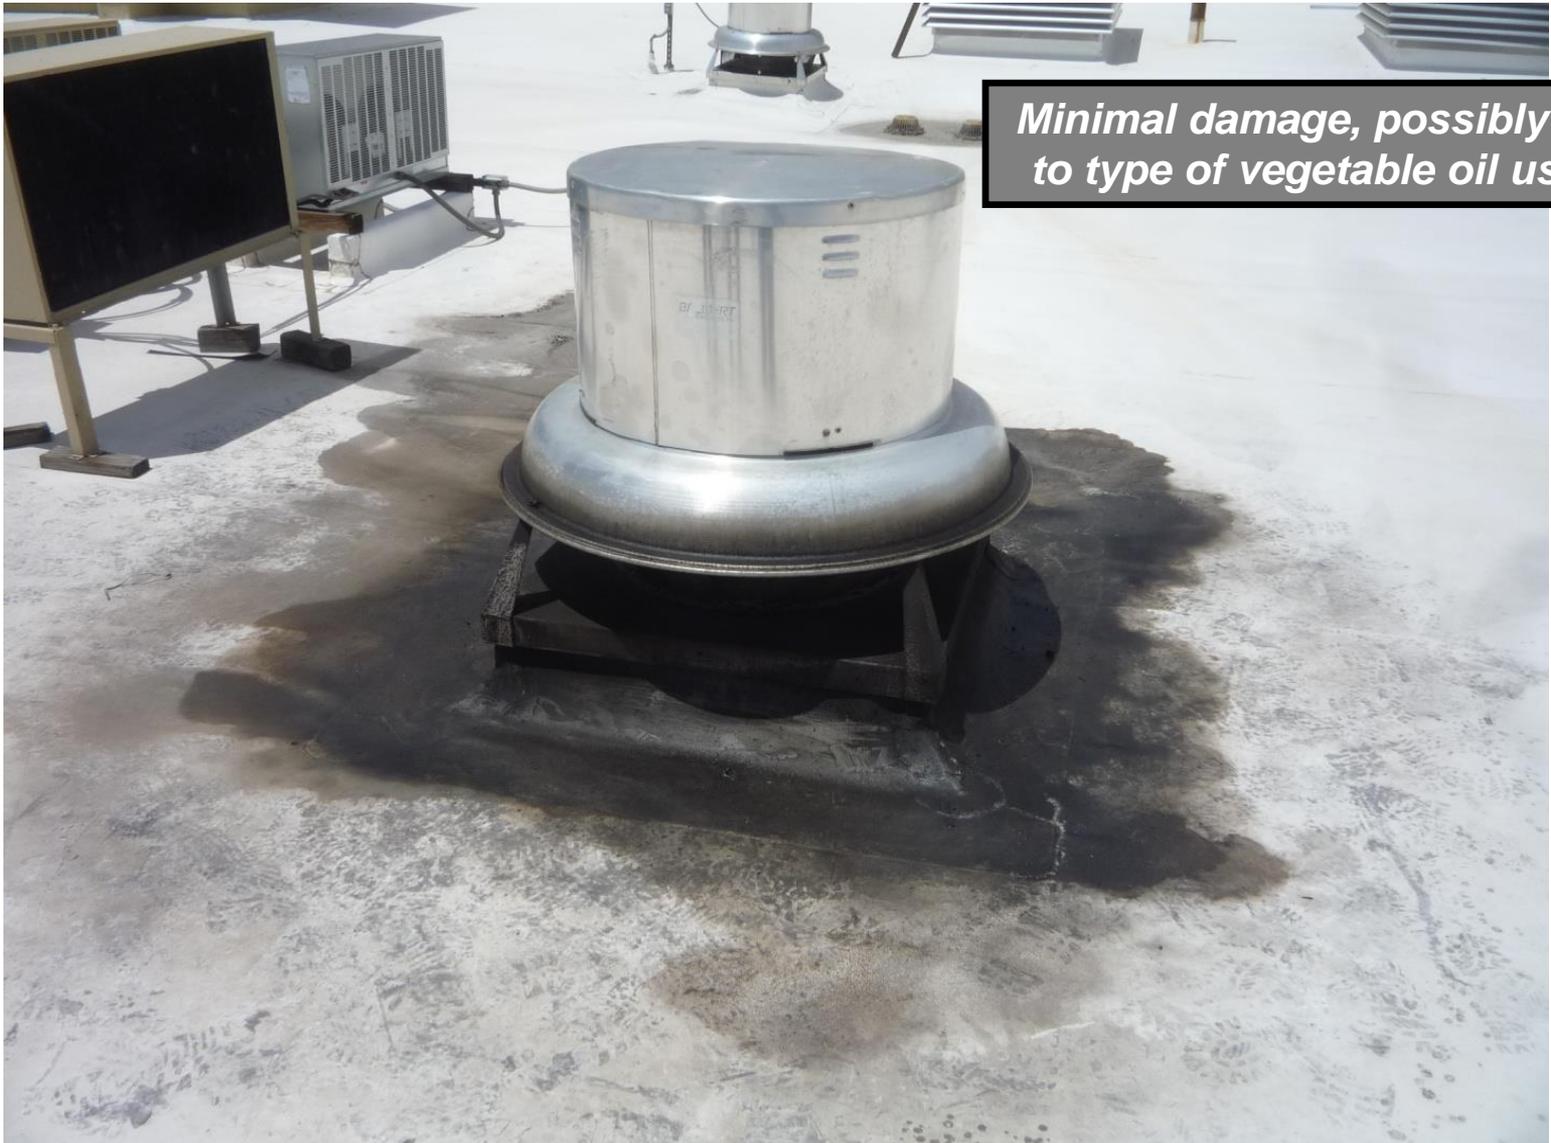
Grease Fan

Minimal damage, possibly due to type of vegetable oil used.

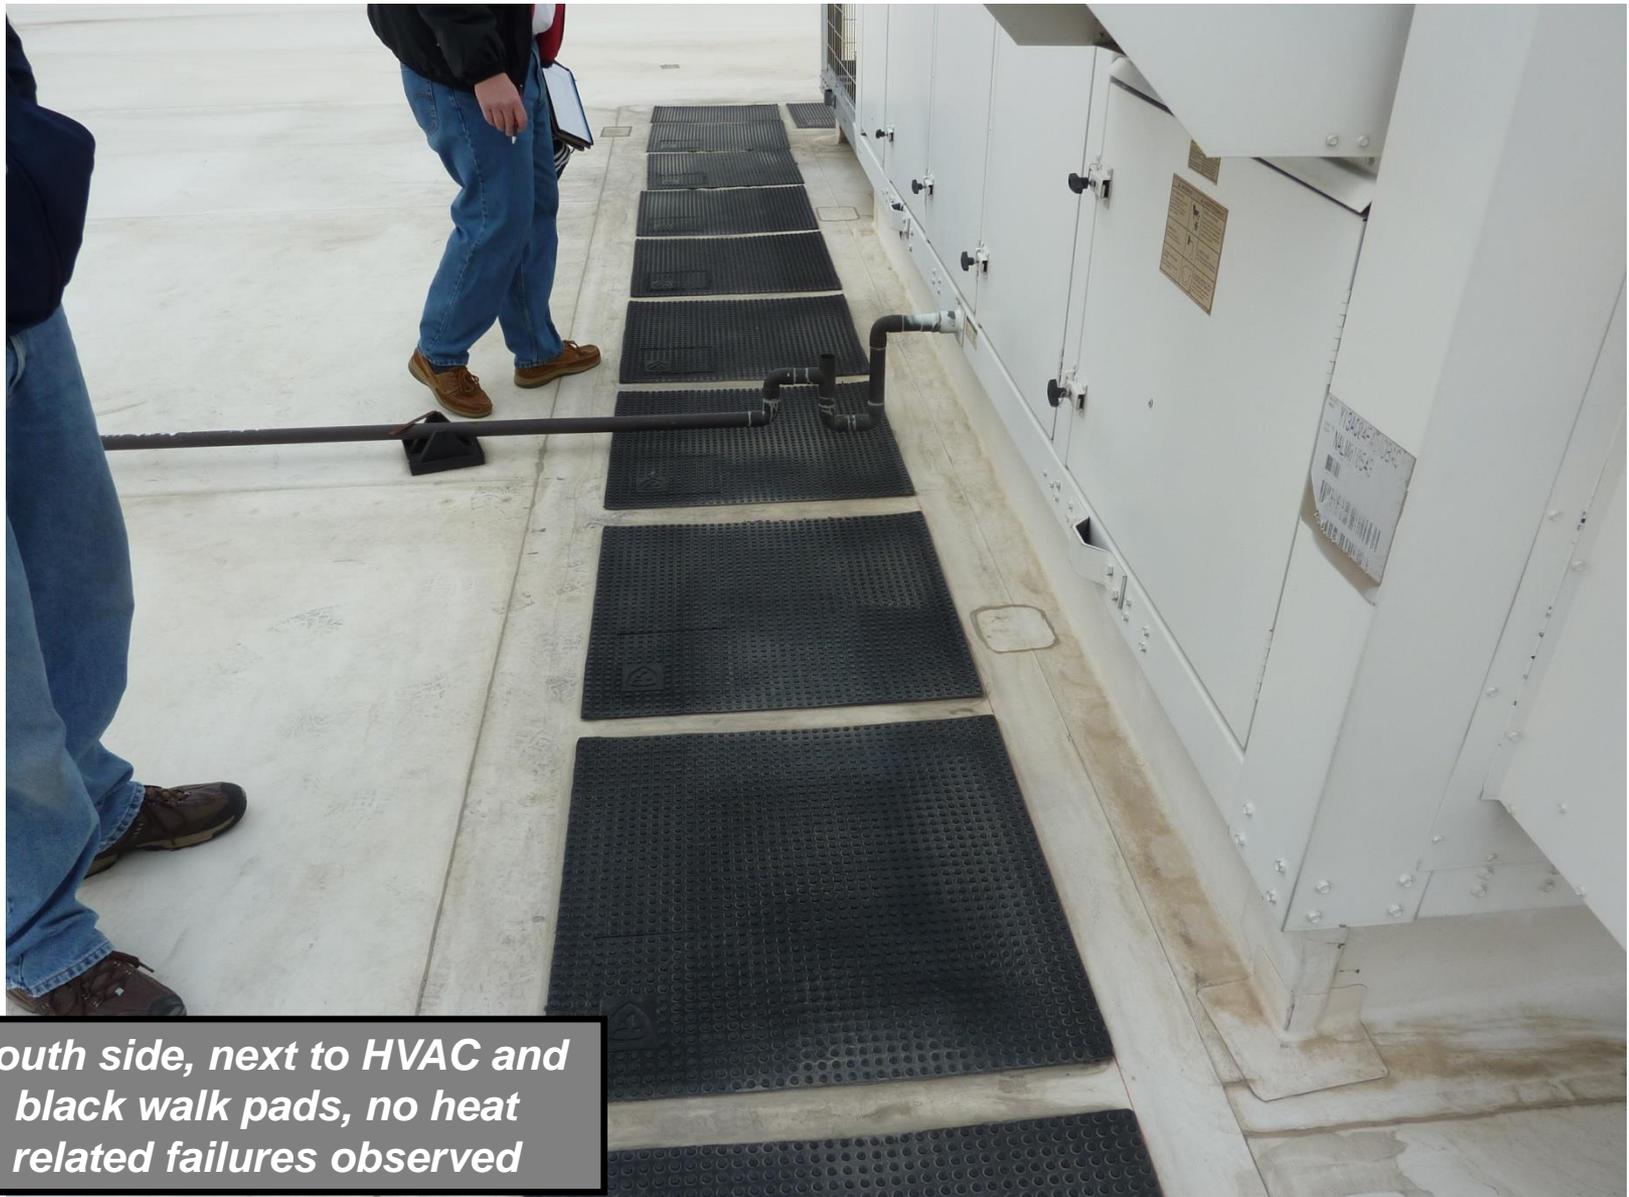
Sysco, Las Vegas, Firestone 8 Years Old

South side, next to HVAC and black walk pads, no heat related failures observed

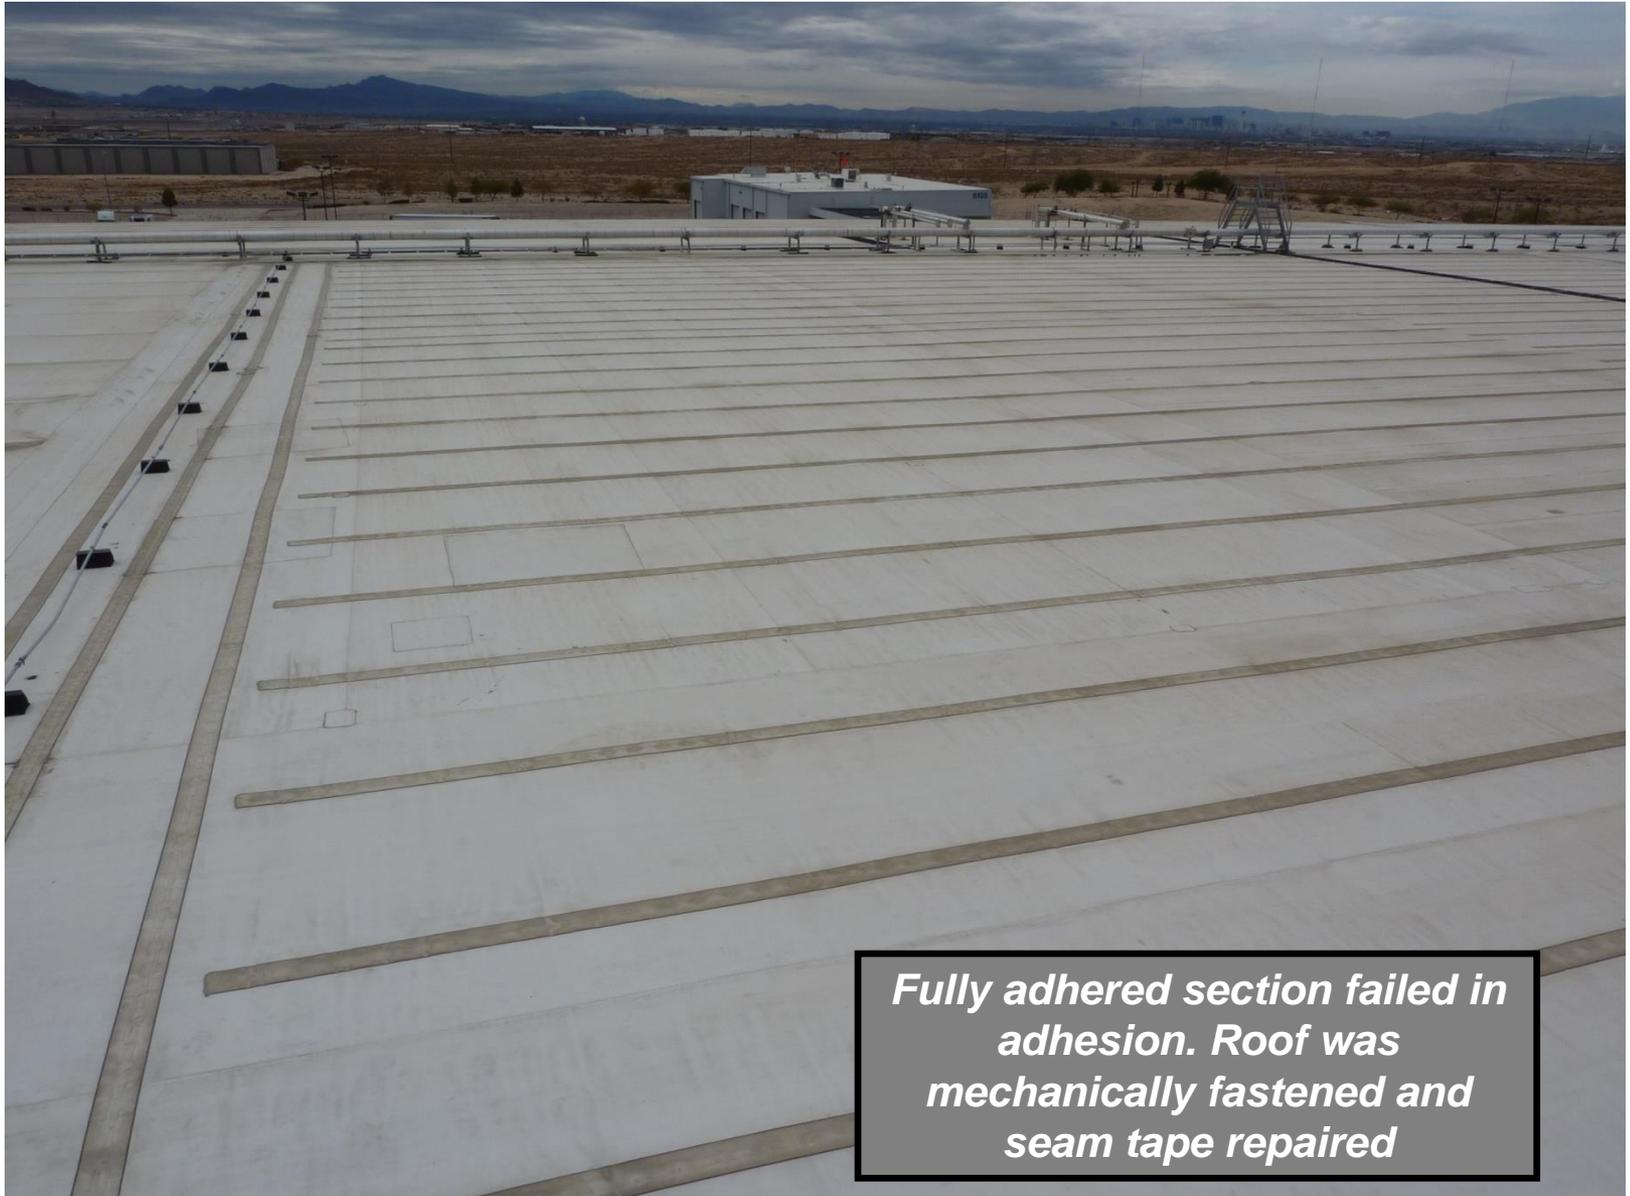
Sysco, Las Vegas, Firestone 8 Years Old

*Fully adhered section failed in
adhesion. Roof was
mechanically fastened and
seam tape repaired*

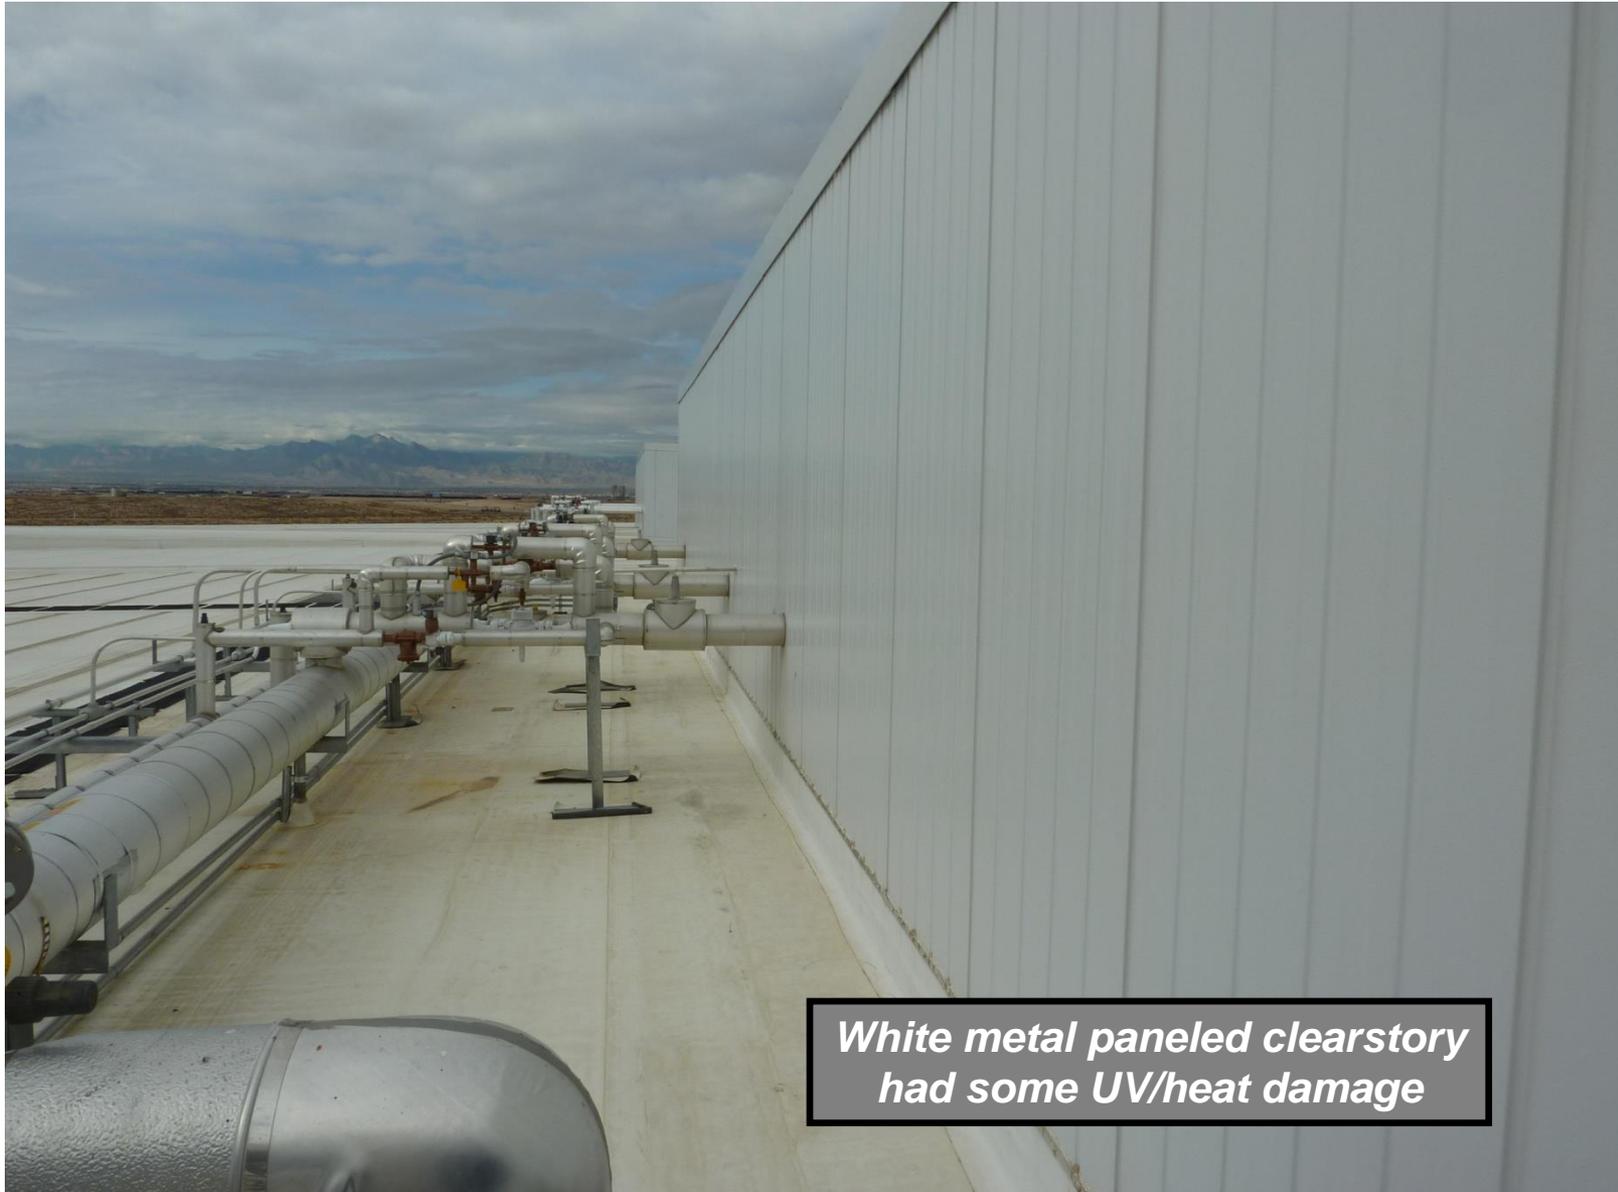
Sysco, Las Vegas, Firestone 8 Years Old

*White metal paneled clearstory
had some UV/heat damage*

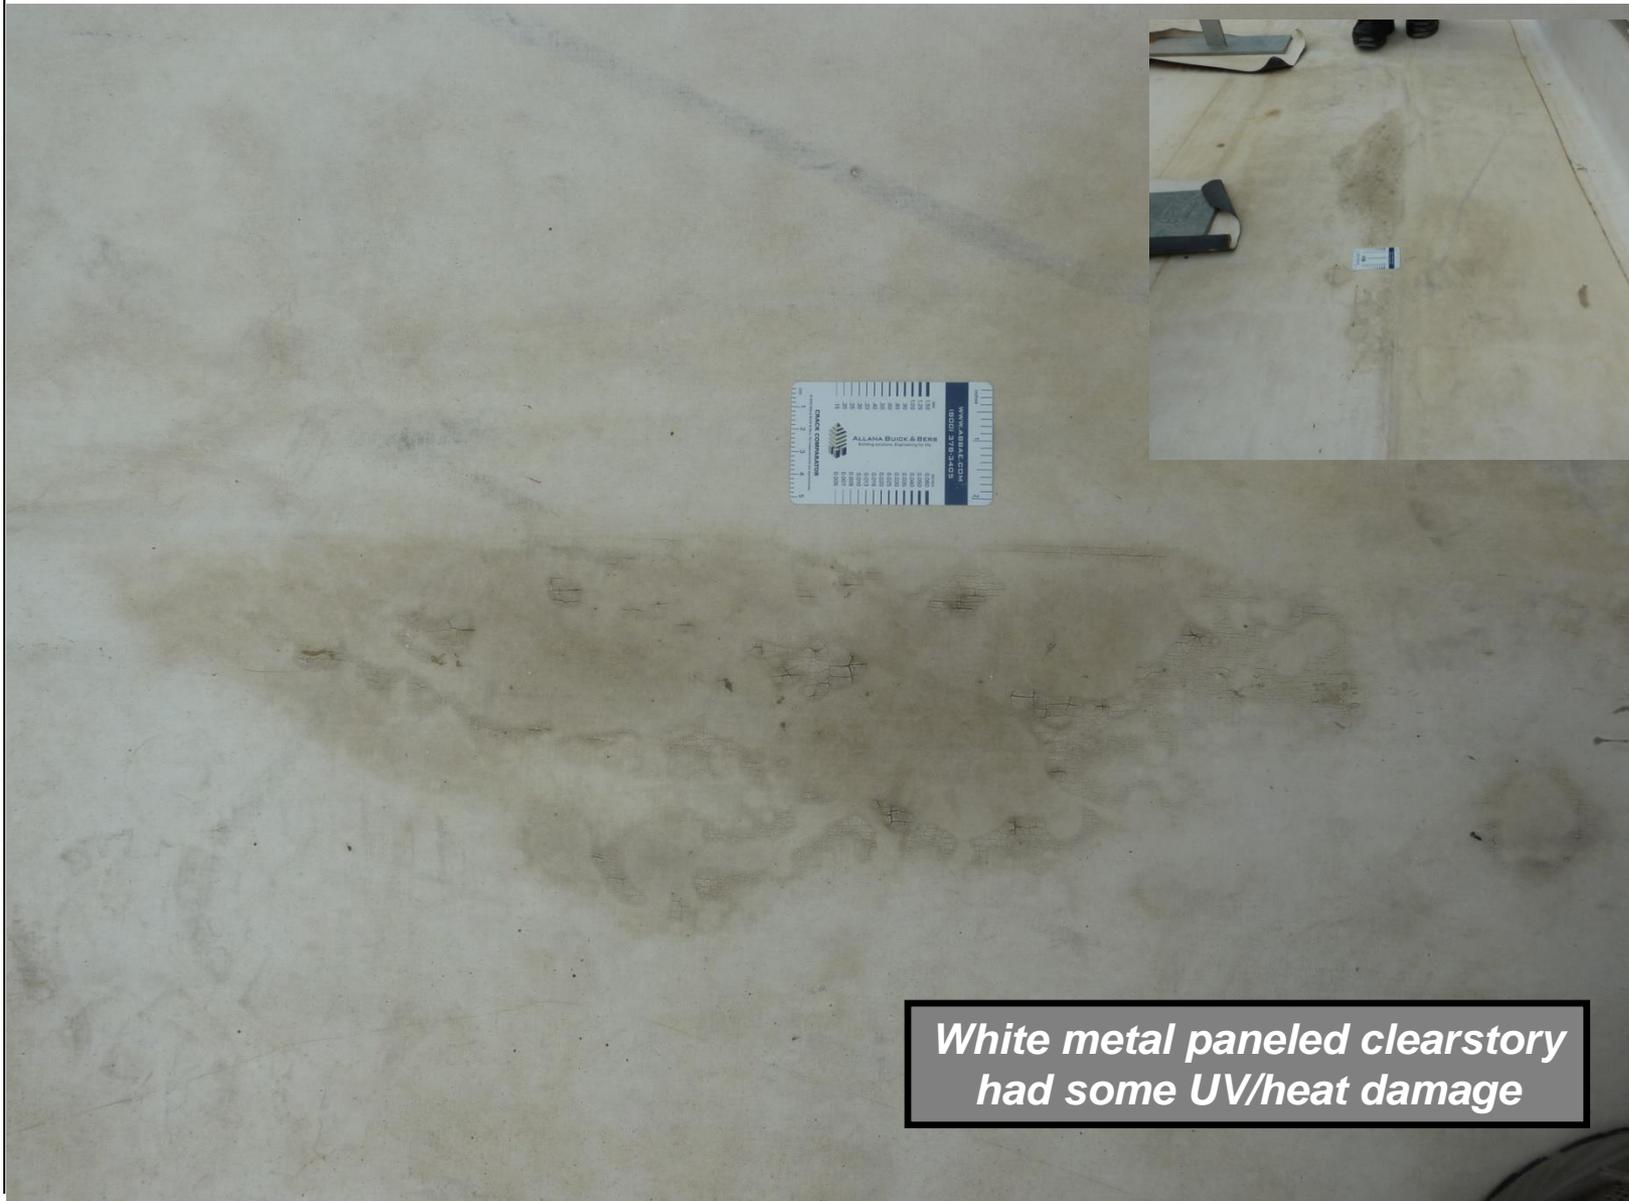
Sysco, Las Vegas, Firestone 8 Years Old

White metal paneled clearstory had some UV/heat damage
