**Critical Review of the Life Span of
TPO and PVC**

RCI Hawaii Seminar

Case Study: PVC

Case Study: TPO

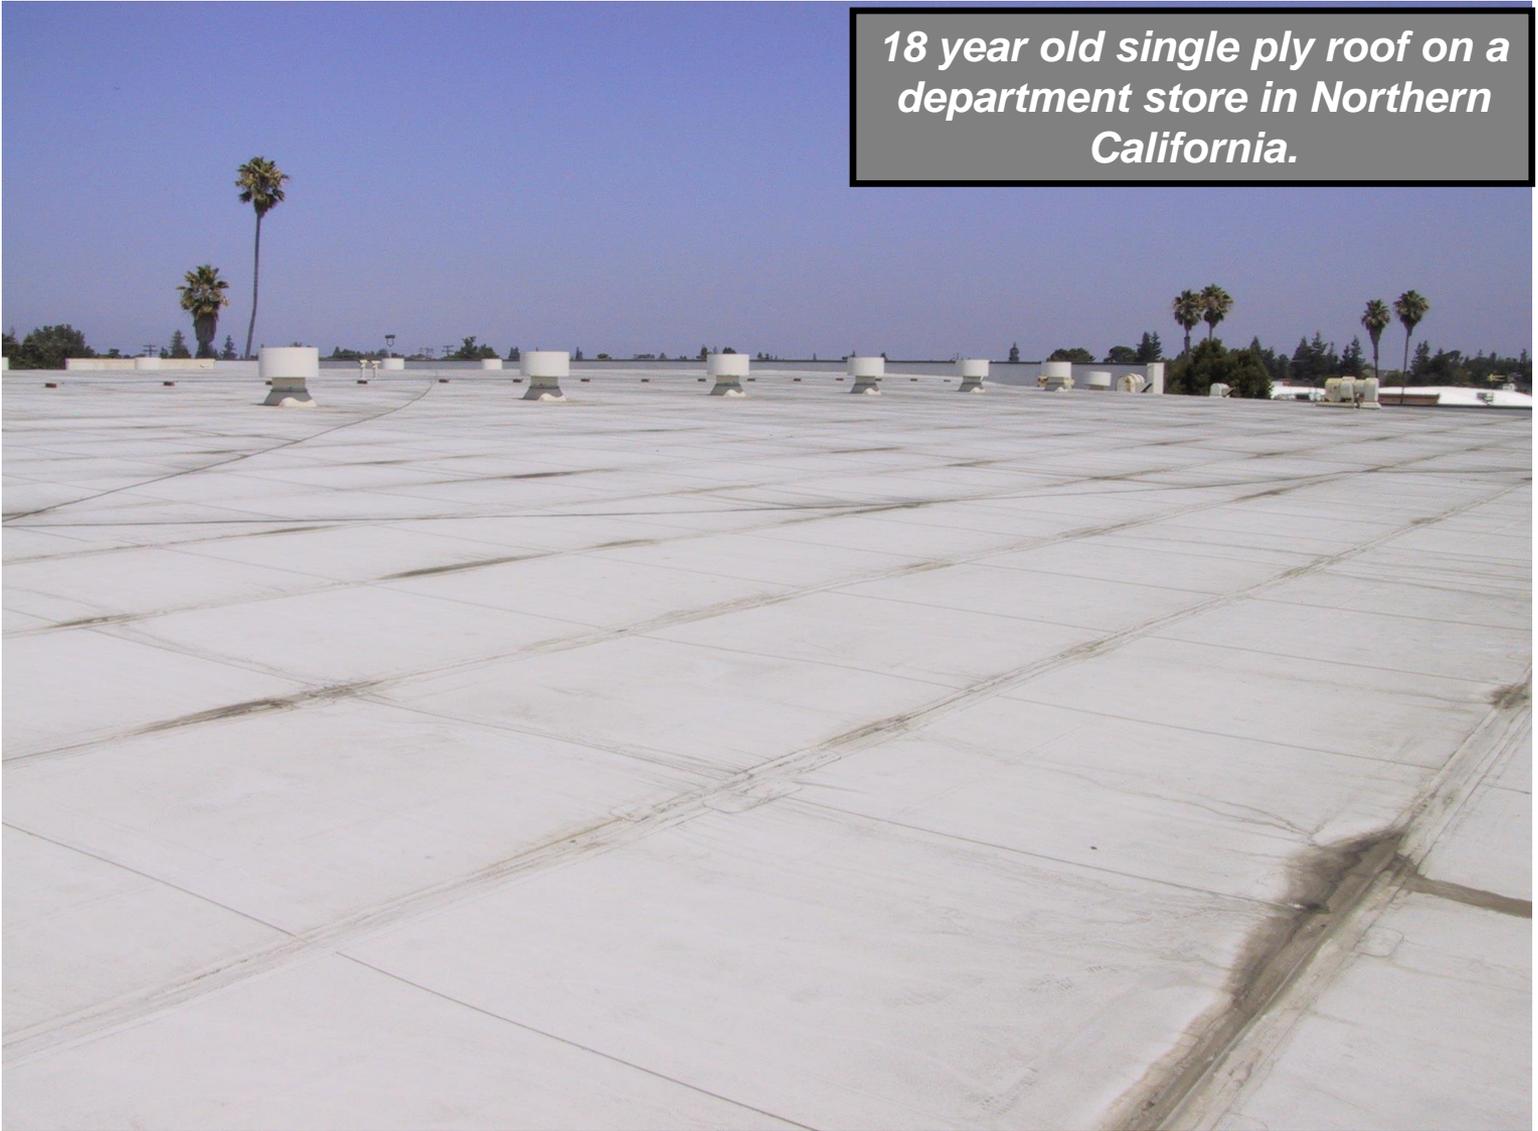
18 year old single ply roof on a department store in Northern California.

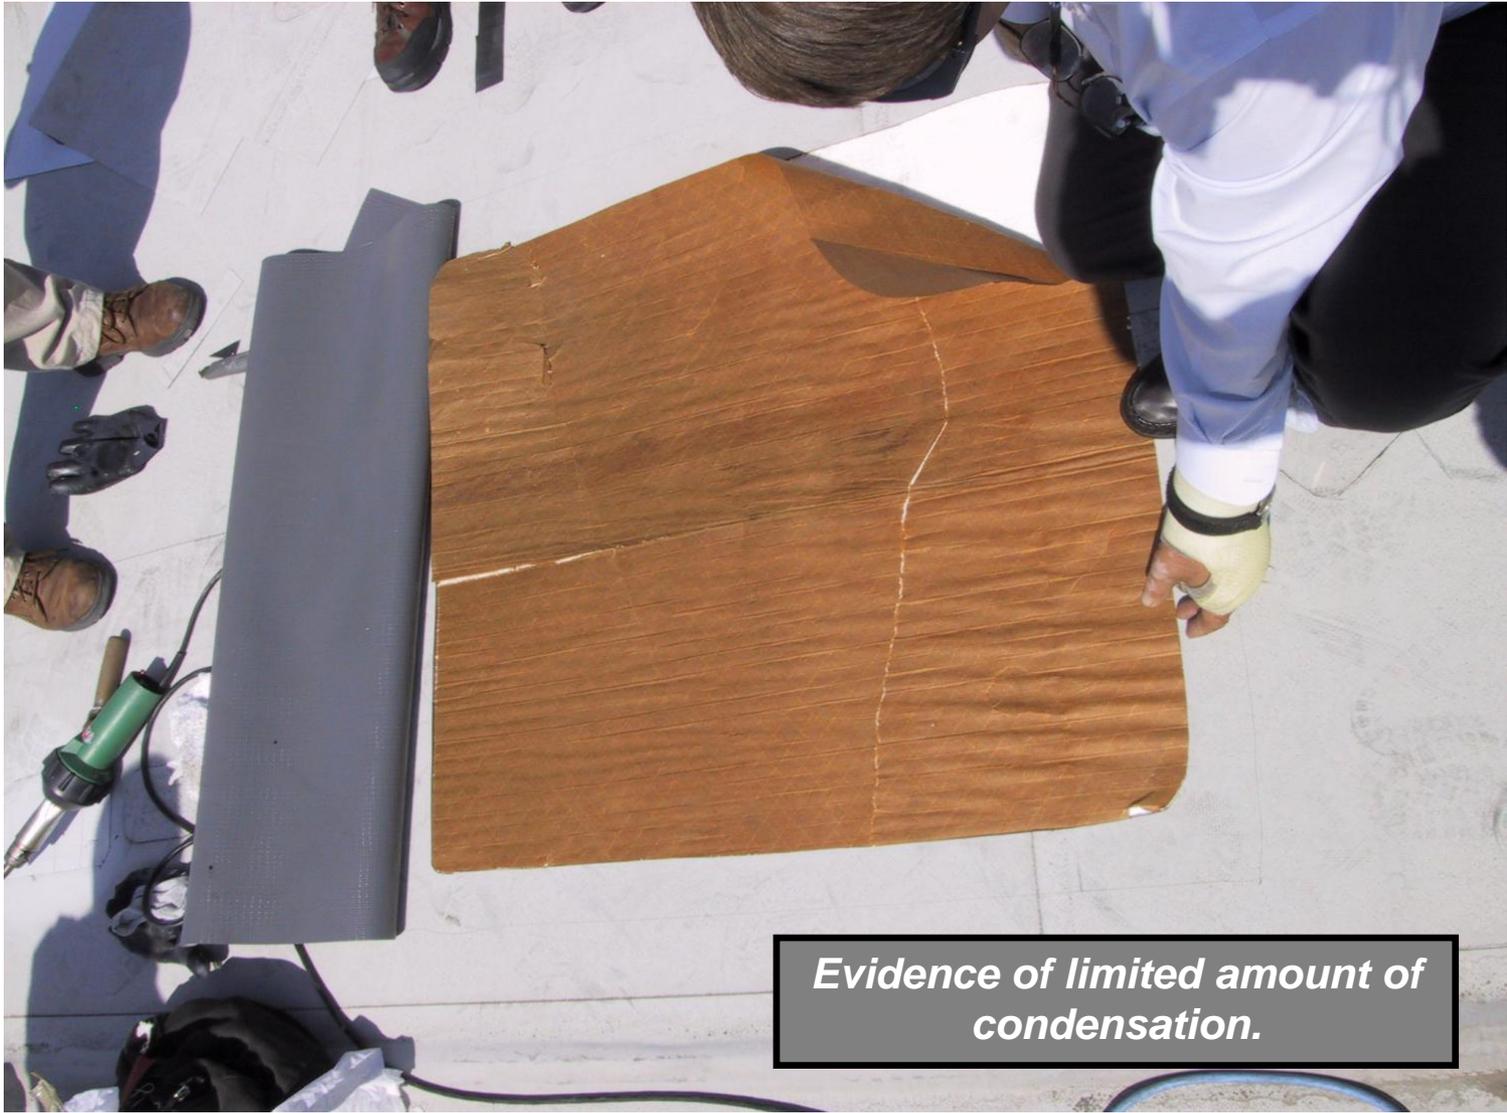
Test cut exposing rosin paper and insulation.

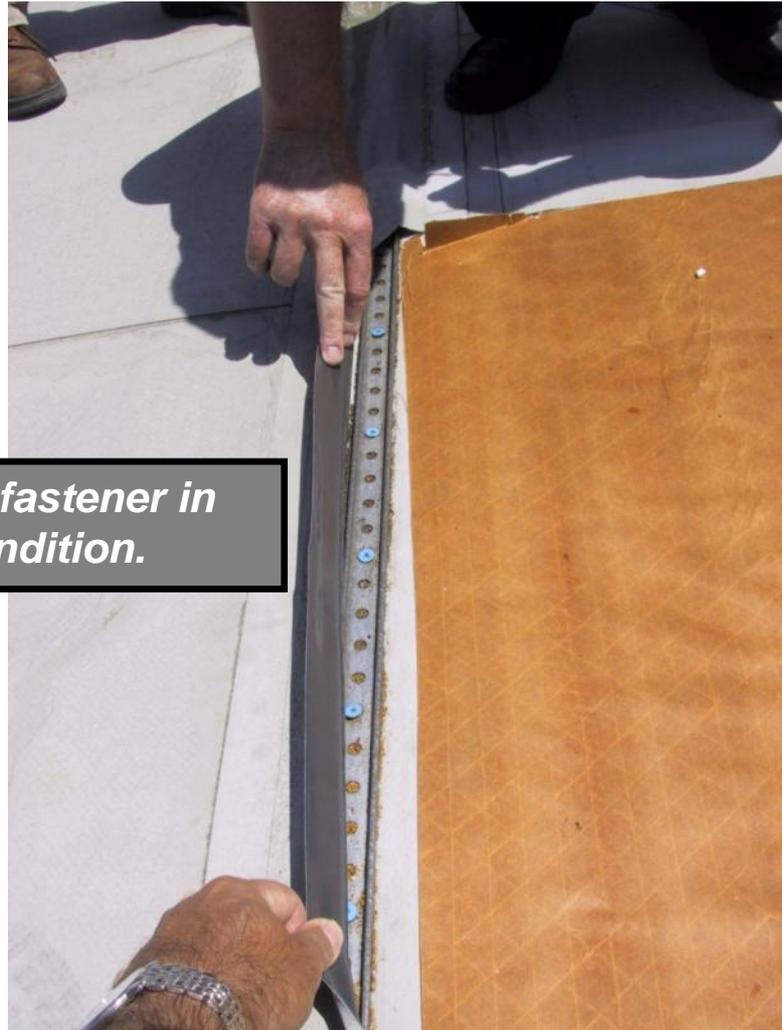
Evidence of limited amount of condensation.

Mechanical bar fastener in excellent condition.

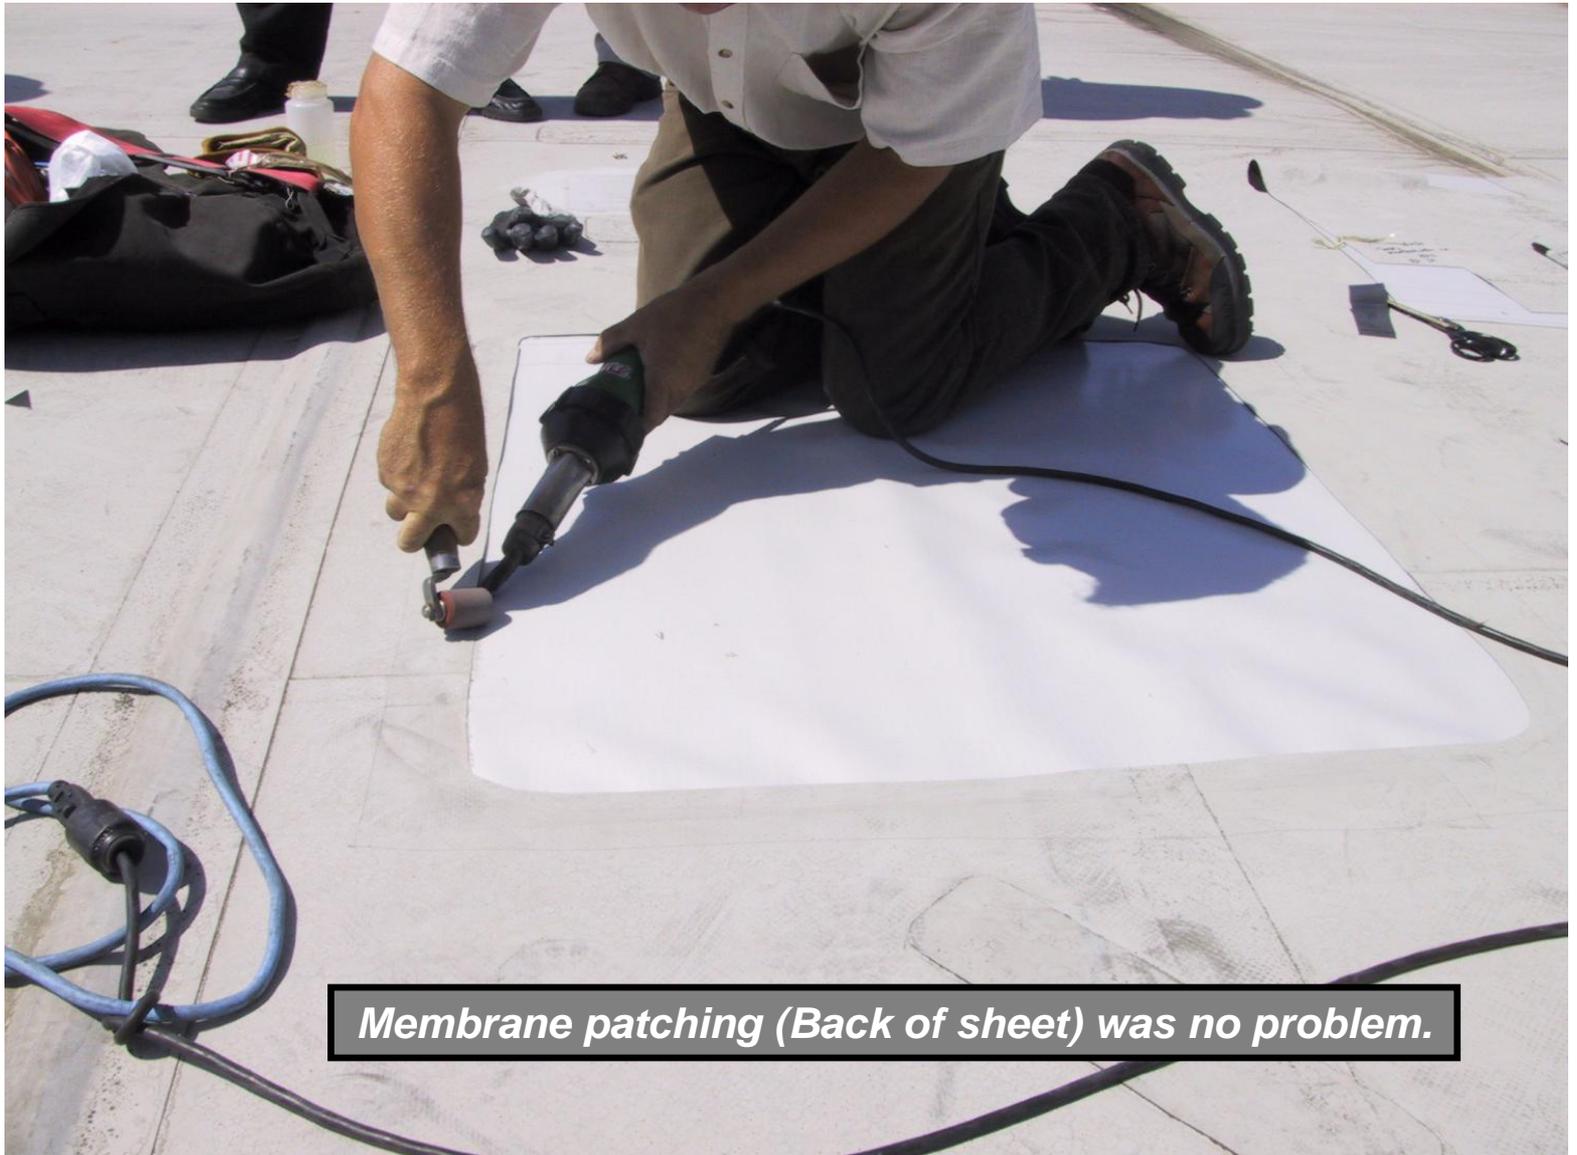
Membrane patching (Back of sheet) was no problem.

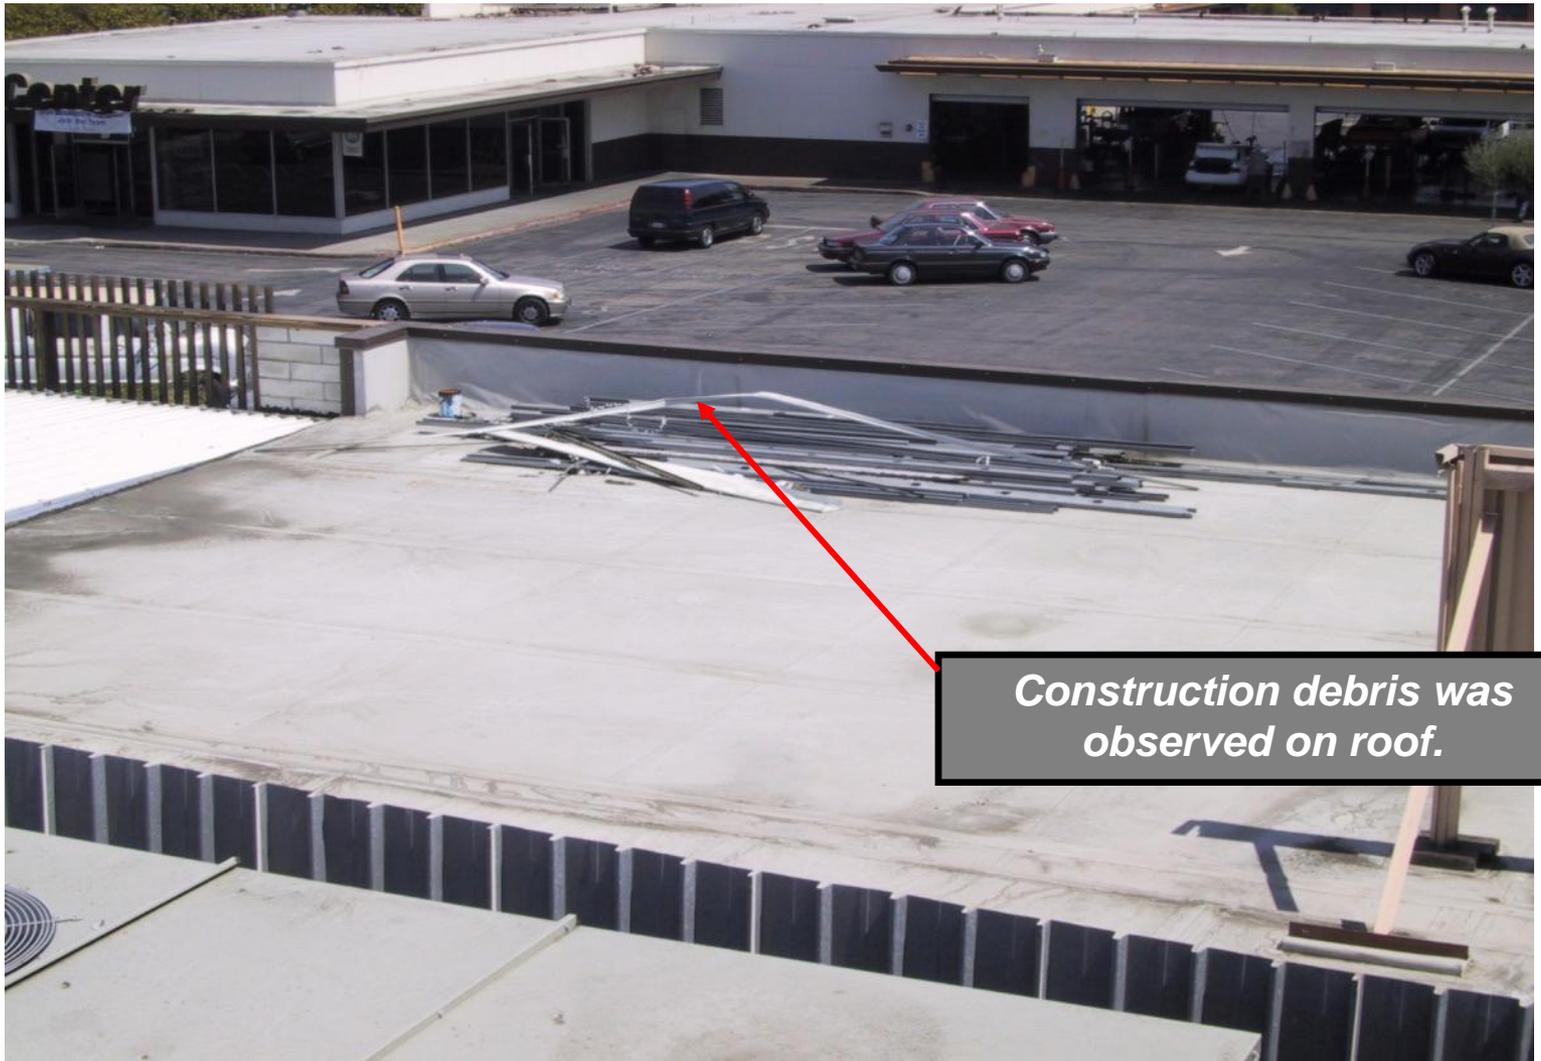
Construction debris was observed on roof.

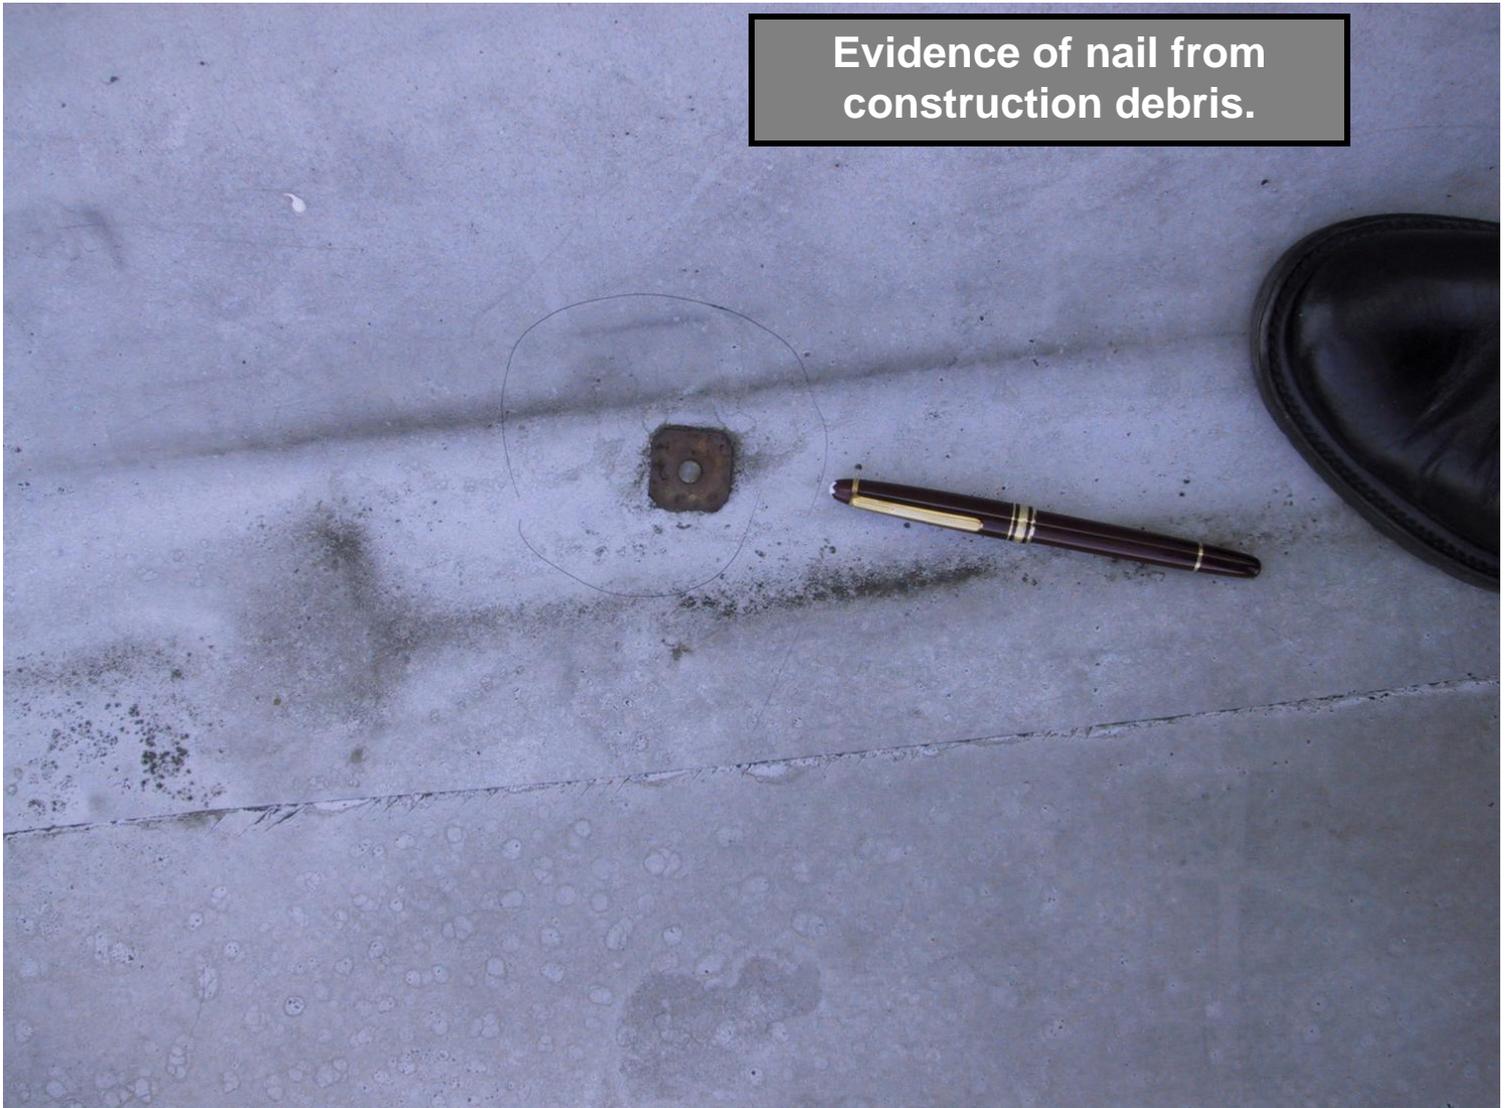
Impact damage from unknown source.

Evidence of nail from construction debris.

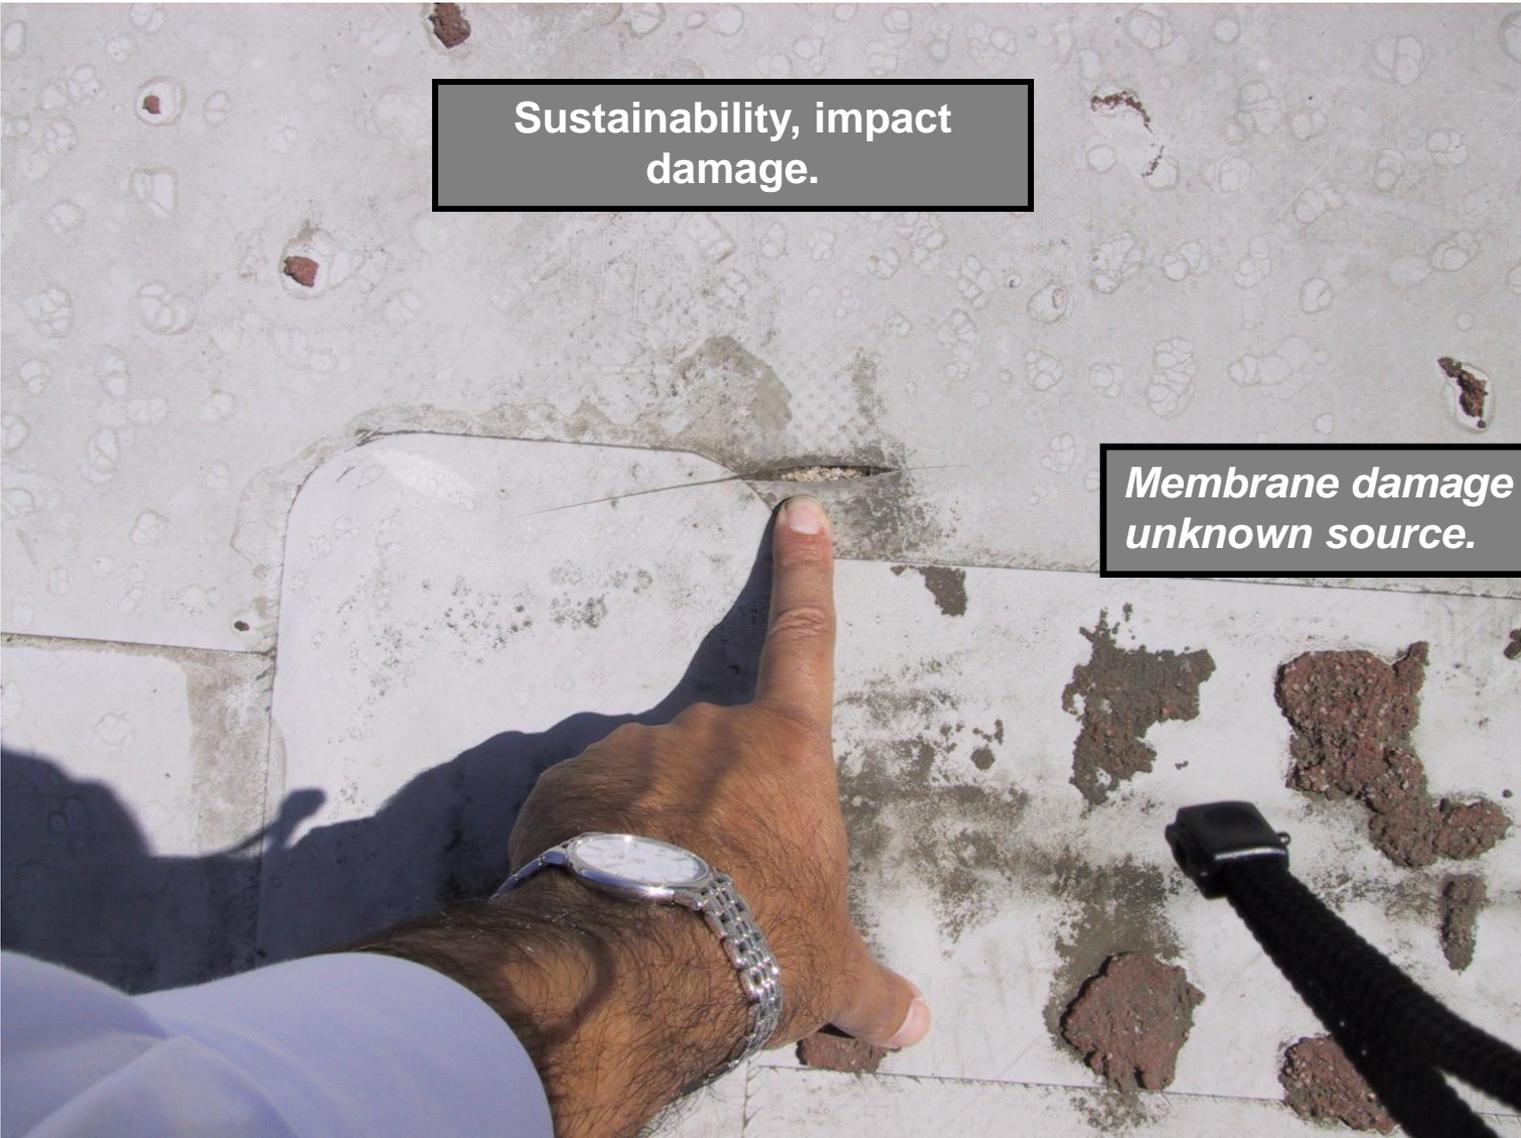
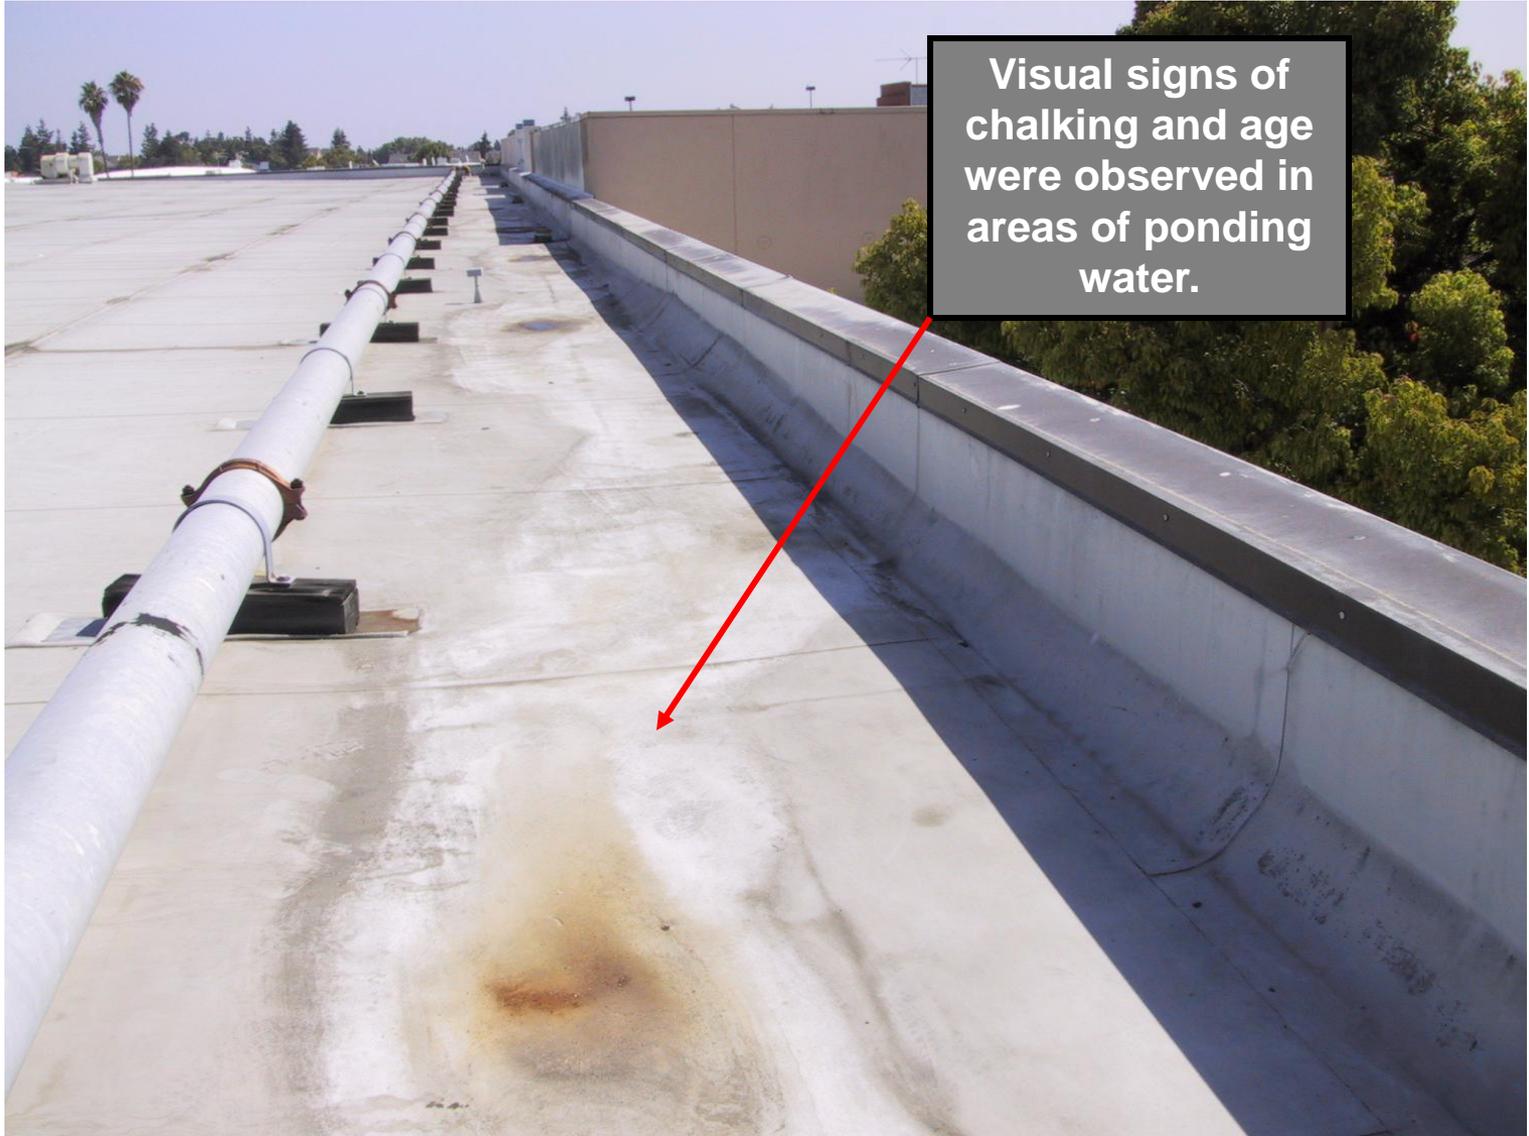
**Sustainability, impact
damage.**

***Membrane damage from
unknown source.***

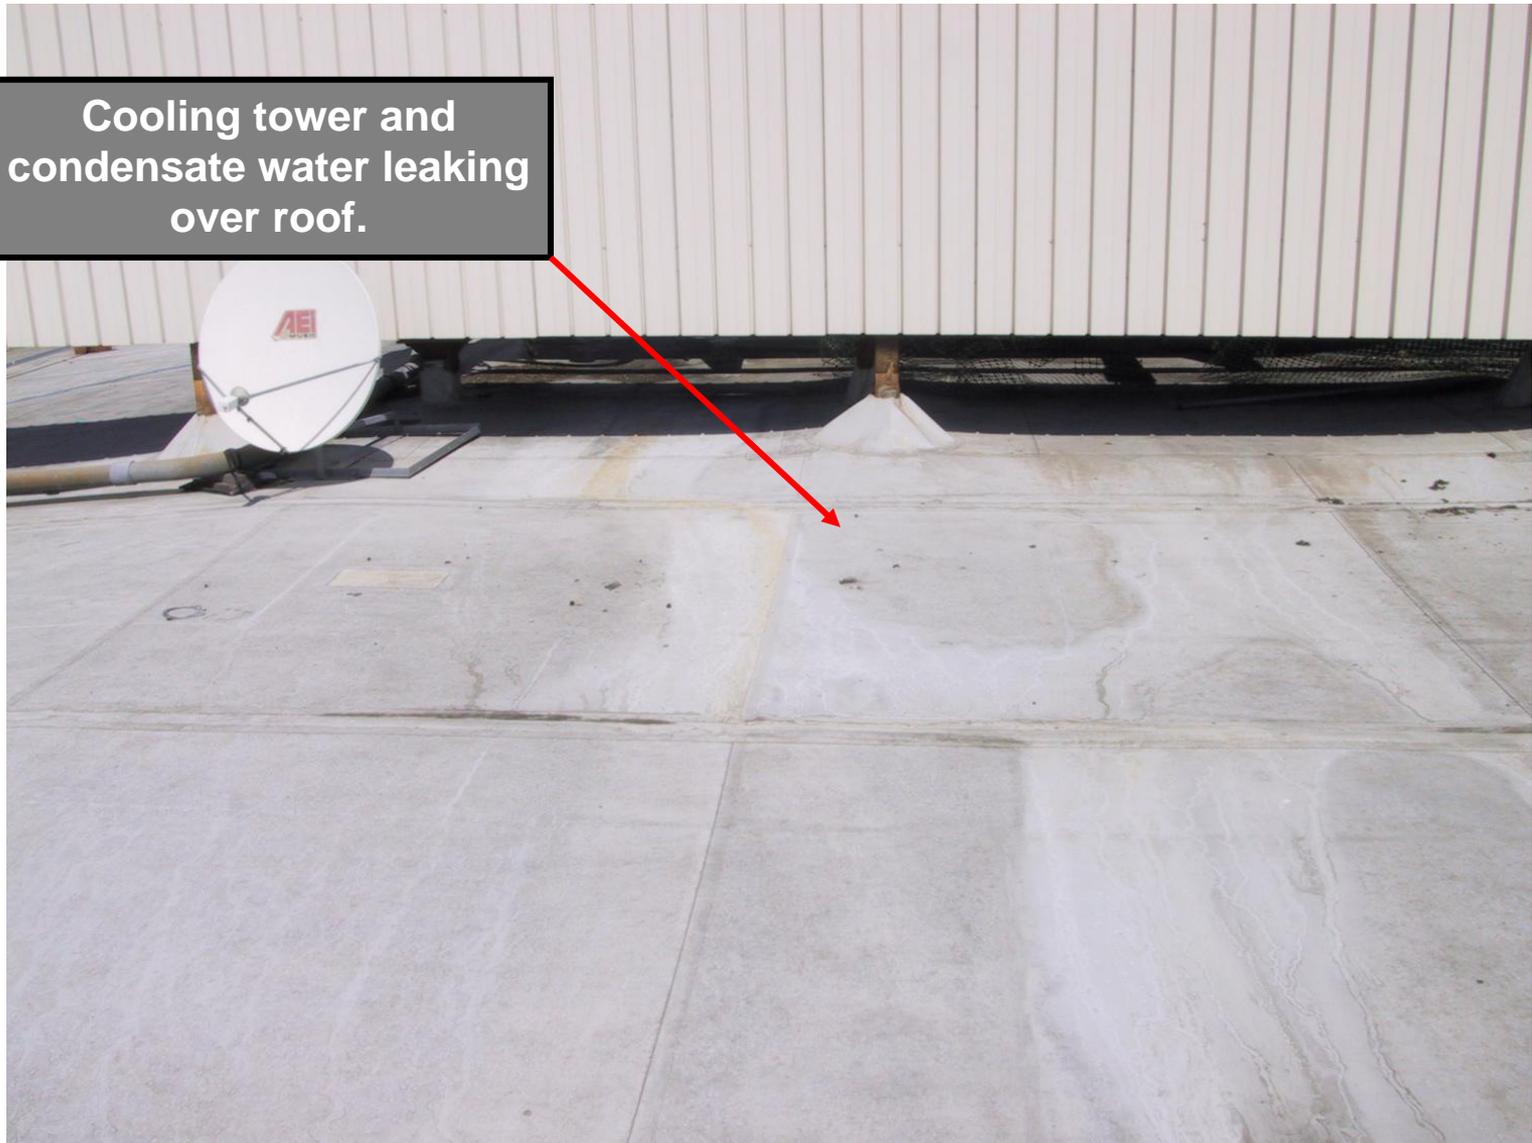
Visual signs of chalking and age were observed in areas of ponding water.

**Cooling tower and
condensate water leaking
over roof.**

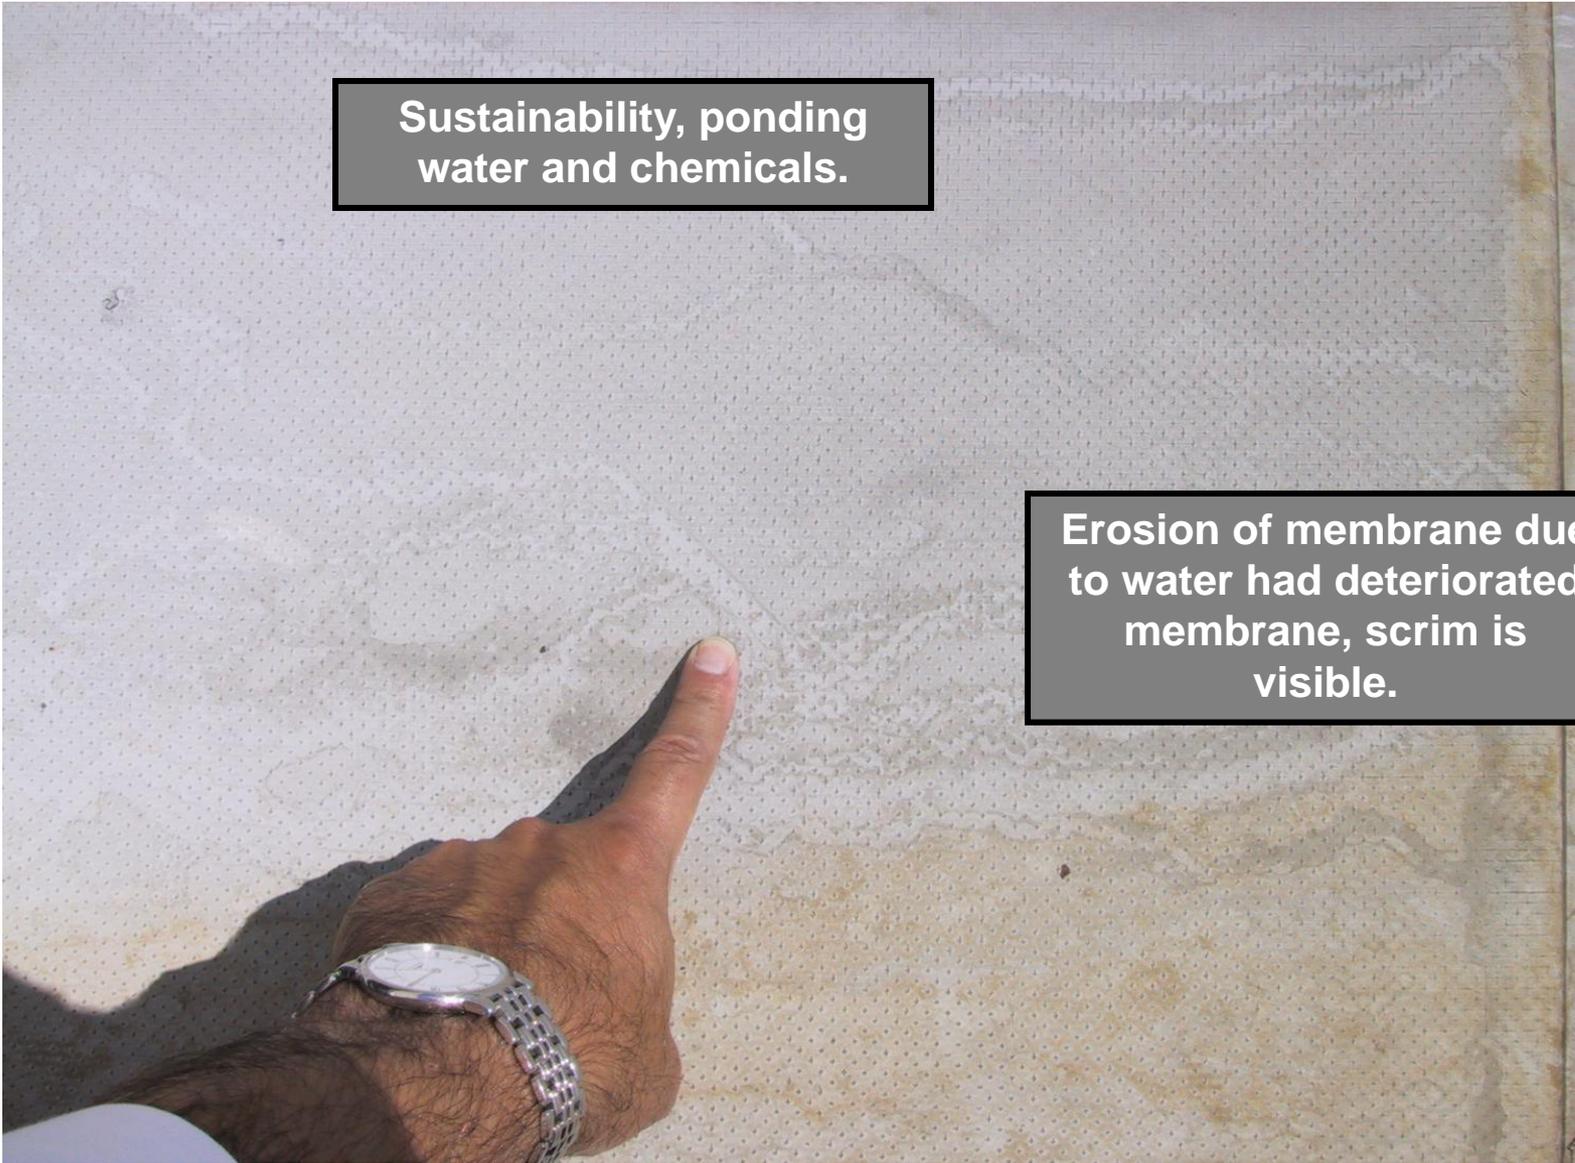
**Sustainability, ponding
water and chemicals.**

**Erosion of membrane due
to water had deteriorated
membrane, scrim is
visible.**

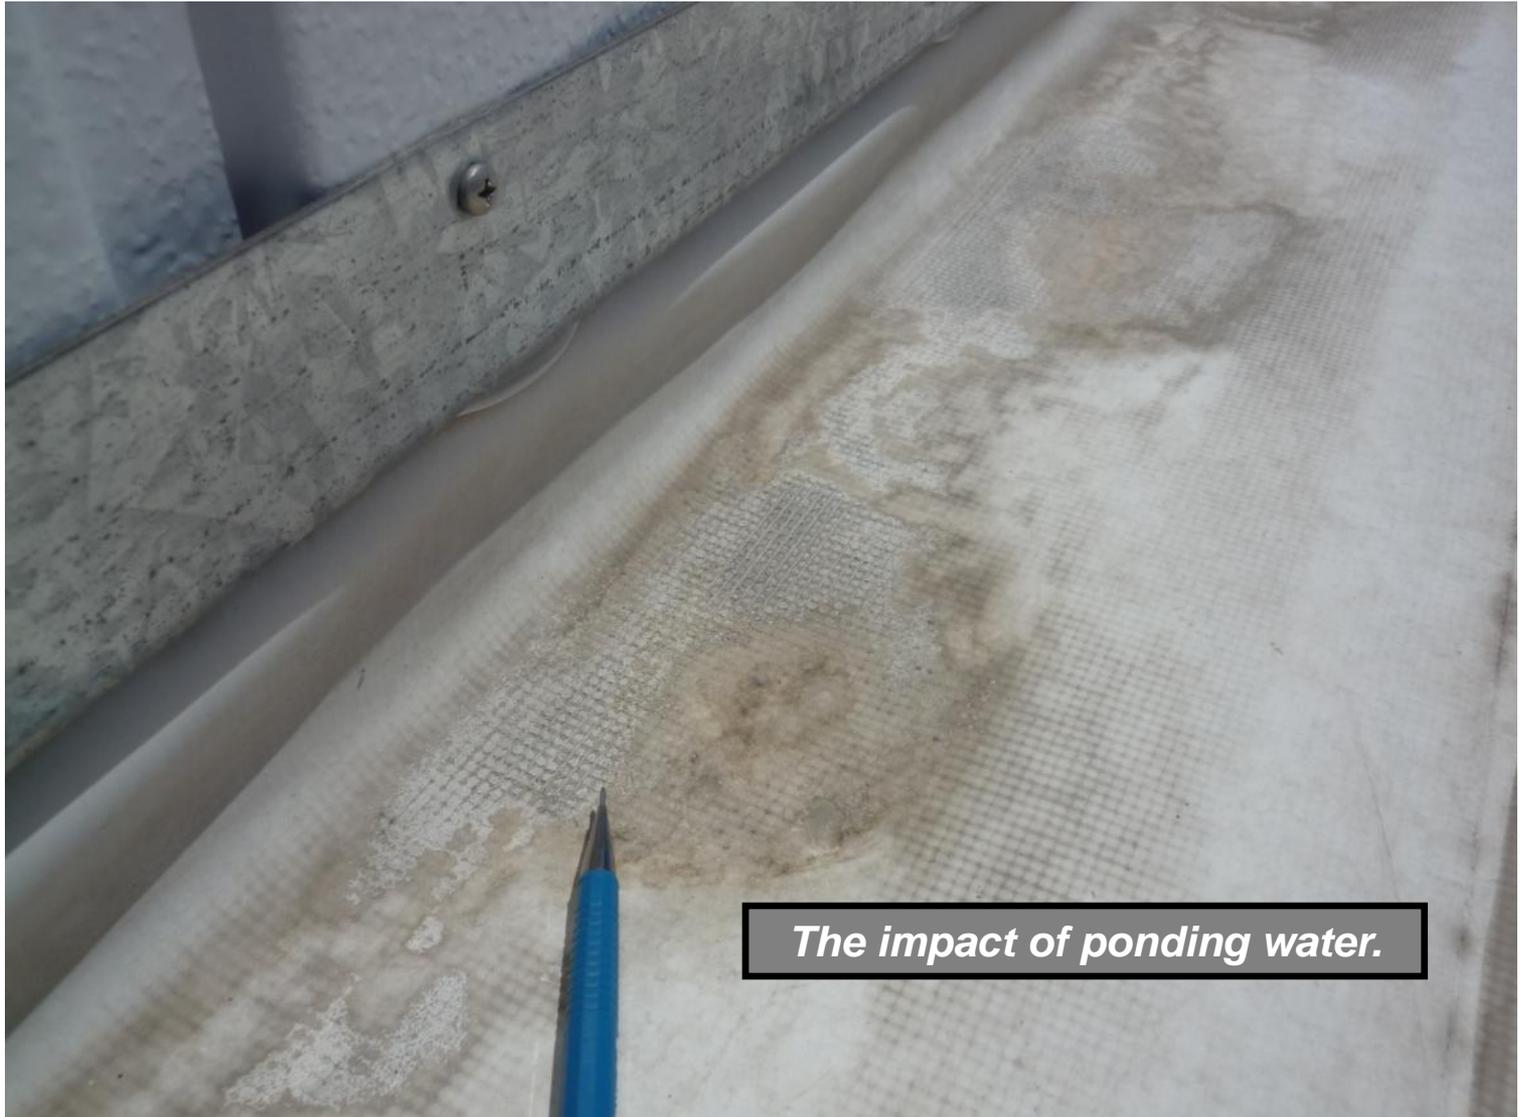
The impact of ponding water.

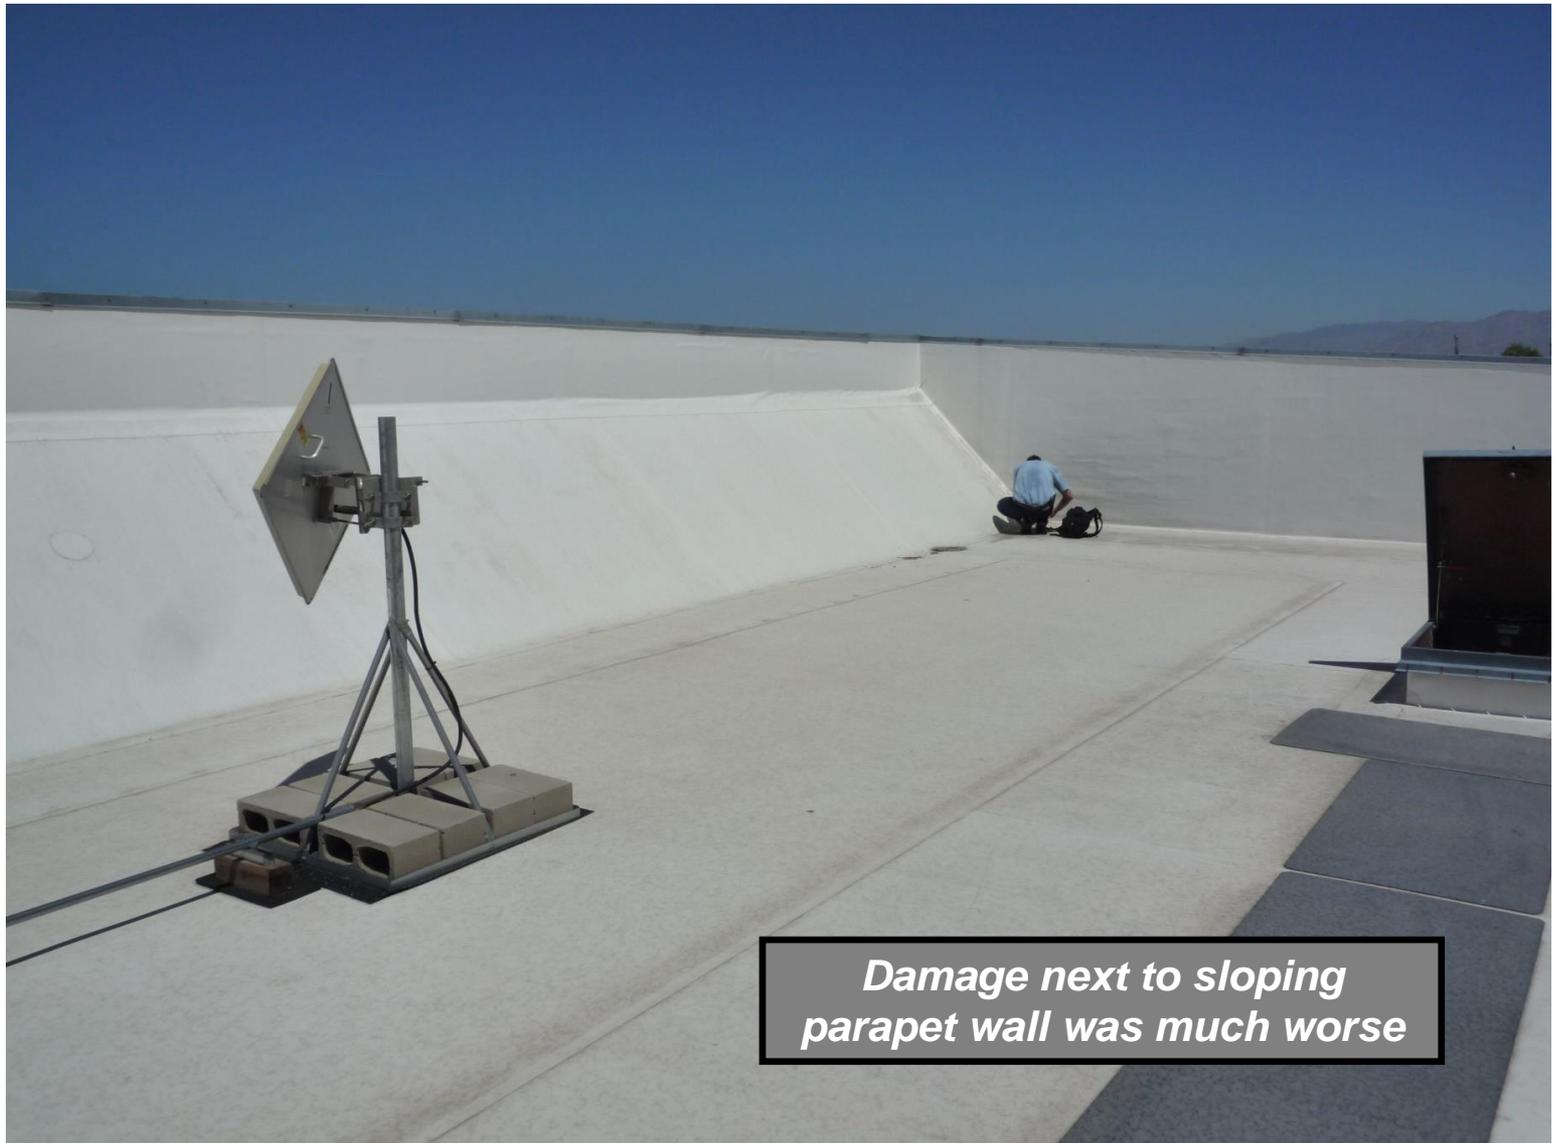
Damage next to sloping parapet wall was much worse

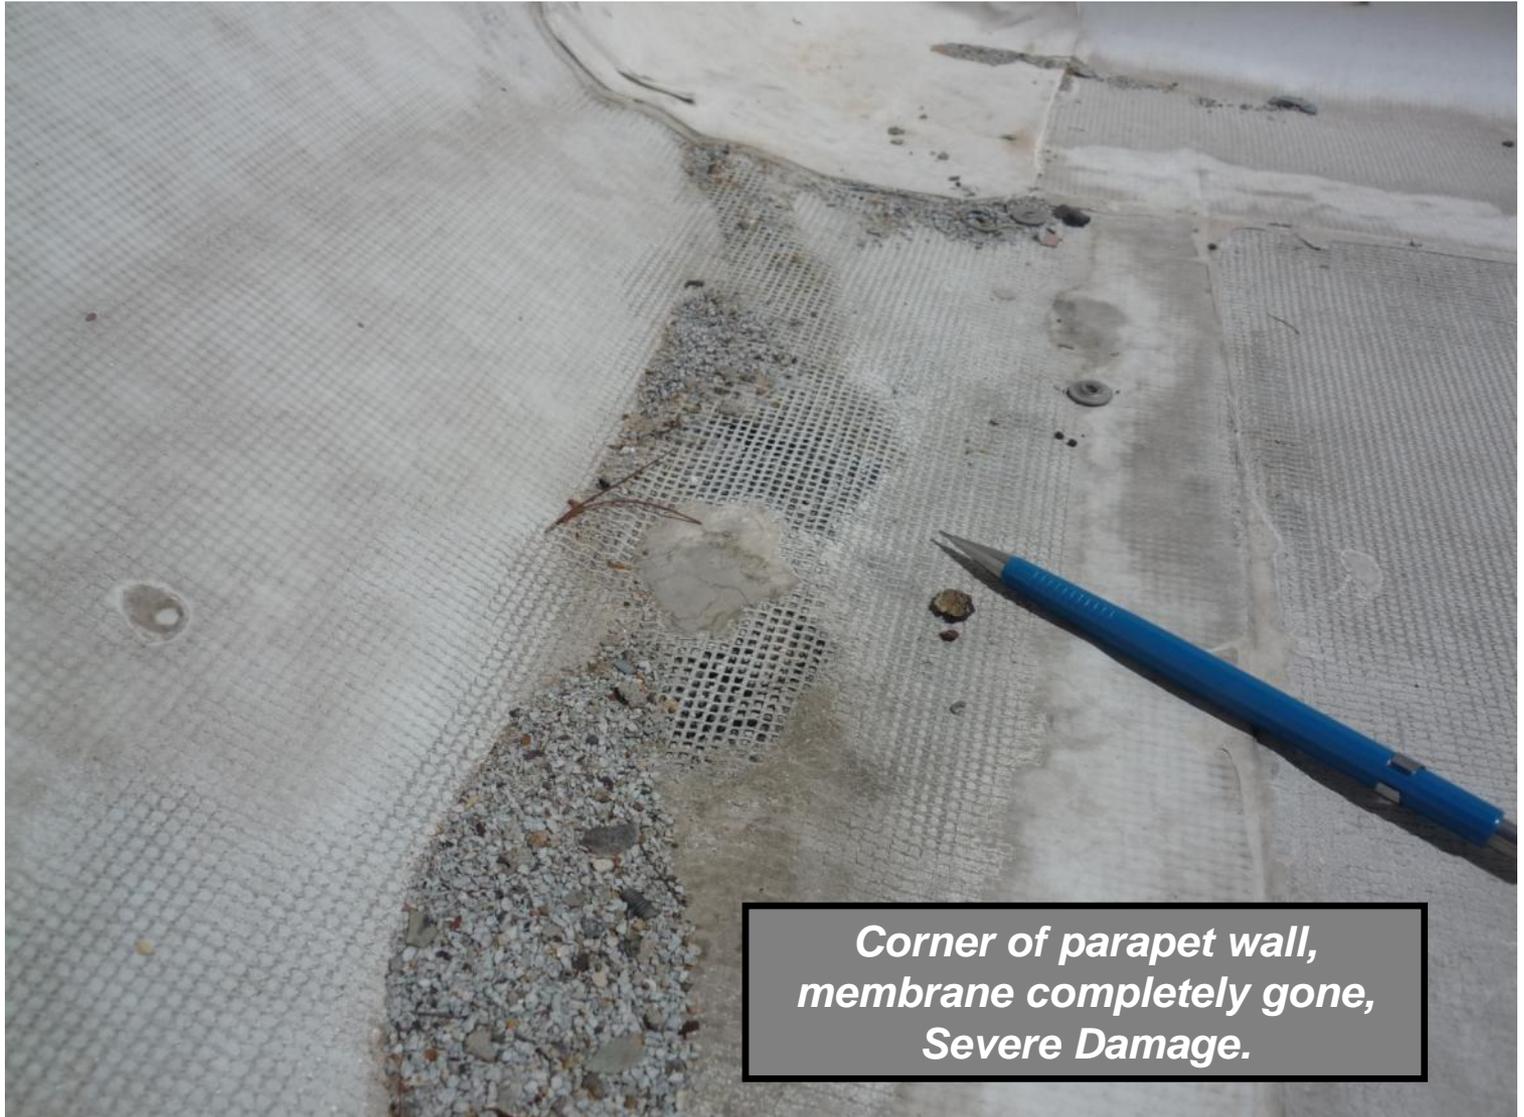
*Corner of parapet wall,
membrane completely gone,
Severe Damage.*
