**Critical Review of the Life Span of
TPO and PVC**

RCI Hawaii Seminar

Case Study: PVC

Case Study: TPO

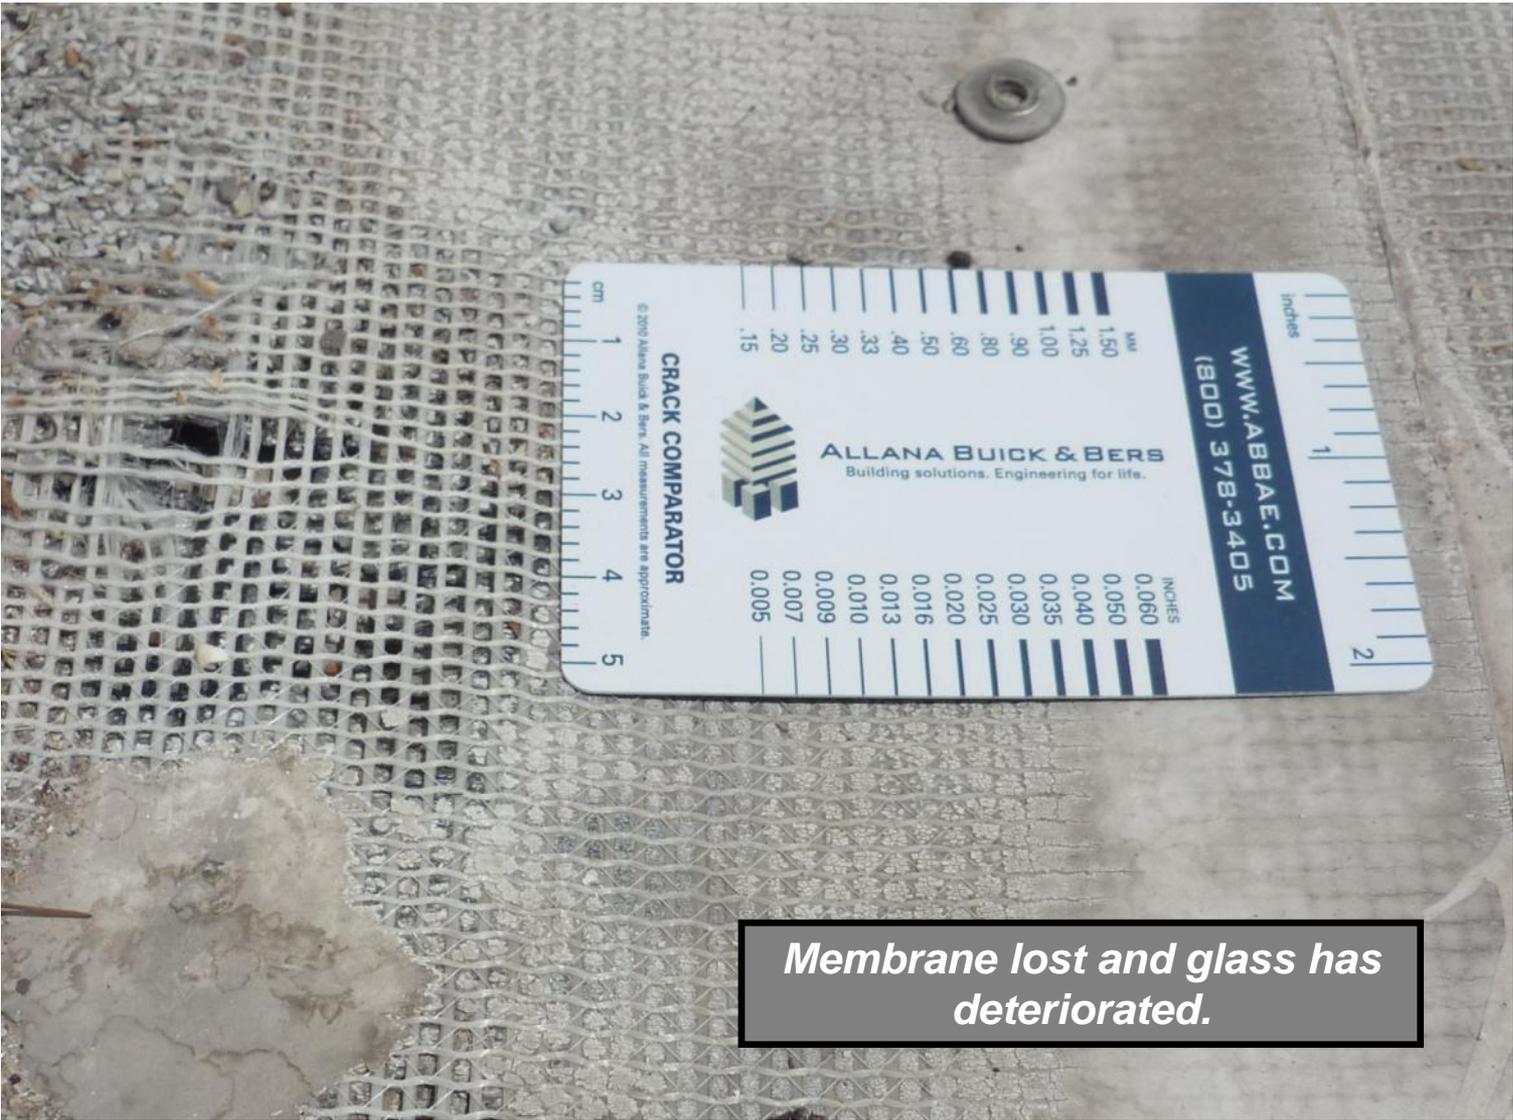
Membrane lost and glass has deteriorated.

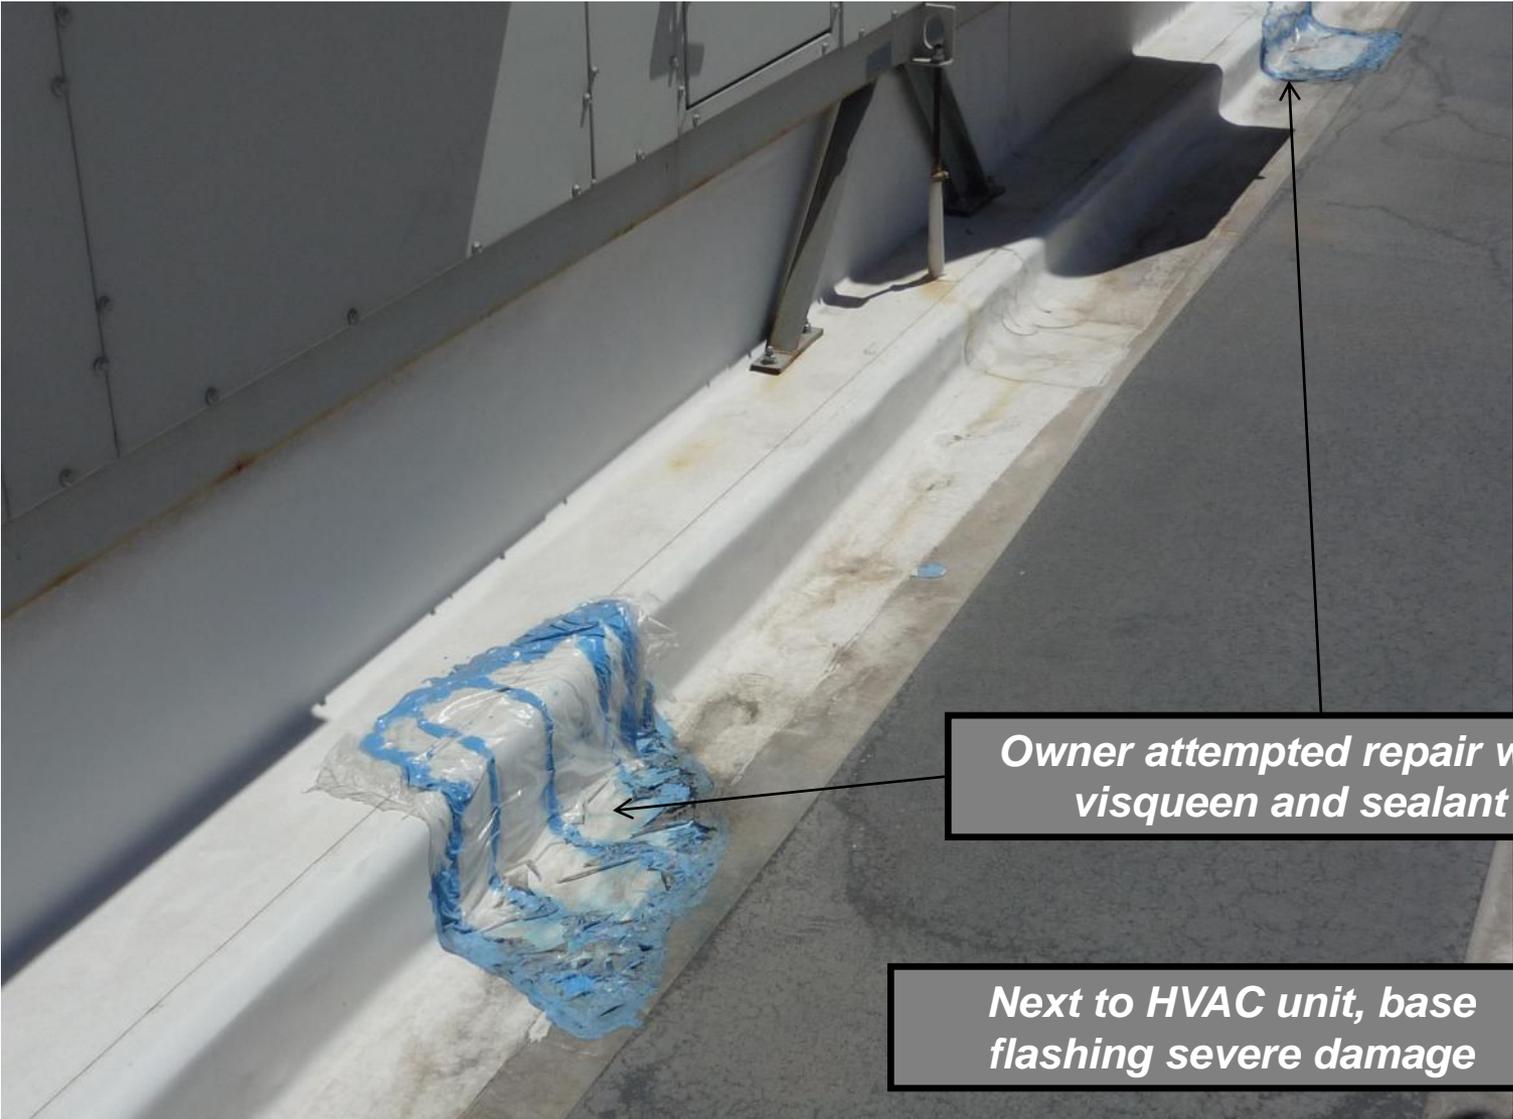
Owner attempted repair with visqueen and sealant

Next to HVAC unit, base flashing severe damage

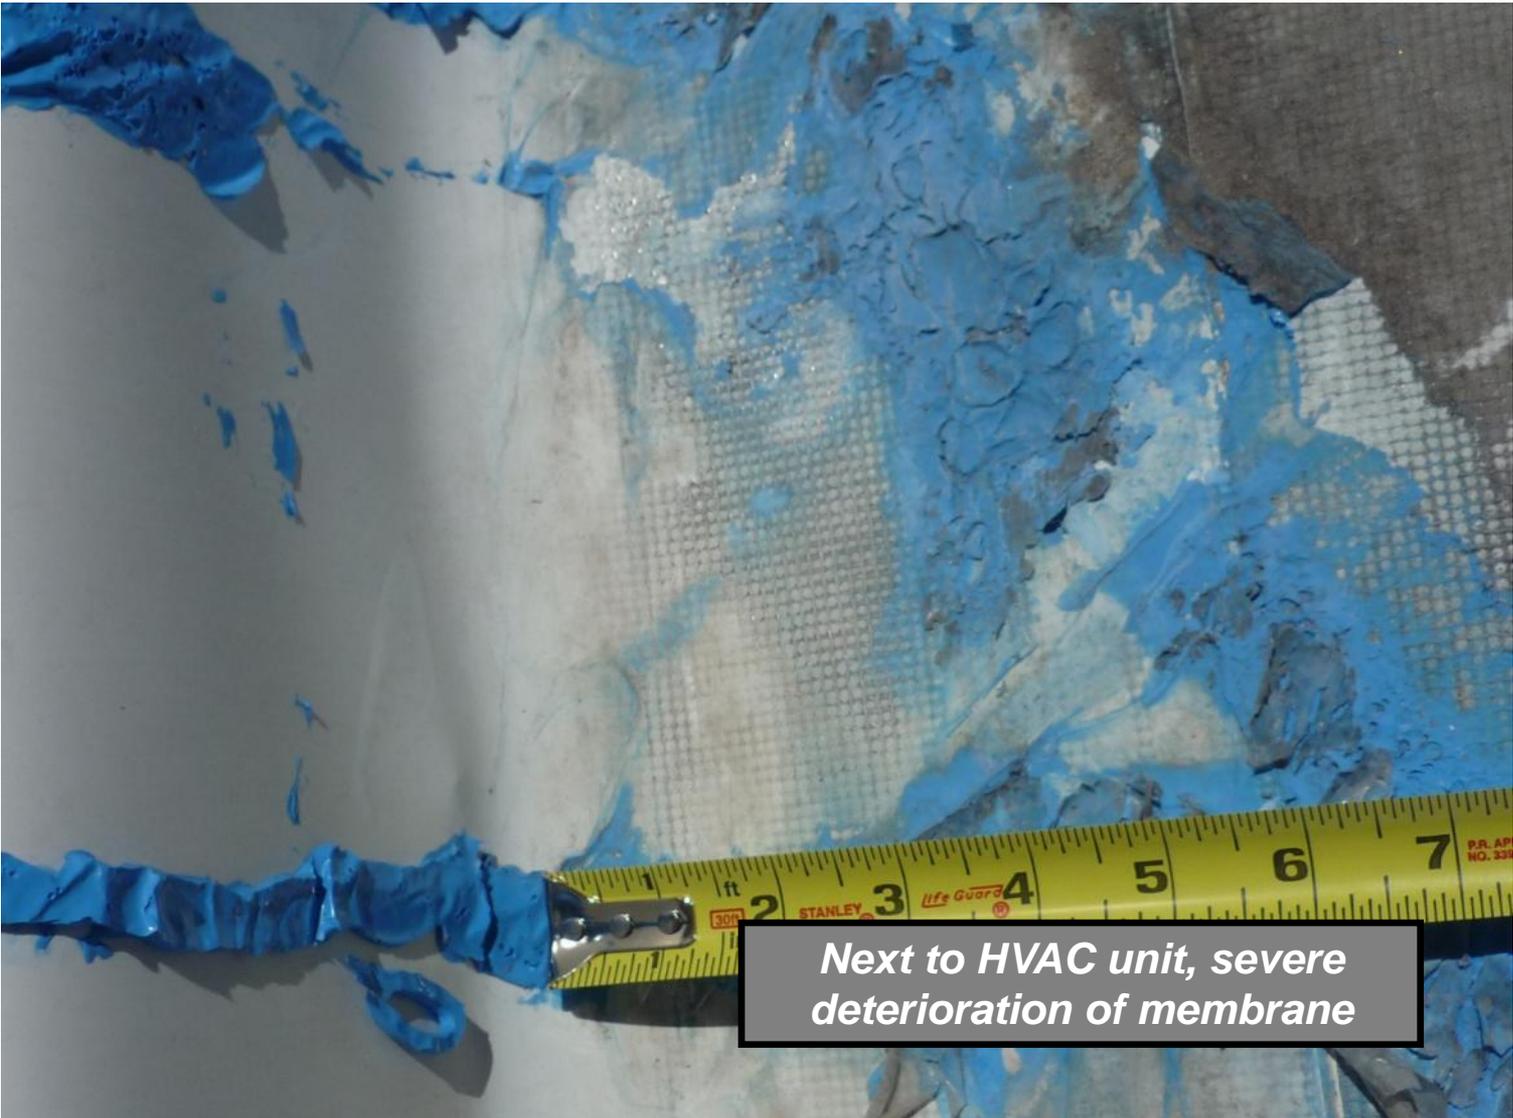
Next to HVAC unit, severe deterioration of membrane

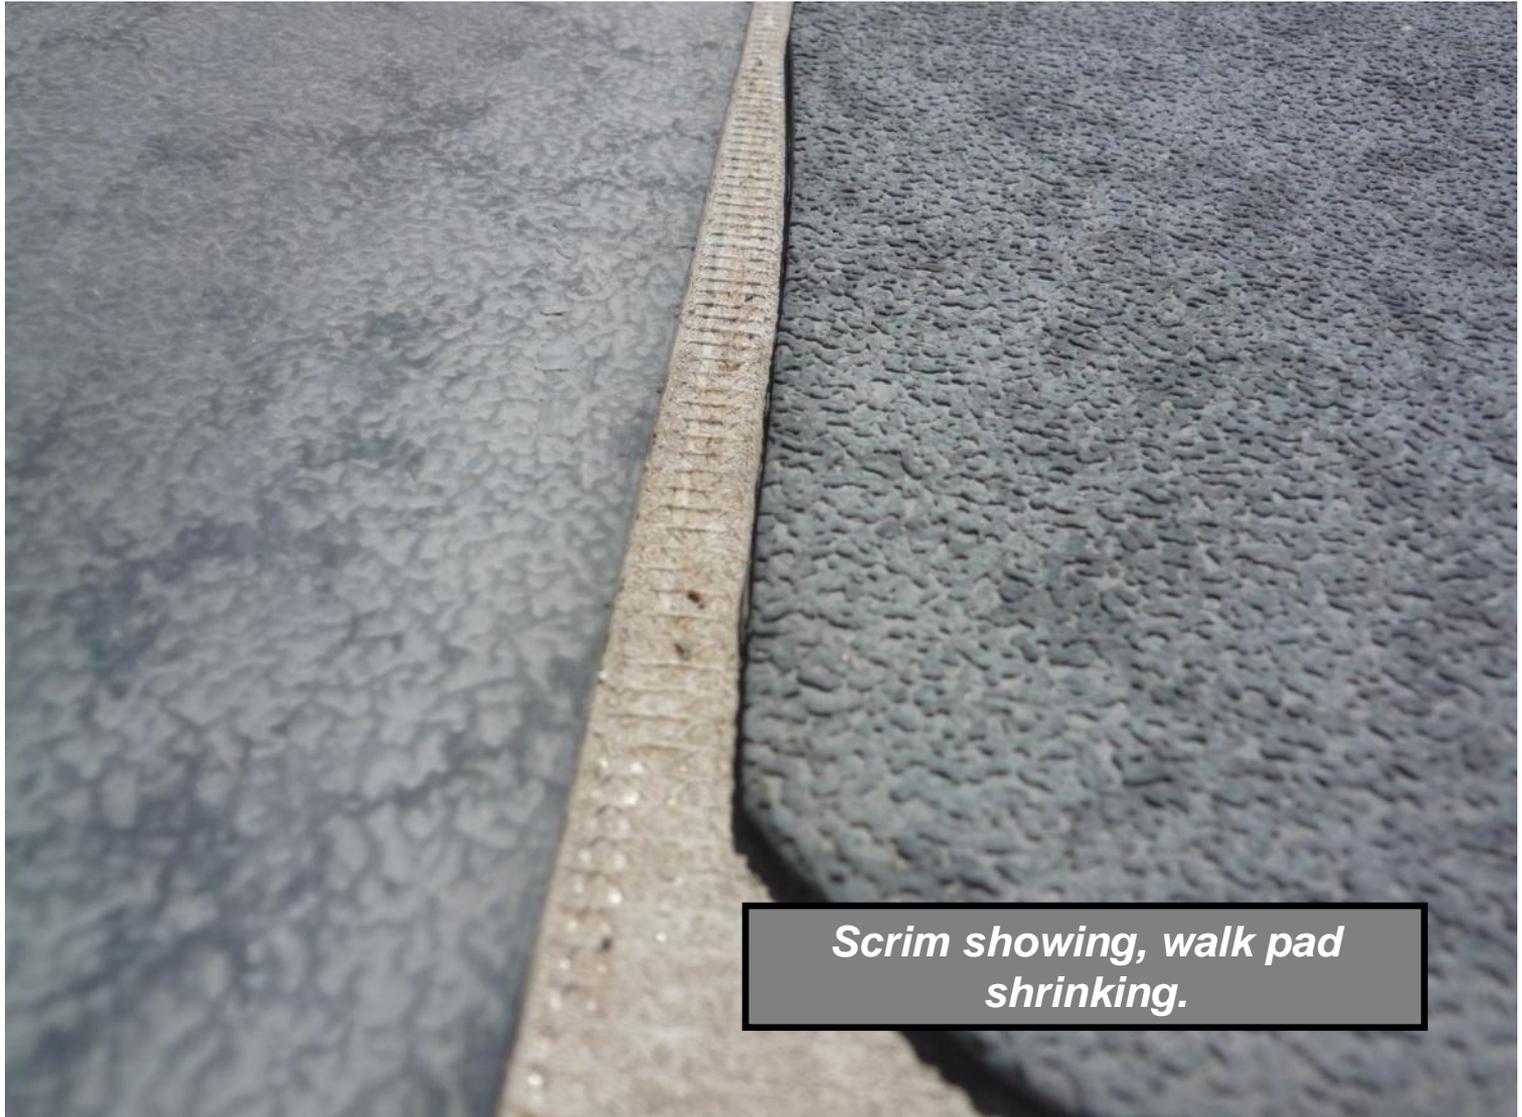
Scrim showing, walk pad shrinking.

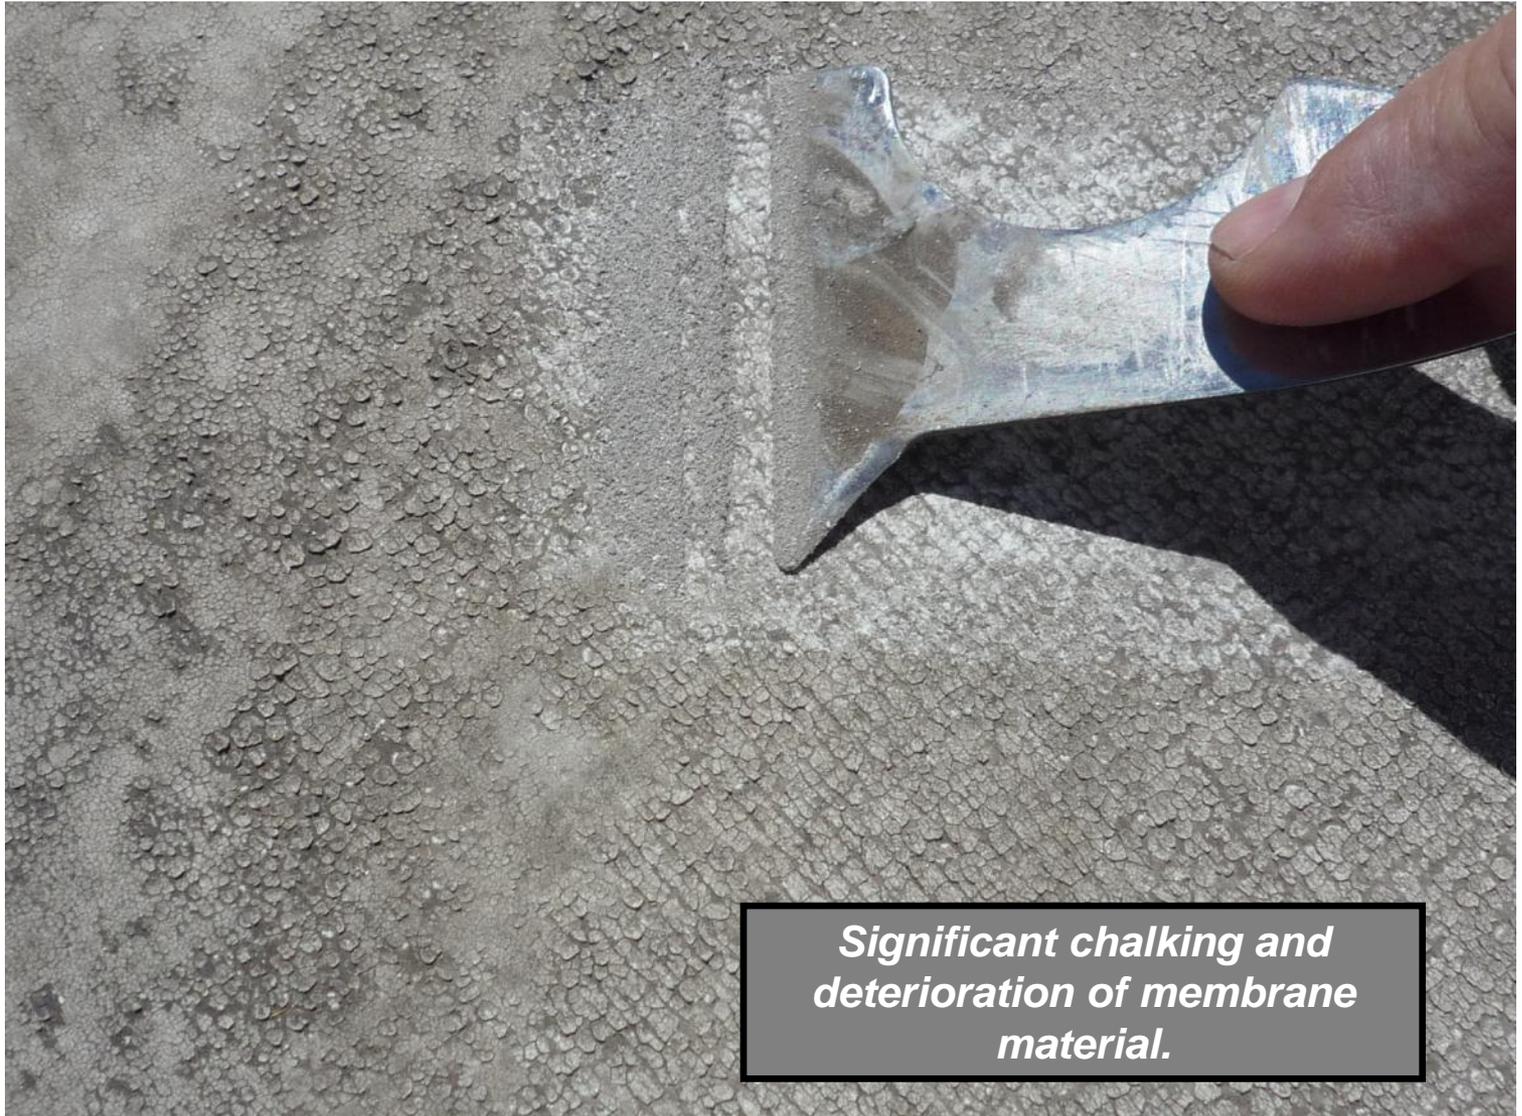
Significant chalking and deterioration of membrane material.

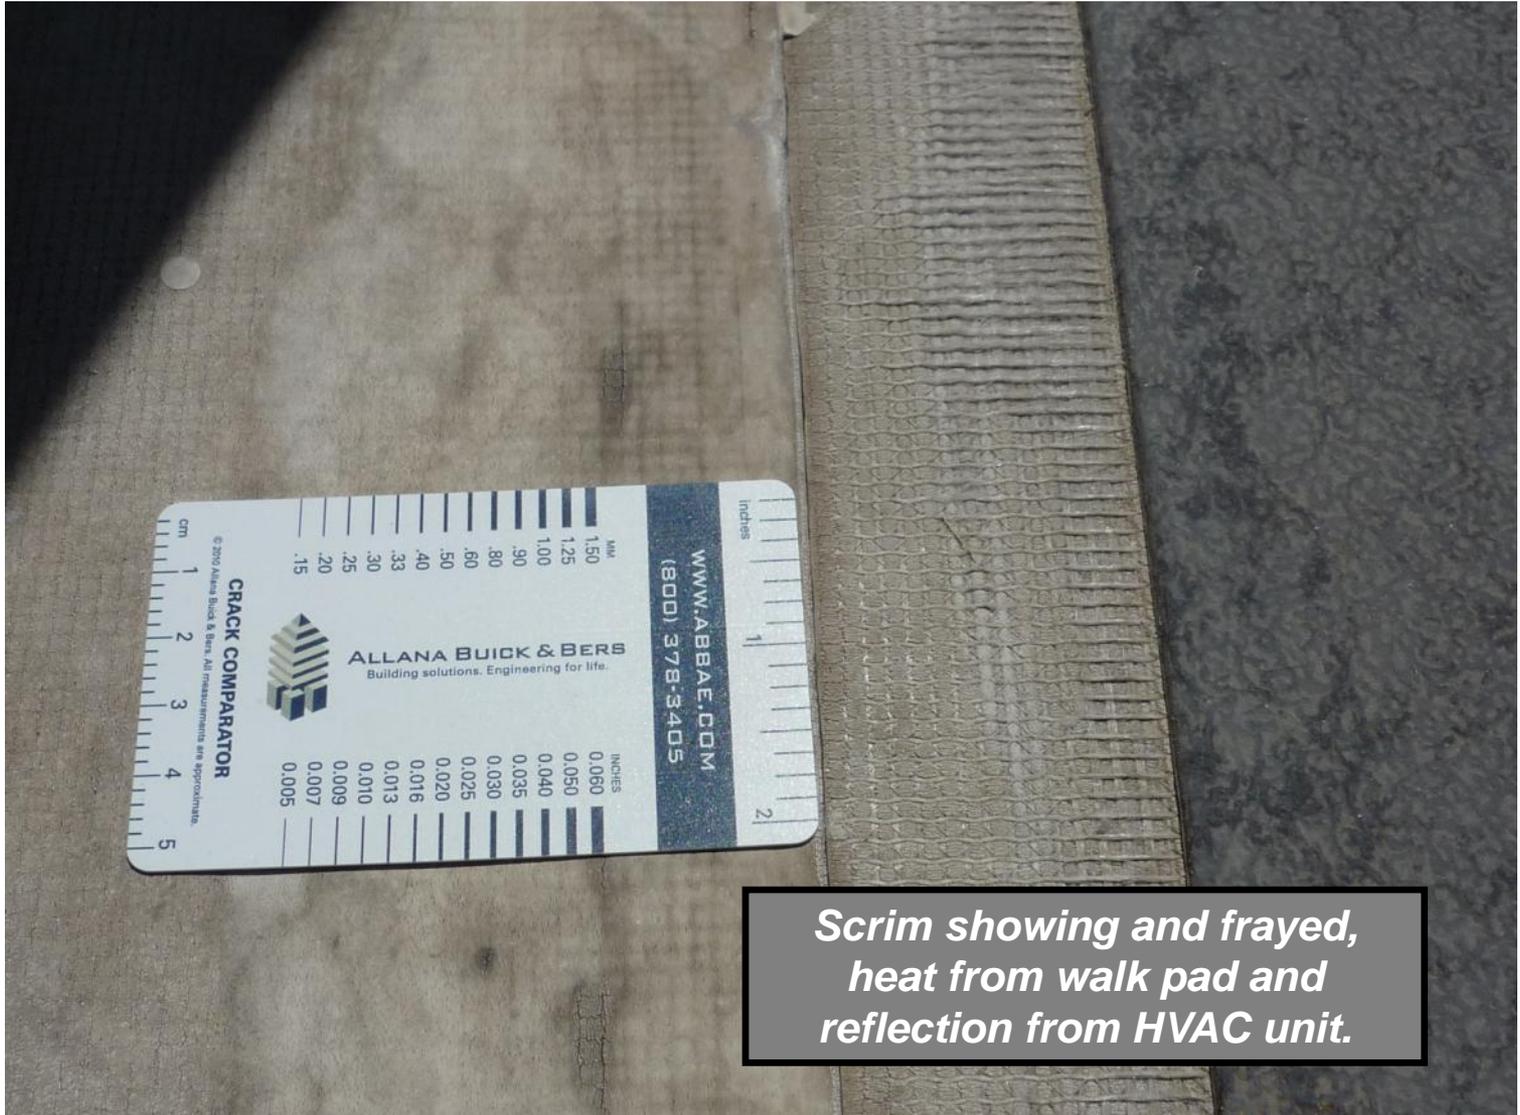
Scrim showing and frayed, heat from walk pad and reflection from HVAC unit.

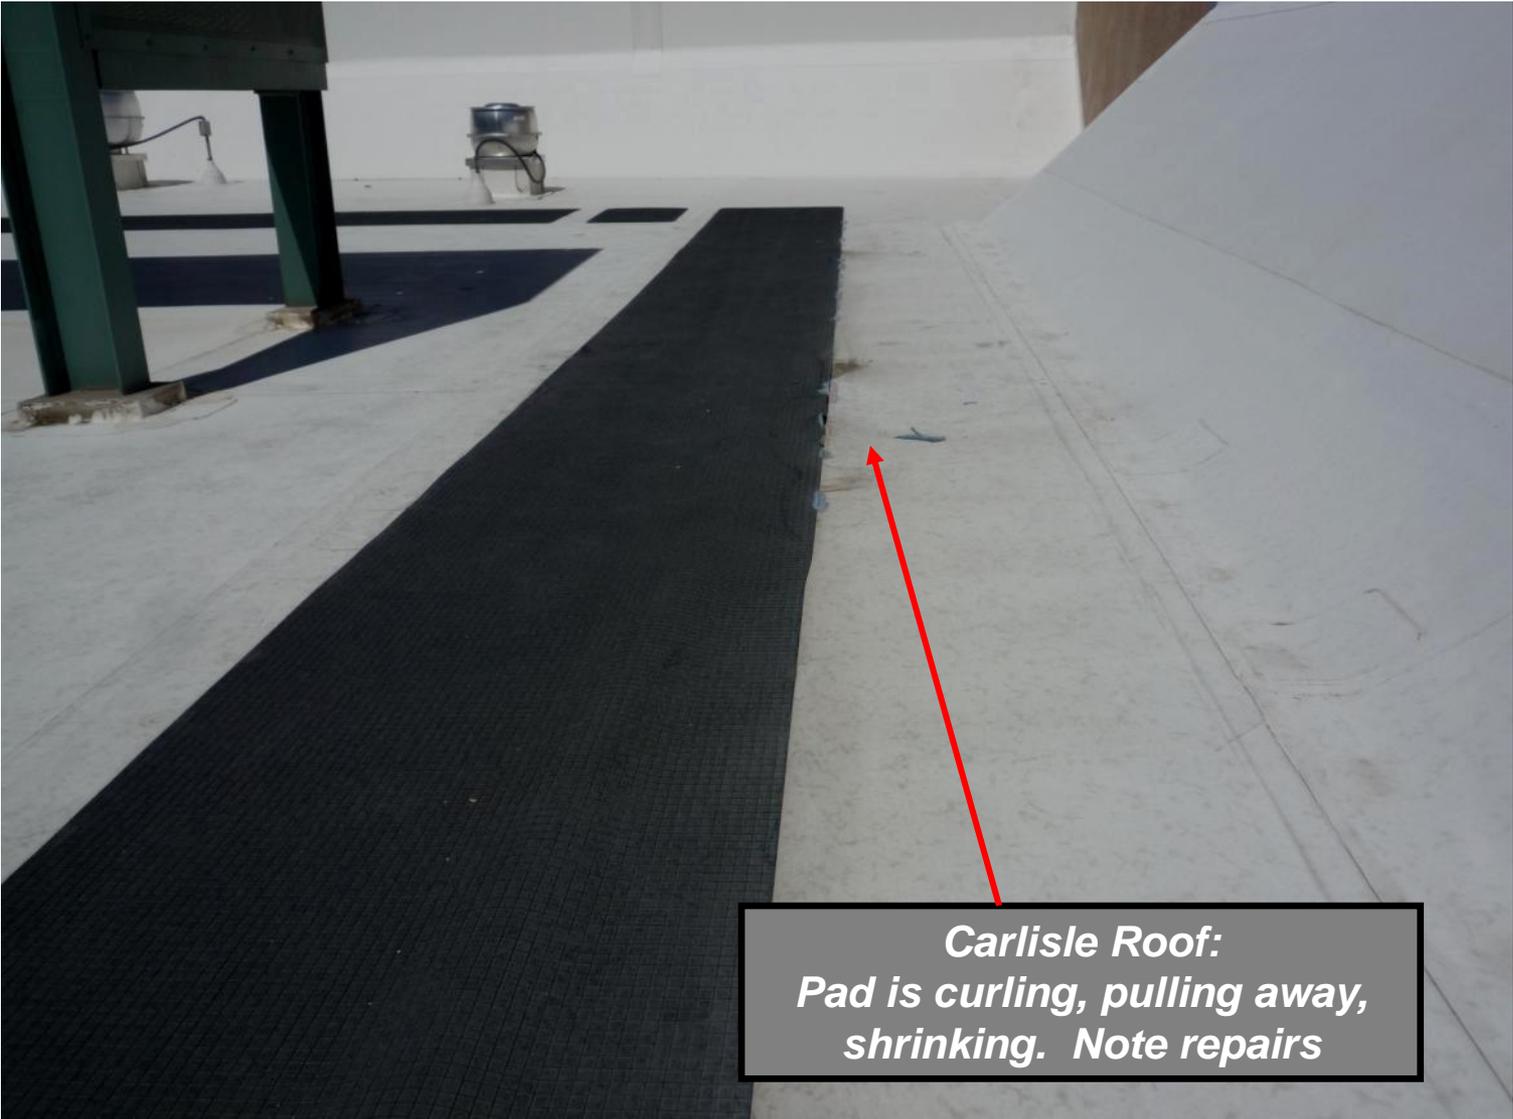
*Carlisle Roof:
Pad is curling, pulling away,
shrinking. Note repairs*

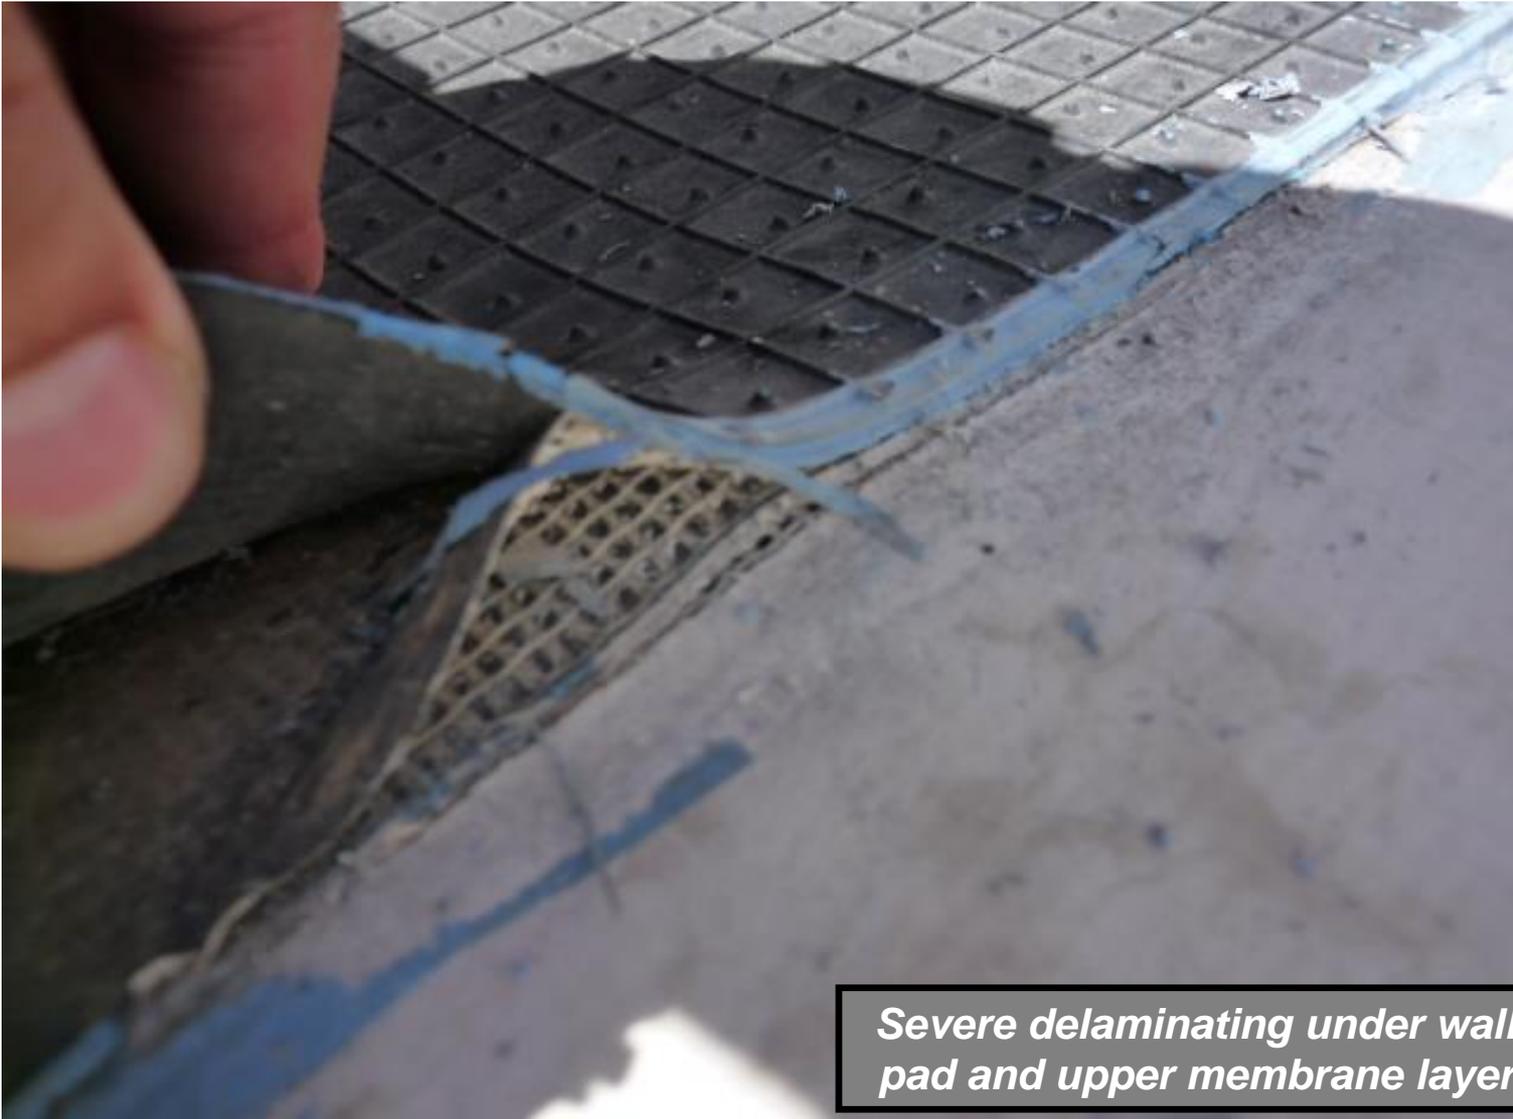
Severe delaminating under walk pad and upper membrane layer.

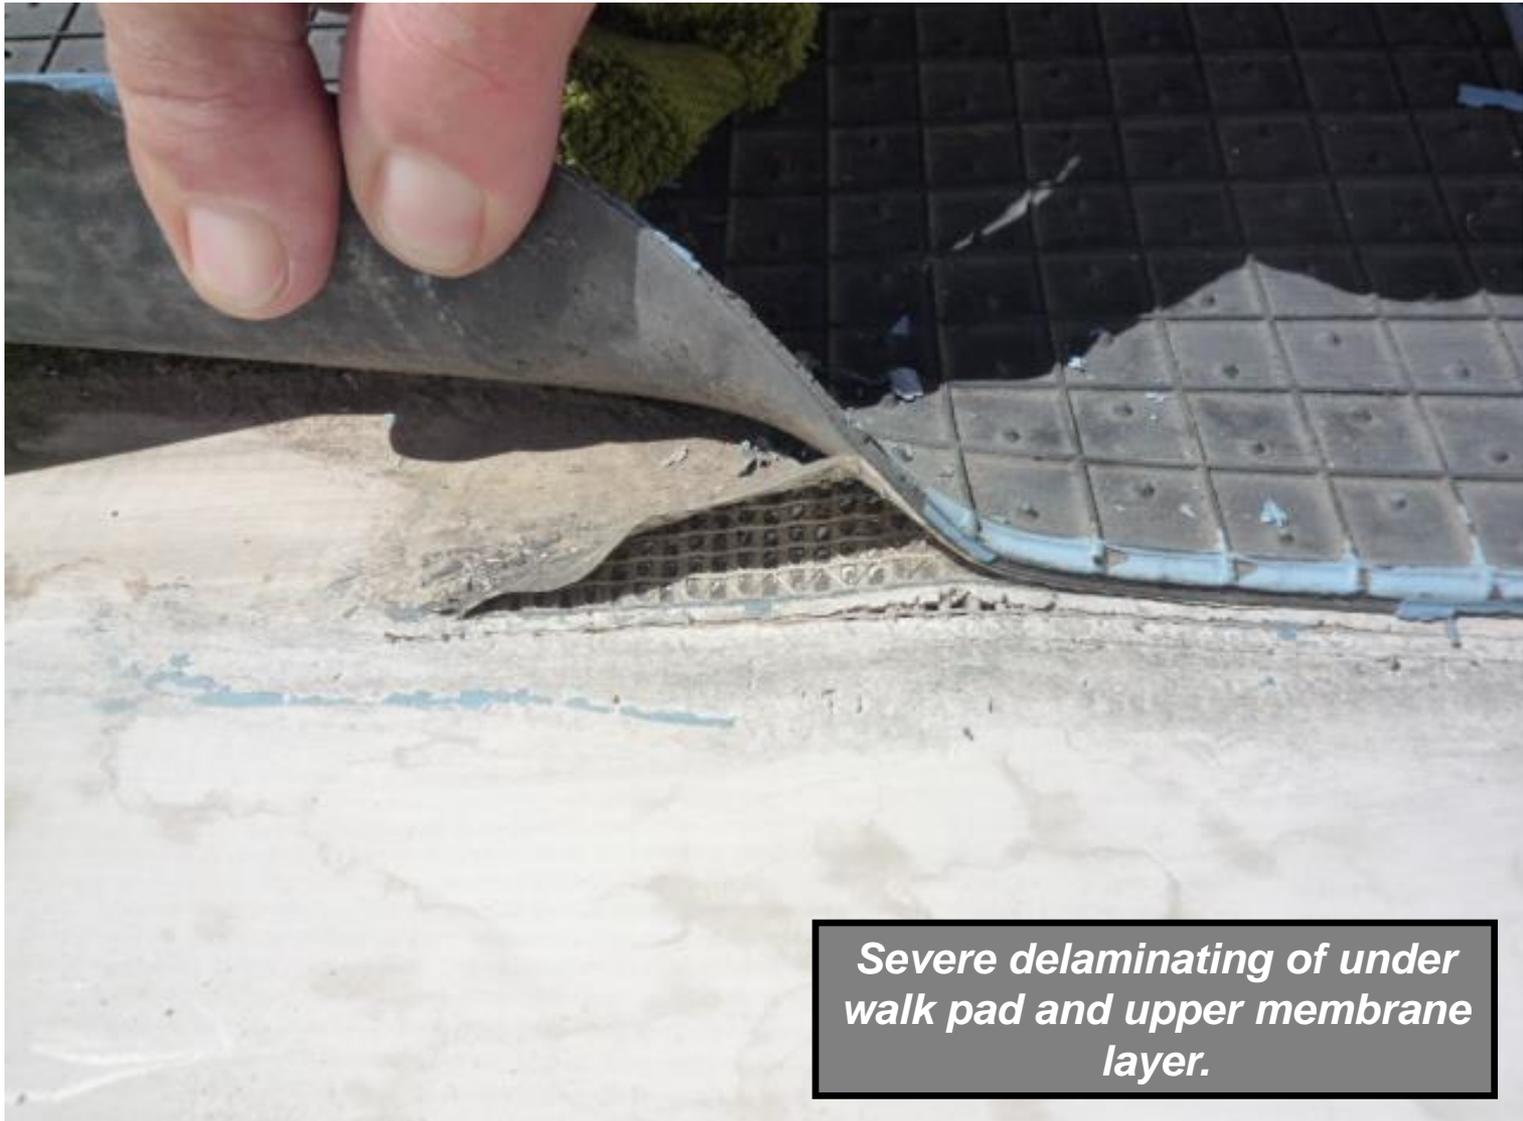
Severe delaminating of under walk pad and upper membrane layer.

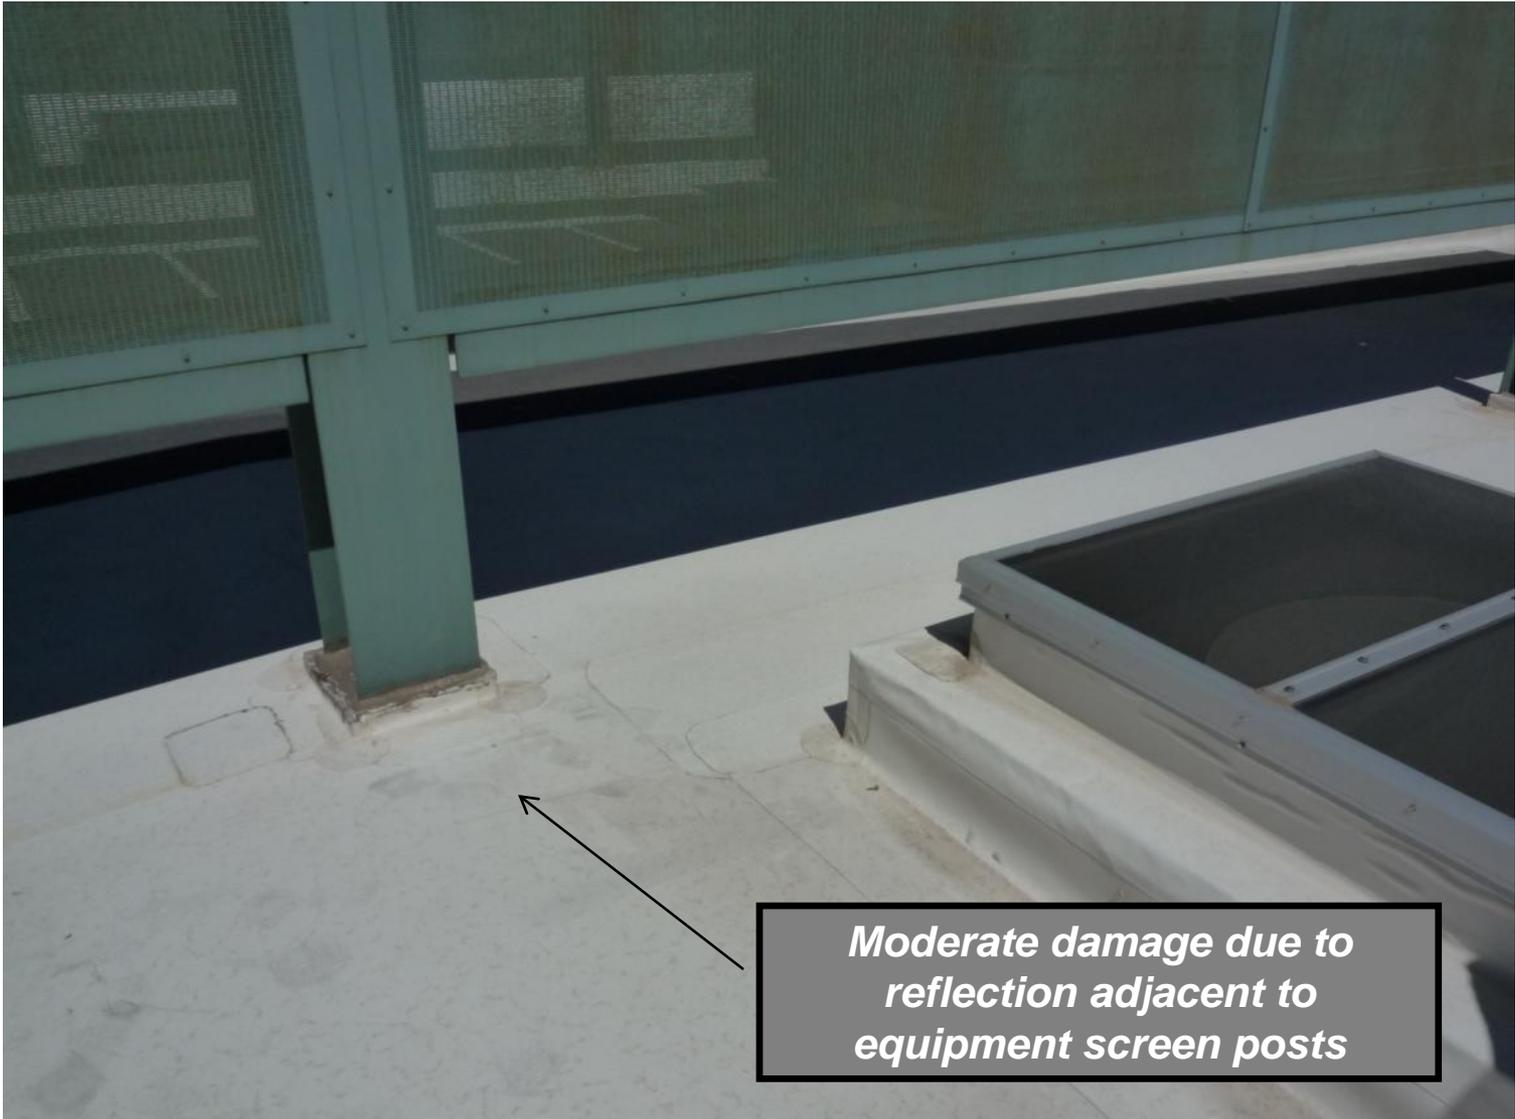
Moderate damage due to reflection adjacent to equipment screen posts

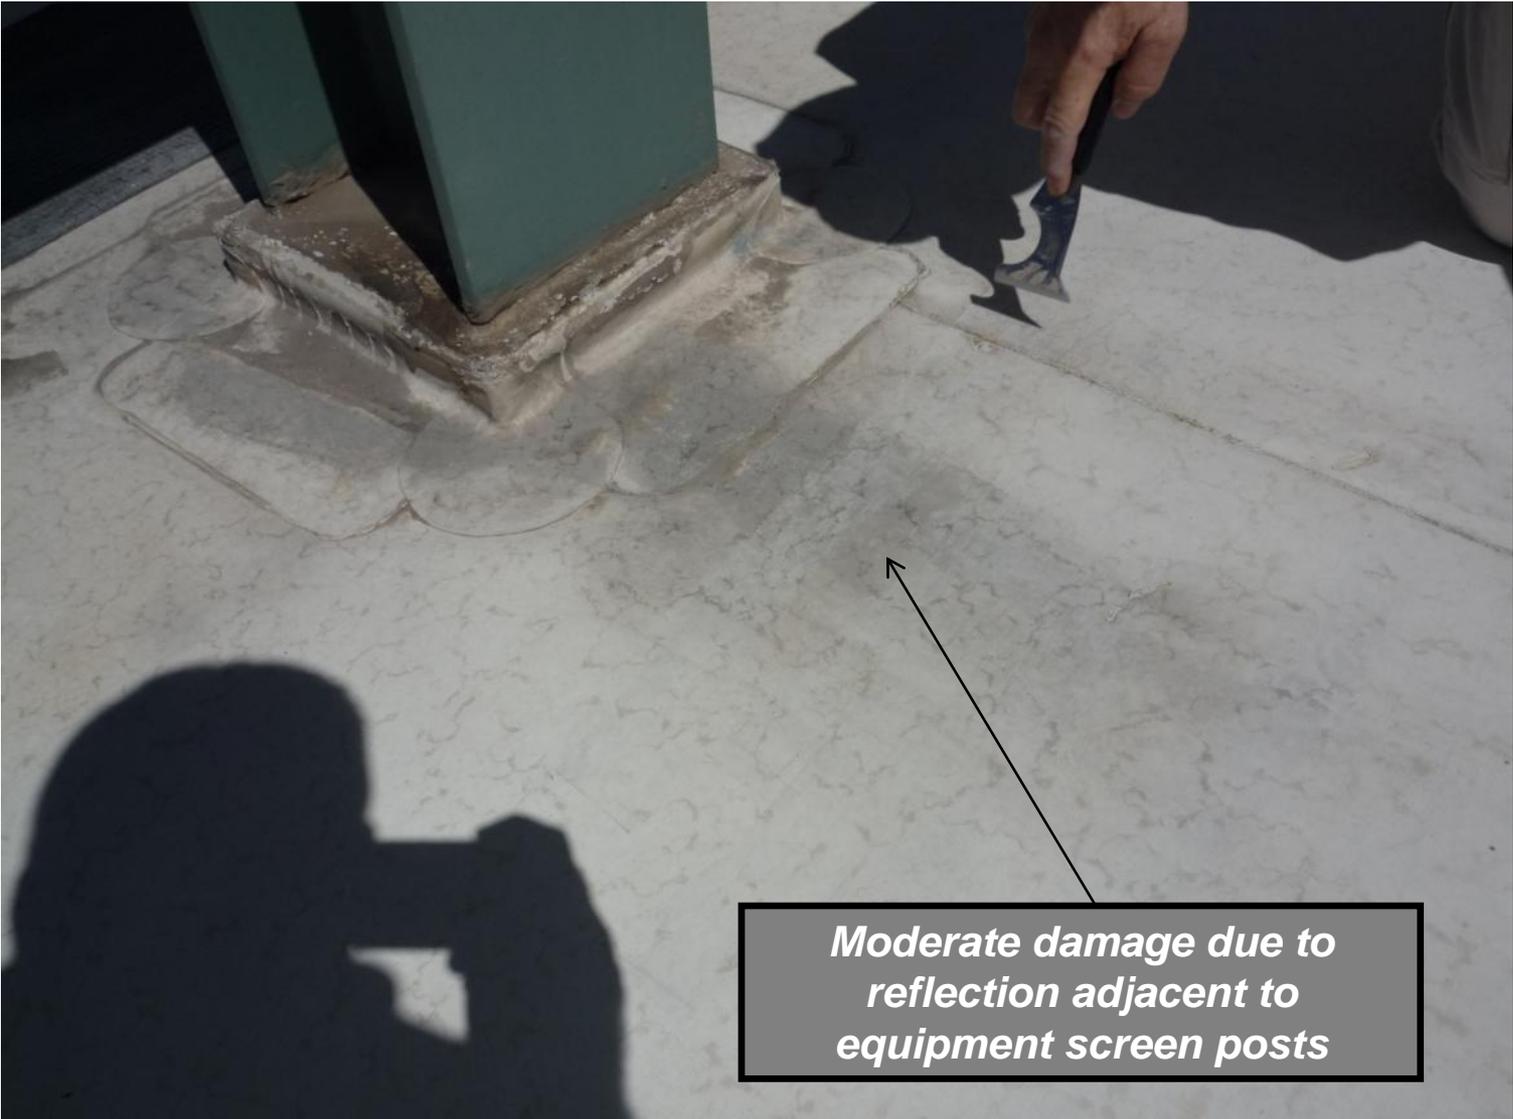
Moderate damage due to reflection adjacent to equipment screen posts

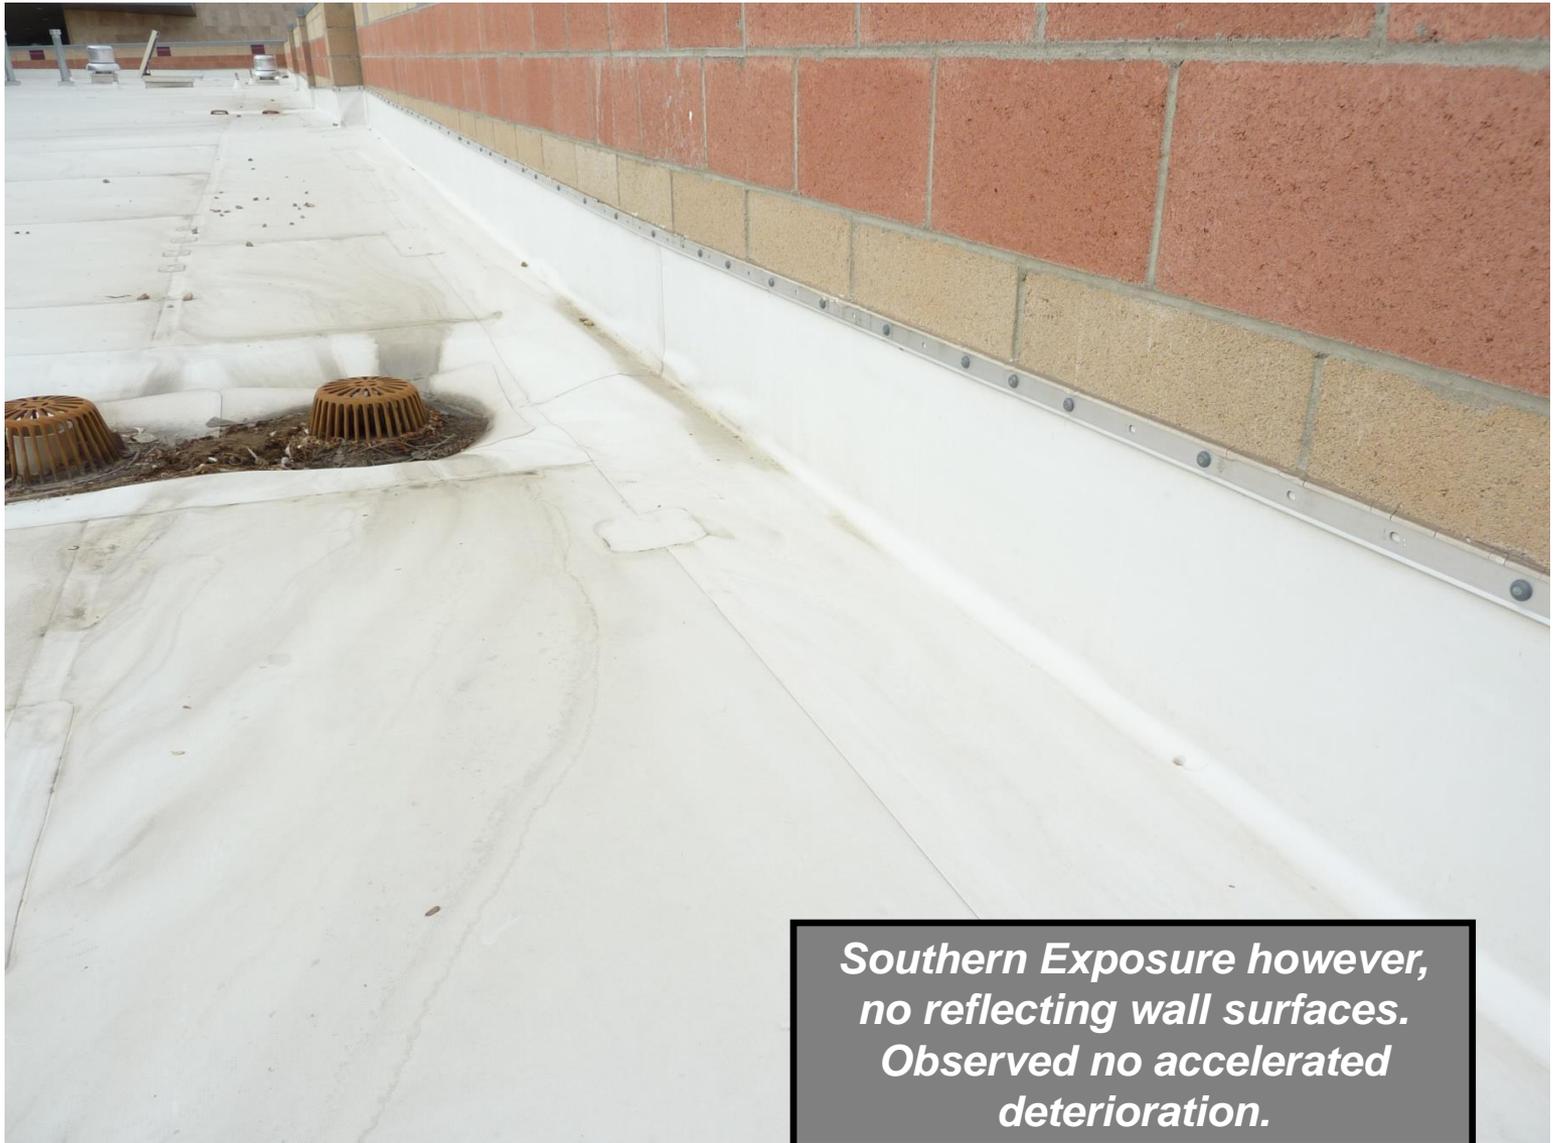
*Southern Exposure however,
no reflecting wall surfaces.
Observed no accelerated
deterioration.*

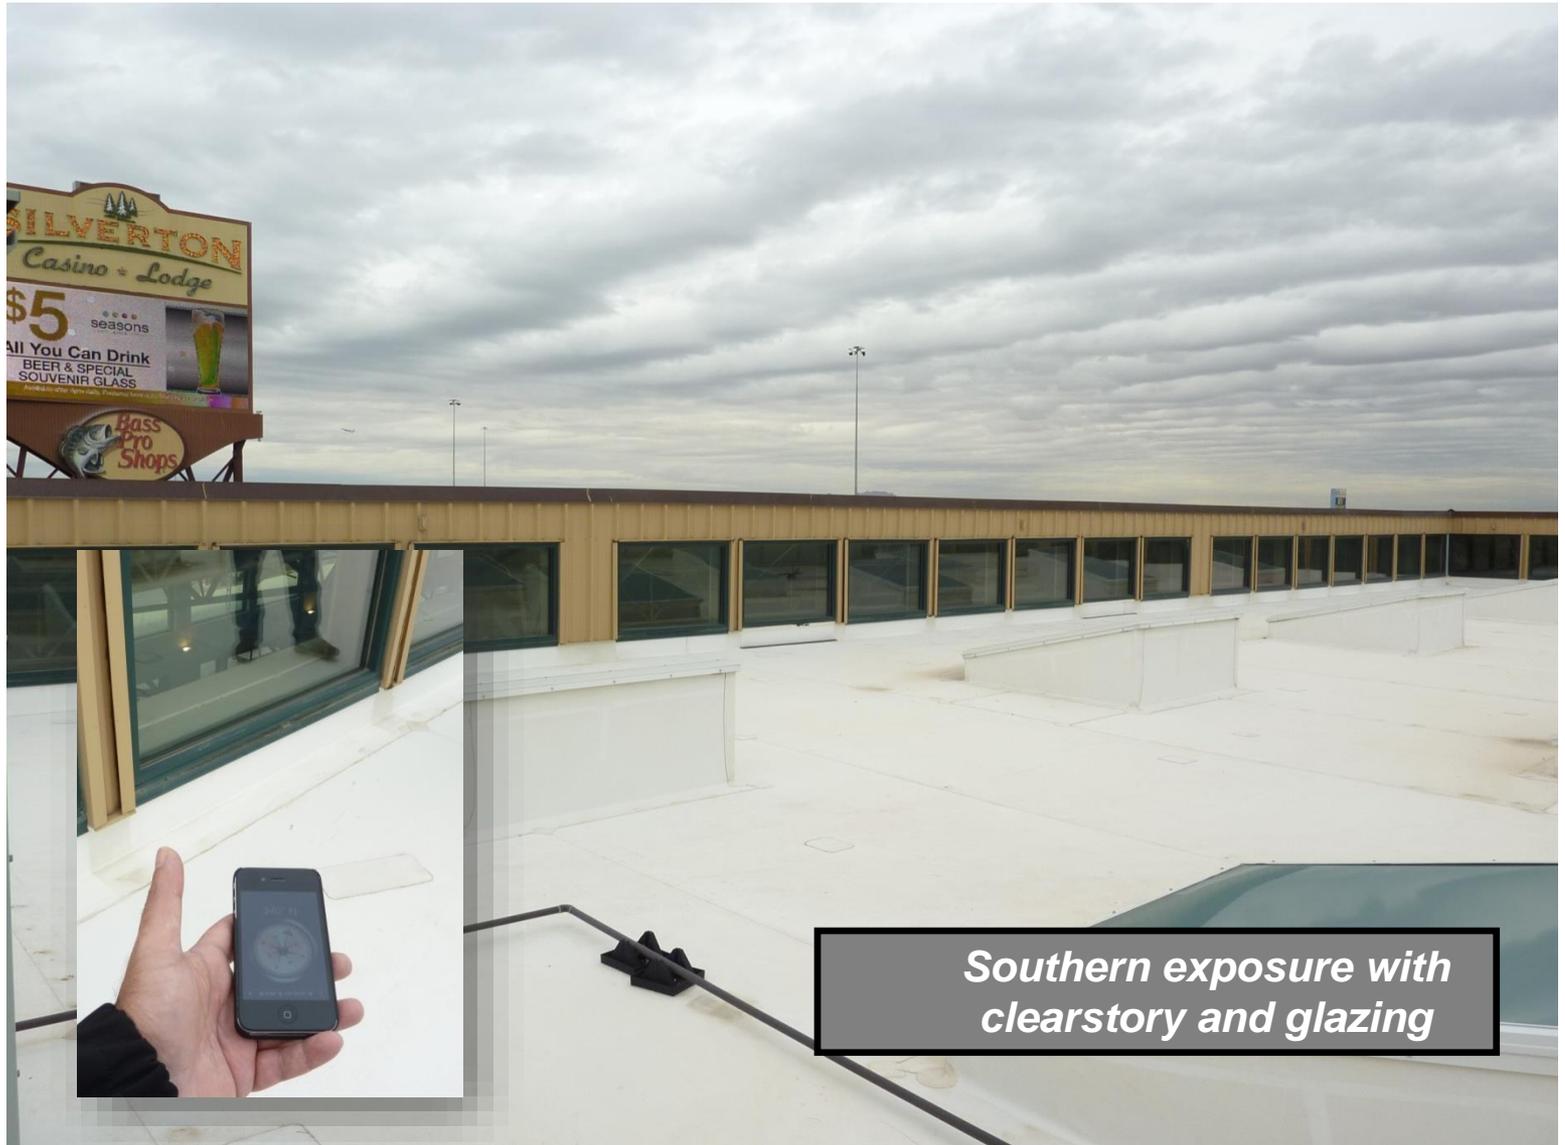
*Southern exposure with
clearstory and glazing*
