**Critical Review of the Life Span of
TPO and PVC**

RCI Hawaii Seminar

Case Study: PVC

Case Study: TPO

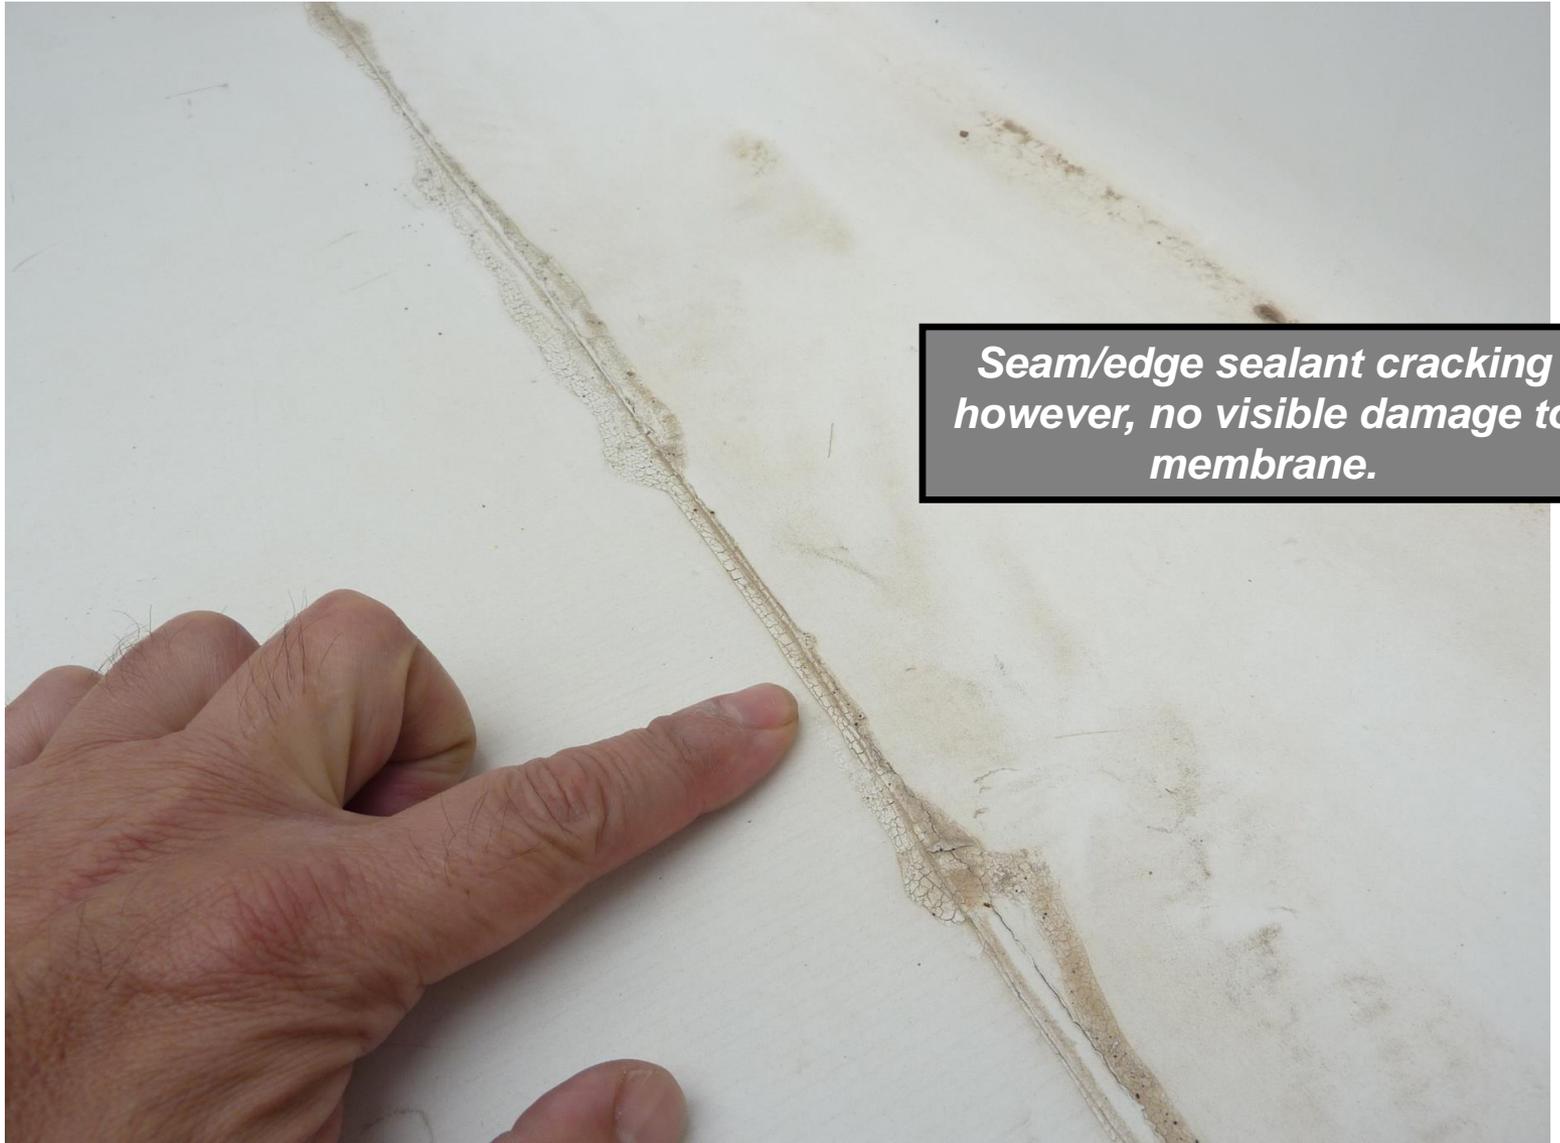
Seam/edge sealant cracking however, no visible damage to membrane.

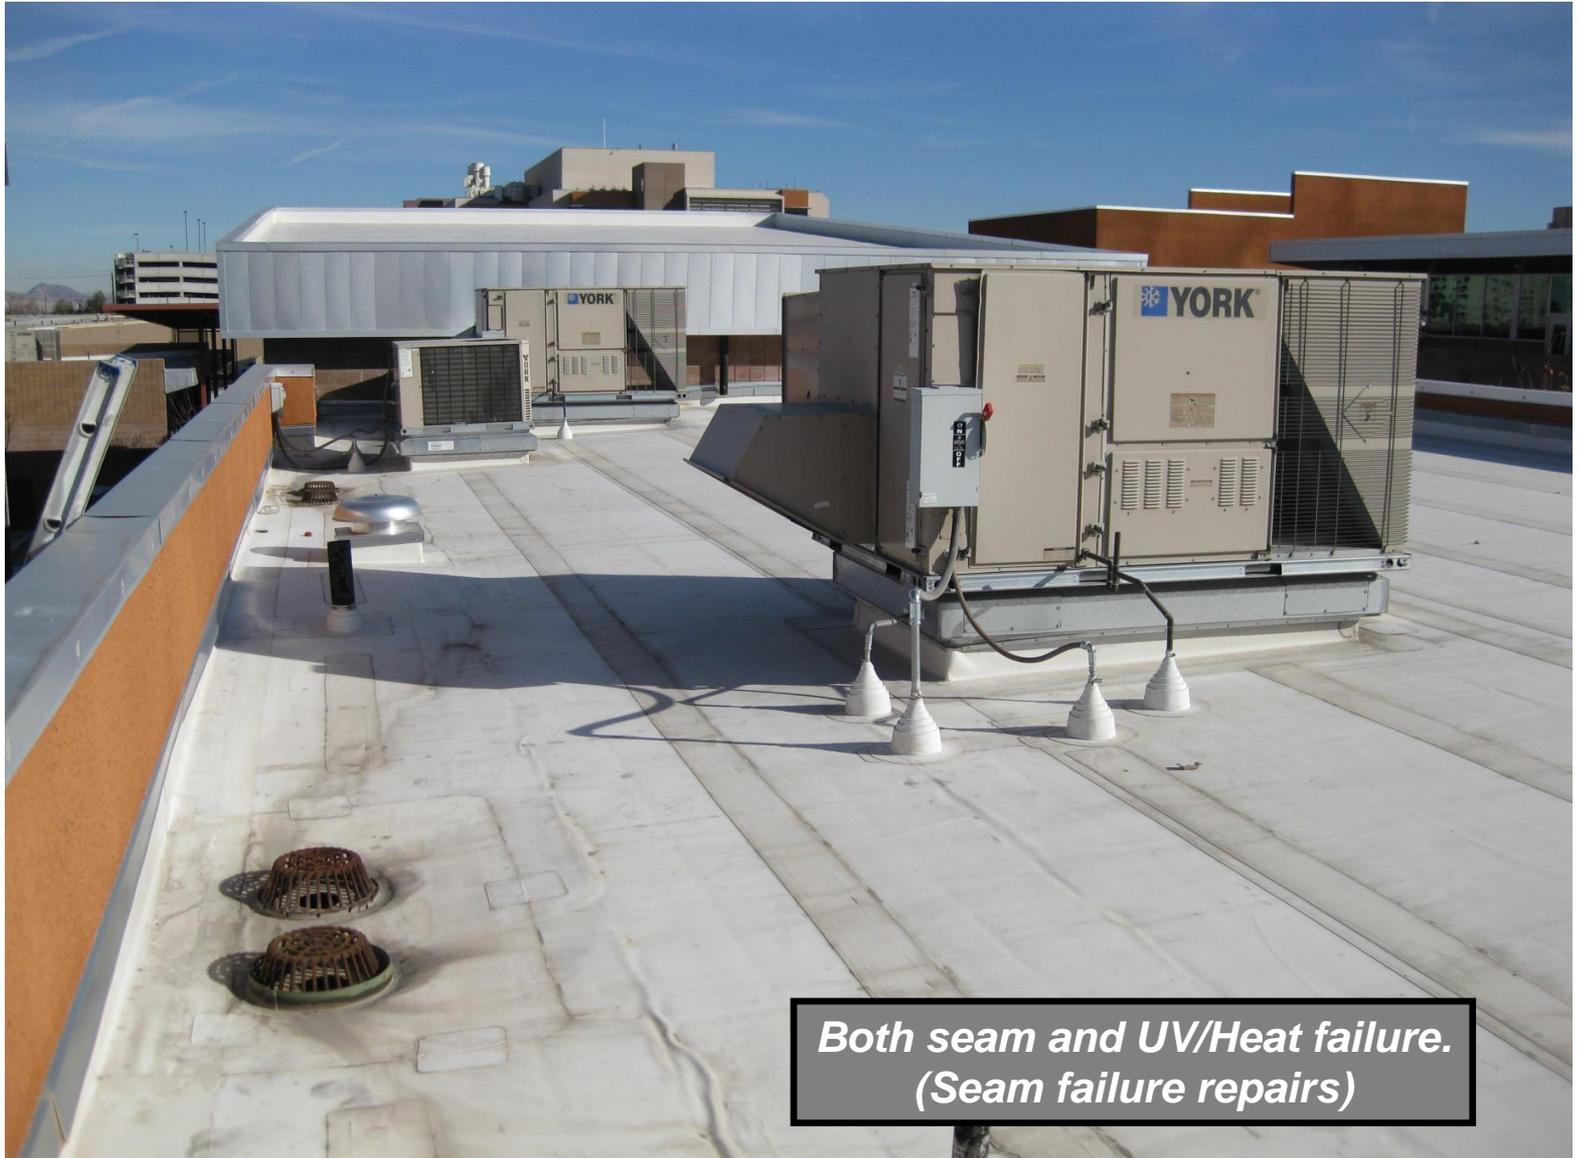
*Both seam and UV/Heat failure.
(Seam failure repairs)*

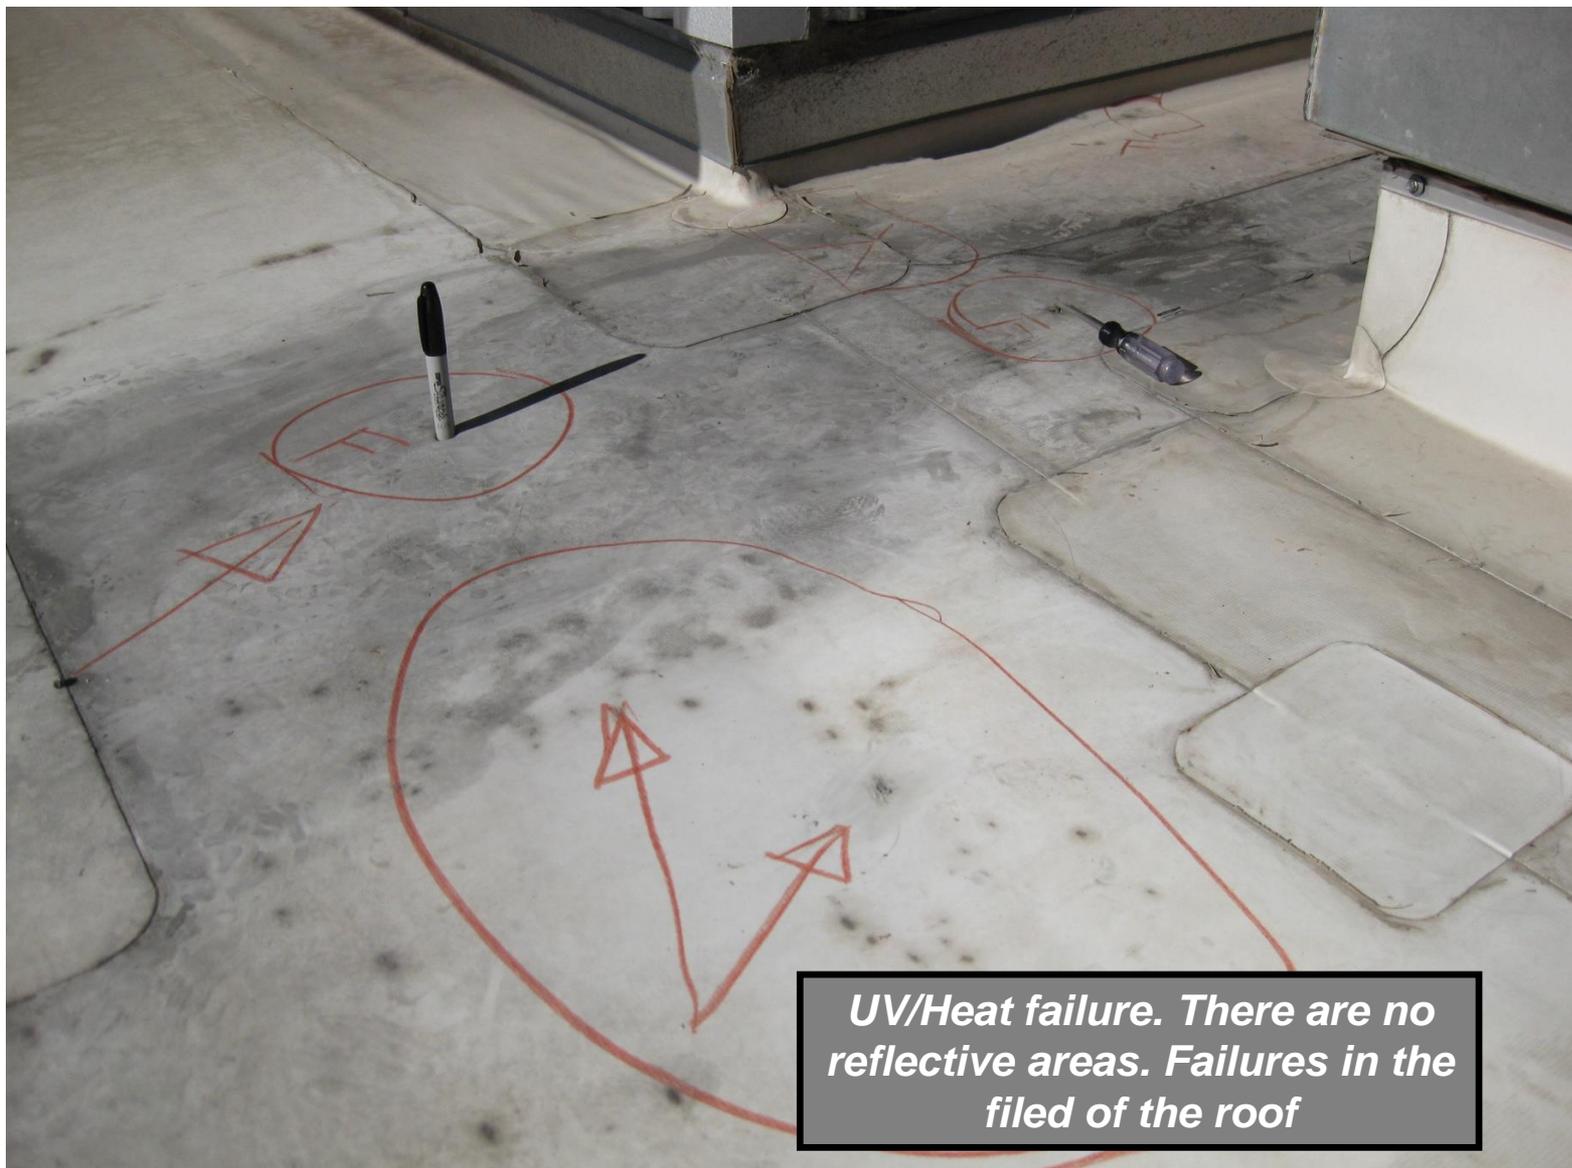
UV/Heat failure. There are no reflective areas. Failures in the field of the roof

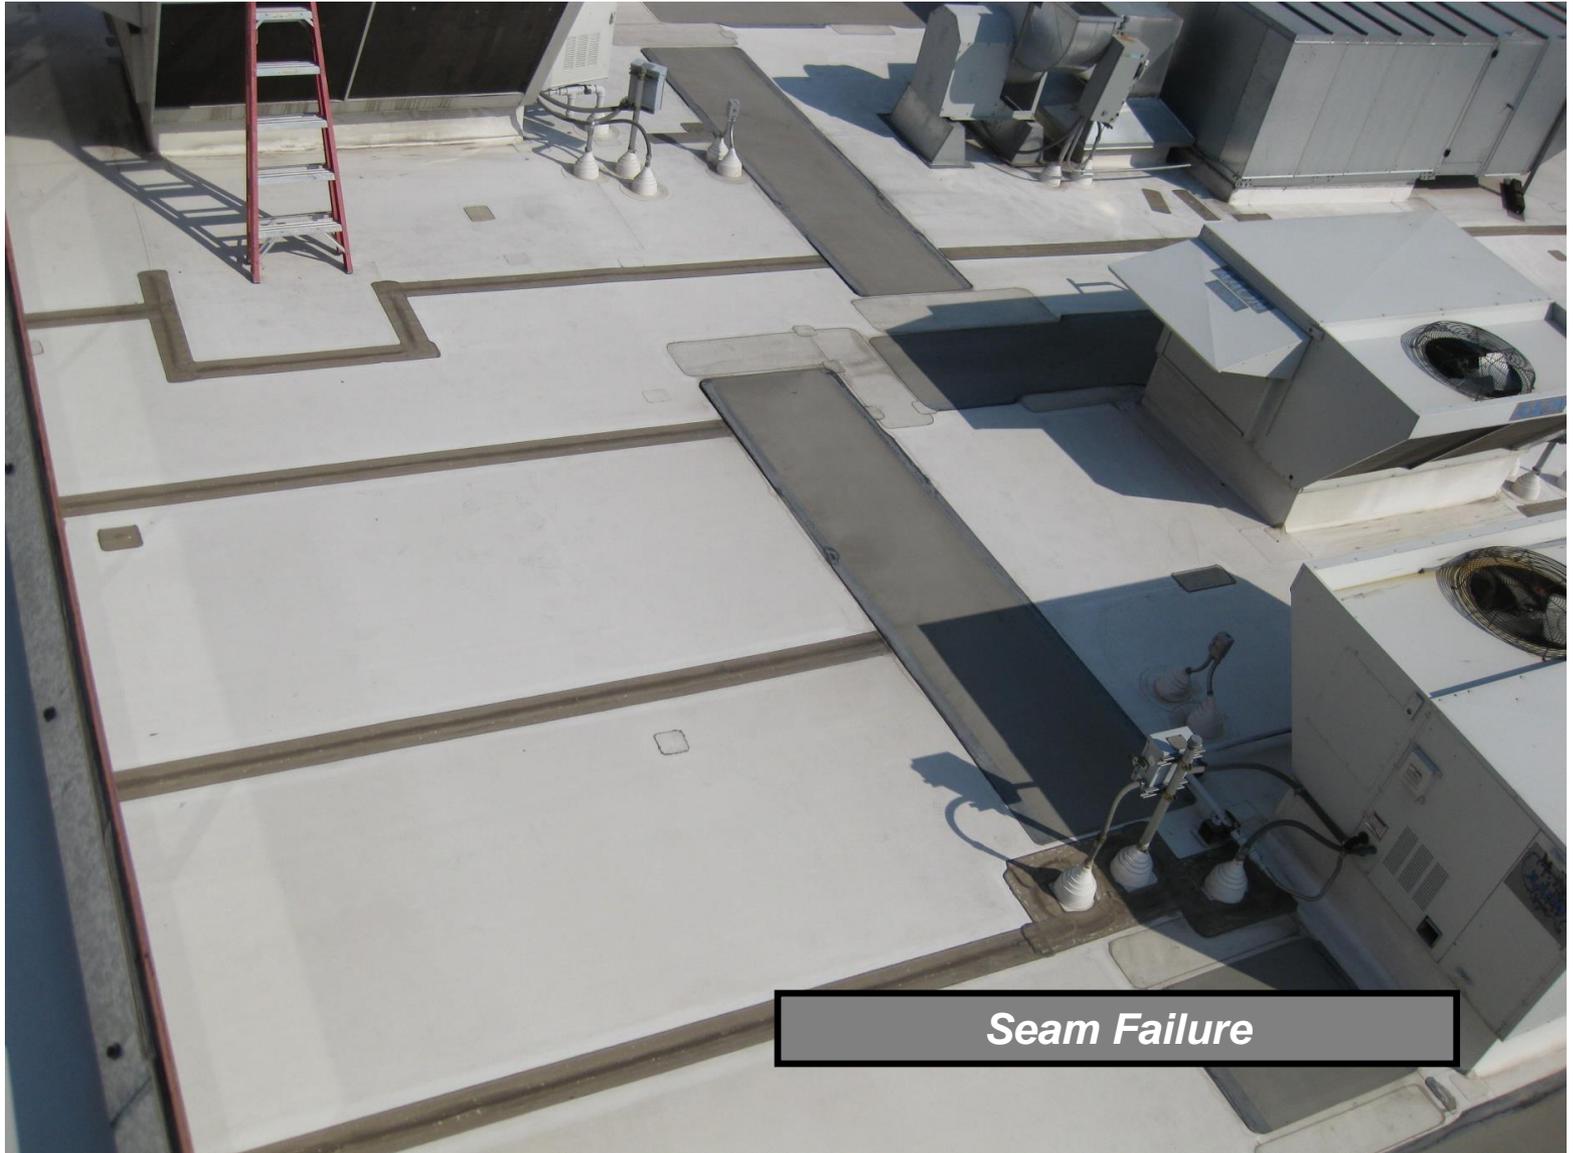
Seam Failure

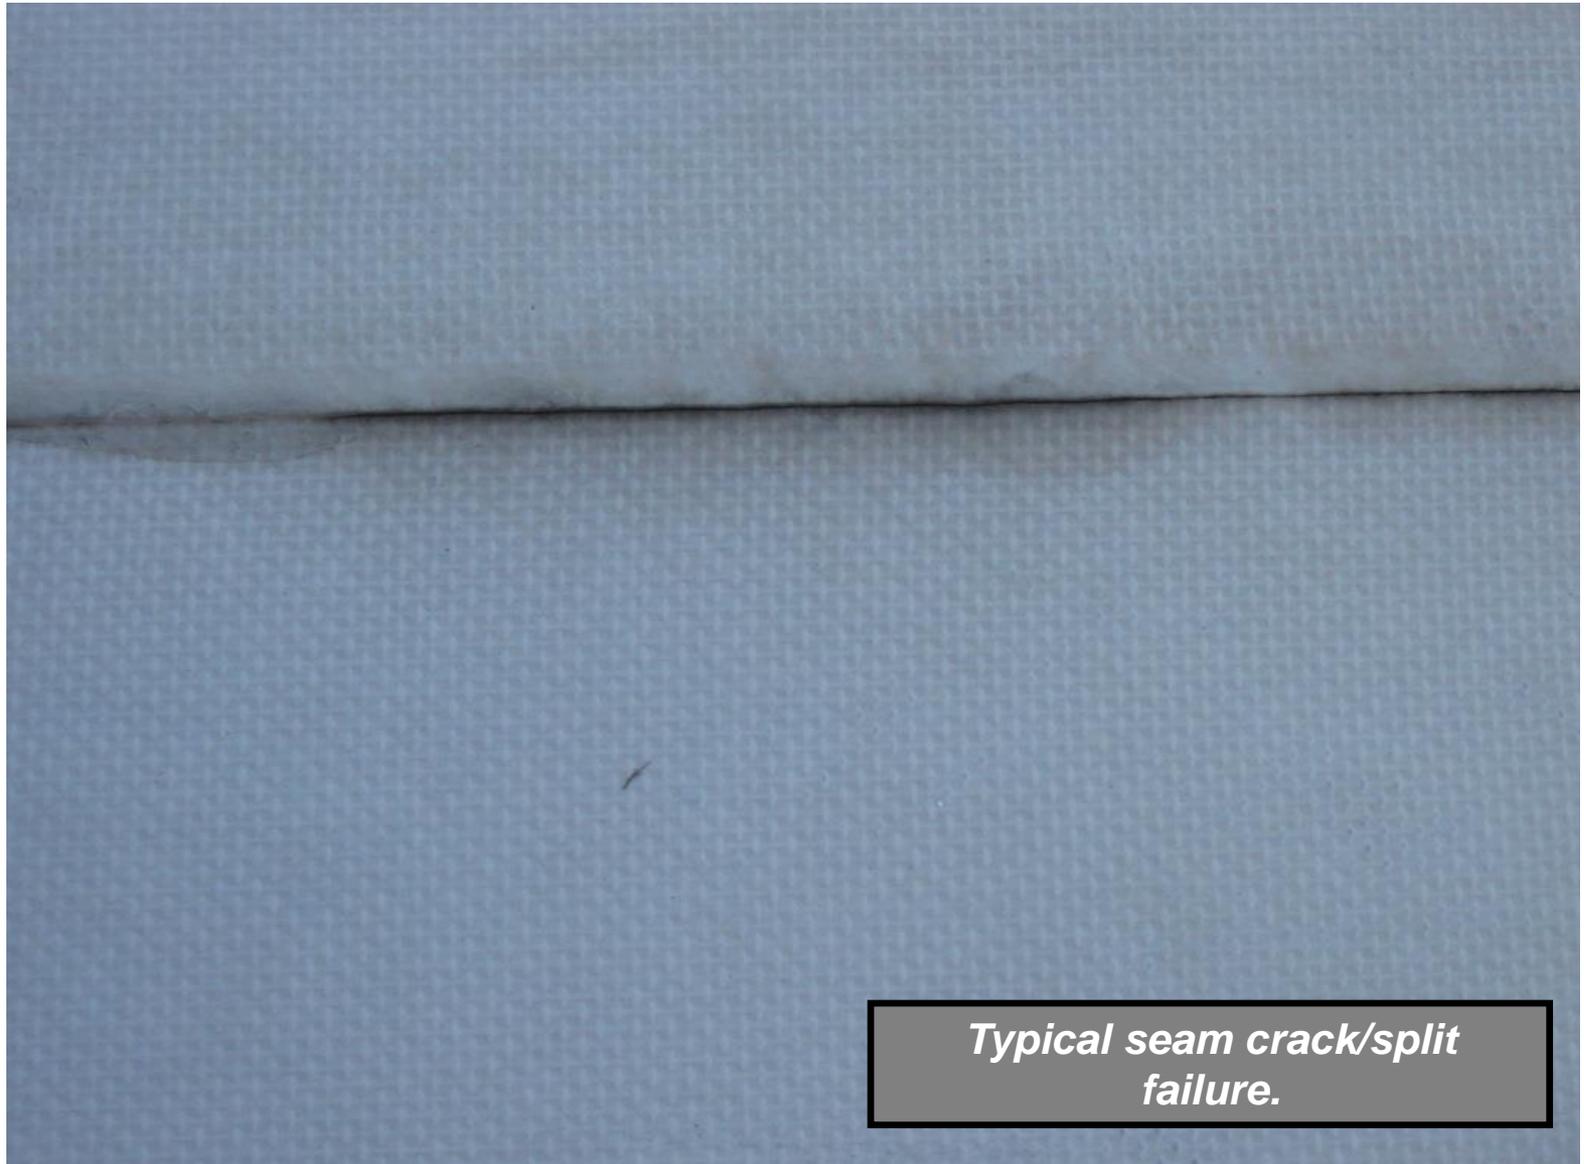
Typical seam crack/split failure.

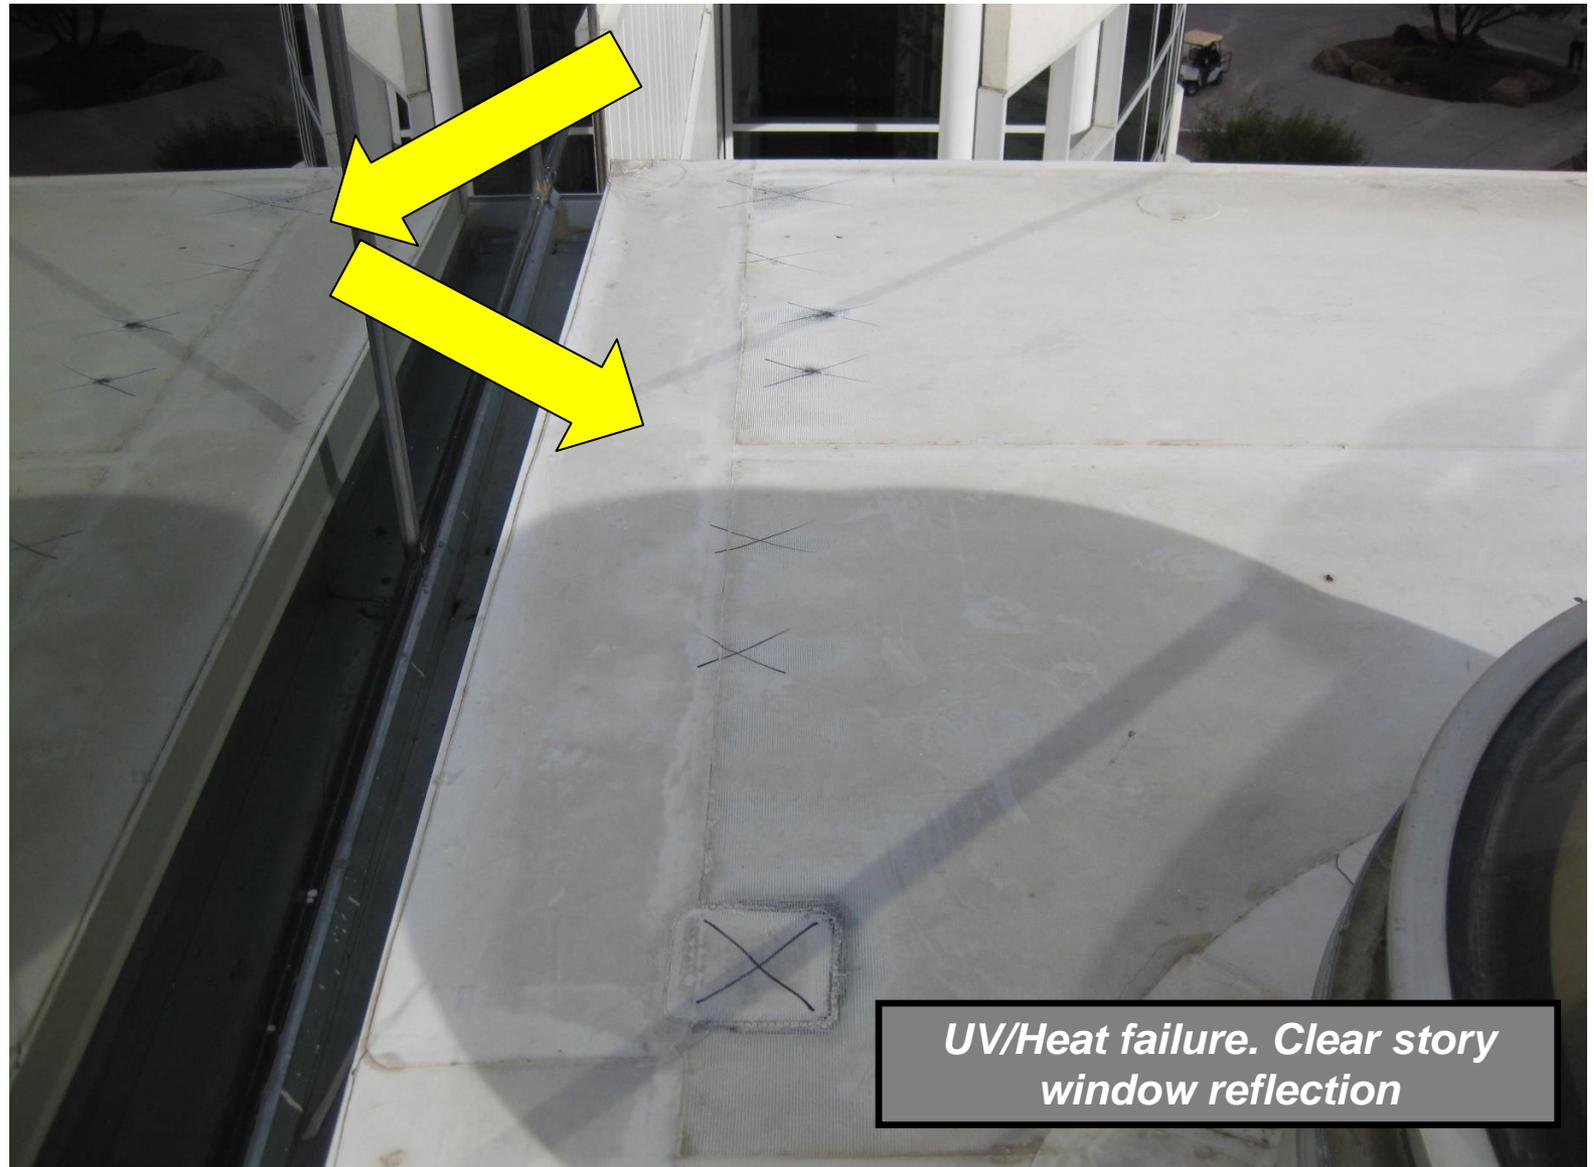
UV/Heat failure. Clear story window reflection

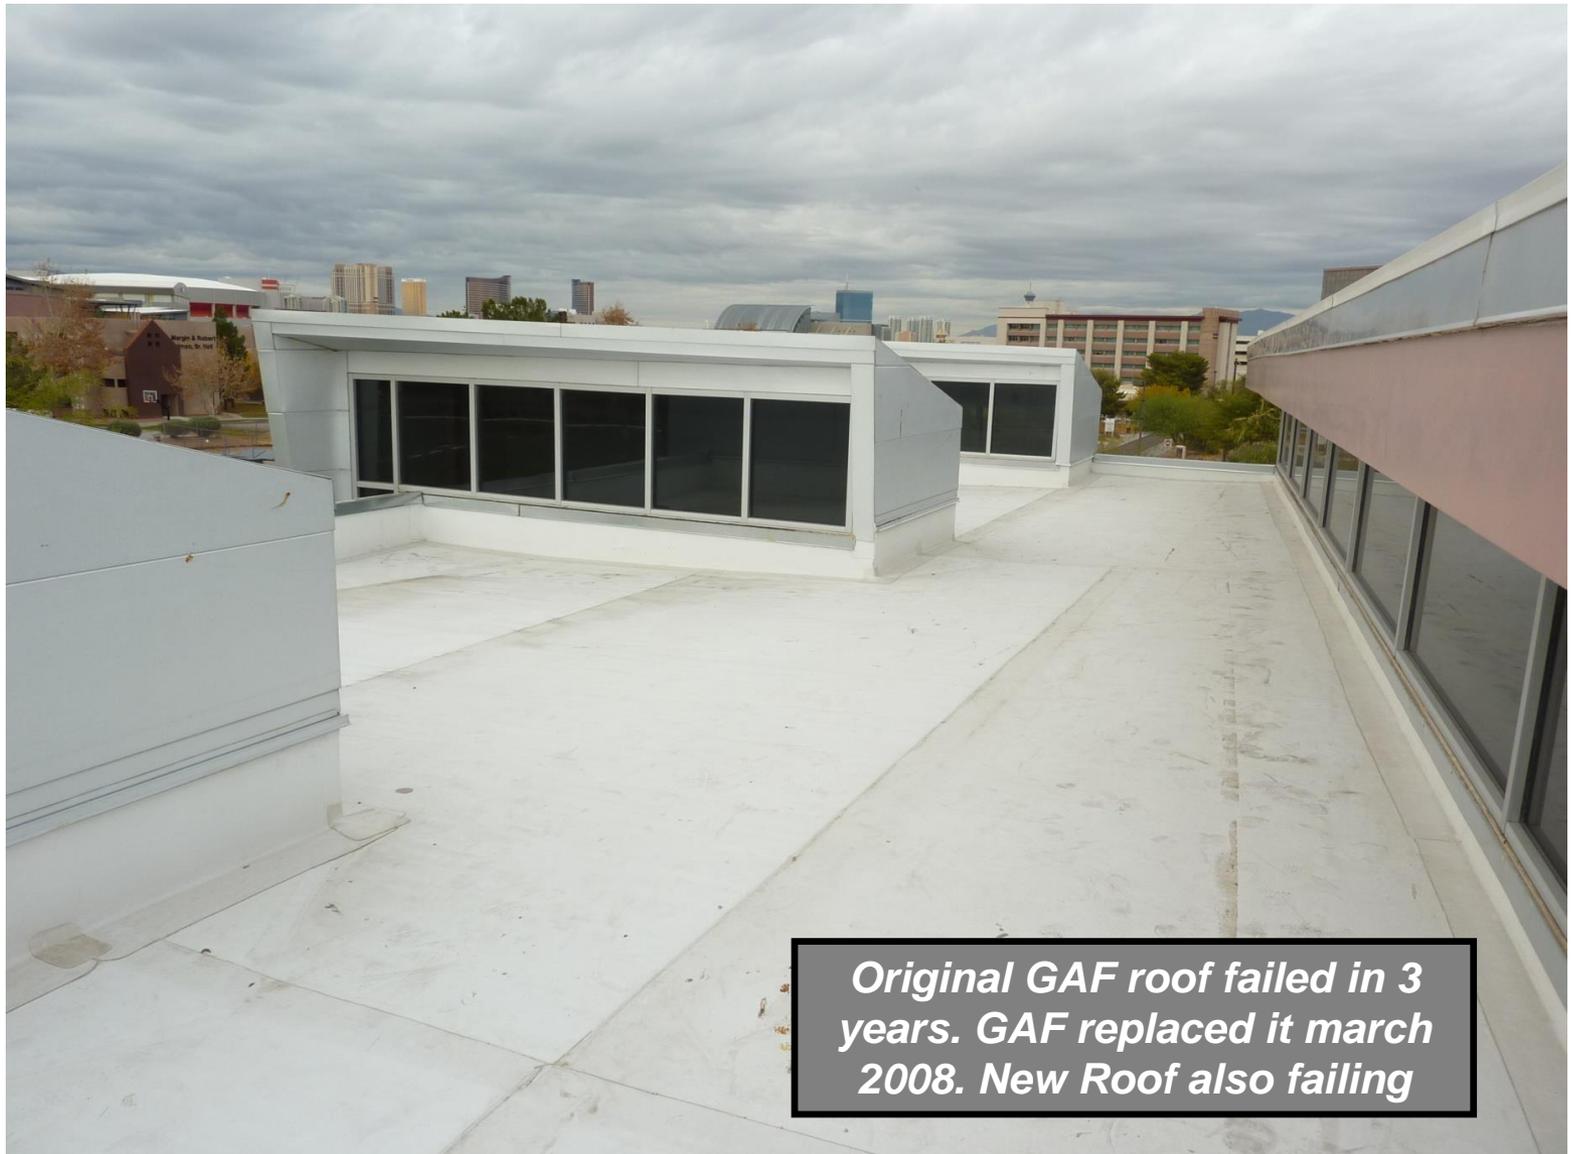
Original GAF roof failed in 3 years. GAF replaced it march 2008. New Roof also failing

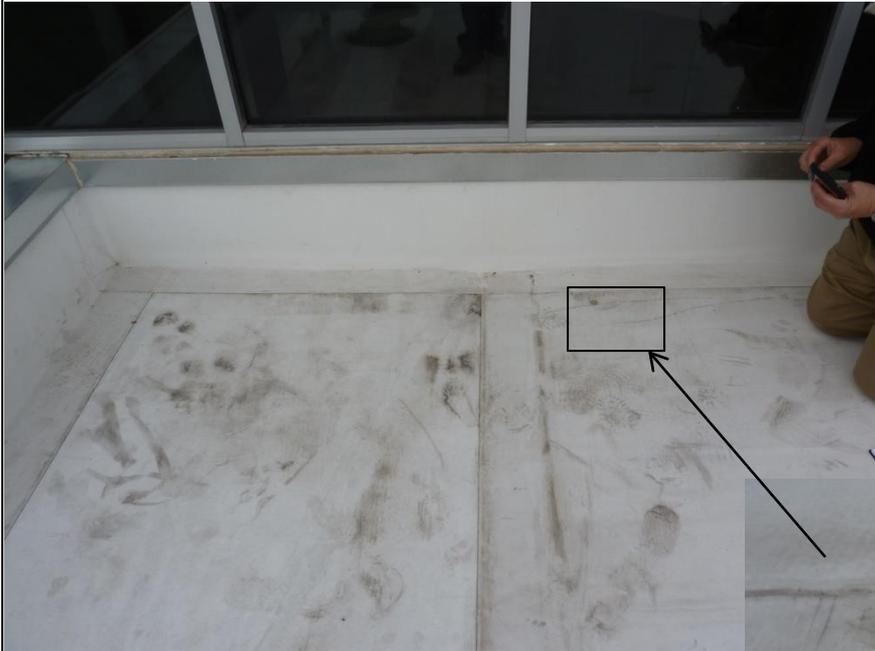
This replacement GAF roof is less than 3 years old!

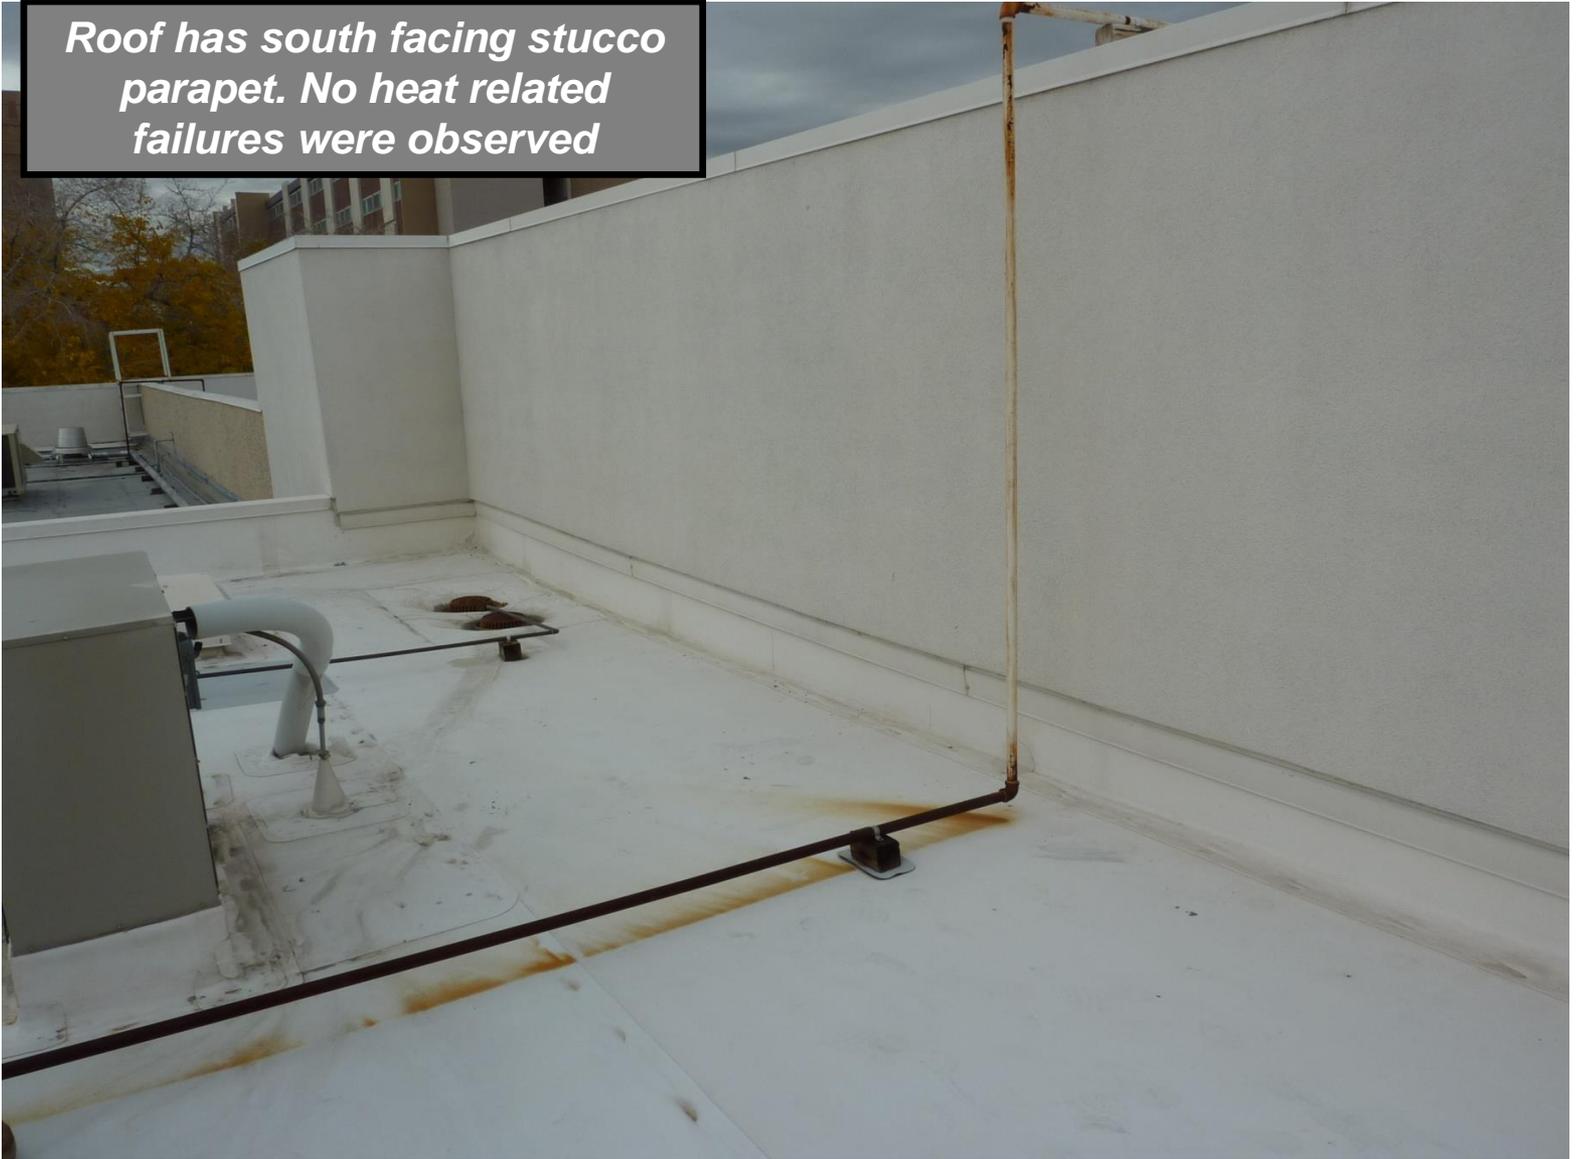
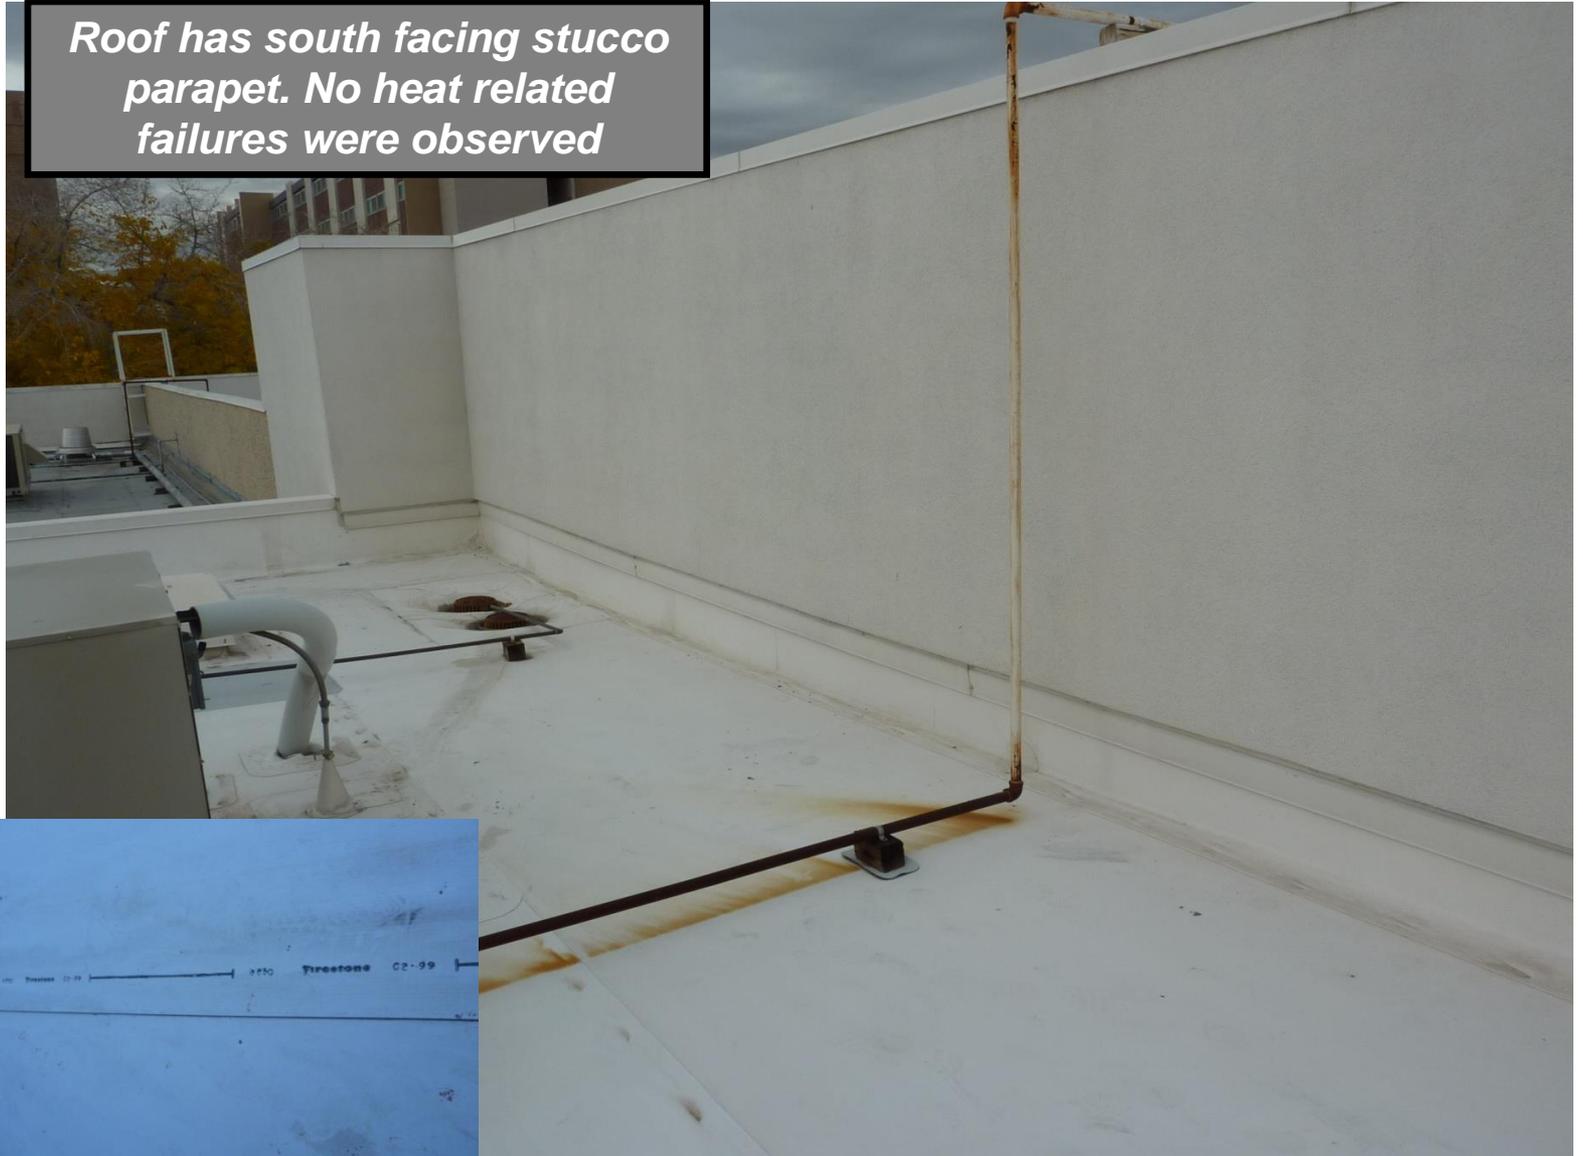
Roof has south facing stucco parapet. No heat related failures were observed

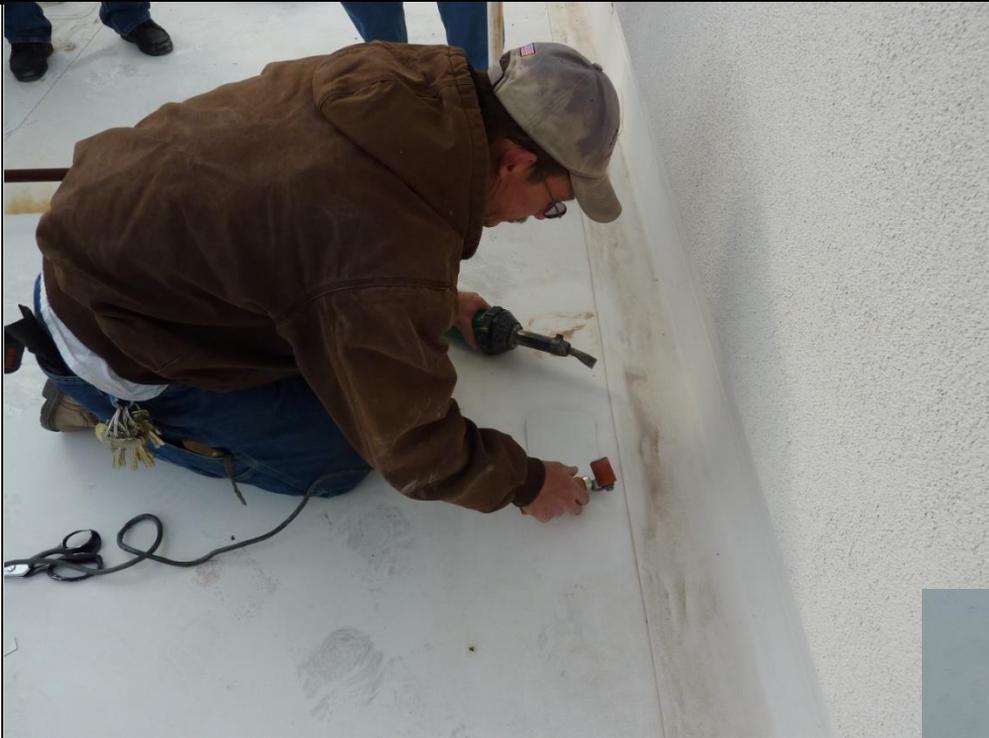
While there were no heat related failures, all attempts to heat weld/patch the roof were unsuccessful.

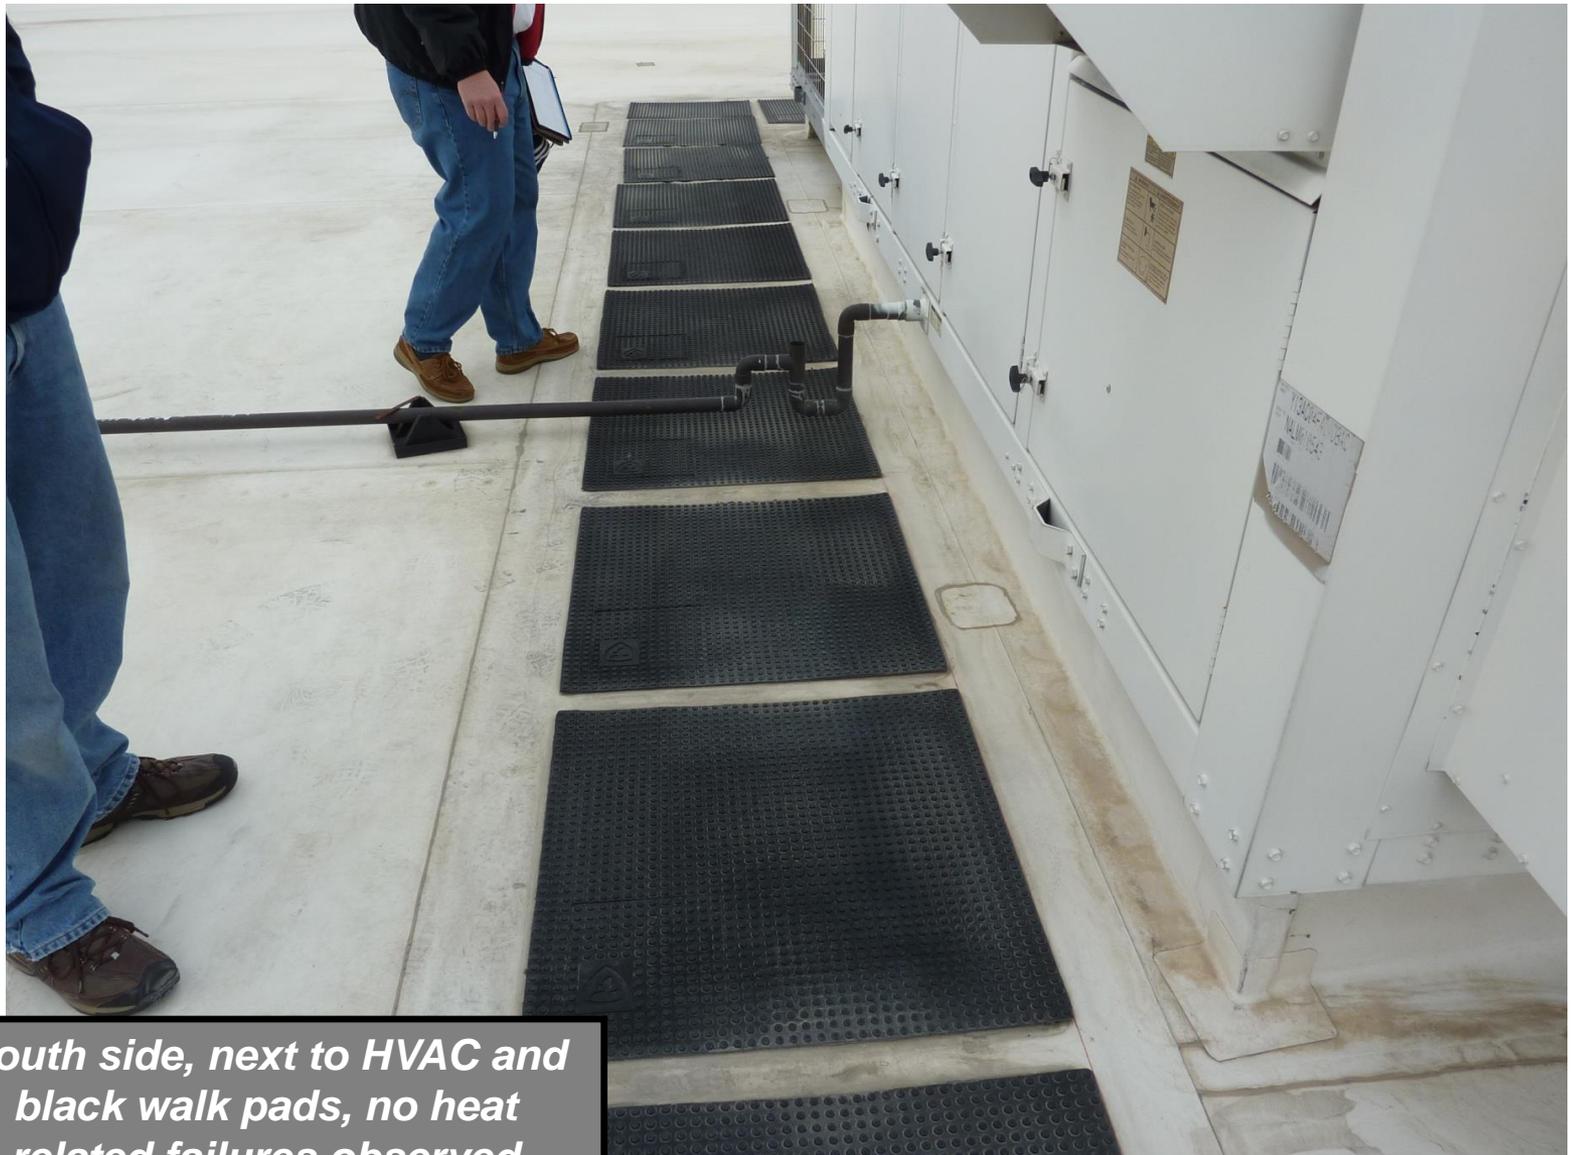
South side, next to HVAC and black walk pads, no heat related failures observed

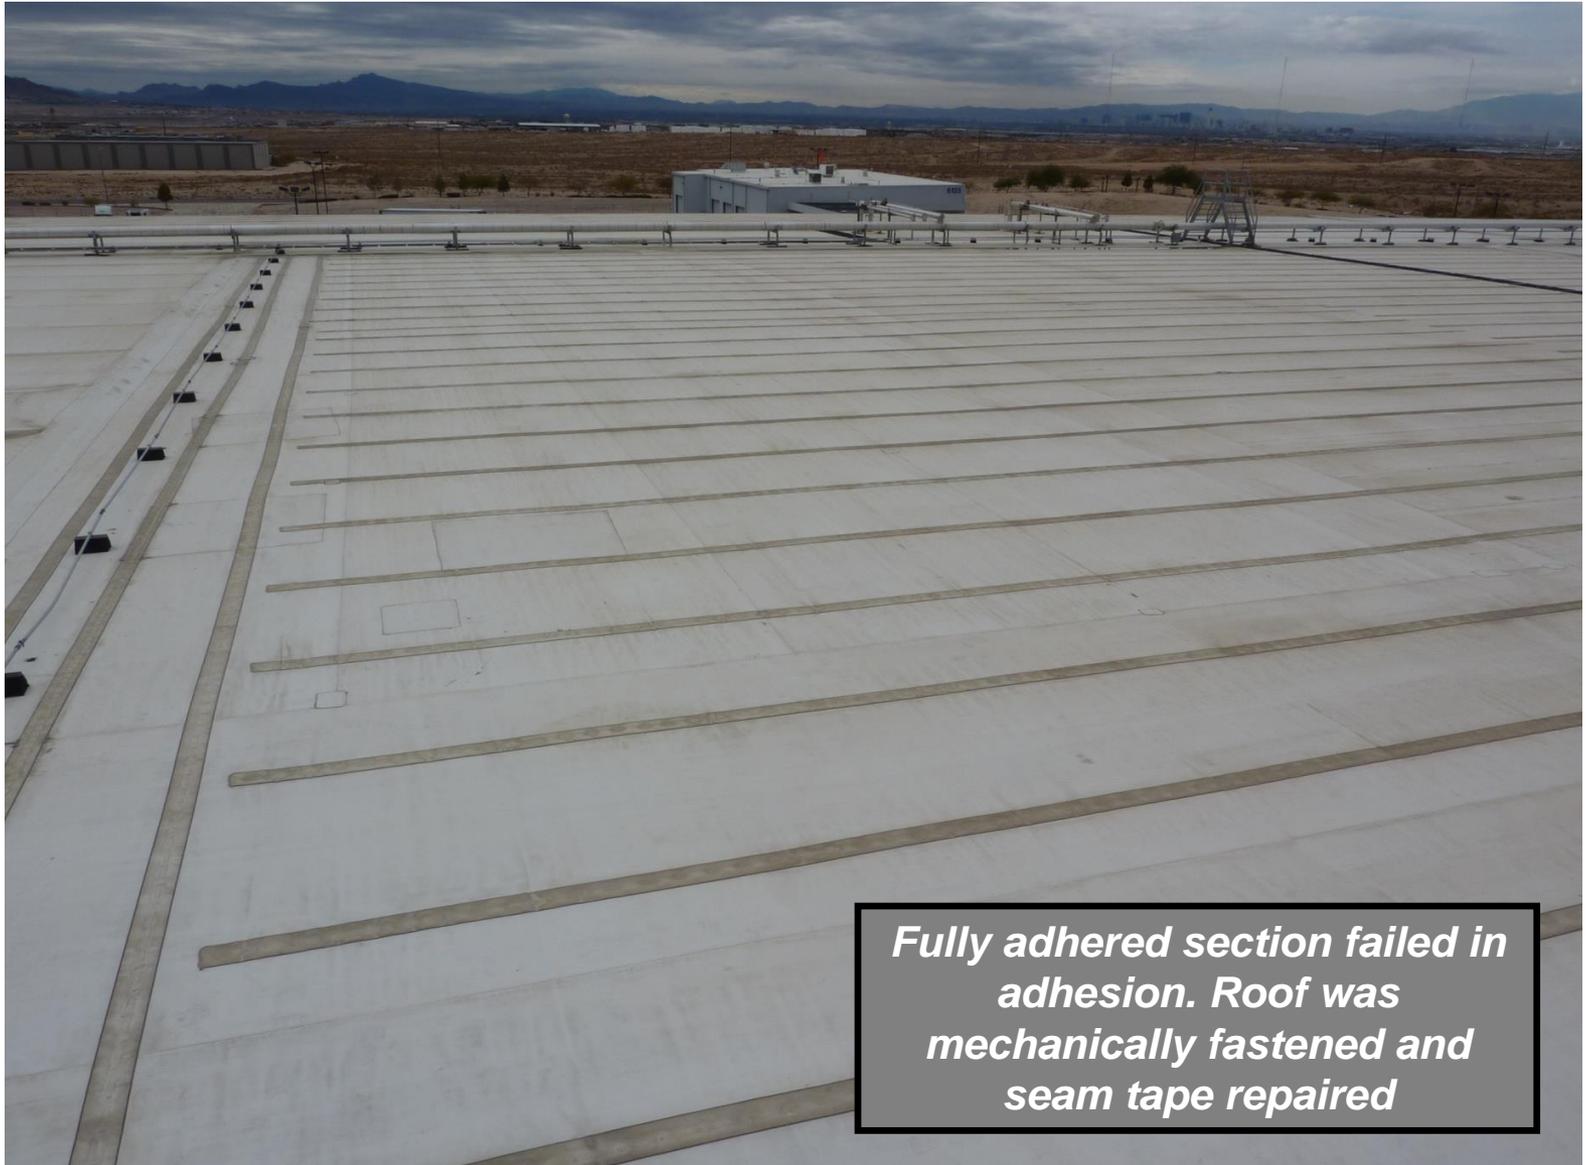
Fully adhered section failed in adhesion. Roof was mechanically fastened and seam tape repaired
