**Critical Review of the Life Span of
TPO and PVC**

RCI Hawaii Seminar

Case Study: PVC

Case Study: TPO

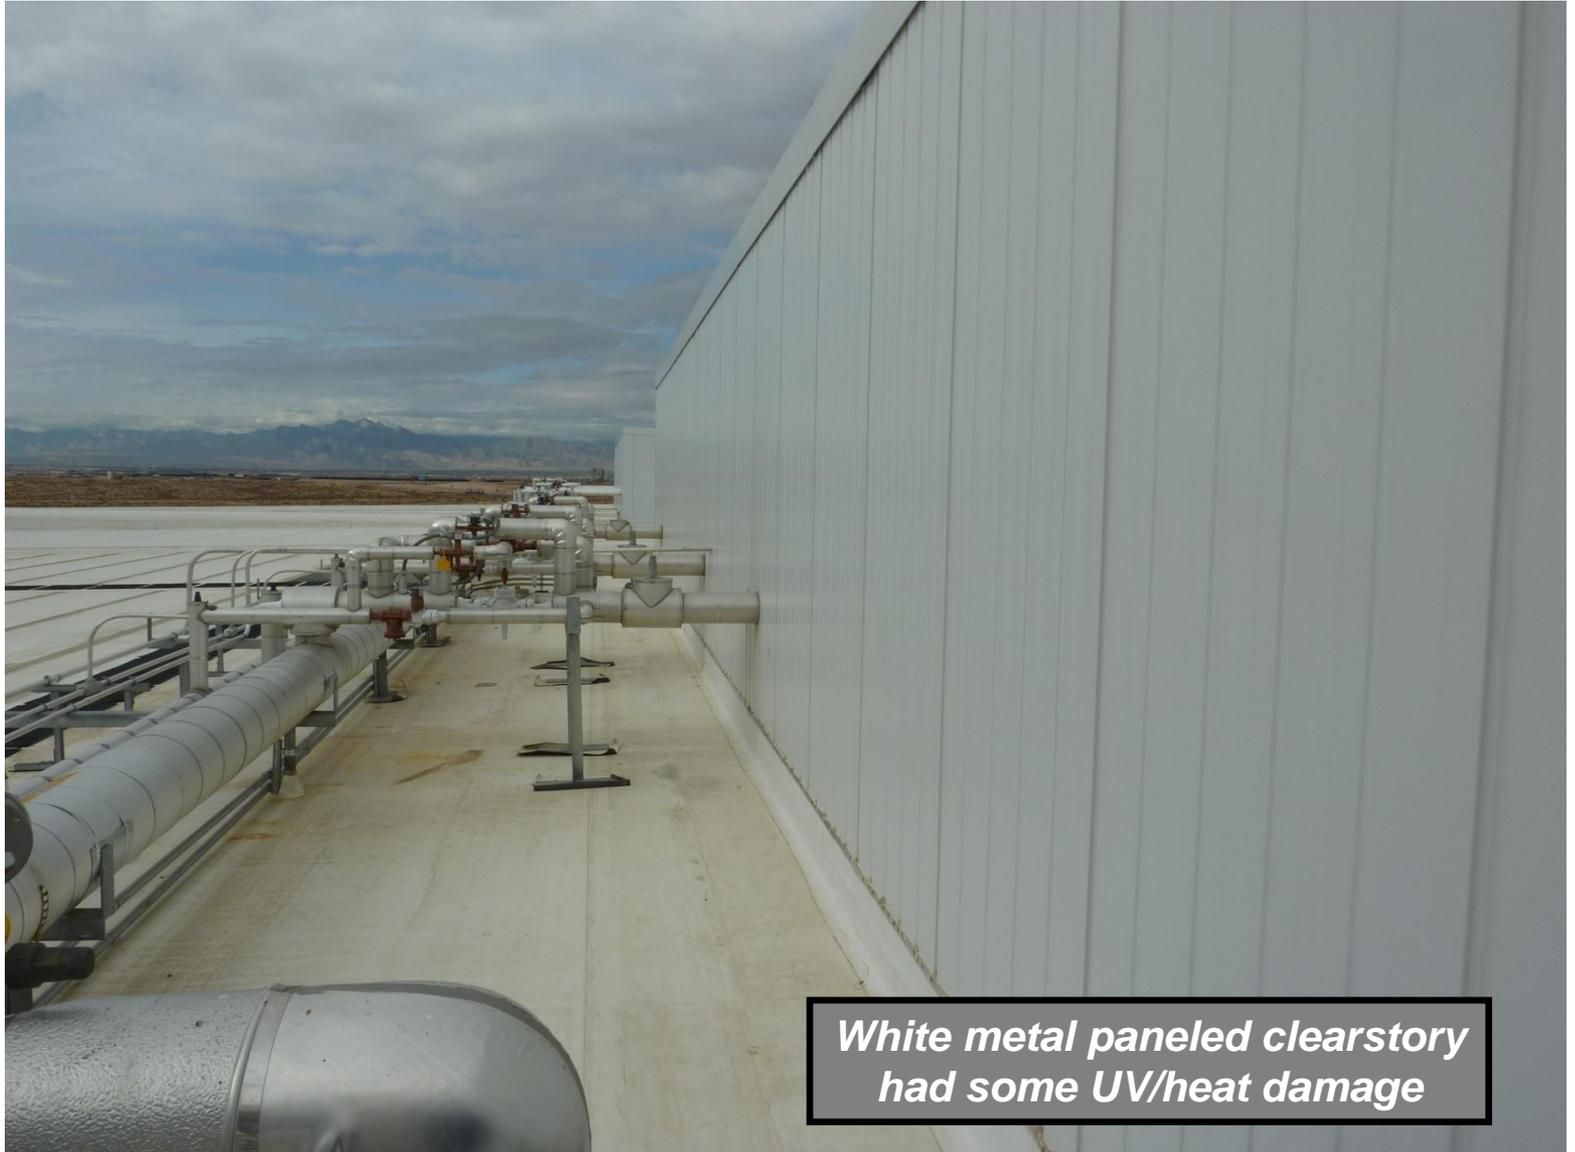
White metal paneled clearstory had some UV/heat damage

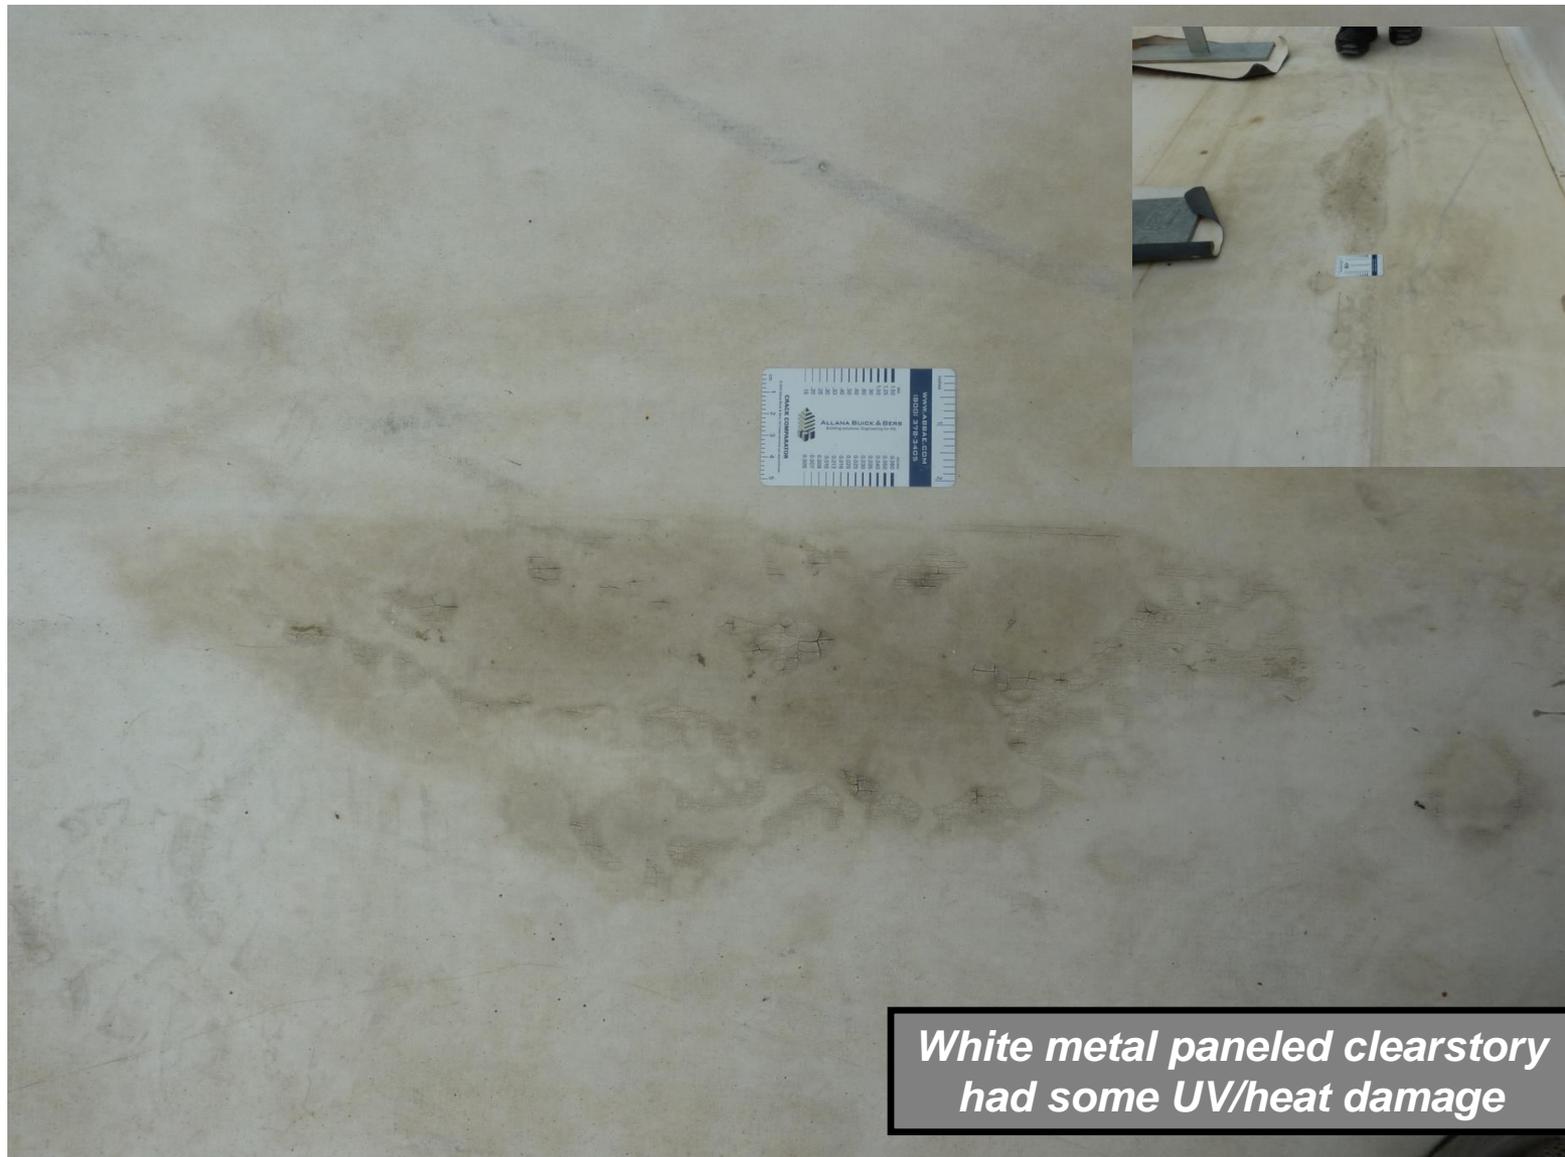
White metal paneled clearstory had some UV/heat damage
