Marina Harbor

Podium Deck Waterproofing
by
Karim P. Allana, PE, RRC, RWC
President
Allana, Buick & Bers, Inc.

Project Overview

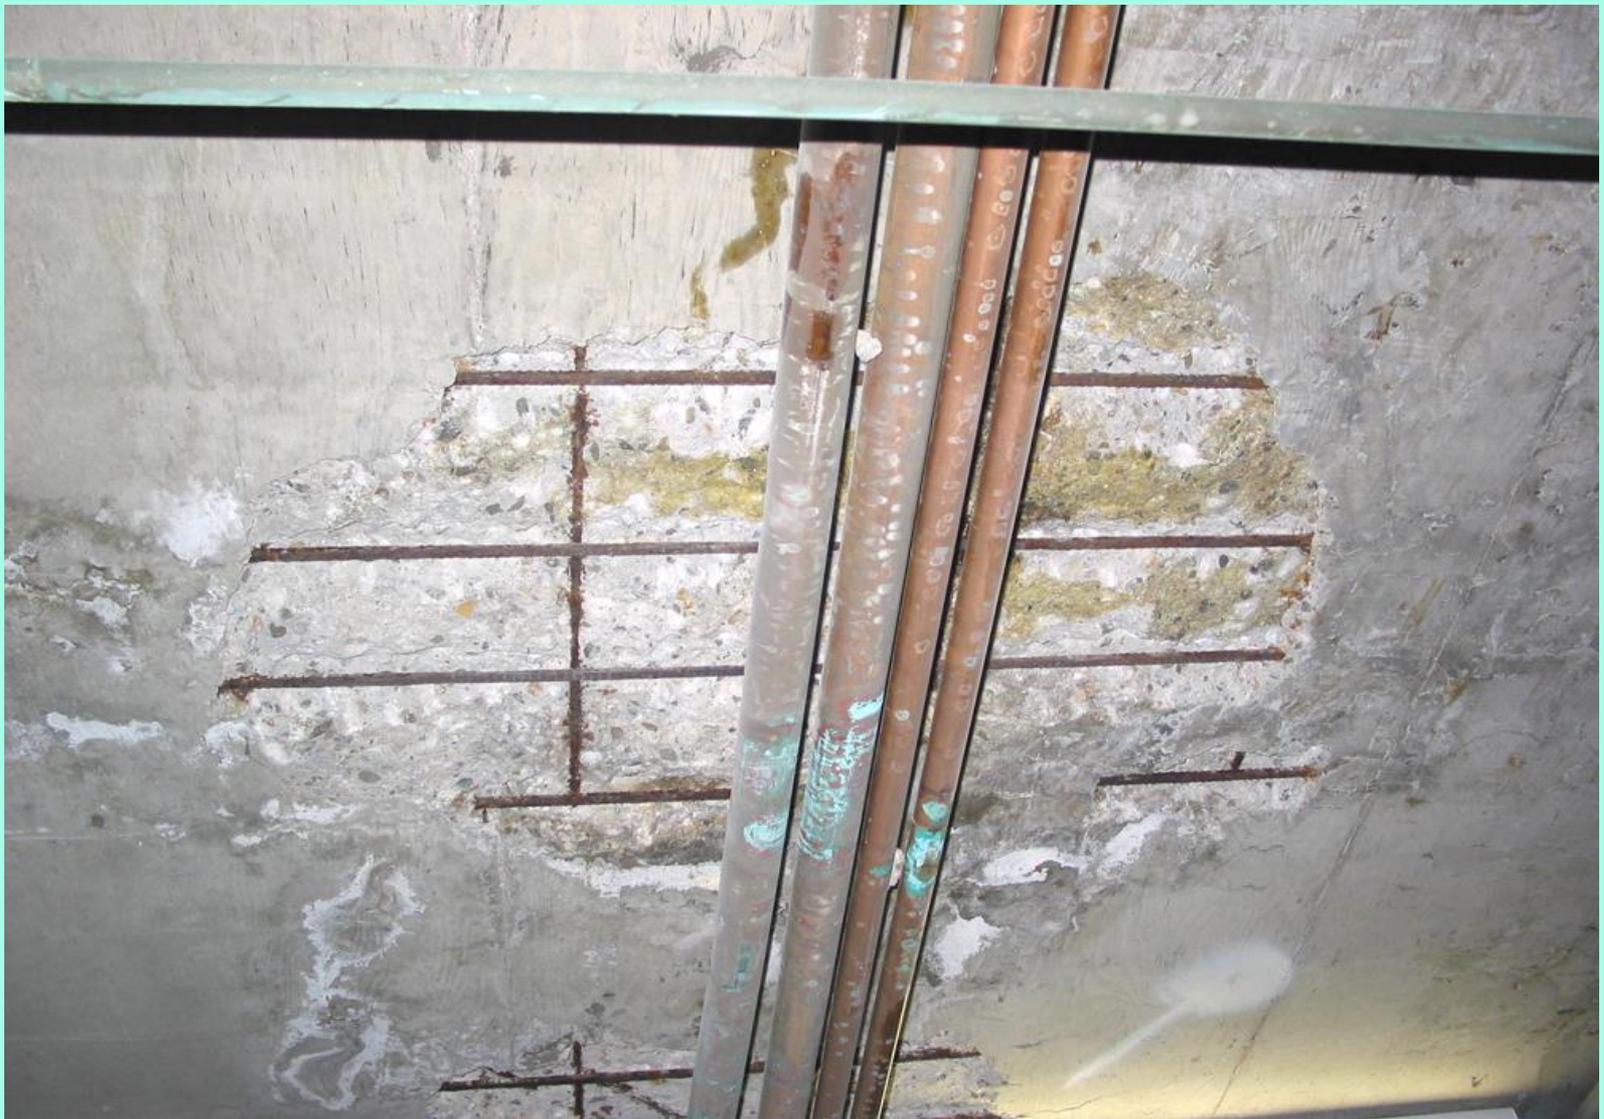
Original Waterproofing Failed, resulted
in leaks and severe spall damage

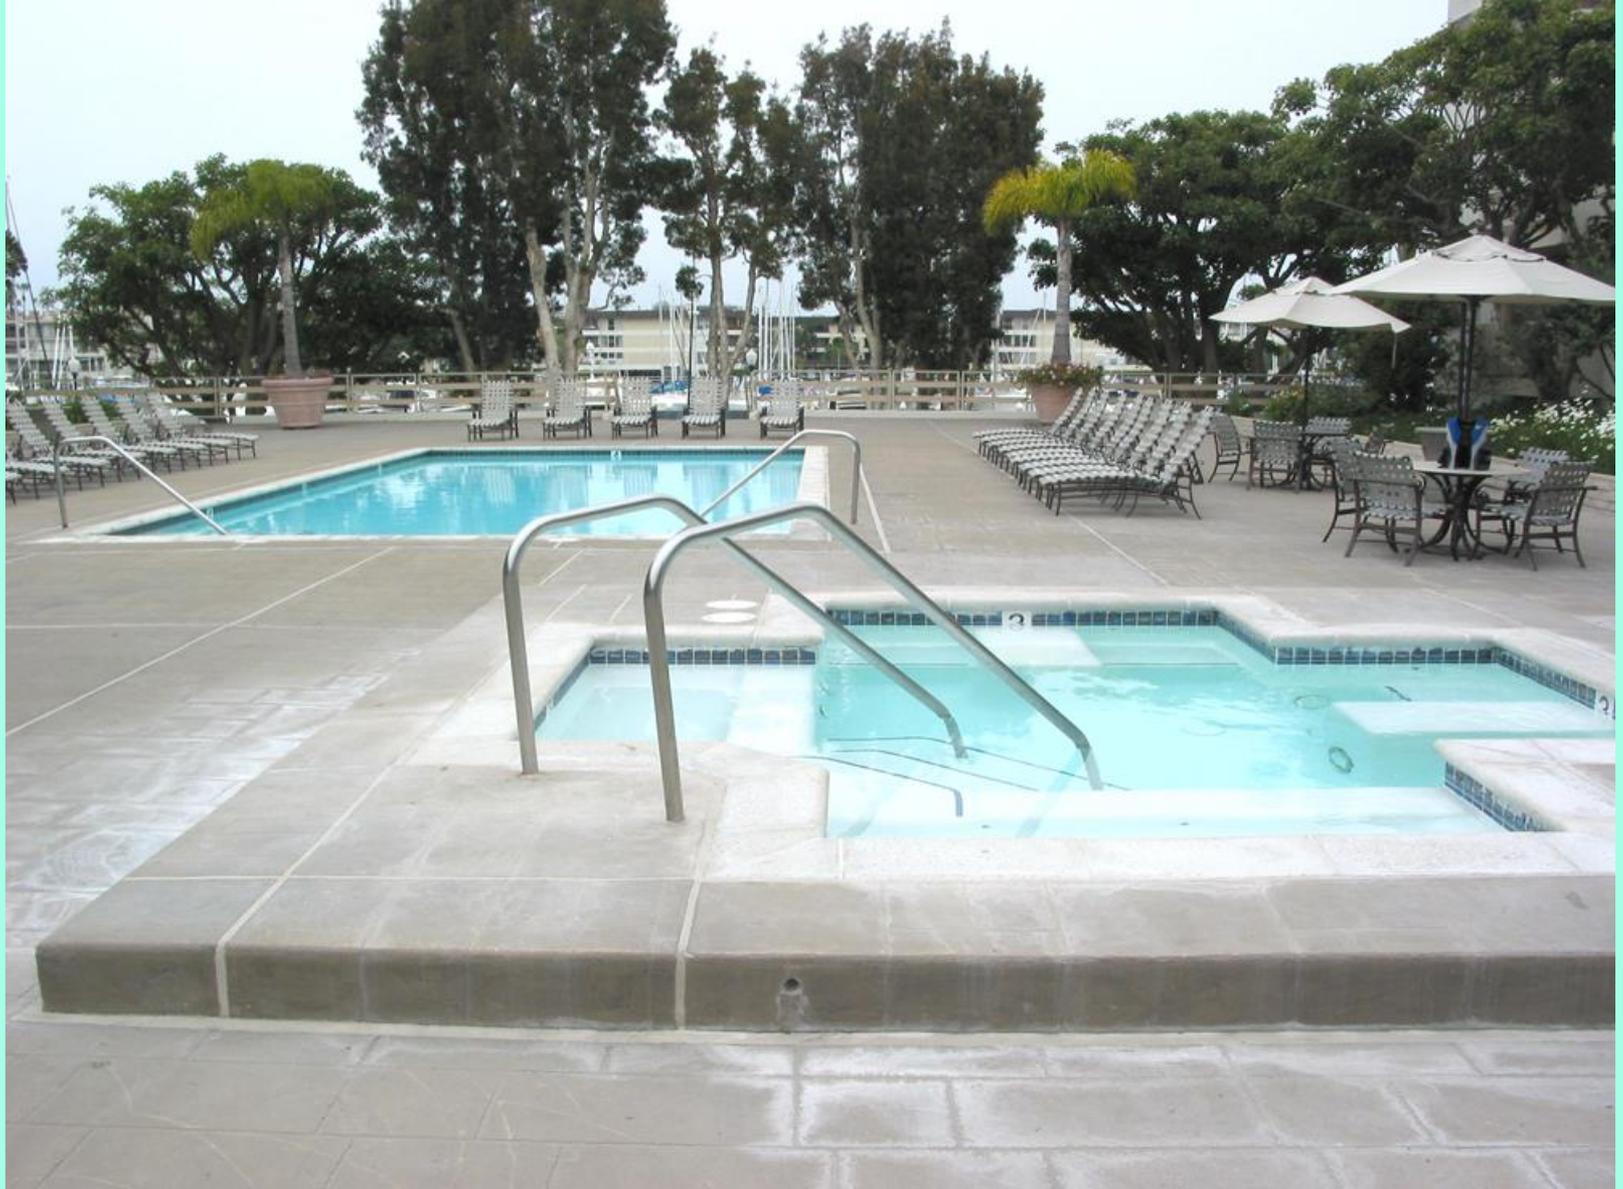
Pool and spa with efflorescence and/or staining

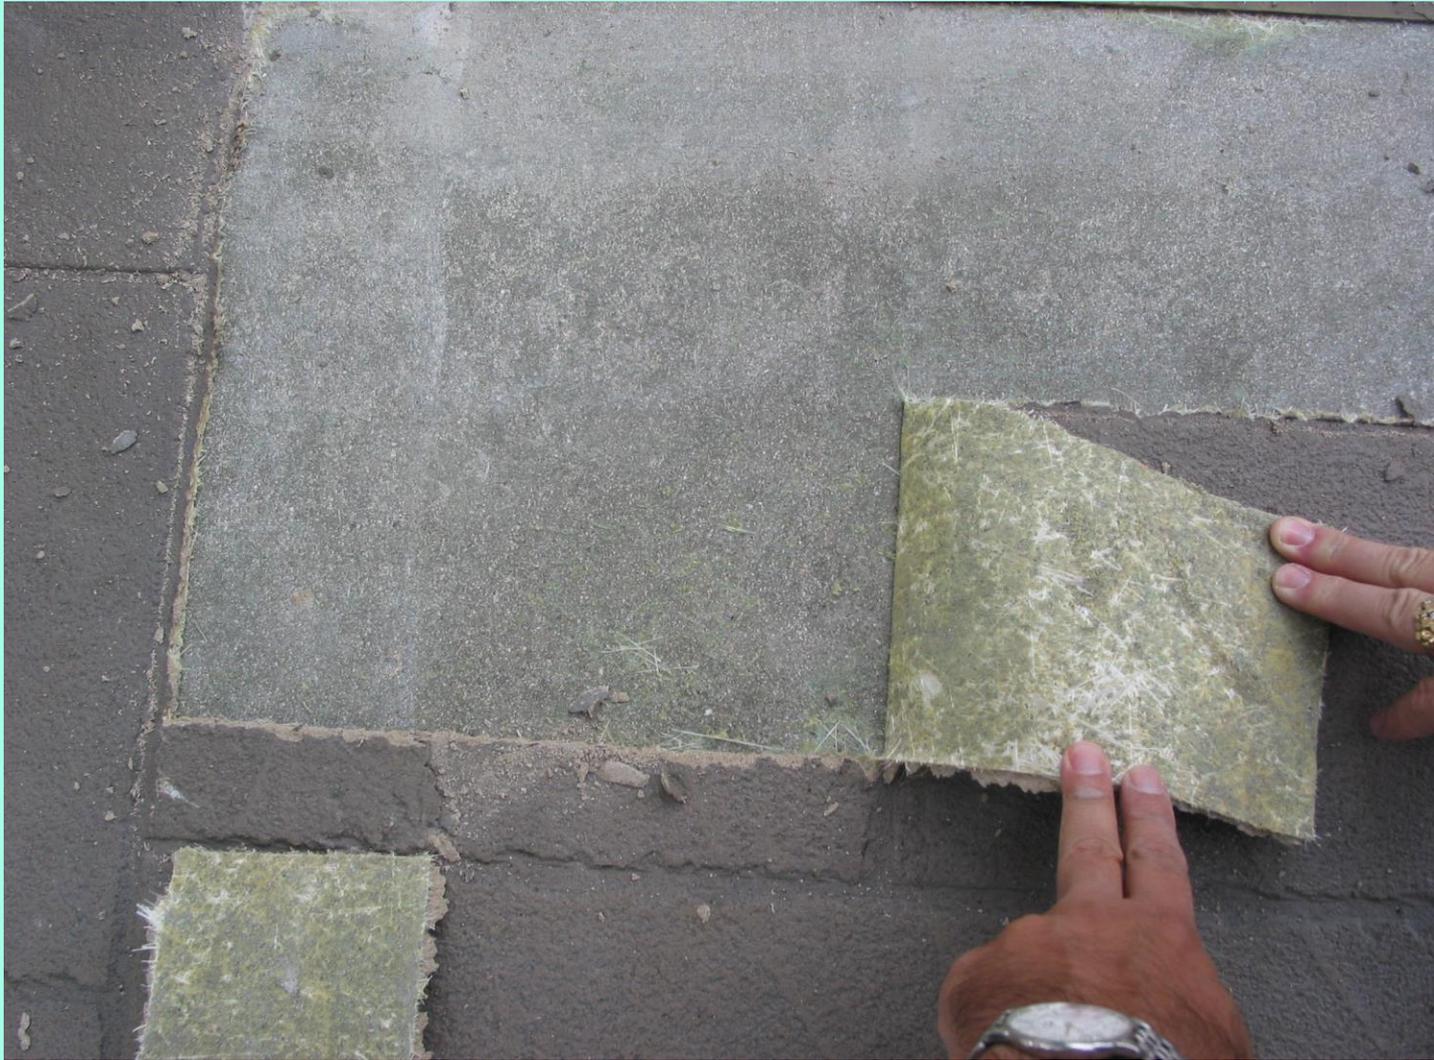
Poor deck preparation resulted in poor adhesion...

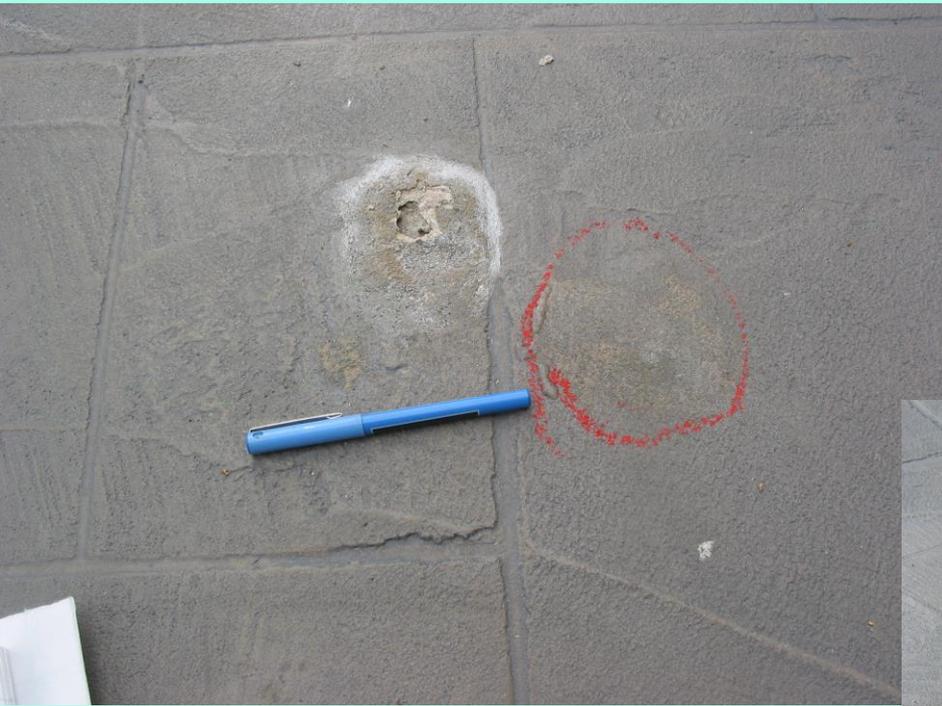
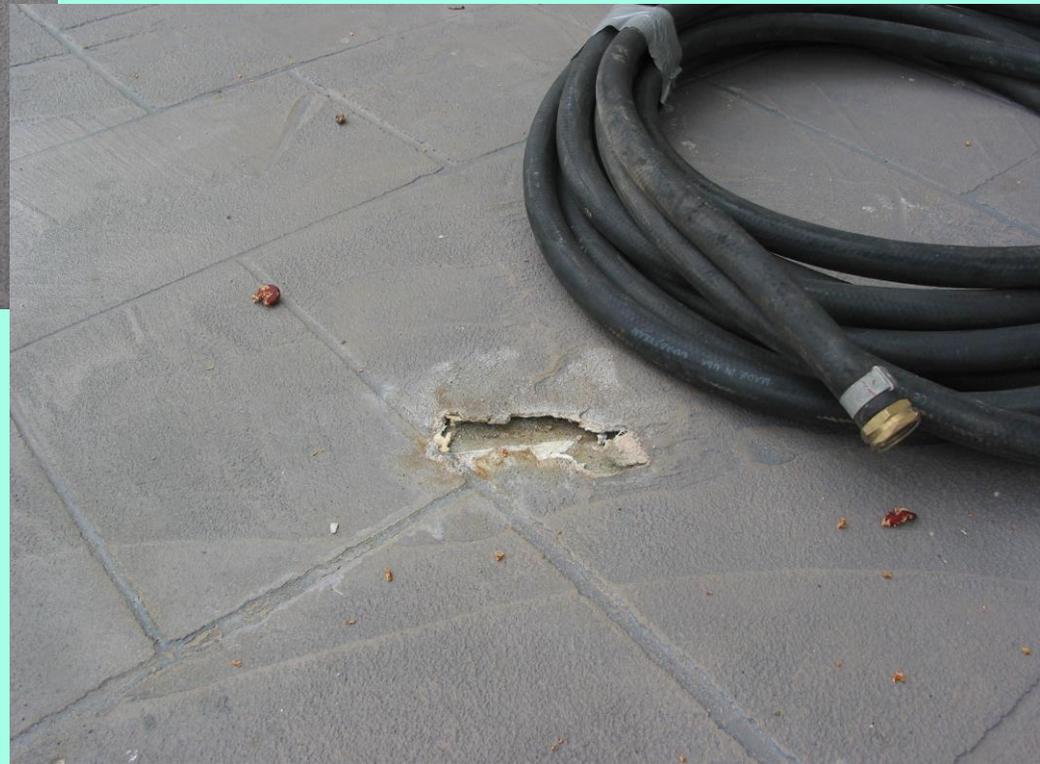
Blisters resulted in
foot traffic damage

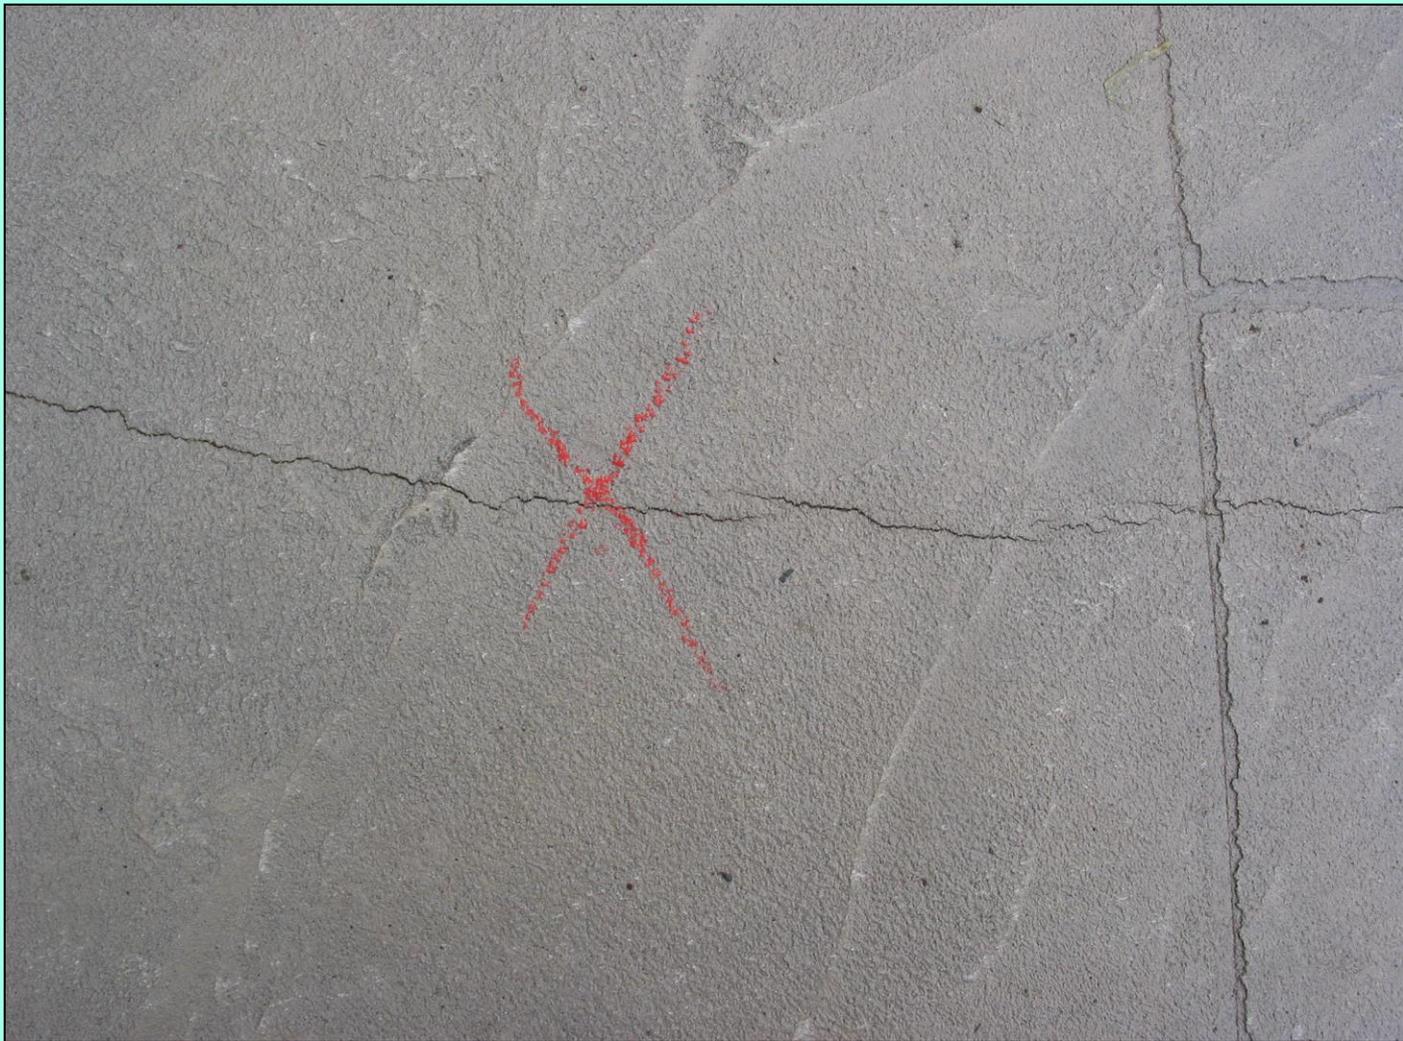
And cracks in the Deck Coating System led to leaks

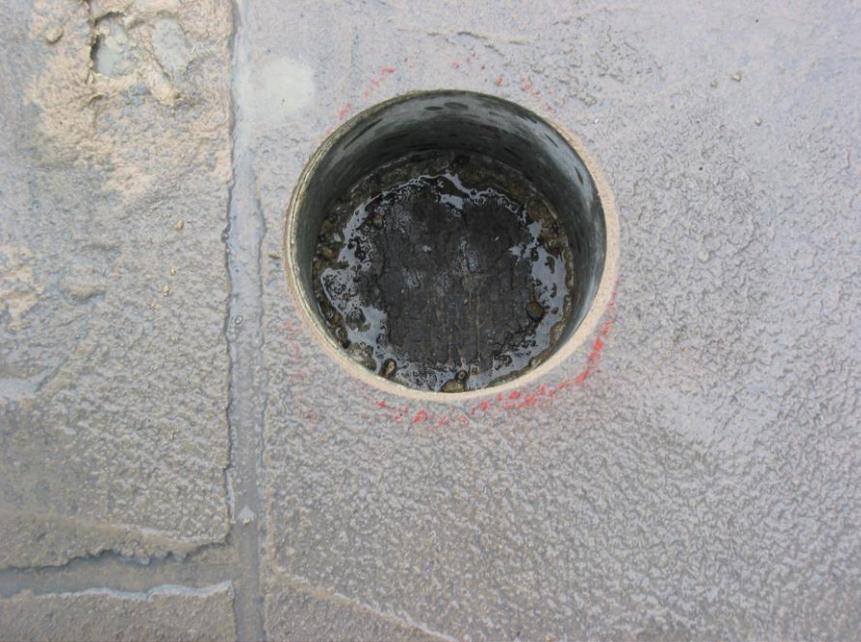
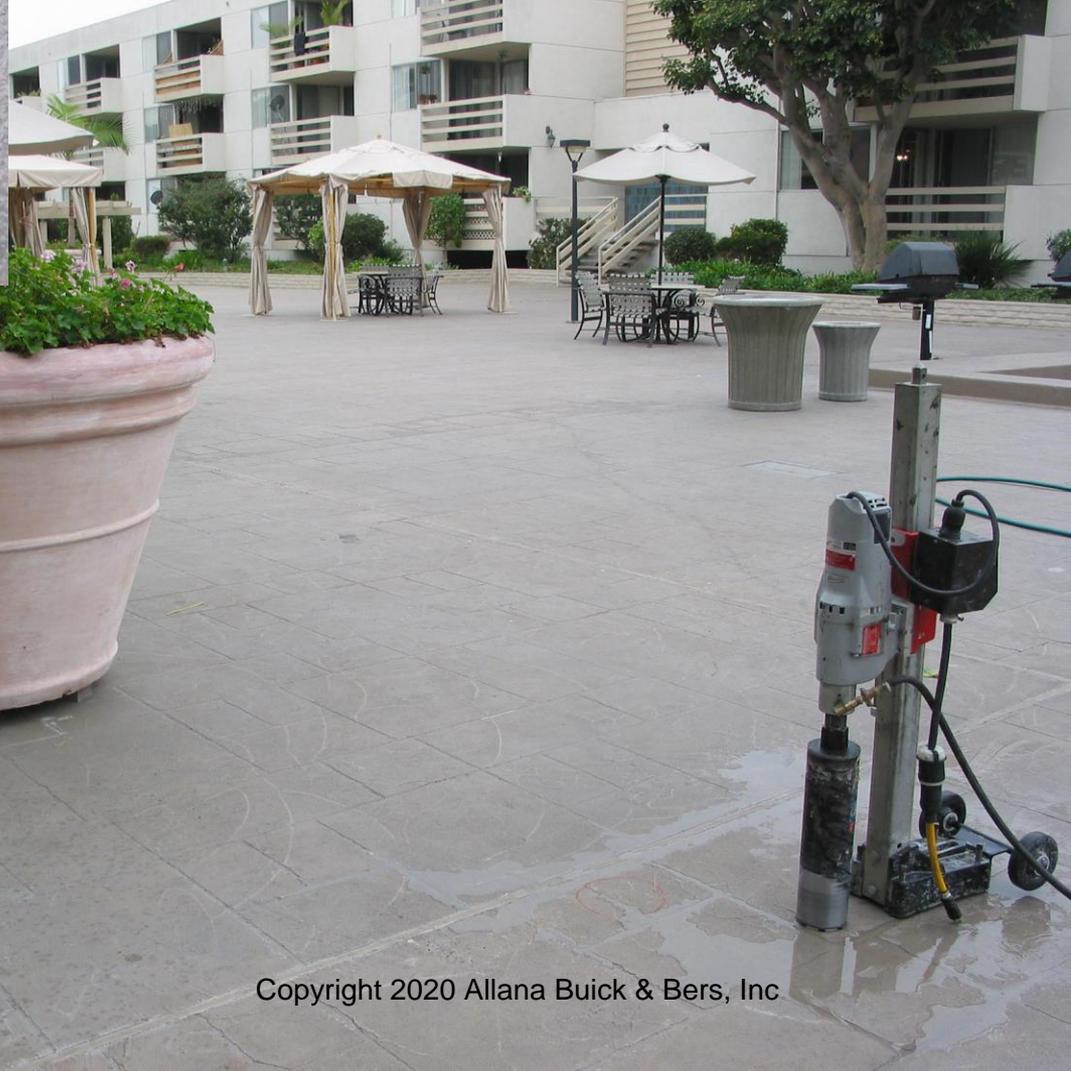
We performed Concrete cores to determine the cause of cracks and premature failure

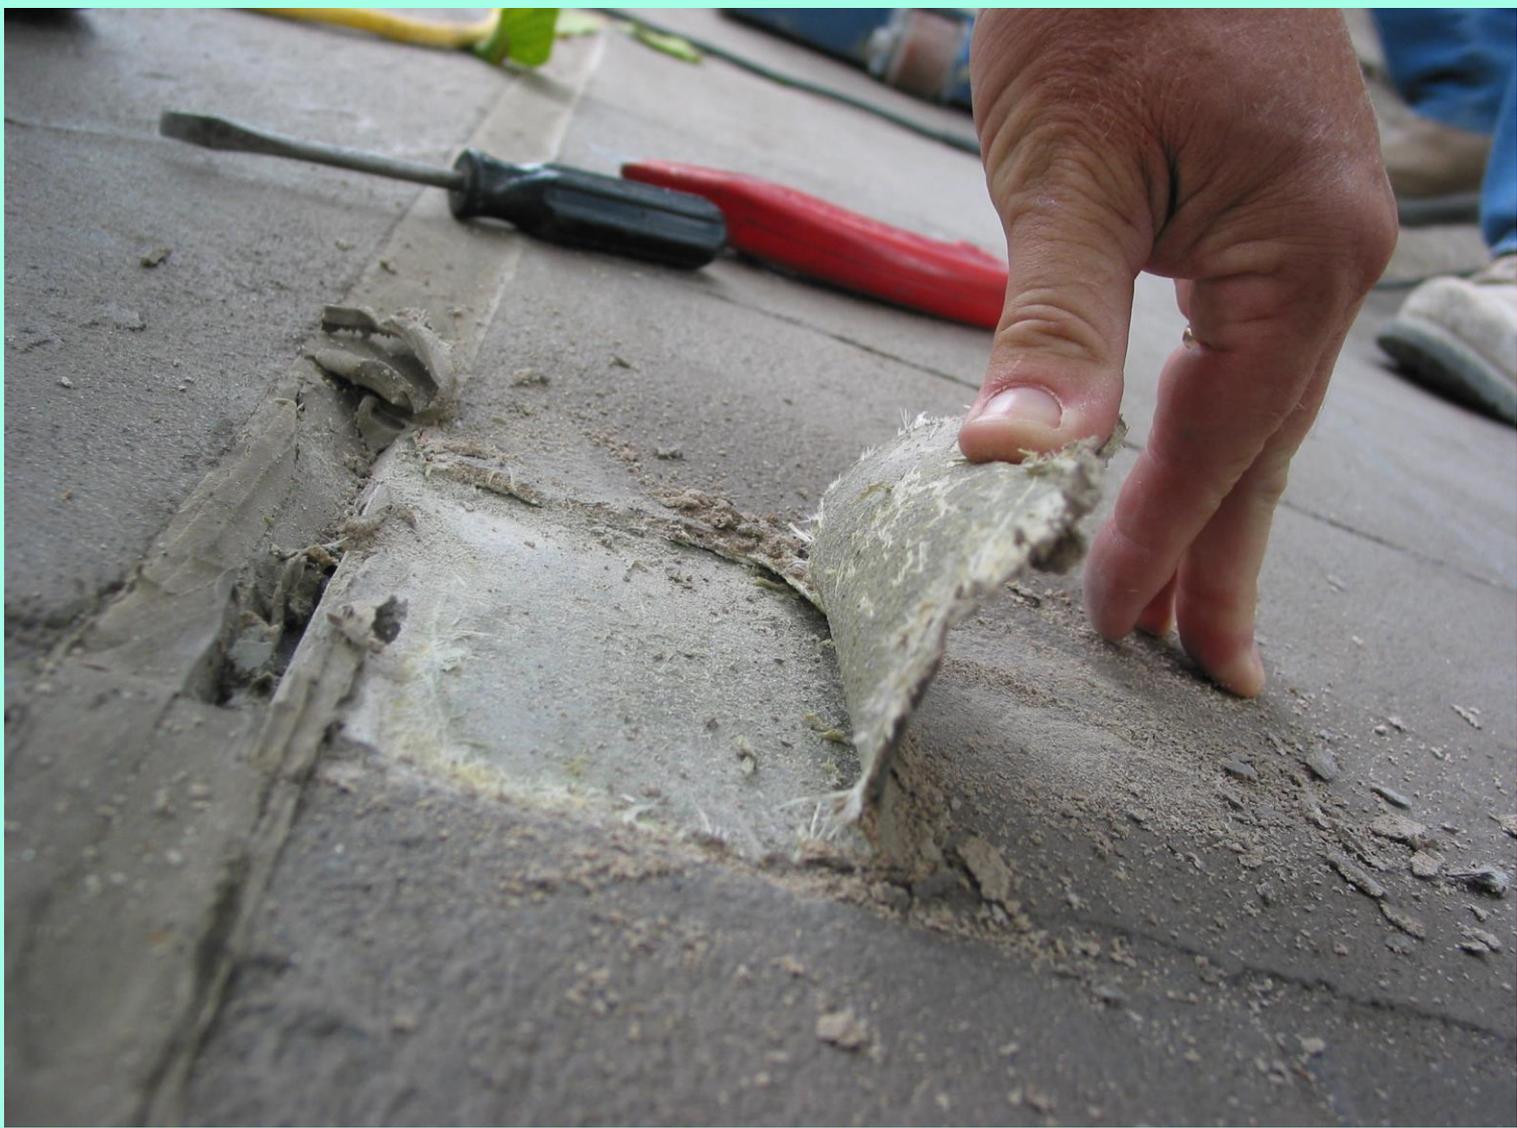
The system was not properly terminated and sealed at the control joints

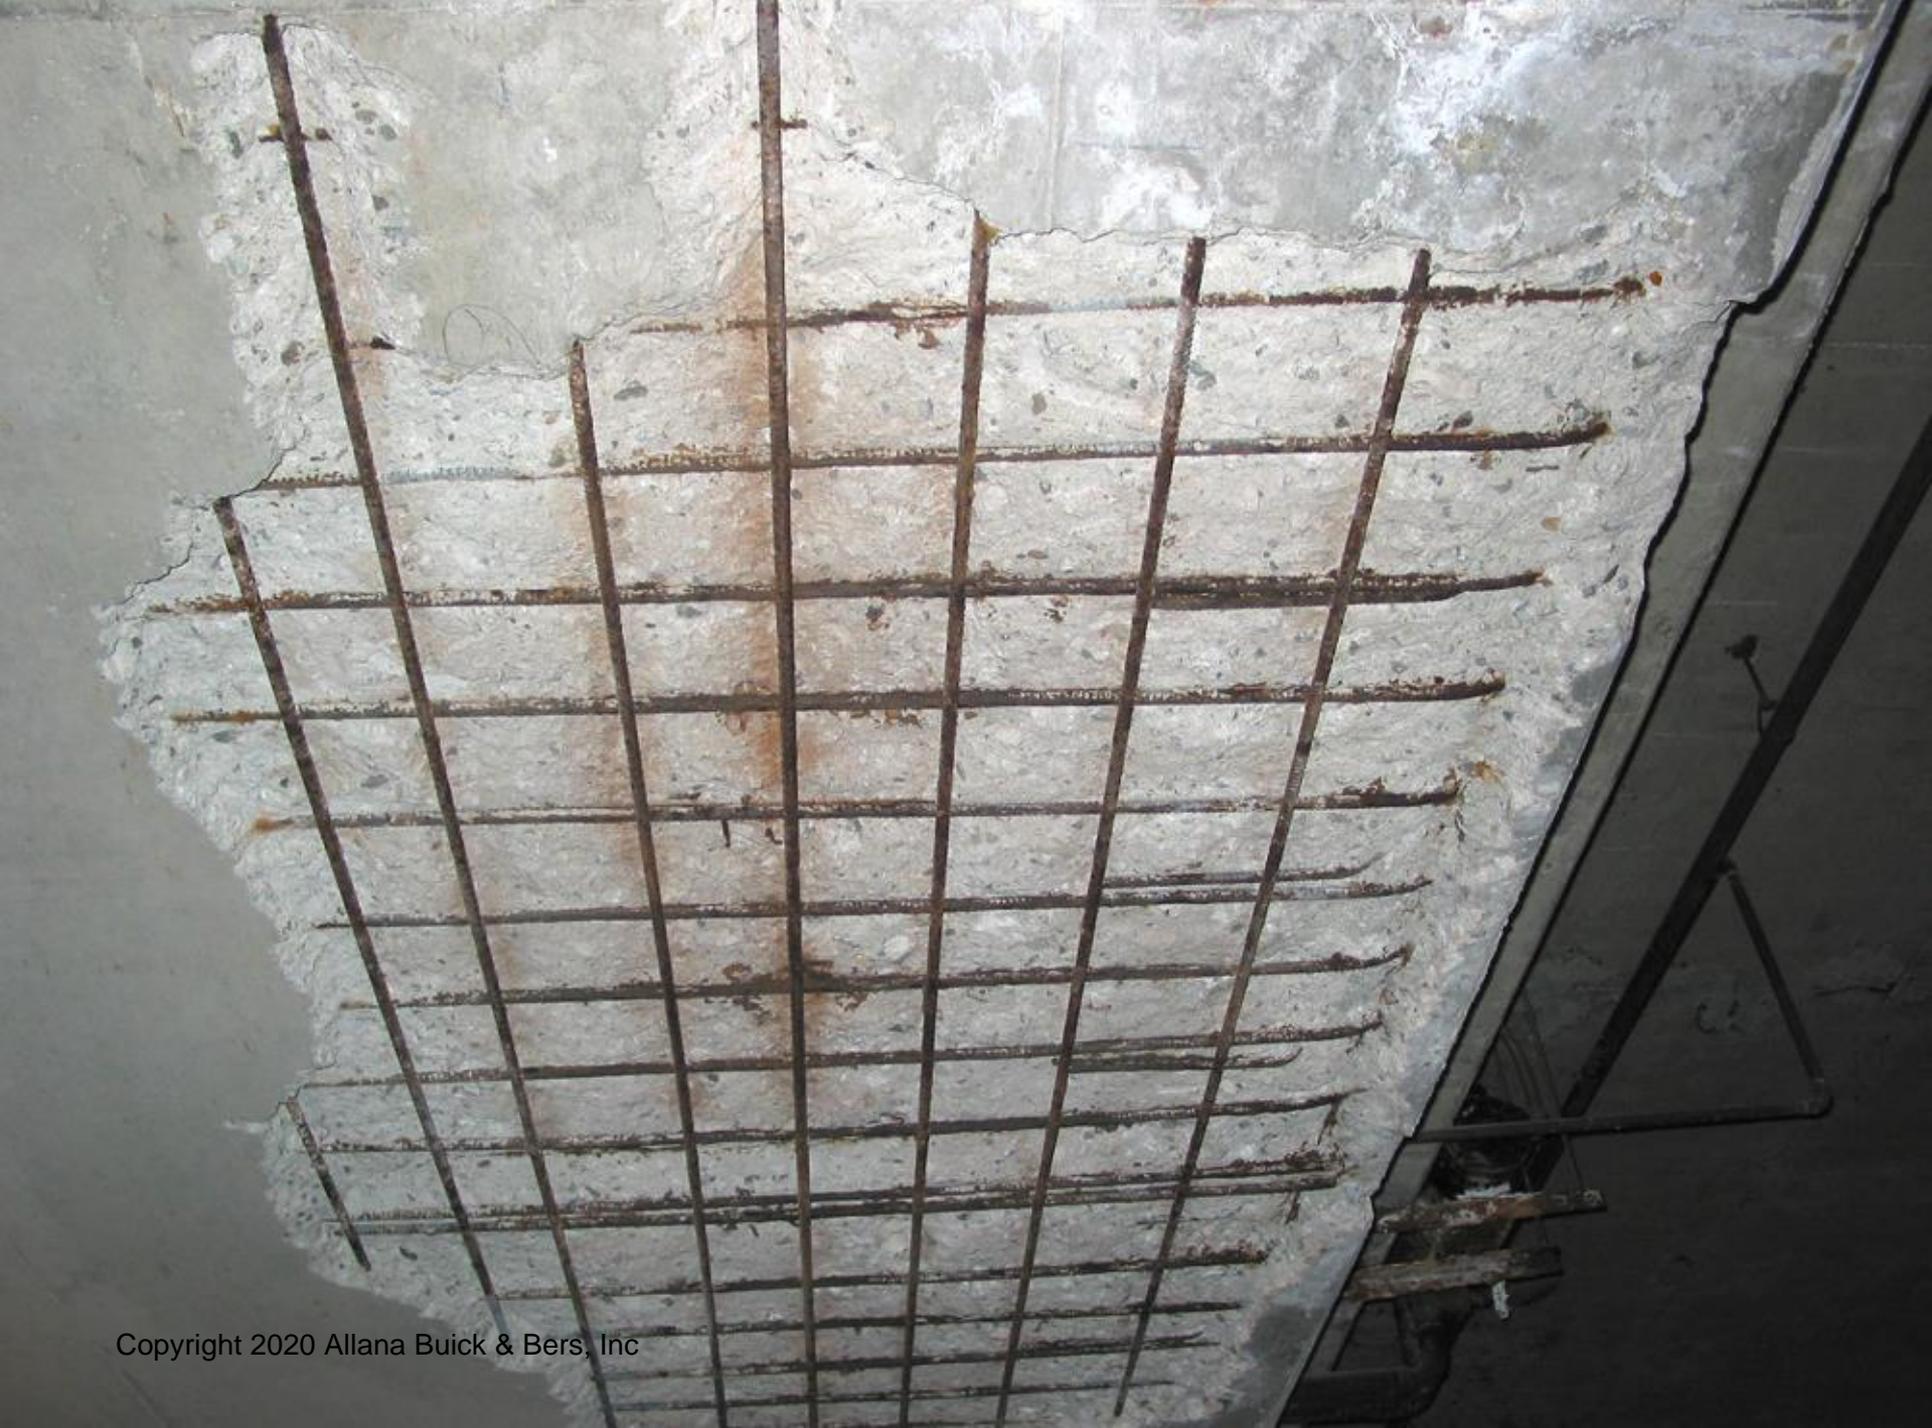
Mode of Membrane Splitting and Deck Failure

Original Deck Had Large Moving Cracks Throughout the Topping Slab. Original Remedial Repair Design Called For Epoxy Healing of Cracks, Which Was Omitted

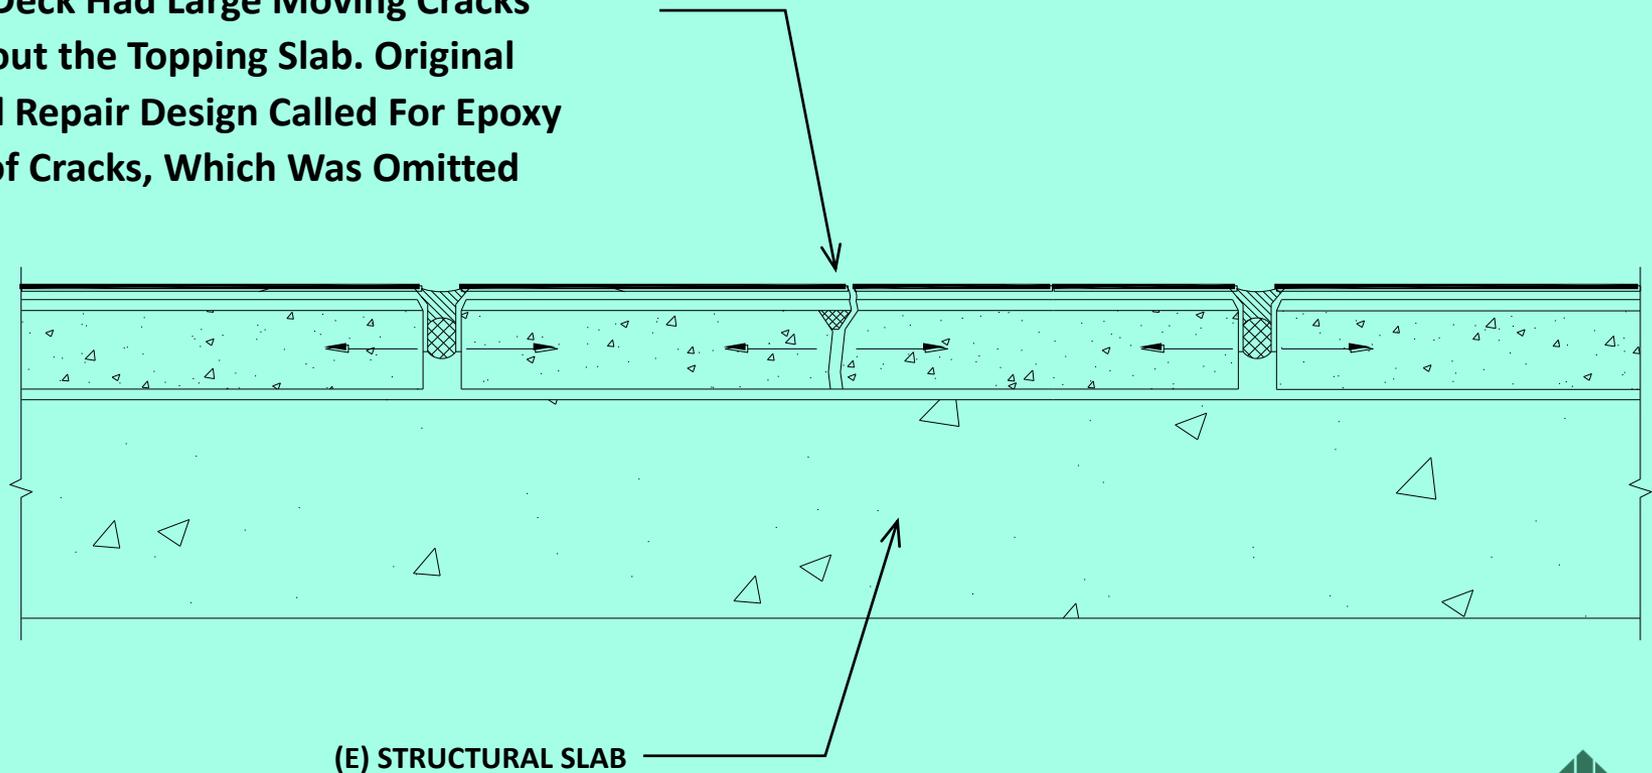
Cracks in Topping Slab were all the Way Through the Slab

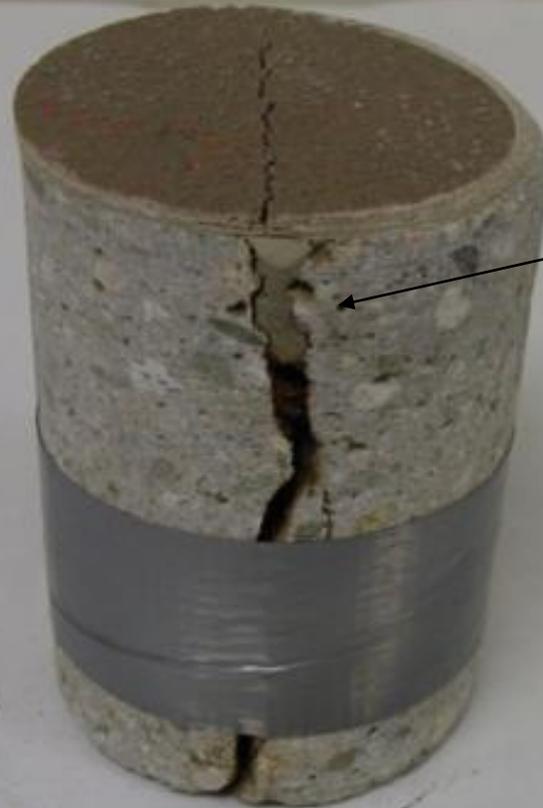
Large cracks in topping slab were filled with polymner modified cement, but not adhered with epoxy

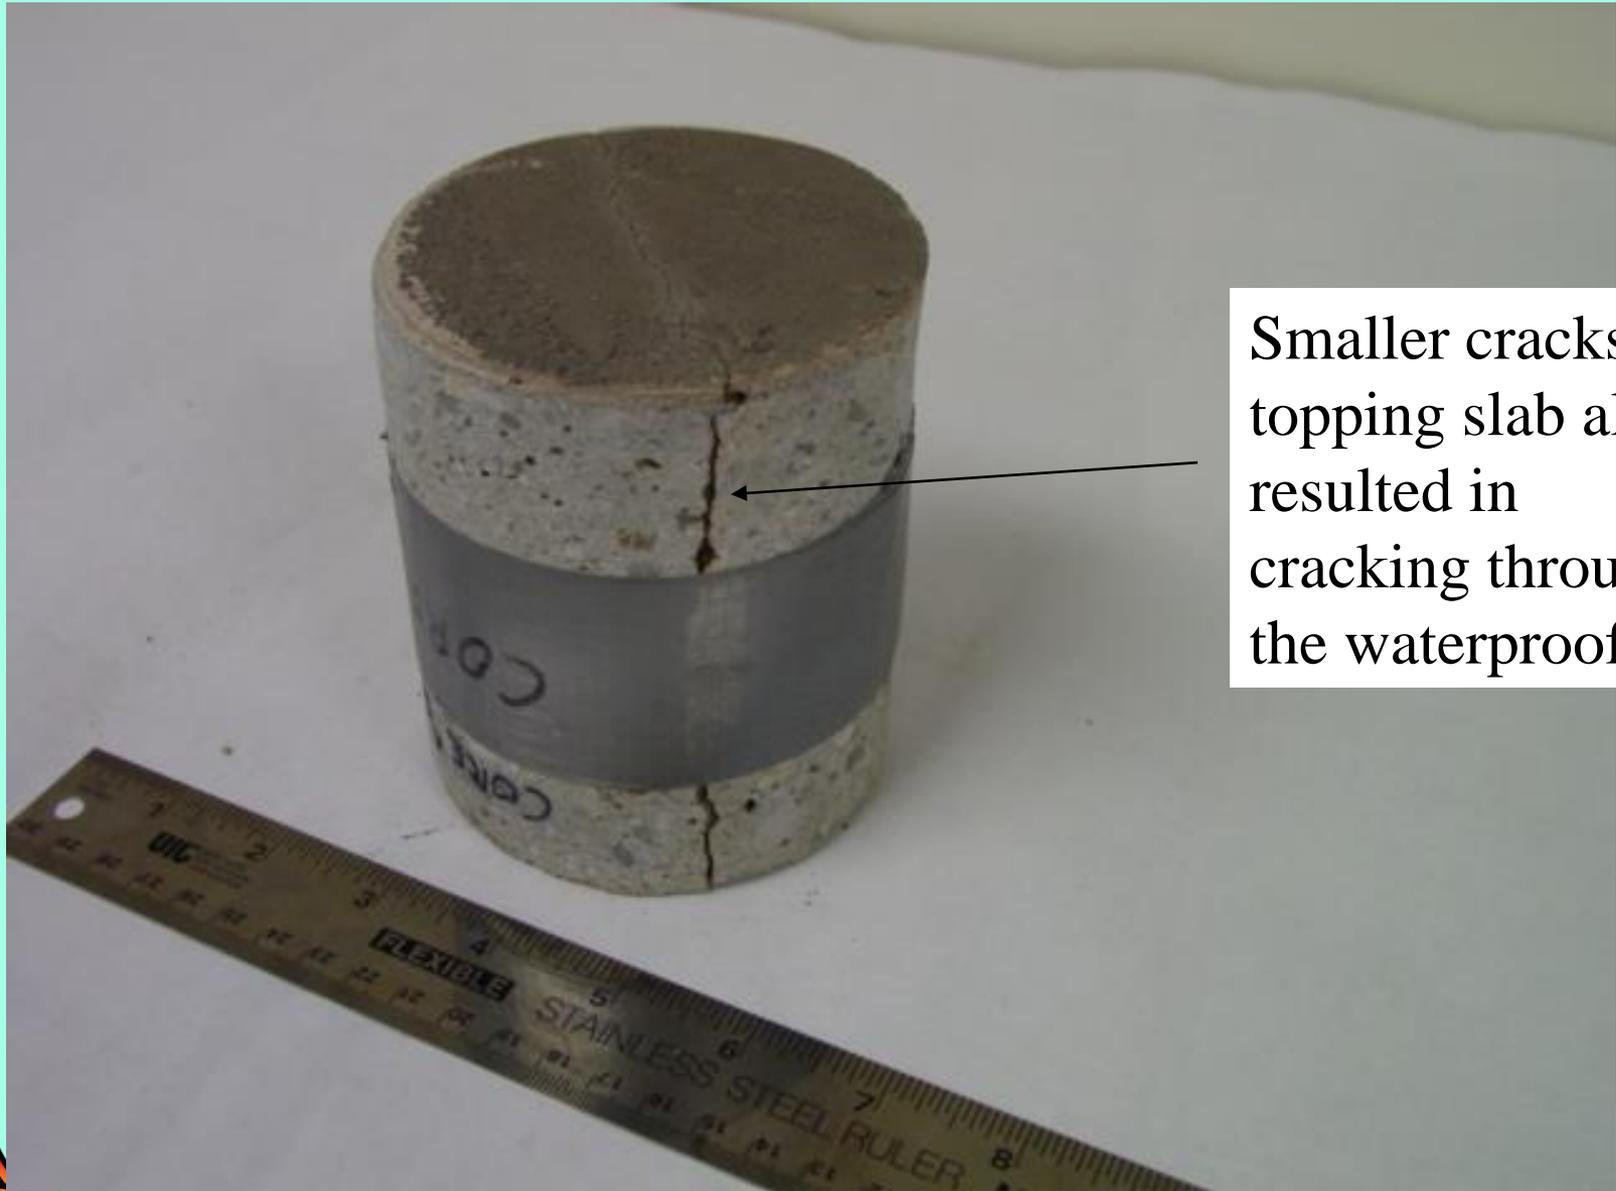
Smaller cracks in topping slab also resulted in cracking through the waterproofing
