Marina Harbor

Podium Deck Waterproofing
by
Karim P. Allana, PE, RRC, RWC
President
Allana, Buick & Bers, Inc.

Project Overview

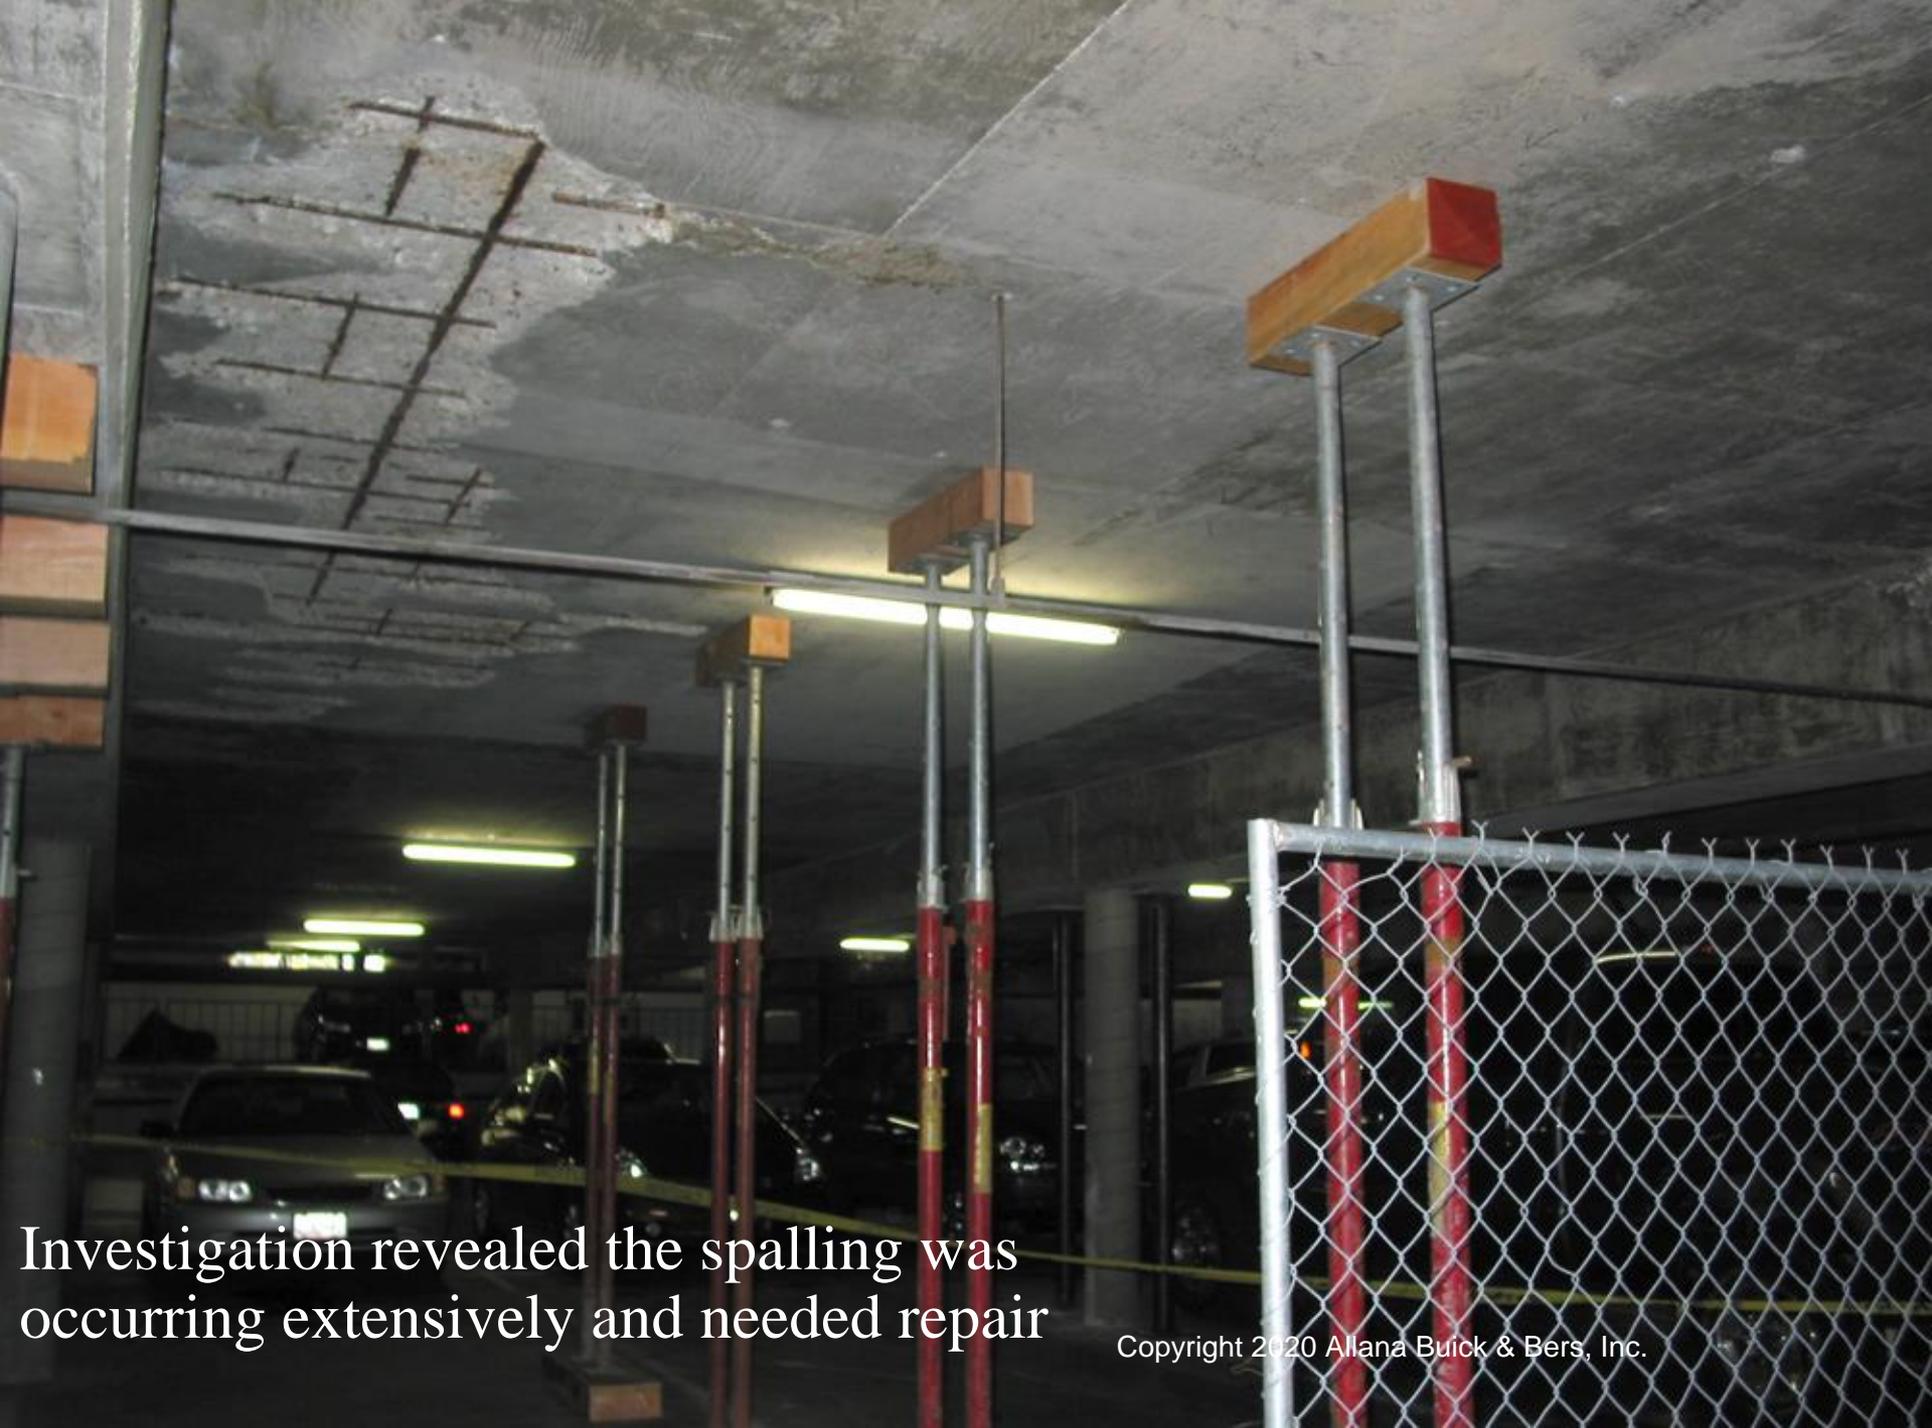
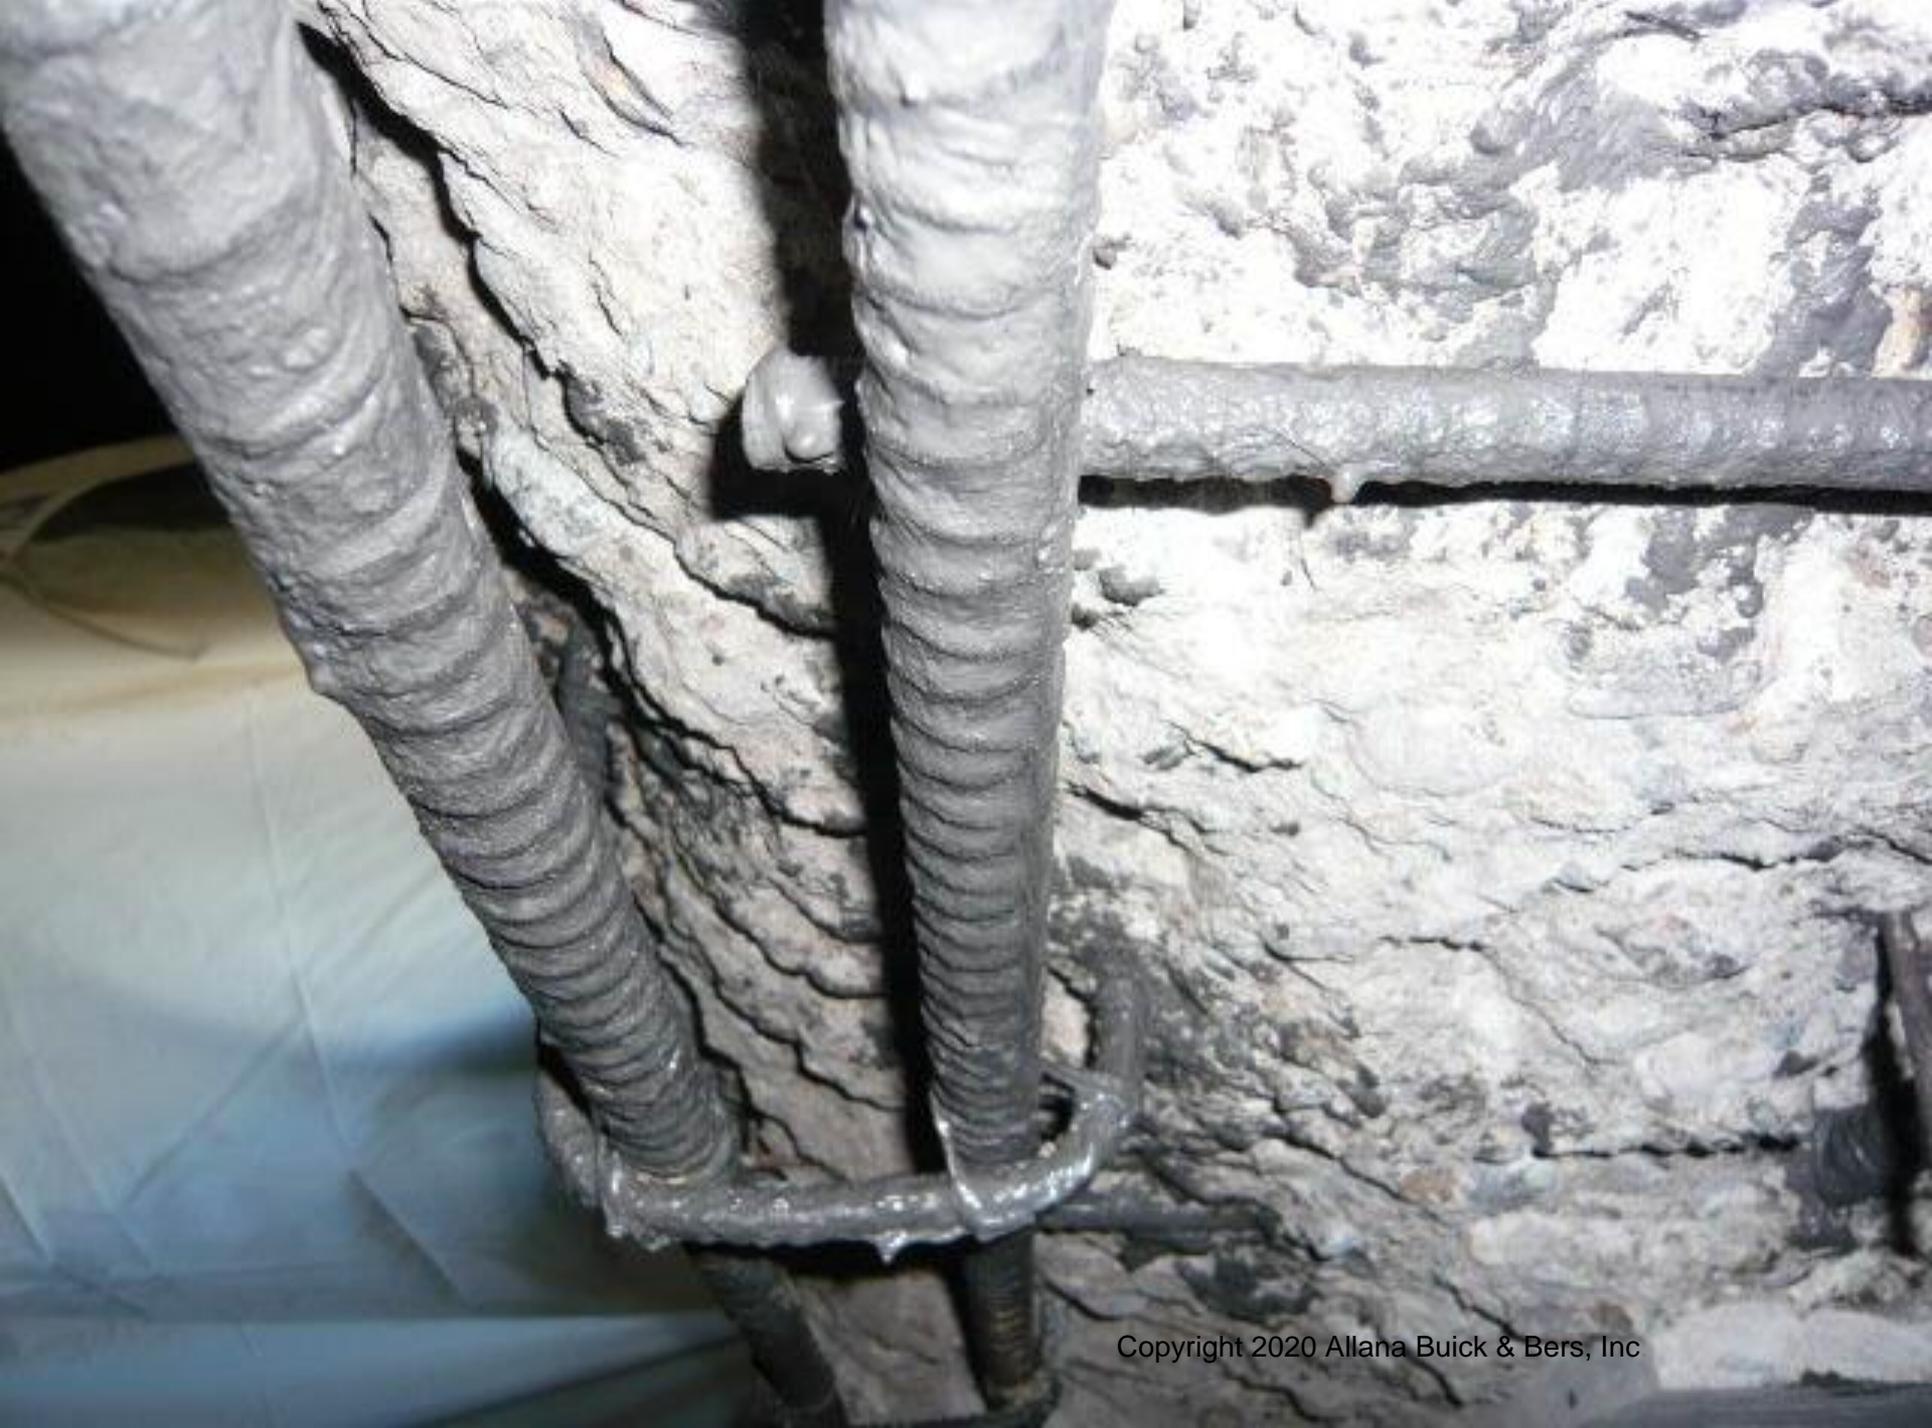
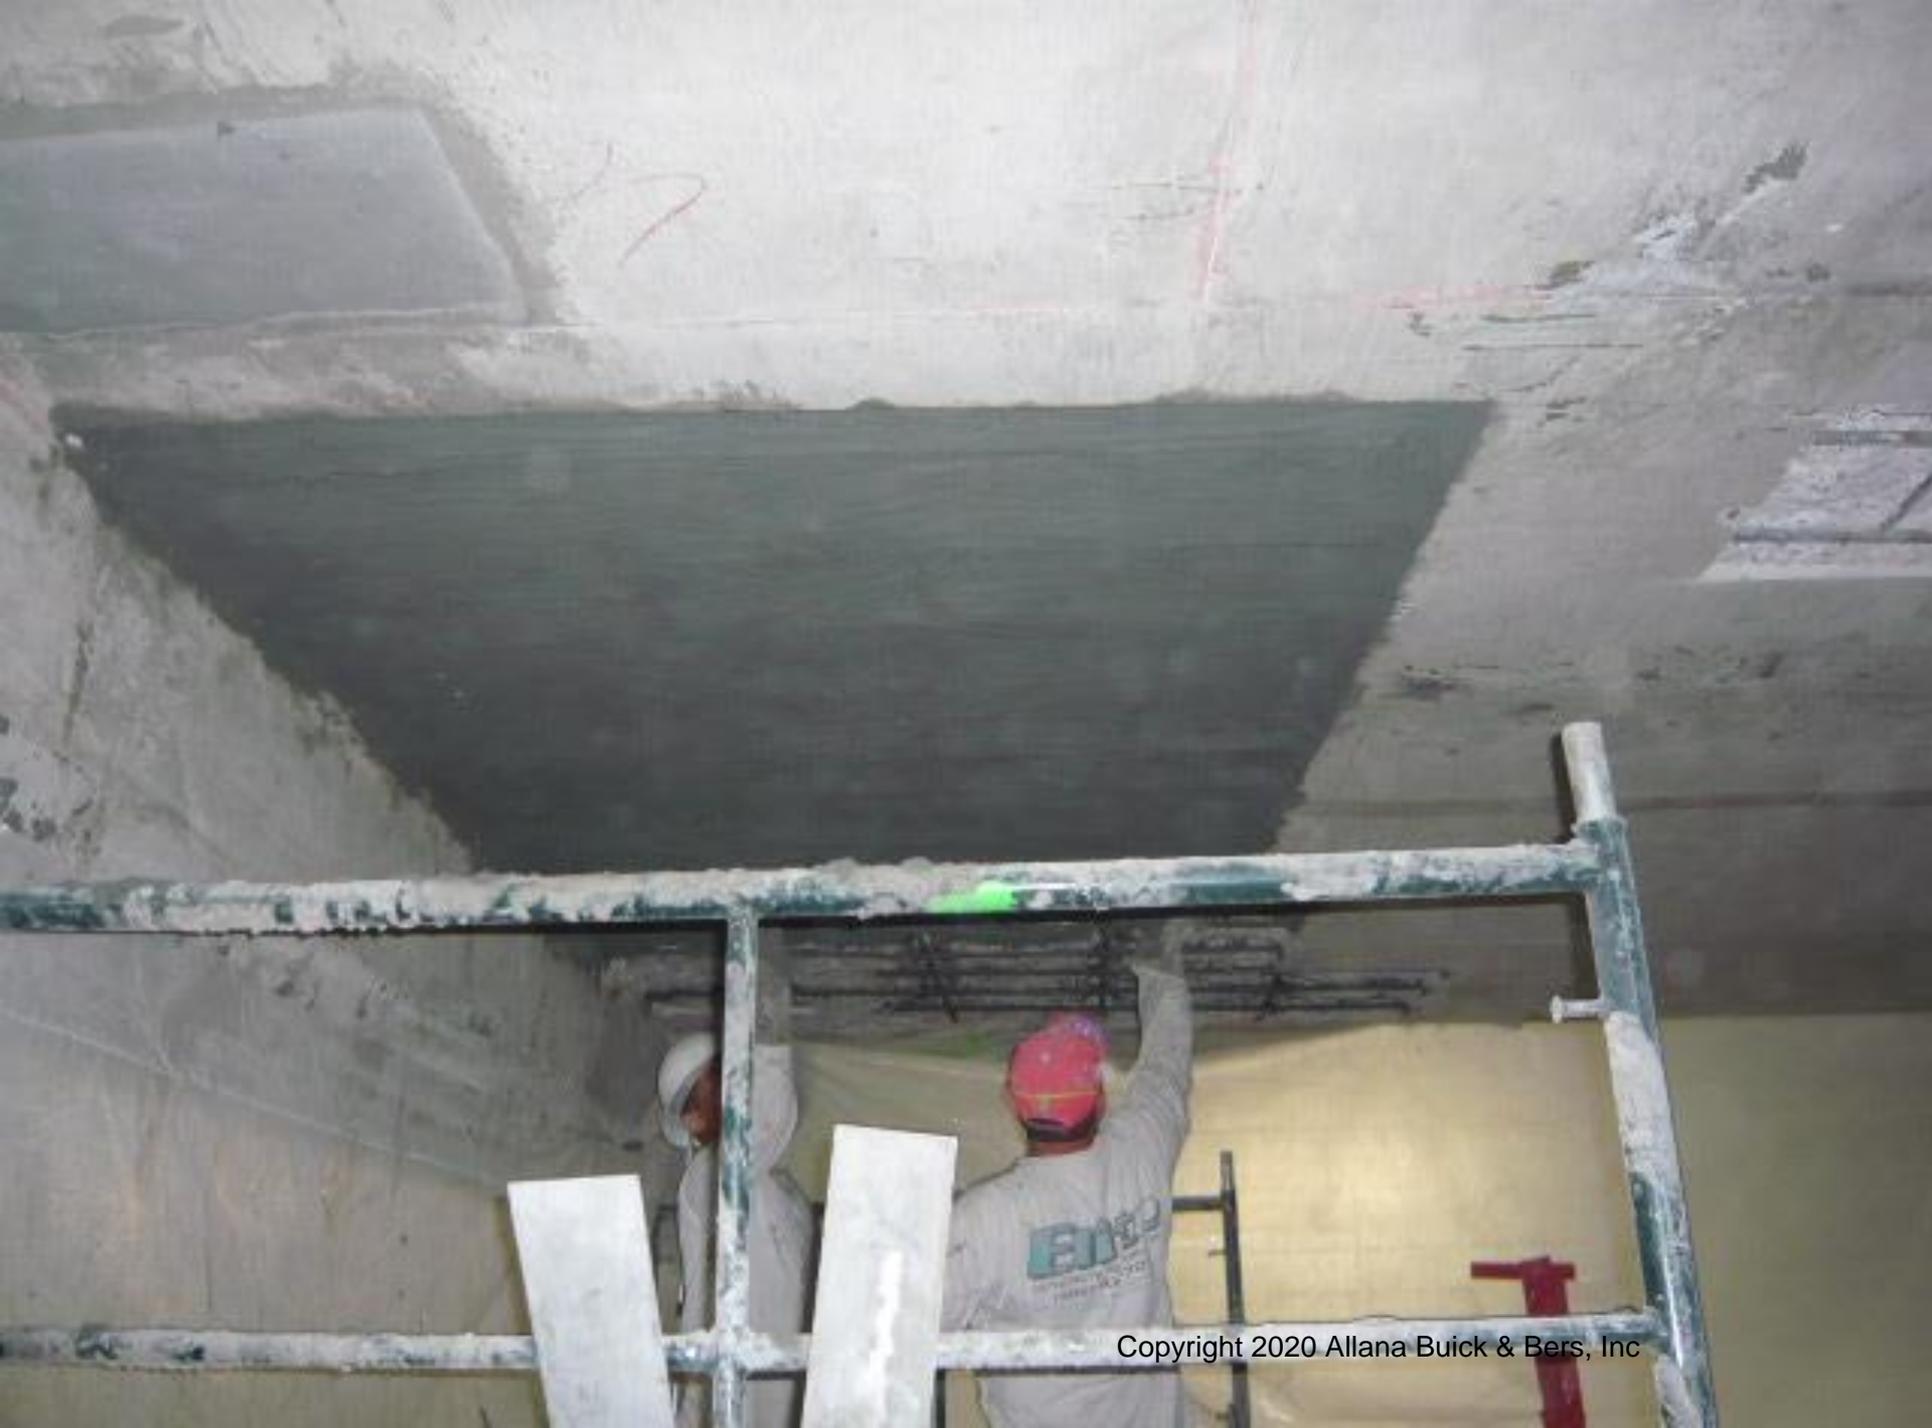
Investigation revealed the spalling was occurring extensively and needed repair
