DRAFT: FENESTRATIONS – VINYL WINDOWS

Karim Allana, PE, RRC, RWC

30th International Convention & Trade Show
March 5-10, 2015 • San Antonio, TX

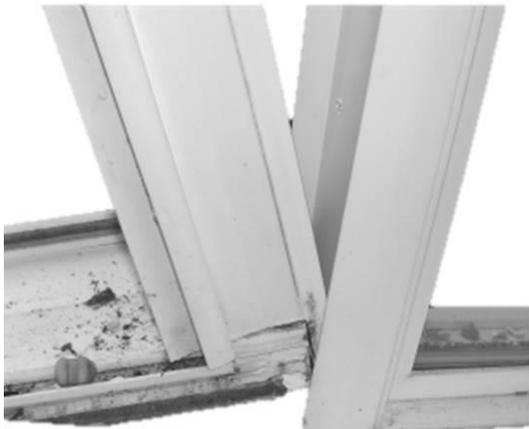
Figure 2A – Common Window Failures

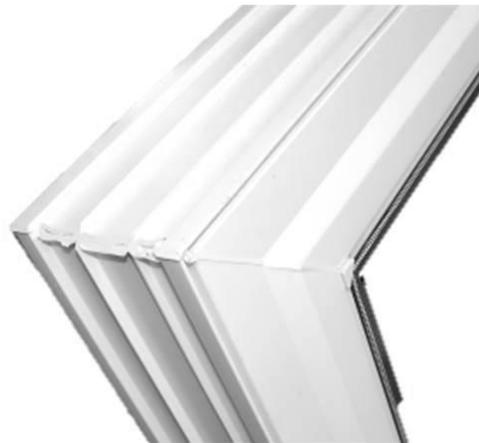
Figure 2B– Common Window Failures

Caulking also sometimes has a difficult time adhering to the PVC due its waviness and flexibility, making it difficult for sealants to adhere properly or uniformly (Figure 2B). As a precaution when working with PVC, adhesion tests must be performed prior to applying sealants to ensure they will adhere and effectively prevent water intrusion. Also as vinyl and PVC have a low melting point, windows tend to bend and sometimes set in the bent position because vinyl has a greater coefficient of thermal expansion, meaning it shrinks and grows more with temperature changes, than the glass window, sealants can often shear because thermal movement of PVC is up to 7 times that of a glass window. The glazing seals, often a kind of foam tape, used in vinyl windows can fail due to internal glazing, an independent window system on the interior side of the window also known as secondary glazing, making the seals vulnerable to long term exposure to UV and water. It is also difficult to obtain high quality vinyl windows due to different manufacturing techniques, imported materials not being subject to as stringent standards

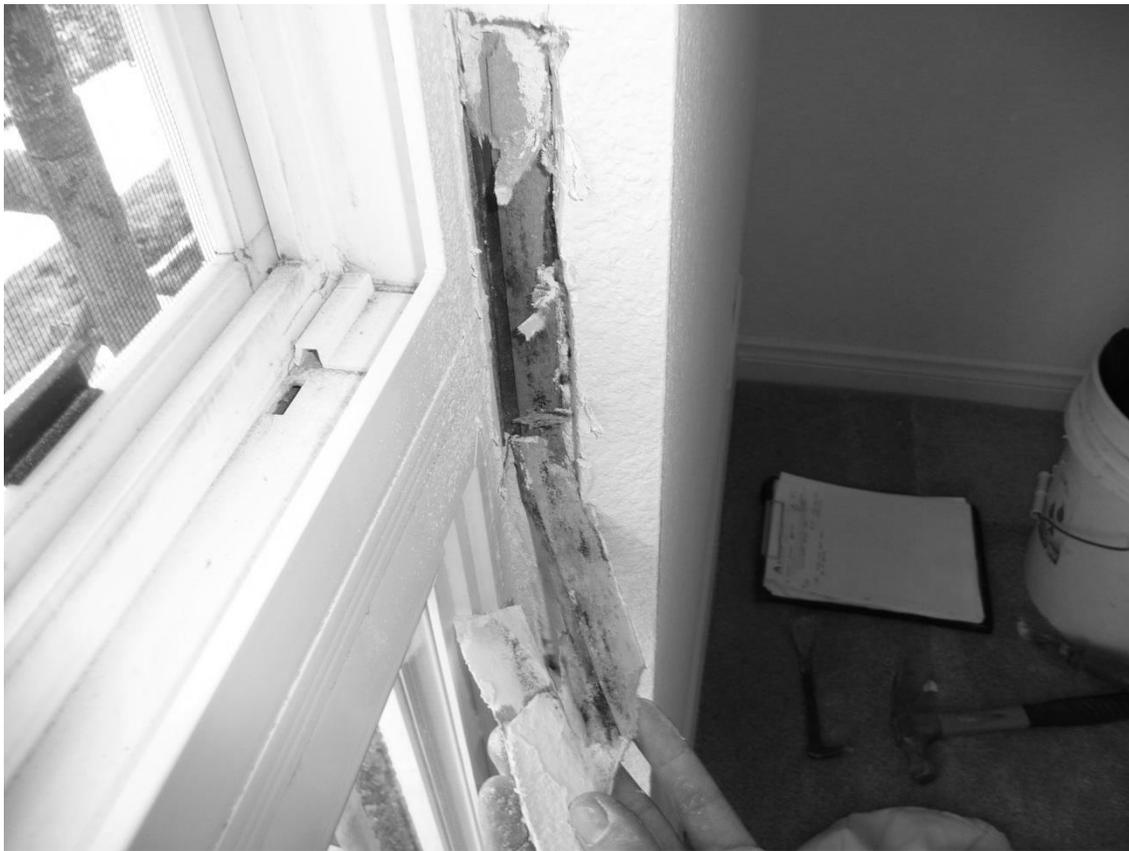
Mulling windows has its inherent risks and issues as well, as mullied joints are a very common area for water intrusion. Because fixed mullions are not flexible unlike the vinyl frames, they do not move with the vinyl window frame and they can crack due to temperature changes resulting in a vertical mullied failure. Mullions and capping trim attachments need to be continuously sealed to the exterior of the window to be effective. Sealant also needs to be applied between the mullions to effectively prevent leaks. Also, we have noticed several examples when screws are driven into the window from the interior during the mulling process, which is another big source of leaks. One of the advantages of vinyl windows is having a continuous welded frame and welded fin; however, mullied windows do not have continuous welded fins often resulting in leaks at

Figure 3A – Vertical Mullion Failure

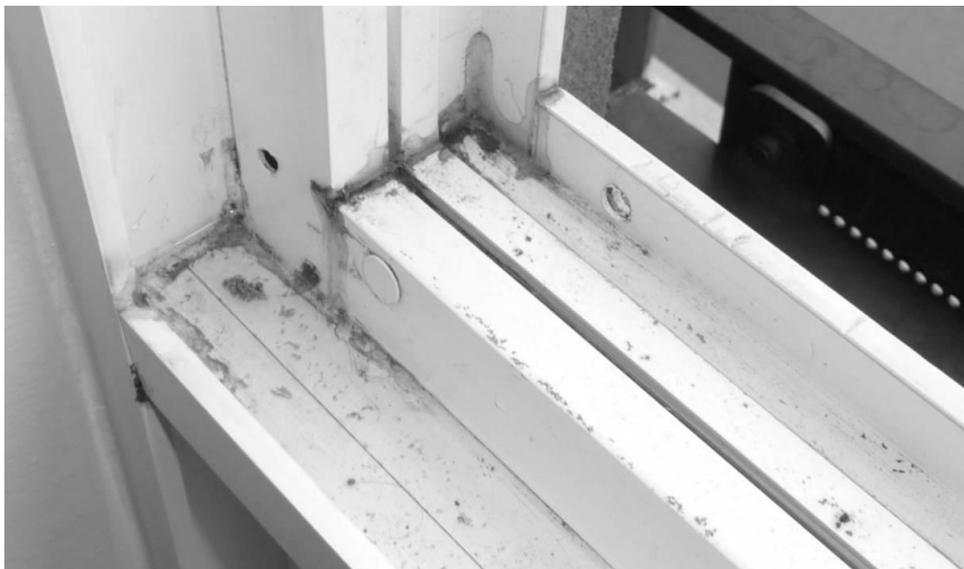
During testing water rushed into the lower frame via the horizontal track which then percolated into the dry sill track and then overflowed onto the wood stool. A fixed “dry” sill track does not provide drainage, leaving no method of managing the water that enters the frame. The water leakage led to rusting of the structural steel reinforcing and buildup of standing water in the lower sill track resulting in growth of mold, mildew, rust, and damaged wood stools. This water intrusion was due to improperly sealed horizontal to vertical coped mullion jamb extrusion joints which allowed water to flow through the sealant-dependent joint in the horizontal mullion into the lower sill track.

Figure 4A – Coped Mullion Joint Failure

Since the window failure was due to improperly sealed joints in the factory, the manufacturer was asked to repair the leaking windows under warranty prior to our testing. Attempts made by the manufacturer were a short term fix and have since failed. The frame was sealed with a silicone sealant from the exterior, and on the frame's interior a hole was drilled to equalize and relieve pressure and expanding foam was blindly injected. During the inspection of the windows, the temporary solution had failed resulting in more damage to interior finishes.
