# Roofs Can Last In Excess of 30 Years But Most Do Not

January 24, 2006

Honolulu, Hawai'i

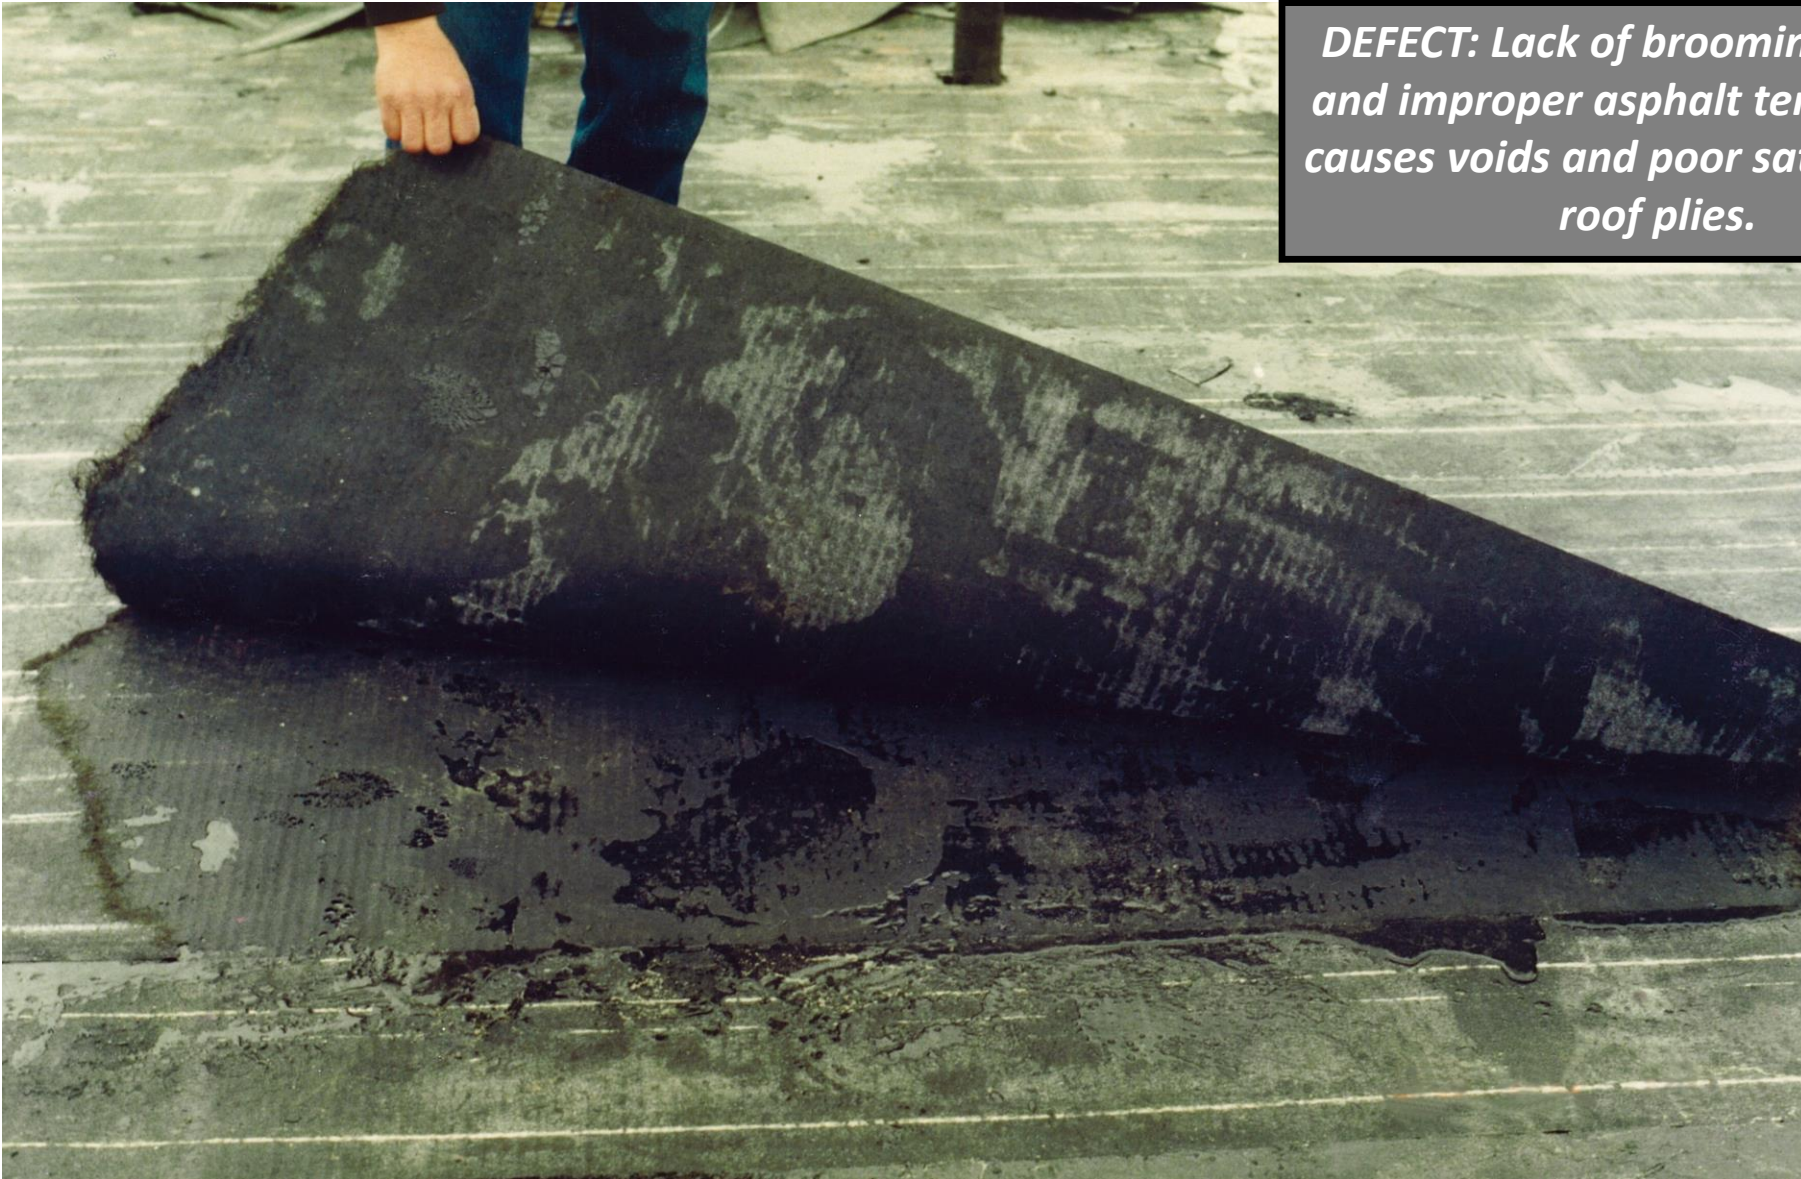
***DEFECT: Lack of brooming of felts and improper asphalt temperature causes voids and poor saturation of roof plies.***

***DEFECT: Improper application of primer couple with lack of sufficient nails, are the leading causes of leaks at sheet metal flashings.***

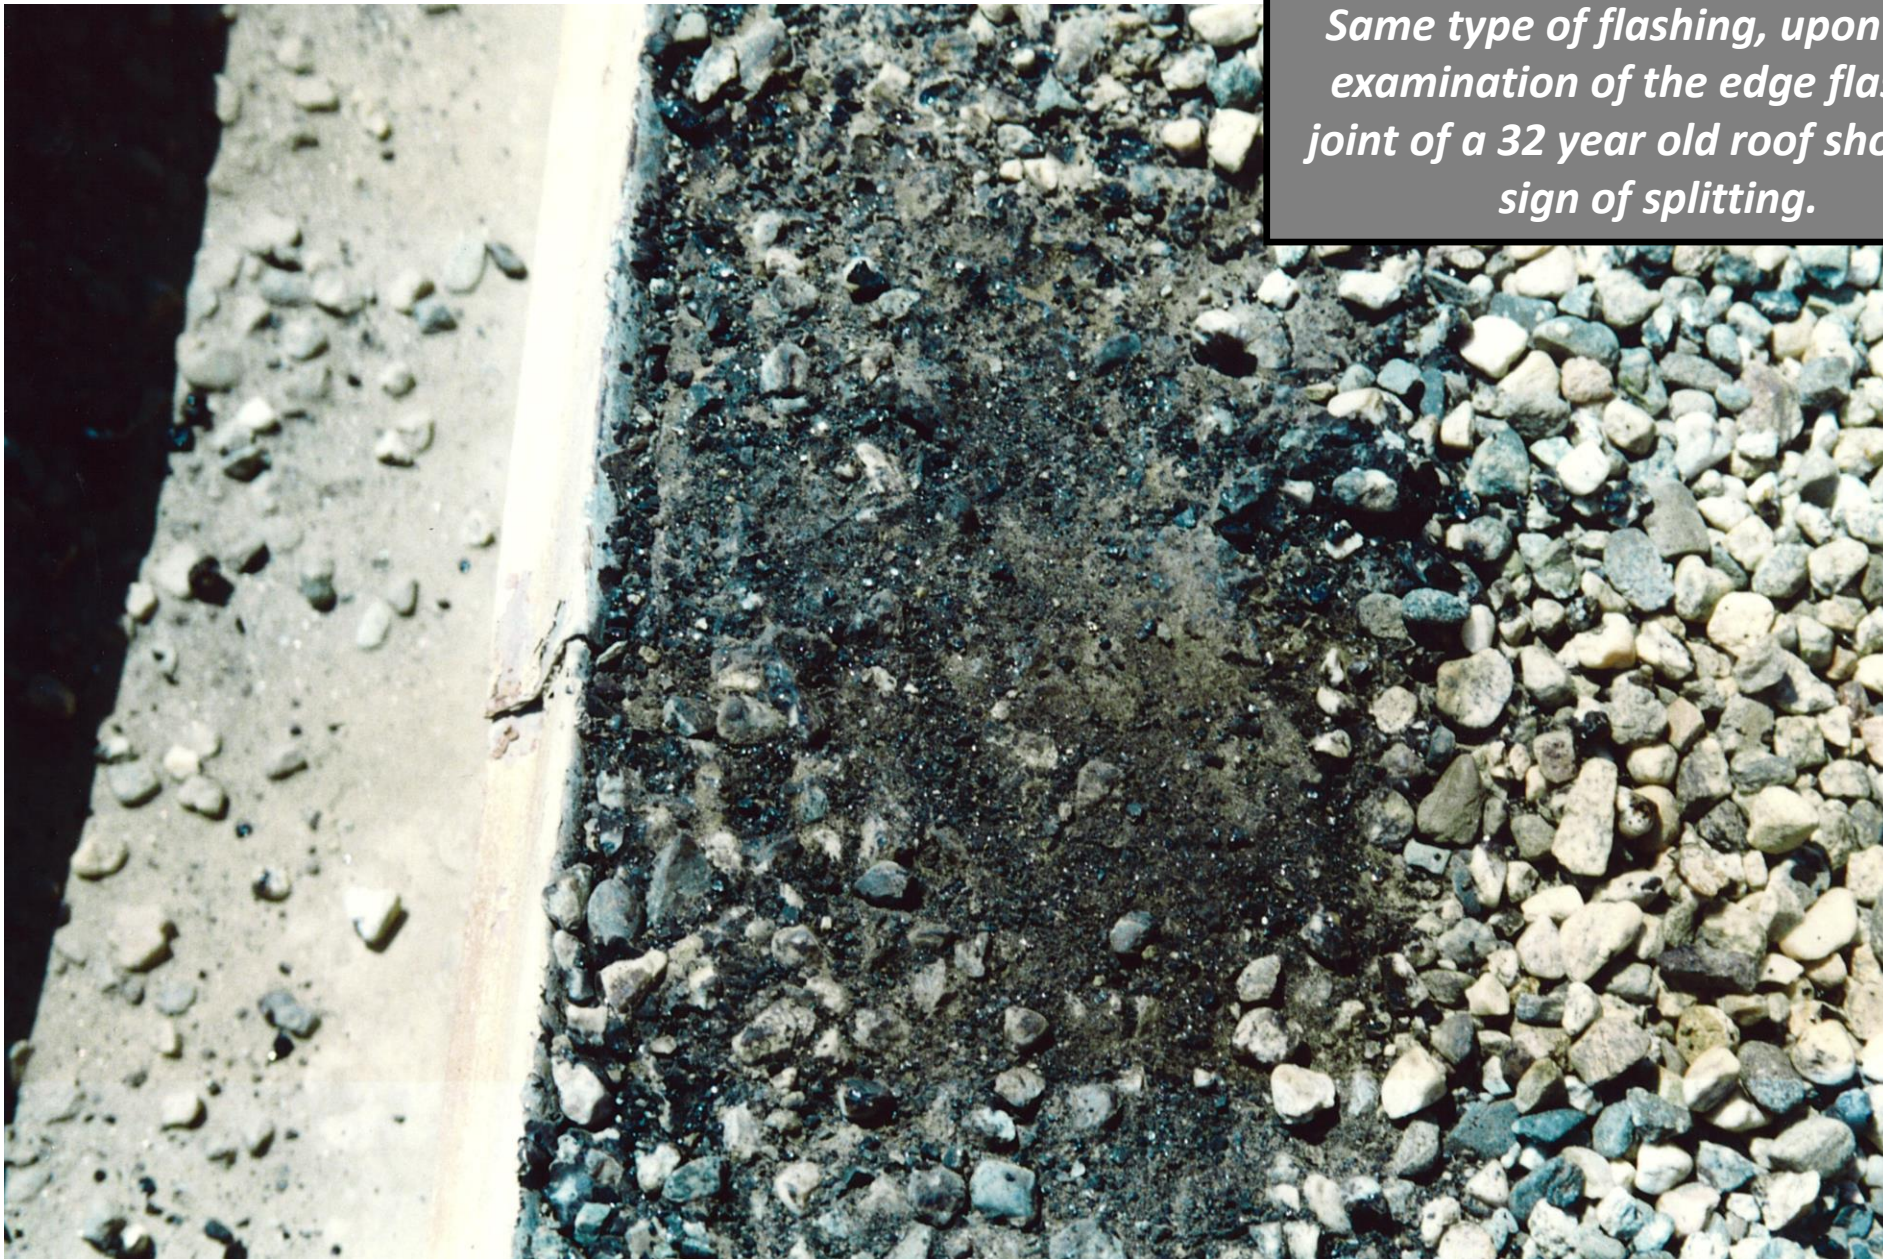
*Same type of flashing, upon close examination of the edge flashing joint of a 32 year old roof shows no sign of splitting.*

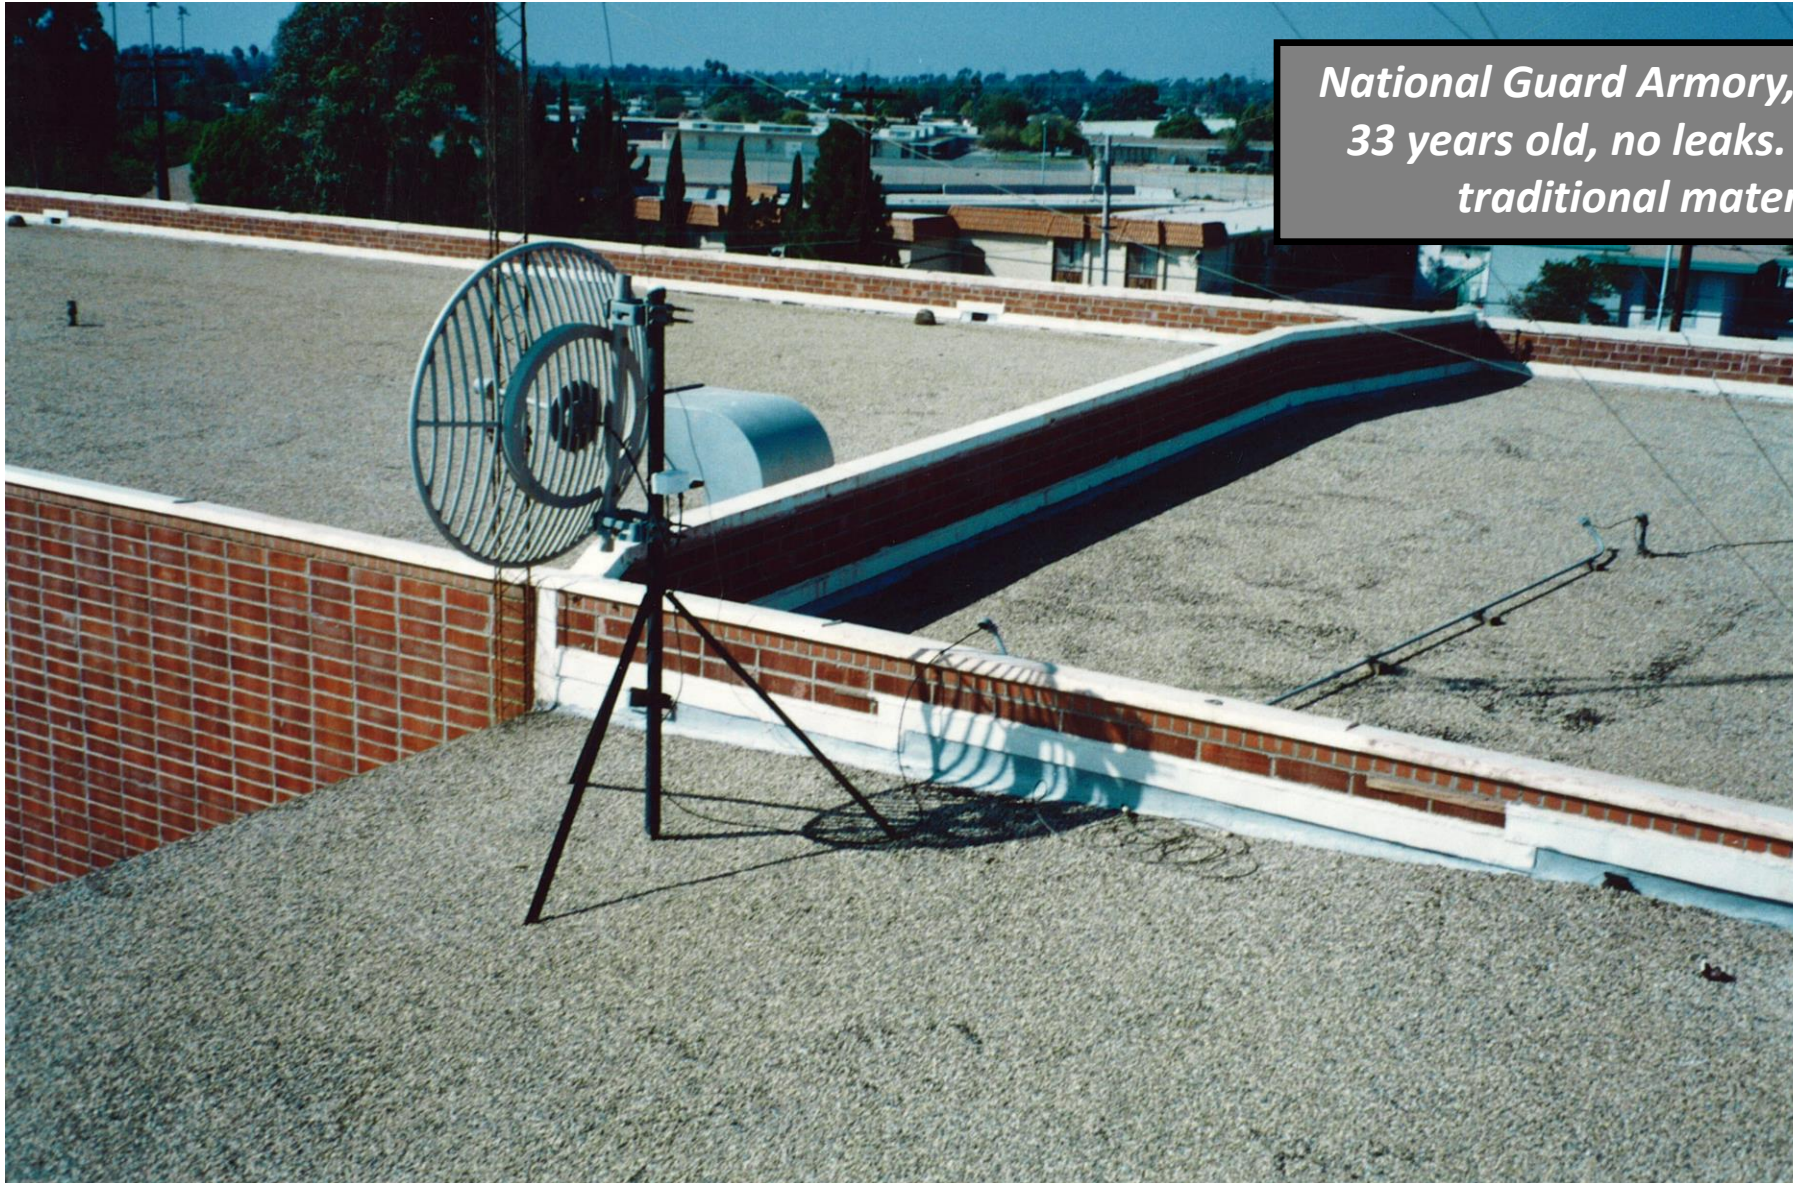
*National Guard Armory, San Diego,  
33 years old, no leaks. Built with  
traditional materials.*

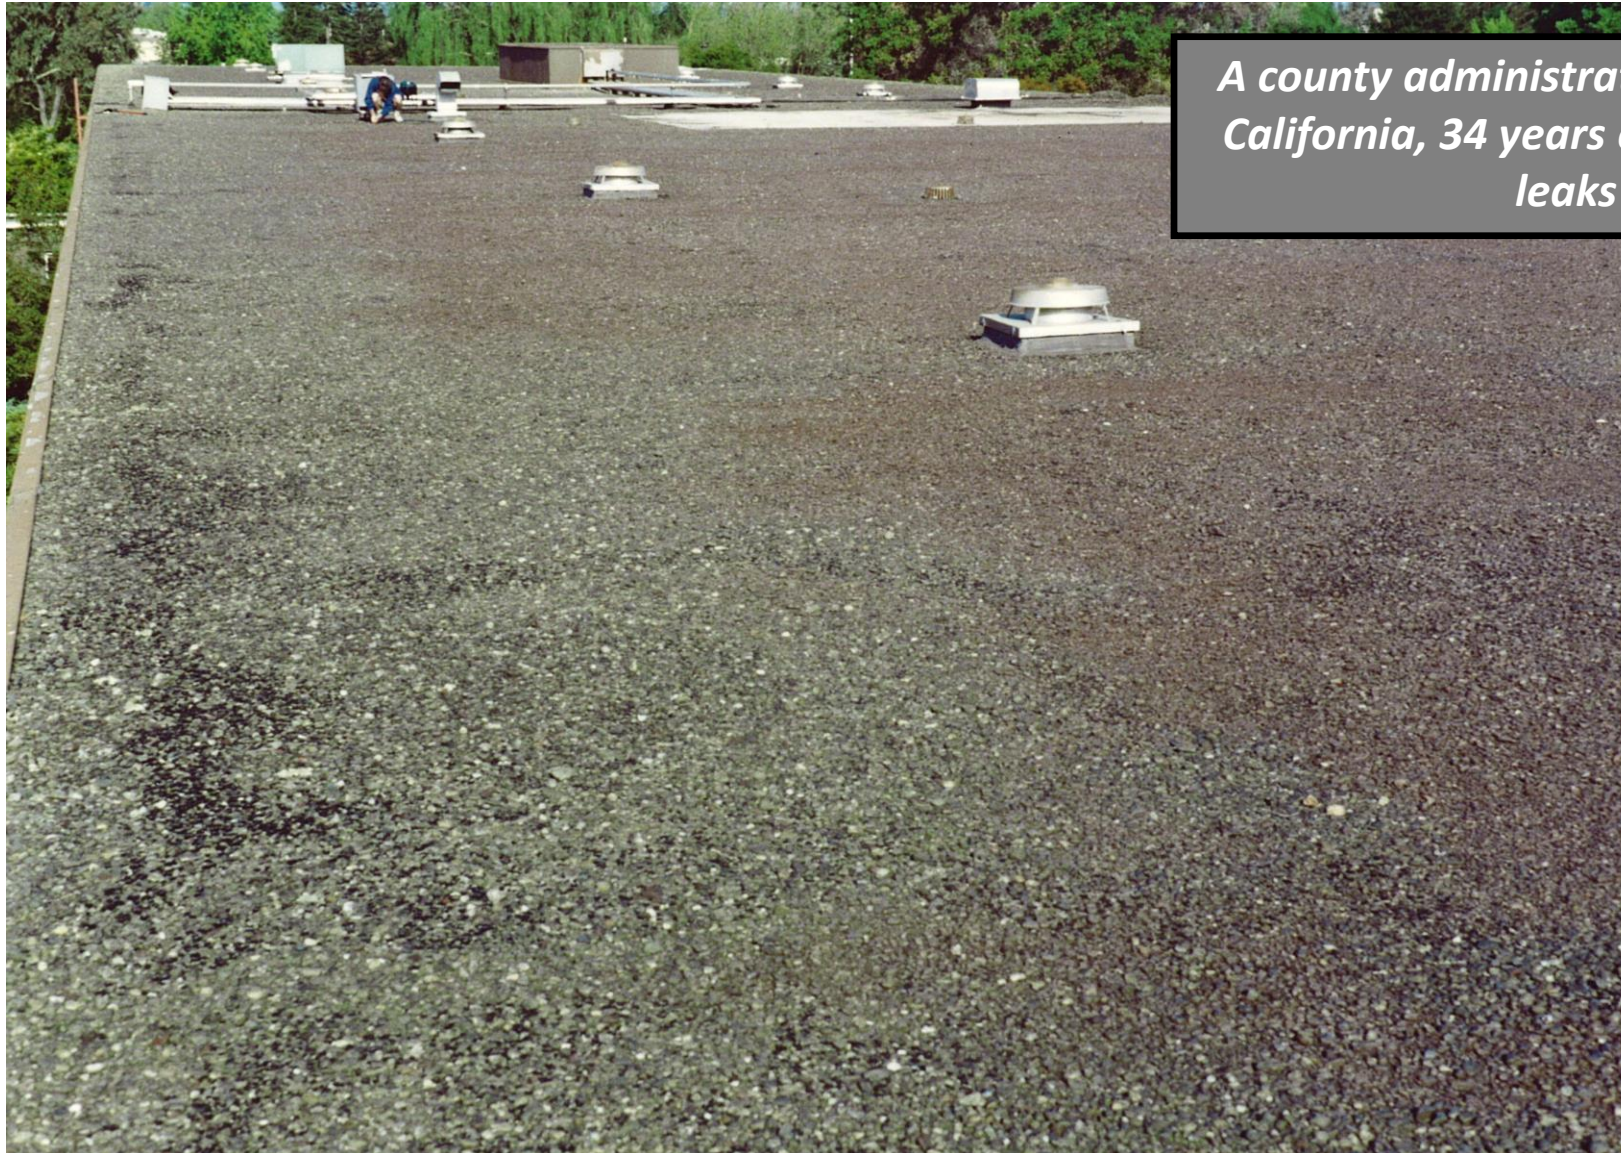
*A county administrative building in California, 34 years old, two minor leaks*

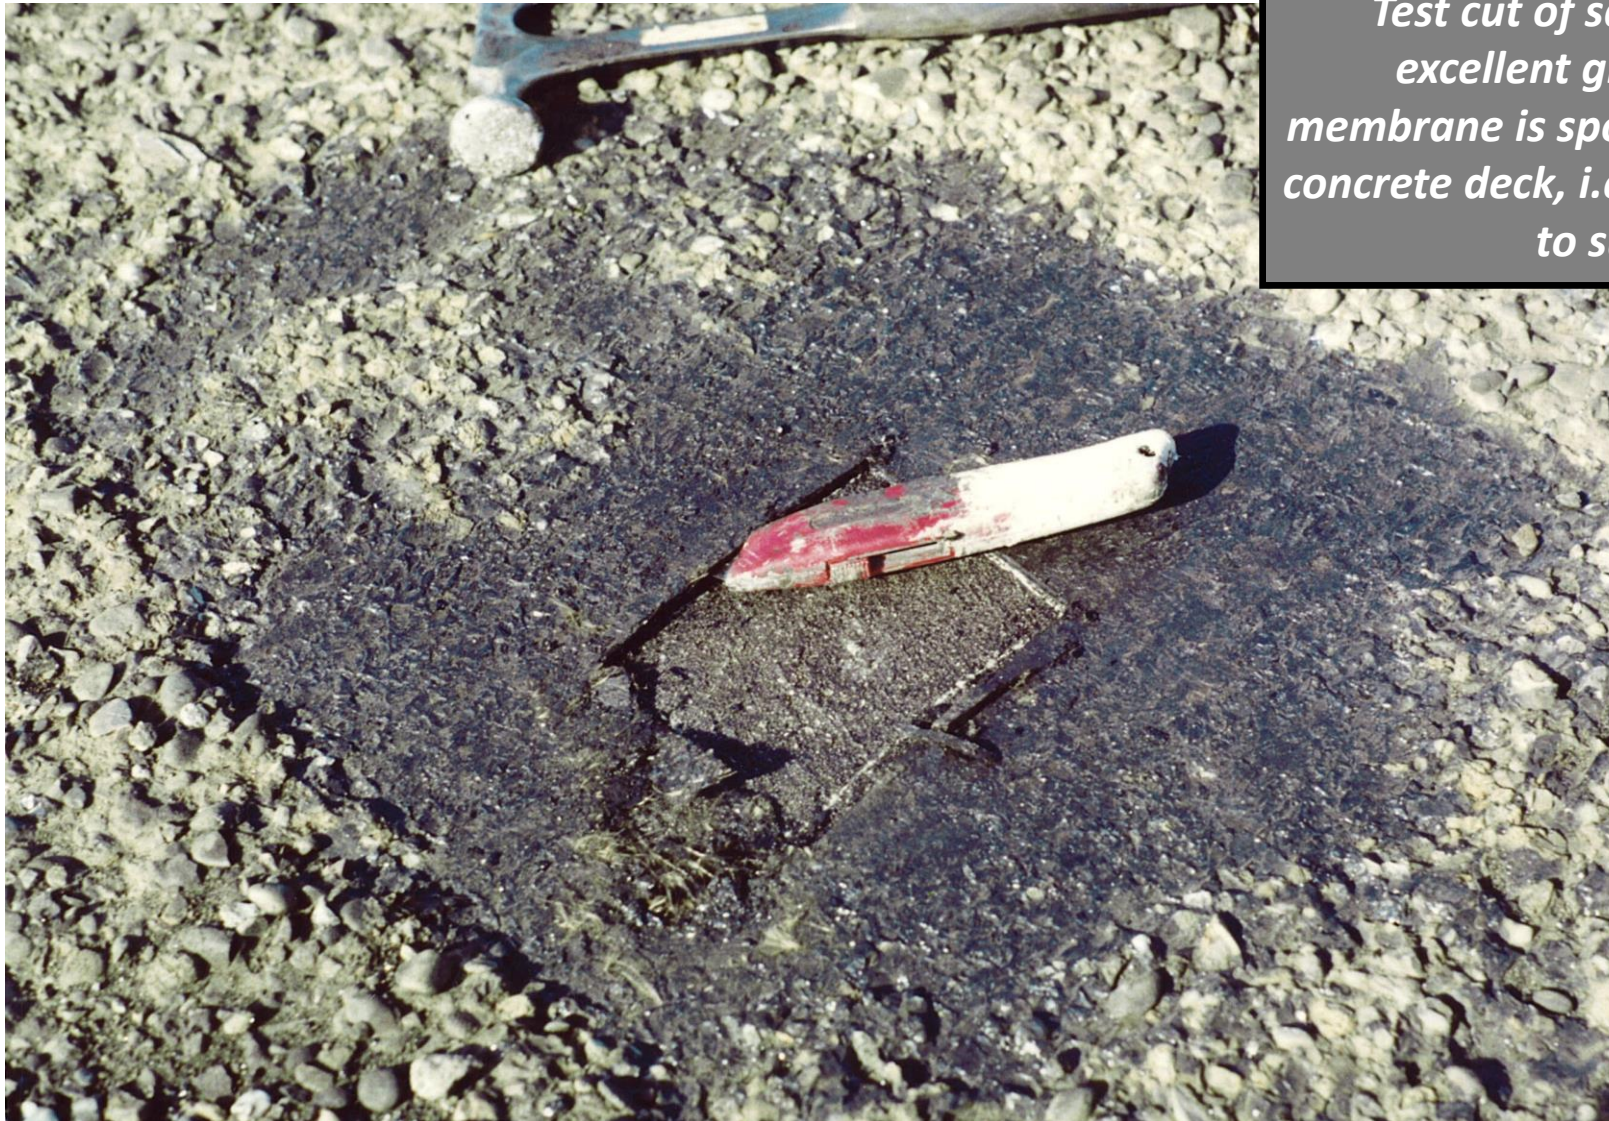
*Test cut of same roof reveals  
excellent gravel surfacing,  
membrane is spot mopped to primed  
concrete deck, i.e. proper securement  
to substrate*

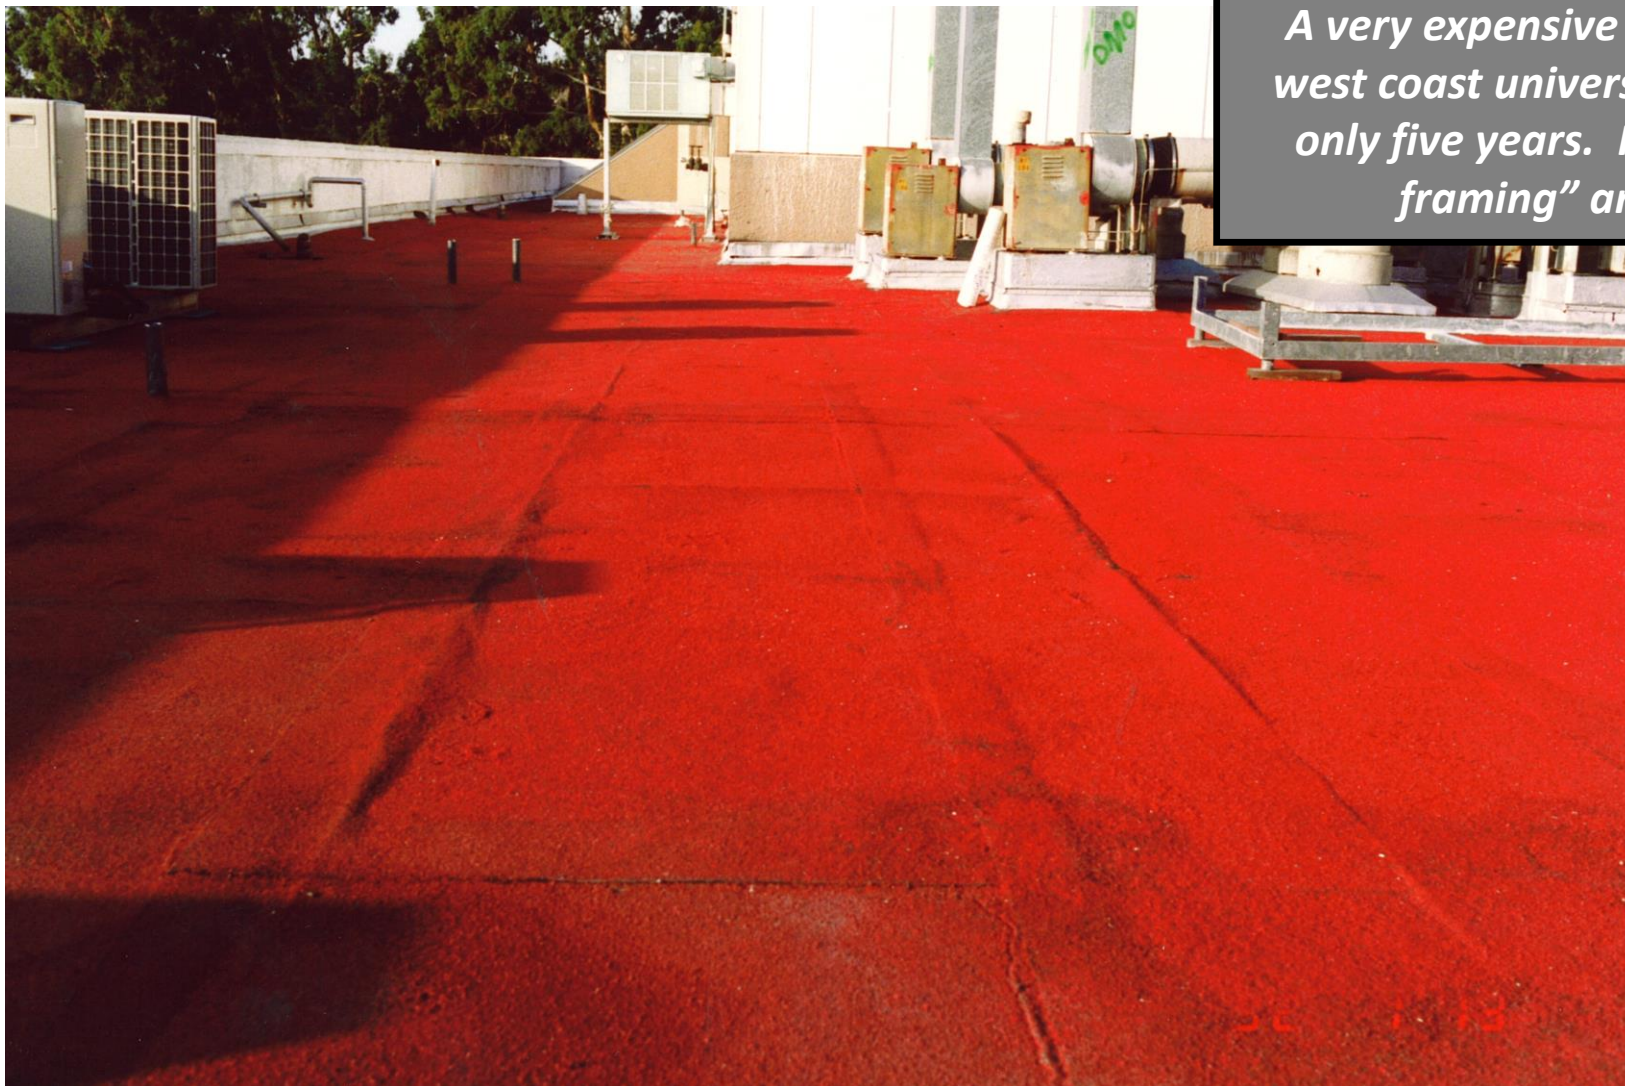
*A very expensive roof at a major west coast university, failing after only five years. Roof is “picture framing” and ridging*

***DEFECT: Improper securement of roof. Inappropriate insulation fasteners, poorly installed, causing cupping of insulation material.***

**PICTURE FRAMING + ROOF SPLITTING CAUSED BY  
POOR FASTENING OF INSULATION BOARD TO SUBSTRATE**

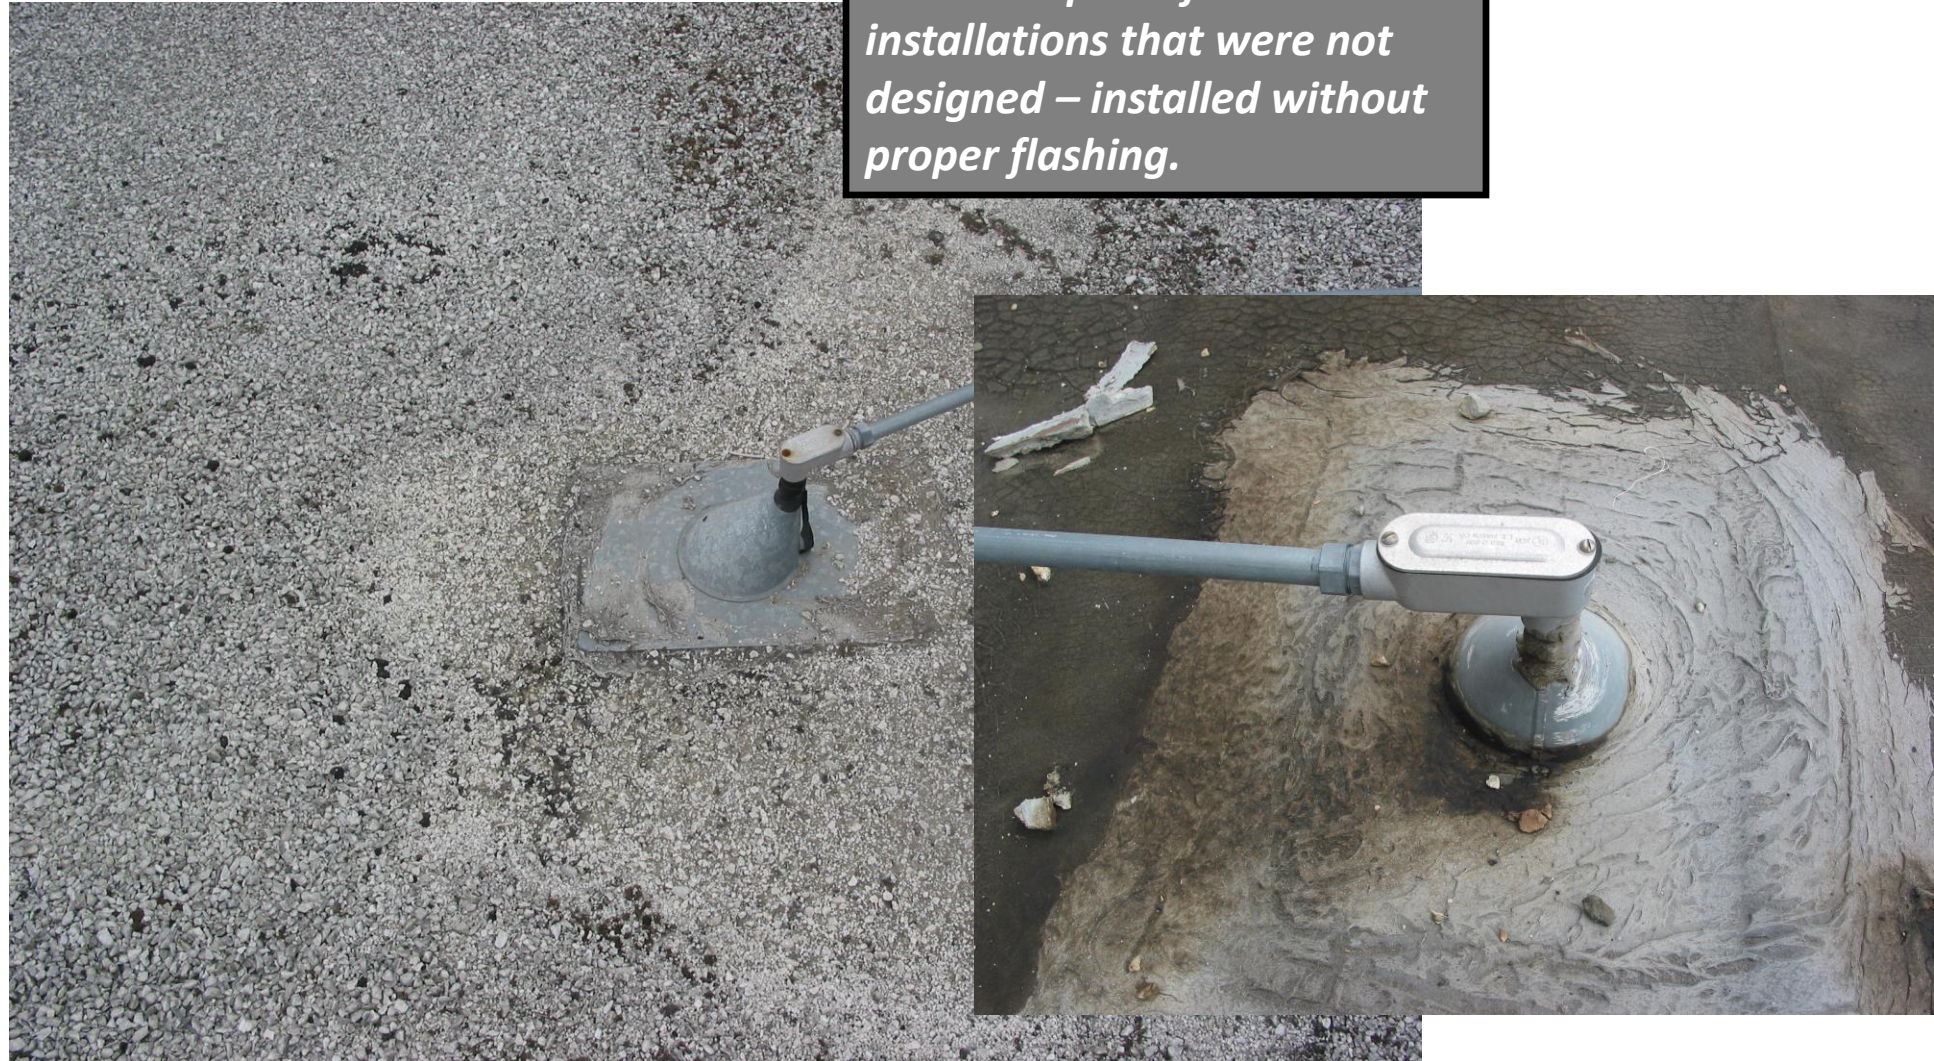
*Two examples of conduits installations that were not designed – installed without proper flashing.*

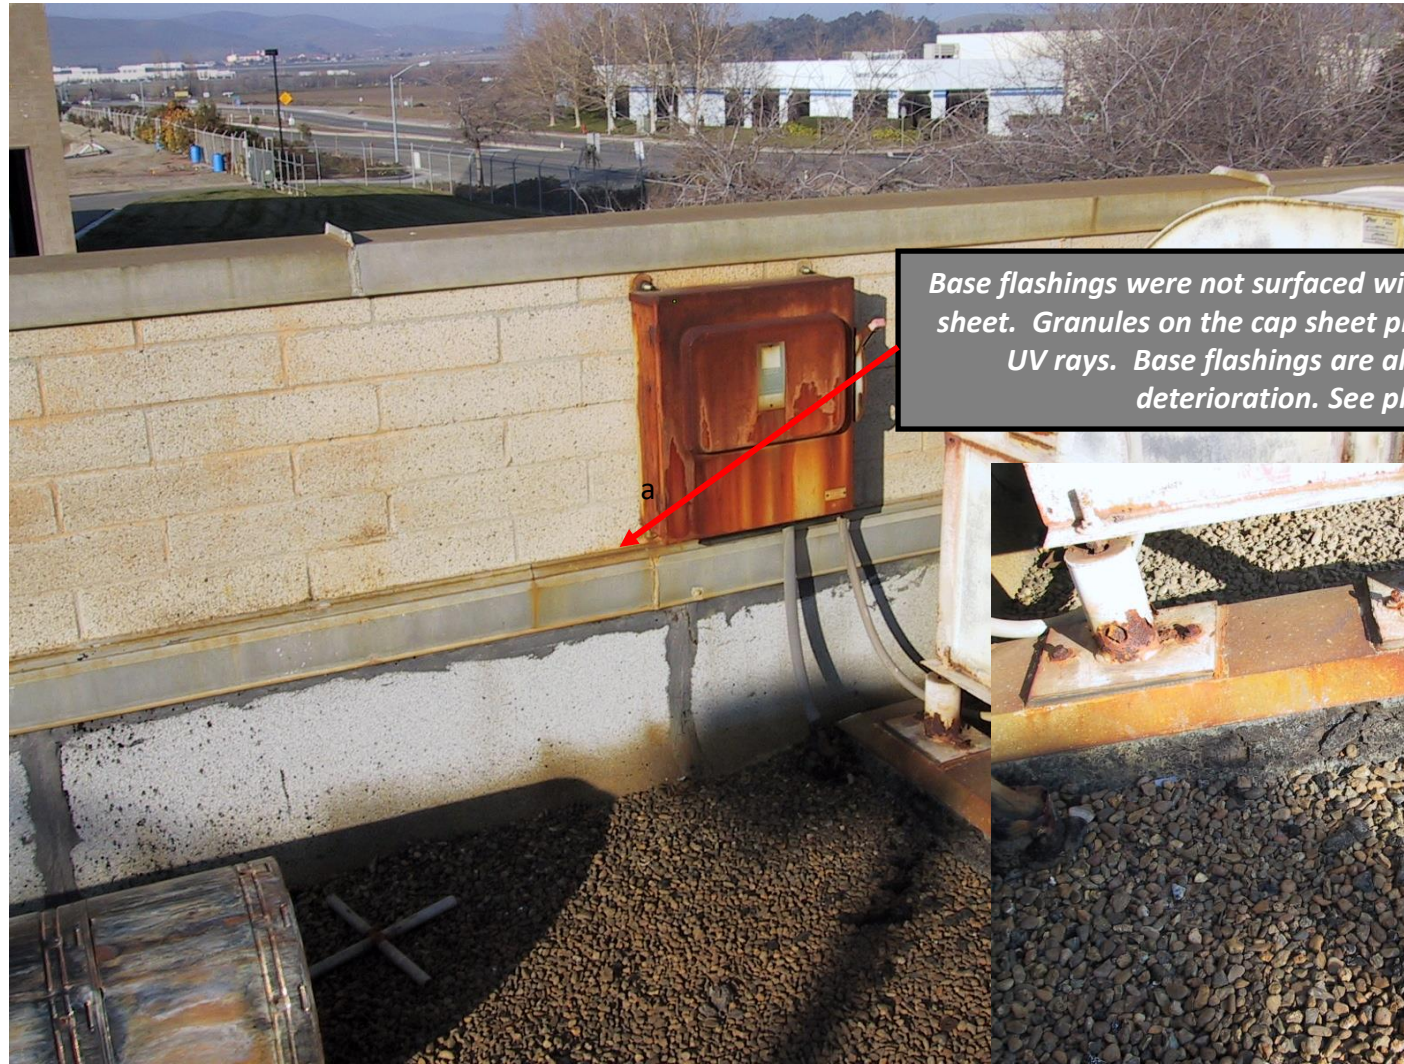
*Base flashings were not surfaced with a protective layer or cap sheet. Granules on the cap sheet protect the membrane from UV rays. Base flashings are also exhibiting signs of deterioration. See photo below.*

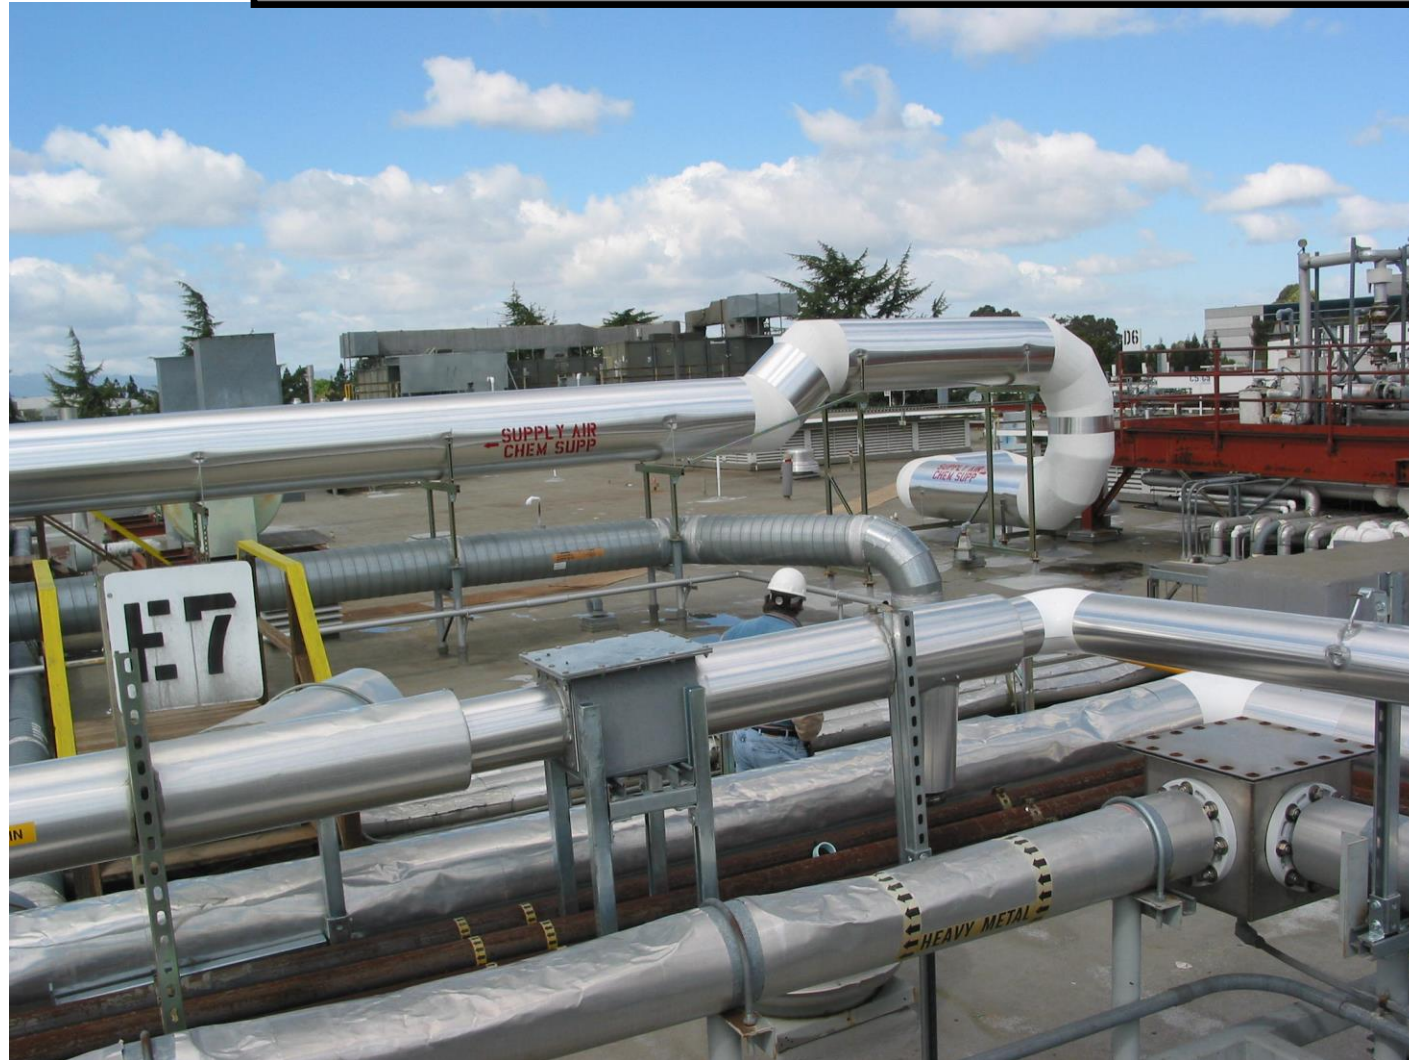
*Foam Roofing on an industrial Building = bad idea*

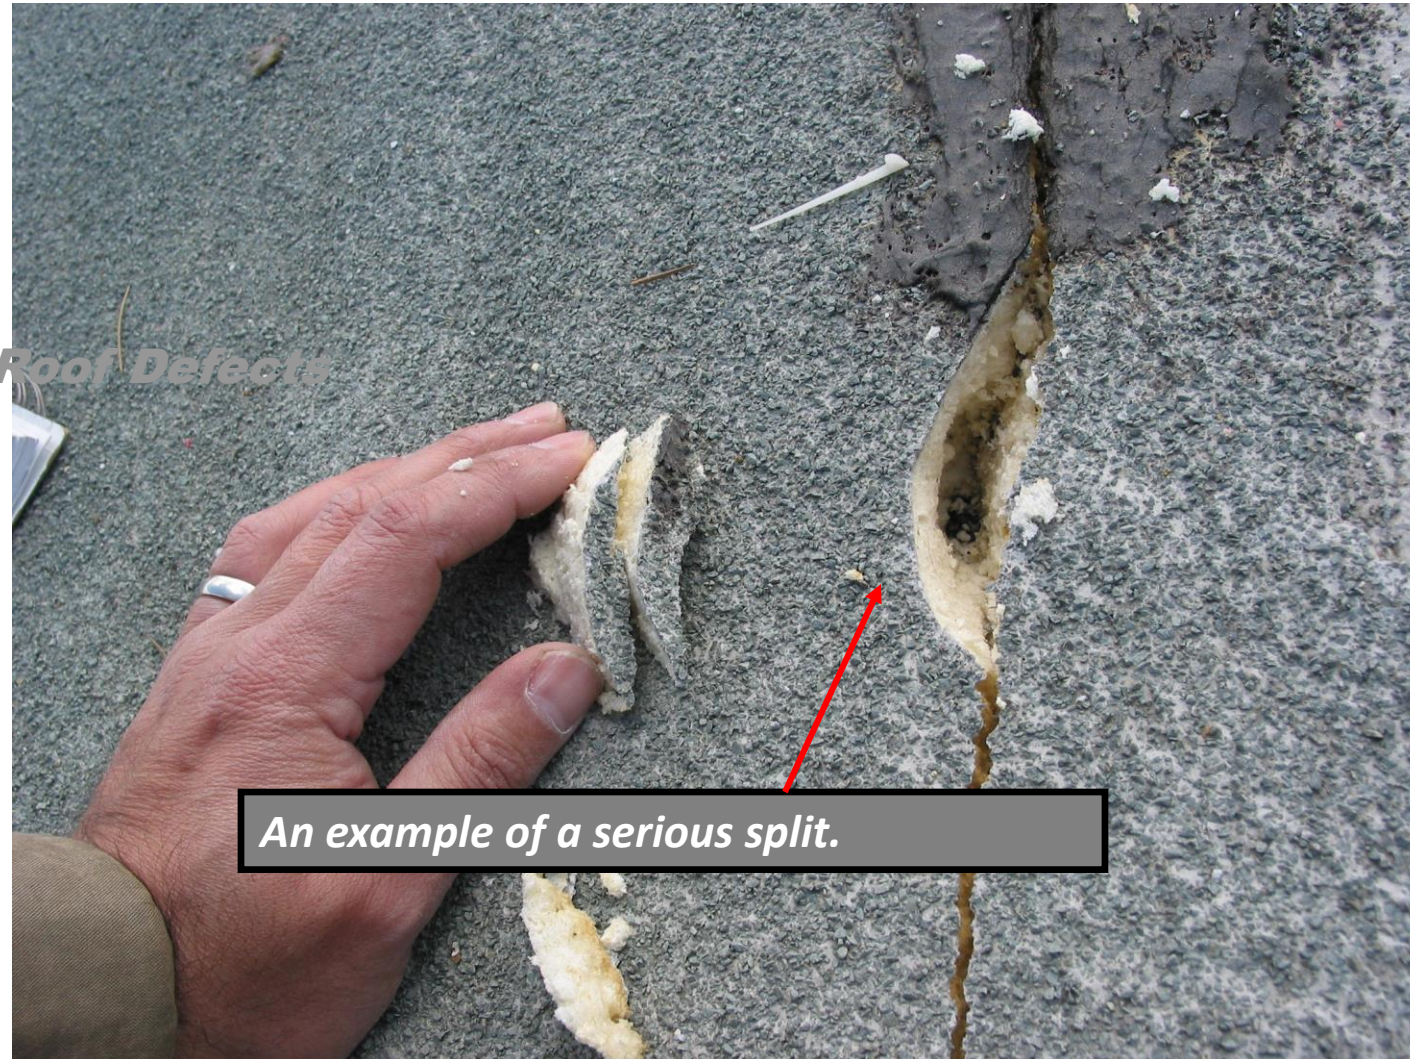
*An example of a serious split.*

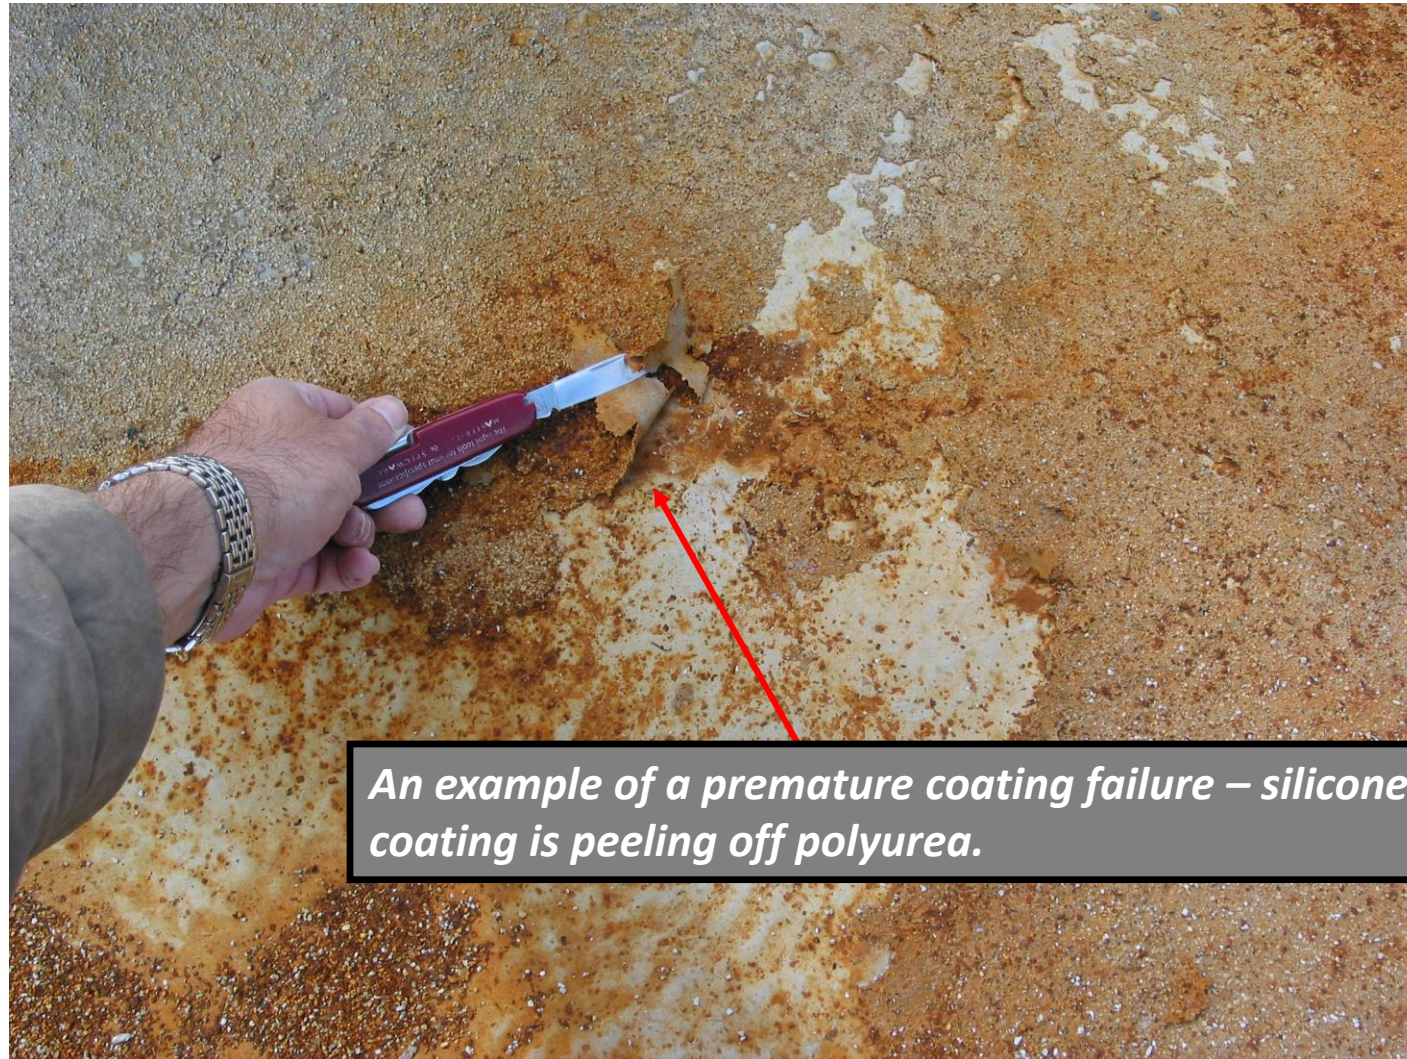
*An example of a premature coating failure – silicone coating is peeling off polyurea.*

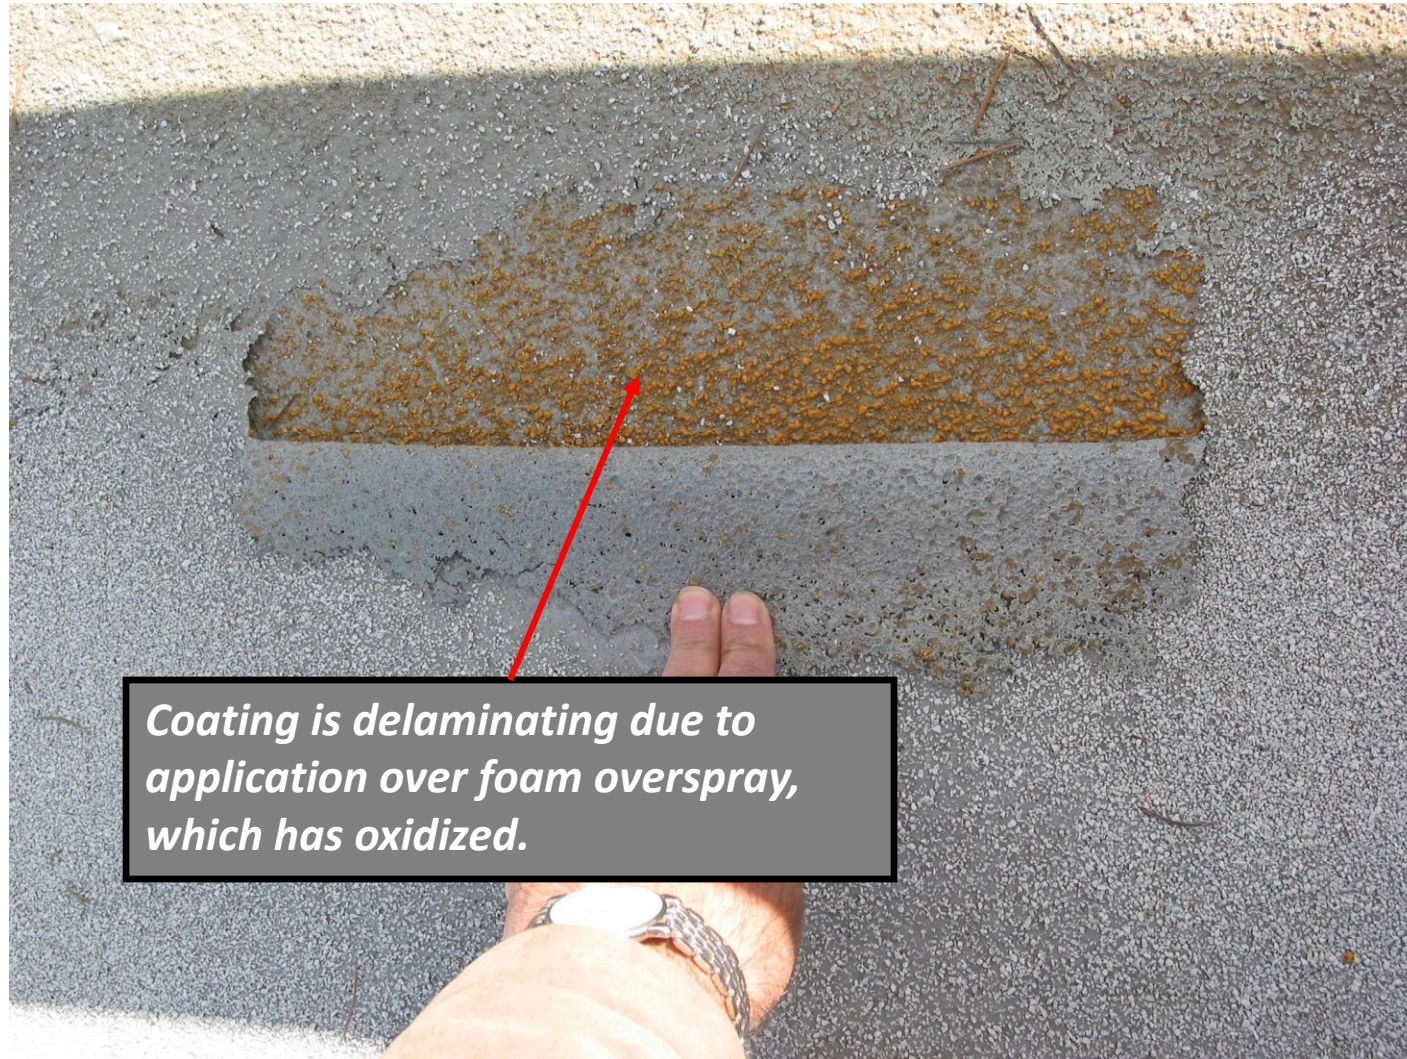
*Coating is delaminating due to application over foam overspray, which has oxidized.*
