# Roofs Can Last In Excess of 30 Years But Most Do Not

January 24, 2006

Honolulu, Hawai'i

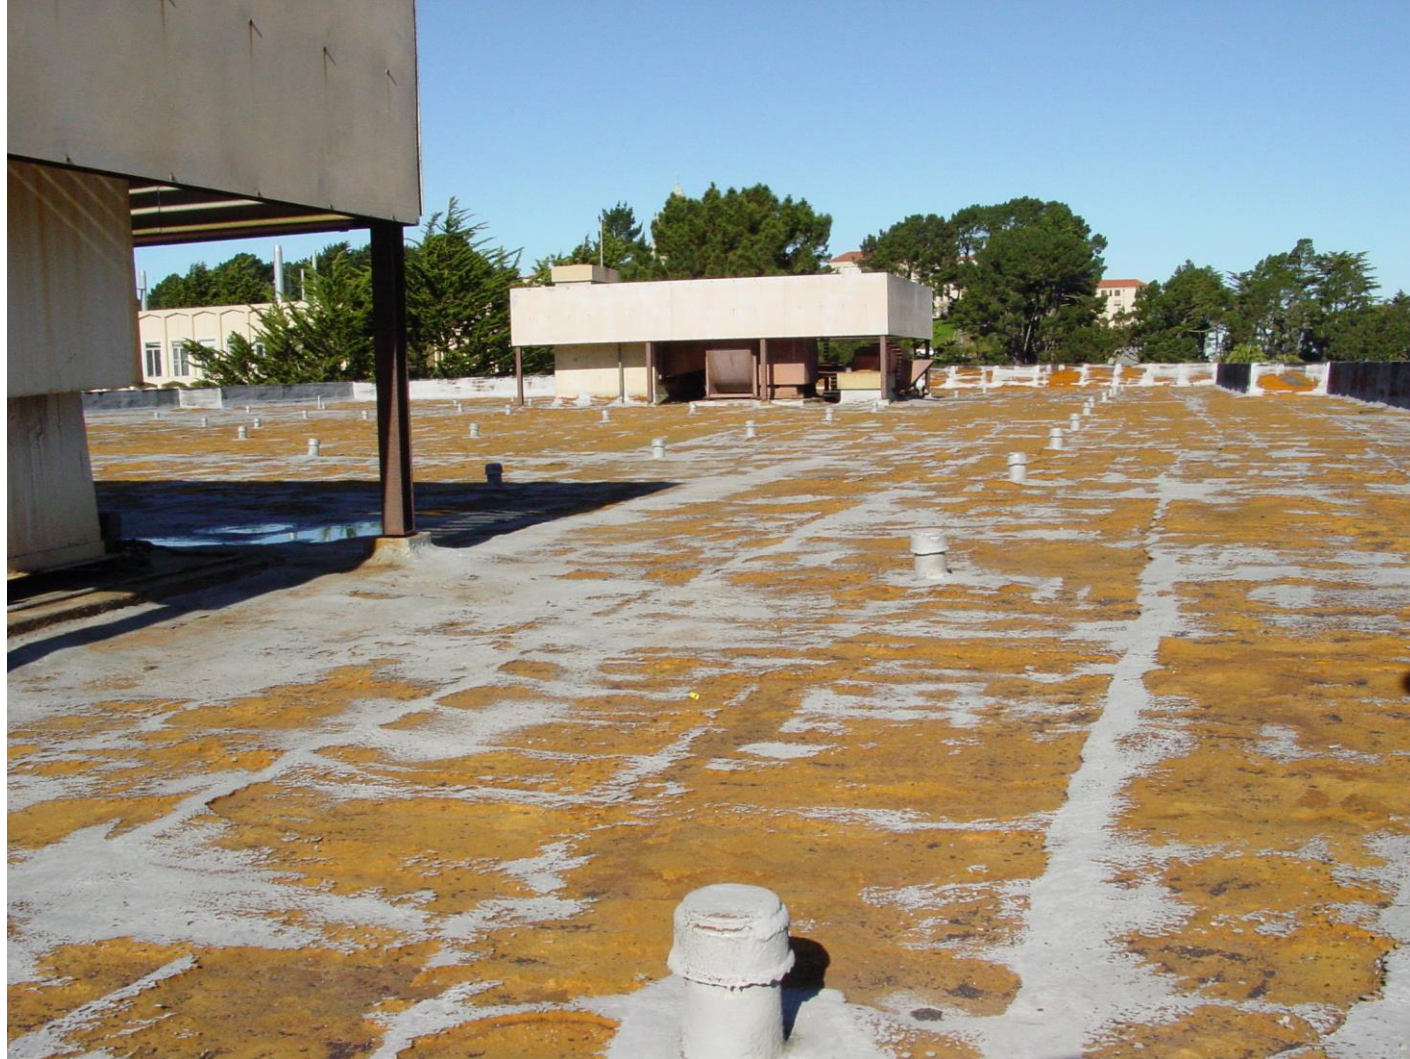
# Foam roof did not receive re-coating in time

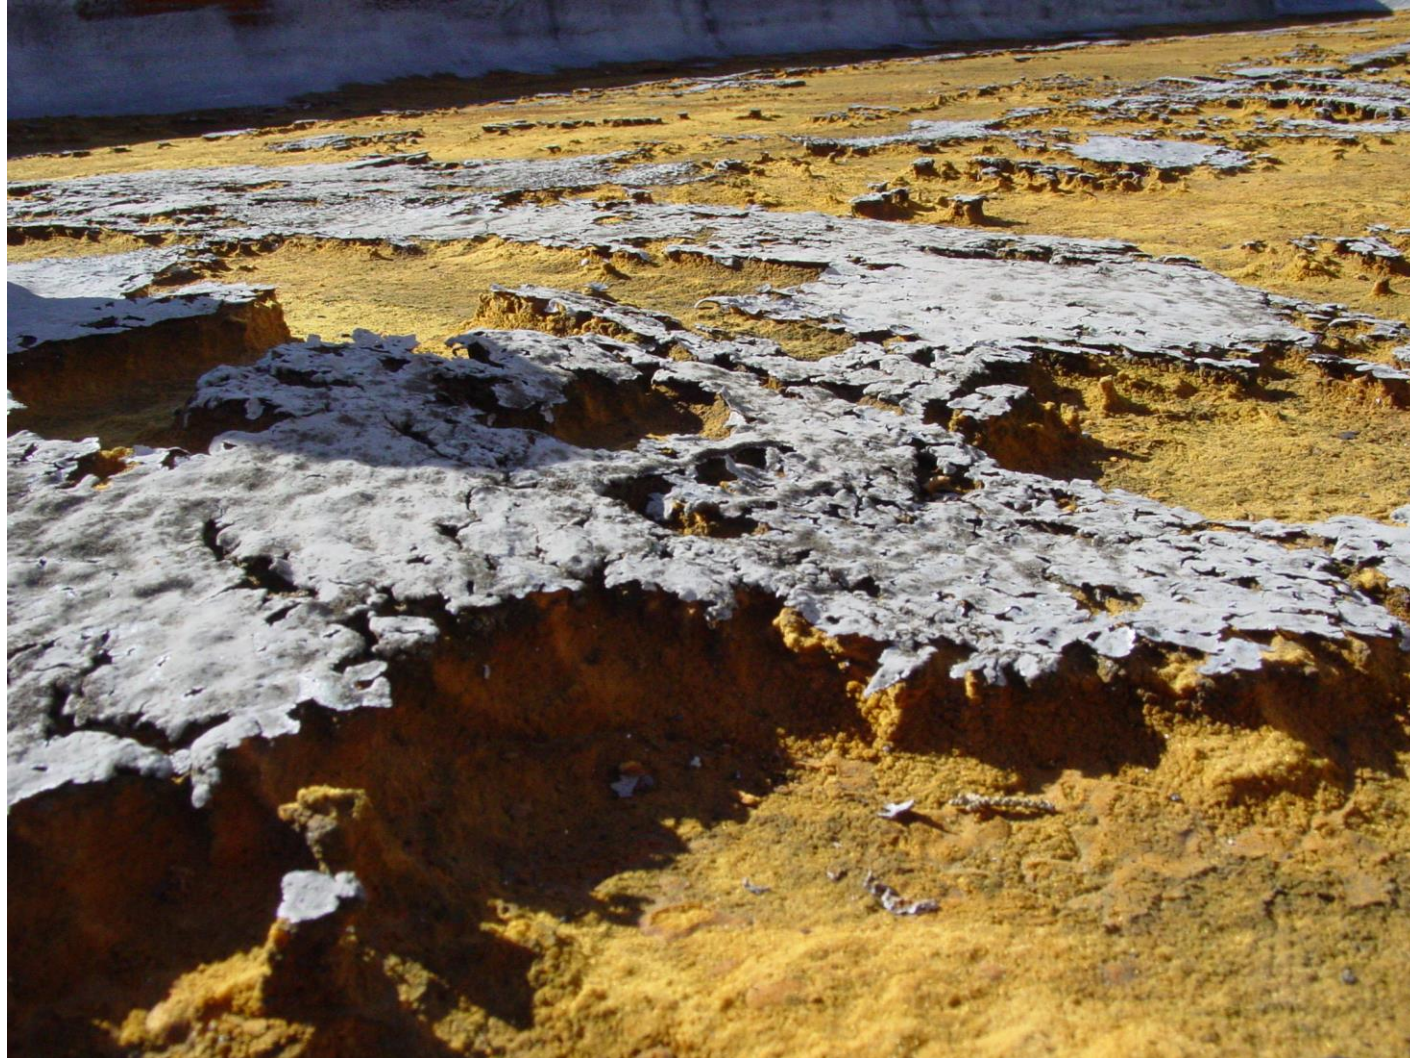
# UV degradation of foam due to loss of coating

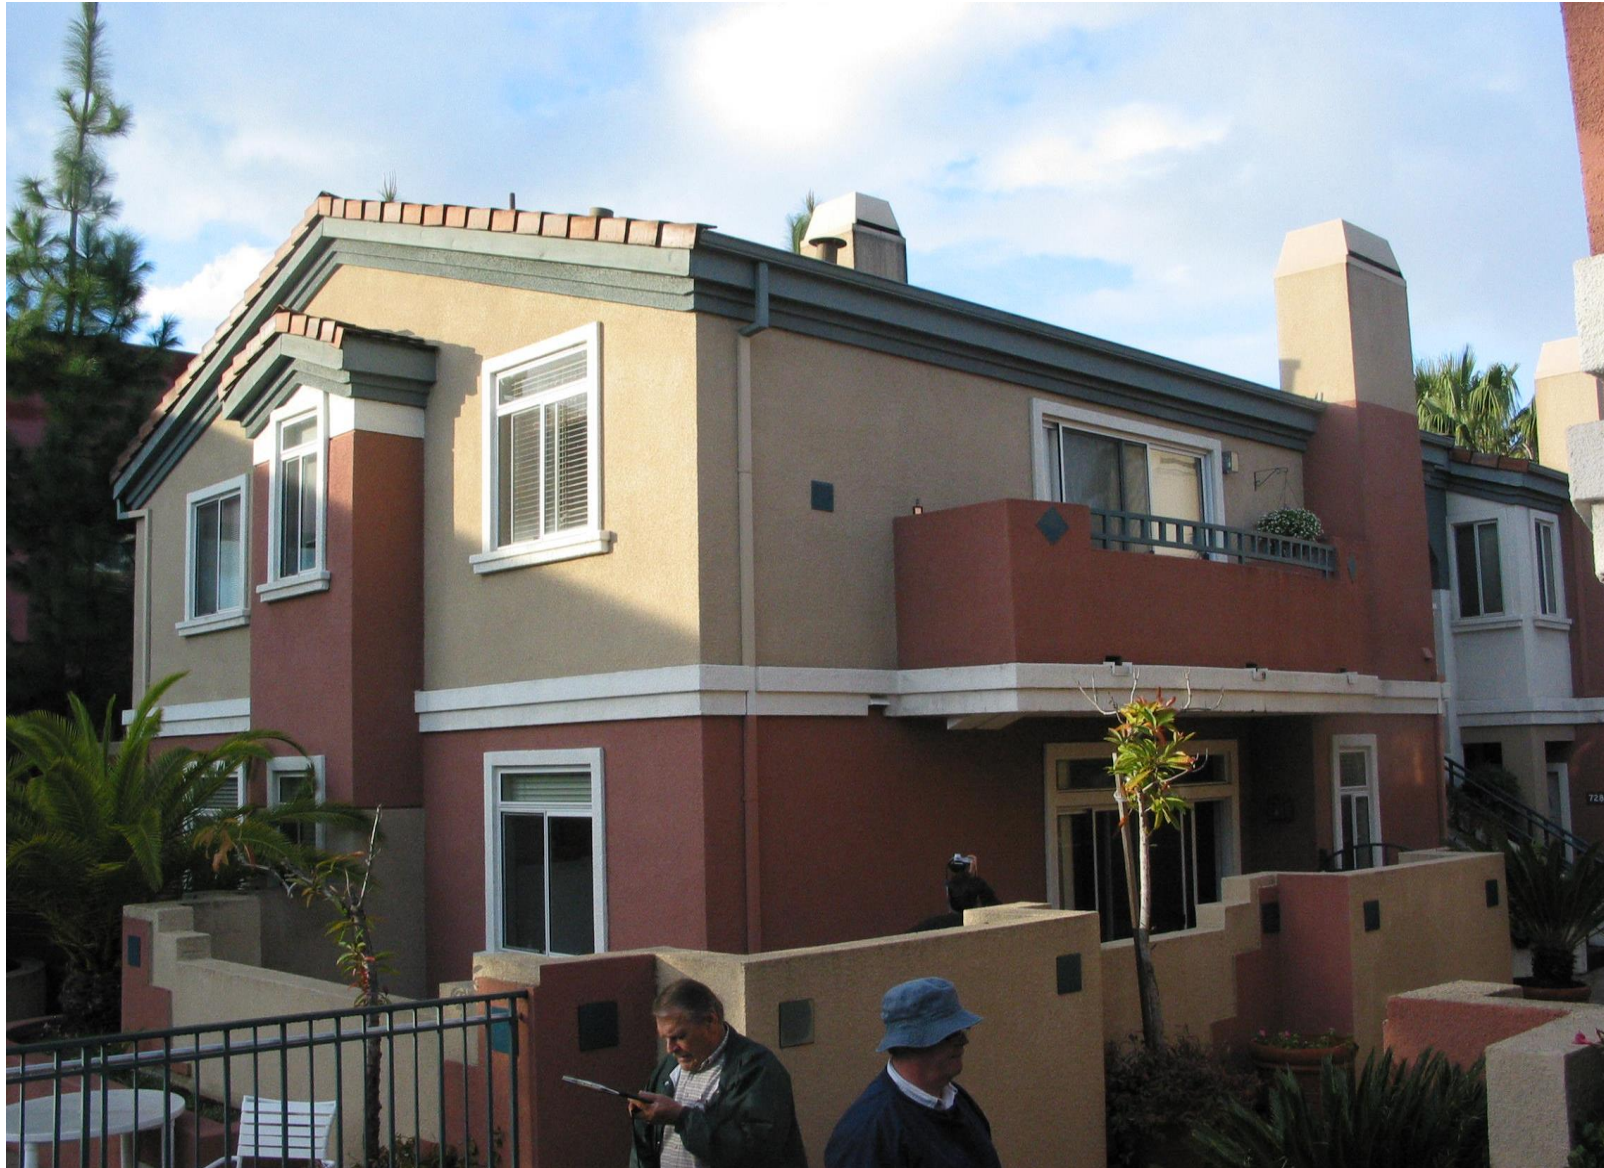
*Significant leaks in ceilings*

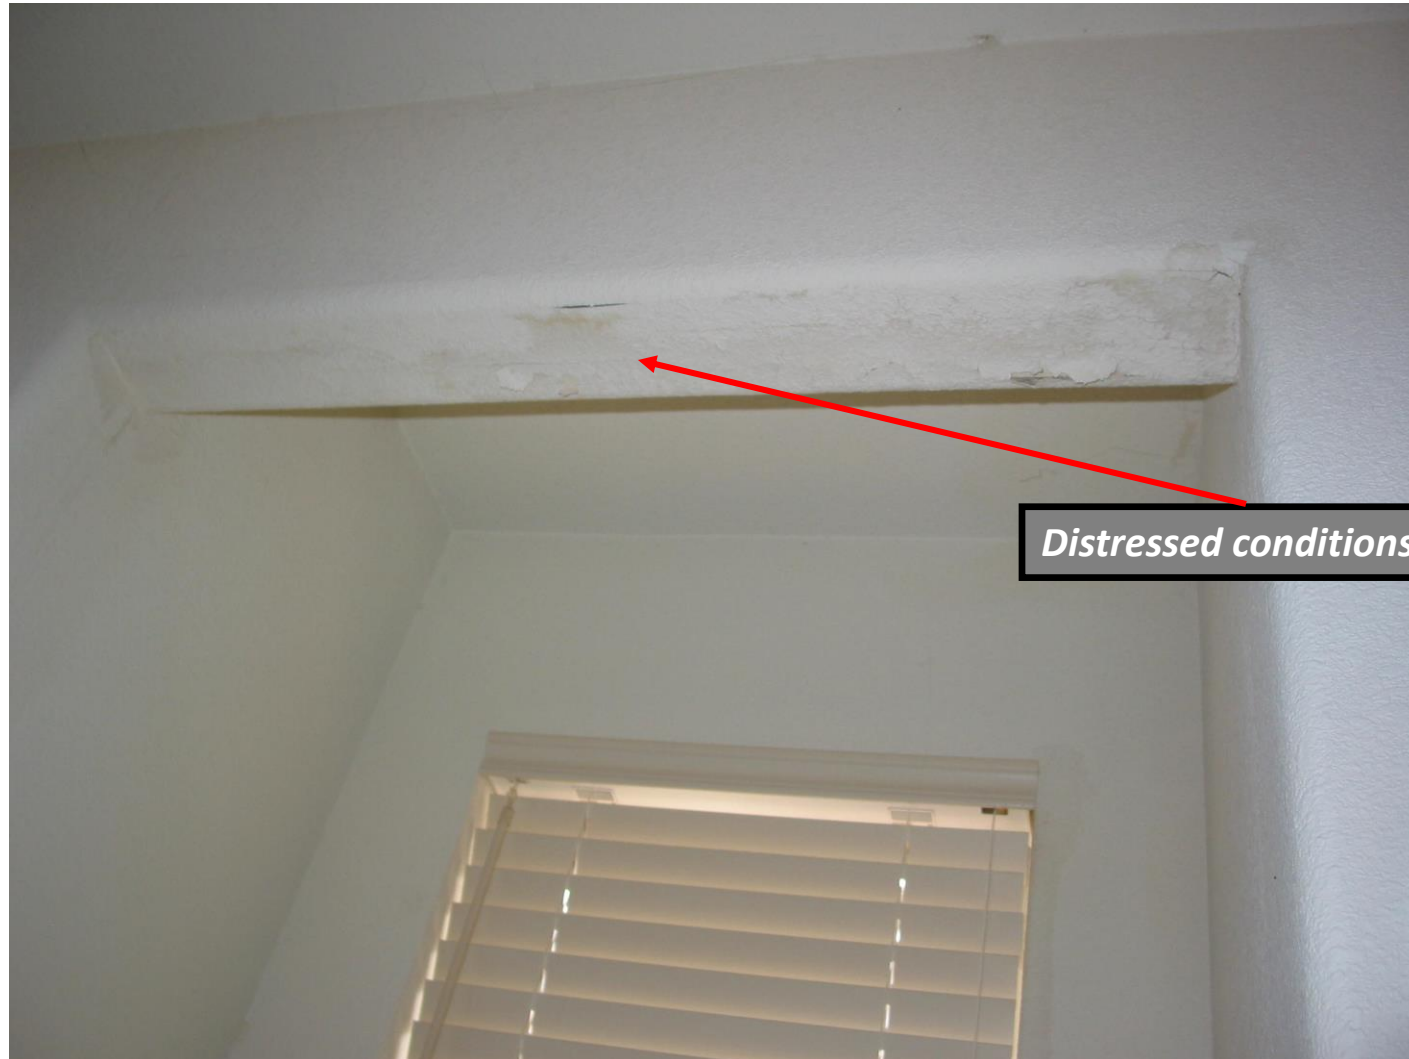
*Distressed conditions*

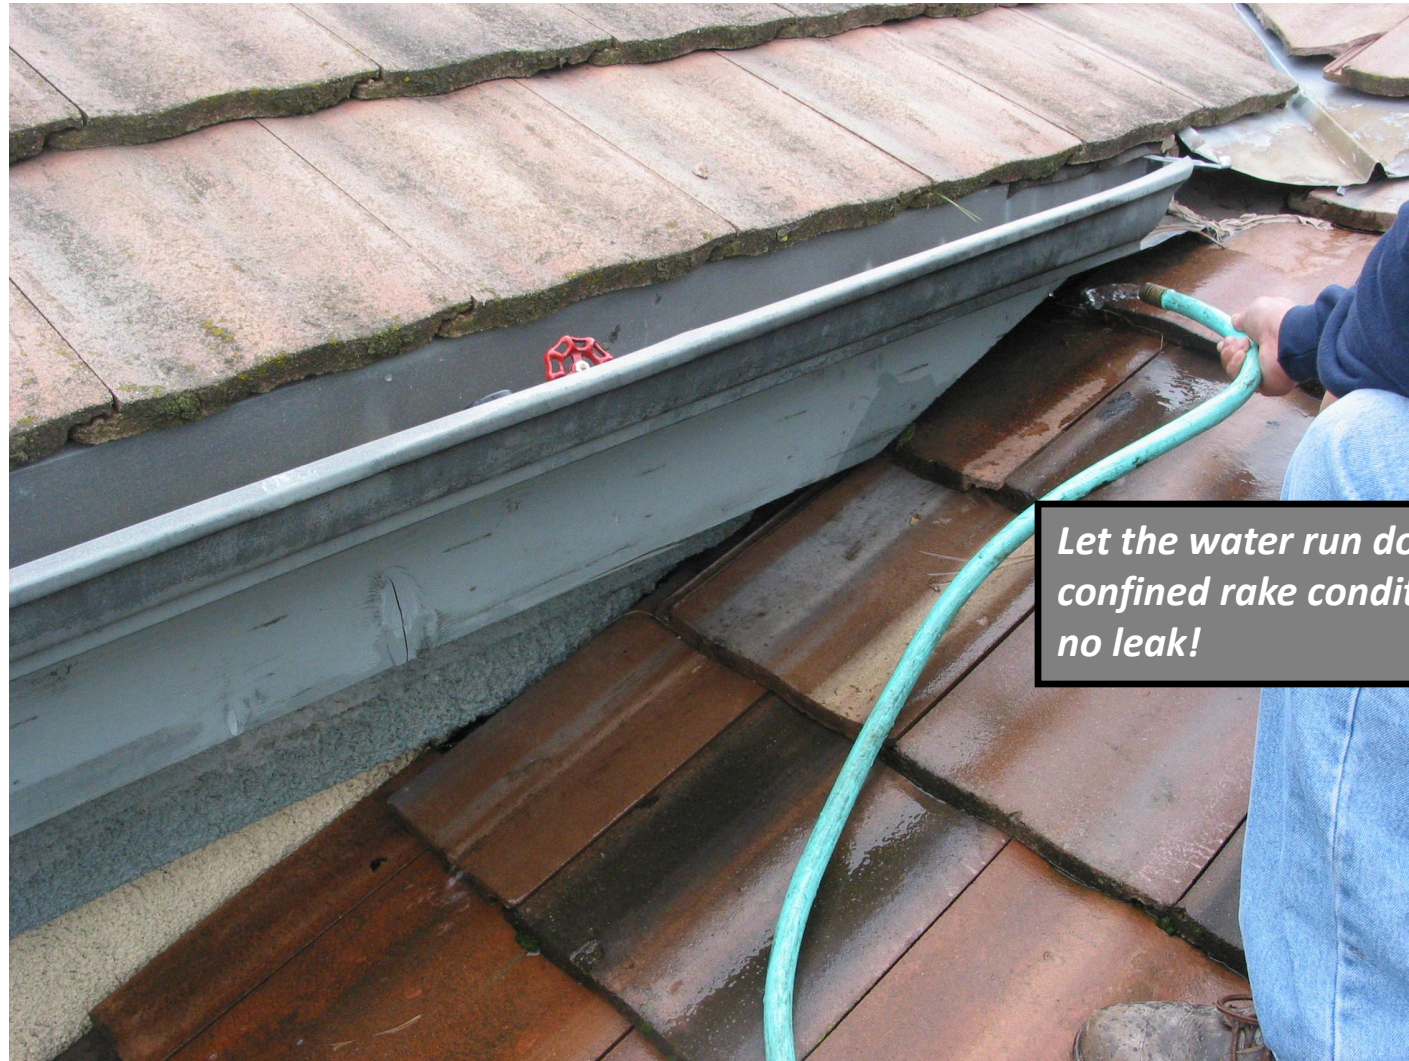
*Let the water run down the  
confined rake condition –  
no leak!*

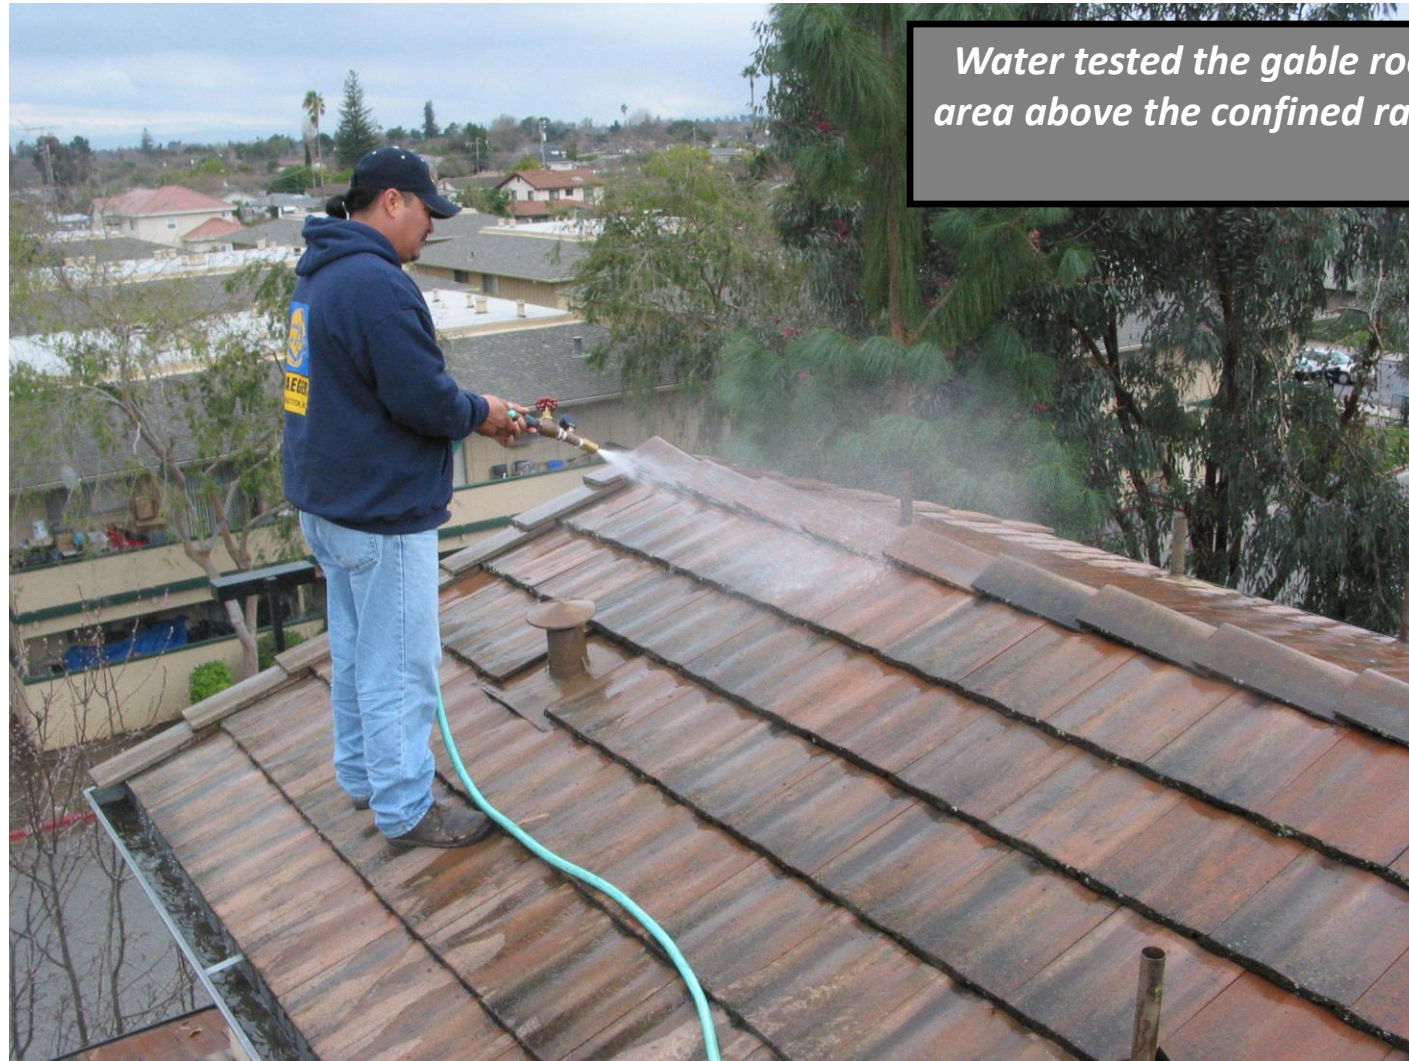
*Water tested the gable roof area above the confined rake.*

Improper membrane was utilized as wind block. 30 lb felt was used instead of 9 inch pressure sensitive adhesive membrane recommended by material manufacturer. But, this was not the primary source of leak in unit below.

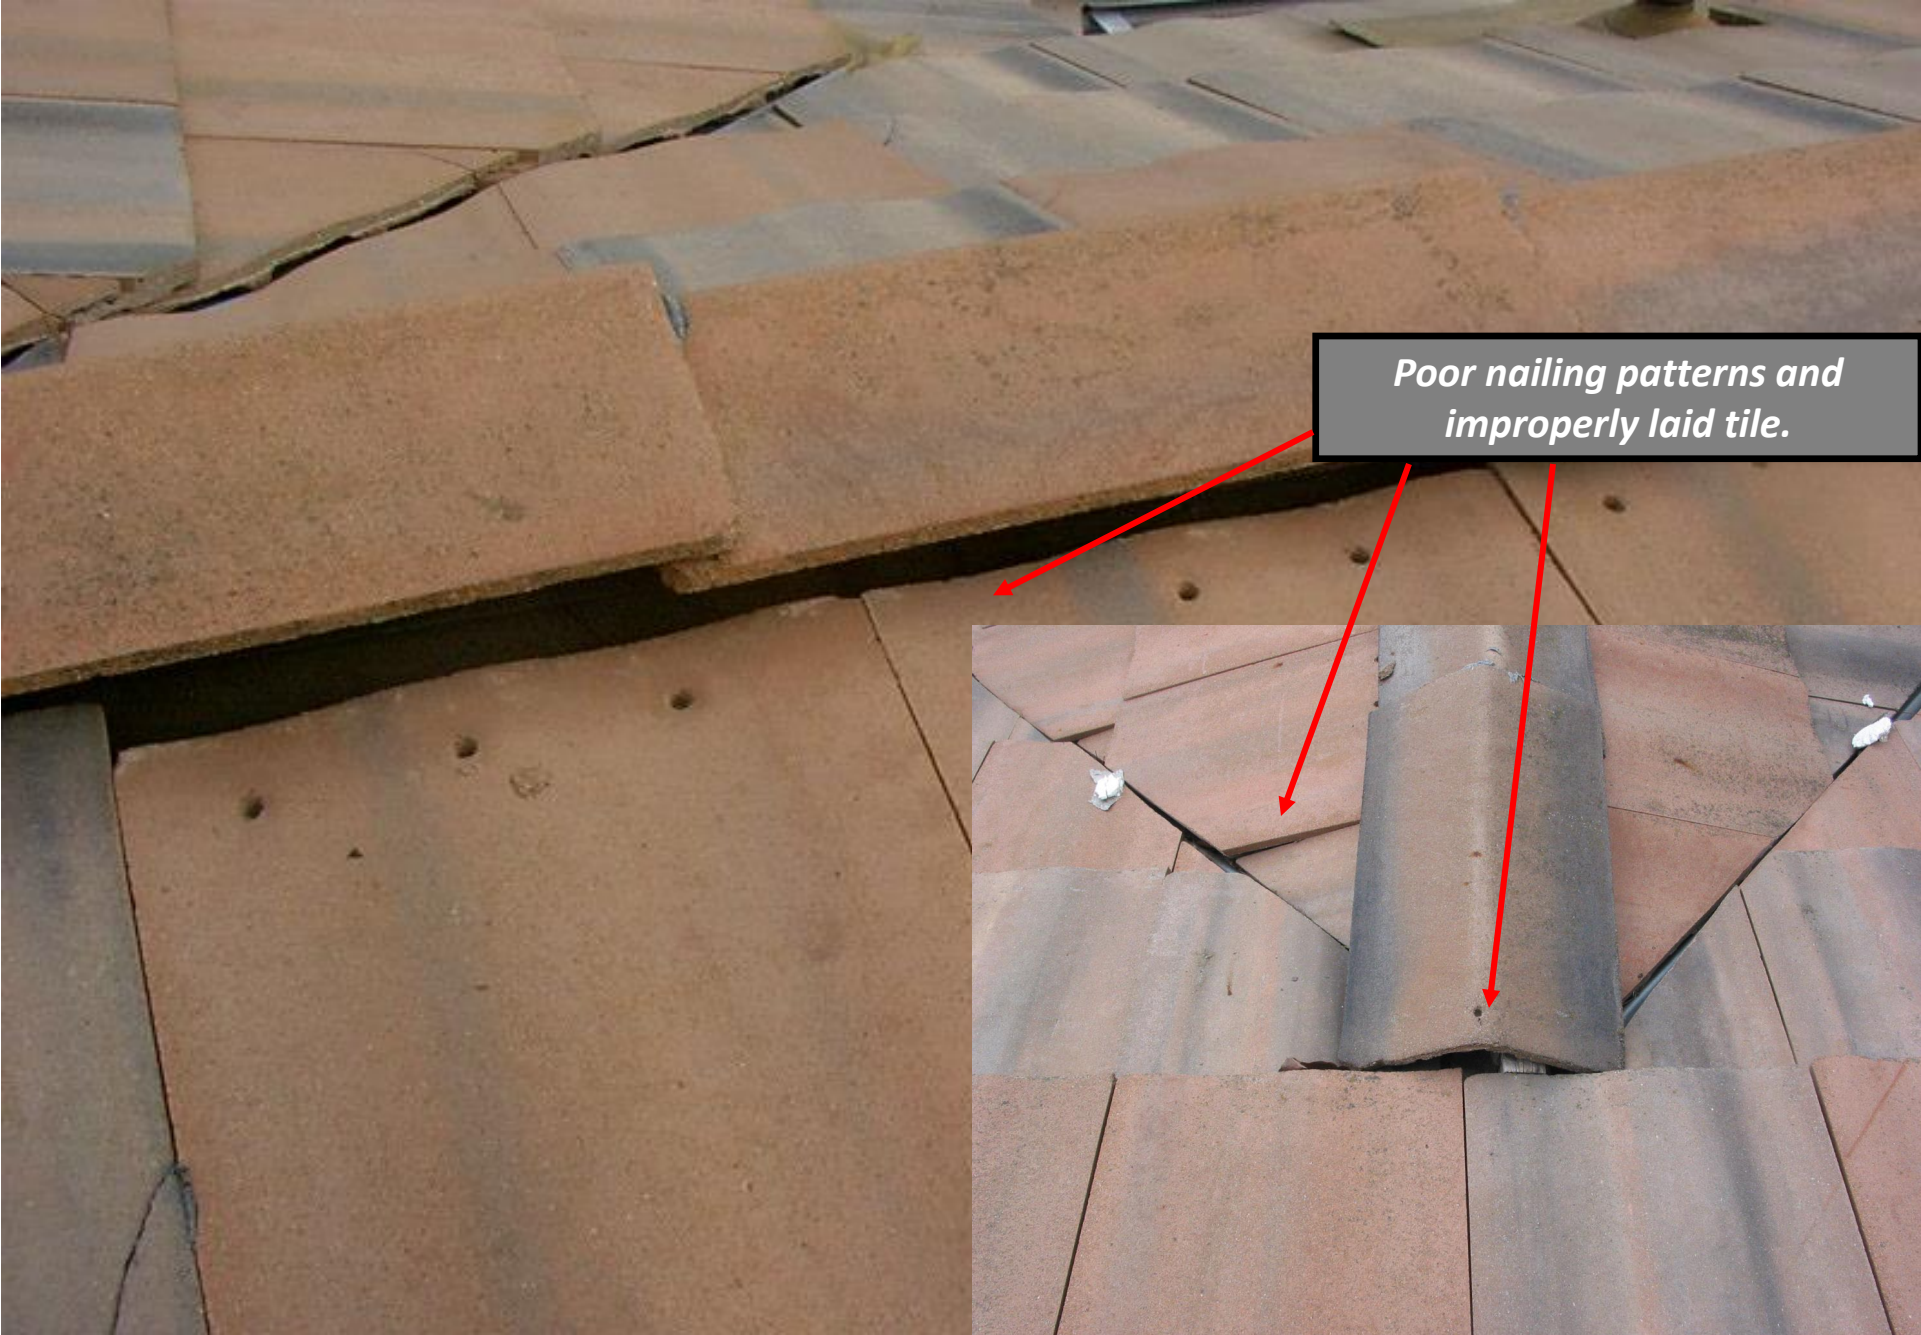
*Poor nailing patterns and  
improperly laid tile.*

*Roof cement covers nails, but  
nails must not be exposed.  
Ridge tile is not lapped  
properly.*

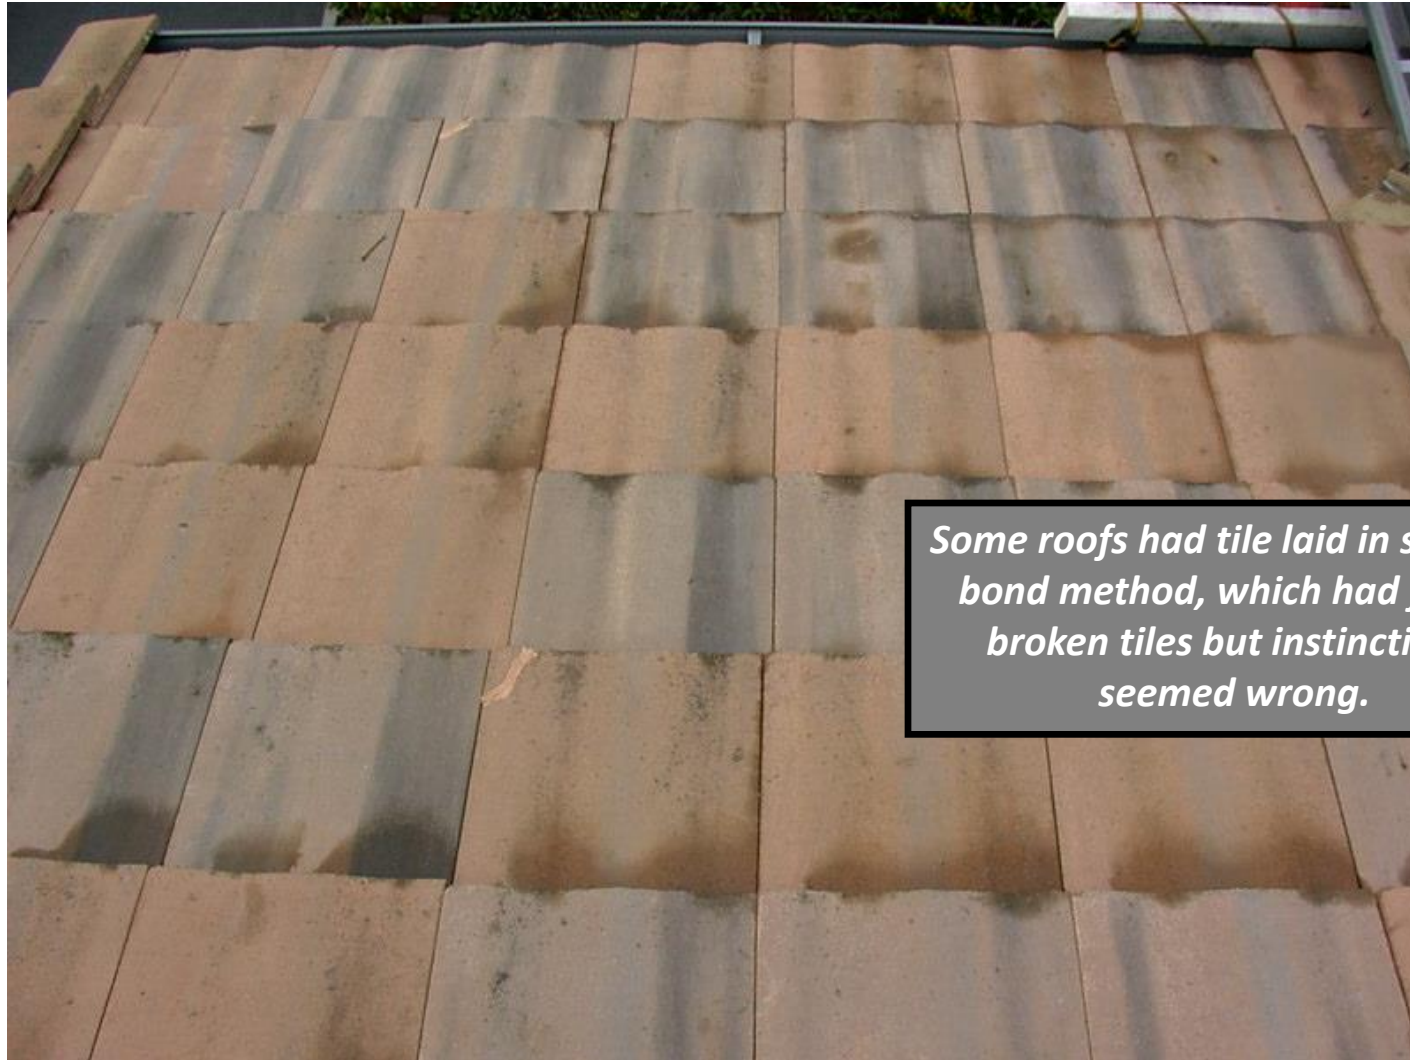
*Some roofs had tile laid in straight bond method, which had fewer broken tiles but instinctively seemed wrong.*

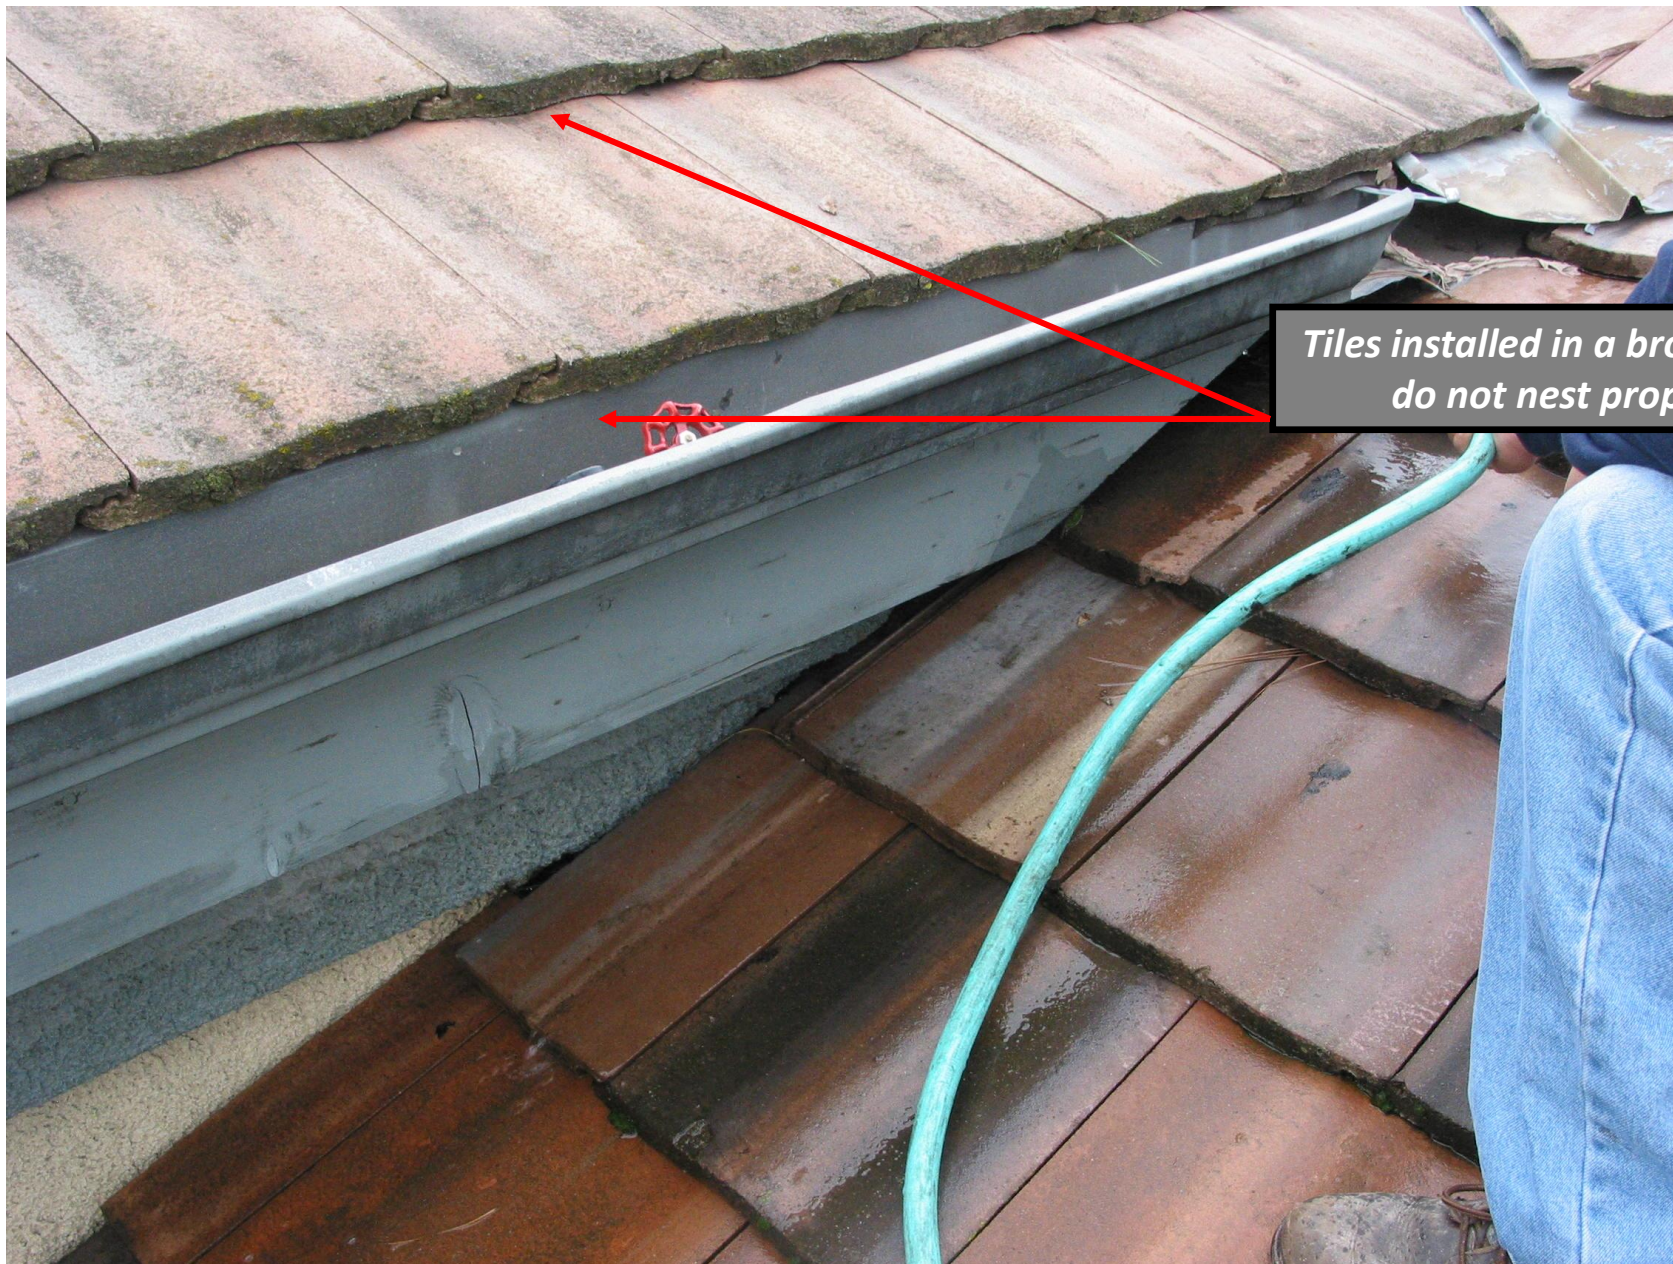
*Joints in tile not parallel  
and are too close, resulting  
in breakage*

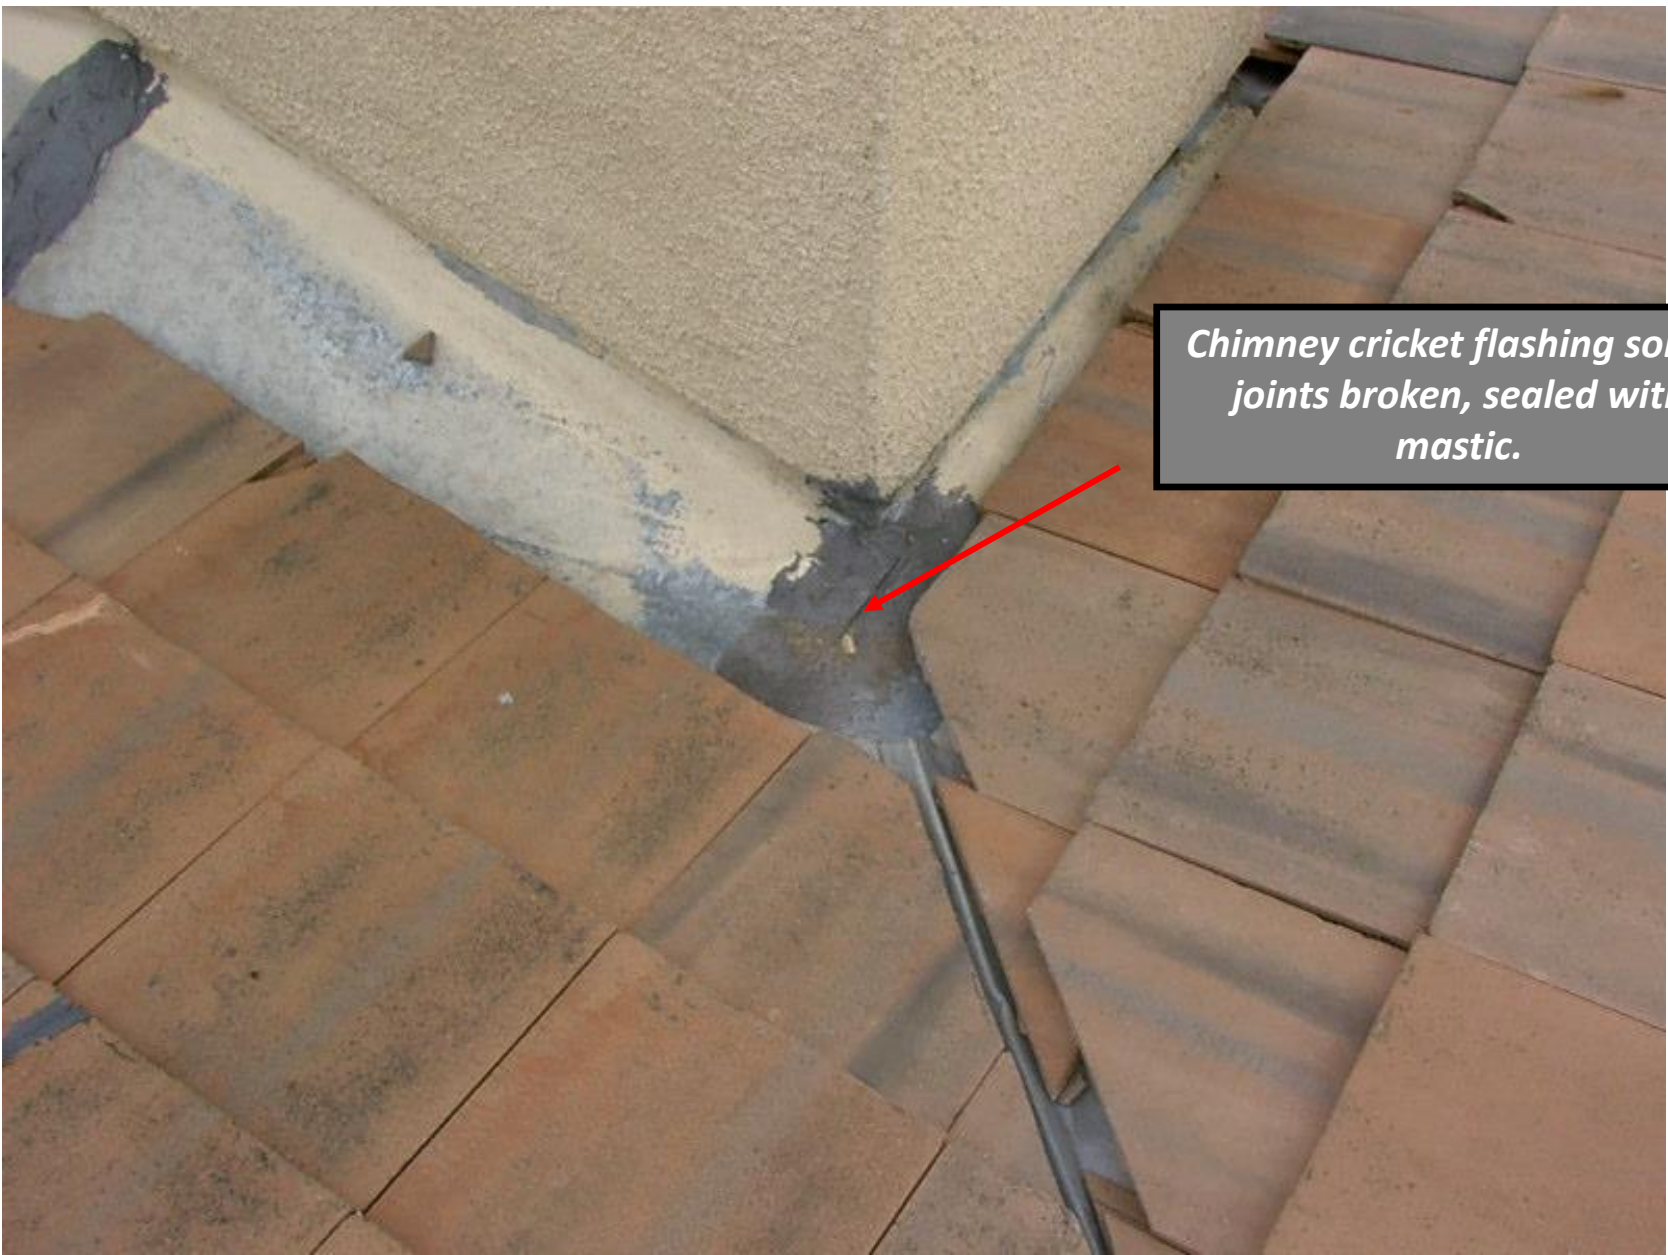
*Chimney cricket flashing solder joints broken, sealed with mastic.*

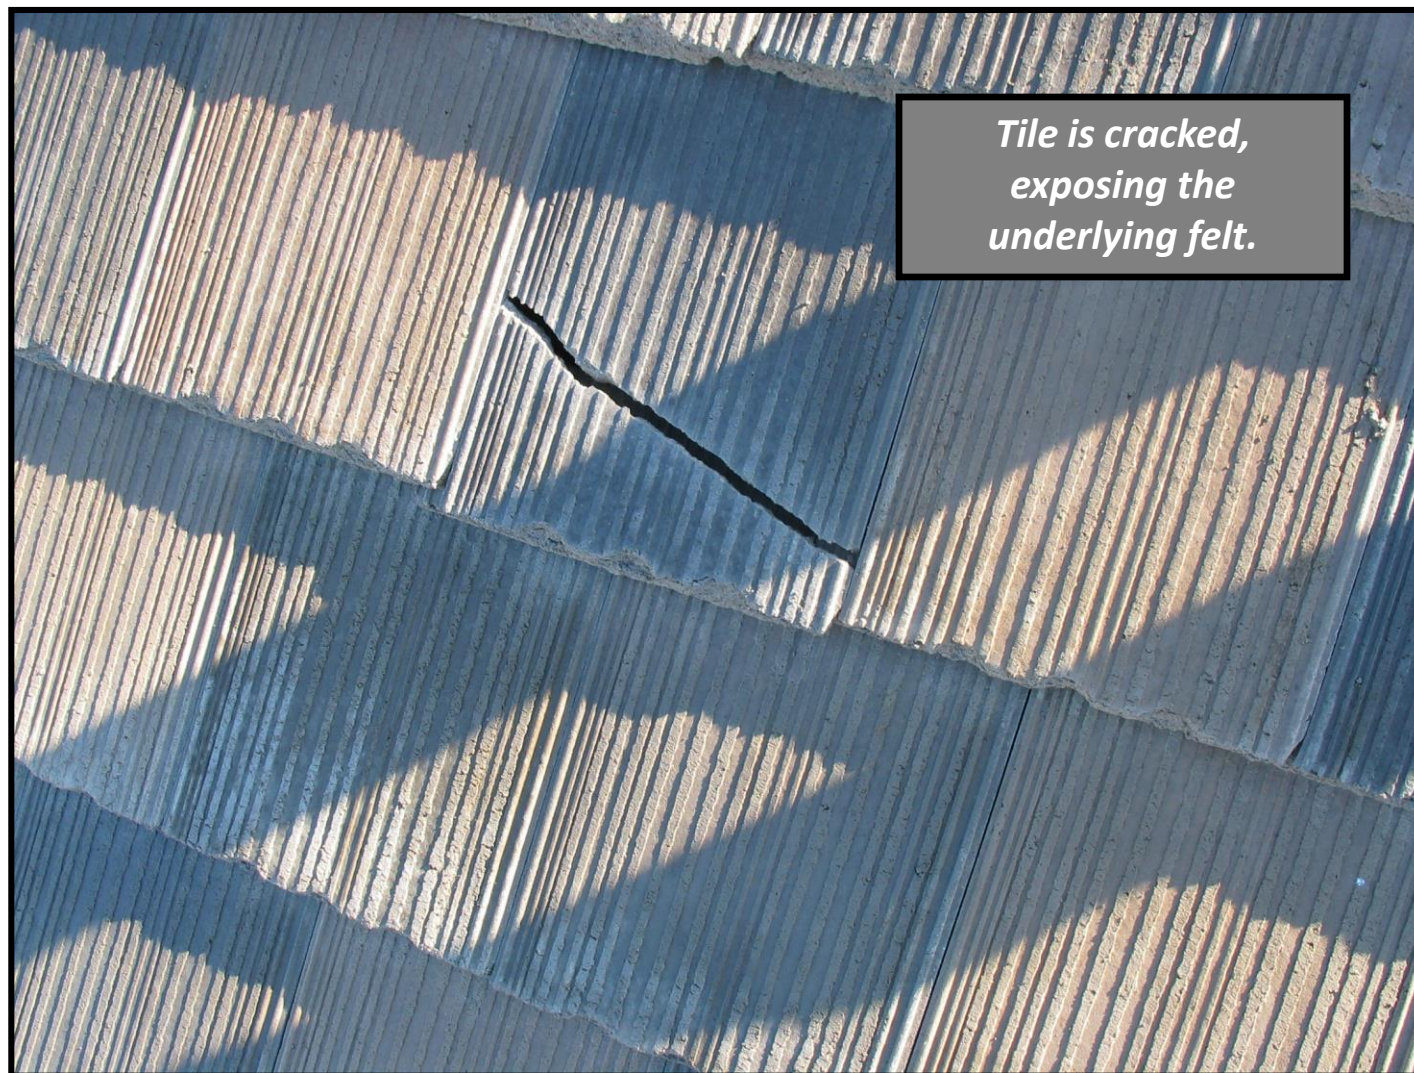
*Tile is cracked,  
exposing the  
underlying felt.*

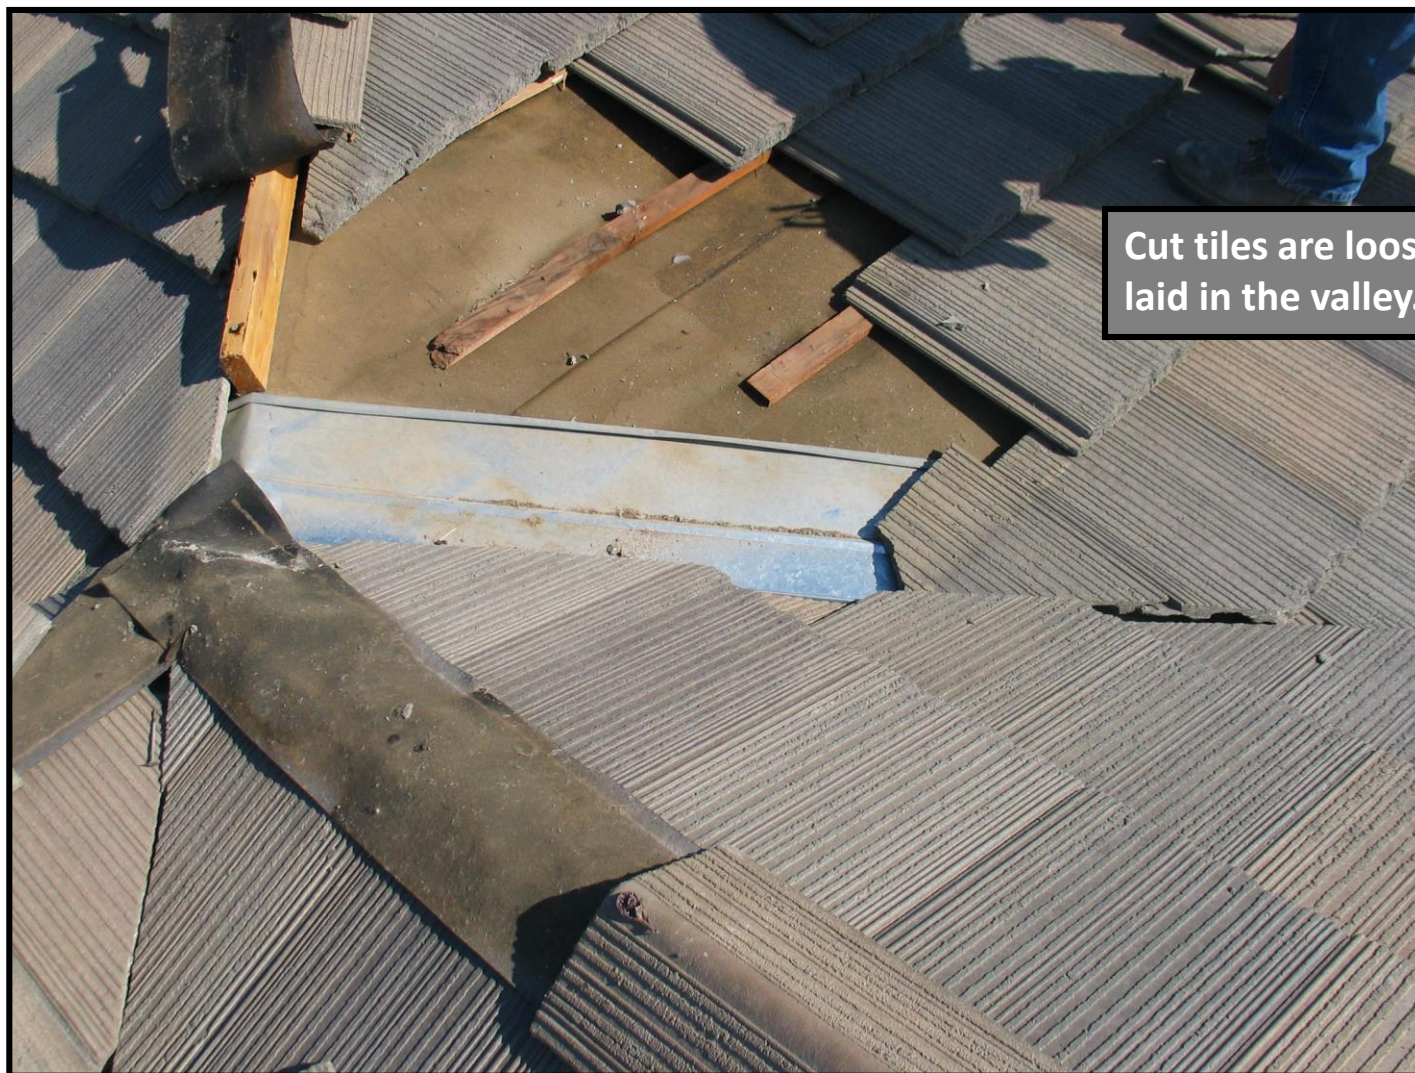
Cut tiles are loose  
laid in the valley.

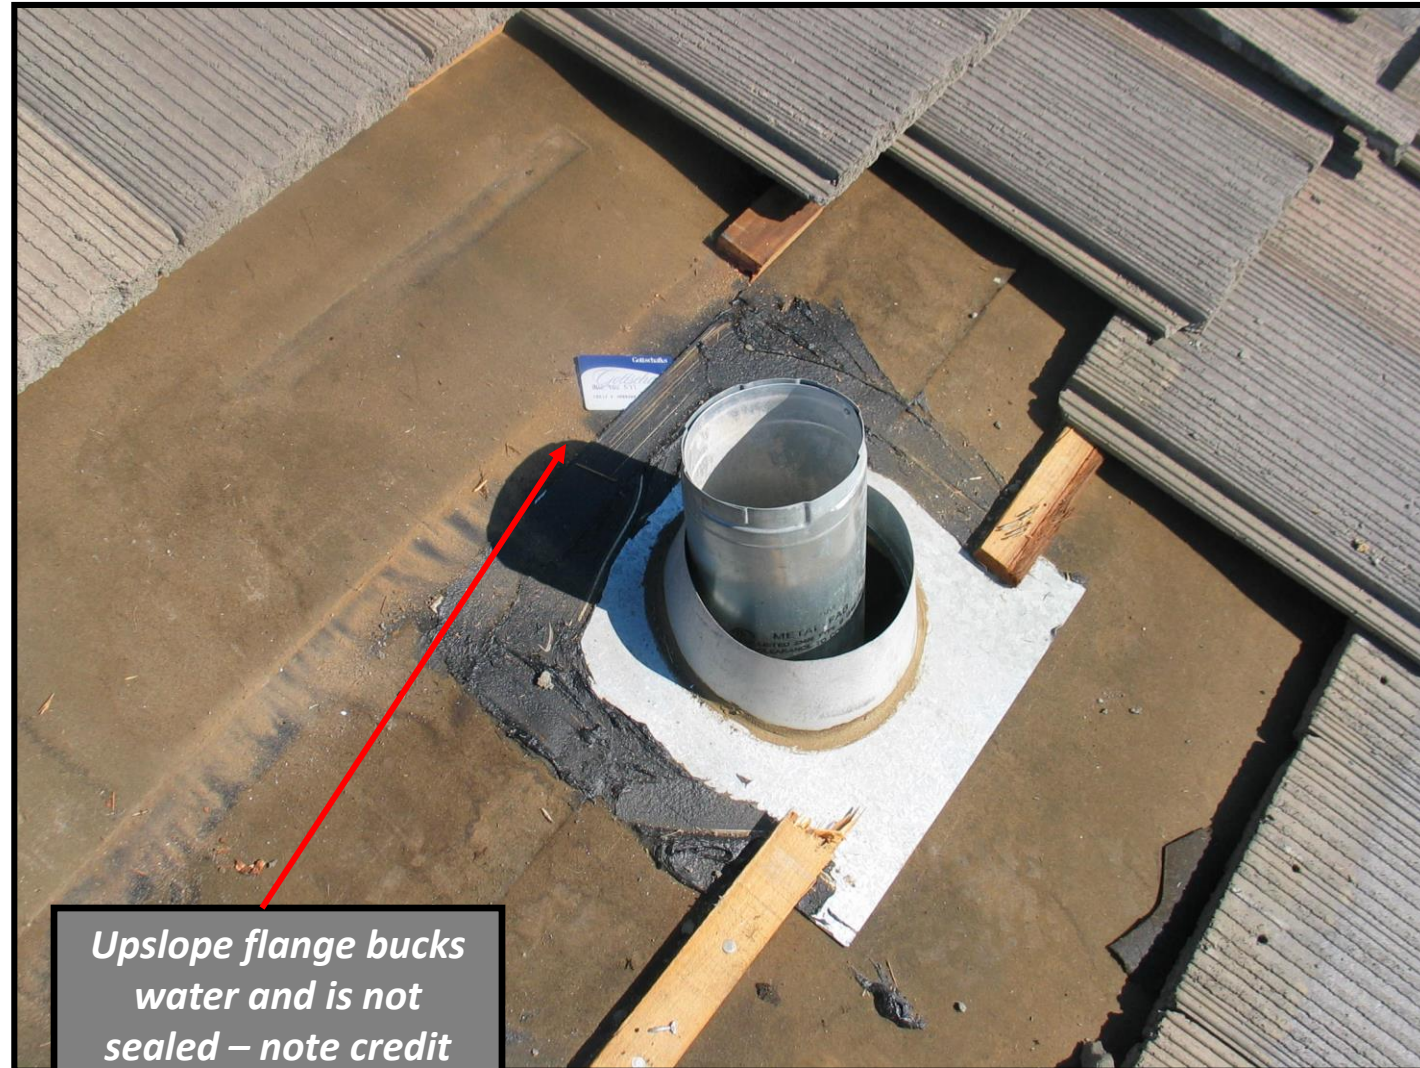
*Upslope flange bucks water and is not sealed – note credit card in joint.*
