# Roofs Can Last In Excess of 30 Years But Most Do Not

January 24, 2006

Honolulu, Hawai'i

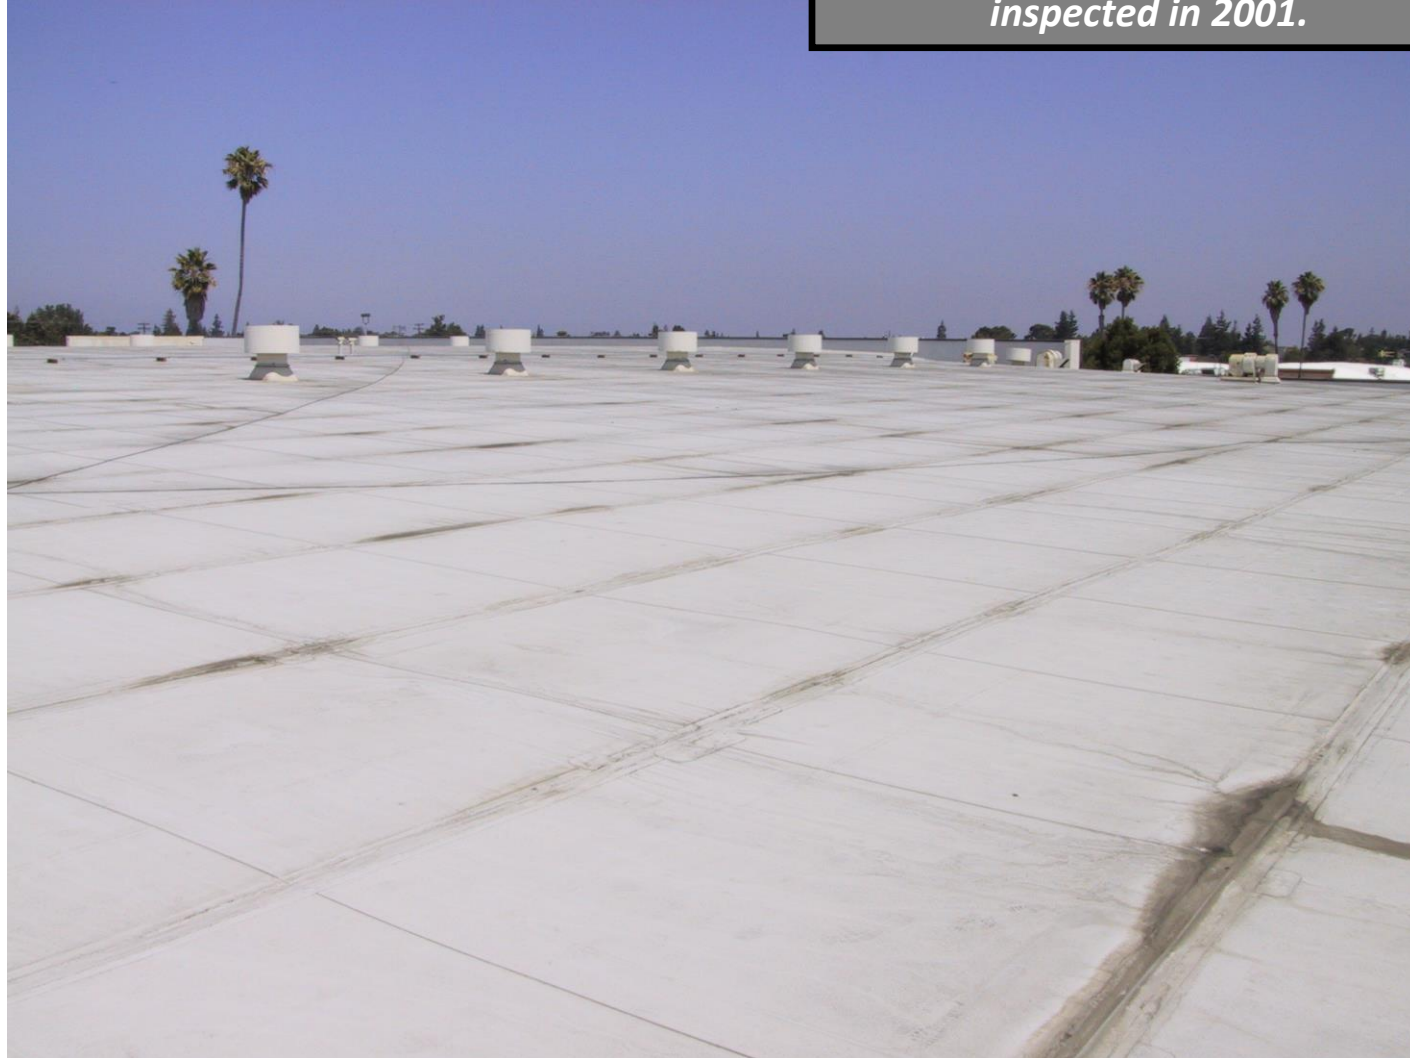
*Example of roof installed in 1983,  
inspected in 2001.*

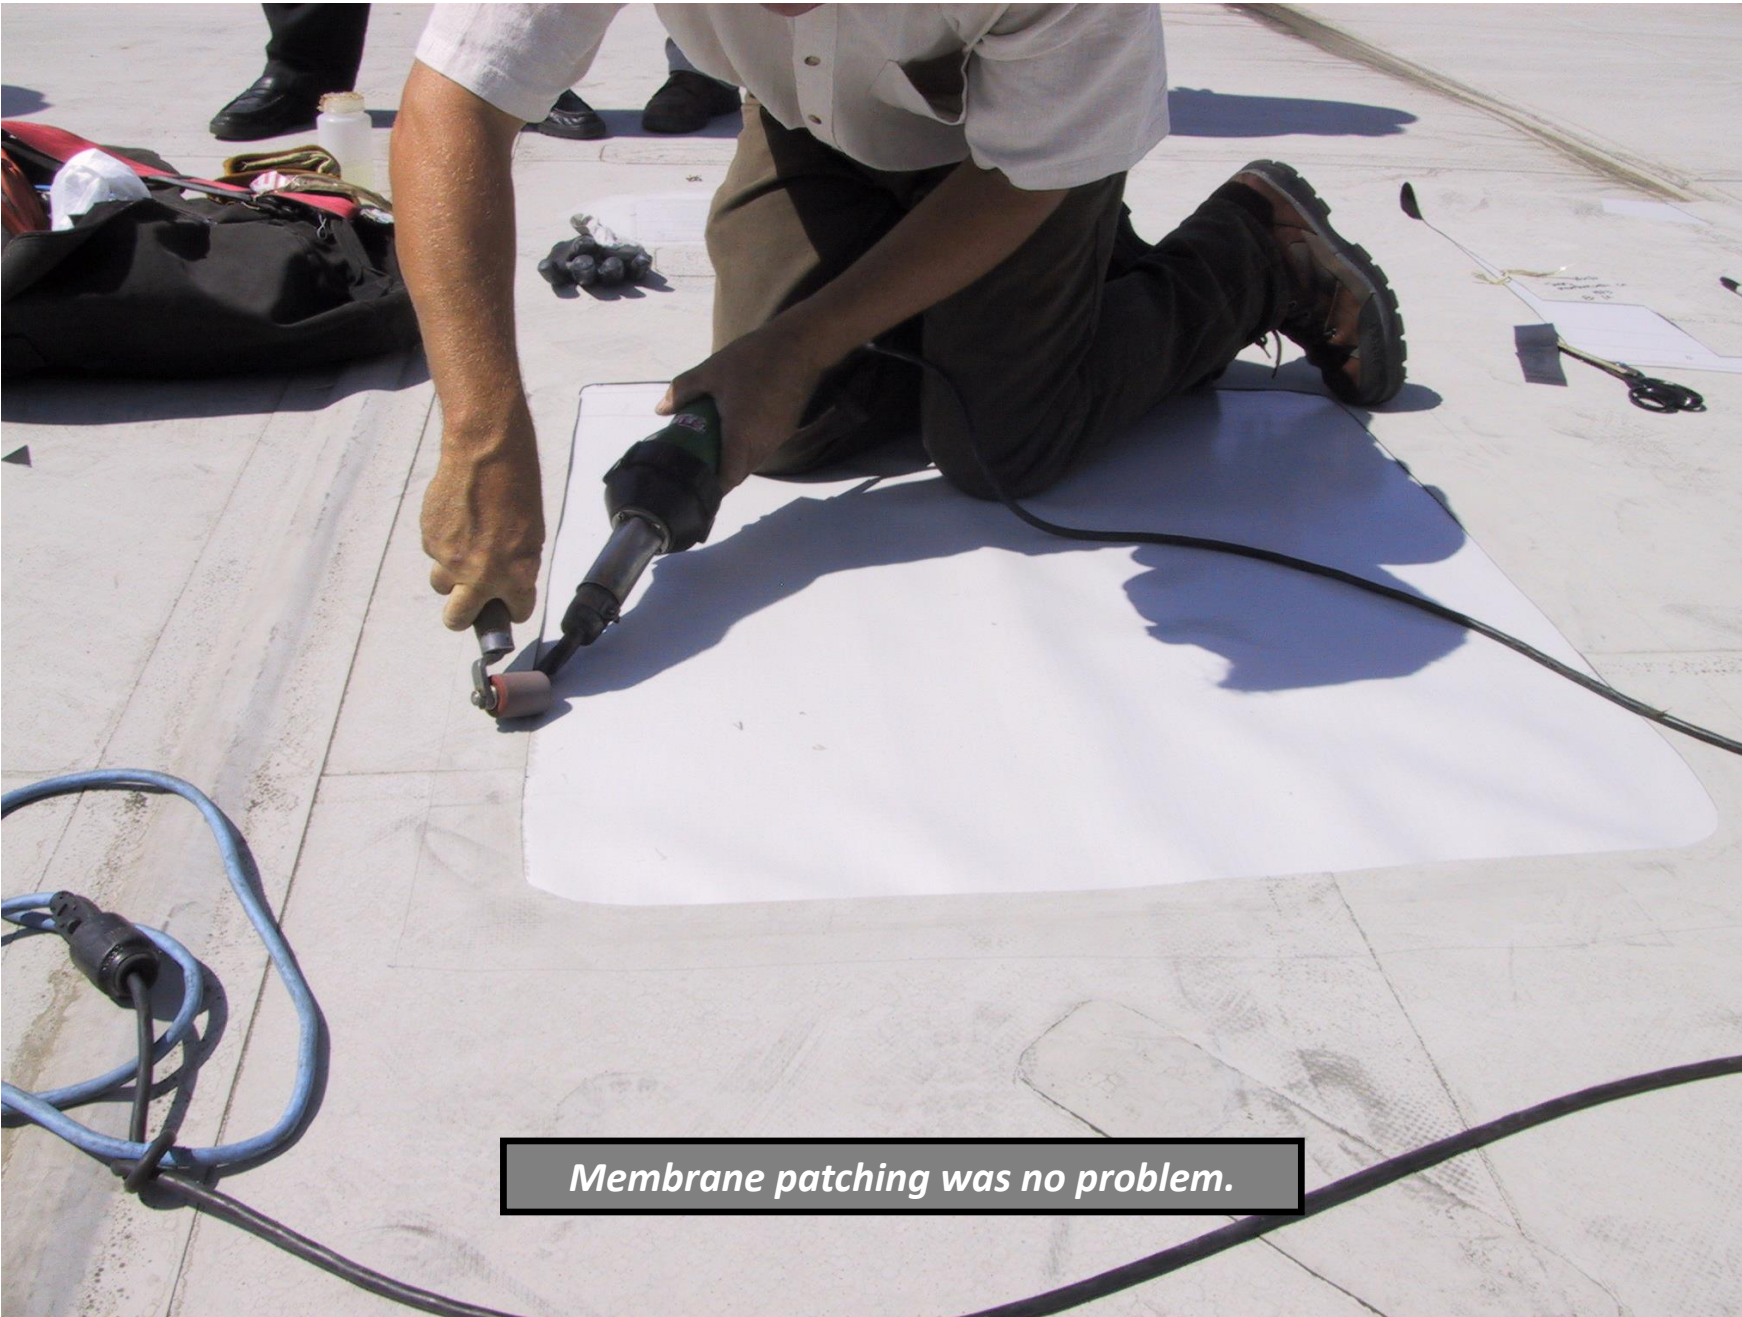
*Membrane patching was no problem.*

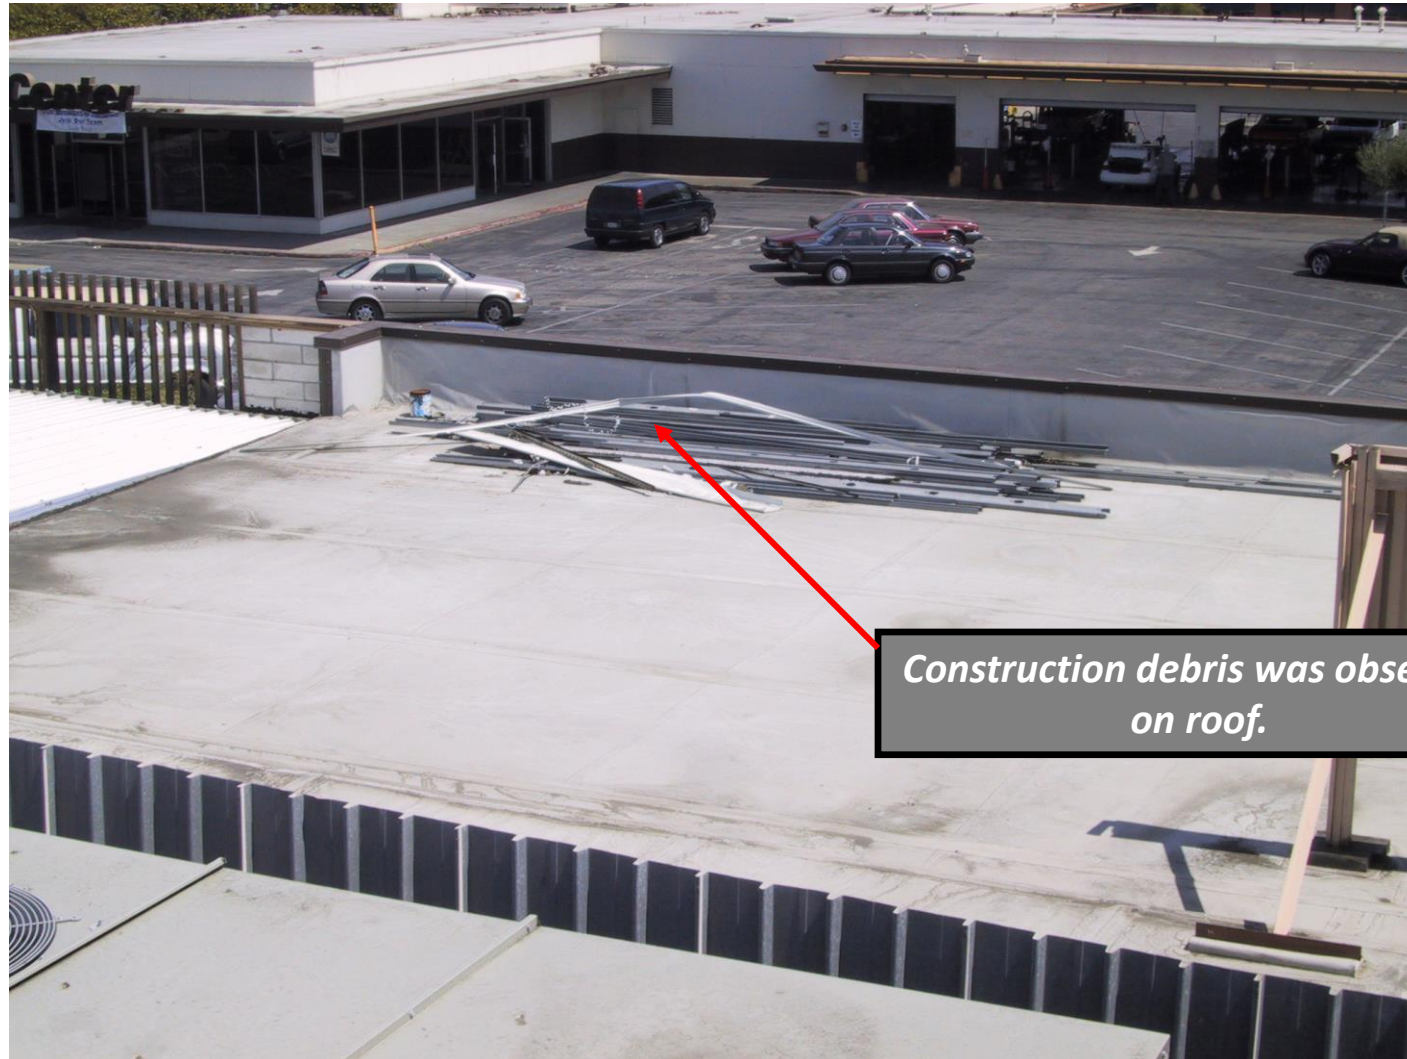
*Construction debris was observed on roof.*

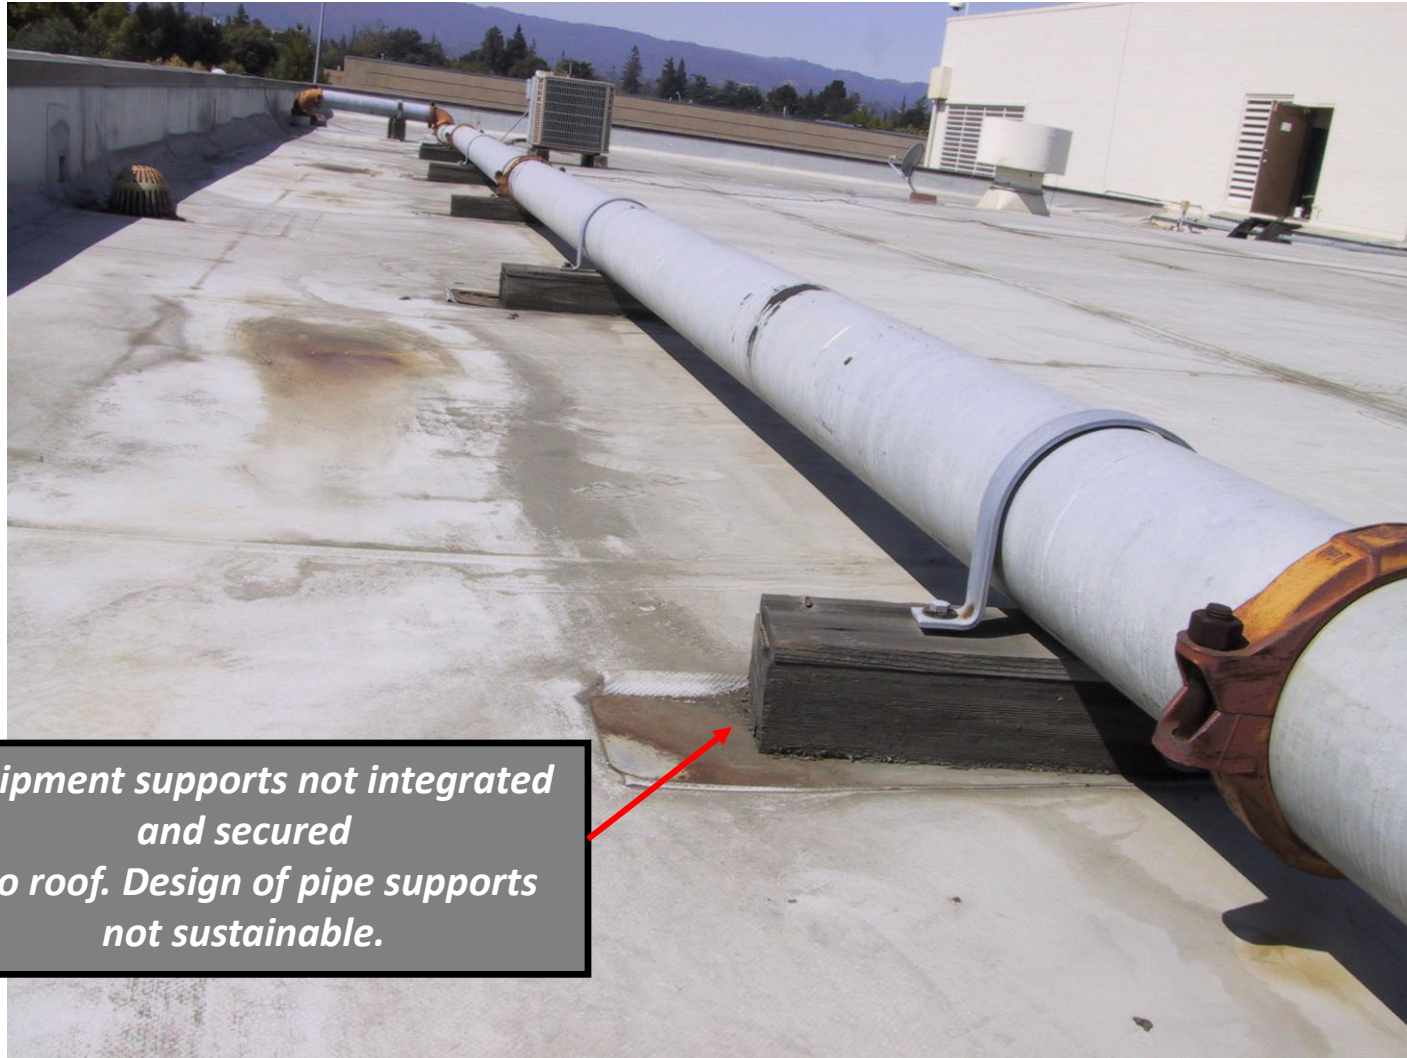
*Equipment supports not integrated and secured into roof. Design of pipe supports not sustainable.*

- DESIGN
  - Original poor design of pipe supports caused damage
  - Poor design of roof drainage caused ponding water and damage
  - Poor design of condensation control mechanism caused damage

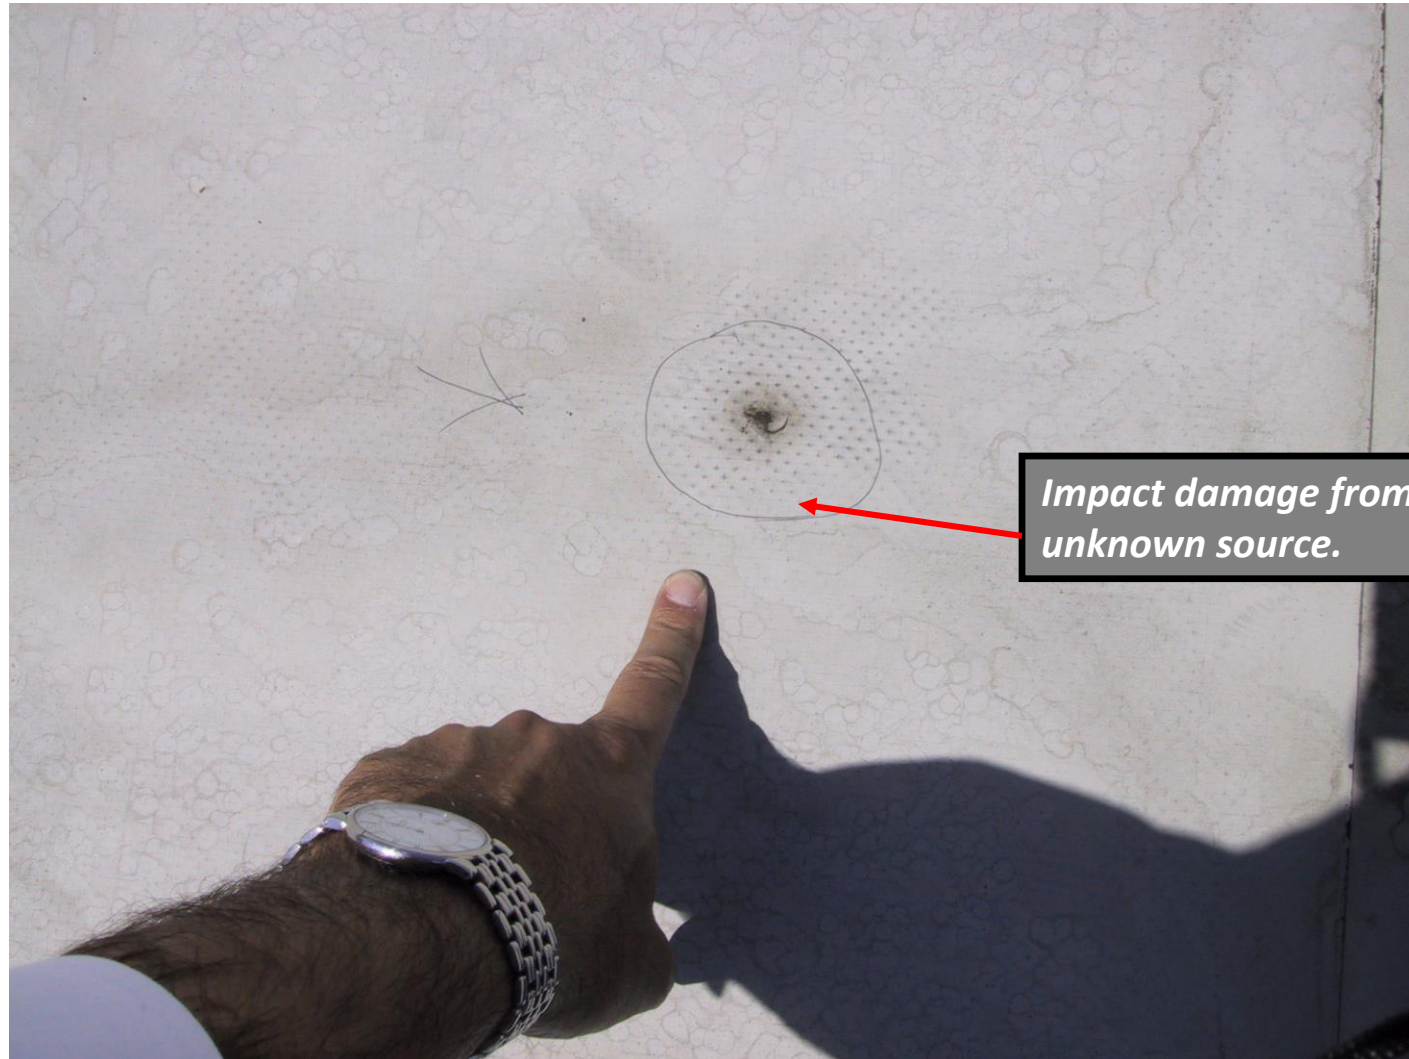
*Impact damage from  
unknown source.*

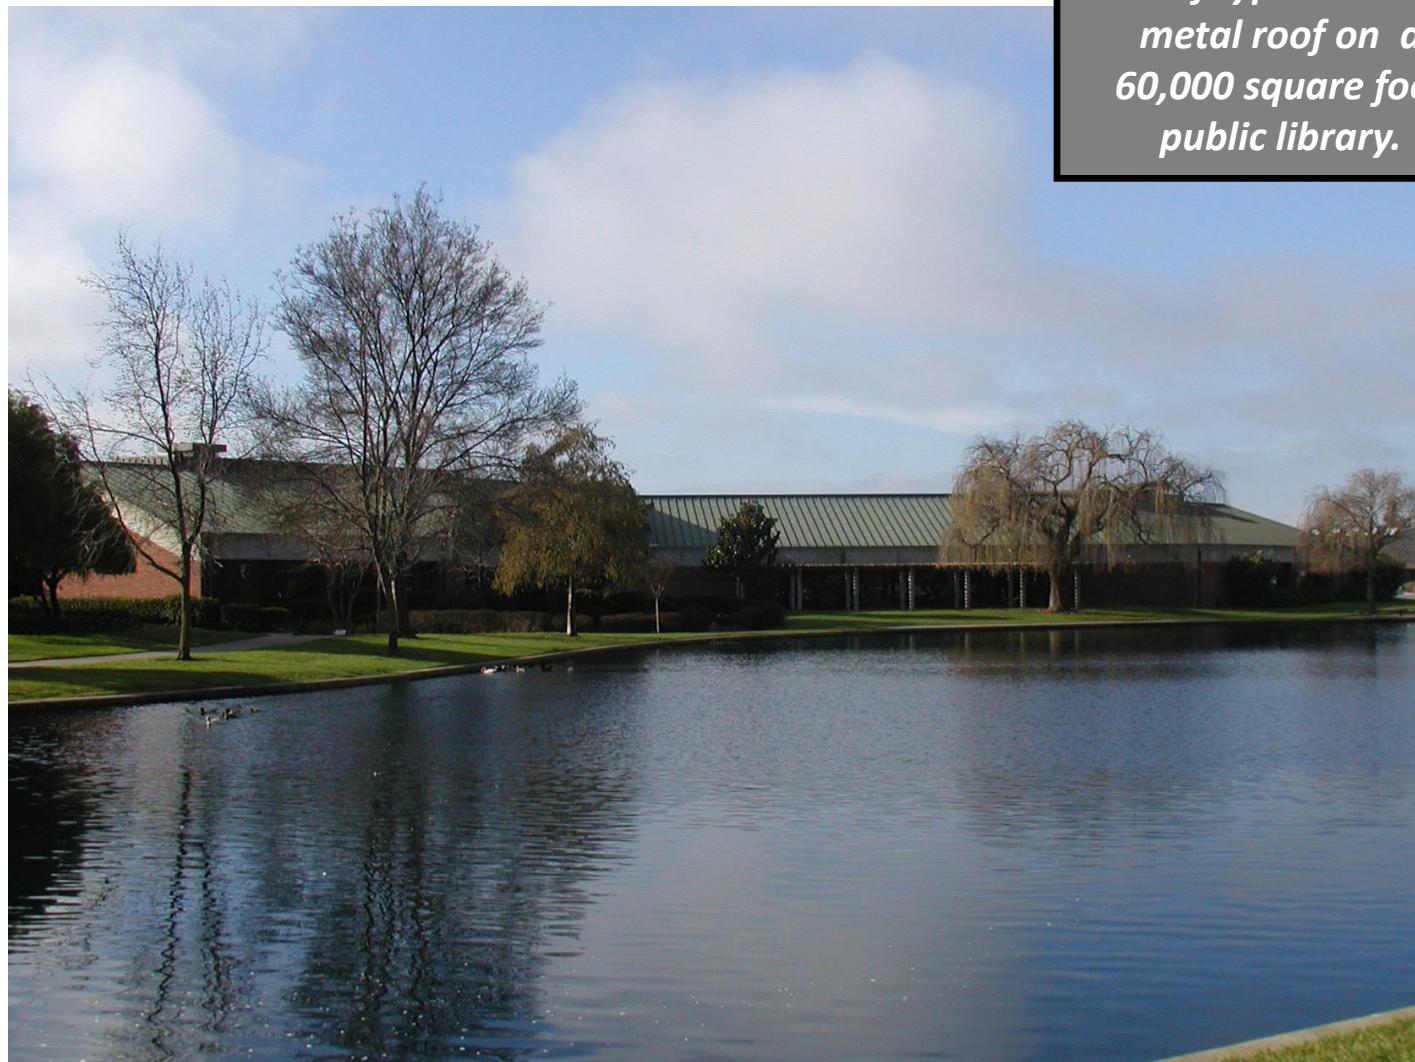
*Roof type: Batten  
metal roof on a  
60,000 square foot  
public library.*

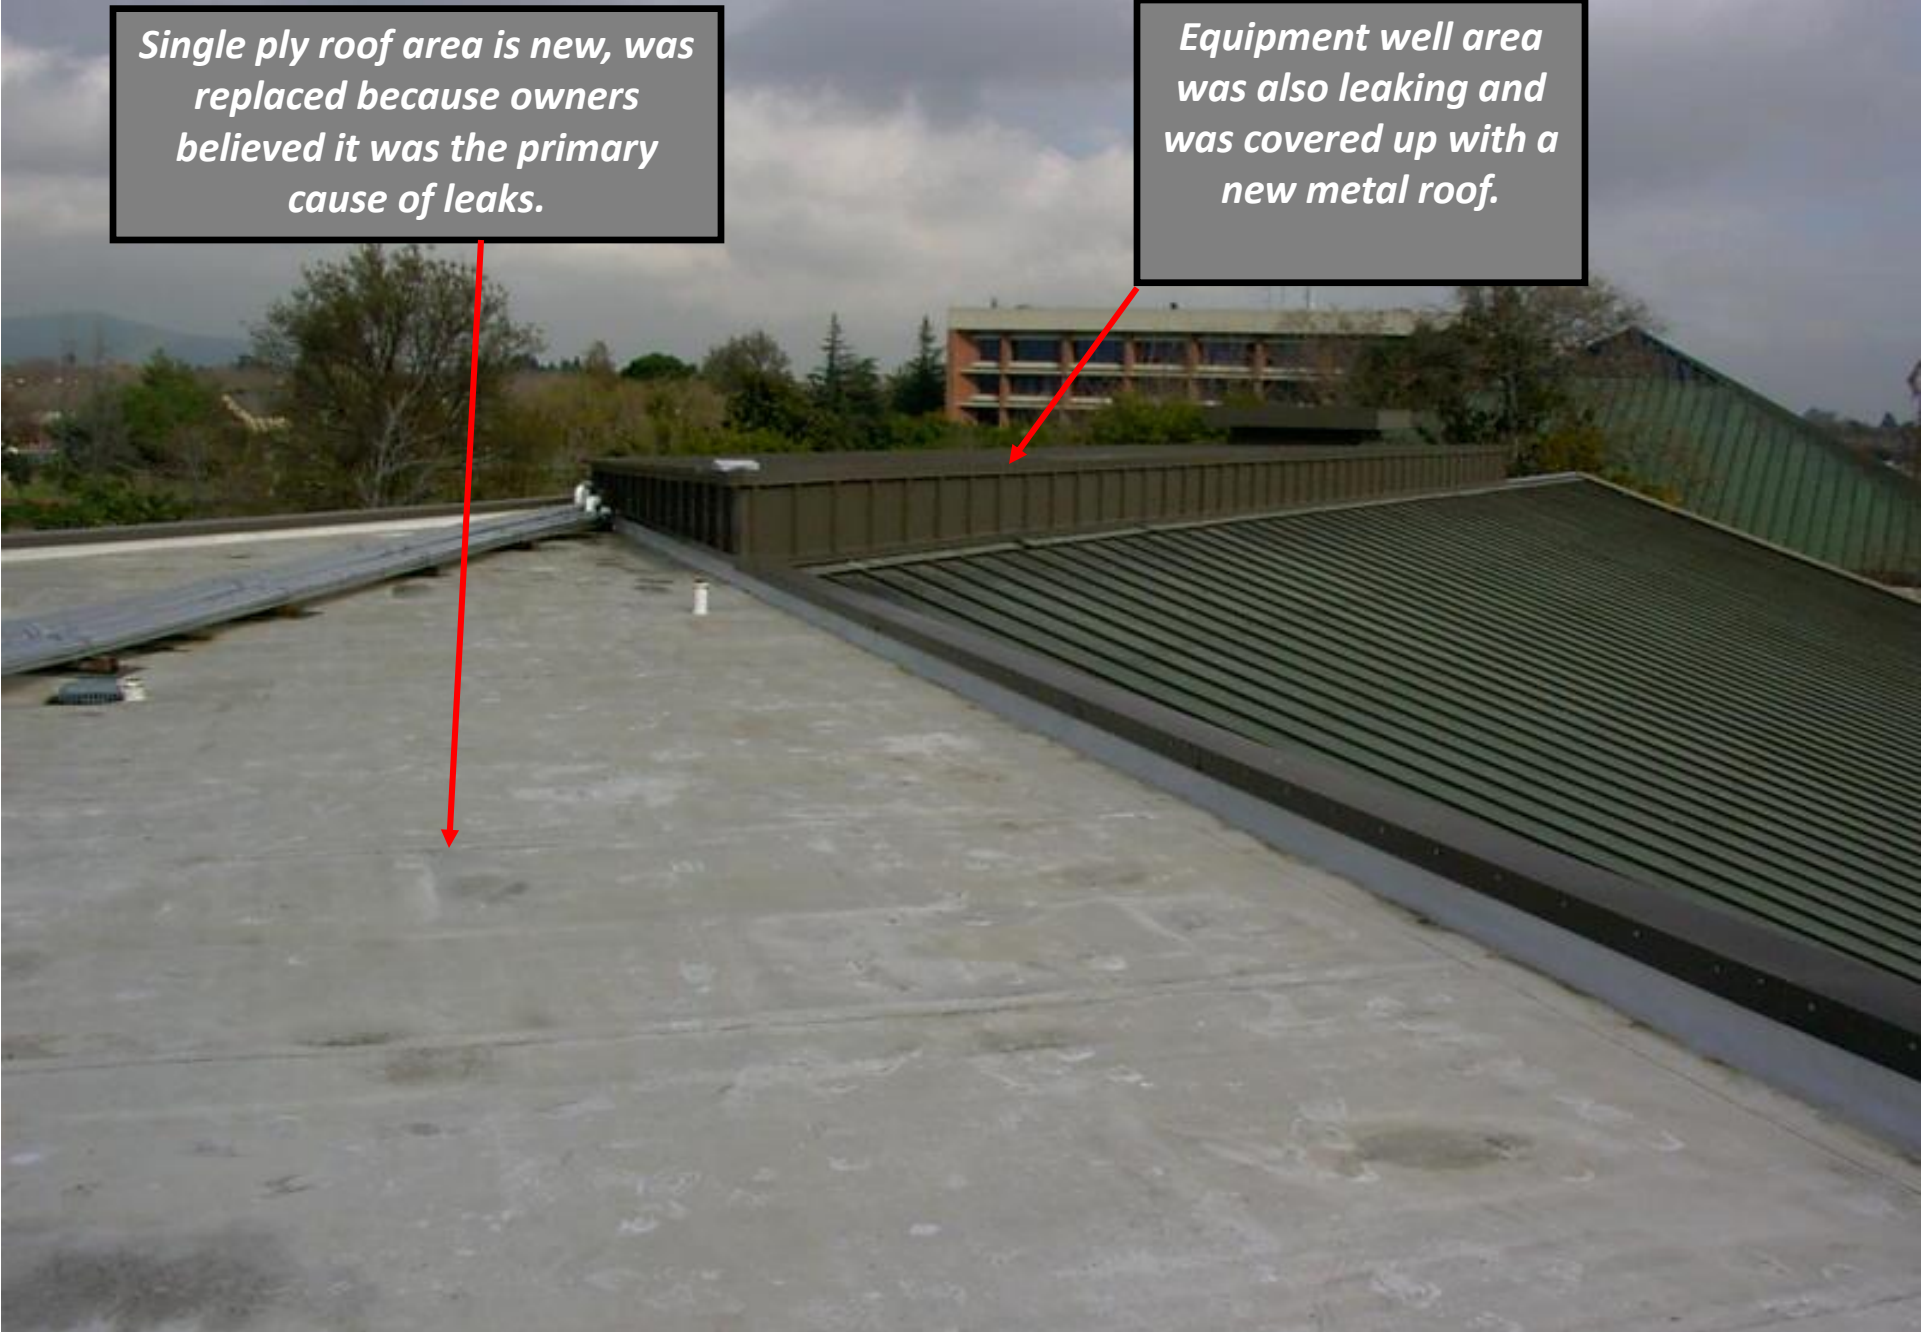
*Single ply roof area is new, was replaced because owners believed it was the primary cause of leaks.*

*Equipment well area was also leaking and was covered up with a new metal roof.*

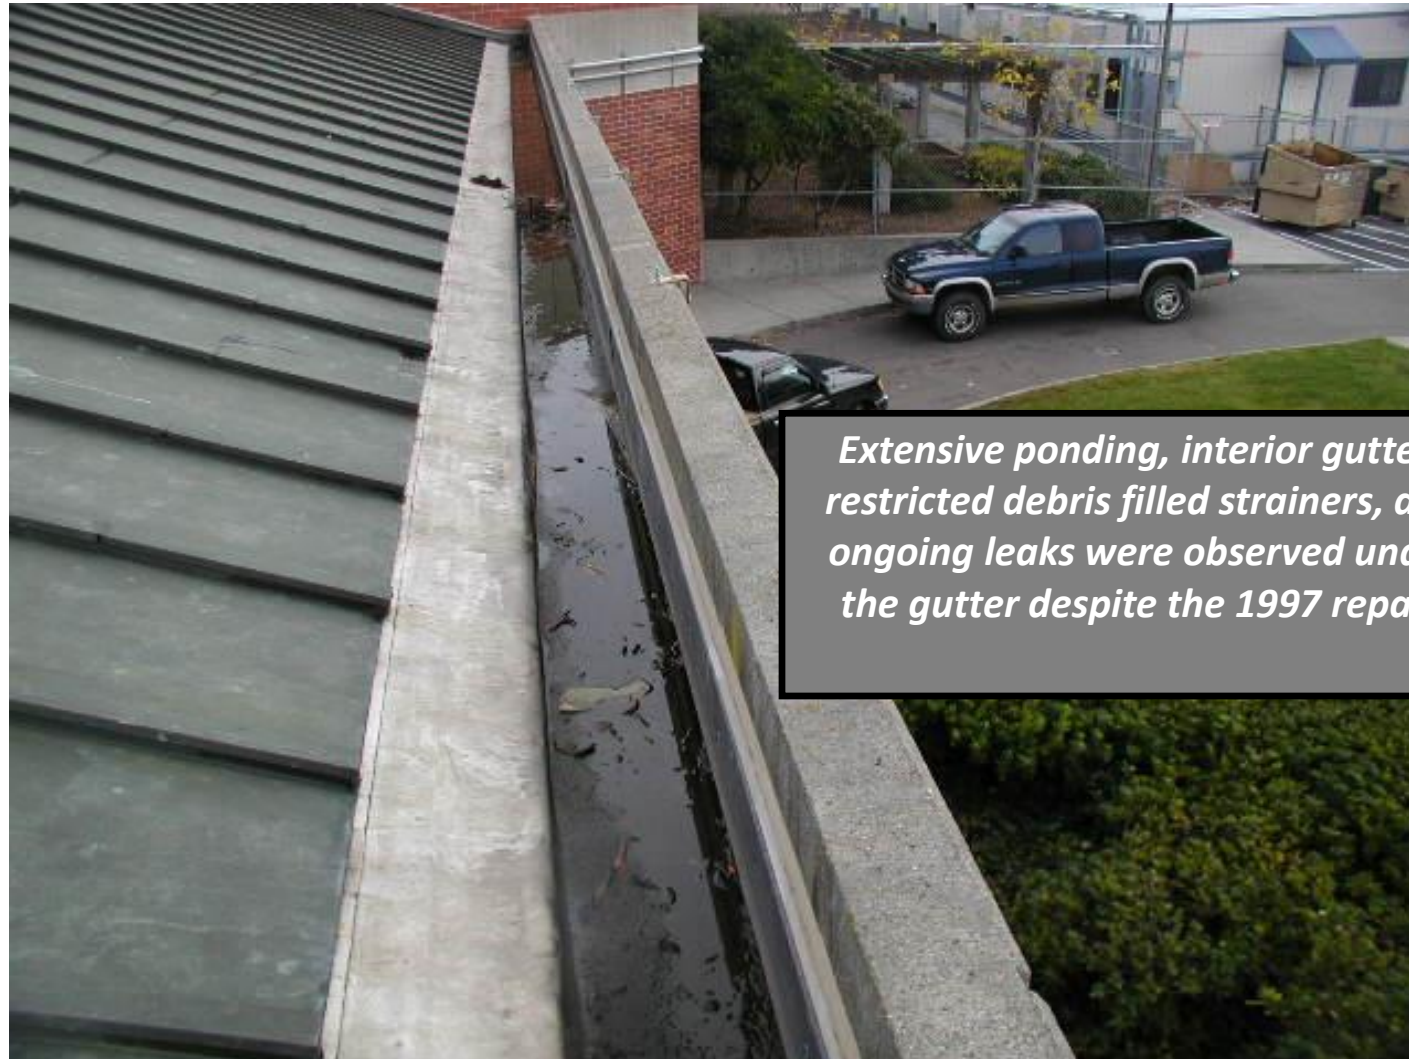
*Extensive ponding, interior gutters restricted debris filled strainers, and ongoing leaks were observed under the gutter despite the 1997 repair.*

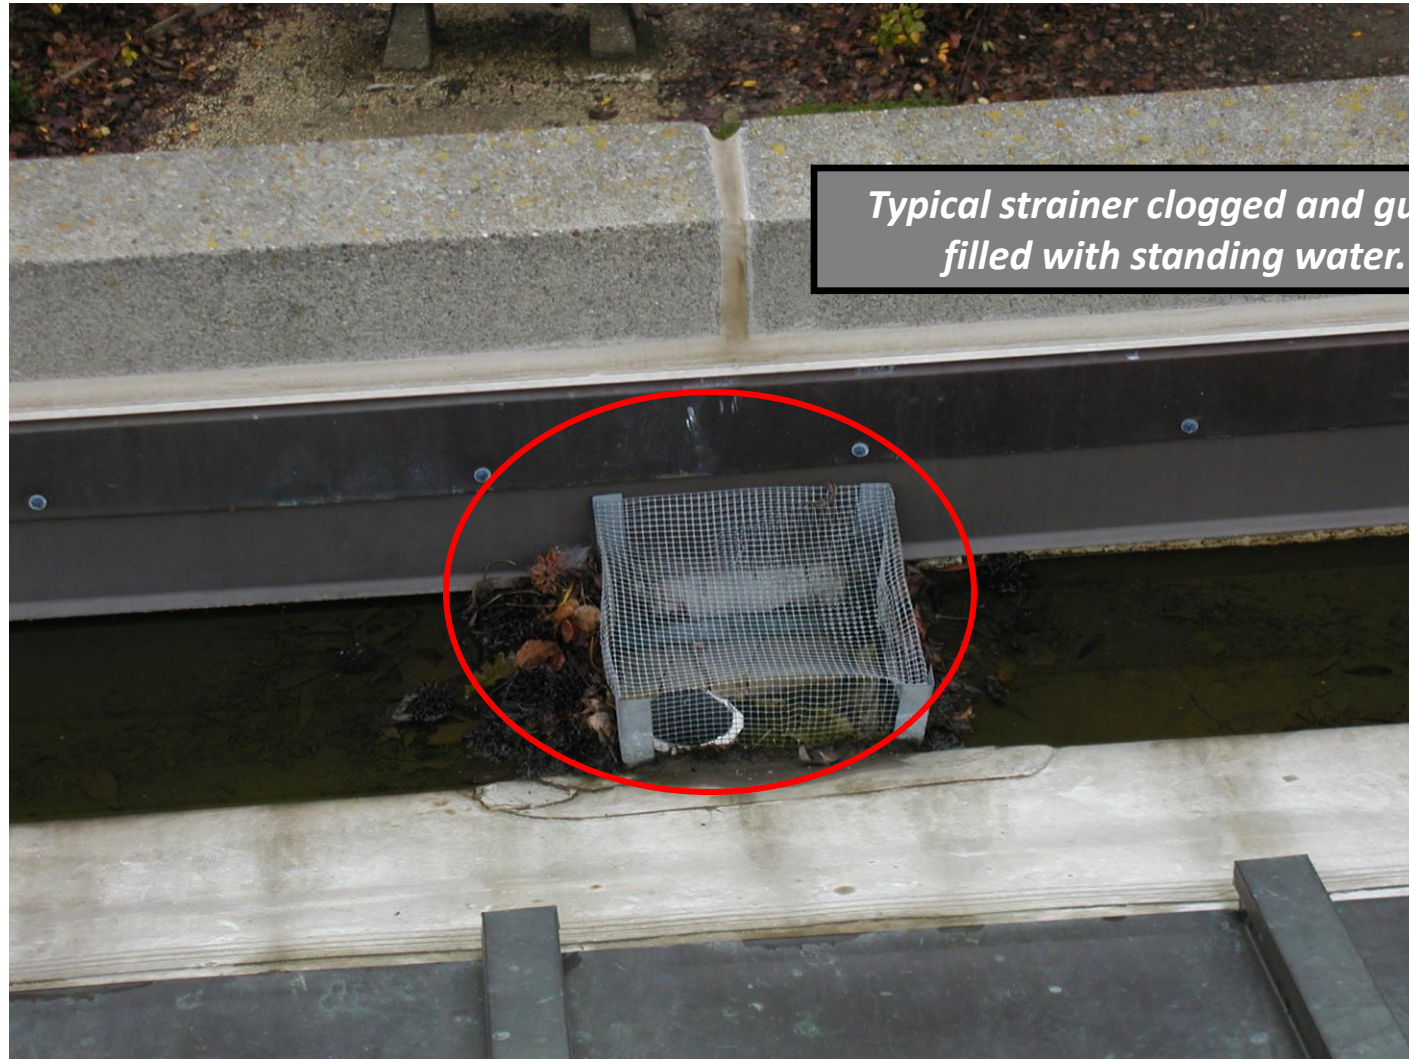
*Typical strainer clogged and gutter filled with standing water.*

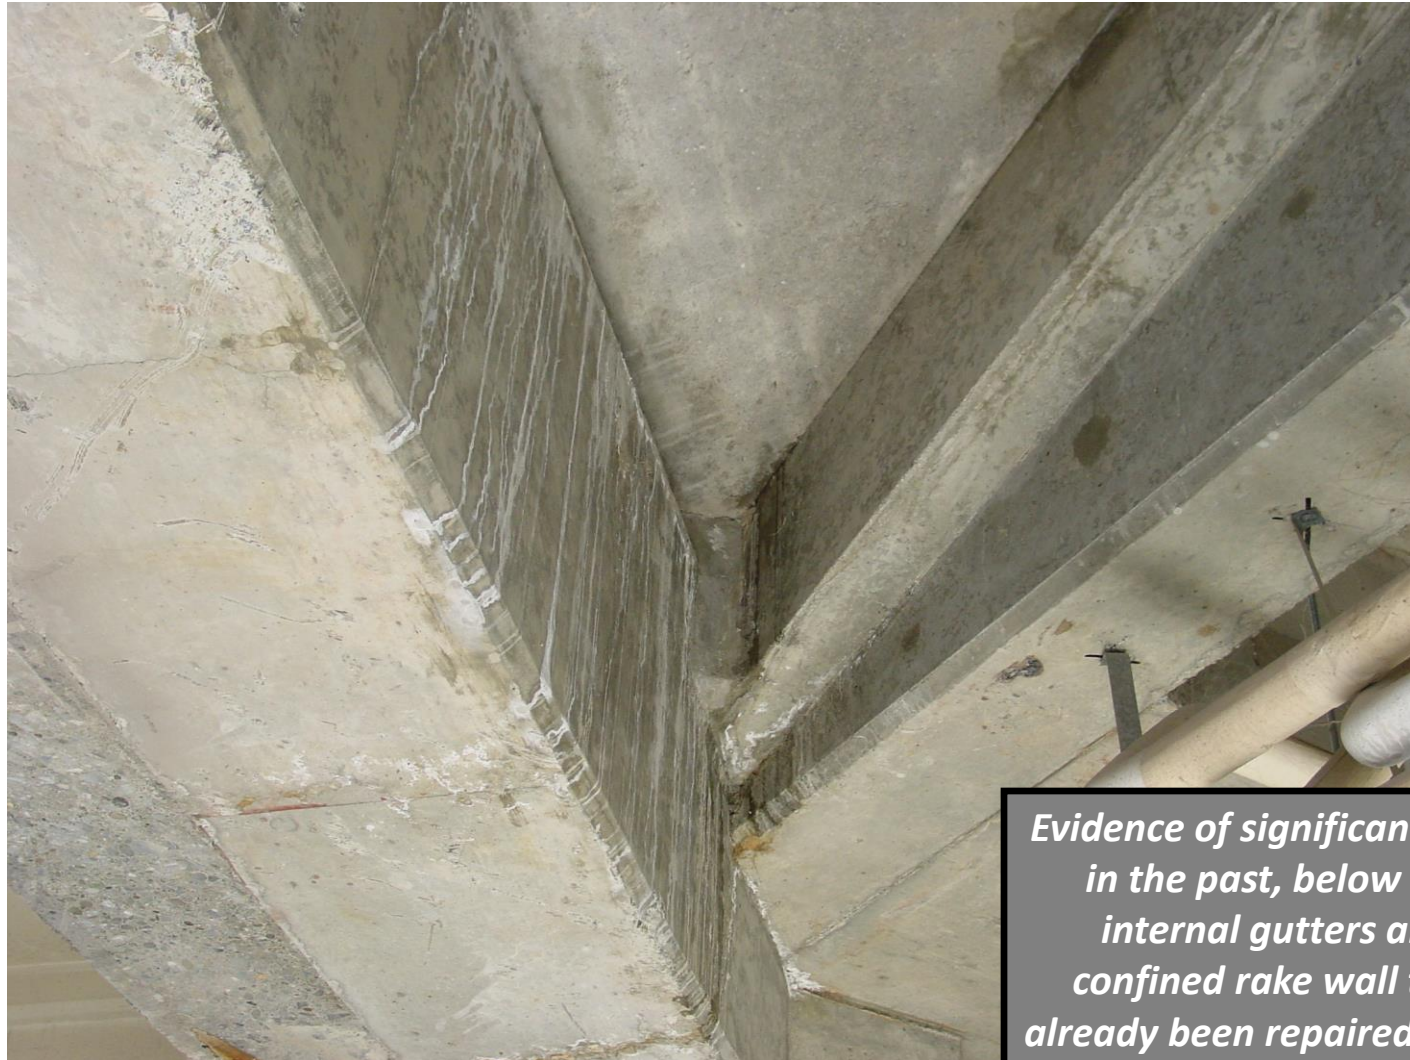
*Evidence of significant leaks in the past, below the internal gutters and confined rake wall that already been repaired, once.*

*Evidence of  
efflorescence through  
CMU wall with brick  
veneer.*

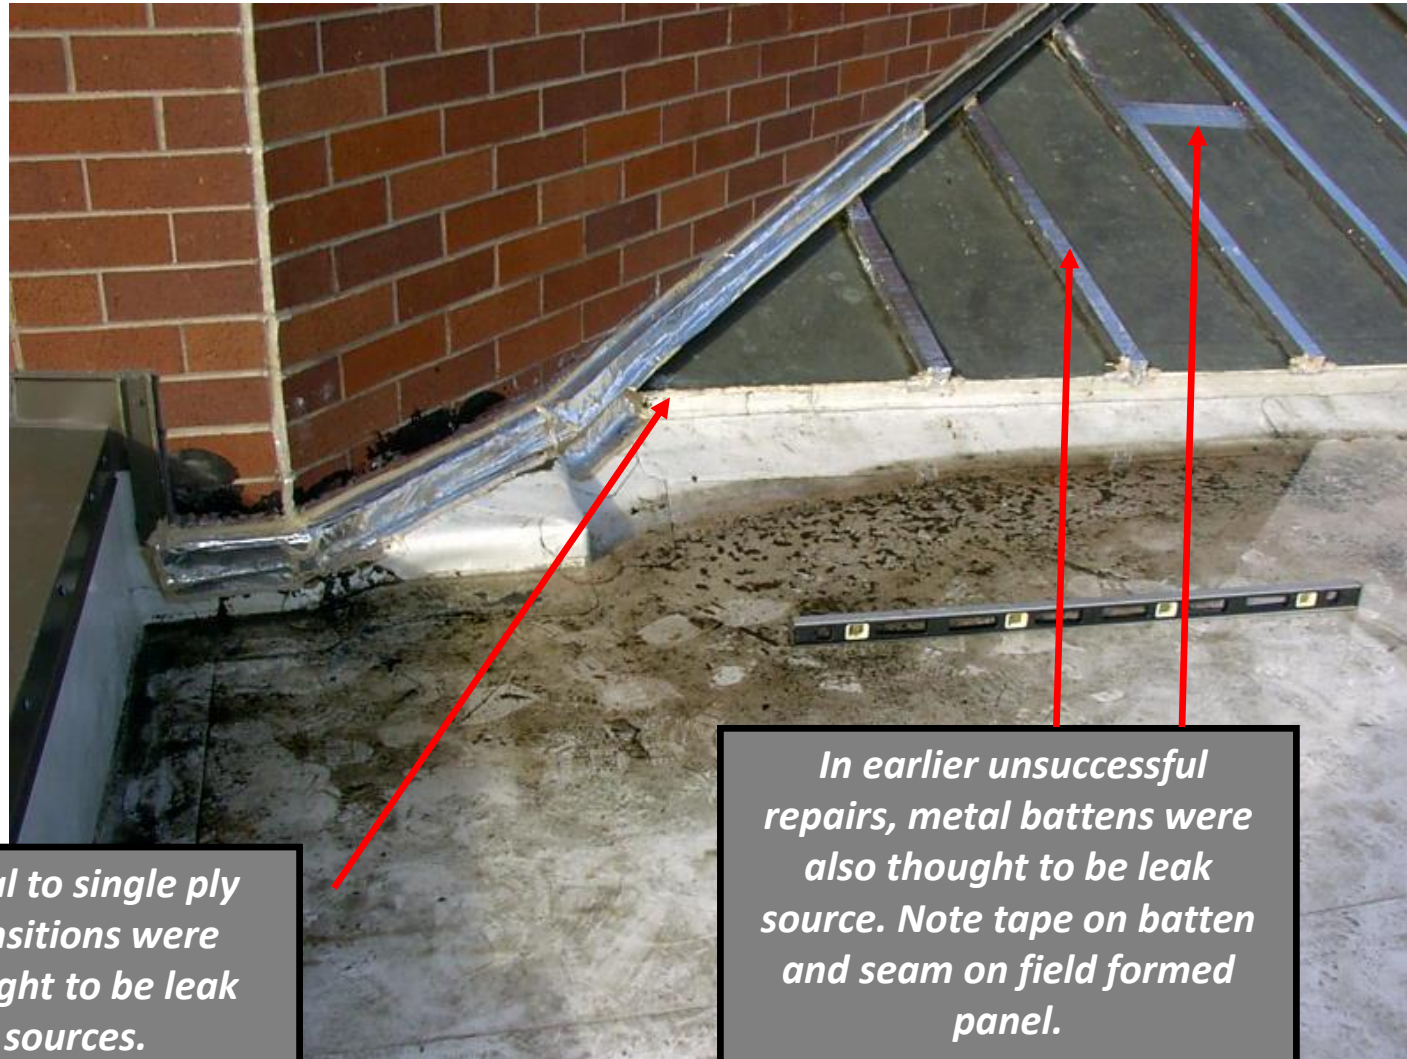
*Metal to single ply transitions were thought to be leak sources.*

*In earlier unsuccessful repairs, metal battens were also thought to be leak source. Note tape on batten and seam on field formed panel.*

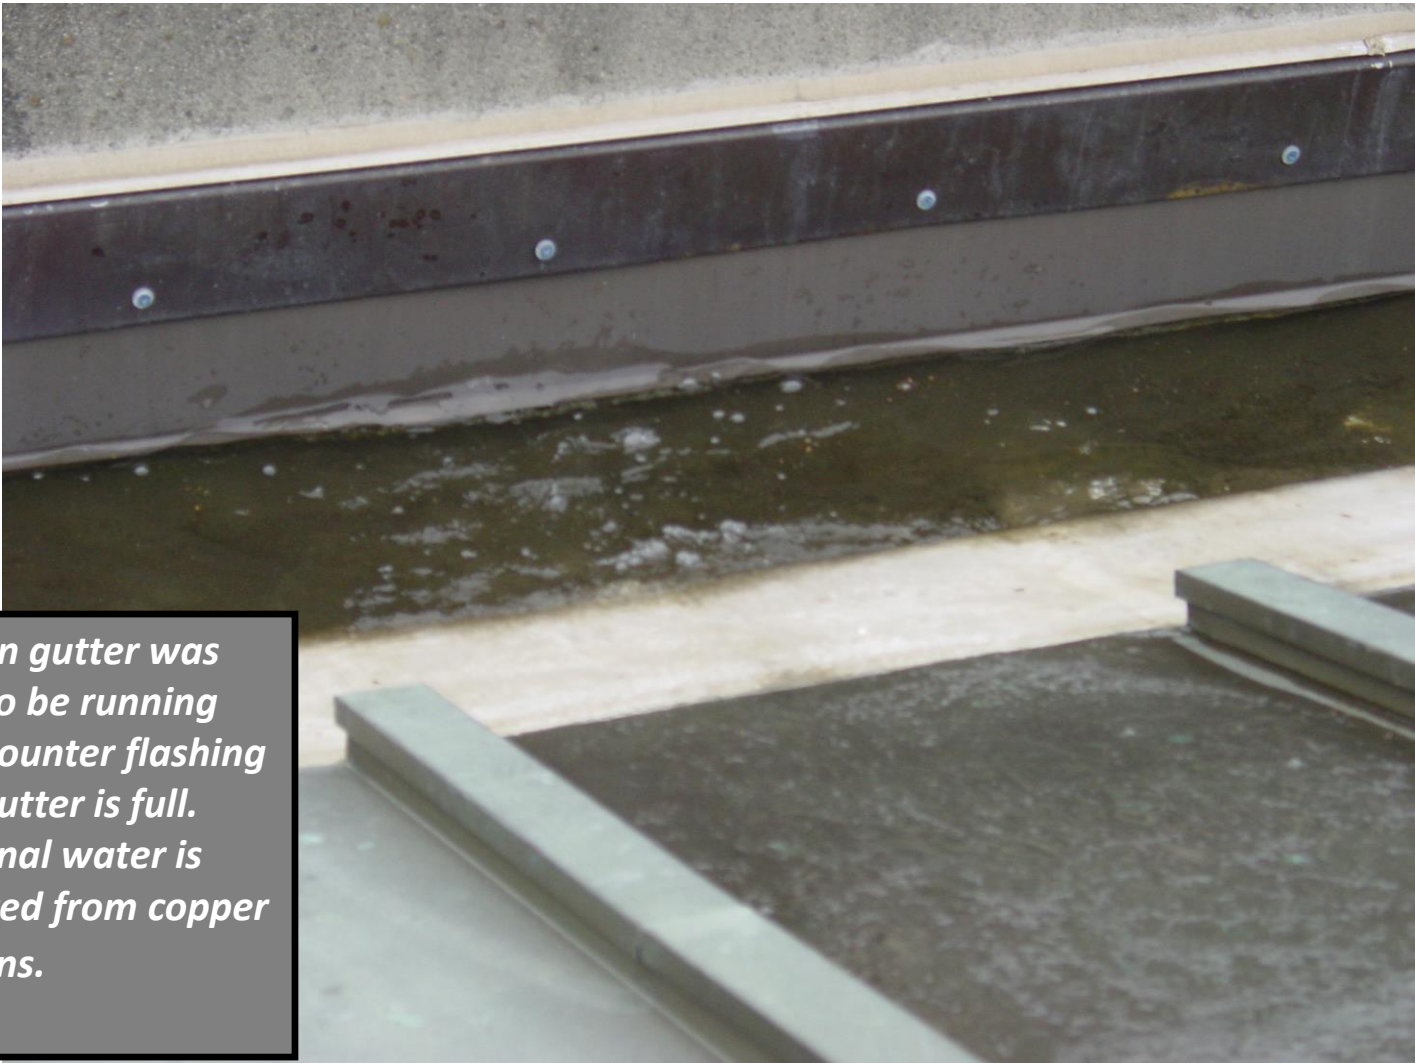
*Water in gutter was found to be running under counter flashing when gutter is full. Additional water is presented from copper roof pans.*

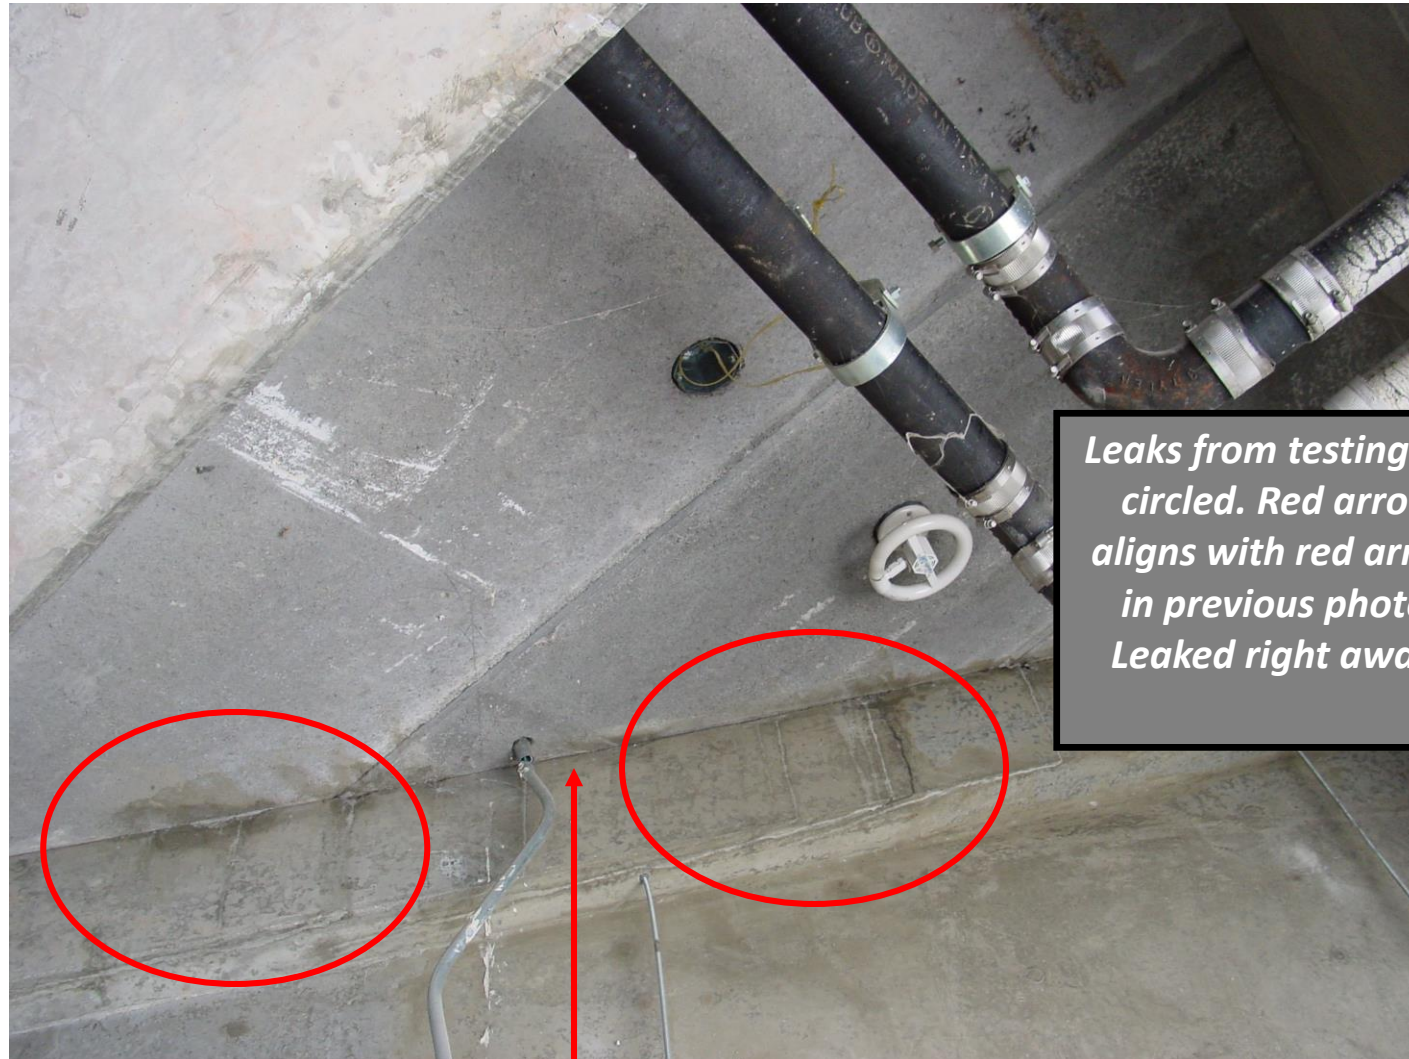
*Leaks from testing are circled. Red arrow aligns with red arrow in previous photo. Leaked right away!*

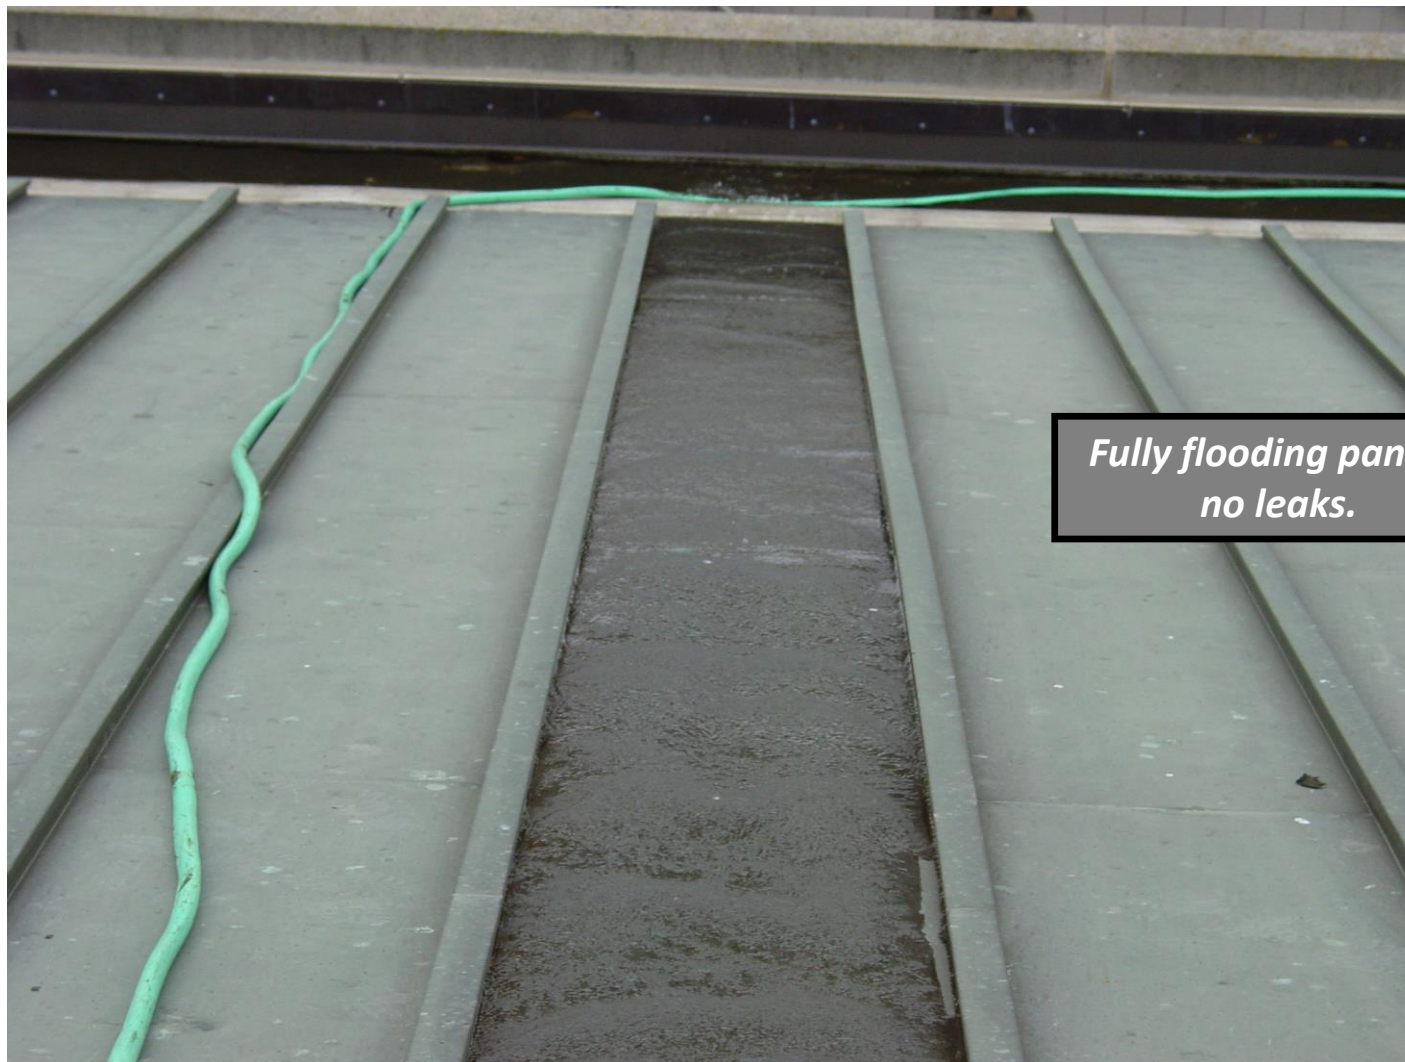
*Fully flooding panel –  
no leaks.*
