# Roofs Can Last In Excess of 30 Years But Most Do Not

January 24, 2006

Honolulu, Hawai'i

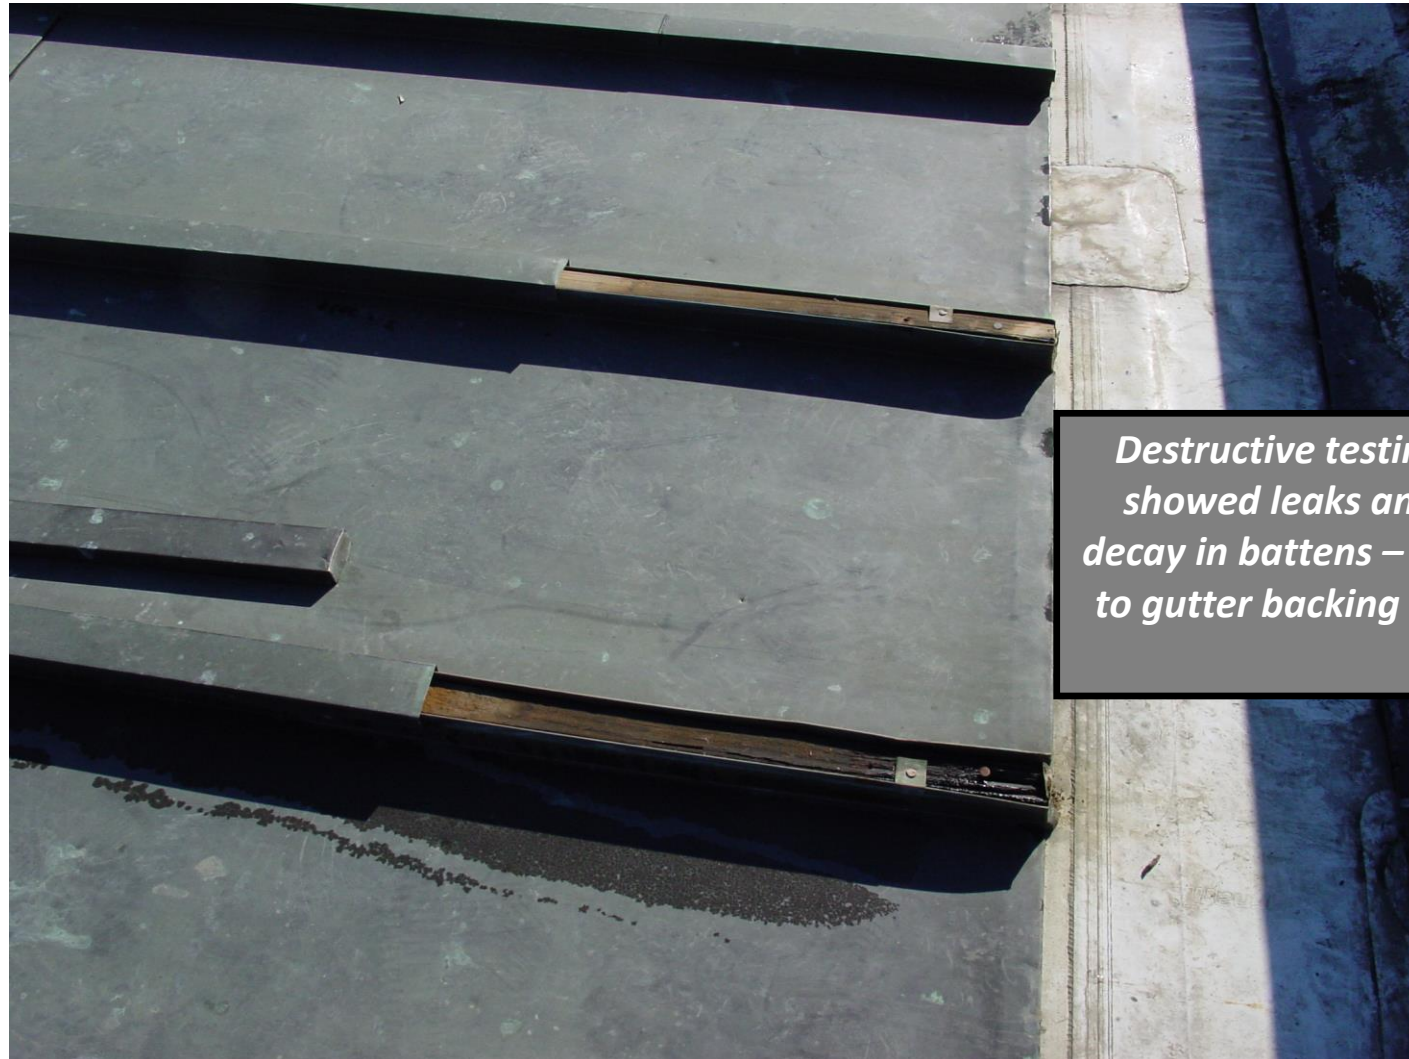
*Destructive testing  
showed leaks and  
decay in battens – due  
to gutter backing up.*

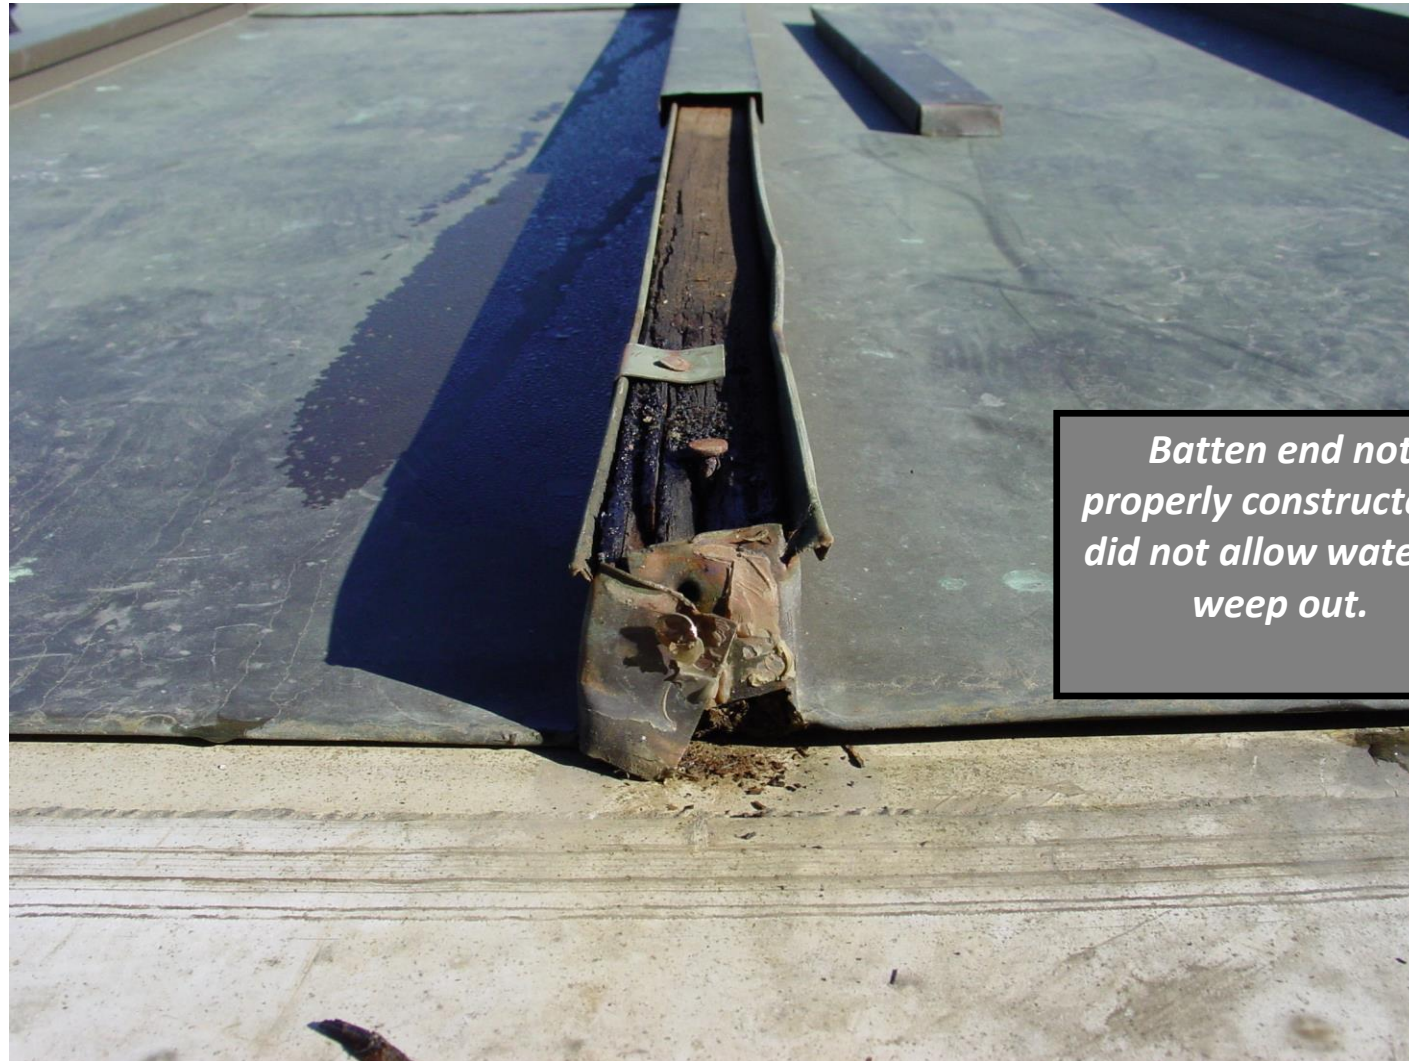
*Batten end not properly constructed – did not allow water to weep out.*
