Waterproofing is Not Skin Deep
Karim P. Allana, P.E., RRC, RWC
President, Allana Buick & Bers, Inc.

Case Study # 1, EIFS Bull Nose, Pleasanton CA

Waterproofing Is Not Skin Deep

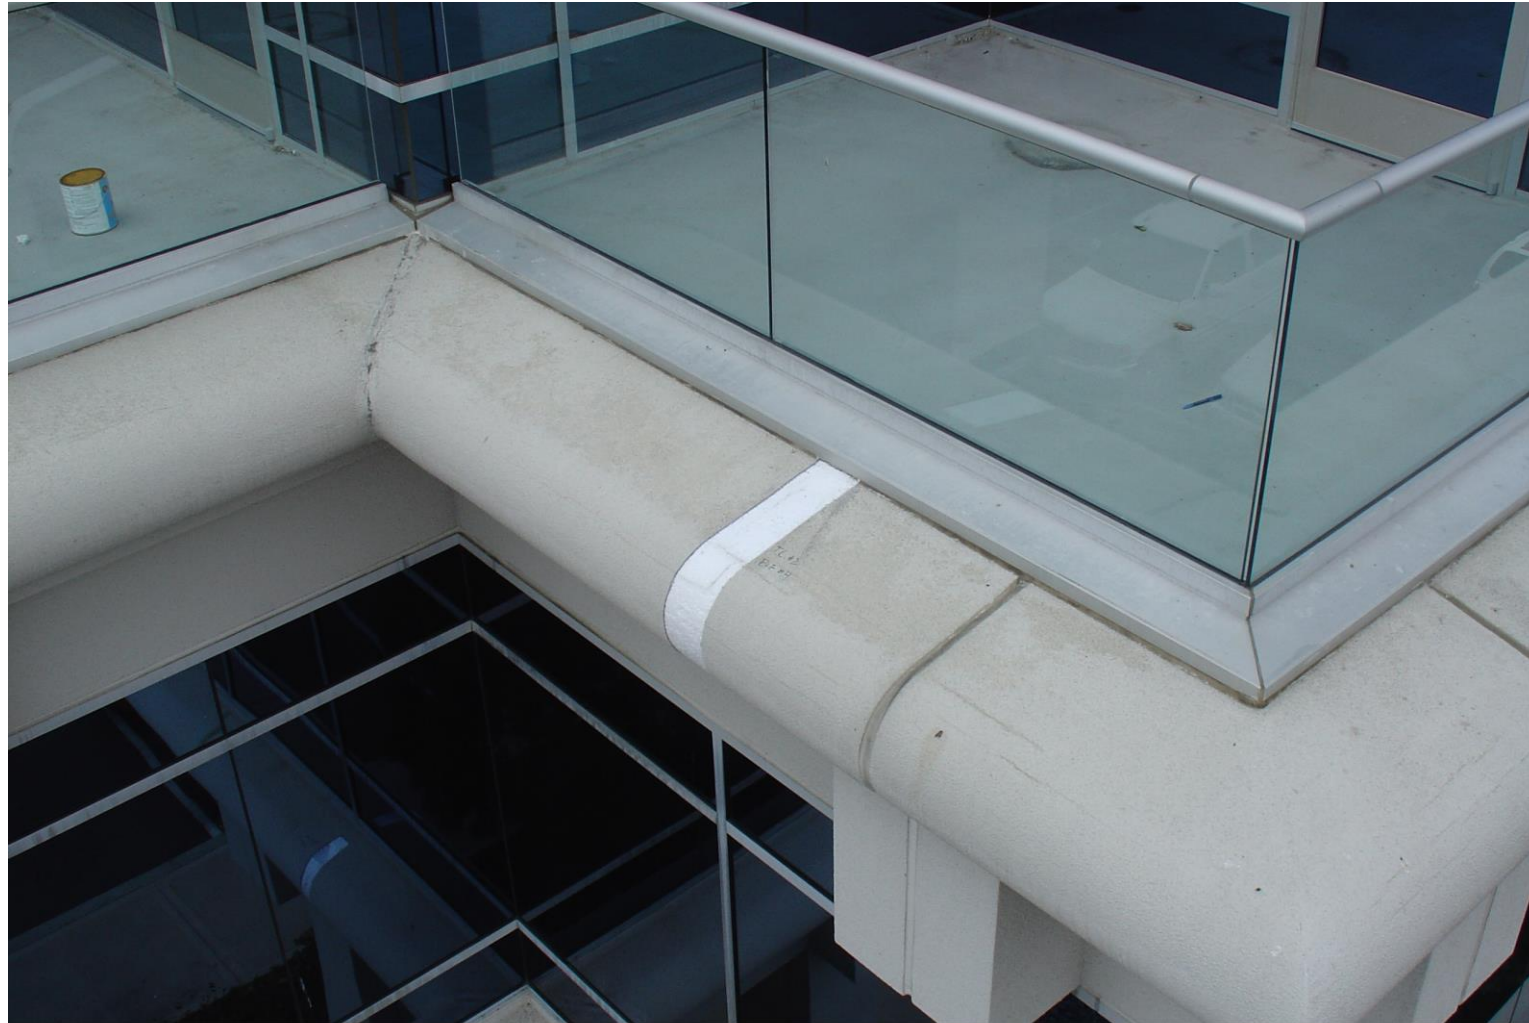
CHA-AL04351

Typical Crack in EIFS Bull Nose

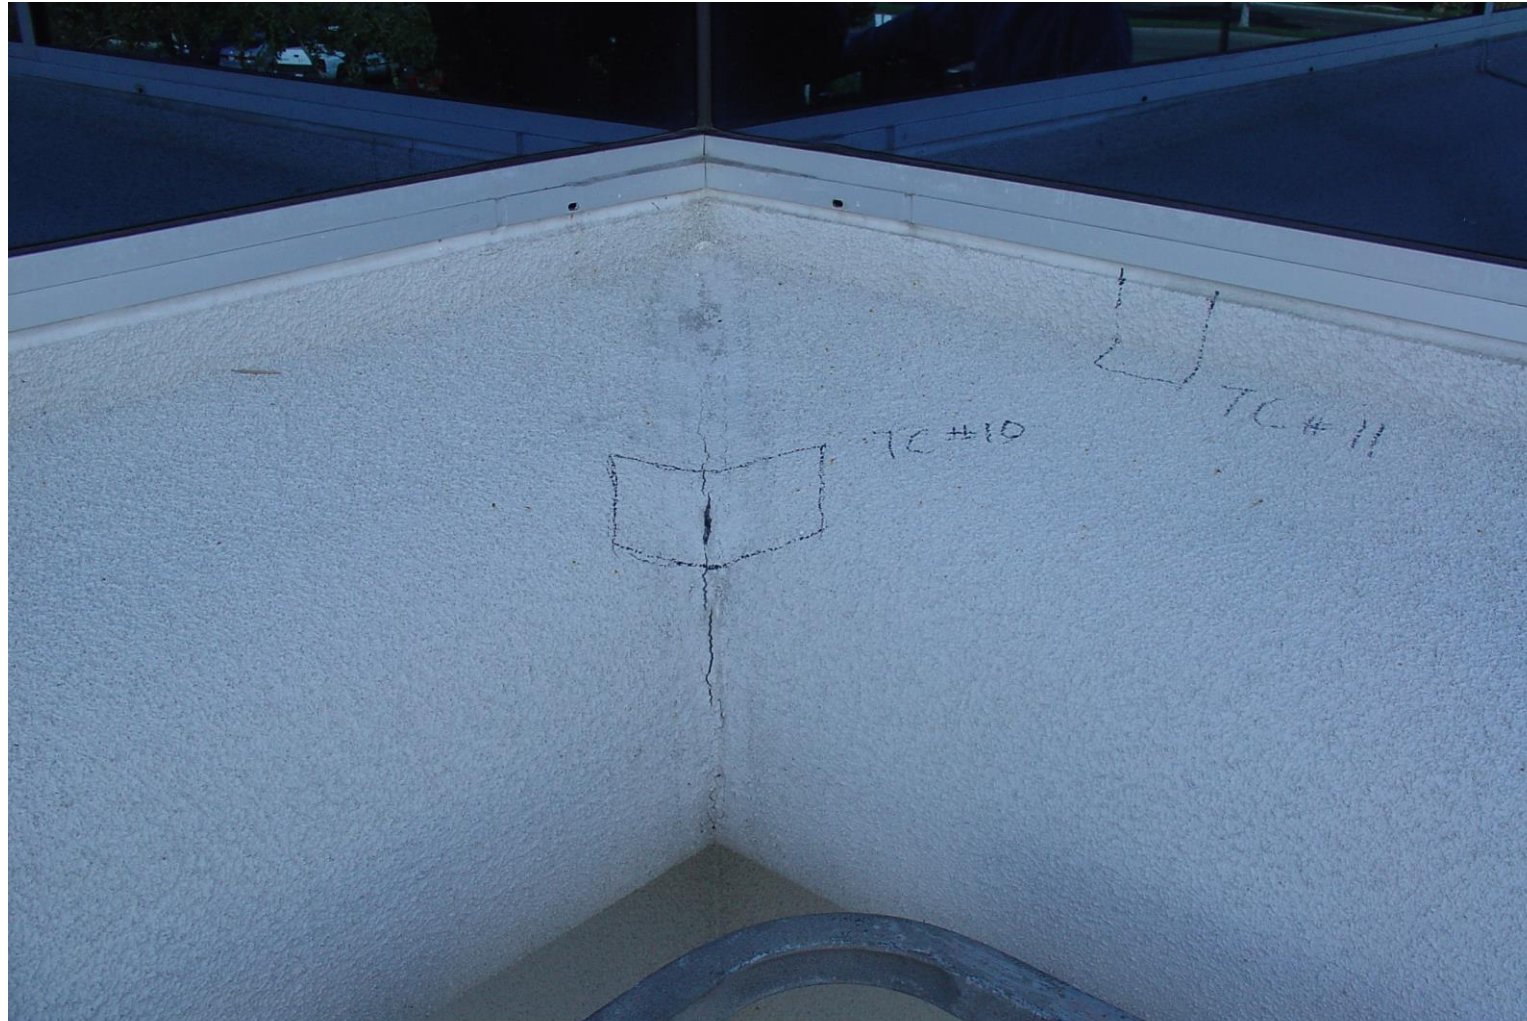
CHA-AL04435

Vertical Crack at inside Corner

DEFECT: Lack of expansion joint at inside corners

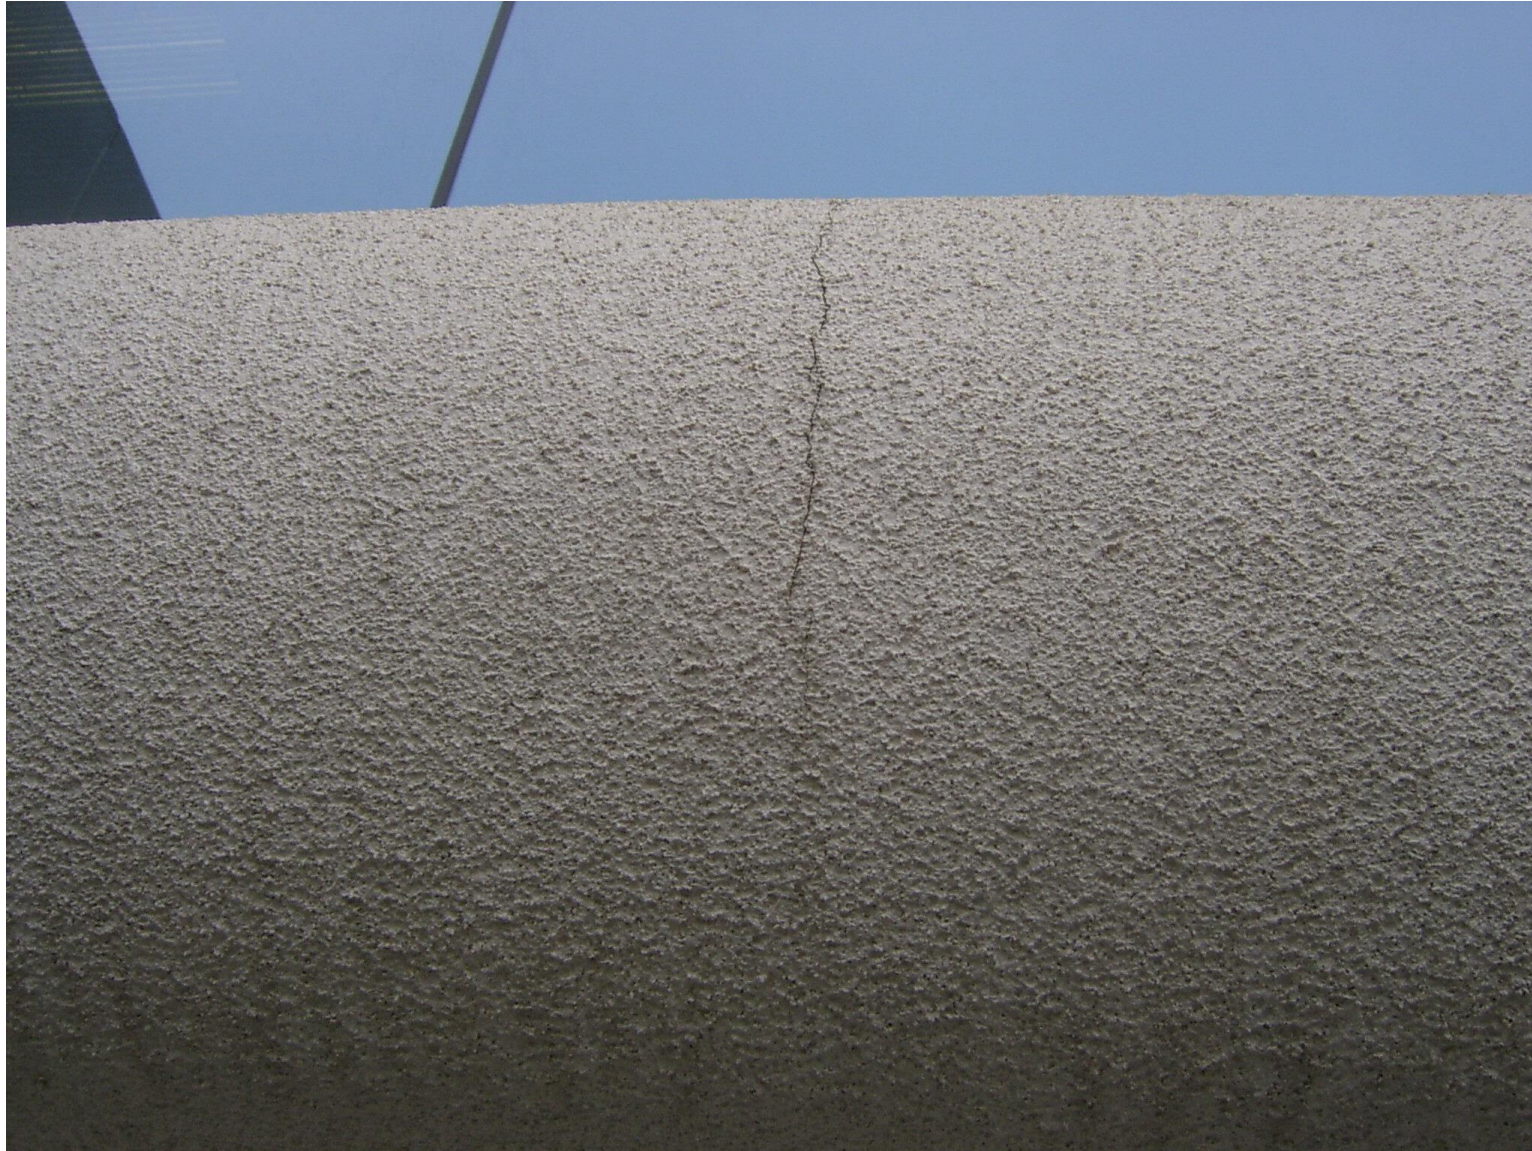
CHA-AL03186

Vertical Crack in the Field

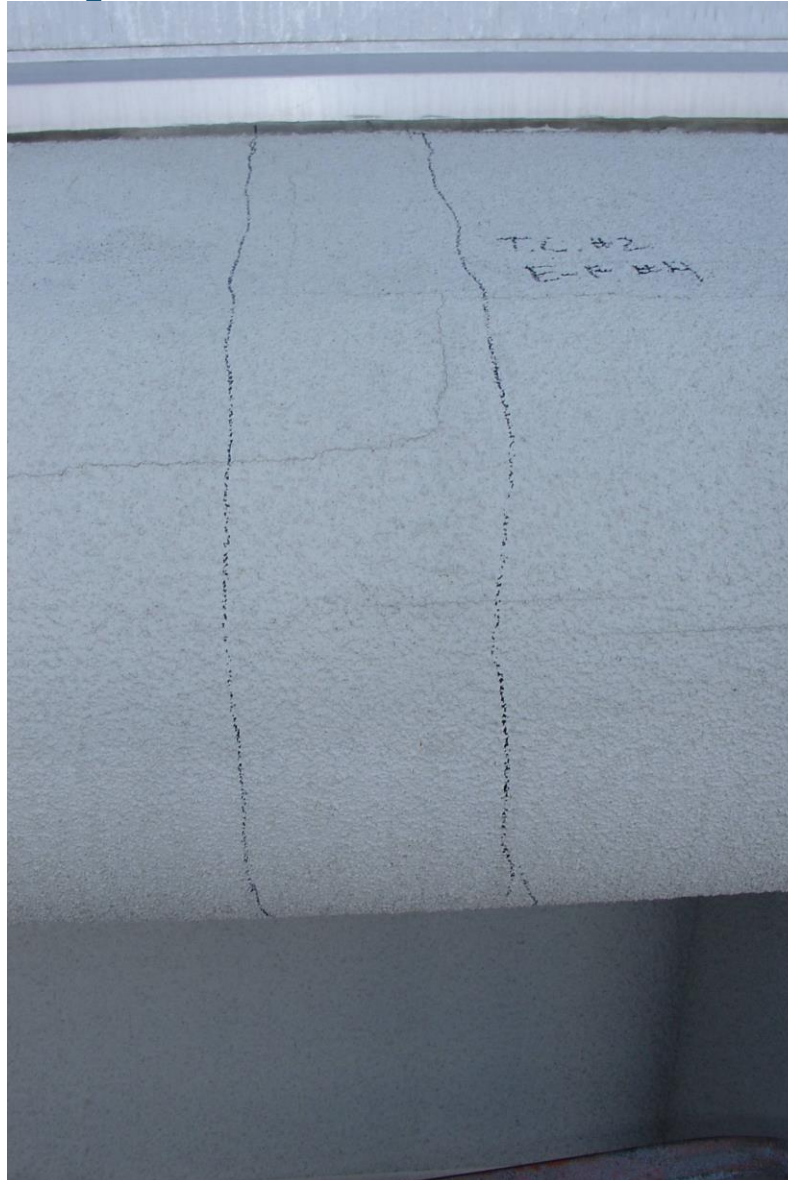
CHA-AL04314

Multiple Cracks, horizontal and vertical

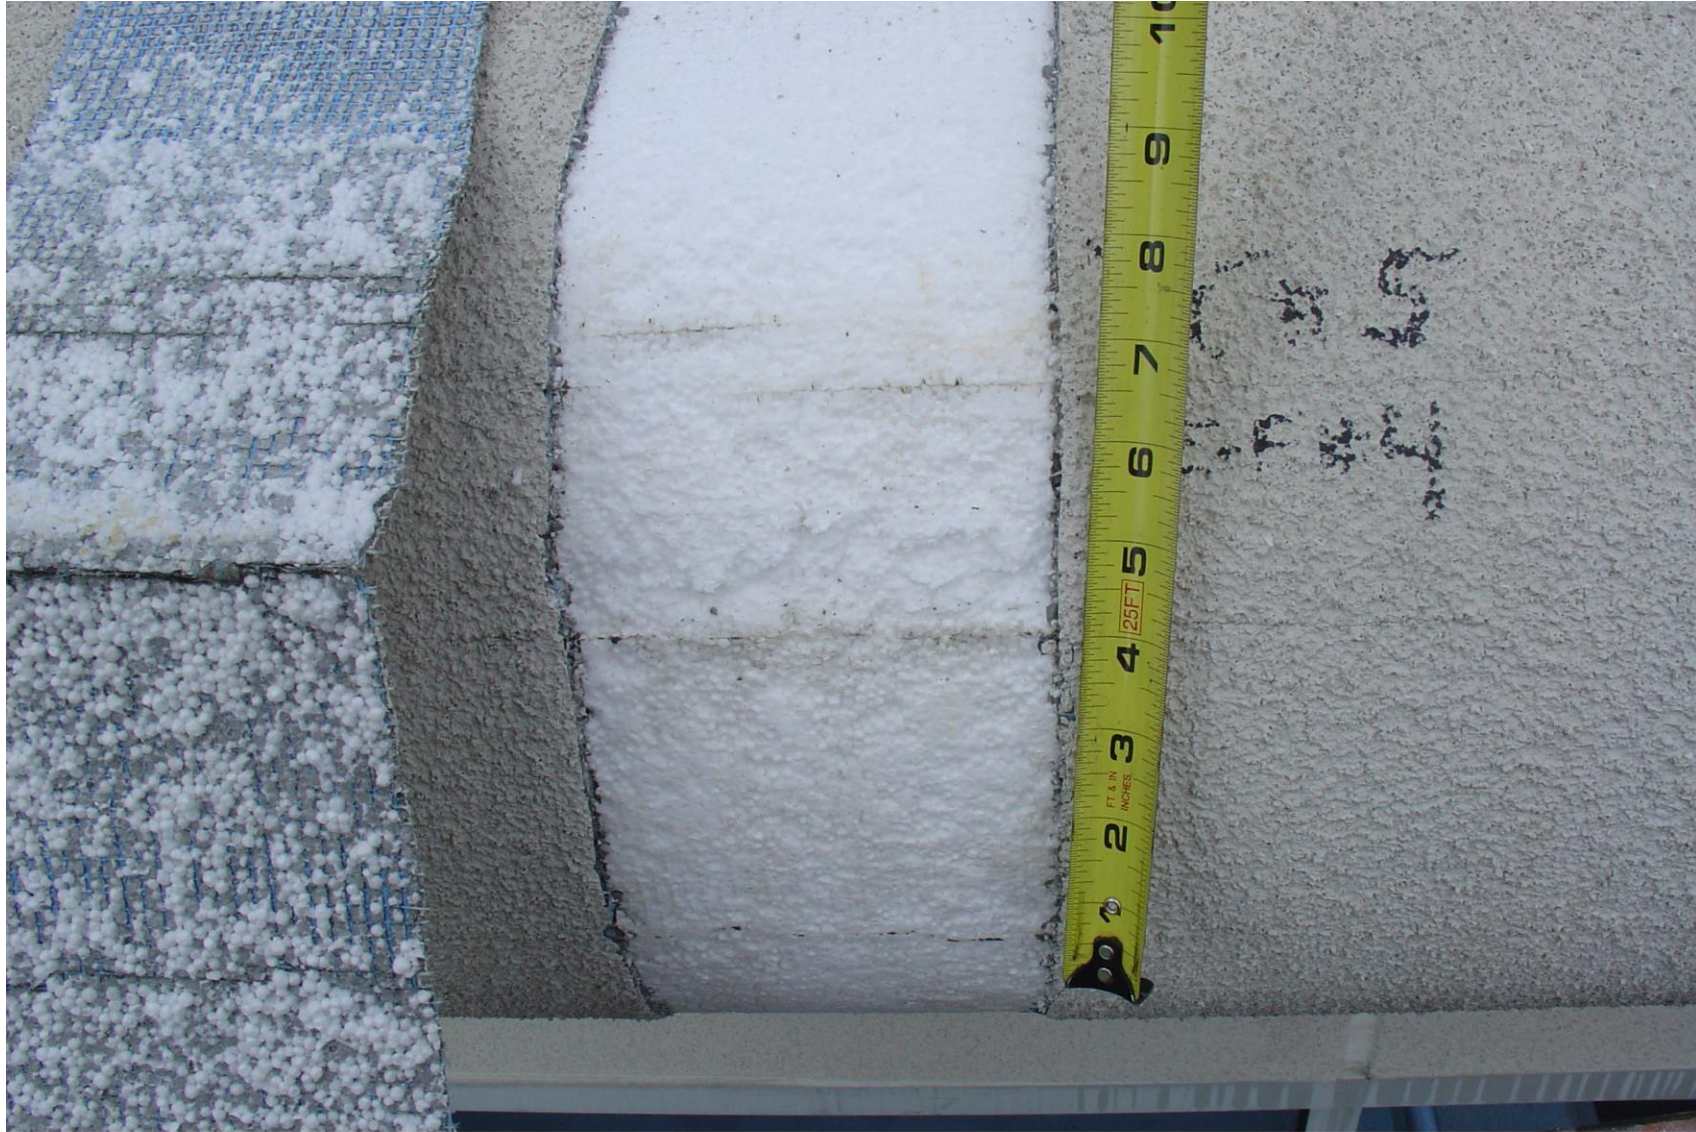
Typical Horizontal Crack Pattern

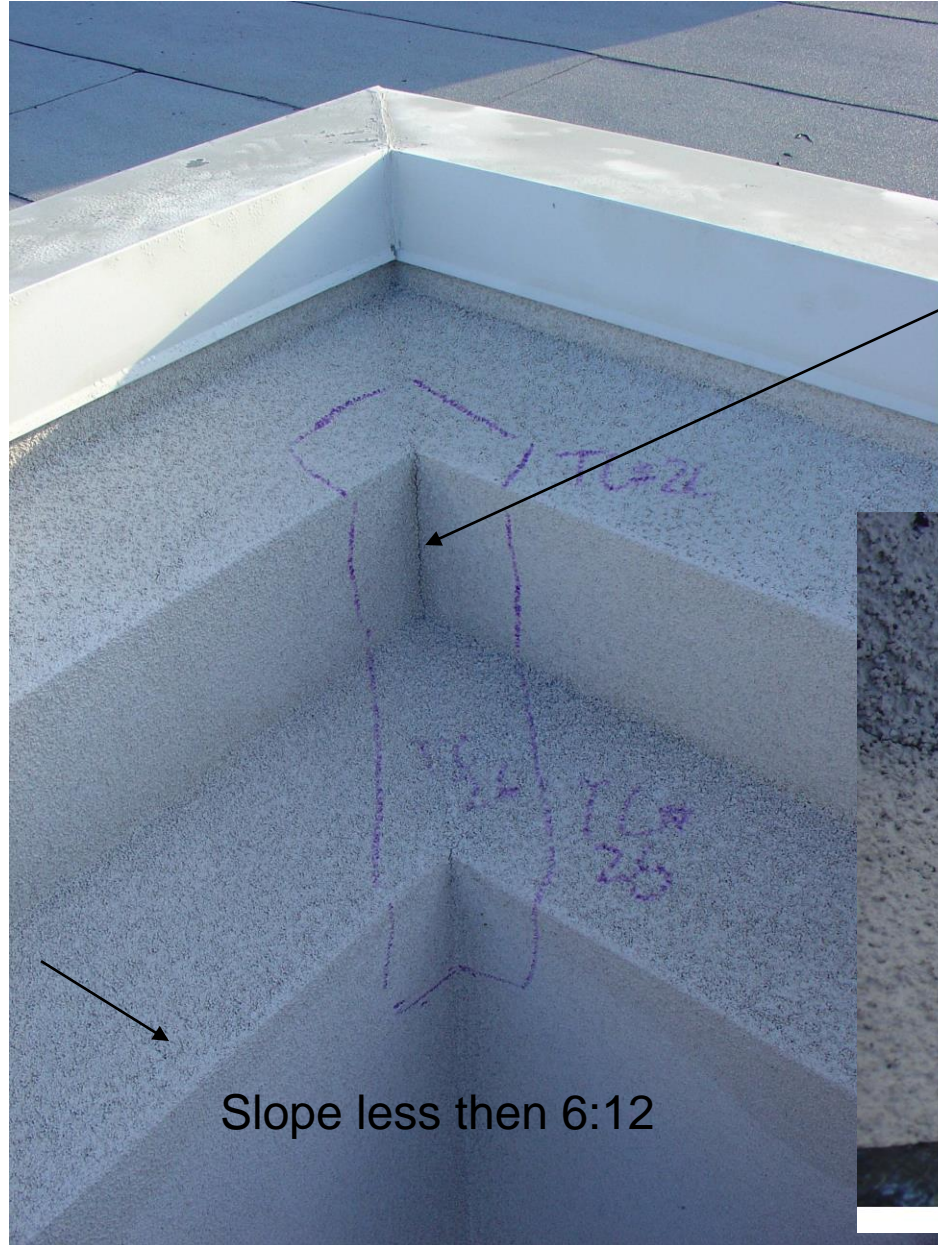
CHA-AL04472

Cracks at Parapet Wall; Lack of Slope

Cracks and splits are caused due to lack for extra reinforcing mesh

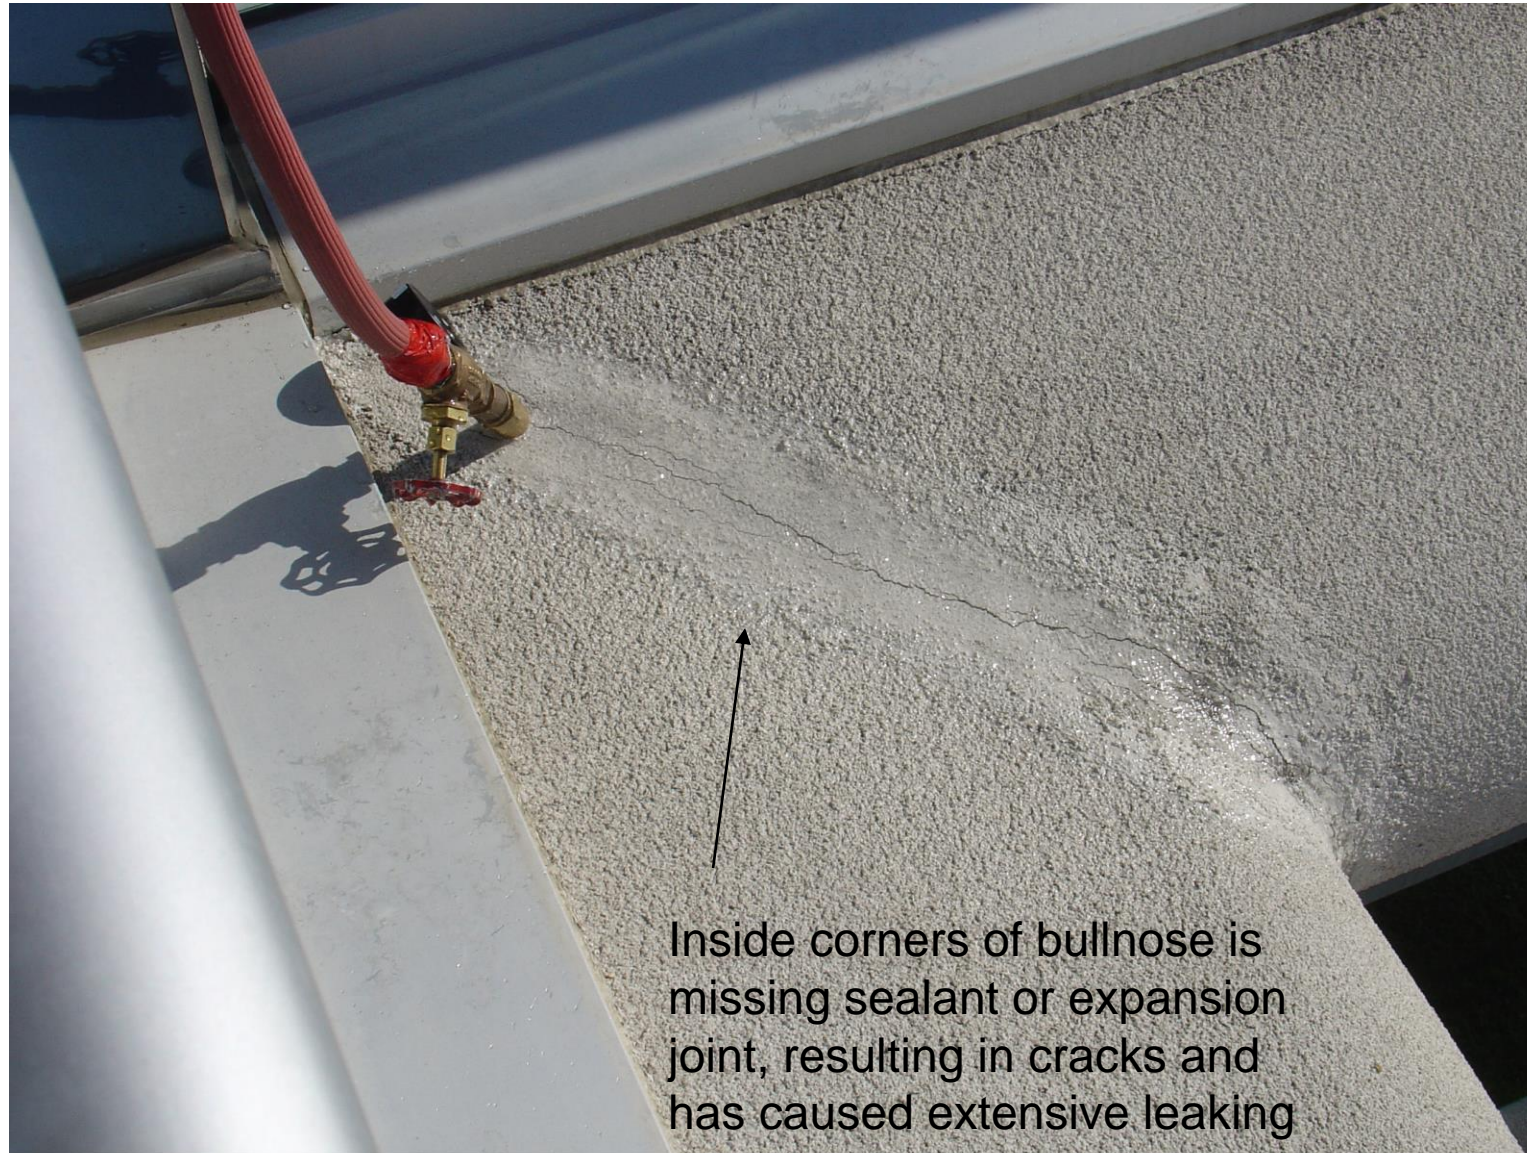
CHA-AL05487

Cracks and leaks at Inside Corner of bull nose

Leak Test Location #4 – Southeast Elevation – above 2nd floor

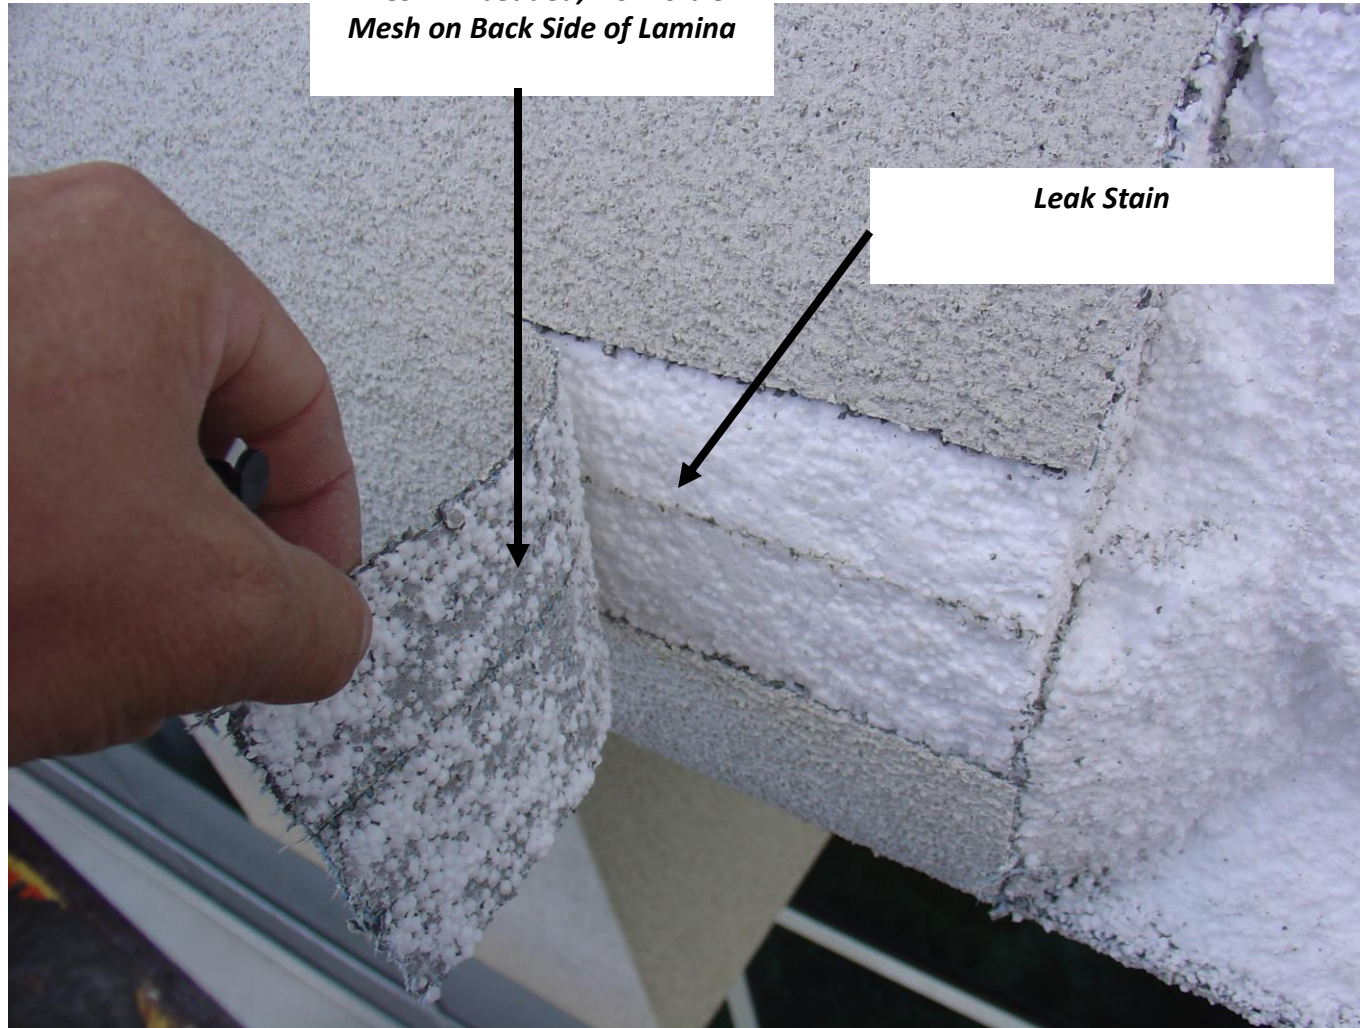
CHA-AL05272

Test Cut #2– East Elevation – 3rd floor line EIFS Bullnose

*Mesh Embedded, No Visible
Mesh on Back Side of Lamina*

Leak Stain

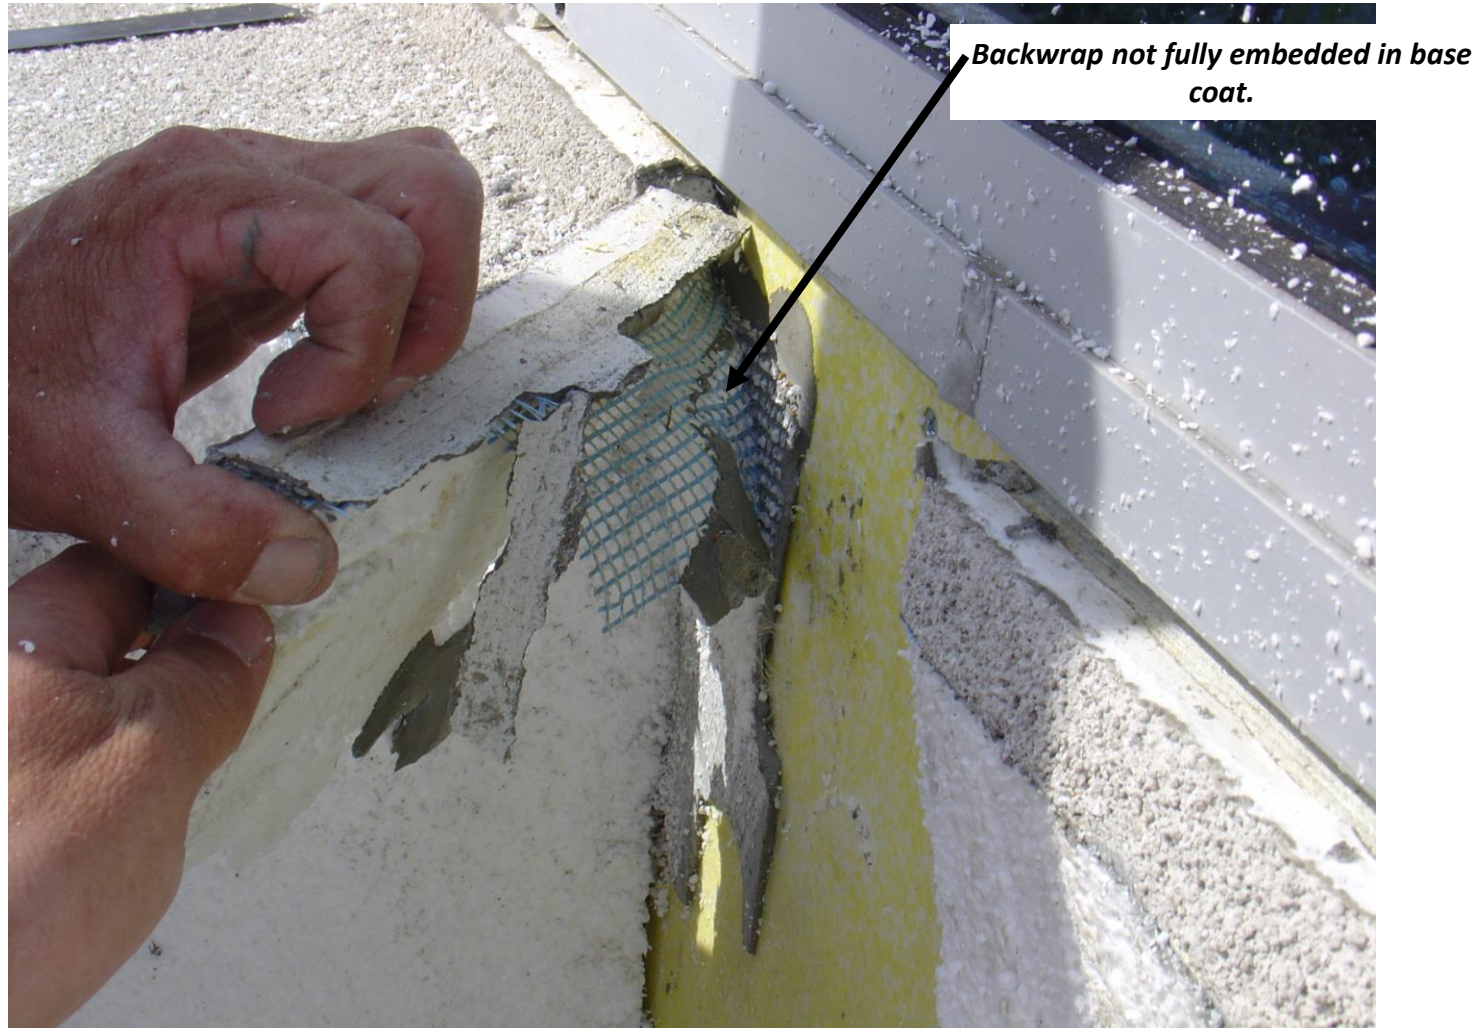
CHA-AL05207

EIFS Defect: Lamina is not backwrapped

Test Cut #3– East Elevation – 4th floor line EIFS Bullnose. Required by Dryvit

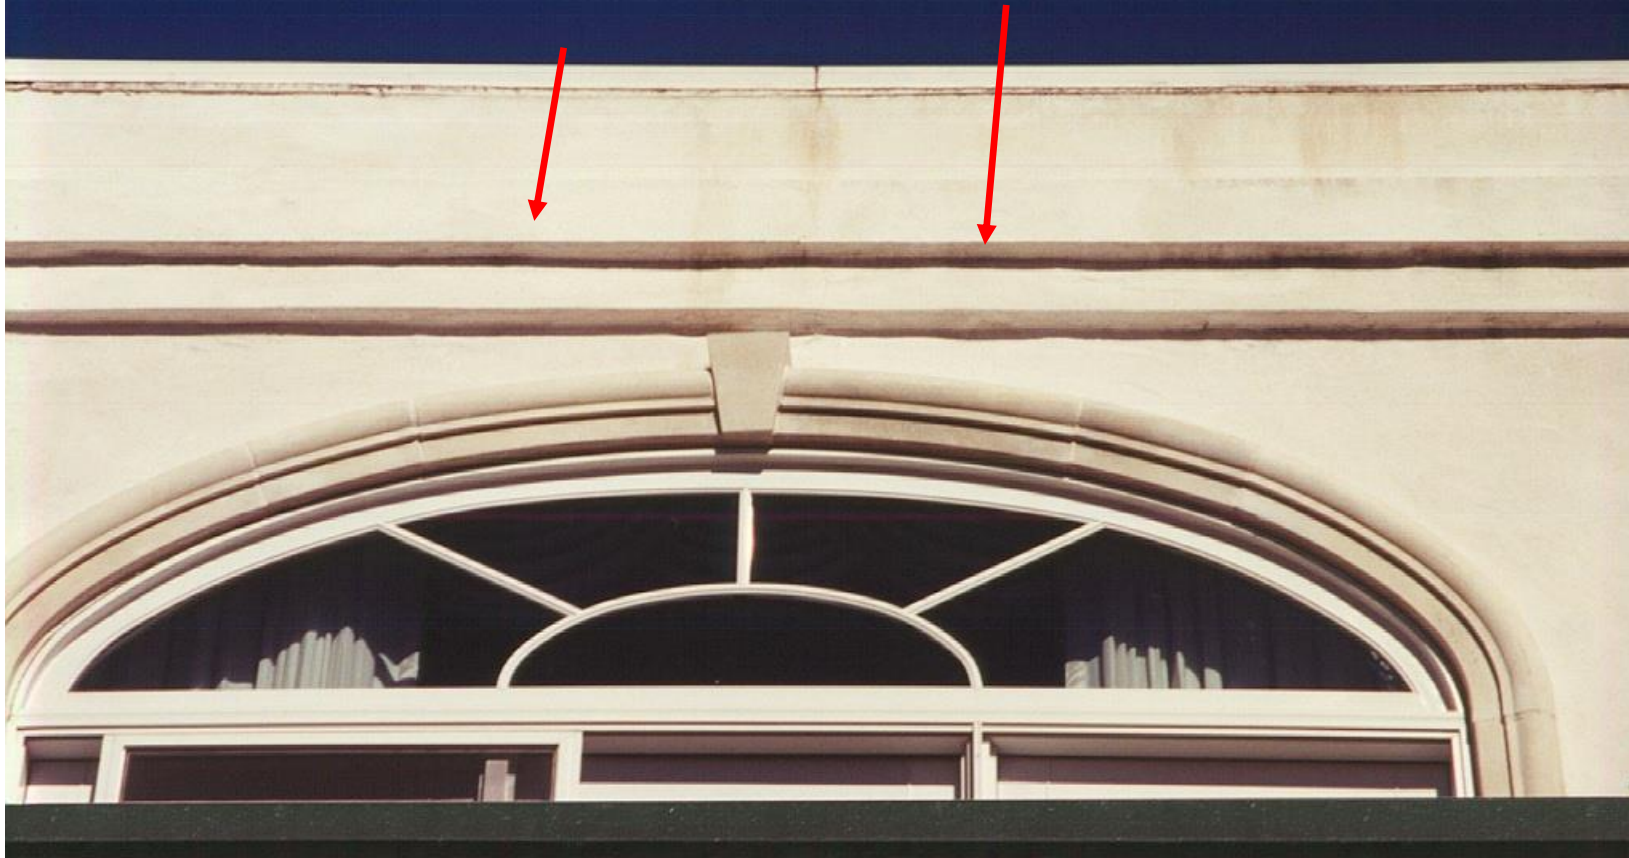
Leaks in cement plaster from the top of parapet wall...Inadequate lap over top of wall

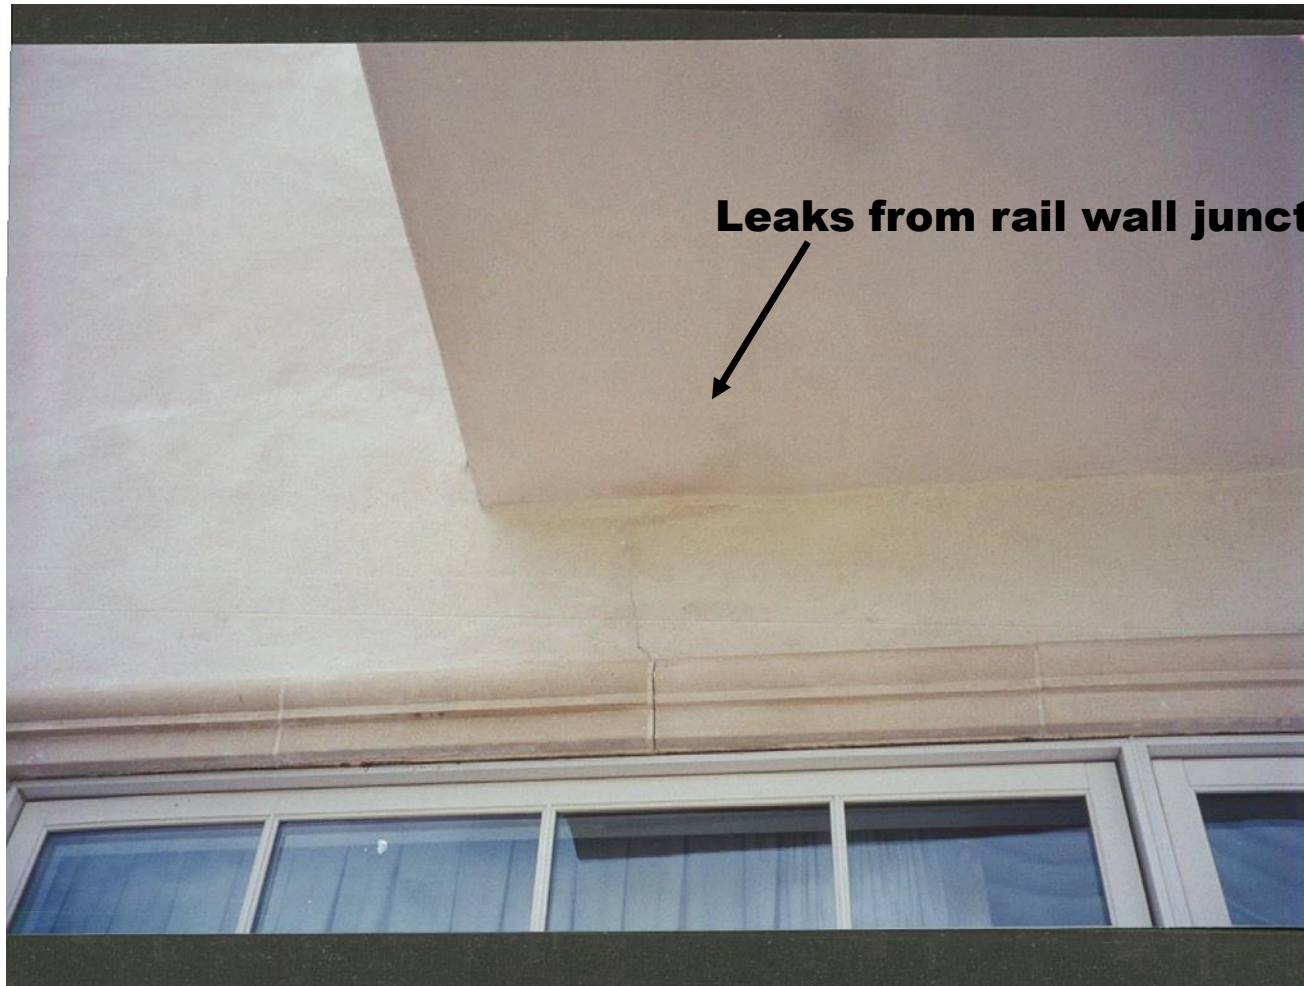
**Leaks from rail
wall junction at
top of plaster**

Leaks from rail wall junction

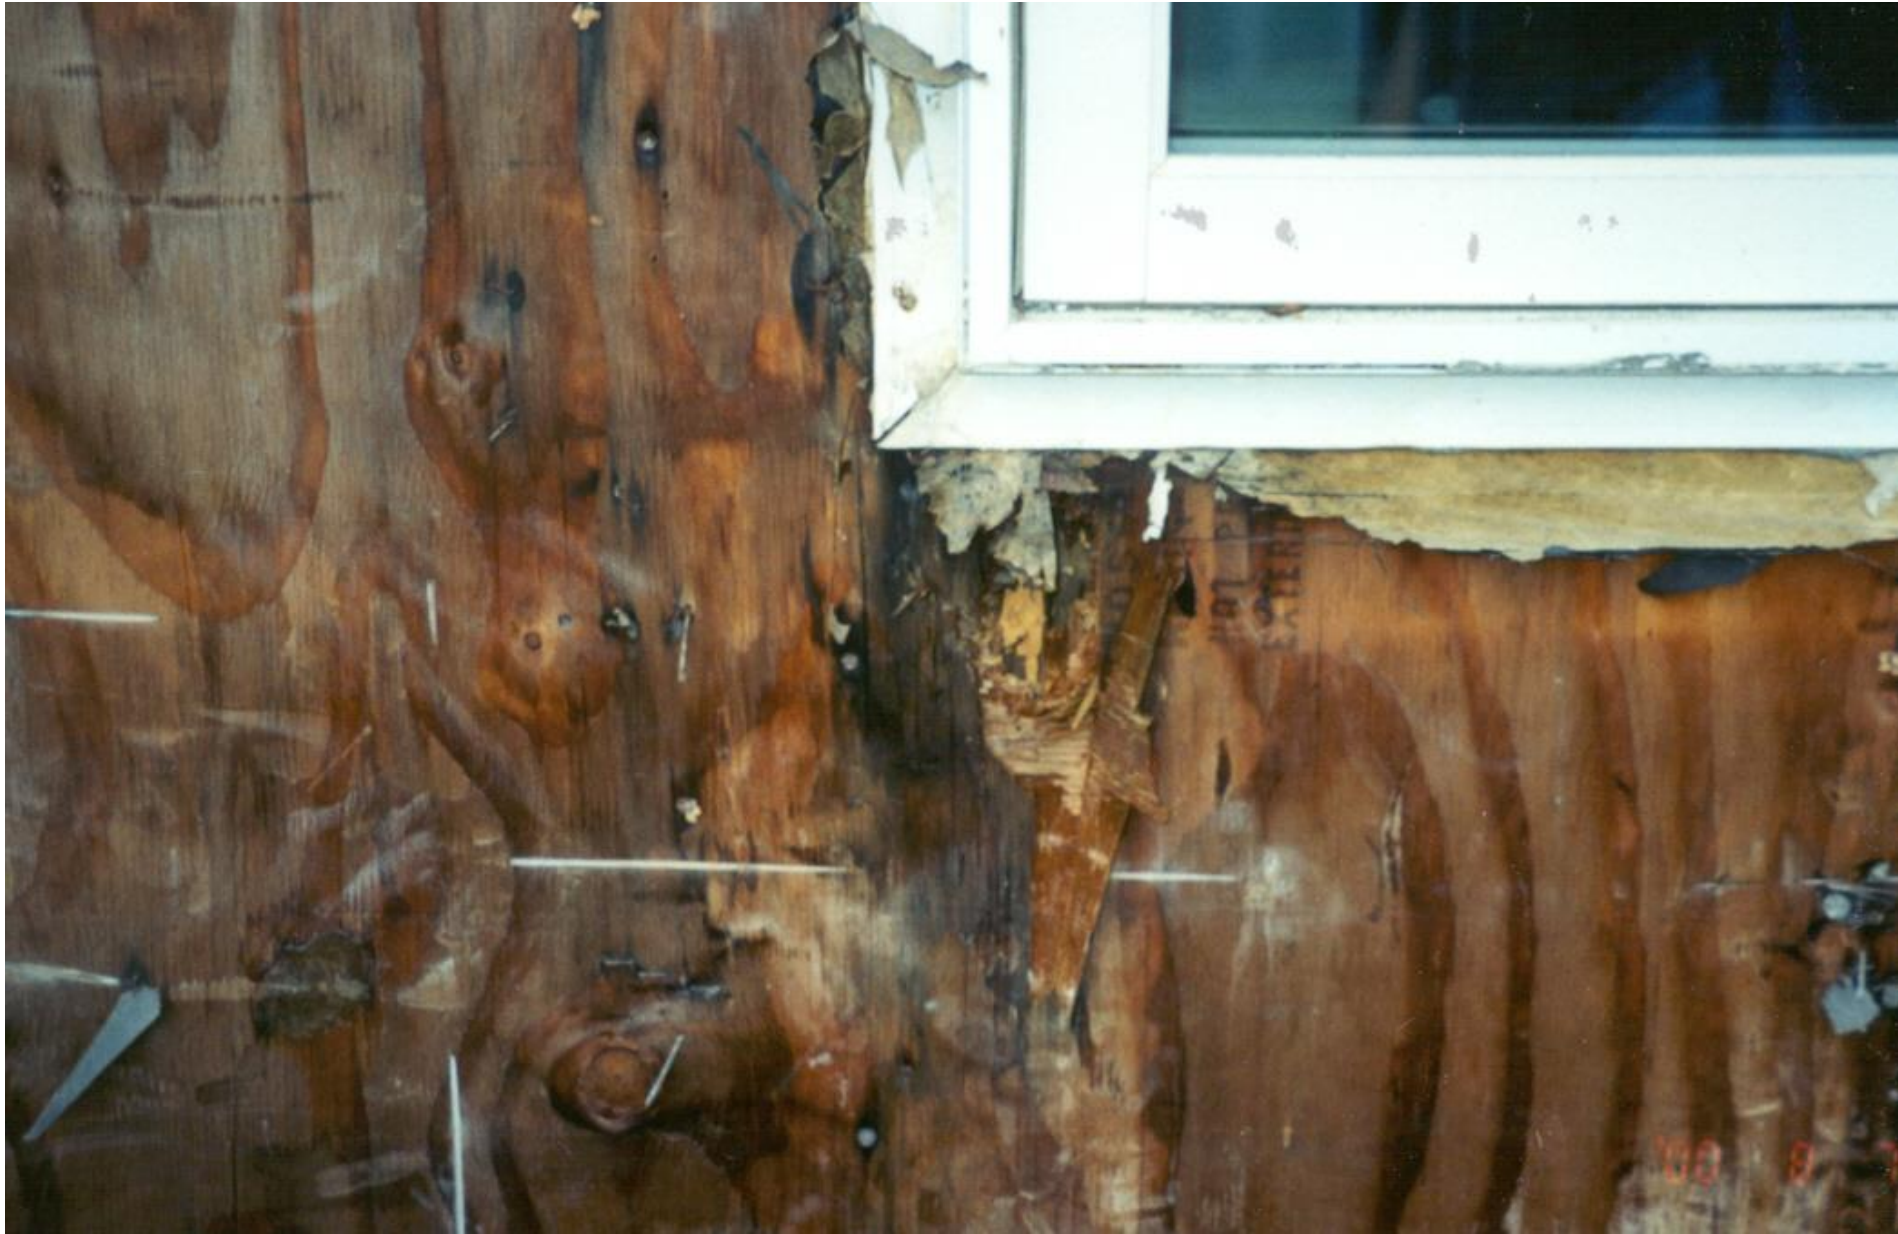
**Cracks and
sealant failure
around window**

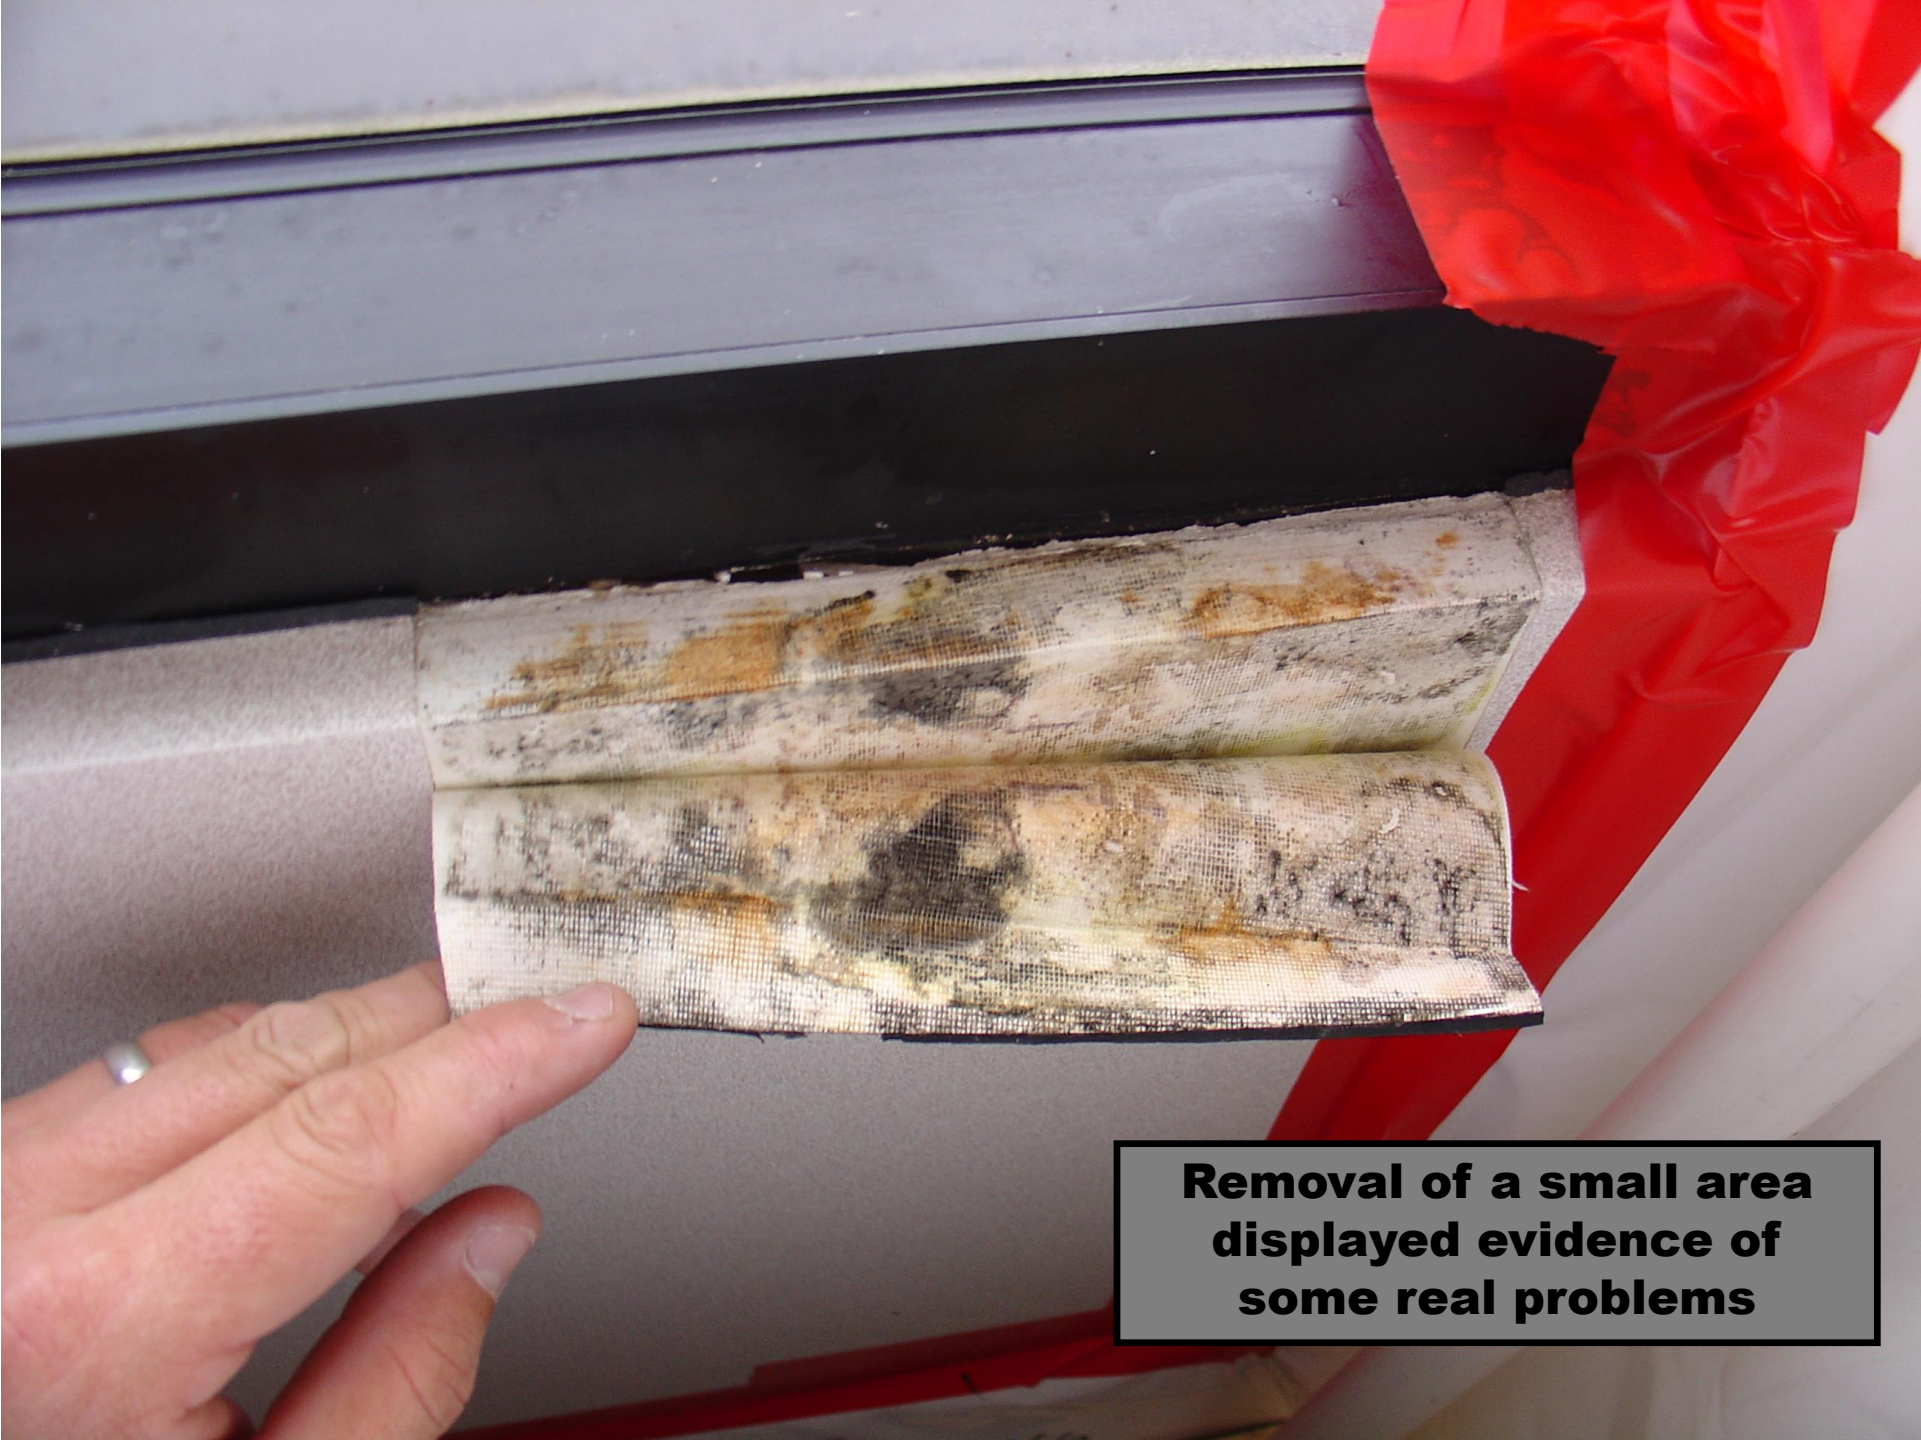
Relatively benign looking vinyl wall paper

**Removal of a small area
displayed evidence of
some real problems**
