Waterproofing is Not Skin Deep
Karim P. Allana, P.E., RRC, RWC
President, Allana Buick & Bers, Inc.

Case Study # 1, EIFS Bull Nose, Pleasanton CA

Waterproofing Is Not Skin Deep

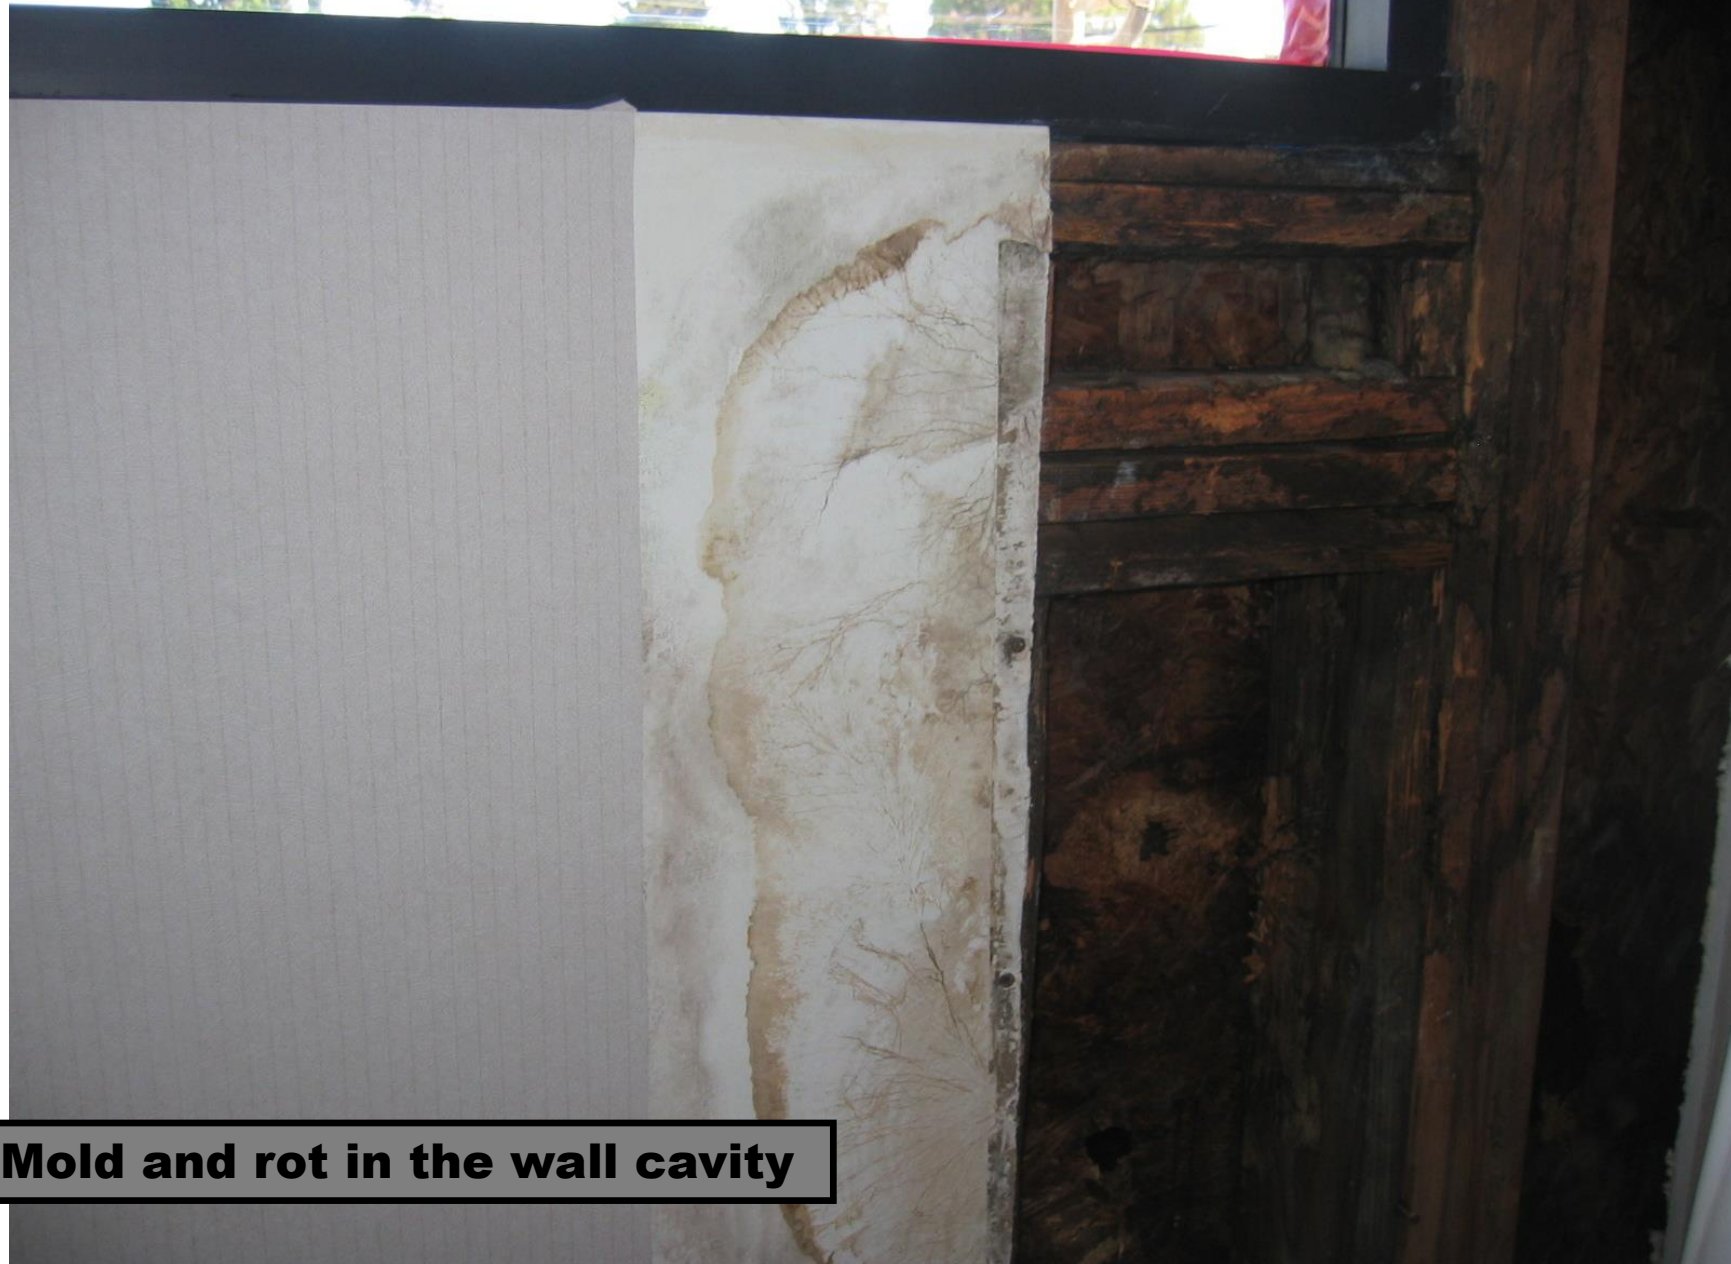
Mold and rot in the wall cavity

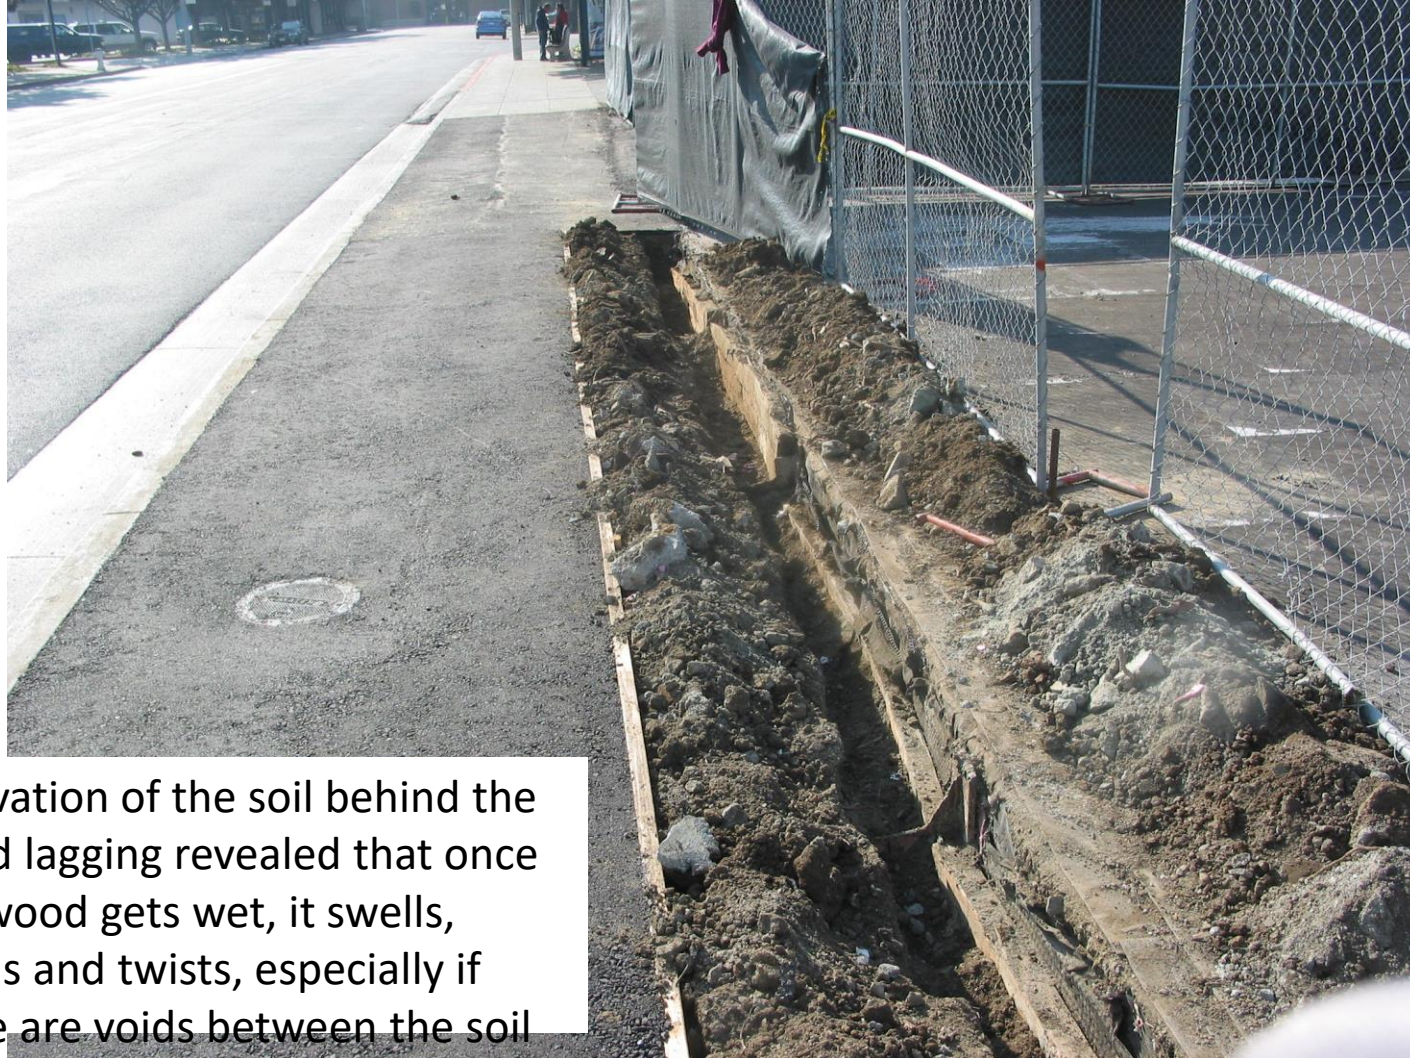
Wood Lagging Issues with Bentonite

Excavation of the soil behind the wood lagging revealed that once the wood gets wet, it swells, bends and twists, especially if there are voids between the soil and wood.

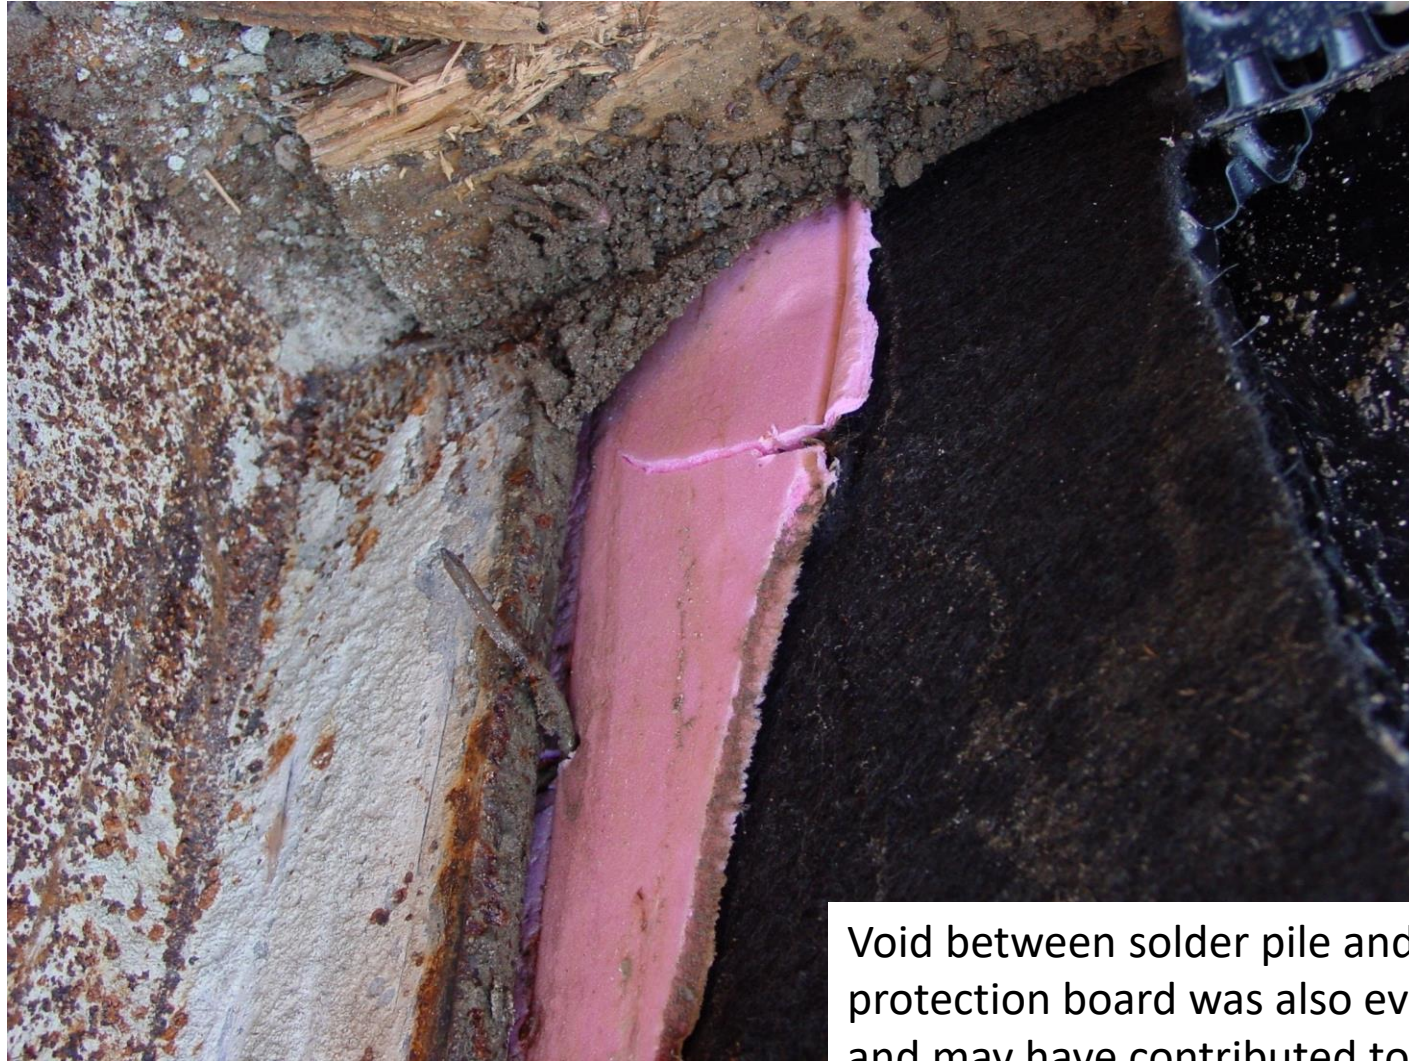
Void between solder pile and foam protection board was also evident and may have contributed to the failure of the bentonite waterproofing system.
