DRAFT: FENESTRATIONS – VINYL WINDOWS

Karim Allana, PE, RRC, RWC

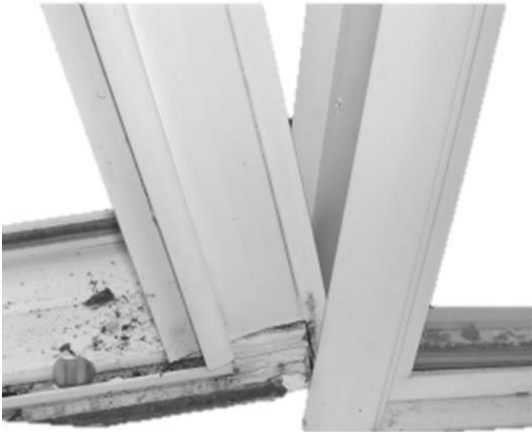
Figure 2A – Common Window Failures

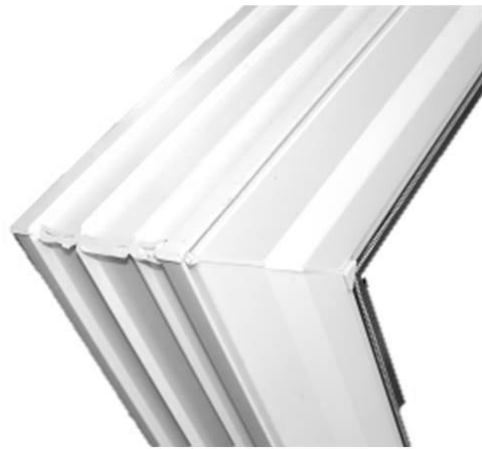
Figure 2B– Common Window Failures

Caulking also sometimes has a difficult time adhering to the PVC due its waviness and flexibility, making it difficult for sealants to adhere properly or uniformly (Figure 2B). As a precaution when working with PVC, adhesion tests must be performed prior to applying sealants to ensure they will adhere and effectively prevent water intrusion. Also as vinyl and PVC have a low melting point, windows tend to bend and sometimes set in the bent position because vinyl has a greater coefficient of thermal expansion, meaning it shrinks and grows more with temperature changes, than the glass window, sealants can often shear because thermal movement of PVC is up to 7 times that of a glass window. The glazing seals, often a kind of foam tape, used in vinyl windows can fail due to internal glazing, an independent window system on the interior side of the window also known as secondary glazing, making the seals vulnerable to long term exposure to UV and water. It is also difficult to obtain high quality vinyl windows due to different manufacturing techniques, imported materials not being subject to as stringent standards

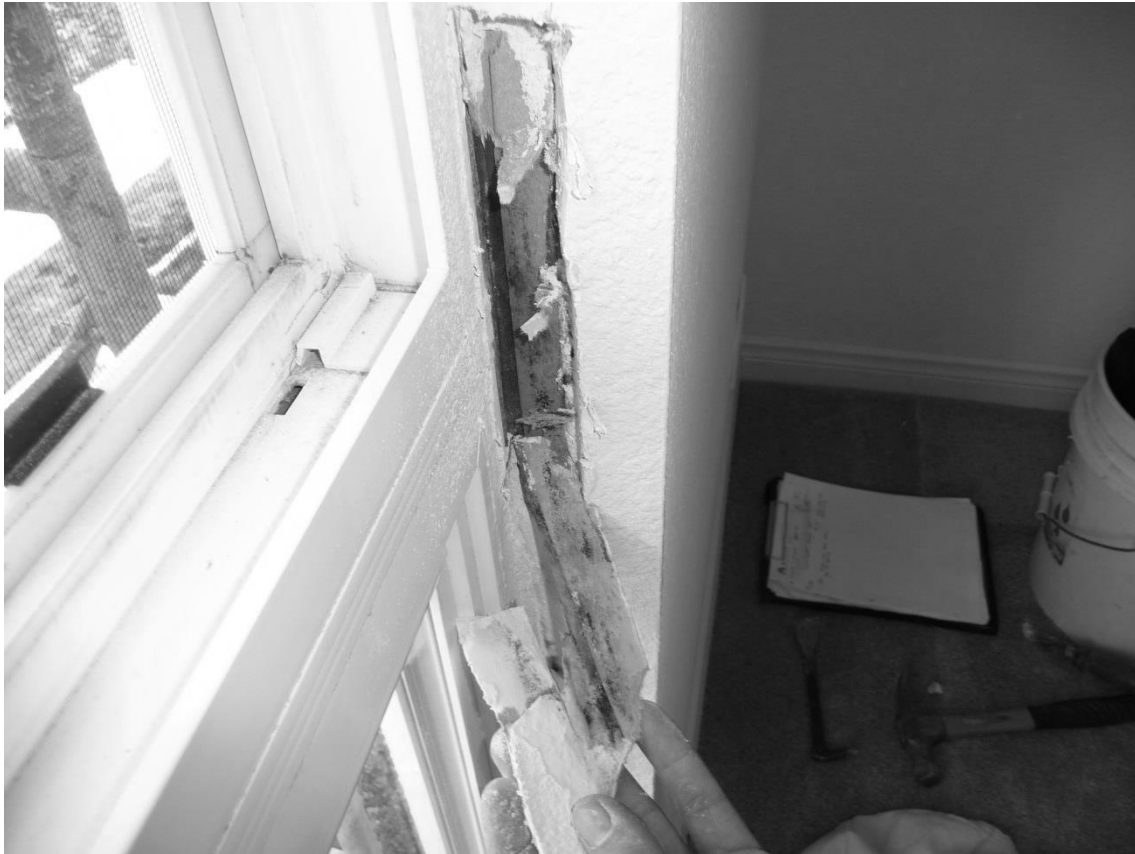
Mulling windows has its inherent risks and issues as well, as mullied joints are a very common area for water intrusion. Because fixed mullions are not flexible unlike the vinyl frames, they do not move with the vinyl window frame and they can crack due to temperature changes resulting in a vertical mullied failure. Mullions and capping trim attachments need to be continuously sealed to the exterior of the window to be effective. Sealant also needs to be applied between the mullions to effectively prevent leaks. Also, we have noticed several examples when screws are driven into the window from the interior during the mulling process, which is another big source of leaks. One of the advantages of vinyl windows is having a continuous welded frame and welded fin; however, mullied windows do not have continuous welded fins often resulting in leaks at

Figure 3A – Vertical Mullion Failure

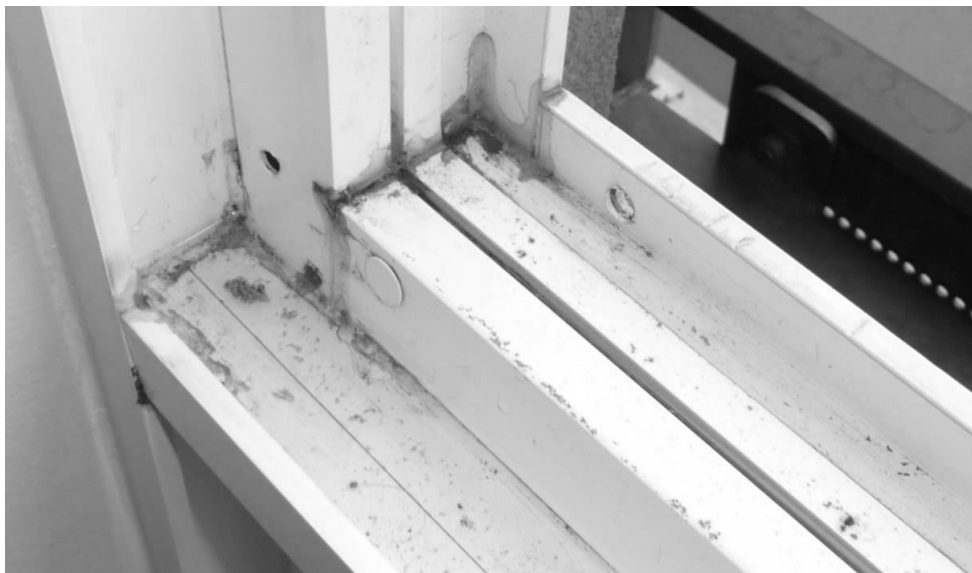
During testing water rushed into the lower frame via the horizontal track which then percolated into the dry sill track and then overflowed onto the wood stool. A fixed “dry” sill track does not provide drainage, leaving no method of managing the water that enters the frame. The water leakage led to rusting of the structural steel reinforcing and buildup of standing water in the lower sill track resulting in growth of mold, mildew, rust, and damaged wood stools. This water intrusion was due to improperly sealed horizontal to vertical coped mullion jamb extrusion joints which allowed water to flow through the sealant-dependent joint in the horizontal mullion into the lower sill track.

Figure 4A – Coped Mullion Joint Failure

There were also leaking fastener holes at the coped juncture in addition to improperly constructed weep holes in the drainage pathway allowing water to leak into the interior of the building. The weep holes found in the windows were only 5 mm in diameter as opposed to the 8 mm or $\frac{5}{16}$ inches recommended by the Glazing Association of North America. The smaller weep hole prevents proper drainage because there is too much surface tension. Out of the 13 windows tested, all 13 failed to protect against water intrusion. To correct the problem, our company recommended a dual seal for the glazing gaskets using both foam or butyl tape in addition to a wet silicone sealant.
