# Understanding Common Roofing Issues & Replacement Options

Allana Buick & Bers, Inc.

# Understanding Common Glazing Issues & Replacement Options

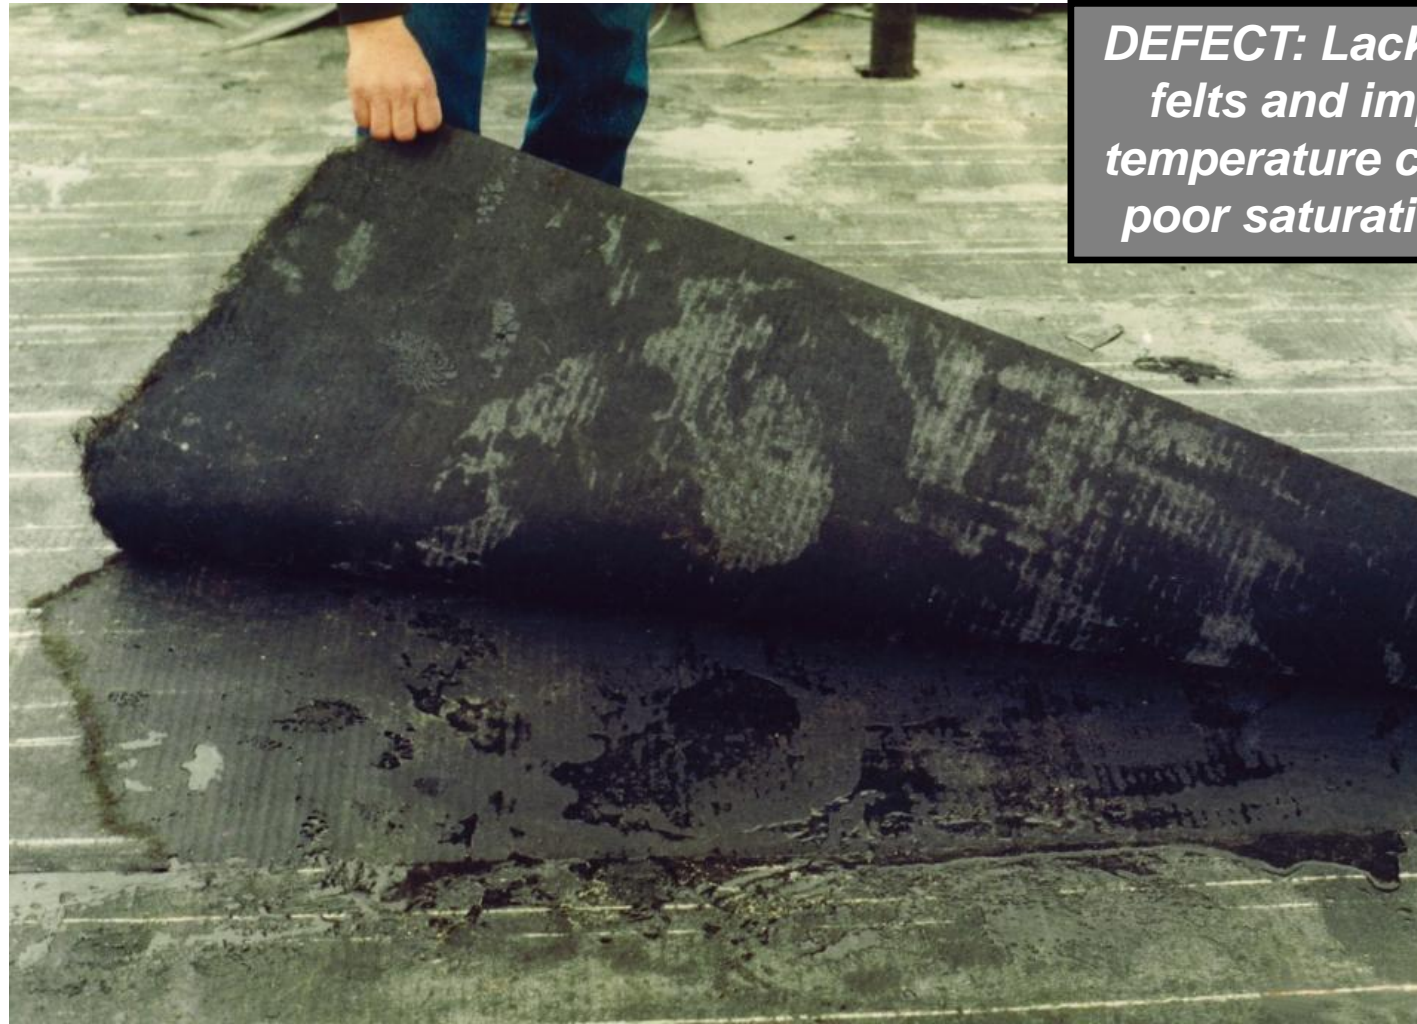
***DEFECT: Lack of brooming of felts and improper asphalt temperature causes voids and poor saturation of roof plies.***

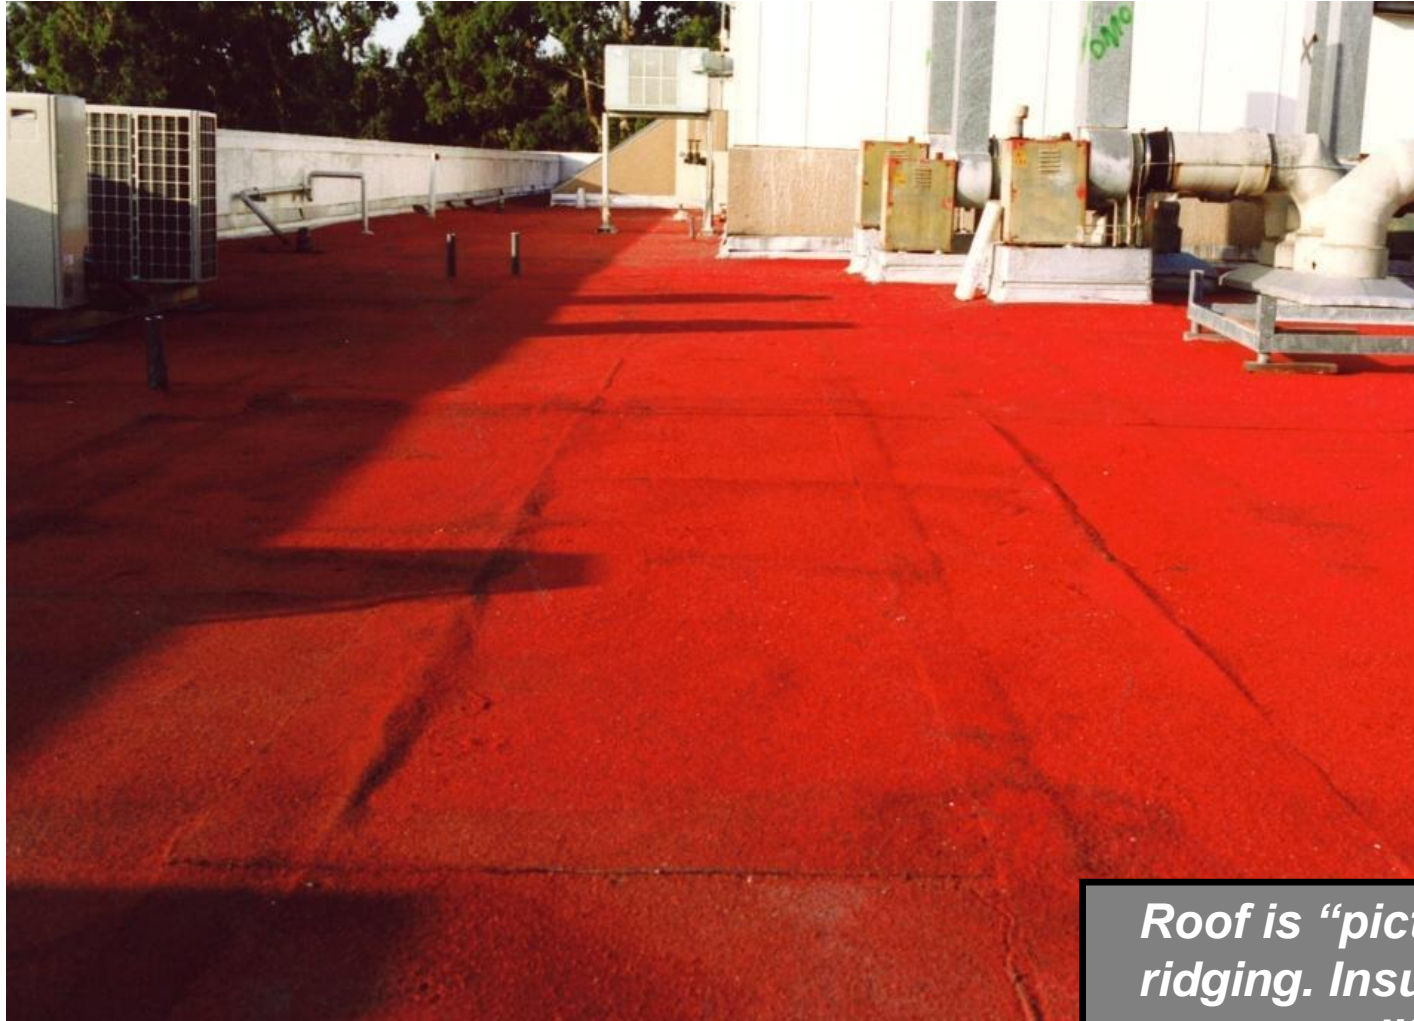
# Example Failure From Roof Attachment Issue

*Roof is “picture framing” and ridging. Insulation boards are lifting up*

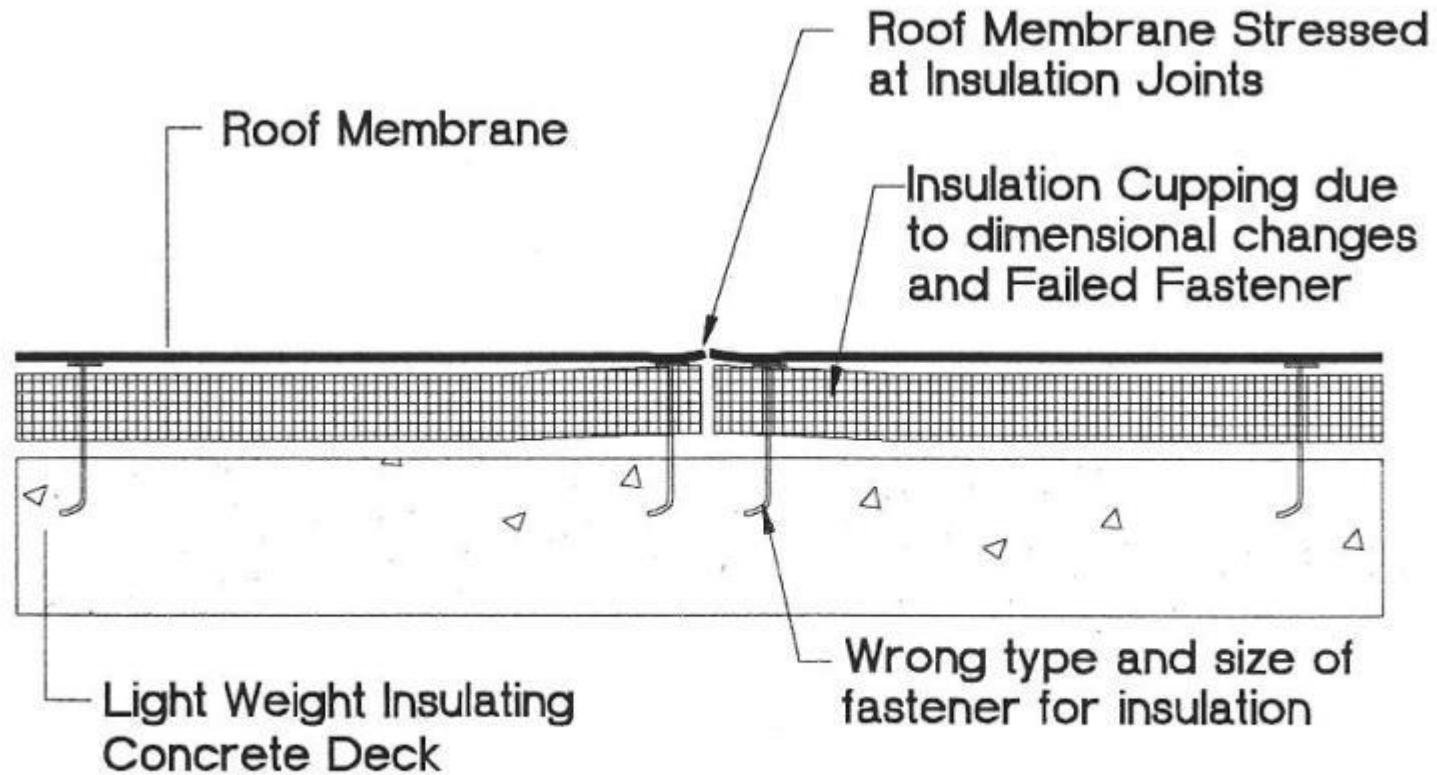
PICTURE FRAMING + ROOF SPLITTING CAUSED BY POOR FASTENING OF INSULATION BOARD TO SUBSTRATE

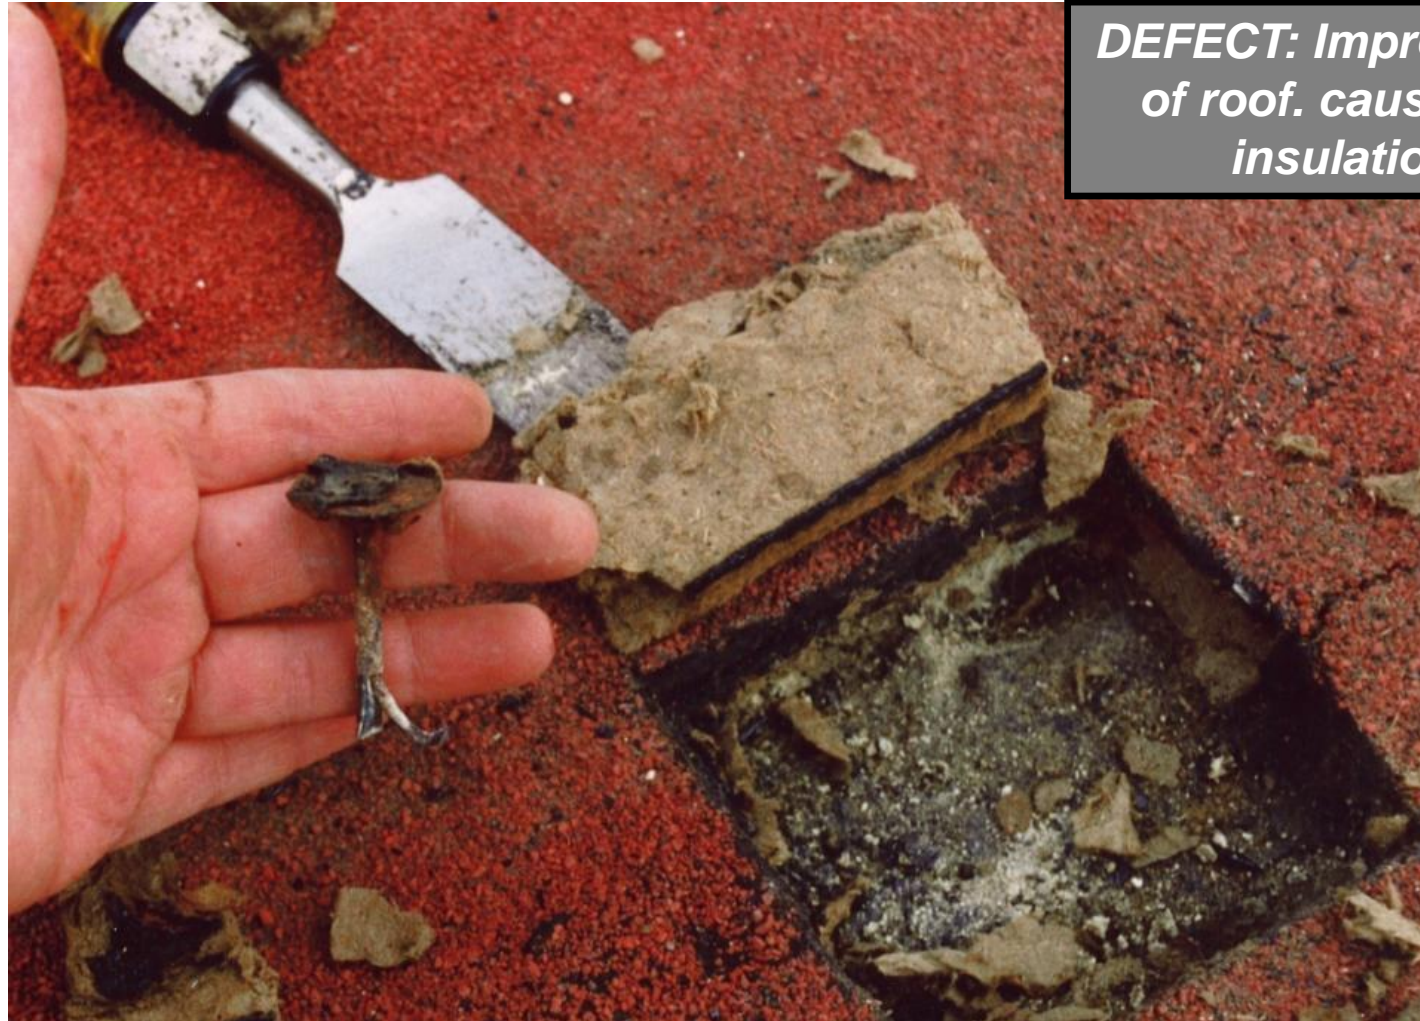
*DEFECT: Improper securement of roof, causing cupping of insulation material.*

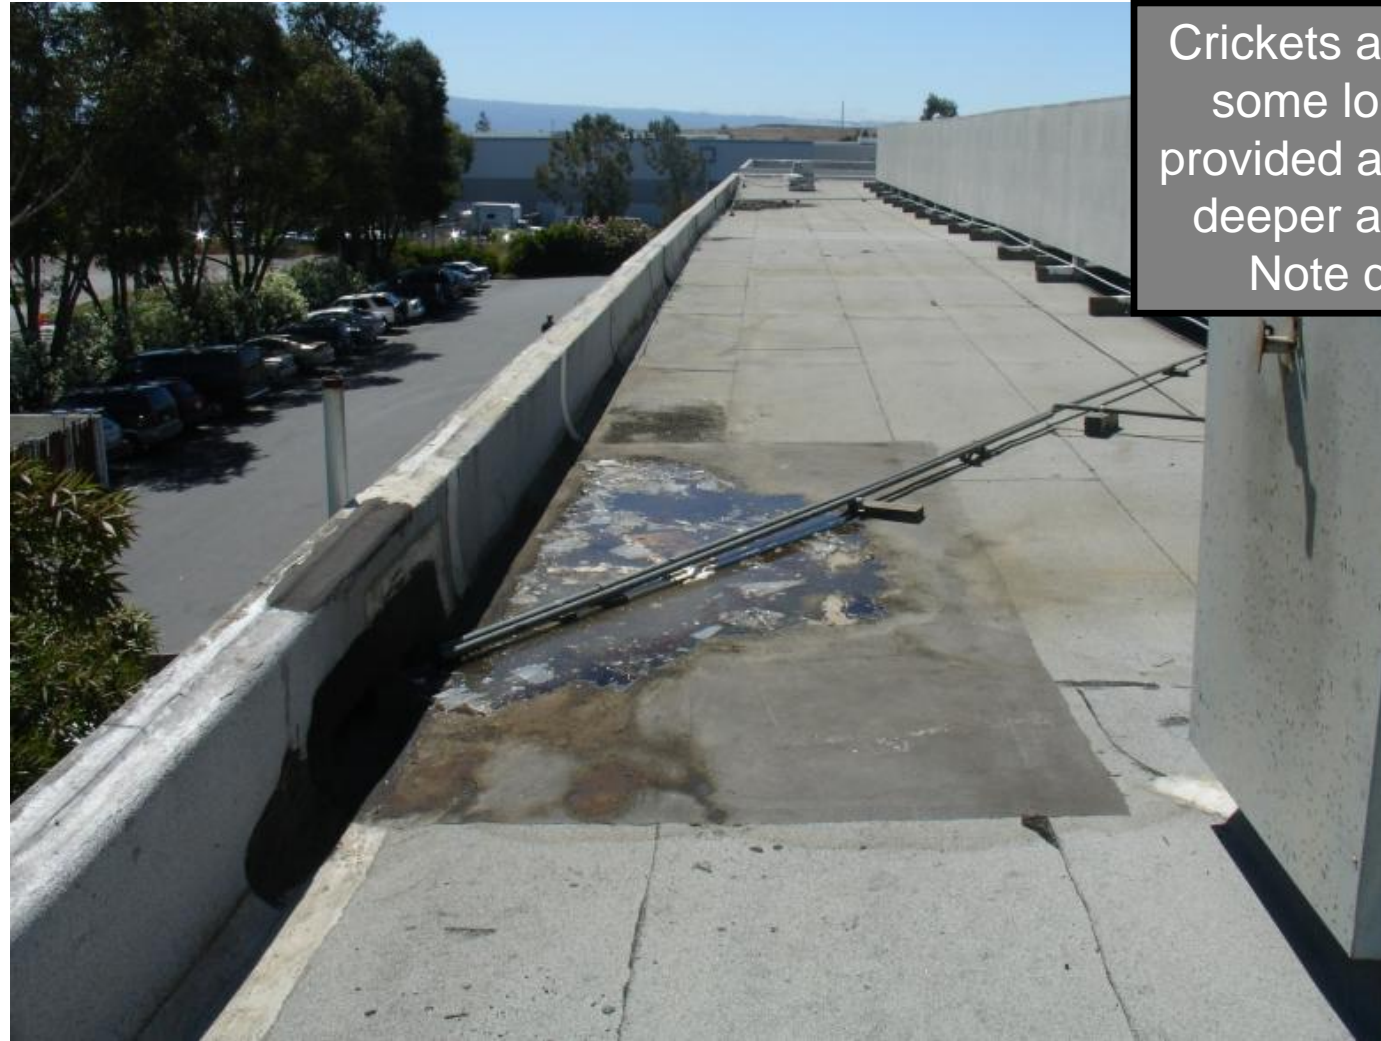
# Ponding Water Leads to Deterioration

Cricketts are undersized in some locations, or not provided at all. Need to be deeper and redesigned. Note deterioration.

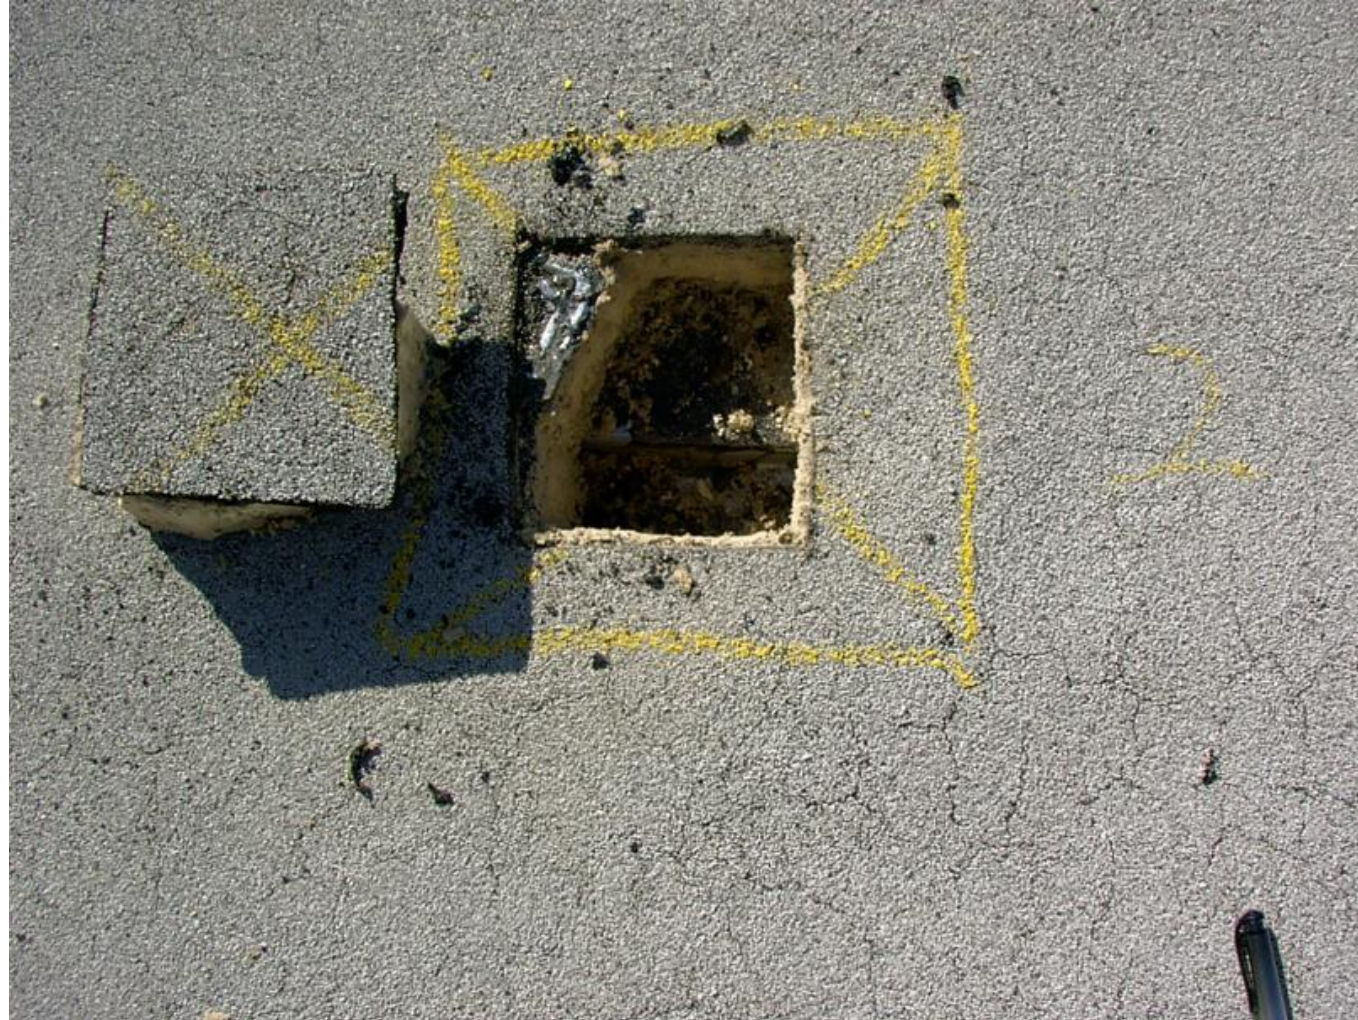
# 12 Year Old SBS Roof Crazeing and UV Damage

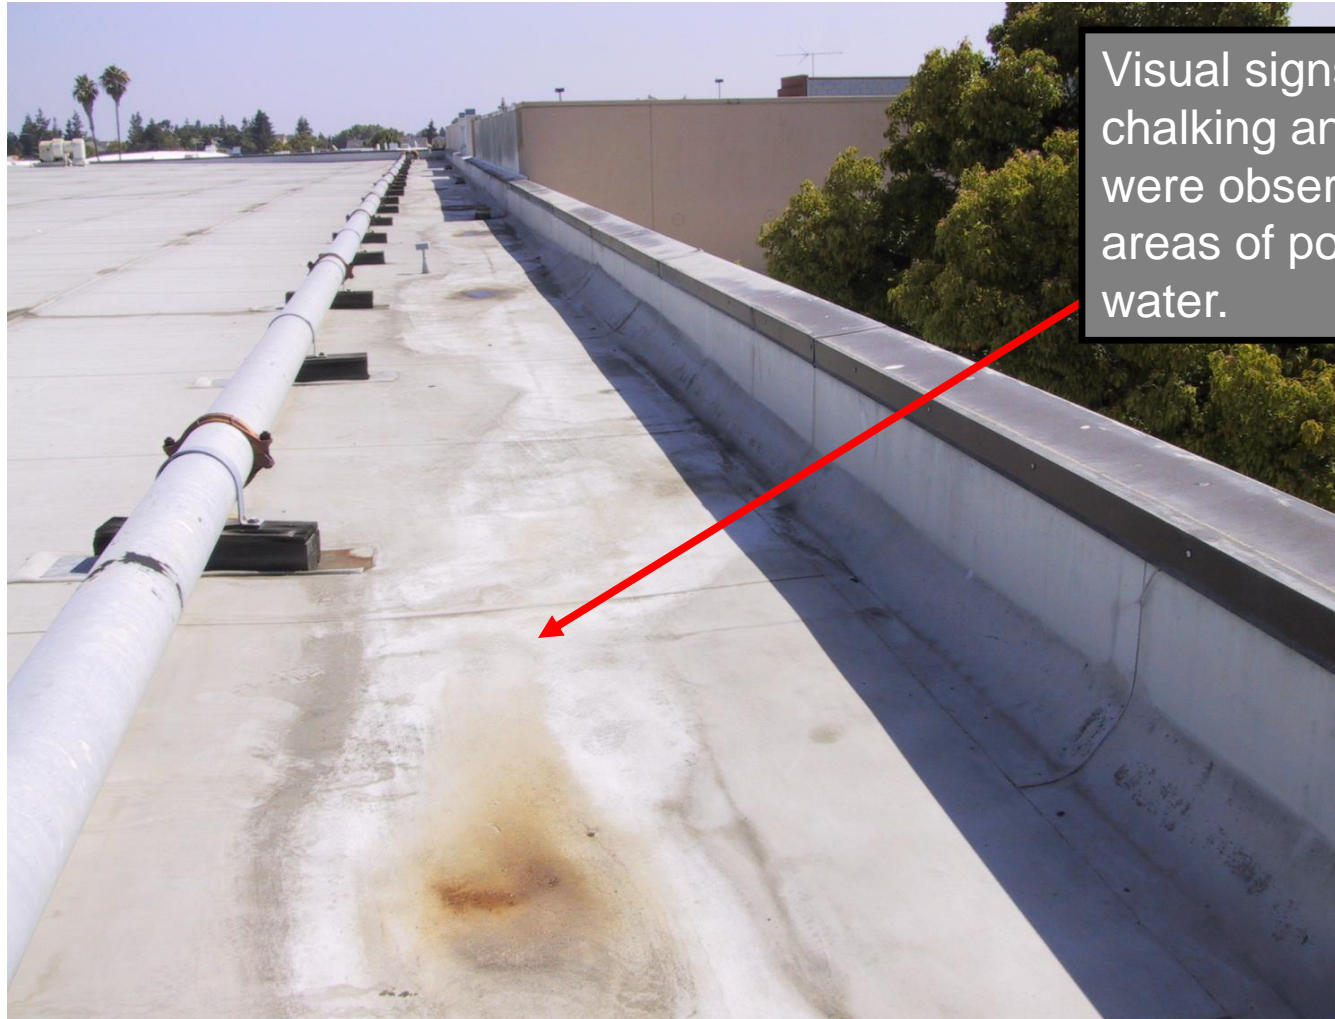
Visual signs of chalking and age were observed in areas of ponding water.

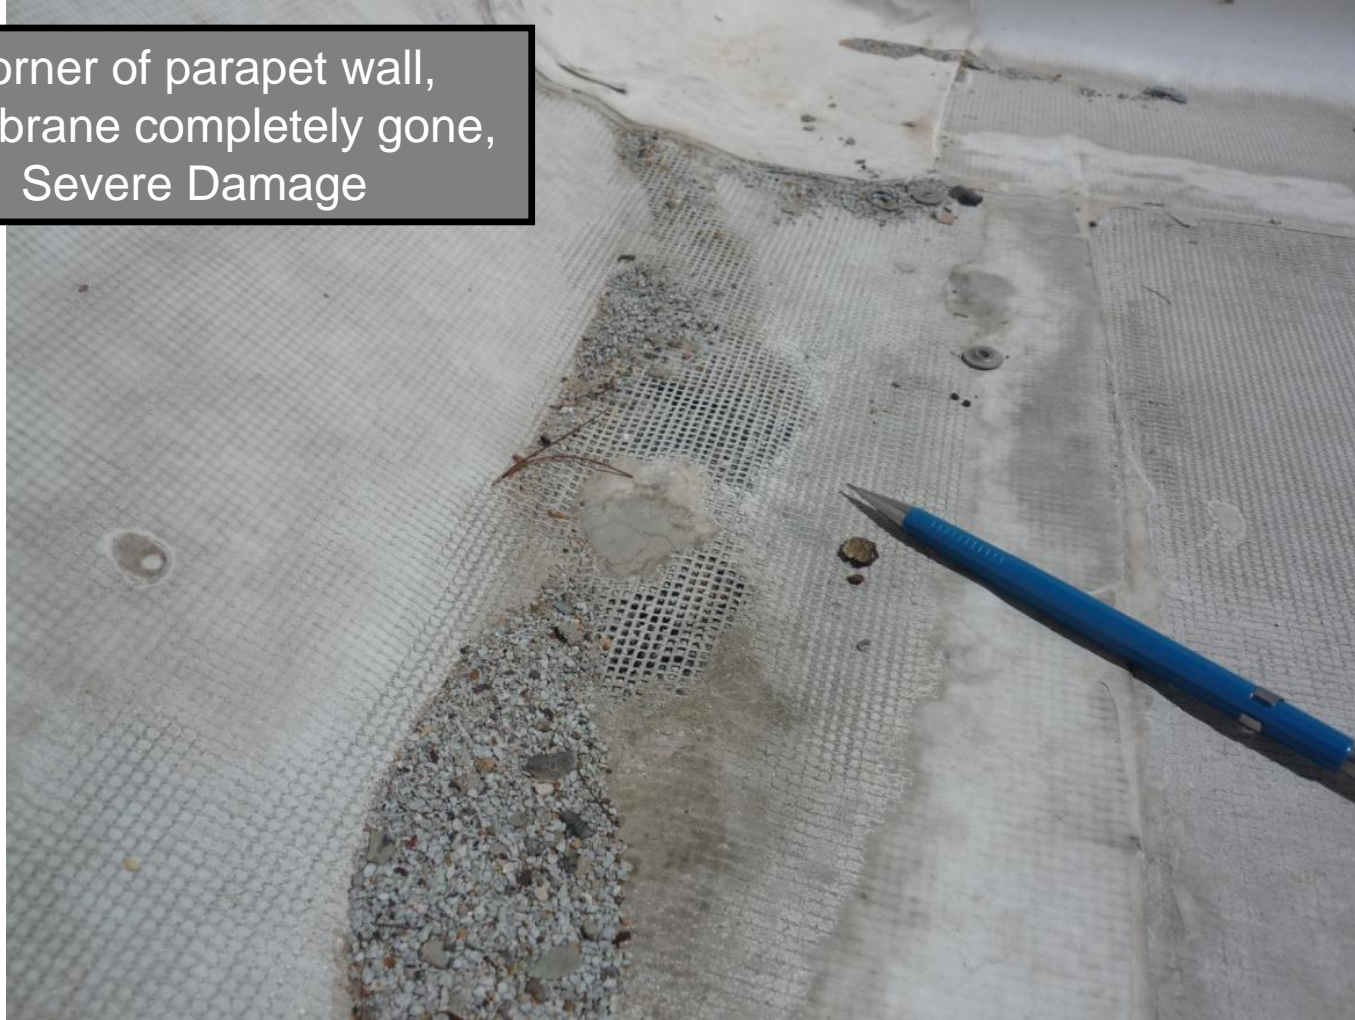
Corner of parapet wall,  
membrane completely gone,  
Severe Damage

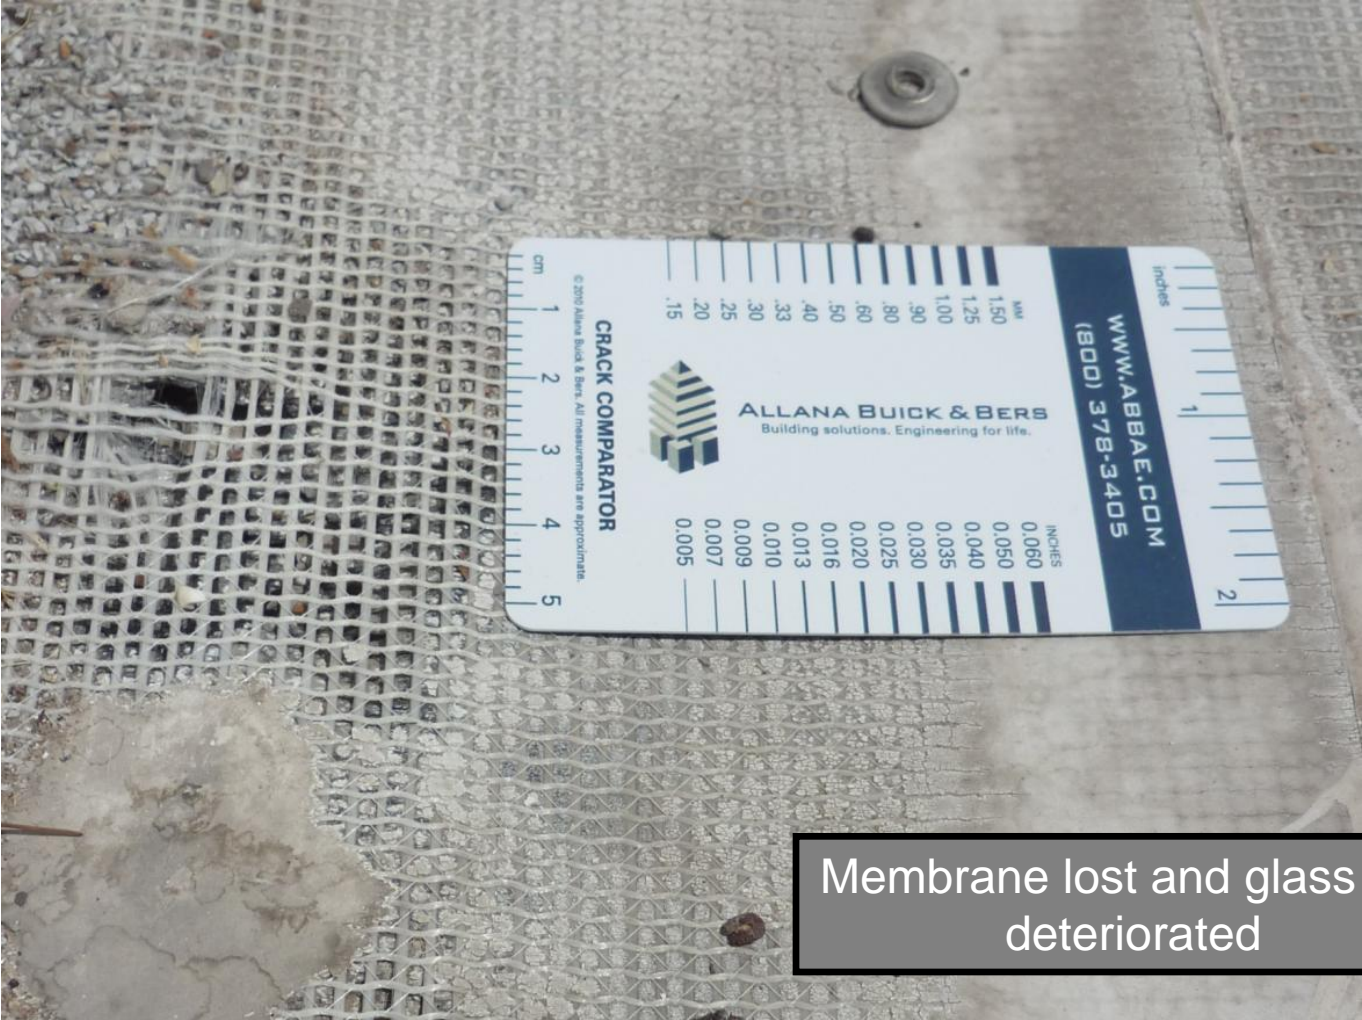
Membrane lost and glass has deteriorated

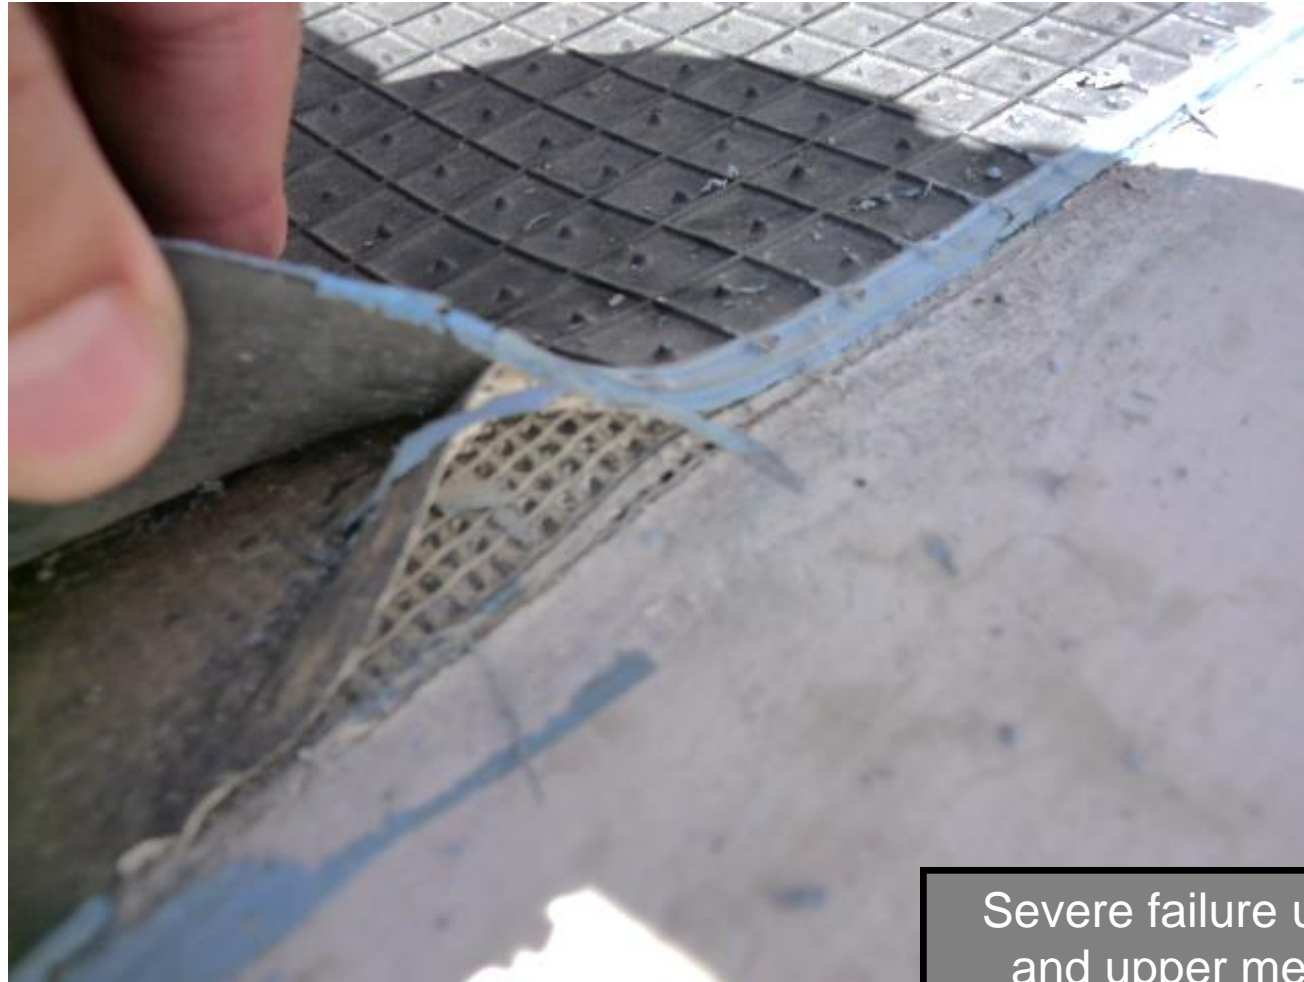
Severe failure under walk pad and upper membrane layer

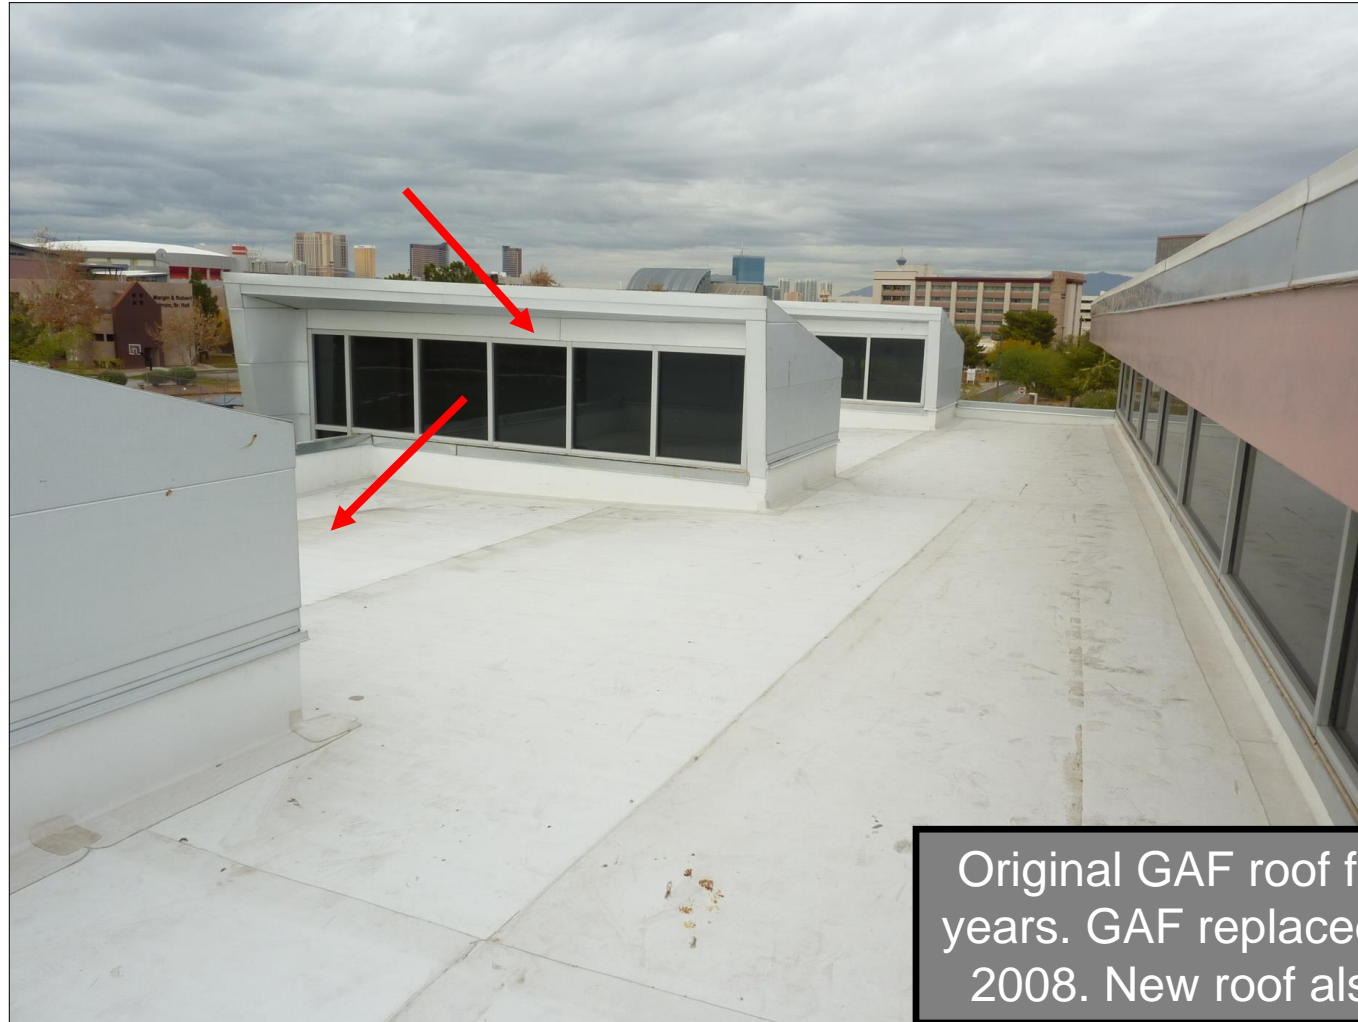
Original GAF roof failed in 3 years. GAF replaced it march 2008. New roof also failing

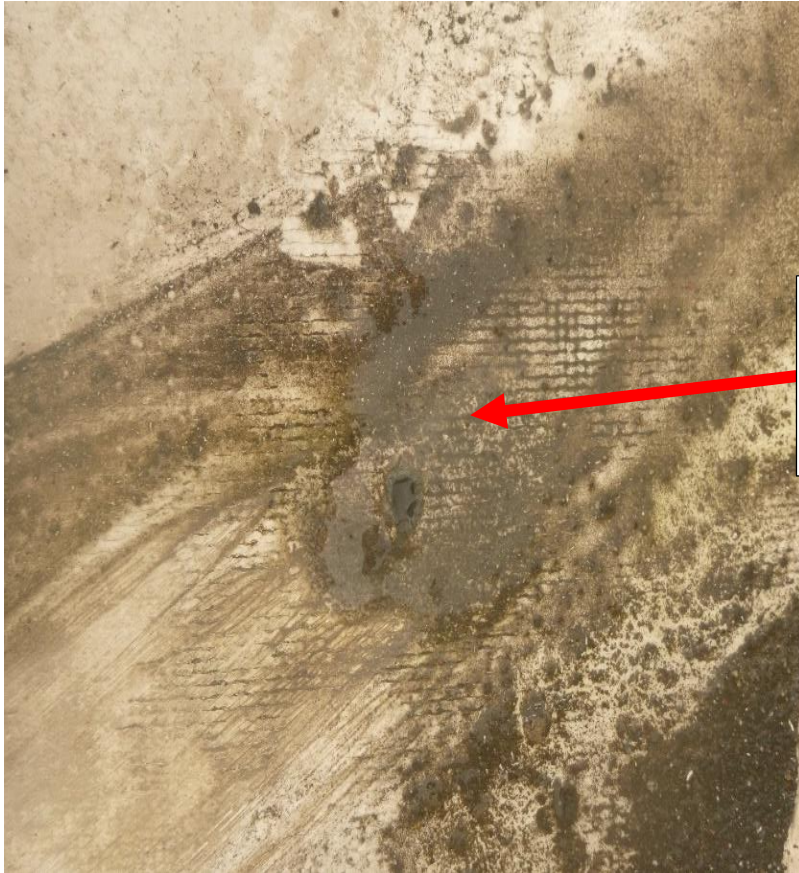
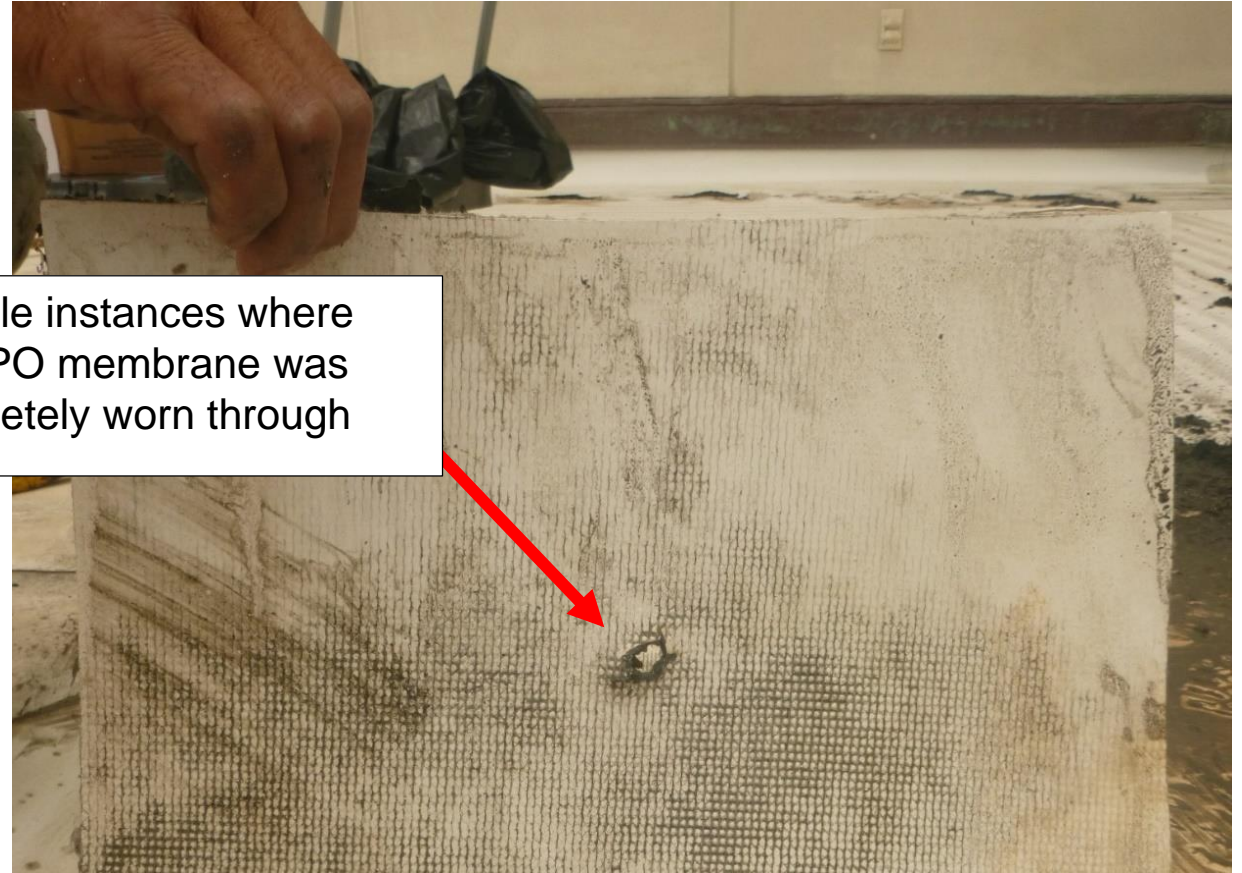
Multiple instances where the TPO membrane was completely worn through

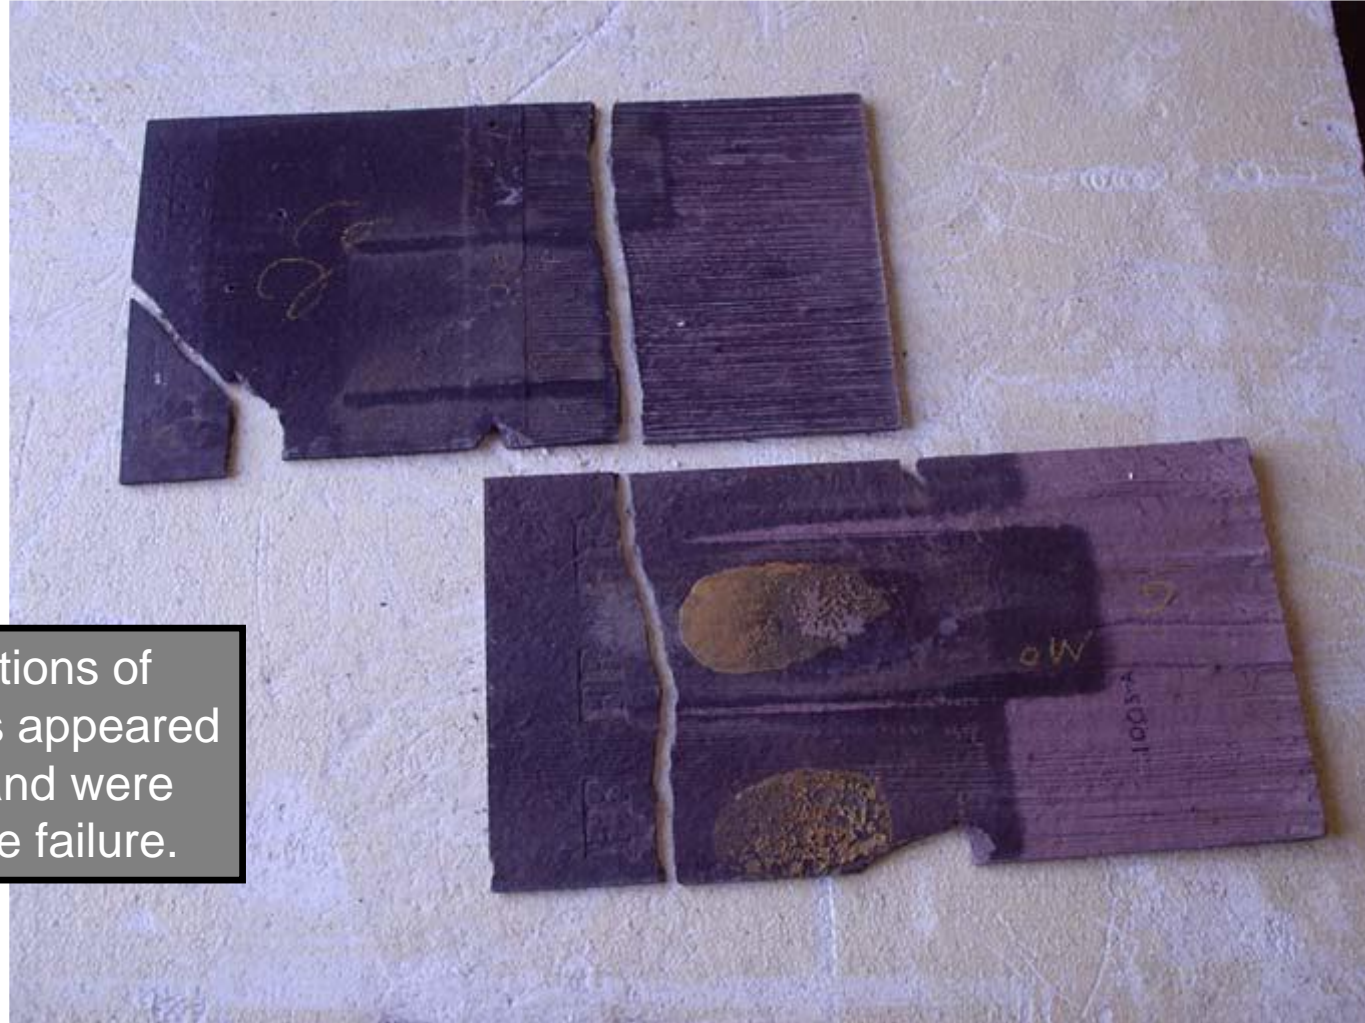
Exposed portions of shingle samples appeared pink in color and were prone to brittle failure.

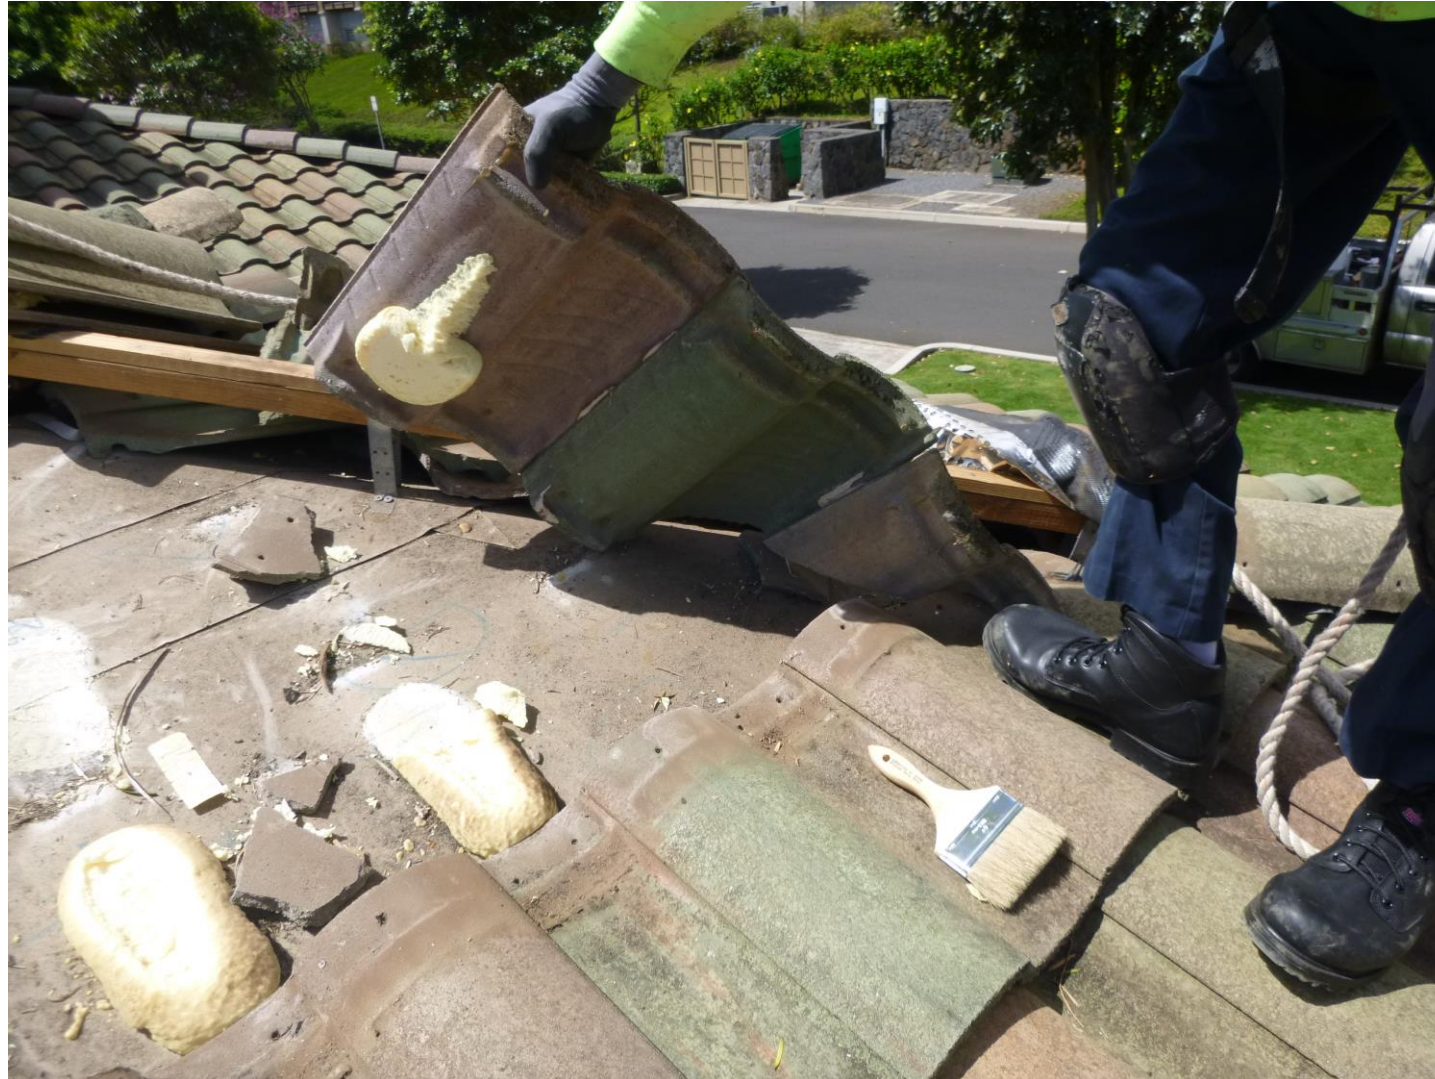
# Foam Adhesive Not Bonded to Underlayment

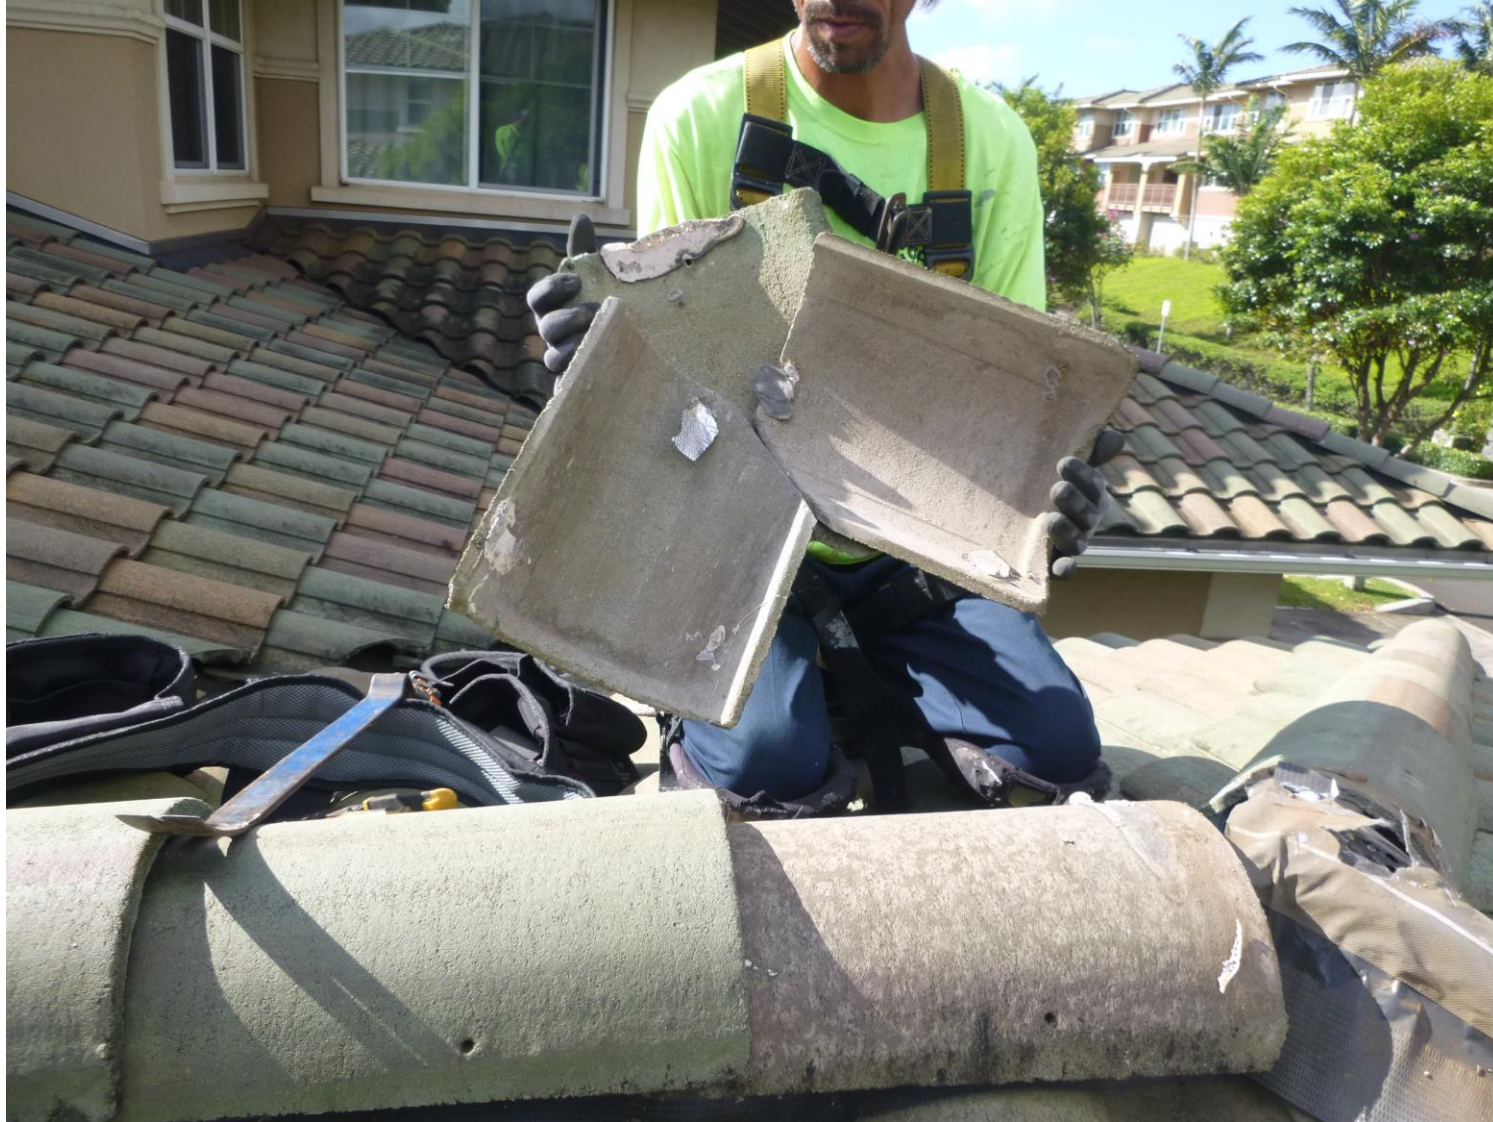
# Tile Adhesive Adhesion Failure
