# Understanding Common Roofing Issues & Replacement Options

Allana Buick & Bers, Inc.

# Understanding Common Glazing Issues & Replacement Options

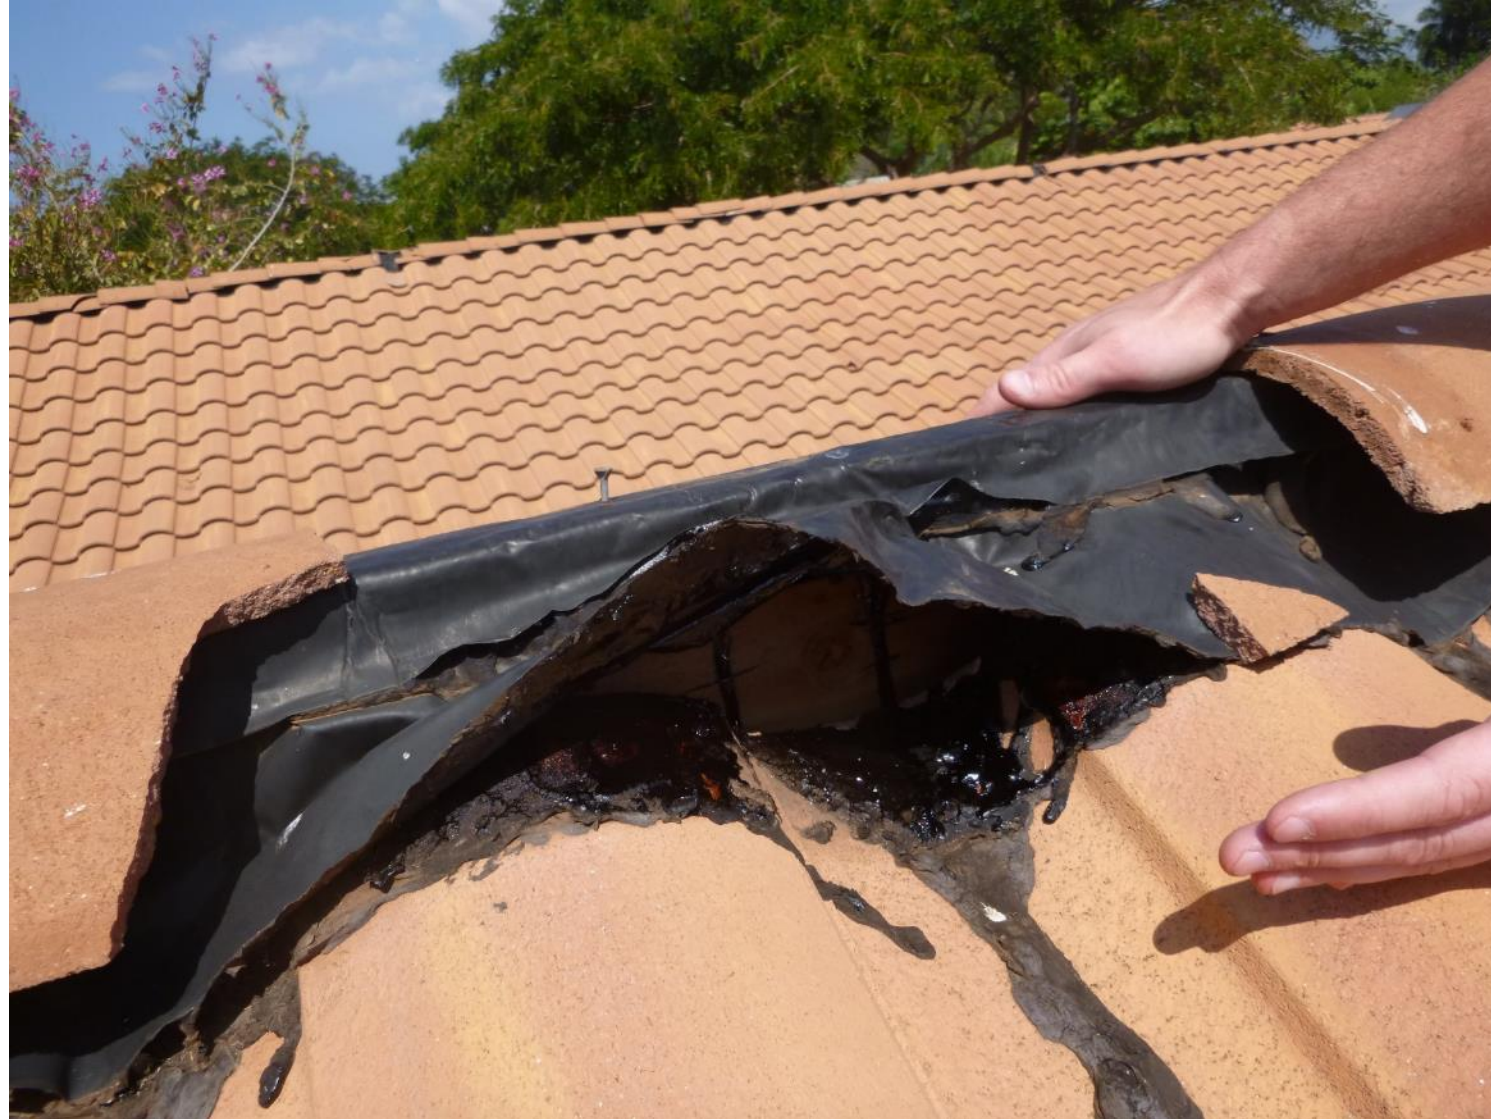
# Self Adhered Modified Bitumen is Melting

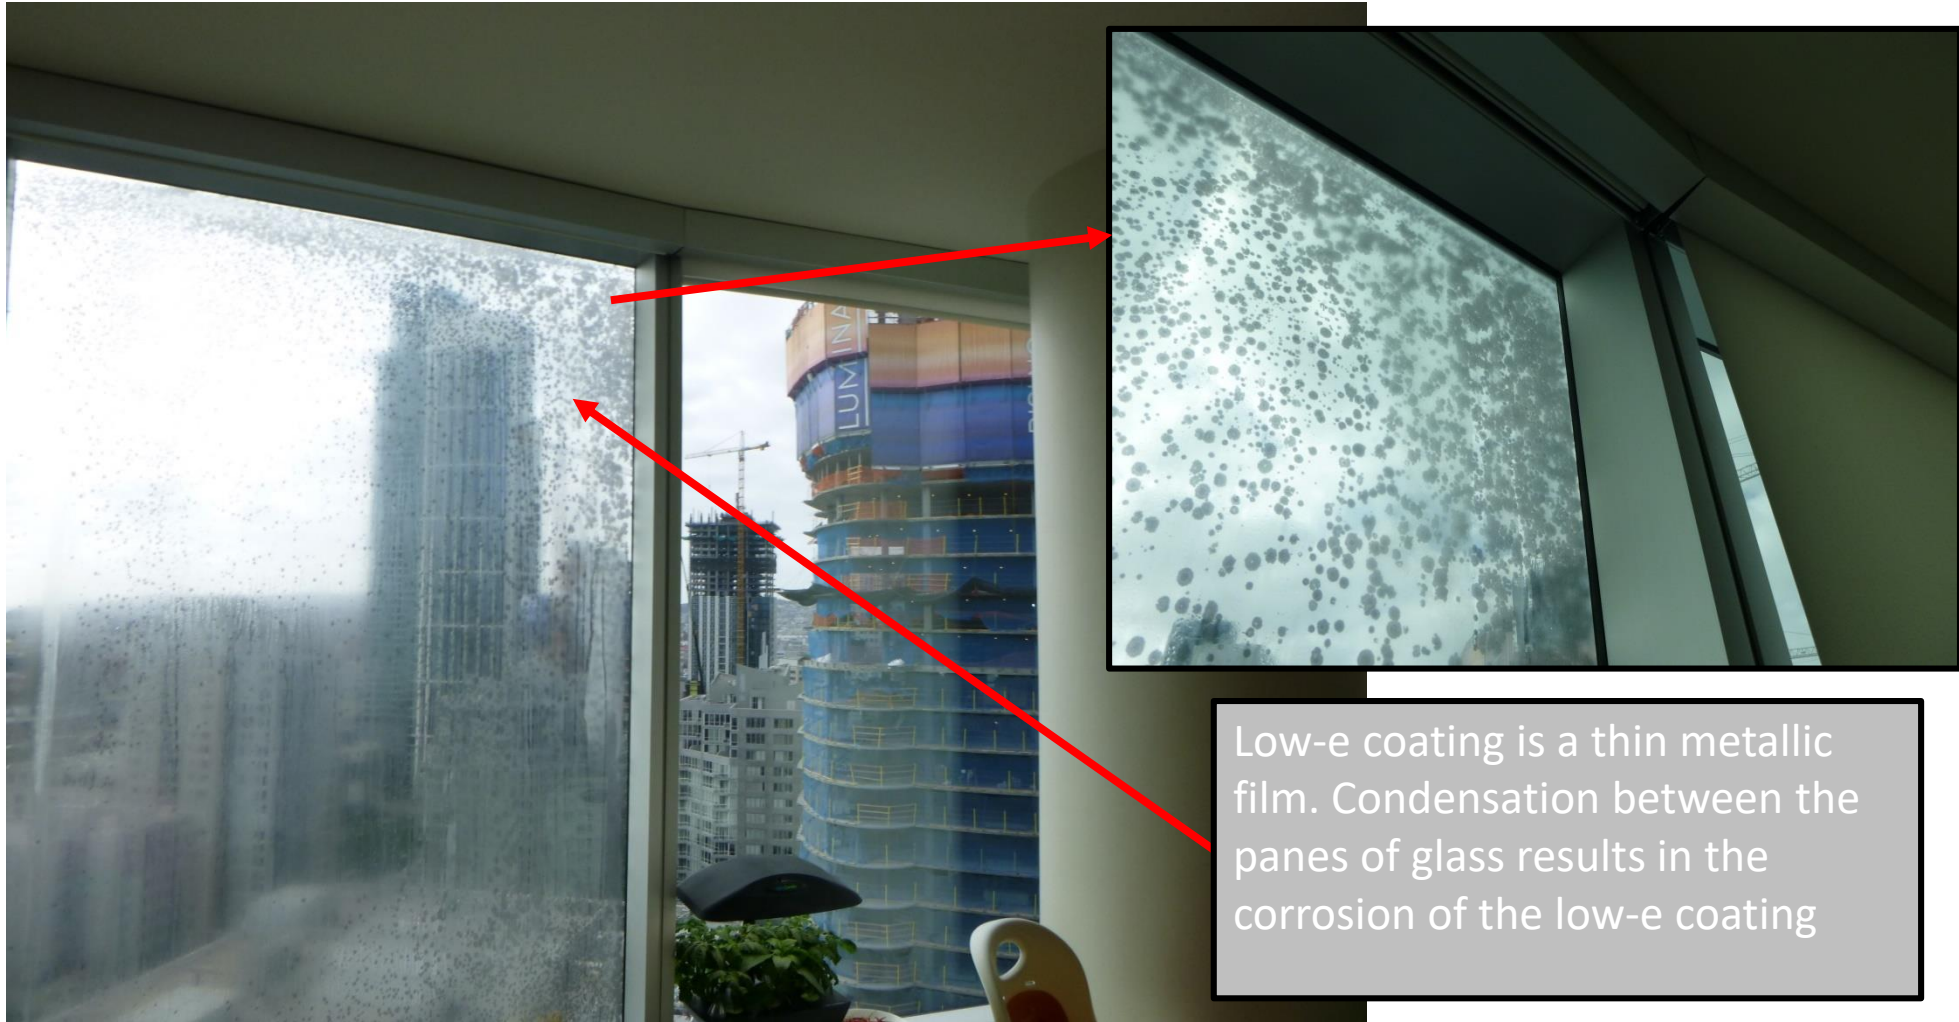
Building D, Unit 28F

Low-e coating is a thin metallic film. Condensation between the panes of glass results in the corrosion of the low-e coating

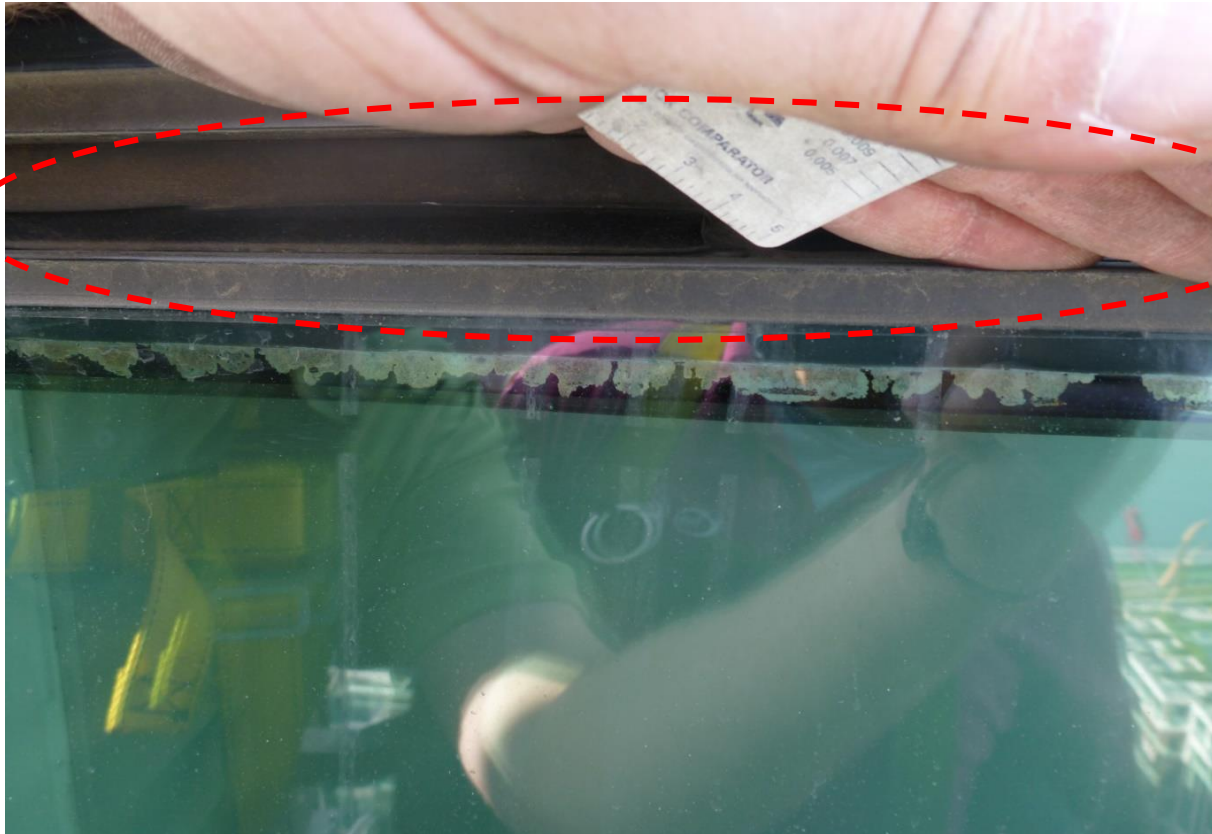
Failure can occur if the Low-e silver coating is not “edge deleted”. Edge of the glass can start corroding and corrosion can spread to the inside, by-passing the seals

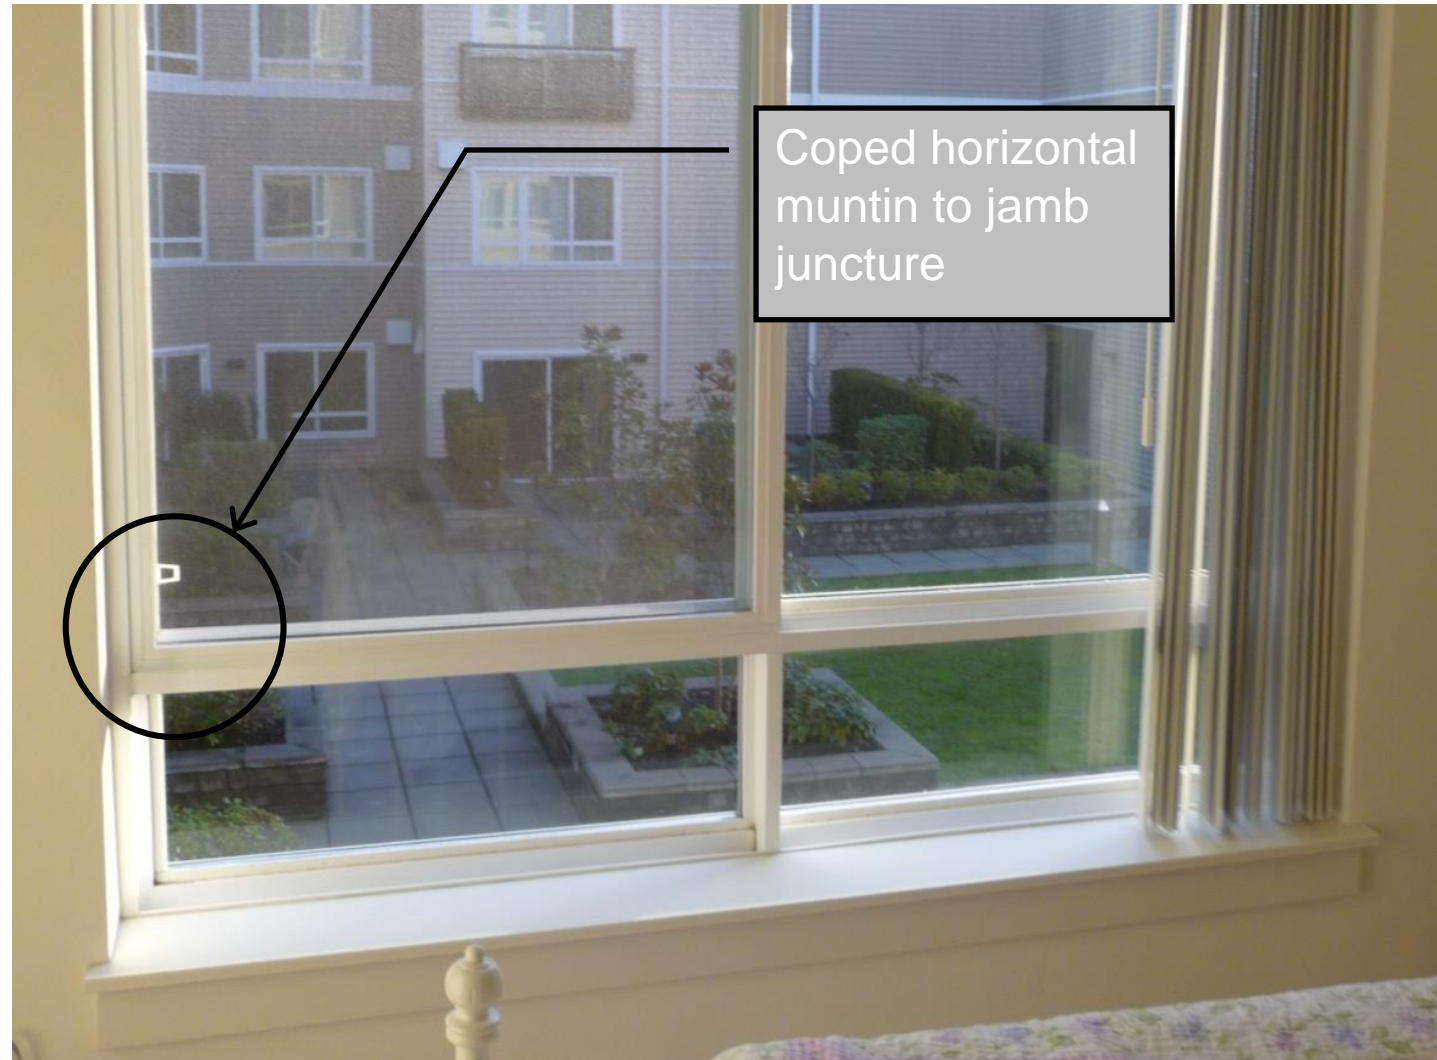
# Window Frame Joint Failure

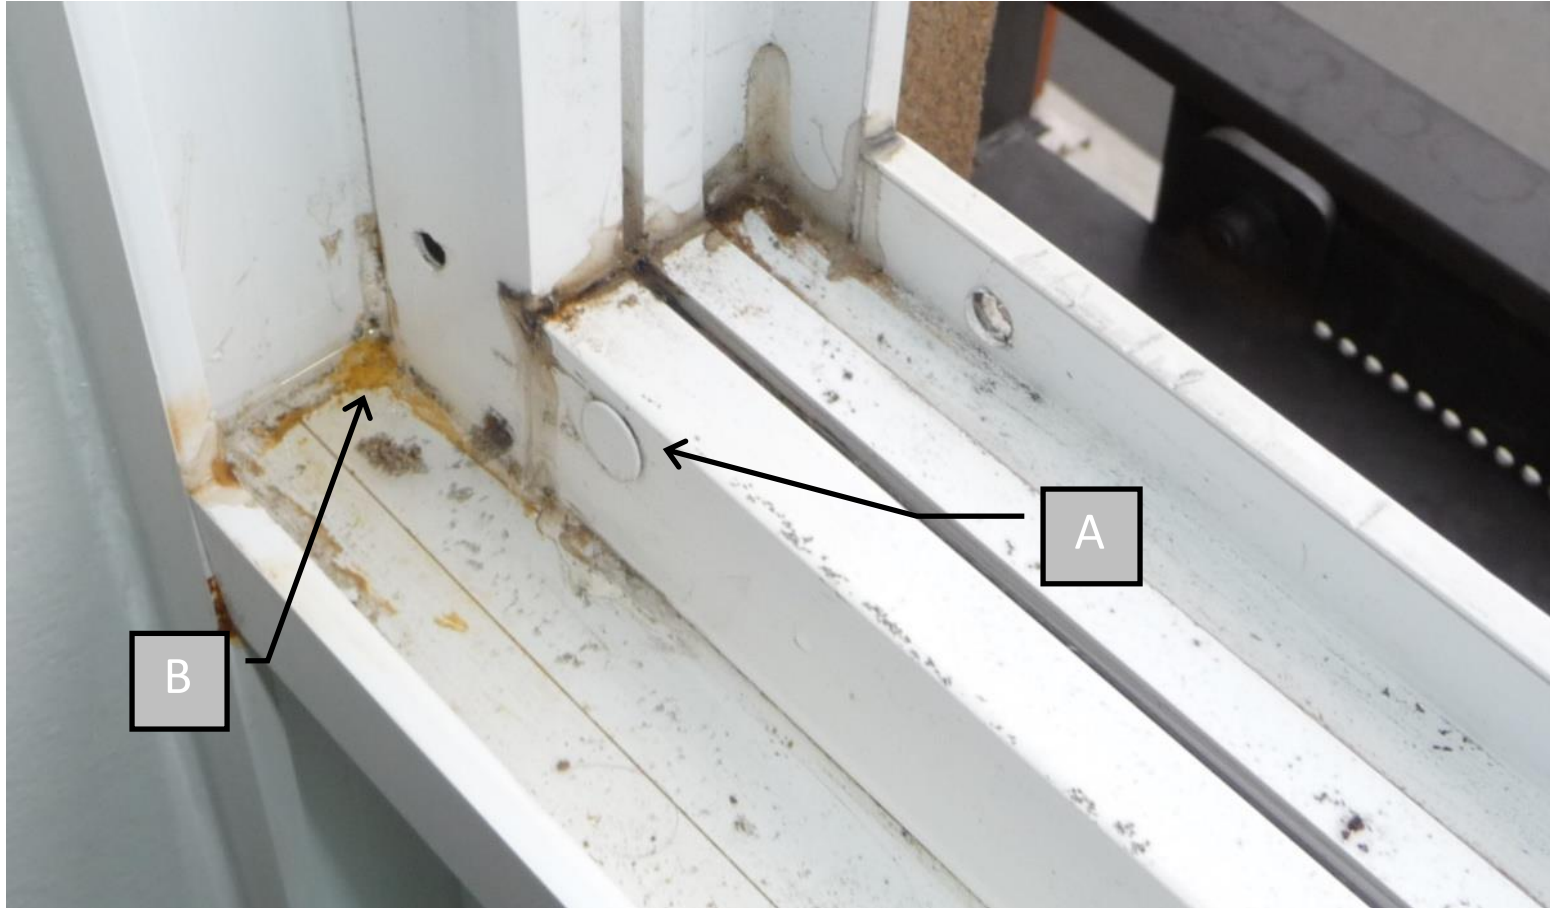
- A = Manufacturer attempted to seal leak by pumping foam at coped joint
- B = Clear silicone sealant, failed attempt to seal coped joint

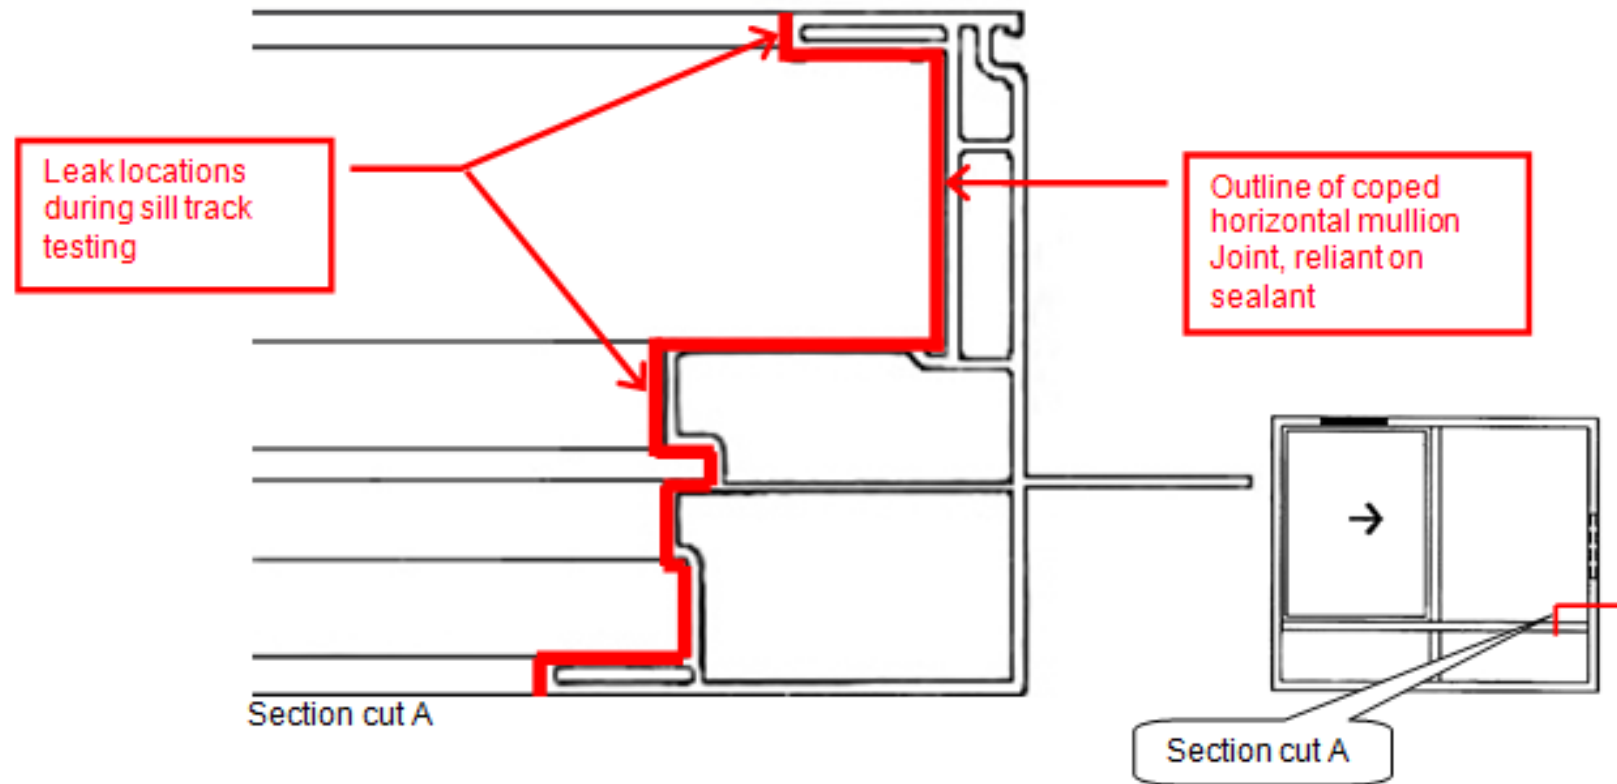
- The sealant-dependent coped joint in the horizontal mullion has failed and allows water to leak through this junction and accumulate in the lower fixed “dry” sill track, which is not designed to receive water.

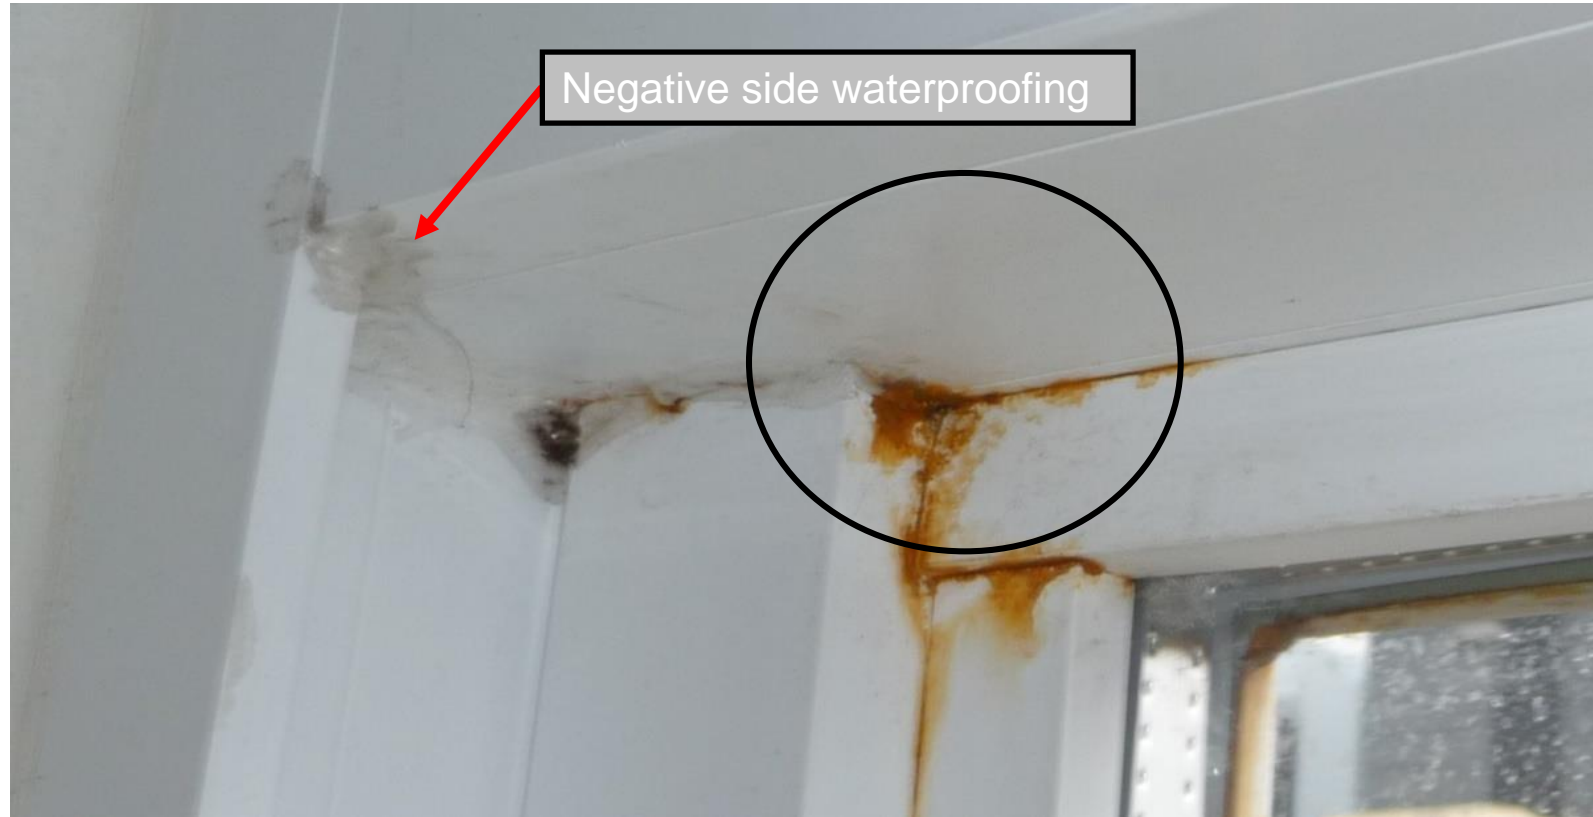
- Sealant installed at underside of coped horizontal-to-vertical mullion joint failed to stop the leak. The leaks are rust staining from the structural steel reinforcement

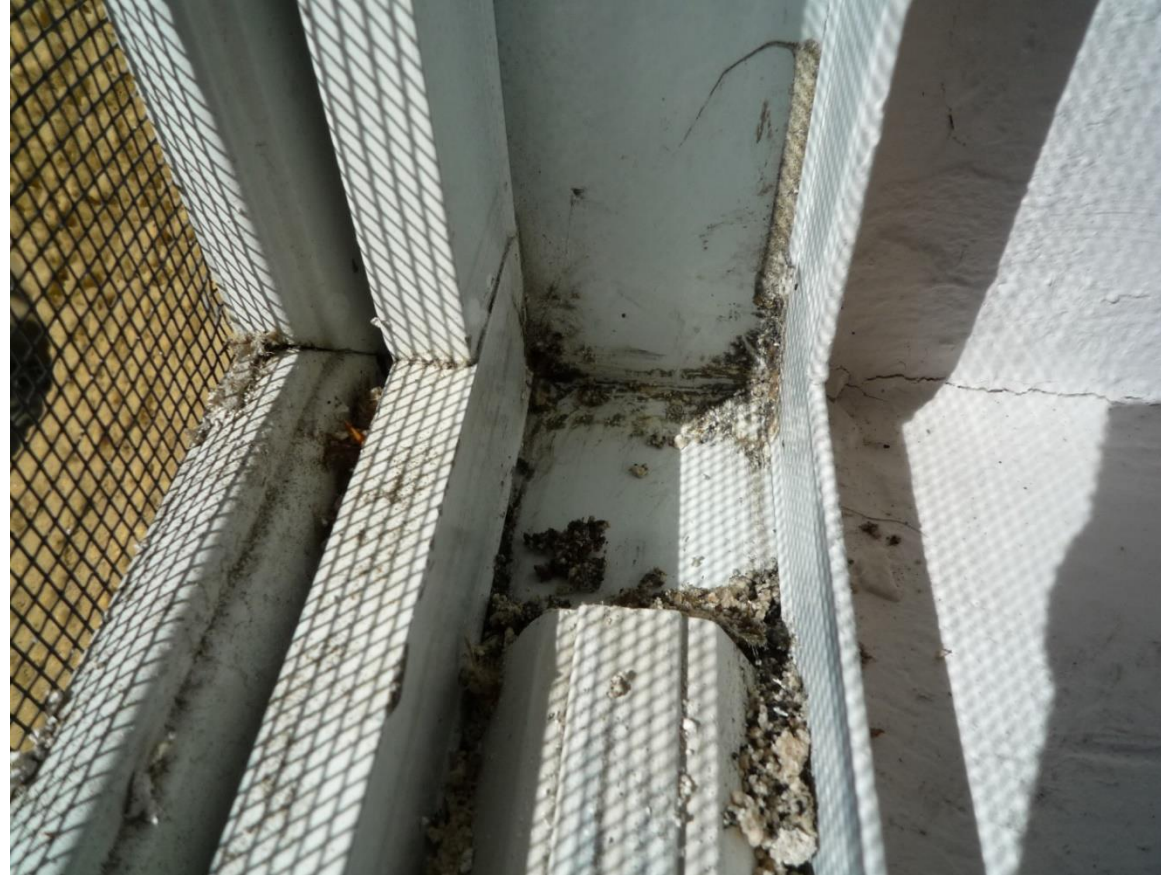
According to recent laboratory testing, the acrylic sealants are inherently not designed for the window frames and can revert to a tacky state due to chemical degradation. These sealants are not recommended where water immersion will occur

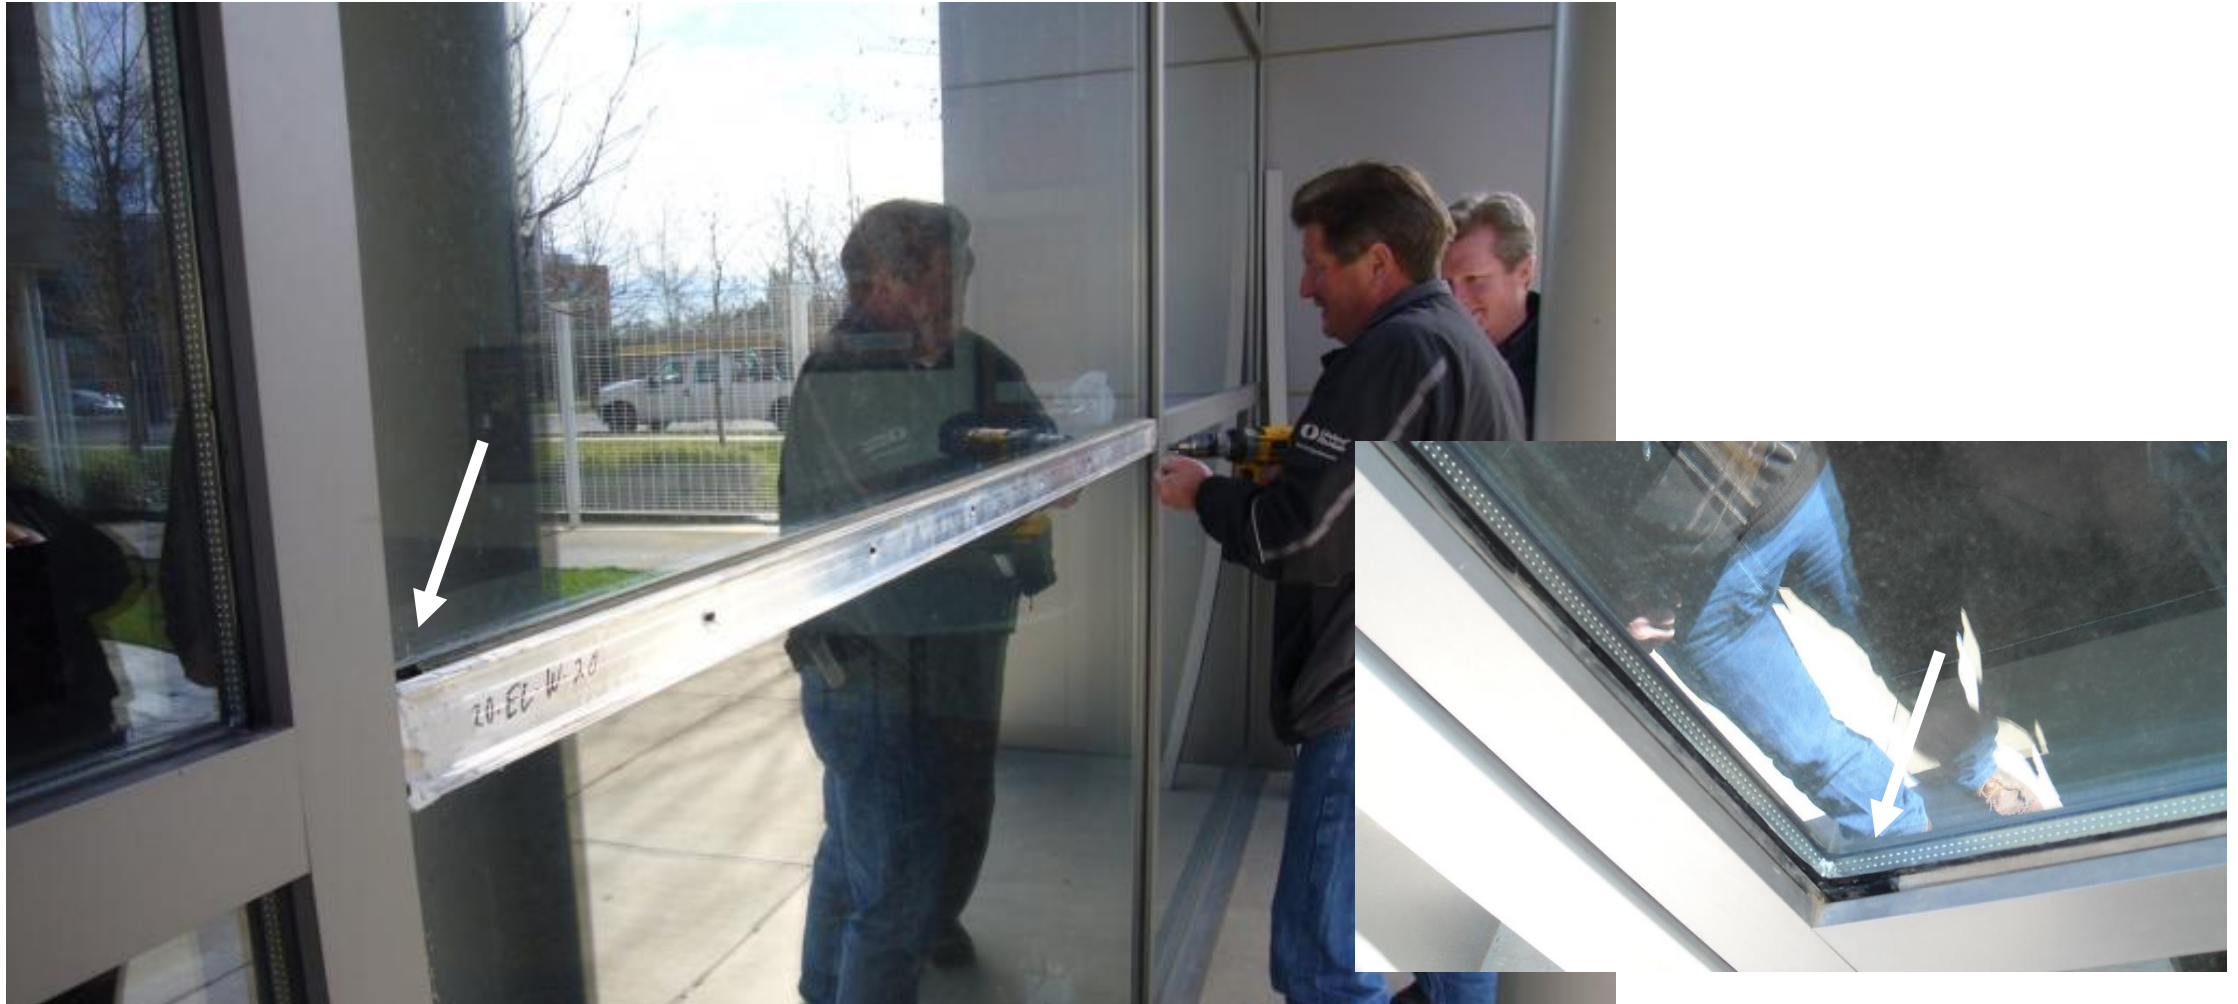
# Gasket Shrinkage / Failure

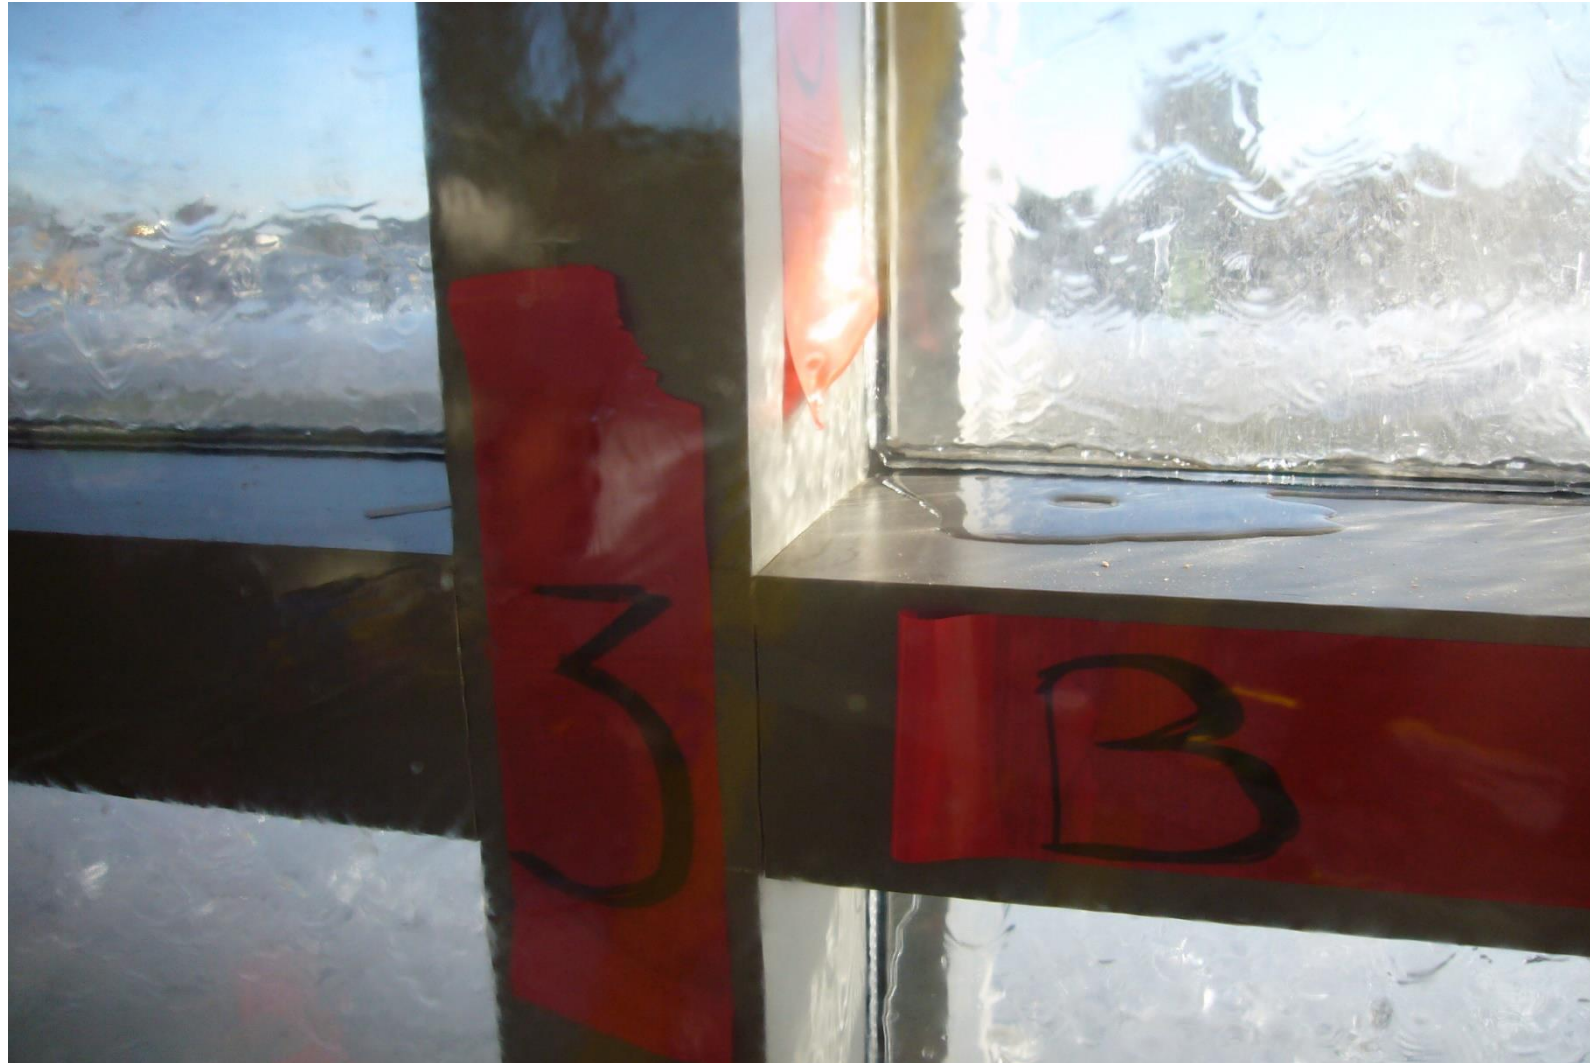
# Gasket Shrinkage Can Cause Leaks

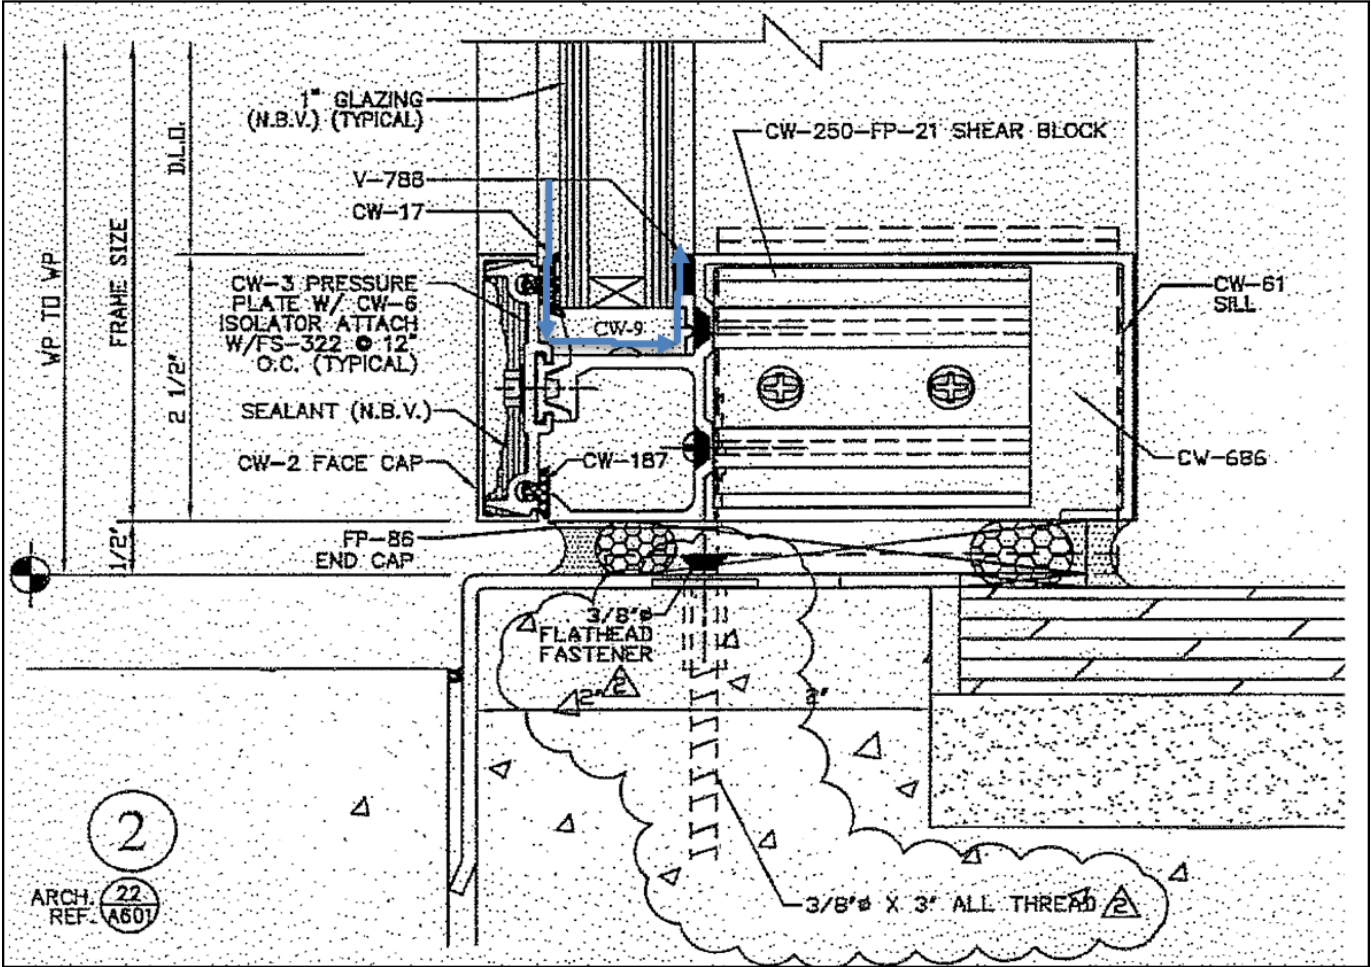
15/16" glazing installed produces a loose seal and leaks

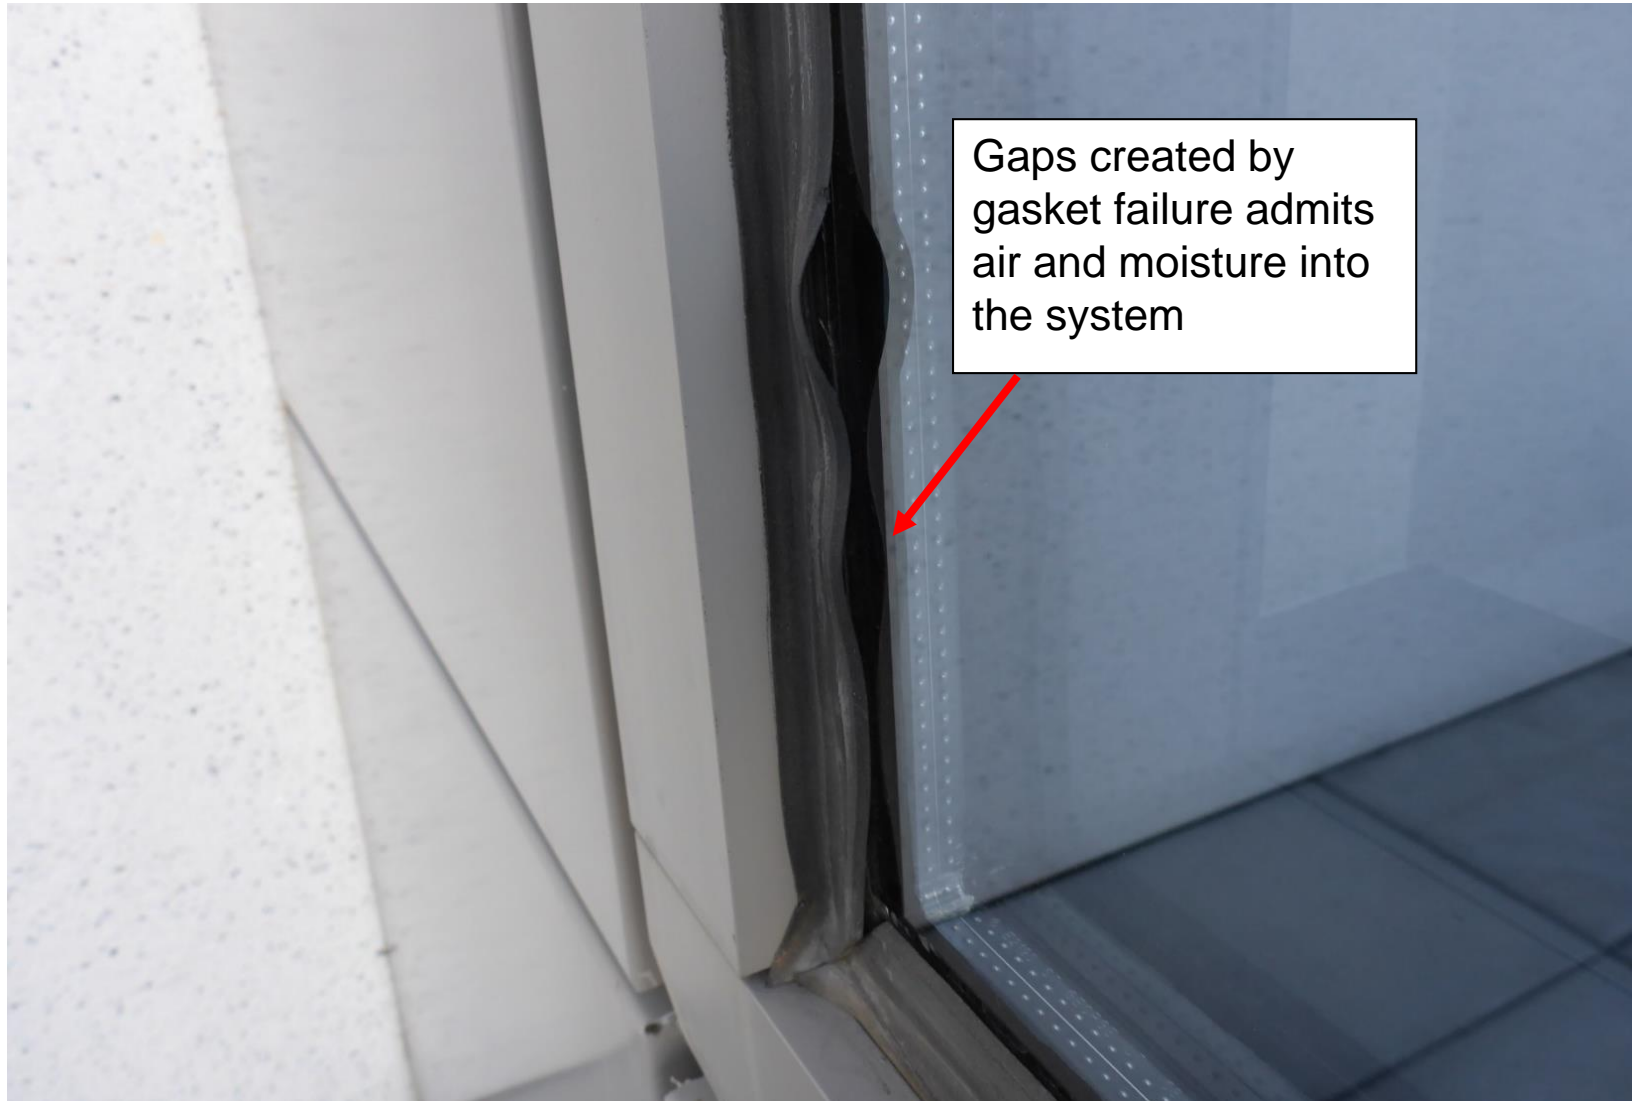
Gaps created by gasket failure admits air and moisture into the system

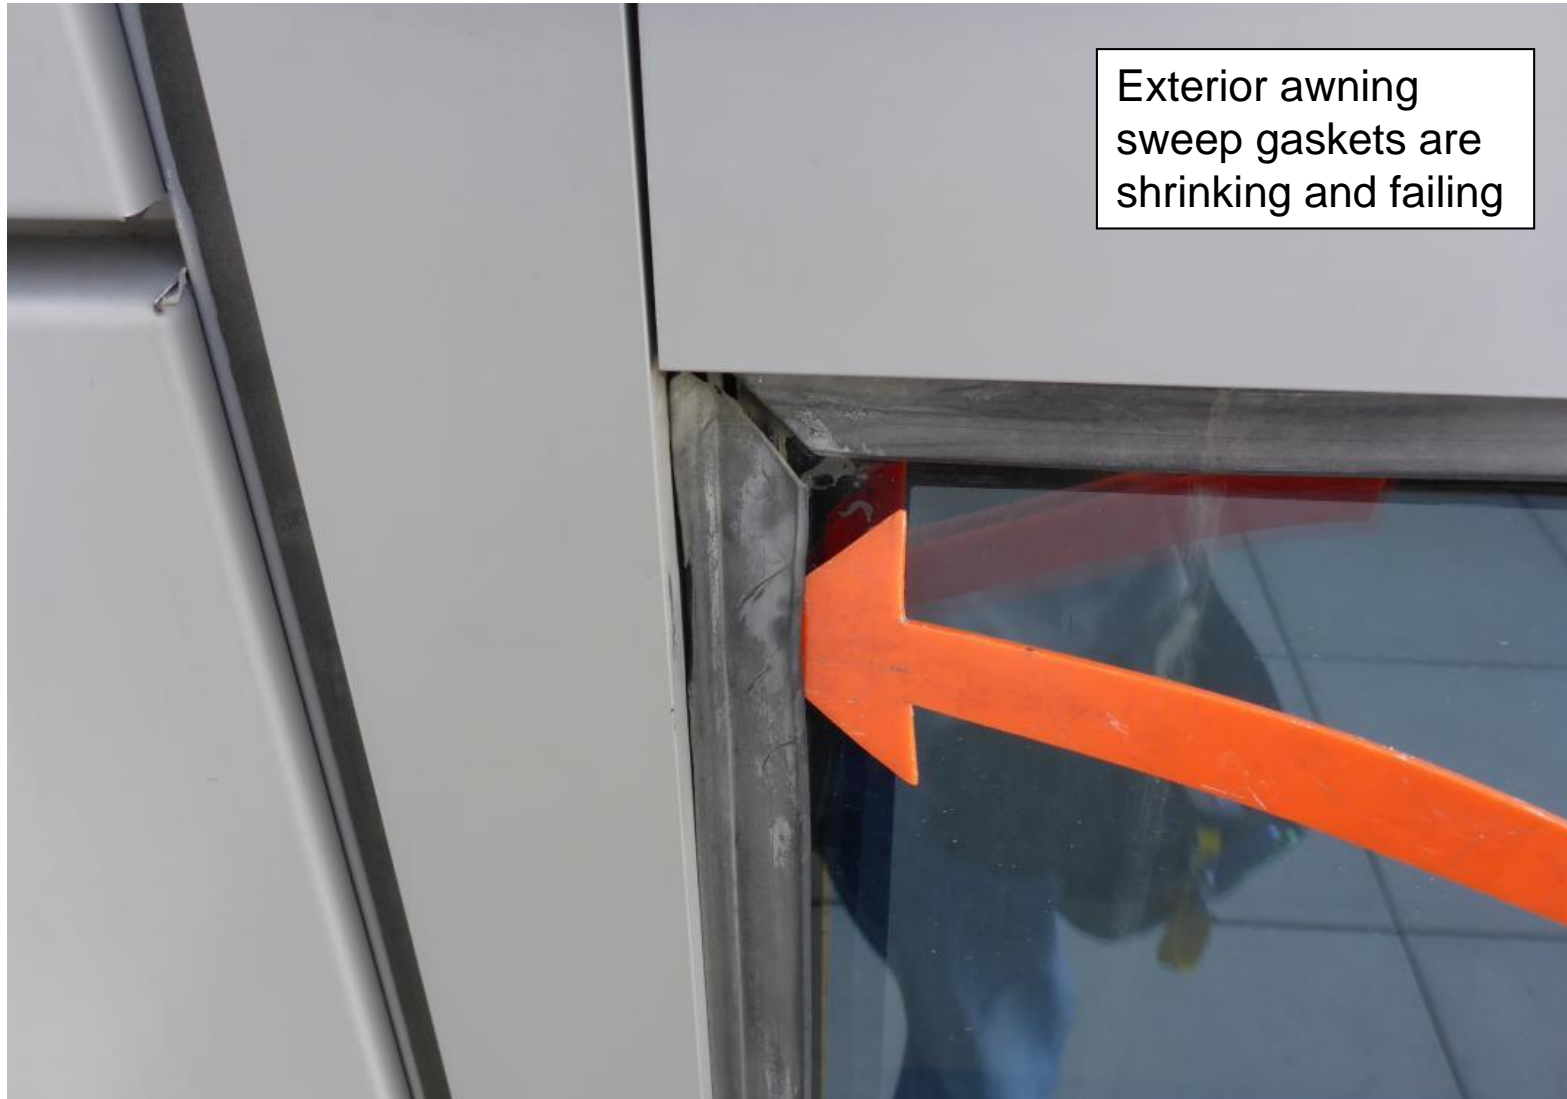
# Gasket Failure Shrinking and Split Corner

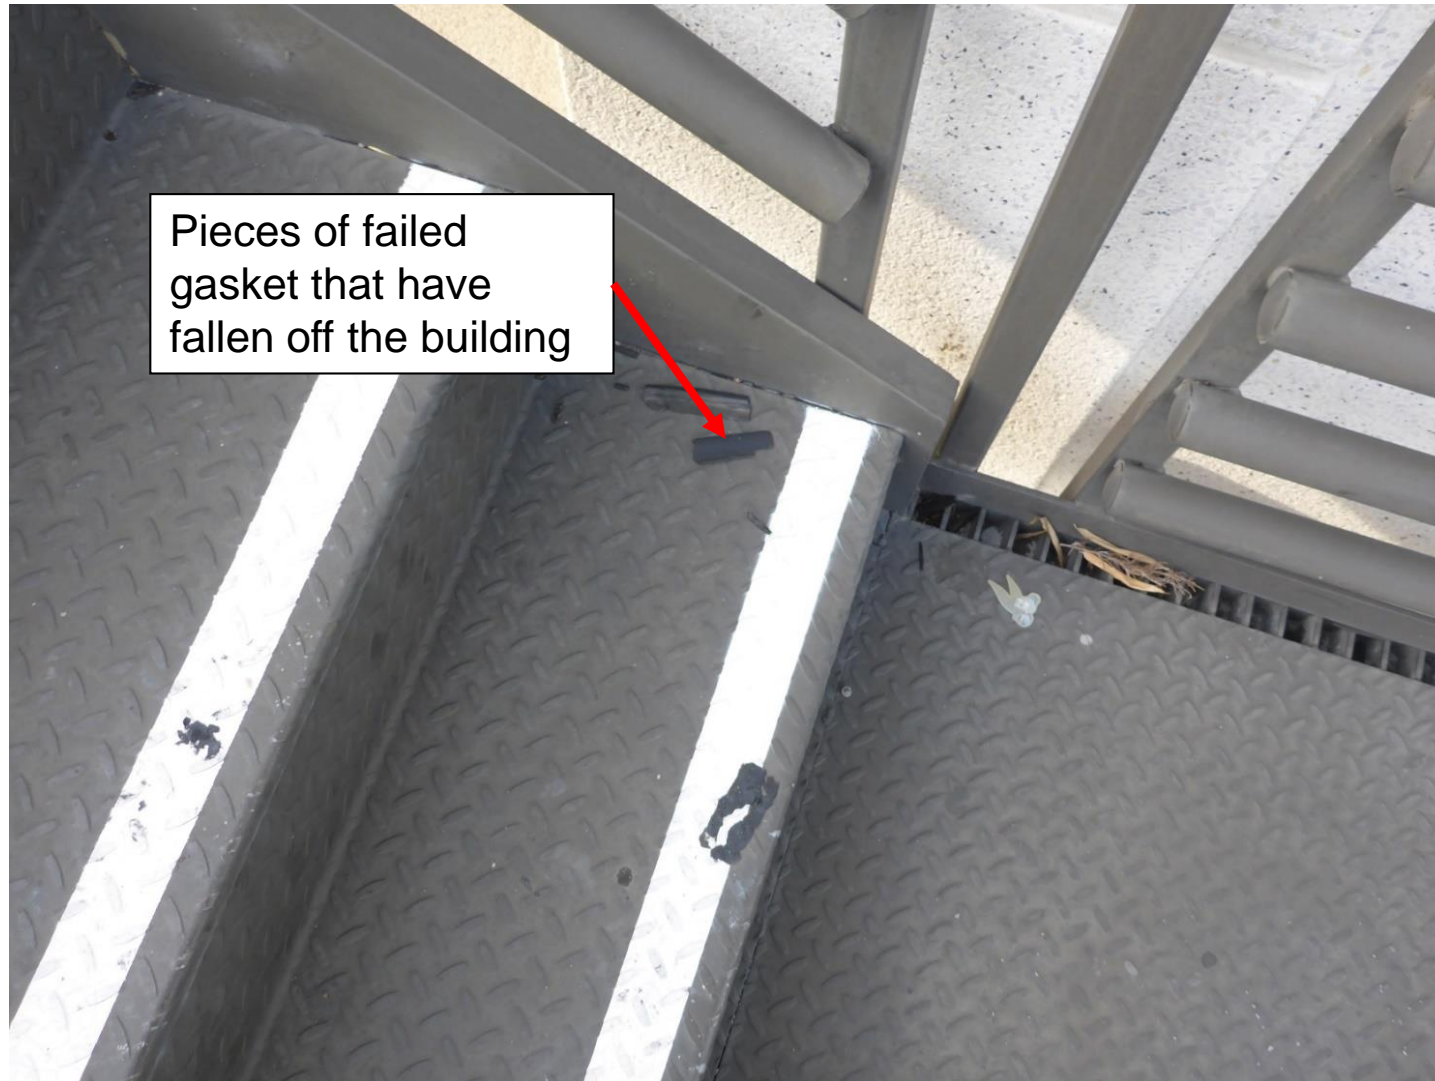
# Gasket Failure- Fallen and Melted Into Stair

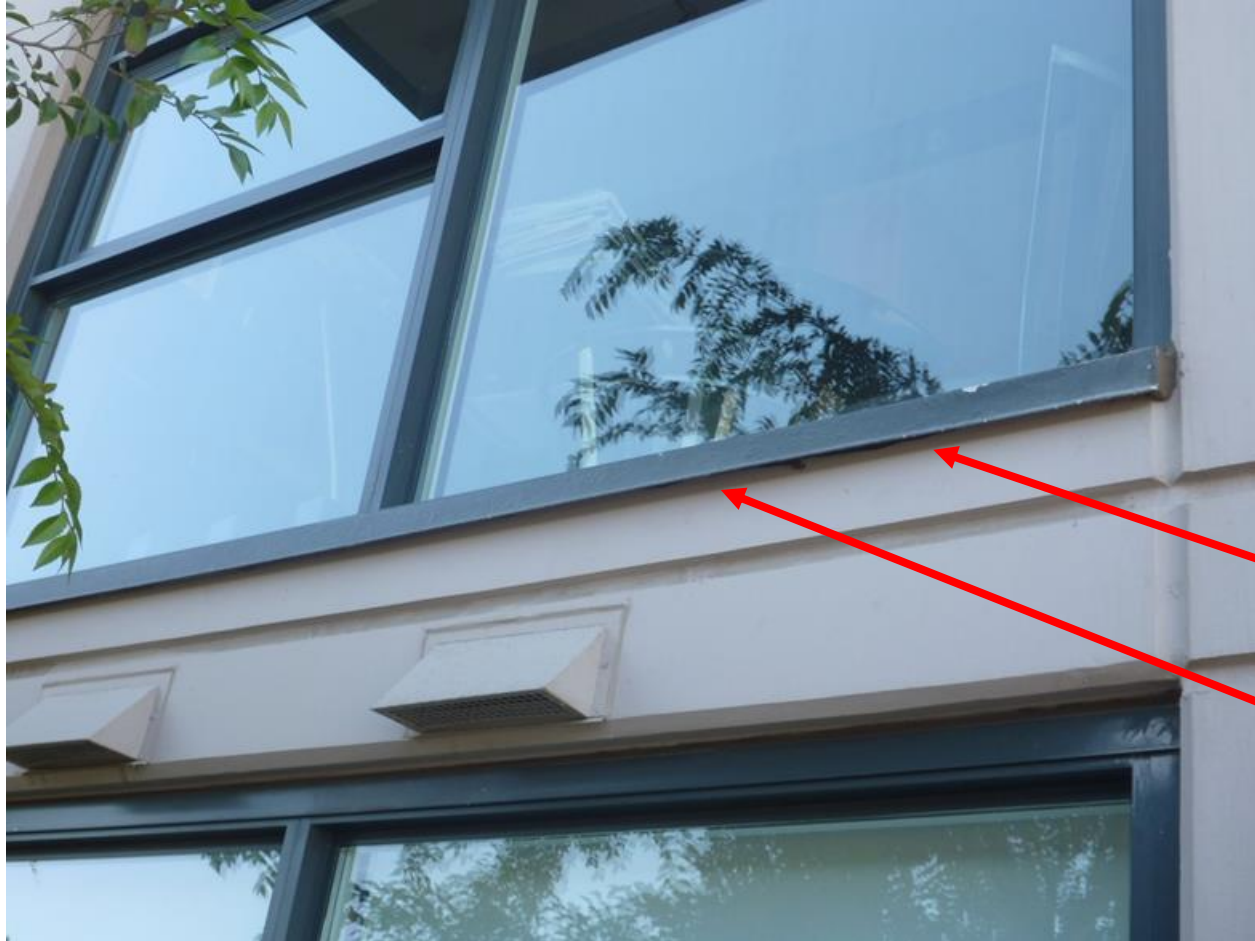
Coating is blistering on window sill flashings
