# Understanding Common Roofing Issues & Replacement Options

Allana Buick & Bers, Inc.

# Understanding Common Glazing Issues & Replacement Options

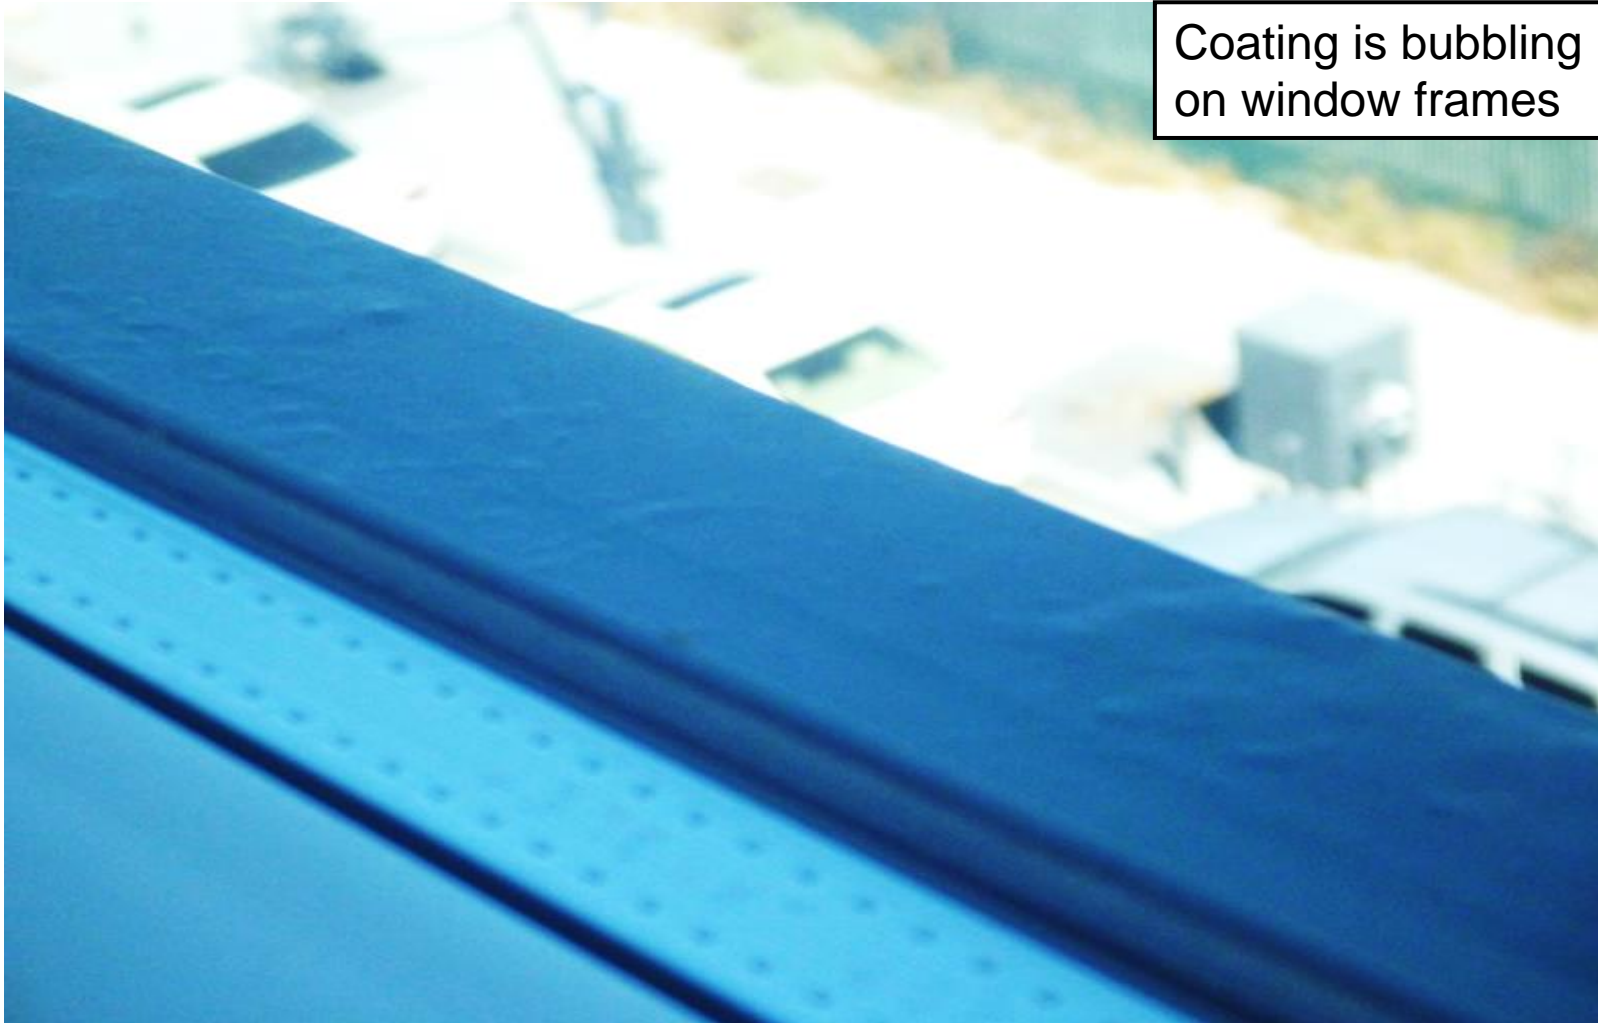
Coating is bubbling on window frames

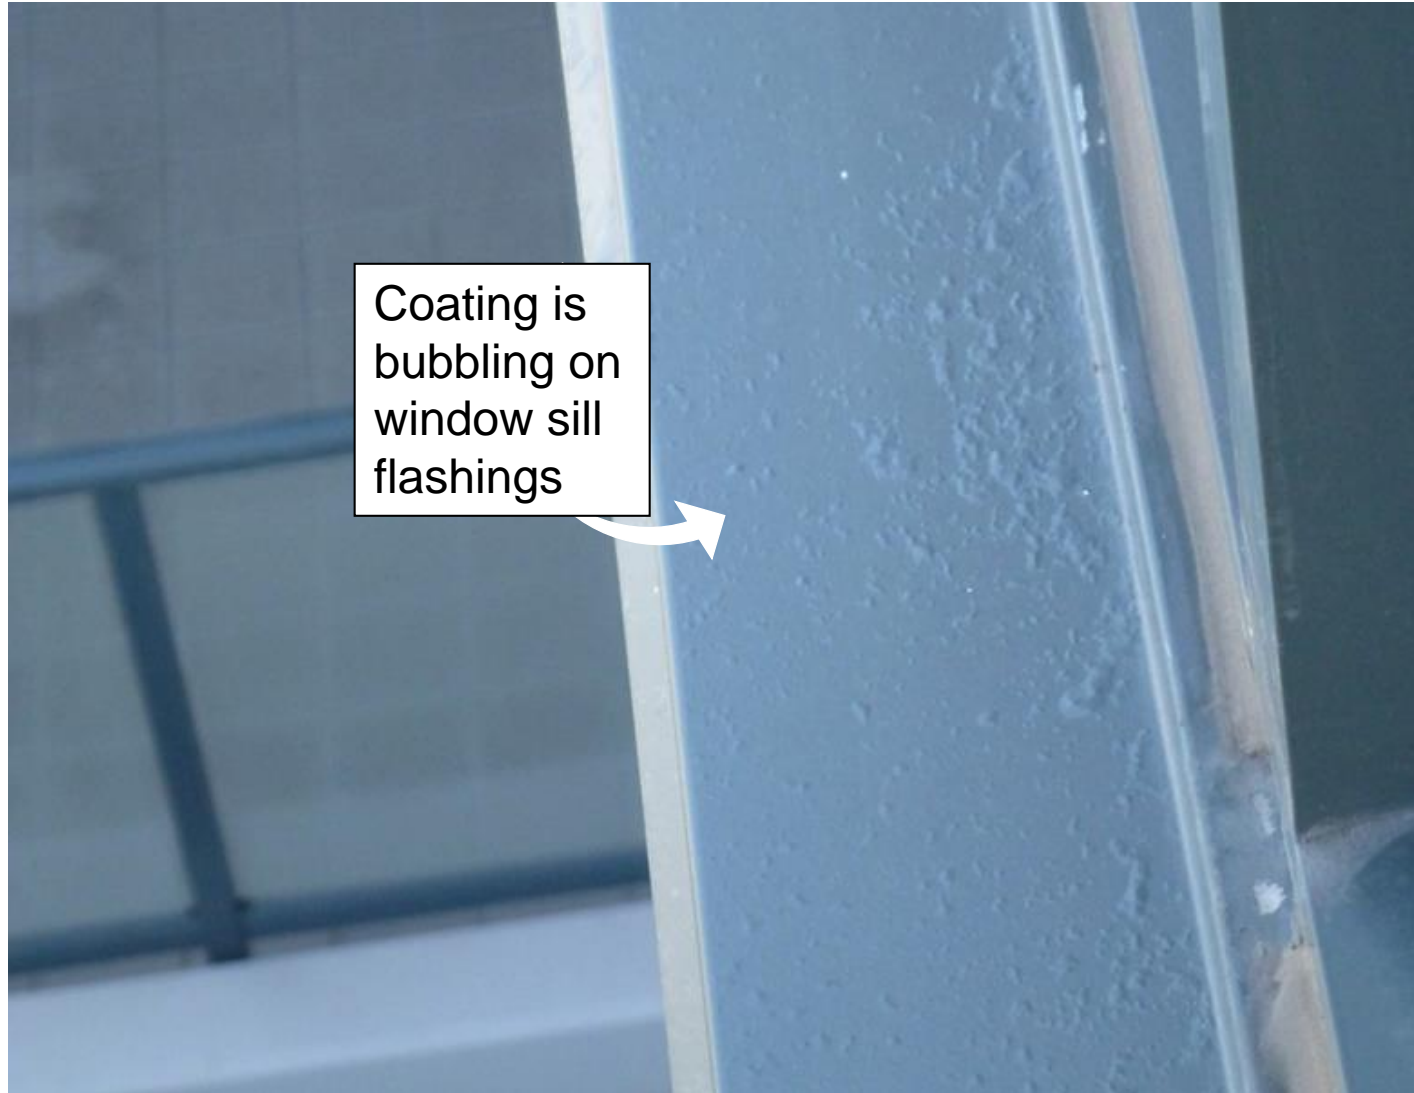
Coating is  
bubbling on  
window sill  
flashings

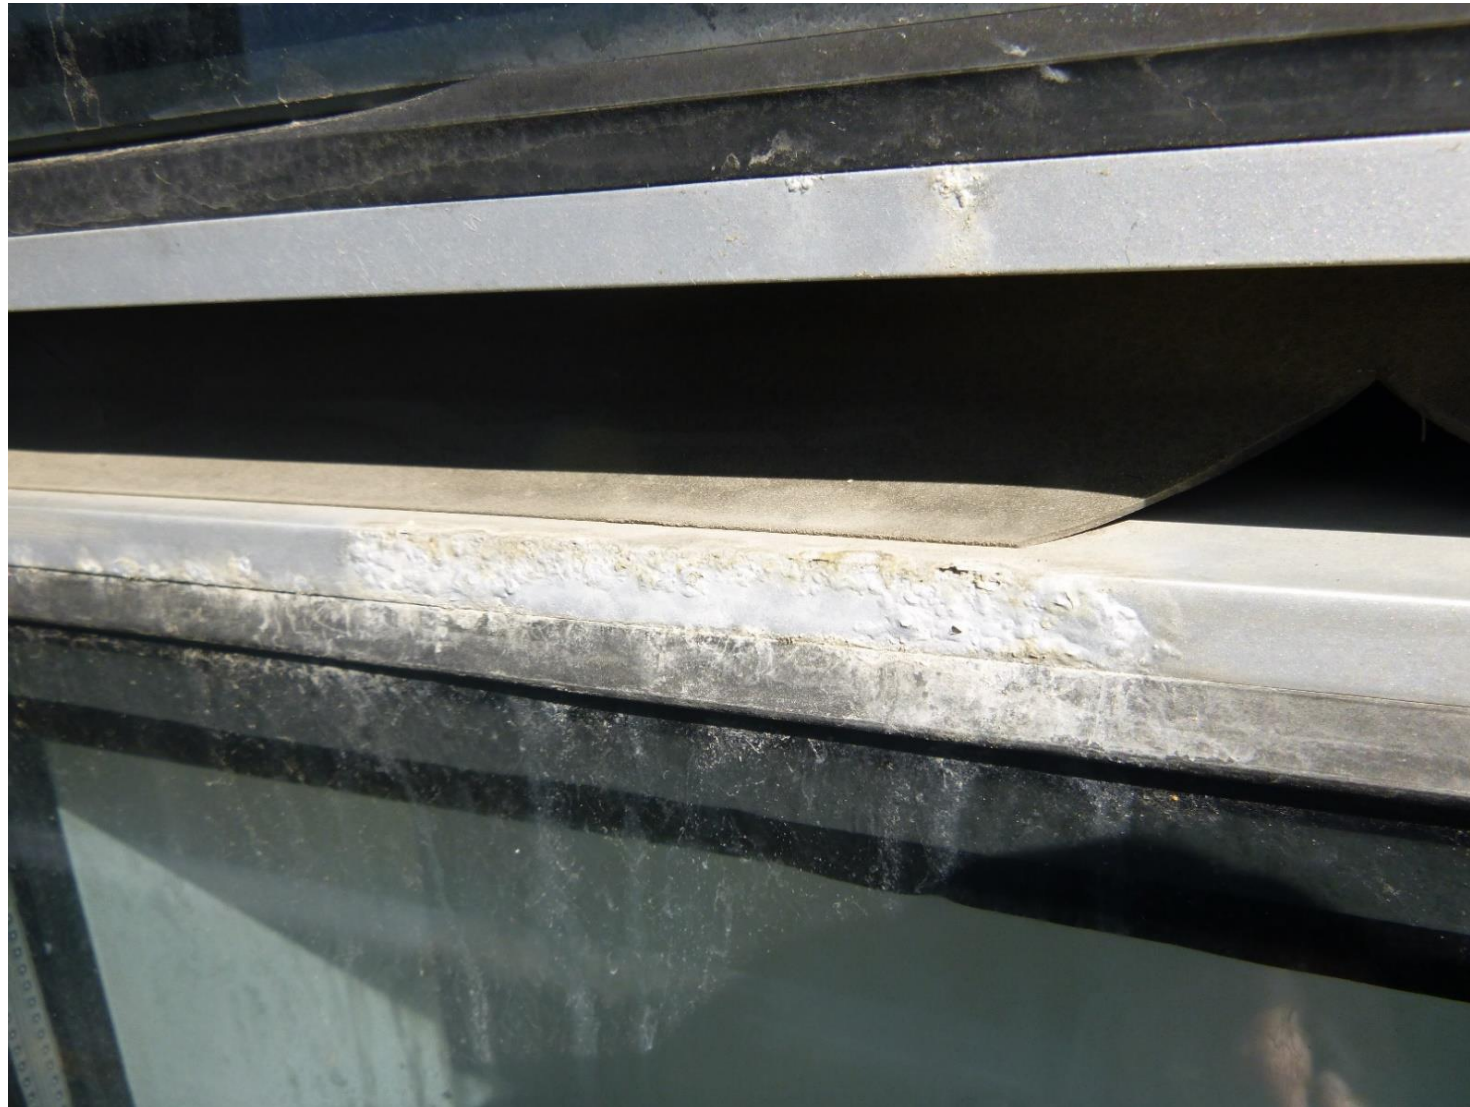
# Coating Failure Advanced to Pitting
