Roofing and Waterproofing Seminar CSI Las Vegas

Karim P. Allana, P.E., RRC, RWC
President, Allana Buick & Bers, Inc.

March 13, 2007

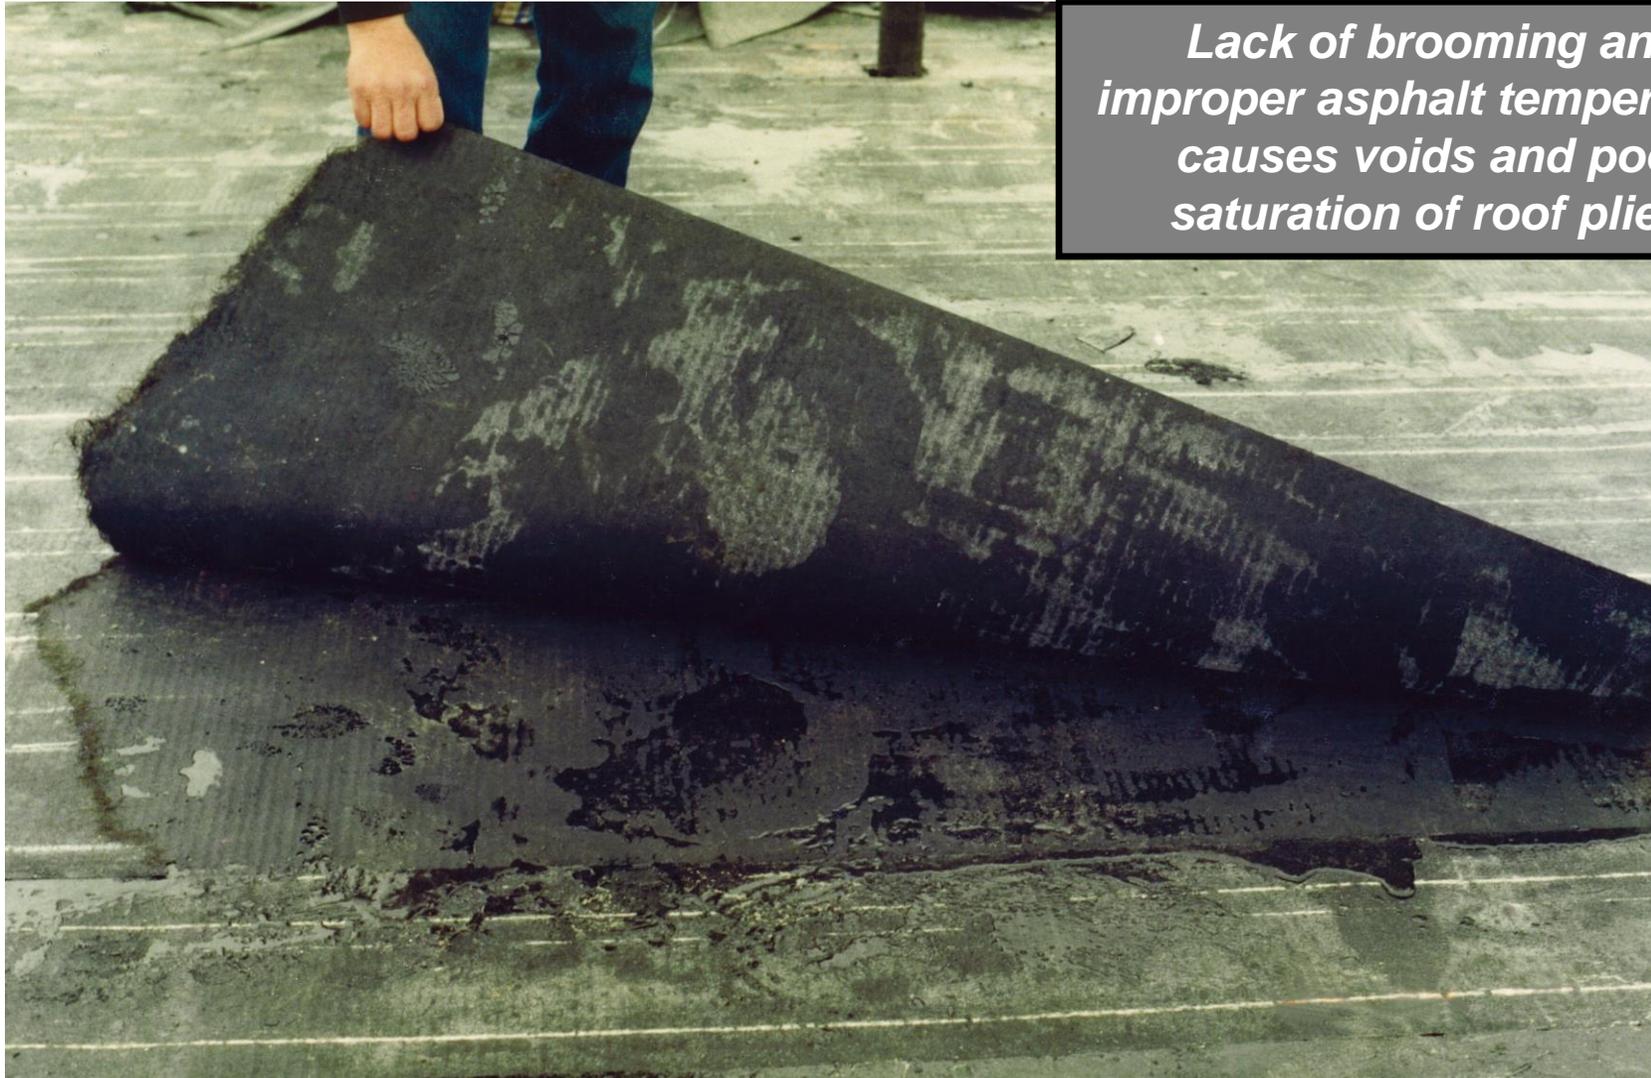
Lack of brooming and improper asphalt temperature causes voids and poor saturation of roof plies.

Improper application of primer couple with lack of sufficient nails, are the leading causes of leaks at sheet metal flashings.

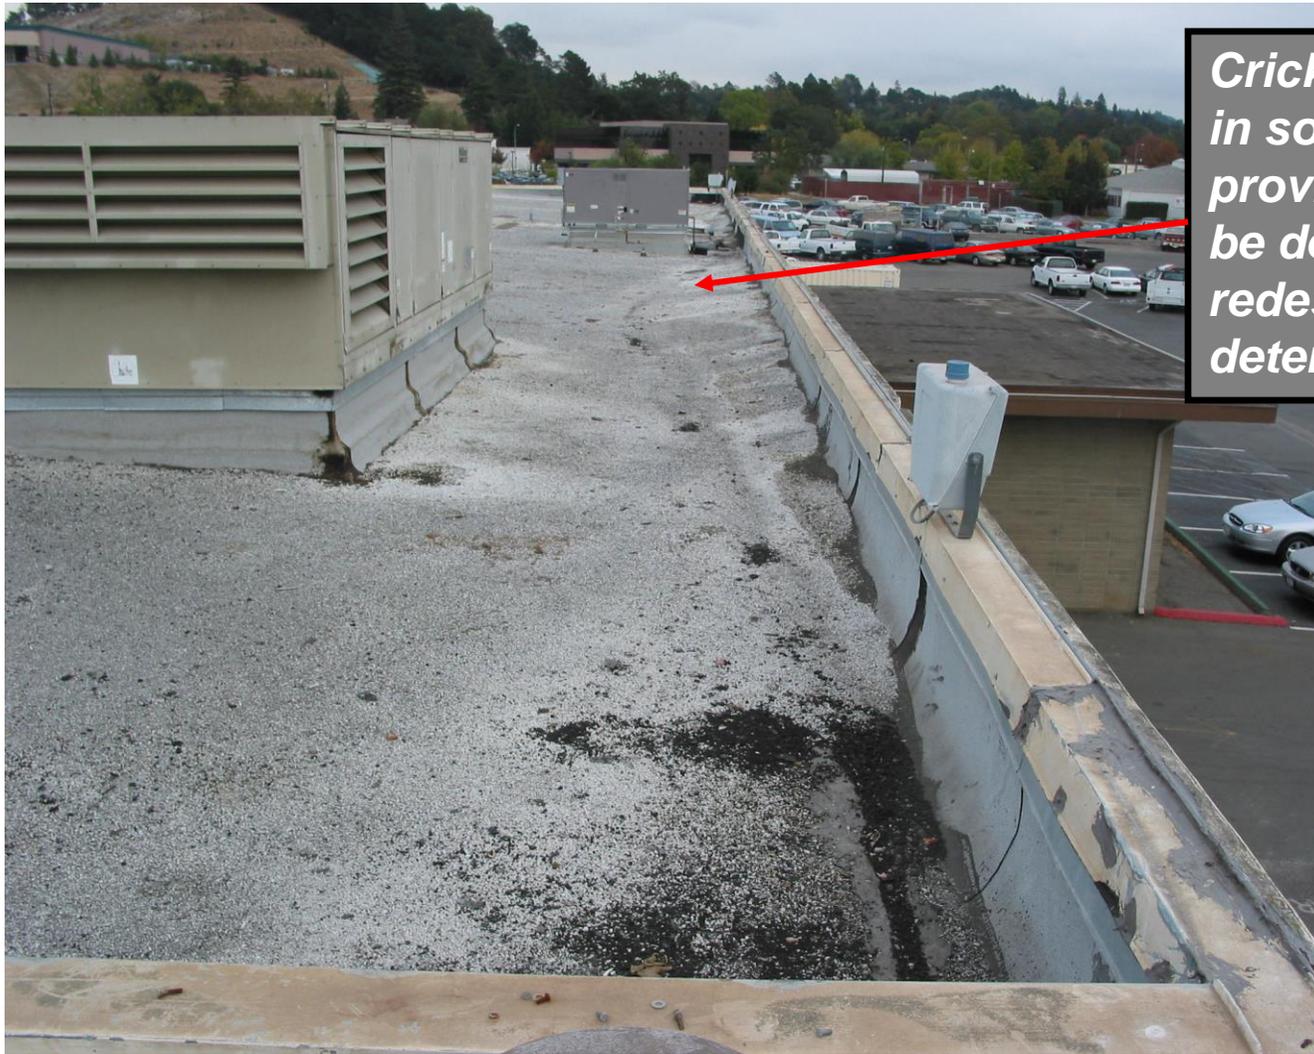
Cricket is undersized in some locations, or not provided at all. Need to be deeper and redesigned. Note deterioration.

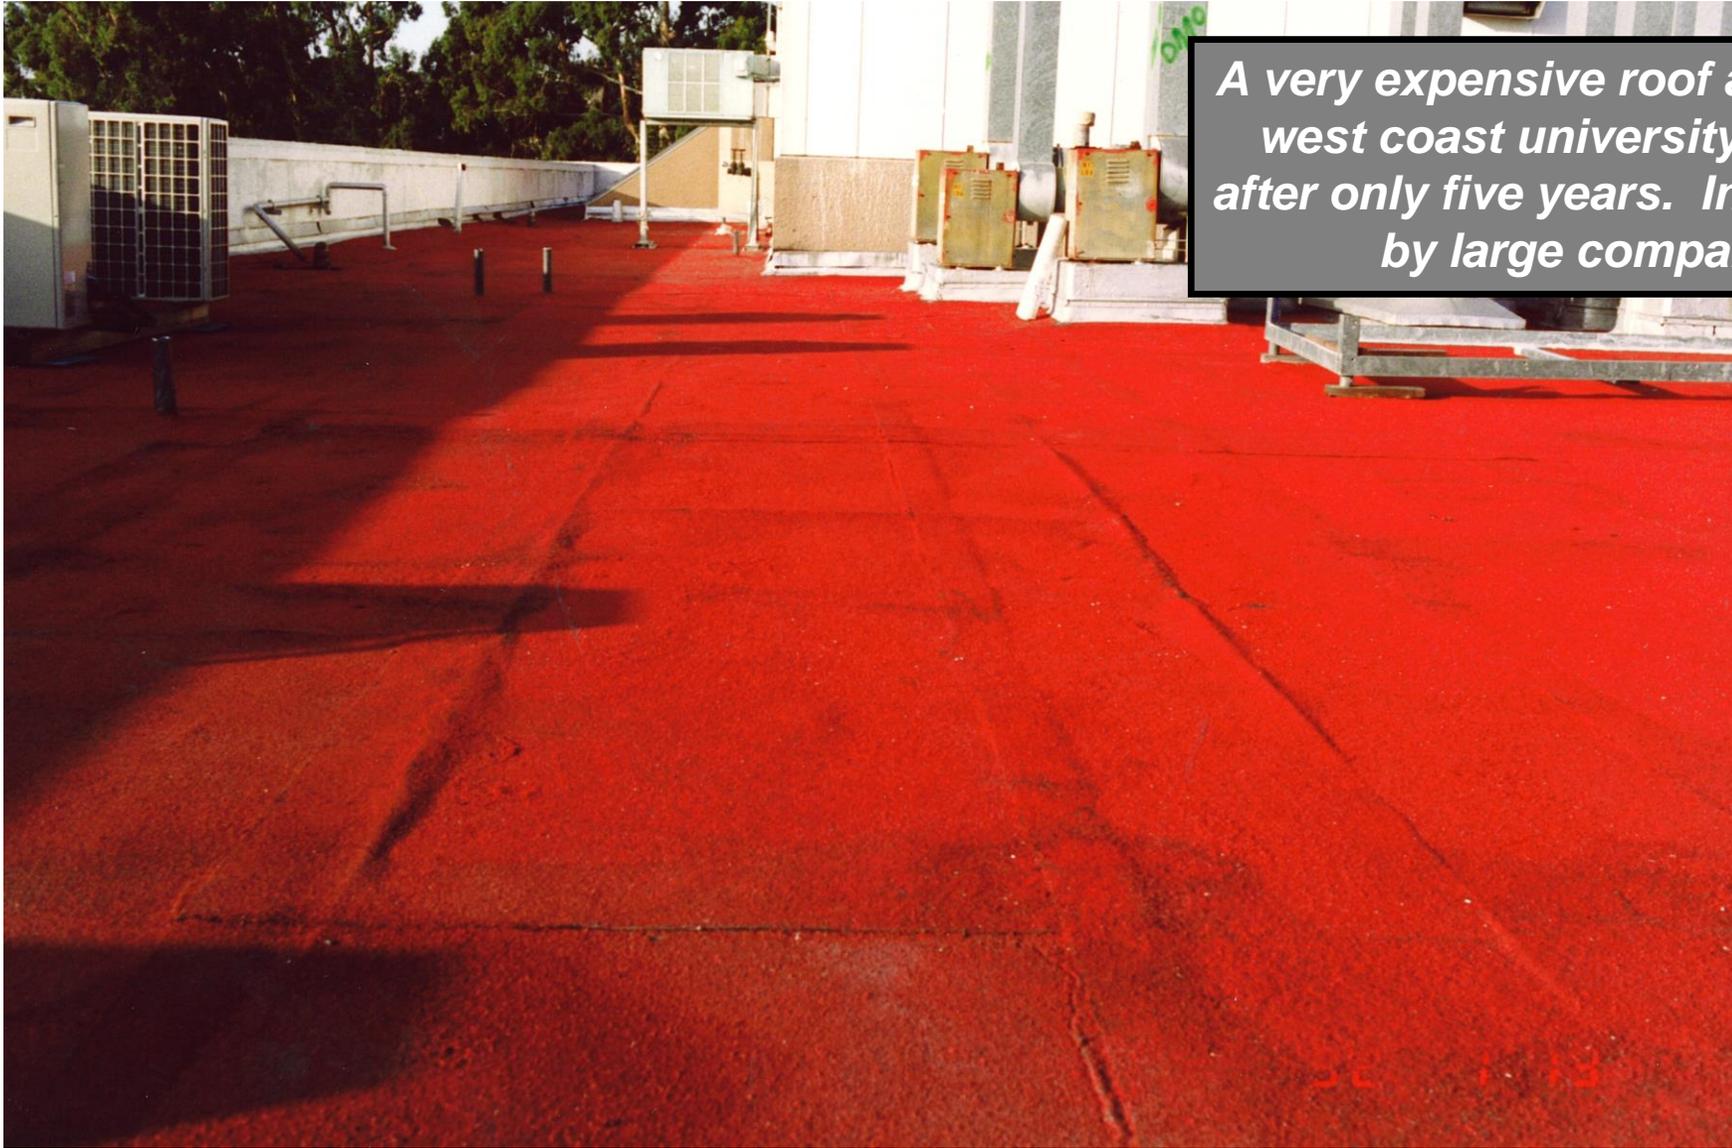
A very expensive roof at a major west coast university, failing after only five years. Installation by large company

Inappropriate fasteners, poorly secured insulation boards, resulted in cupping of boards and ridging.

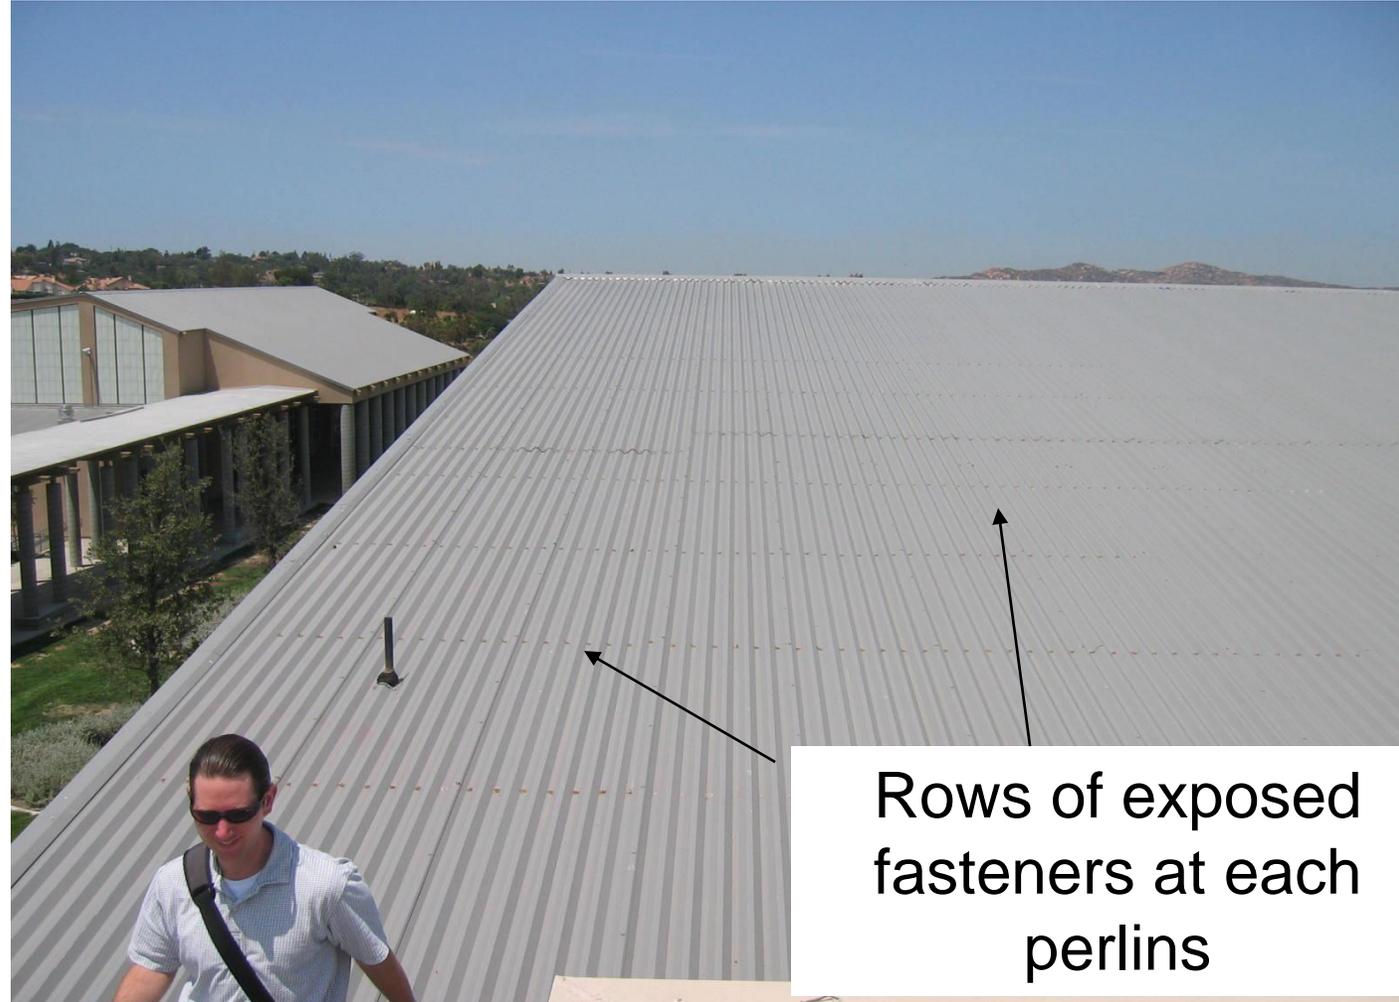
Thermal movement causes exposed fasteners to back out. Fastener back-out is a huge issue over wood framed buildings.

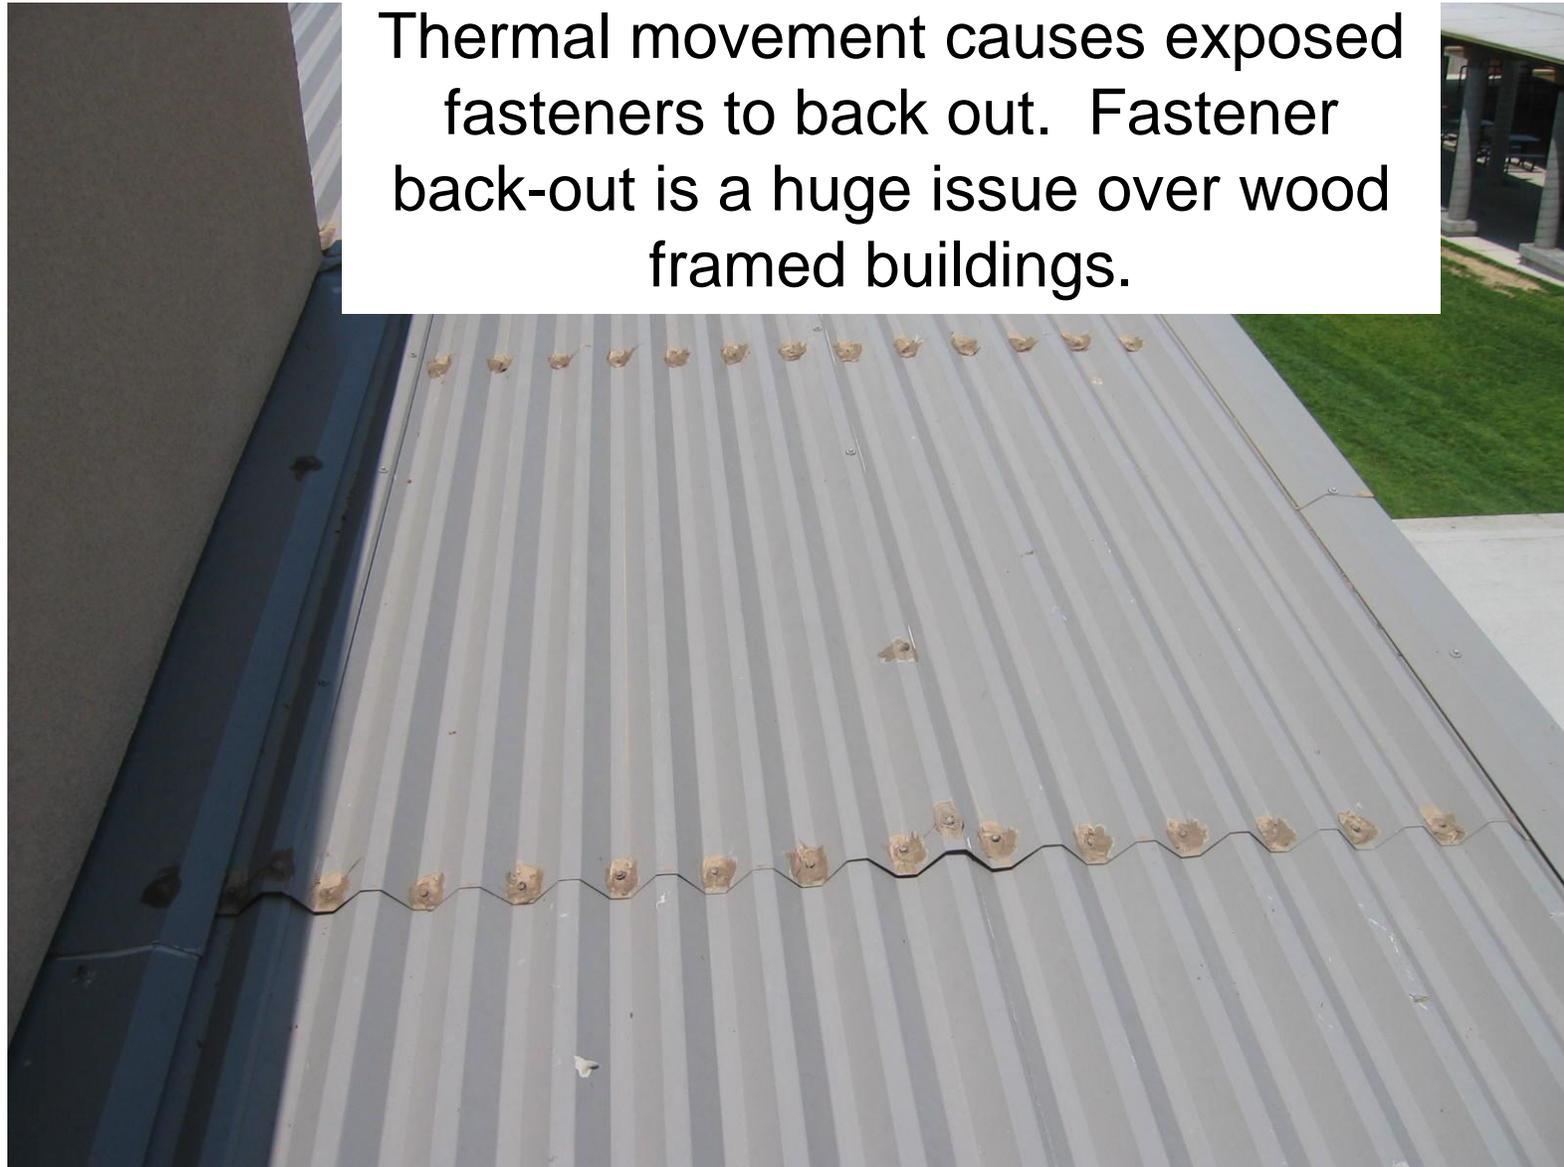
Water Test for Exposed Fastener Leakage

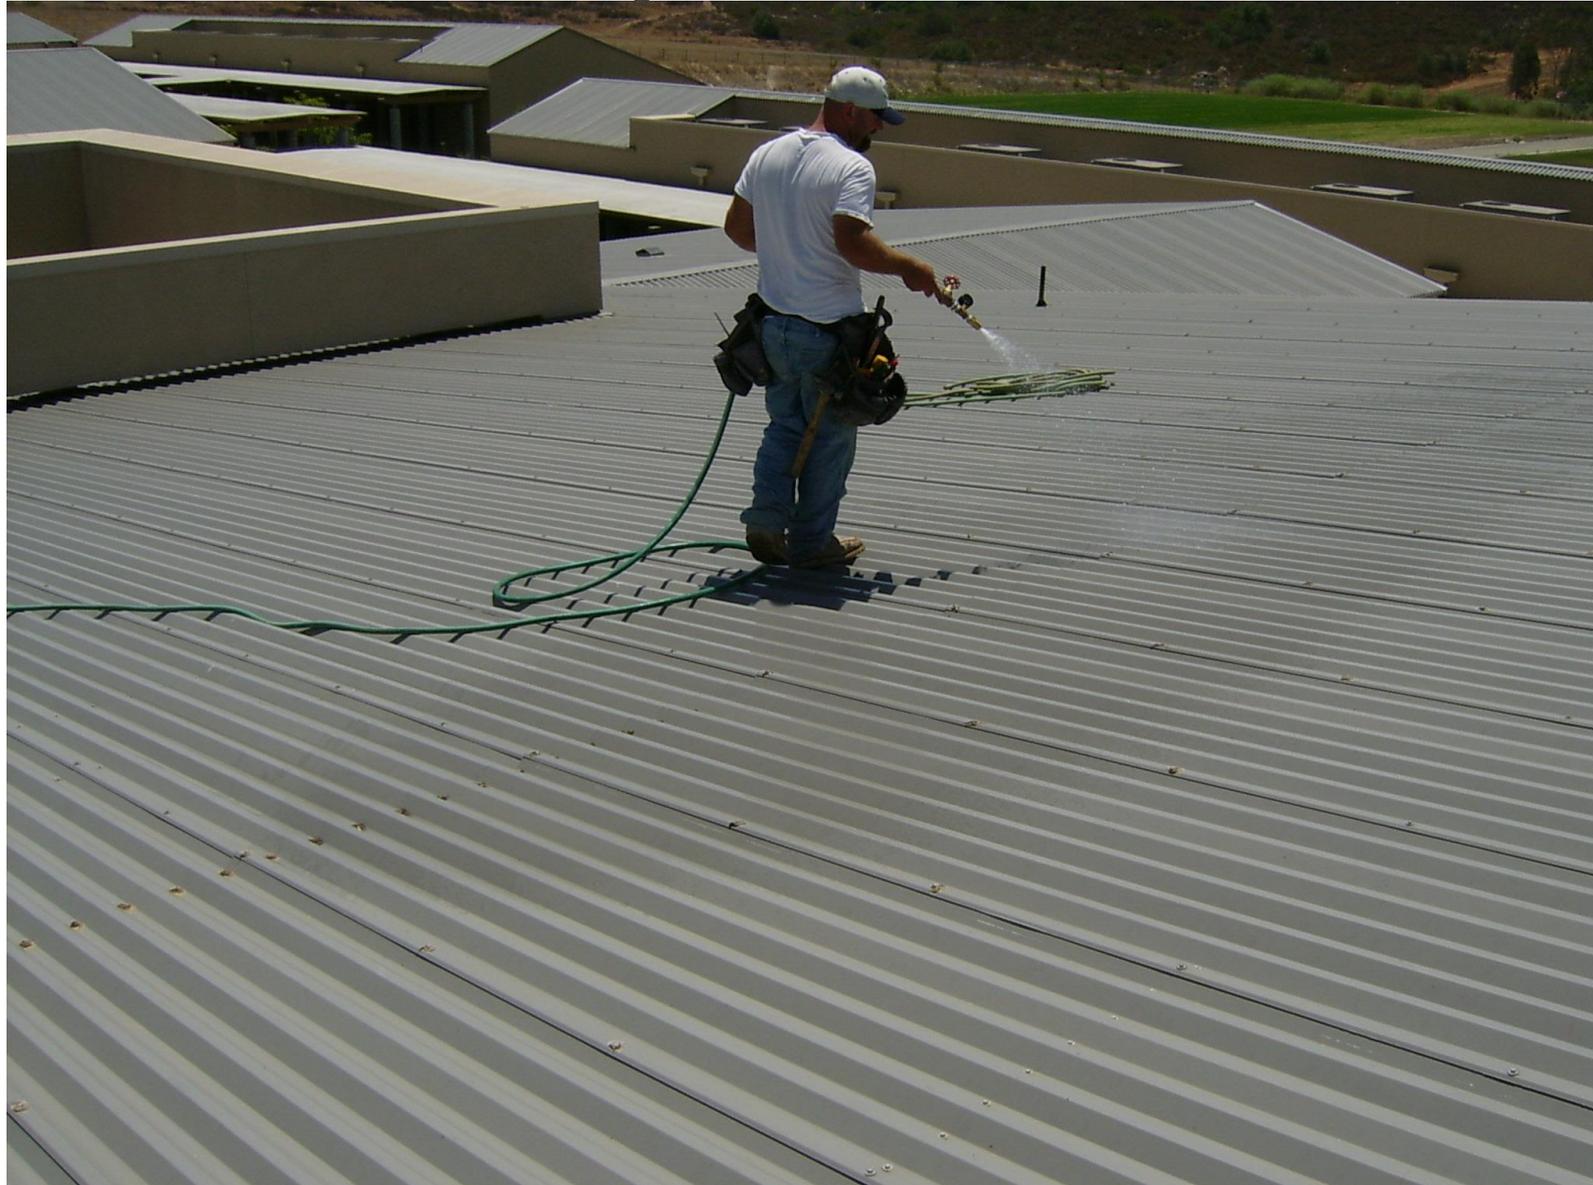
Fastener Leaks

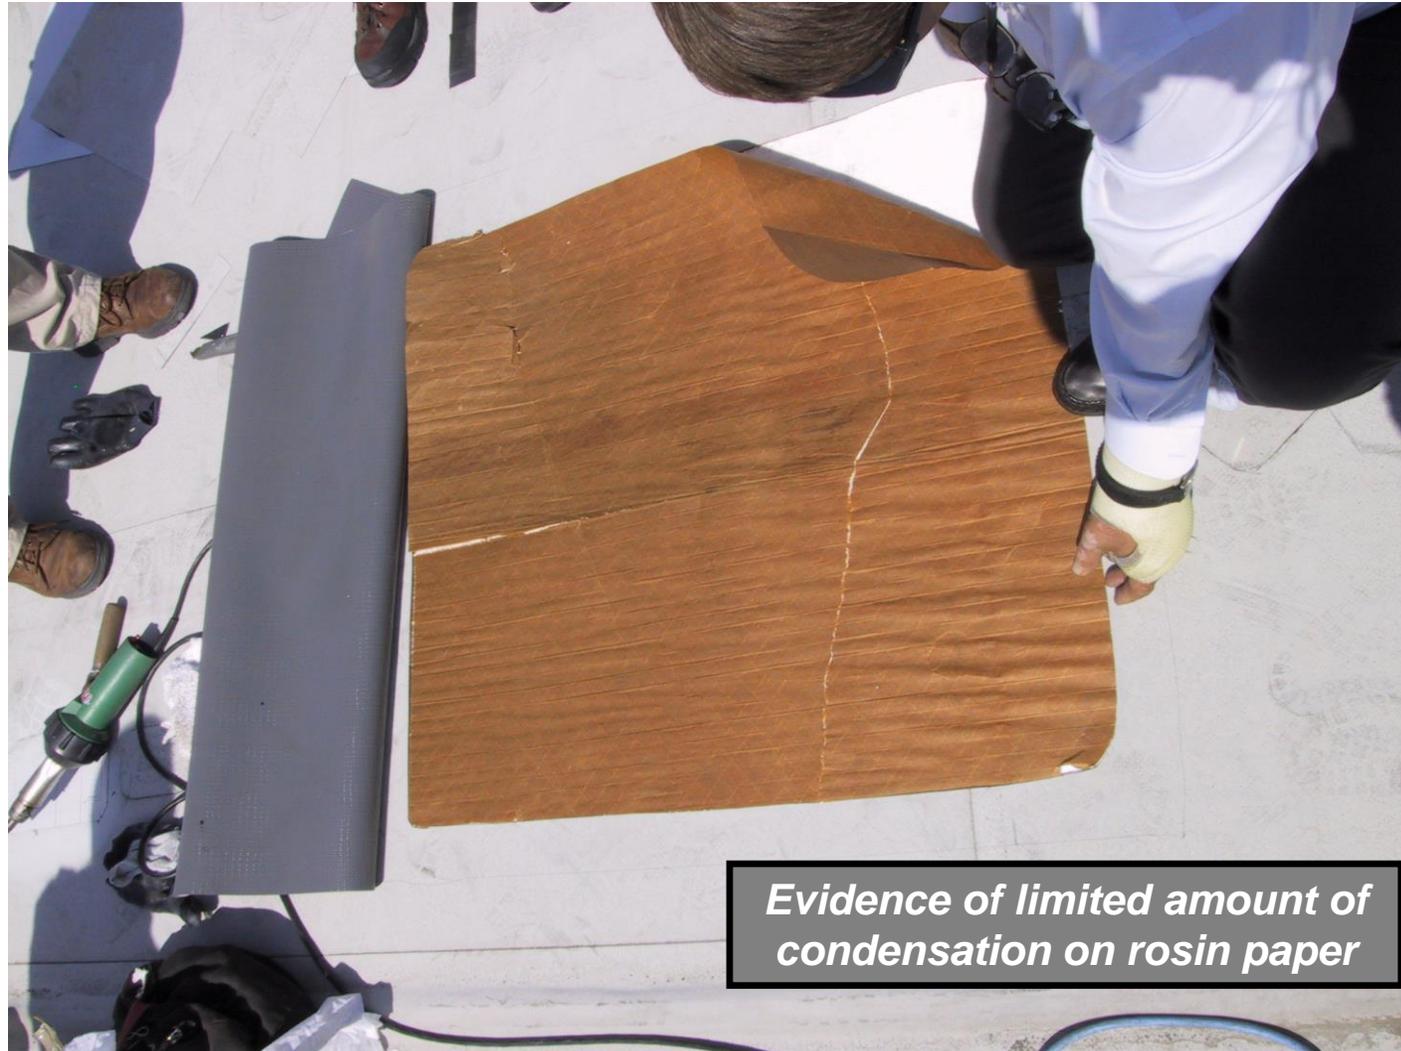
Evidence of limited amount of condensation on rosin paper

*Mechanical bar fastener in
excellent condition*

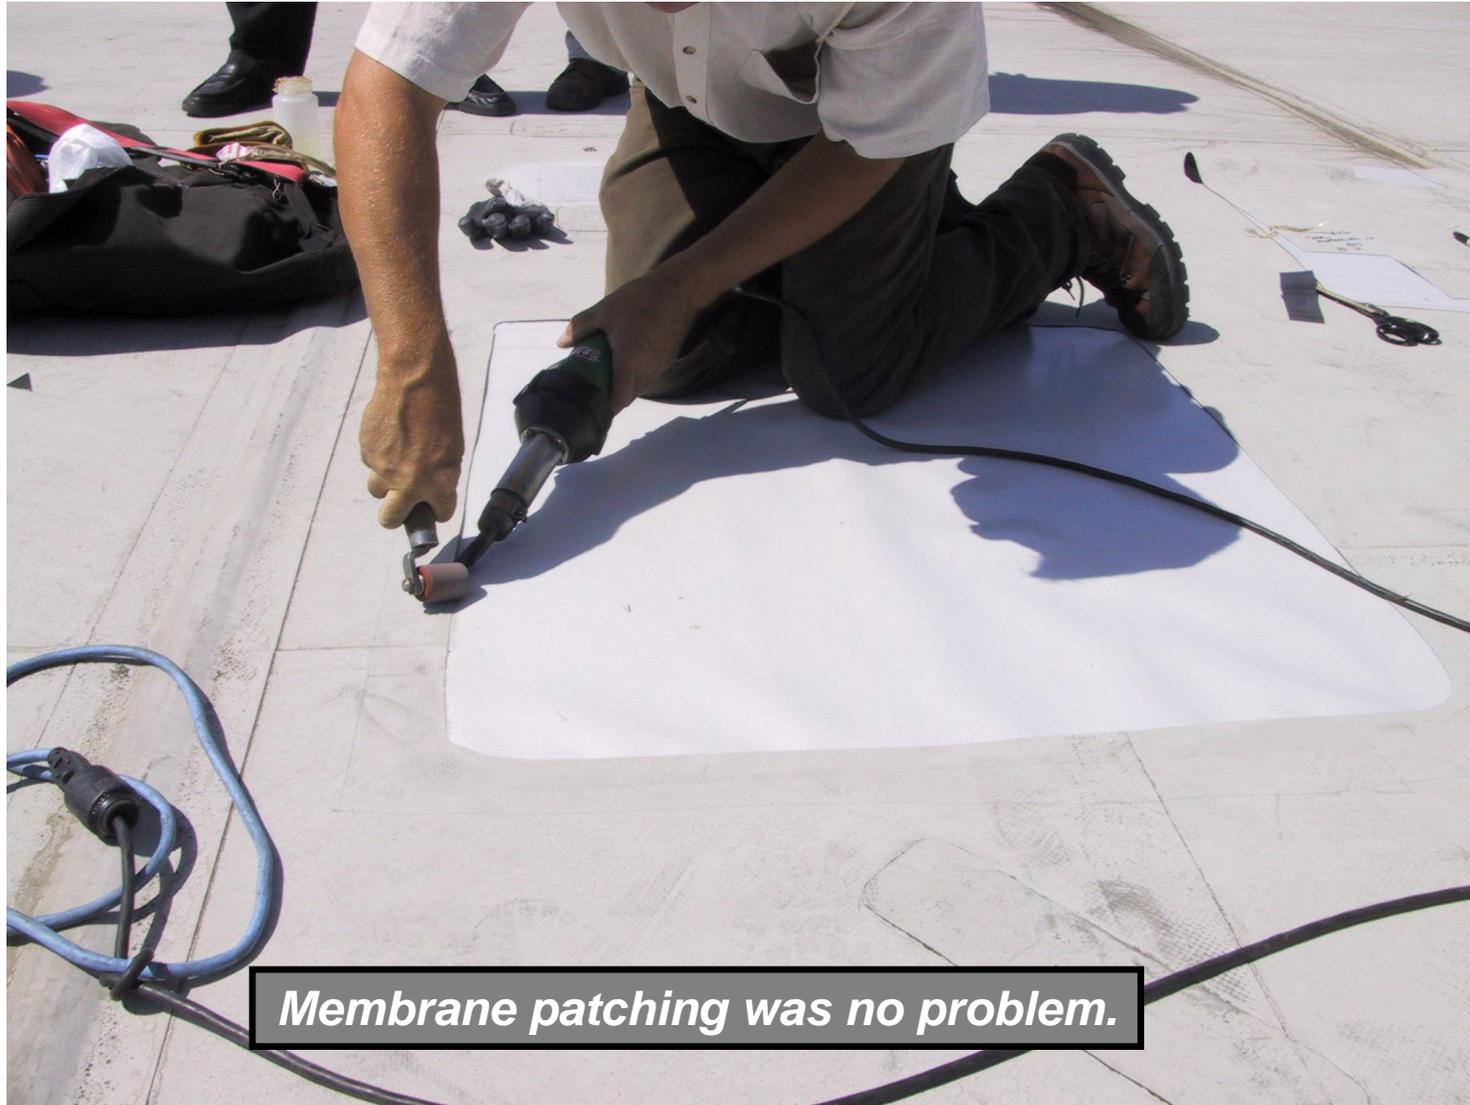
Membrane patching was no problem.

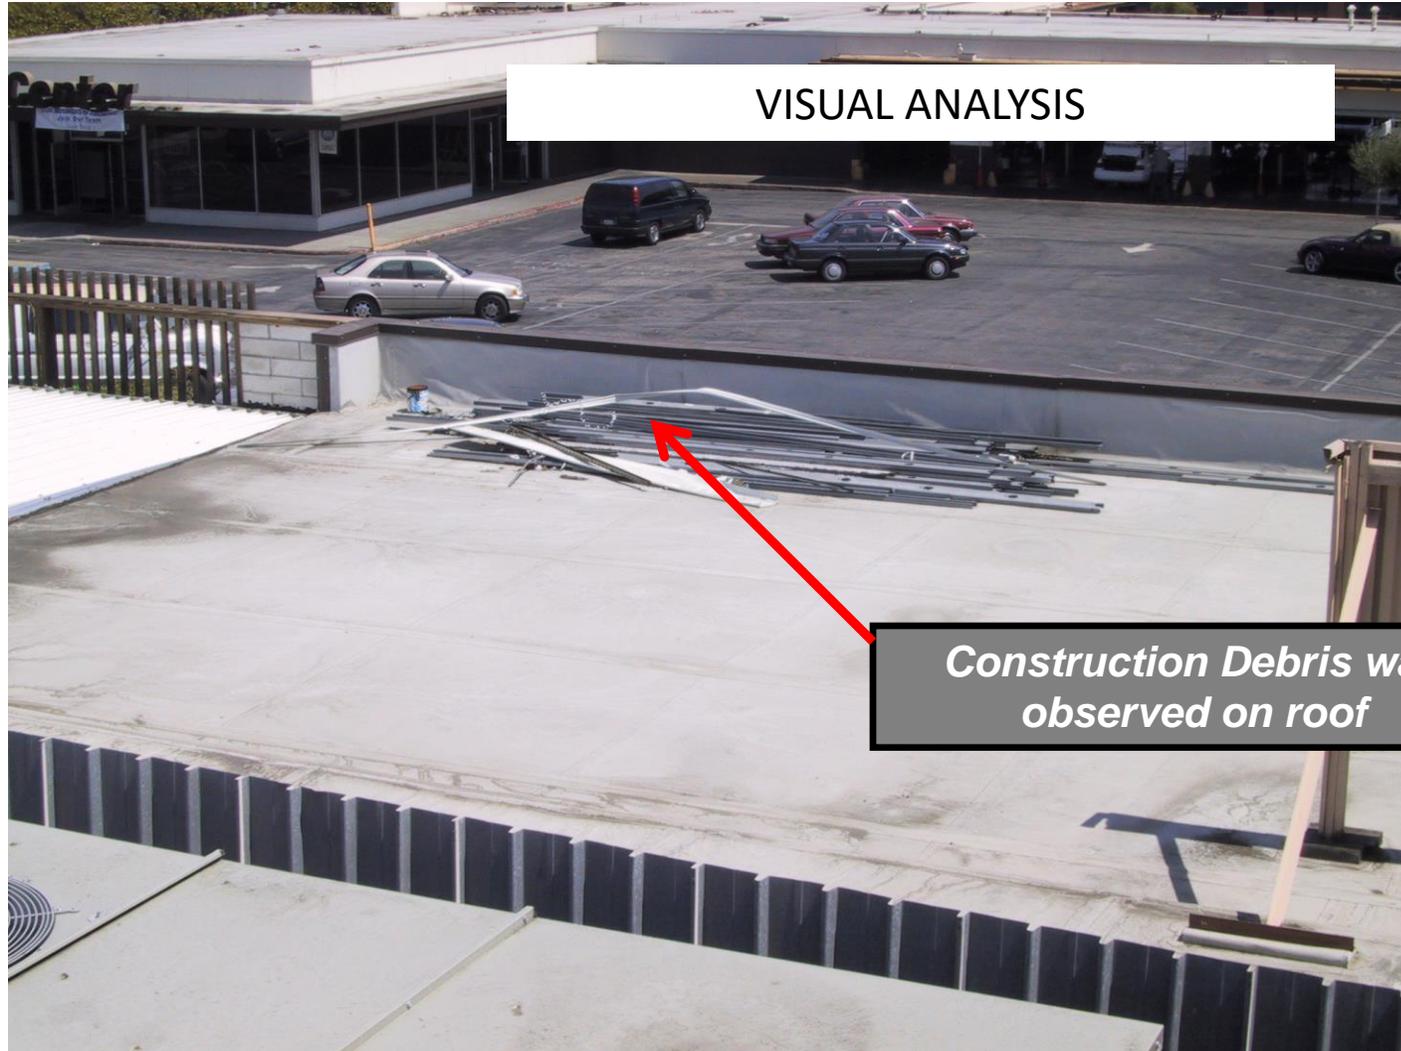
Construction Debris was observed on roof

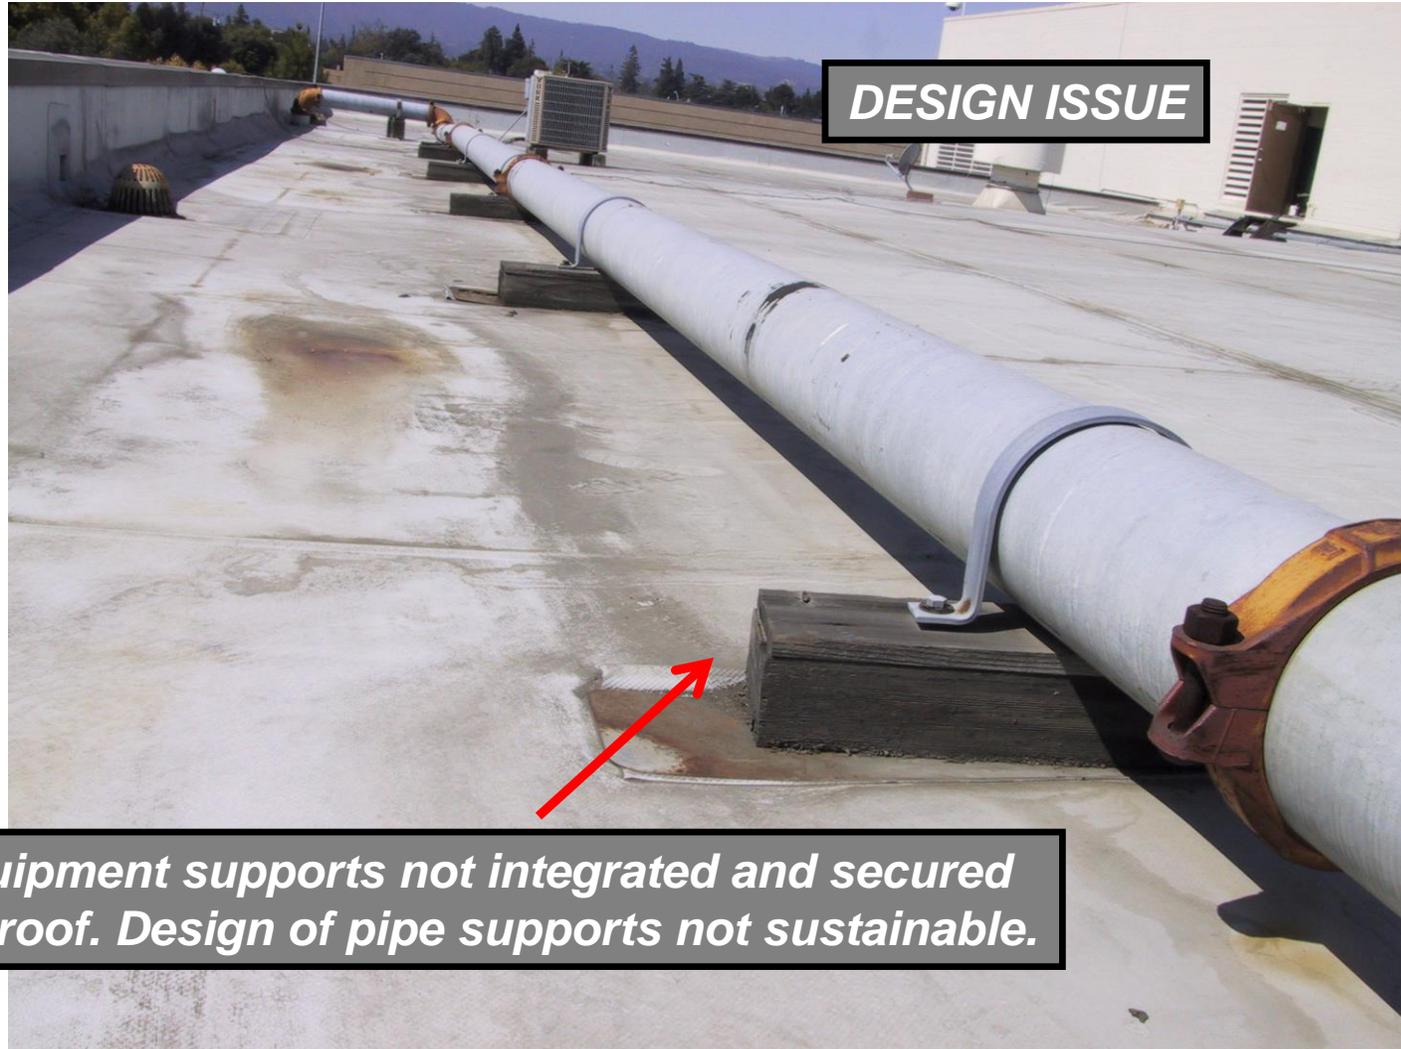
Equipment supports not integrated and secured into roof. Design of pipe supports not sustainable.

- **3.DESIGN**
 - Original poor design of pipe supports caused damage
 - Poor design of roof drainage caused ponding water and damage
 - Poor design of condensation control mechanism caused damage

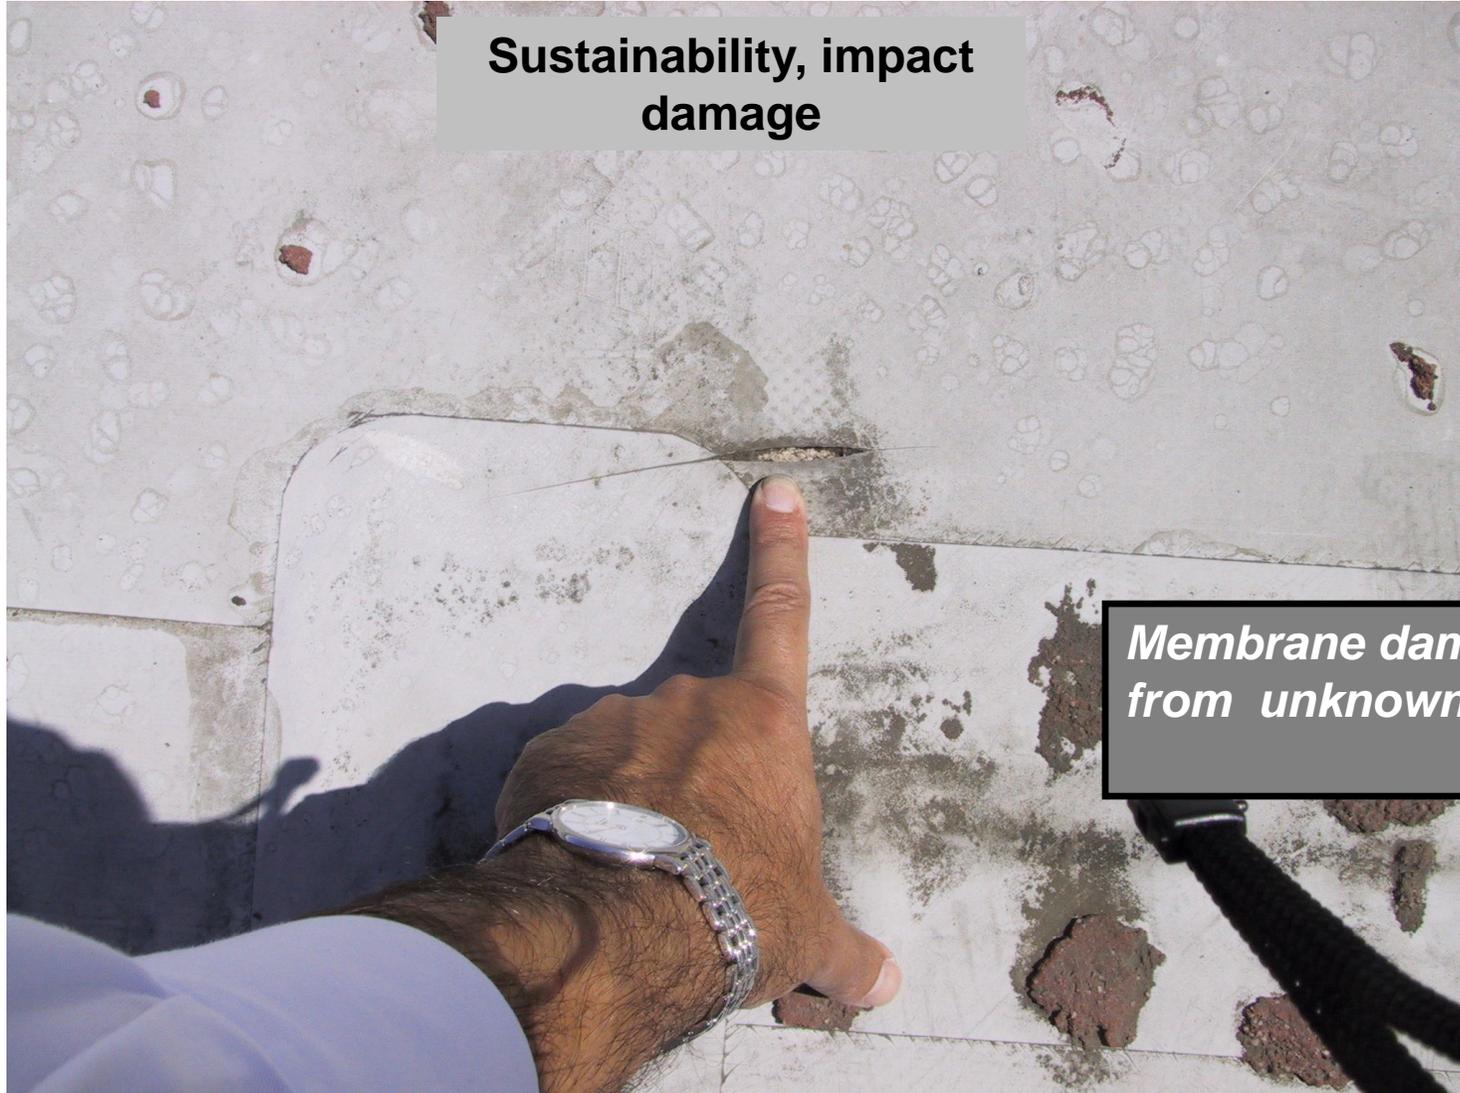
*Membrane damage
from unknown source*

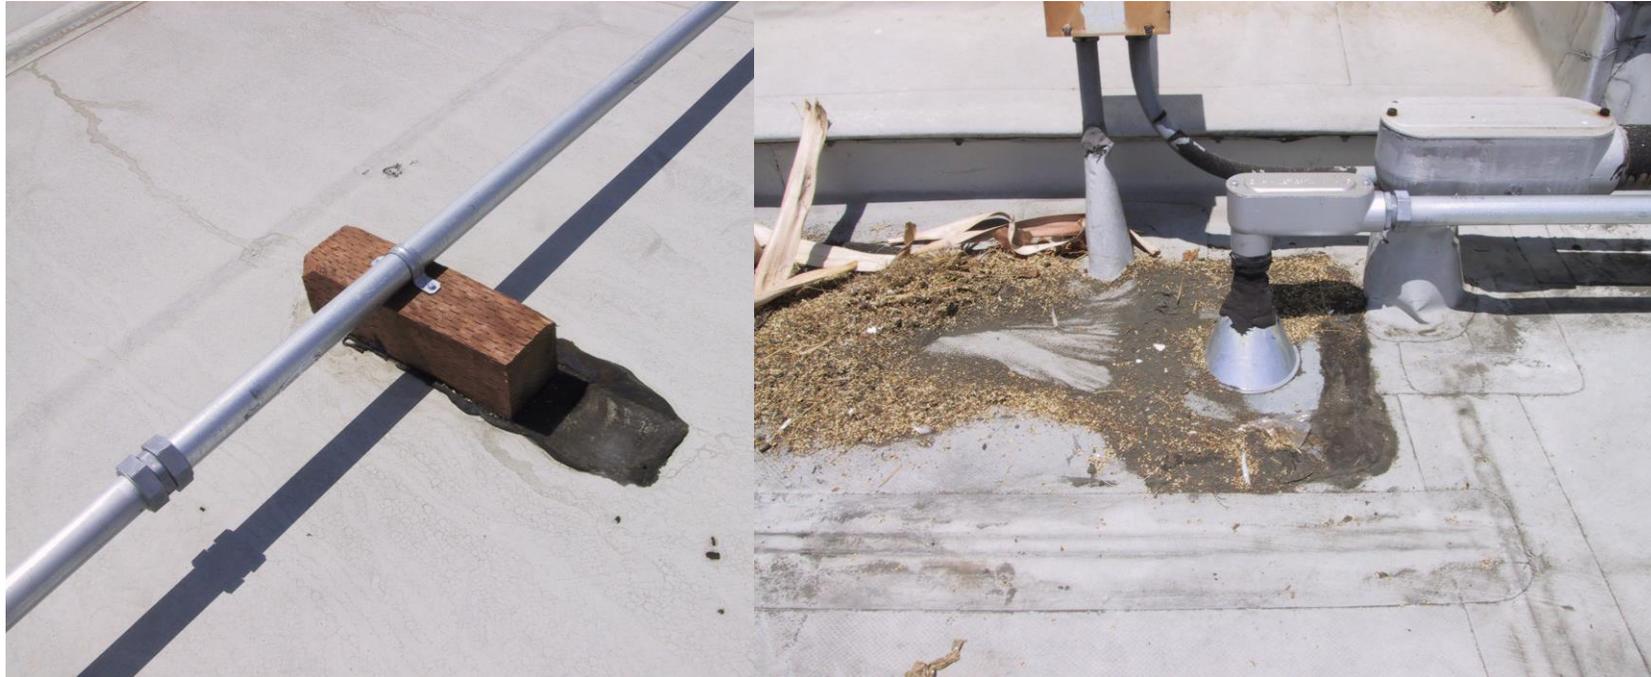
New electrical pipe added, pipe jack set in mastic (not properly flashed with single ply) and wood block set in mastic (incompatible with PVC)

- **MAINTENANCE**
 - Lack of frequent inspection
 - Lack of proper roof protection during remodel construction
 - Lack of proper maintenance of HVAC equipment damaged the roof
 - New pipe penetrations not properly flashed (use of asphalt mastic)

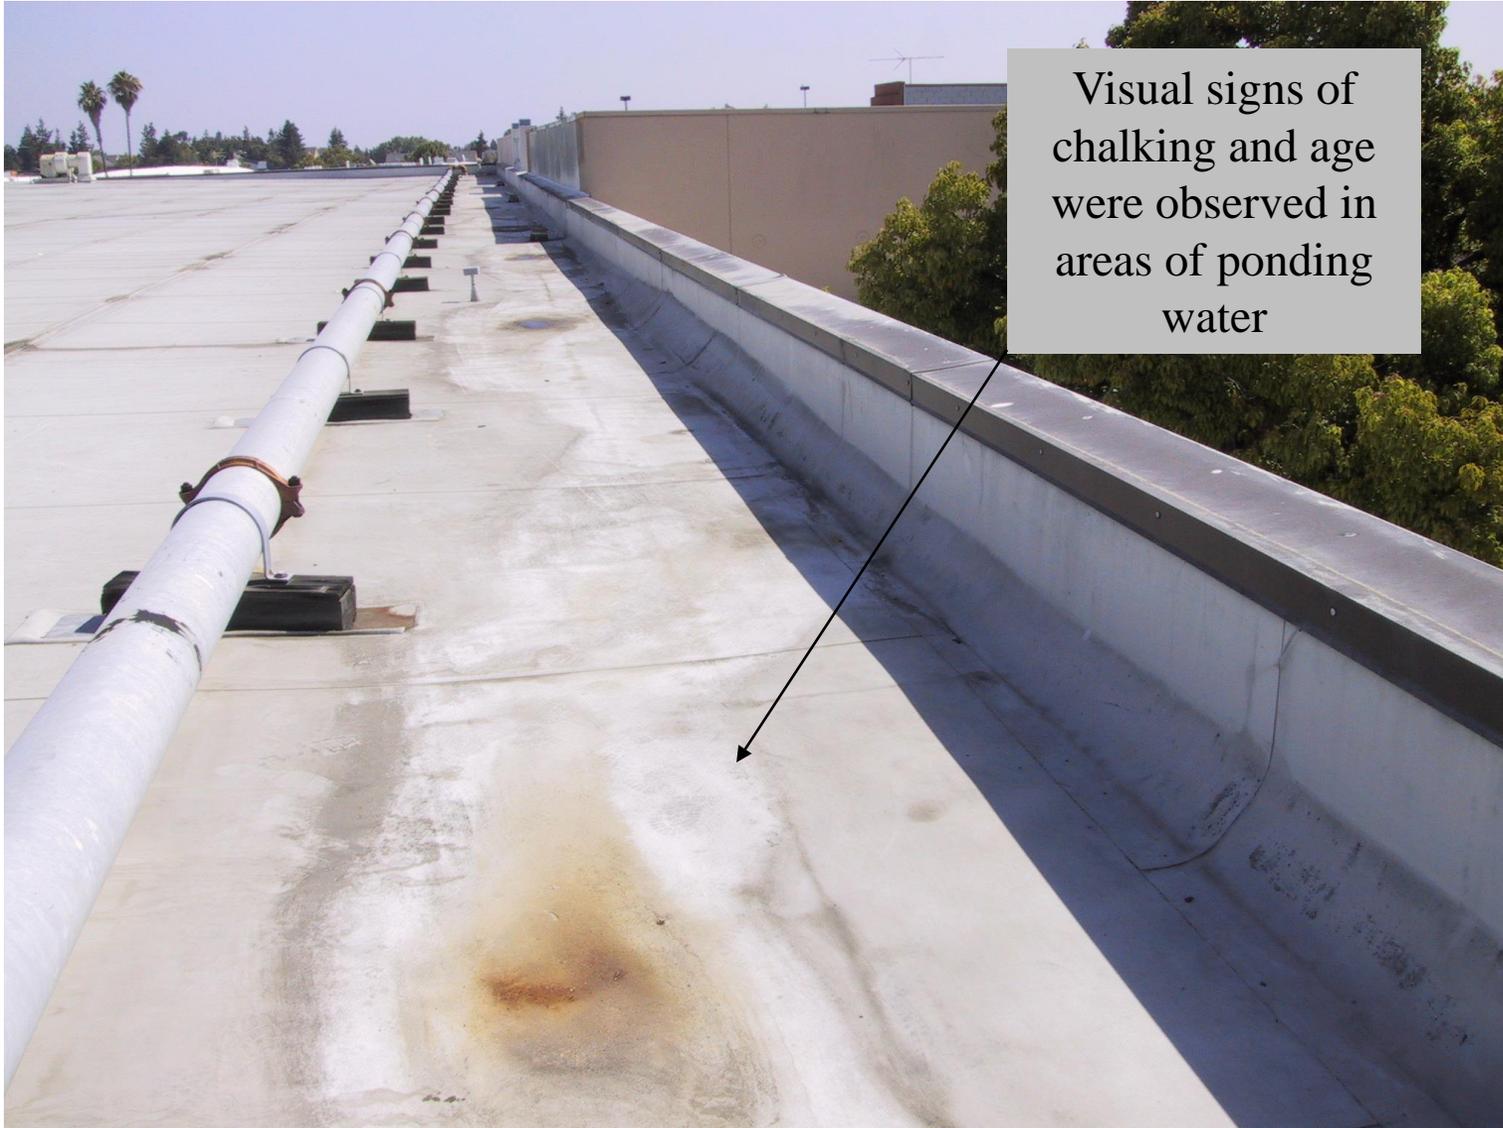
Visual signs of chalking and age were observed in areas of ponding water

Cooling tower and
condensate water leaking
over roof

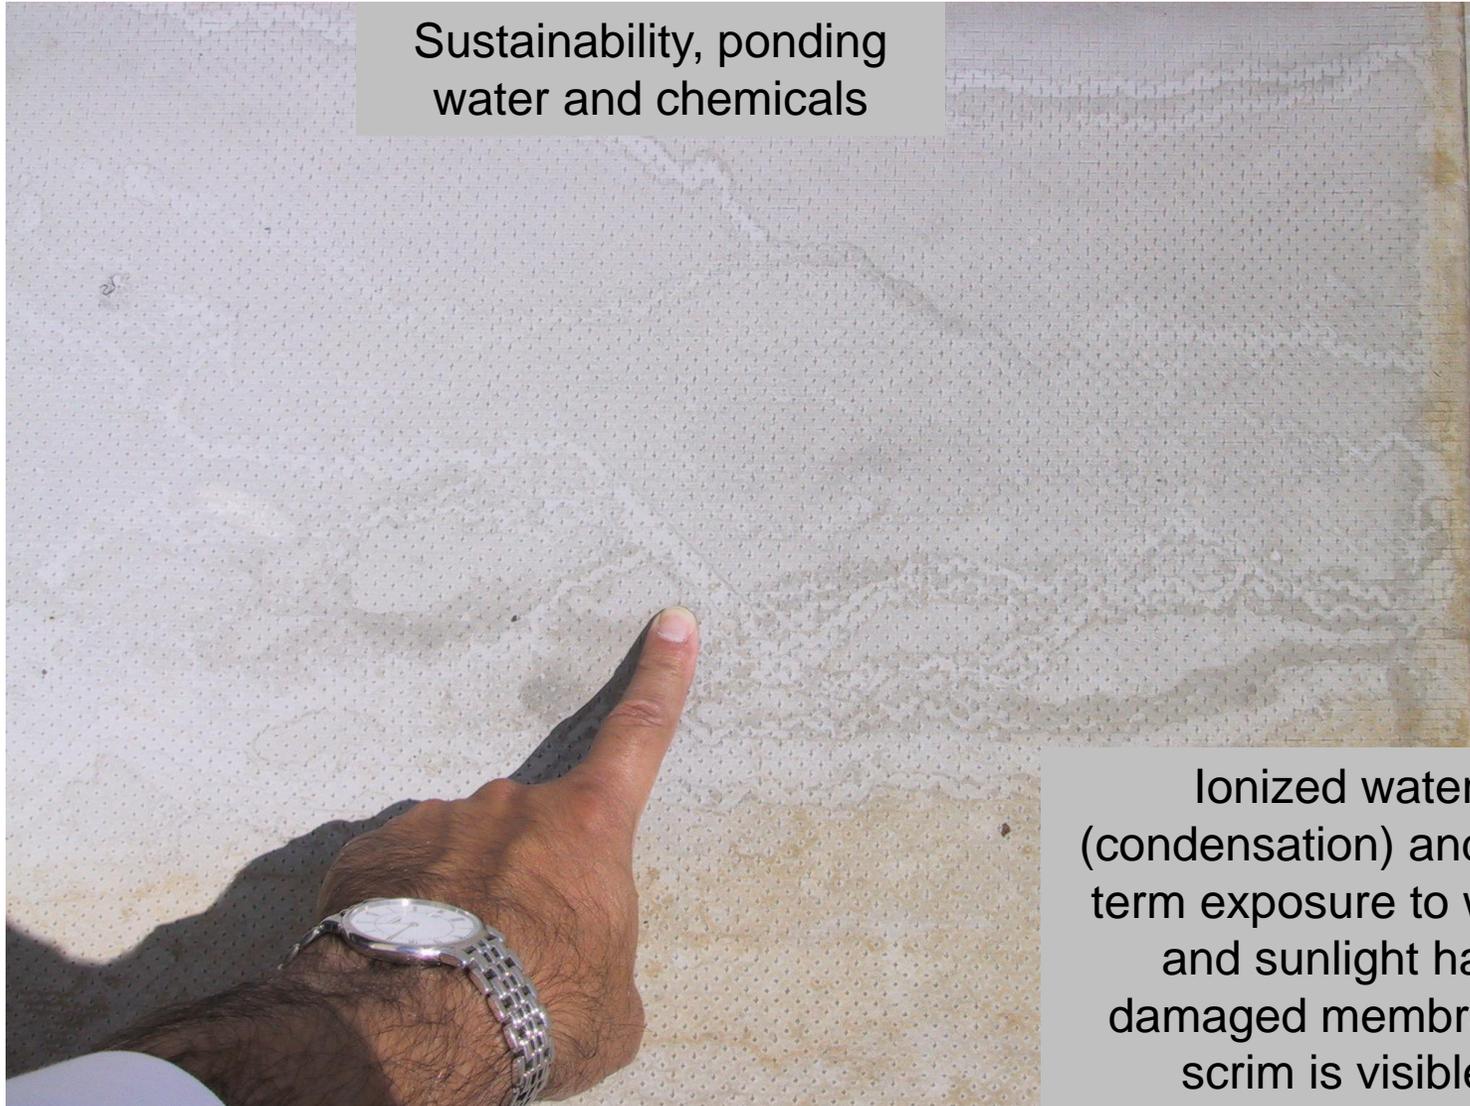
Ionized water
(condensation) and long
term exposure to water
and sunlight has
damaged membrane,
scrim is visible
