Roofing and Waterproofing Seminar CSI Las Vegas

Karim P. Allana, P.E., RRC, RWC
President, Allana Buick & Bers, Inc.

March 13, 2007

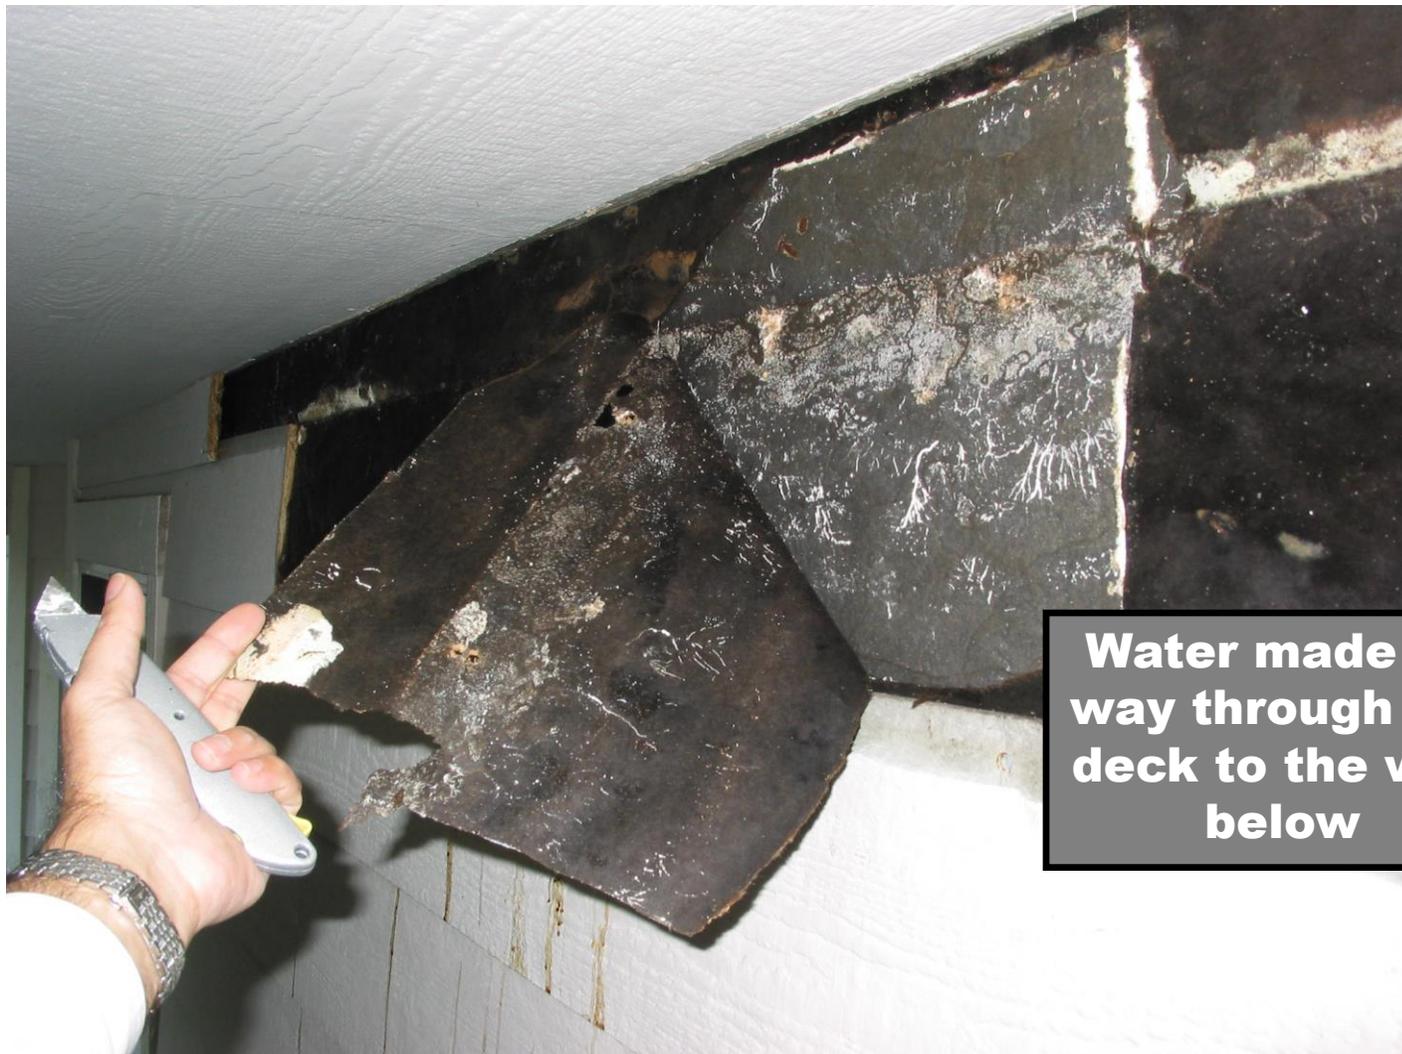
Water made its way through the deck to the wall below

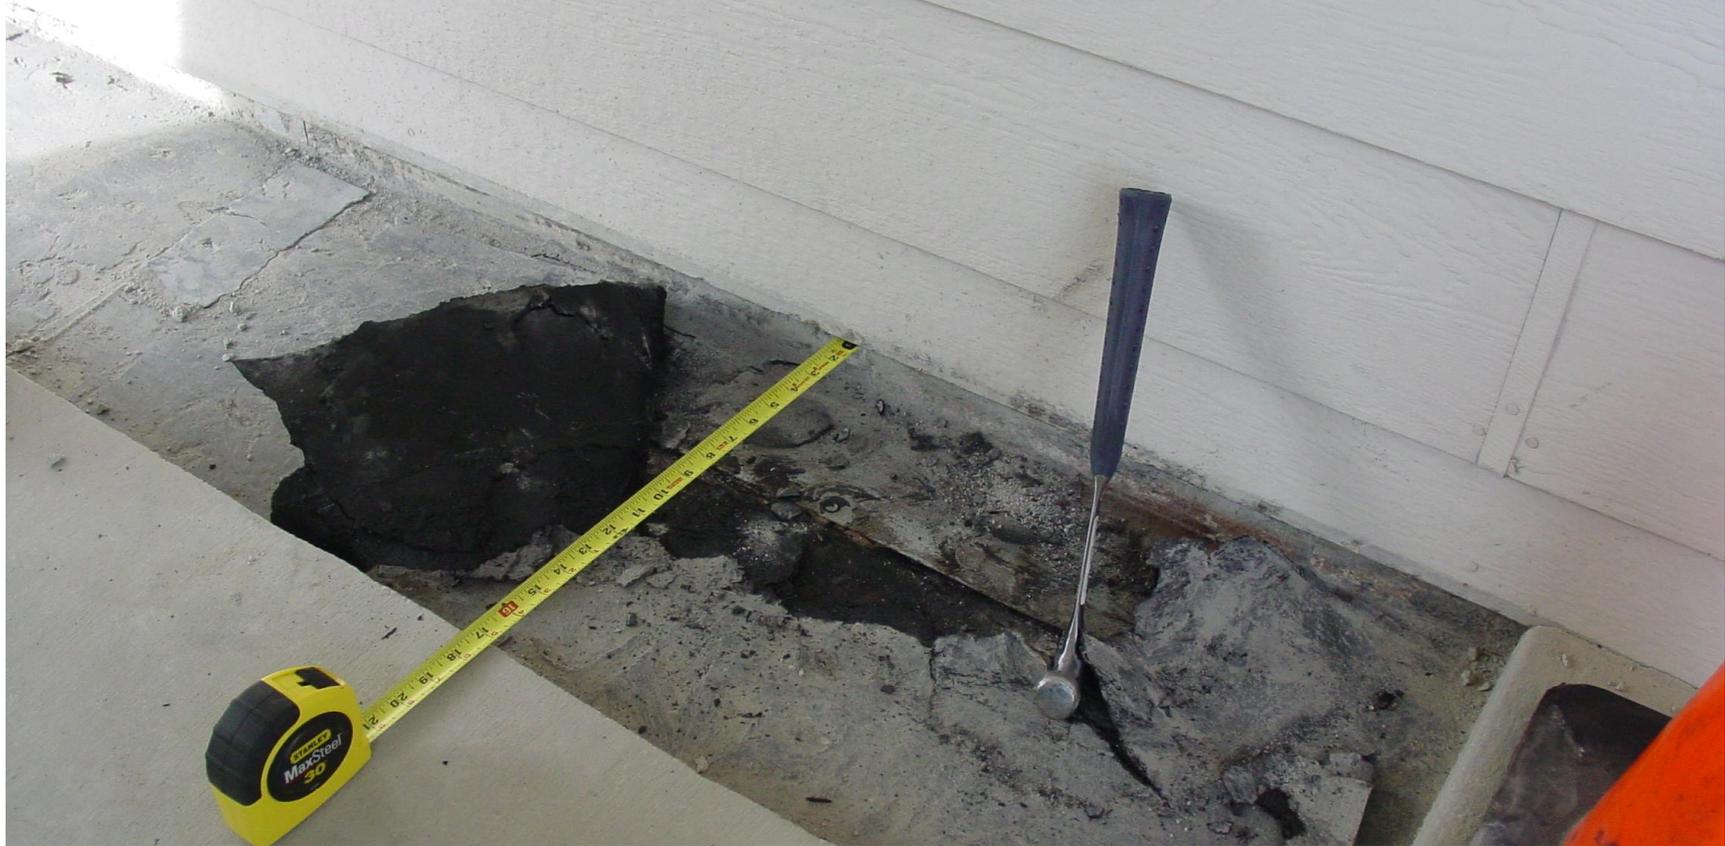
- “L Flashing was improperly used in BUR Assembly
- Flashing was not primed, lack of adhesion
- Flashing was not soldered or sealed properly

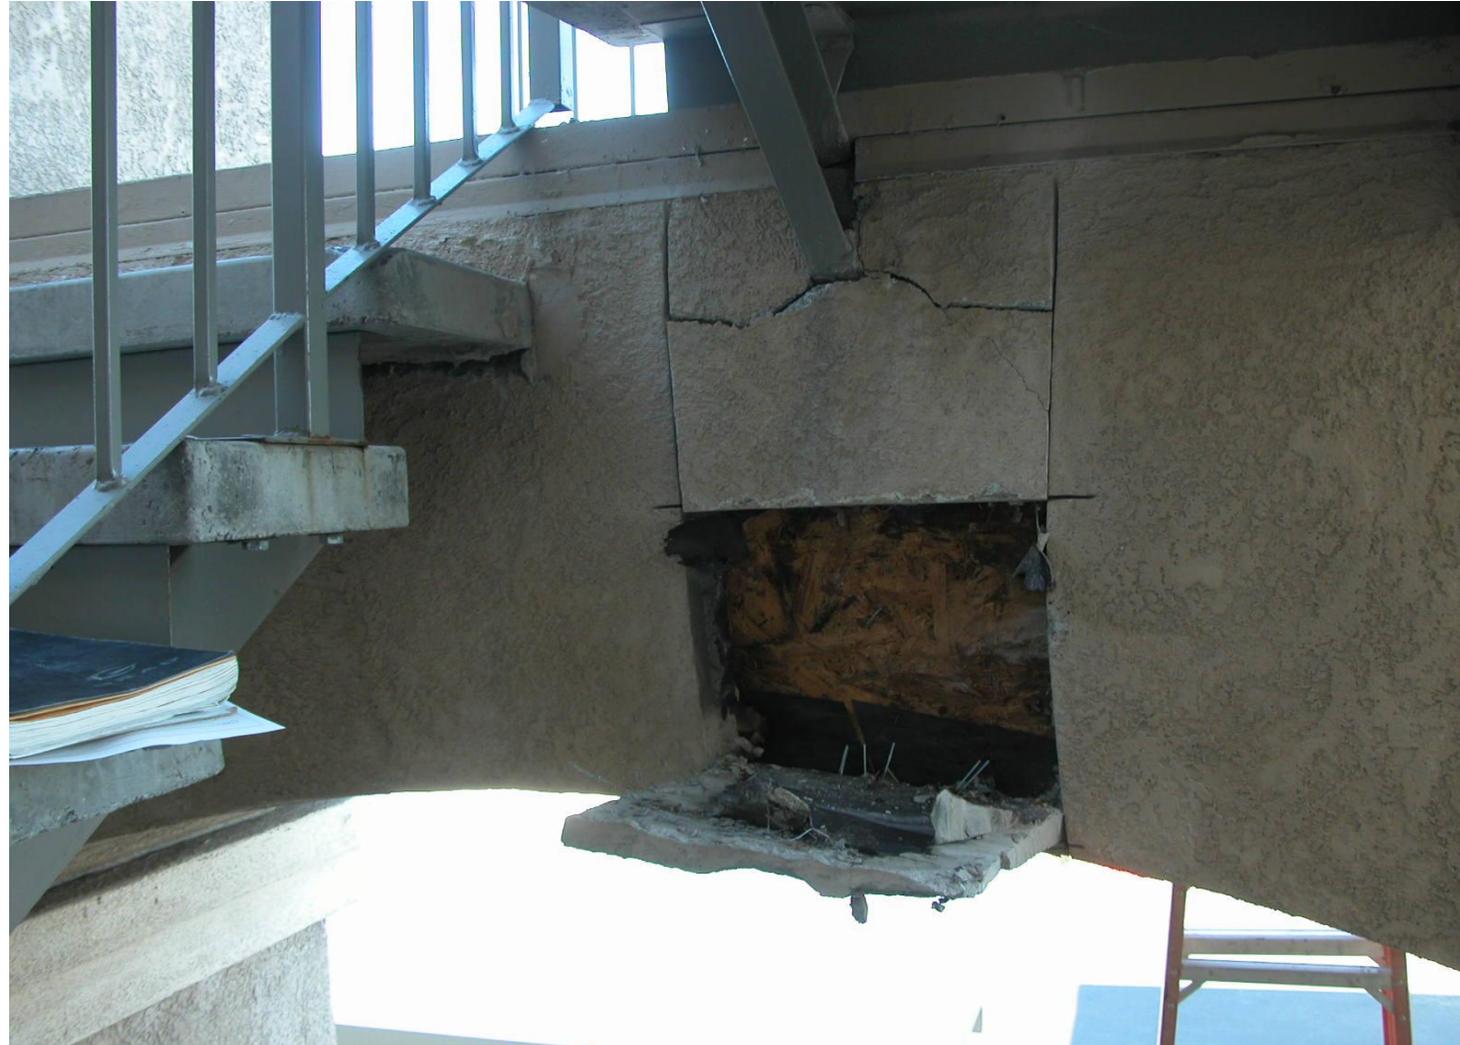
Leaks at Stringer, Waterproofing, Sheet Metal Stucco

Leaks from multiple Sources

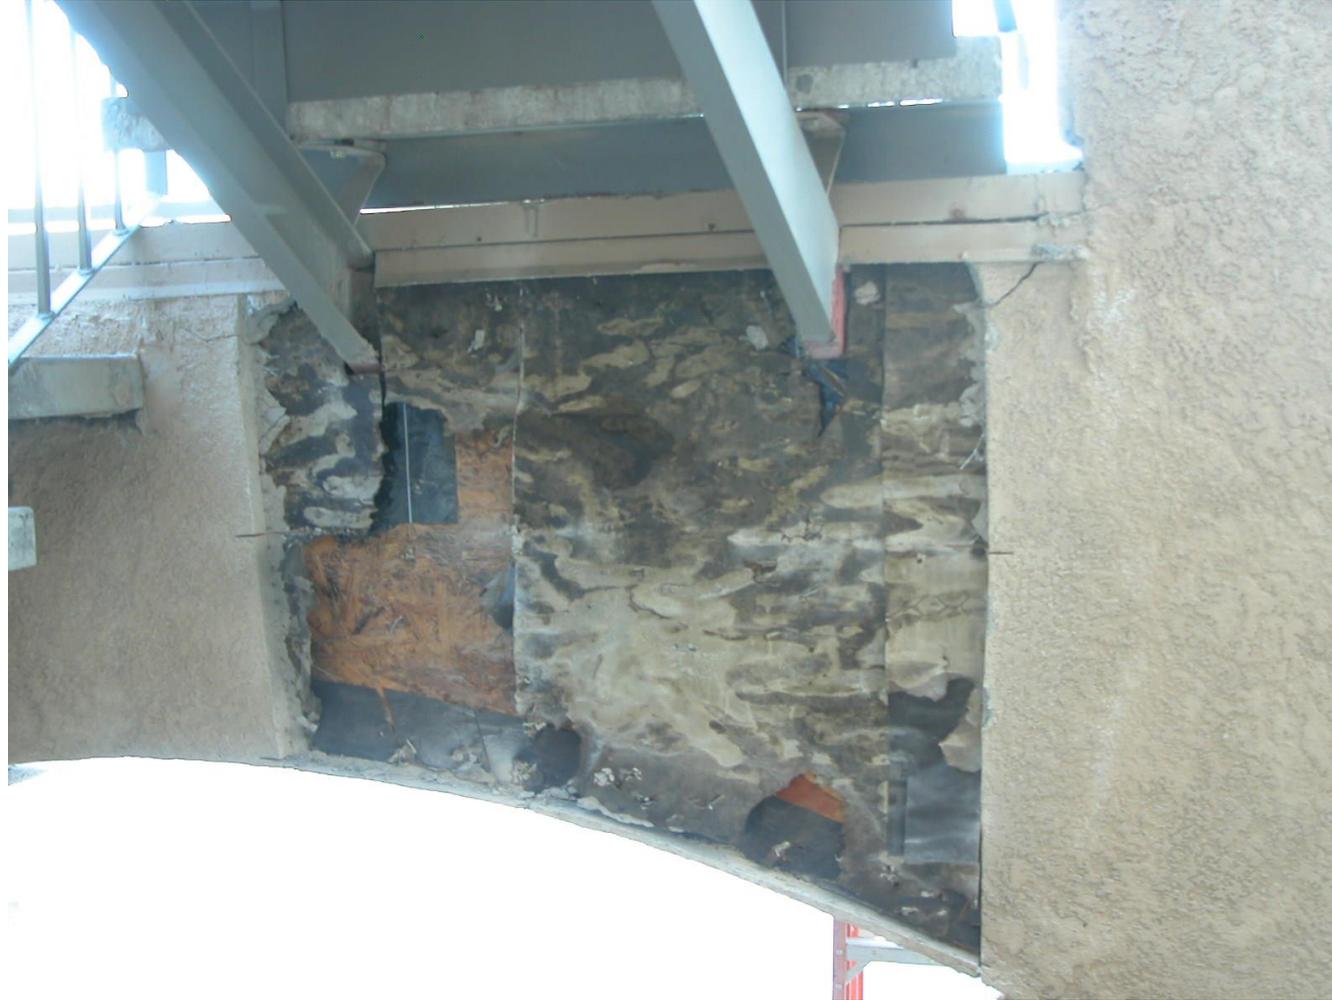
Edge Metal Joins Leak

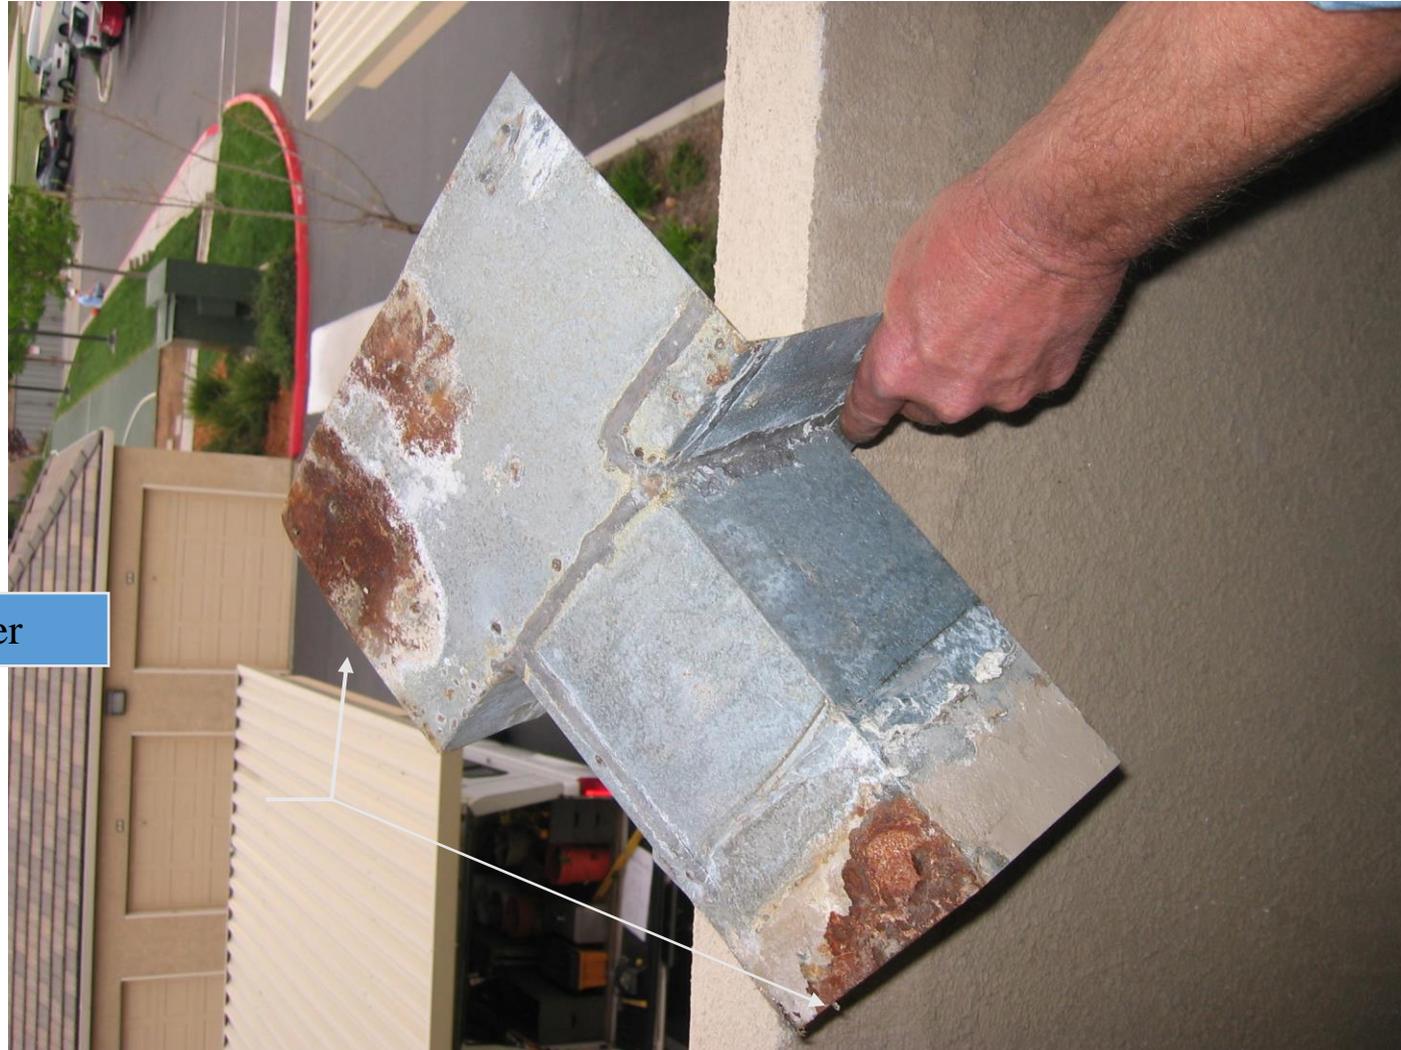
Balcony Scupper Rusting in 3 Years

Rusted scupper

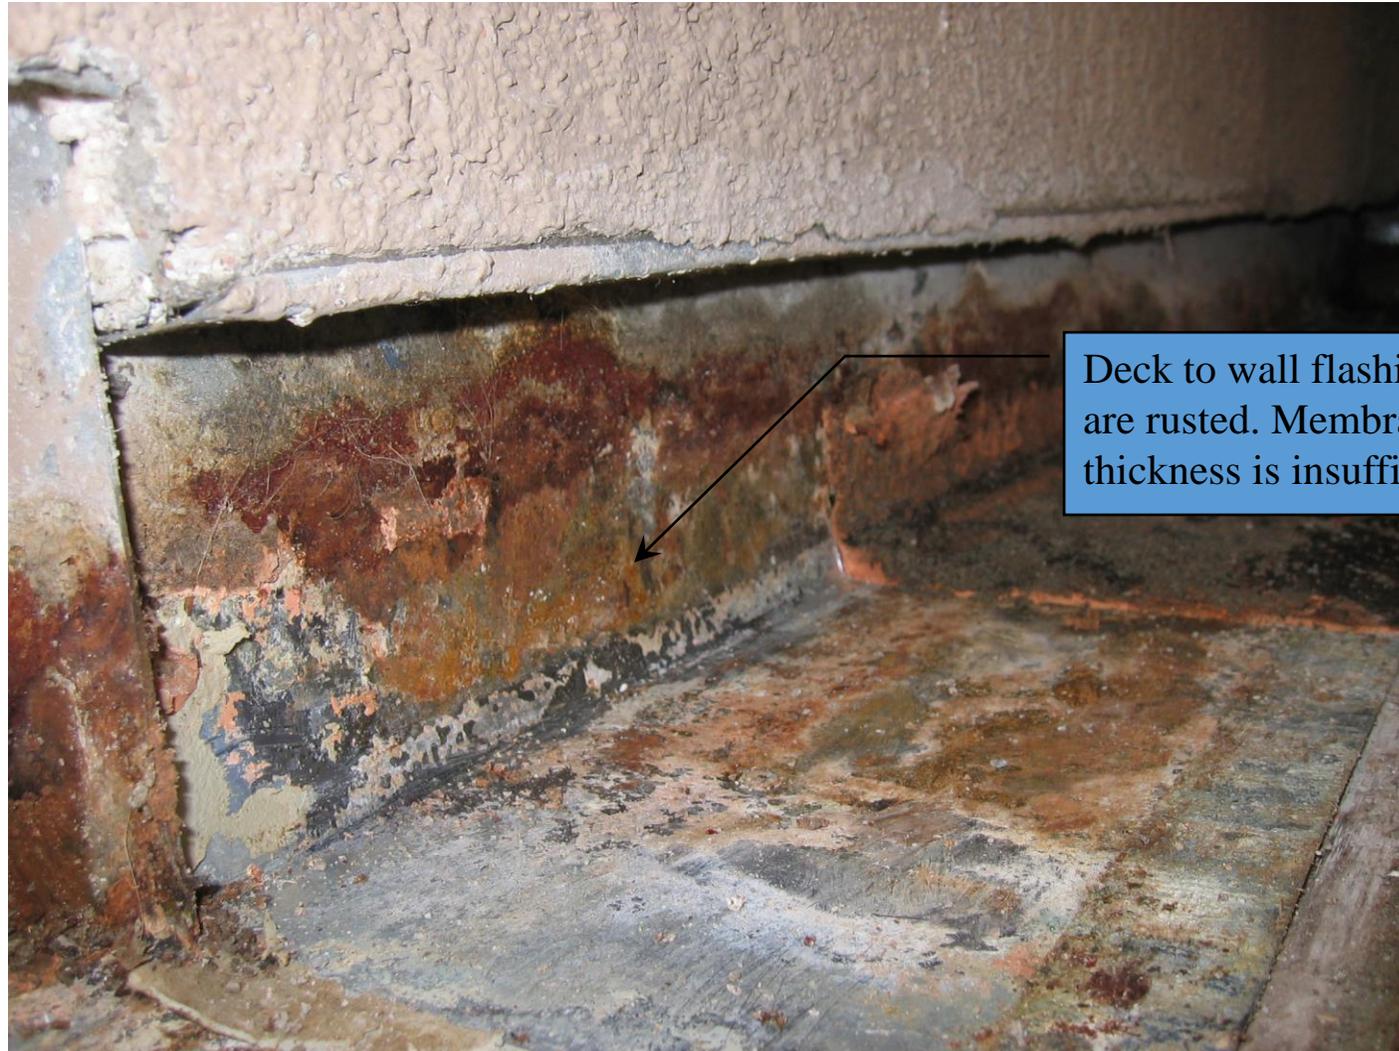
Breezeway-Unit 325 (Membrane too thin)

Deck to wall flashings are rusted. Membrane thickness is insufficient

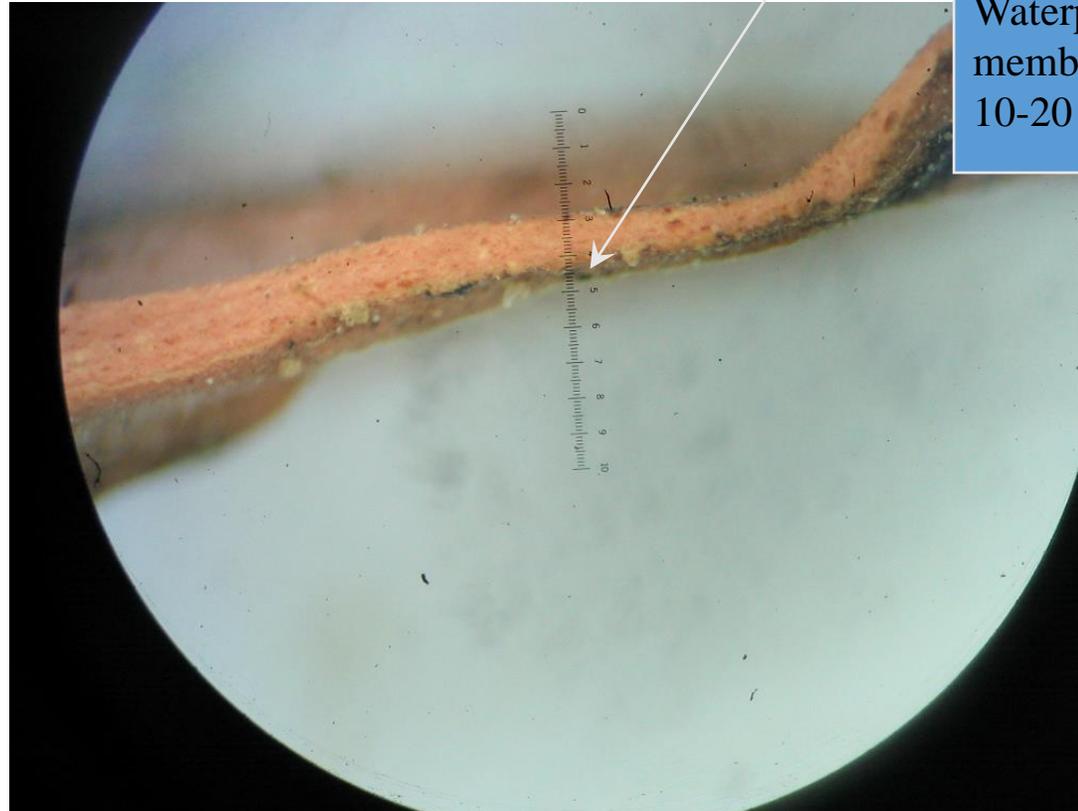
Waterproofing membrane is too thin, 10-20 mils.

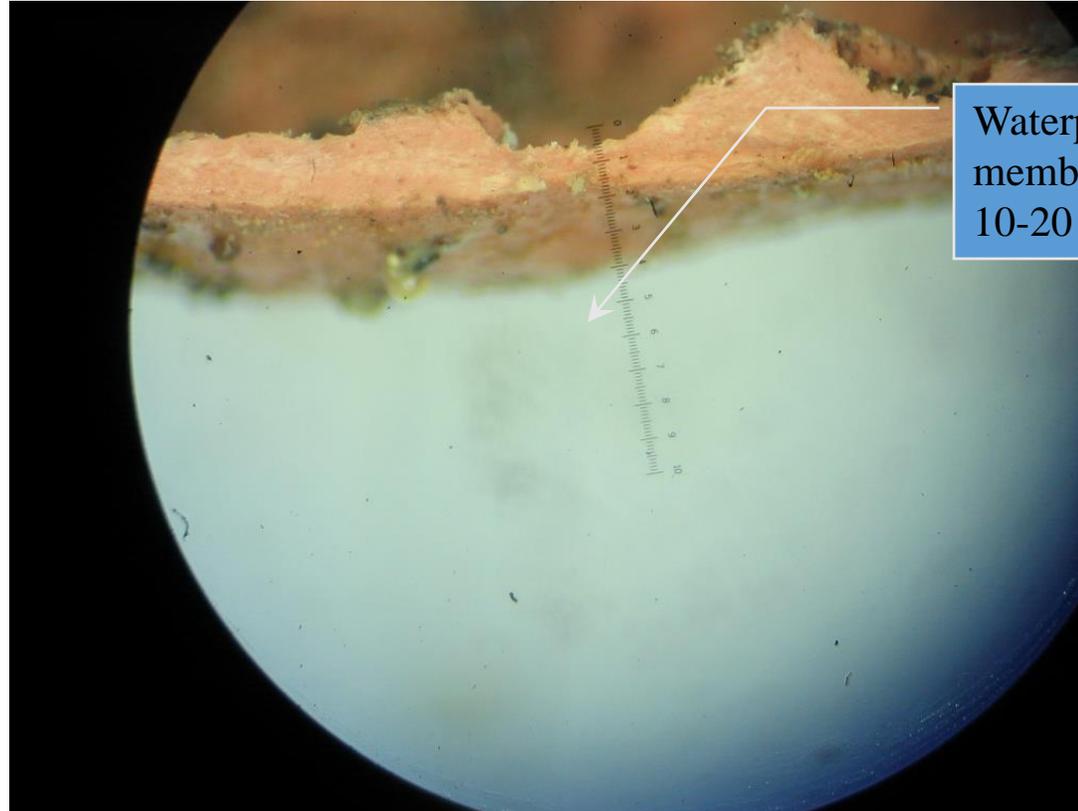
Irregular Thickness of Waterproofing Membrane

Waterproofing membrane is too thin, 10-20 mils.

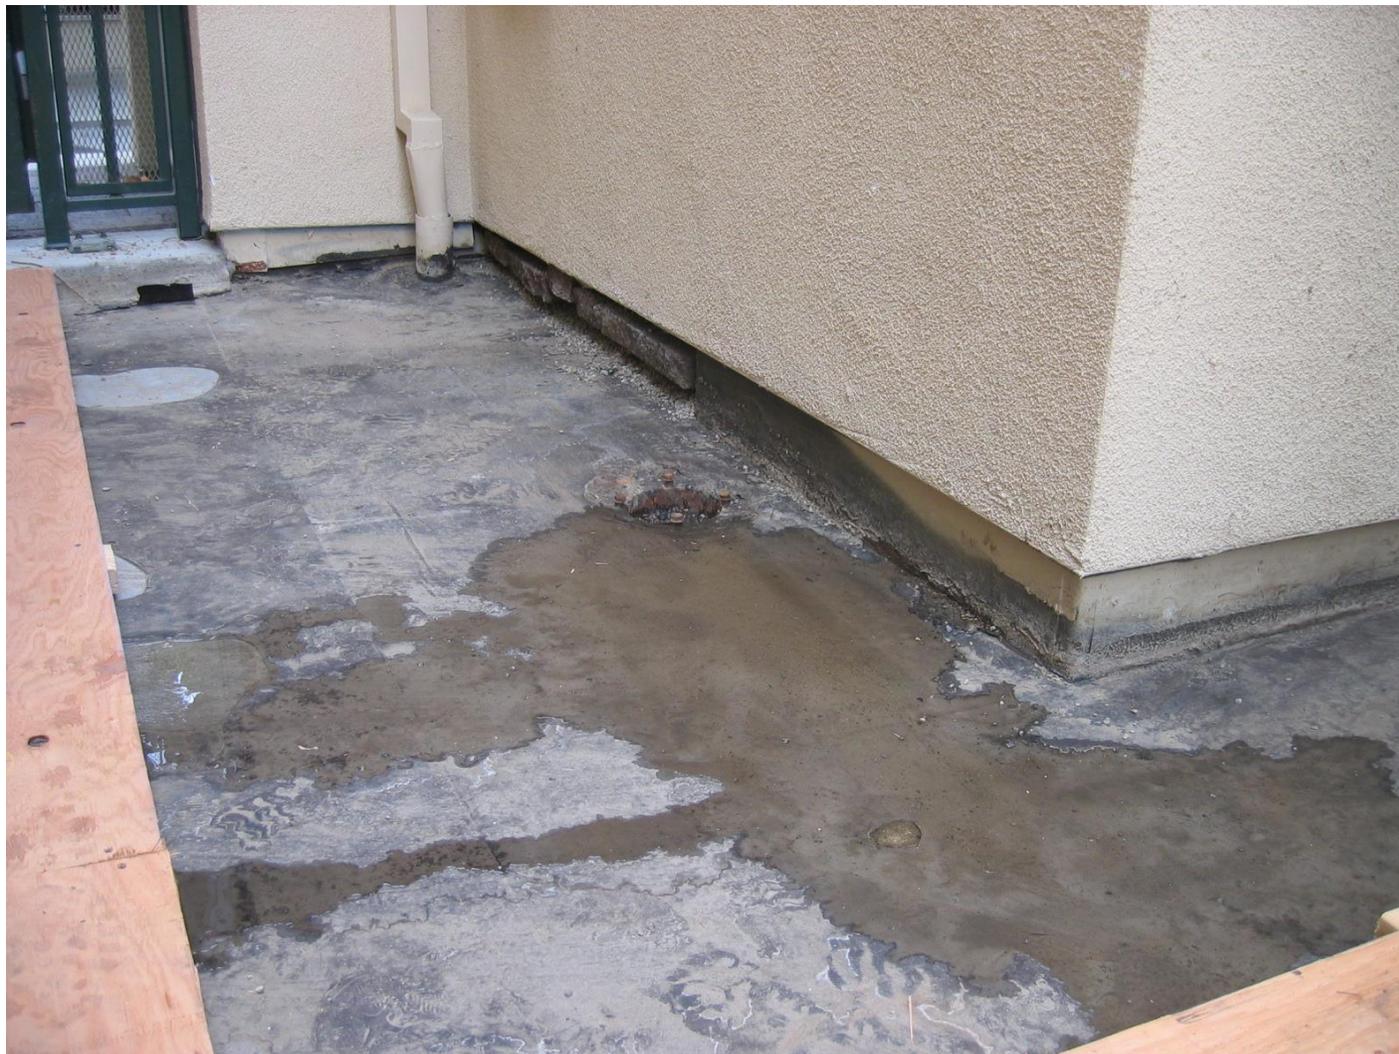
Blisters in membrane

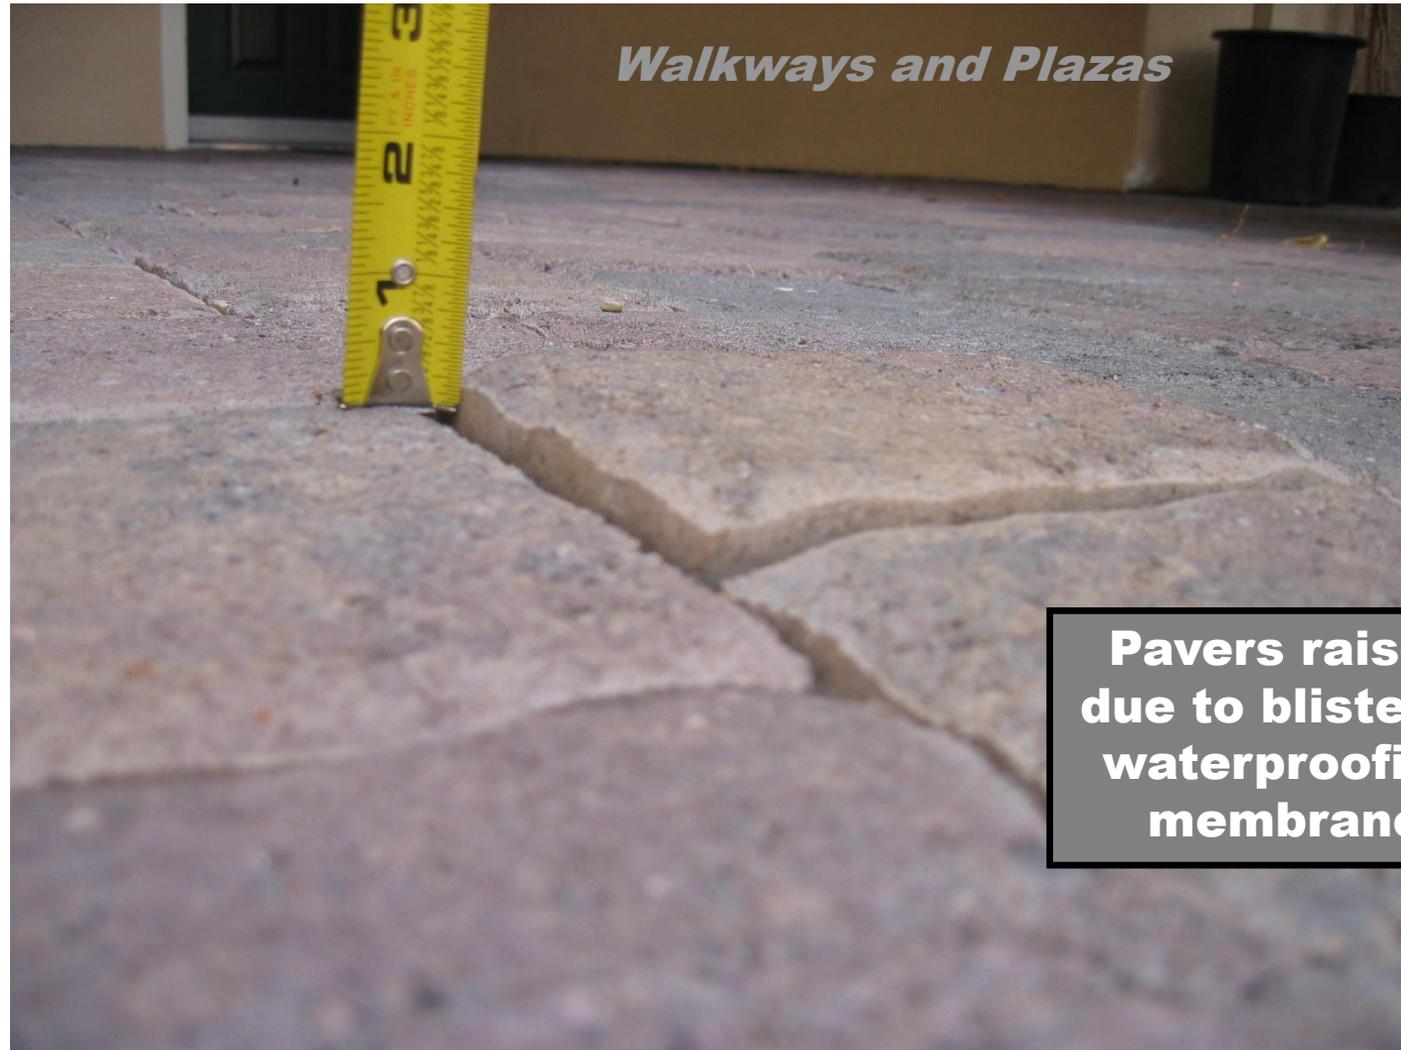
**Pavers raised
due to blistered
waterproofing
membrane**

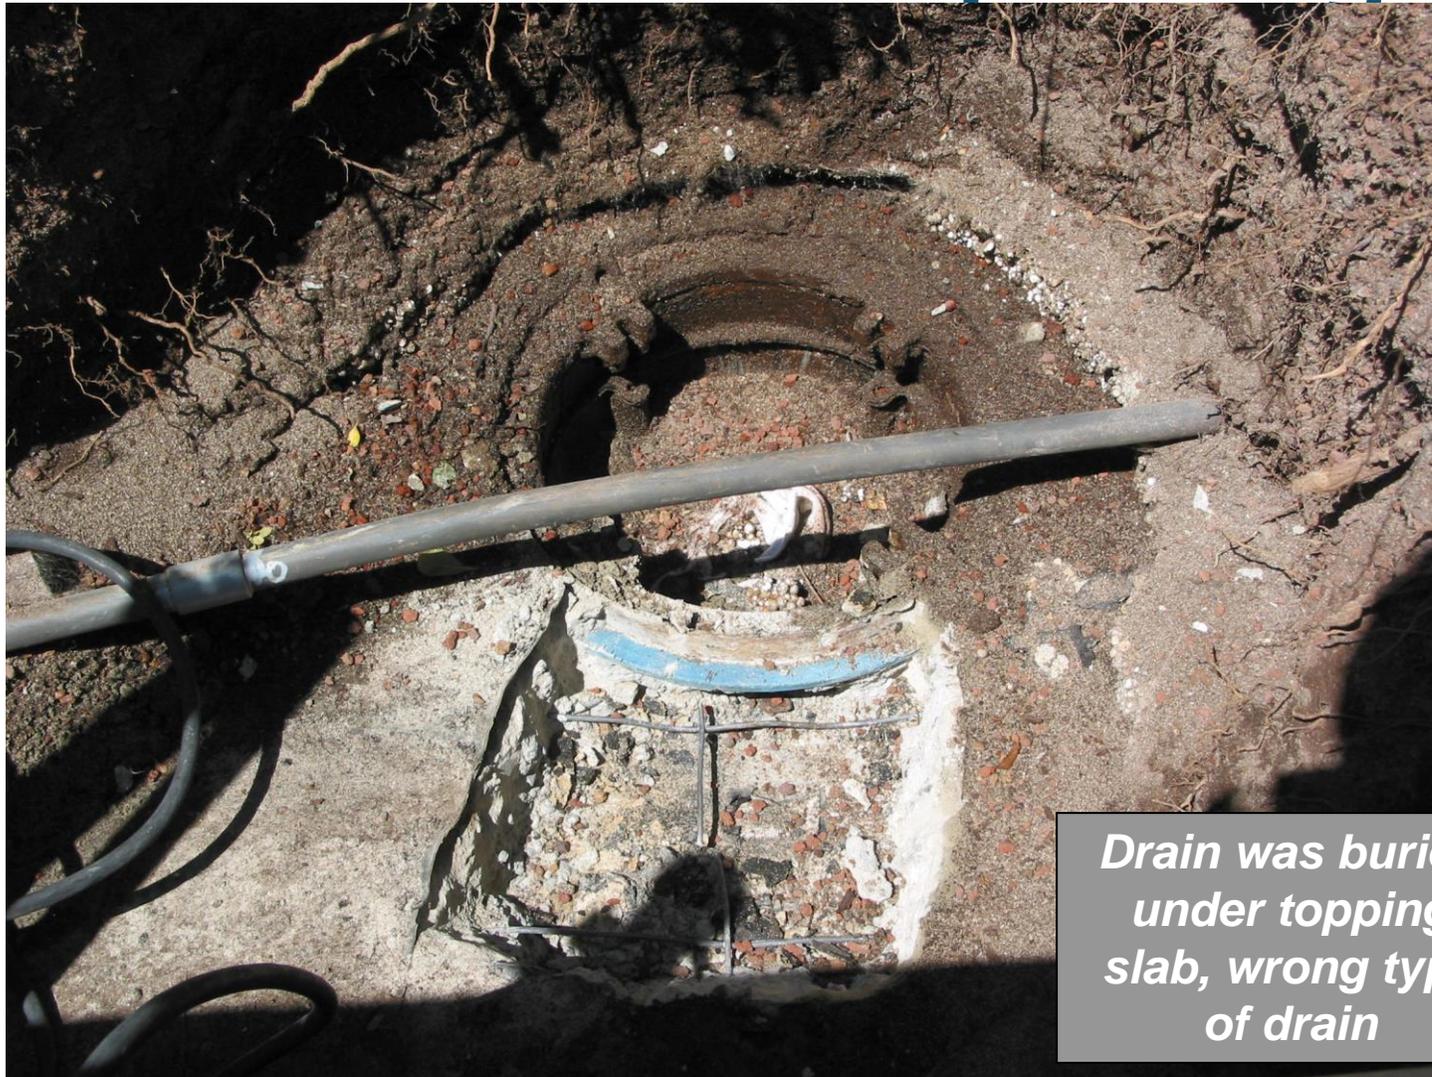
*Drain was buried
under topping
slab, wrong type
of drain*

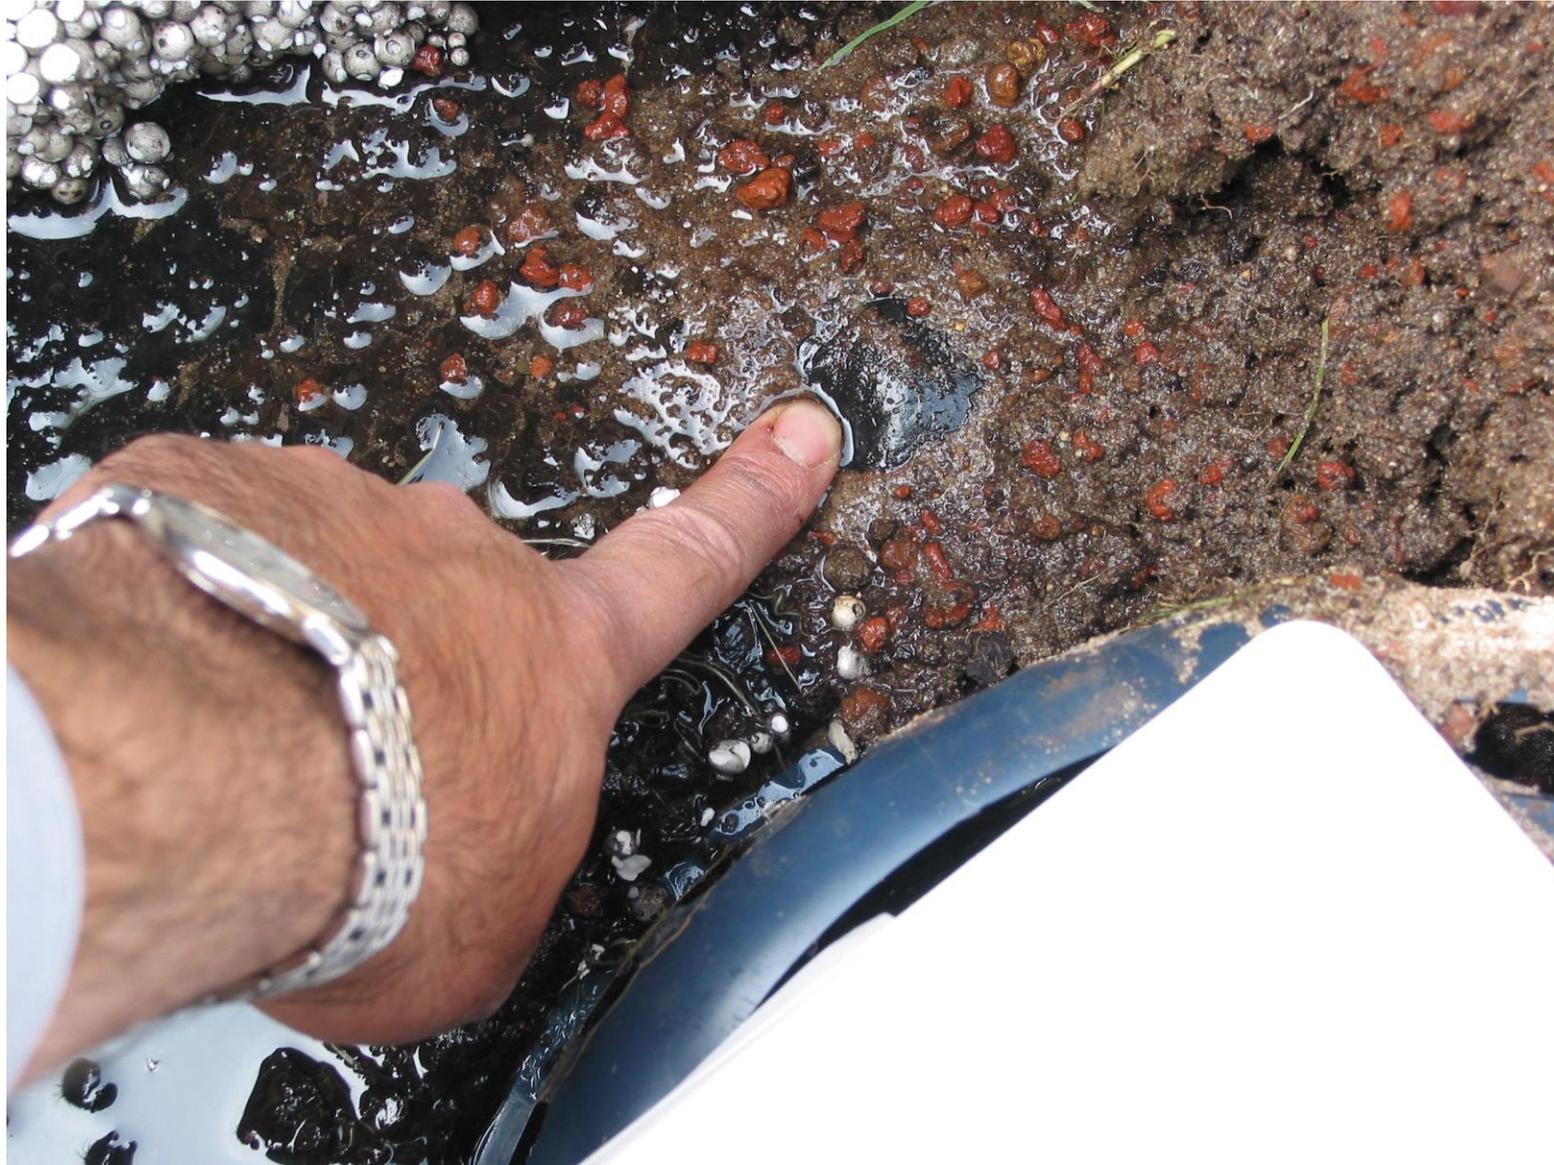
Water Filled Blister

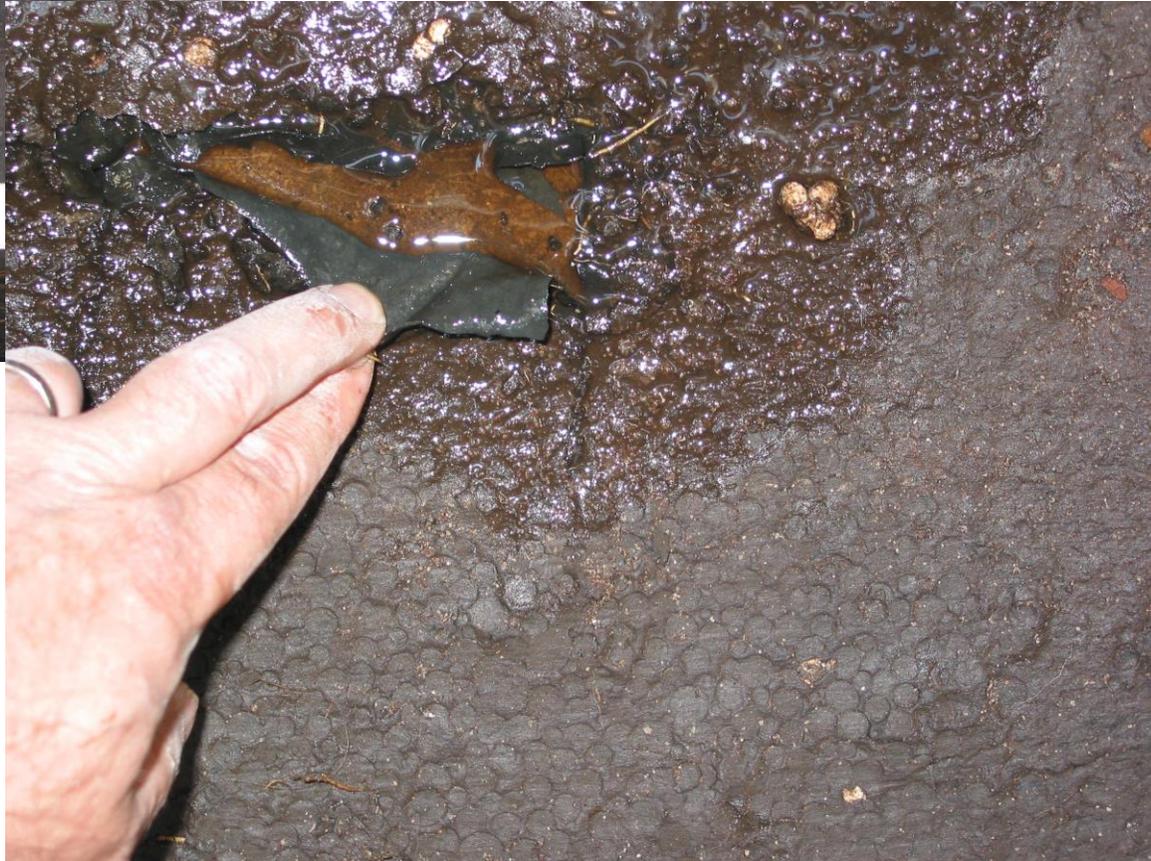
Water Filled Blisters Due to osmotic action
