Increasing Your Property Value Recognizing Leaks and Problems

CAA Seminar – Increasing Your Property Value
March 23, 2004

Increasing Your Property Value Maintenance and Repair Strategies

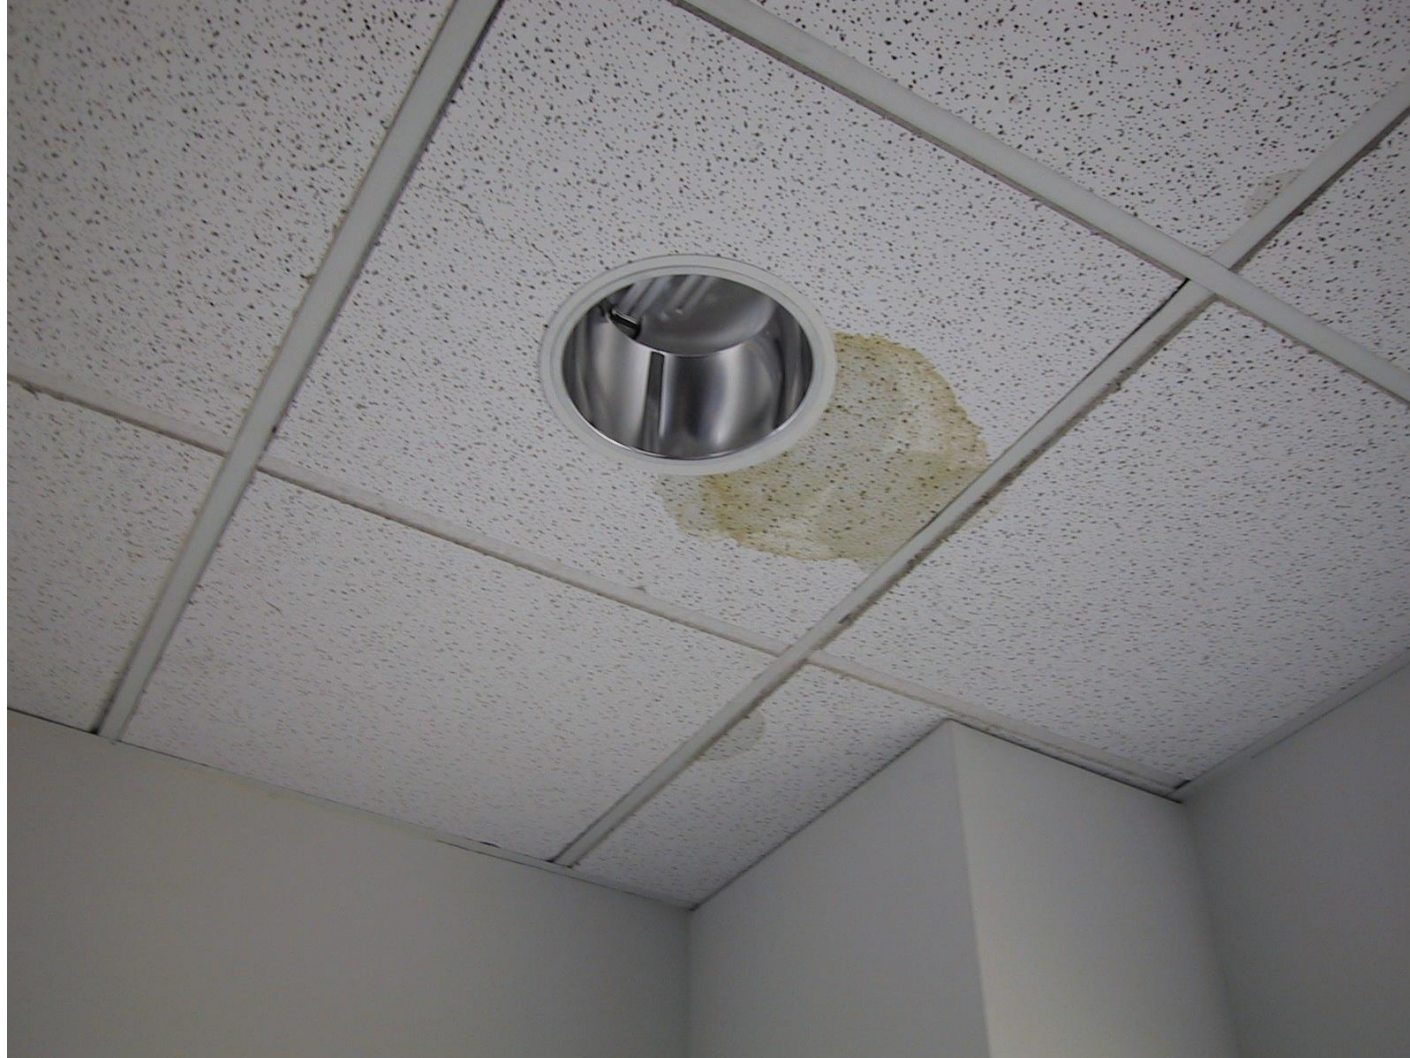
Look for stains, no matter how minor or small

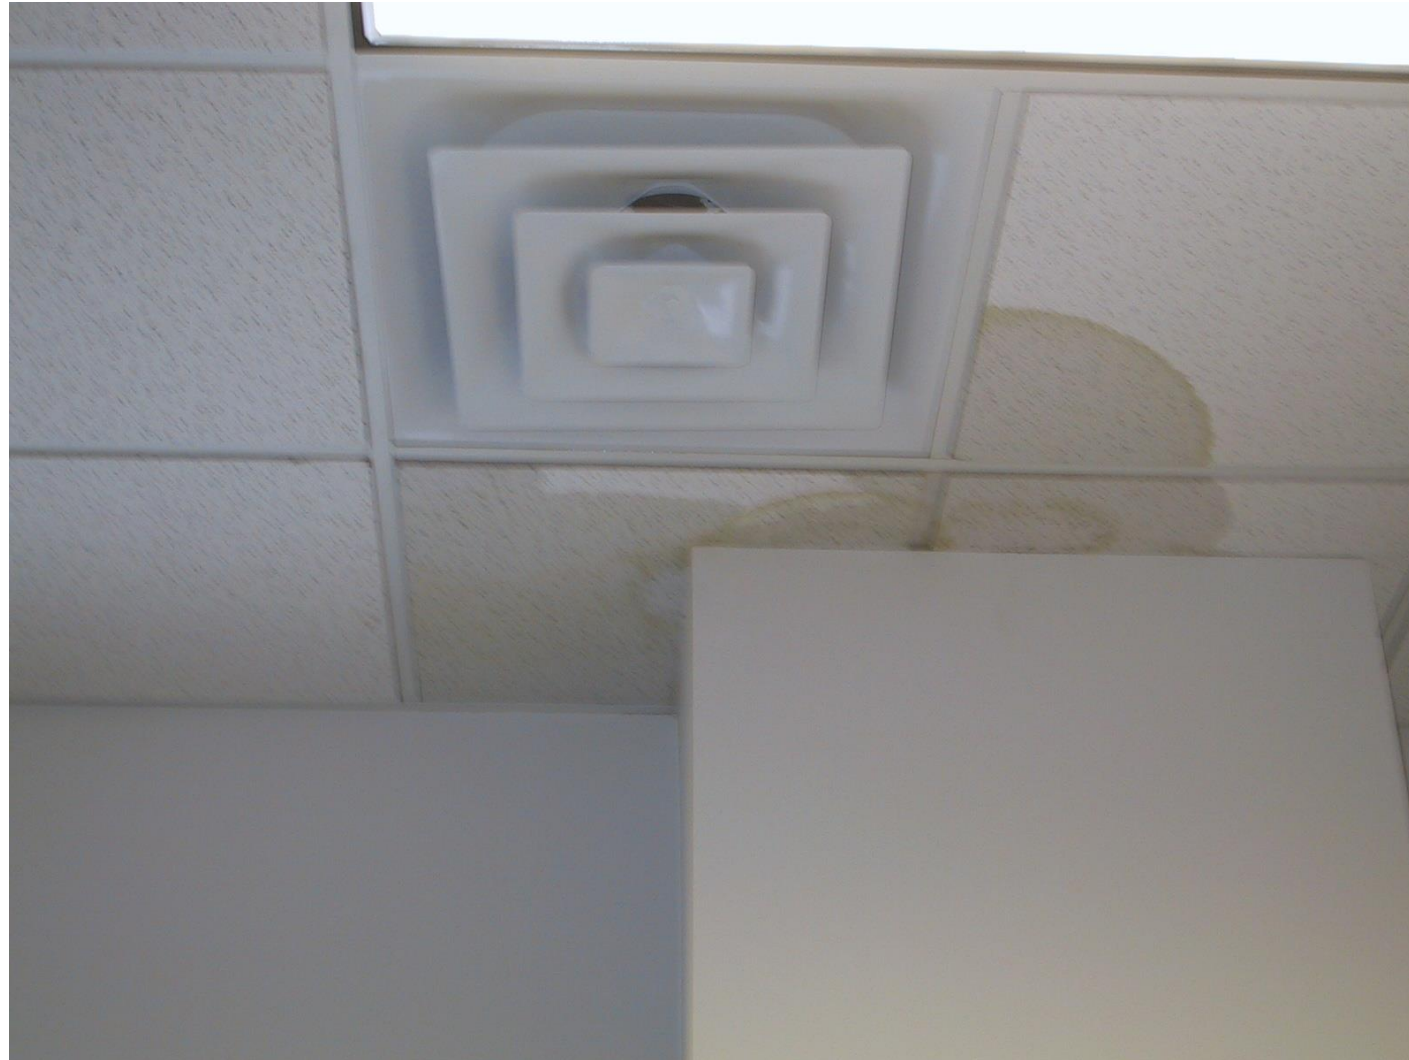
Investigate, roof leak or HVAC condensation?

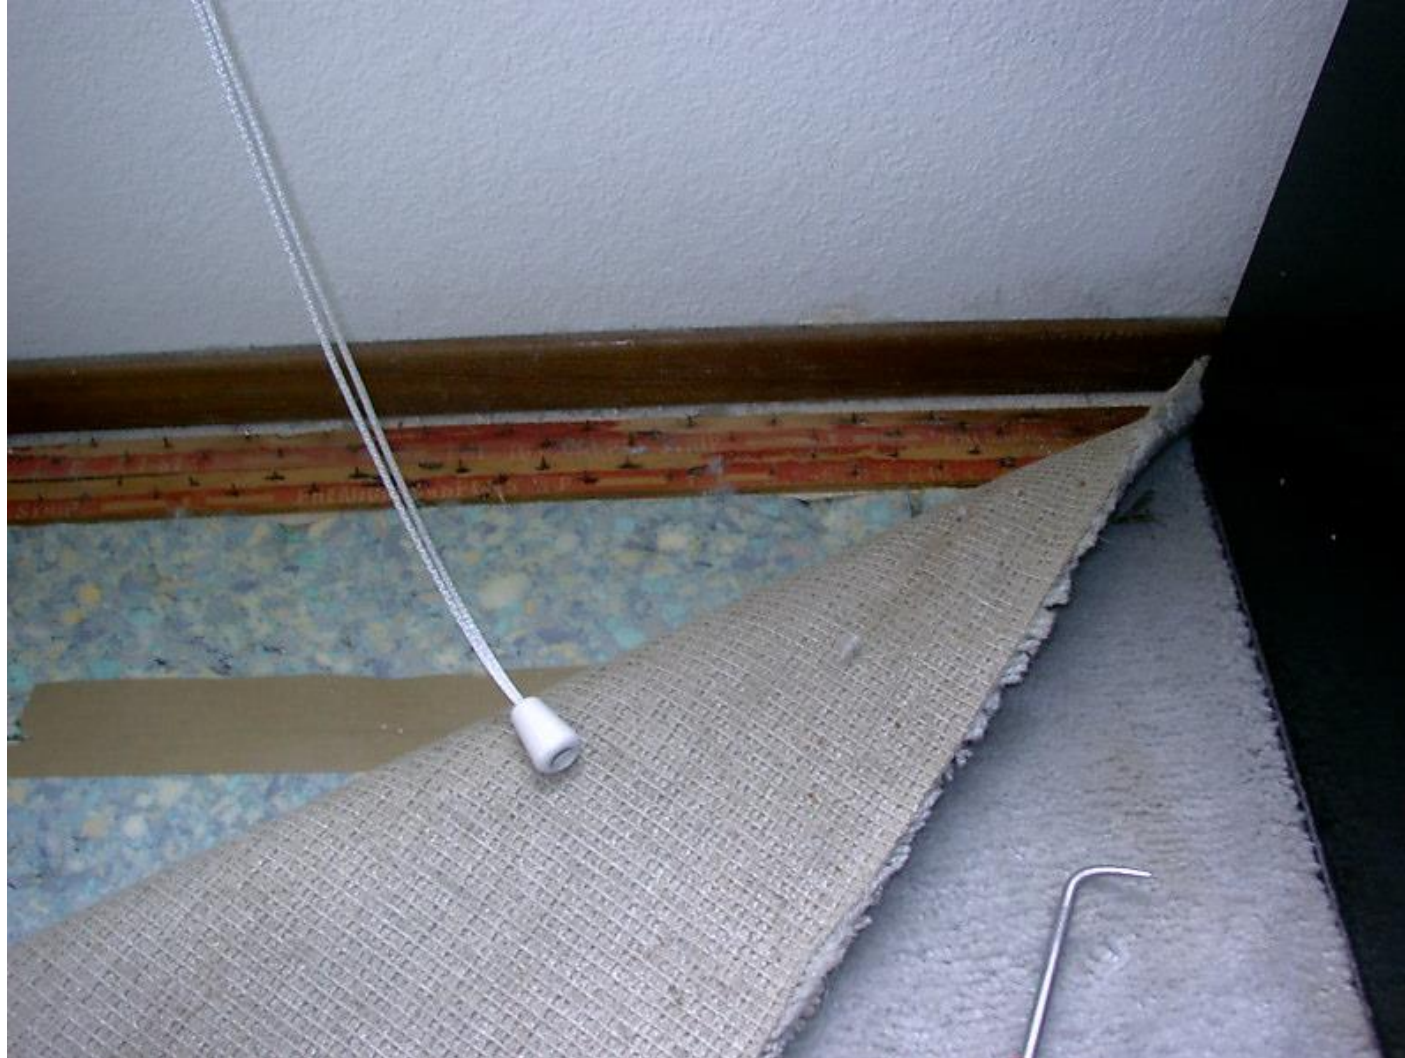
Leak detection...carpet tack strip tells the story

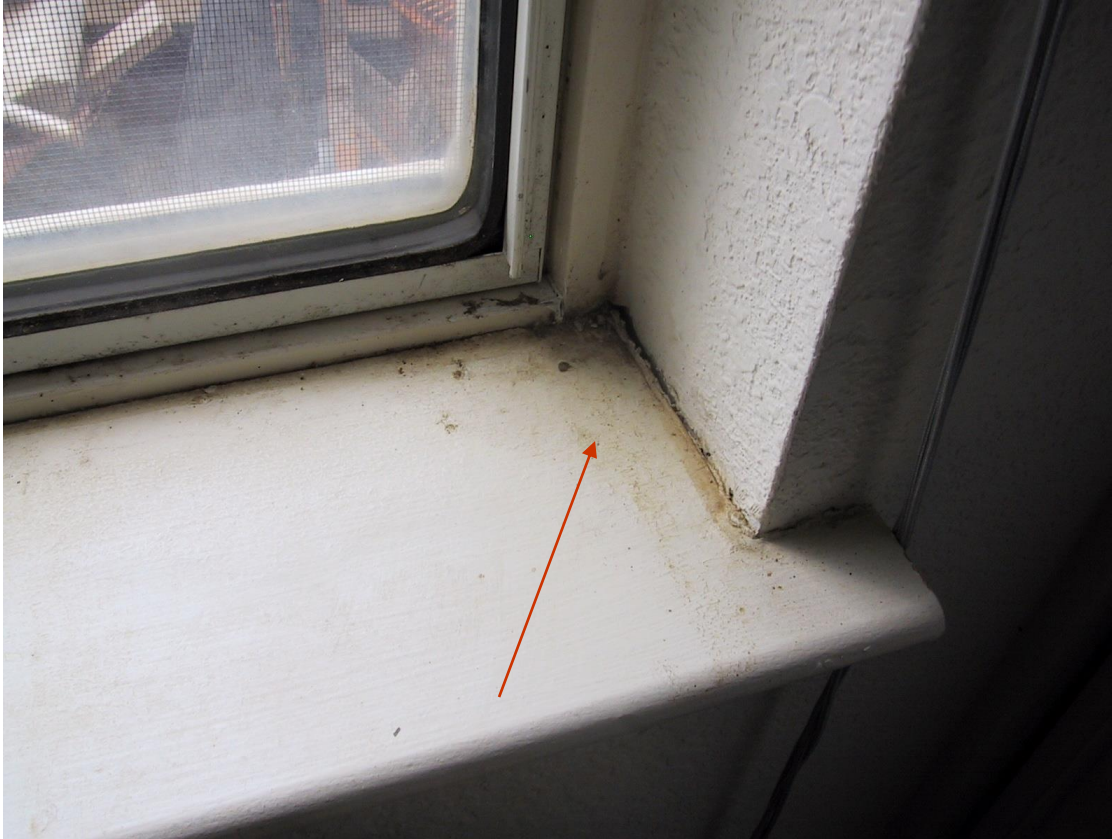
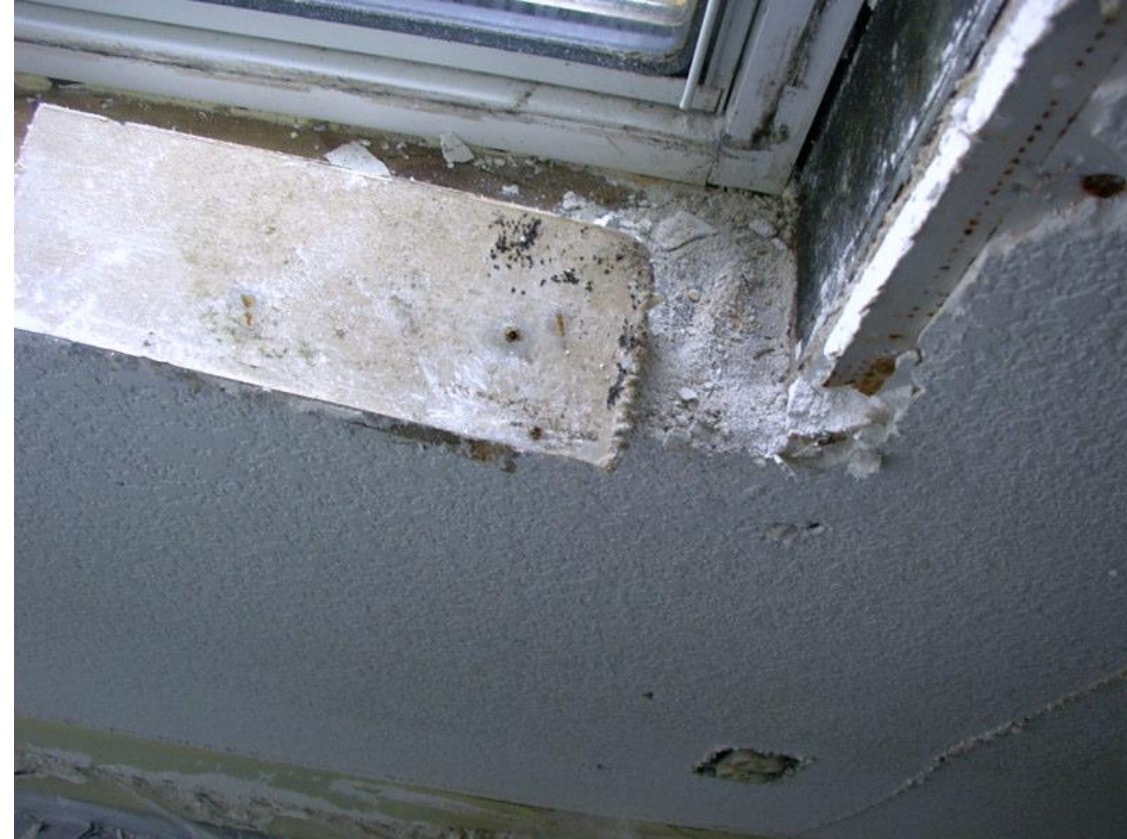
Signs of leaks, small stains often damage is much greater

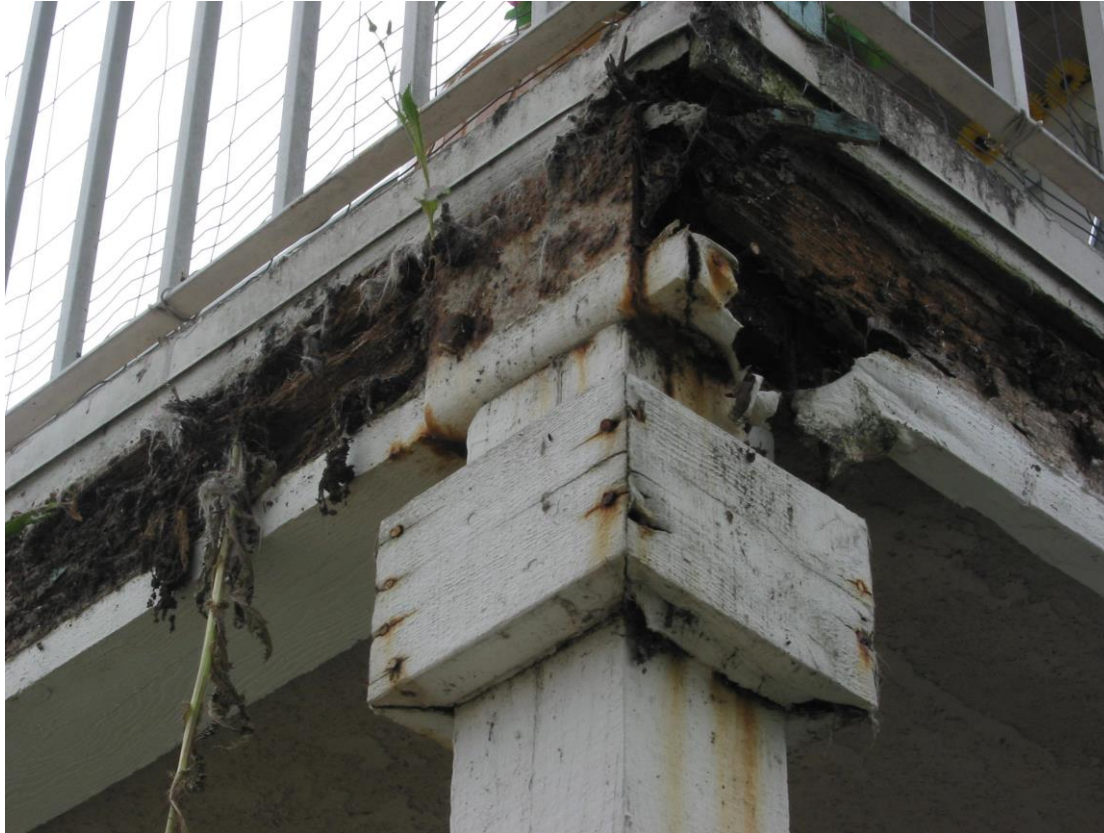
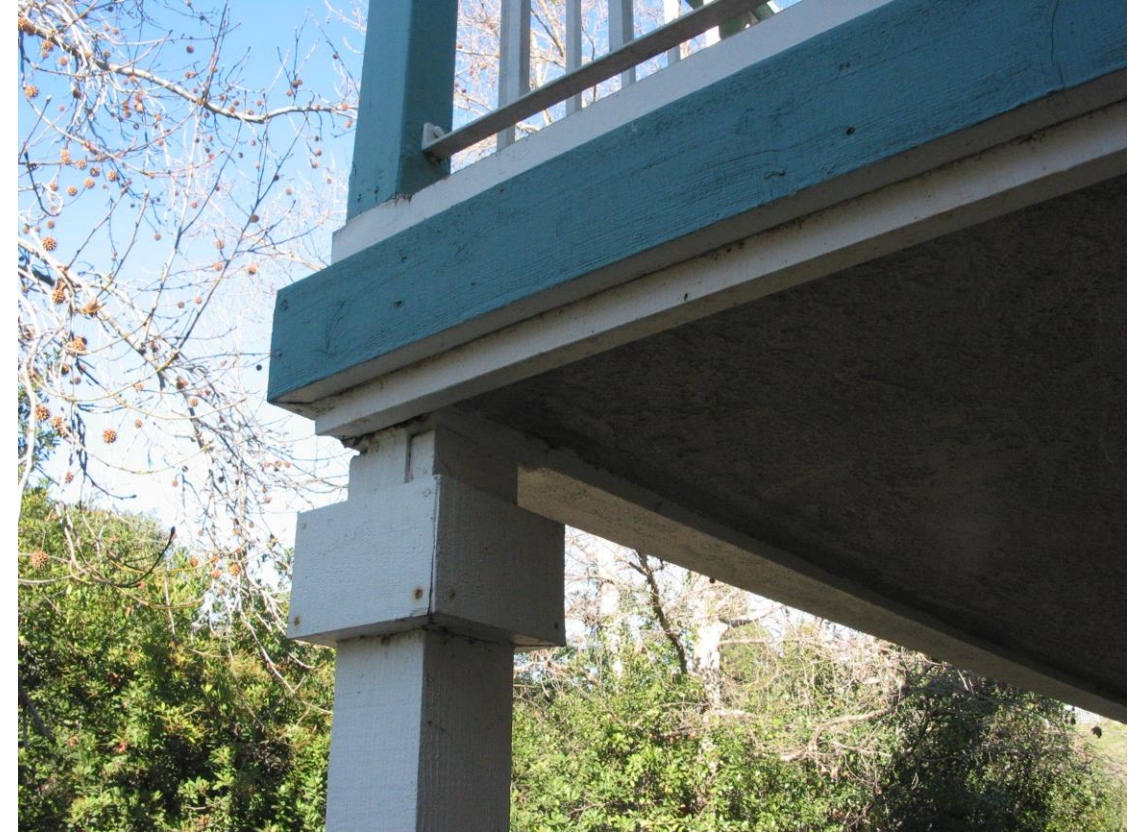
Wood to wood contact traps water and promotes decay

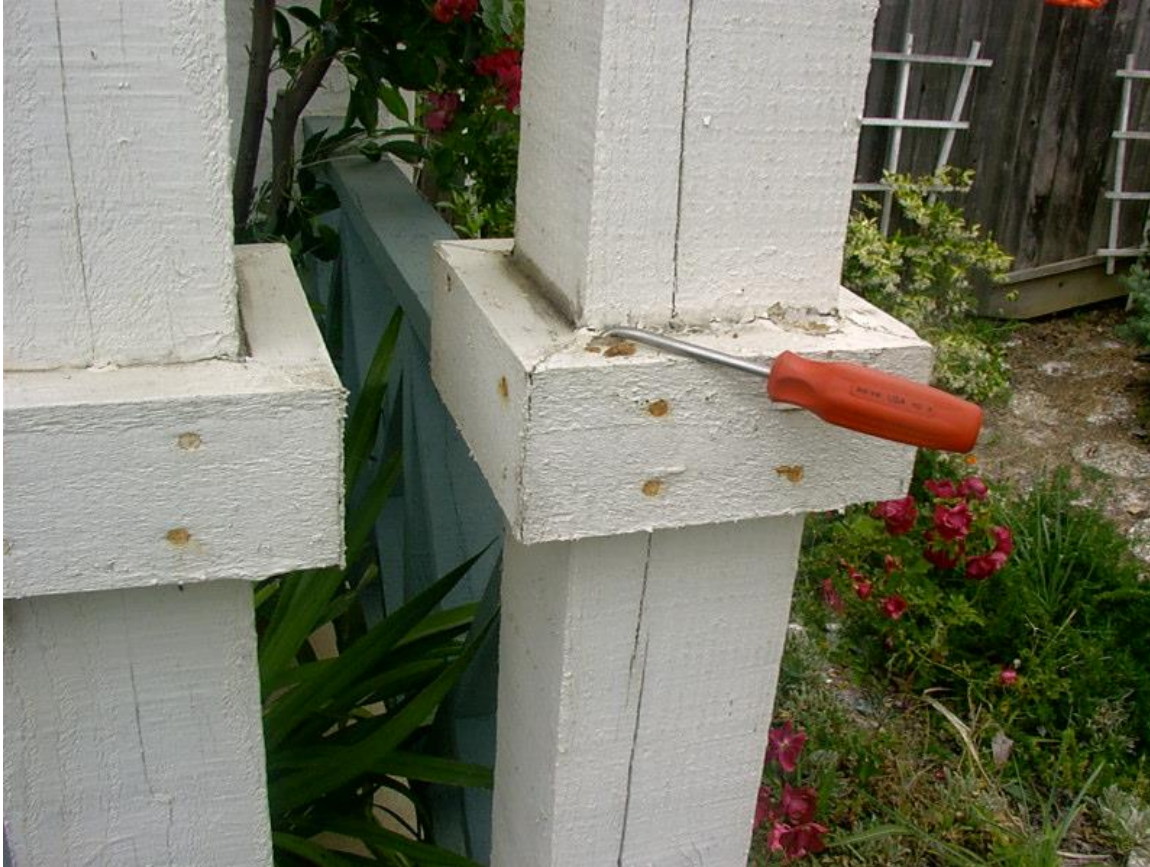
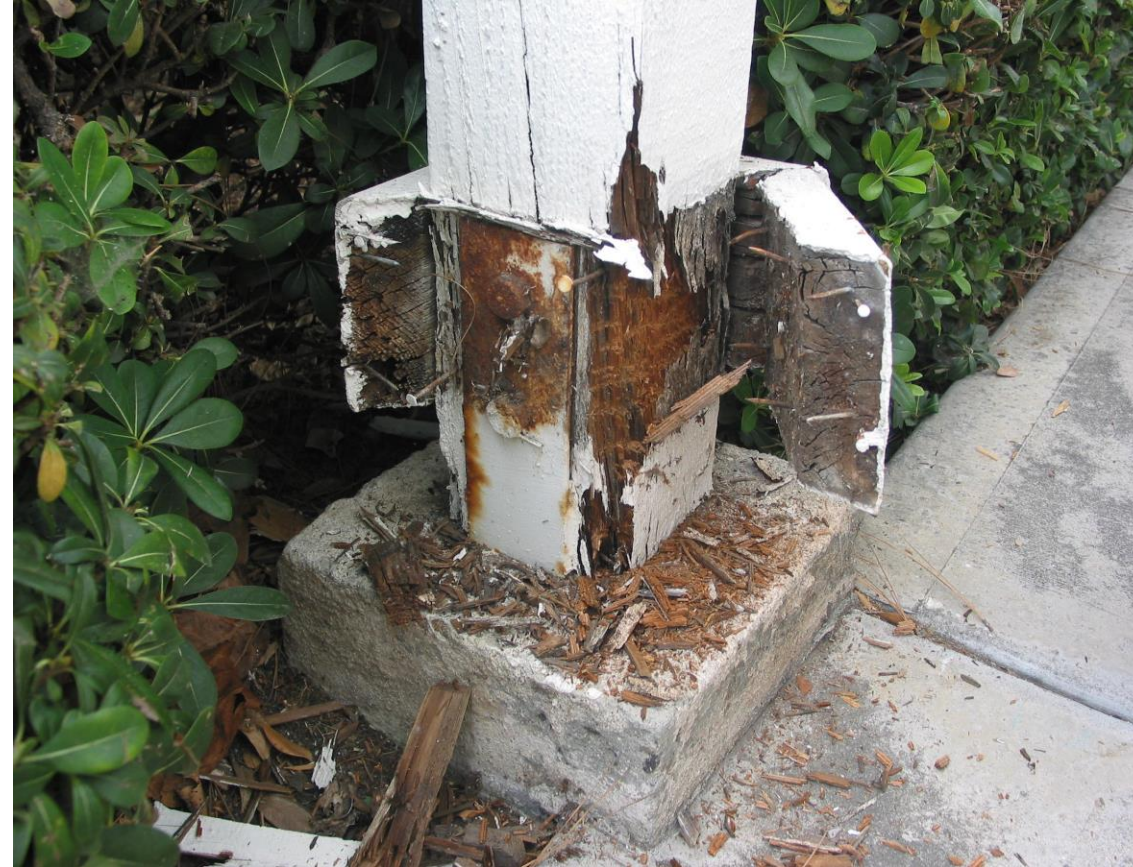
Wood trim over wood column + sprinklers

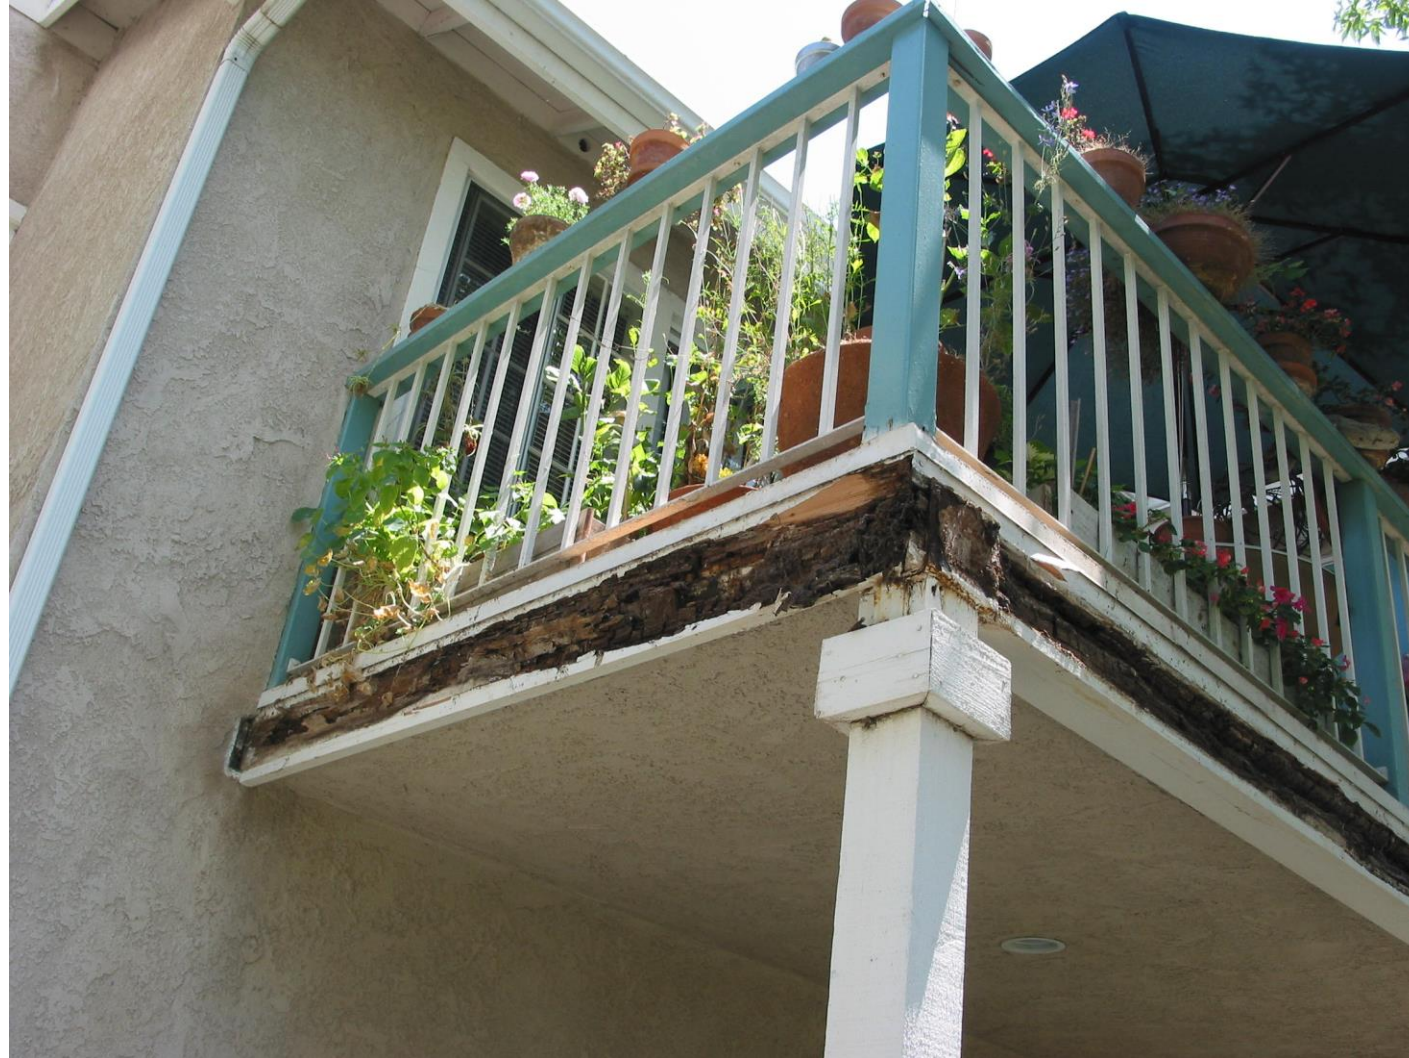
Wood bands over wood beams + landscaping on deck.....bad idea!

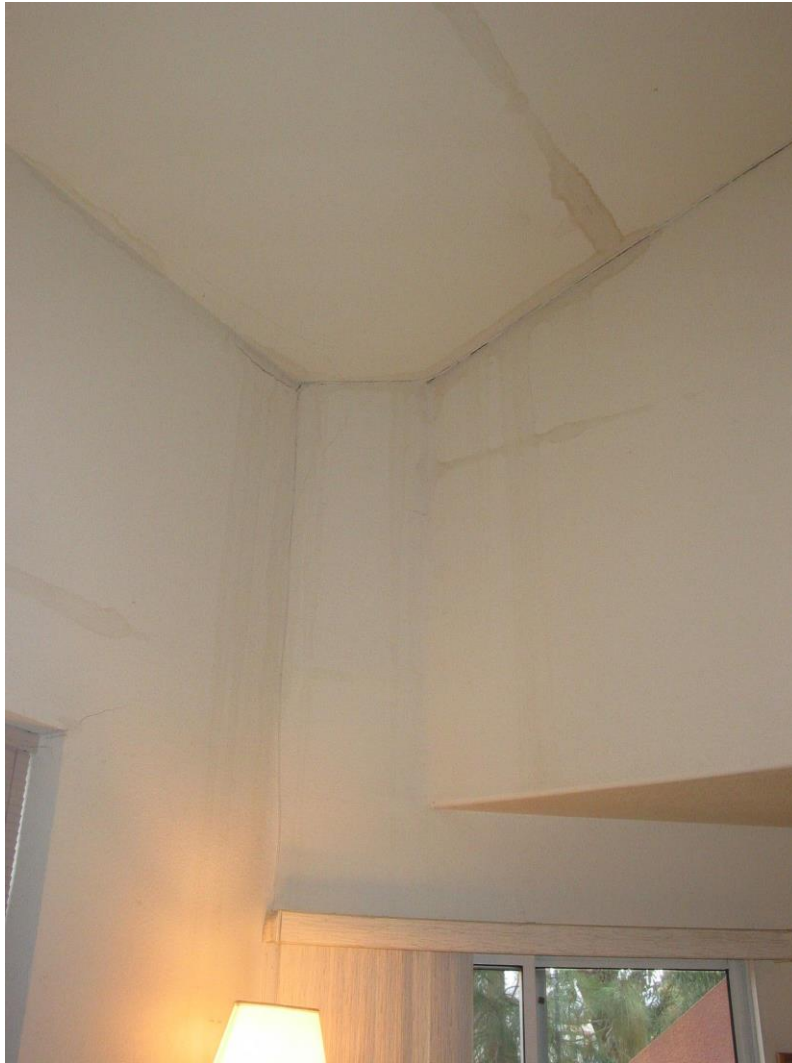
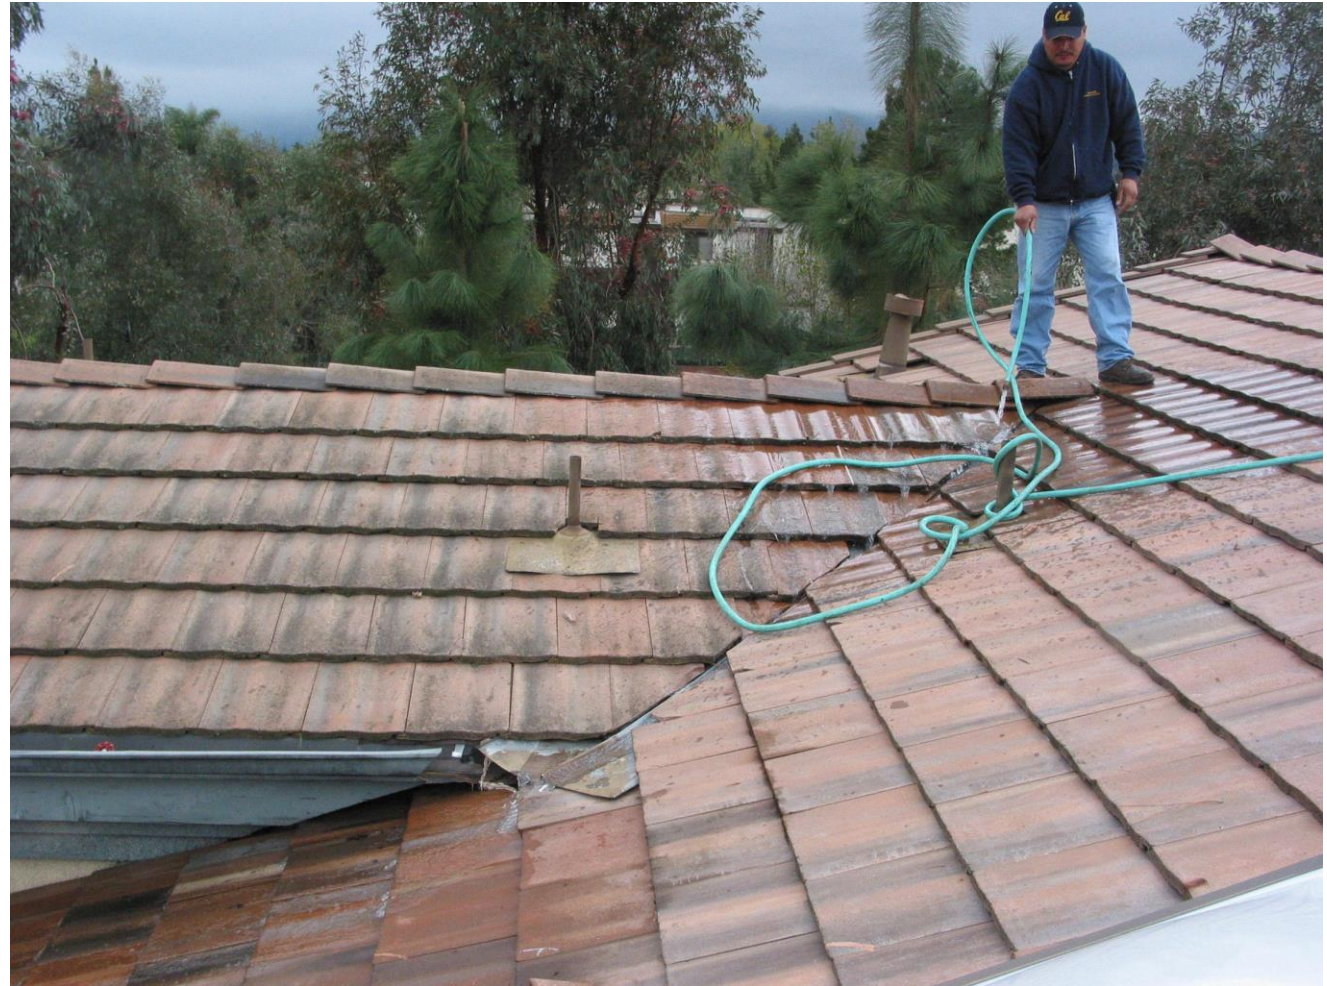
Tile roof leak investigation

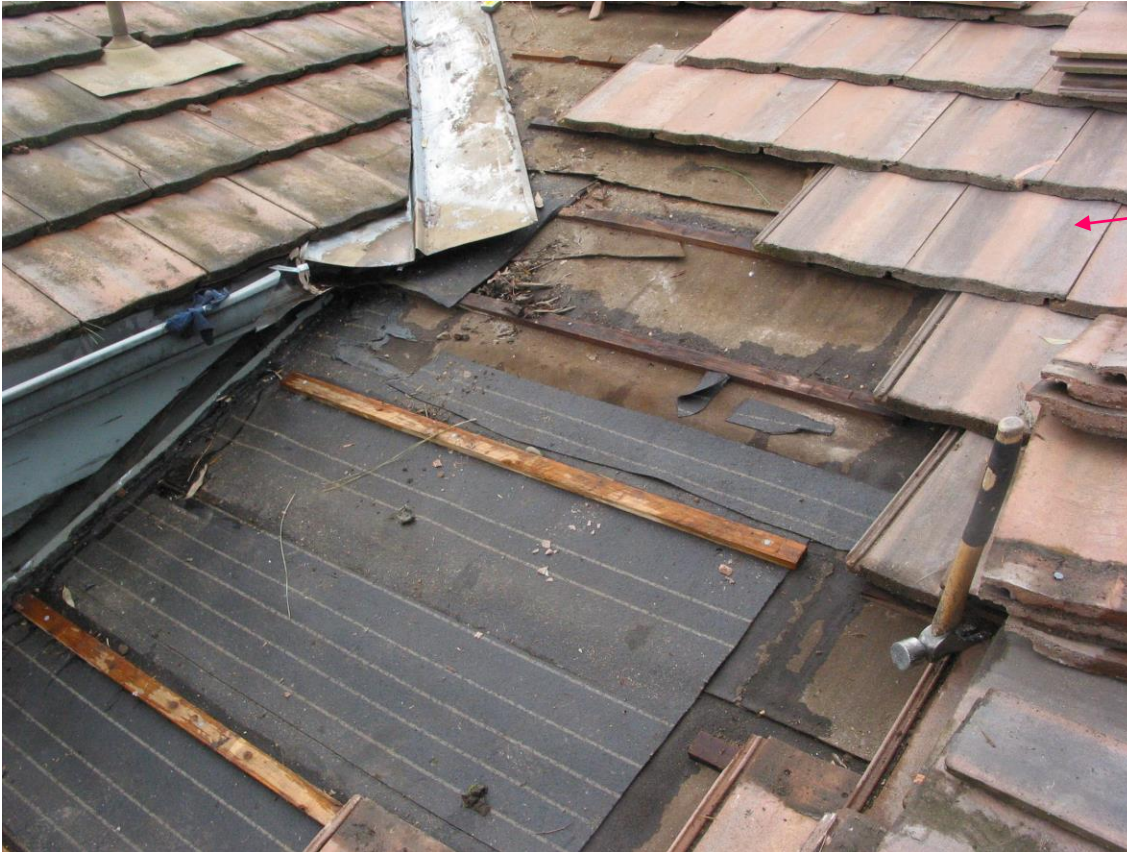
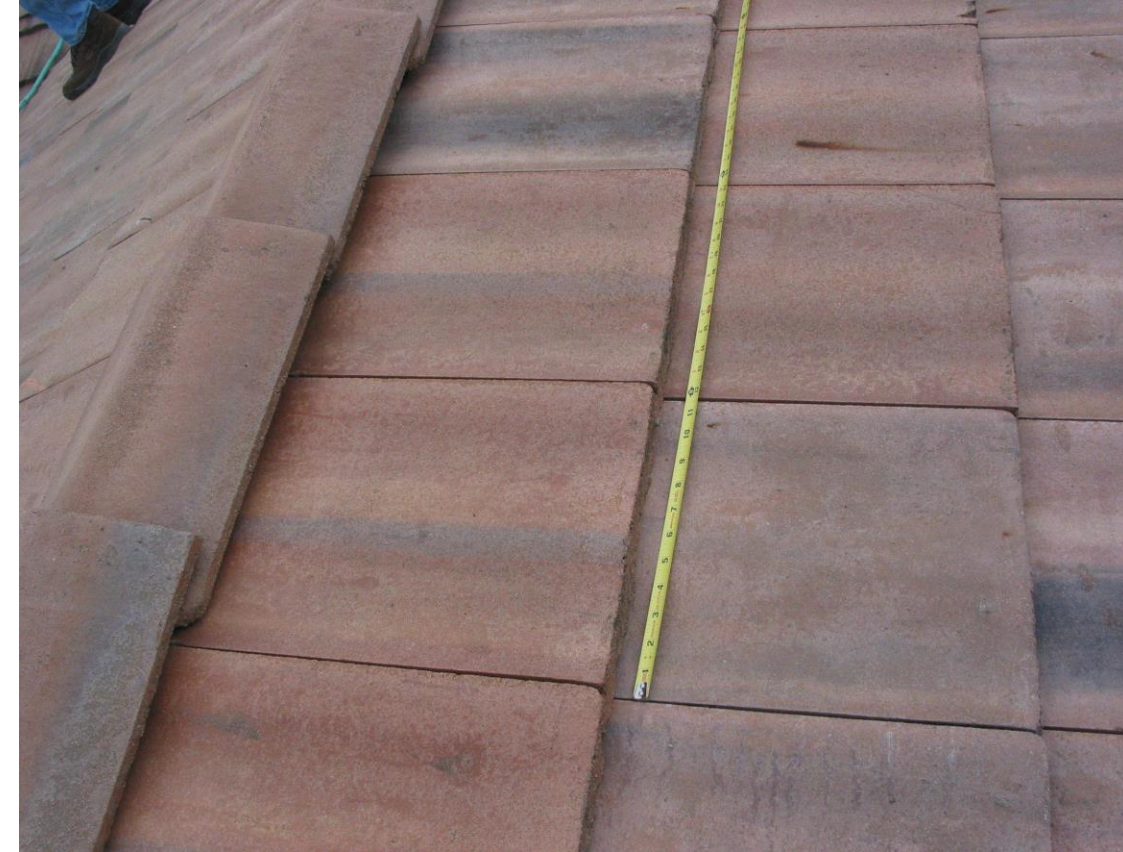
Cracked tiles, improper running bond pattern caused the leaks

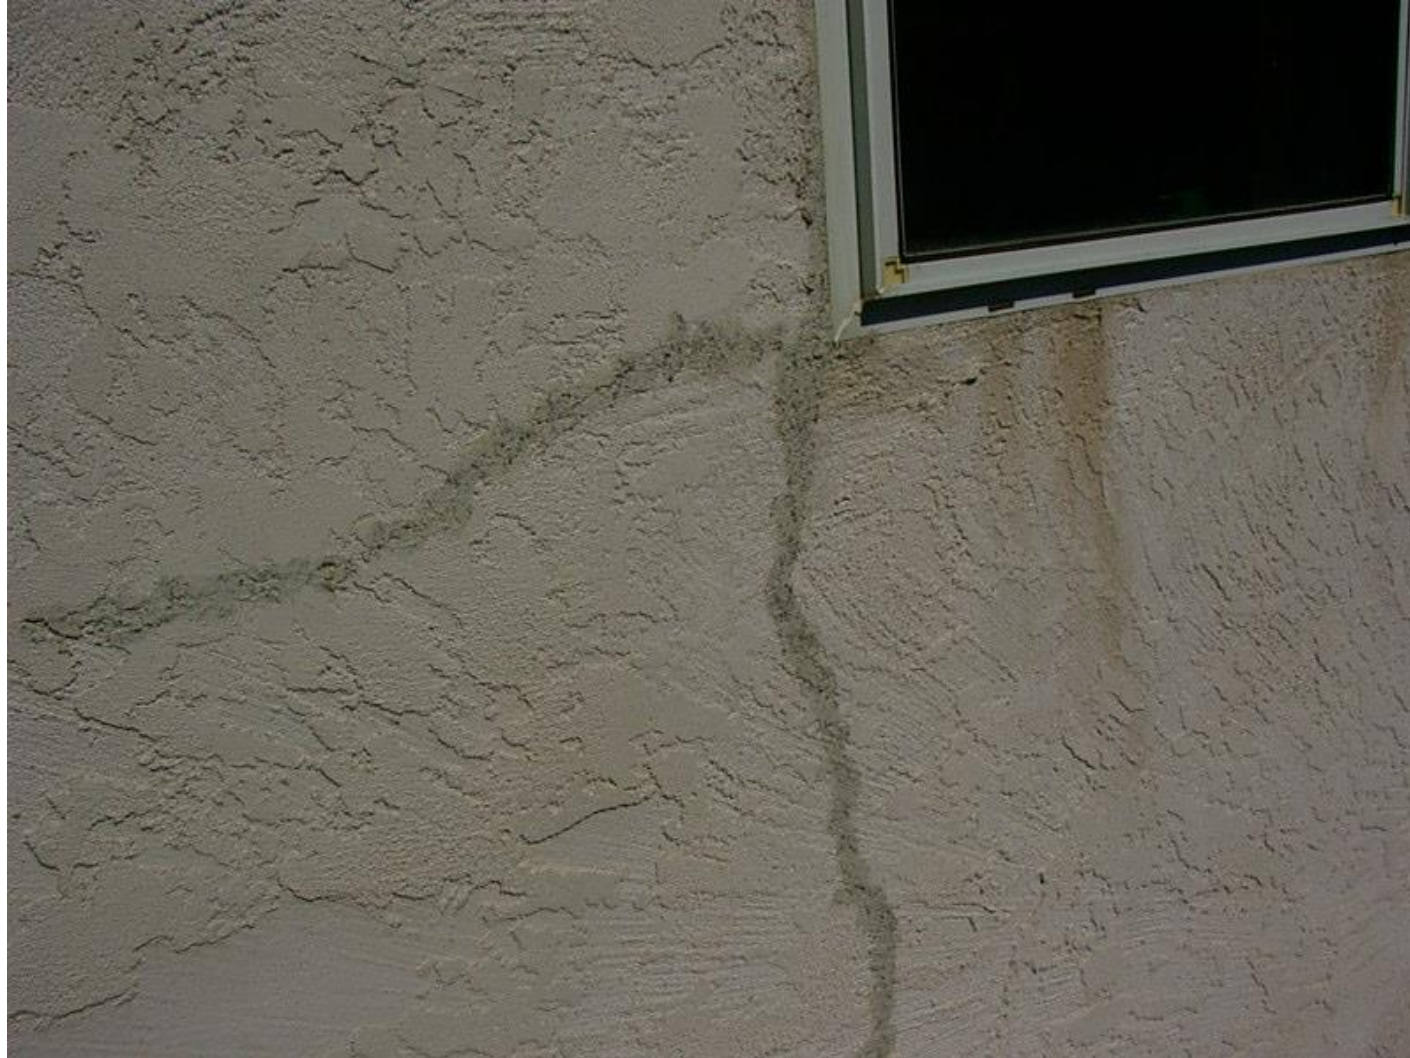
Look for water stains or unusual cracks in cement plaster

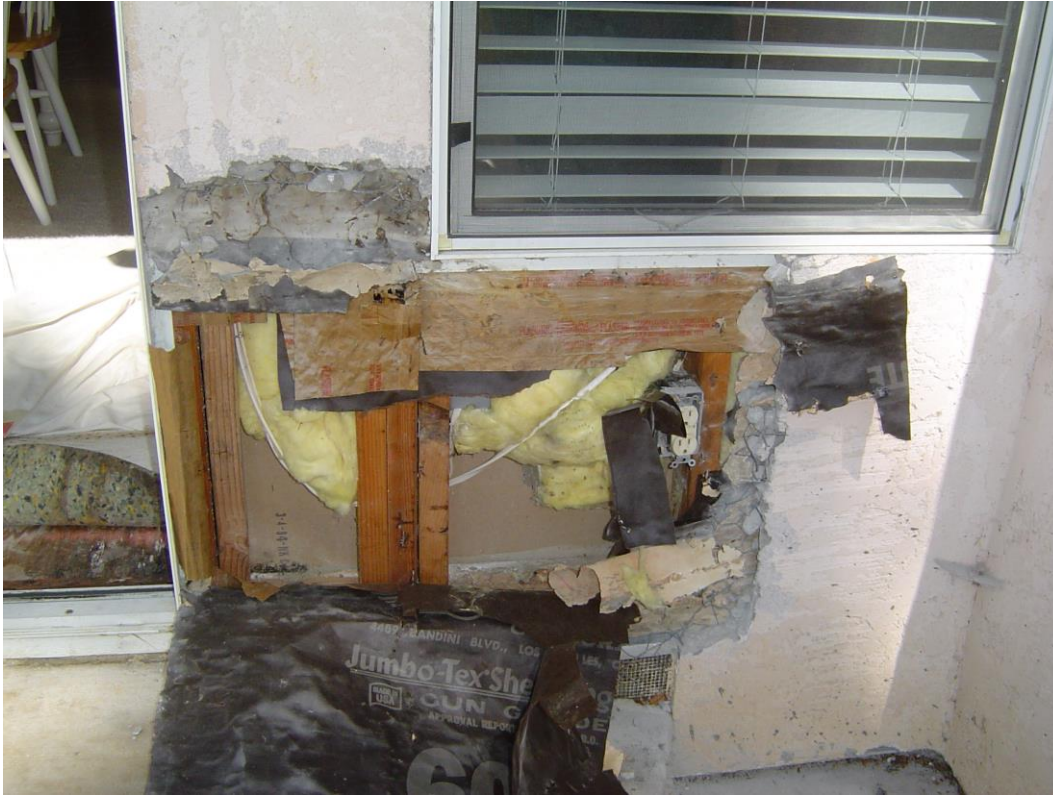
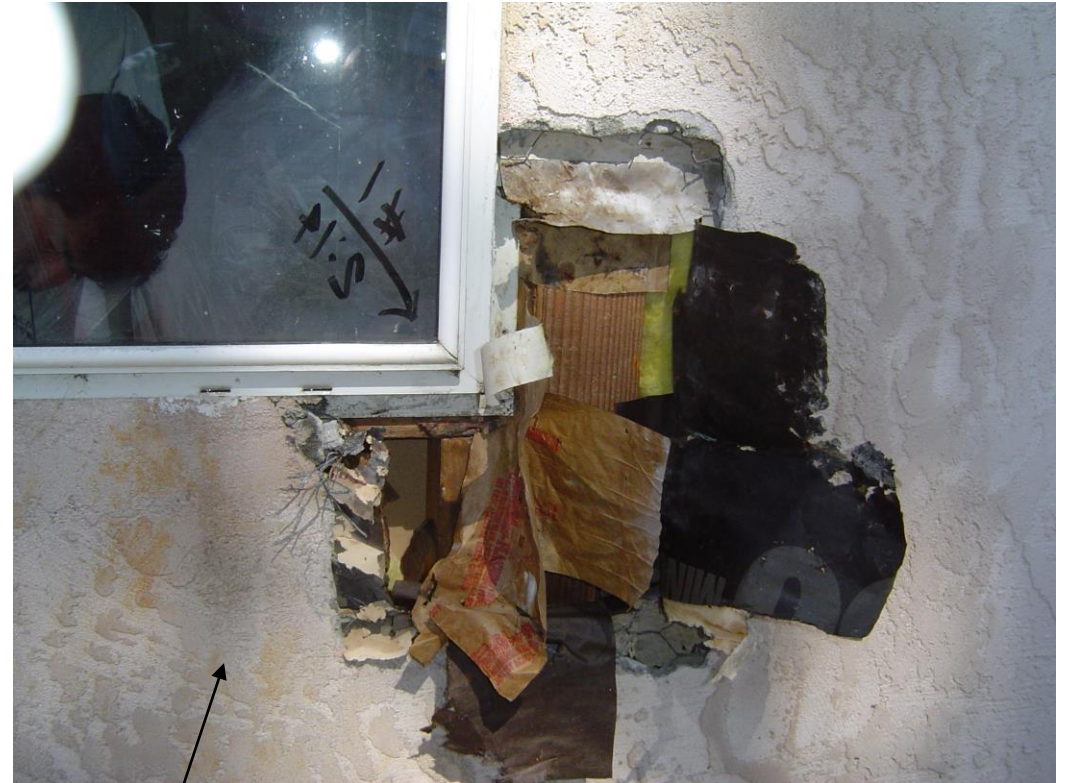
Typical window frames in cement plaster allow water intrusion. Seal edges of window and exterior plaster

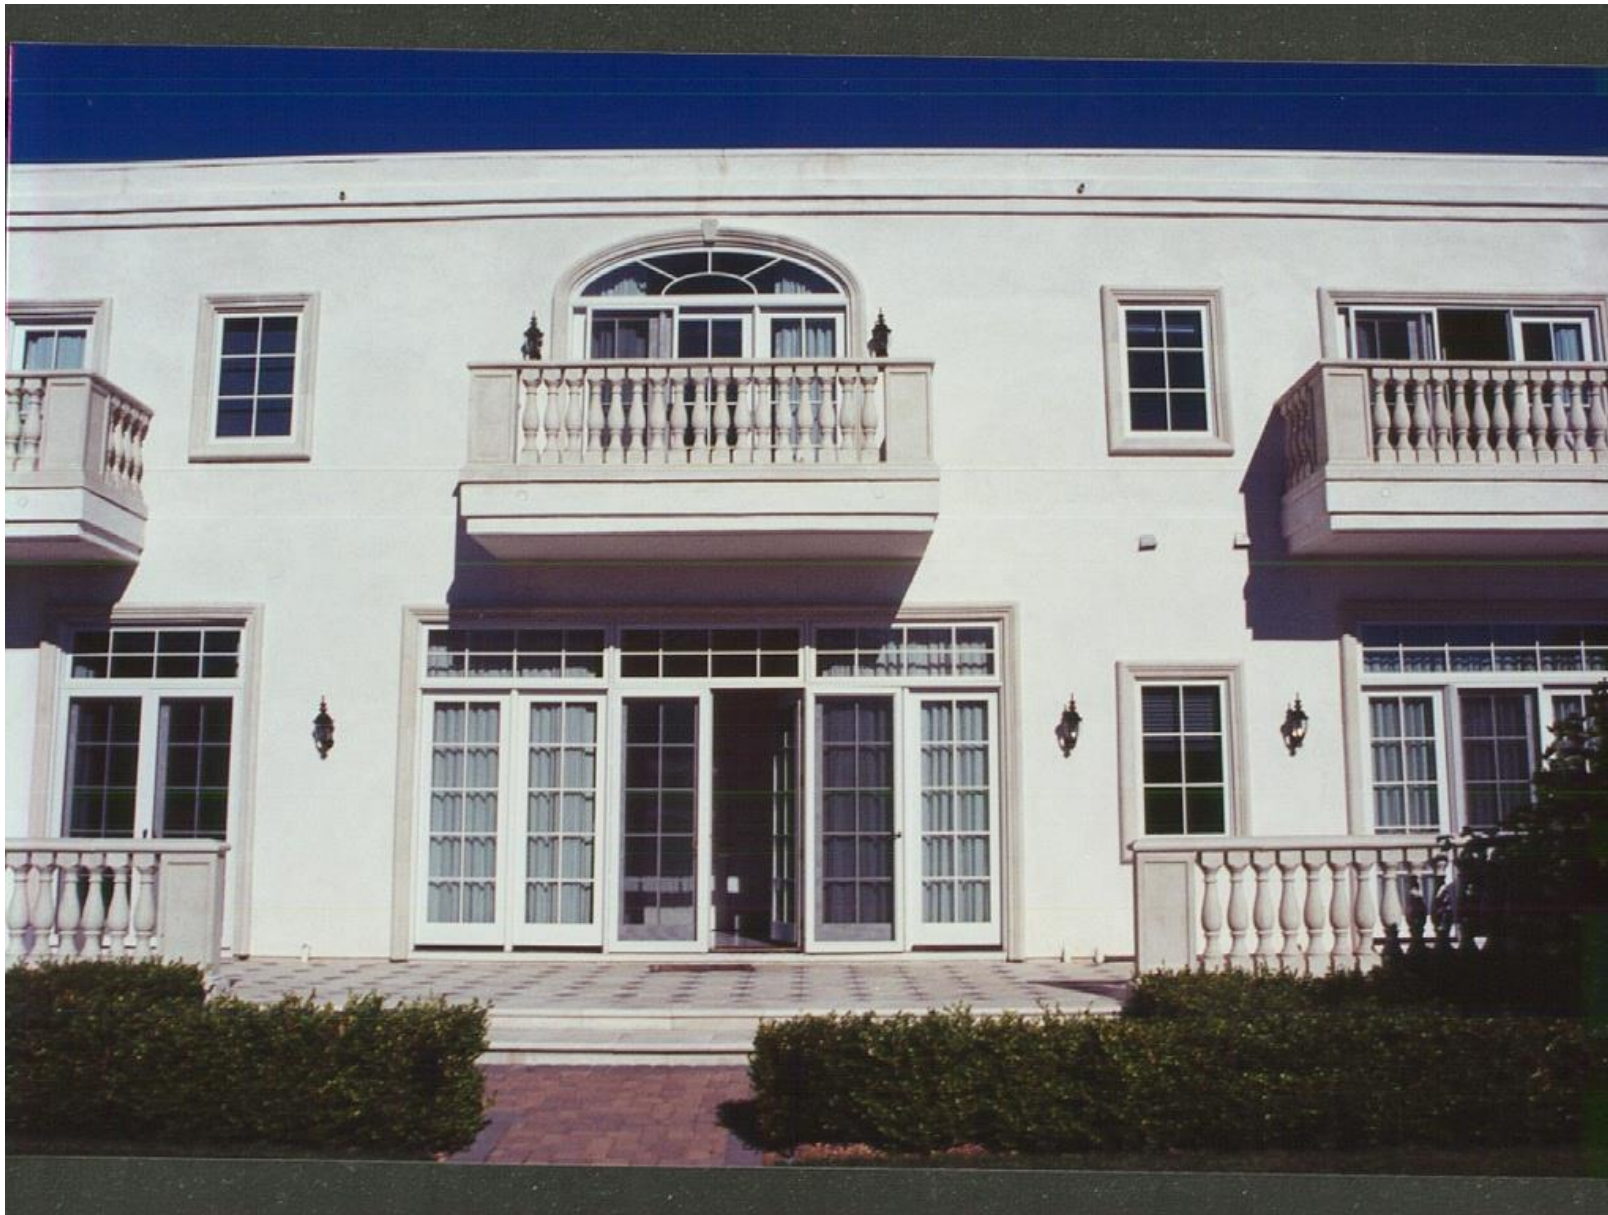
Stucco stain, discoloration

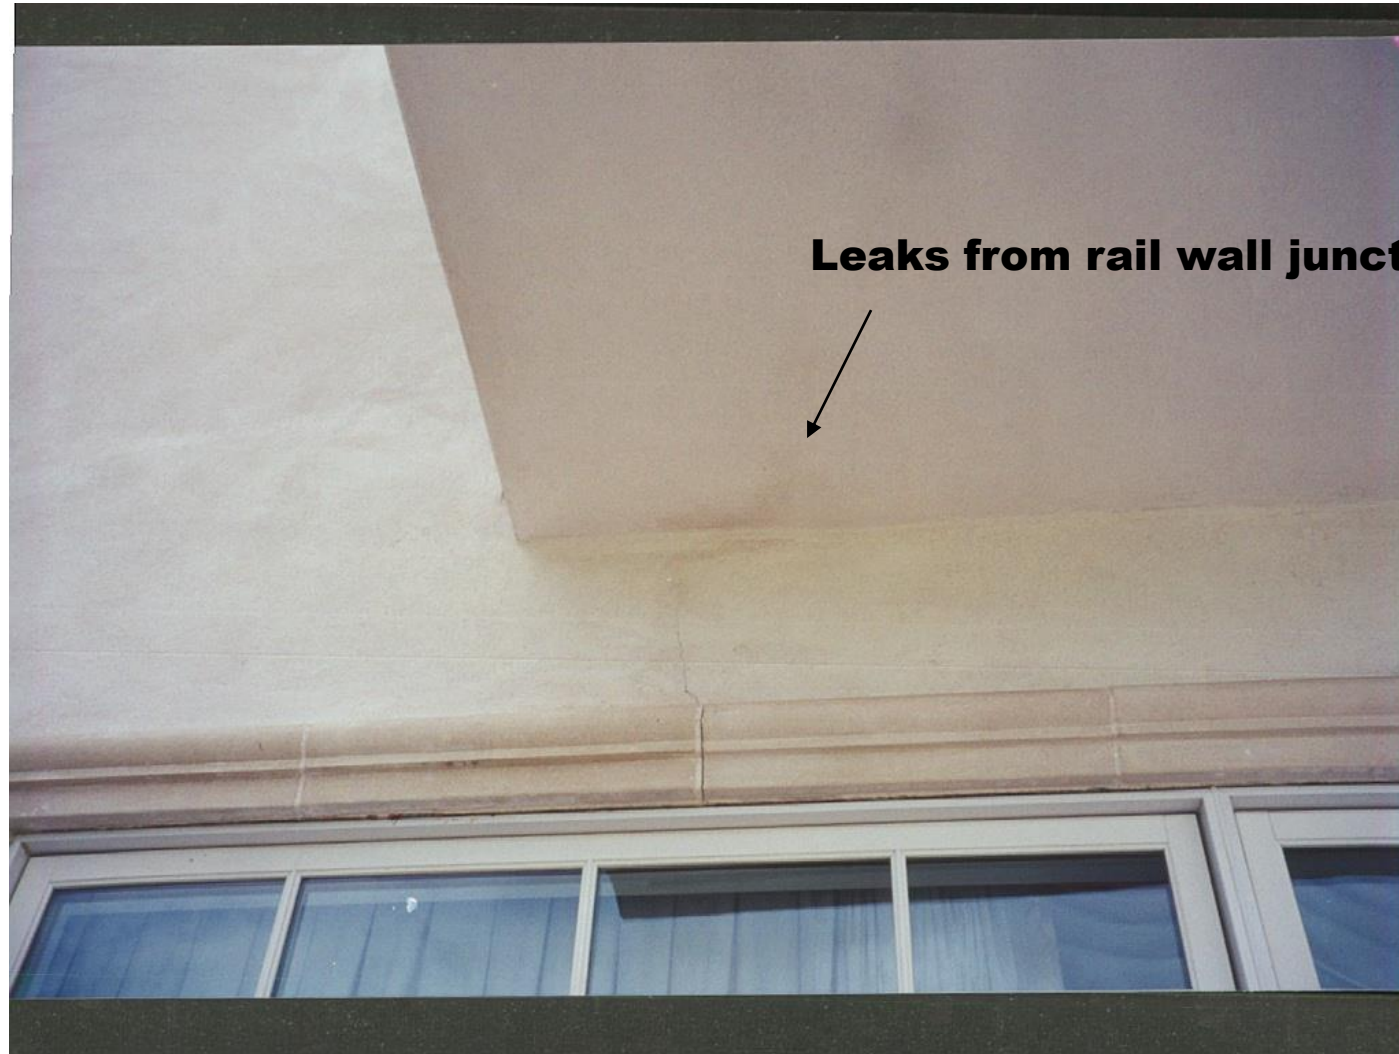
**Leaks from
rail wall
junction**
