Increasing Your Property Value Recognizing Leaks and Problems

CAA Seminar – Increasing Your Property Value
March 23, 2004

Increasing Your Property Value Maintenance and Repair Strategies

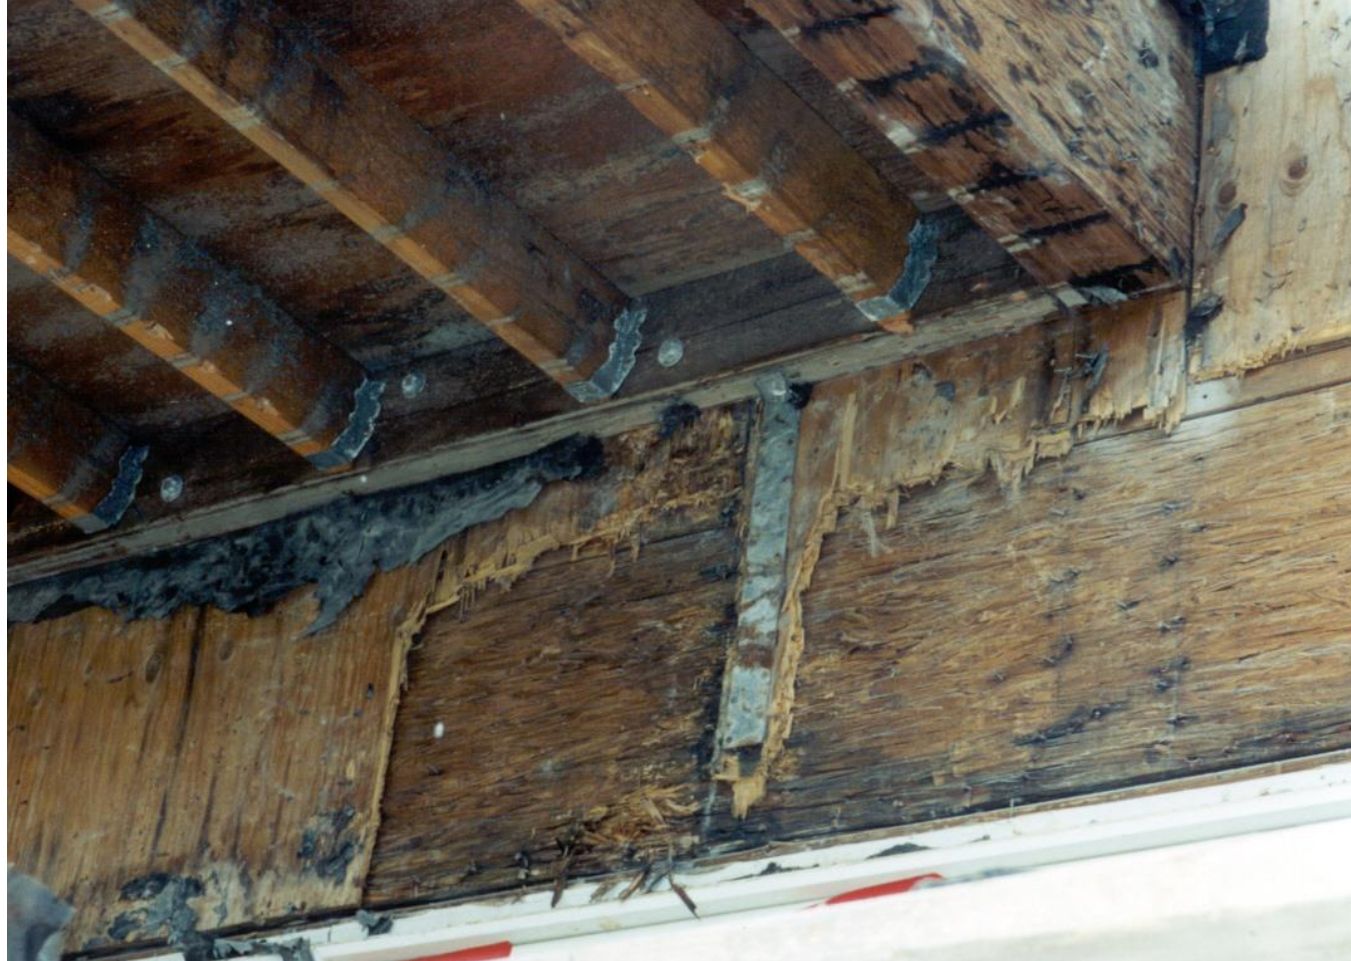
This innocent looking leak caused a lot of damage

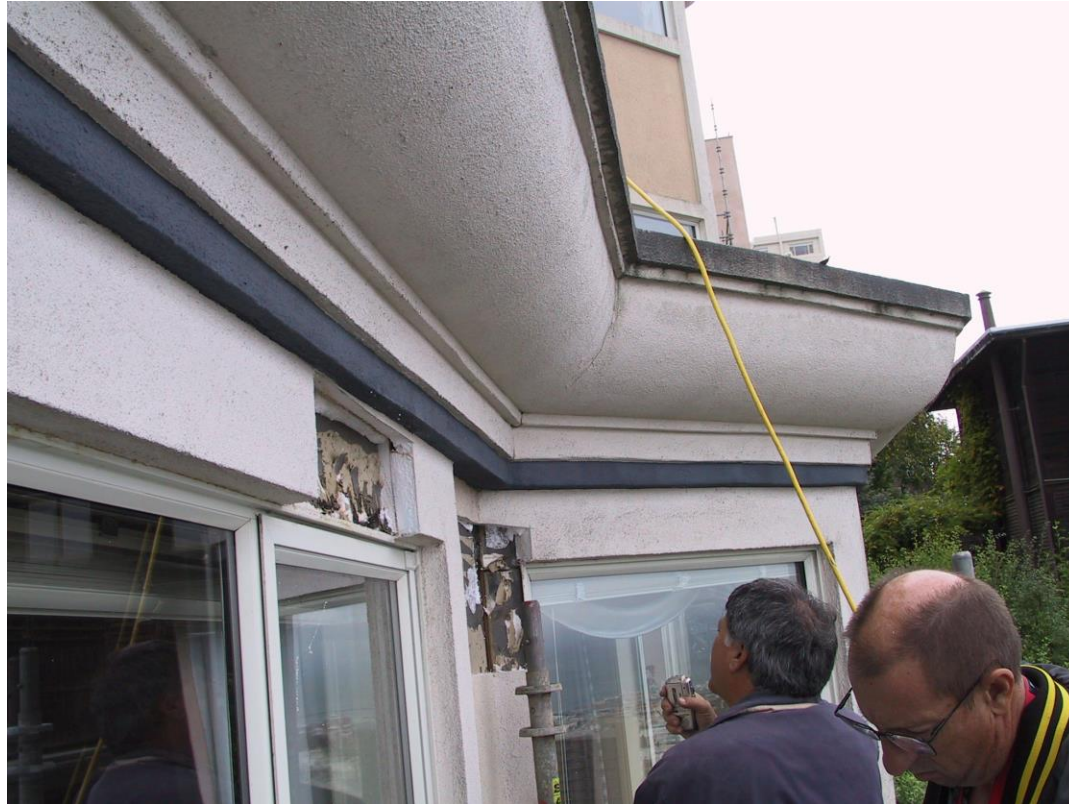
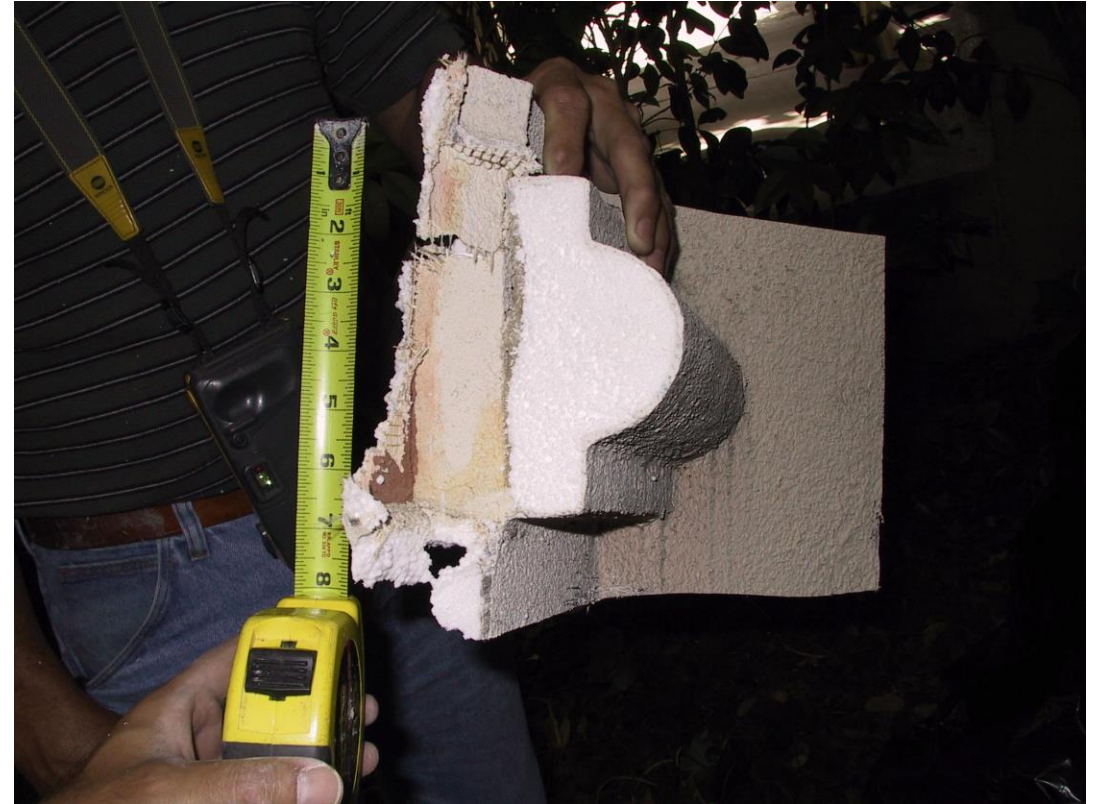
Exterior Insulation and Foam System (EIFS)

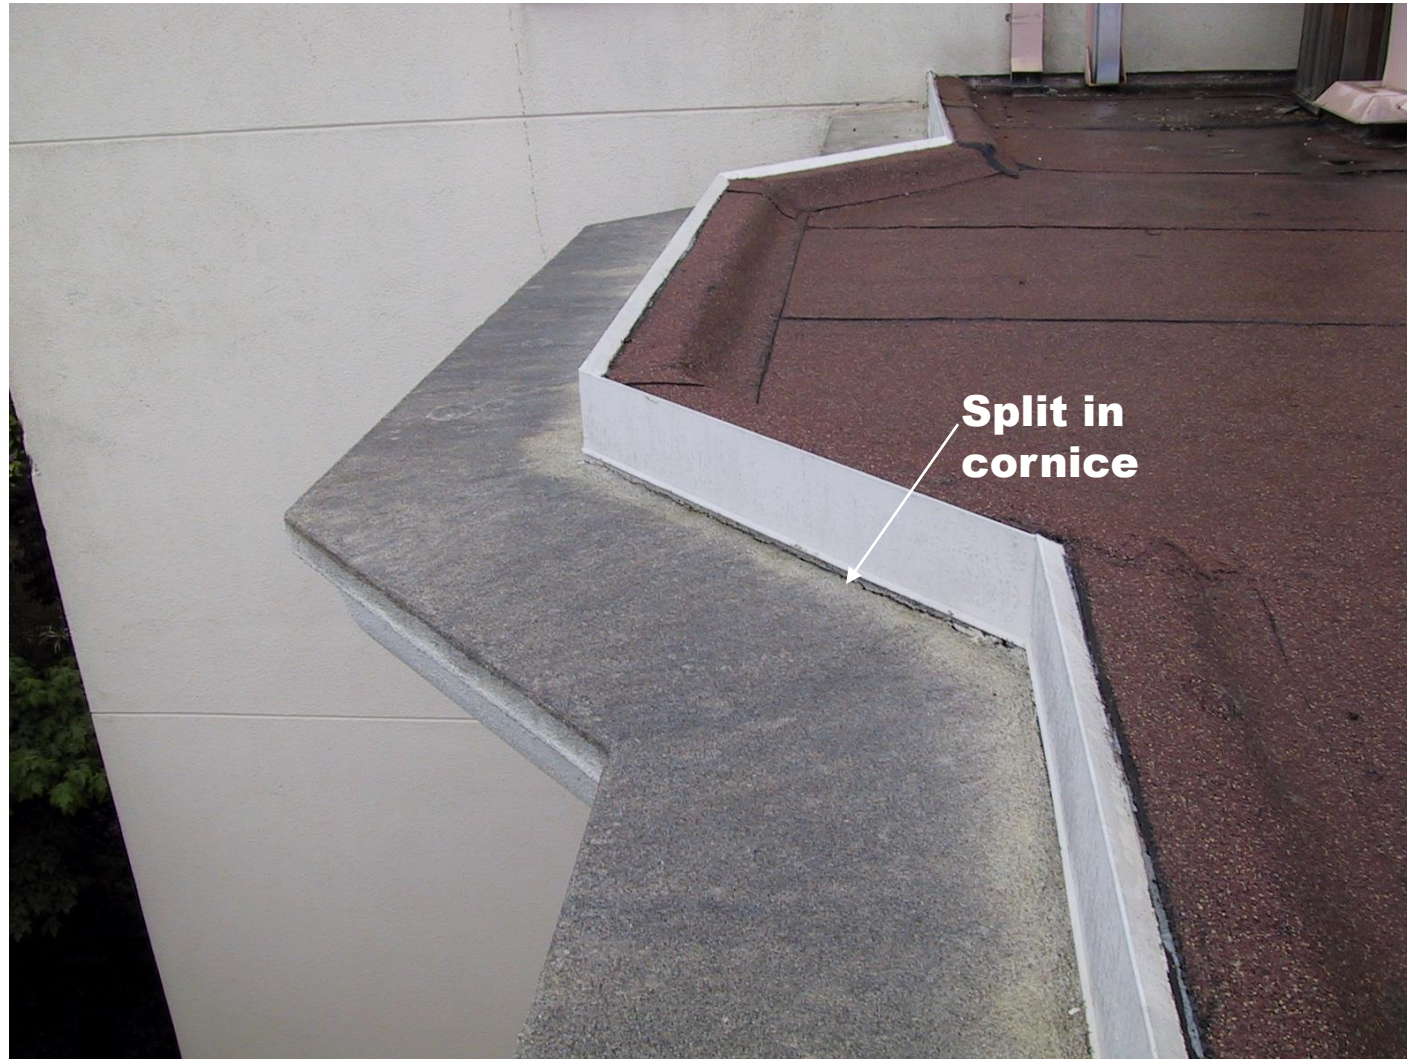
EIFS cornice, low slope, algae, and split

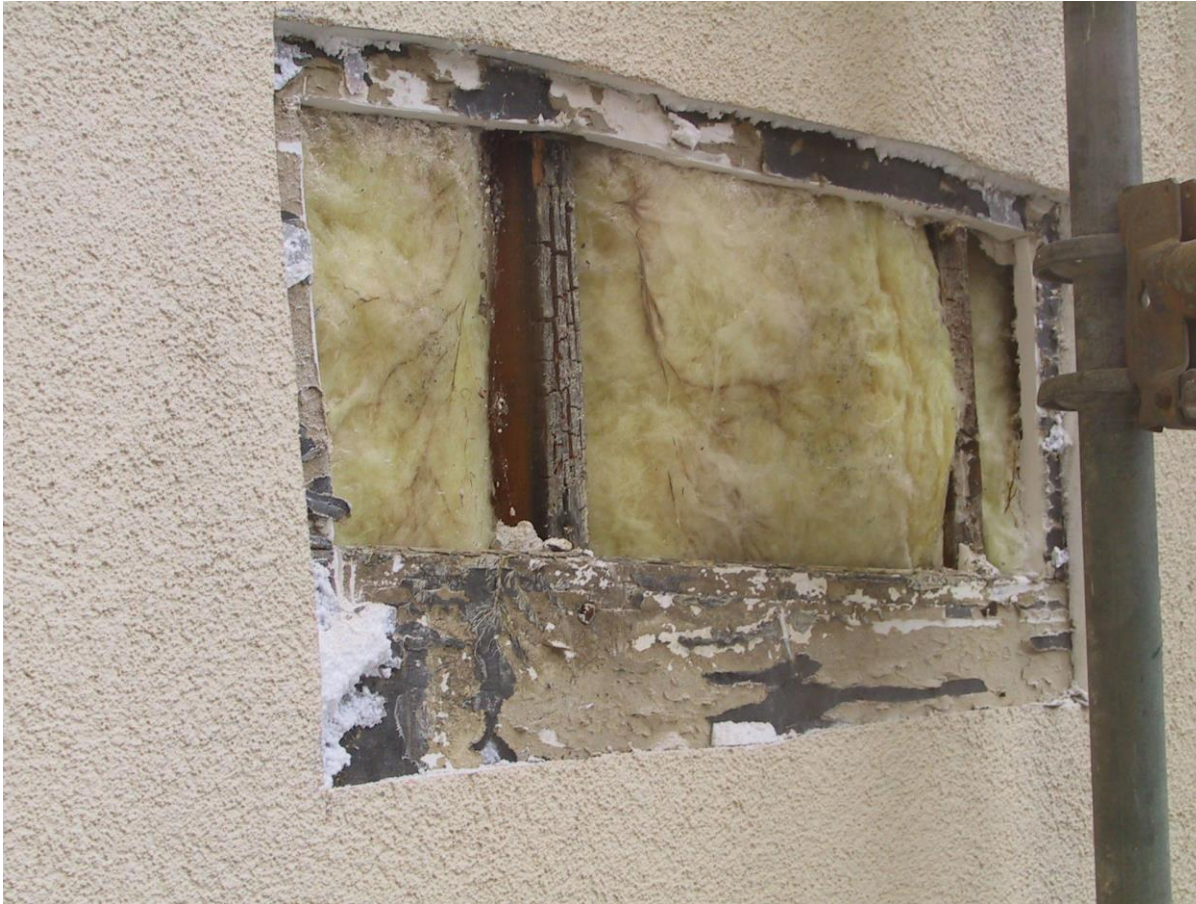
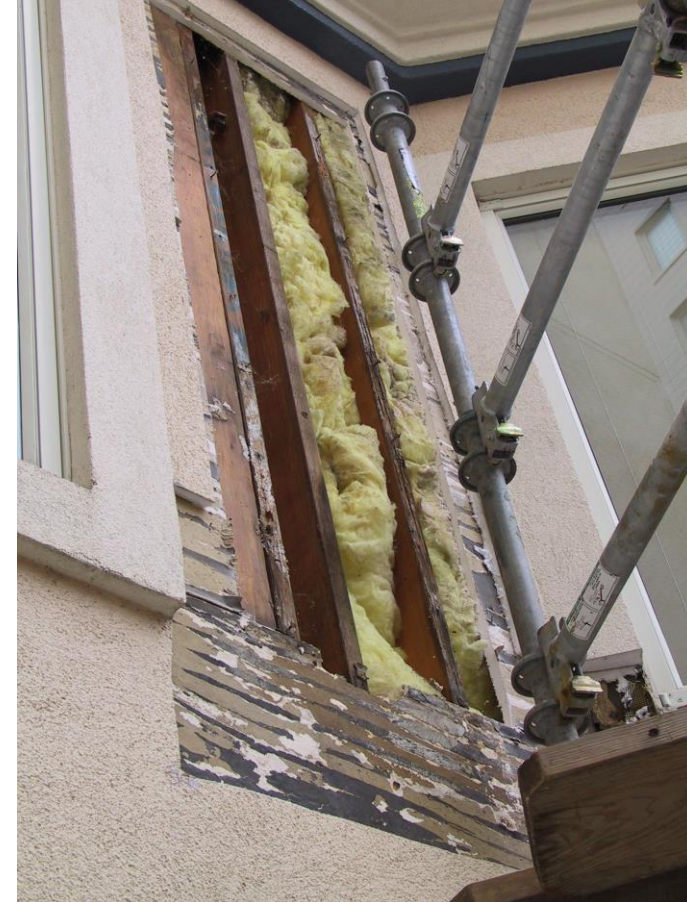
EIFS cornice (lack of slope) allowed this water intrusion

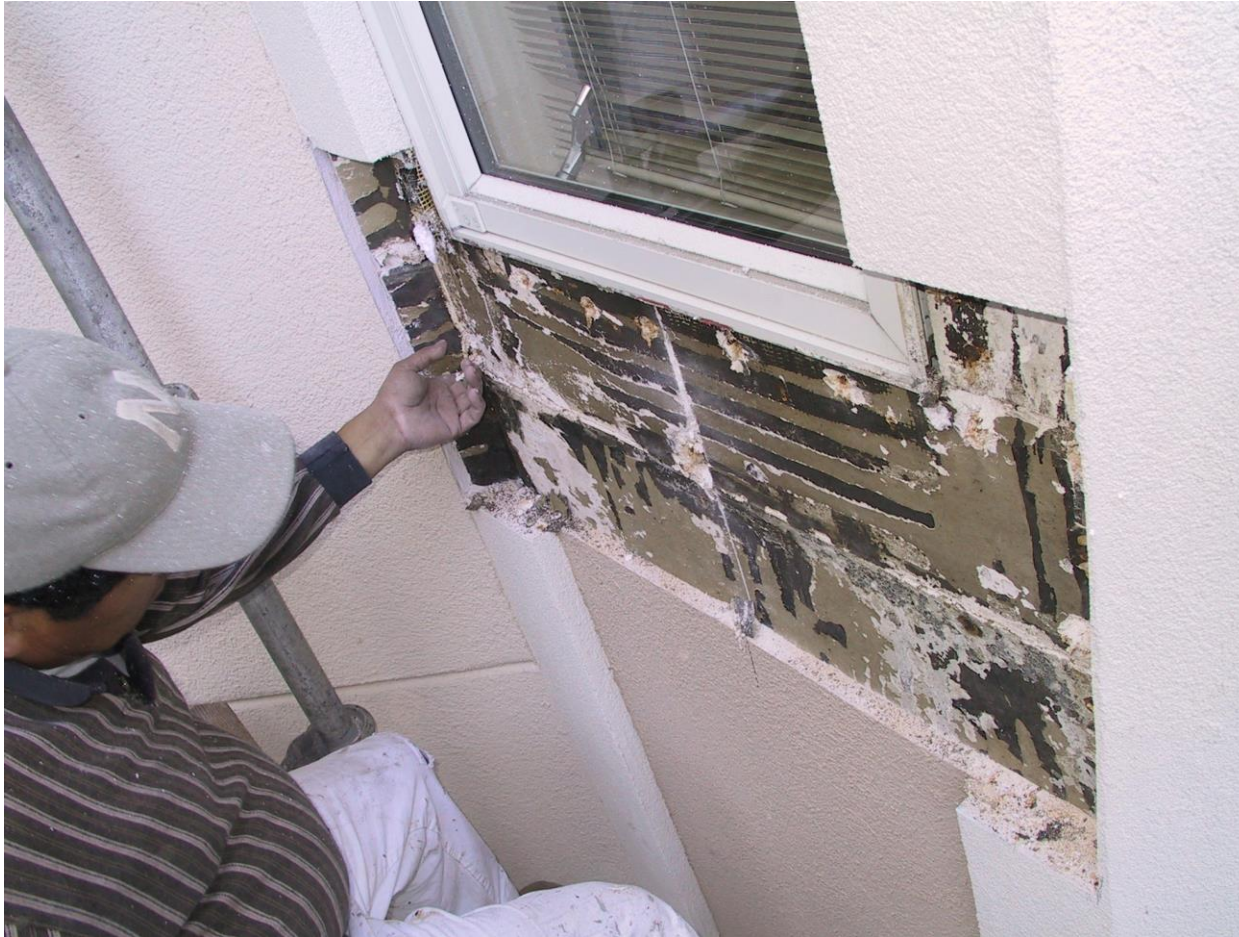
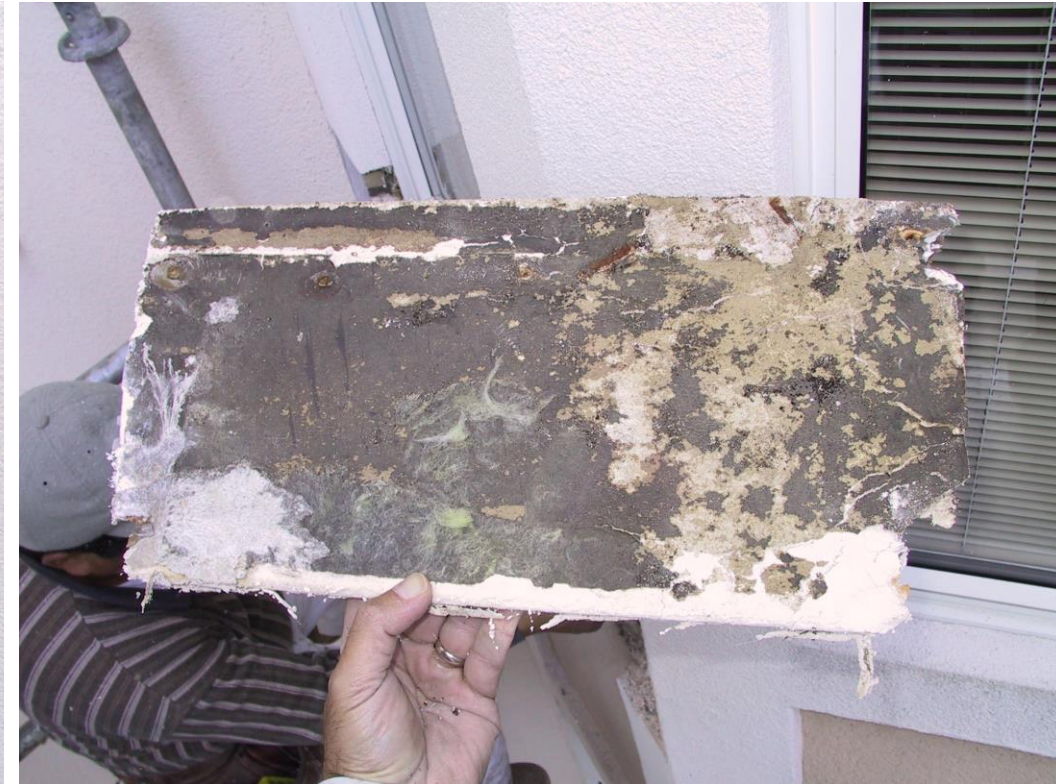
All window to exterior cladding needs to be closely inspected, especially EIFS. Seal dependent on sealant

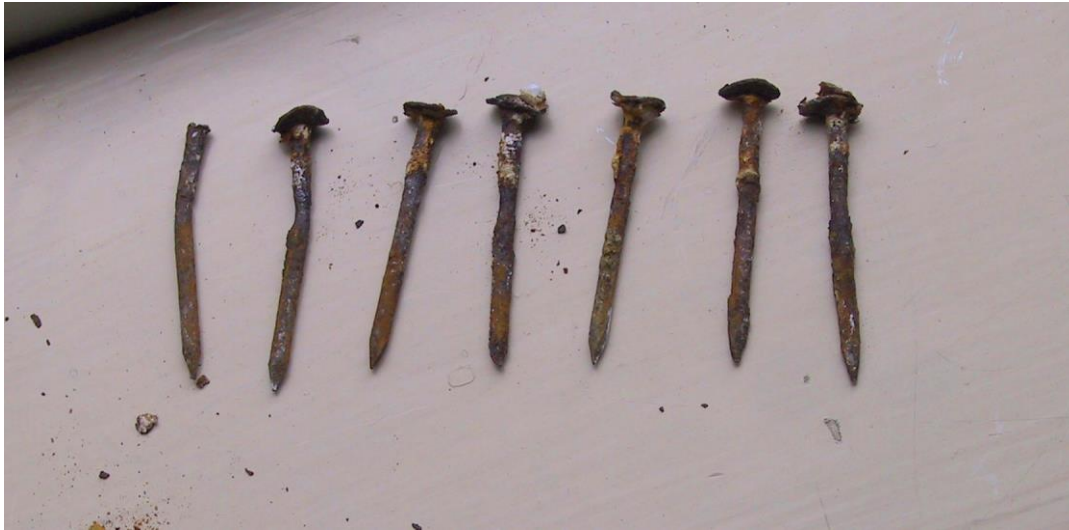
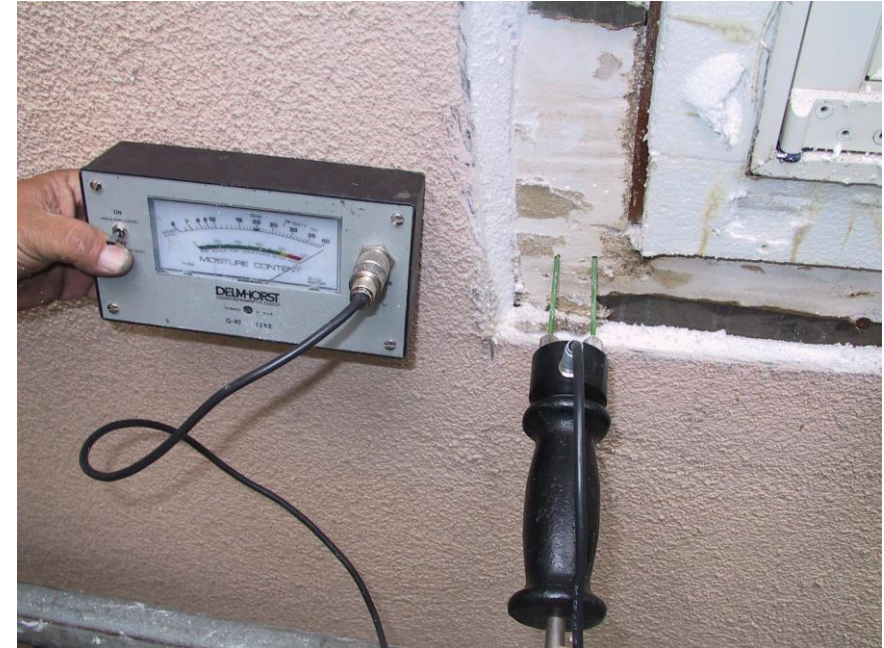
Gypsum wall board holds water, promotes mold growth, and corrodes fasteners

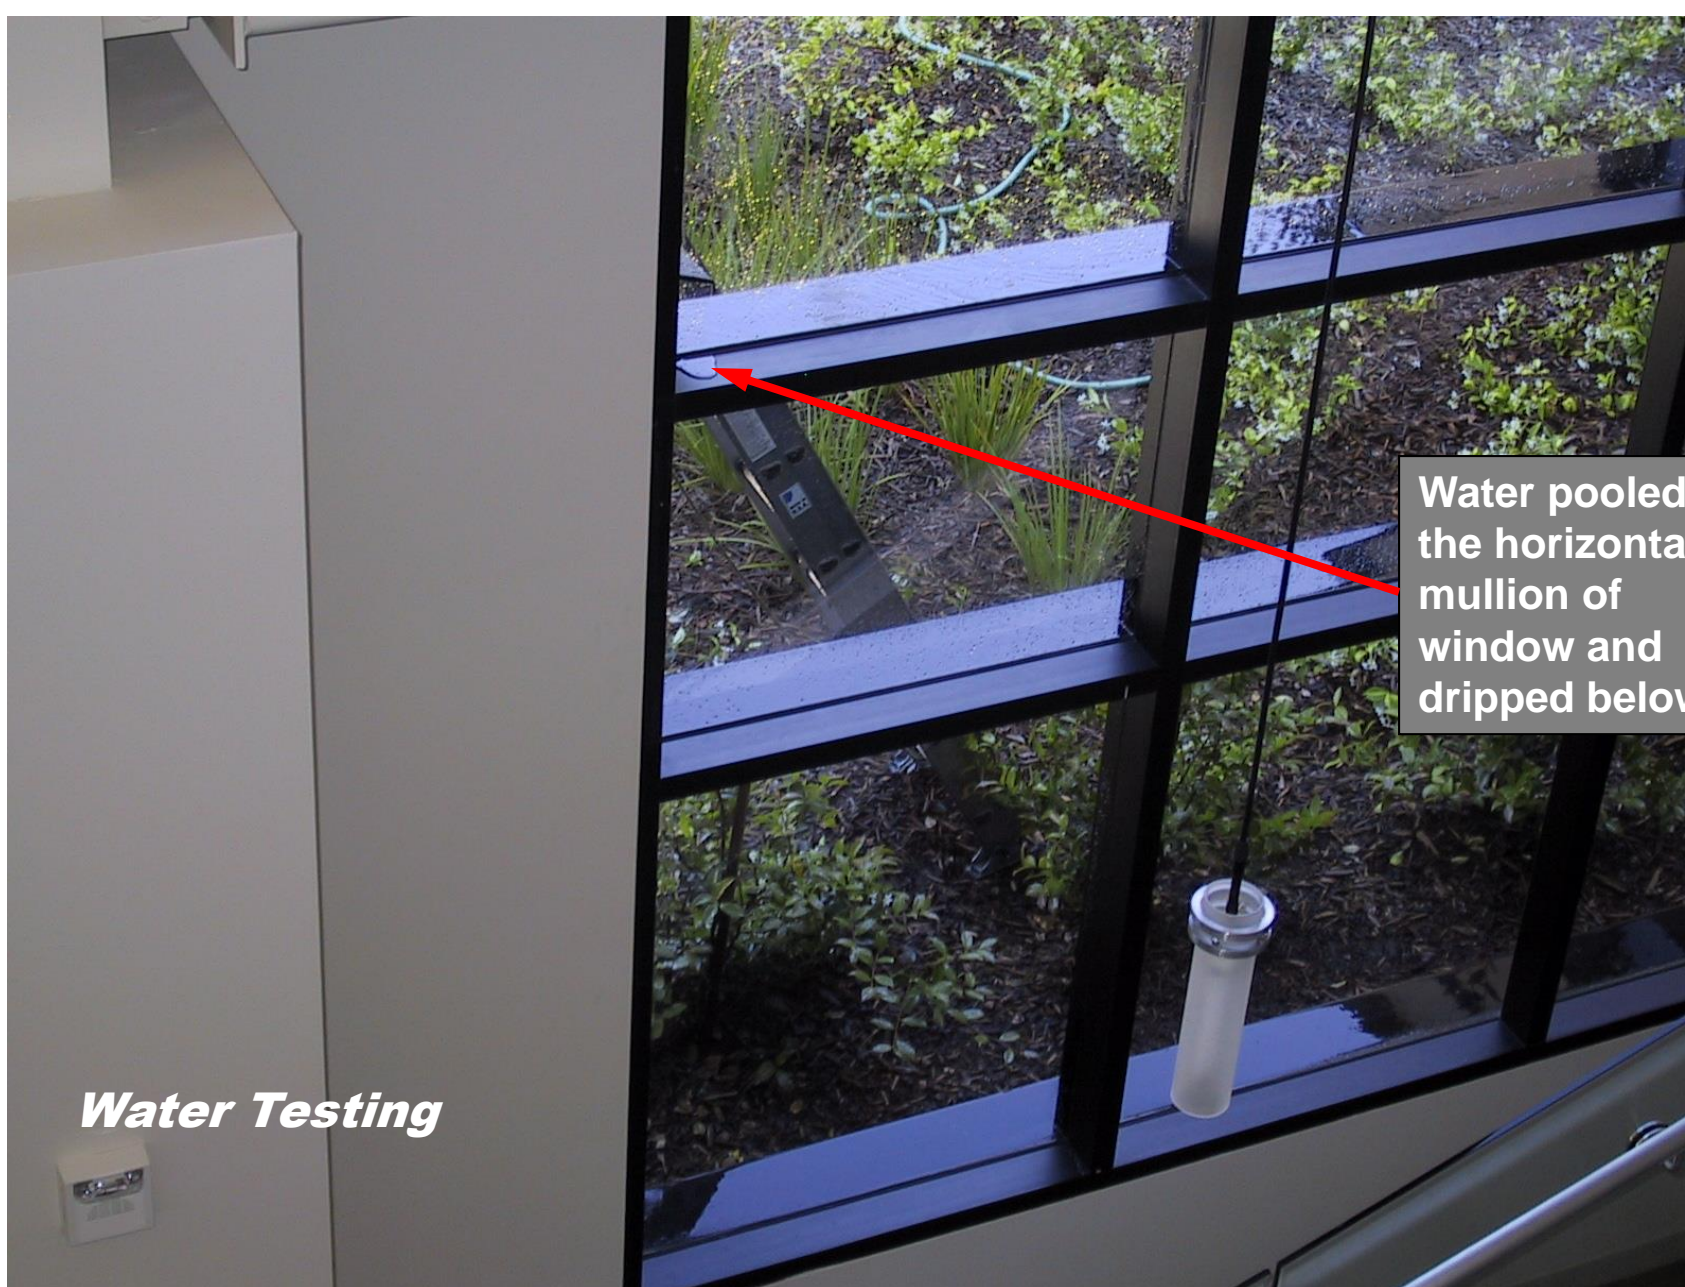
On-site
maintenance
personnel
recognized water
stains

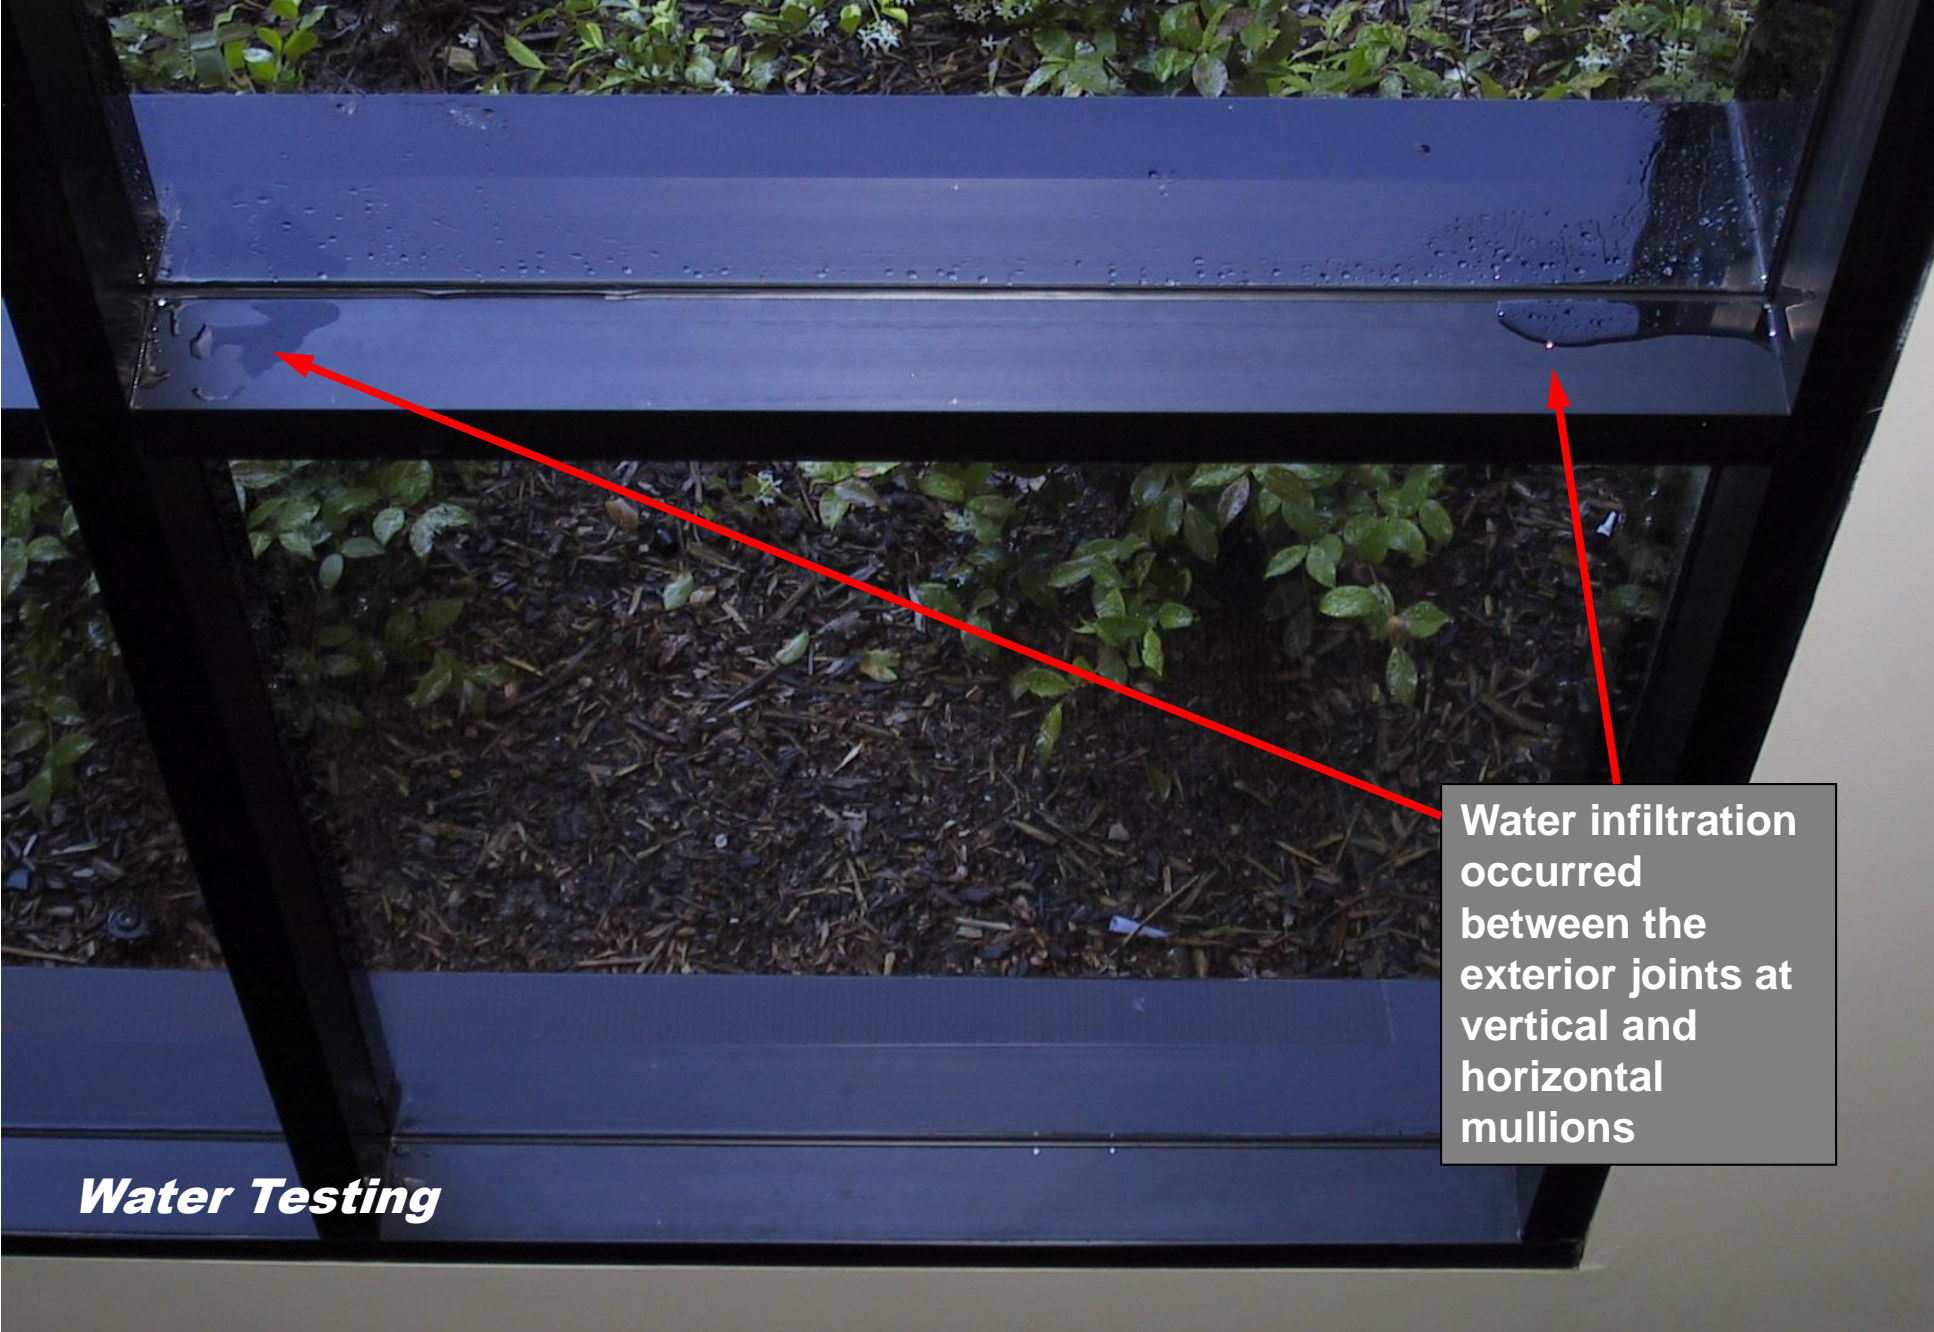
Water Testing

Water pooled on the horizontal mullion of window and dripped below

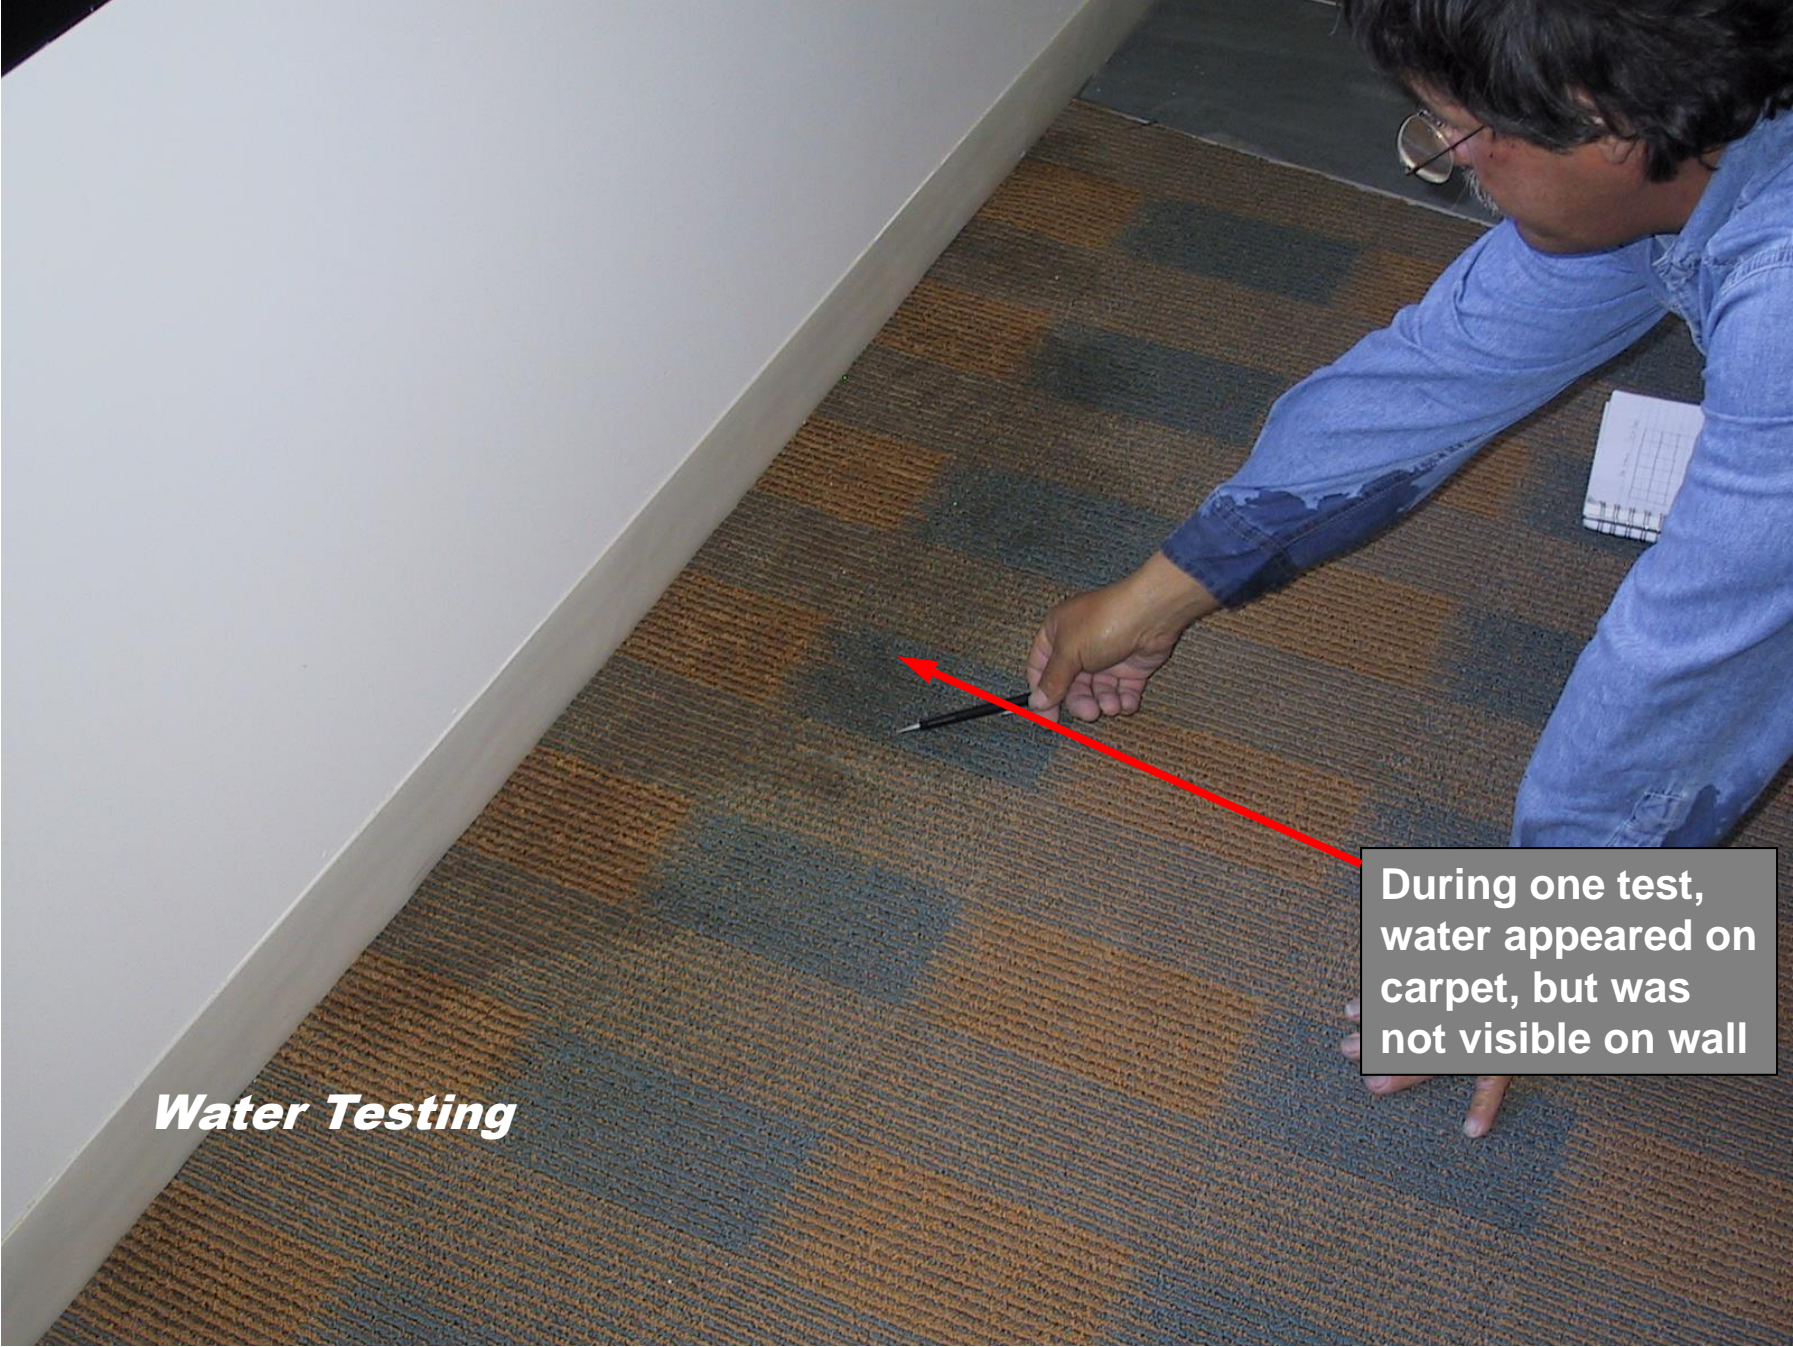
Water Testing

Water infiltration occurred between the exterior joints at vertical and horizontal mullions

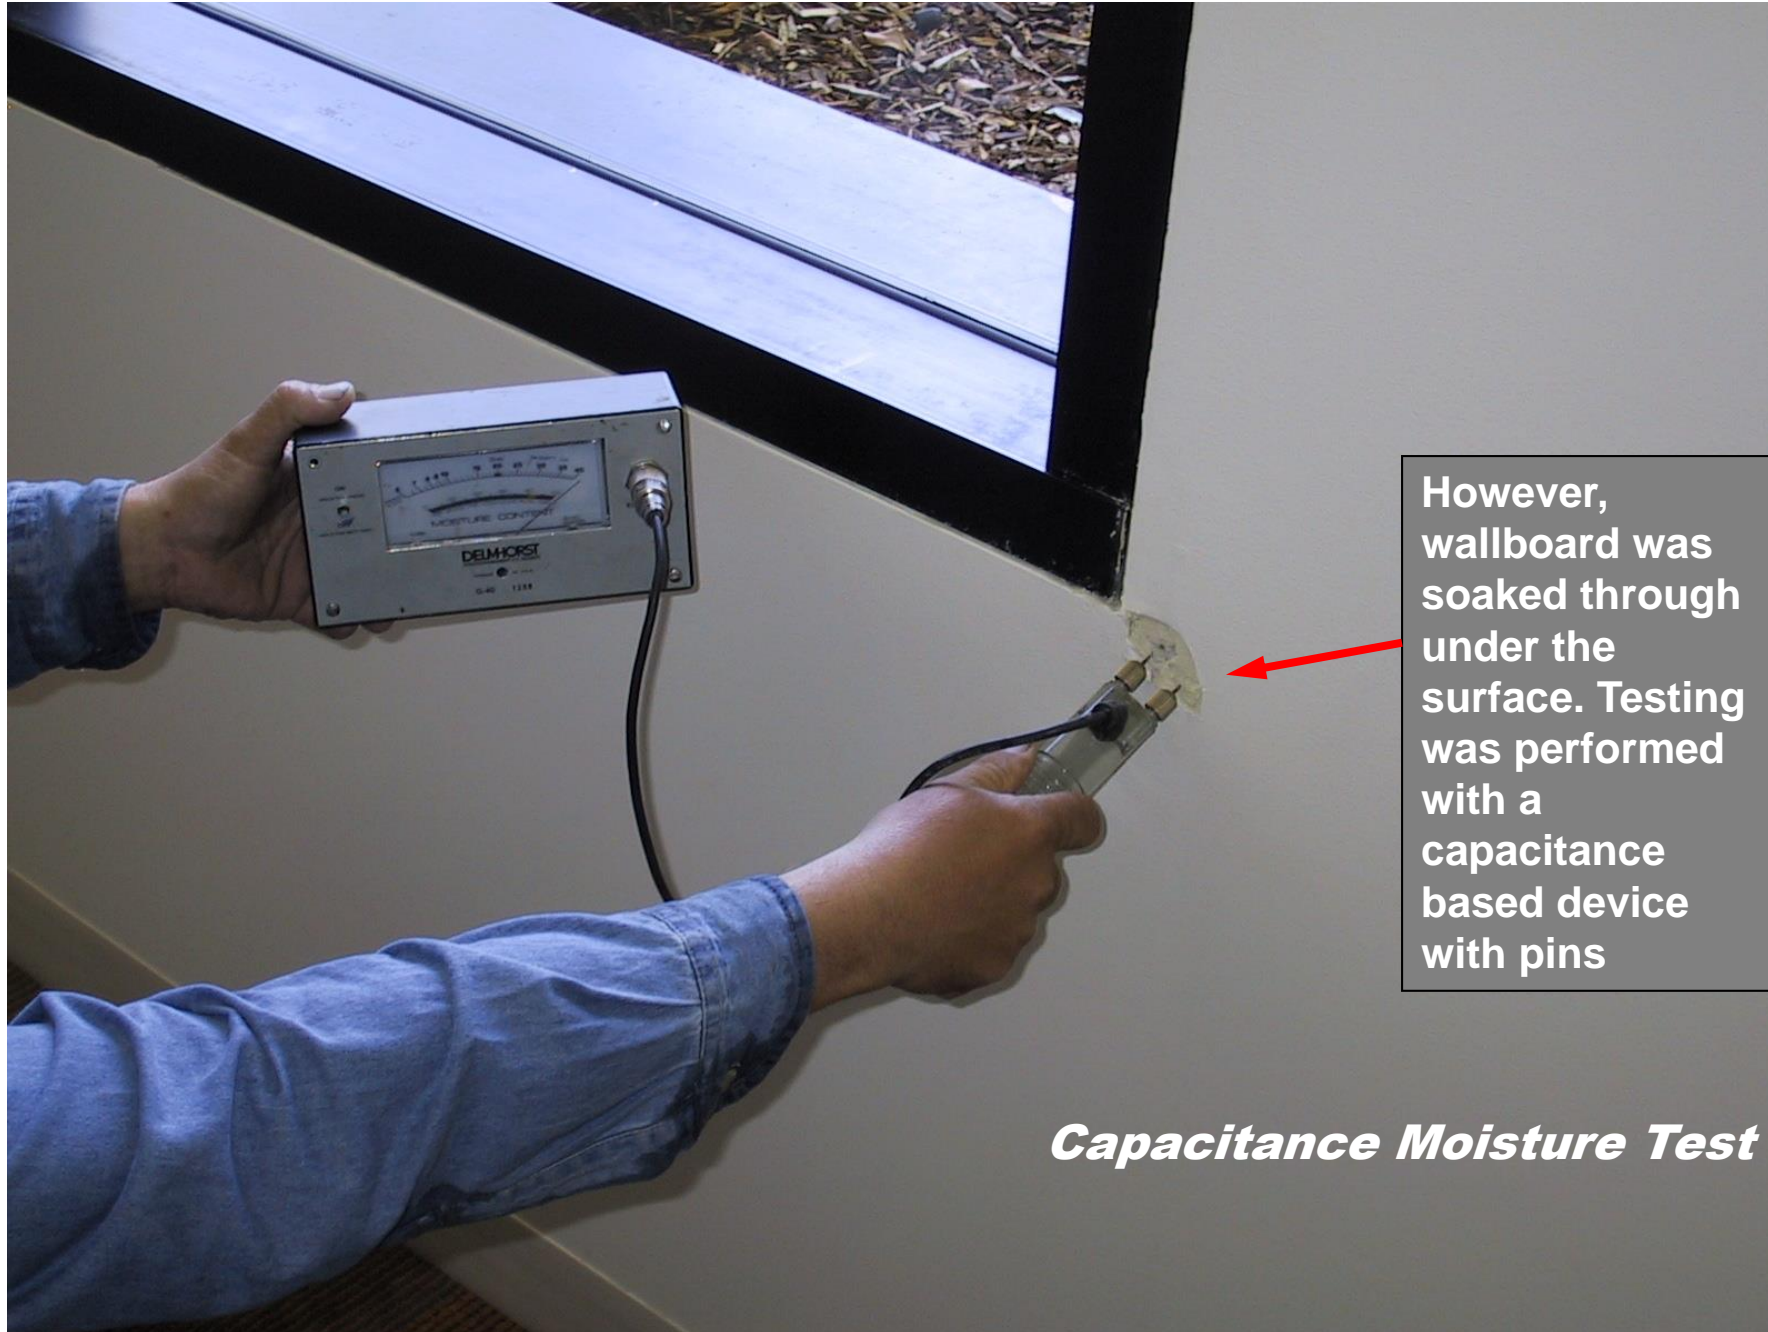
Water Testing

During one test,
water appeared on
carpet, but was
not visible on wall

However, wallboard was soaked through under the surface. Testing was performed with a capacitance based device with pins

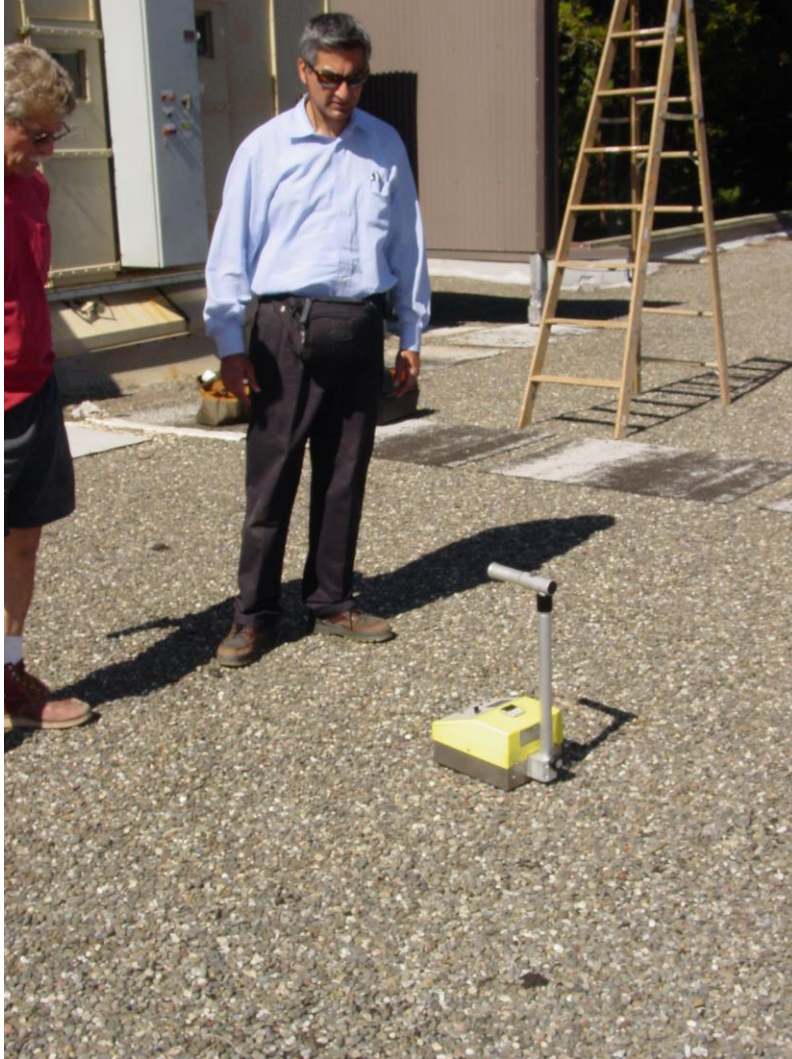
Nuclear troxler testing equipment

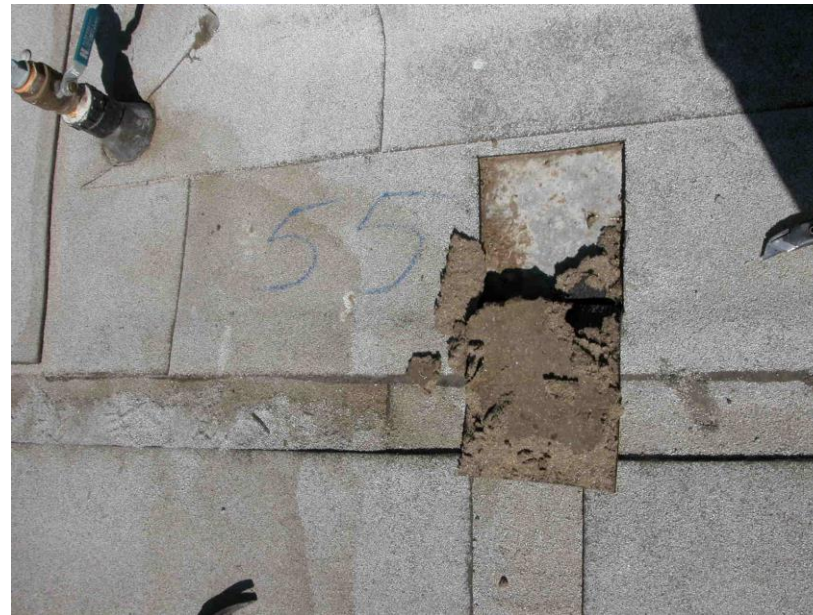
LEFT: Taking measurements

RIGHT: Test cut to corroborate result, saturated insulation
