Below Grade Waterproofing...

Introduction to Basic Types of Waterproofing and Vapor Barrier Systems, Common Failure Modes, and Design Considerations

Project Case Study

- Forensic Case Study Sunnyvale, California
- Waterproofing failure of Downtown Sunnyvale Garage
- Work performed for a construction defect litigation case
- Bentonite/HDPE composite system was installed and had failed
- 2nd largest below-grade structure in Northern California
- Largest below-grade waterproofing repair of it's kind in California

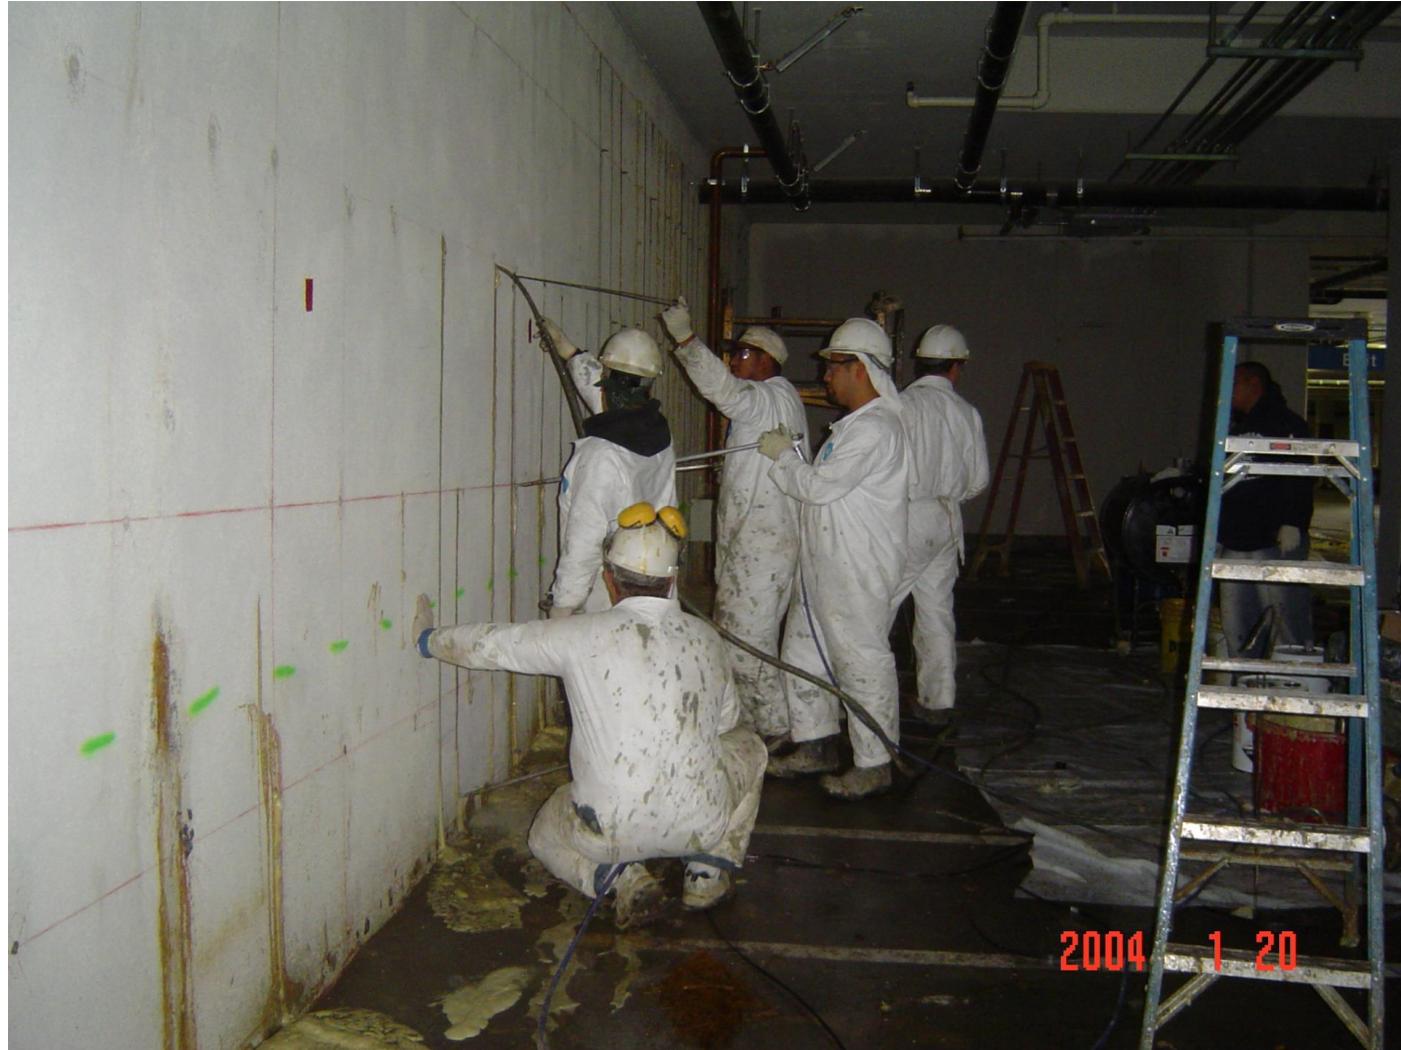
Project Case Study Cont.

- Structure experience extensive leaking throughout below-grade perimeter walls
- Built on zero lot line with shotcrete foundation walls against wood lagging and soldier pile retention walls

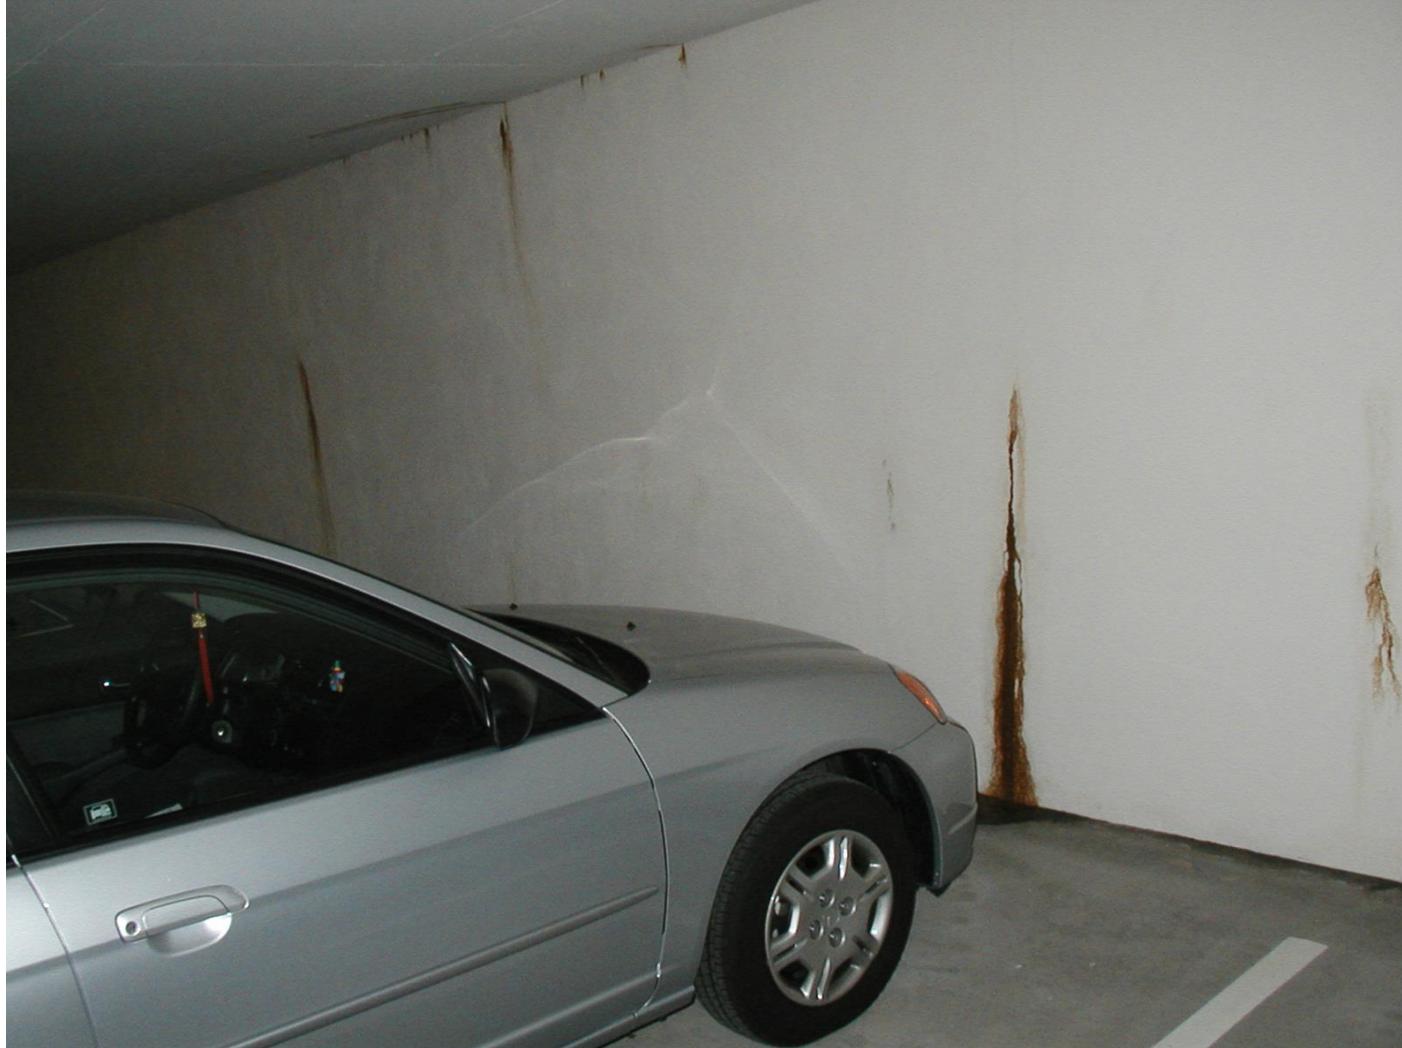
- Following Picture shows the excavation of the soil behind wood lagging revealed that once the wood got wet it was
 - Swelling
 - Bending
 - Twisting
 - Especially if there were voids between the soil and wood

Downtown Sunnyvale Garage Leaked Throughout From Day 1

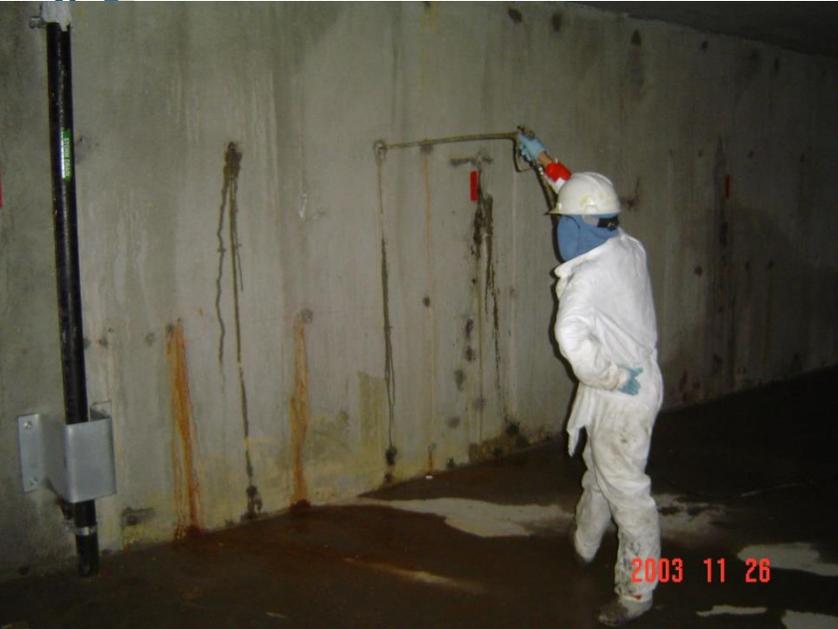
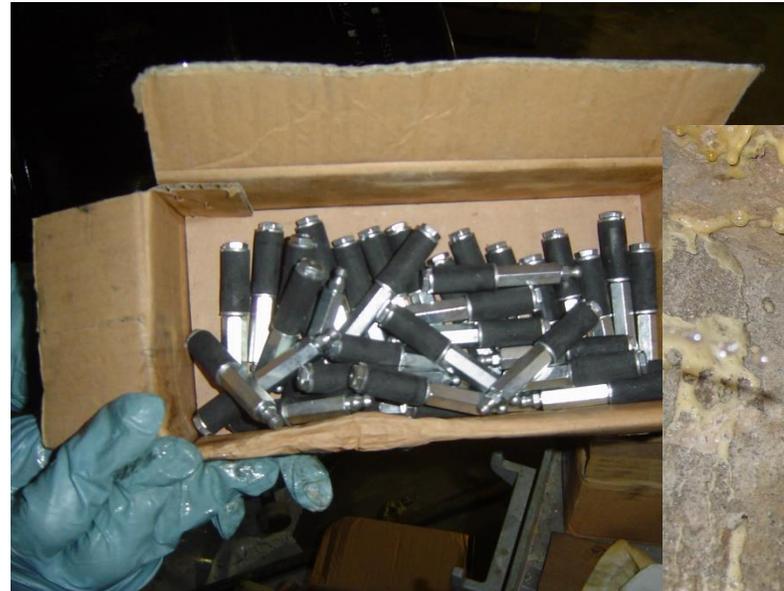
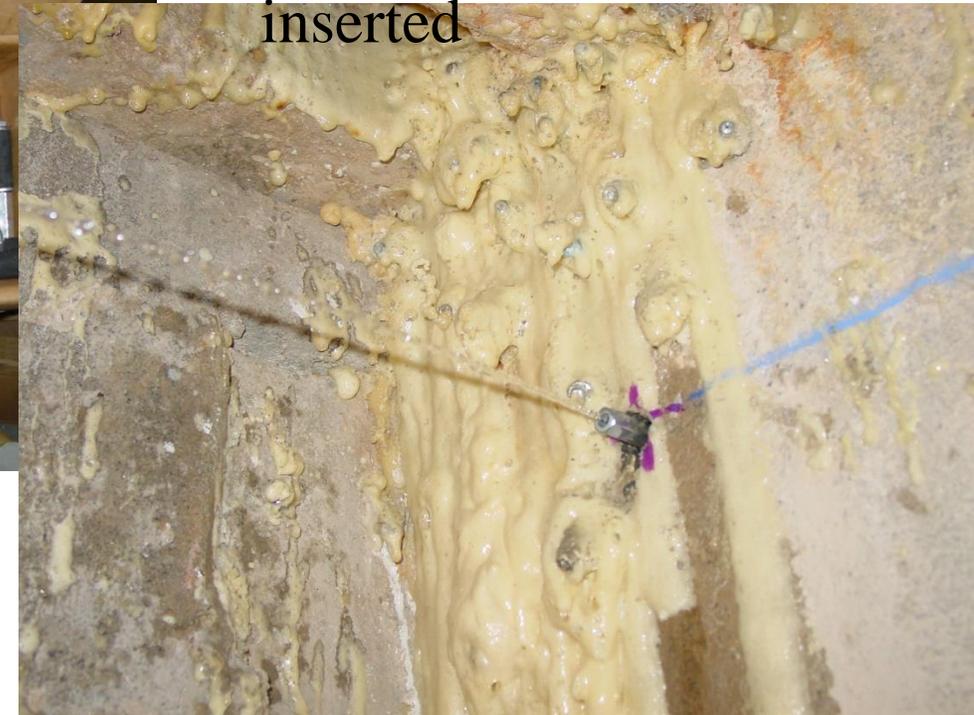
Chemical Grout was Injected 24" O.C.

Injection in Progress

3/8" holes are drilled through the slab and injection ports inserted

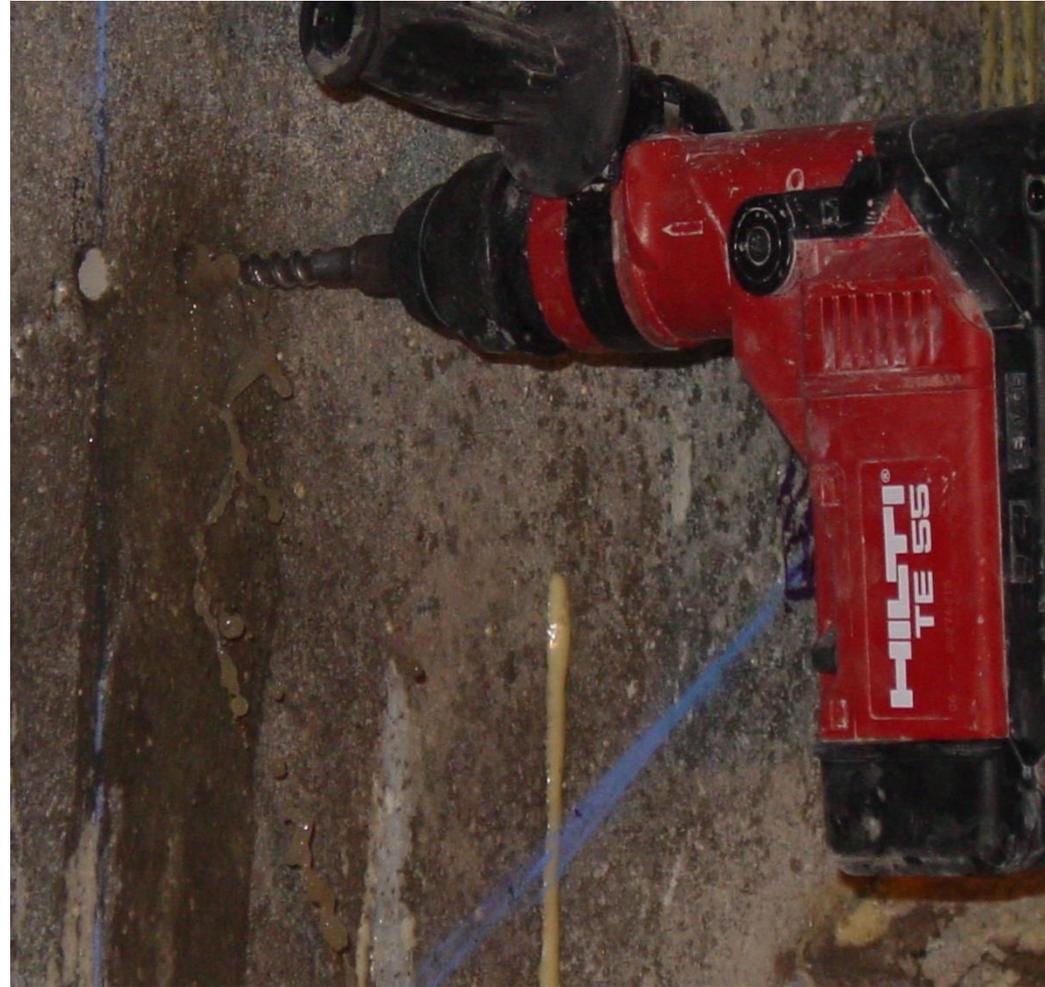
Repairs included:

- Drilling 5/8" diameter holes on a 4' on center grid formation through 18" thick shotcrete foundation wall
- Several types of hydro-active grouts were injected through the holes

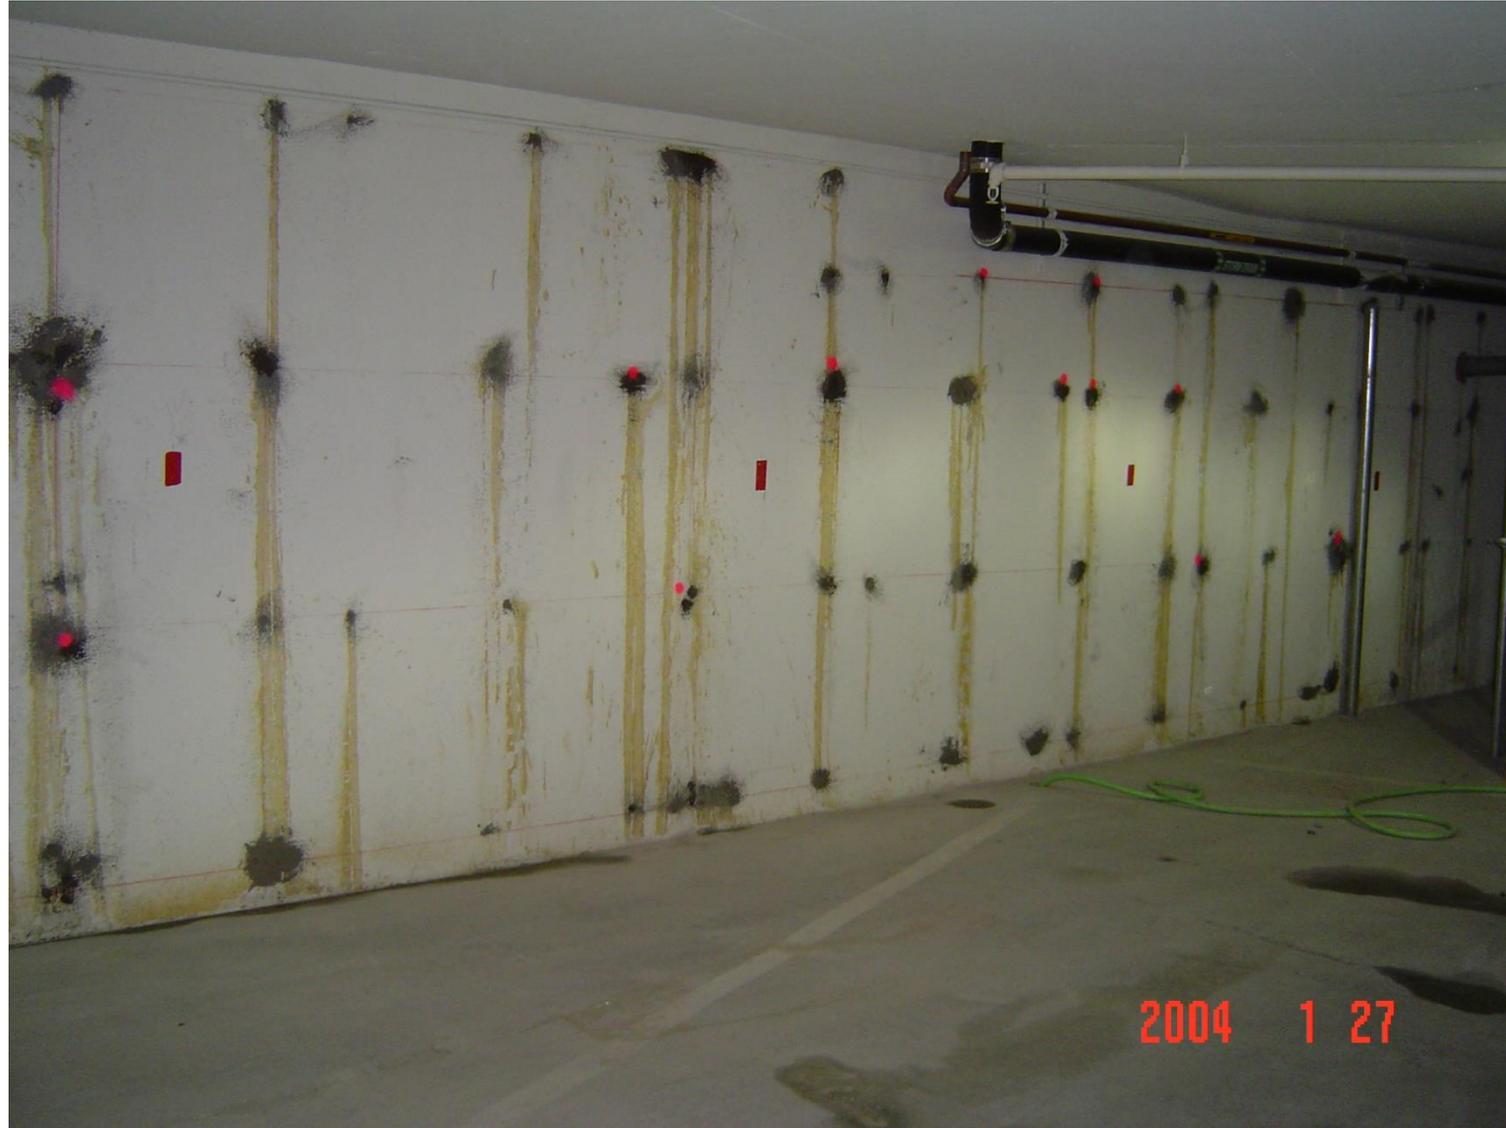
Grout Creates a “Curtain” Behind Concrete

- Grout Characteristics
- Quickly expands and cures upon contact with water to form a water barrier behind the surface of the wall and under portions of the slab
- Designed to fill an voids behind foundation wall
- Upon reaching maximum confinement, grout continues to internally expand thus increasing in density, pressure and makes foam closed cell and waterproof

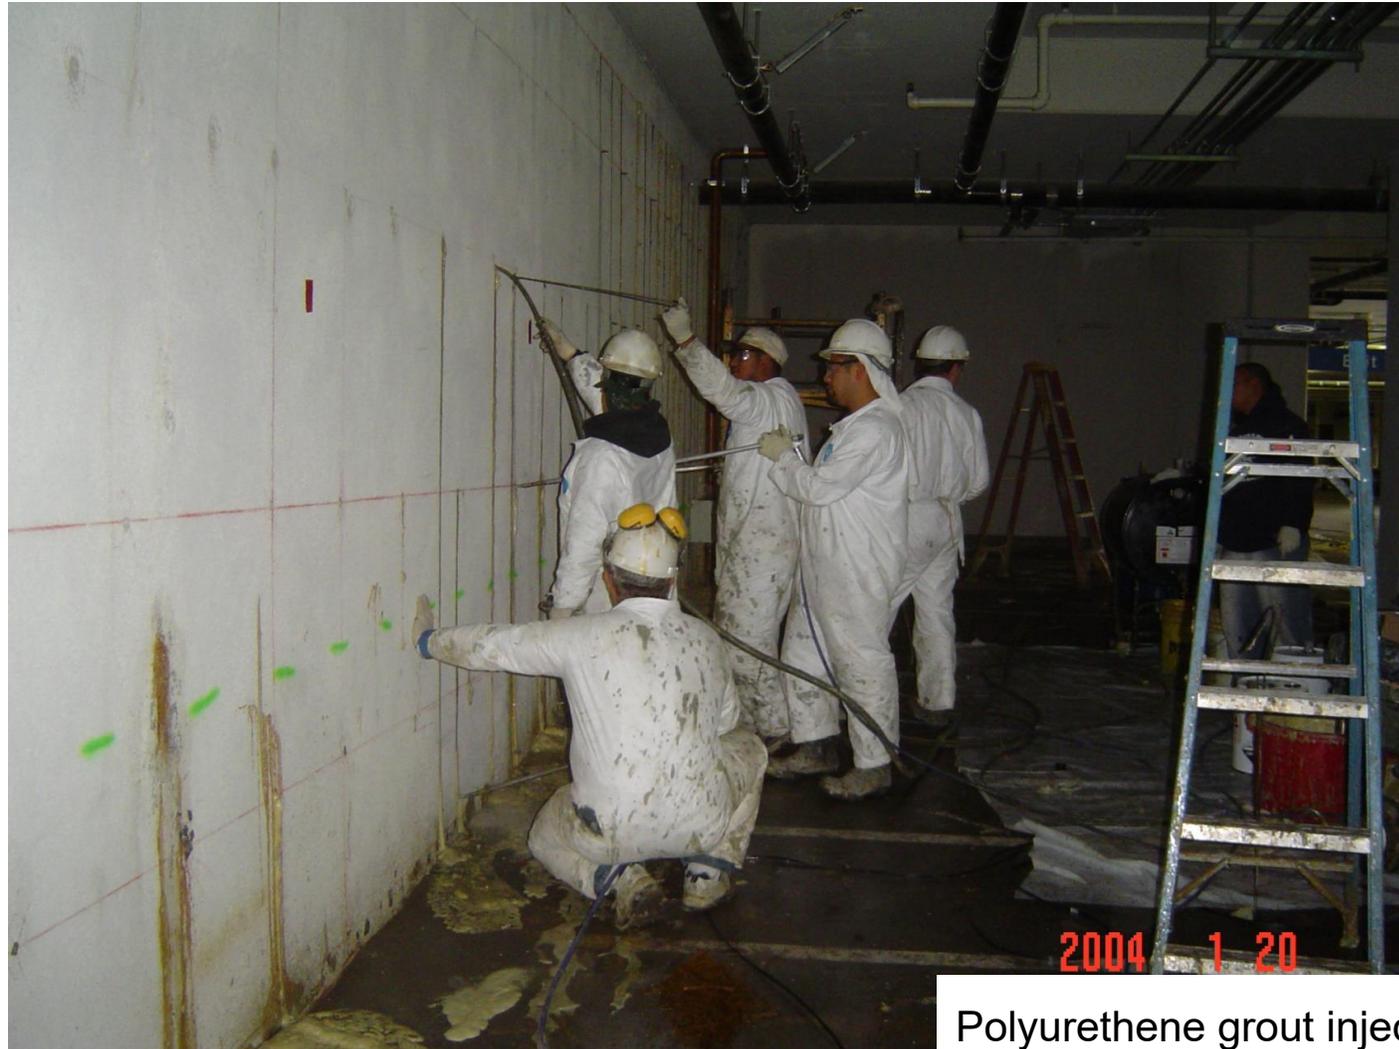
The Repair of Failed Garage Cost Over \$3M

Polyurethane grout injection 2' on center at a cost of \$35/SF

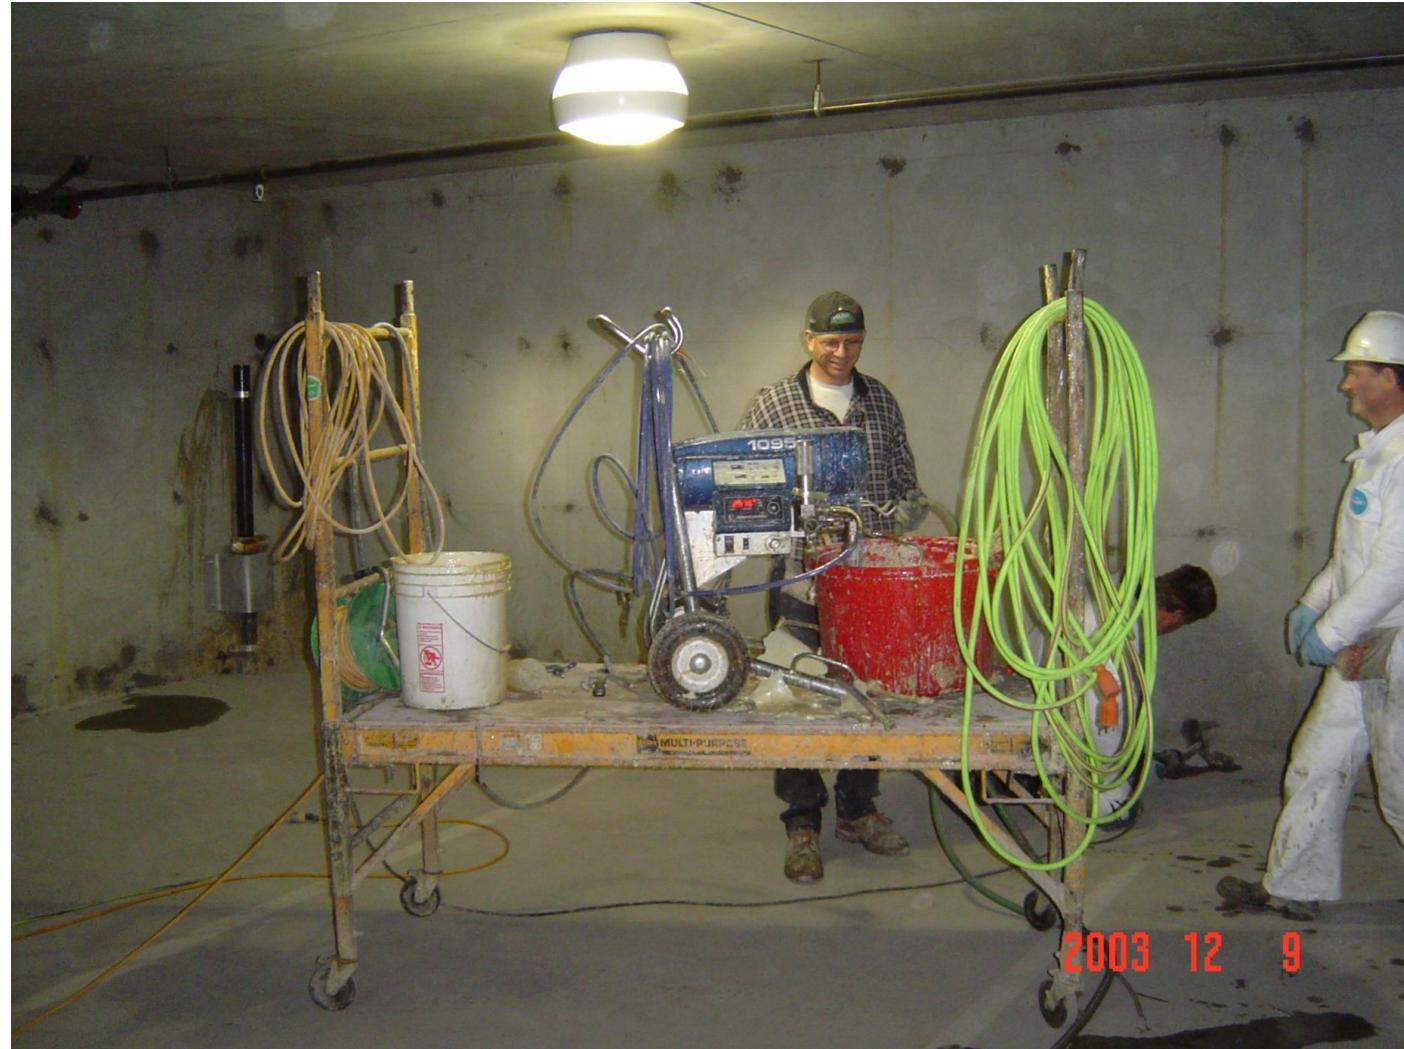
Typical Injection Equipment

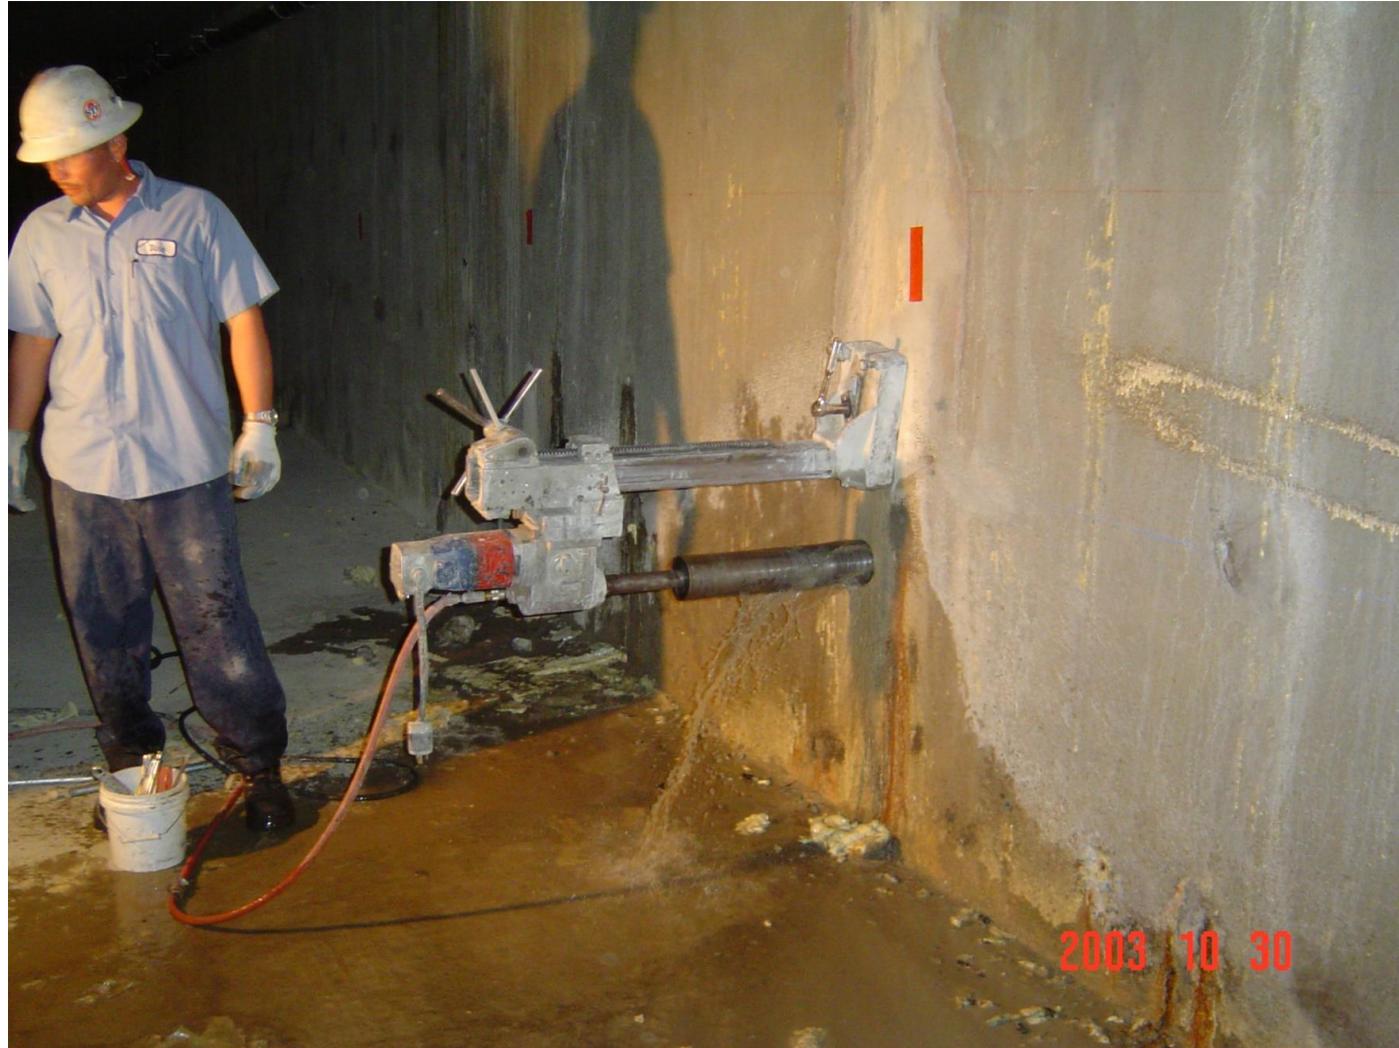
Concrete Cores Were Taken To Assess Performance

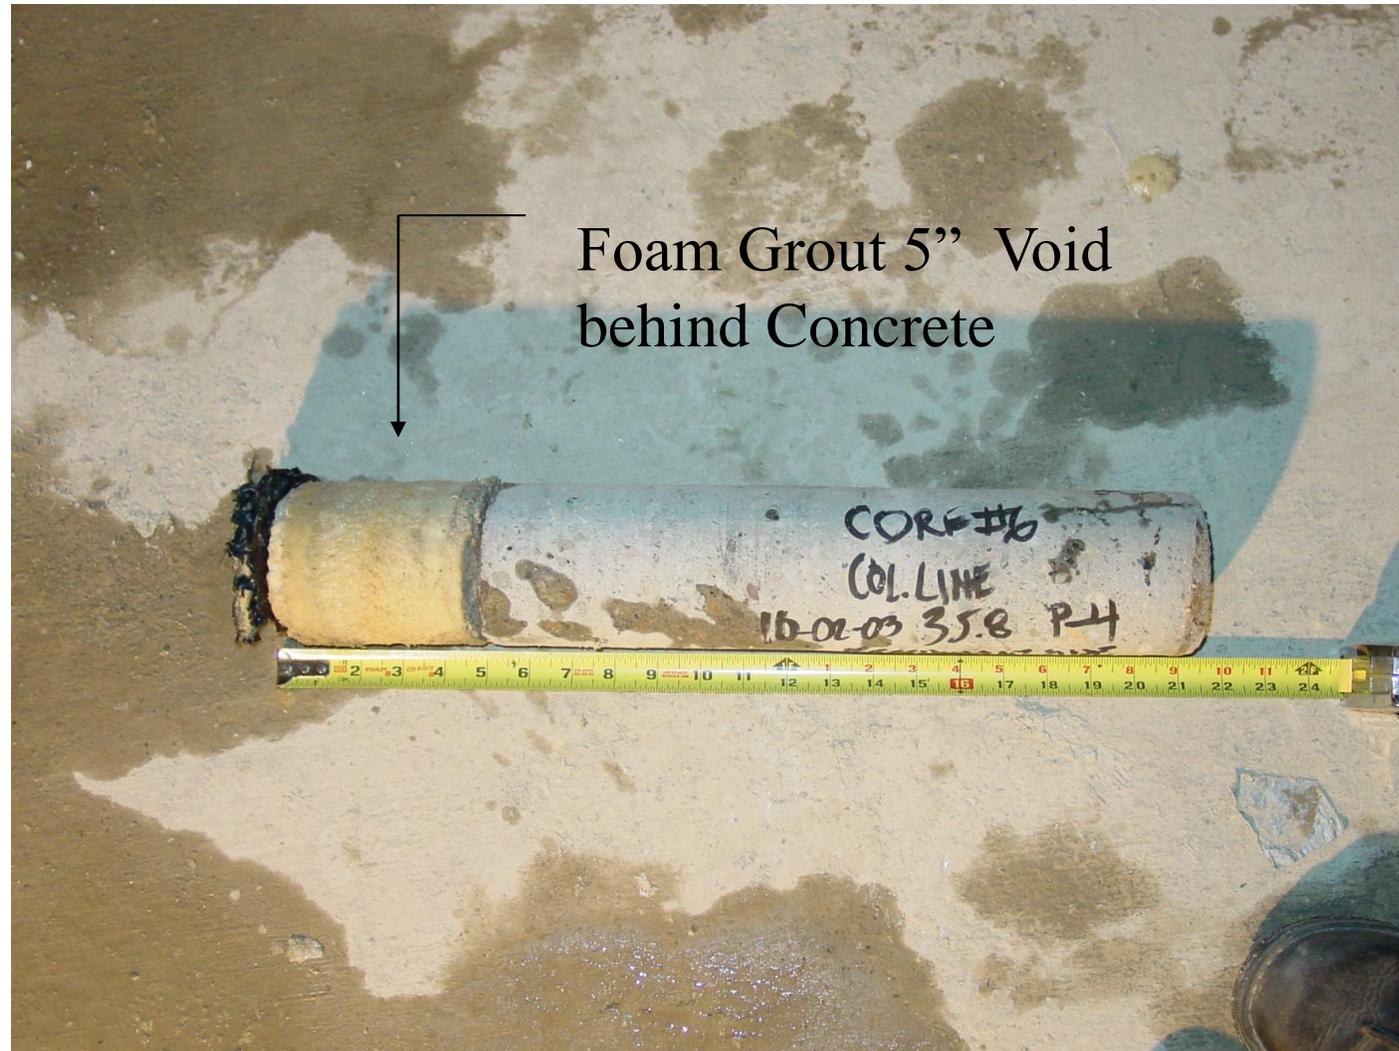
Cores Showed Large Voids Behind Shotcrete

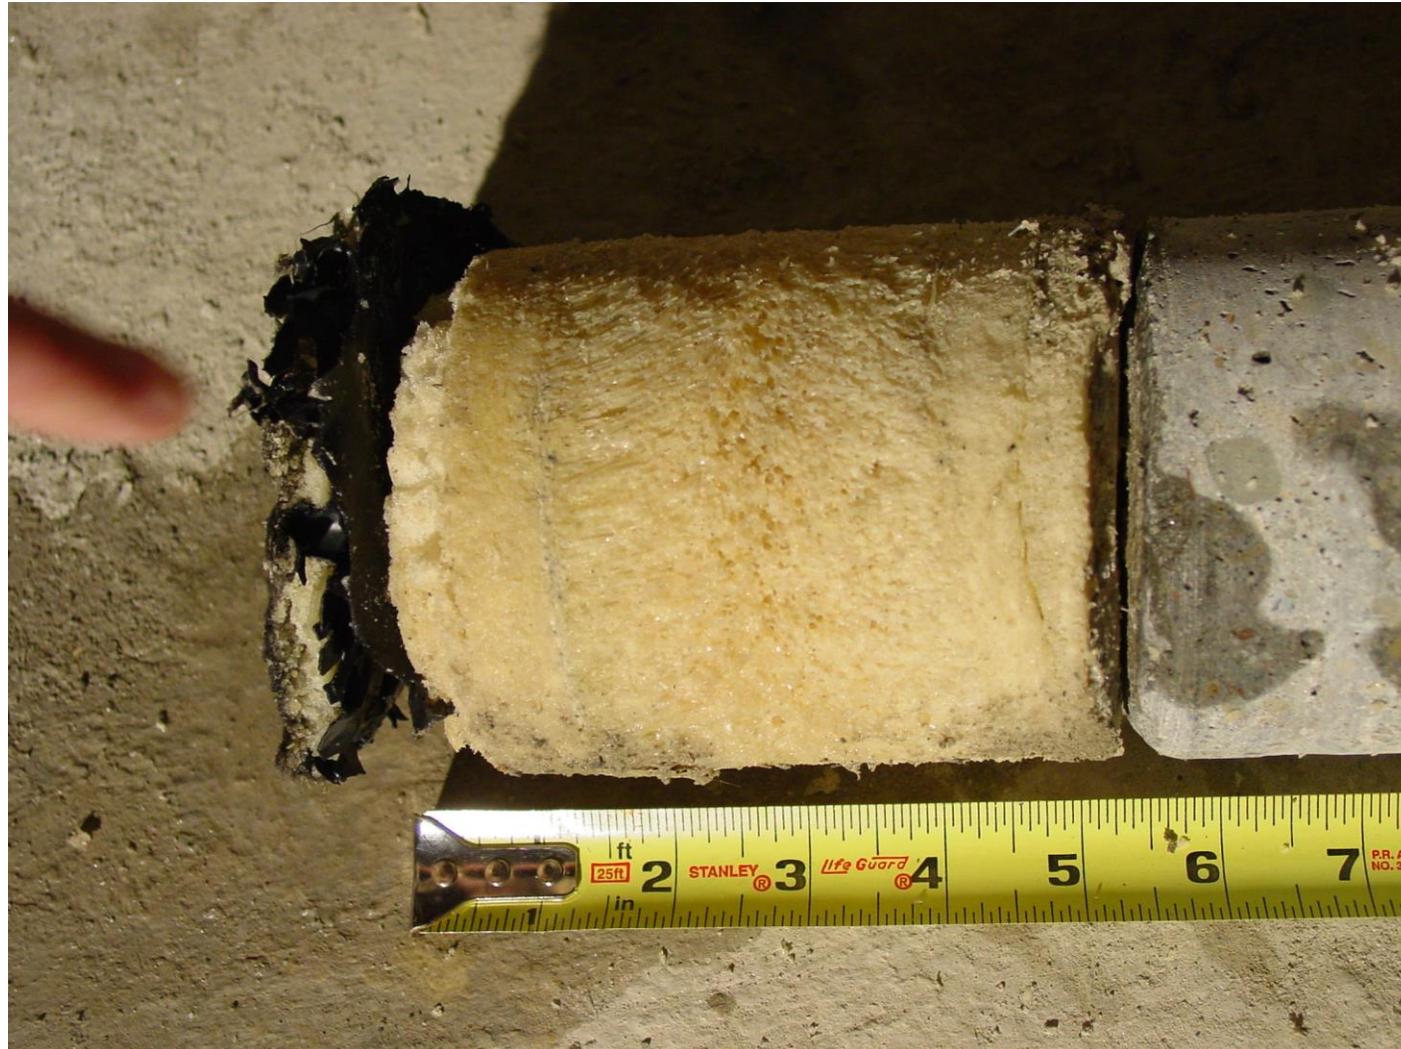
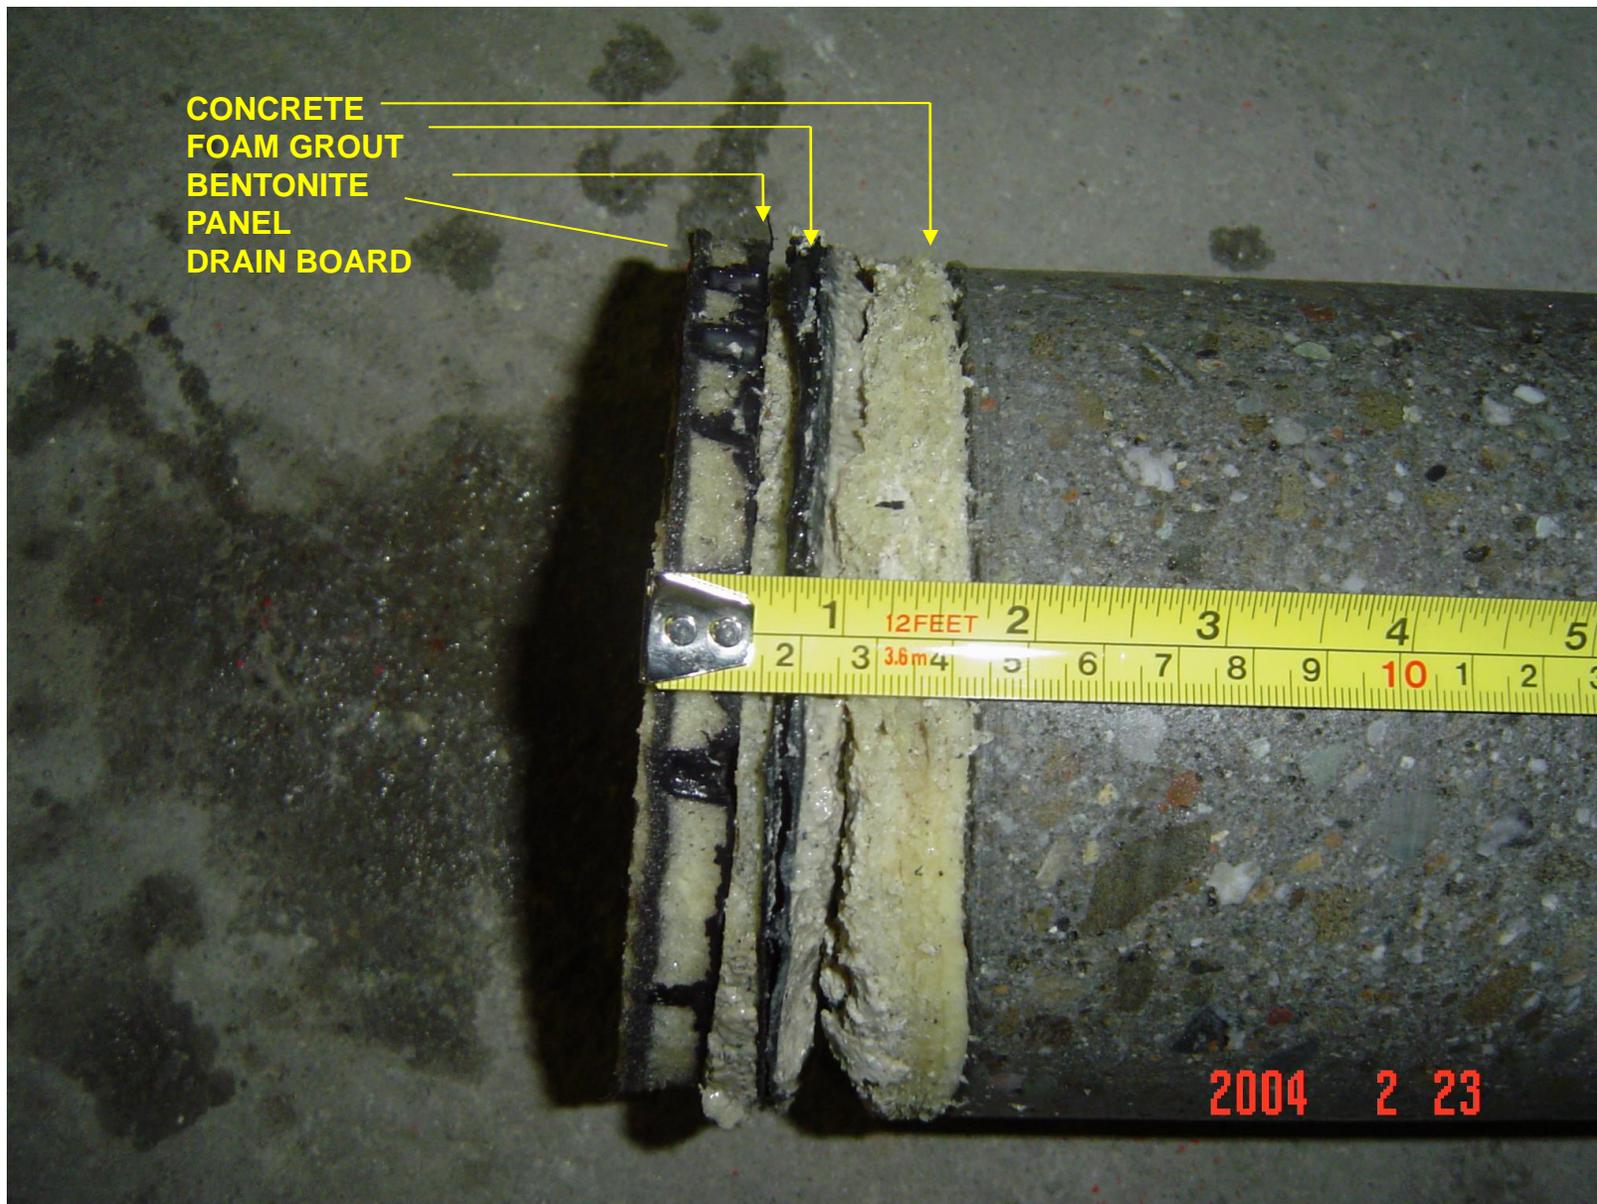
What Caused the Voids Behind Shotcrete?

Voids were present on both sides of the retaining wall and ranged from 1" thick to up to 4" thick.

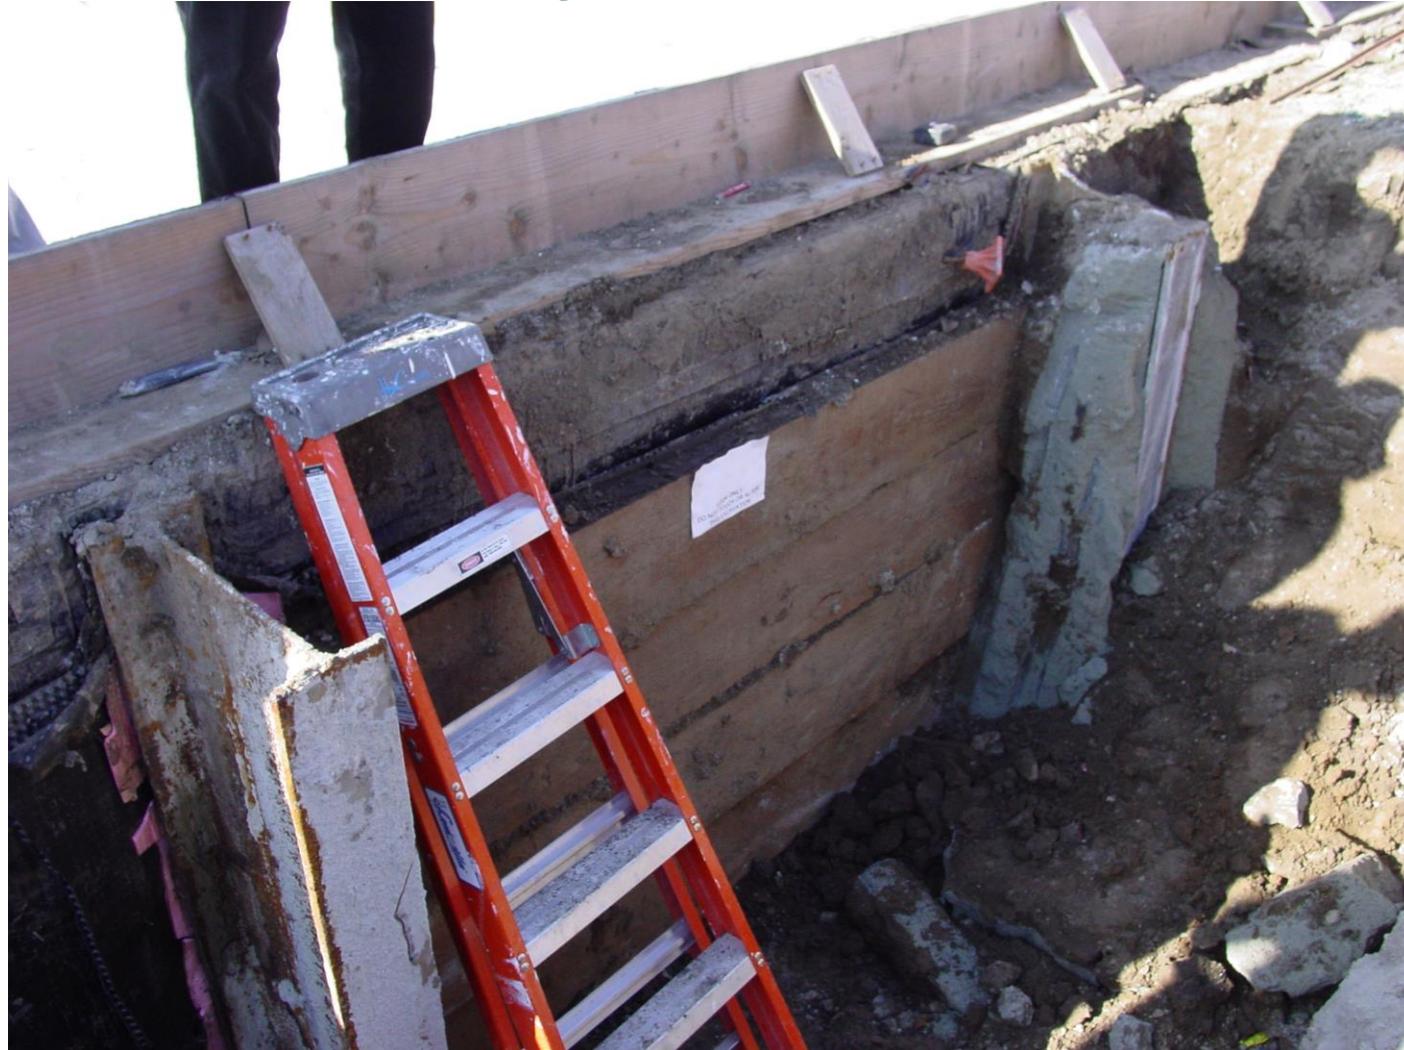
Site was Excavated to Forensically Analyze Failure

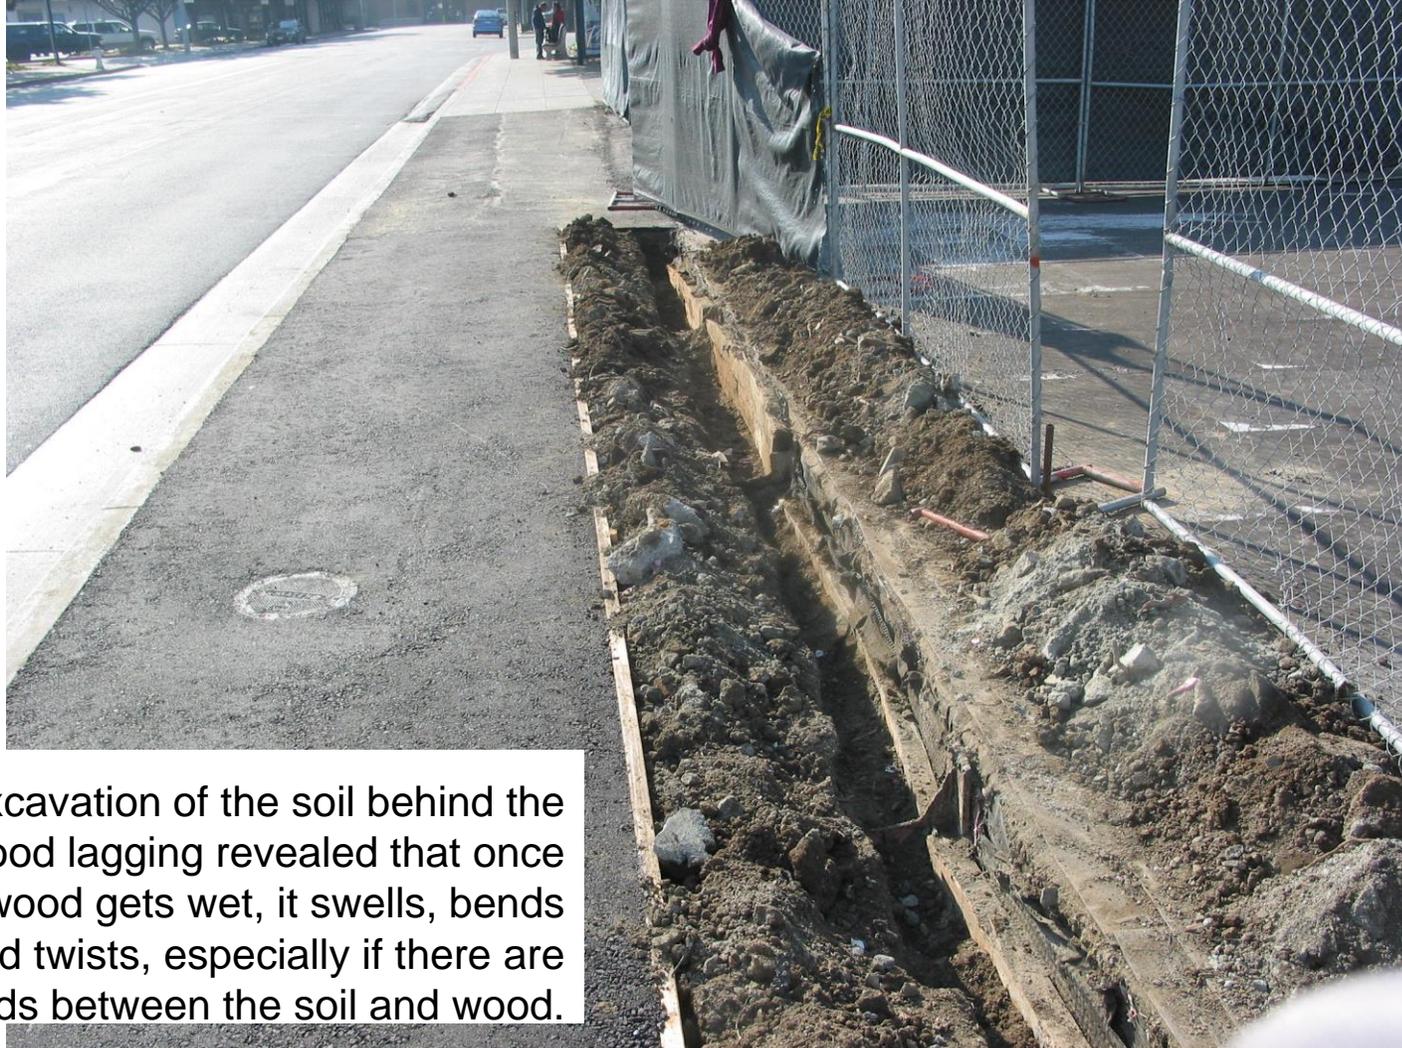
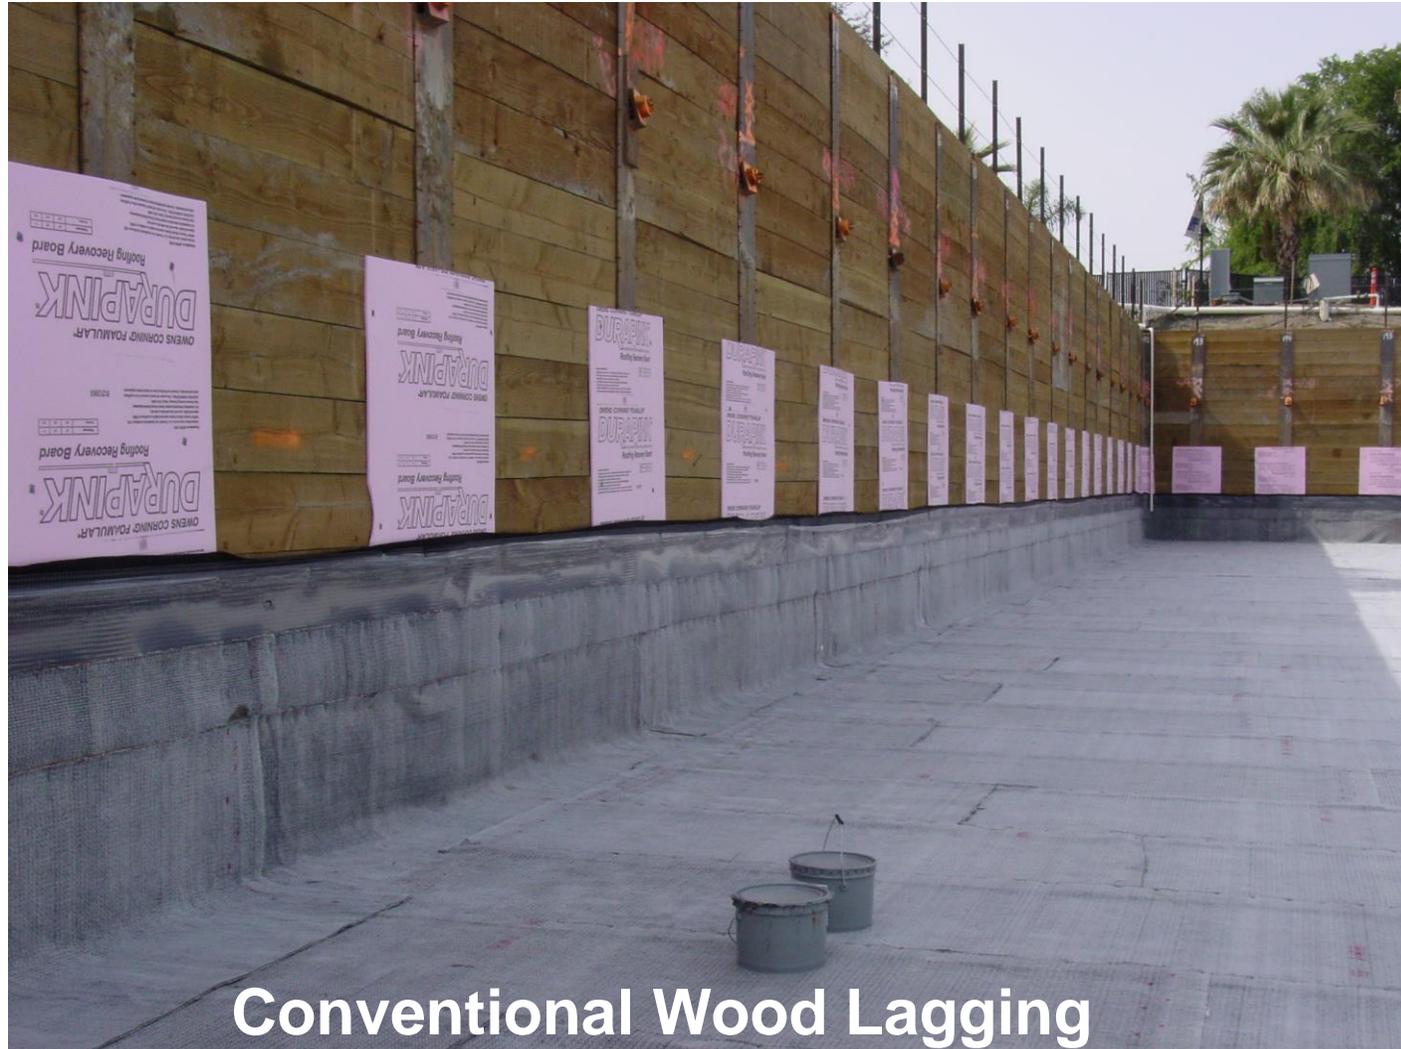
Wood Lagging Issues with Bentonite

Excavation of the soil behind the wood lagging revealed that once the wood gets wet, it swells, bends and twists, especially if there are voids between the soil and wood.

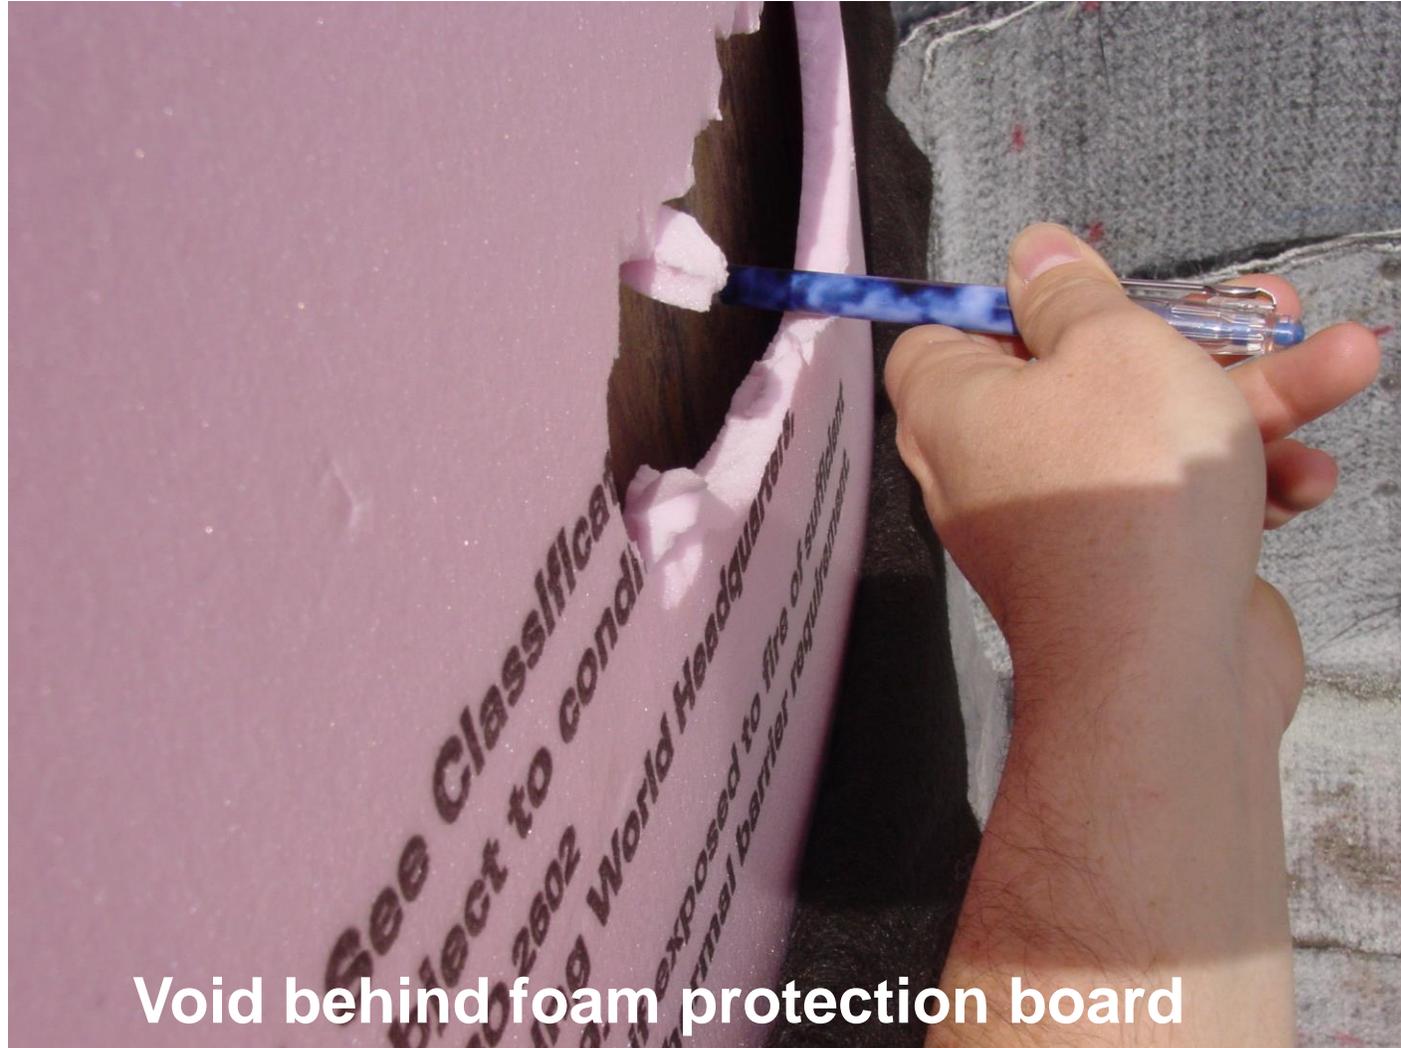
Conventional Wood Lagging

Void behind foam protection board
