Below Grade Waterproofing...

Introduction to Basic Types of Waterproofing and Vapor Barrier Systems, Common Failure Modes, and Design Considerations

Project Case Study

- Forensic Case Study Sunnyvale, California
- Waterproofing failure of Downtown Sunnyvale Garage
- Work performed for a construction defect litigation case
- Bentonite/HDPE composite system was installed and had failed
- 2nd largest below-grade structure in Northern California
- Largest below-grade waterproofing repair of it's kind in California

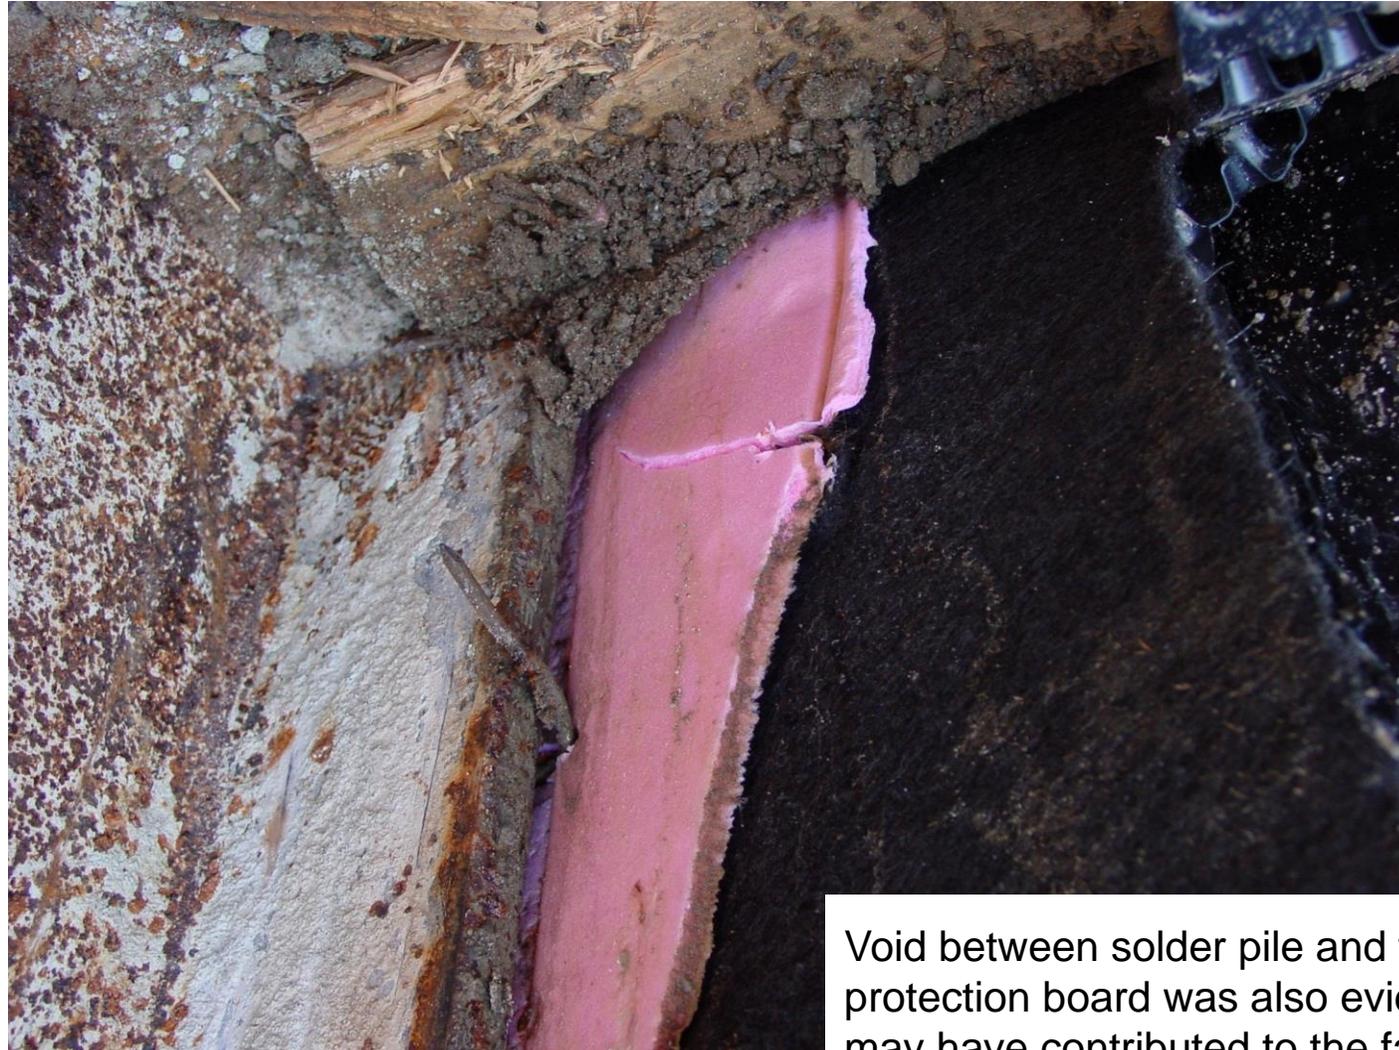
Voids and Lack of Confinement = Failure

Void between solder pile and foam protection board was also evident and may have contributed to the failure of the bentonite waterproofing system.

- Bentonite requires confinement to work
- Wood lagging can have gaps and voids in the behind it which can allow lagging to move back
- Wood twists and cups when it gets wet, leaving voids
- Protection board at solder pile left voids and potentially reduced the system's effectiveness
