ALLANA BUICK & BERS

Case History, Downtown Sunnyvale Garage, Below Grade Waterproofing Failure

- Forensic Case Study Sunnyvale, California
- Waterproofing failure of Downtown Sunnyvale Garage
- Work performed for a construction defect litigation case
- Bentonite/HDPE composite system was installed and had failed
- 2nd largest below-grade structure in Northern California
- Largest below-grade waterproofing repair of it's kind in California

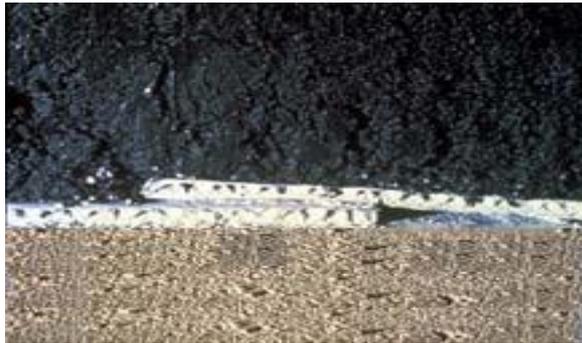
1. Bentonite Installed Dry

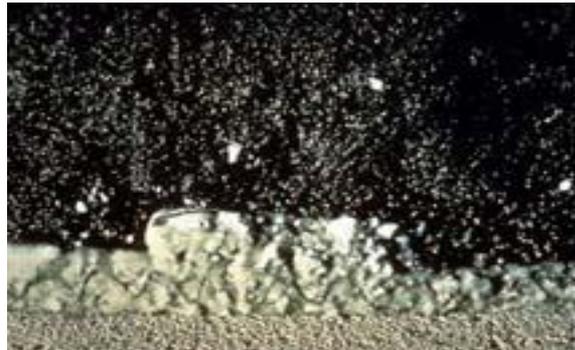
2. Granules quickly transform when wet

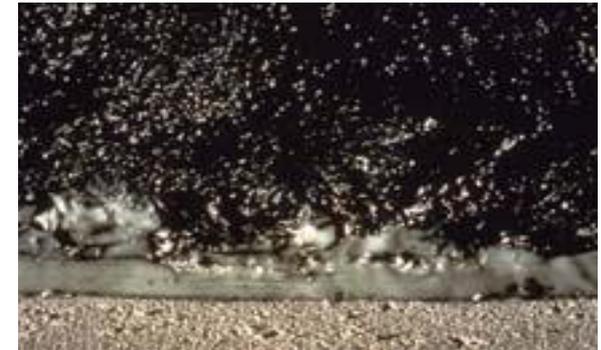
3. Seamless Bentonite Membrane

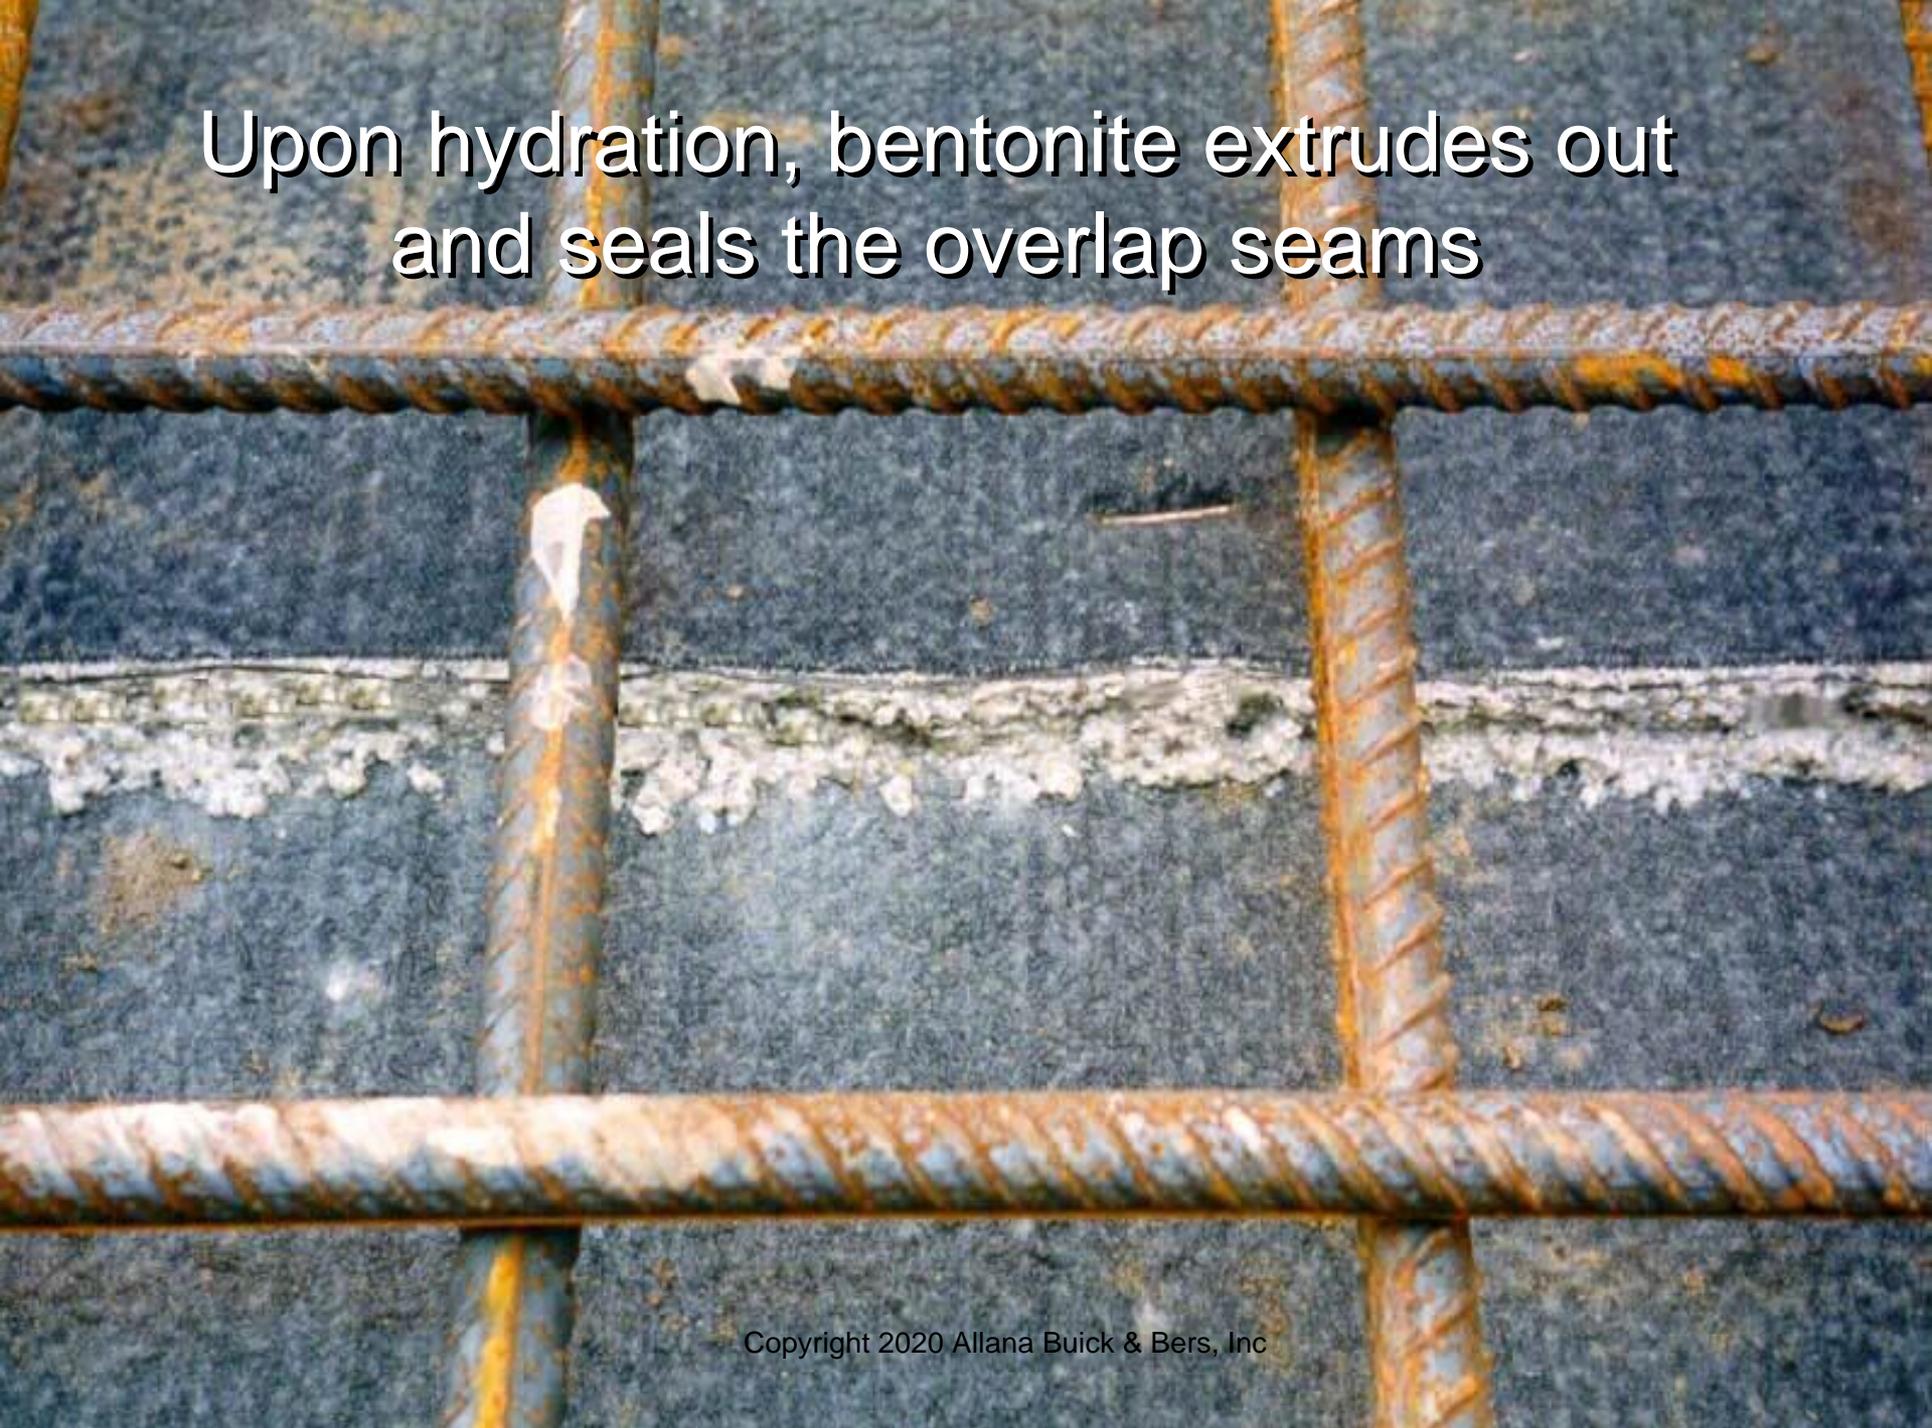
Upon hydration, bentonite extrudes out
and seals the overlap seams

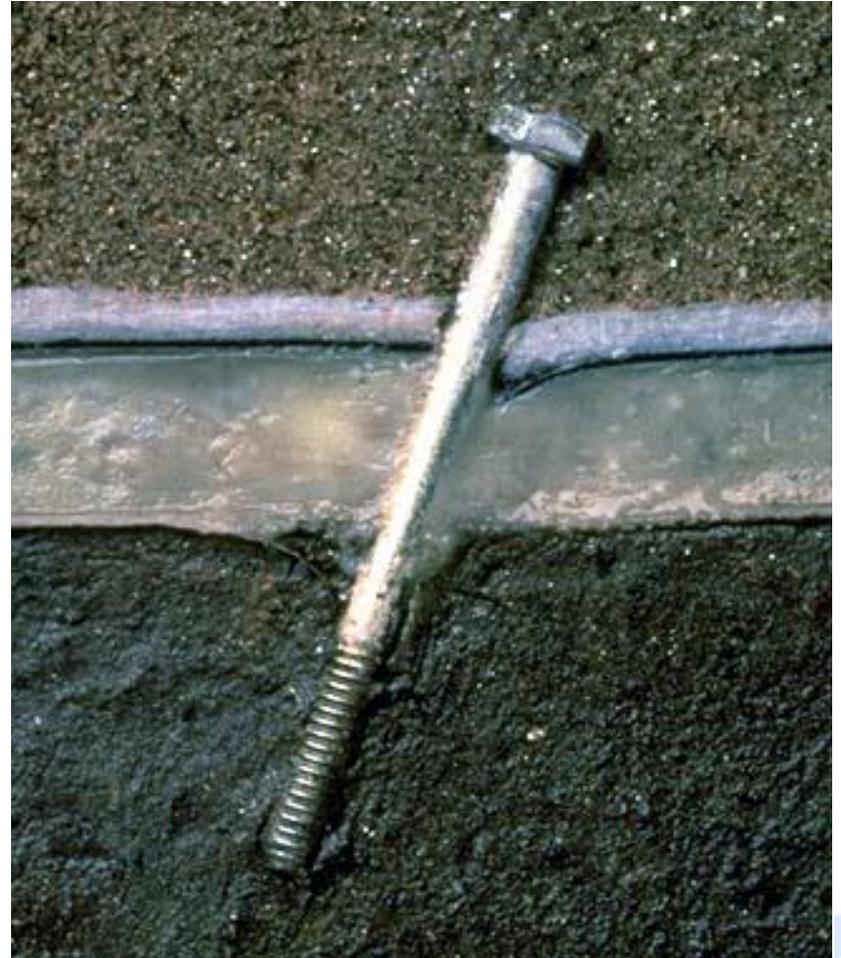
Bentonite Requires Confinement

When hydrated, bentonite expands and conforms to irregular surfaces, penetrations, and infiltrates cracks and voids in the concrete

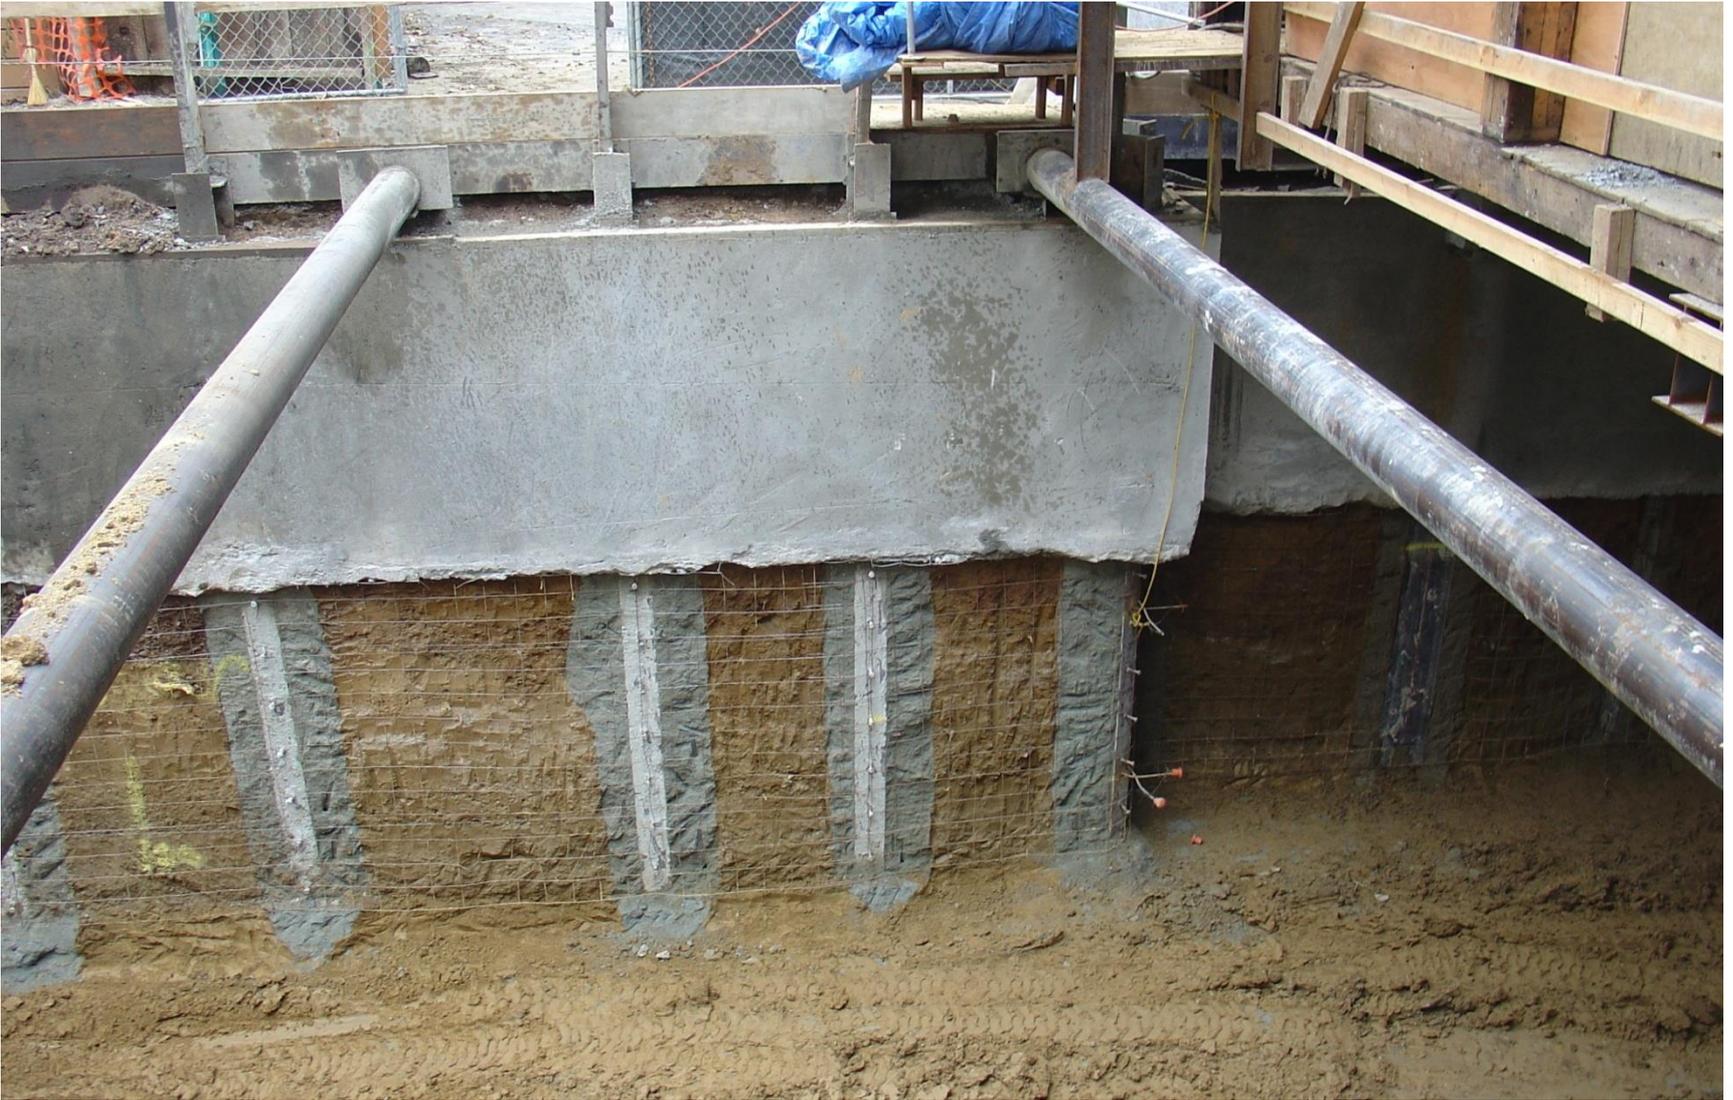
- Soldier piles are predrilled at intervals along the wall's baseline. The piles are placed in the hole and backfilled with lean-mix concrete. As the excavation in front of the wall proceeds, shotcrete lagging is installed between the soldier piles in lifts. Tieback anchors may be installed and stressed to provide lateral restraint.

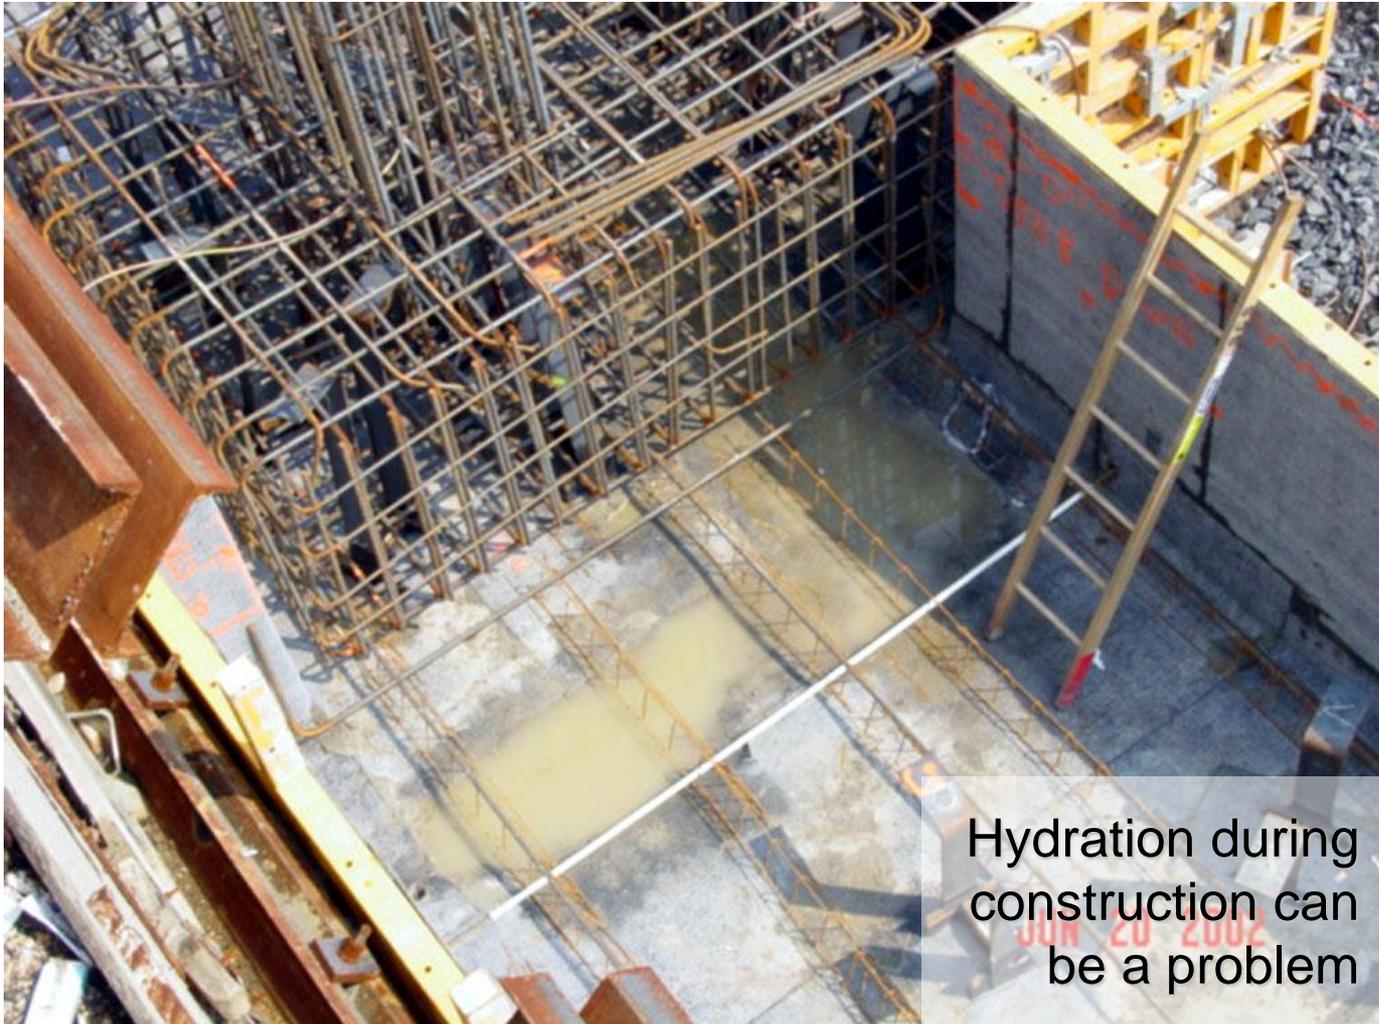
Prehydration Due to Rain can Lead to Failure

Hydration during construction can be a problem

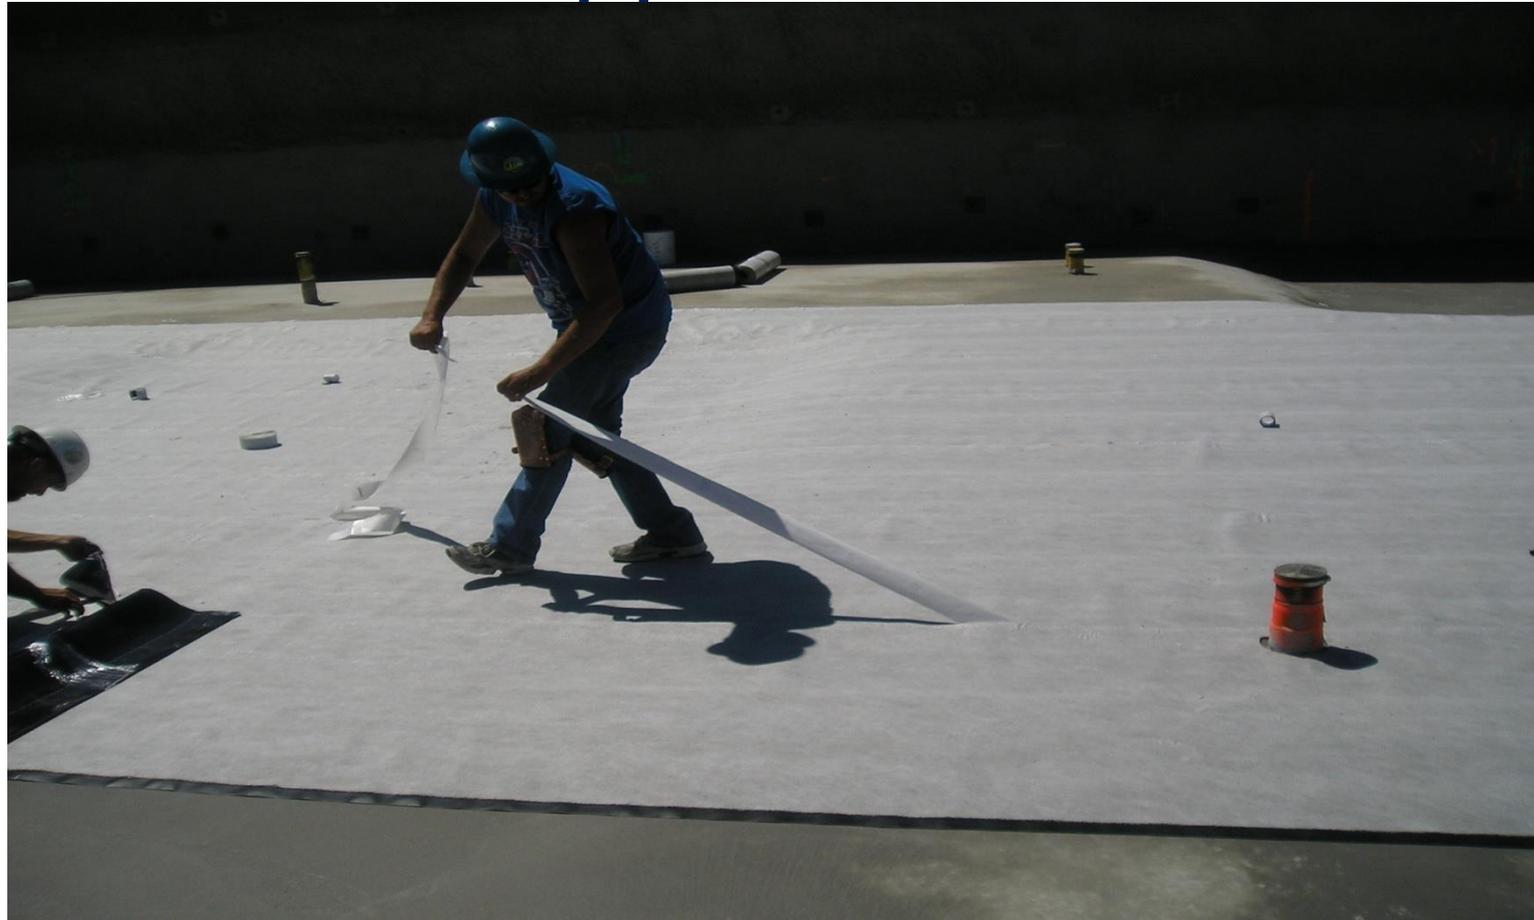
Typical Paraseal Membrane Application

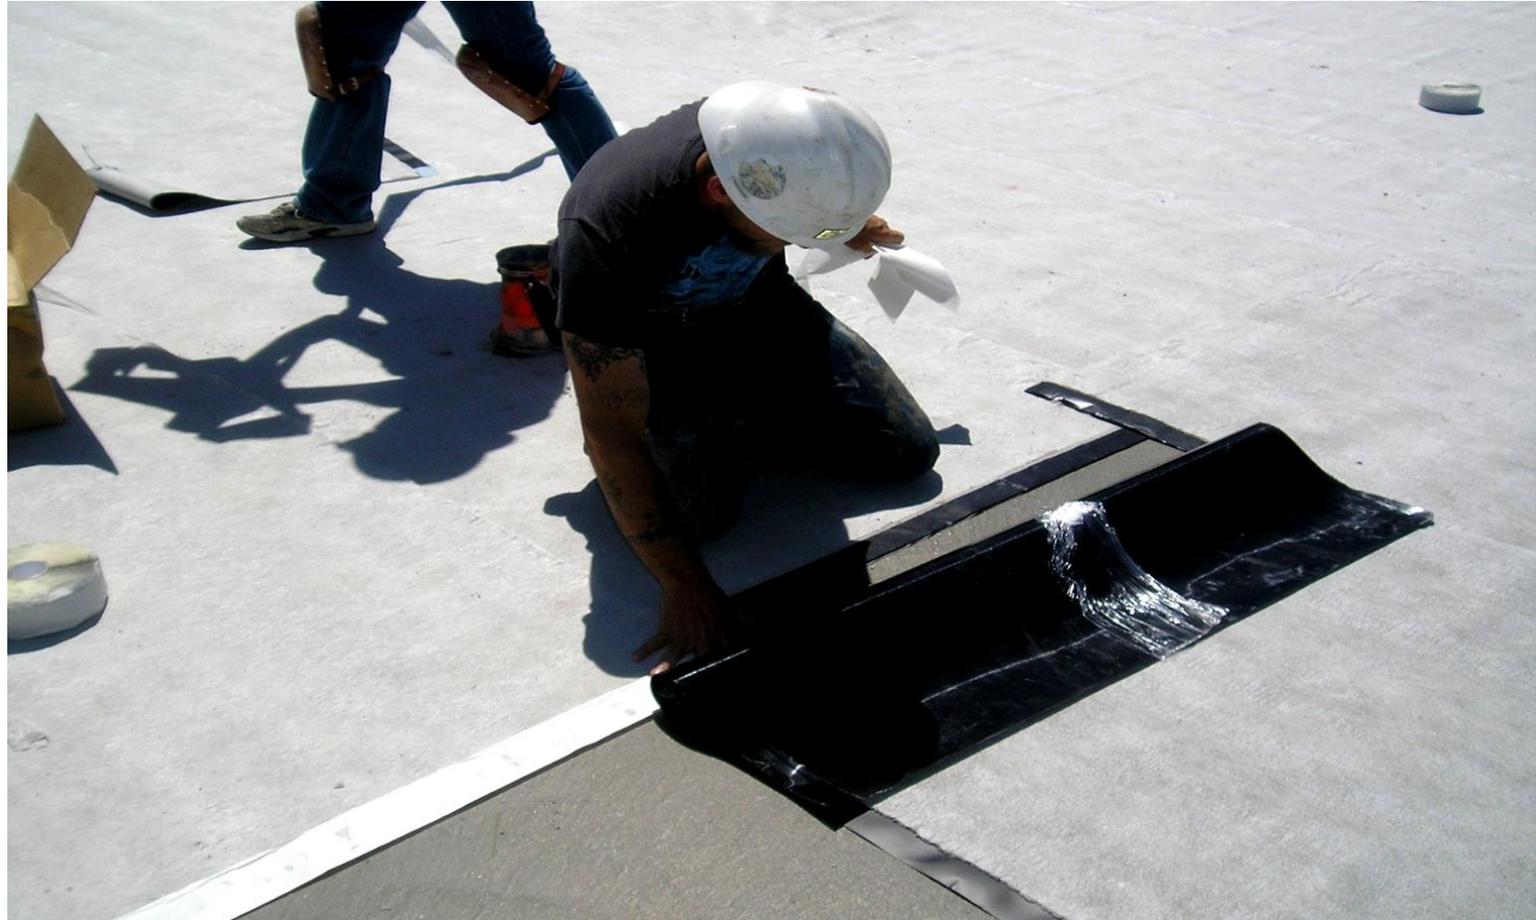
Seam Tape Being Applied

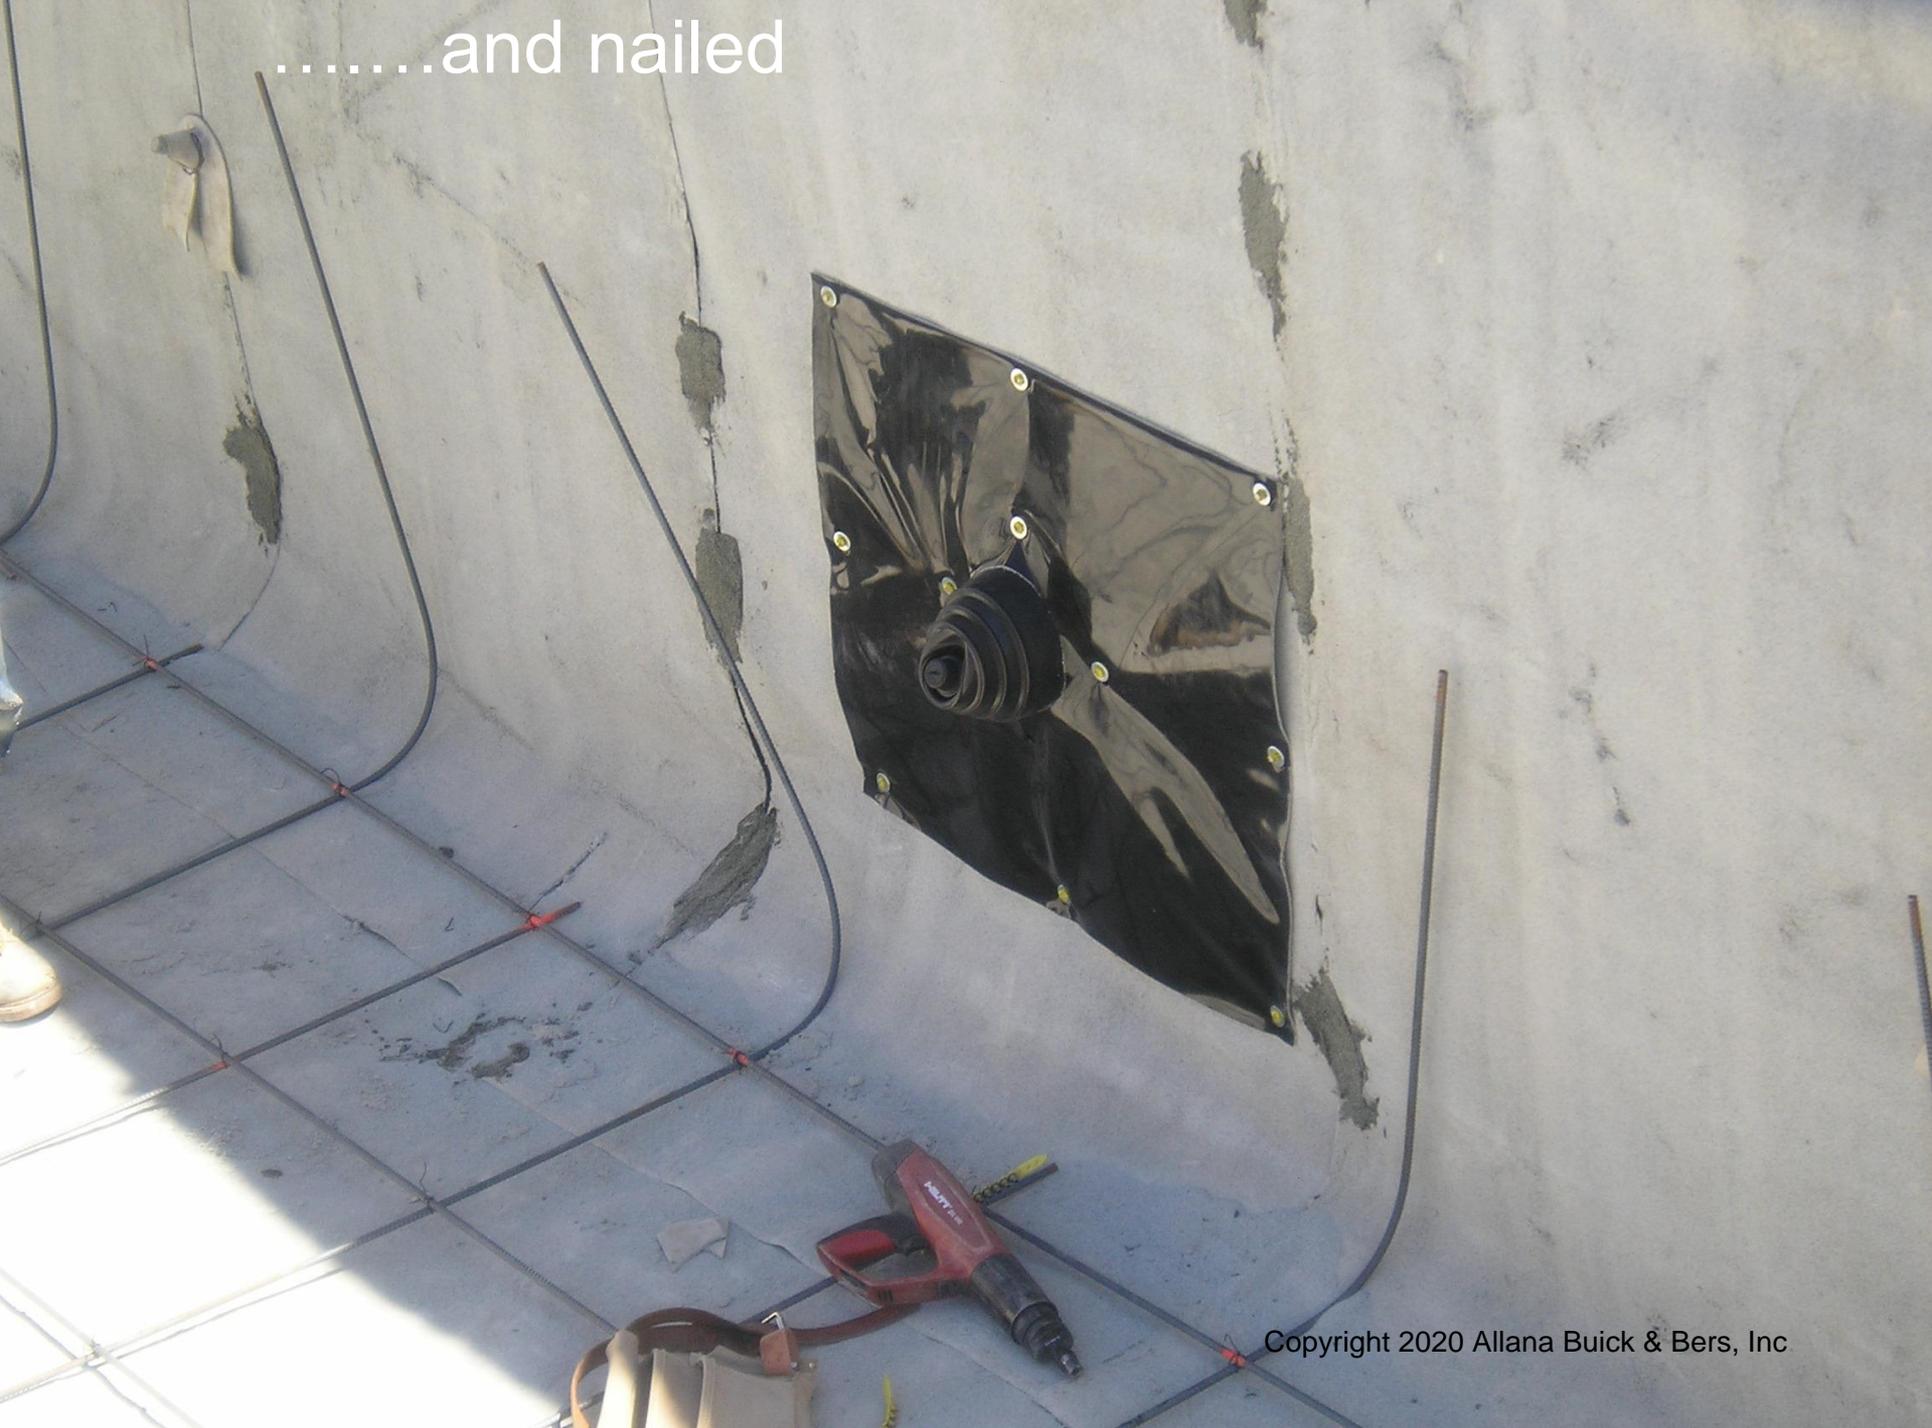
Witches Hat Over a Tieback Head

- The penetration is detailed with Parastick n' Dry (bentonite waterstop), and the witches hat (molded polyethelyne) is filled with Paramastic
- The hat is nailed over the tieback, and another target sheet of Paraseal is installed over it
- Double protection of bentonite.

.....and nailed

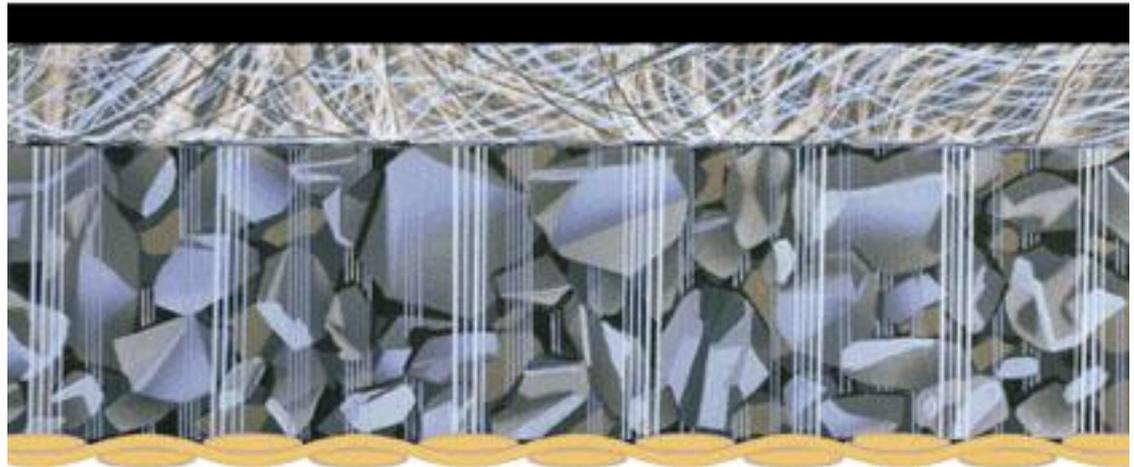
VOLTEX DS

CROSS-SECTION ILLUSTRATION

HDPE LINER

NON-WOVEN FABRIC

GRANULAR BENTONITE

1.1-LBS./SF

WOVEN FABRIC

- Interlocking Geotextile Waterproofing System
 1. Comprised of two high-strength geotextiles sandwiching bentonite, which are interlocked through a needle punching process
 2. Includes a integrated polyethylene liner for added protection and vapor barrier
- Sandwiches 1.10lbs of bentonite per square foot
- Designed for waterproofing under slabs and blind-side applications

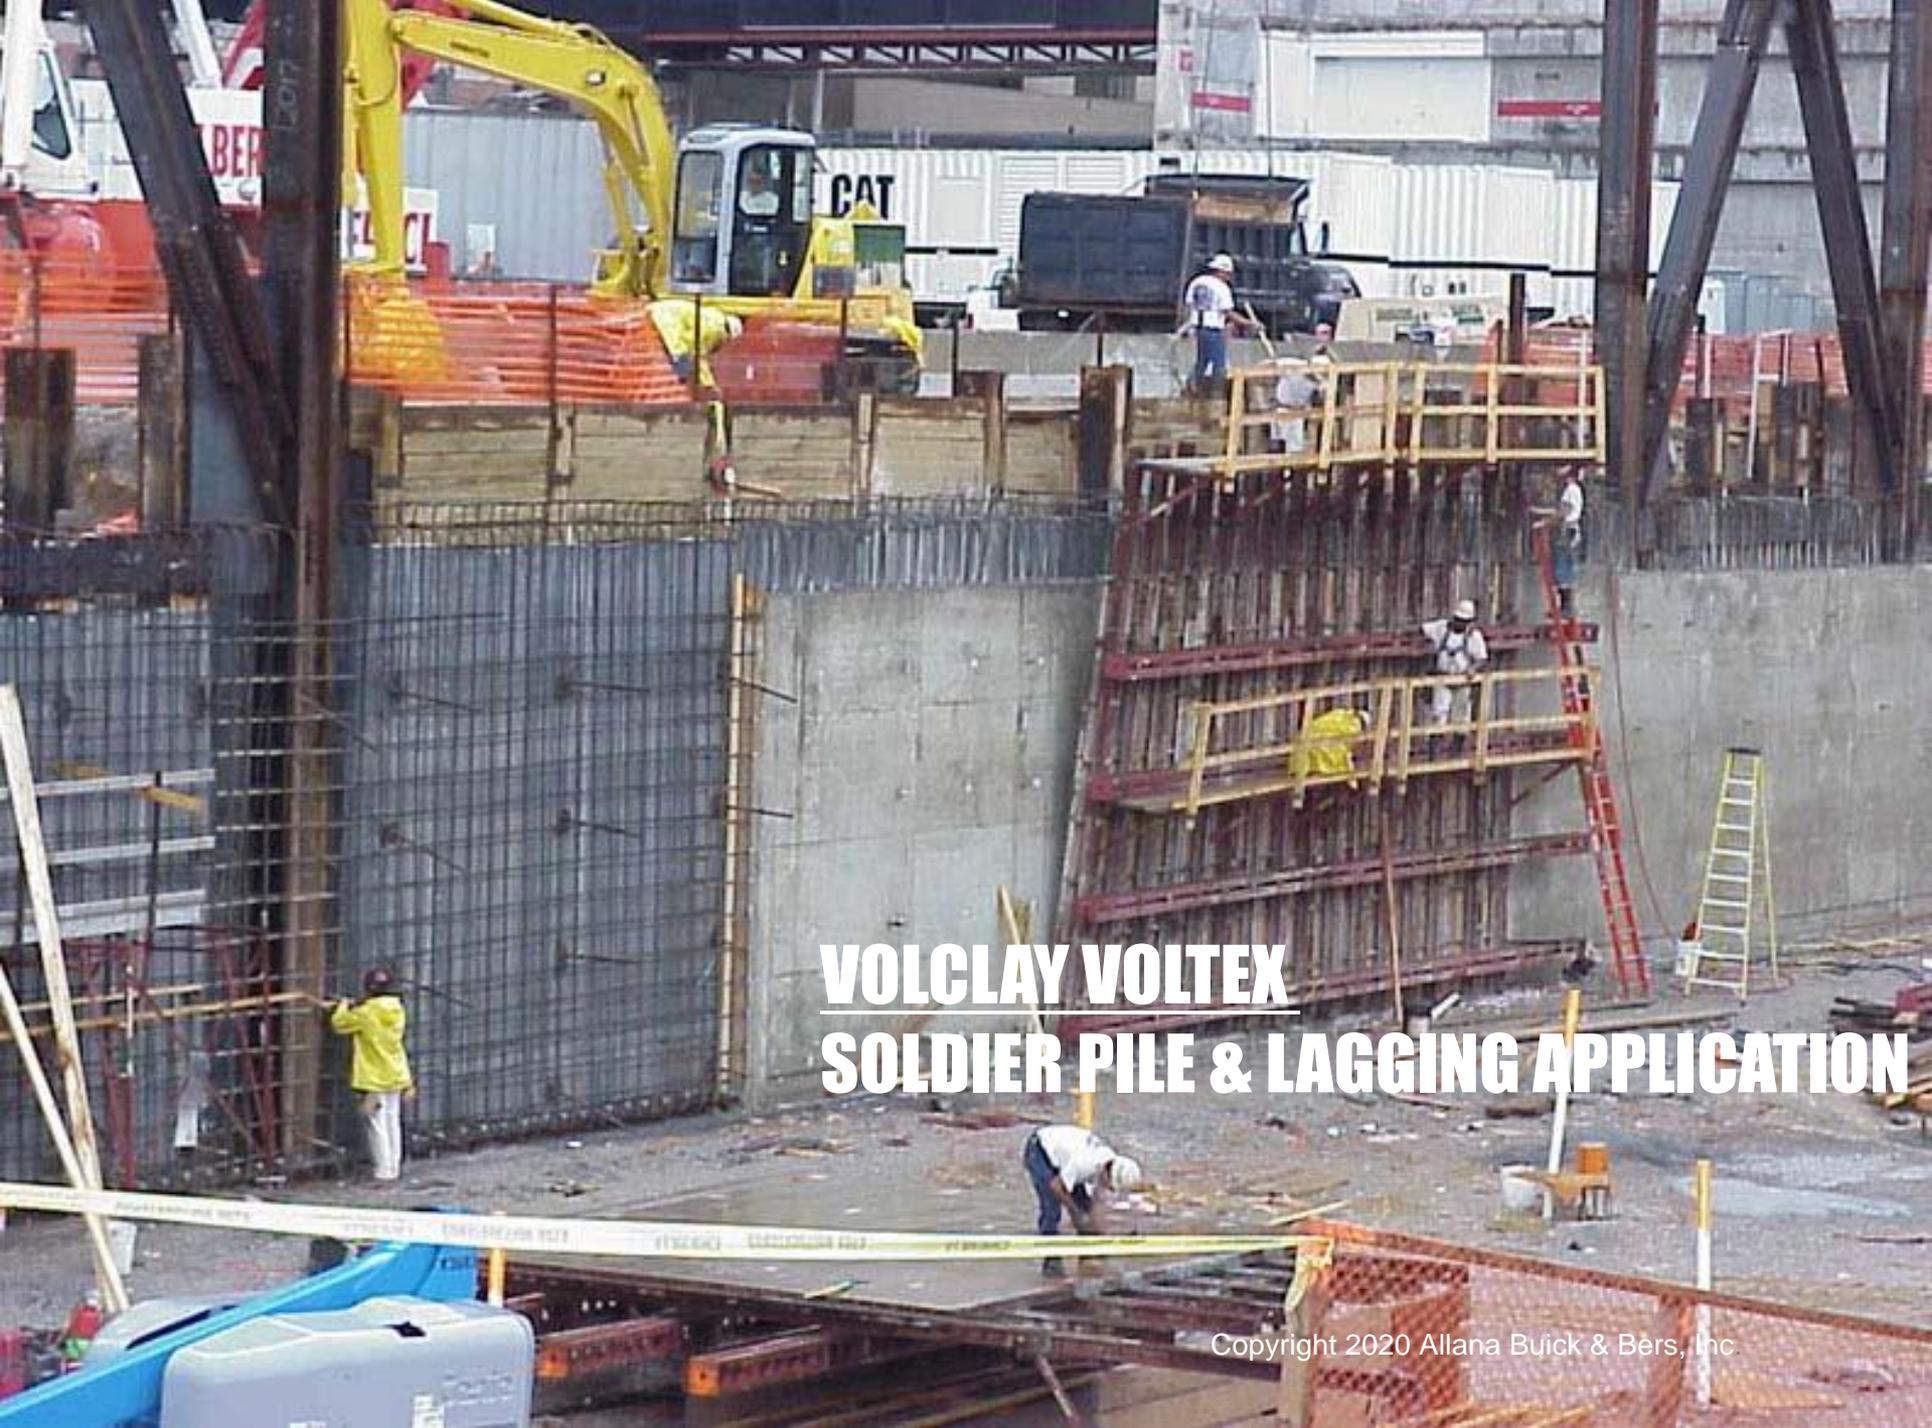
VOLCLAY VOLTEX SOLDIER PILE & LAGGING APPLICATION

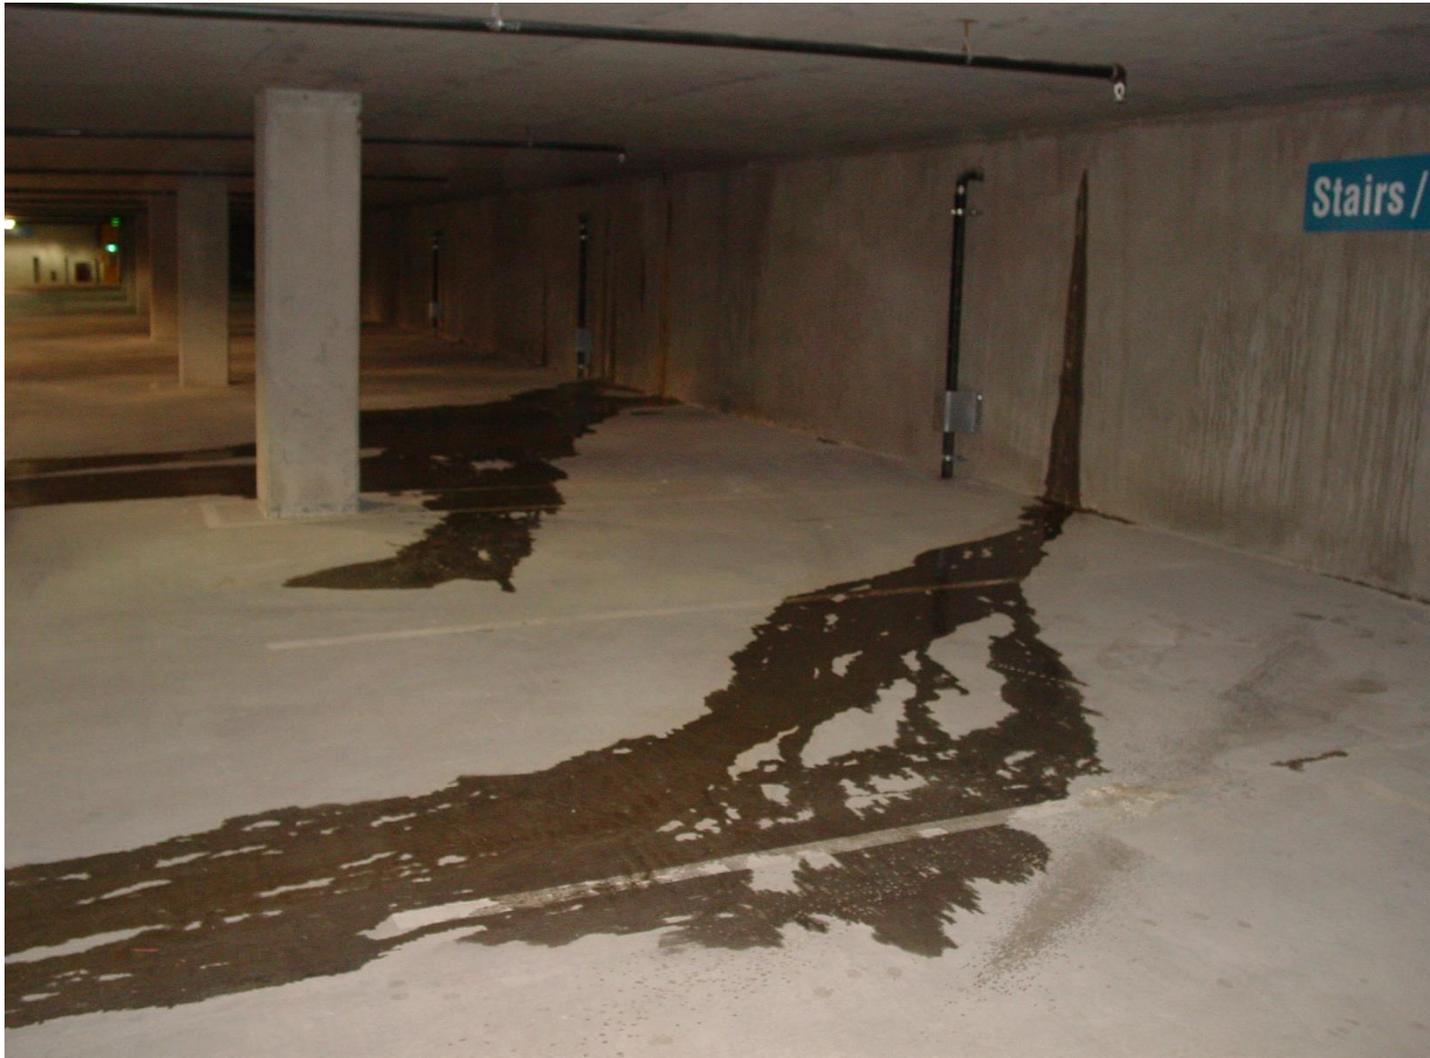
Garage Structure is 2 stories Below the Water Table

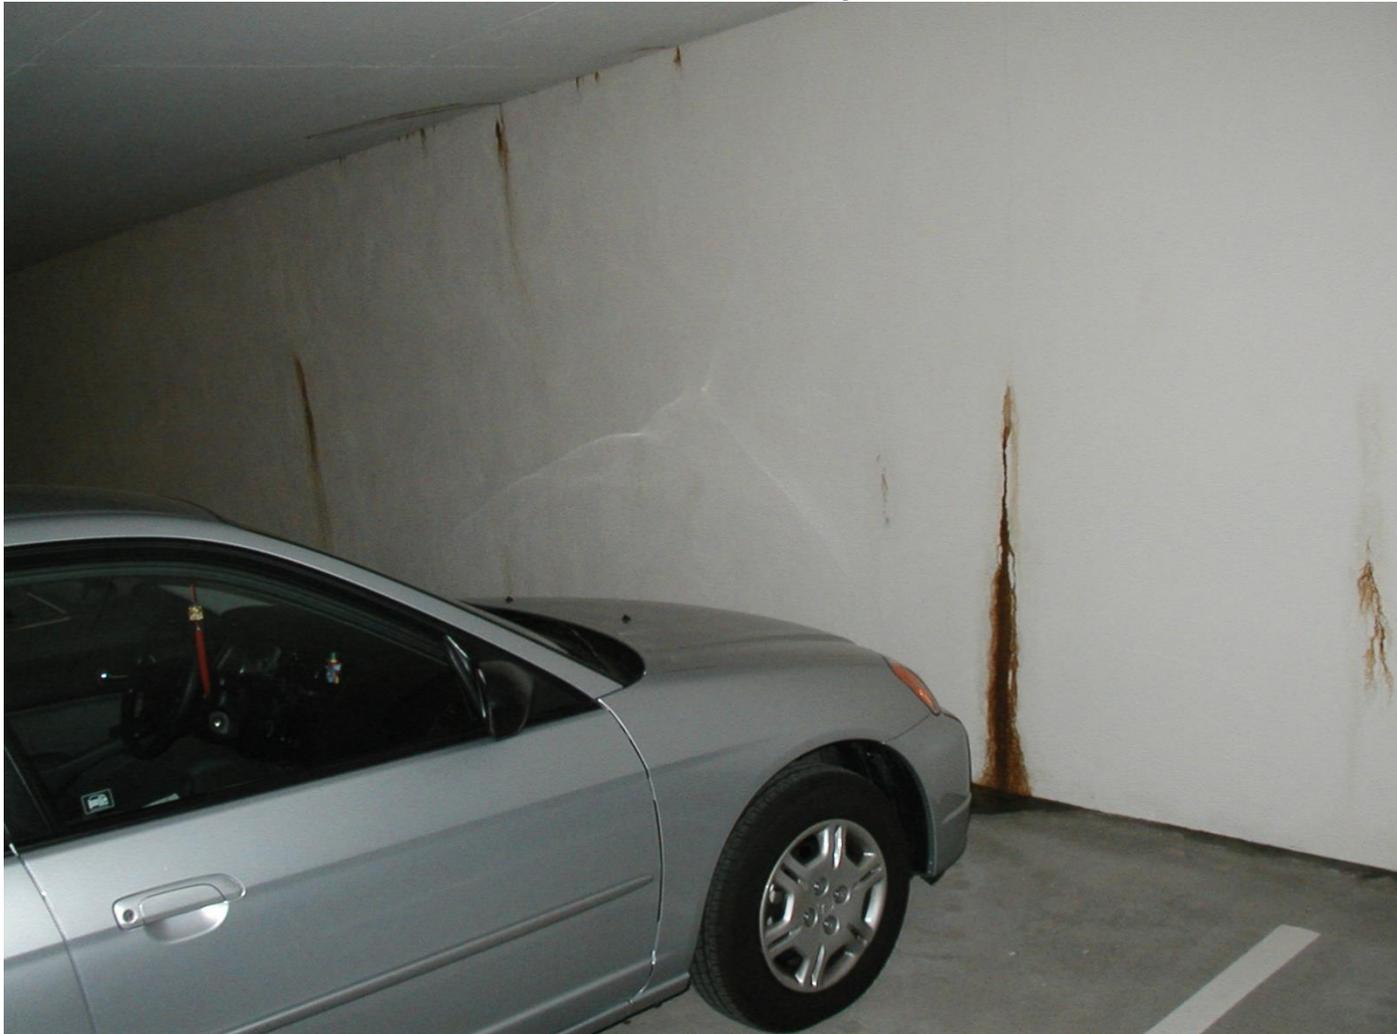
Downtown Sunnyvale Garage Leaked From Day 1

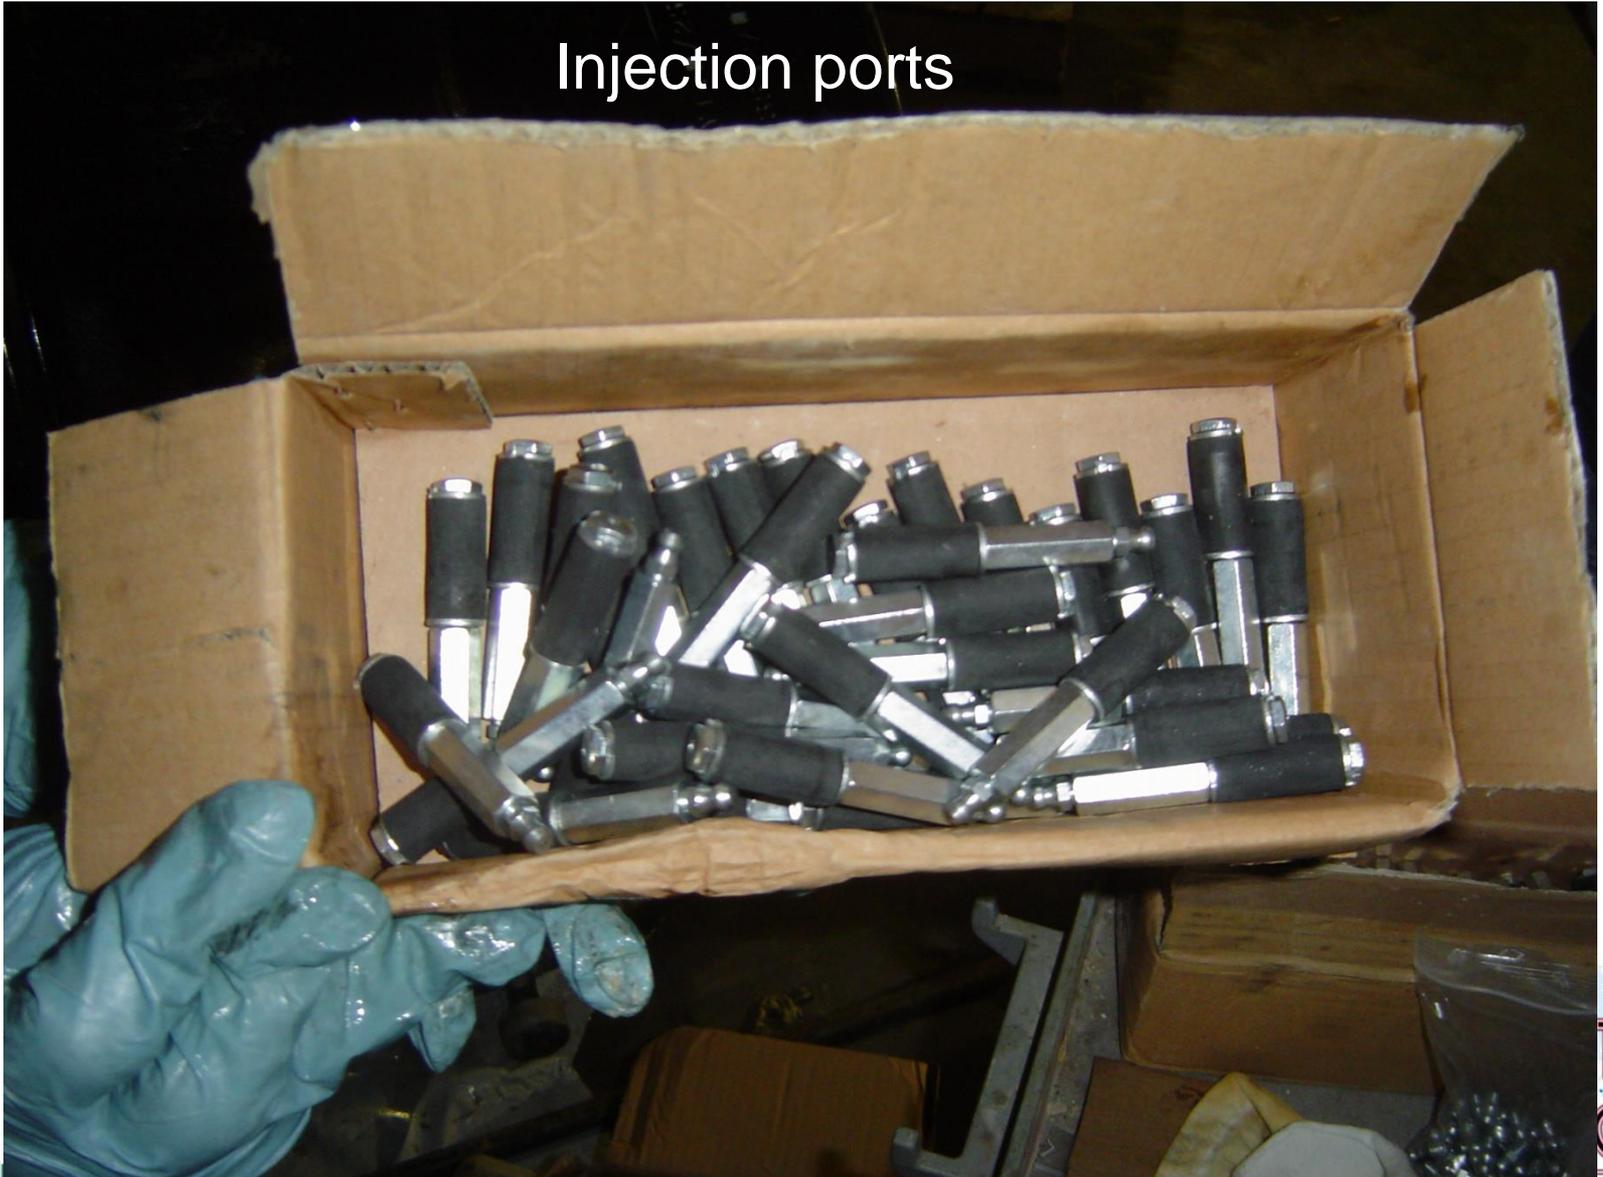
Chemical Grout was Injected 24" O.C.

Injection ports

- Drilling 5/8" diameter holes on a 4' on center grid formation through 18" thick shotcrete foundation wall
- Several types of hydro-active grouts were injected through the holes
