ALLANA BUICK & BERS

Case History, Downtown Sunnyvale Garage, Below Grade Waterproofing Failure

- Forensic Case Study Sunnyvale, California
- Waterproofing failure of Downtown Sunnyvale Garage
- Work performed for a construction defect litigation case
- Bentonite/HDPE composite system was installed and had failed
- 2nd largest below-grade structure in Northern California
- Largest below-grade waterproofing repair of it's kind in California

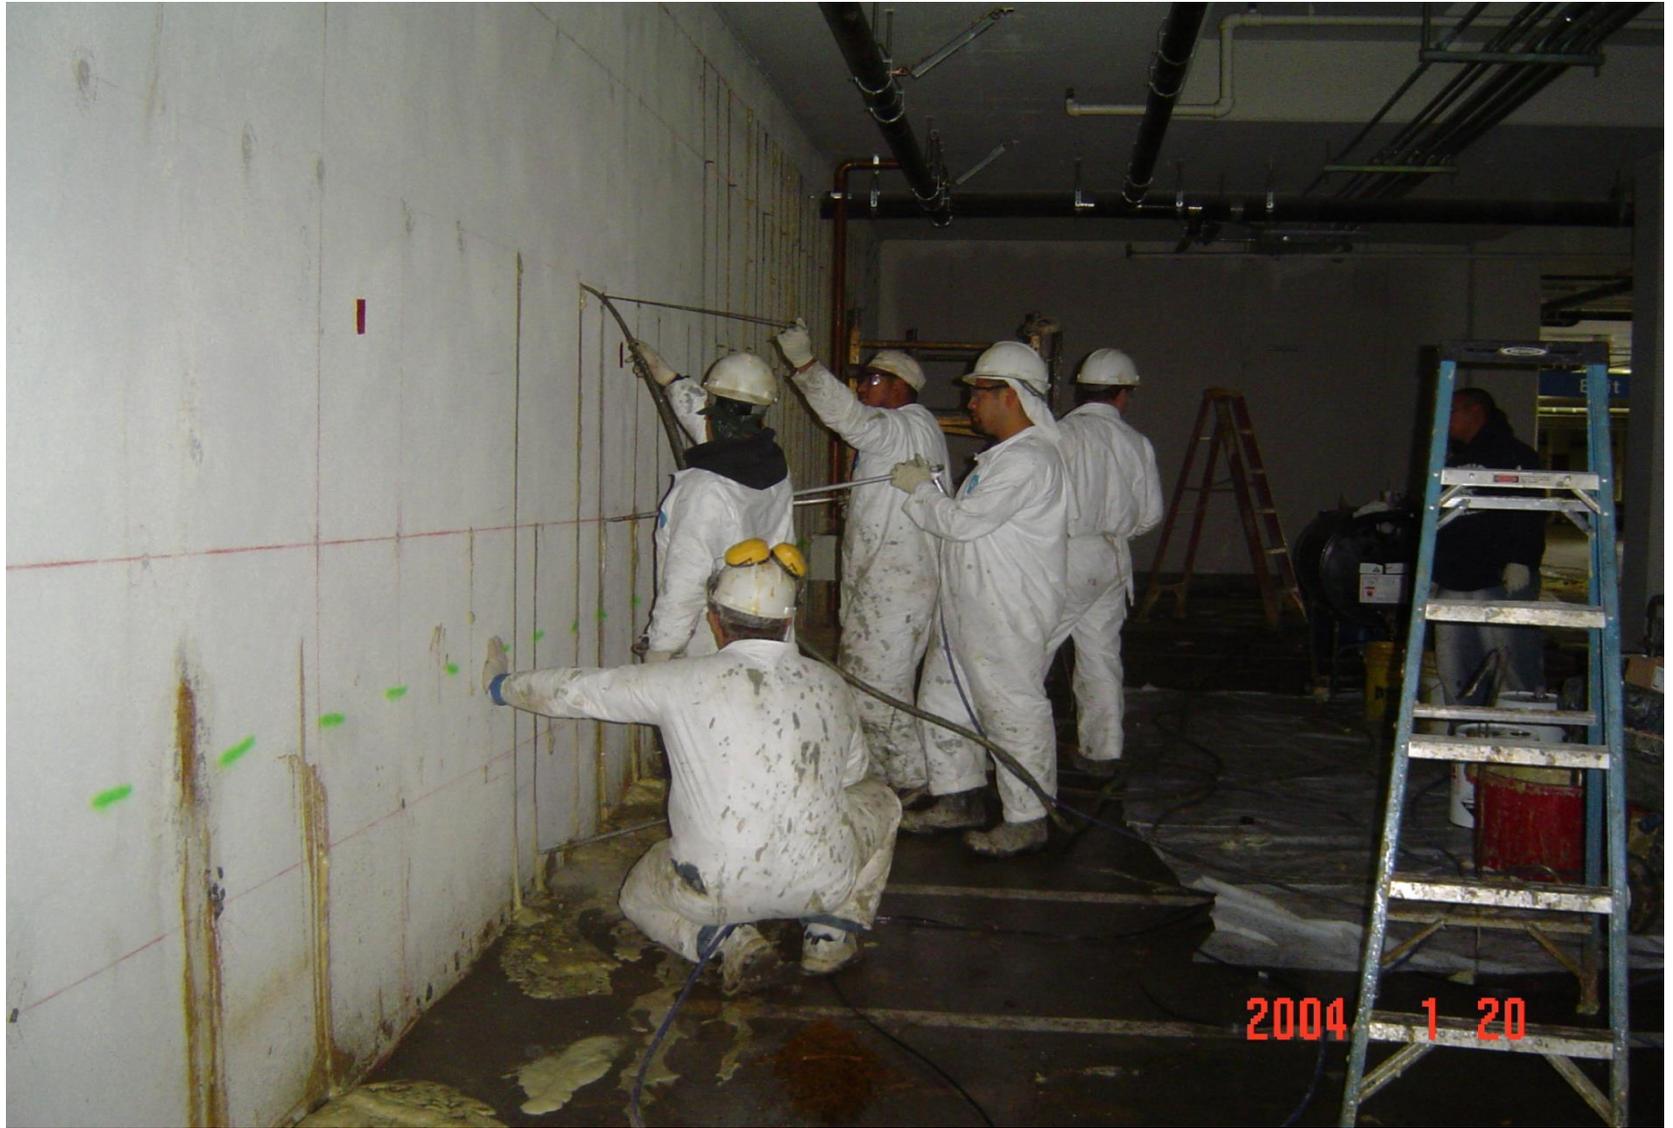
Repair work in progress

- Drilling 5/8" diameter holes on a 4' on center grid formation through 18" thick shotcrete foundation wall
- Several types of hydro-active grouts were injected through the holes

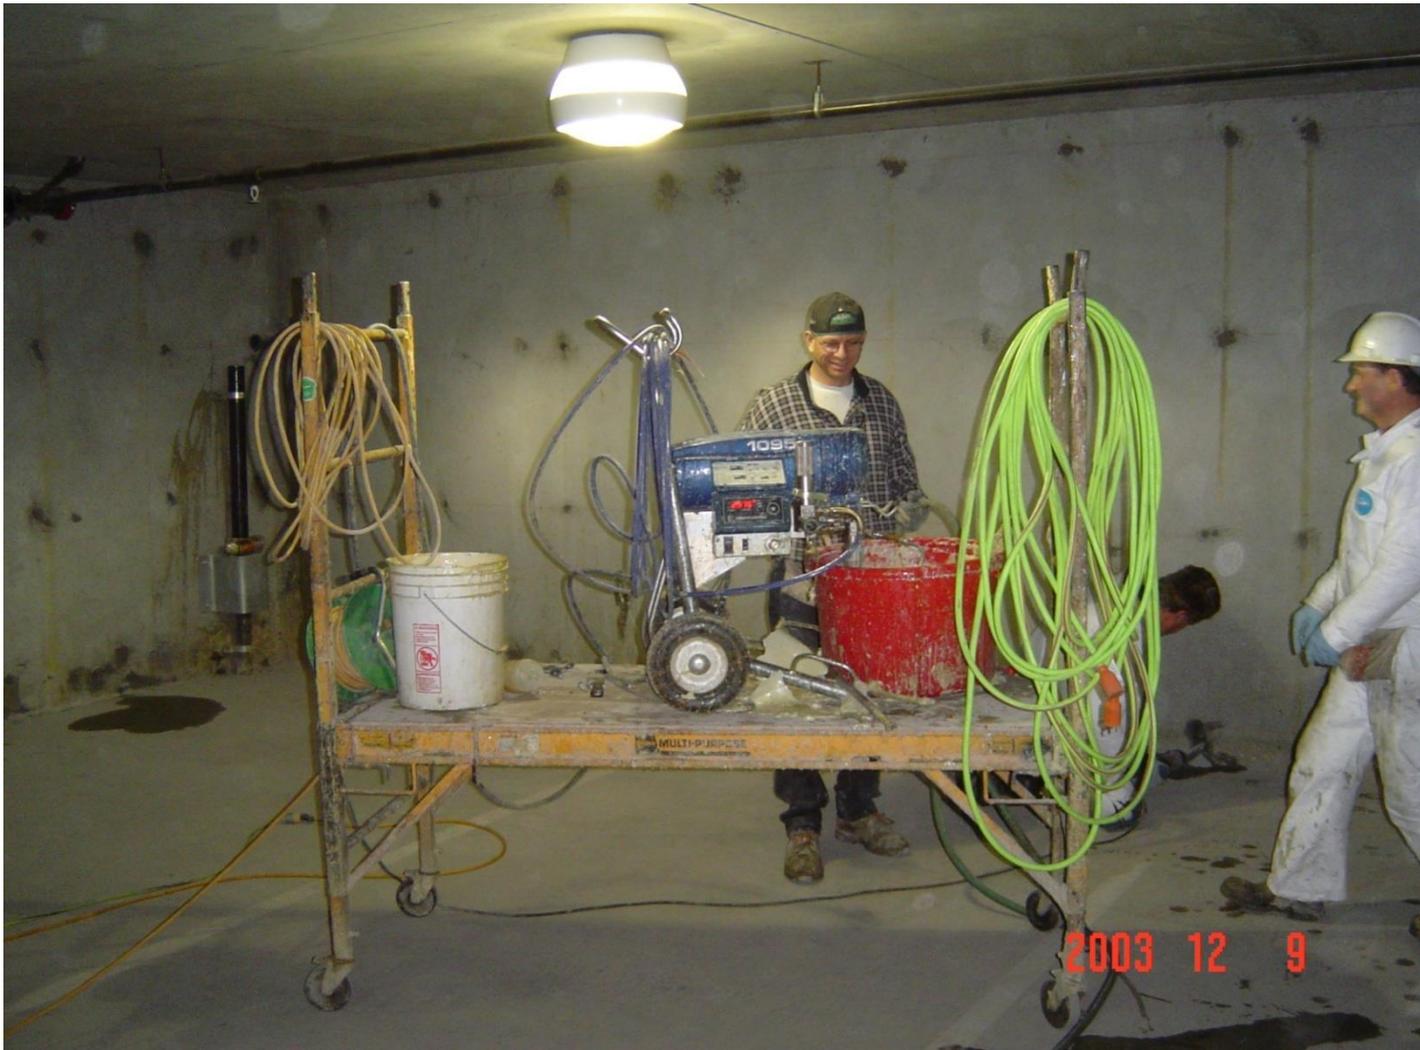
Typical Injection Equipment

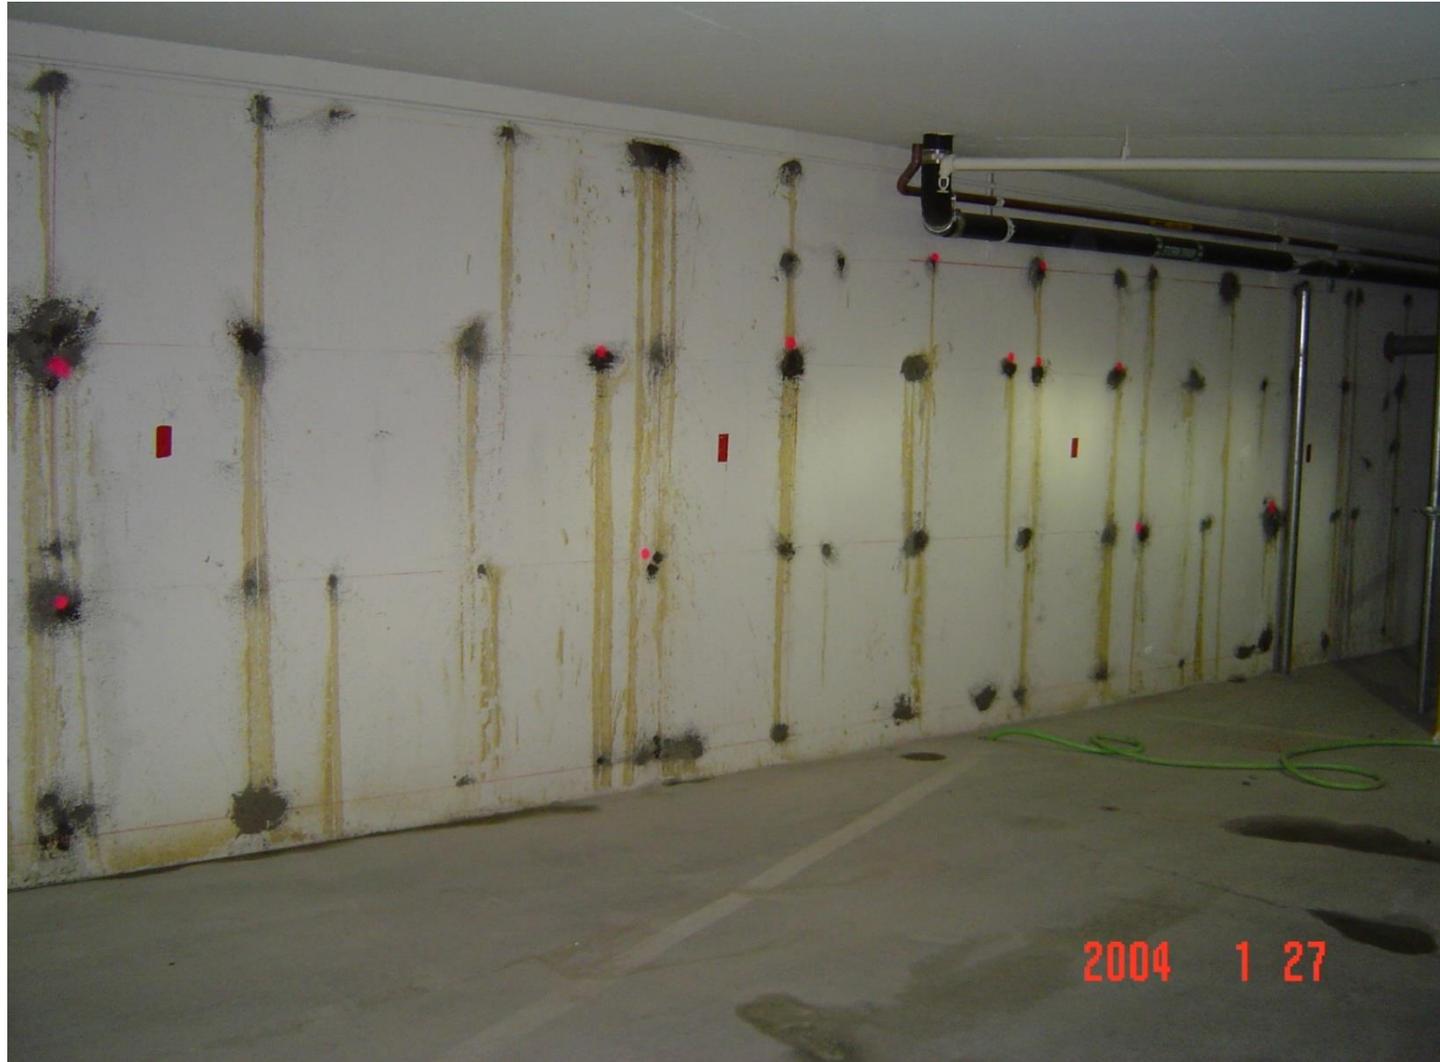
Grout Creates a “Curtain” Behind Concrete

- Grout Characteristics
- Quickly expands and cures upon contact with water to form a water barrier behind the surface of the wall and under portions of the slab
- Designed to fill an voids behind foundation wall
- Upon reaching maximum confinement, grout continues to internally expand thus increasing in density

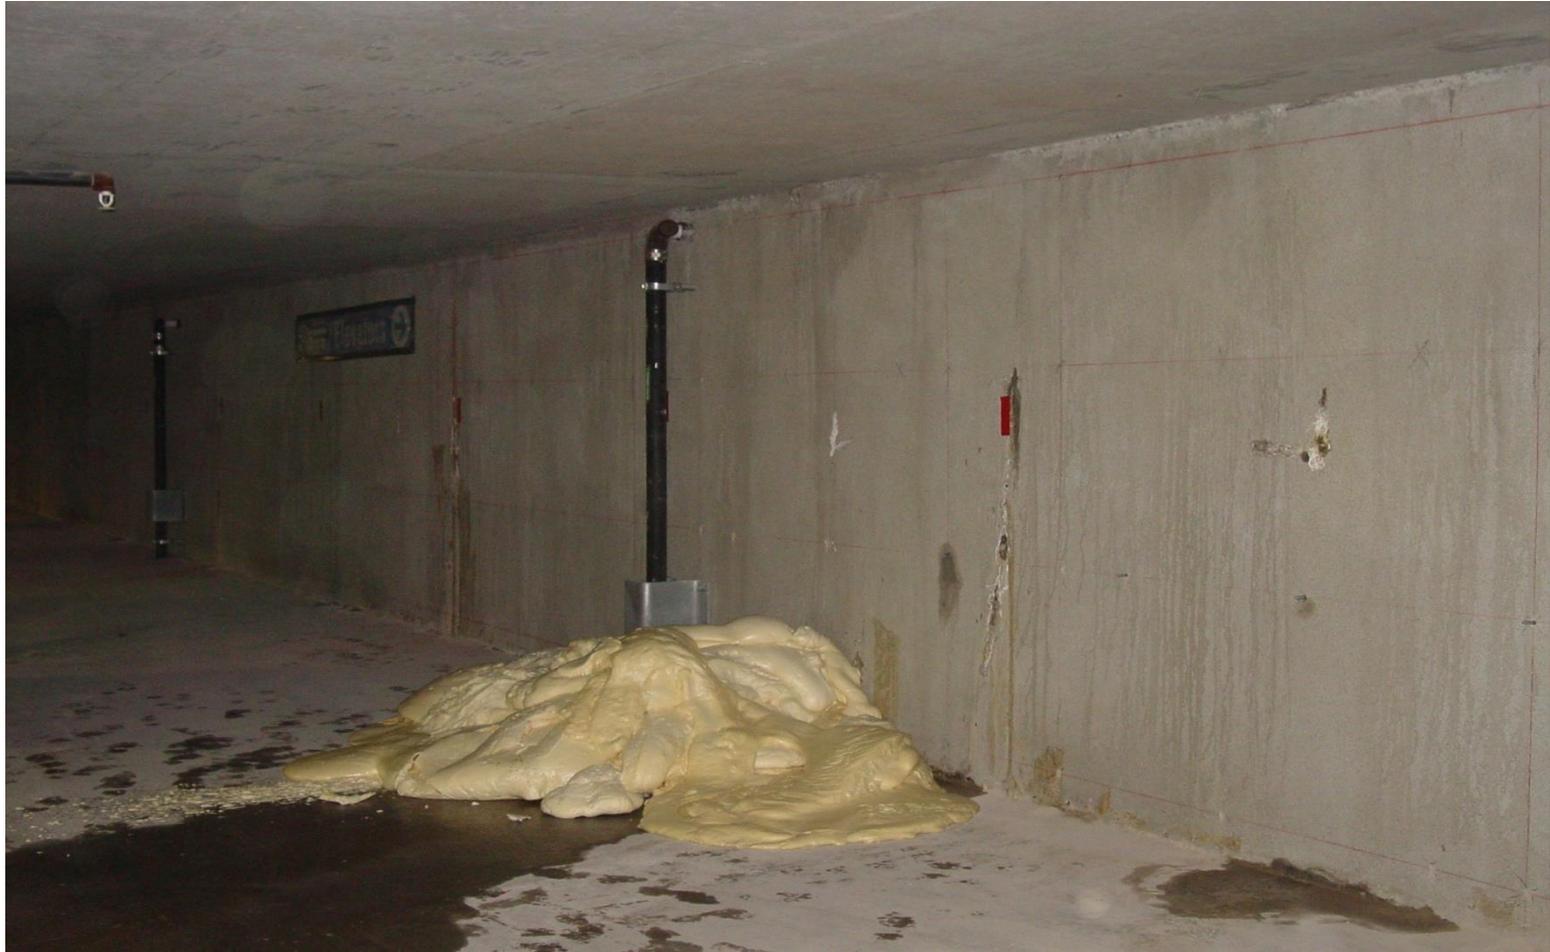
Foam Sometimes Leaves a Mess

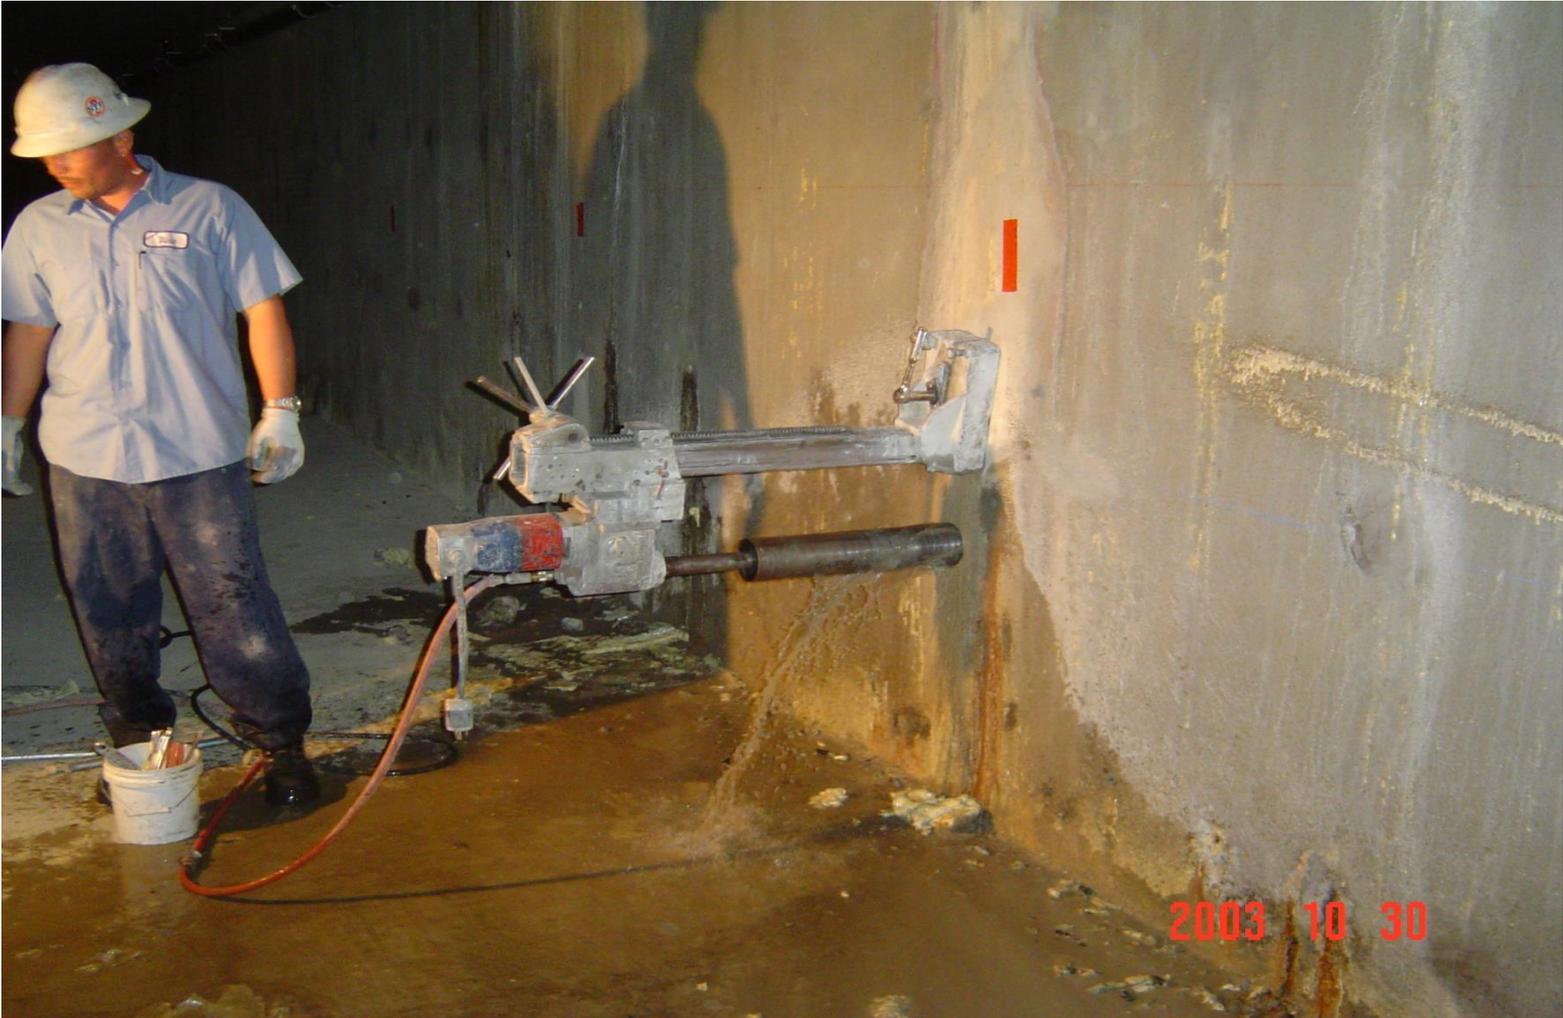
Concrete Cores Were Taken To Asses Performance

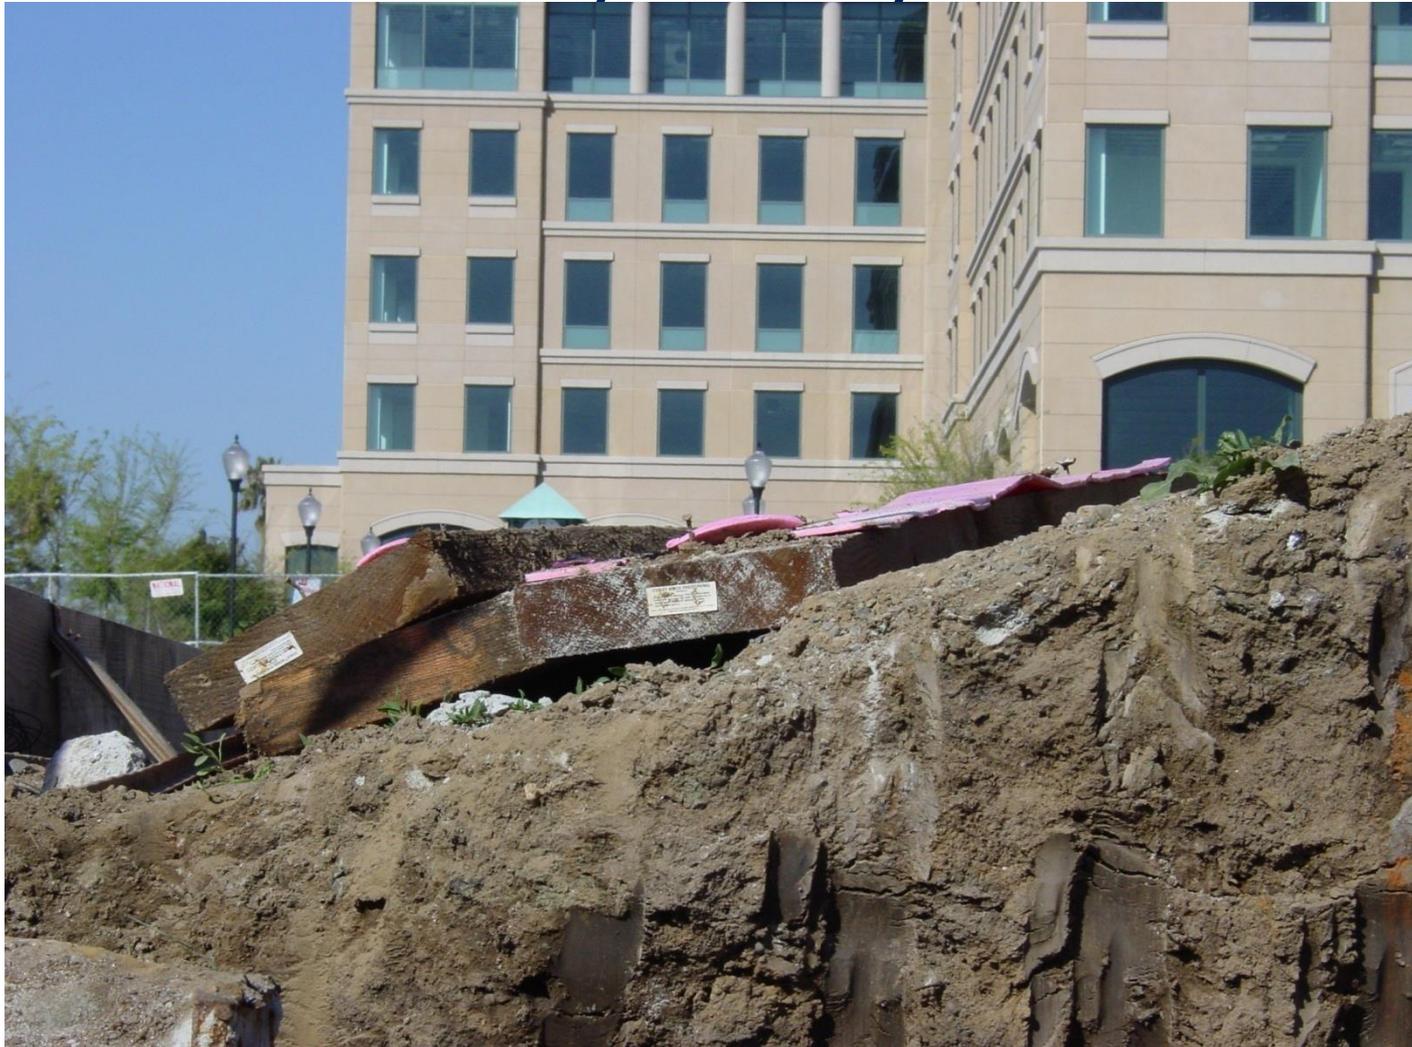
Site was Excavated to Forensically Analyze Failure

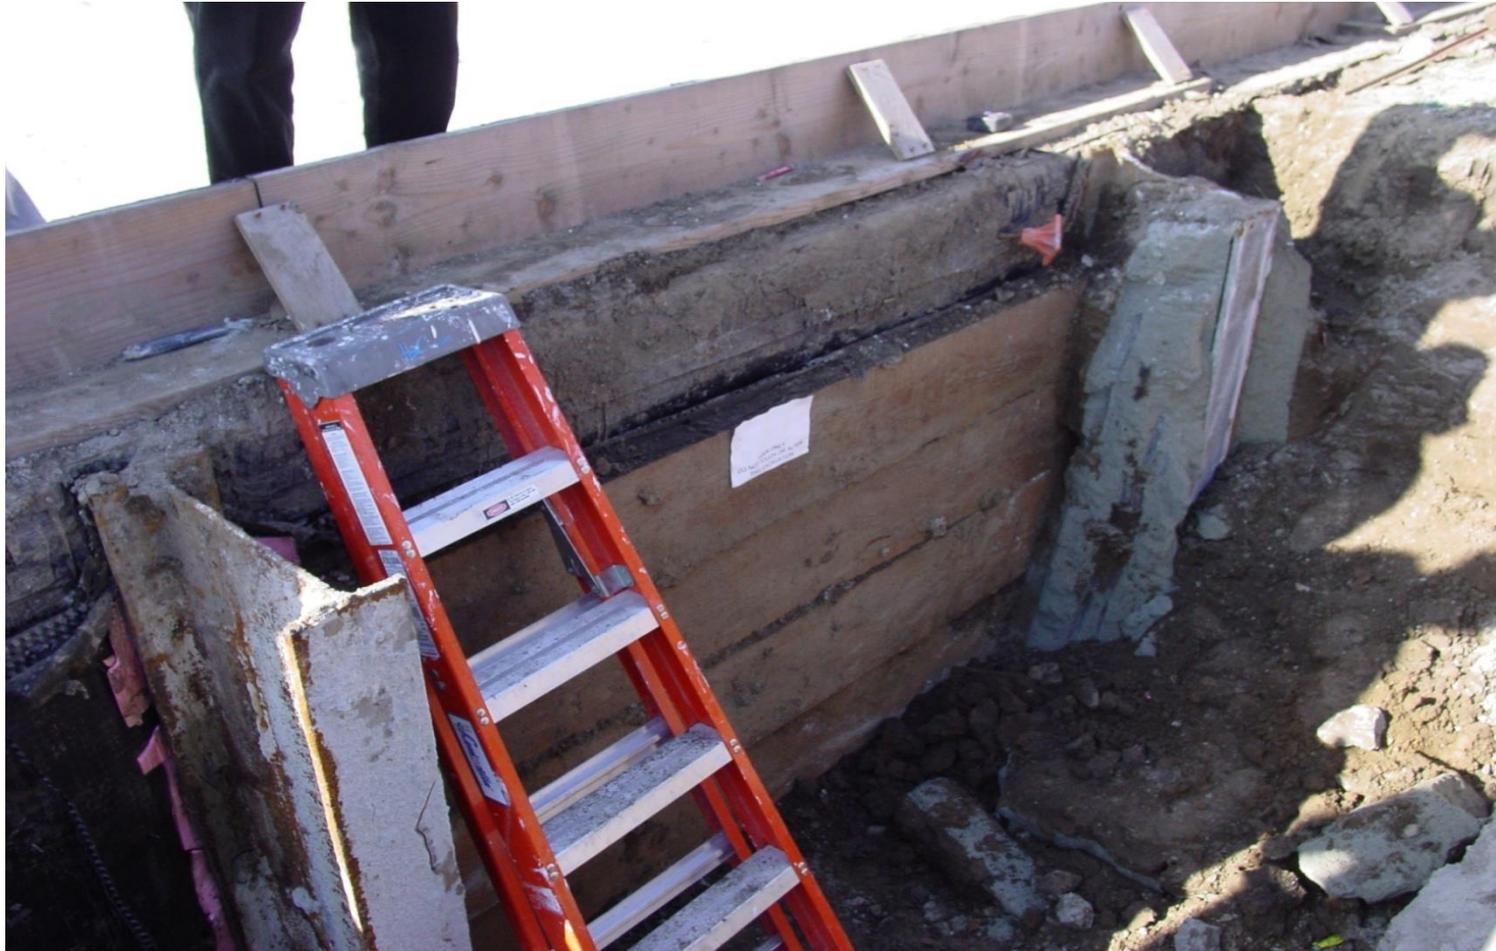
Site was Excavated to Forensically Analyze Failure

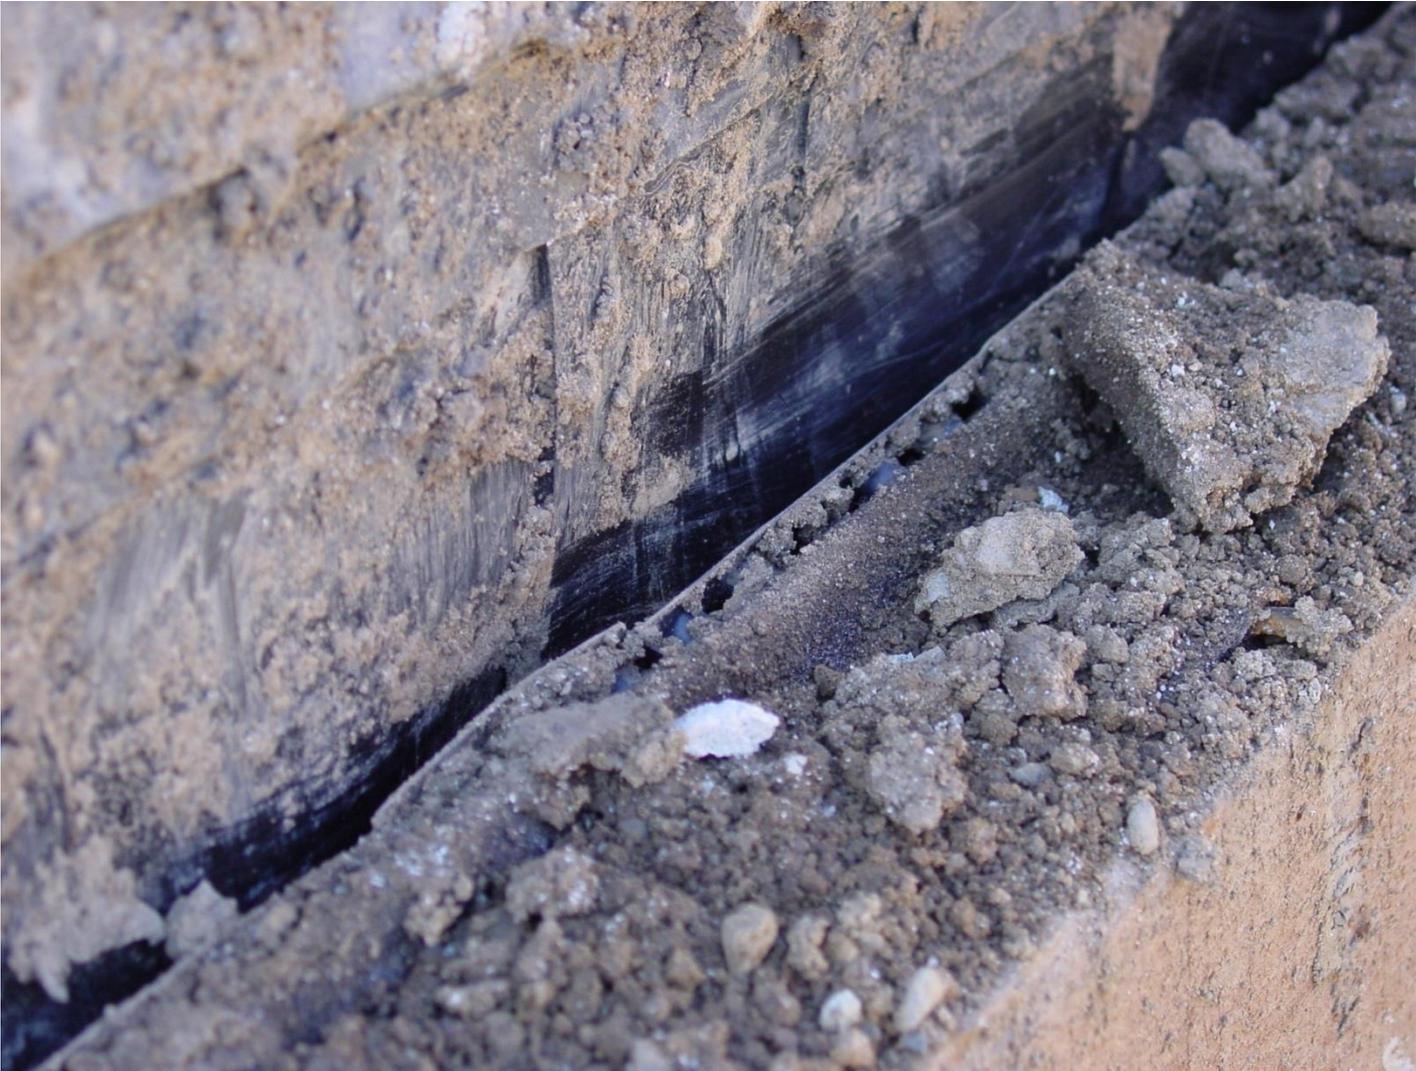
Gap Between Lagging and Shotcrete

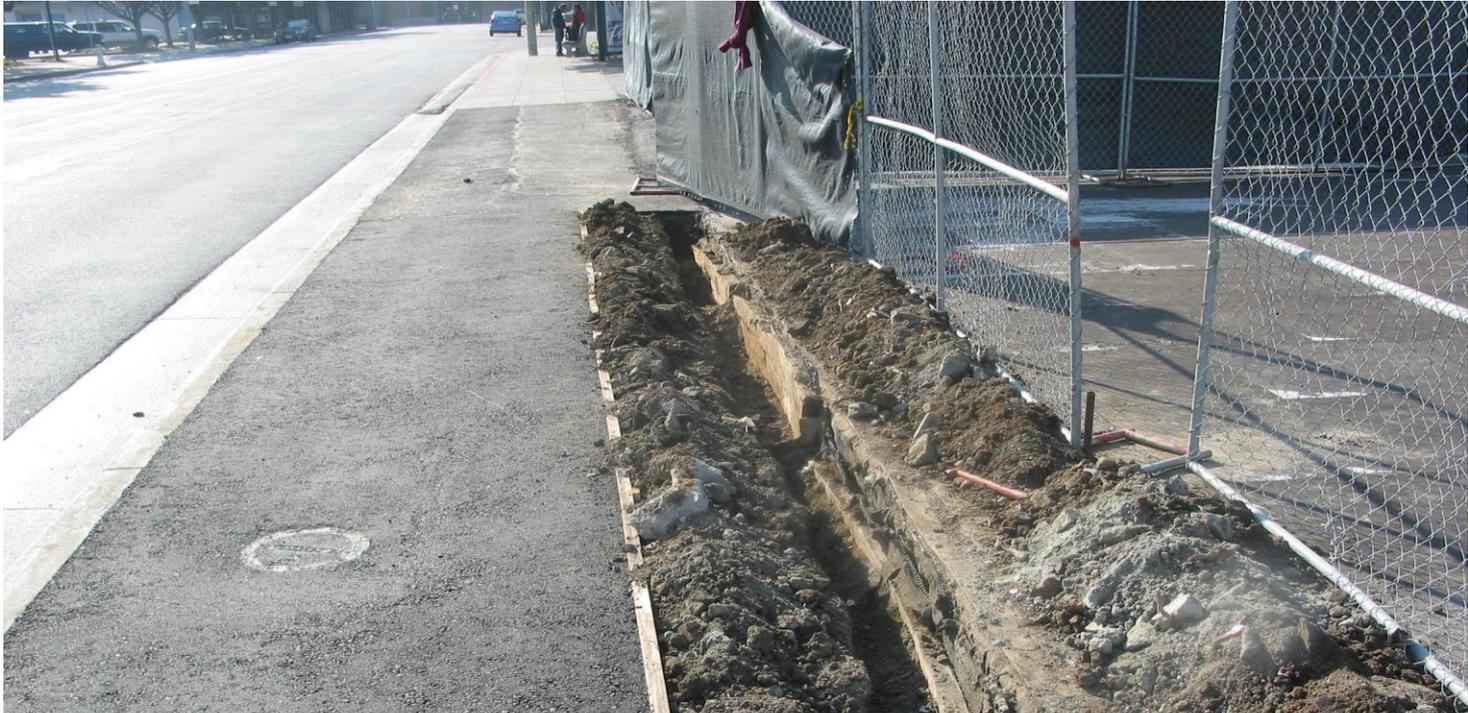
Wood Lagging Issues with Bentonite

Excavation of the soil behind the wood lagging revealed that once the wood gets wet, it swells, bends and twists, especially if there are voids between the soil and wood.

- Bentonite requires confinement to work
- Wood lagging can have gaps and voids in the behind it which can allow lagging to move back
- Wood twists and cups when it gets wet, leaving voids
- Protection board at solder pile left large voids and potentially reduced the system's effectiveness

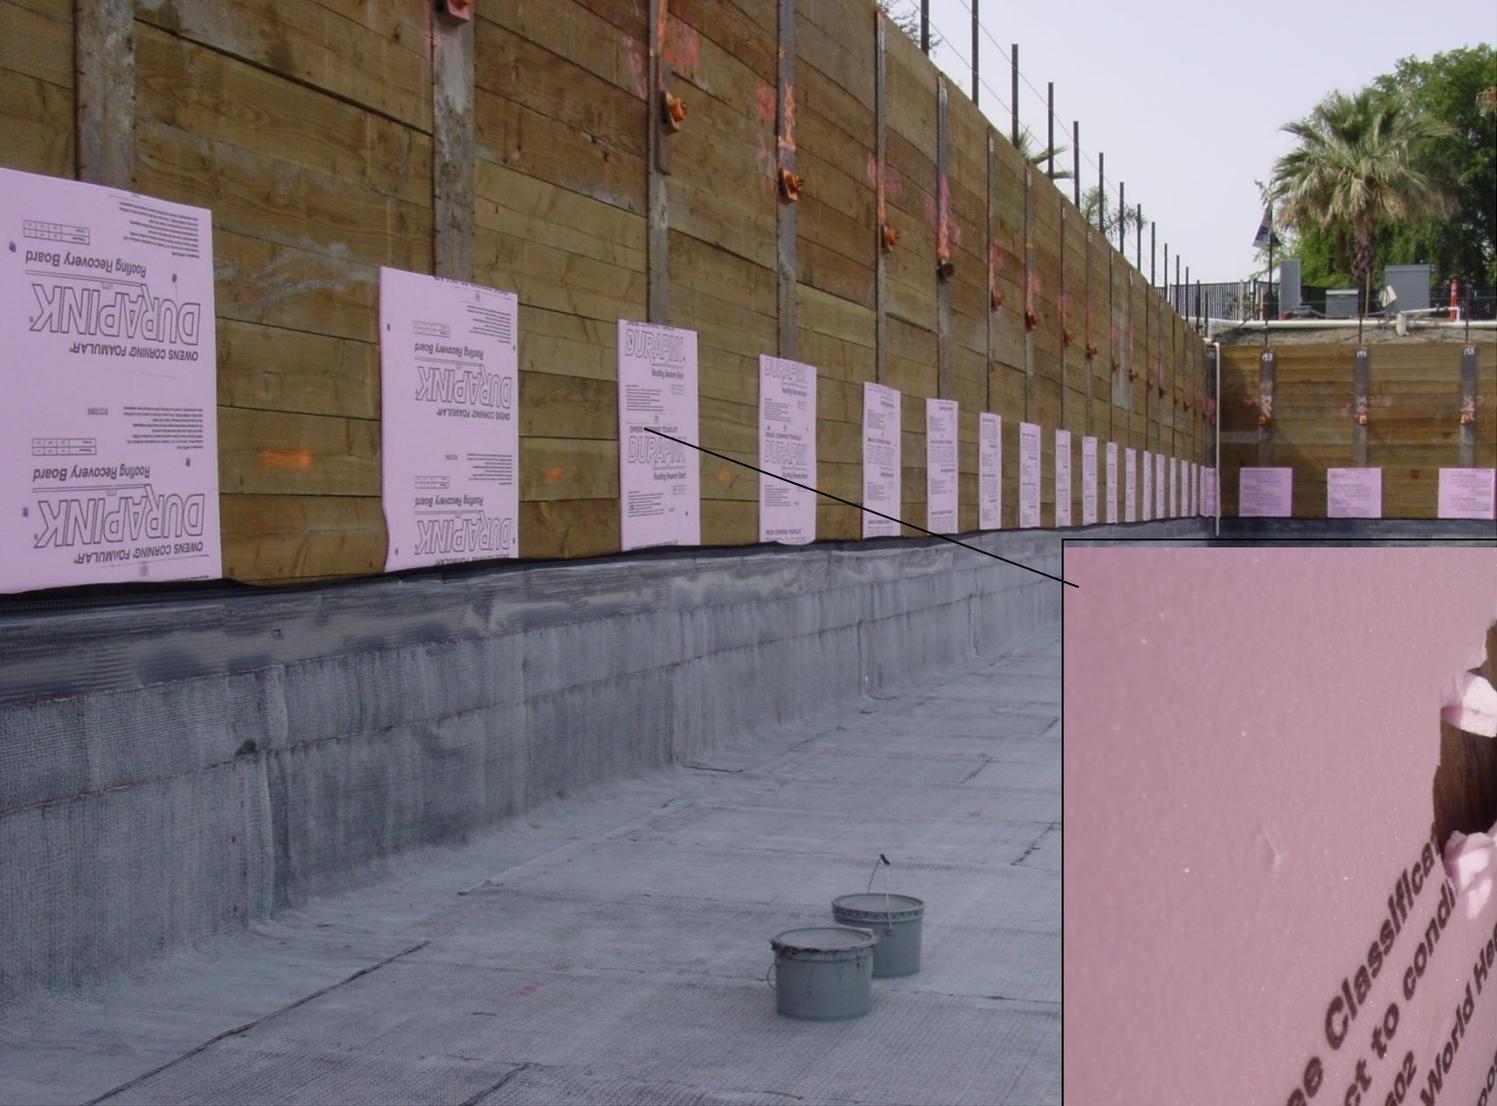
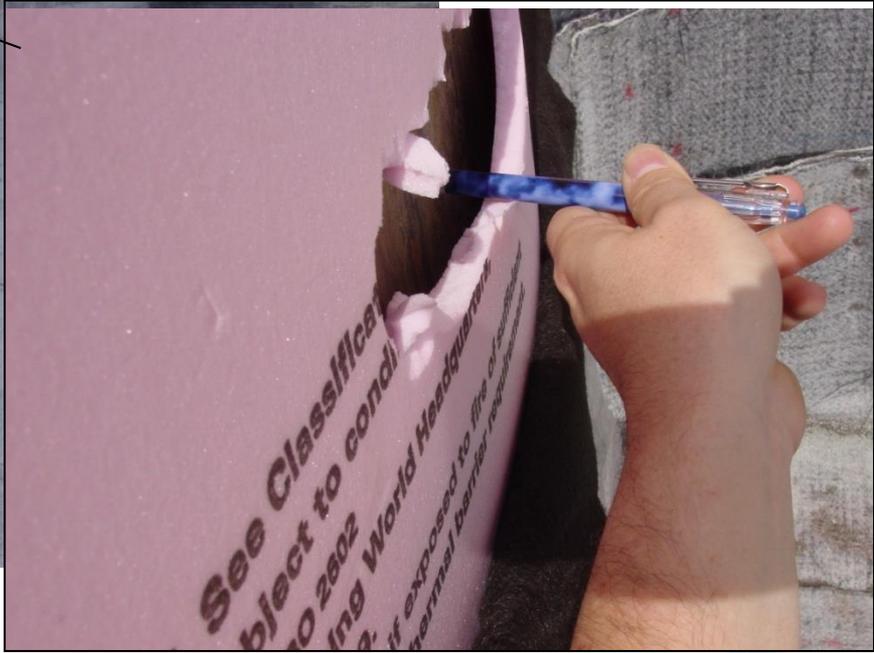
Void behind foam protection board

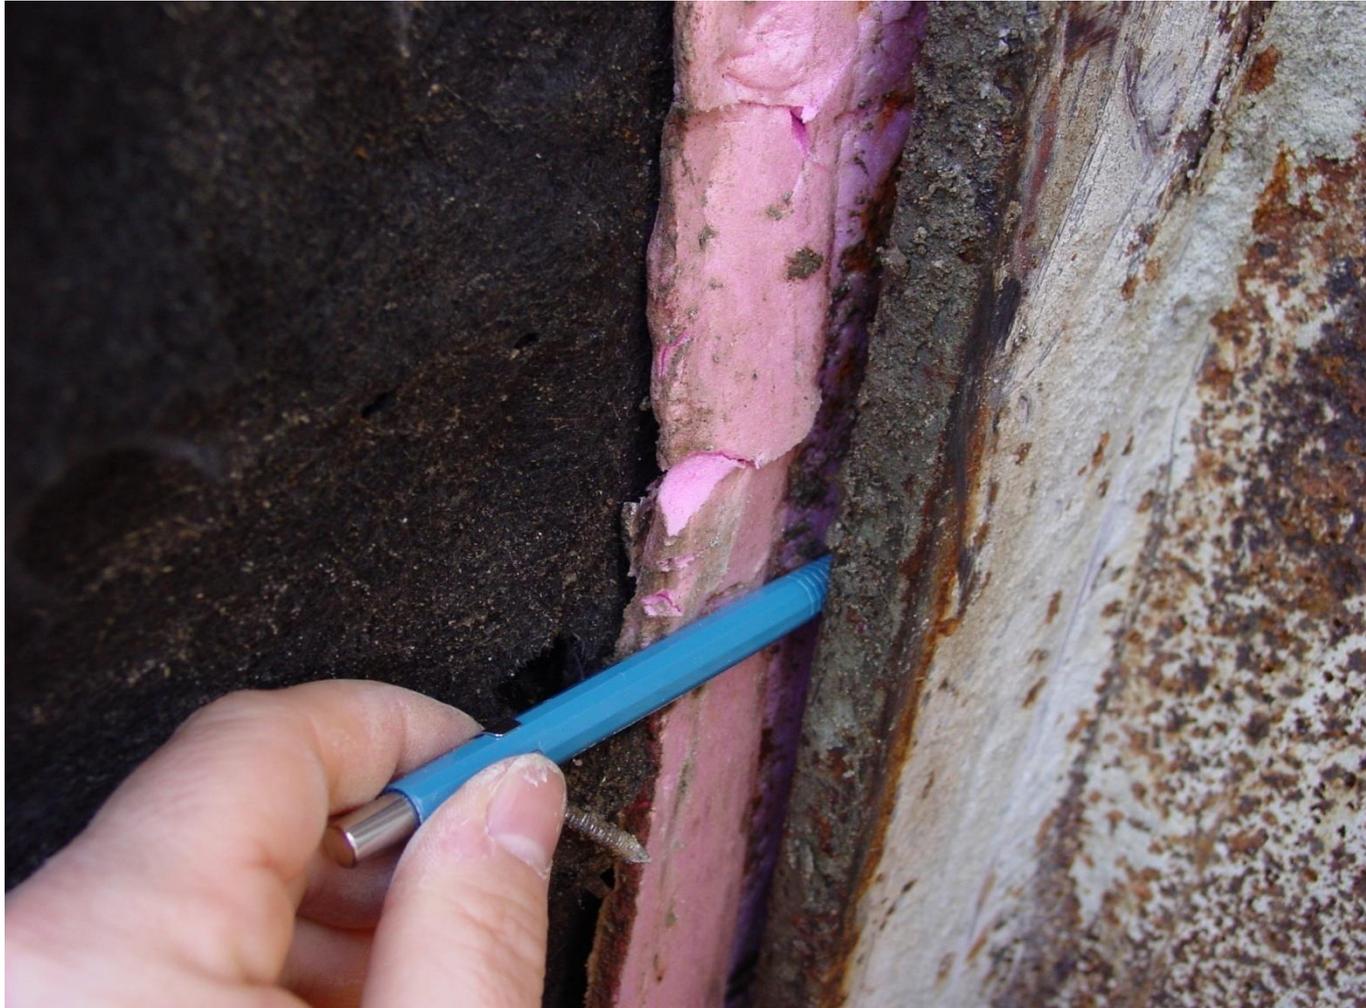
Void Behind Protection Board

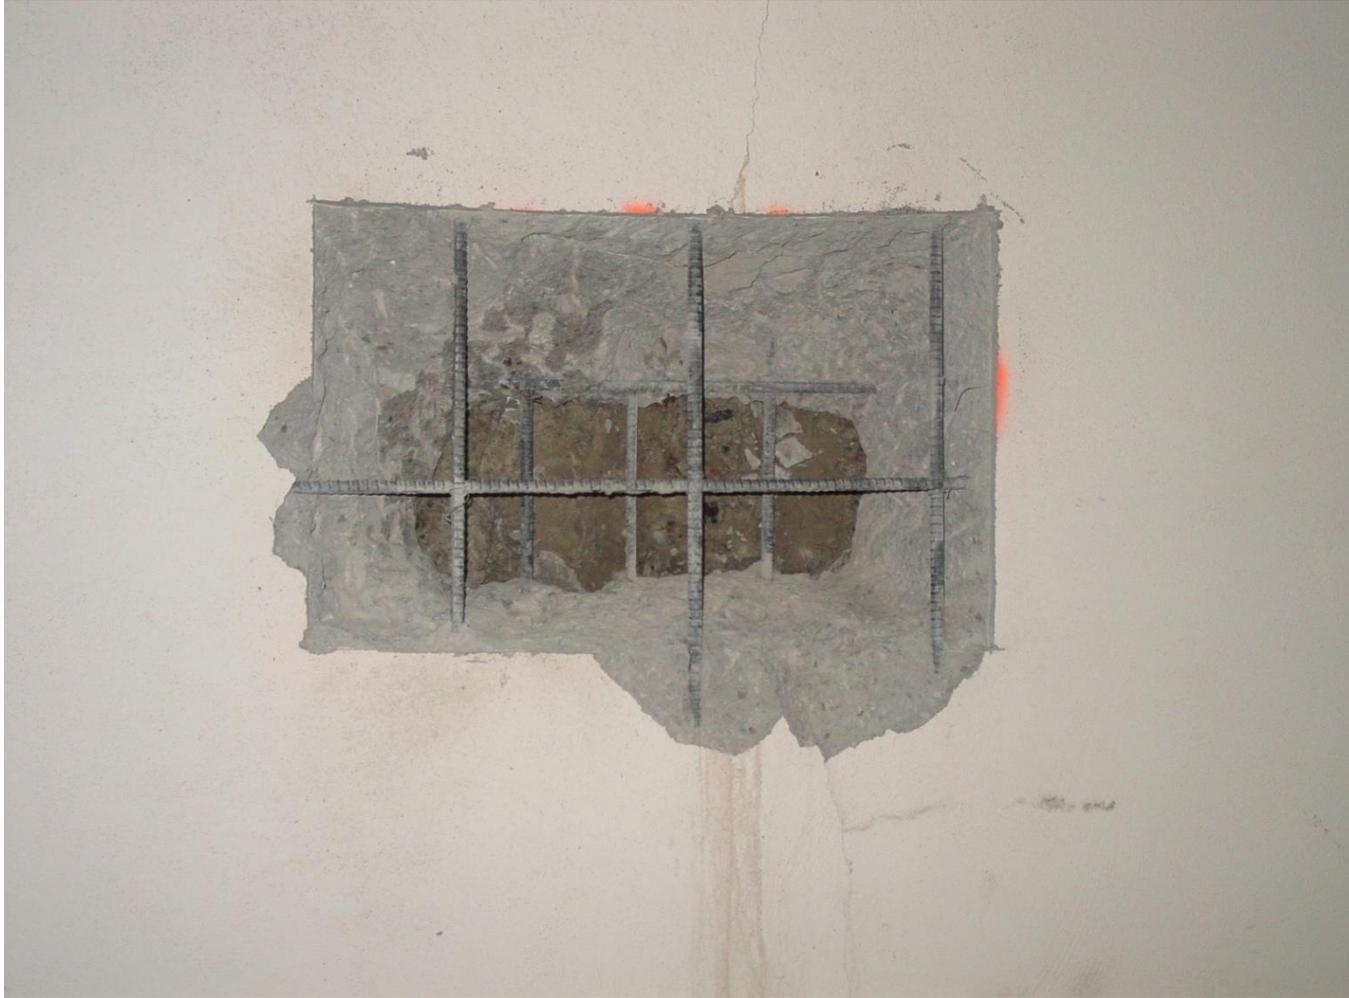
Section of Concrete Was Jack Hammered and Removed Inside
