**Building Envelope Preventive  
Maintenance and Repair**

**Roofs, Solar, Curtain Walls, Exterior  
Cladding; and Budgeting Tips**

**Karim Allana, PE, RWC, RRC**

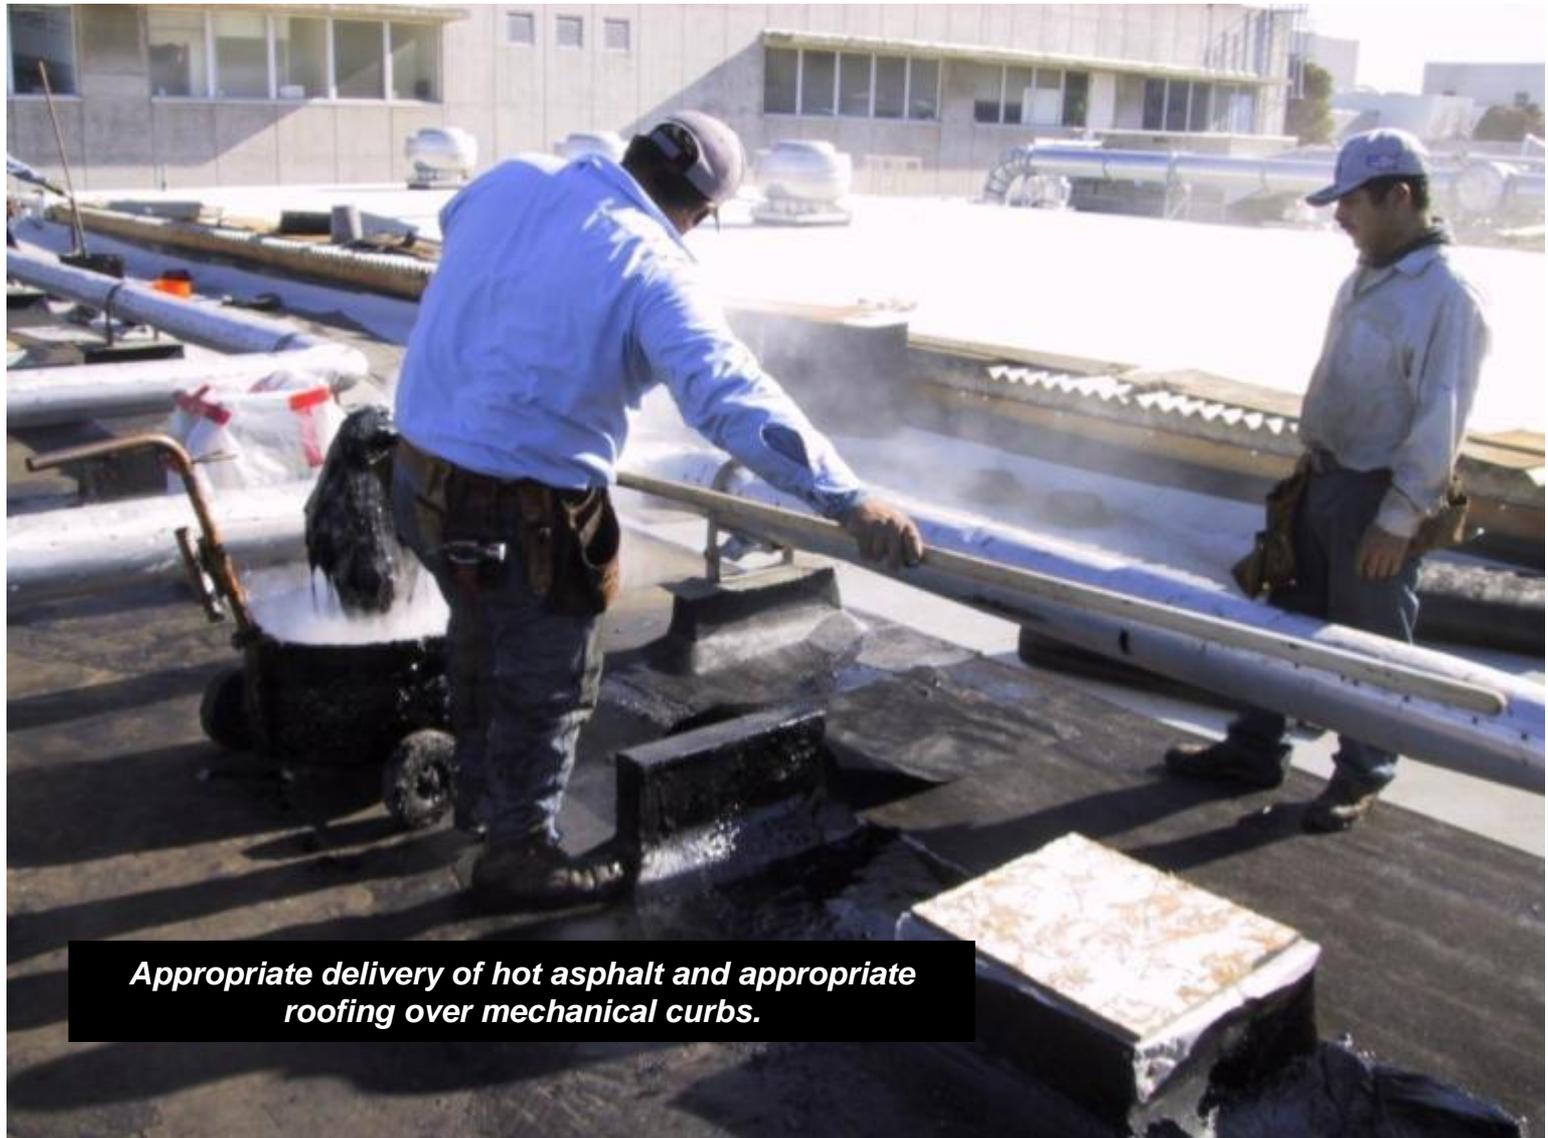
# Hot Applied Built Up Roof (BUR)

*Appropriate delivery of hot asphalt and appropriate roofing over mechanical curbs.*

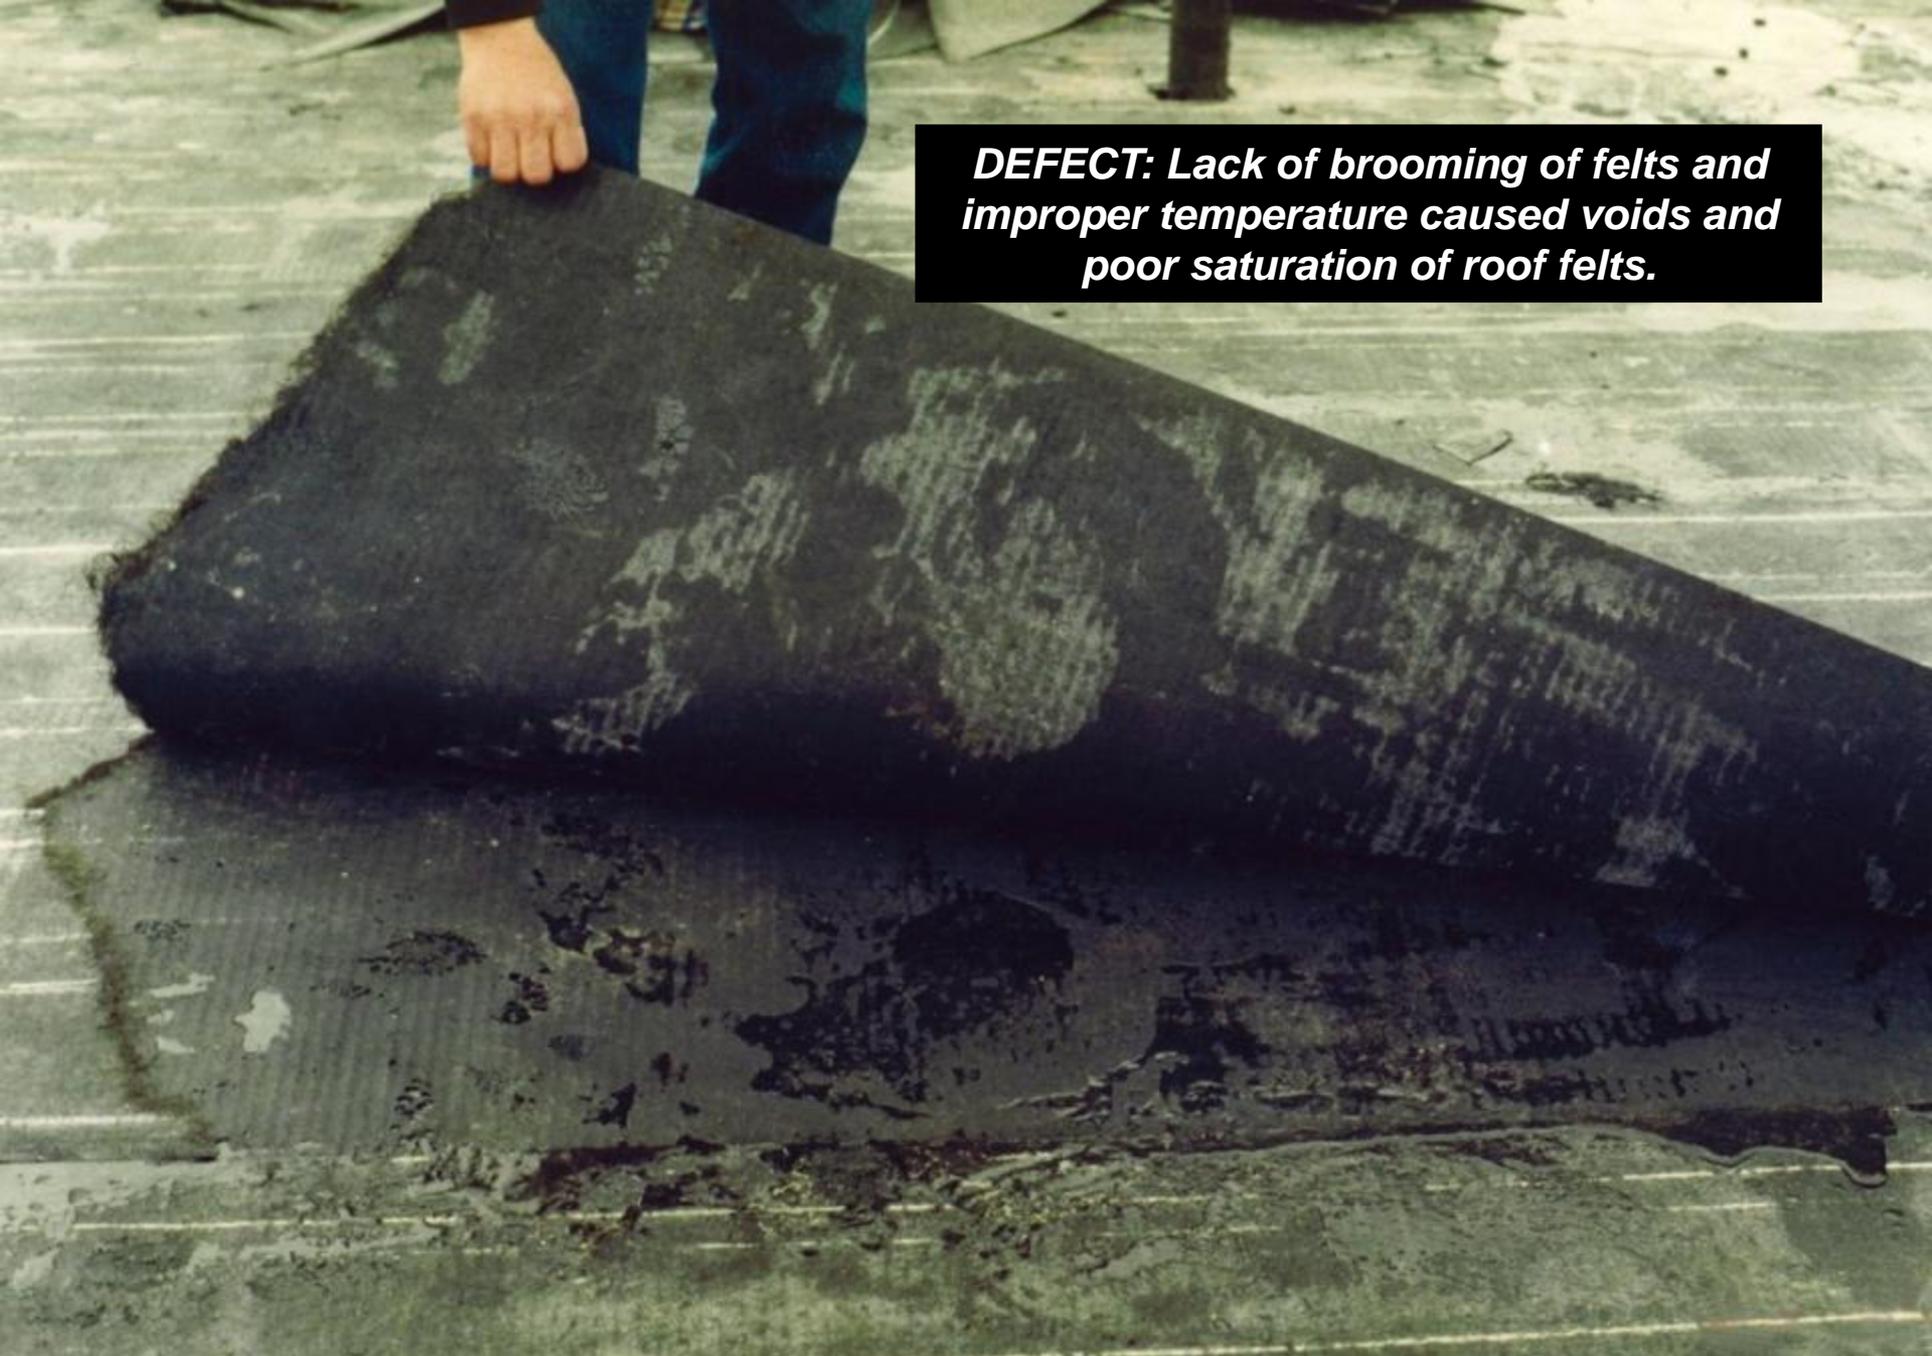
***DEFECT: Lack of brooming of felts and improper temperature caused voids and poor saturation of roof felts.***

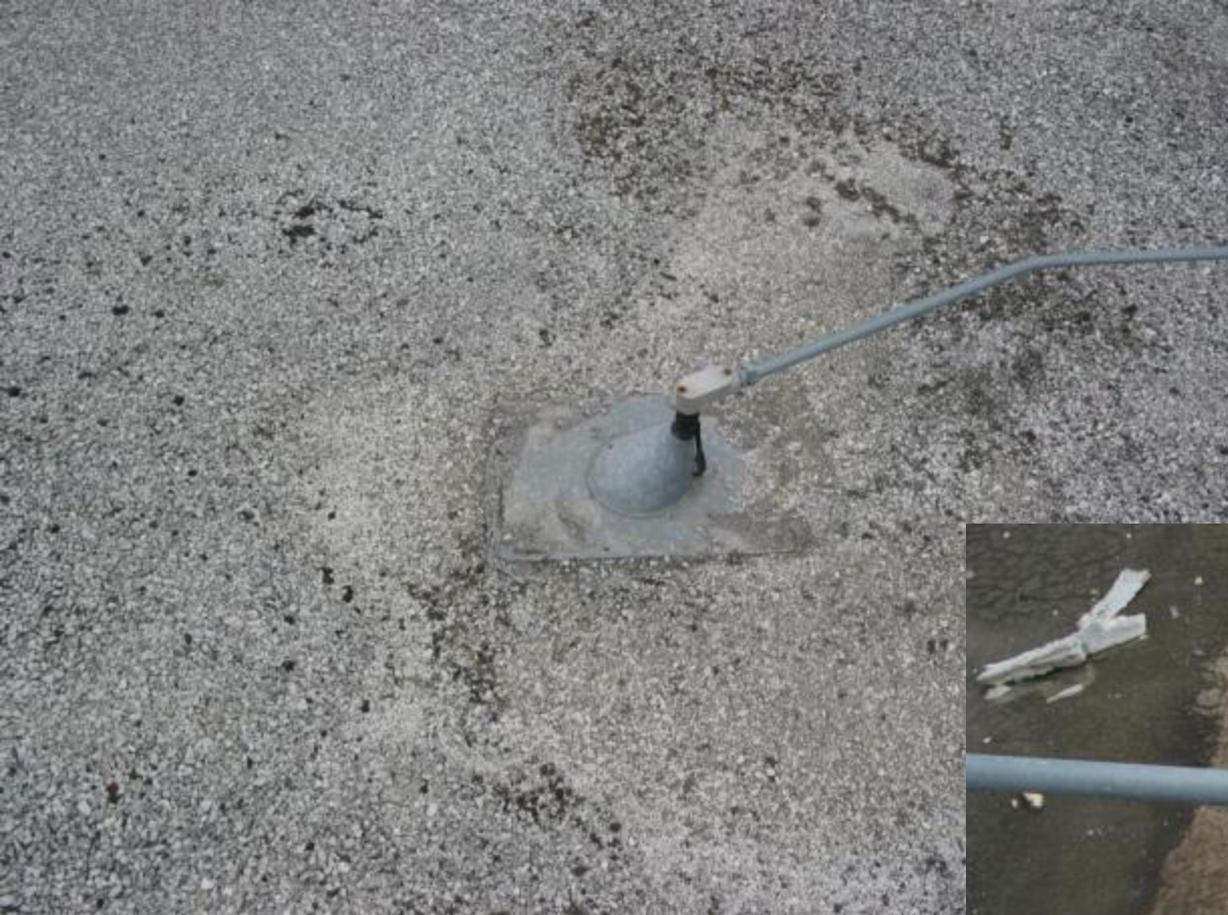
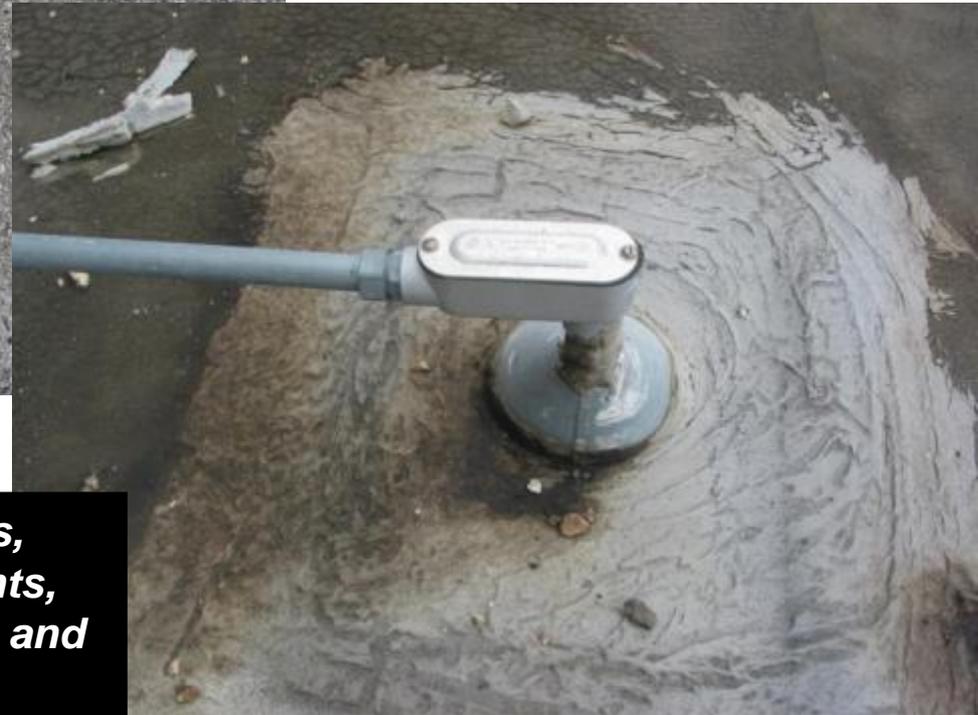
***Roofs go through many additions, alterations and tenant improvements, usually resulting in premature leaks and loss of life expectancy.***

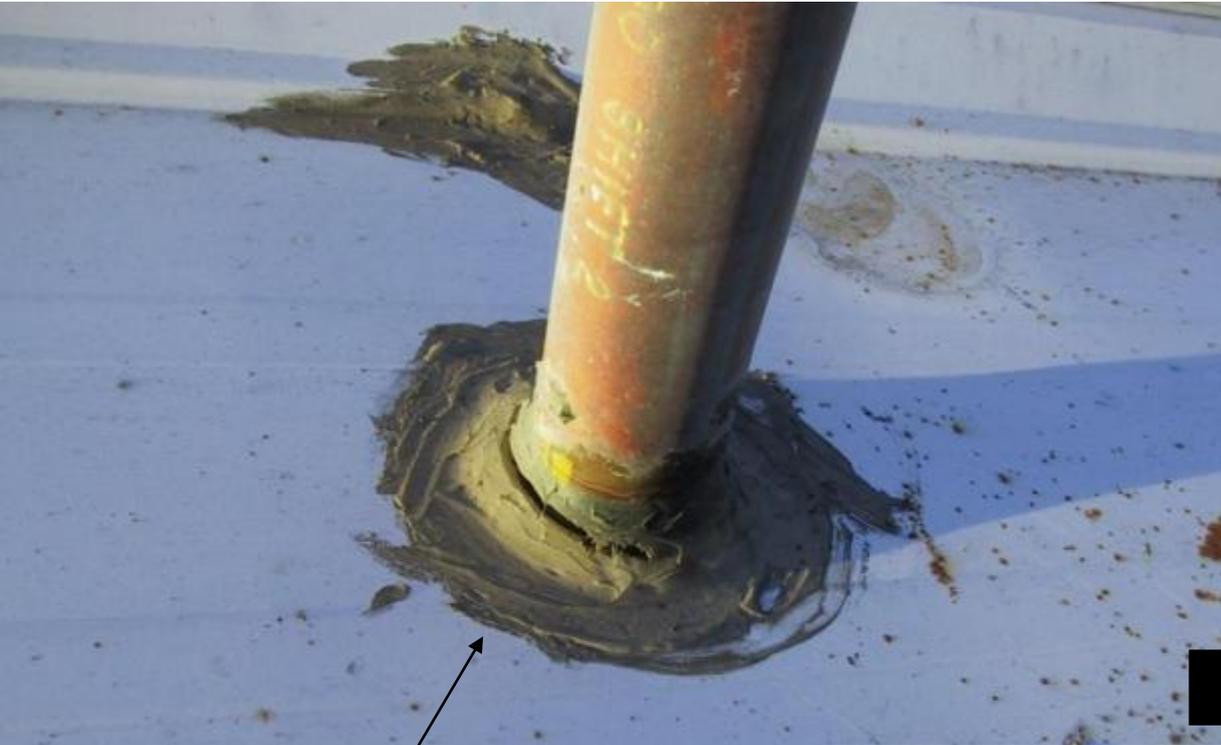
***Proper installation.***

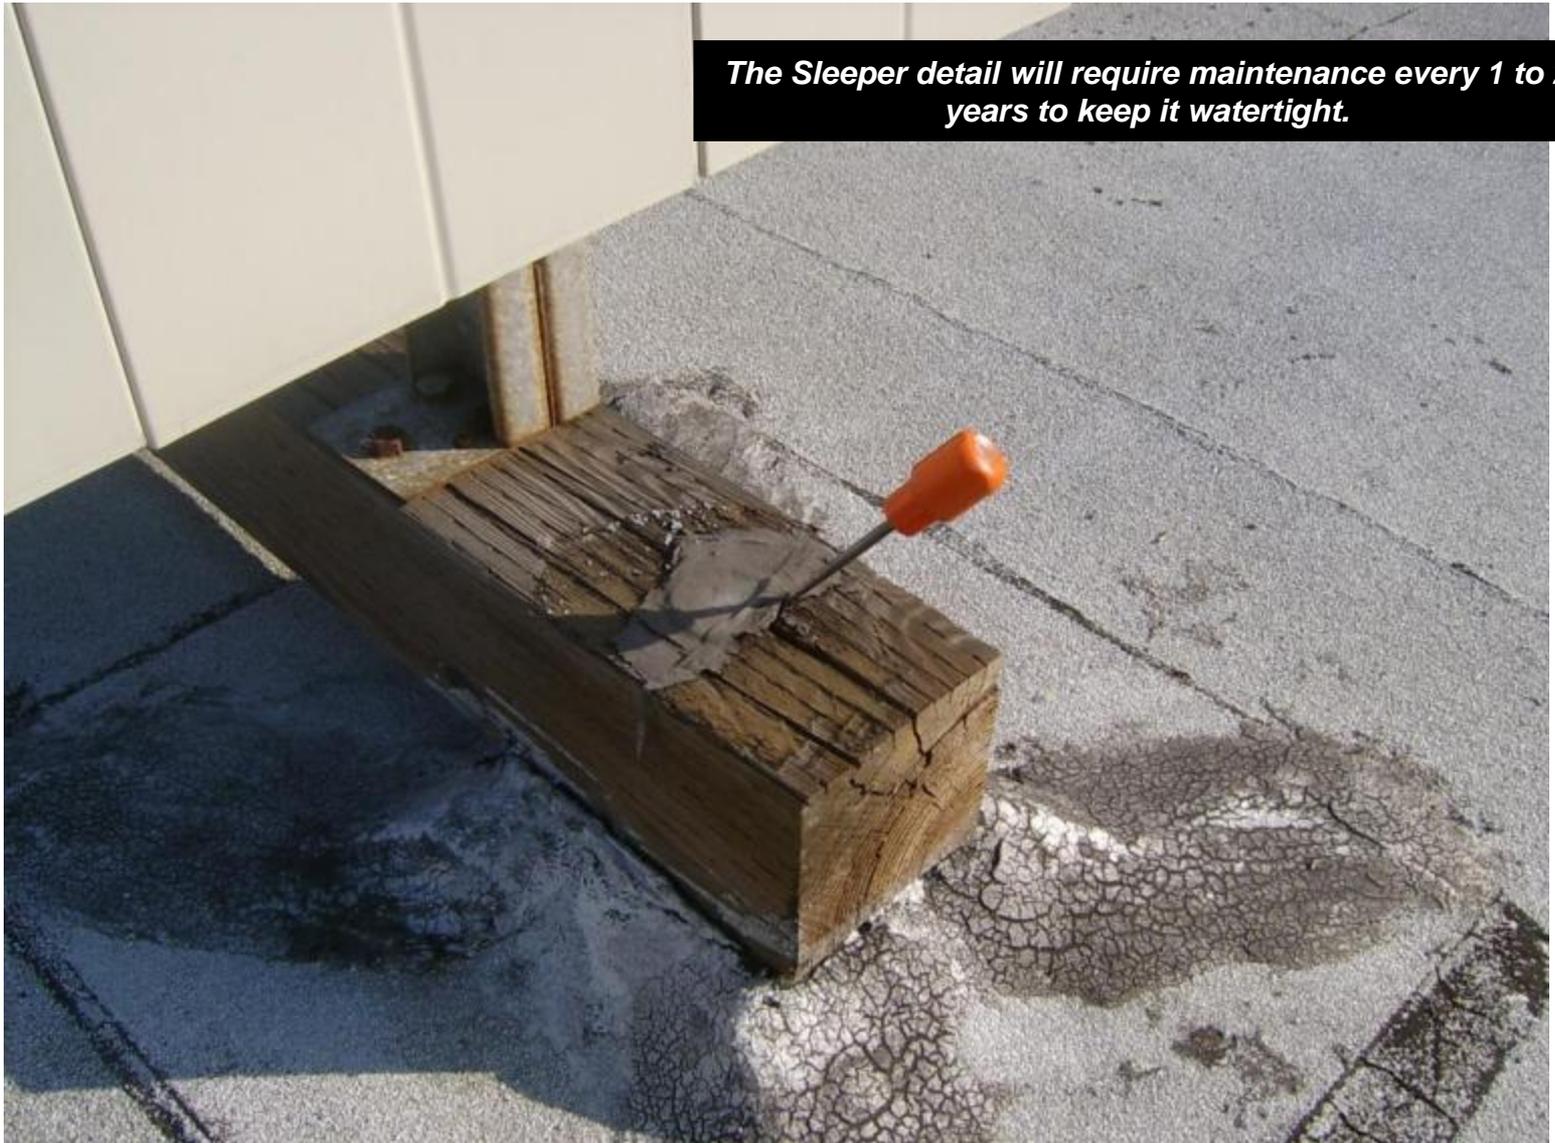
# Poor Sleeper Construction

*The Sleeper detail will require maintenance every 1 to 2 years to keep it watertight.*

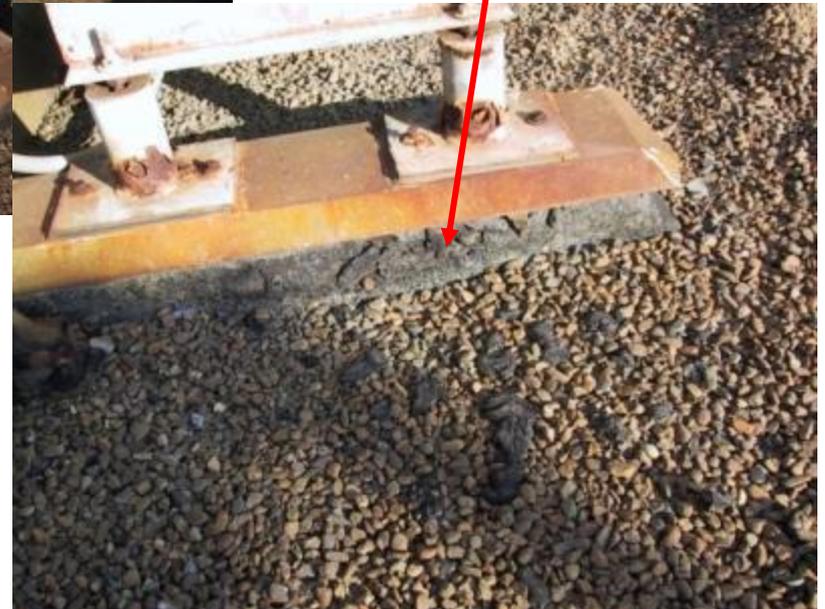
# Base Flashing Repairs OR Maintenance?

*Base flashings (Horizontal to vertical junction) are exposed to more UV and physical abuse.*

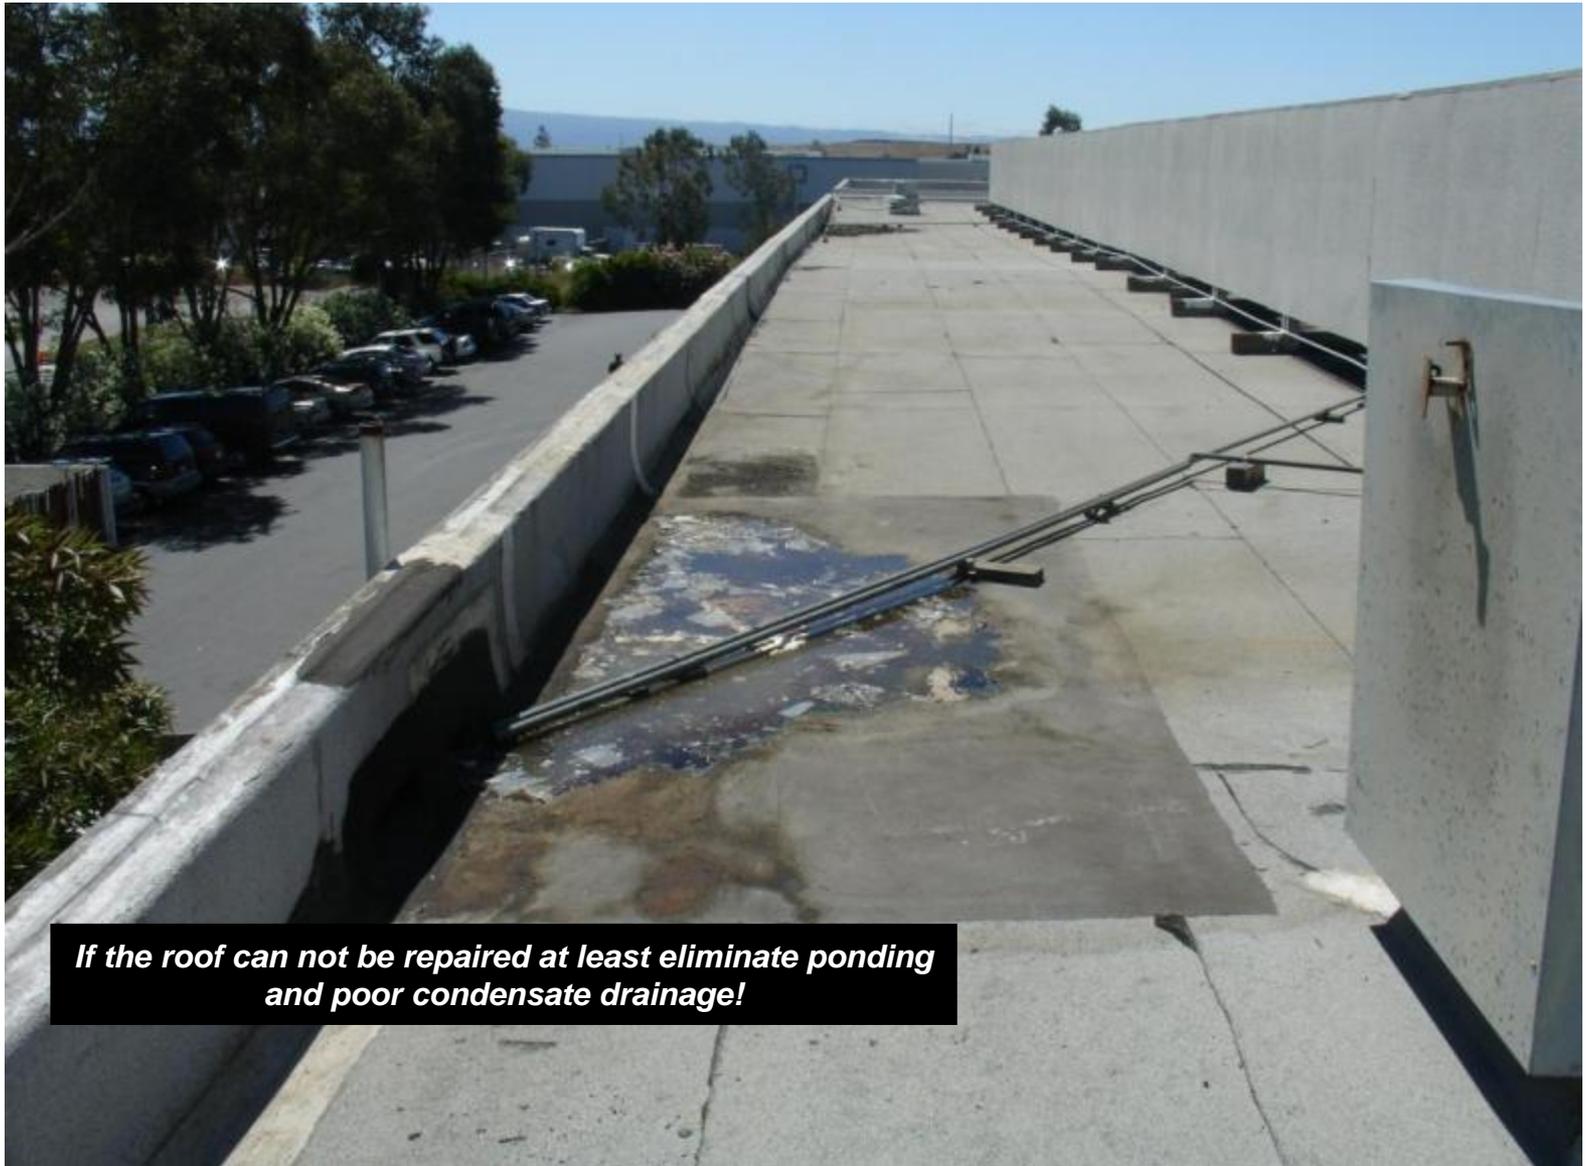
# Ponding Water Leads to Deterioration

*If the roof can not be repaired at least eliminate ponding and poor condensate drainage!*

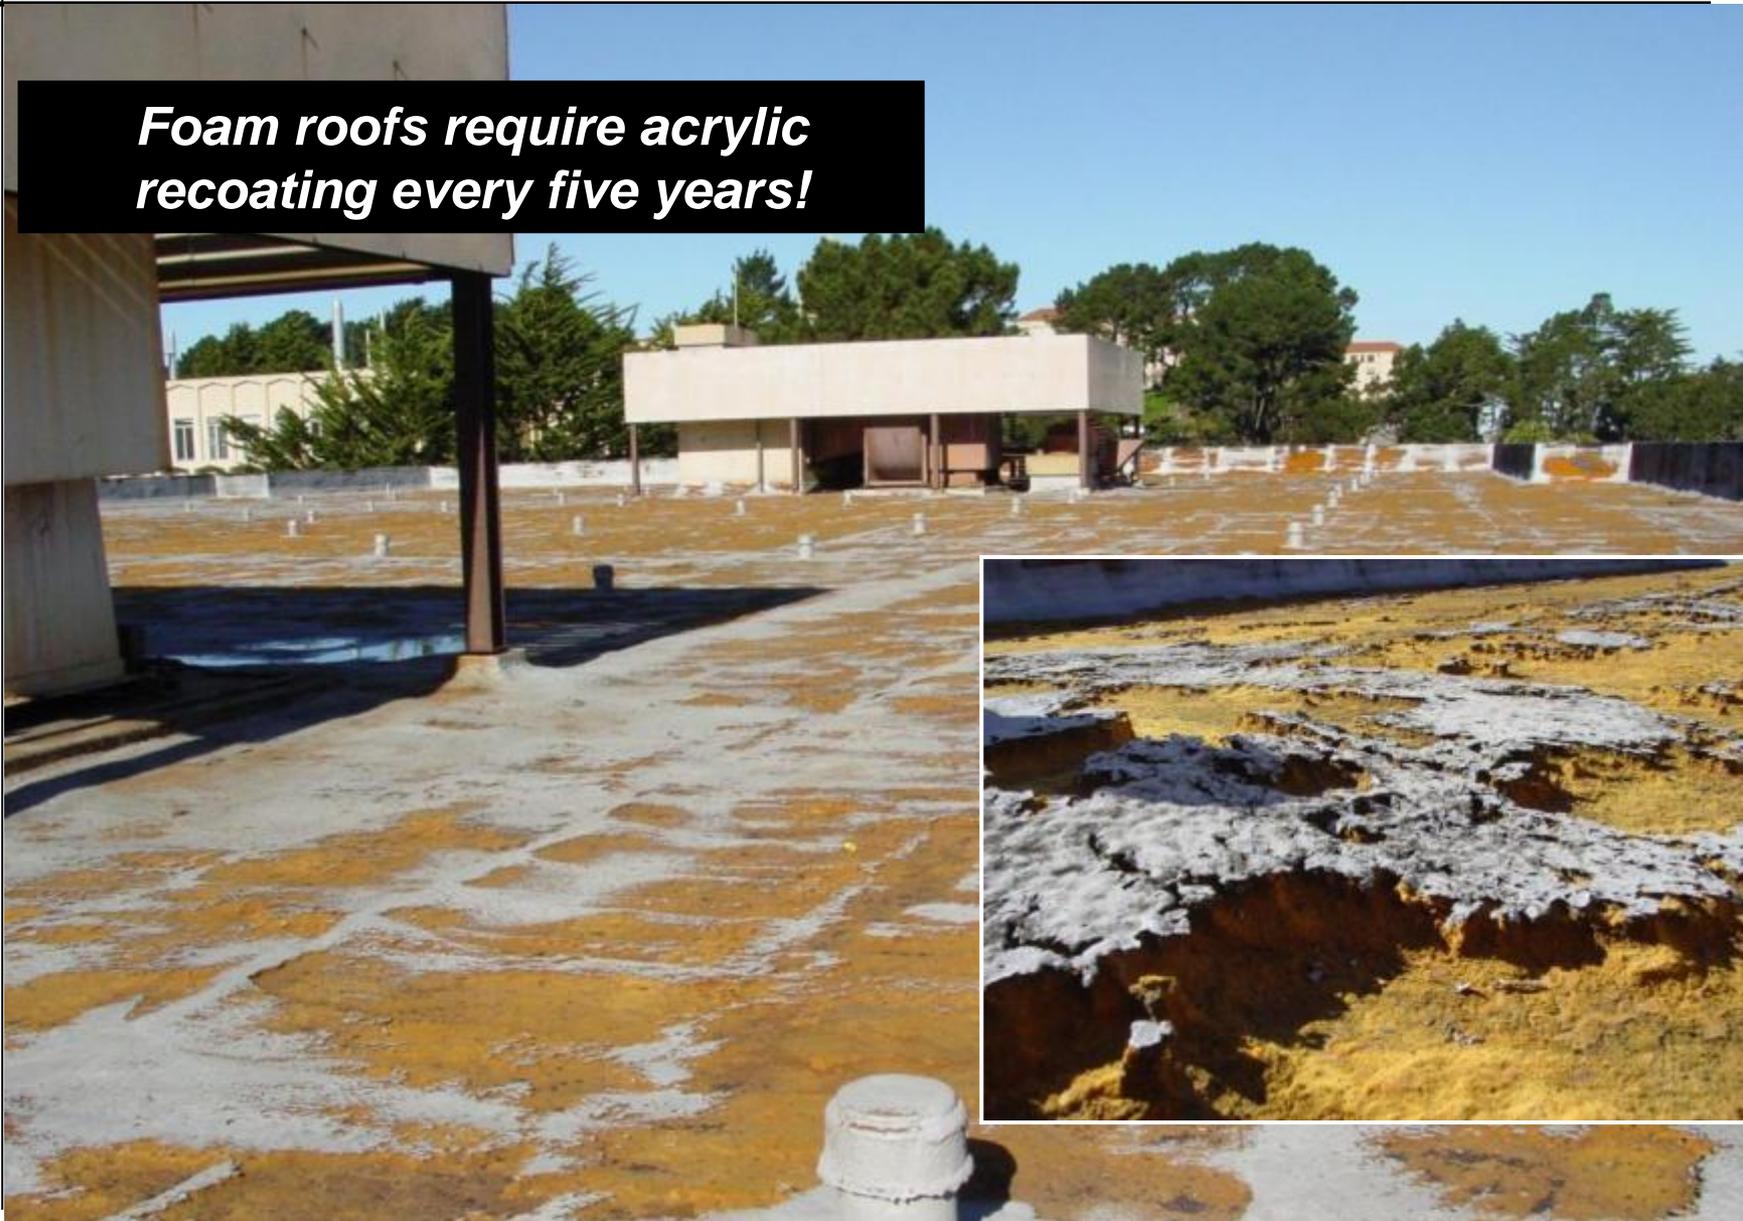
# Proper Maintenance Cycle

*Foam roofs require acrylic  
recoating every five years!*

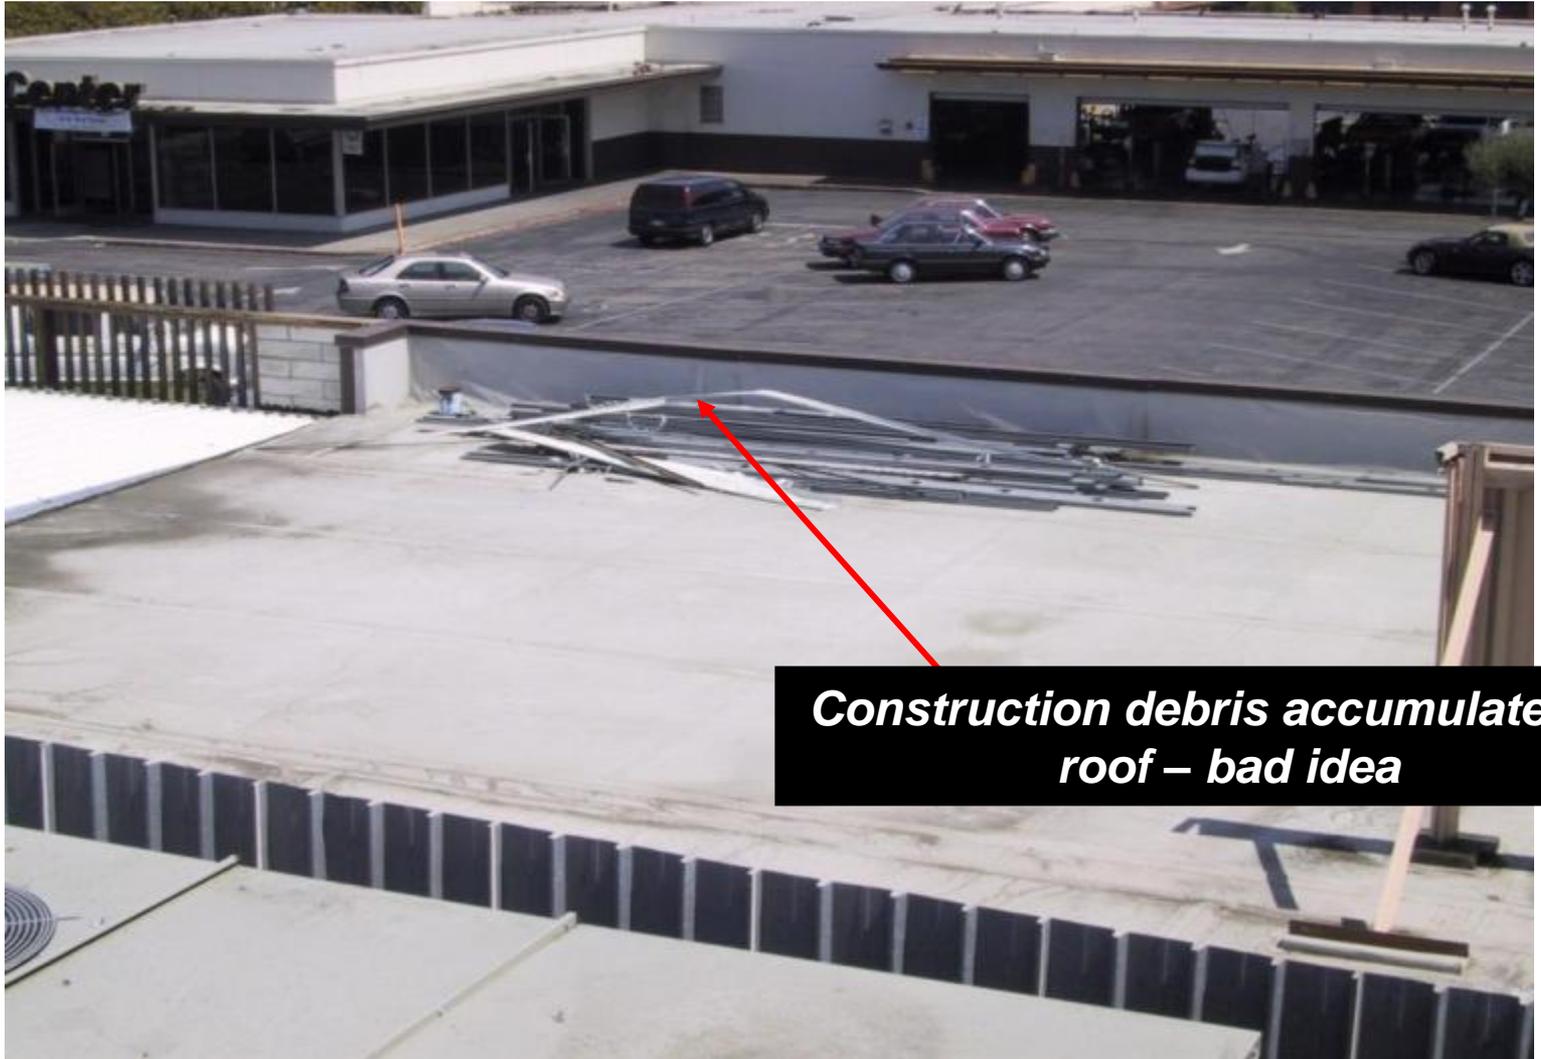
# Excessive Wear and Abuse

***Construction debris accumulated on roof – bad idea***

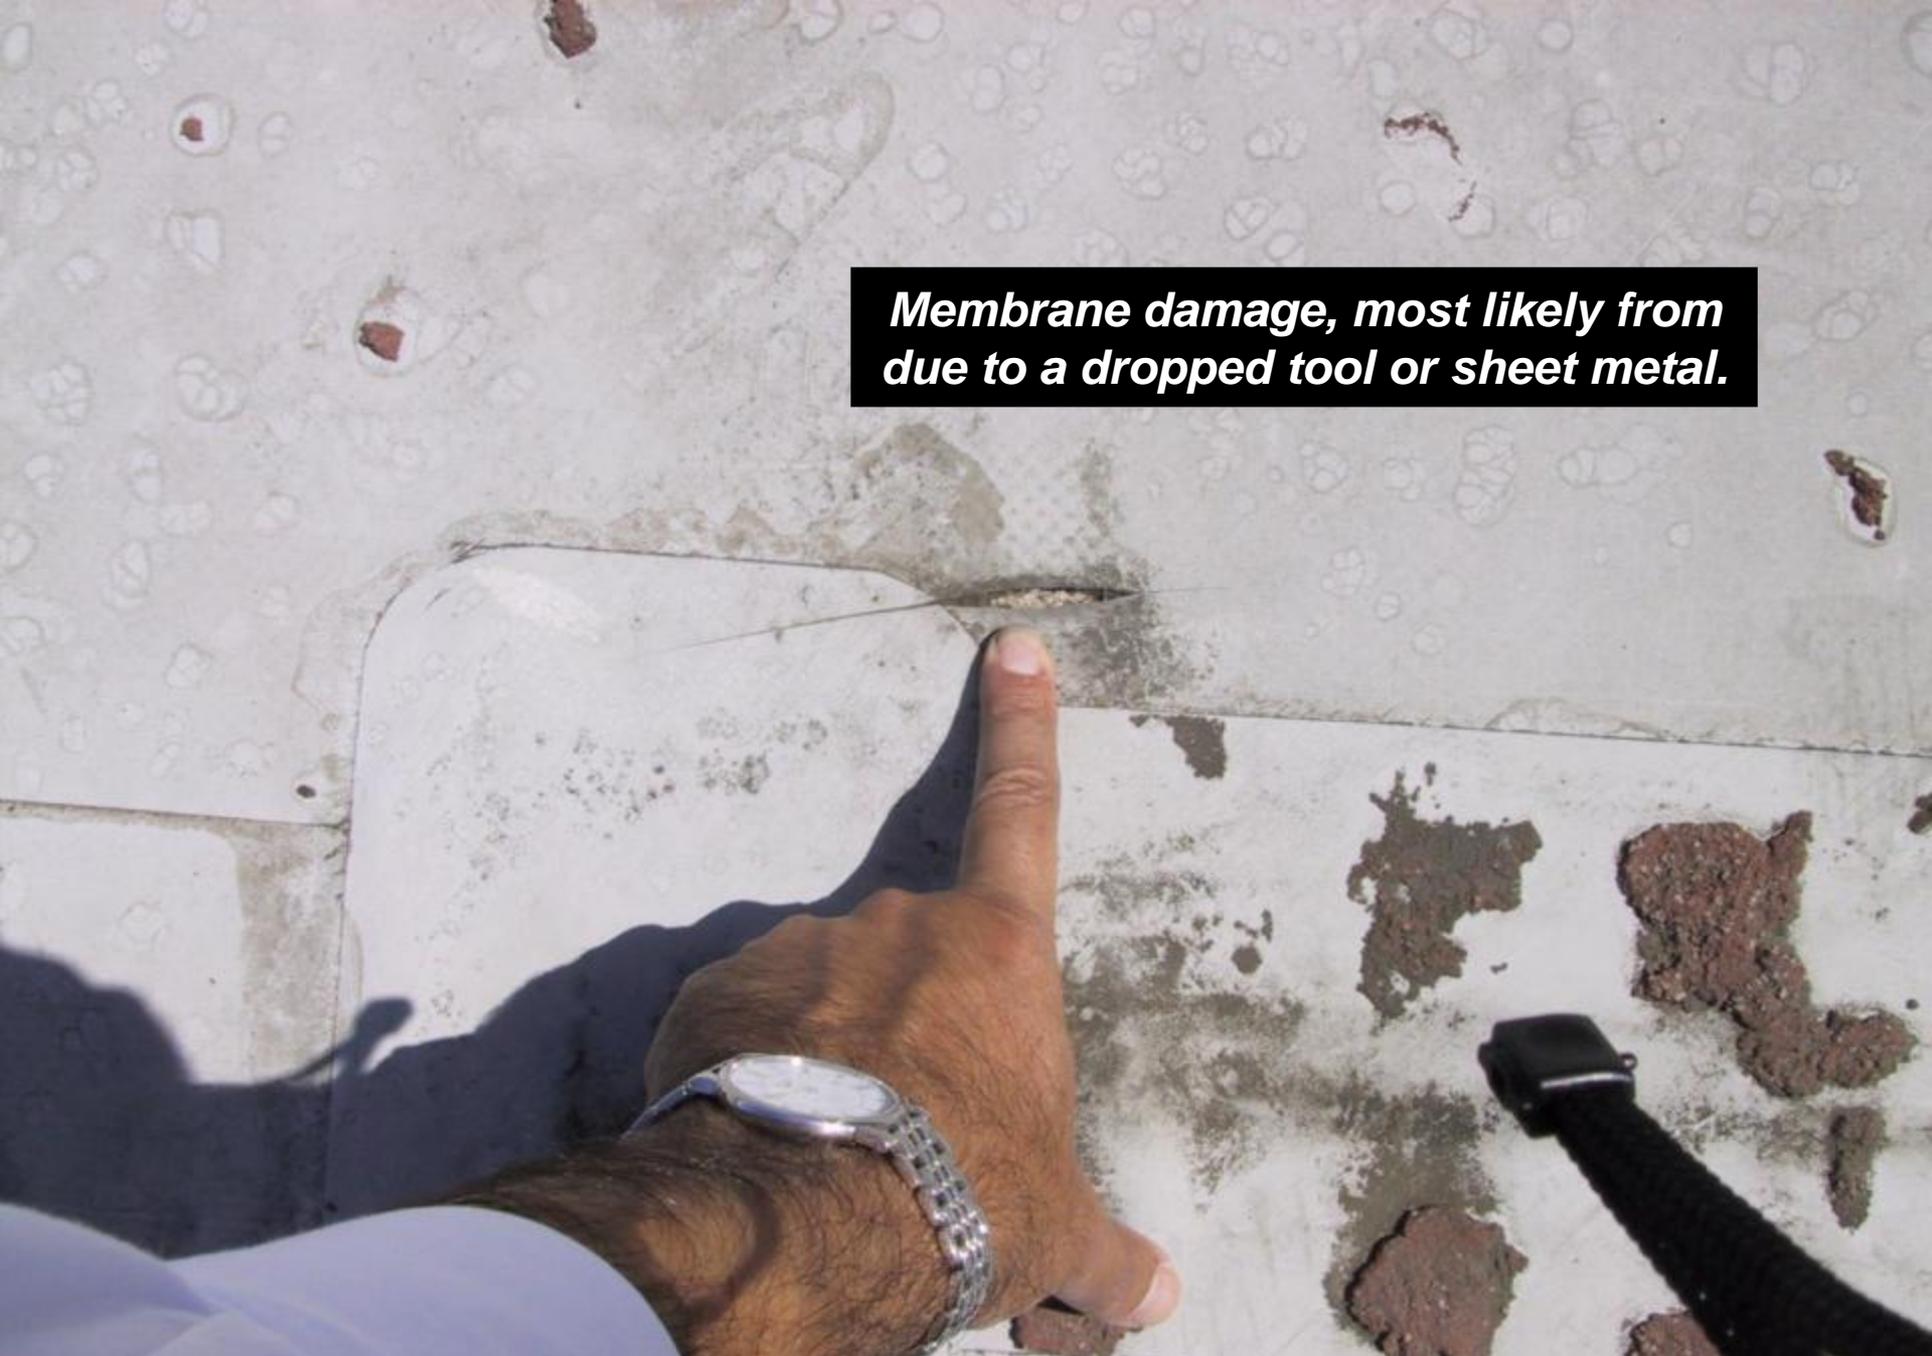
***Membrane damage, most likely from due to a dropped tool or sheet metal.***

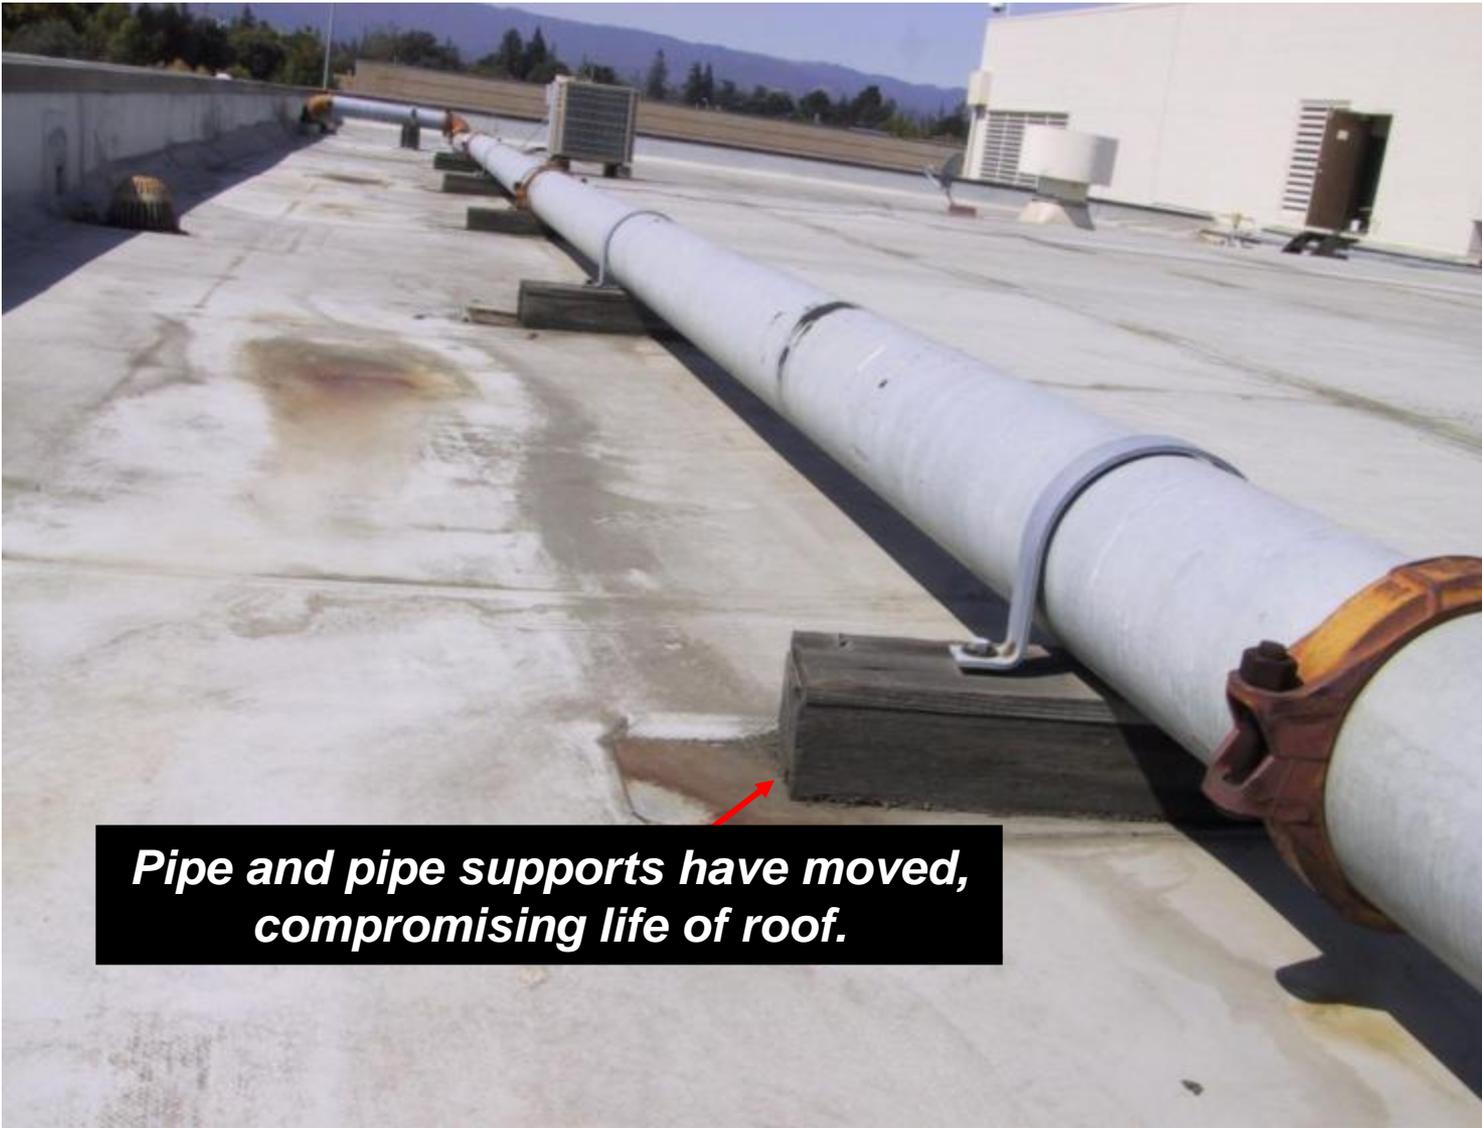
# Design Issue – Result in Ongoing Maintenance Headache

*Pipe and pipe supports have moved, compromising life of roof.*

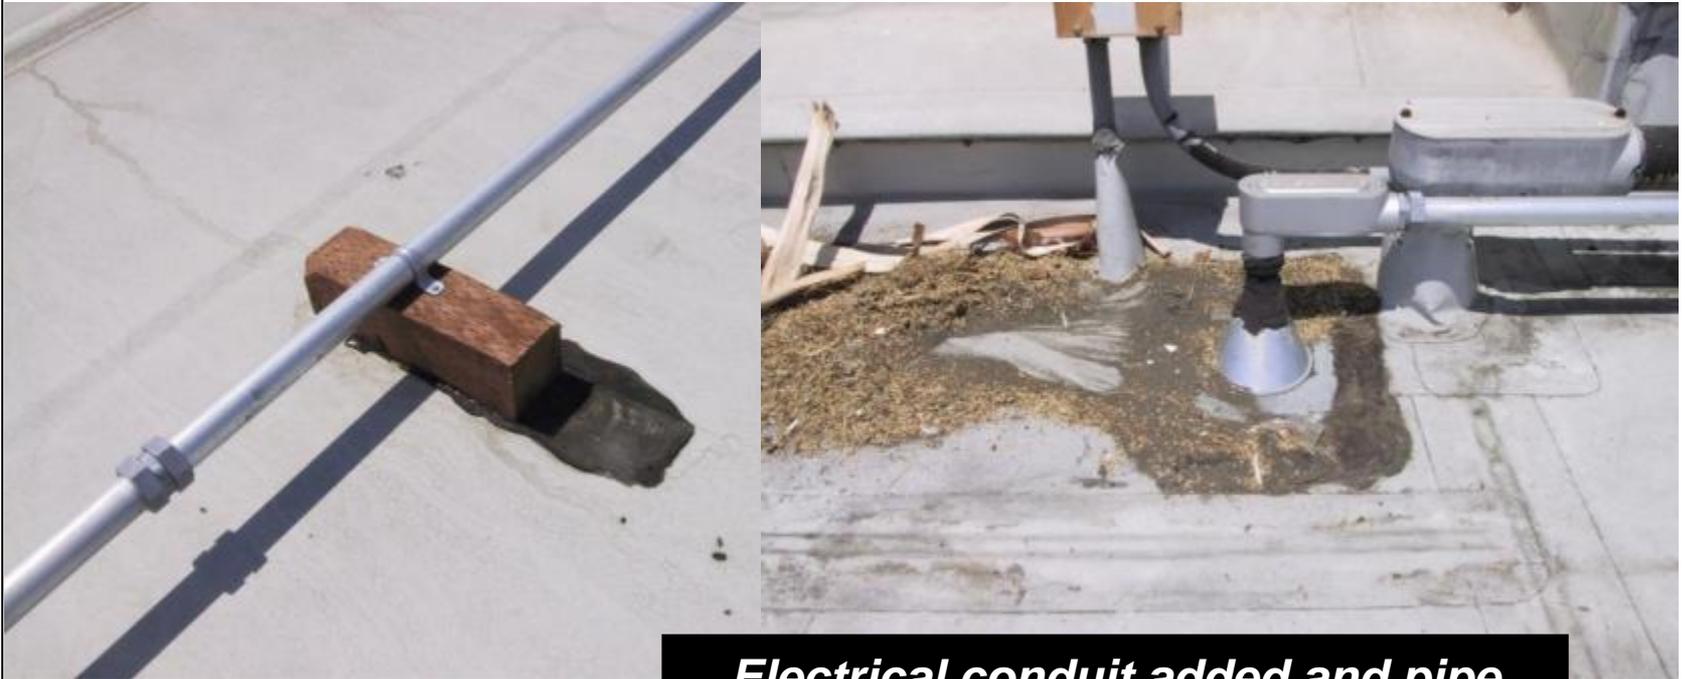
# Improper Tenant Improvement Work

***Electrical conduit added and pipe jack added, both set in mastic that is incompatible with PVC.***

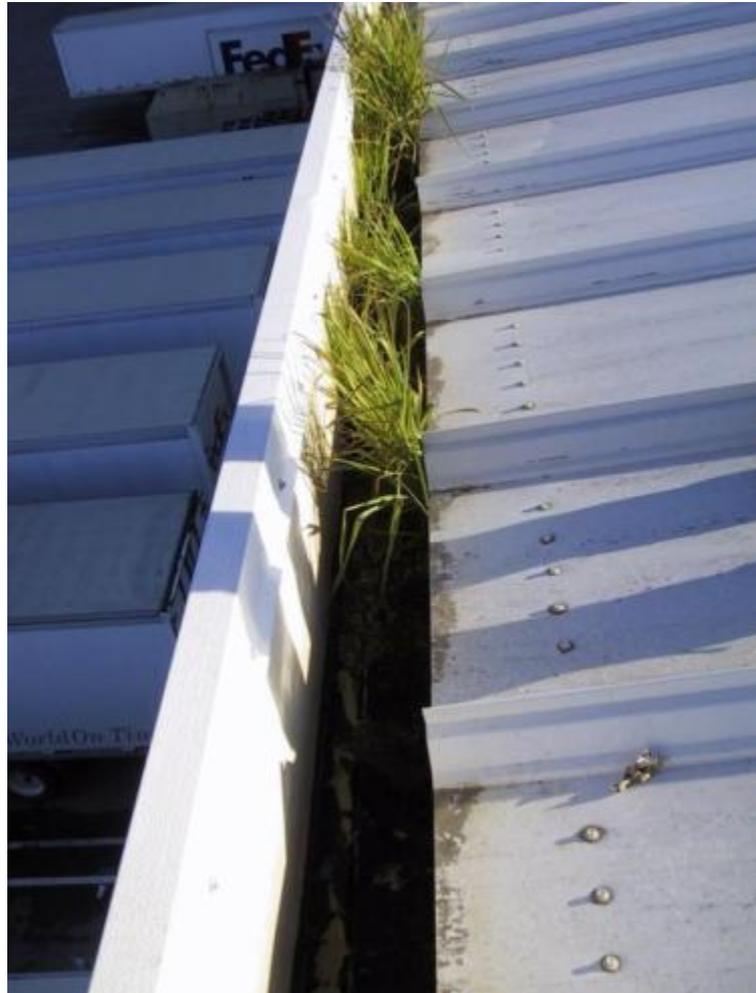
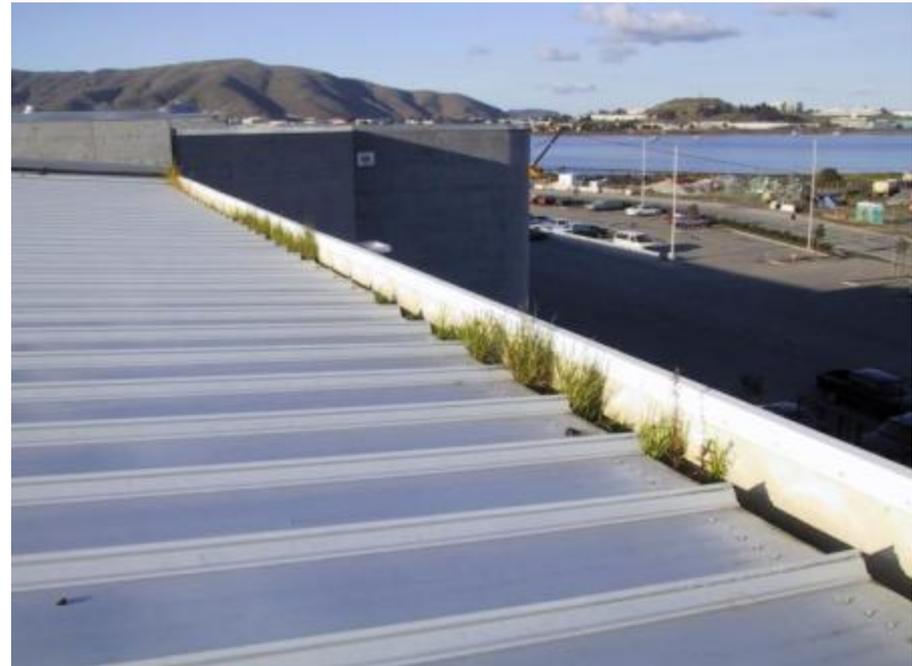
# Gutter Defect Requires More Maintenance

Slope in gutter was omitted, resulted in weed growth, which restricted flow of water and caused leaks and increased need for maintenance
