**Building Envelope Preventive  
Maintenance and Repair**

**Roofs, Solar, Curtain Walls, Exterior  
Cladding; and Budgeting Tips**

**Karim Allana, PE, RWC, RRC**

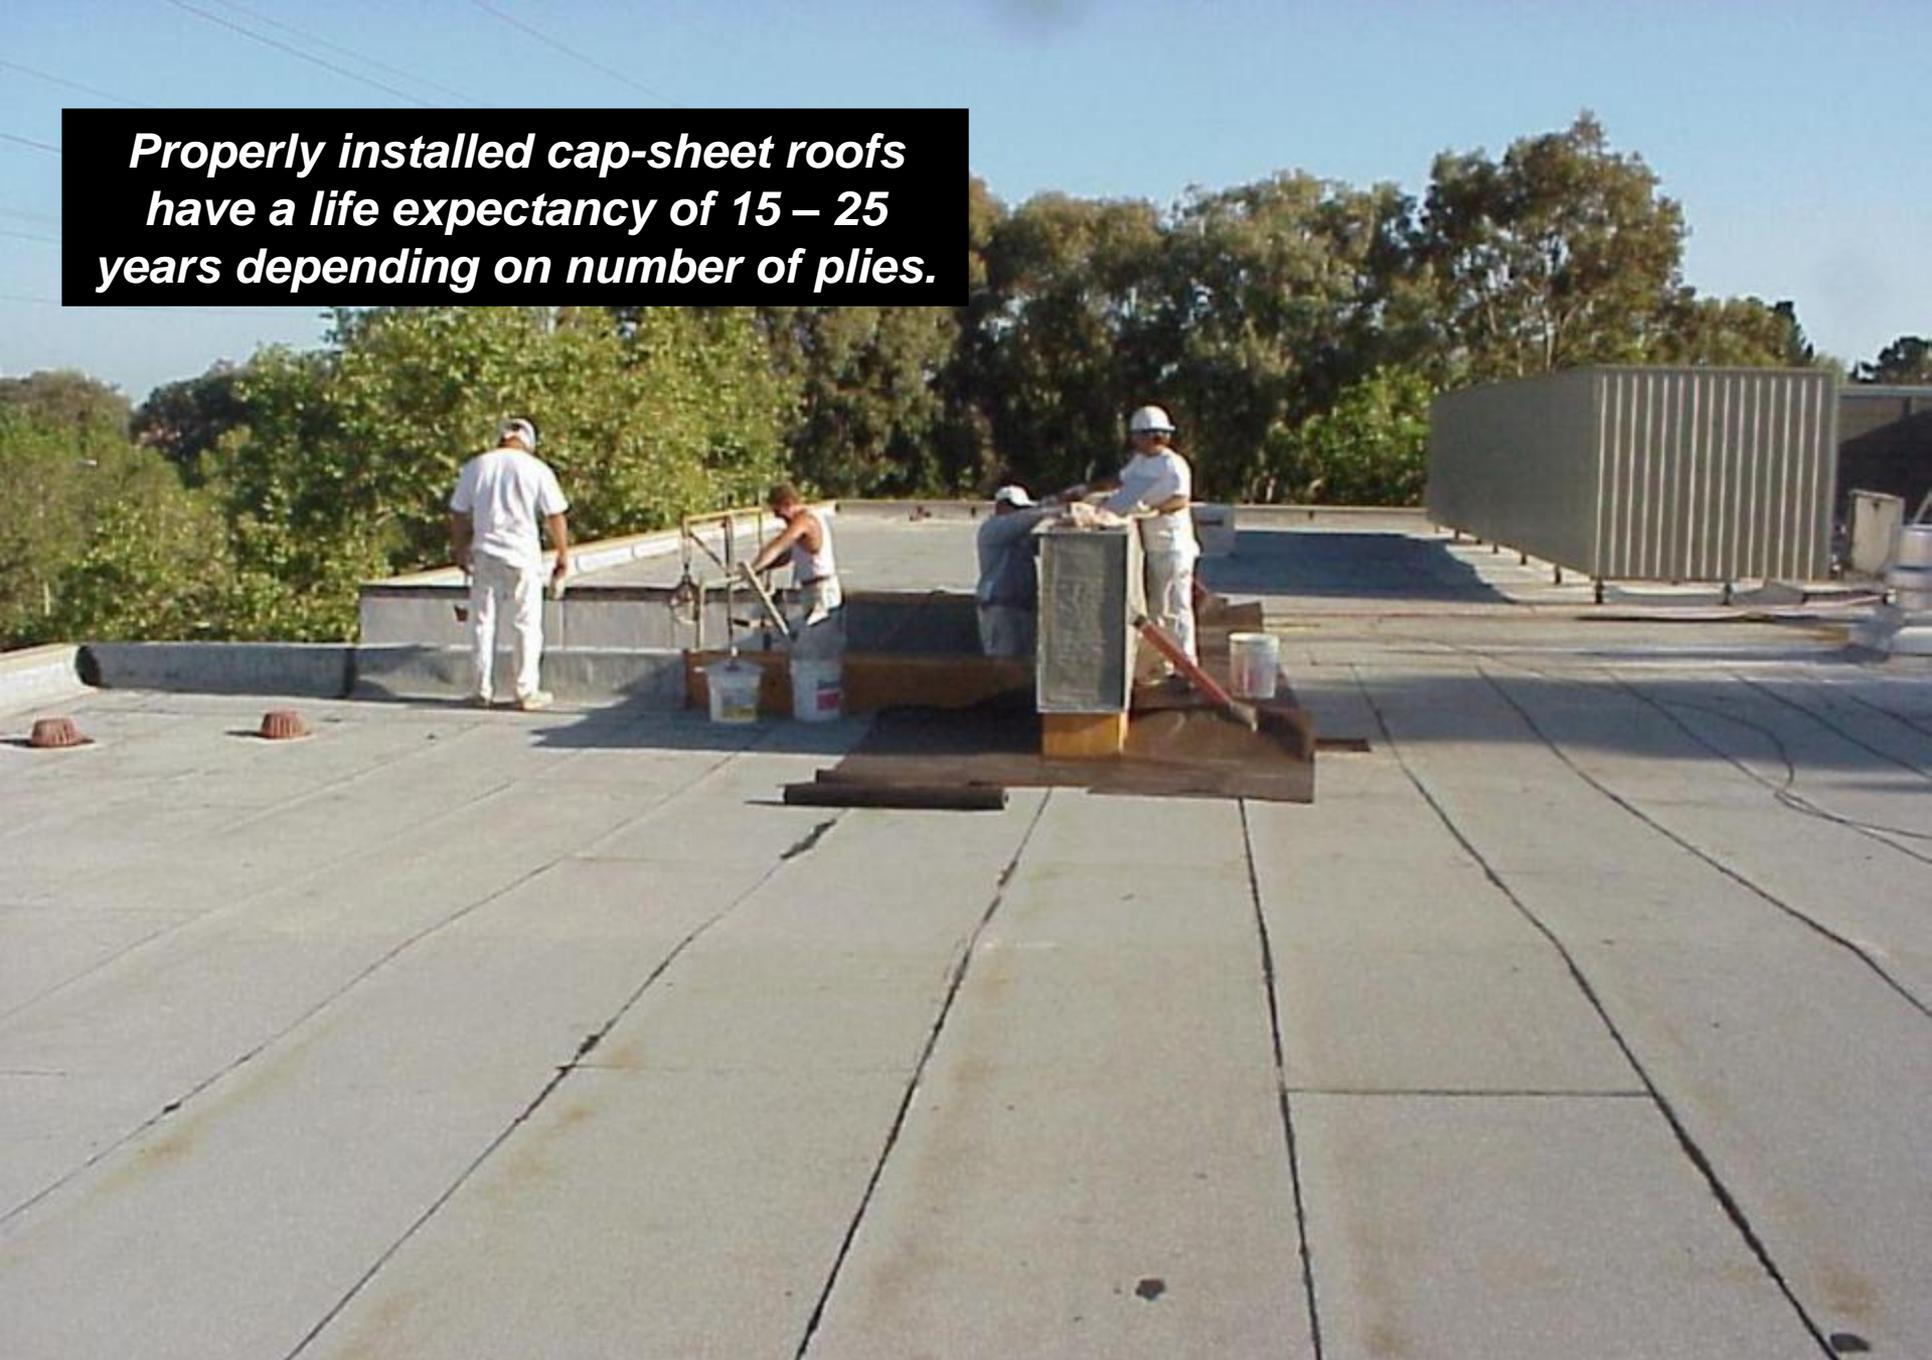
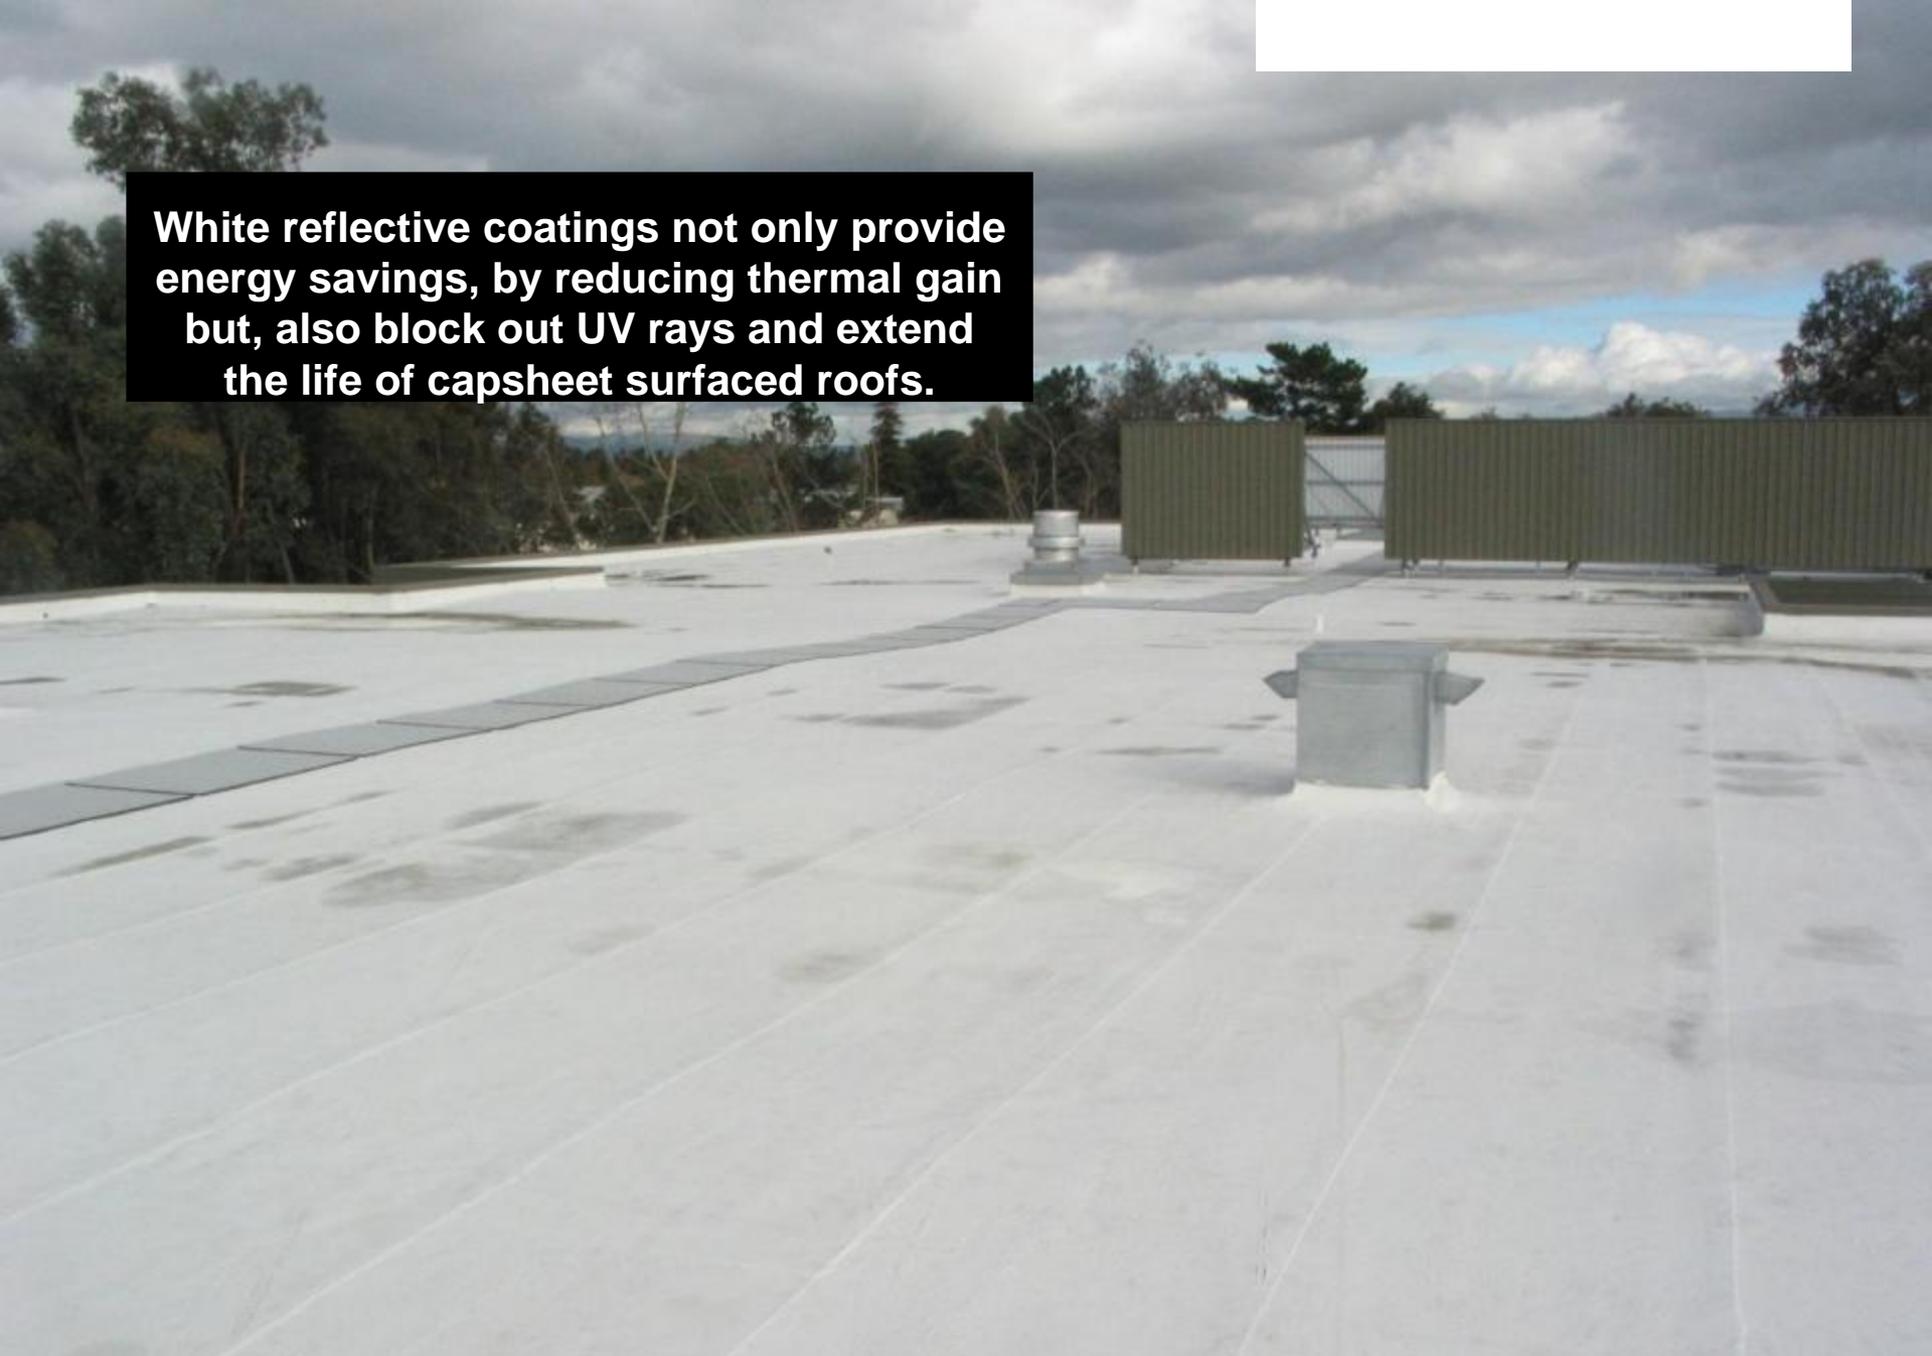
***Properly installed cap-sheet roofs  
have a life expectancy of 15 – 25  
years depending on number of plies.***

**White reflective coatings not only provide energy savings, by reducing thermal gain but, also block out UV rays and extend the life of capsheet surfaced roofs.**

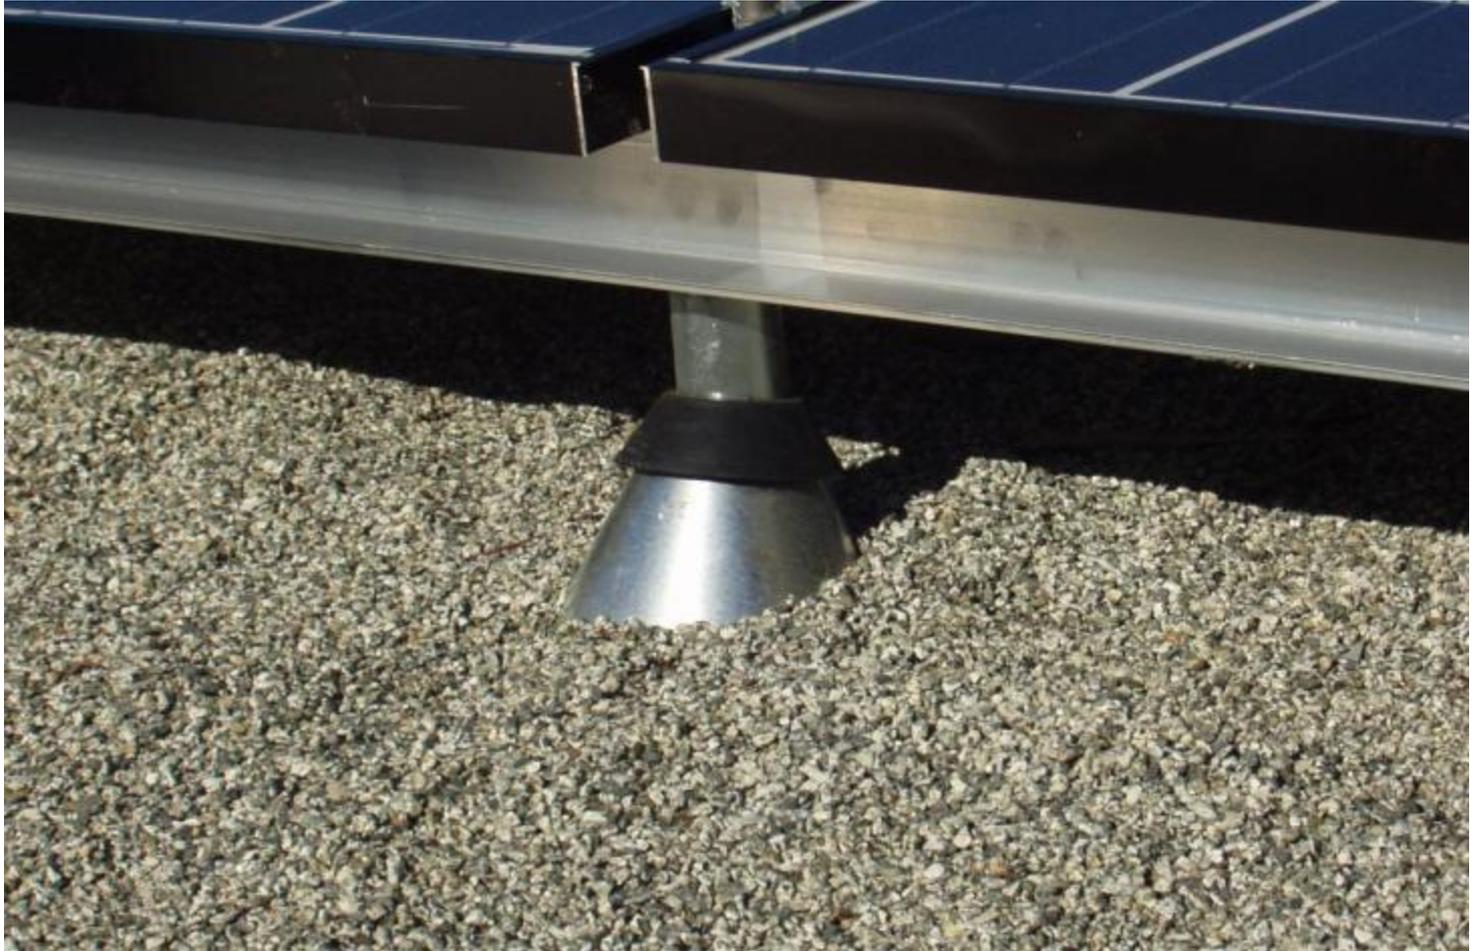
# Proper Mounting and Racking

## Roof Mount - Attached to Structure

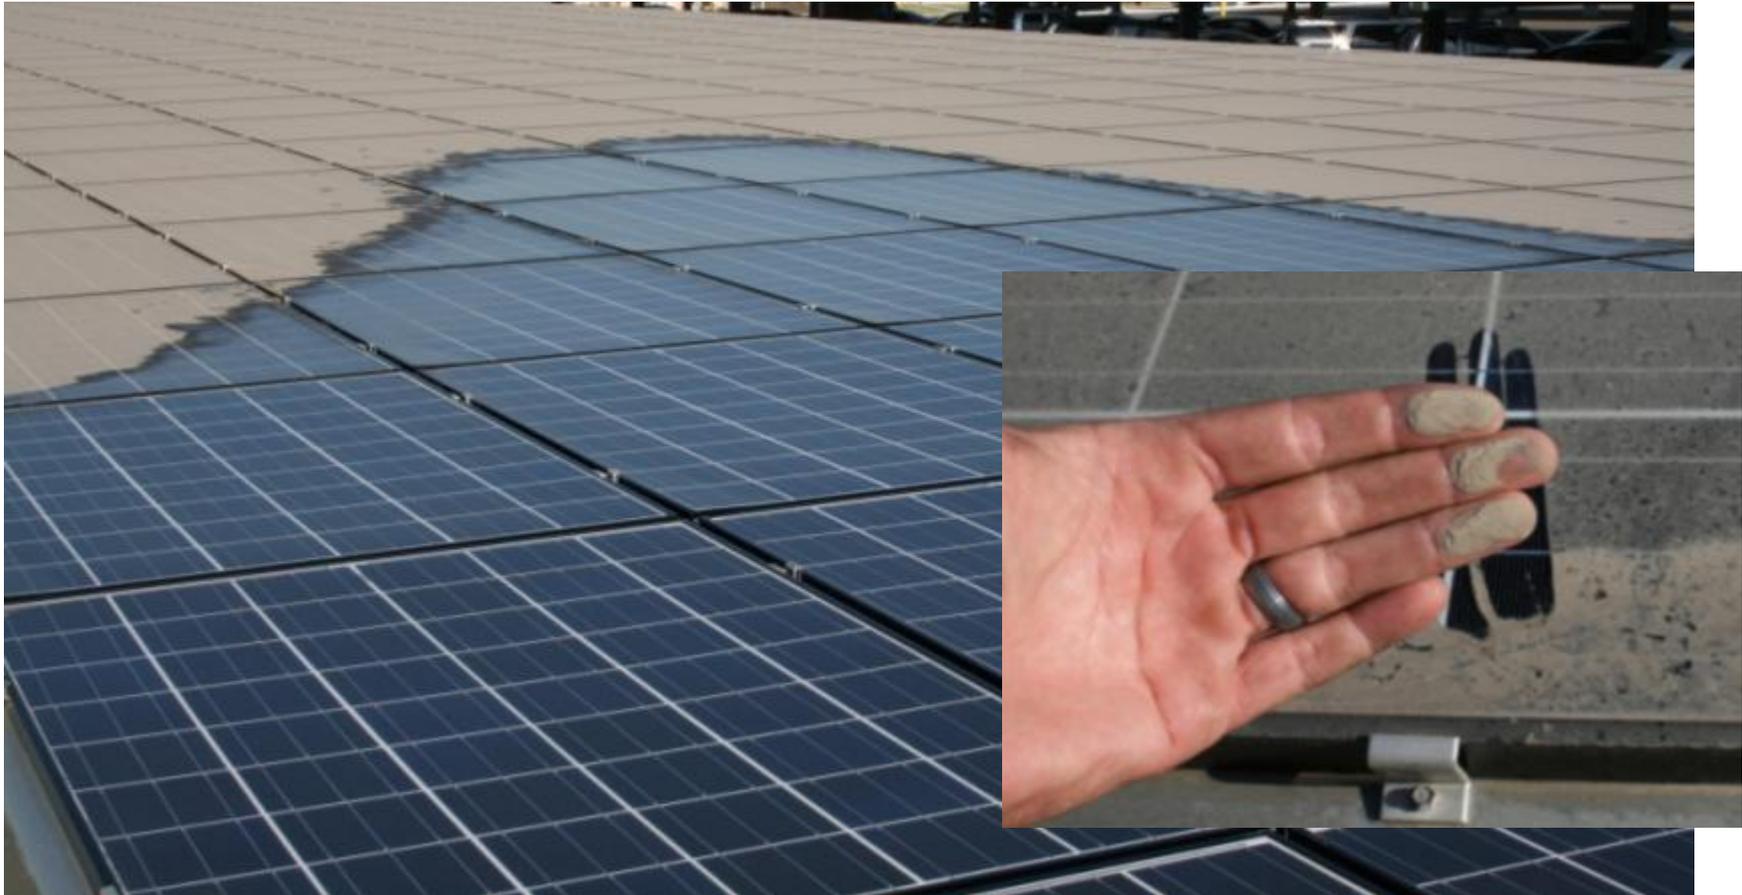
# Importance of Maintenance

Excessive dirt build-up on PV modules creates “**Hot Spots**”.  
Can cause cell series wiring to prematurely fail  
and VOID the manufacturer’s warranties

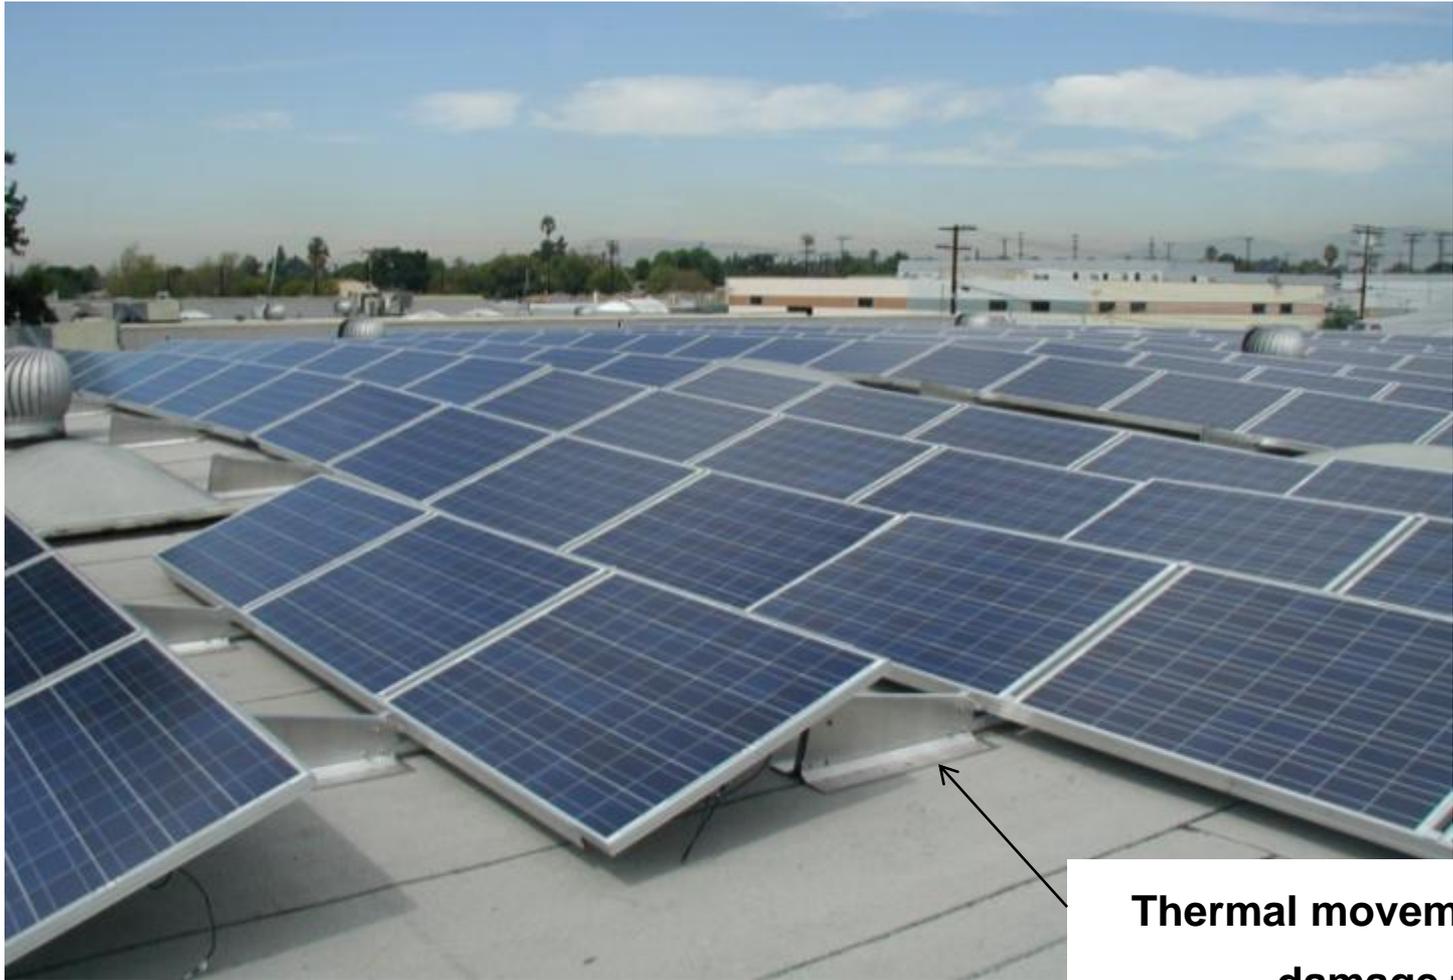
## Roof Mount Non-penetrating - Ballasted

**Thermal movement can  
damage the roof**

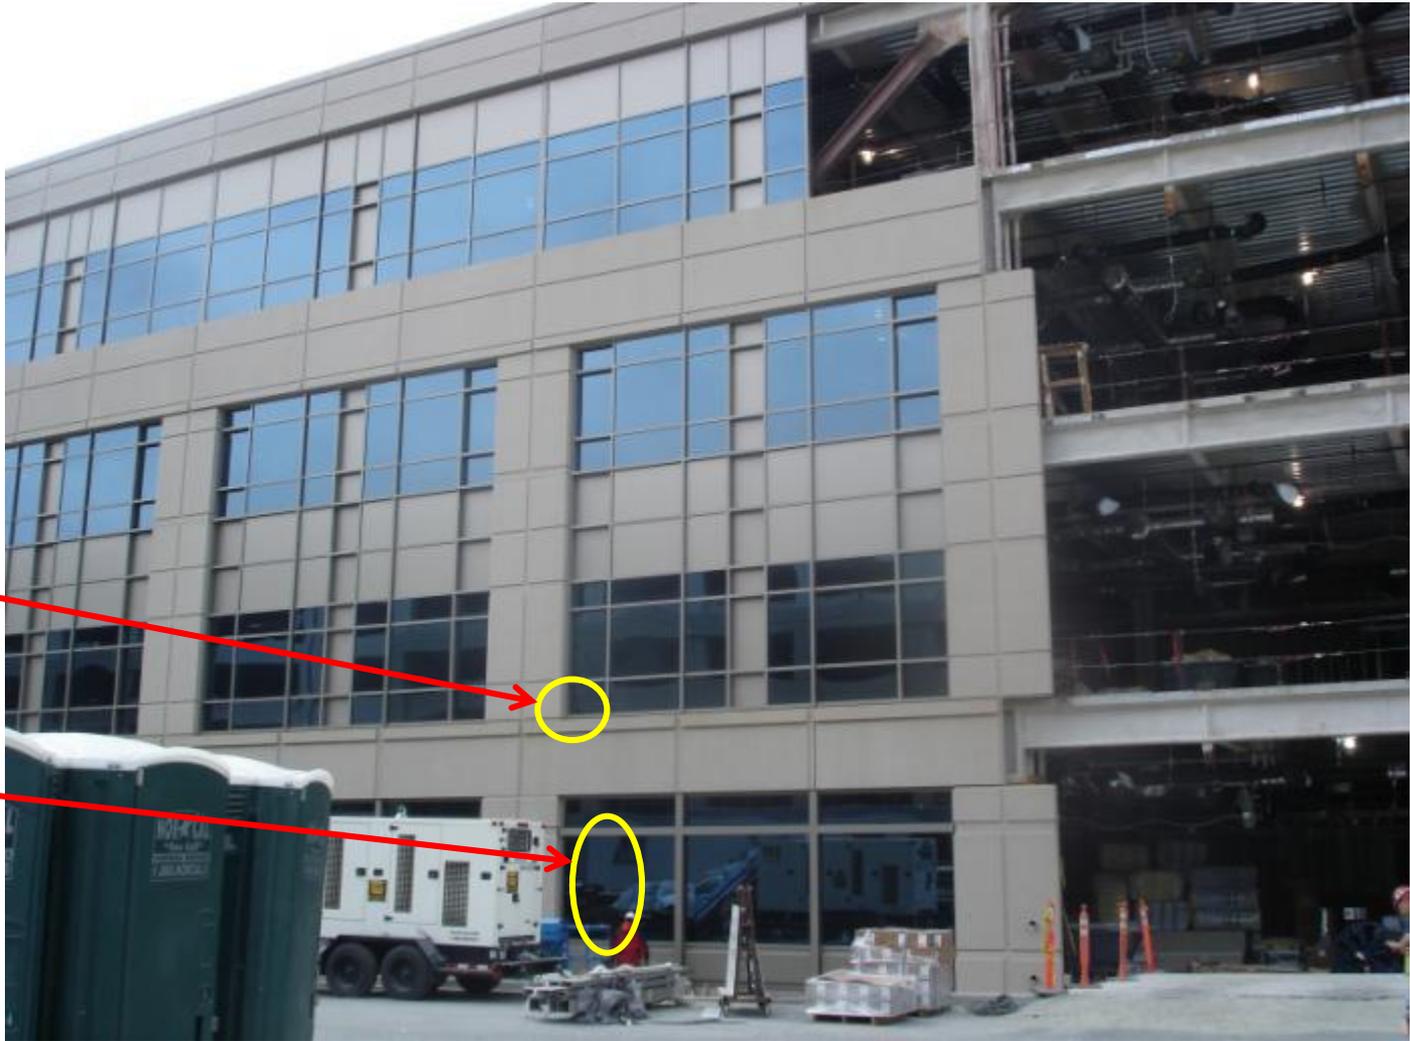
# System Vulnerabilities

Leak observed on the 2<sup>nd</sup> floor after the first spray test at the GFRC panel

Leak observed on the 1<sup>st</sup> floor after the third spray test at the (inviso vert.)

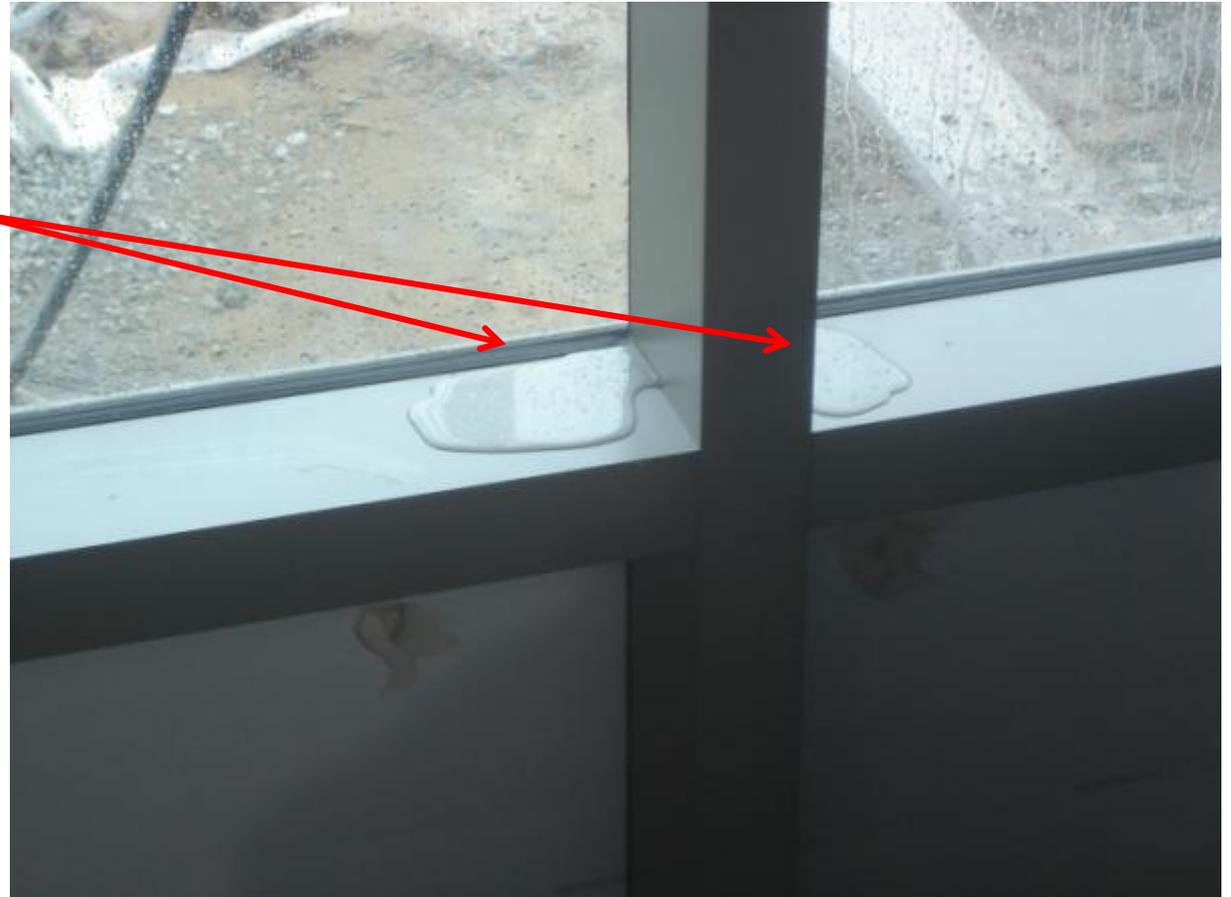
# System Failures

Leak observed on the 1<sup>st</sup> floor  
after the third spray test at the

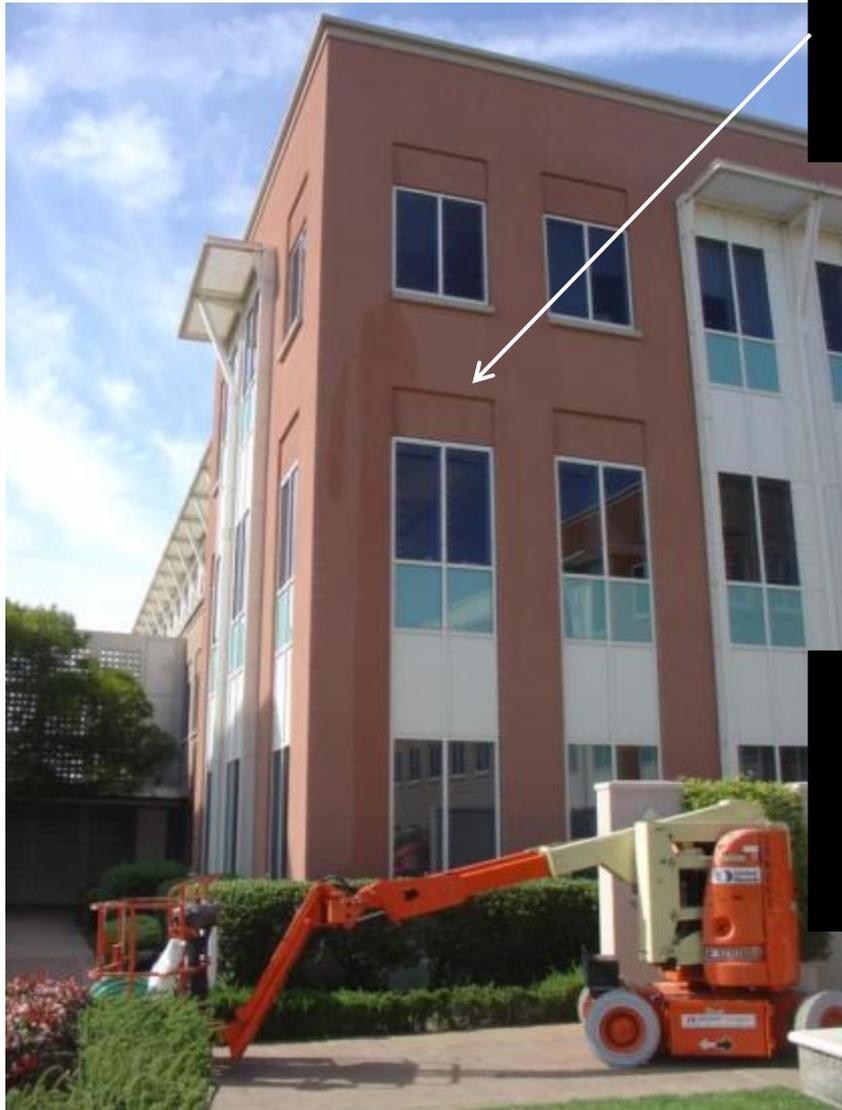
# EIFS Preventive Maintenance - Investigation

**EIFS exterior on building at large Silicon Valley Campus. Occupant of office had reported major leaks.**

**ABB was hired to determine causes and if possible prescribe major preventive maintenance repairs rather than very expensive replacement of entire skin of all 13 buildings (several \$\$\$\$ million).**

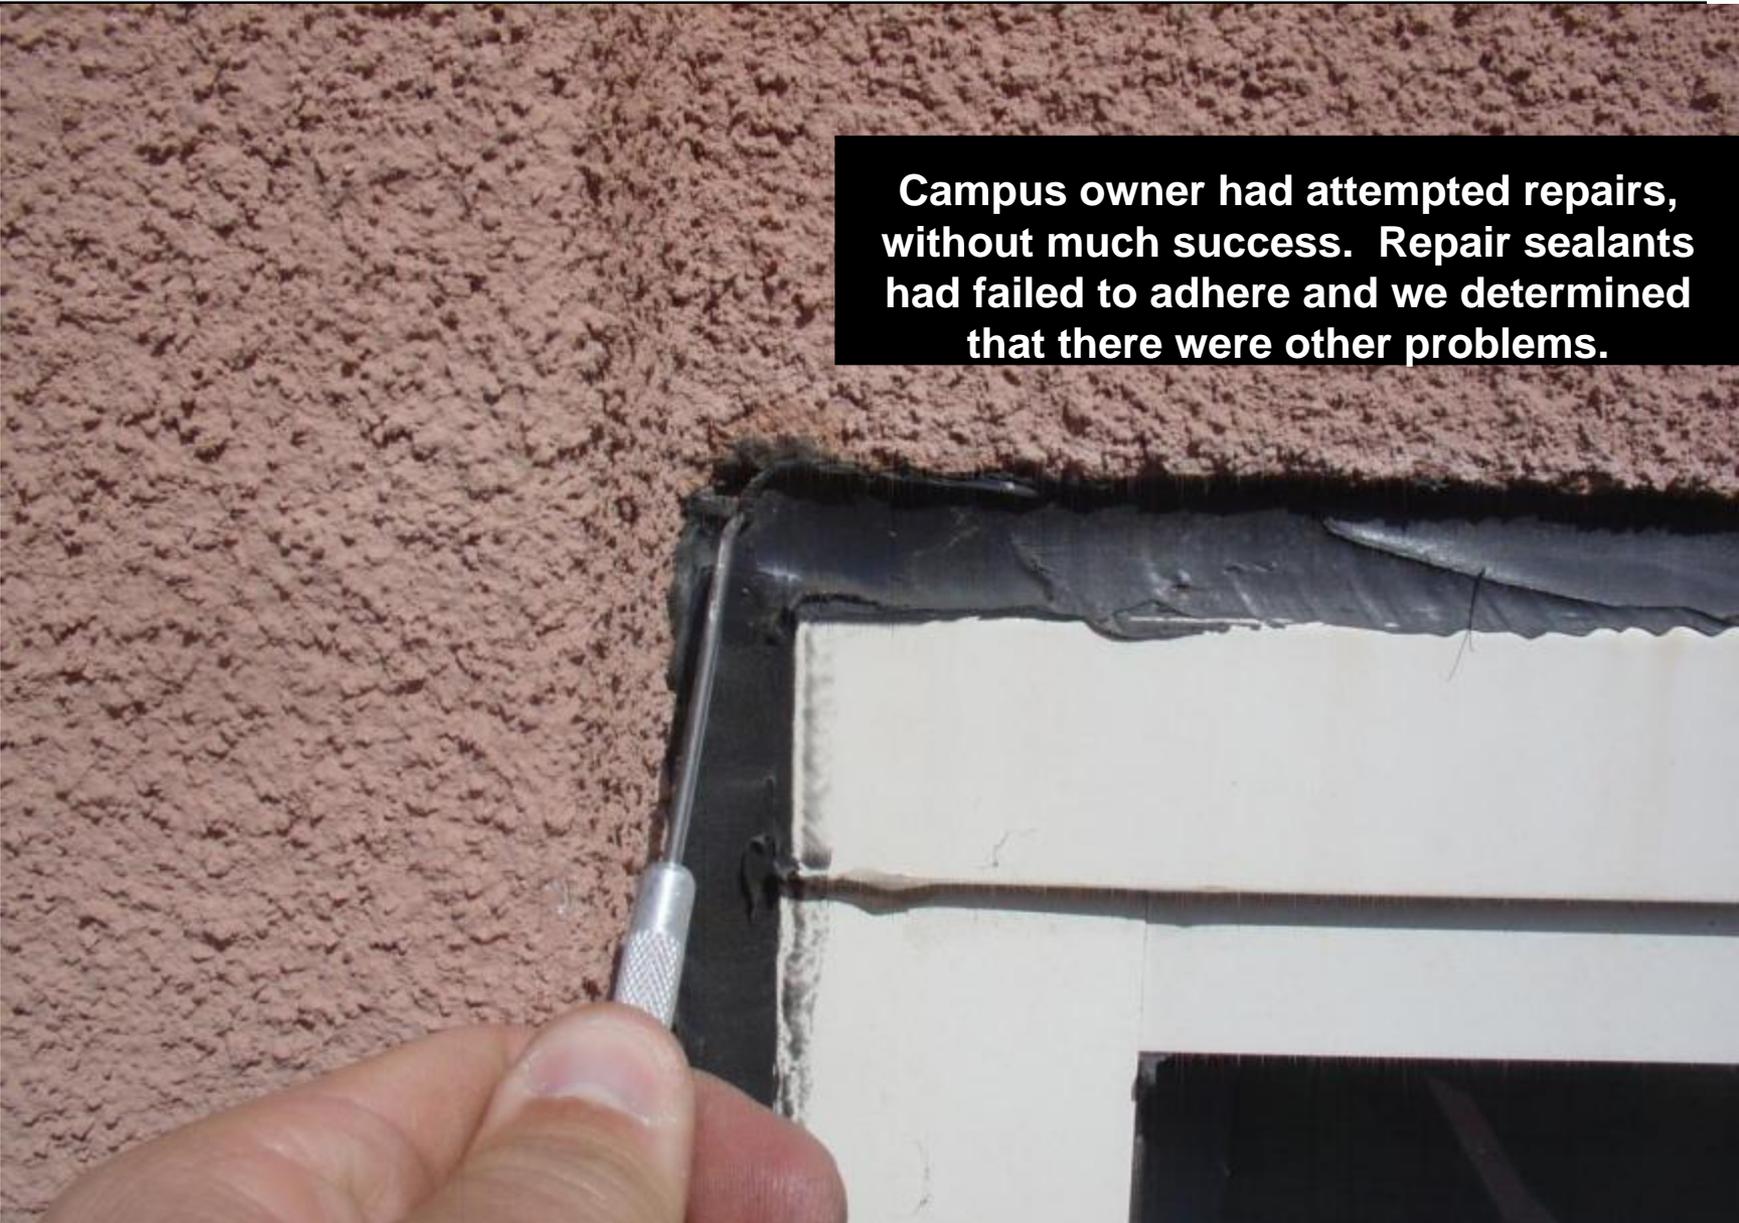
# Client Had Made Attempts at Repairs

Campus owner had attempted repairs, without much success. Repair sealants had failed to adhere and we determined that there were other problems.
