Gaylord Opryland Resort  
& Convention Center

# **Building Envelope Technology Symposium**

# Horizontal Above Grade Waterproofing

Karim Allana  
CEO and Principal  
*Allana Buick and Bers, Inc.*

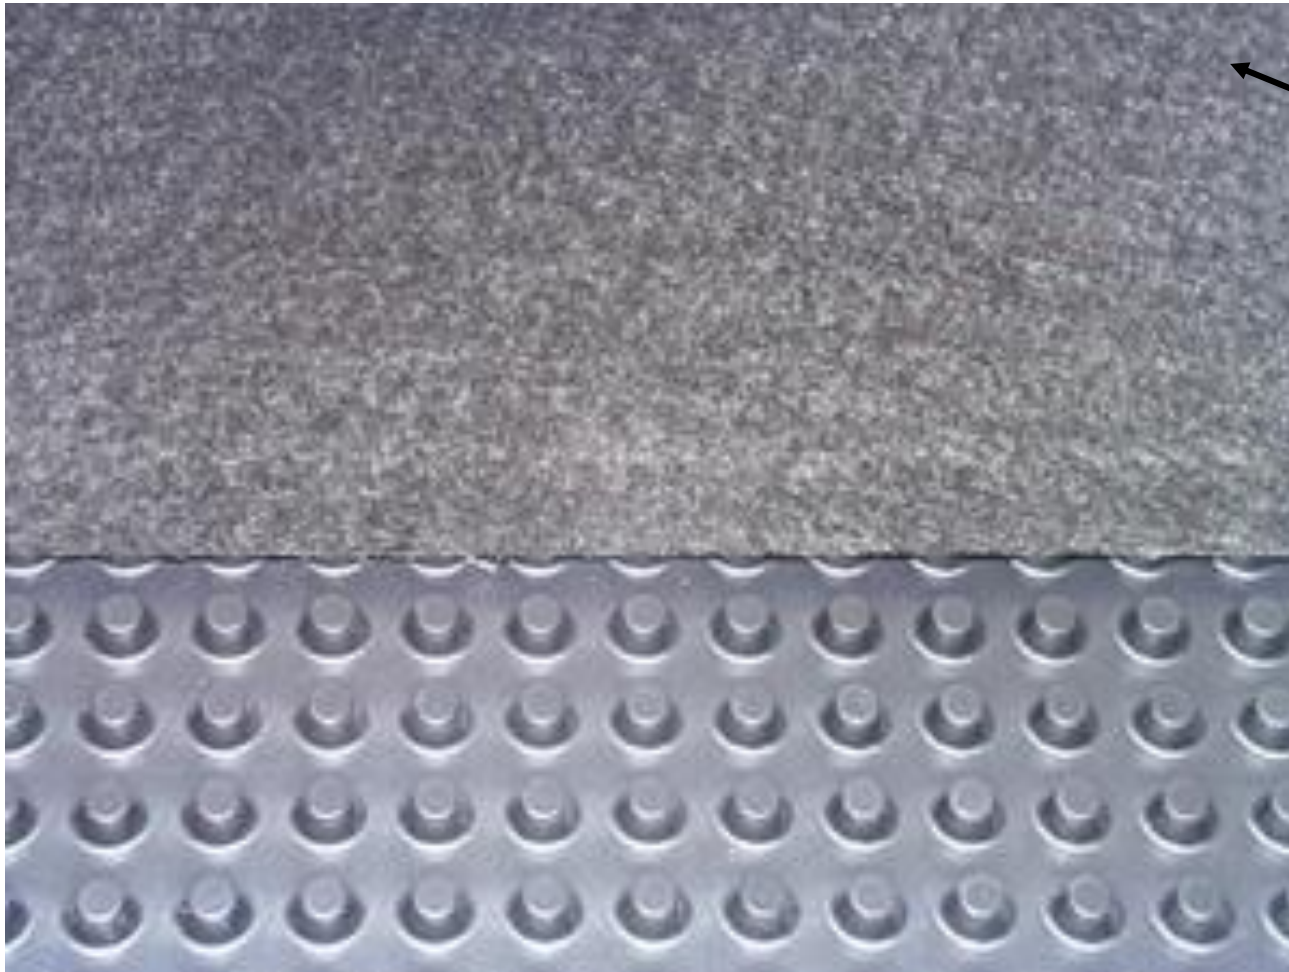
Filter fabric is often used to protect the weep holes in sub-slab drain weeps. Plastic cores can be cut away leaving filter fabric available for wrapping drain weep holes

- **Placed above the waterproofing layer**
  - Conducts water to sub-drain
  - In conjunction with surface slope, prevents standing water on waterproofing membrane
  - Reduces hydrostatic head in assembly
- **Plastic cores with filter fabric covering**
  - High compressive strength
  - Filter fabric prevents fines from clogging drain path
  - Carefully select to match loading and traffic

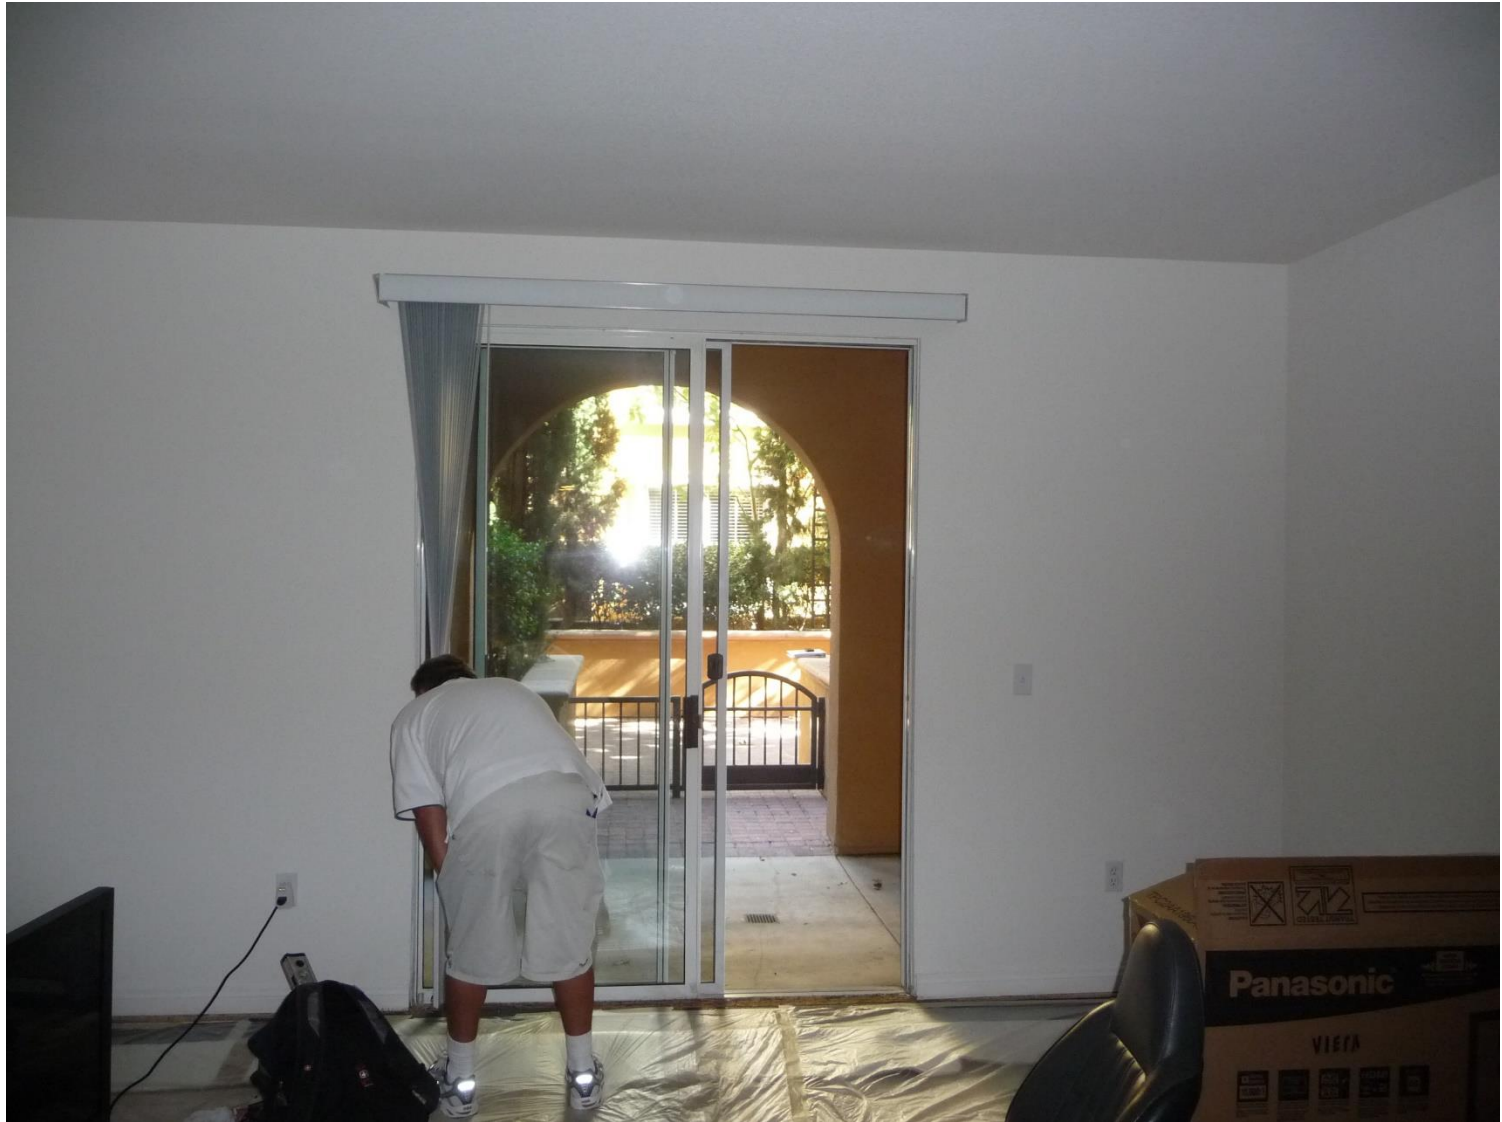
This sliding door was leaking deep under a recess

- **Podium style Type V construction with 4 stories of wood framing over podium**
- **Post-tensioned concrete slab podium construction**
- **Sliding door well under an overhanging structure leaks**

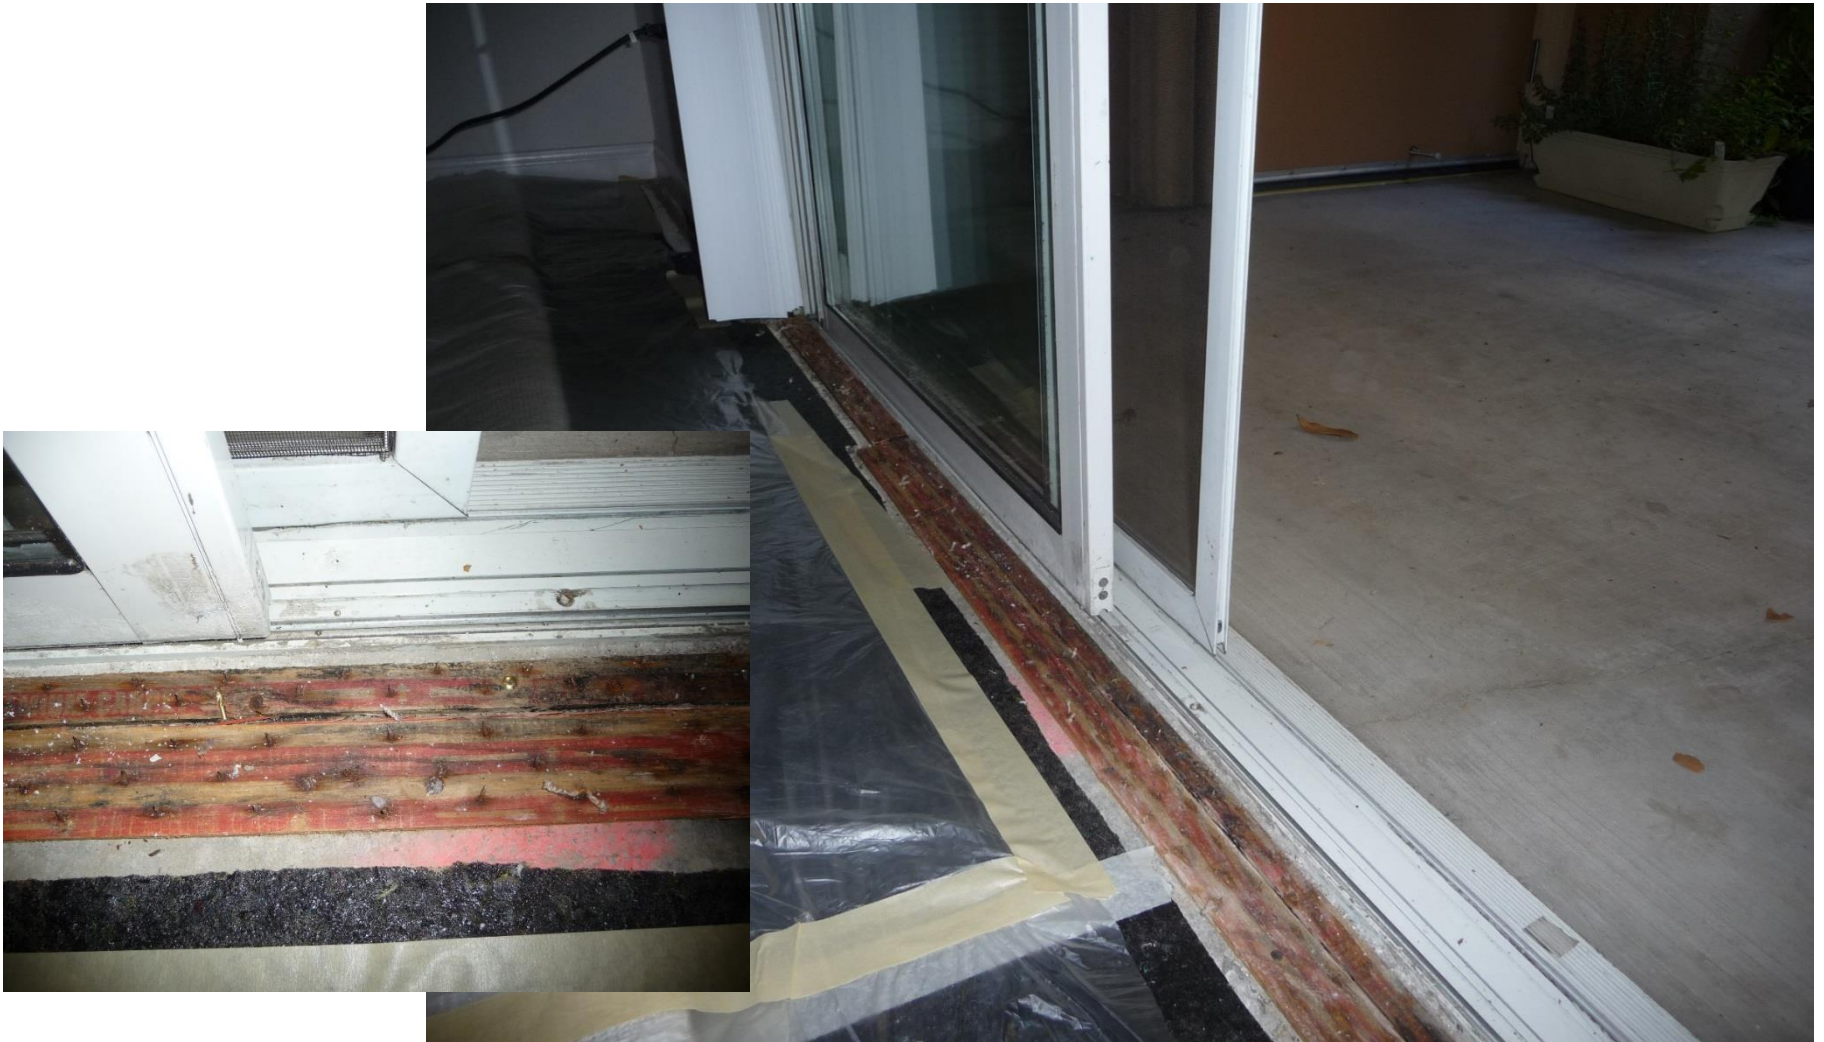
Existing Damage at carpet tack strip

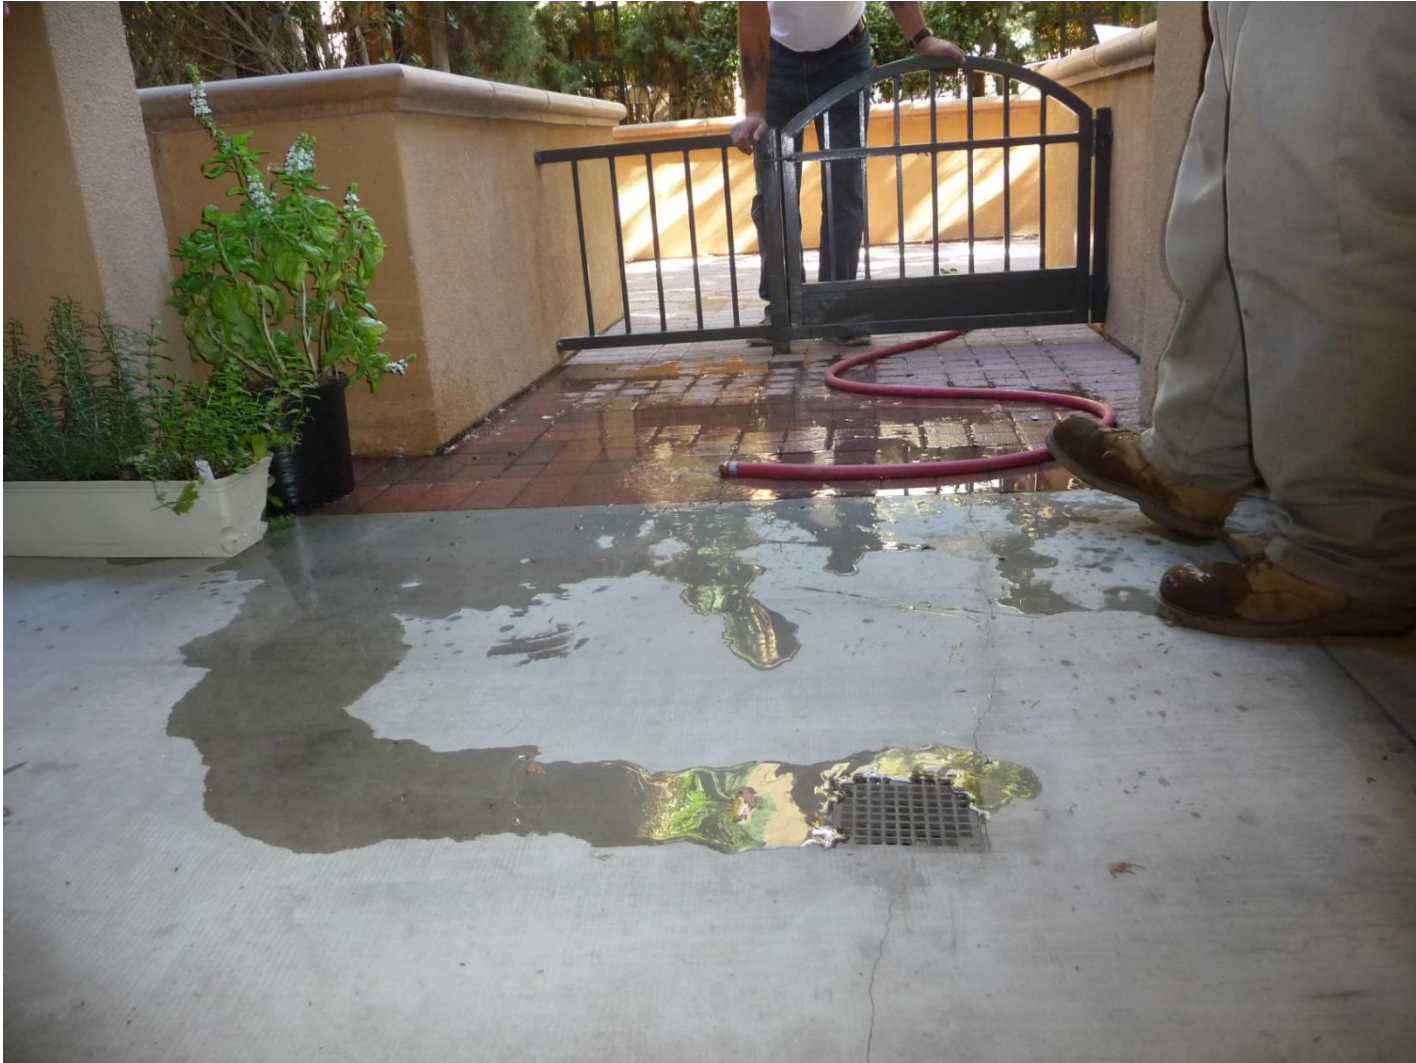
Water test 20 feet away from sliding door

- **Water testing consisted of placing water on the topping slab approximately 20 feet away from the sliding door**
- **Water never placed against sliding glass door or building wall**
- **Water appeared at the face of the building wall and at the sliding glass door**

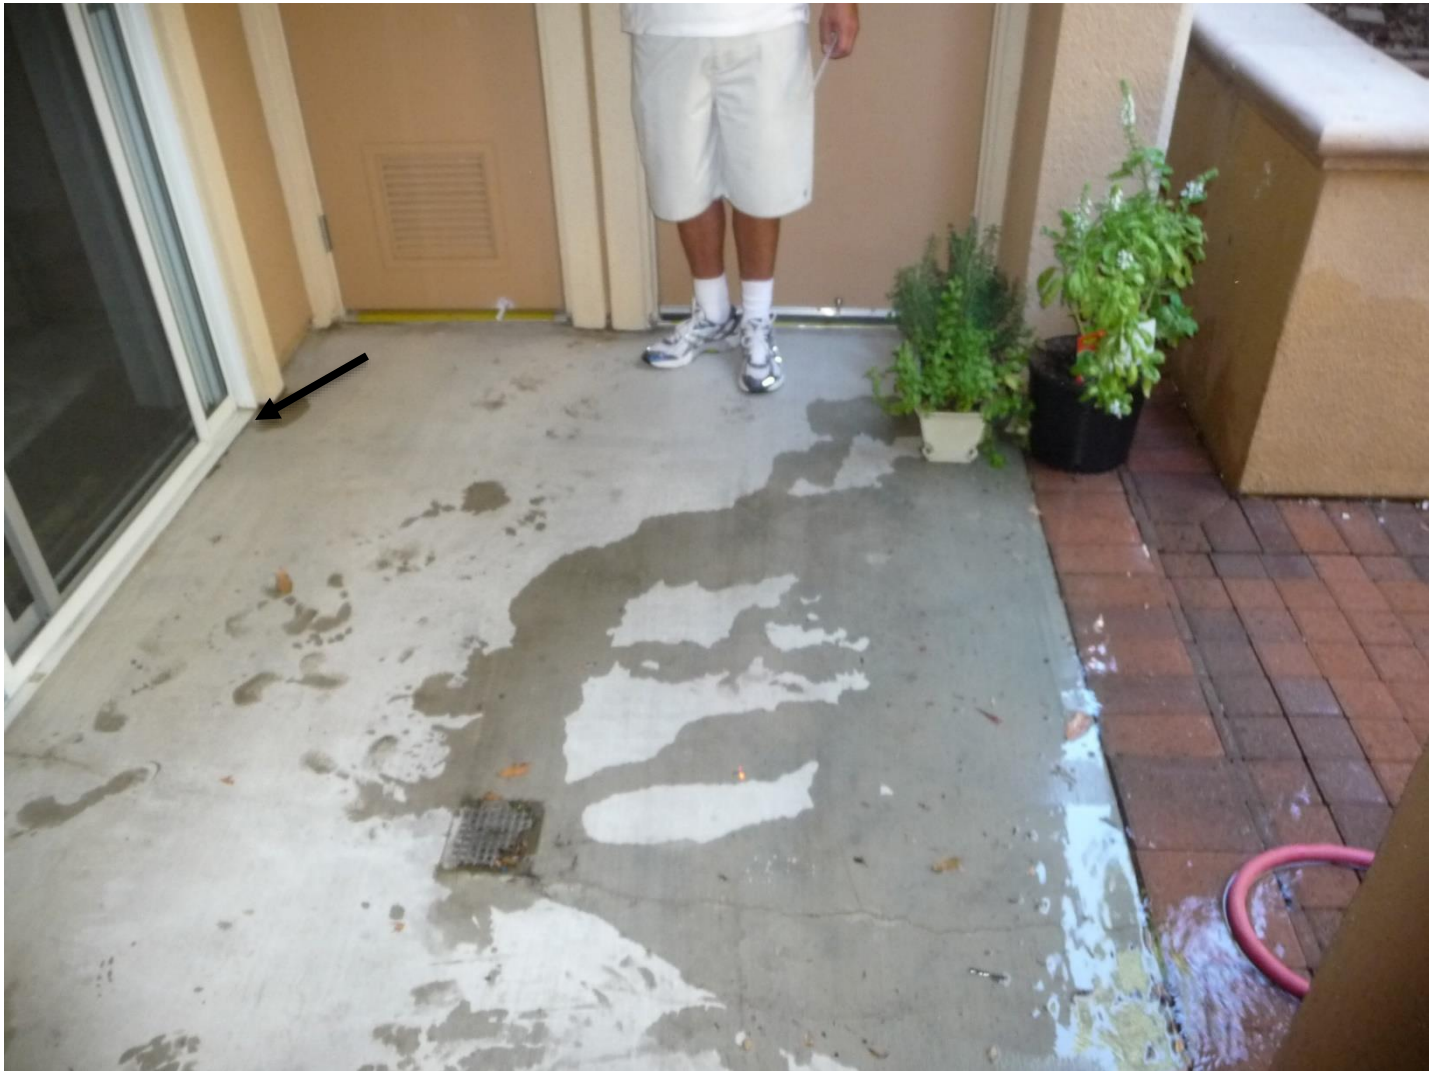
Water never directly flowed to the door

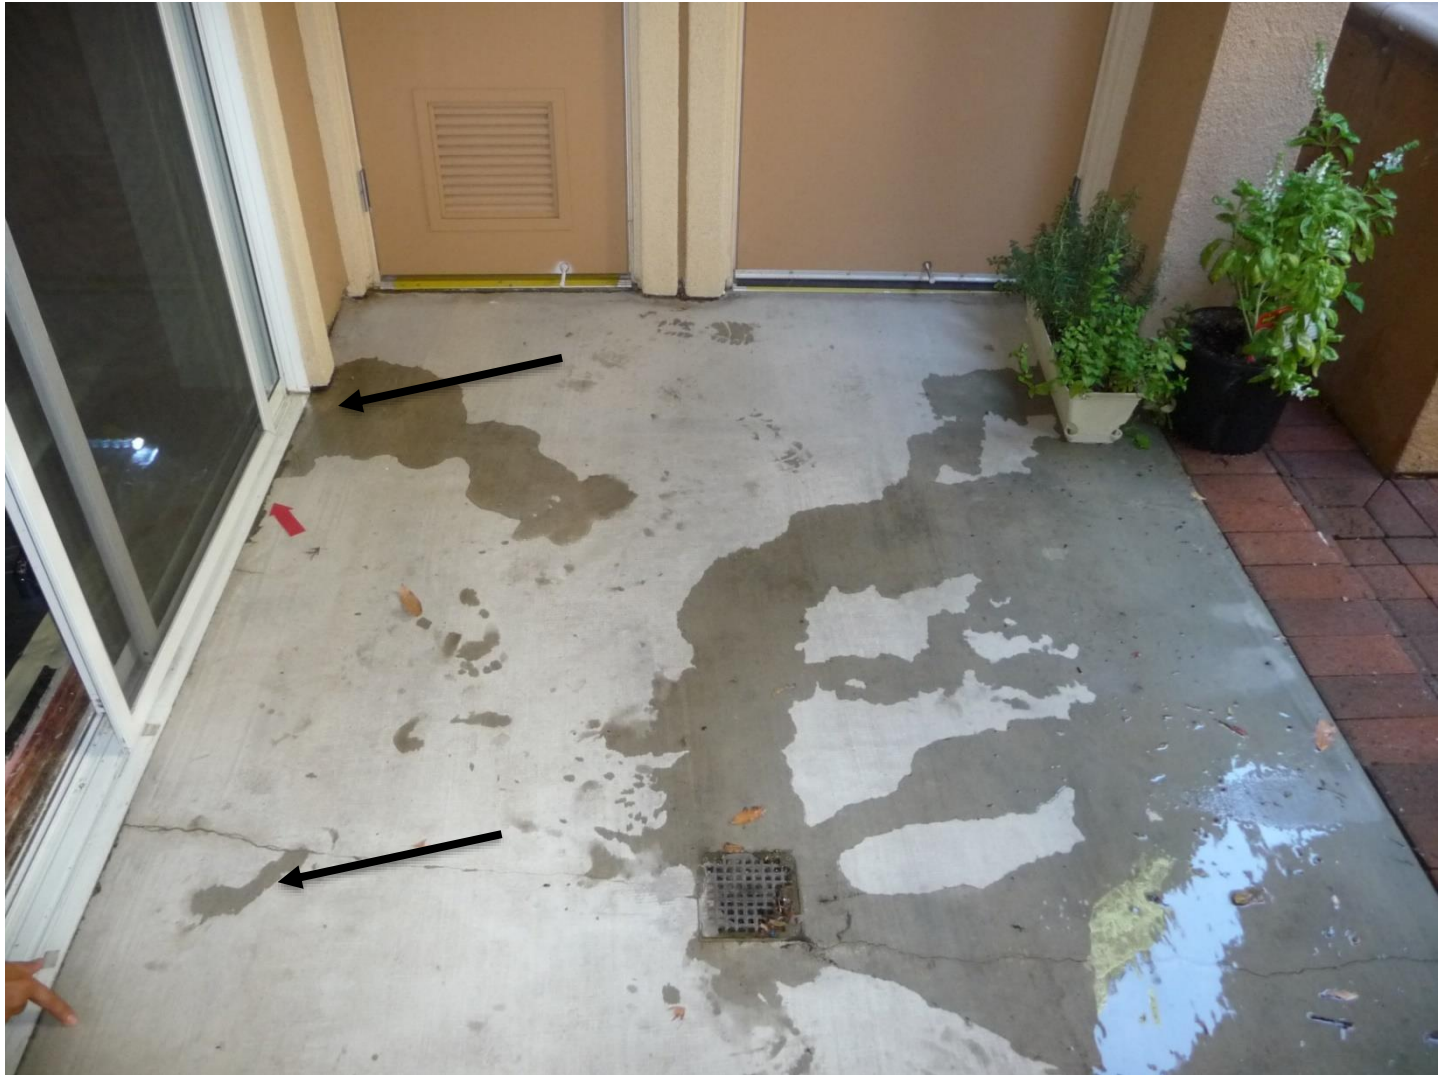
More and more water started to emerge from door jamb

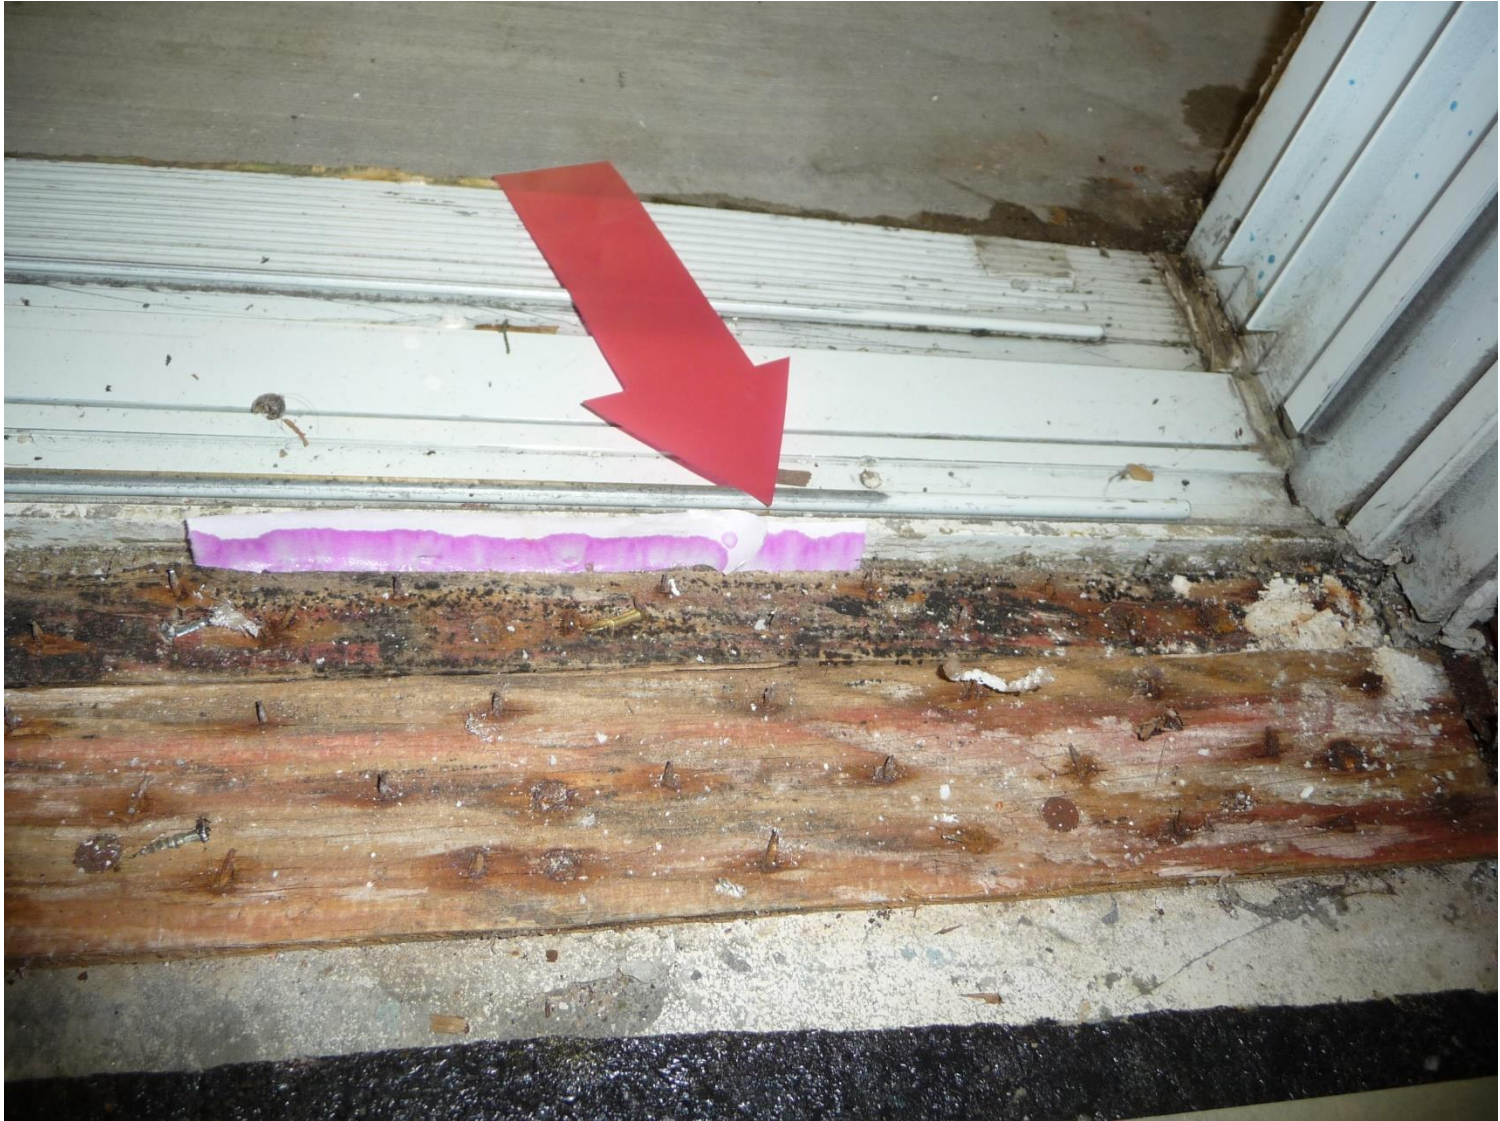
Water started to emerge at the inside!!

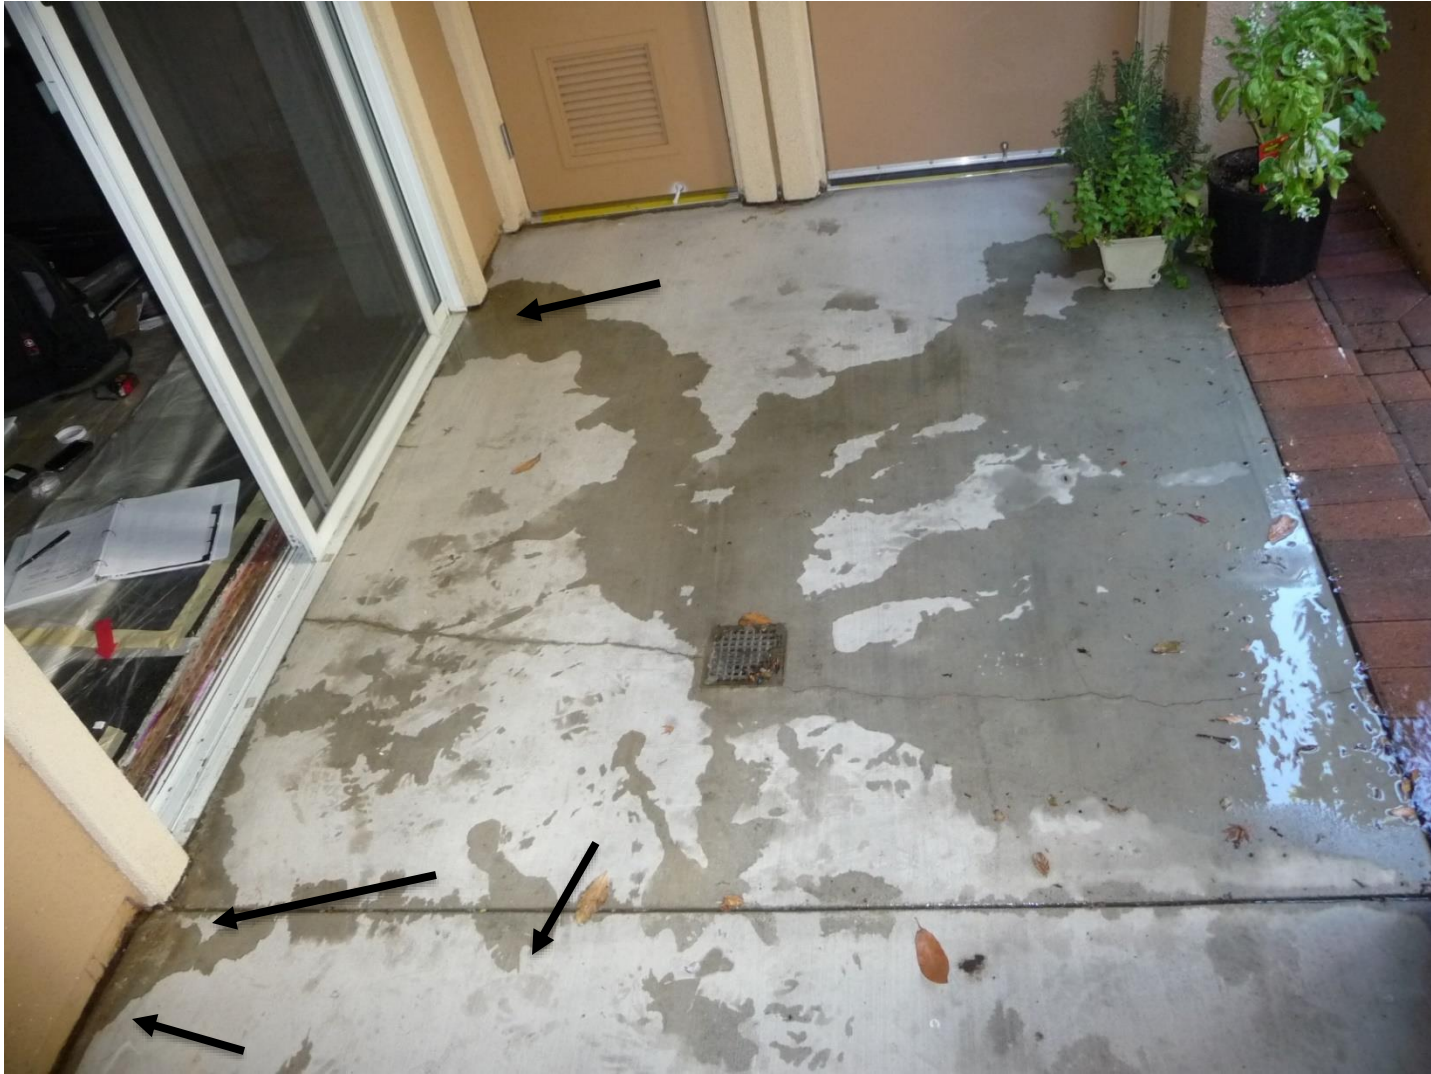
Always slope the structural slab!

- **Water entered drain but also saturated the topping slab, paver system and separation materials**
- **The drain weeps at the waterproofing membrane level are small and were partially plugged with concrete and waterproofing**
- **Water built a hydrostatic head equal to the surface of the topping slab**
- **Slopes in topping slab often cause height of topping slab to be higher than interior floor**
- **Water can collect and travel around cold joints and perimeter and leak at doors and sliders**

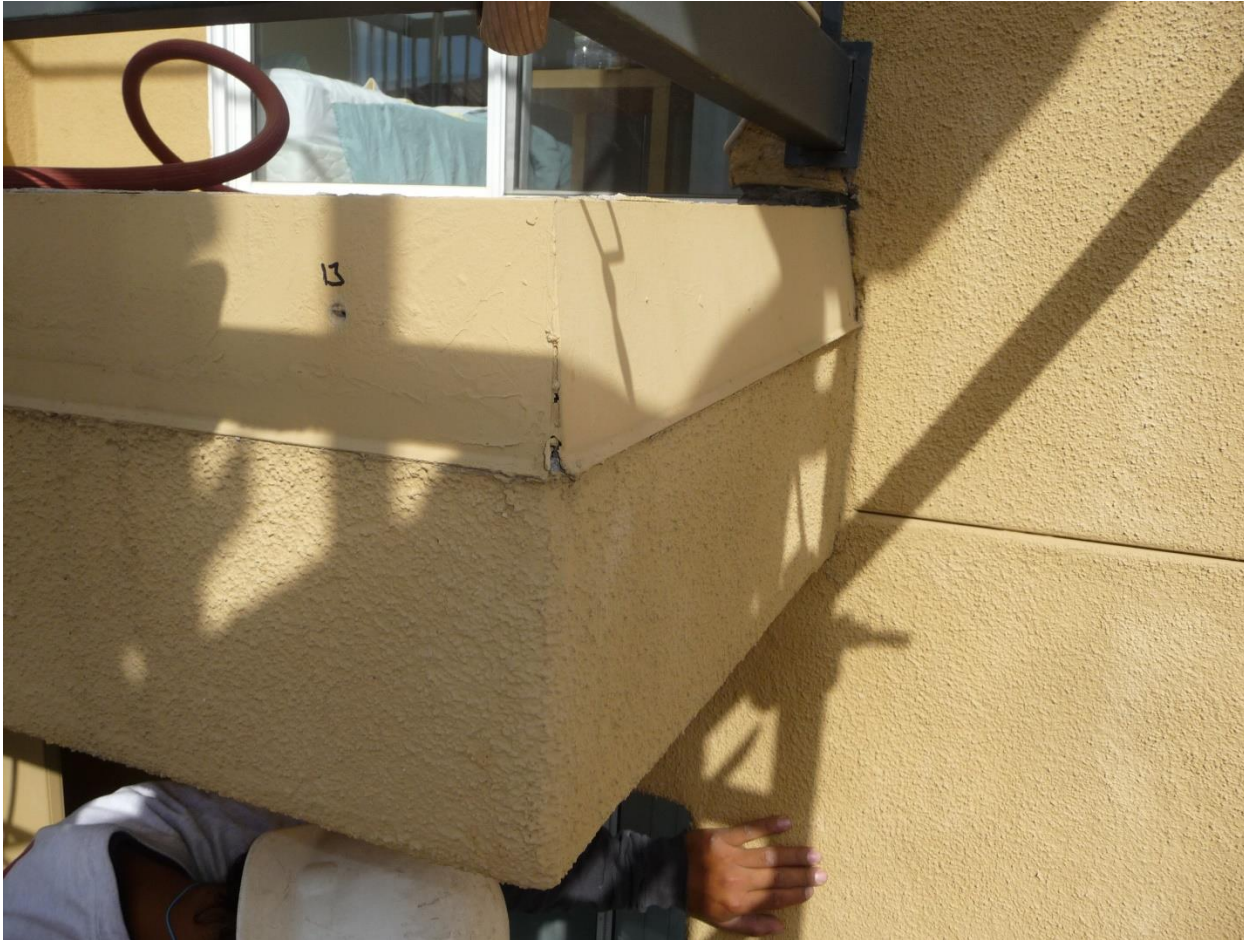
Con-form Edge Metal

Extruded aluminum metal edge used as both a form for retaining concrete as well as a “flashing”

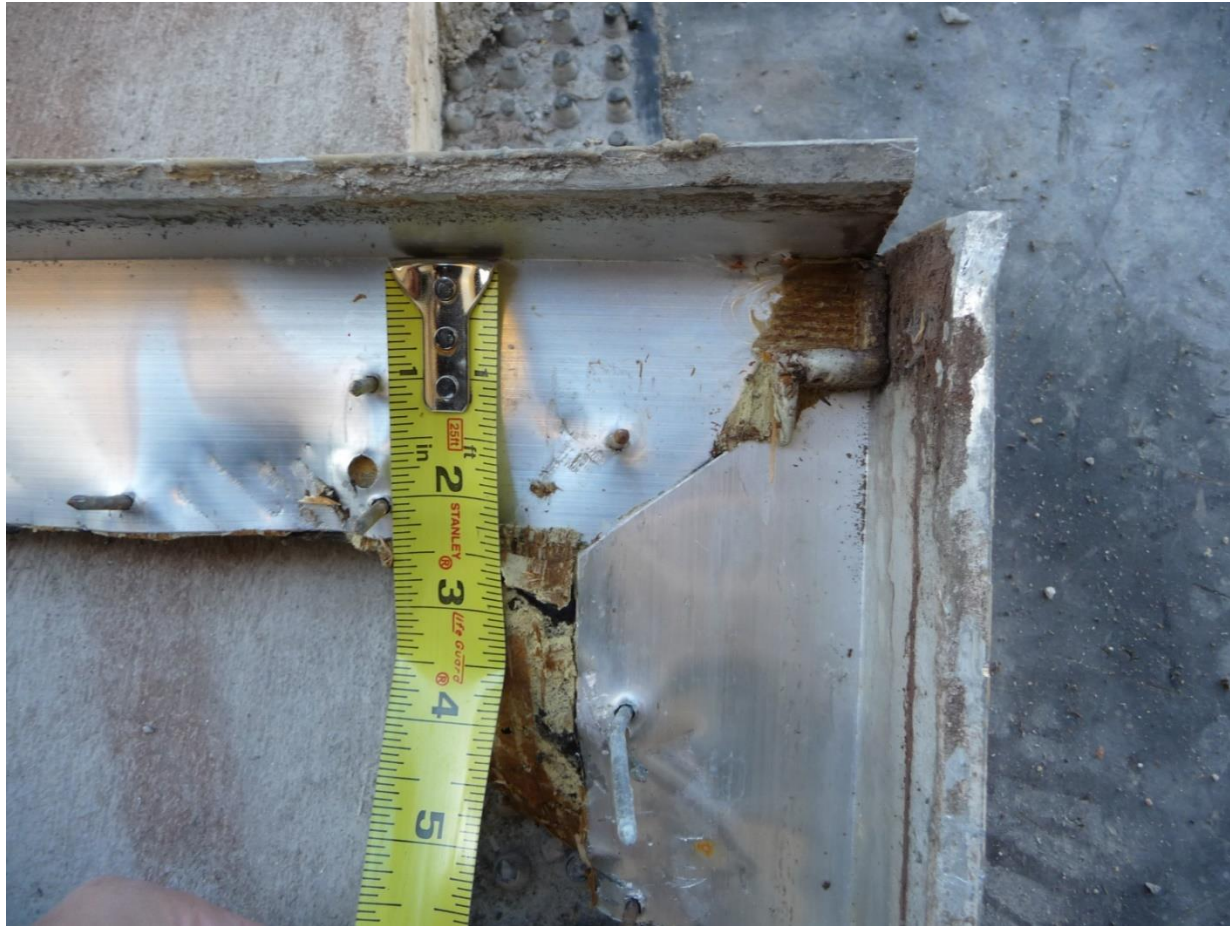
Difficult to integrate Aluminum with GSM flashings other 3 sides. Corners can't be soldered, separation of dissimilar materials and proper integration.

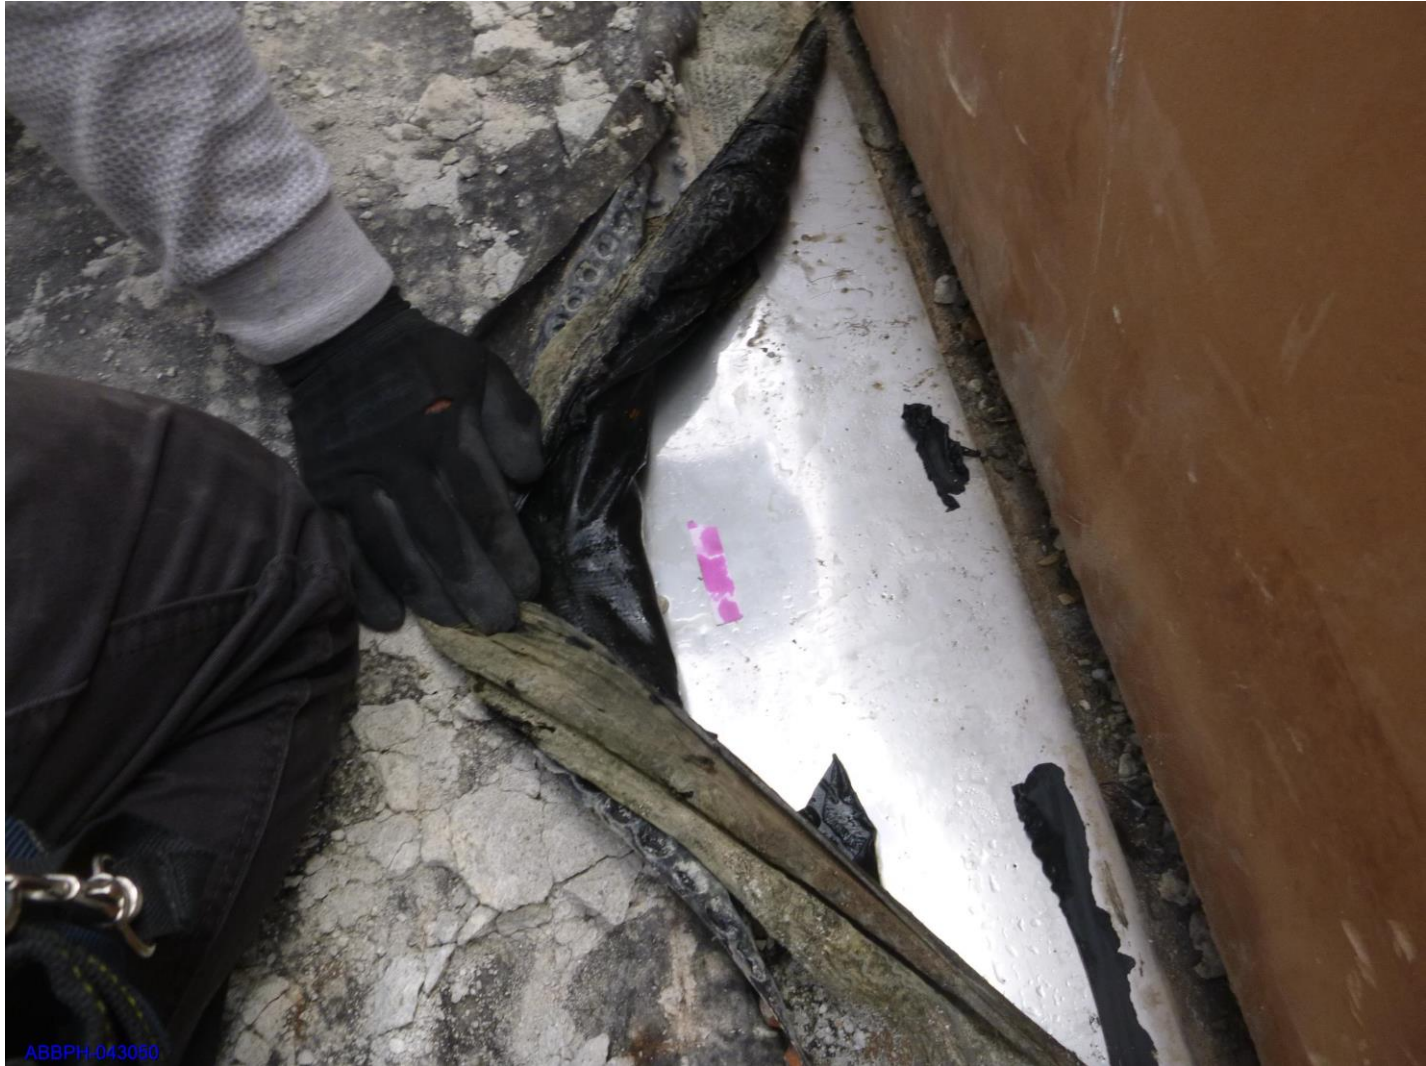
# Membrane, Adhesion Failure to Stainless

Lack of priming or prepping

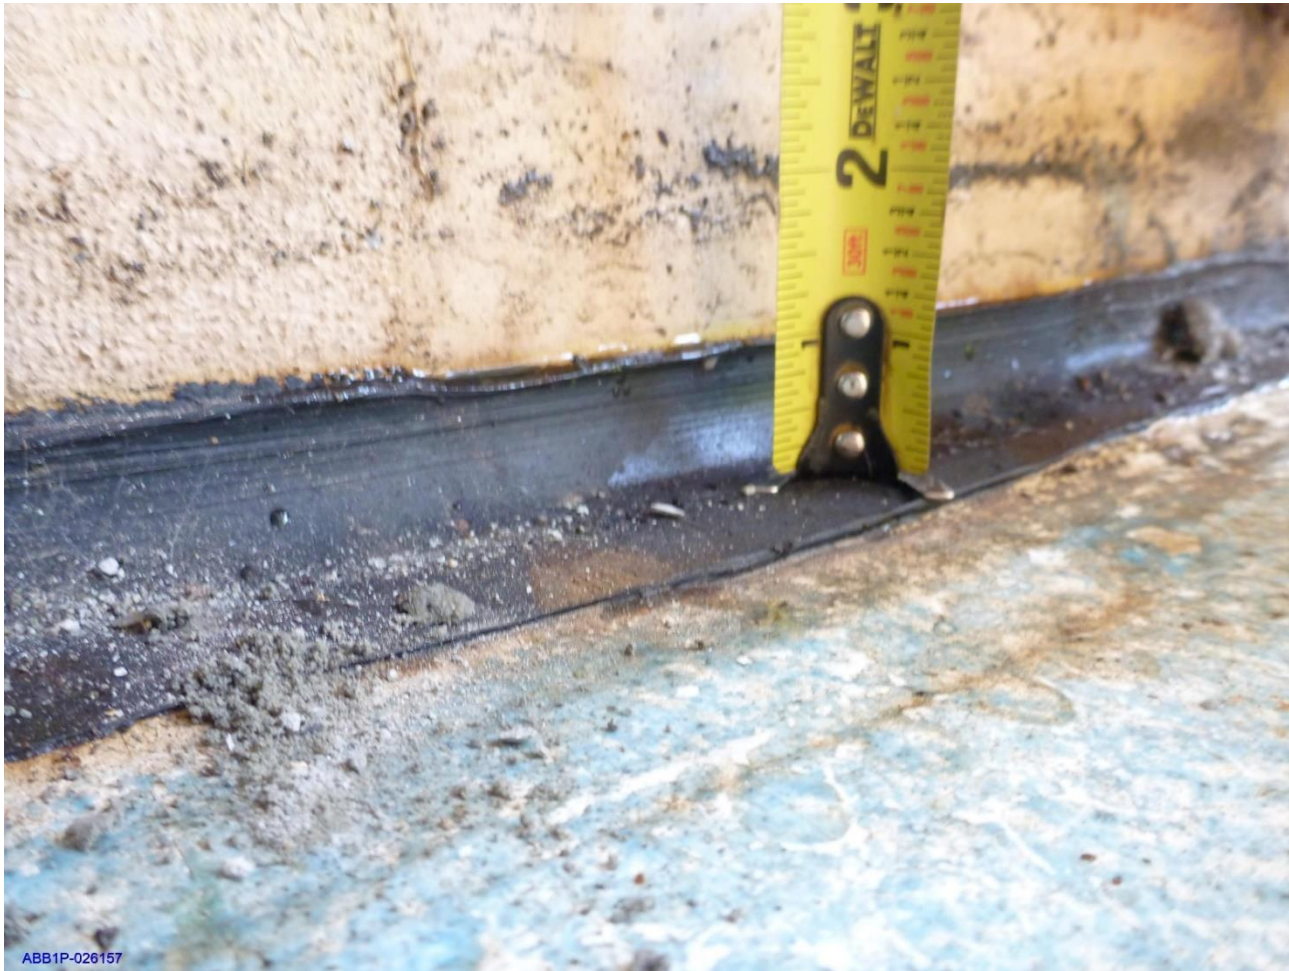
- **Incomplete or improper composition base flashings**
  - Lack of membrane flashing extensions

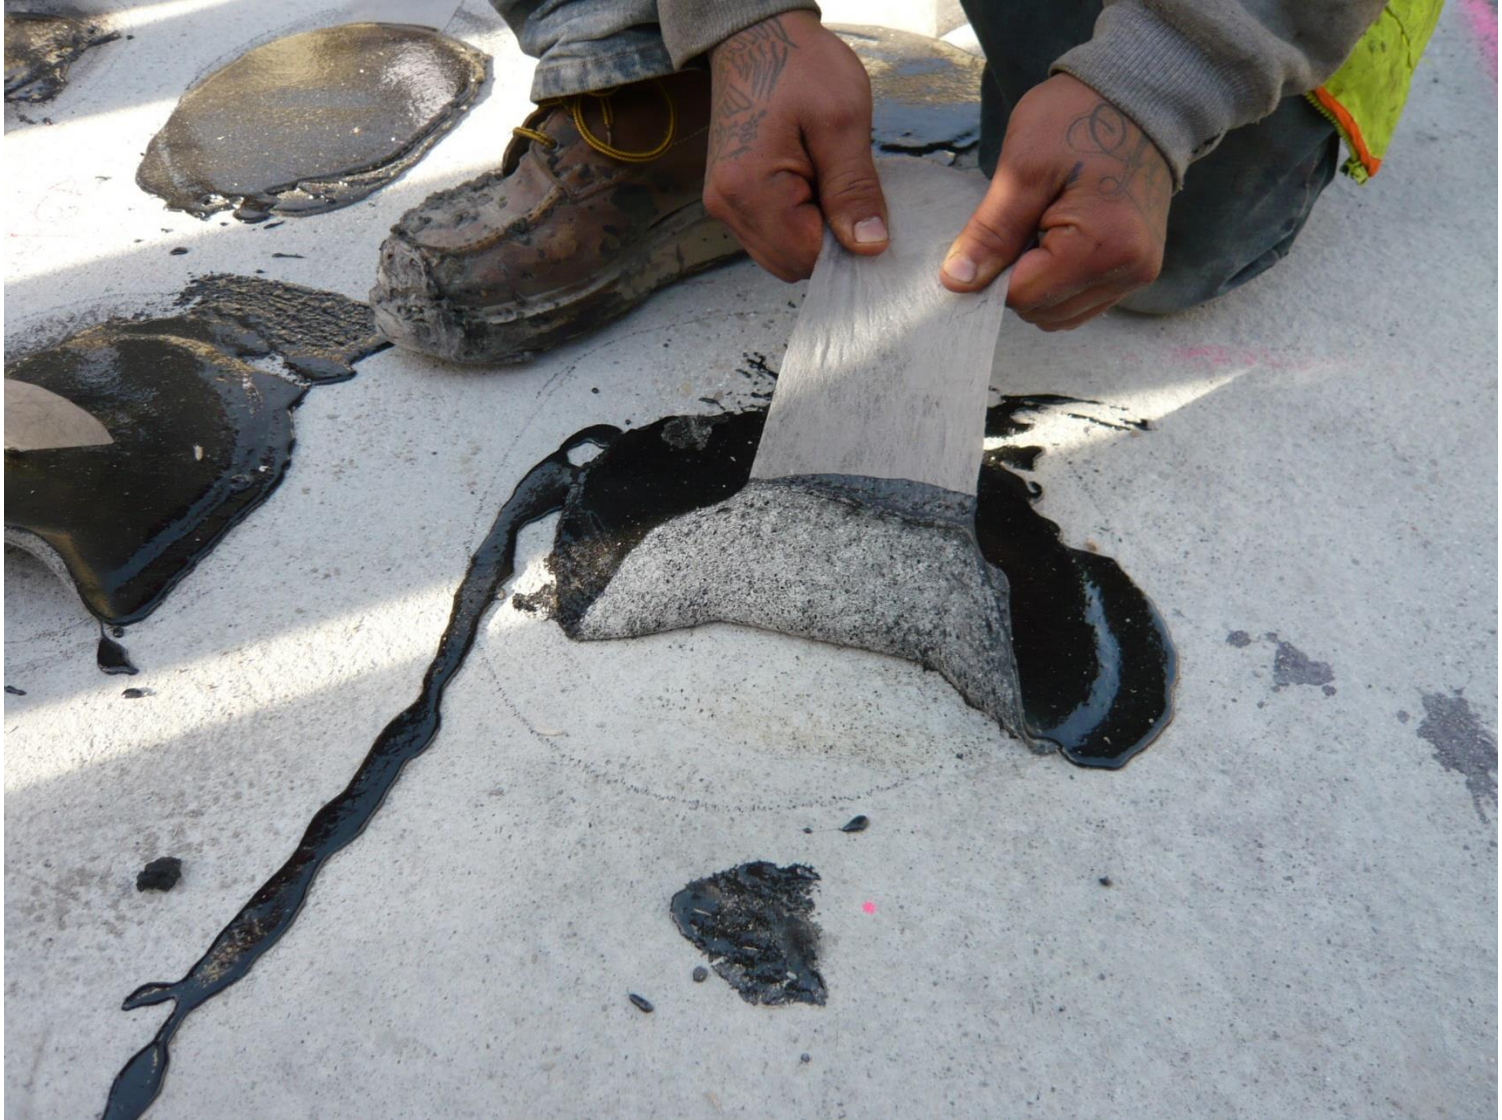
# HRA Adhesion Test Failure (Concrete Cohesion)

- The podium slab was poured in mid November
- It may have been raining when they finished pouring
- The temperatures recorded during this period was about freezing
- The surface of the concrete was very soft

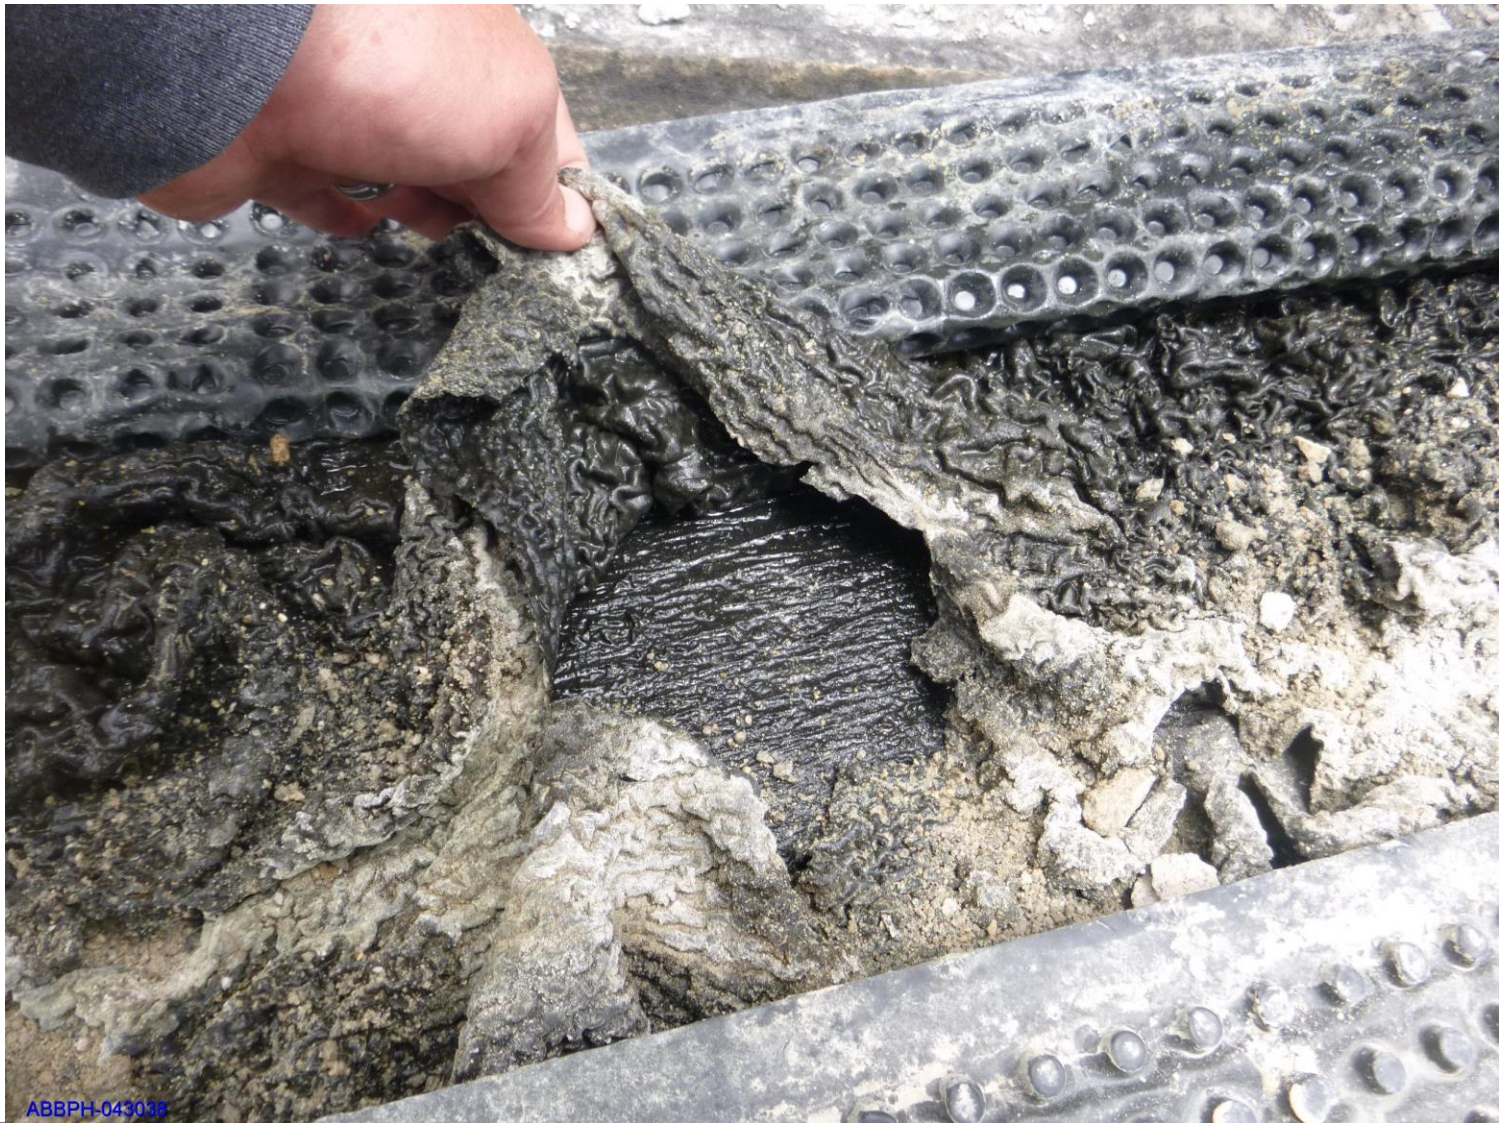
# Membrane Swelling Due To Ponding
