Building Envelope Technology Symposium

Performance of Weather Resistant Barriers in Stucco Assembly

Karim P. Allana, PE, RRC, RWC

Allana Buick & Bers, Inc.

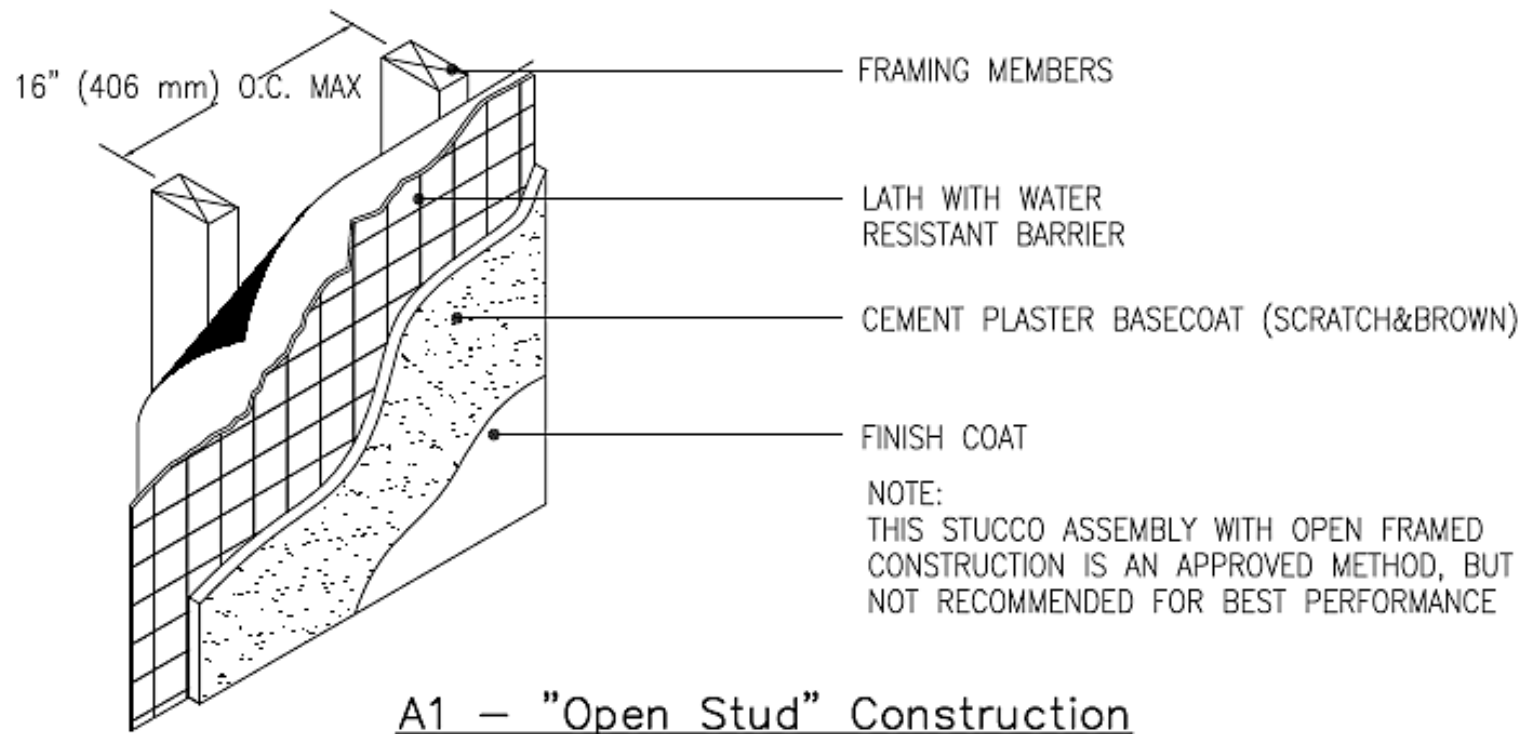
Stucco Wall Assemblies

NOTE: THESE ASSEMBLIES INDICATE ONLY THE BASIC COMPONENTS

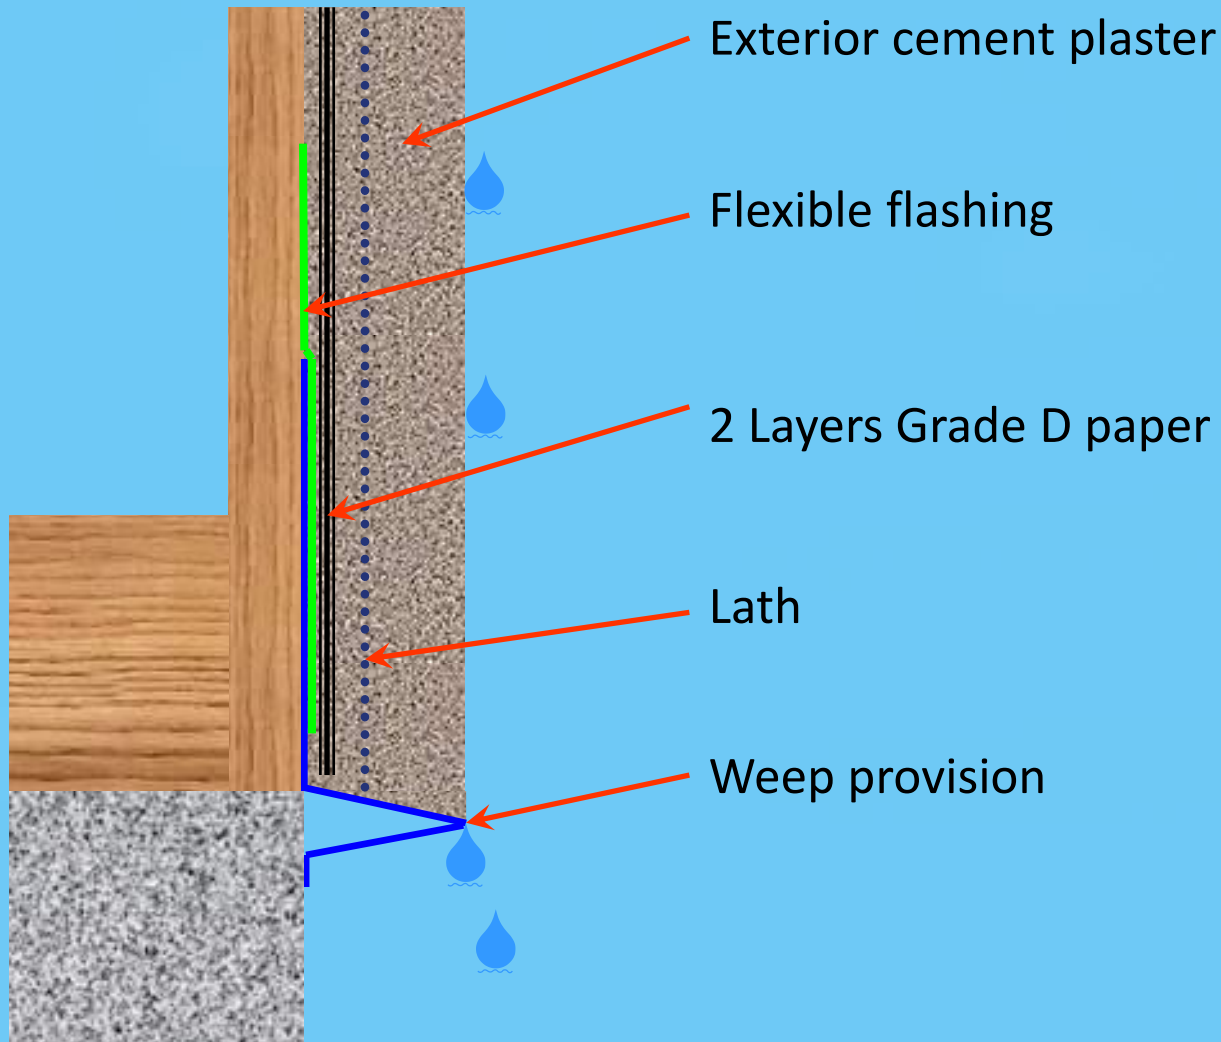
Cement Plaster, Moisture Drained System

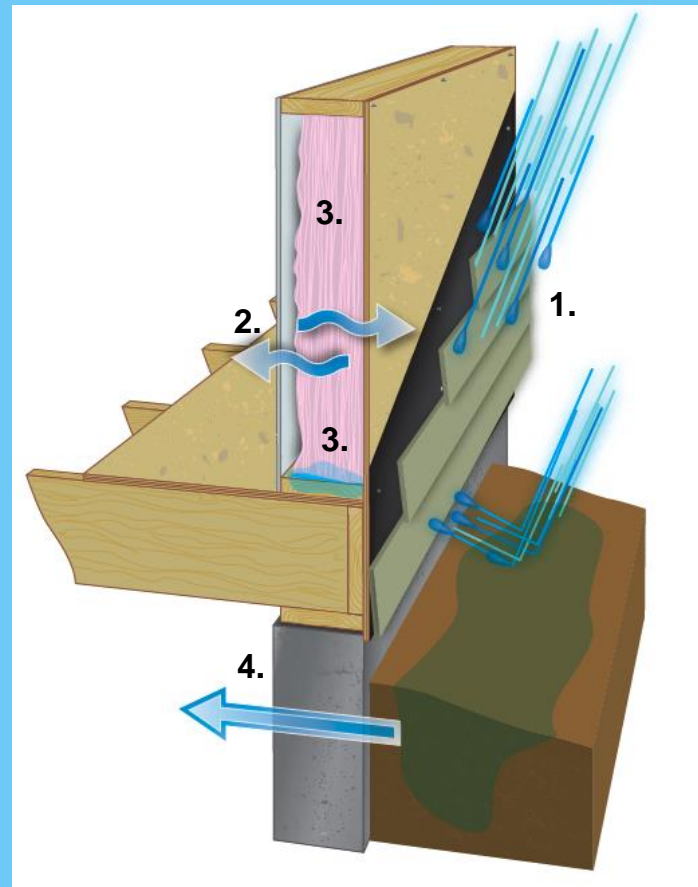
Wall Wetting Mechanisms are Complex

1. Rain

- Absorption (wicking)
- Penetration
- Splash and drips

2. Water Vapor

- Diffusion
- Convection (air leaks)

3. Built-in Moisture

- Vapor
- Liquid/frozen

4. Ground Moisture

- Capillary
- Diffusion
- Liquid penetration

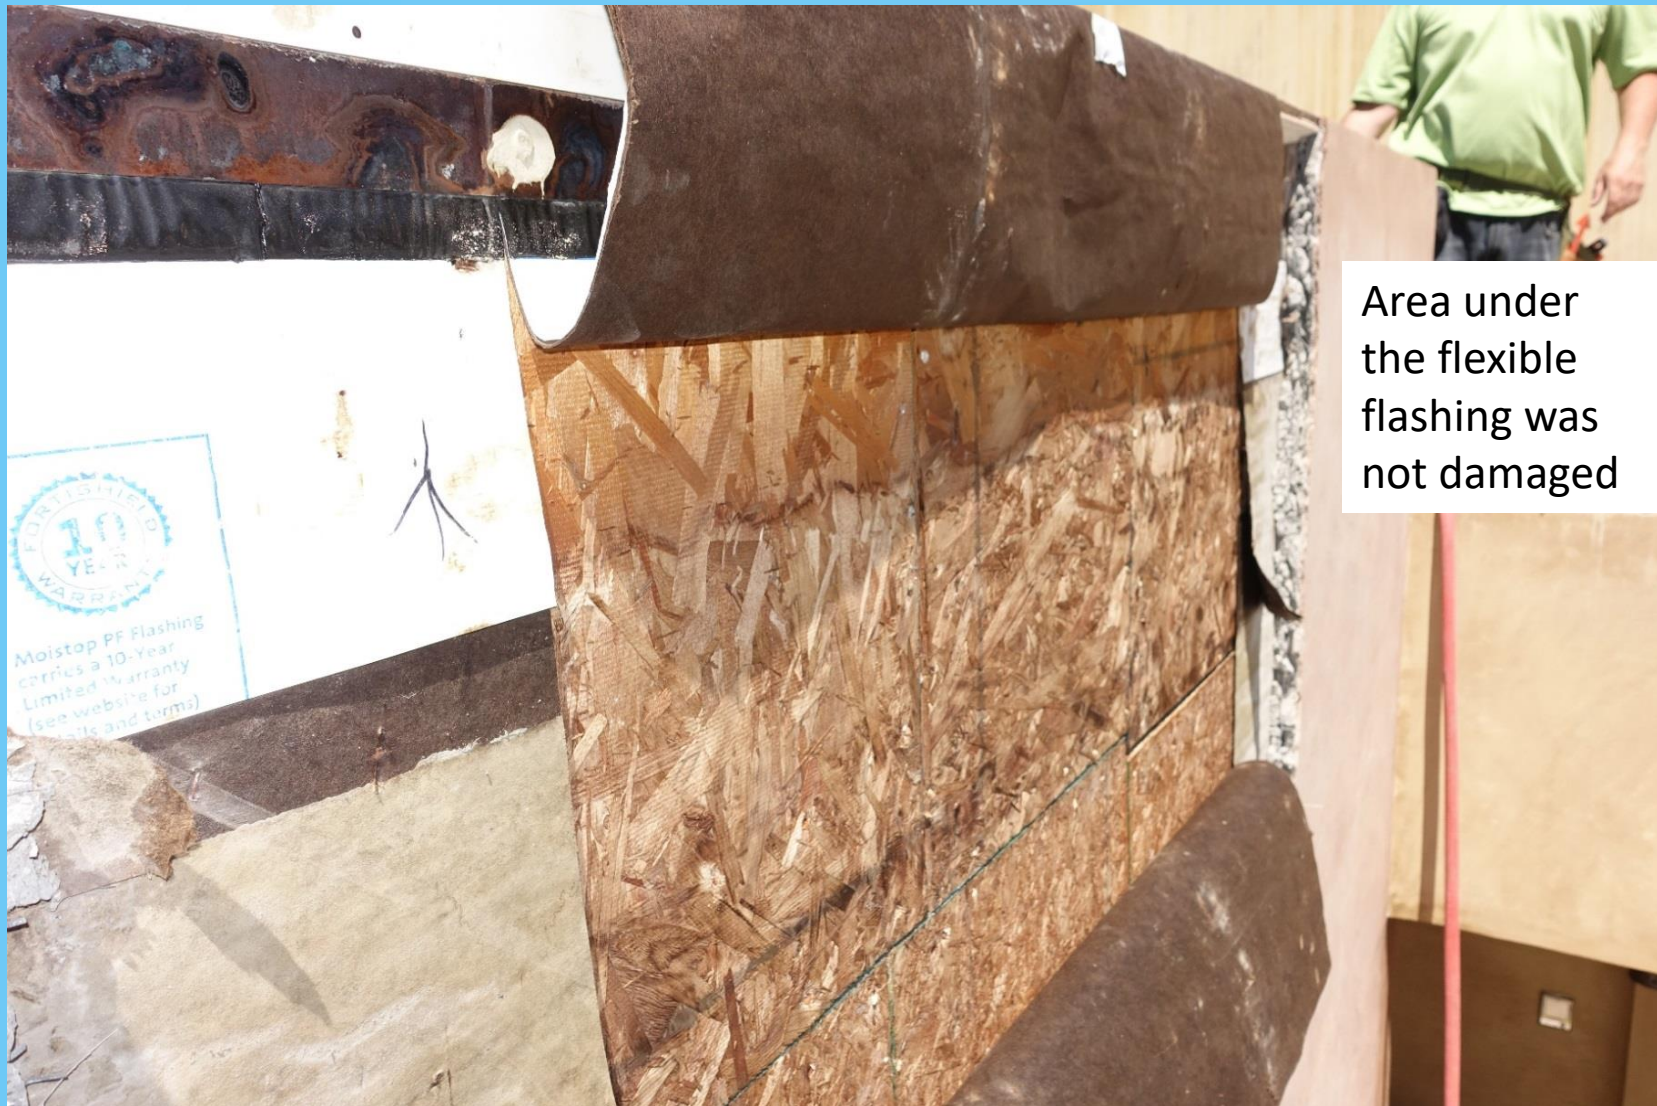
Water Soaked Through Paper

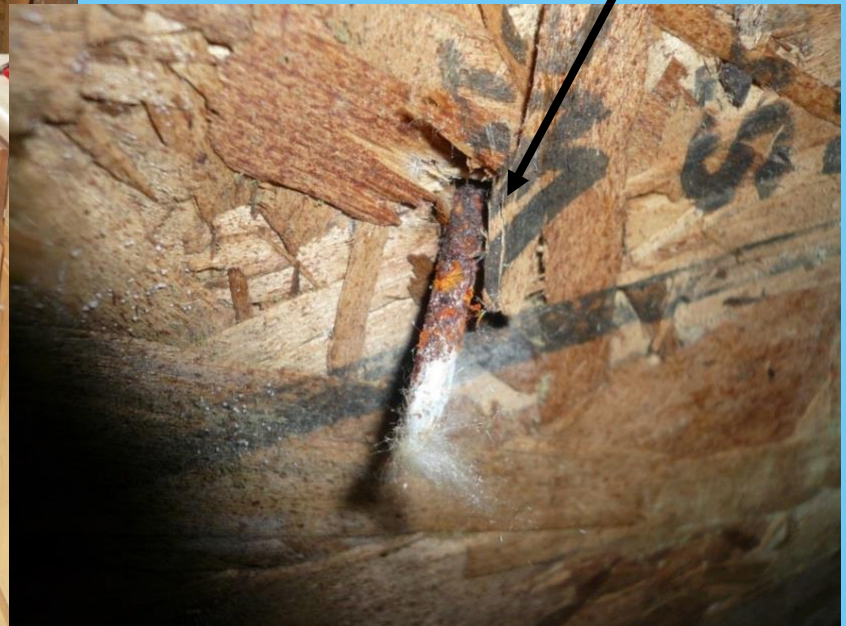
Faster (Shiner)
corroded from
inside

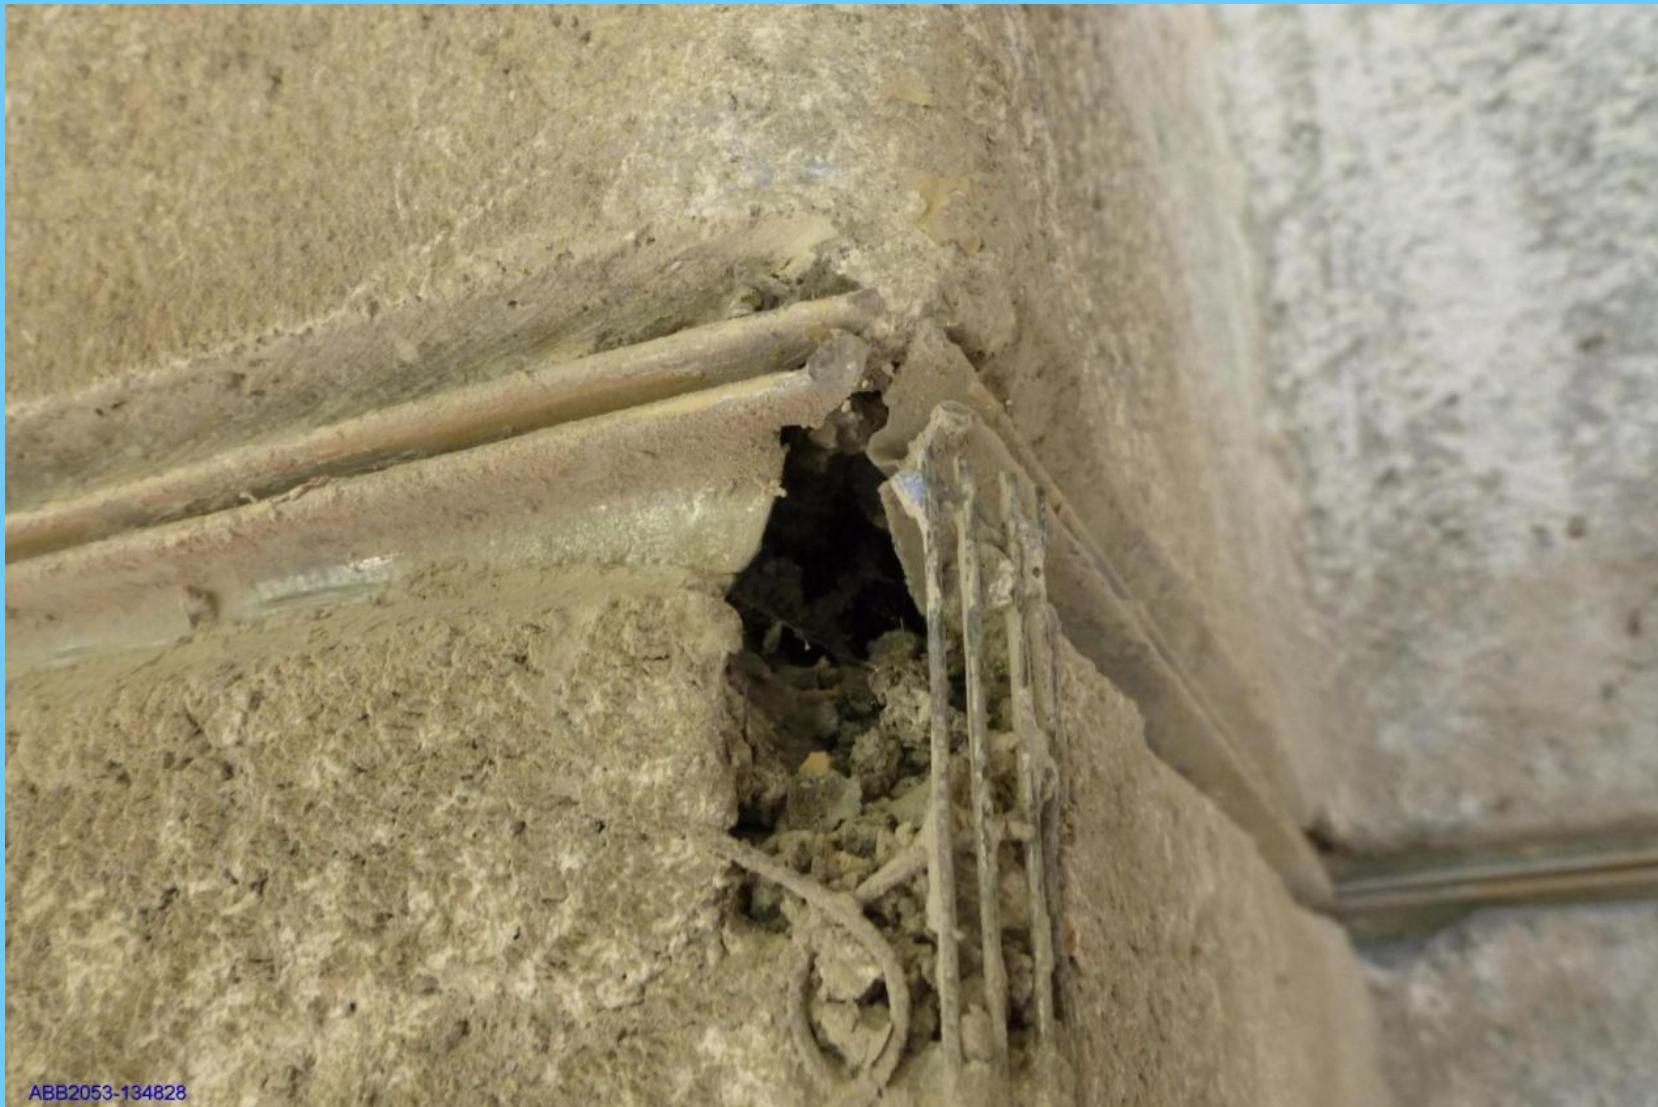
ABB2053-134828

Sources of Water, Corners of Control Joint

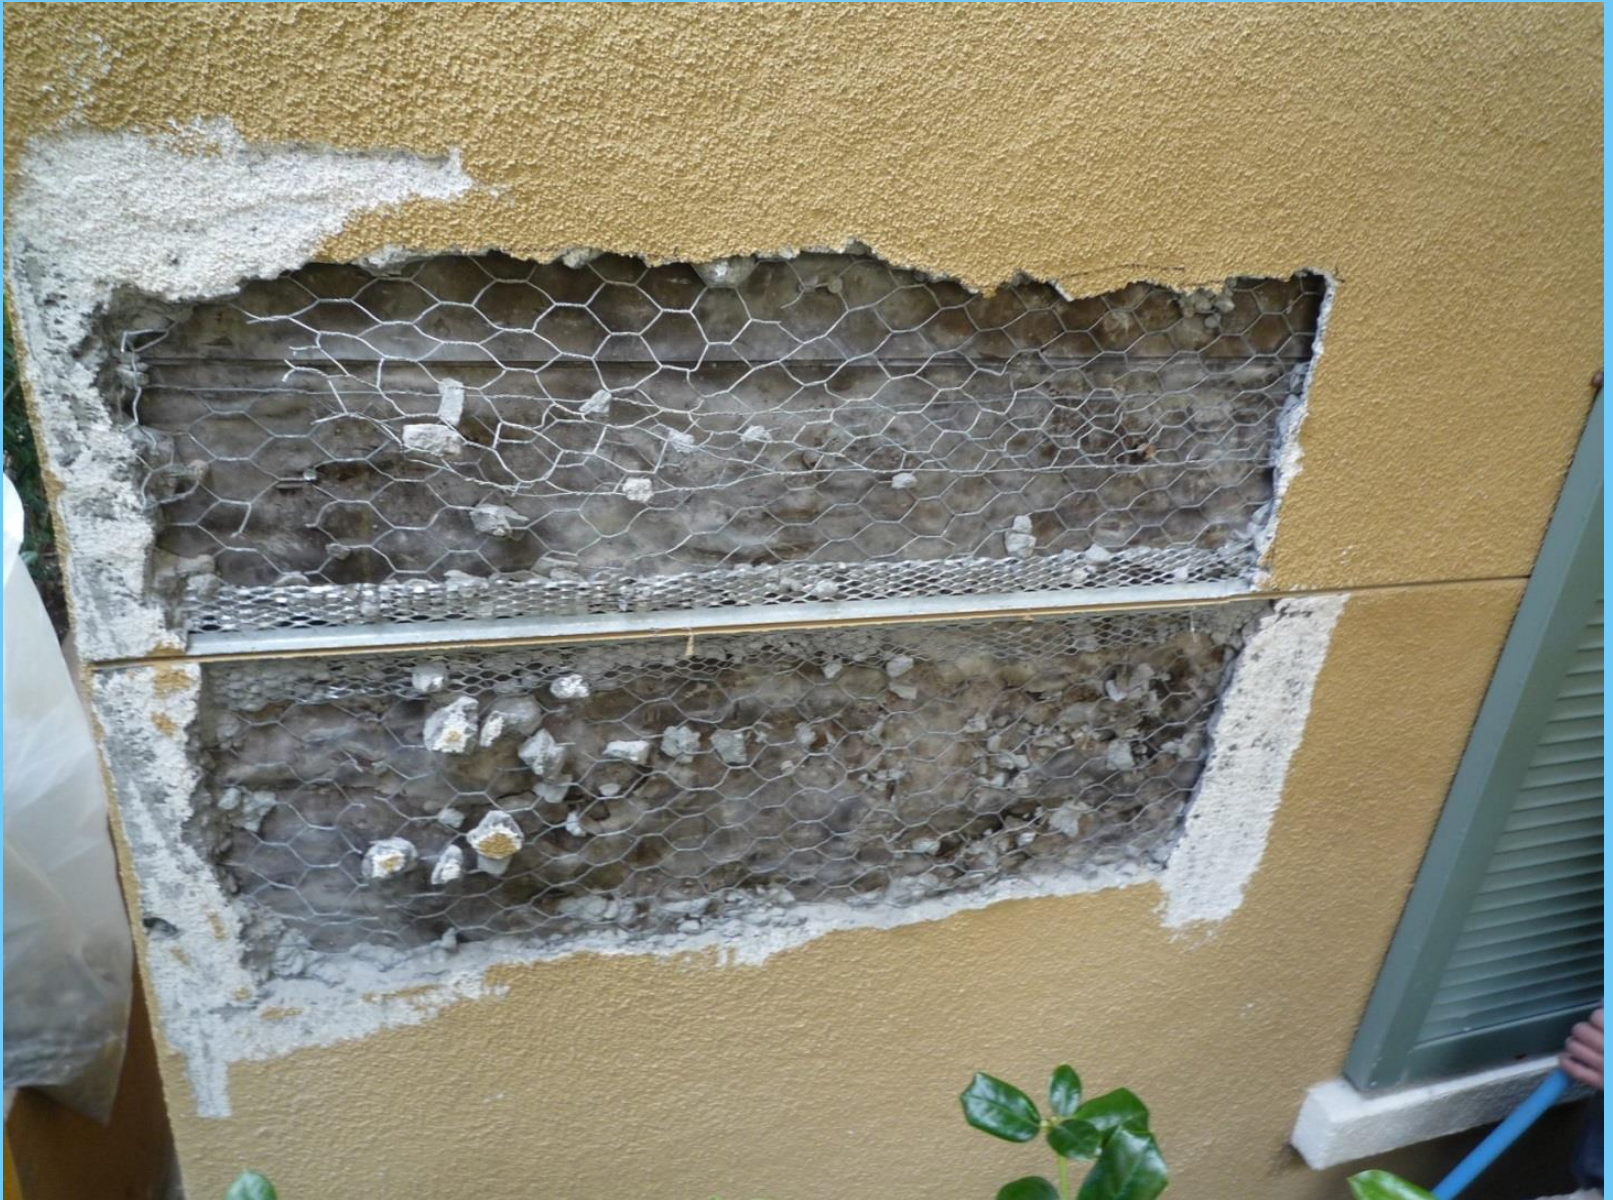
Control Joints Nailed Tight To Paper

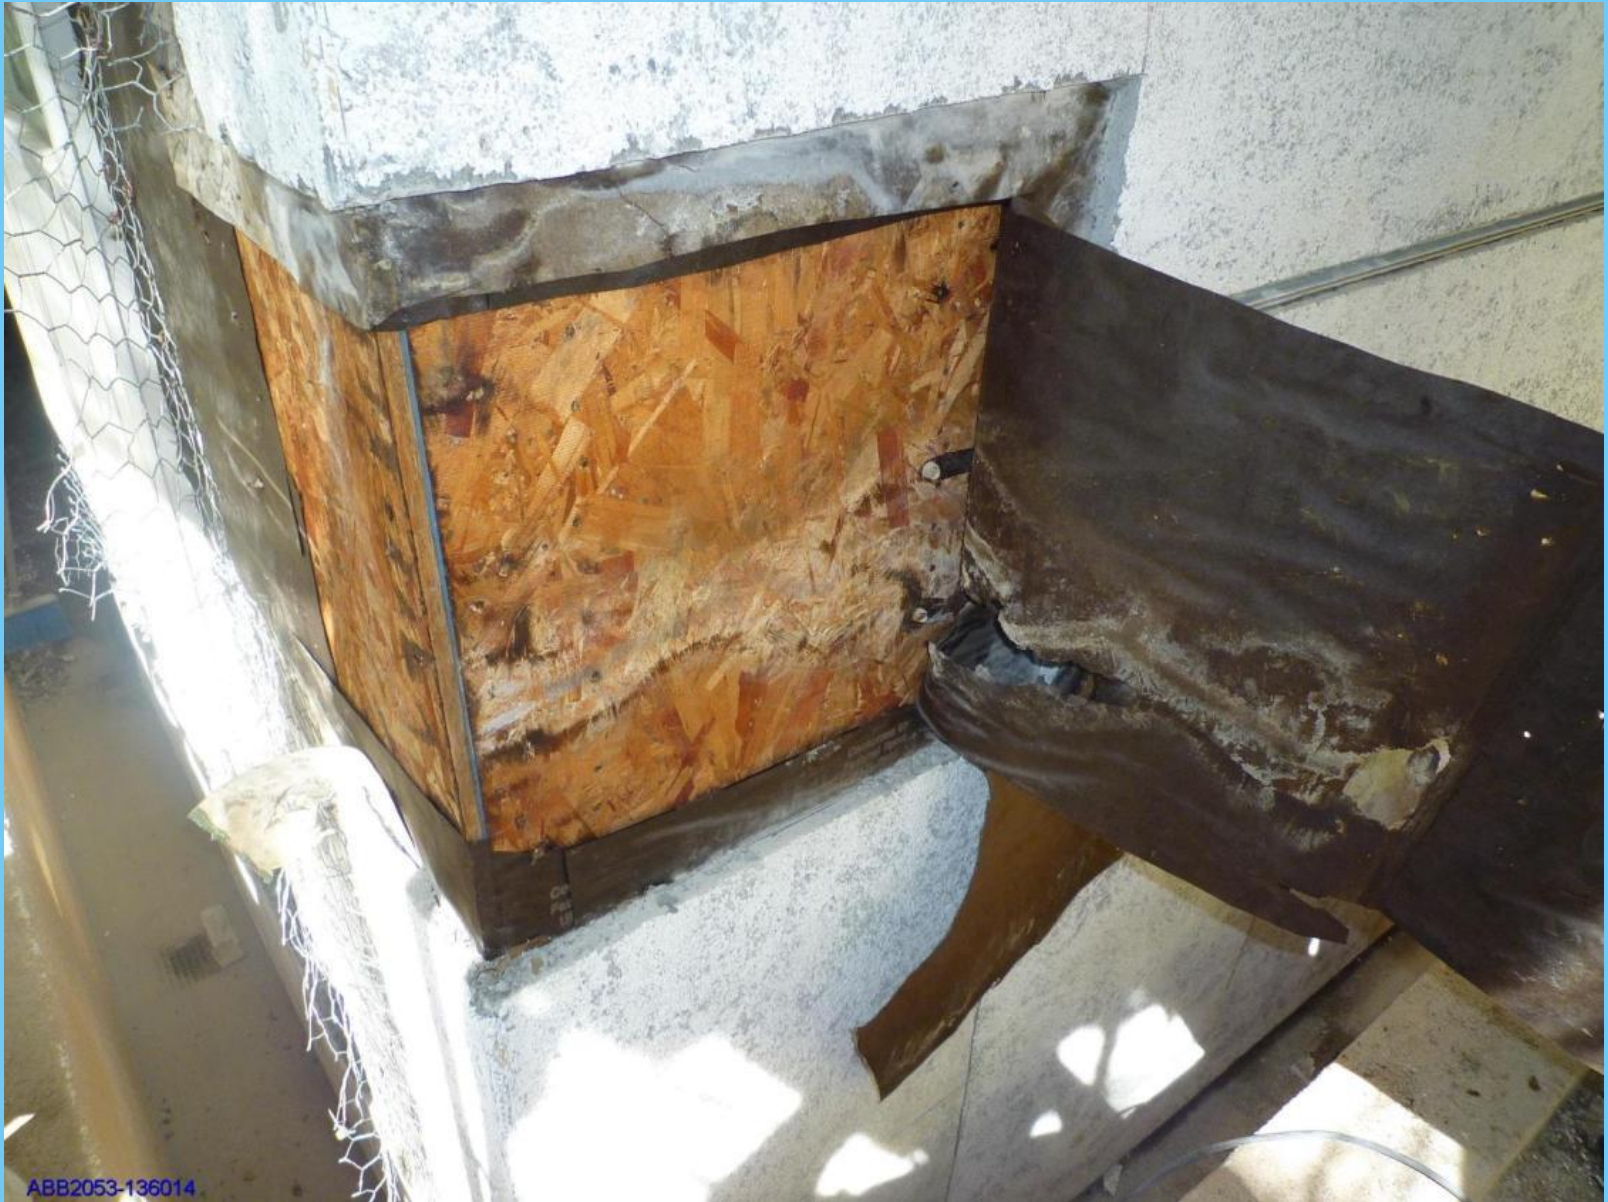
Sources of Water, Corner Mold at Control Joint

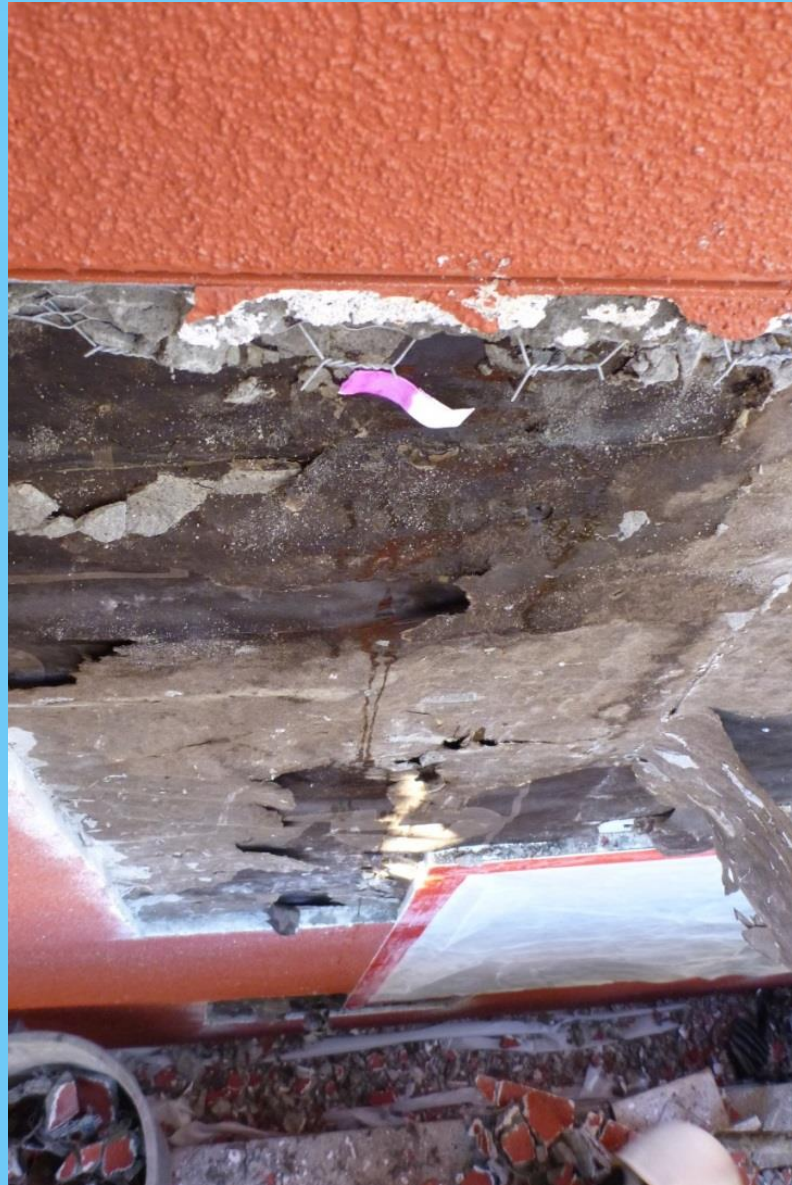
Water Actively Dripping Under Control Joint

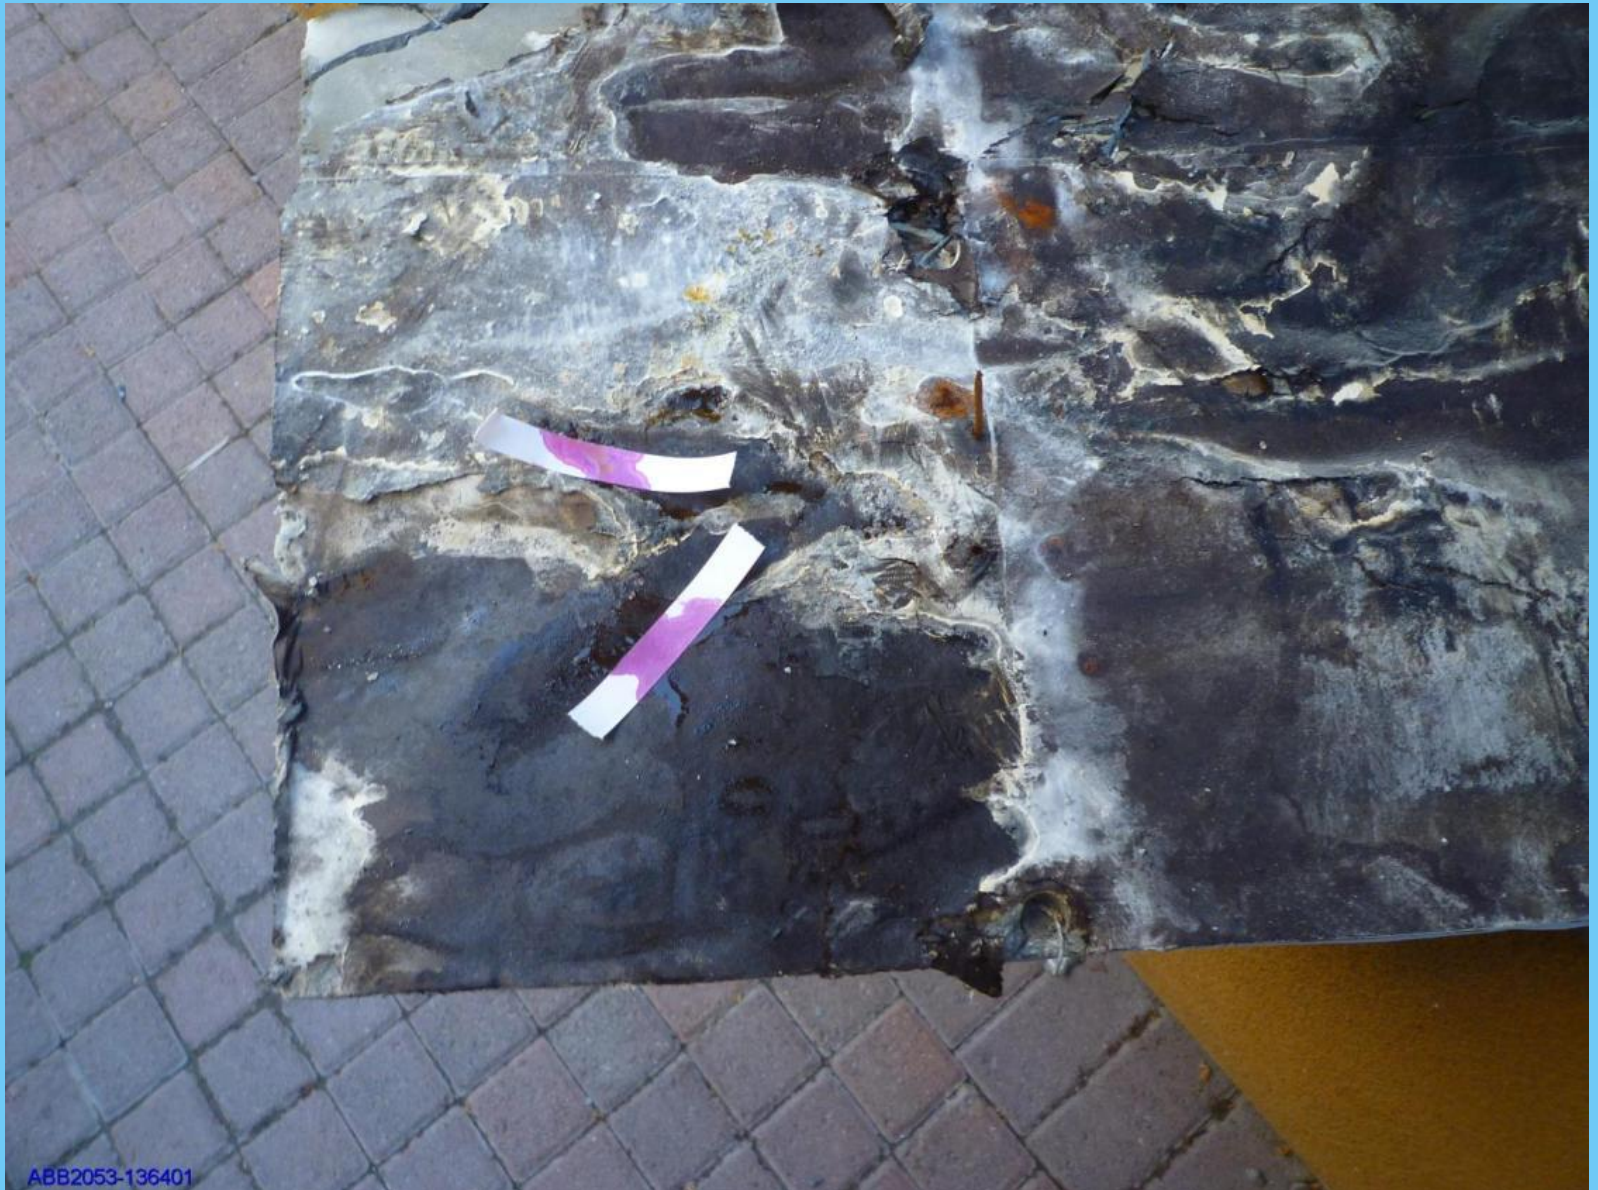
WRB is Completely Saturated

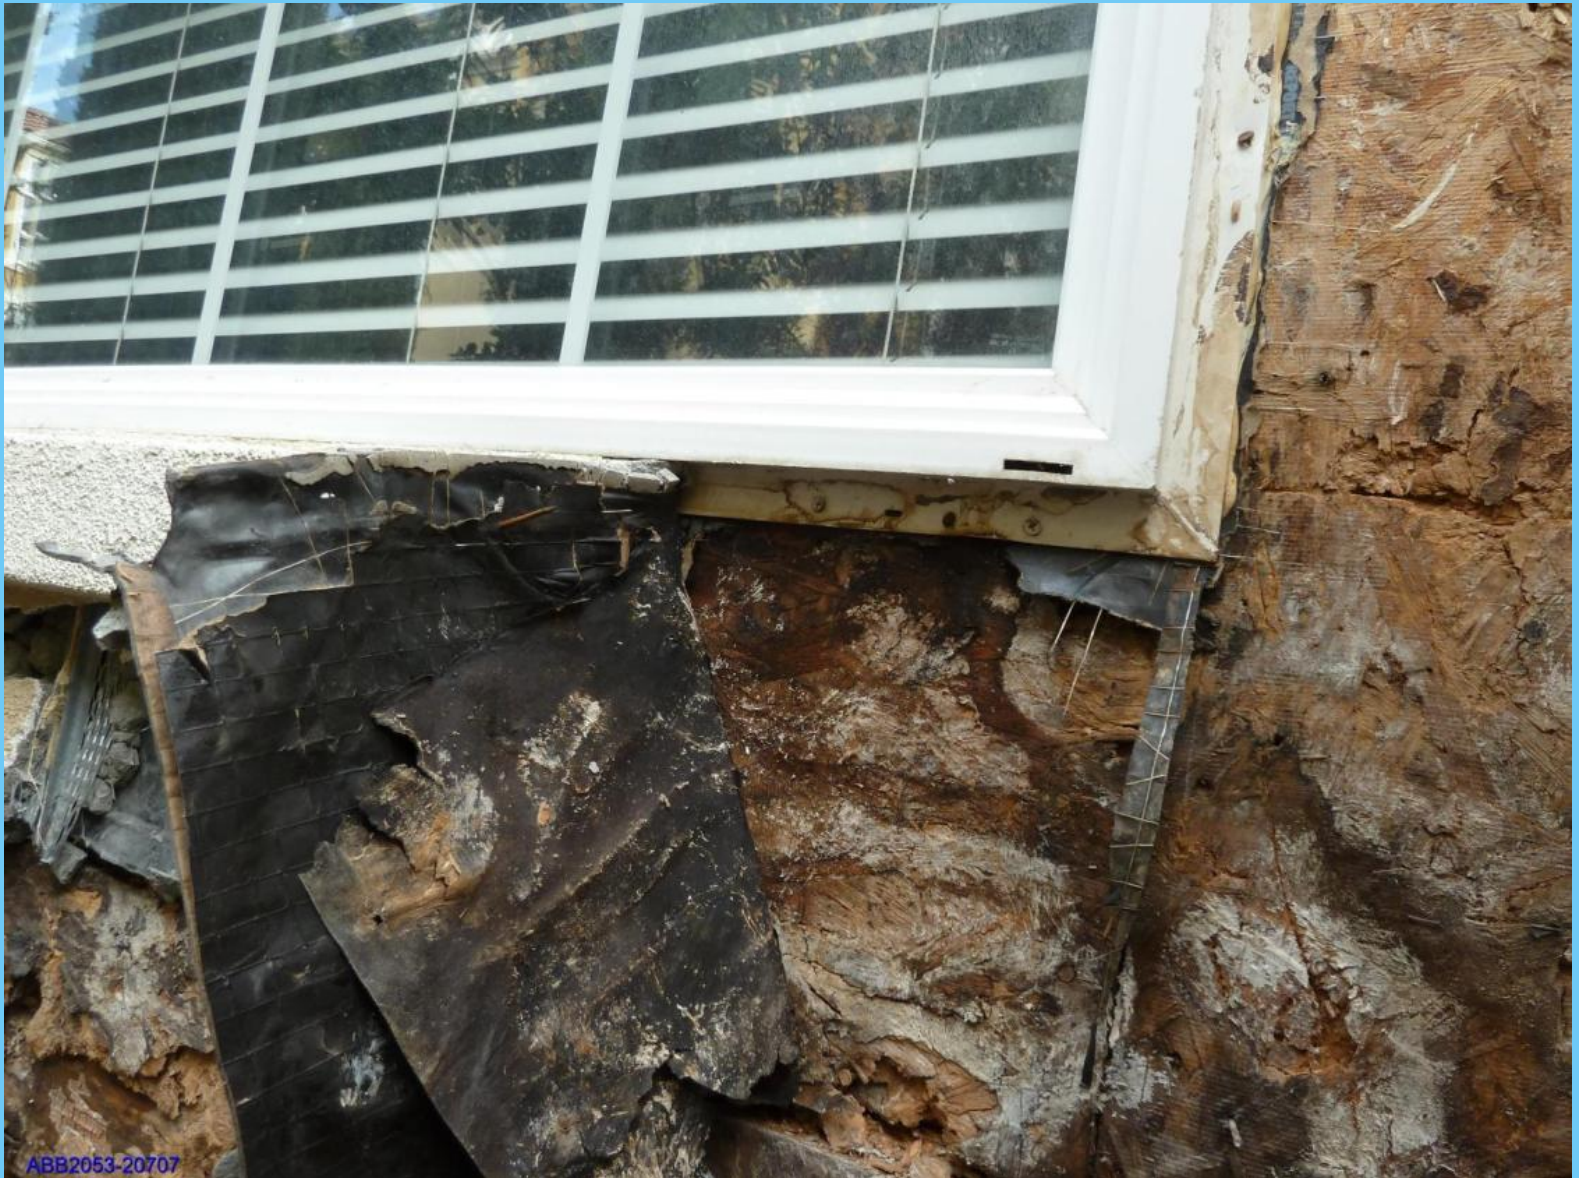
Damage from Window Flashing Issues

ID: Window-2104 LR, Unit: 2104, Window, Severe Damage, Peel and stick installed to face of fin and not adhered

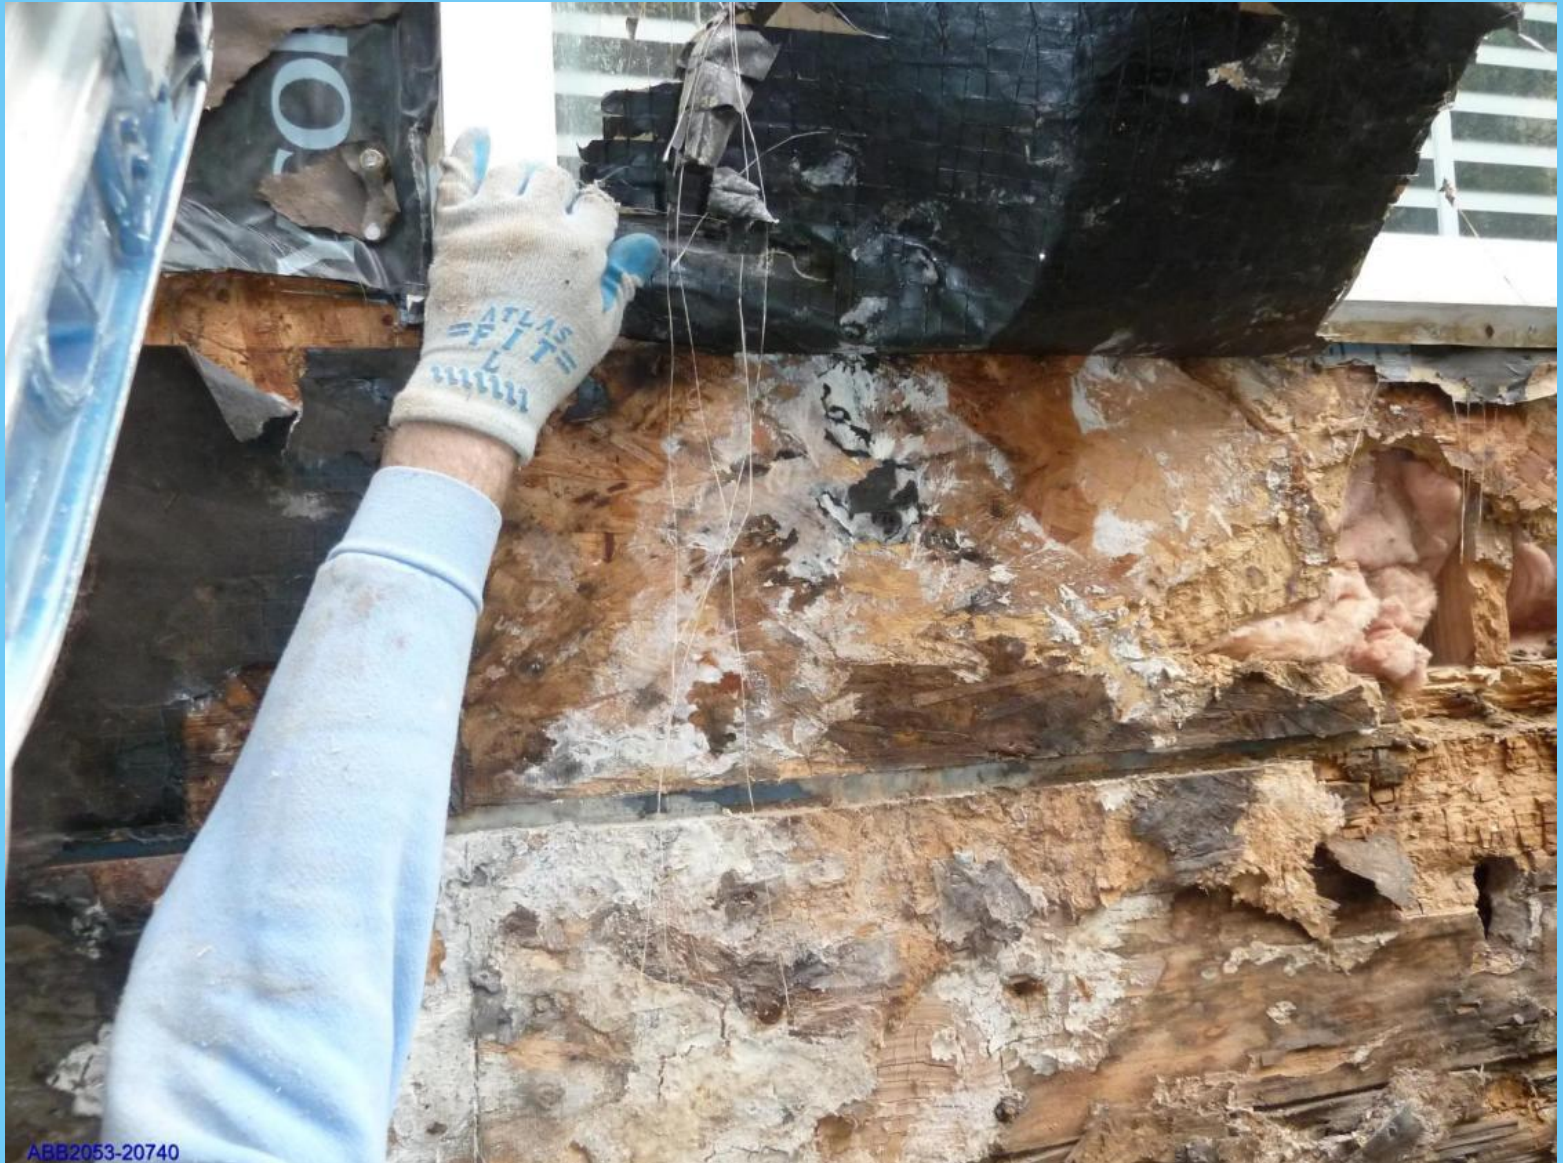
ABB2053-20740

Improperly Installed Window Flexible Flashings

ID: Window-2104 LR, Unit: 2104, Window, Severe Damage, Peel and stick installed to face of fin and not adhered

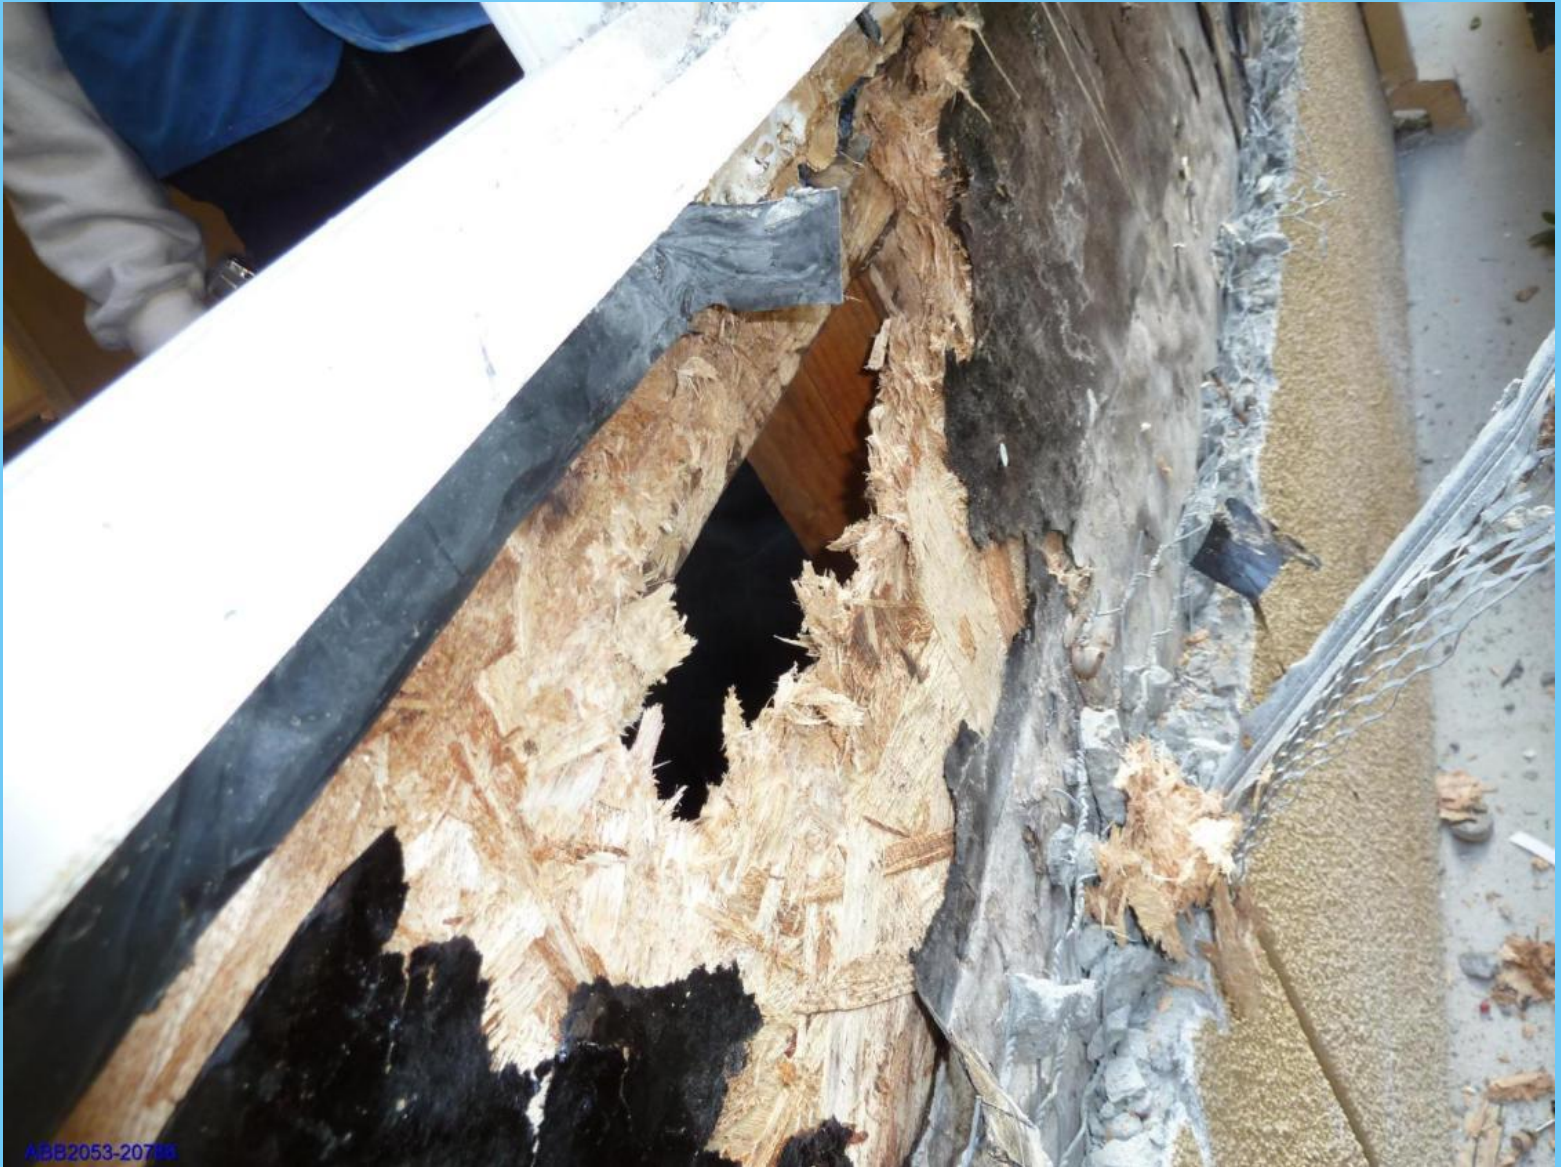
ABB2053-20708

Under Window Damage to OSB

ID: Window-3108, Unit: 3108, Window

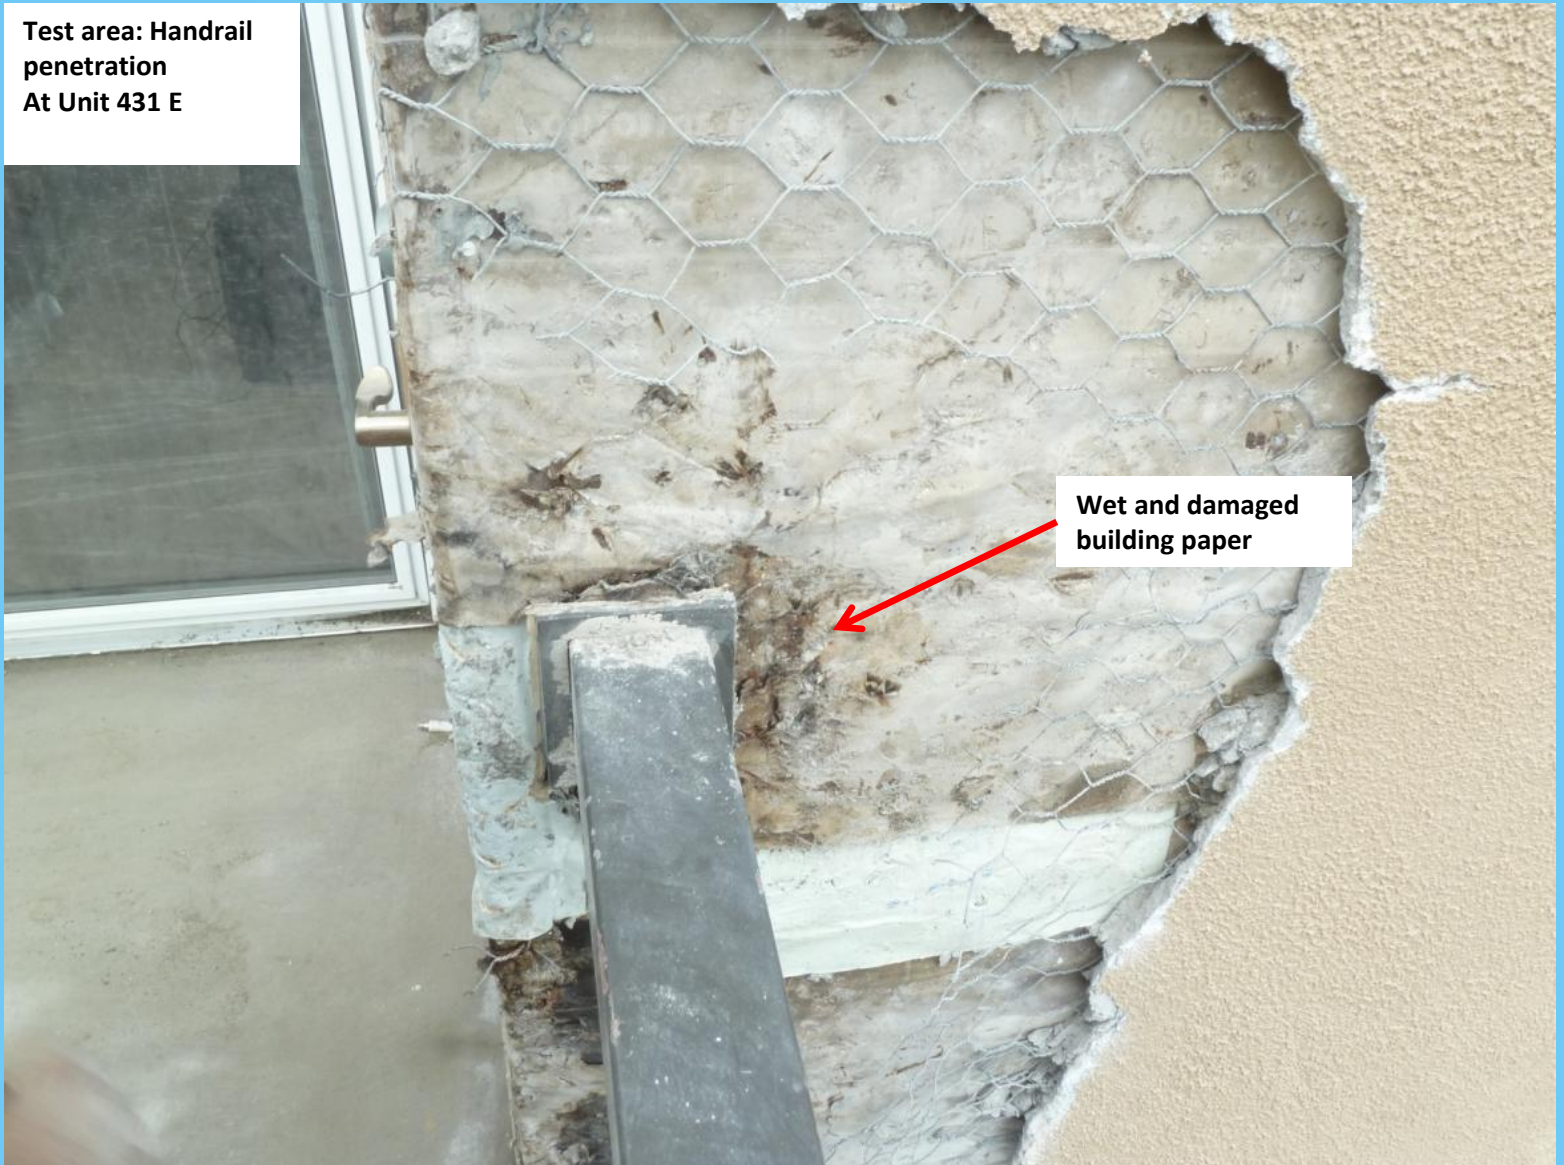
Stucco Demo at Handrail Penetration

Test area: Handrail
penetration
At Unit 431 E

Wet and damaged
building paper
