Building Envelope Technology Symposium

Performance of Weather Resistant Barriers in Stucco Assembly

Karim P. Allana, PE, RRC, RWC

Allana Buick & Bers, Inc.

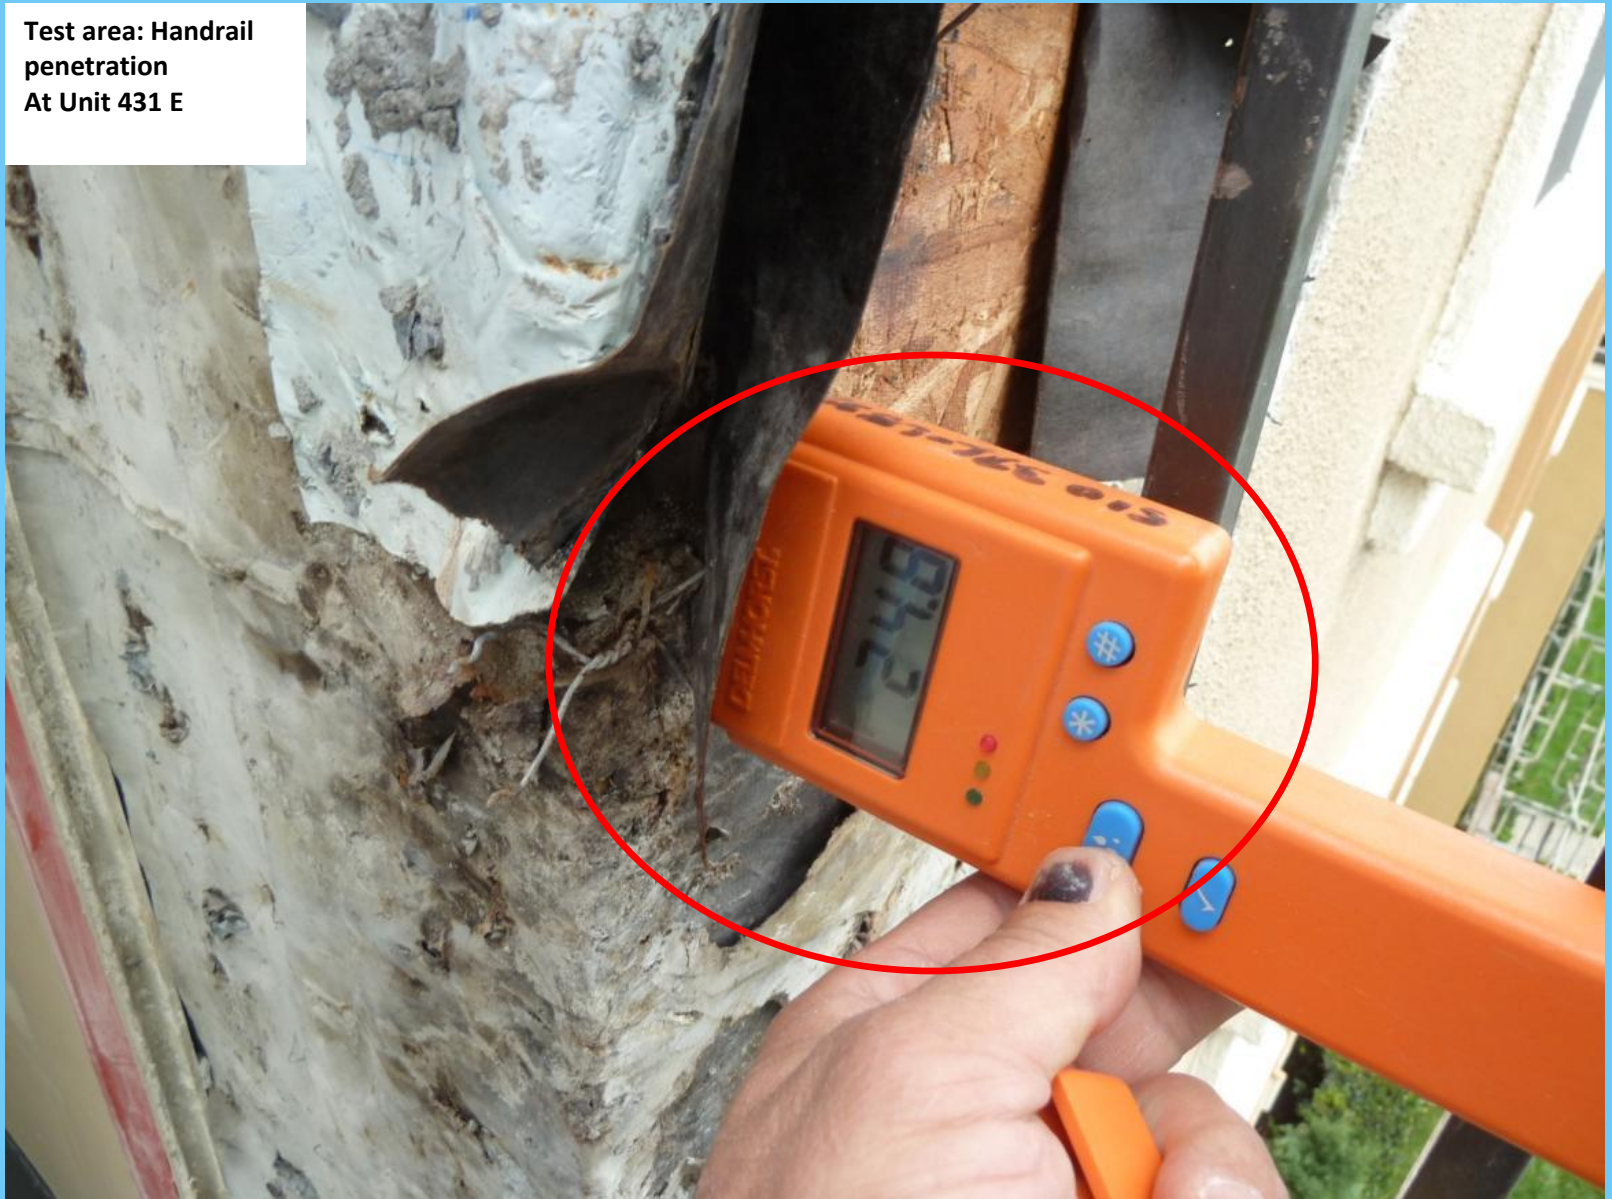
High Moisture Content in OSB 24.8%

Test area: Handrail
penetration
At Unit 431 E

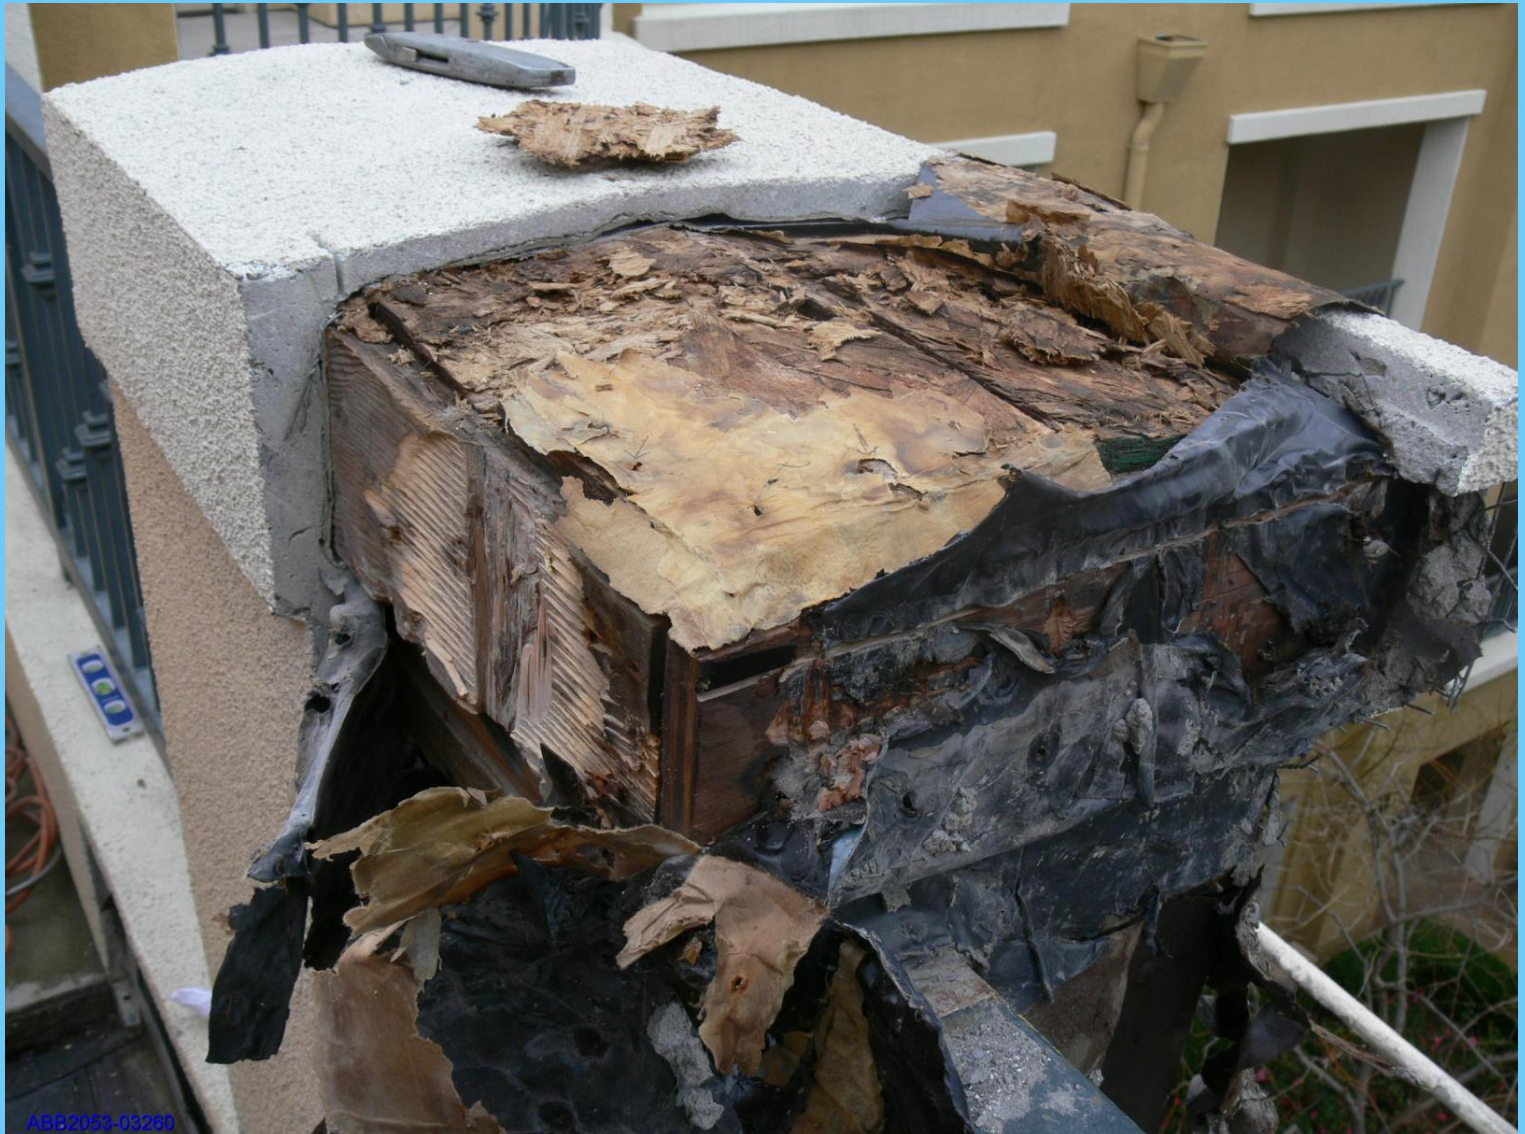
ABB2053-03260

Horizontal Areas Of Plaster

ID: Walkway-1406, Unit: 1406, Scupper at Walkway

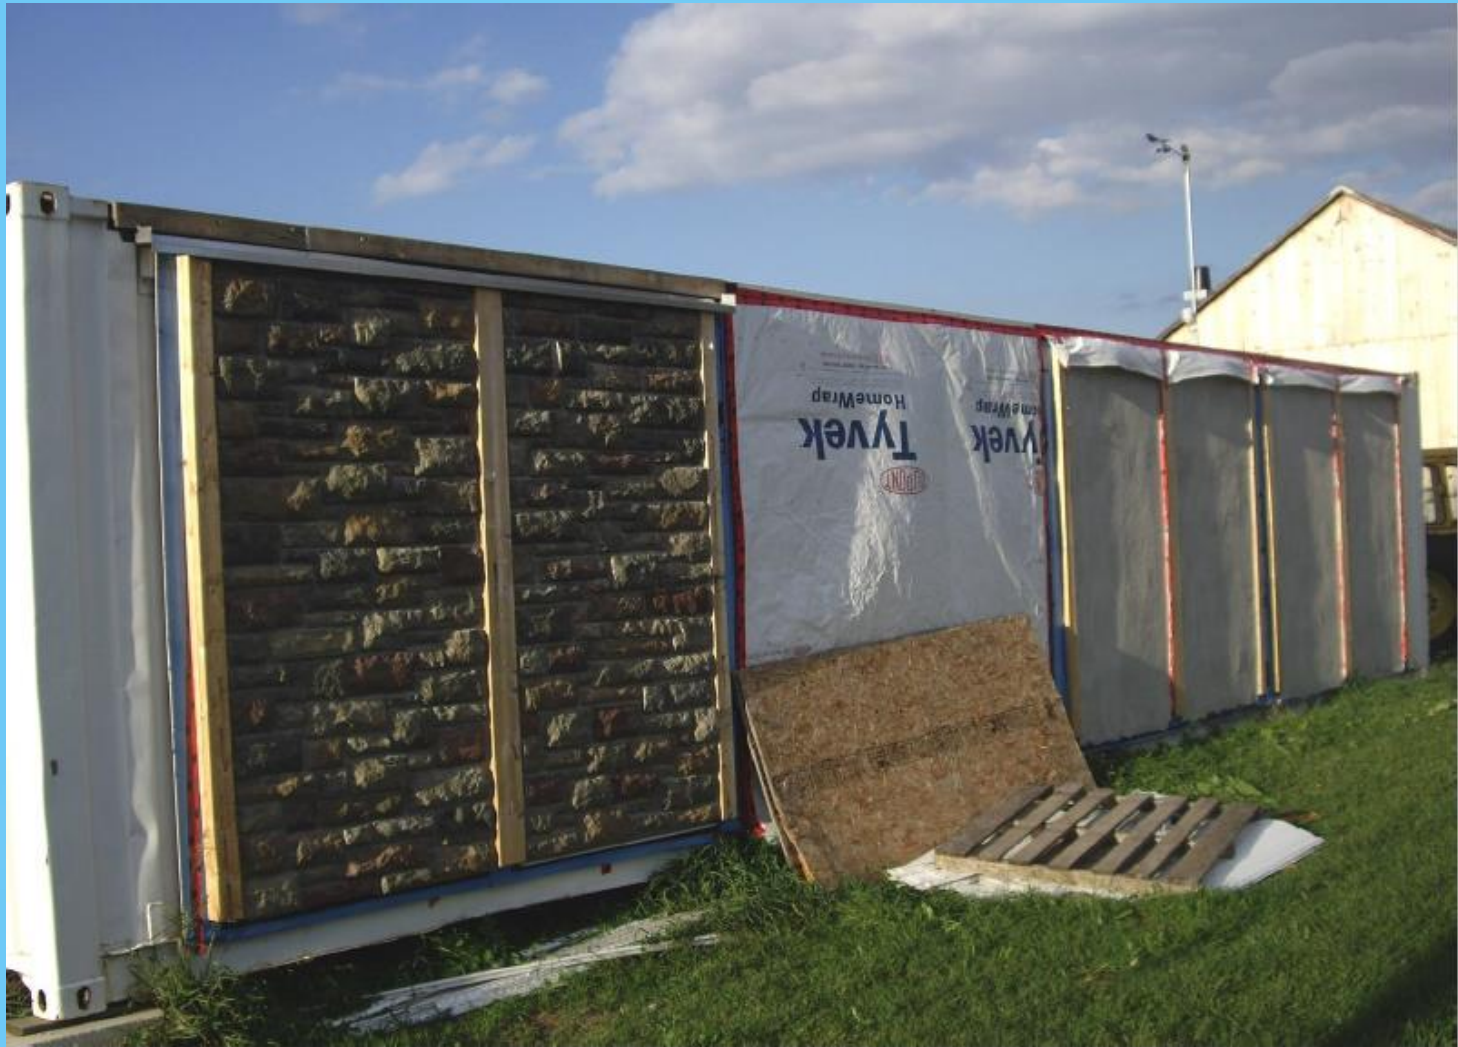
Field Performance Testing South Carolina

Field performance testing at testhut in Waterloo, ON
Dr. John Straube, Building Science Corporation

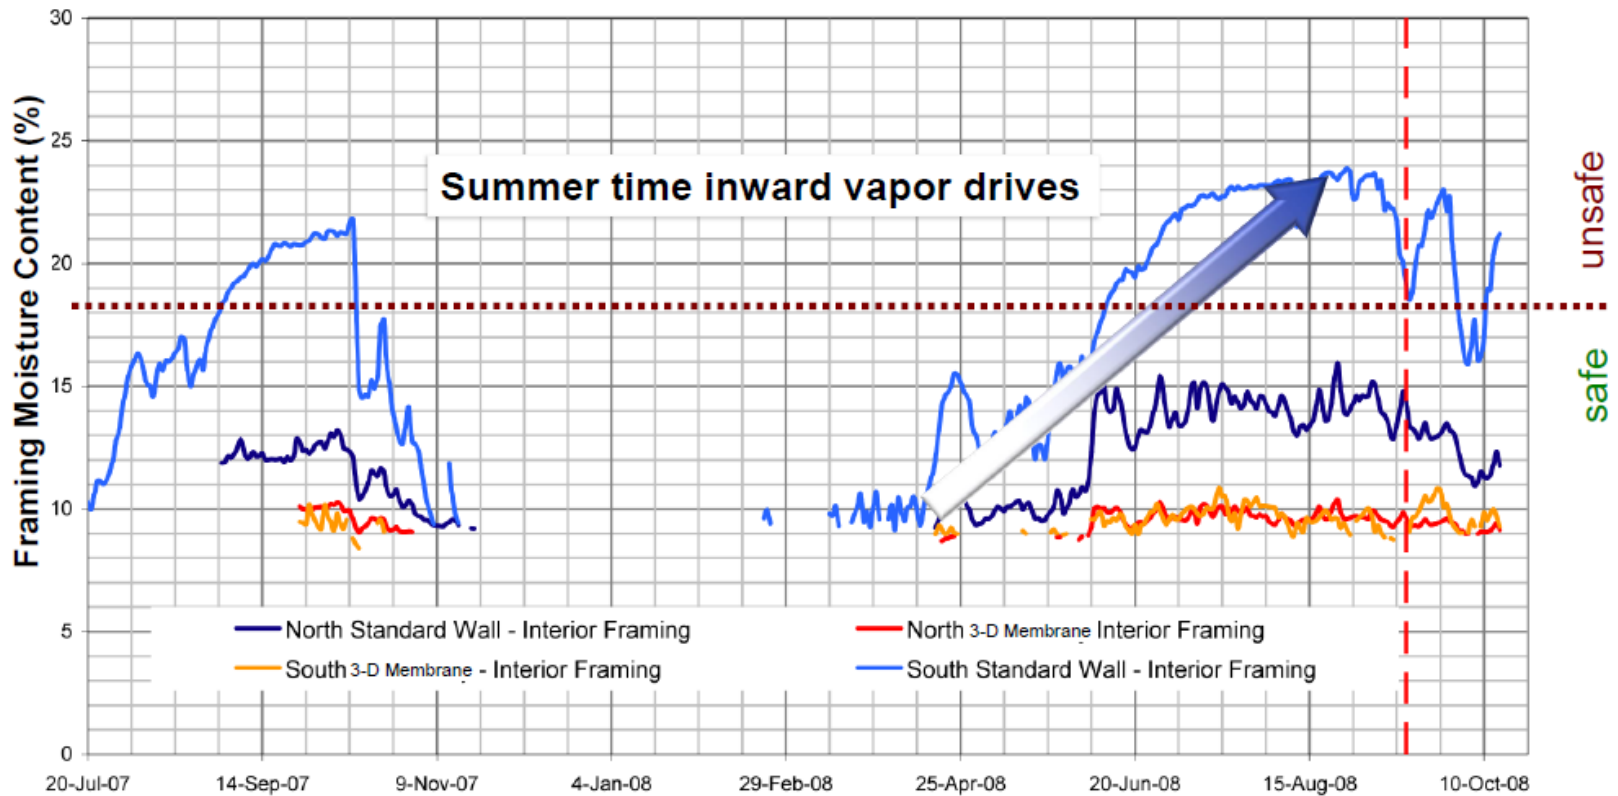
Absorption of Water Can Lead To Damage

Framing Moisture Content

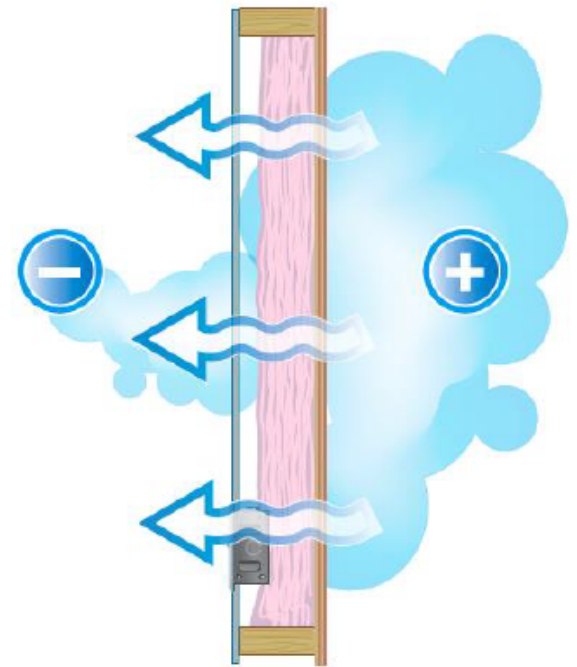
Vapor diffusion is driven by
Vapor Pressure Differentials

If moisture content in air is different inside and outside of a wall, vapor diffusion will occur until the vapor pressure differential is eliminated (equal vapor pressure on either side of the wall)

Resistance to vapor diffusion depends on water vapor permeance of materials
(perm rating)

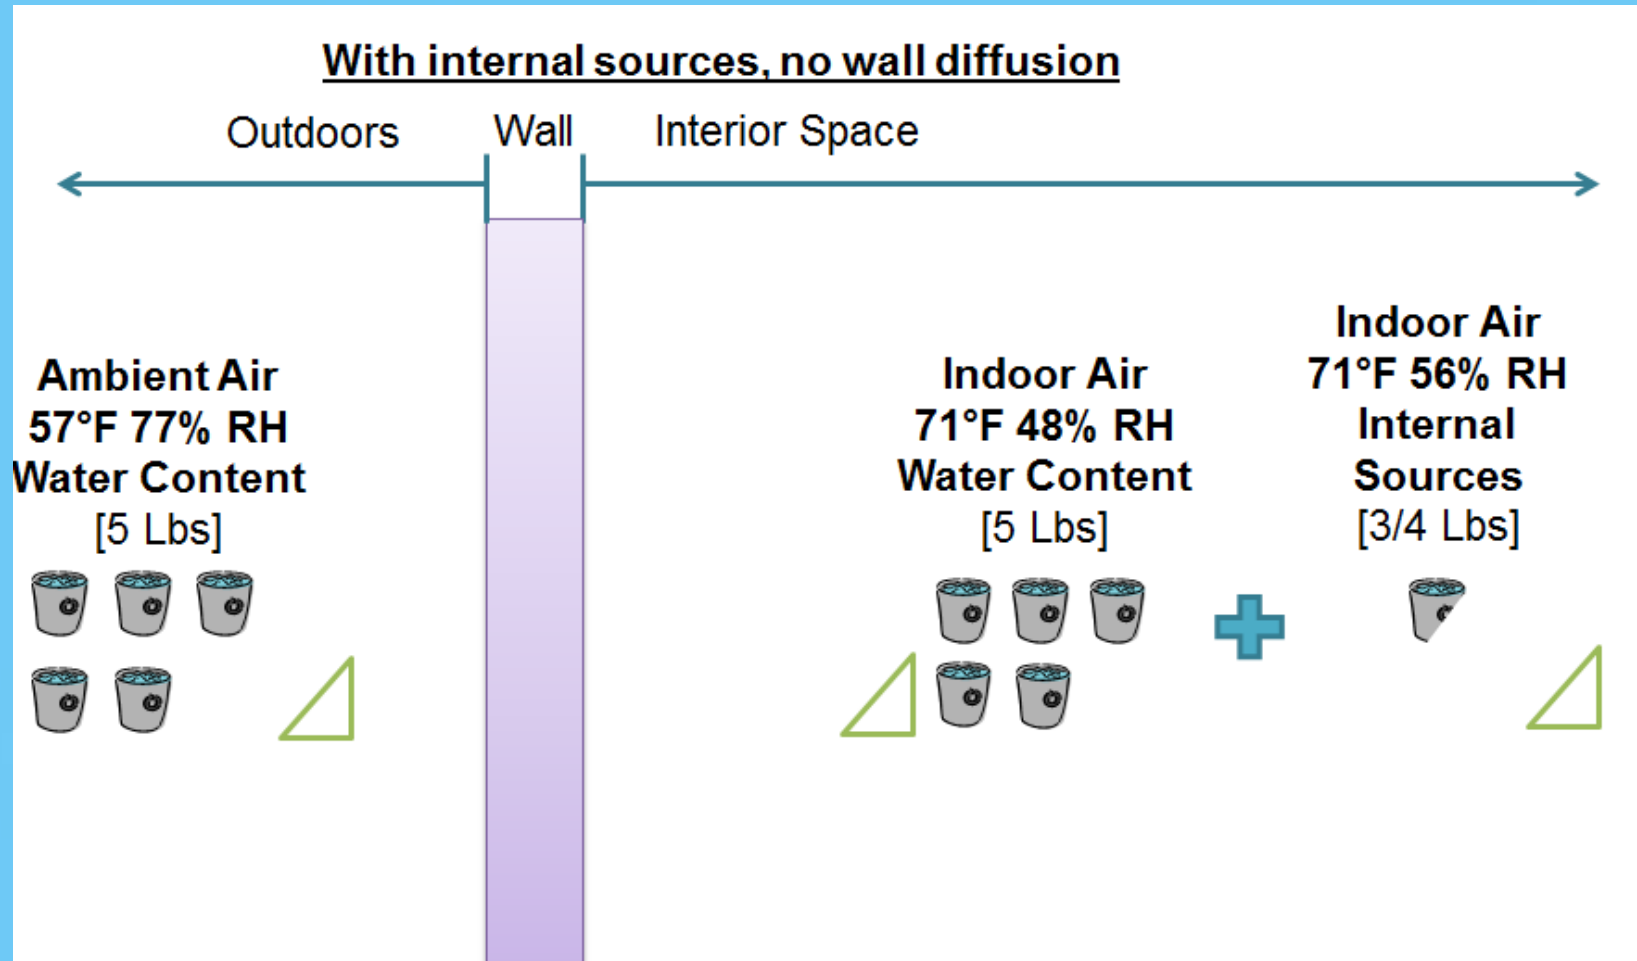
- **Actual conditions measured in a 2 bedroom residential unit:**
 - 937 sq. ft.
- **Natural ambient air moisture content:**
 - 57°F dry bulb, 77% relative humidity
- **Interior space room conditions:**
 - 71°F dry bulb, 80% relative humidity
- **Internal moisture sources include:**
 - (2) 15 min. showers a day
 - (1) 10 min. boiling pots a day
 - (1) 20 min. hand dish washing
 - 12 hours of person seated at rest
 - 2 hours of person at moderate work
 - 1 hours of person at light exercise

Moisture Diffusion Study Results

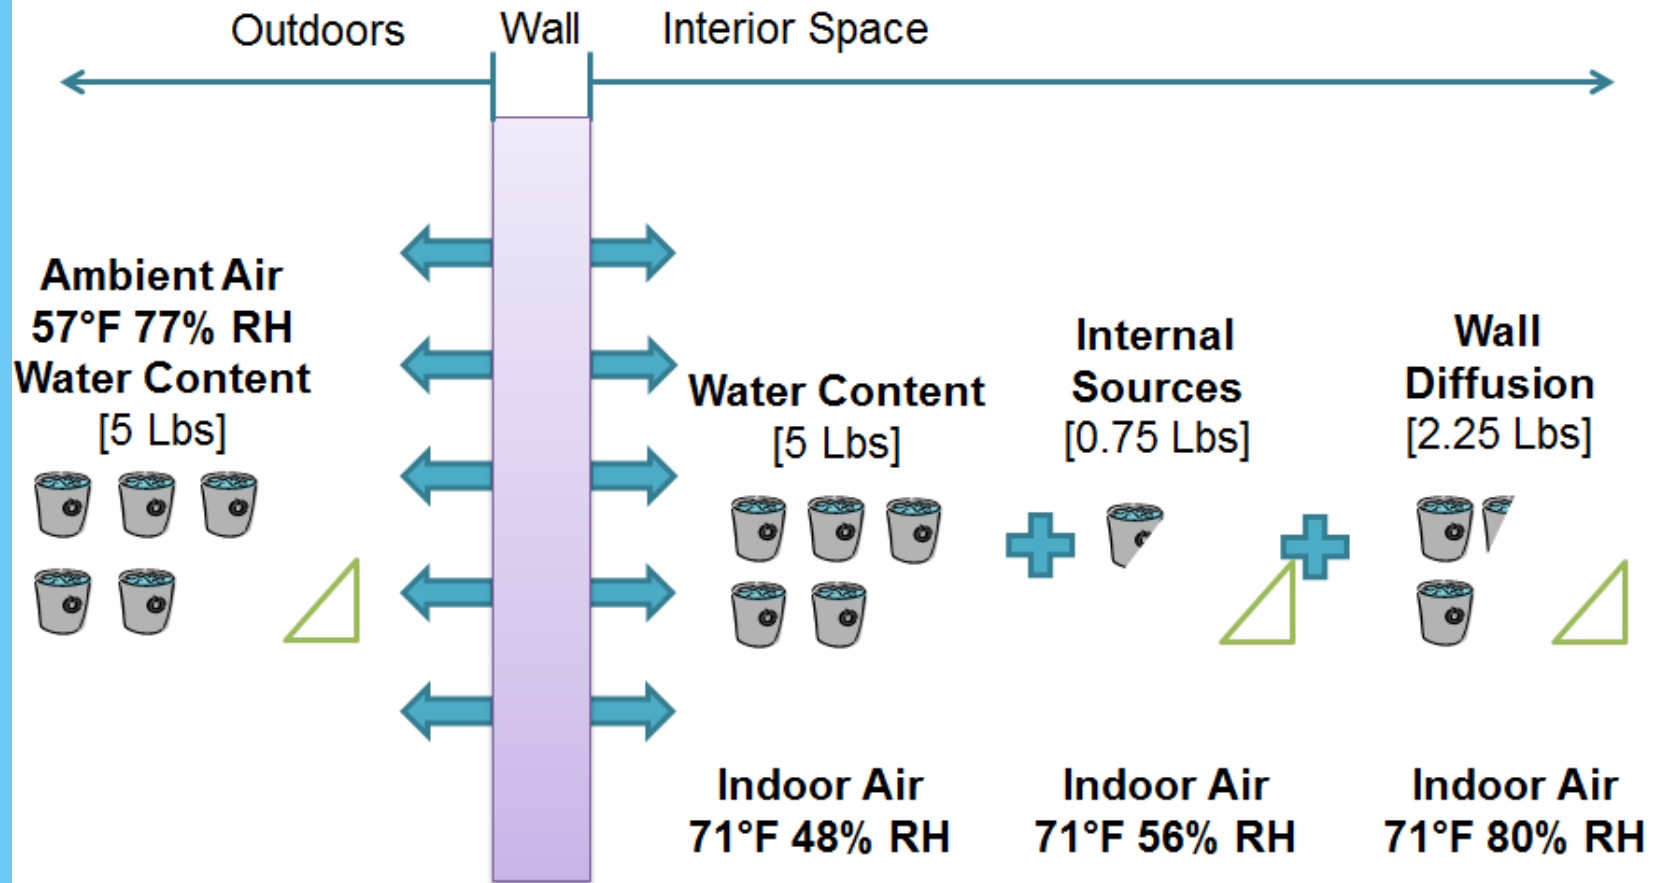
Moisture Diffusion Study Results

With internal sources + wall diffusion due to excessive cracking and defects

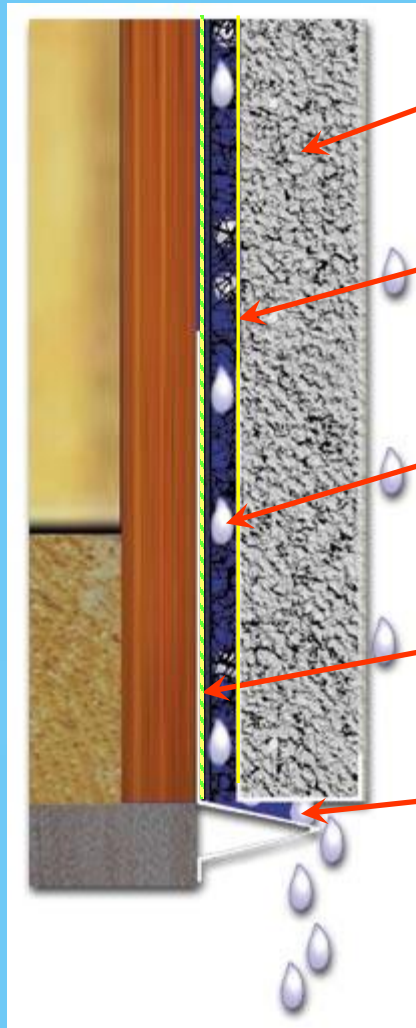
Moisture Management System With Drain Mat

Exterior cement plaster

Outboard moisture barrier

Drainage cavity

Inboard moisture barrier

Weep provision

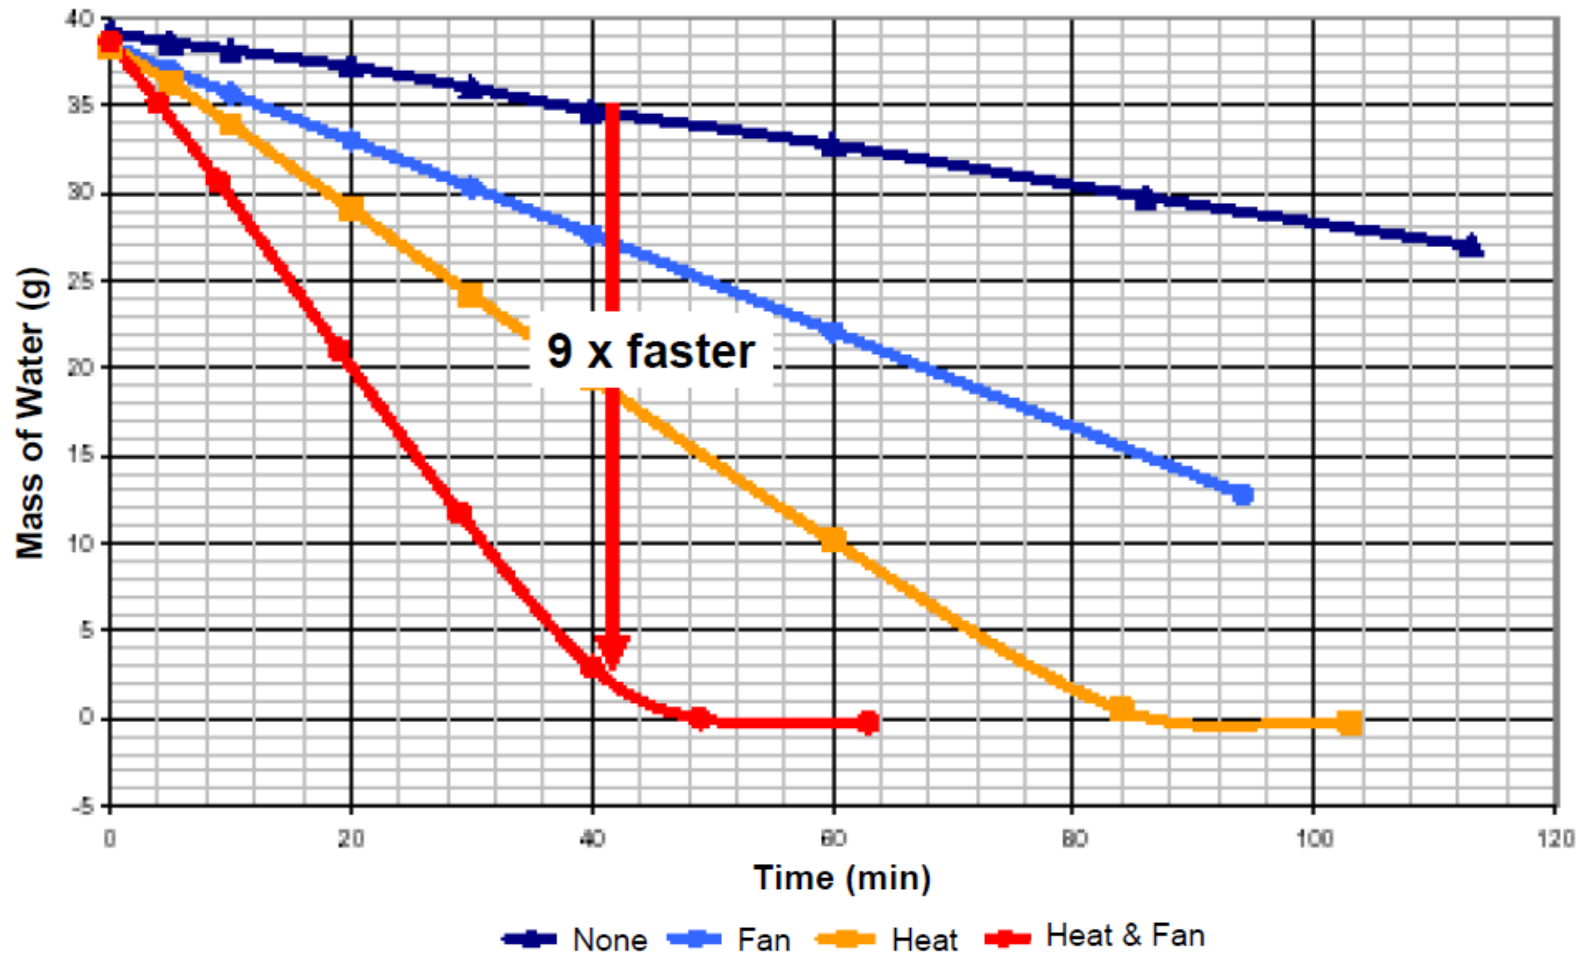
Paper Towel Wetting Analysis (Dr. Straube)

Comparison of different Drying Techniques on Paper Towel Wetting

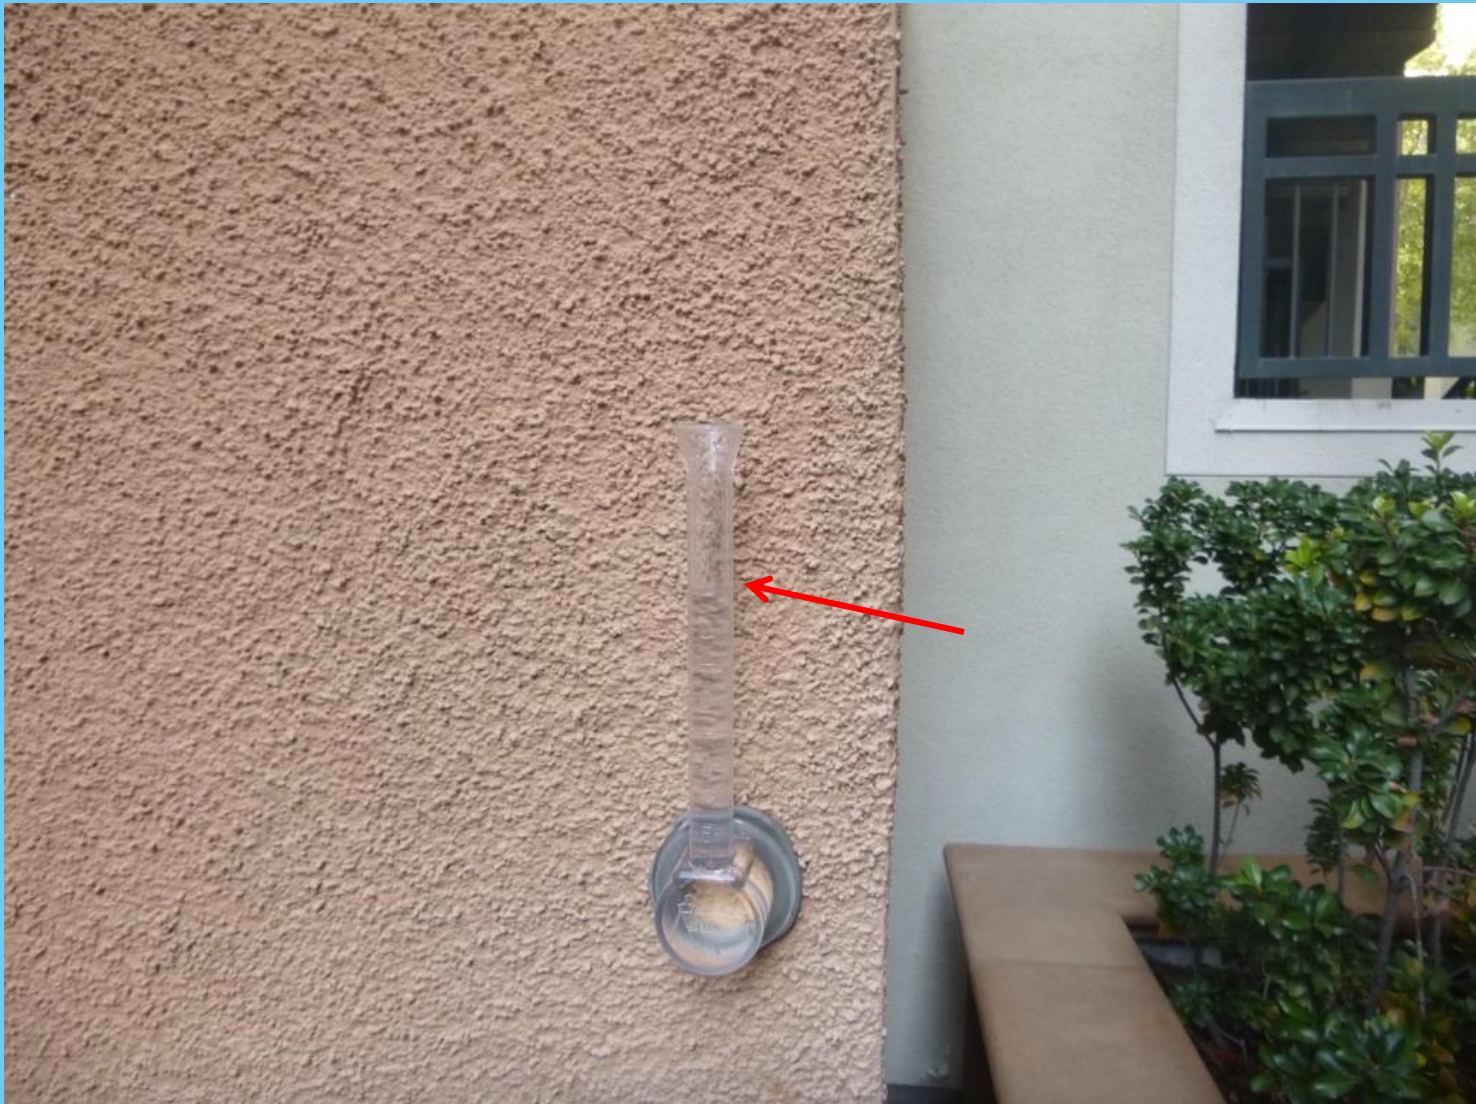
Pines B2 - Water Dropped Almost Immediately

Building 4-Location 8-A. Water dropped to a level almost immediately before we could take a photo of full tube.

- **Pines B-2**
 - 11/18 locations significantly lost water = 61%
- **Pines B-1 STO Finish**
 - No locations lost water
- **Pines B-1 BMI Stucco**
 - No locations lost water

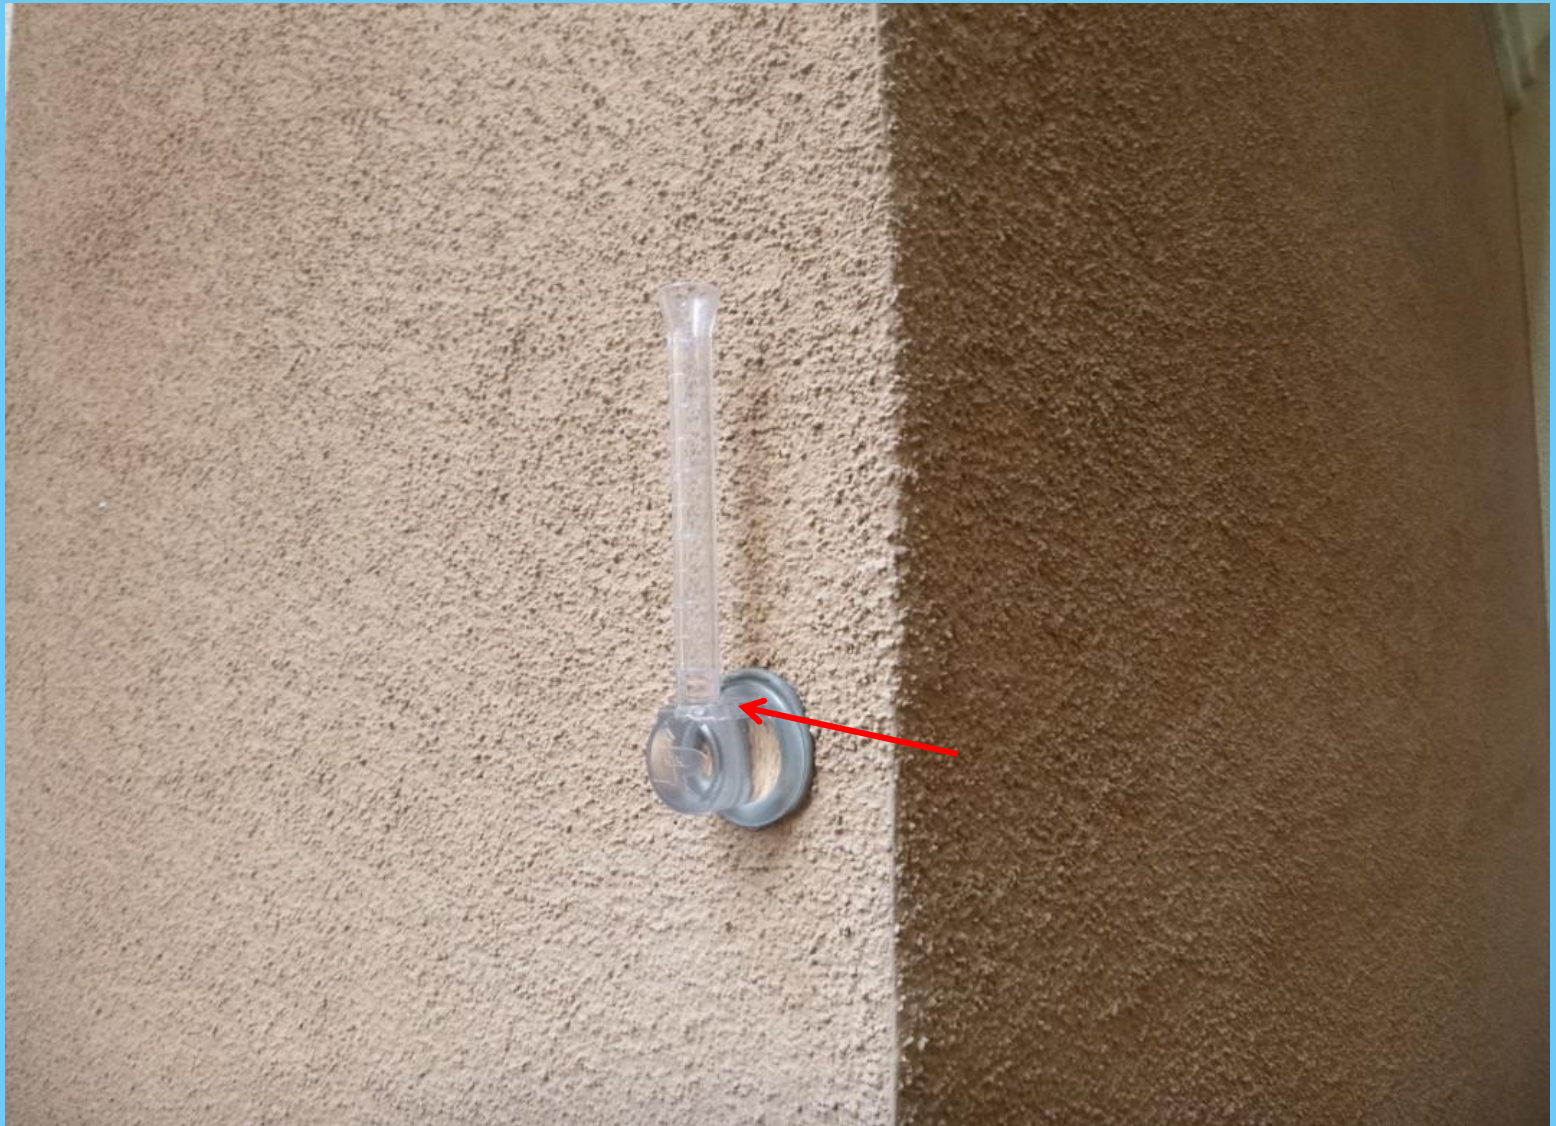
End of Test – In 15 Minutes

Building 4-Location 8-A. Water dropped to bottom of circular body of the tube near the end of the test.

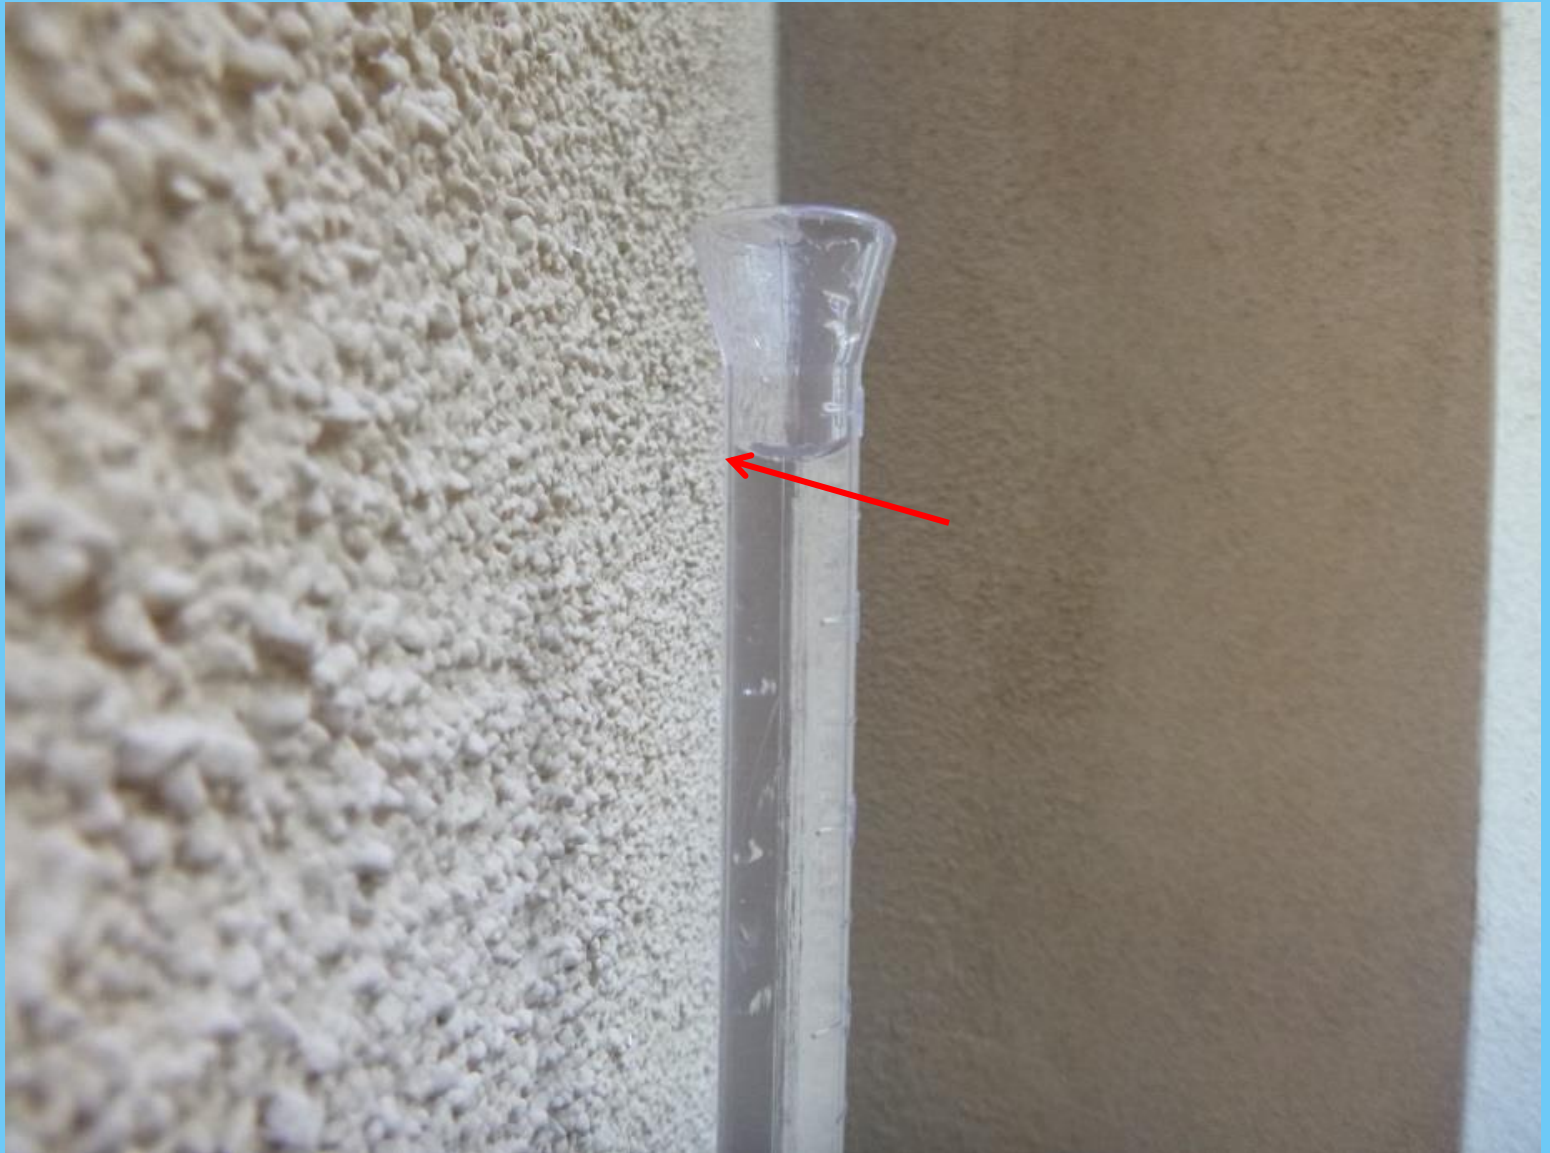
End of Test – In 15 Minutes

Building 3 Location 6-A, full Rilem tube

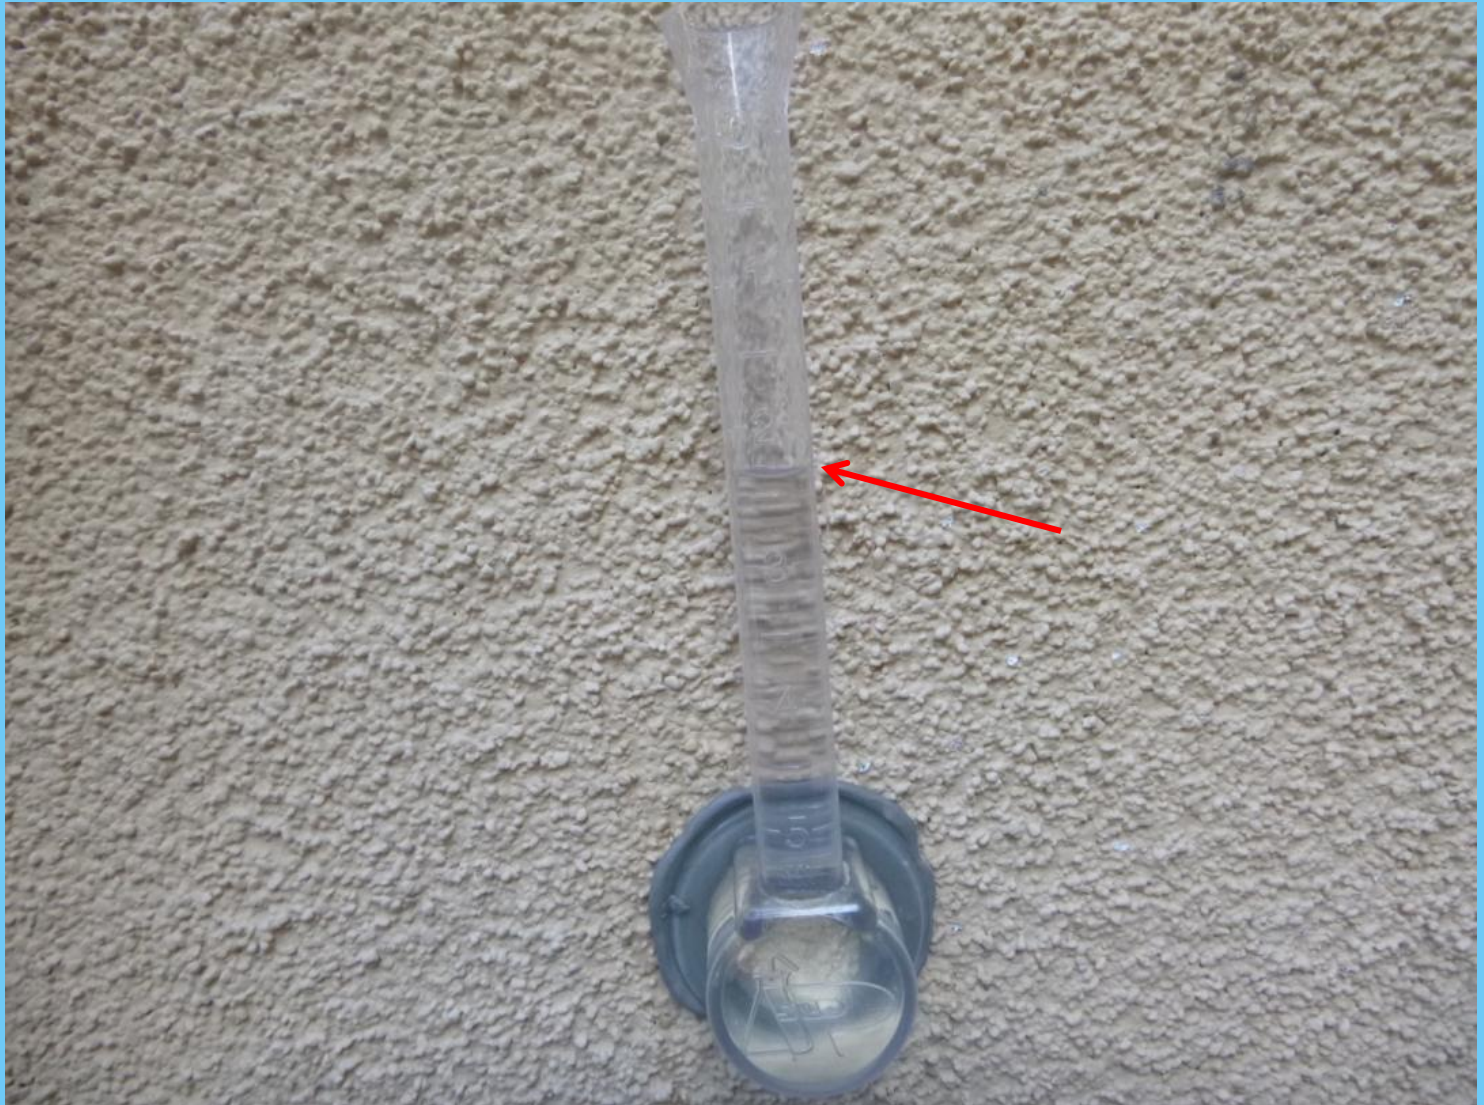
Rilem Tube Level Dropped in 15 min

Building 3 Location 6-A, water level at end of test.

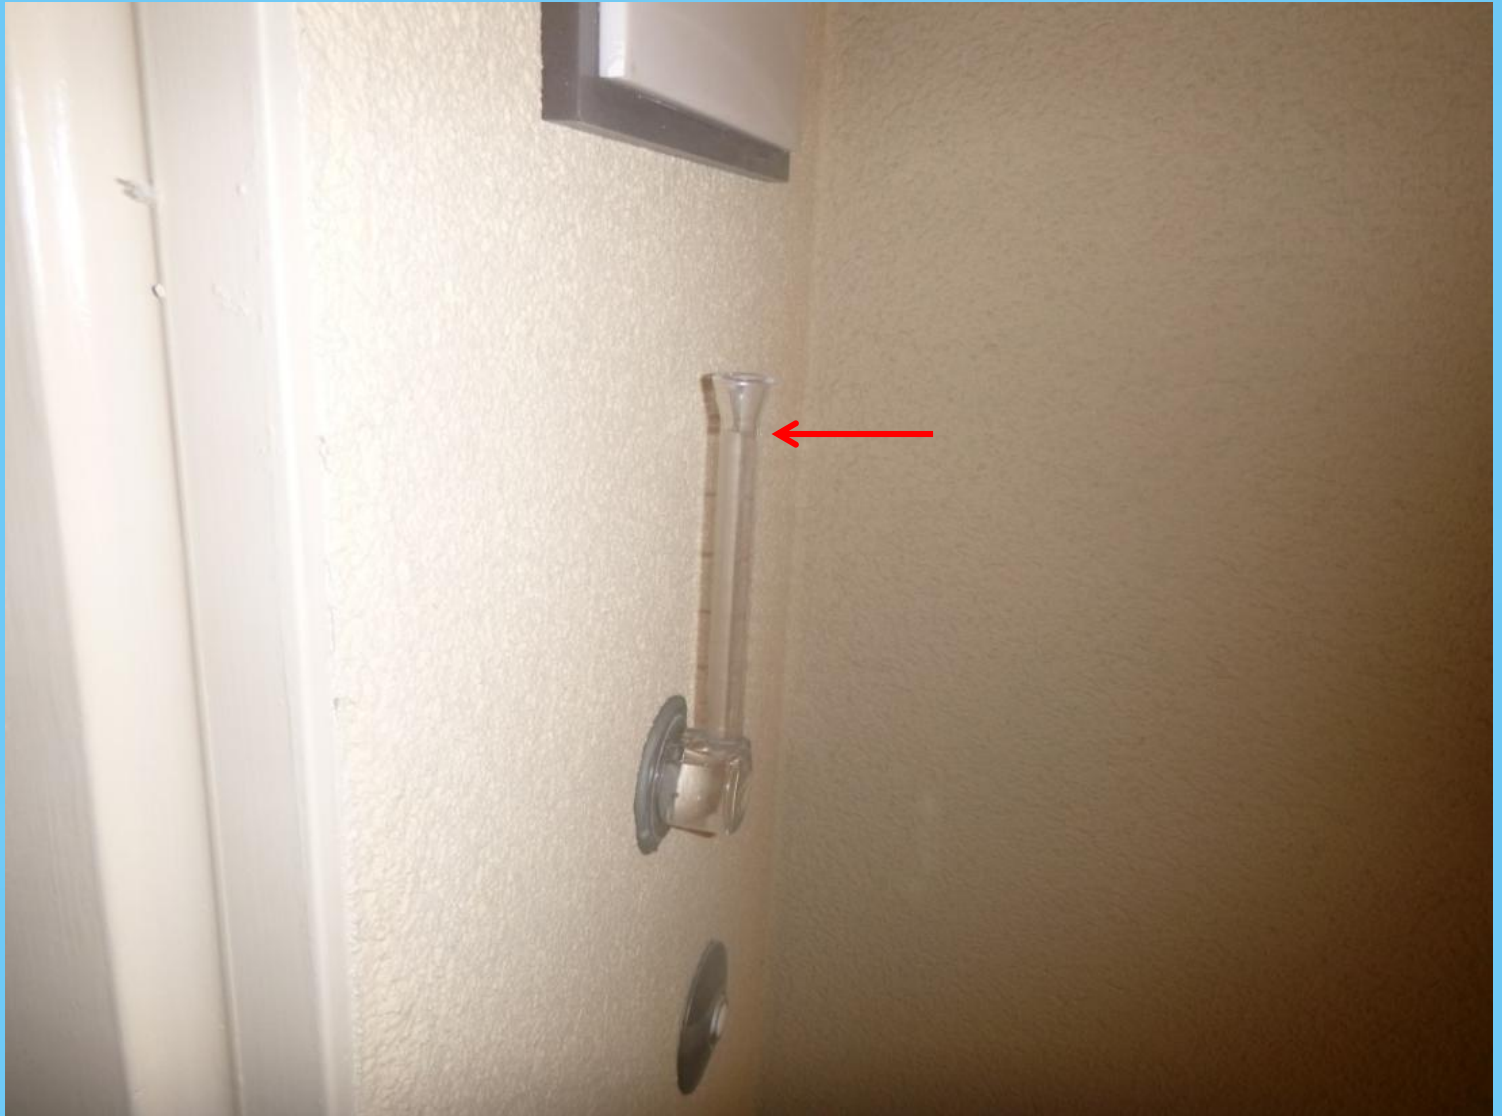
STO Finish - End of Test –Tube Full

Building Pines B-1 Bldg. 1 Unit 1111 Rilem test over new Sto Finish-Tube is full at end of test.

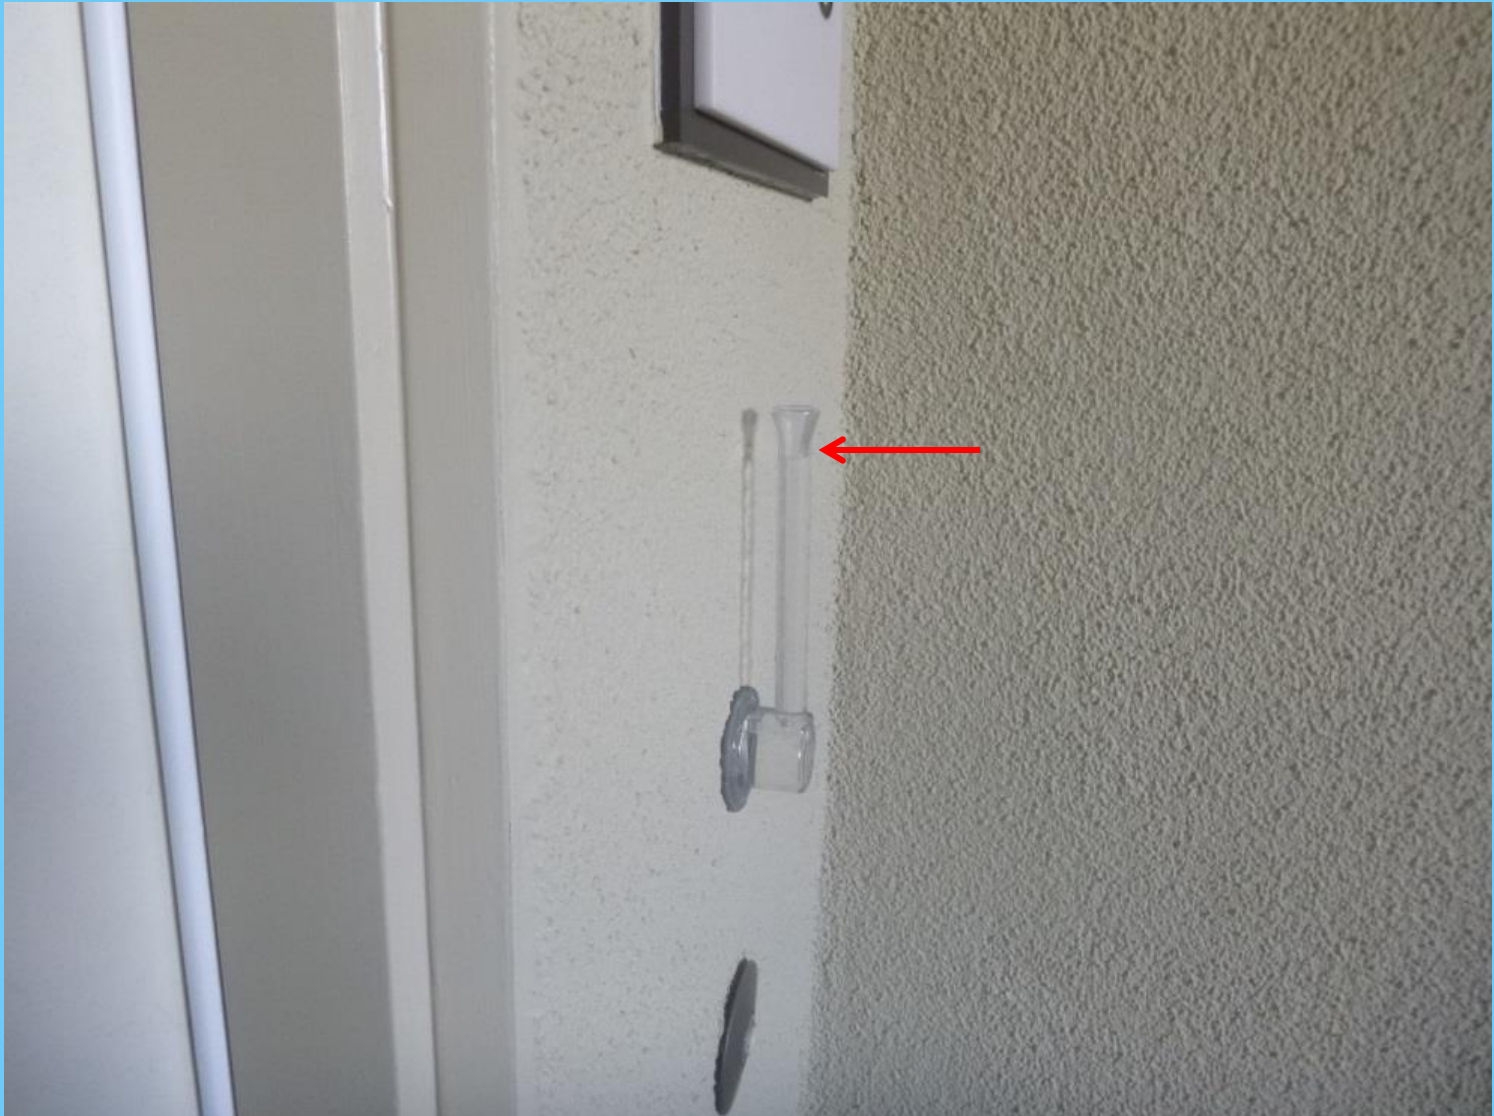
Pre-Mix Stucco - End of Test –Tube Full

Building Pines B-1 Bldg. 2 Unit 2110 Rilem test over new BMI stucco-tube is full at end of test.
