Building Envelope Technology Symposium

Performance of Weather Resistant Barriers in Stucco Assembly

Karim P. Allana, PE, RRC, RWC

Allana Buick & Bers, Inc.

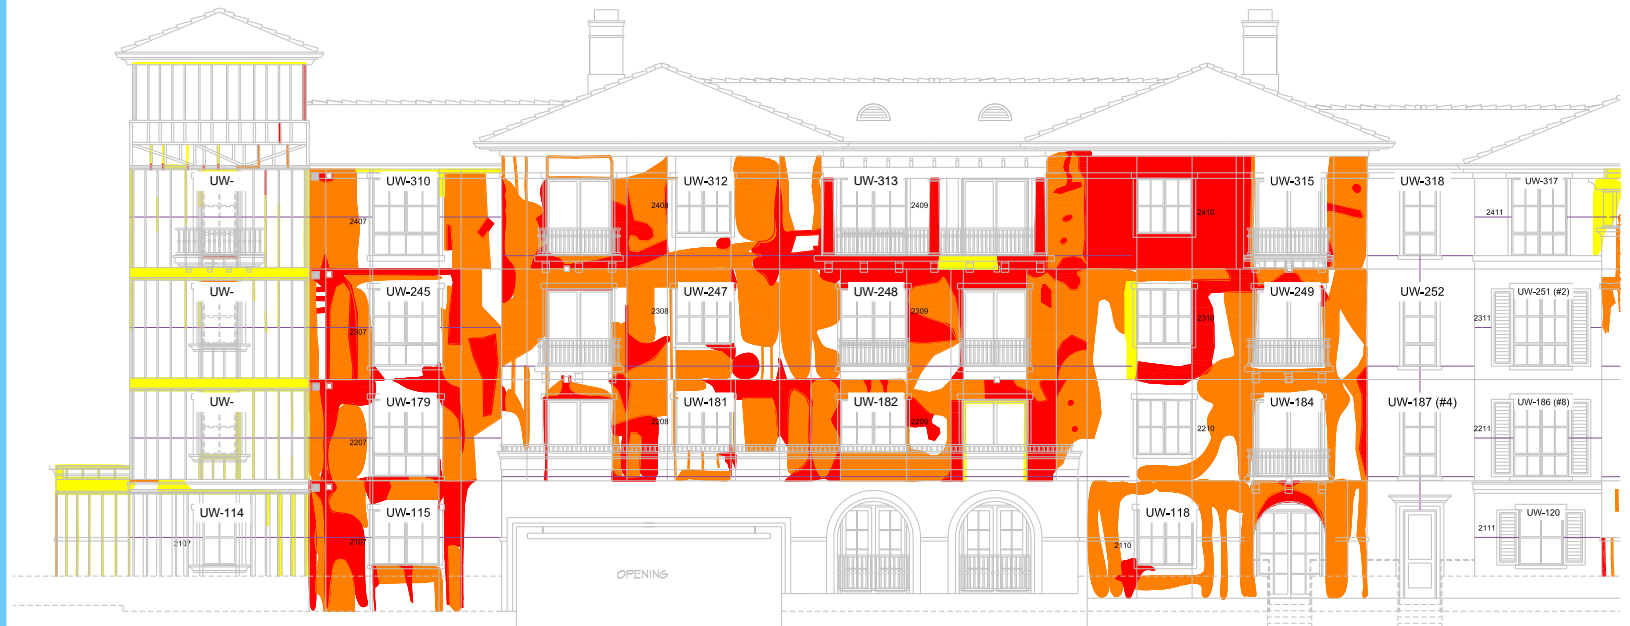
Damage – San Jose Apartment– South Elevation

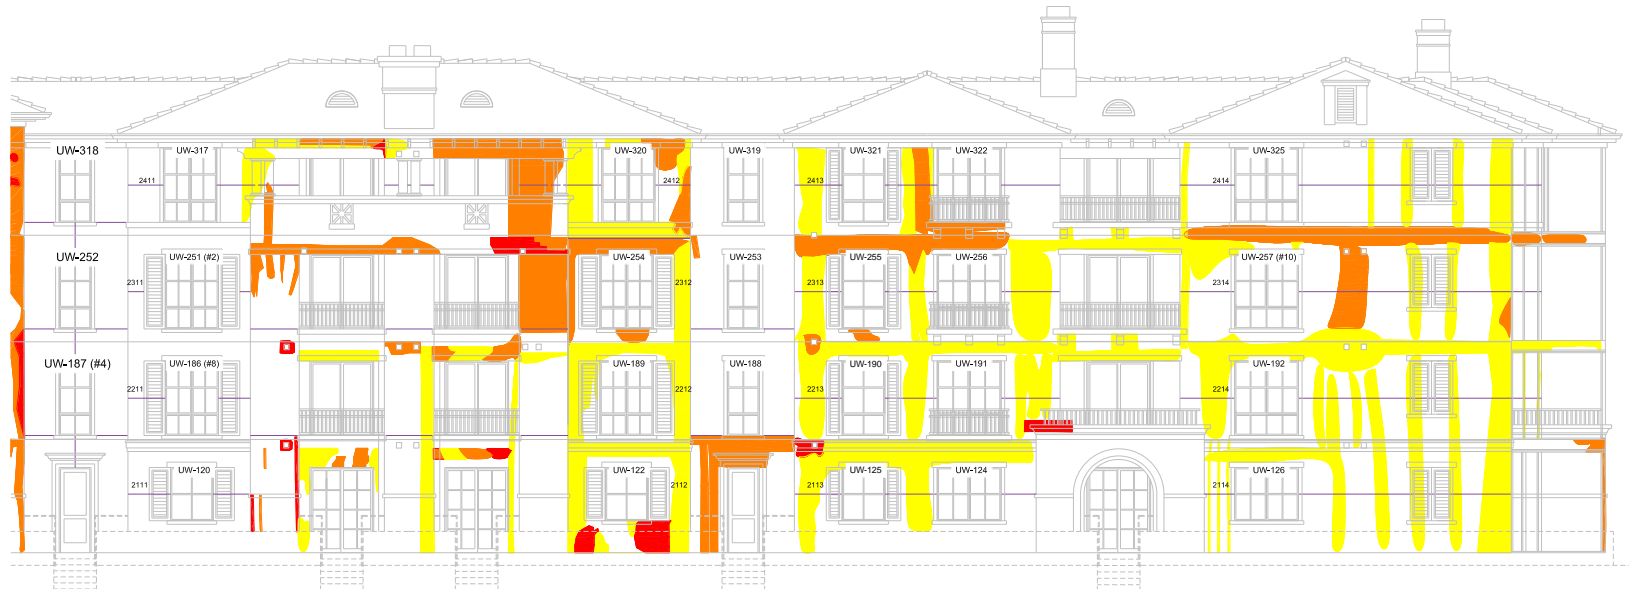
Damage - San Jose Apartment South Elevation

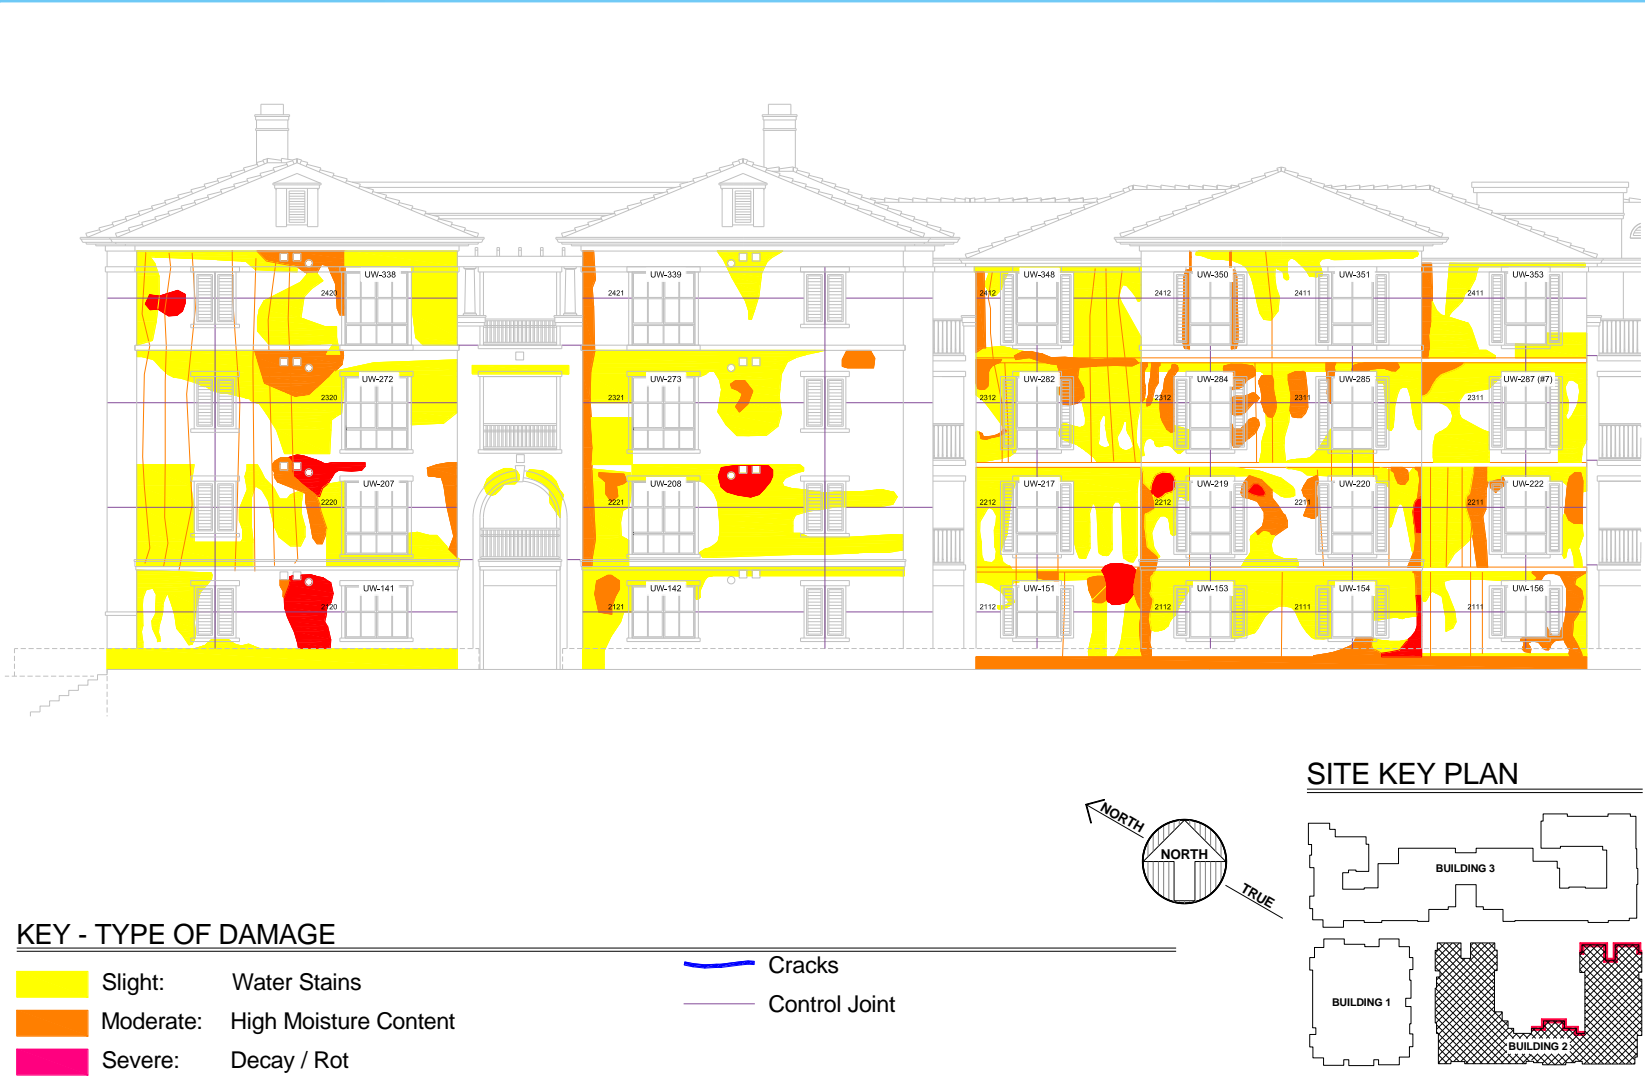
Damage - San Jose Apartment North Elevation

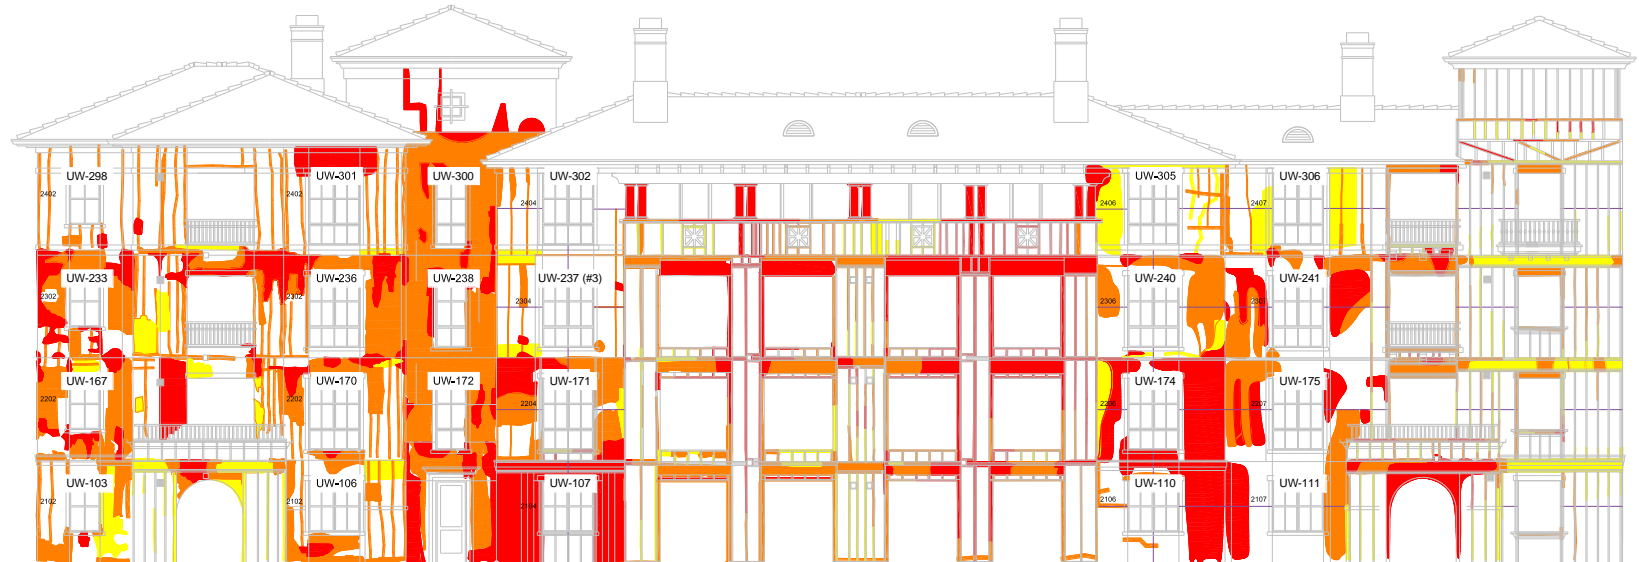
Damage - San Jose Apartment West Elevation

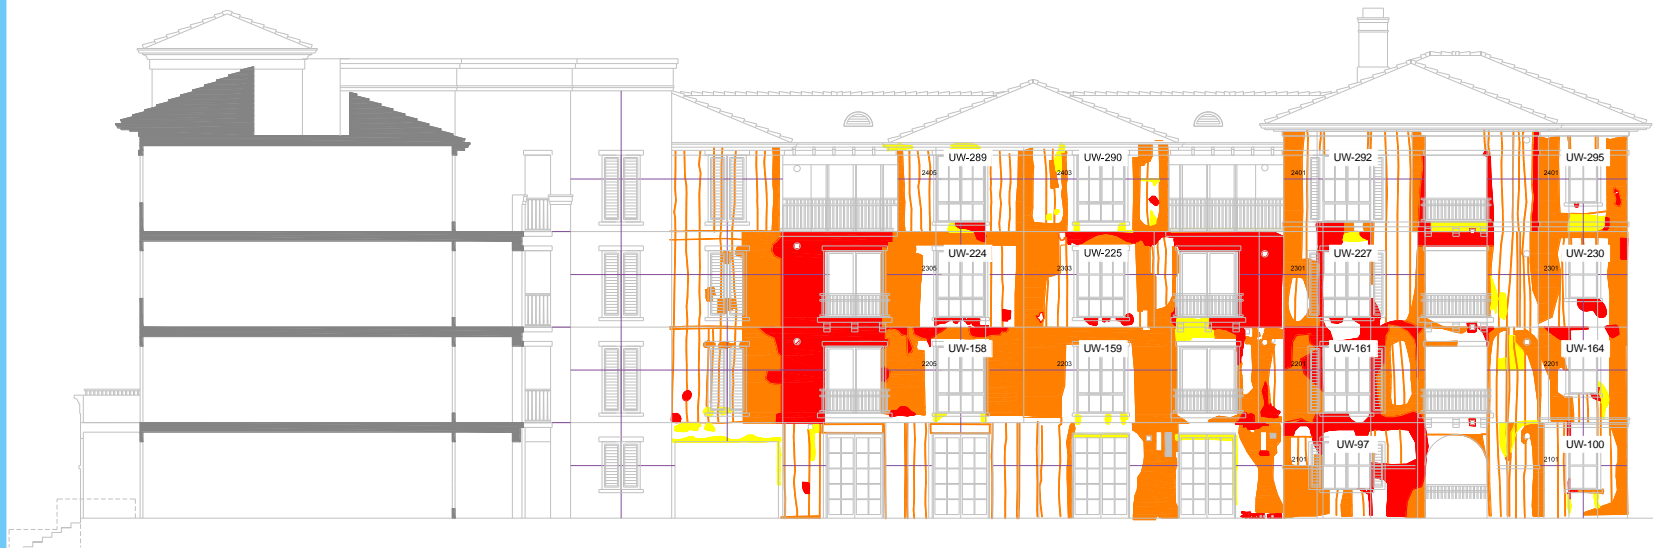
Damage - San Jose Apartment East Elevation

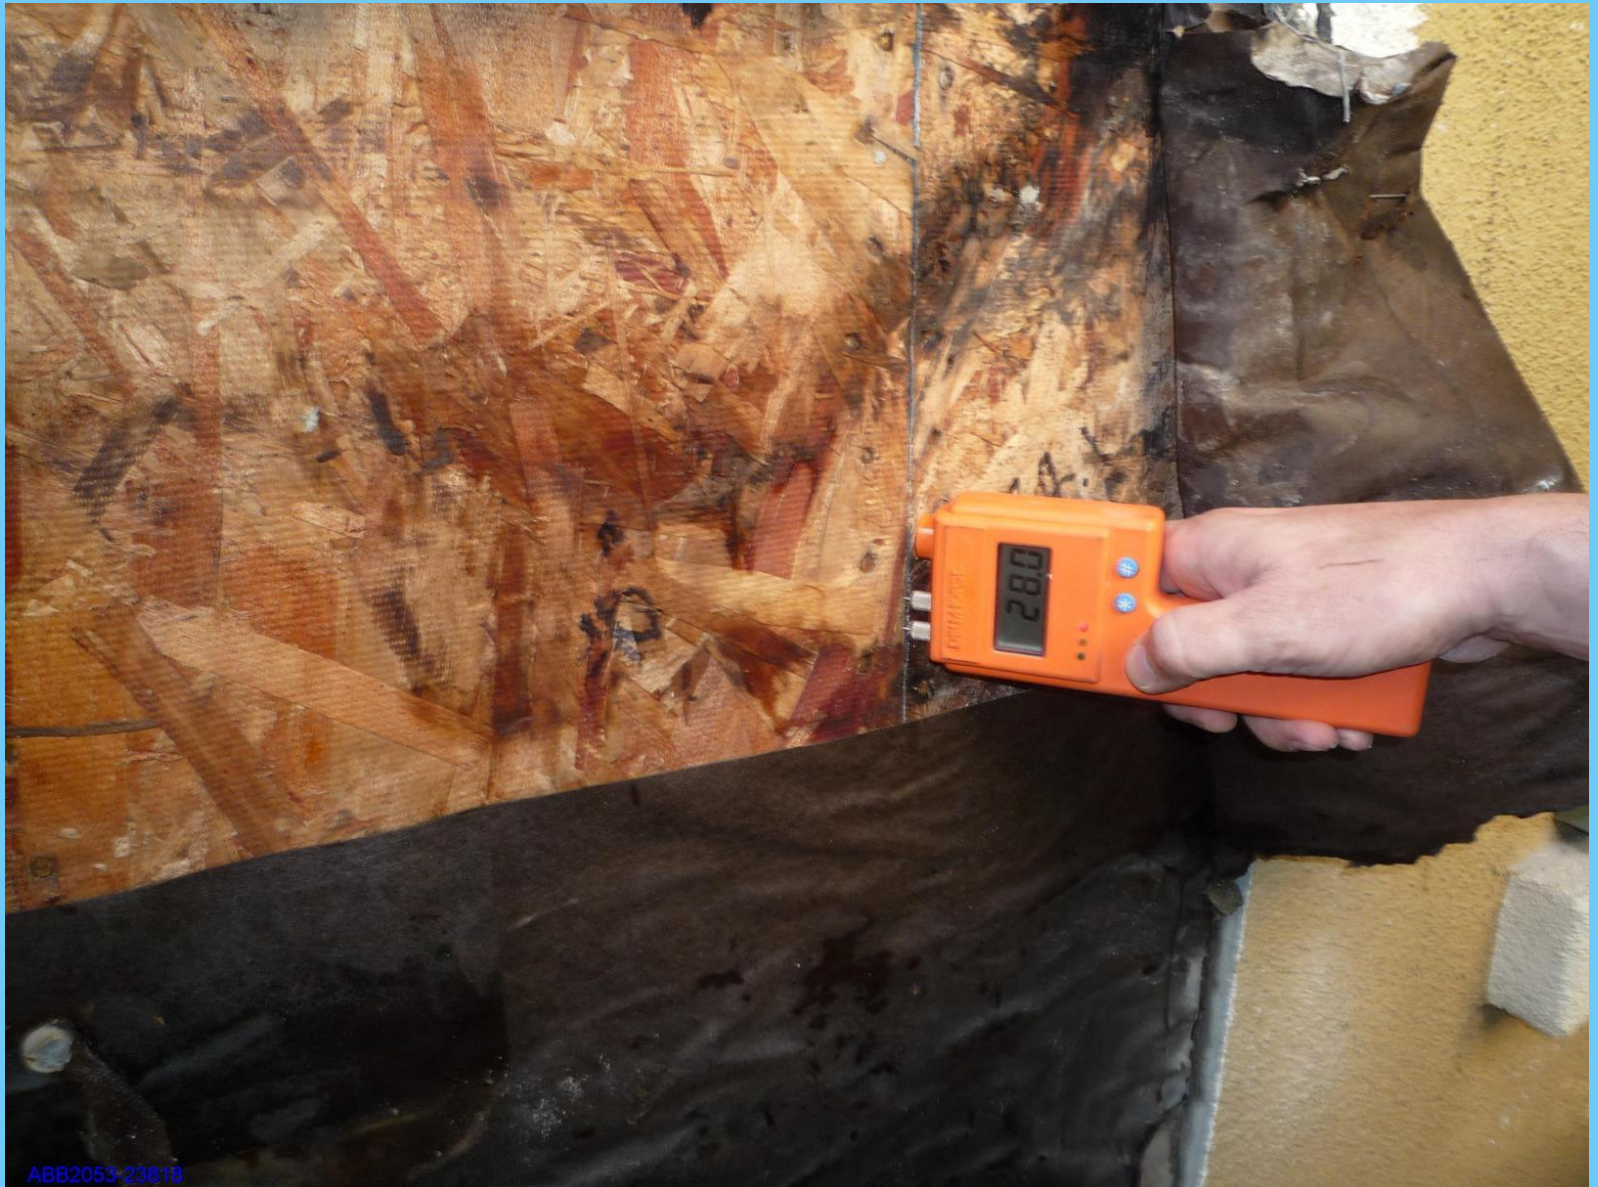
Damage Ranges From Slight To Severe

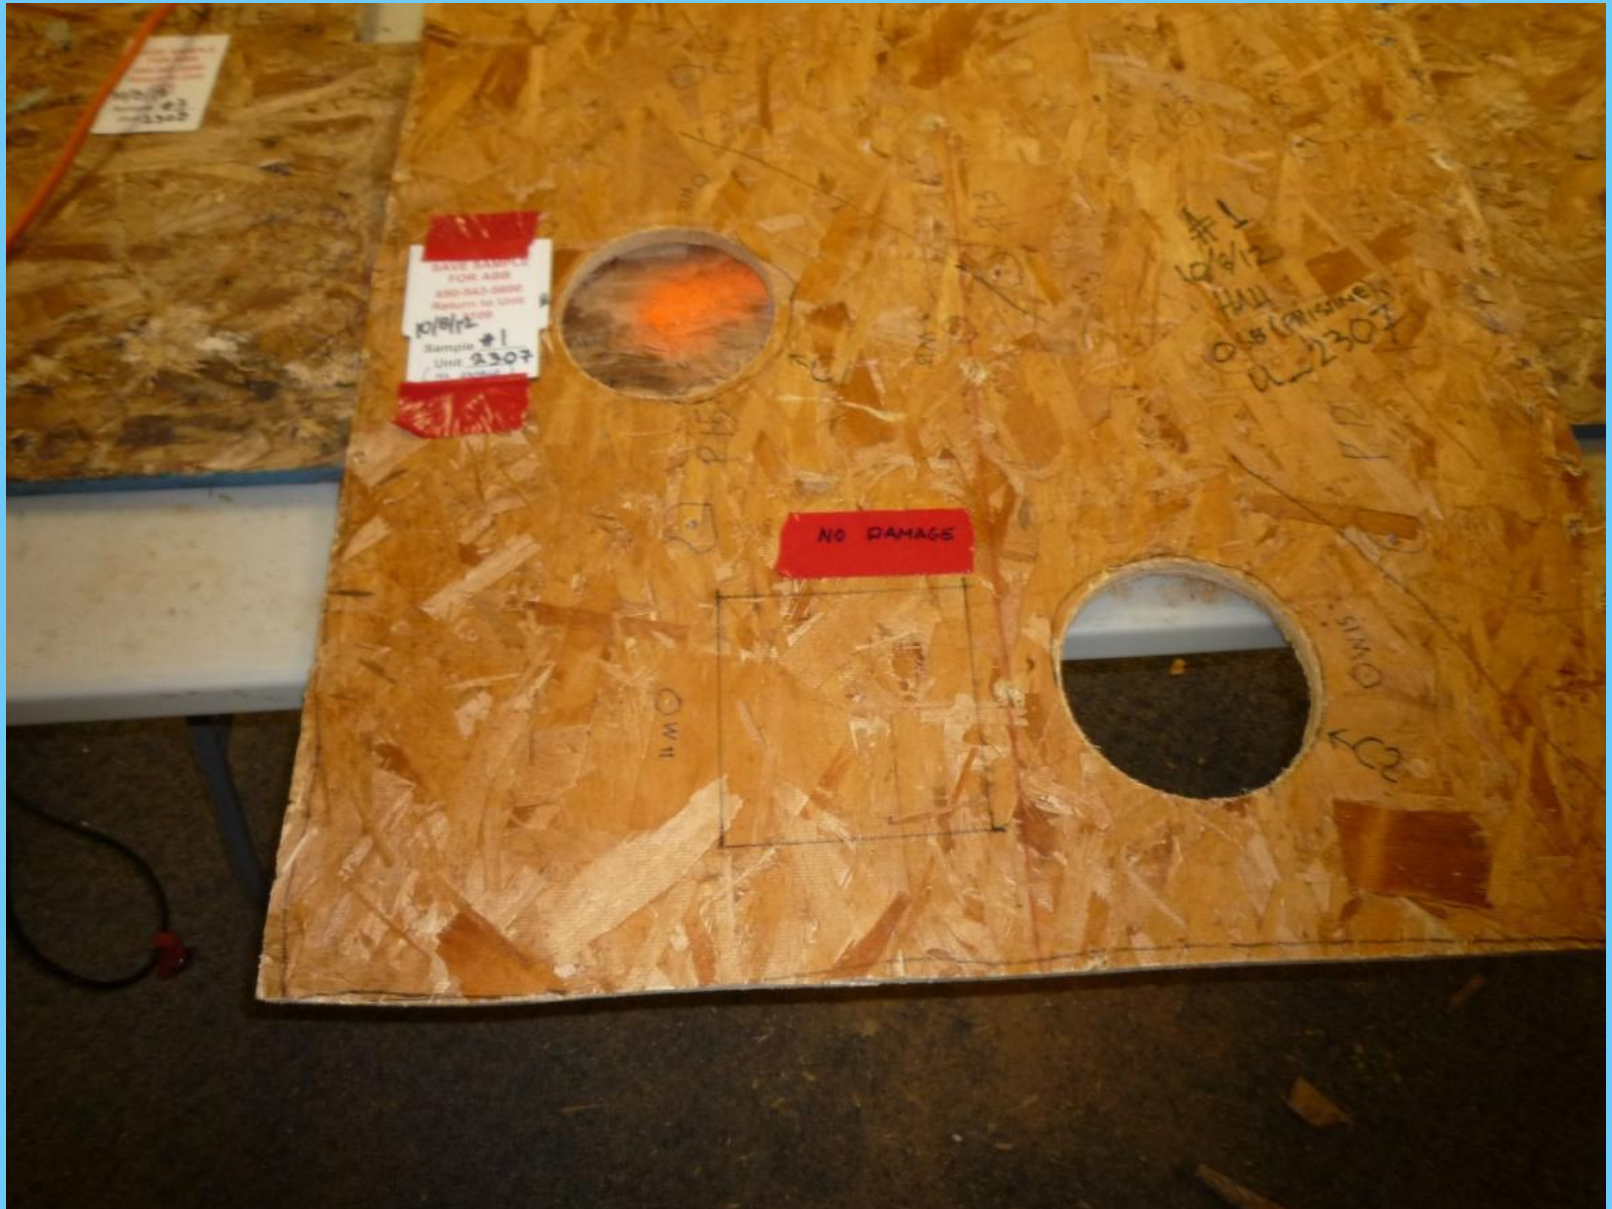
OSB Damaged State: No Damage

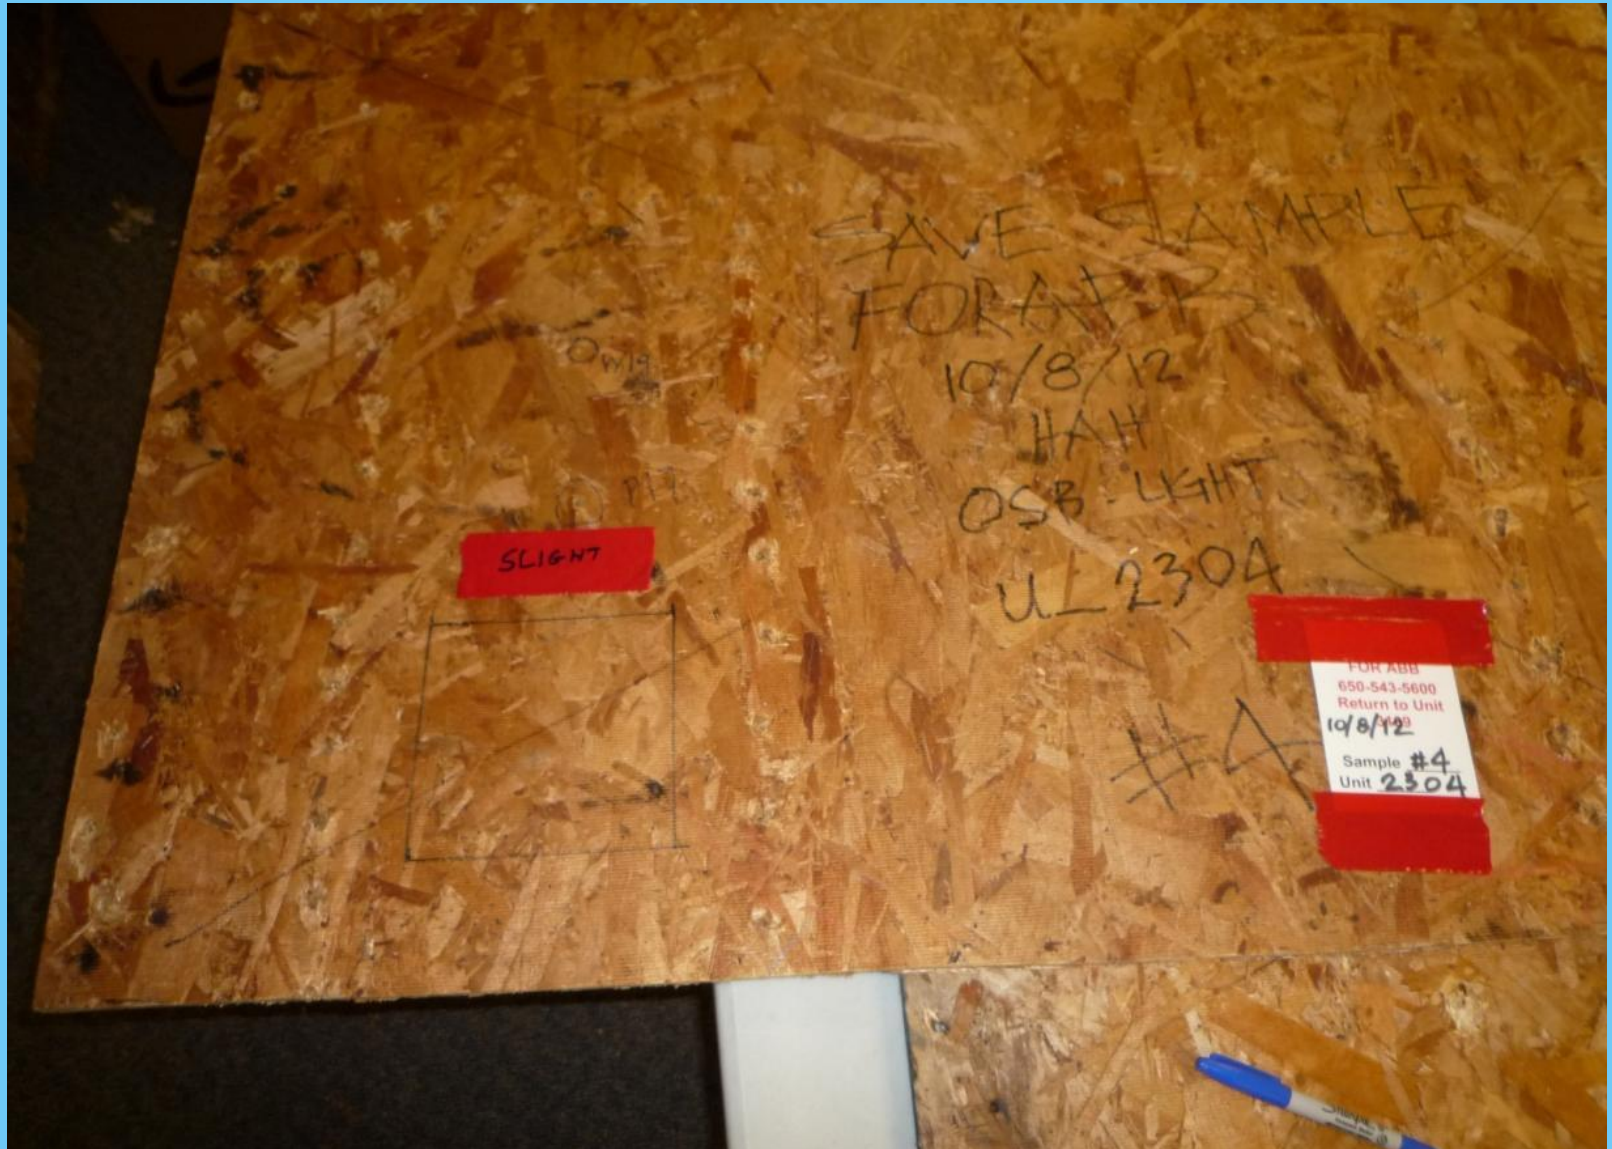
OSB Damaged State: Slight Damage

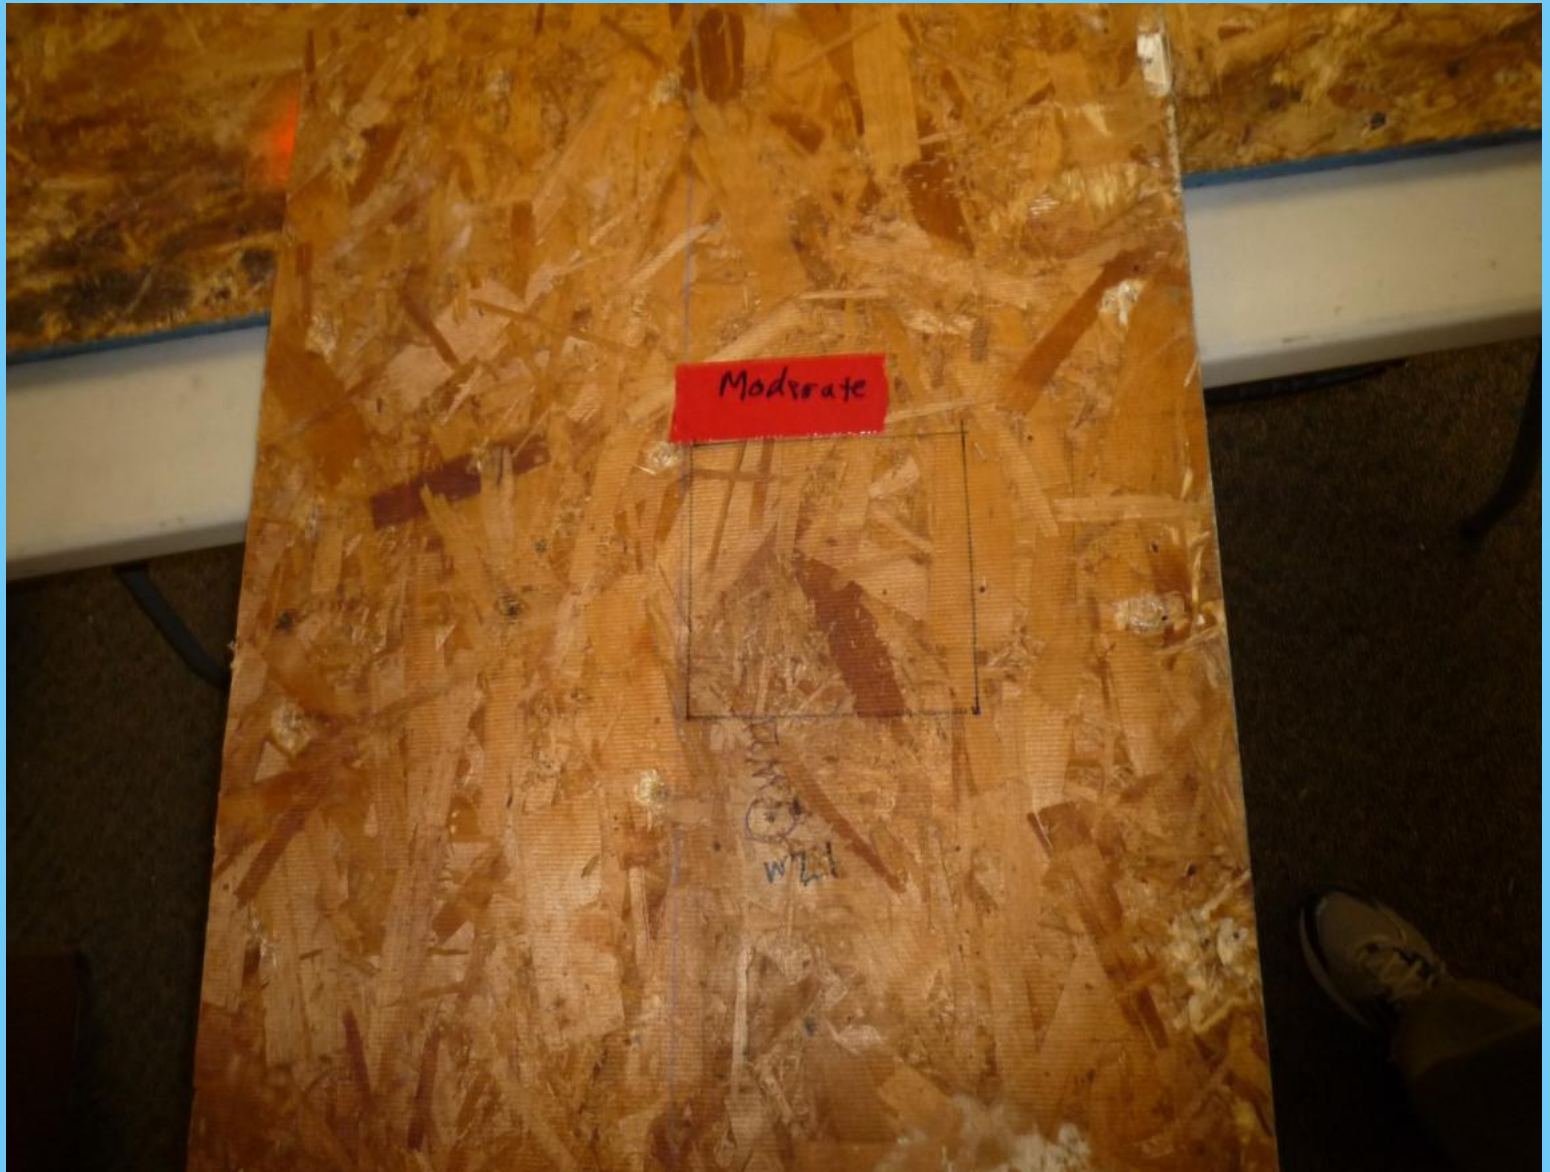
OSB Damaged State: Moderate Damage

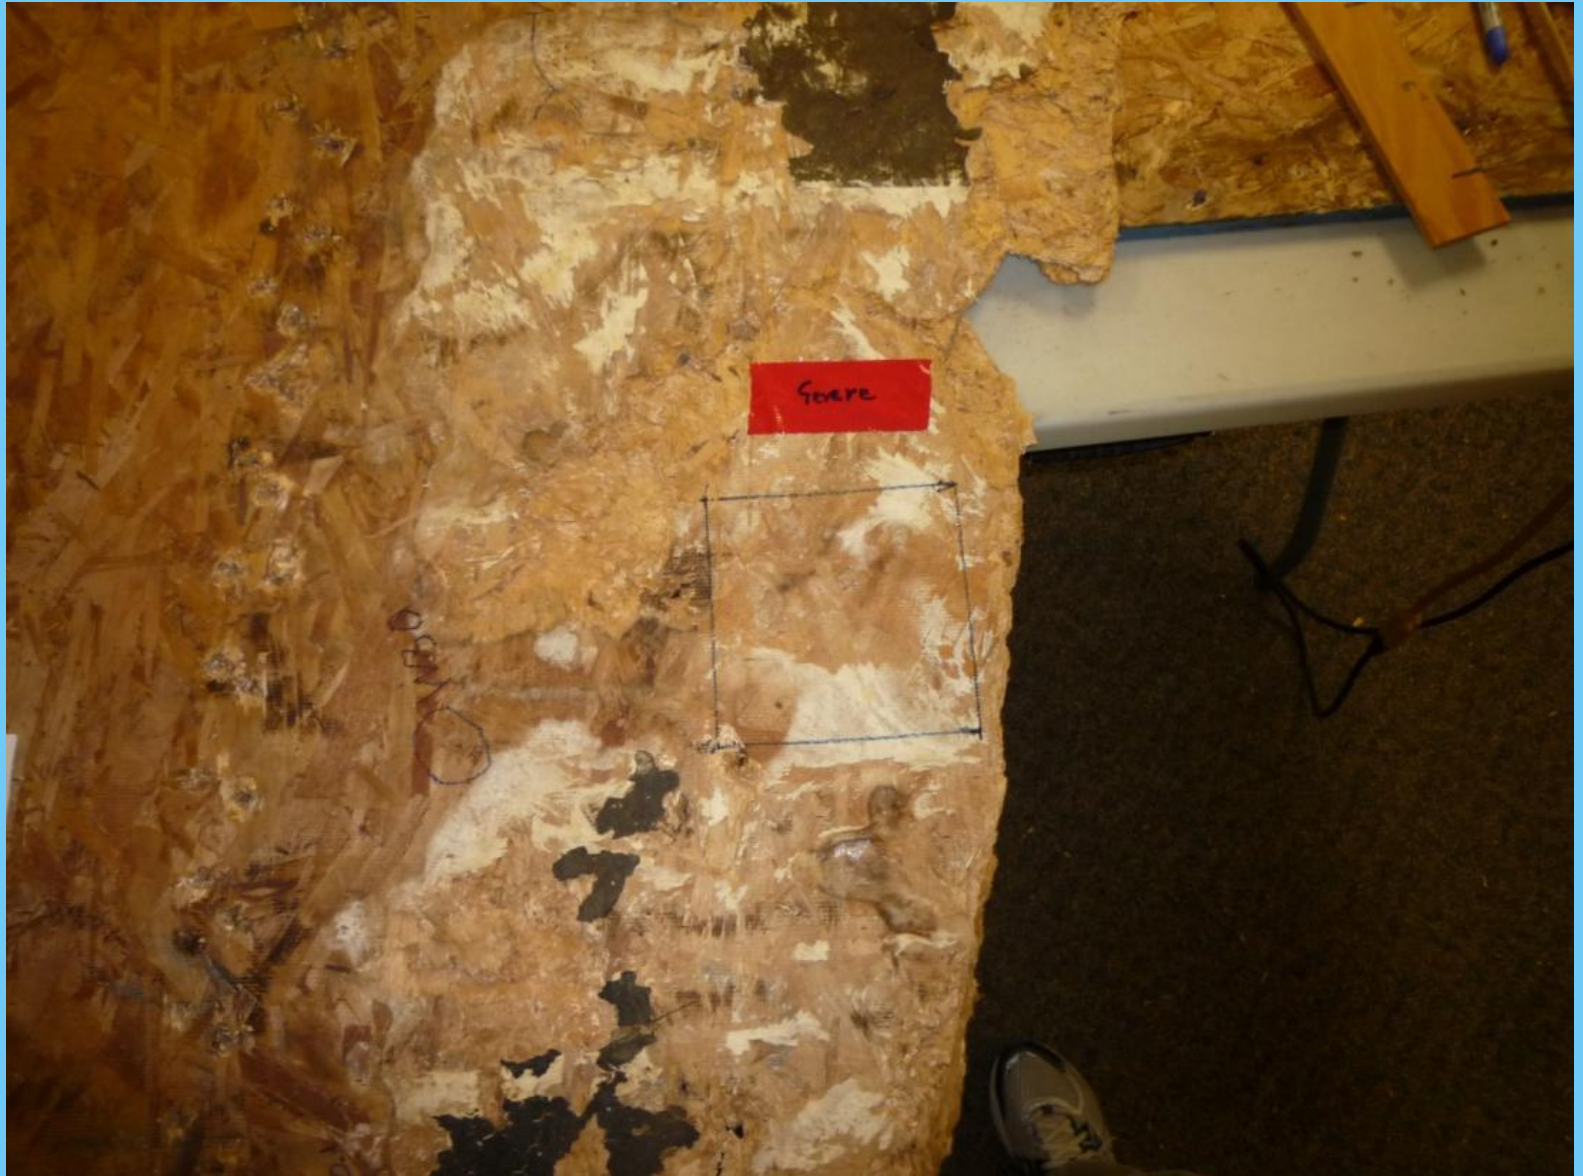
OSB Damaged State: Severe Damage

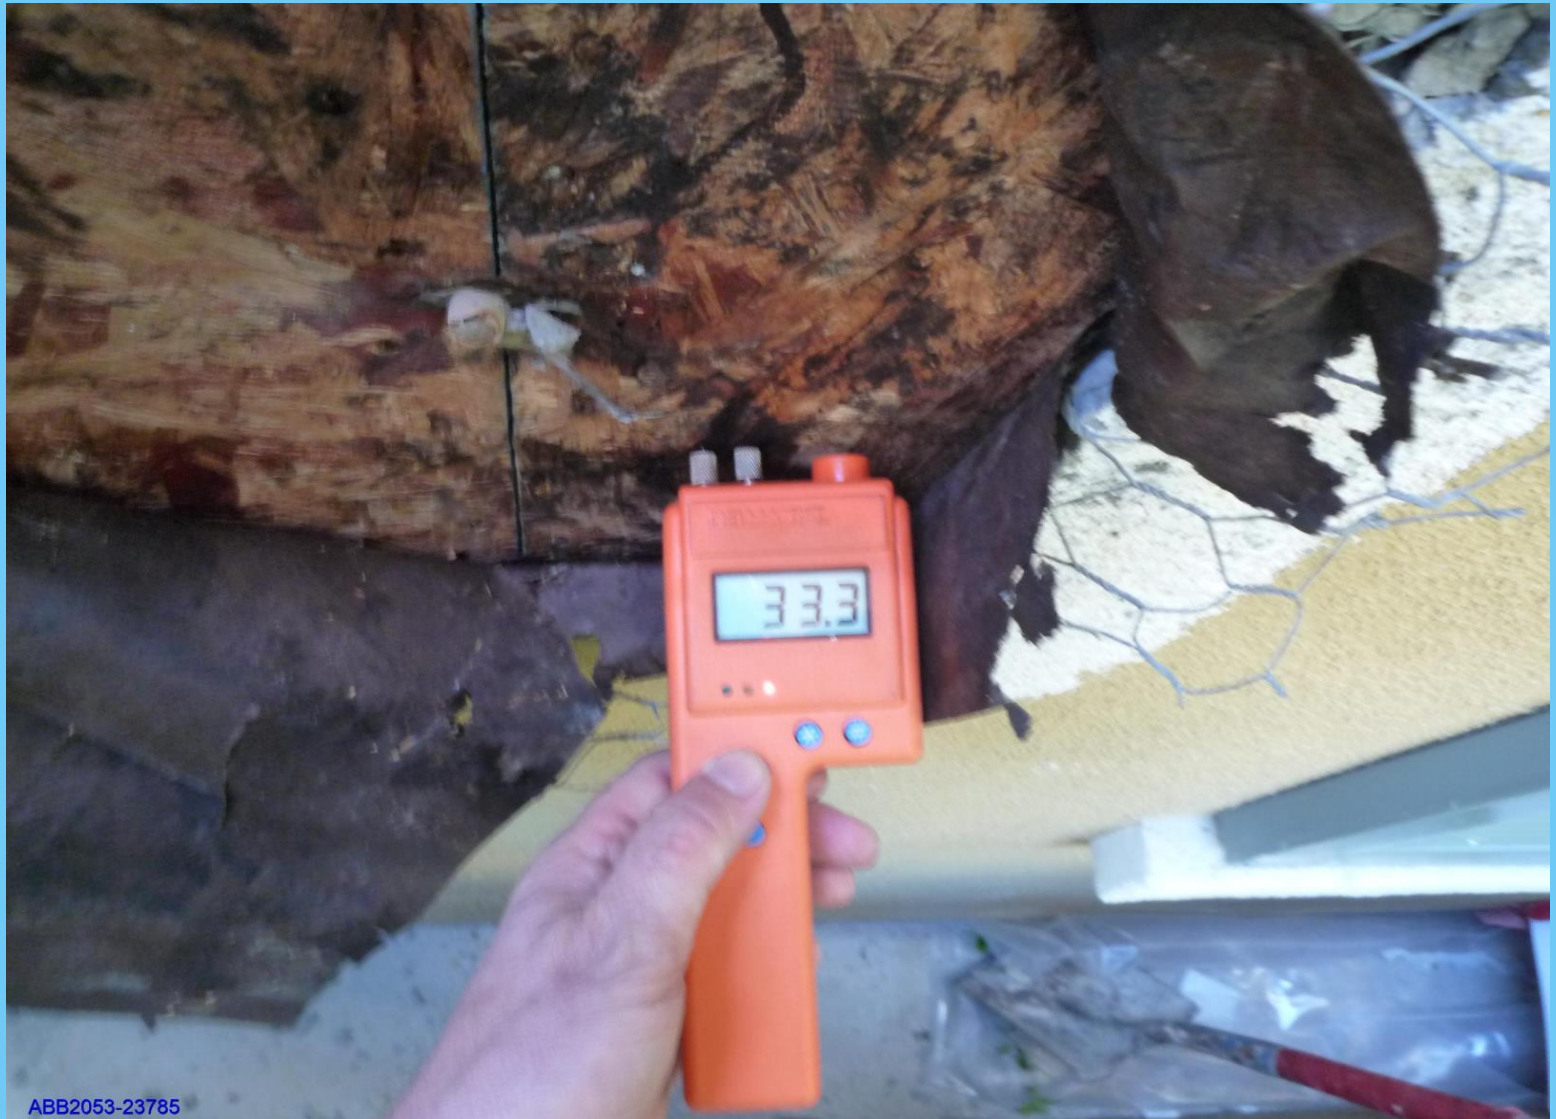
ABB2053-23785

OSB Damaged State: Severe Damage

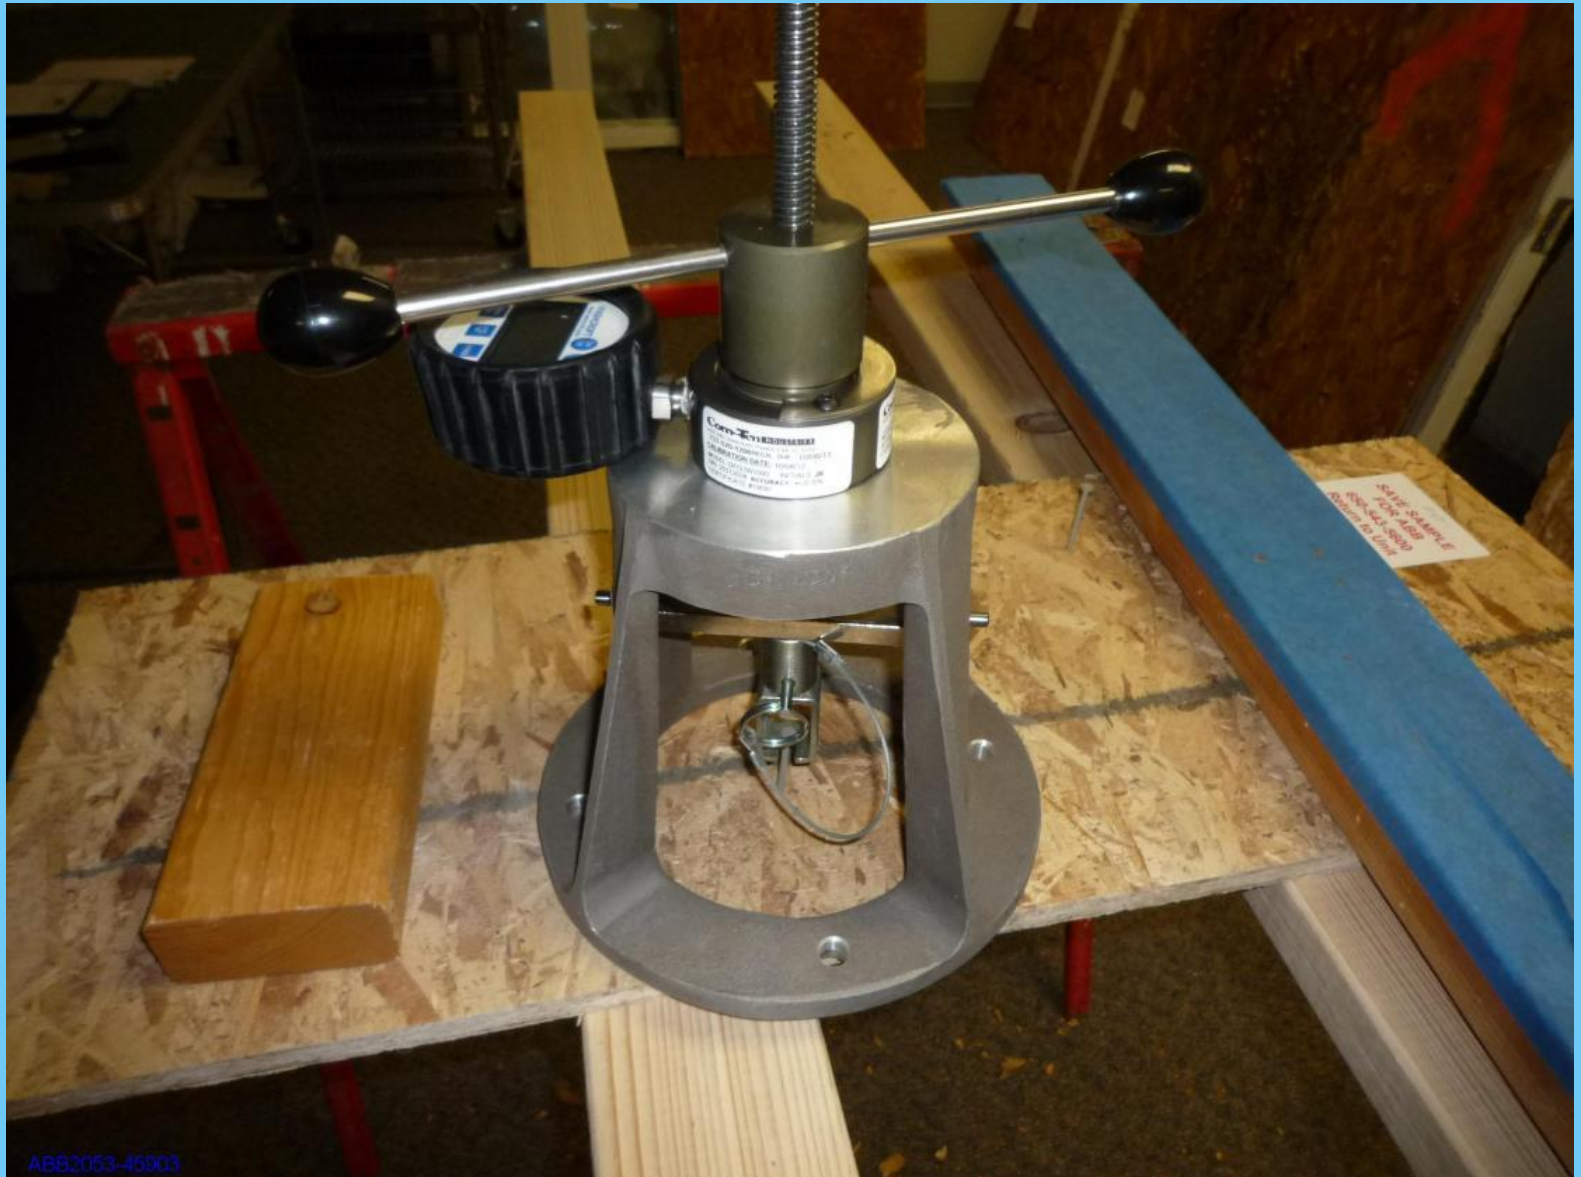
Nail Pull Through Strength Test: ASTM D1037

Nail Pull Tests Per ASTM D1037

- ABBAE performed 5 pull tests of each damage state level of Pines OSB Per ASTM 1037
- A Pull Through Test is an indication of loss of strength and structural integrity

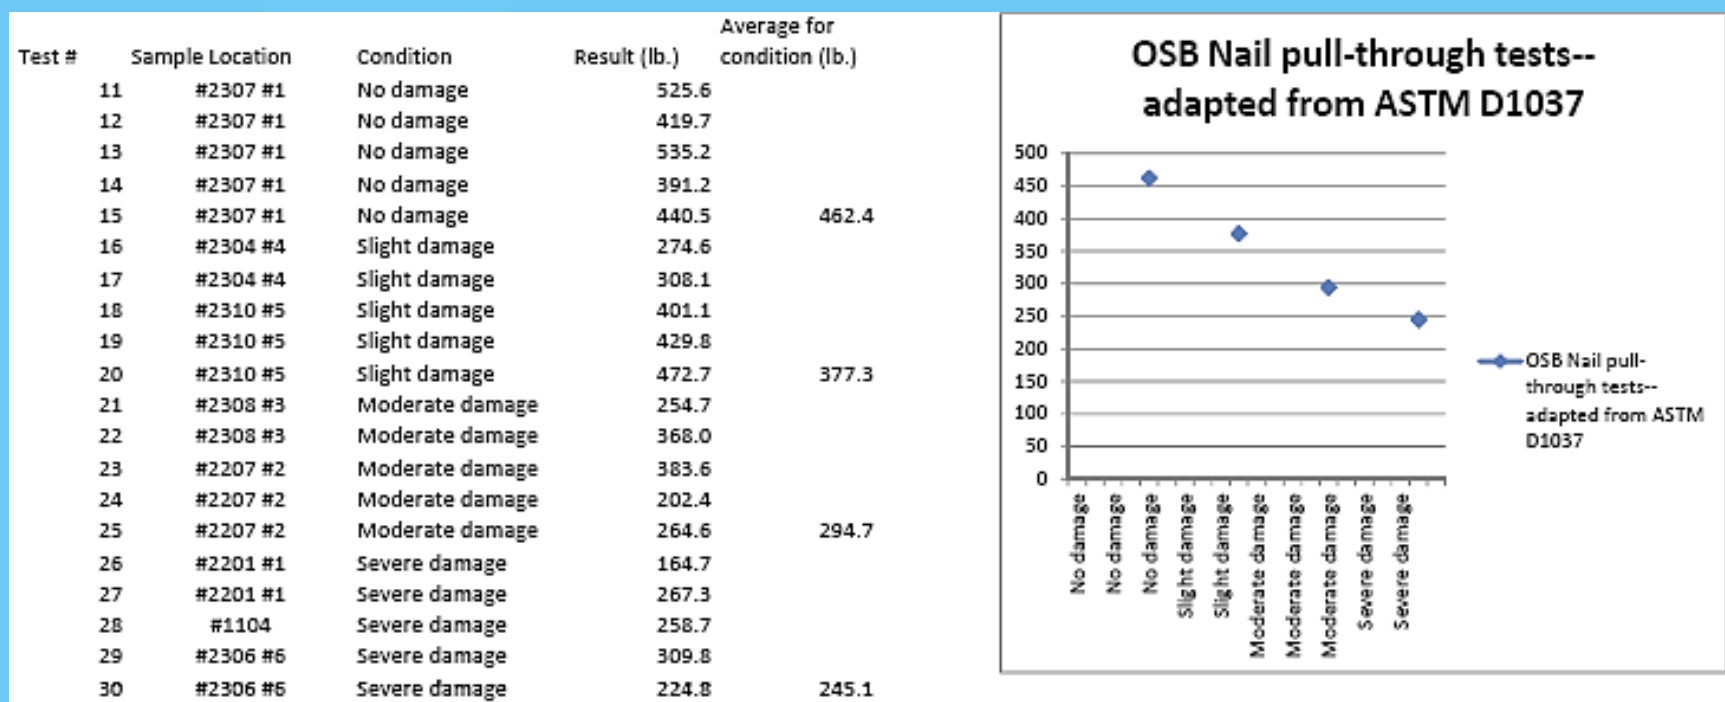
OSB Nail Pull Tests – Loss of Strength

Pull through test results are:

2053: Pines Parcel B-1, Tests Performed by Dennis Wobber 10/9/2012

OSB Nail pull-through tests--adapted from ASTM D1037

Water Damaged Panels significantly lose structural strength:

Slight Damage	19% less nail pull out strength
Moderate Damage	36% less
Severe Damage	46-100% less

In shear tests, panels typically fail from edge nail pull out or panel tear-through.

The above results show the projected approximate loss of shear values for each damage level.

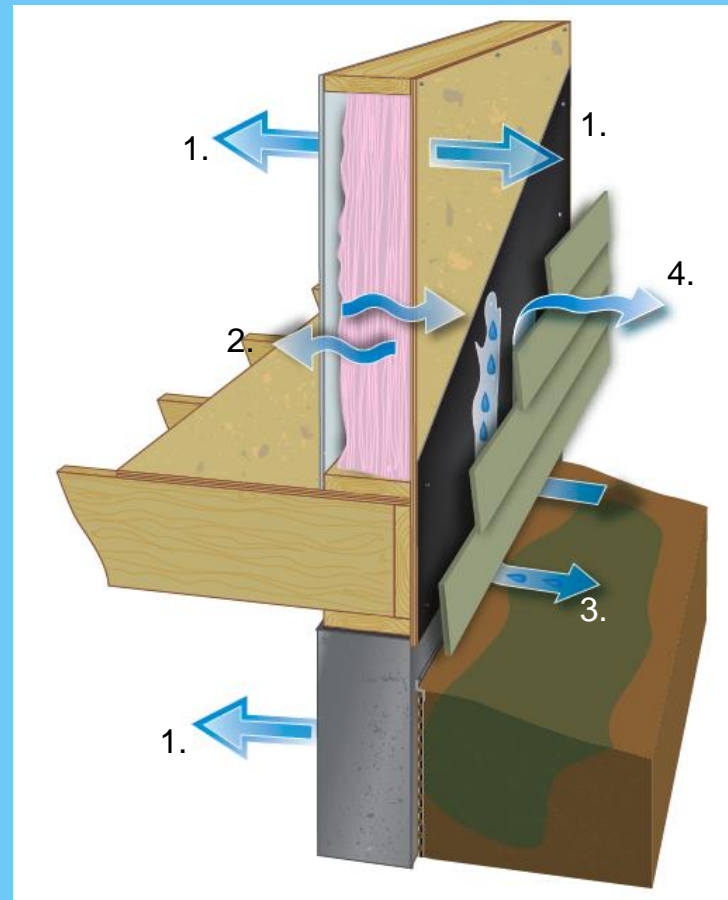
Wall Drying Mechanisms

Ventilated Rainscreen for Improved
Moisture Management

1. Surface Evaporation
2. Diffusion / Convection
3. Drainage
4. Air Exchange (Ventilation)
