## **CURTAIN WALL FAILURES – DESIGN OR PRODUCTS**

**Karim Allana, PE, RRC, RWC**

**2017 Symposium on Building Envelope Technology  
November 13-14, 2017 – Champions Gate, Florida**

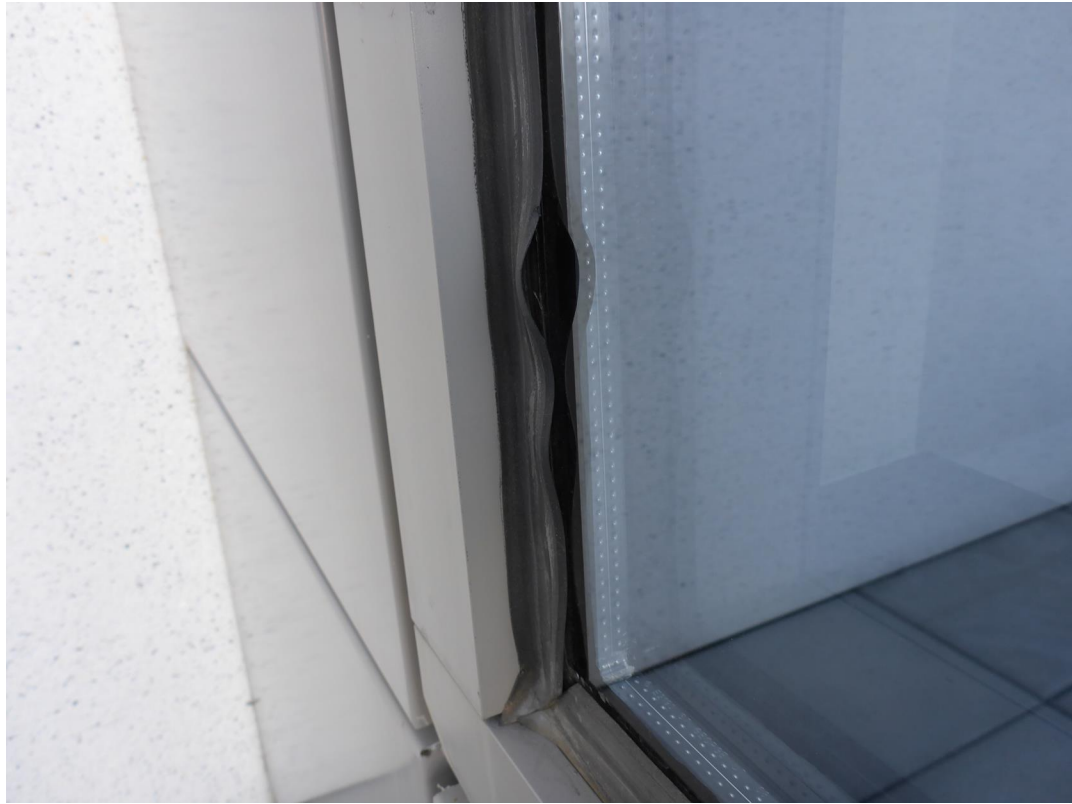
As gaskets age, they begin to dry out, shrink, and crack. The elastic material degrades when subjected to ultraviolet radiation and freeze-thaw cycles, much like an old rubber band. At first, air spaces are created by the shrinking, dried gaskets which admit air and moisture into the system. This can lead to condensation, drafts, and leaks. As the gaskets further disintegrate, they may loosen and pull away from the frame. Without the support of flexible gaskets, the glass loses stability and may shatter or blow out. For this reason, it is important to maintain and routinely replace gaskets to keep the curtain wall system operational and safe.

Figure 3: Example of Gasketing Failure

Shrinking of exterior gaskets is a common concern and is not always easy to fix. Although some systems, such as those incorporating pressure bars, allow for gasket replacement without removal of the glazing, it is difficult or impossible to replace gaskets in most curtain wall systems without removing the glass. Wet sealing may be an option. It involves cutting out worn gaskets and adding perimeter sealant. However, wet sealing does not generally result in a reliable water barrier. It also creates a demand for ongoing maintenance. In many cases, the required ¼” minimum dimension for the wet sealing is not present. Where possible, it is best to maintain the original glazing system and start with sustainable gaskets capable of long term performance like silicone.

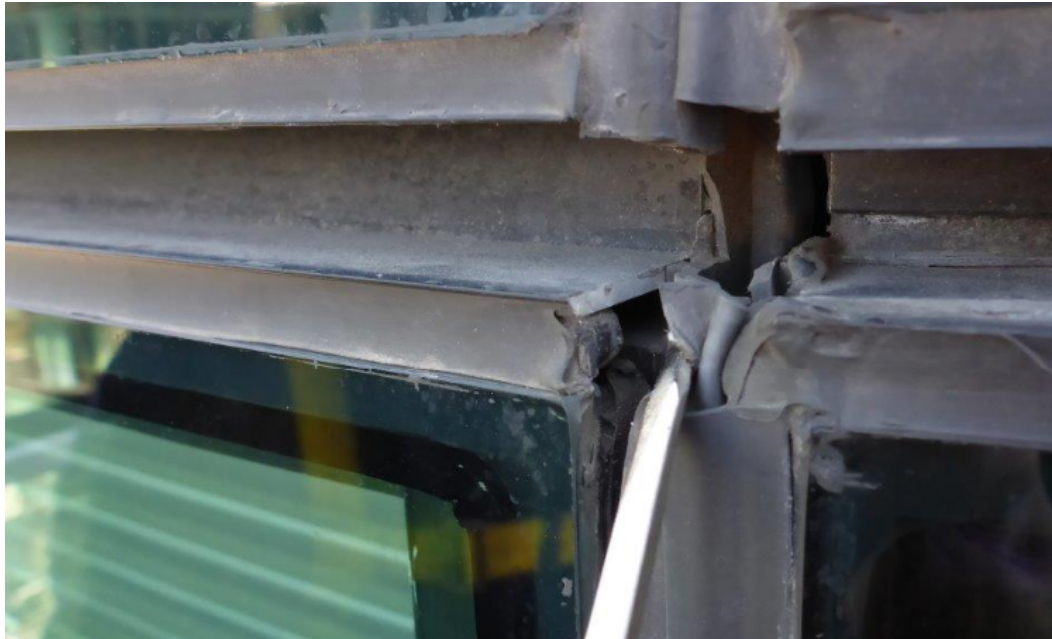
In this case, seals were ineffectively executed or degraded, allowing water to enter the glazing system and literally sit on top of the glass. As a result, water or water vapor permeated the silicone secondary seal and attacked the low "E" coating (located on the inside surface of the exterior lite) causing glass corrosion.

Figure 4: Path of Water Intrusion over IGU Glass Edge

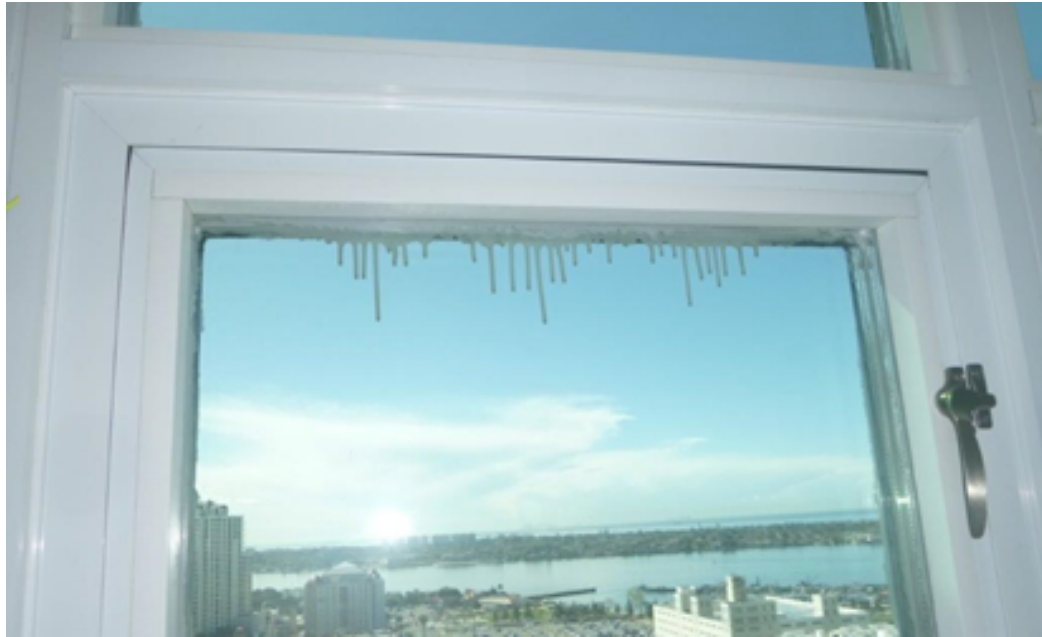
The migration of the PIB typically takes place within the airspace of the IGU and we believe it is triggered or worsened by exposure to solar radiation (heat) and UV. We have also noticed that operable windows seem to display more migration than adjacent fixed panels which further reinforces the notion of the PIB as “thinning” as a result of direct solar exposure.

Figure 7: Example of PIB Migration

In our experience, this issue is limited to PIB that is grey in color by a particular manufacturer. In laboratory testing it has been determined that the percentage of solids (polymer) within the grey colored PIB is 64.8% with plasticizers as low as 2.6%. This compares to control samples of PIB that have 97.5% polymer and about 30% plasticizer by weight.

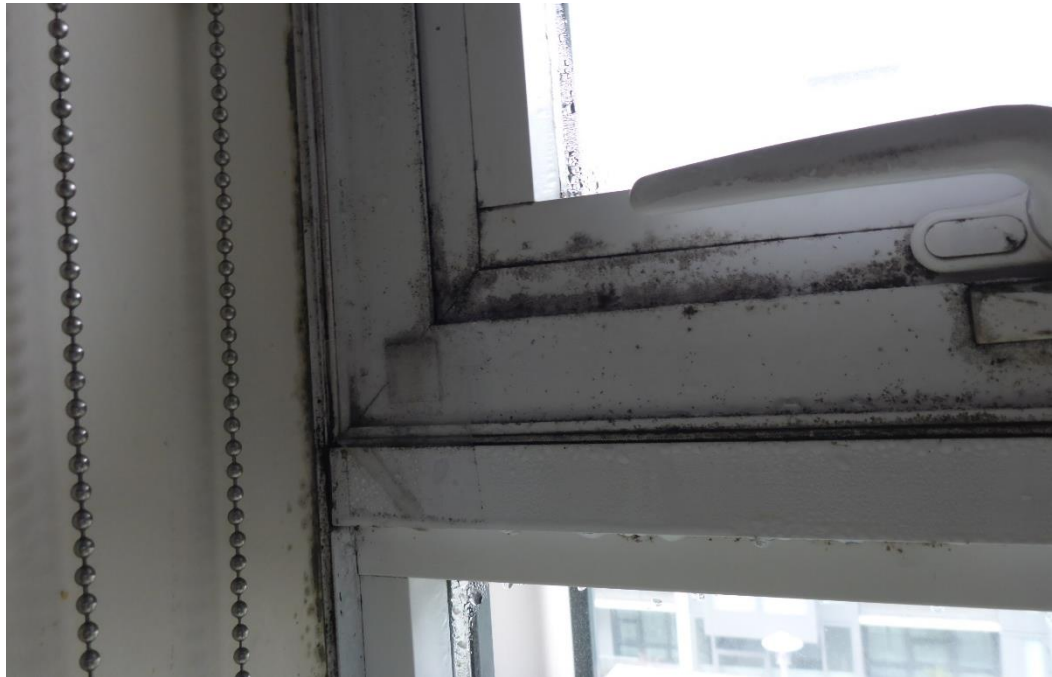
Condensation occurs when the temperature of the glass or aluminum frame in a curtain wall reaches the dew point temperature of the interior space conditions. Water forms on the surface of the glass or aluminum and can cause damage to the interior finishes. Basic design against condensation ensures that the Condensation Resistance Factor (CRF) of a given curtain wall section meets the requirement of the space, which is based on the expected temperature and humidity of the space. Designers should be aware that the CRF is an average and cannot account for cold spaces in the facility which can cause localized condensation.

Figure 8: Example of Condensation Failure

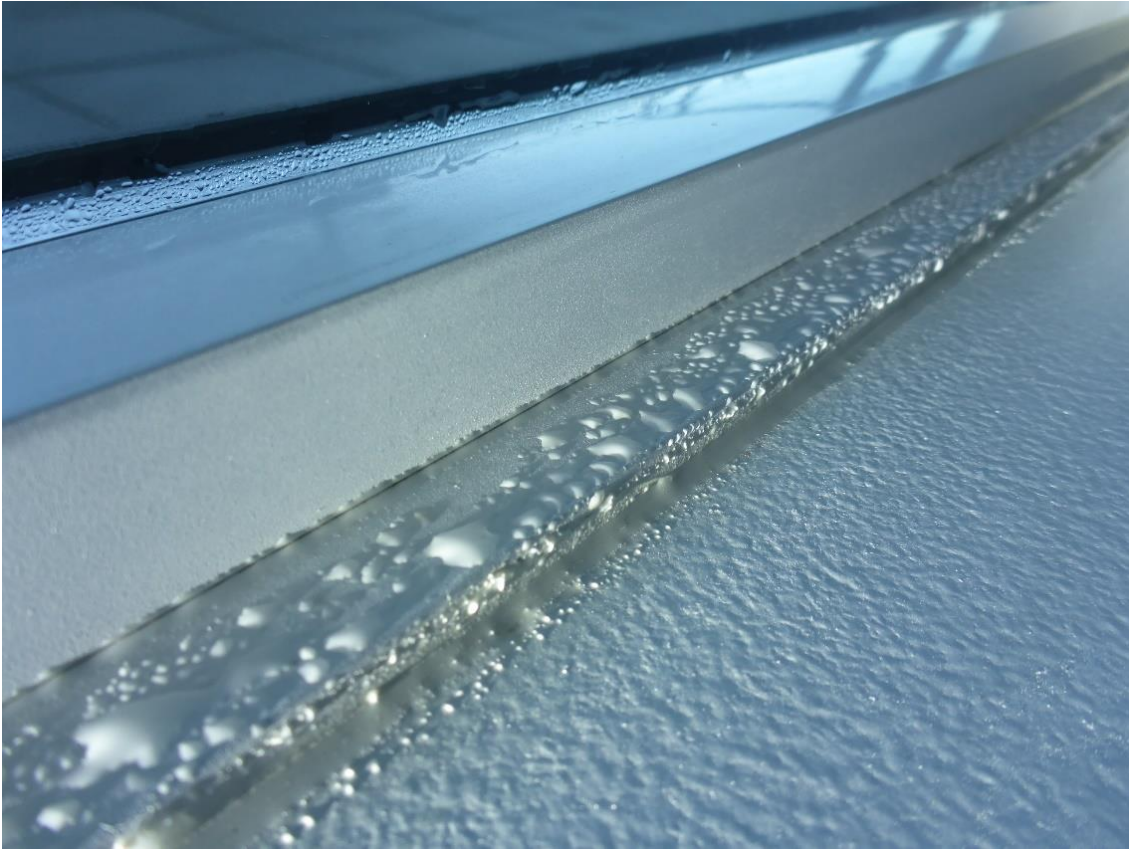
Figure 10: Condensation on an Interior Window Surface

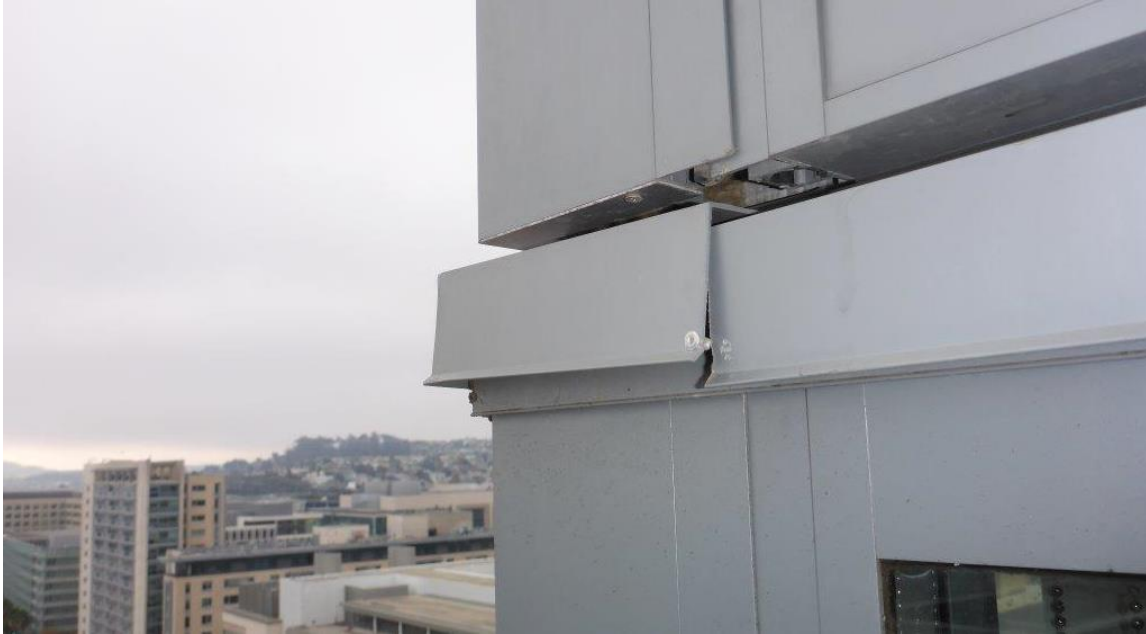
Poorly installed trim covers and accessories can pose not only a danger to people and property below. Trim covers and accessories can be snapped in place or adhered using structural glazing tape alone without mechanical attachments. However, poor quality control of the products during the manufacturing process can provide potential problems in the long term. Dies used for extruding covers can wear out resulting in poor fit and holding strength. Checking for tolerances and proper preparation and adhesion can be critical to long-term performance.

Figure 11: Sample of Trim Cover Failure

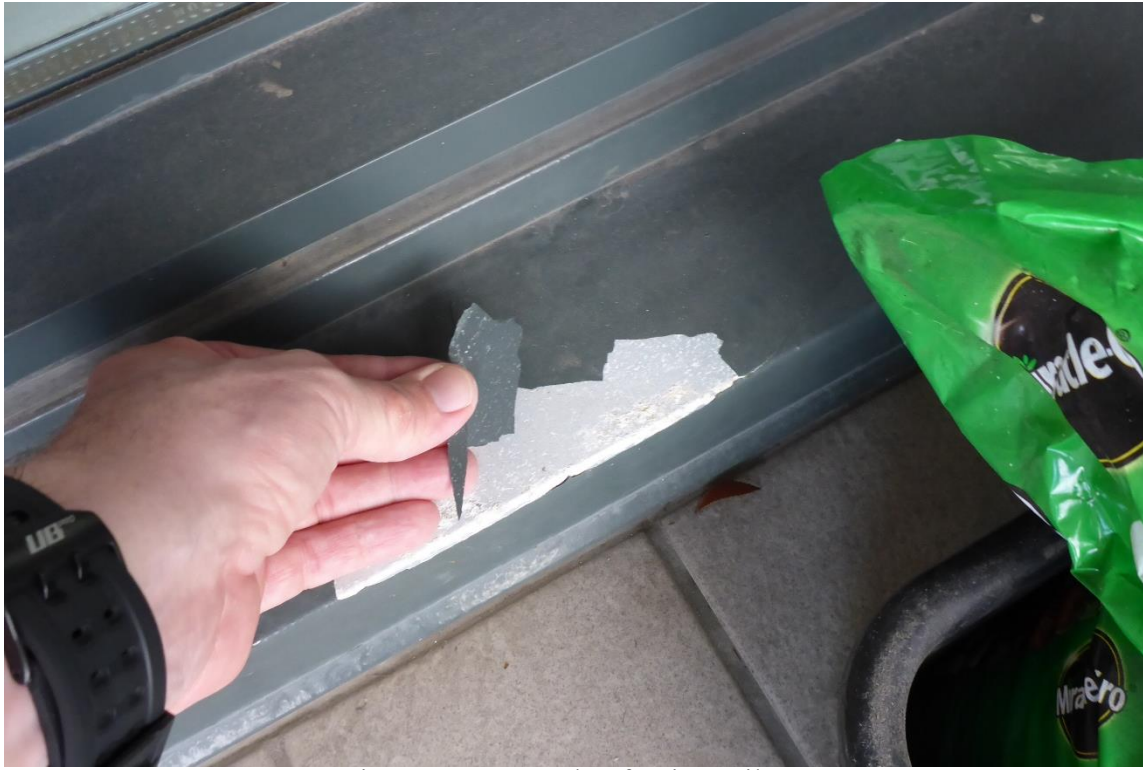
We have found that corrosion of metal surfaces is accelerated if the proper preparation and coating requirements are not followed. When measured with an Elcometer, we have seen a 0.3 mil paint coating that was found to be 0.1 mil or less.

Figure 12: Example of Paint Failure

There are several Architectural grade paint finishes available on the market but we typically recommend Fluoropolymer paint finishes (like Kynar) that meet AAMA 2605 certification. But like all paint, even Kynar based paint finishes need proper preparation and application to perform as intended.

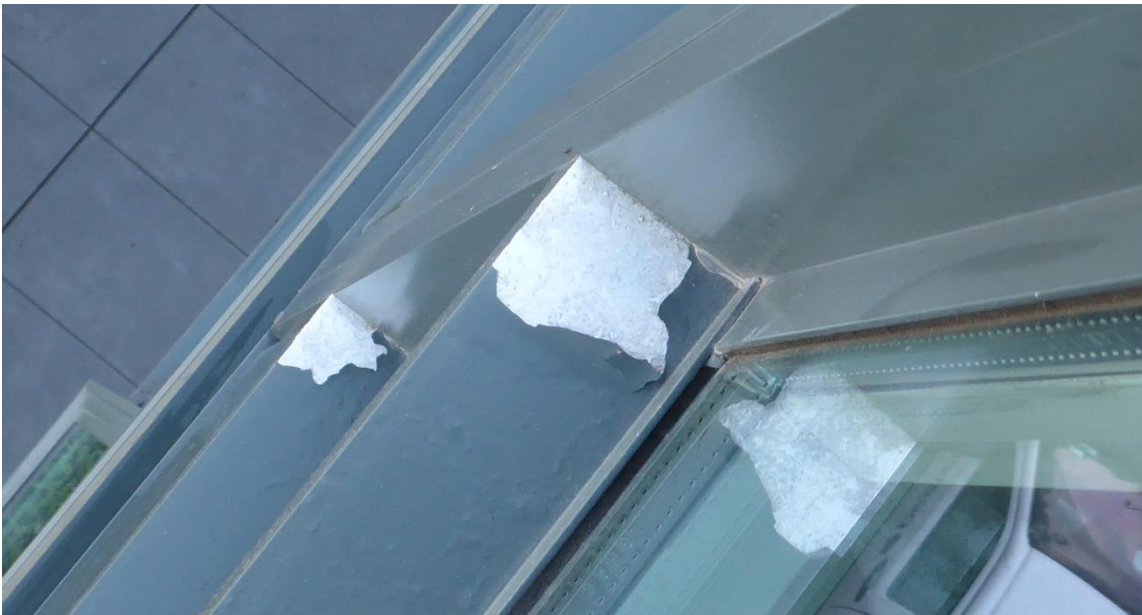
Paint finishes are either “wet” like the typical Kynar application or “dry” like powder based paint finishes. Both are applied electrostatically, so application is limited to factory environments.

Figure 13: Example of Paint Failure

Paint failures are relatively infrequent when compared to some of the other failure modes in window wall and curtain wall systems but remediation of failures is particularly difficult. Often the failure is related to lack of or inadequate pre-treatment or, where primers are part of the application, but were improperly applied to the base metal being painted.
