# **PERFORMANCE OF WEATHER RESISTANT BARRIERS IN STUCCO ASSEMBLY**

Karim Allana, PE, RRC, RWC

2016 Symposium on Building Envelope Technology  
October 17-18, 2016 - Houston, Texas

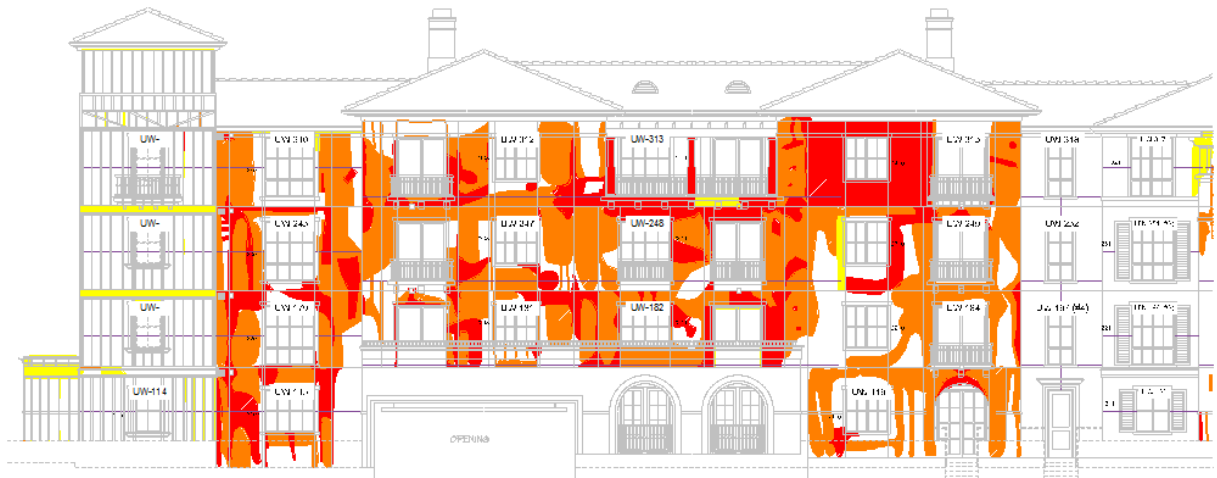
Figure 6A: Damage – South Elevation – Partial

We had the opportunity to conduct an extensive study of dozens of large multi-family buildings and some large single-family homes with traditional building paper and either cement board siding or stucco. In both, siding types of assembly and stucco assembly, the siding/stucco was completely removed to expose the condition of the OSB or plywood or gypsum sheathing. While some of the damage to the sheathing was definitely due to leaks from wall penetrations or improperly flashed horizontal waterproofing systems, we surprisingly documented a lot of moisture movement and damage due to moisture soaking through the building paper and damaging the wood sheathing (Figures 6A and 6B).

Depending on the elevation, we observed and documented damage to the wood sheathing and graphed it visually to depict damage. We realized that other than poking the sheathing with an awl, most experts were not using any scientific means for analyzing the damage to the sheathing. Surprisingly, even though the sheathing was discolored due to different levels of water damage, slight, moderate and some severe areas passed the “awl” poke test.

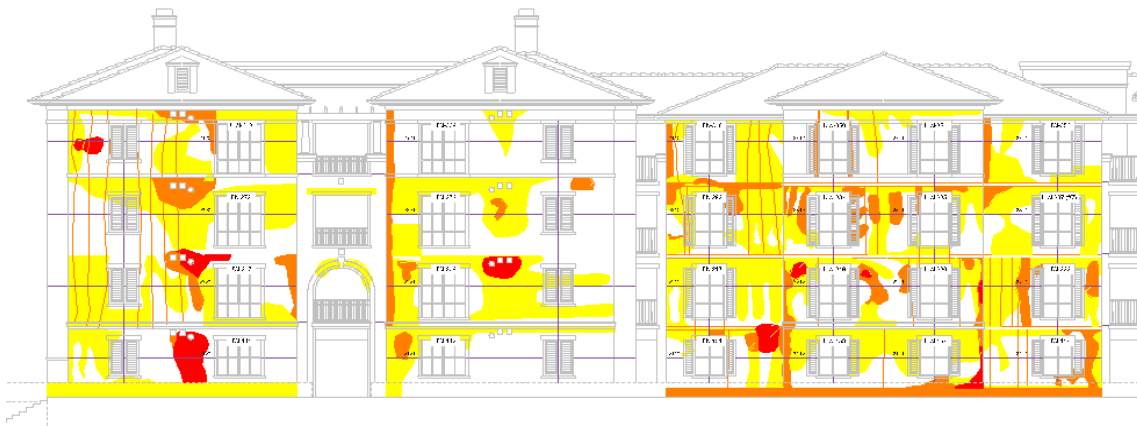
Figure 6B: North Elevation - Partial

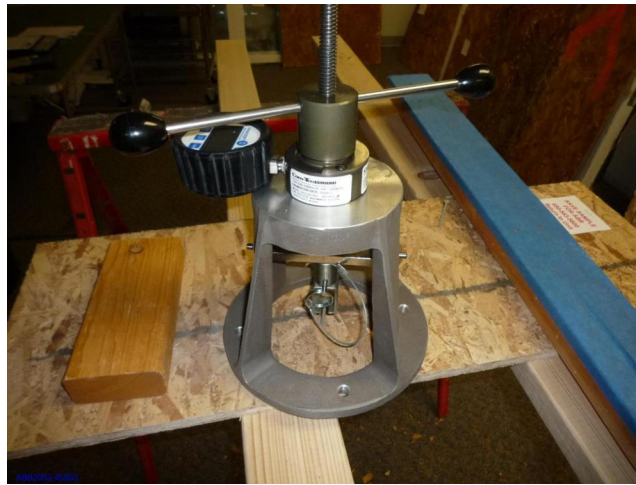
Figure 6C: ASTM D-1037 Nail Pull Tests – Loss of Strength

To make the assessment process more scientific, we went on to create a testing protocol using ASTM D1037, which is a nail pull through test (Figure 6C). The nail pull through tests were more telling and representative of loss of structural value such as shear value. These types of tests can provide a detailed profile of force exerted over time and gives a more realistic assessment of the loss in structural capacity (Figure 6D). Using the standard measurements, we were able to demonstrate a significant difference in nail pull out strength between slight, moderate and severely damaged areas.

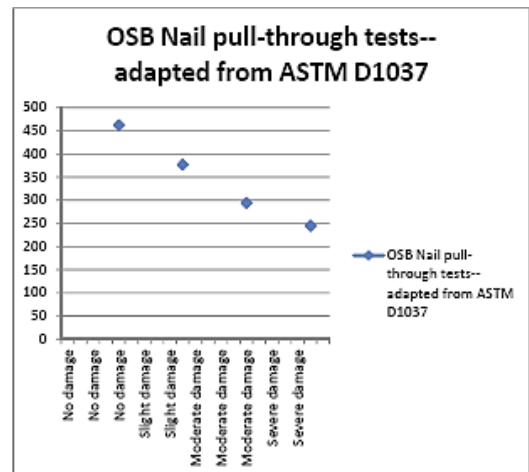
Slight Damage 19% less nail pull out strength  
Moderate Damage 36% less  
Severe Damage 46-100% less

Figure 6D: Nail Pull Through Strength Test: ASTM D1037

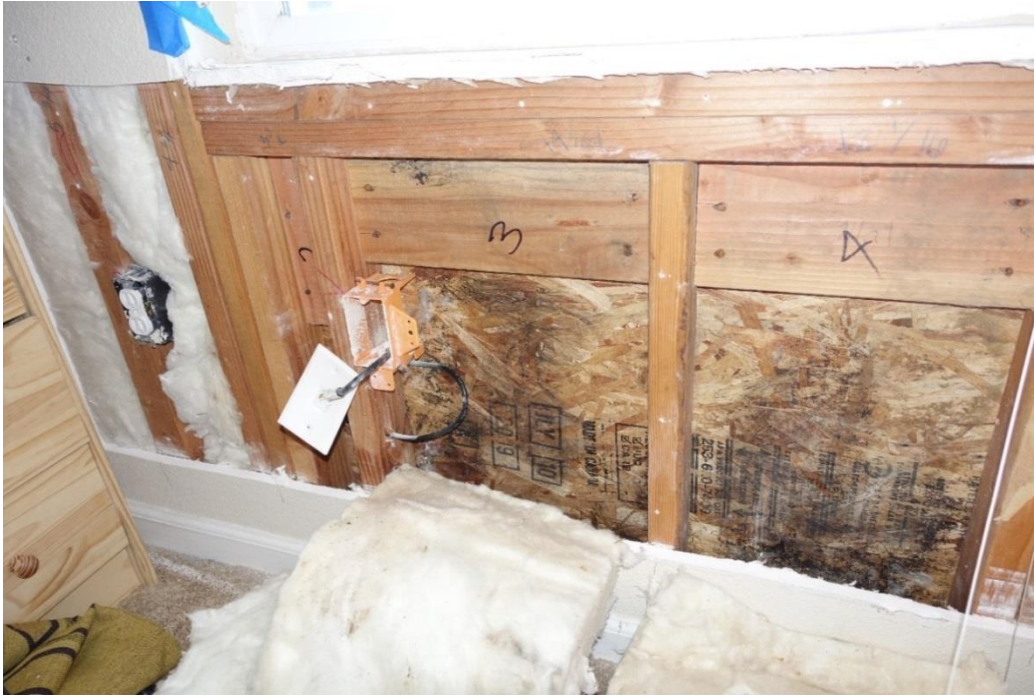
Figure 8: Uniform Damage Behind Fiber Cement Siding

Tightly fastened horizontal control joints, expansion joints or reveals create water cut-offs and water tends to collect above them. Generally, we see fastener rusting and moderate to severe damage both above and below horizontal control/reveal joints. Unsealed joints in control, expansion and reveal joints as well as screeds and corners can be a source of unintended water on WRB. Applying flexible flashings behind these joints, reveals and screeds, both on the horizontal and vertical helps mitigate some of the damage. Examples of this type of assembly and the results of damage are in Figures 7 and 8.

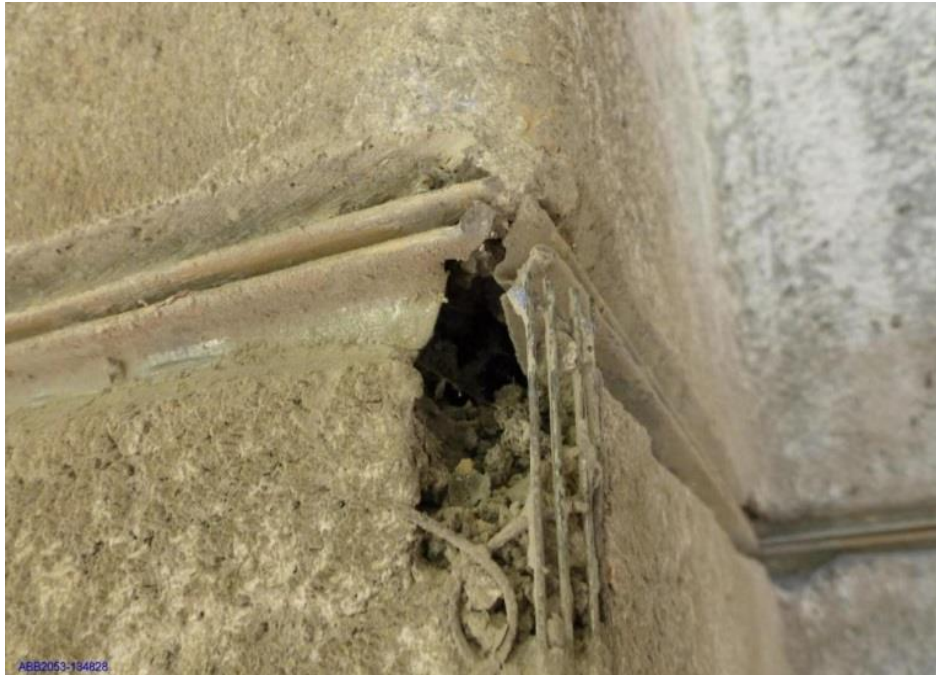
Figure 9A: Control Joint Corner Unsealed

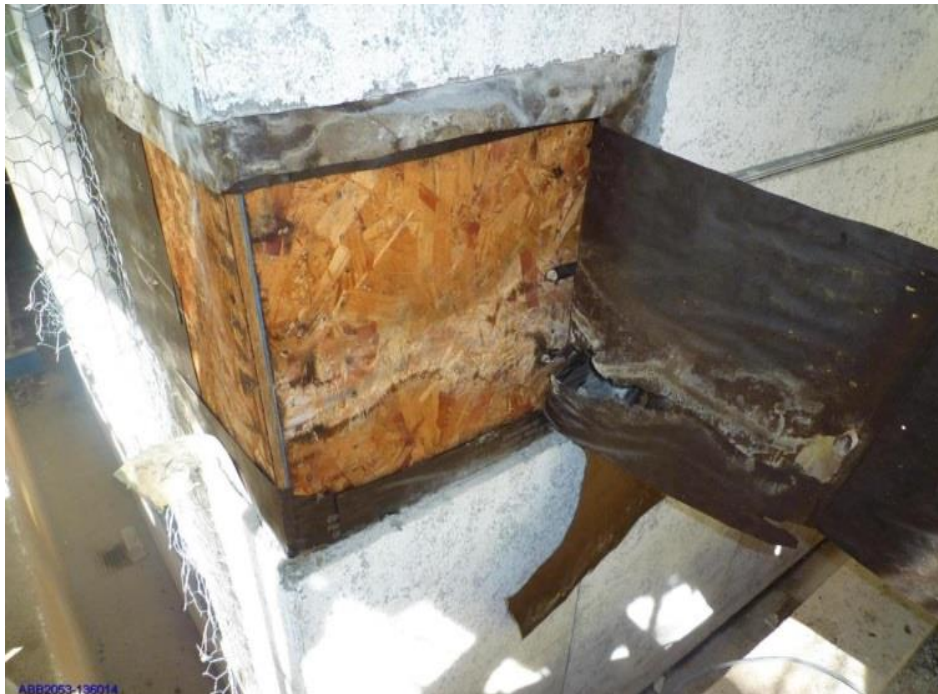
Figure 9B: Control Joint Impedes Water Drainage
