Recognizing Leaks and Problems

CAA Seminar – Increasing Your Property Value
March 23, 2004

Recognizing Leaks and Distress

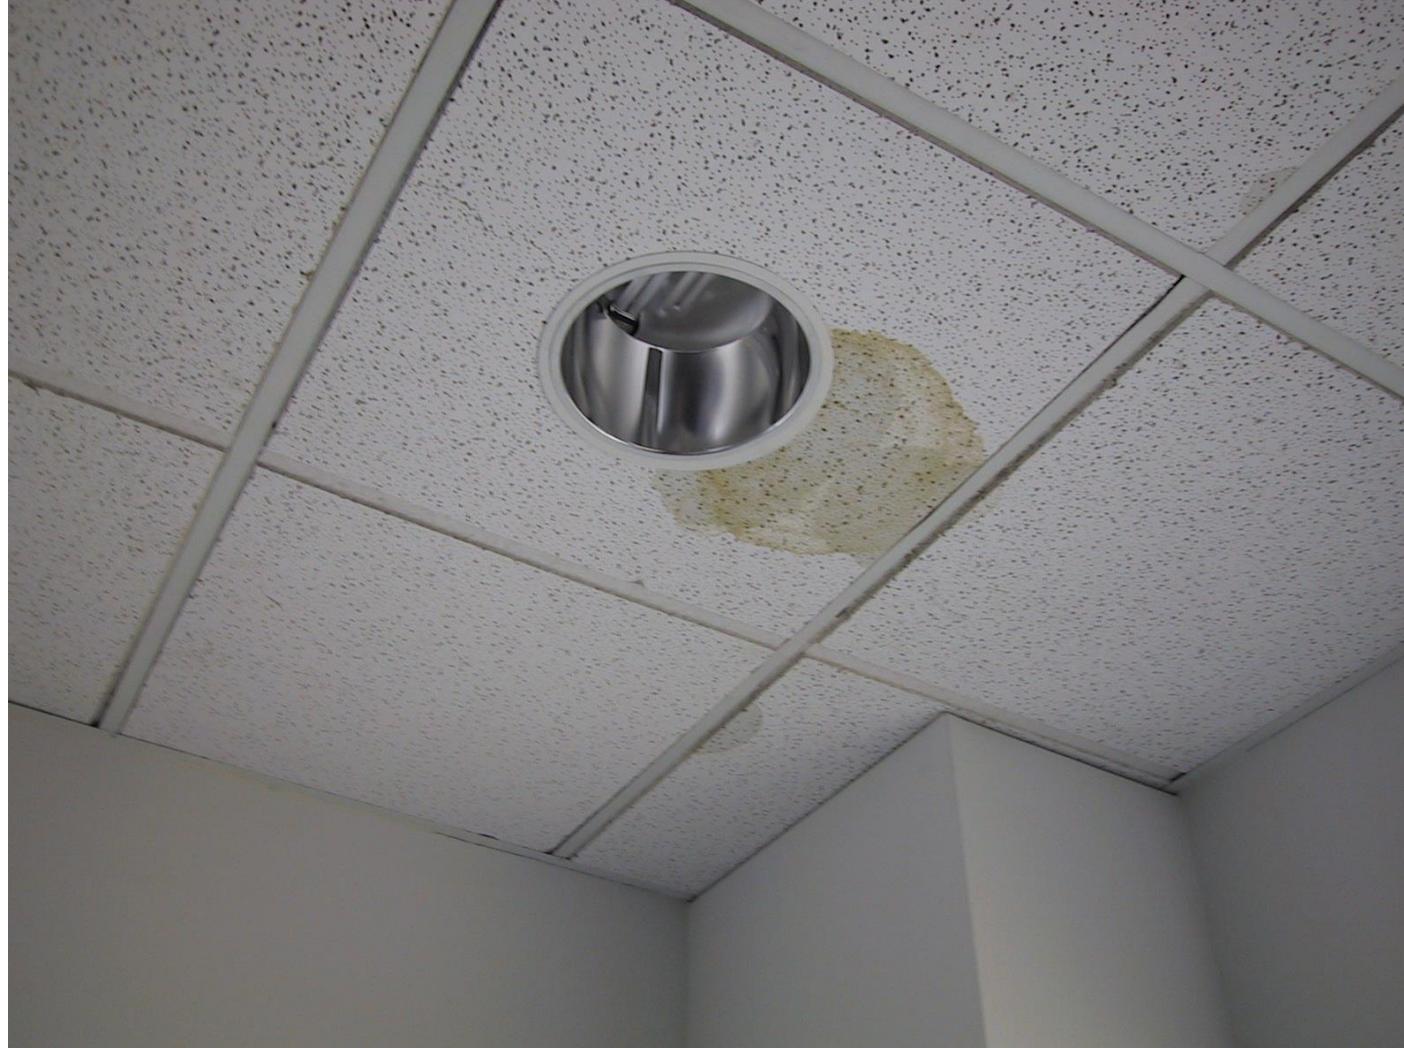
Look for stains, no matter how minor or small

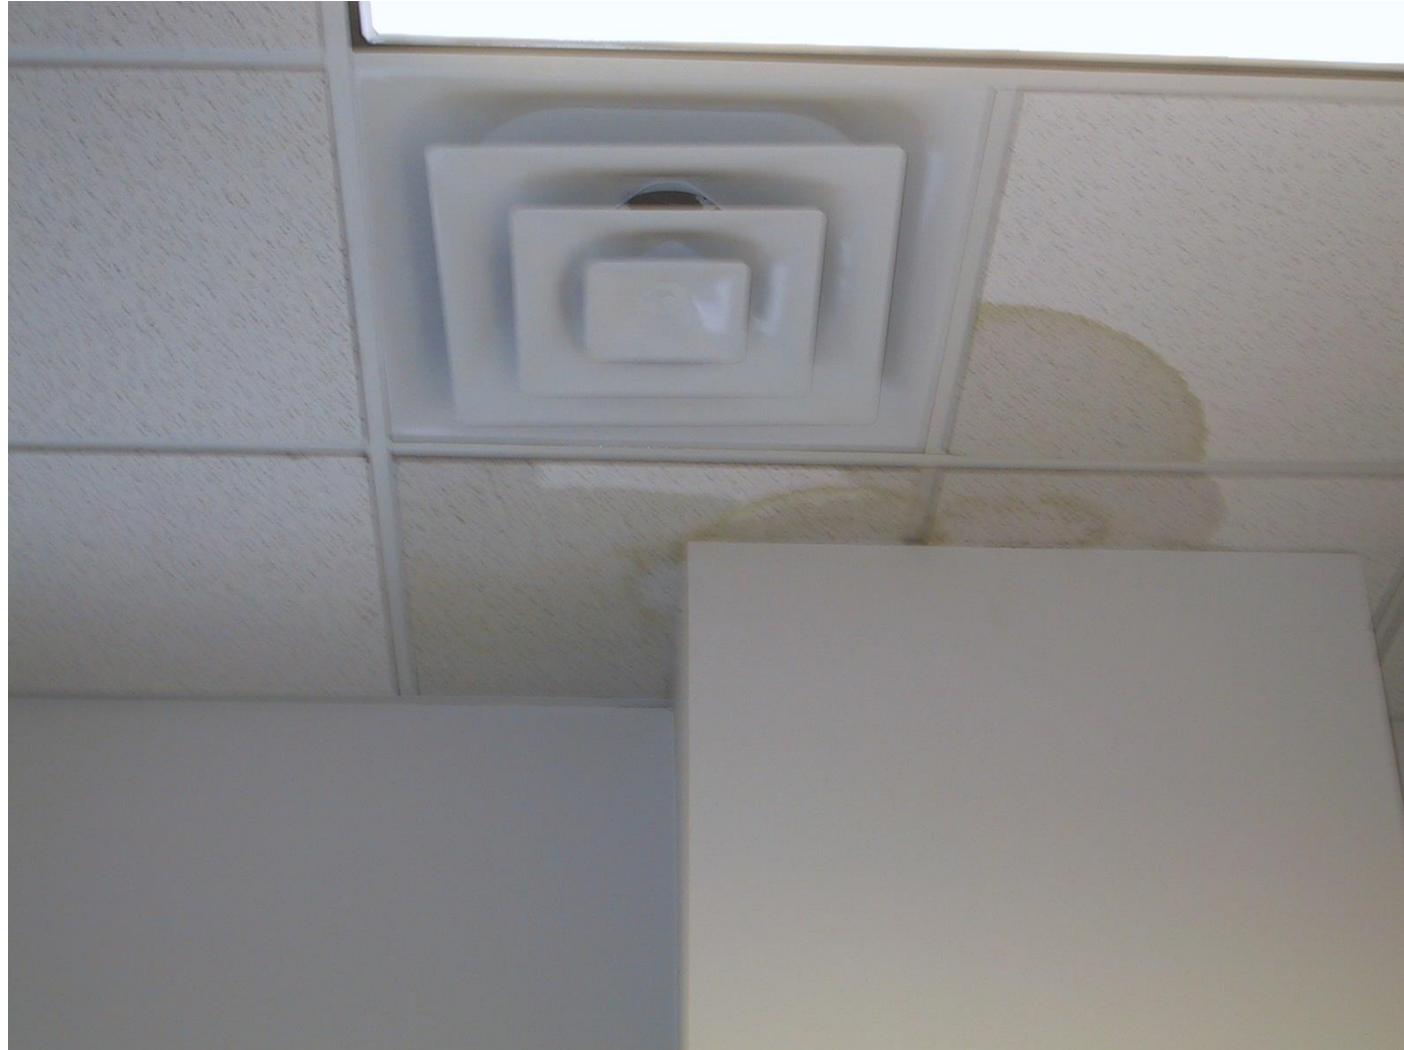
Investigate, roof leak or HVAC condensation?

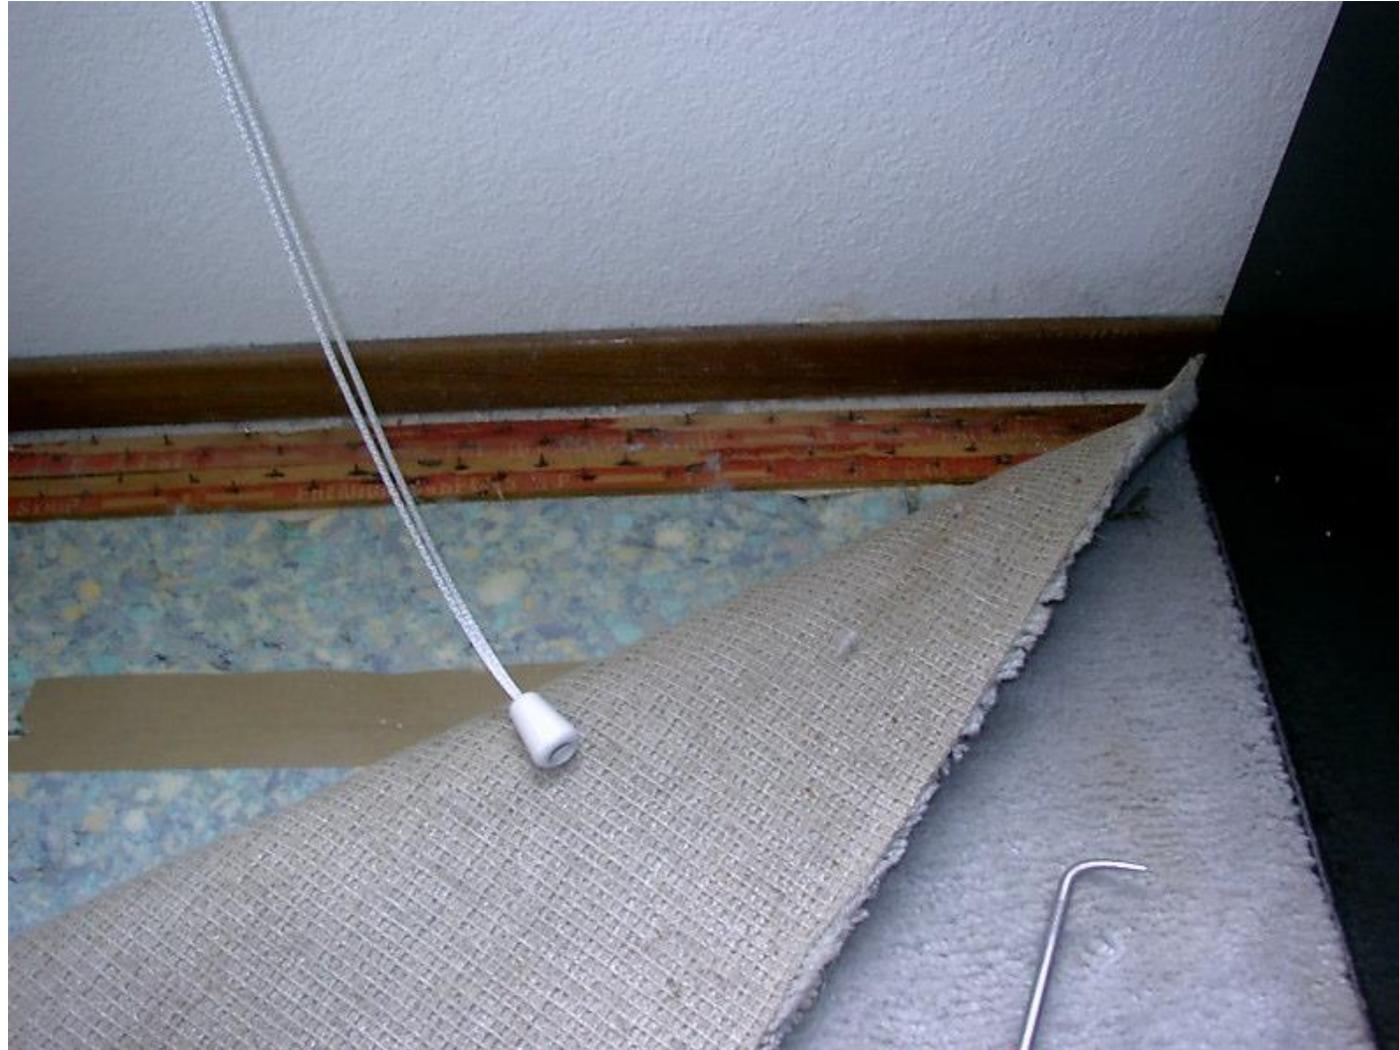
Leak detection... carpet tack strip tells the story

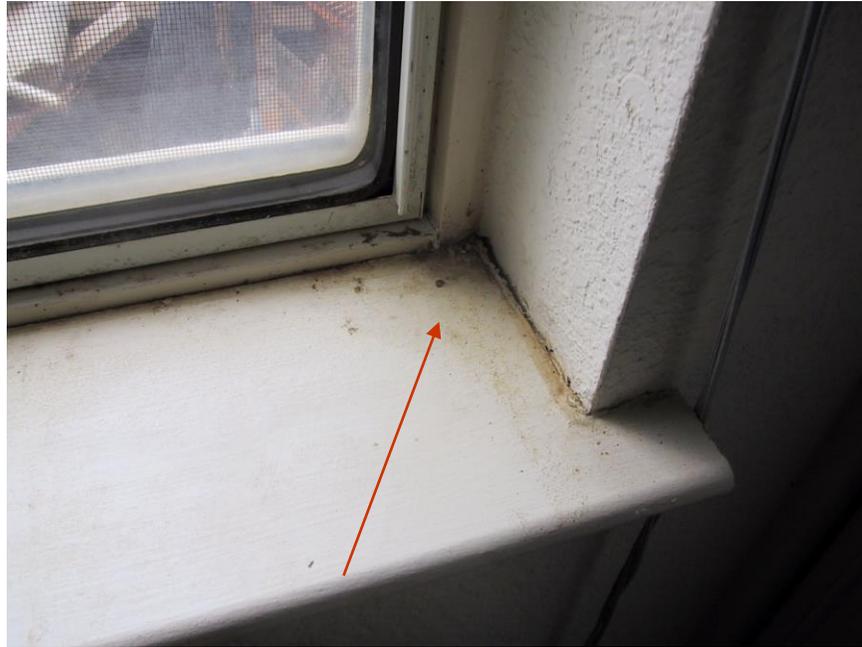
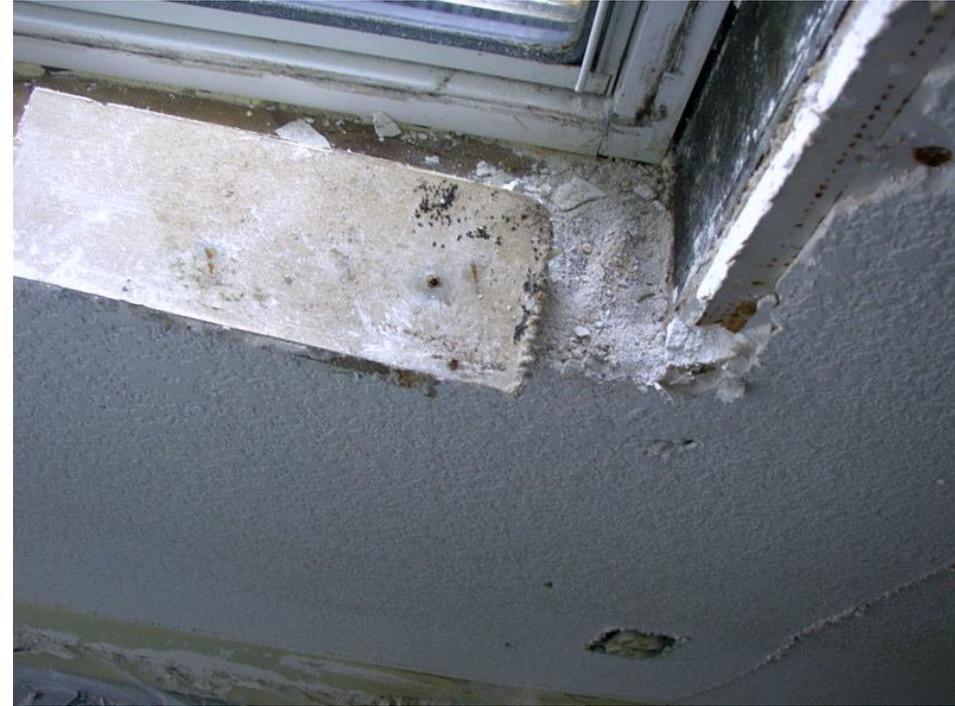
Signs of leaks, small stains often damage is much greater

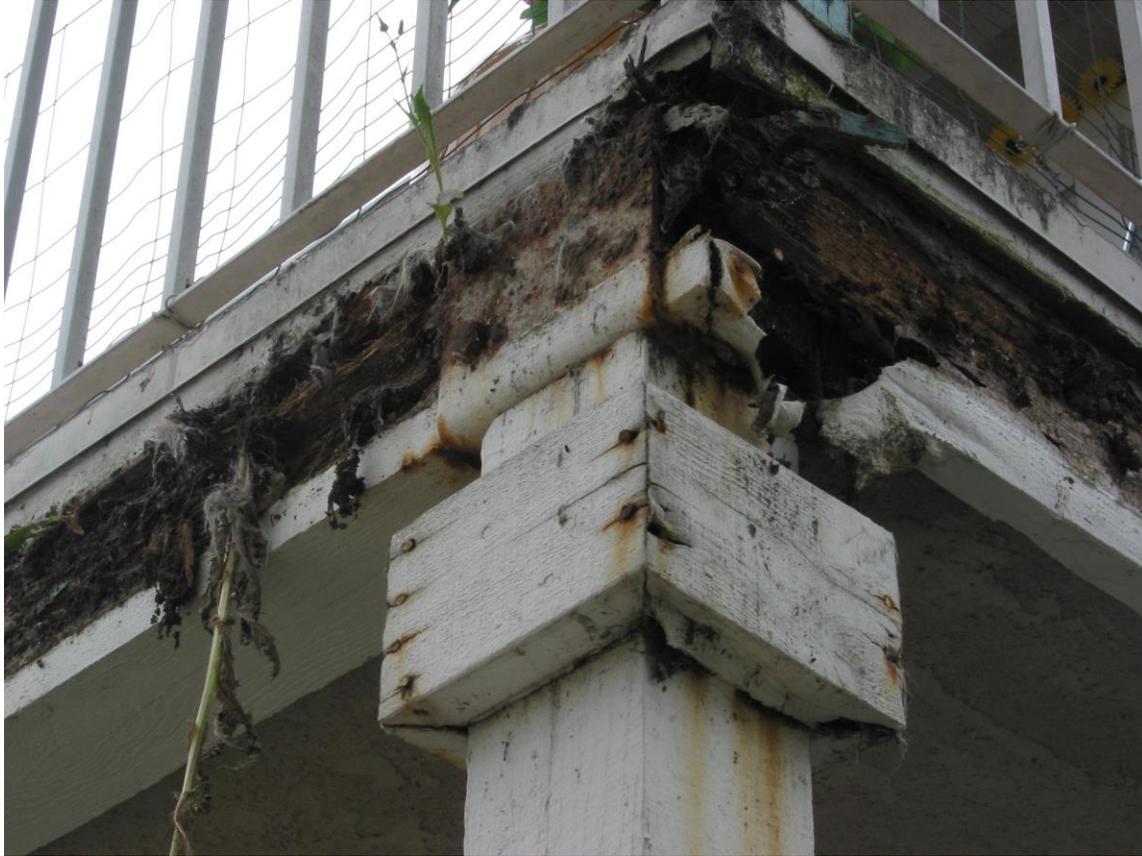
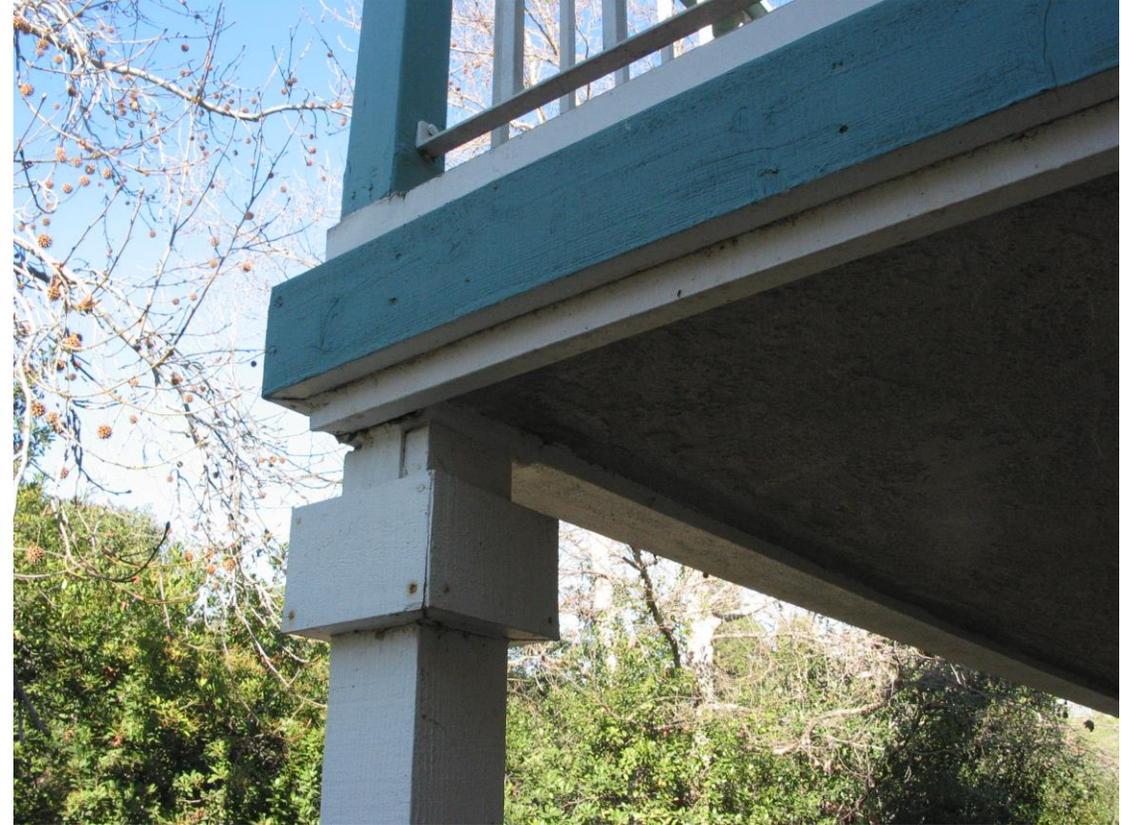
Wood to wood contact traps water and promotes decay

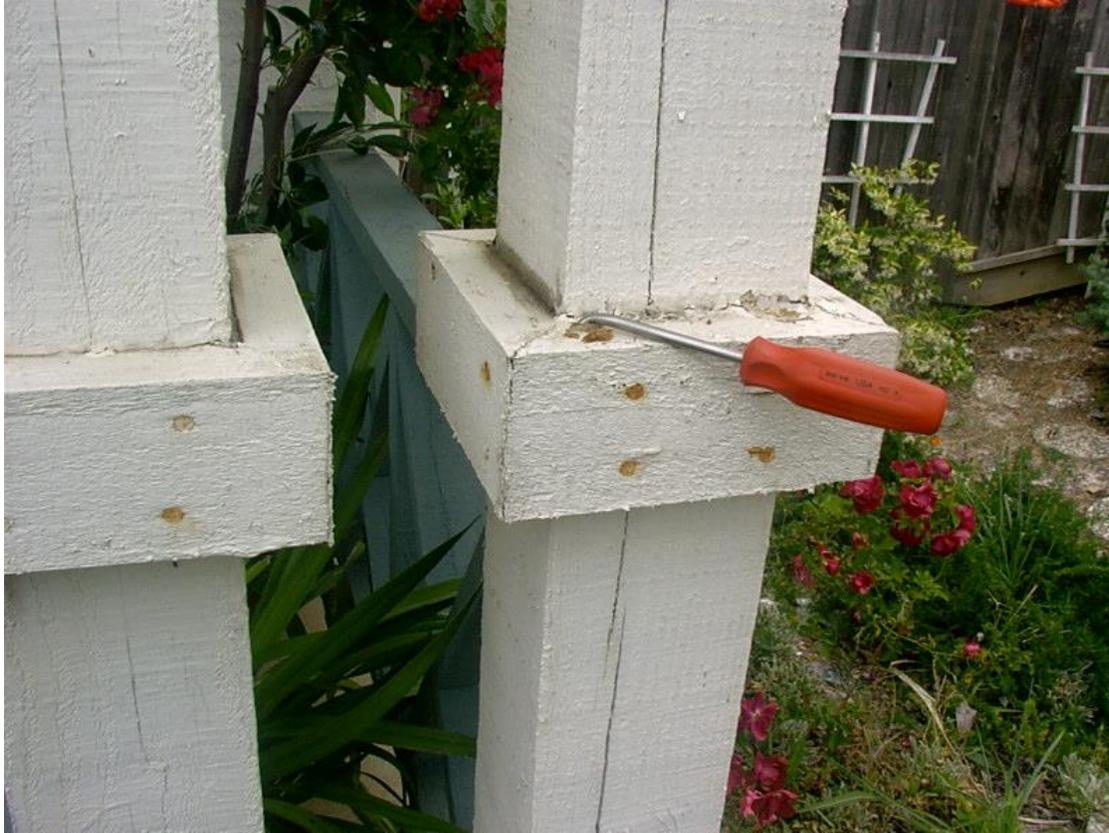
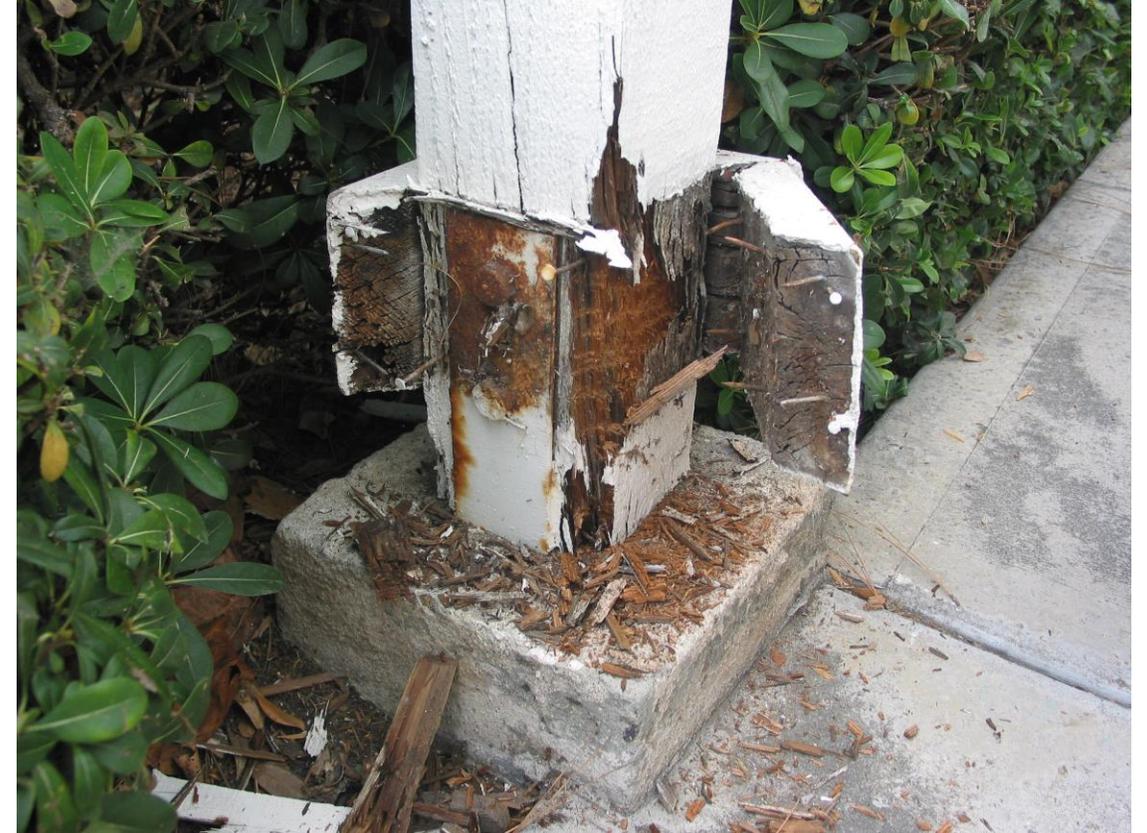
Wood trim over wood column + sprinklers

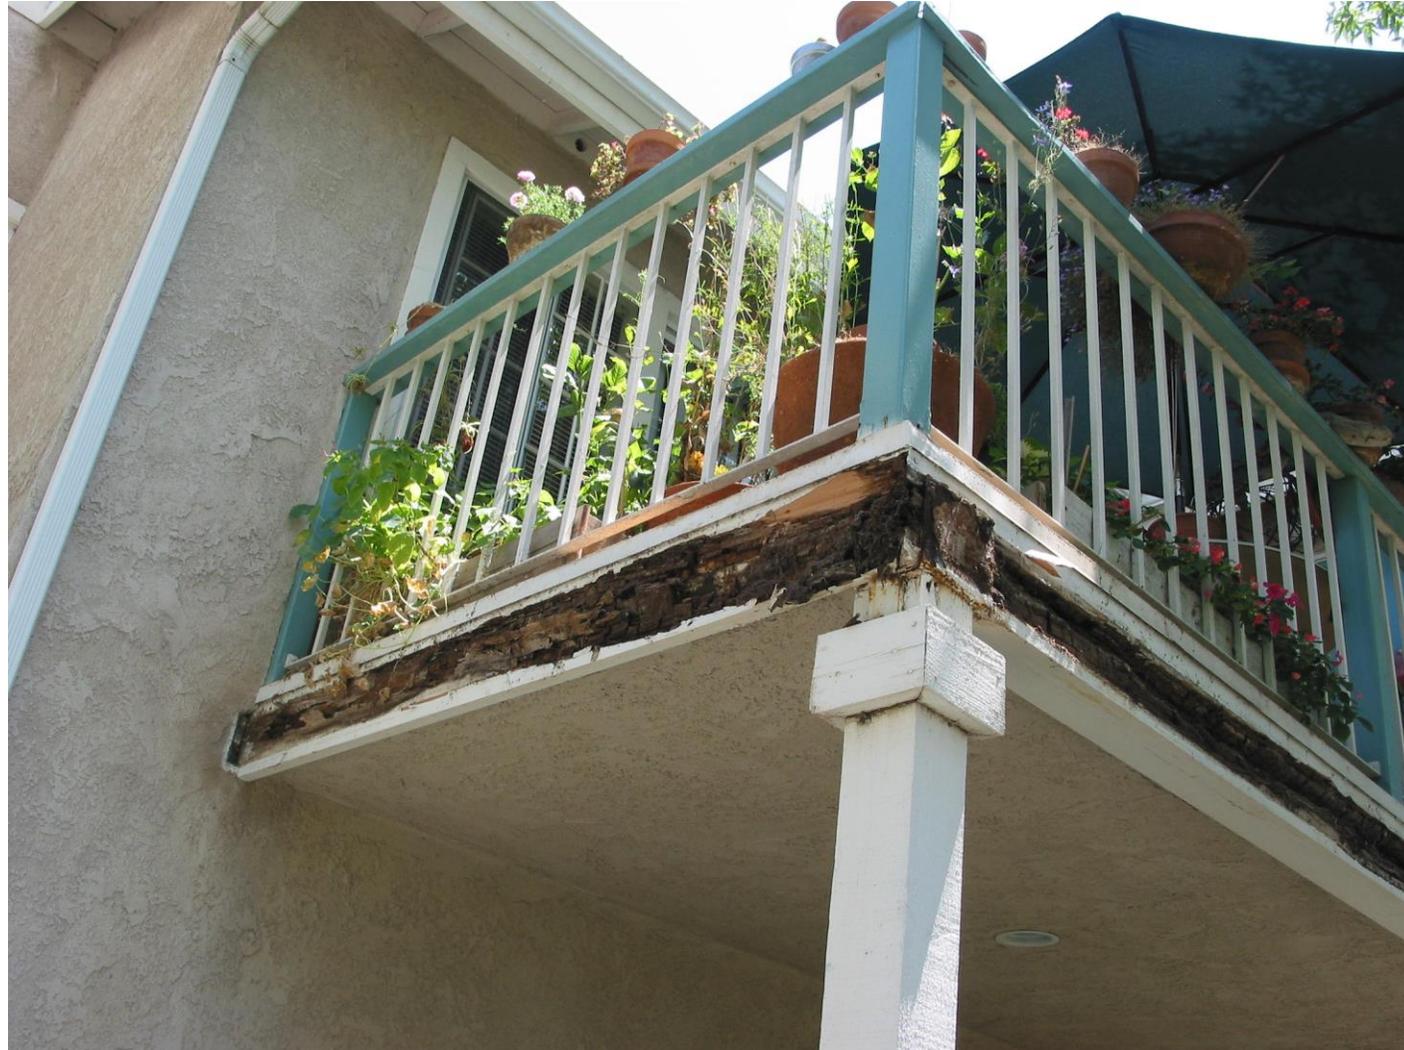
Wood bands over wood beams + landscaping on deck.....bad idea!

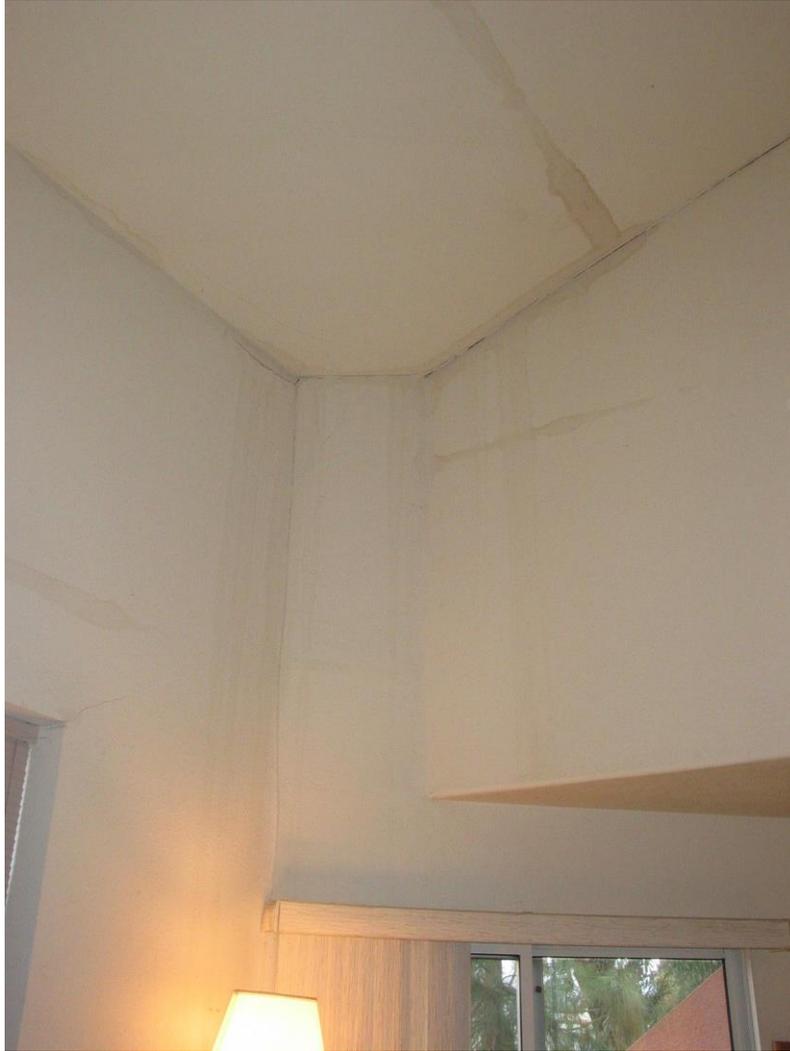
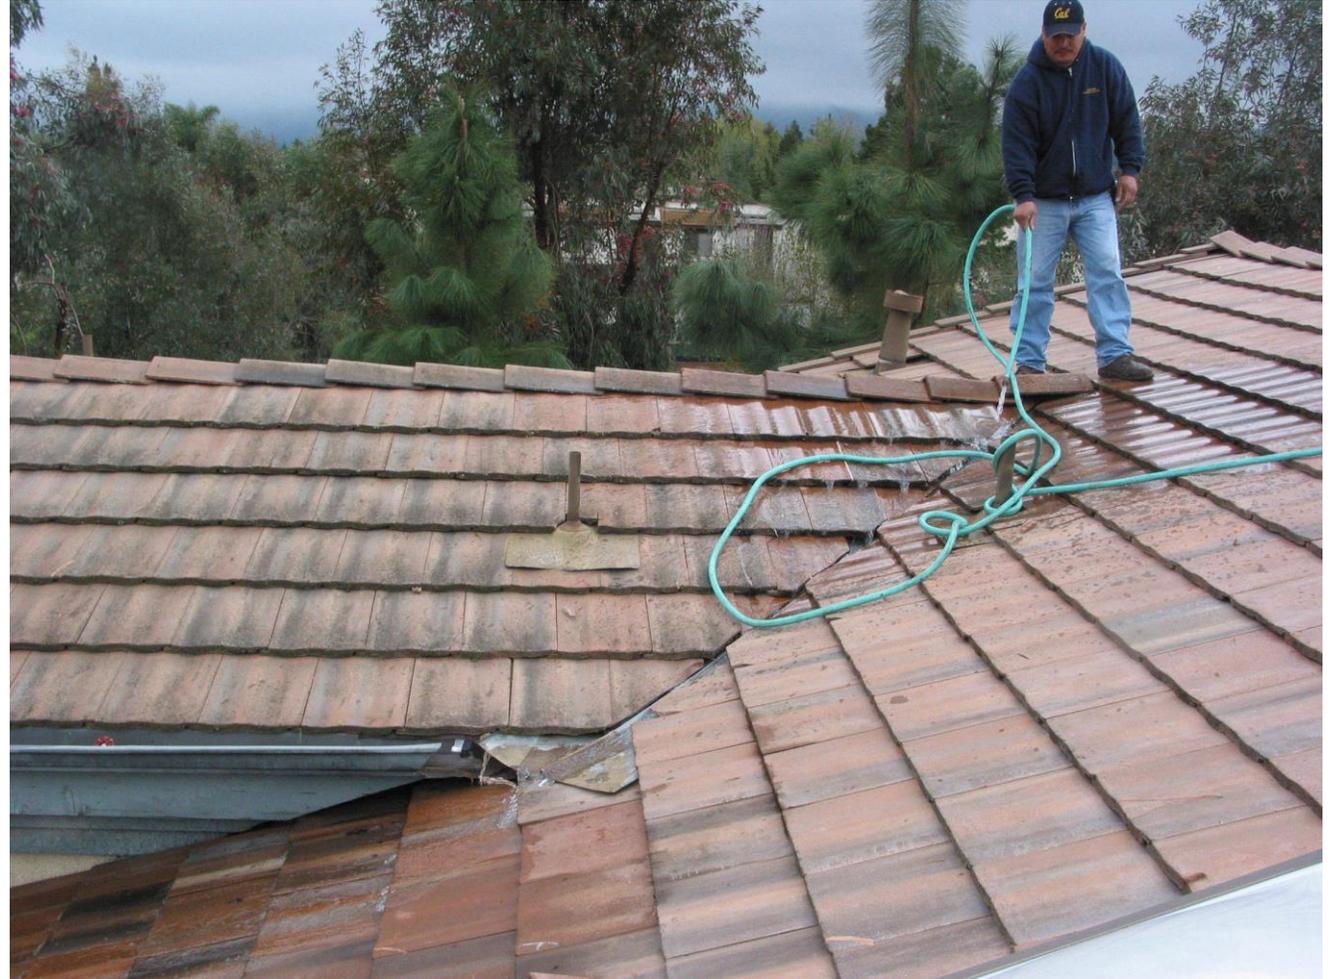
Tile roof leak investigation

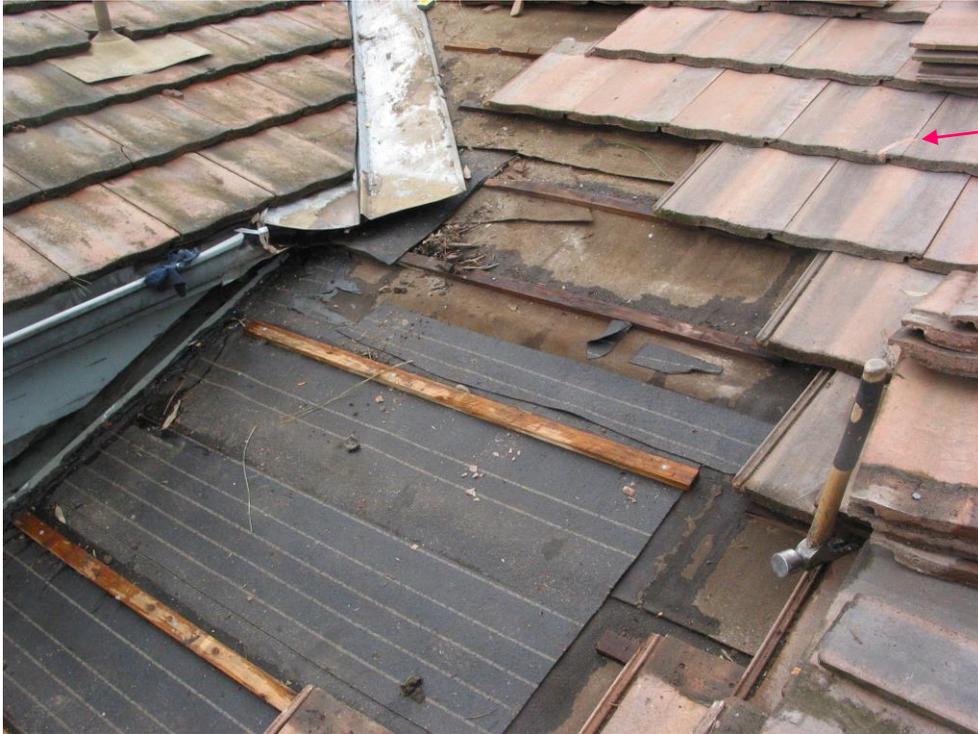
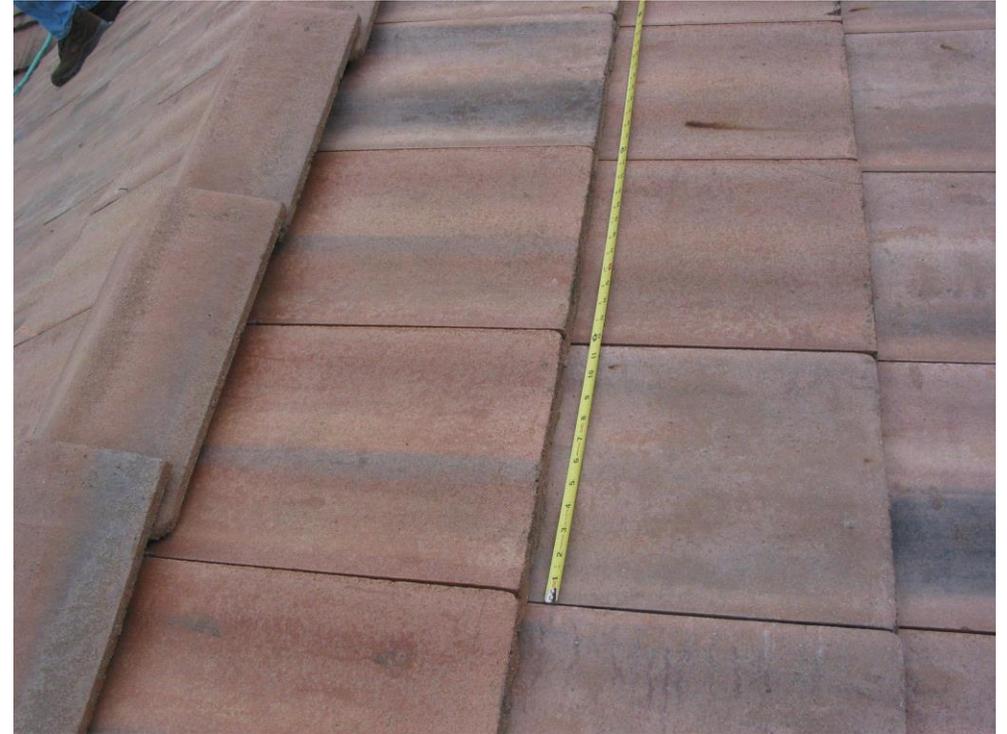
Cracked tiles, improper running bond pattern caused the leaks

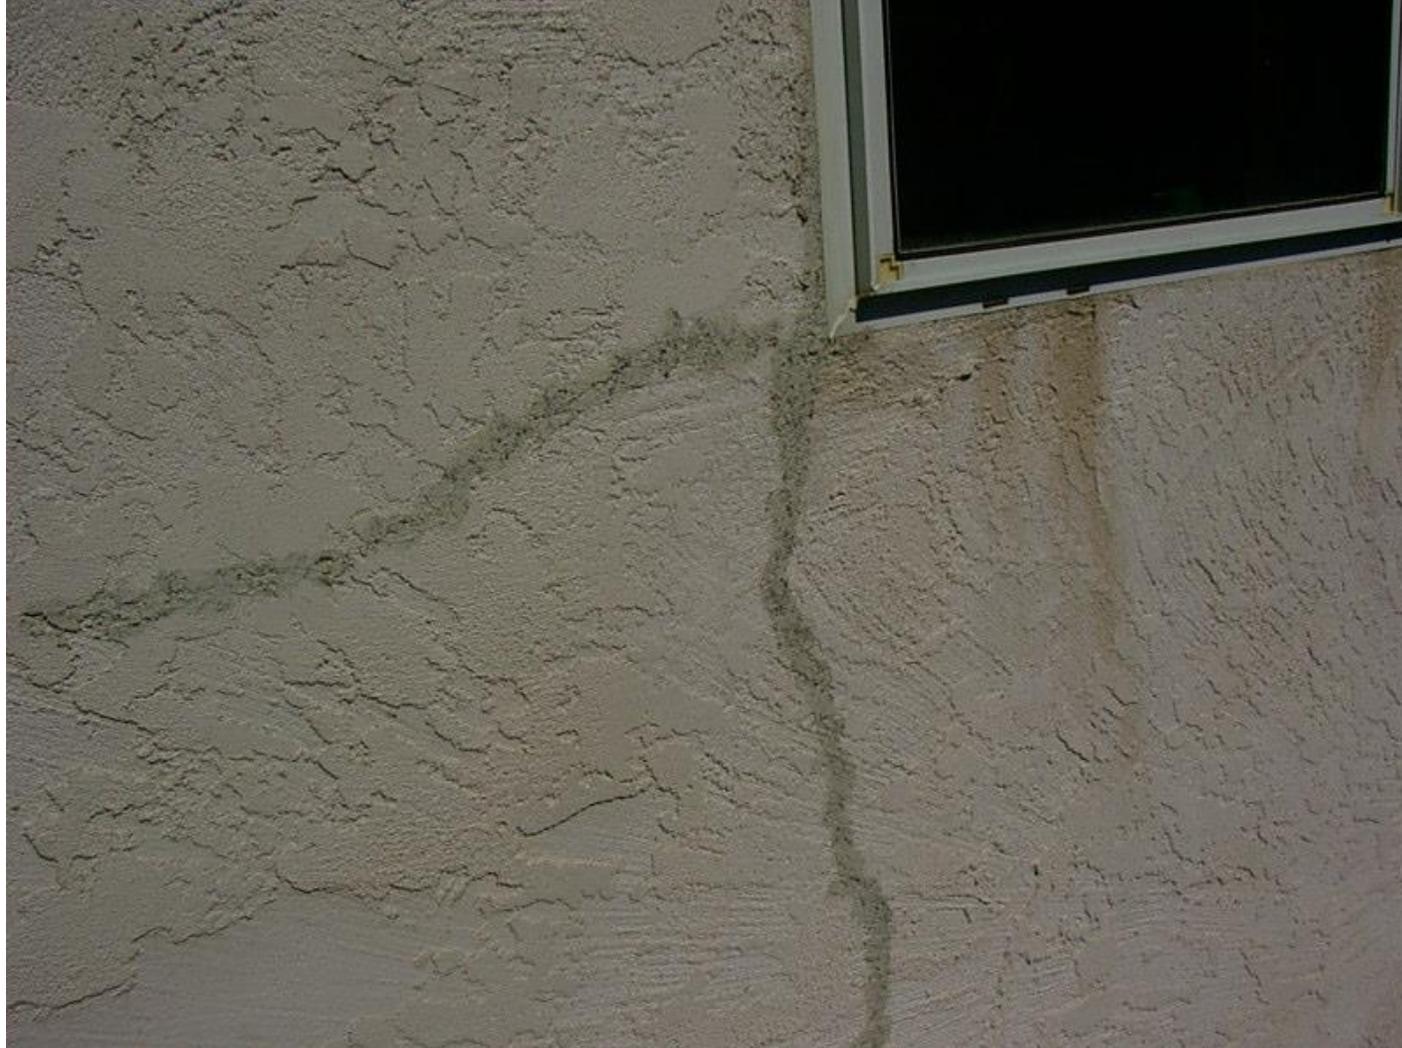
Look for water stains or unusual cracks in cement plaster

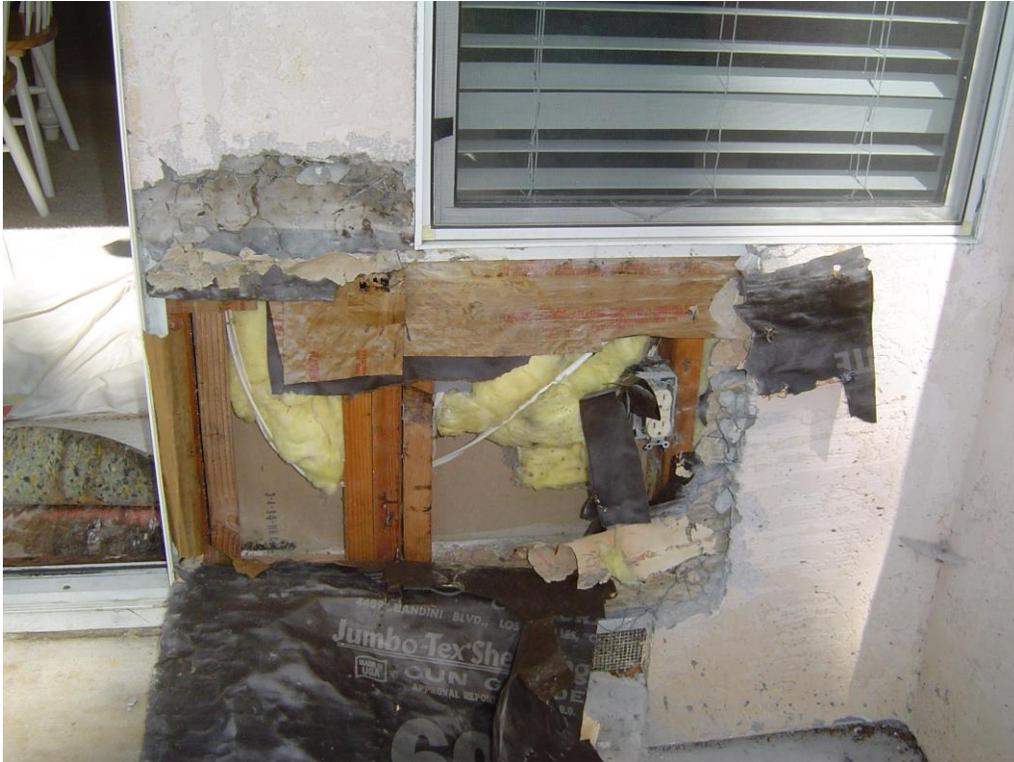
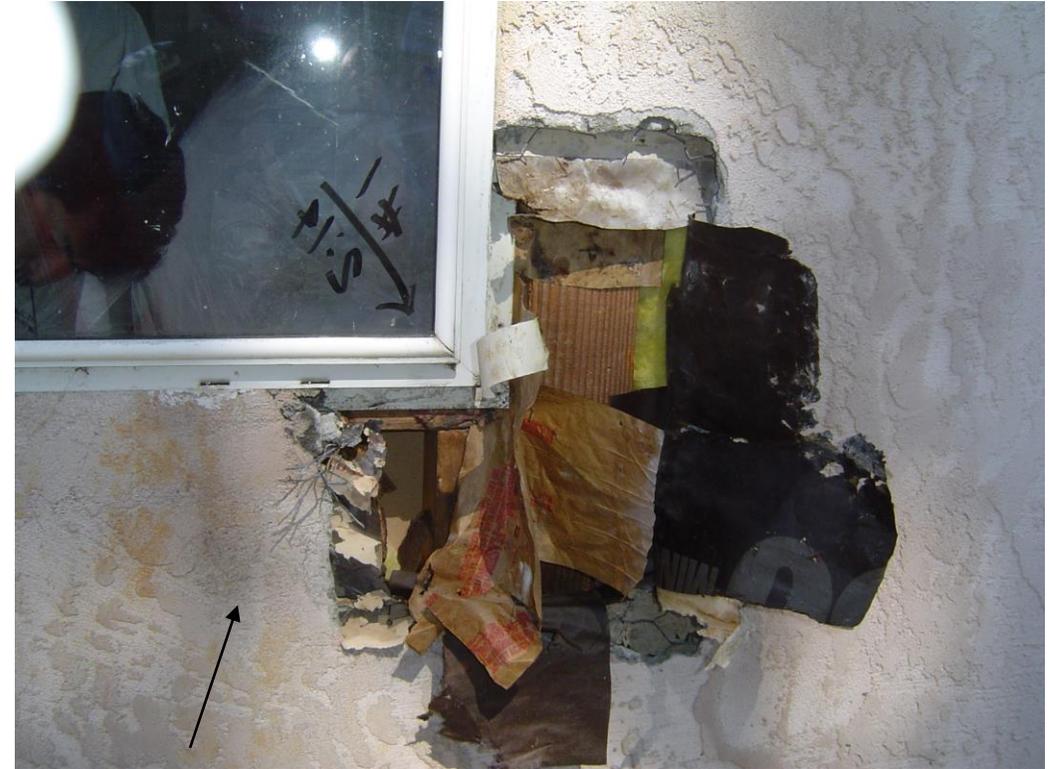
Typical window frames in cement plaster allow water intrusion. Seal edges of window and exterior plaster

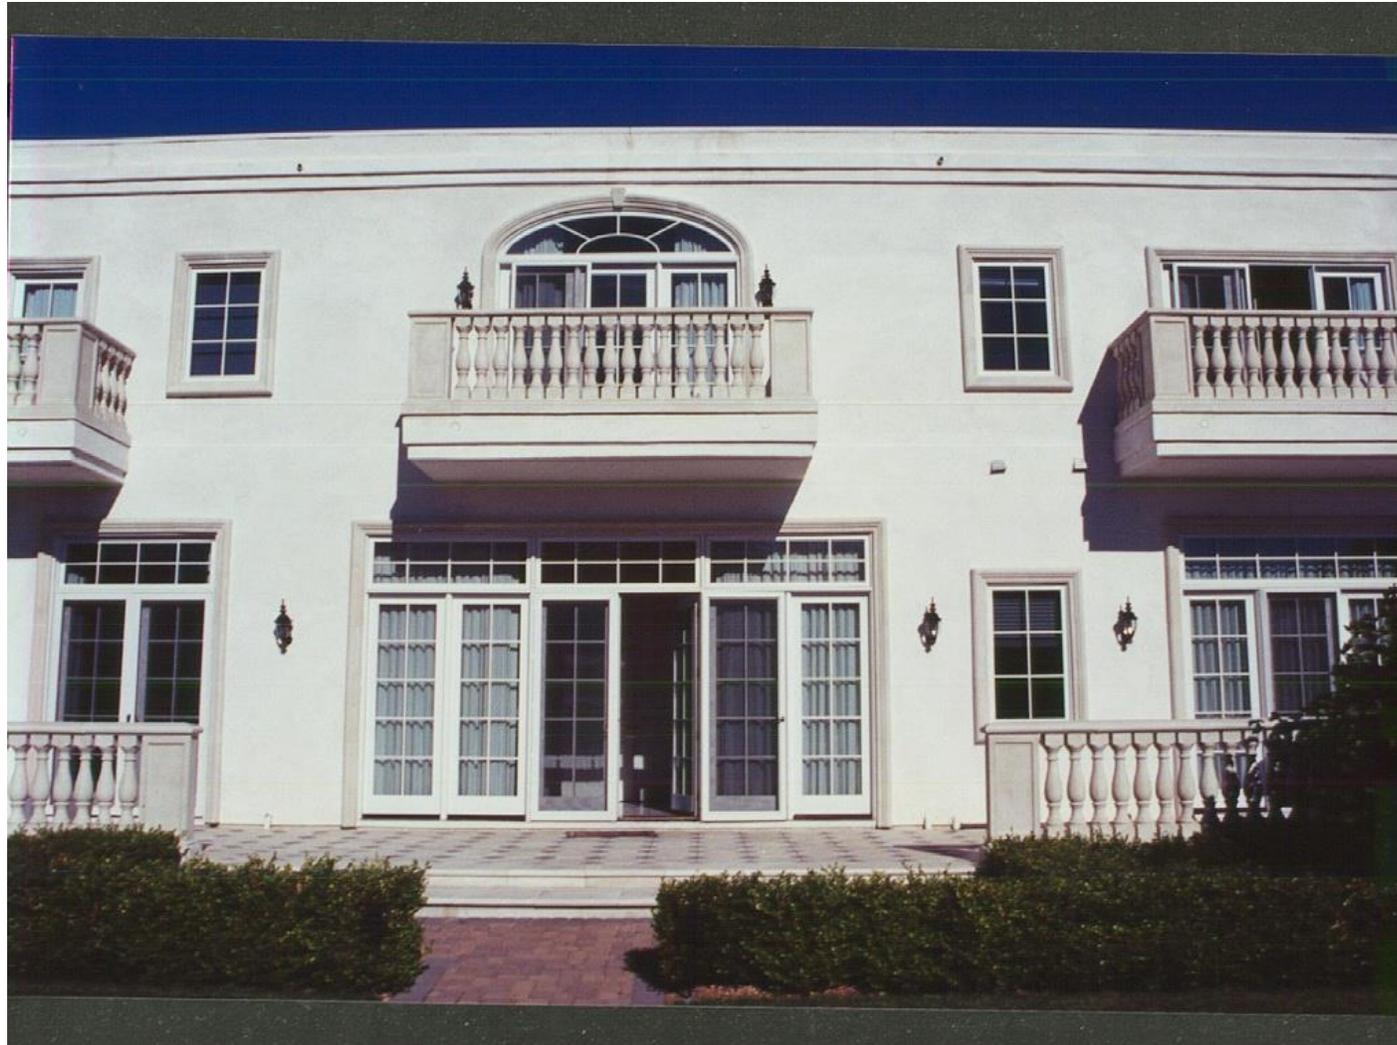
Stucco stain, discoloration

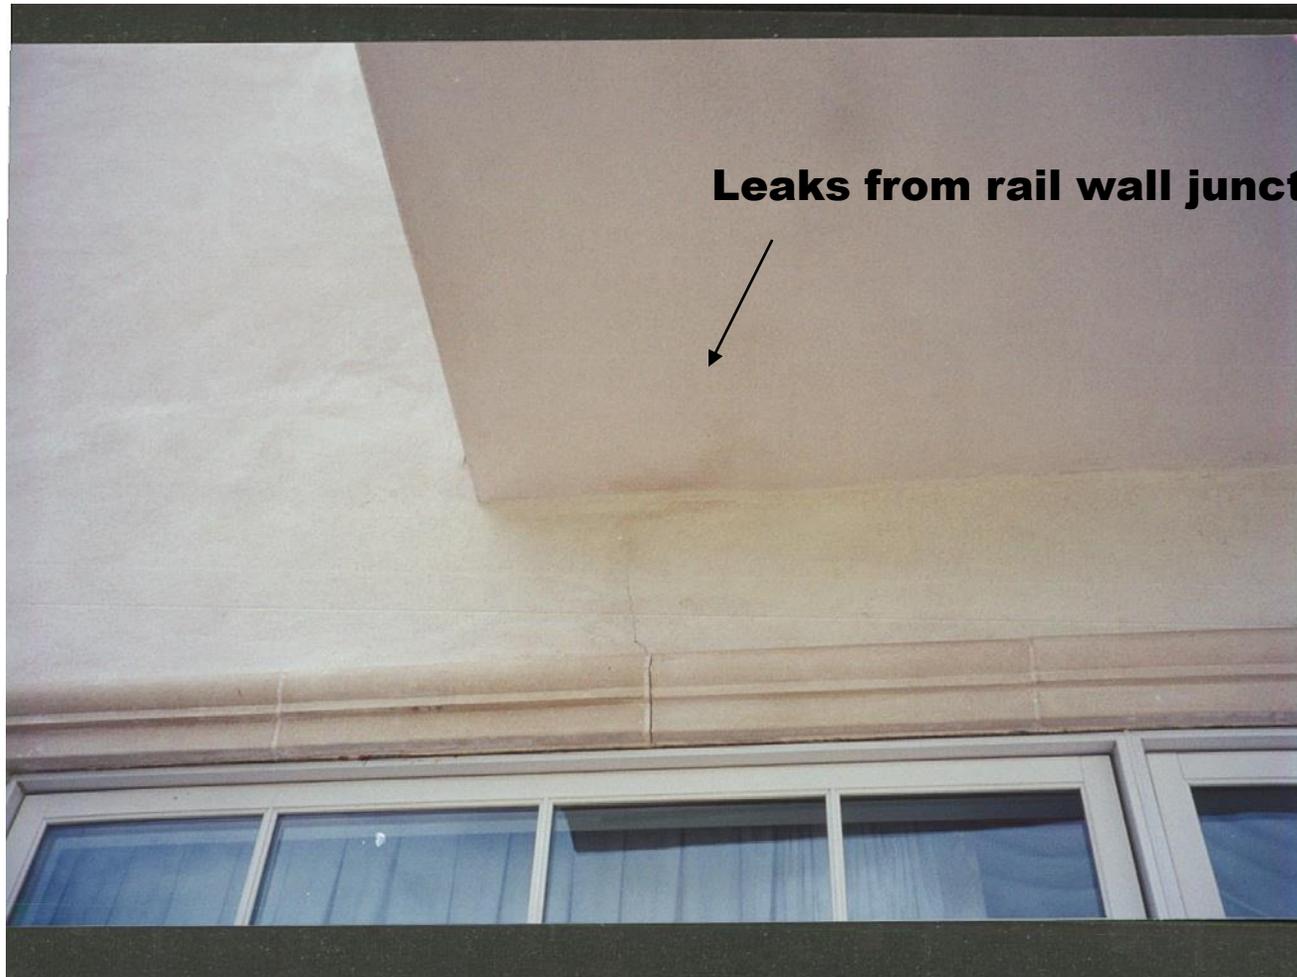
**Leaks from
rail wall
junction**

Leaks from rail wall junction

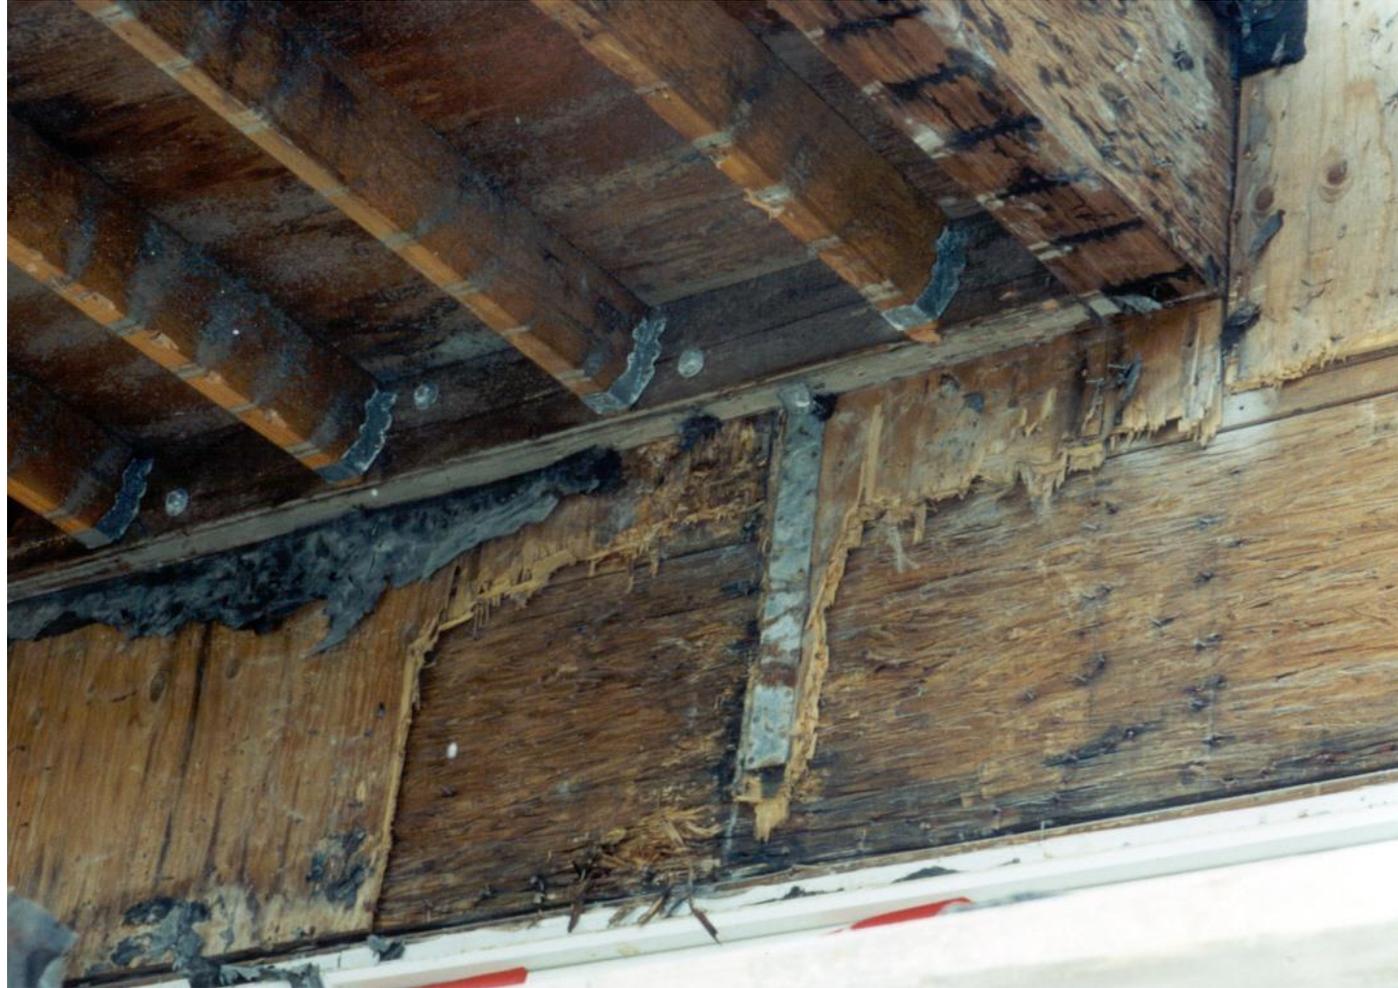
This innocent looking leak caused a lot of damage
